Publication No. FHWA-RD-89-157

February 1989

Full-Scale Side Impact Testing

Federal Highway Administration

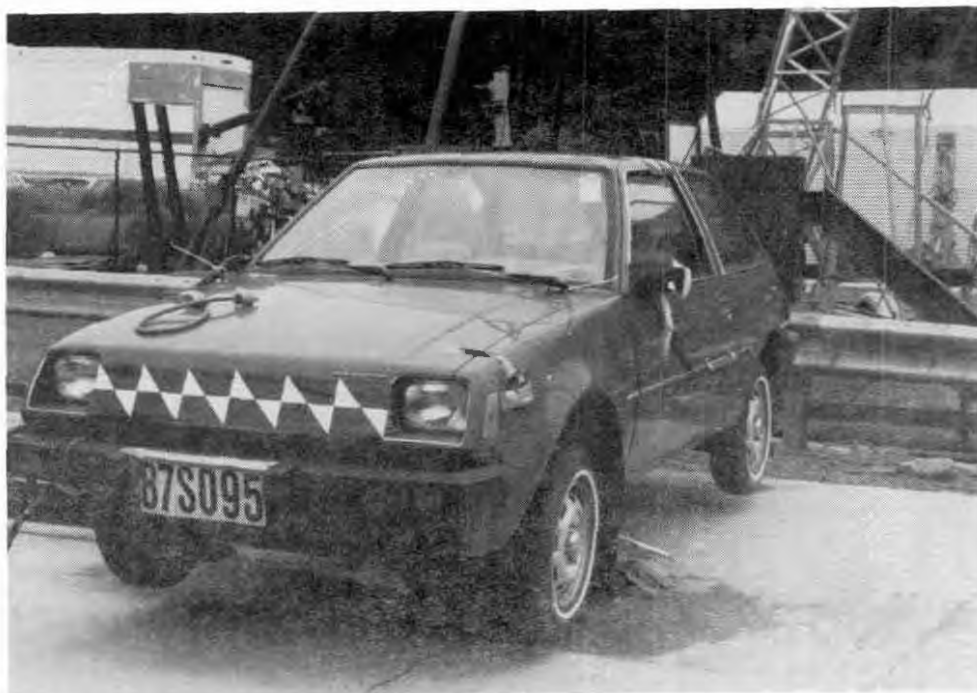
Figure 7. Typical test vehicle.

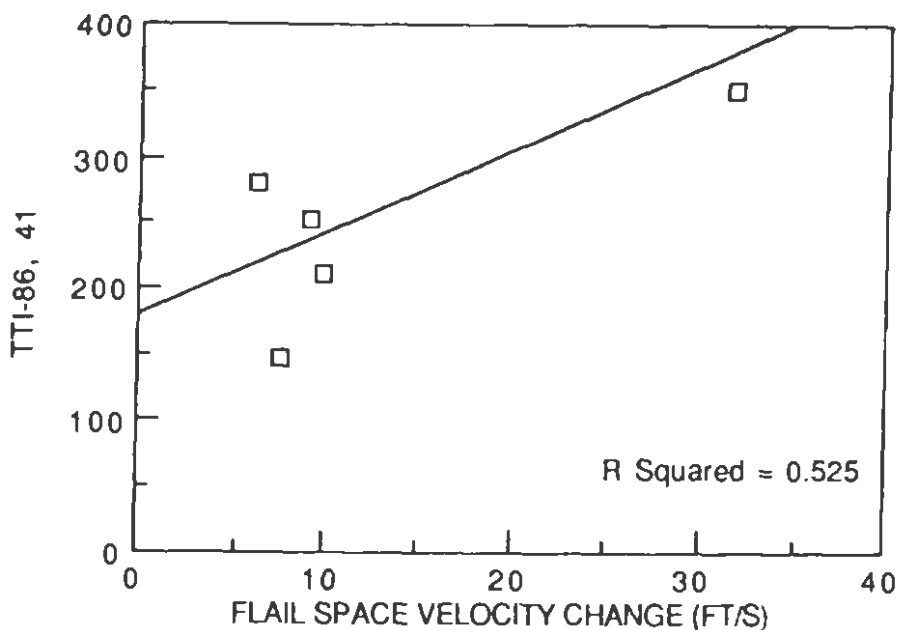
Figure 12. TTI-86,41 versus flail space velocity change for partial data set.

Flail space velocity change is a primary vehicle based measure of injury severity. When TTI-86,41 was compared with flail space velocity change for all tests, the R squared coefficient obtained was very low indicating a poor correlation (see figure 11). In figure 12, the comparison is limited to those tests with identical impact locations, that is, aligned with the dummy (tests 1 through 4 and 8). The R squared correlation coefficient is 0.53. This R squared value indicates a moderate correlation between the two measures when this partial data set is used. Additionally, the slope of the regression

curve is positive, indicating that lower values of TTI-86,41 result in lower values of flail space velocity change, as is expected.

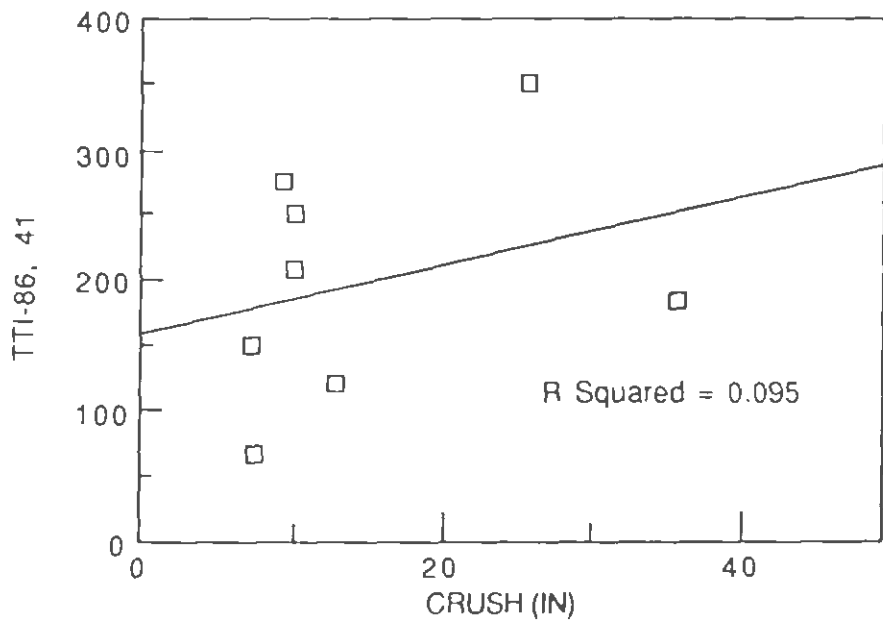
Figure 13. TTI-86,41 versus static crush depth for all tests.

Vehicle static crush depth is a secondary vehicle based measure of injury severity. When TTI-86,41 was compared with static crush depth for all tests, the R squared coefficient obtained was very low (as in the previous comparison), again indicating a poor correlation. This is shown in figure 13. The comparison was then limited to those tests where the impact was aligned with the dummy (tests 1 through 4 and 8). As shown in figure 14 (a plot of this partial data set) the R squared coefficient obtained was 0.66, also indicating moderate correlation between the two measures. As was the case with the previous data set, the slope of the regression curve is positive indicating lower values of TTI-86,41 for lower values of static crush depth, as expected.

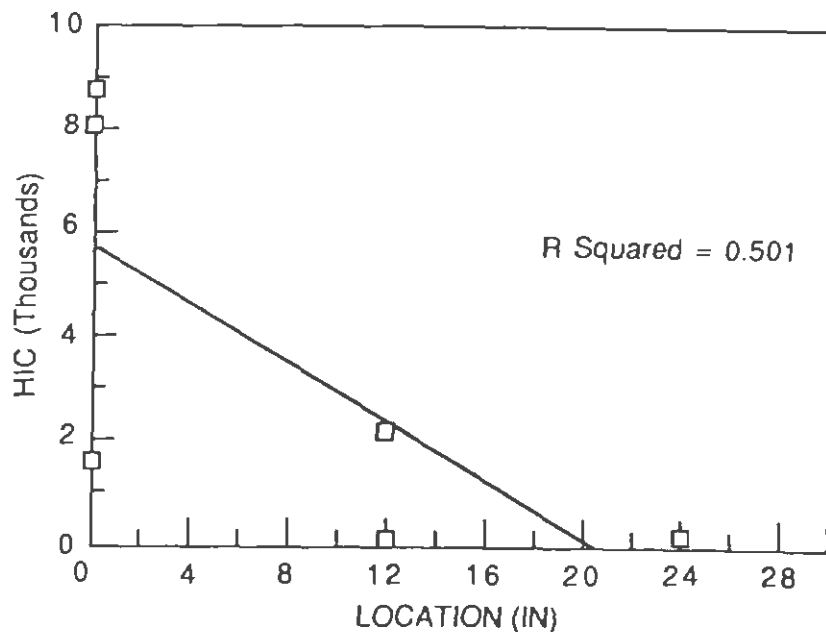
Figure 15. HIC versus crush location.

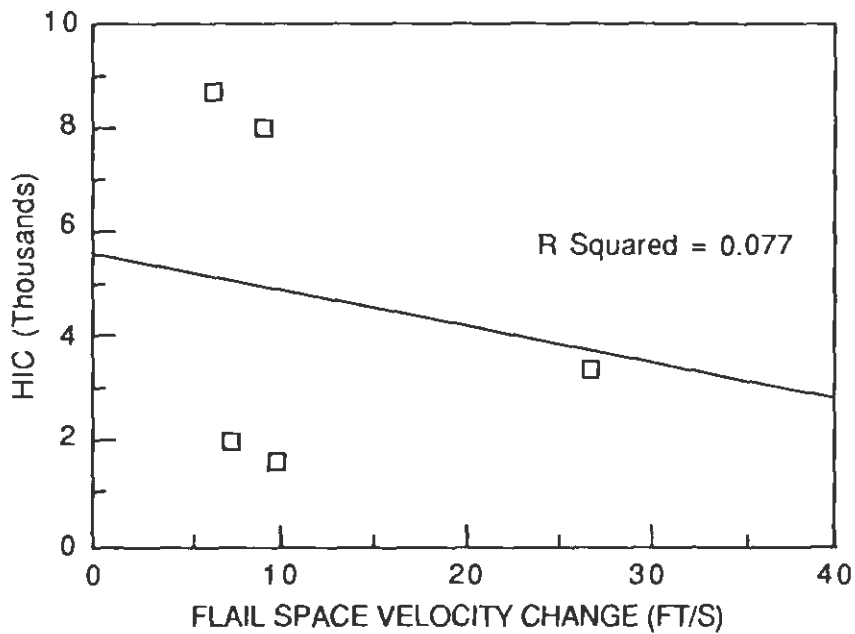
Figure 17. HIC versus flail space velocity change for partial data set.

HIC values were compared to flail space velocity change values for all tests. The associated R squared coefficient was 0.08. The complete data set is shown in figure 16. The partial set of tests (comprised of all impacts aligned with the dummy) is presented in figure 17. Again, the associated R squared value is low, 0.08. These low correlation values indicate almost no correlation between HIC and flail space velocity change measures for both comparisons. This is in contrast to TTI-86,41, where moderate correlation

exists for the partial set of tests. This perhaps reflects the fact that the side impact dummy head and neck have not been designed and validated for impacts into the side of the head. It definitely reflects the fact that HIC values varied over a wide range (from a low of near 1600 to a high near 8700) for four data points where the flail space velocity changes were similar. The reason for this wide variation and resulting low correlation is not well understood at this time.

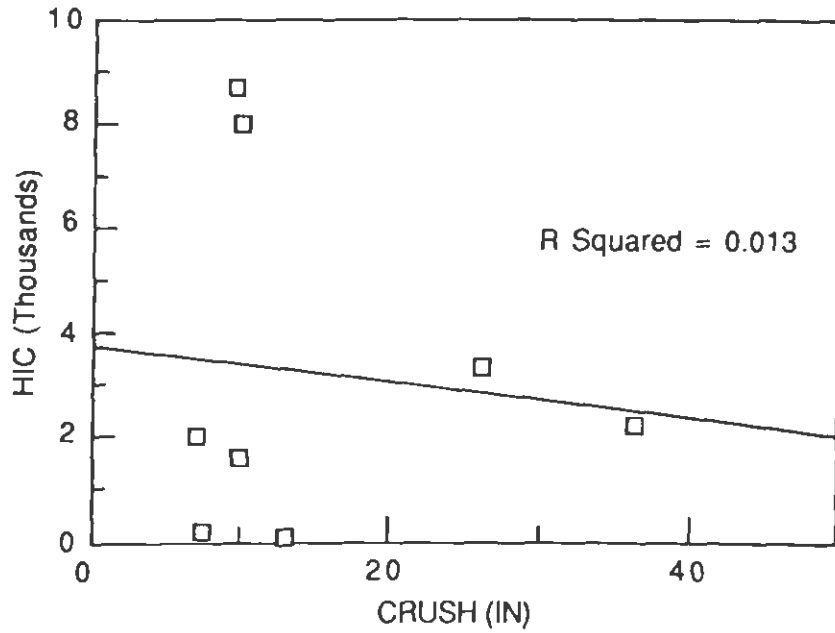
Figure 18. HIC versus crush for all tests.

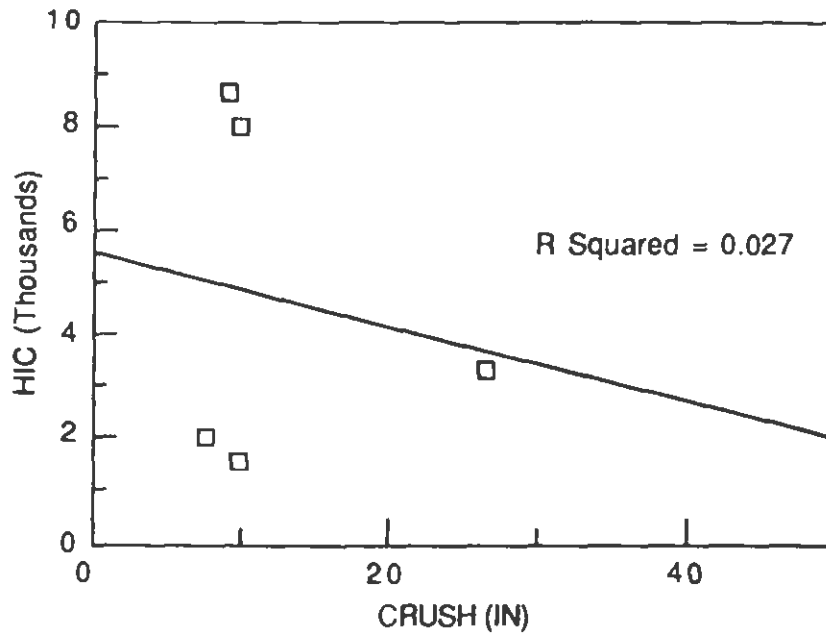
Figure 19. HIC versus crush for partial data set.

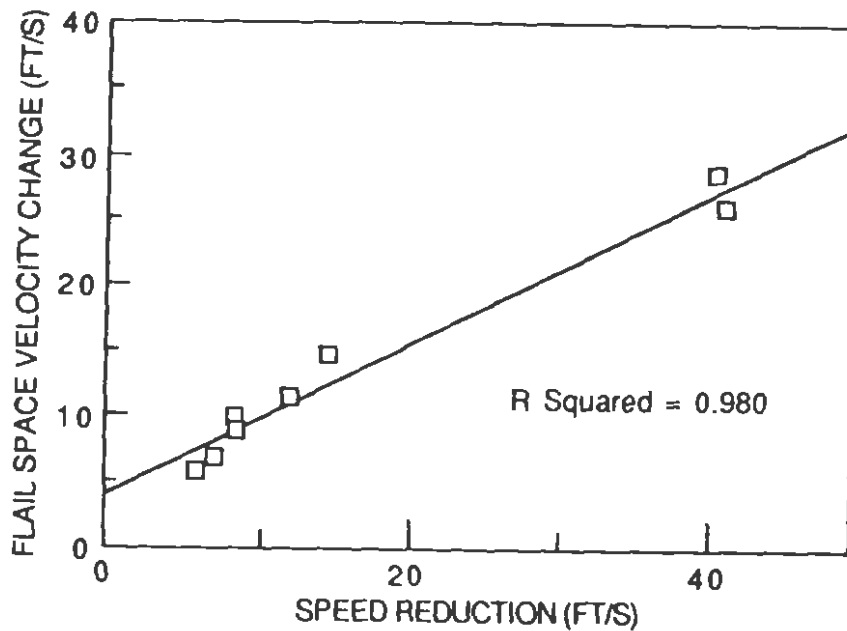
Figure 22. Vehicle speed reduction versus flail space velocity change.

higher. No tests for statistical significance were applied due to the limited amount of data. Comparisons between vehicle based measurements showed high correlations.

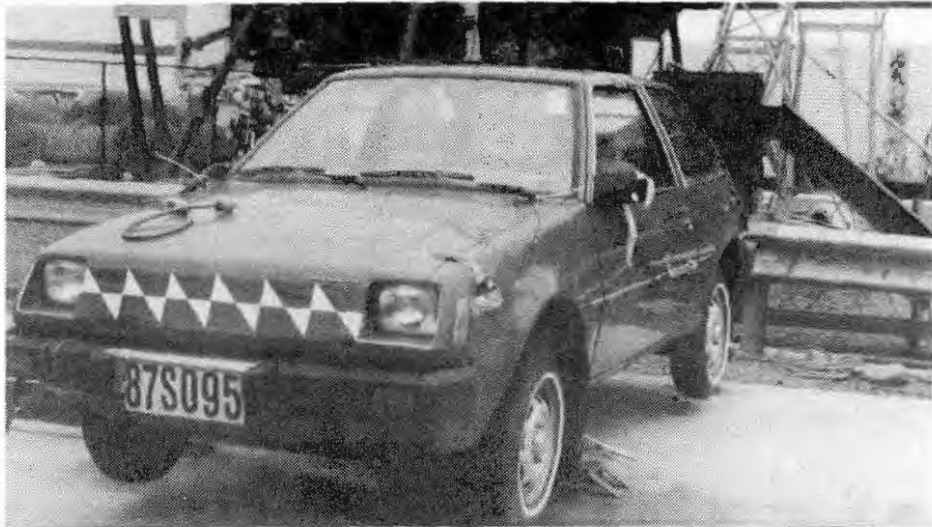
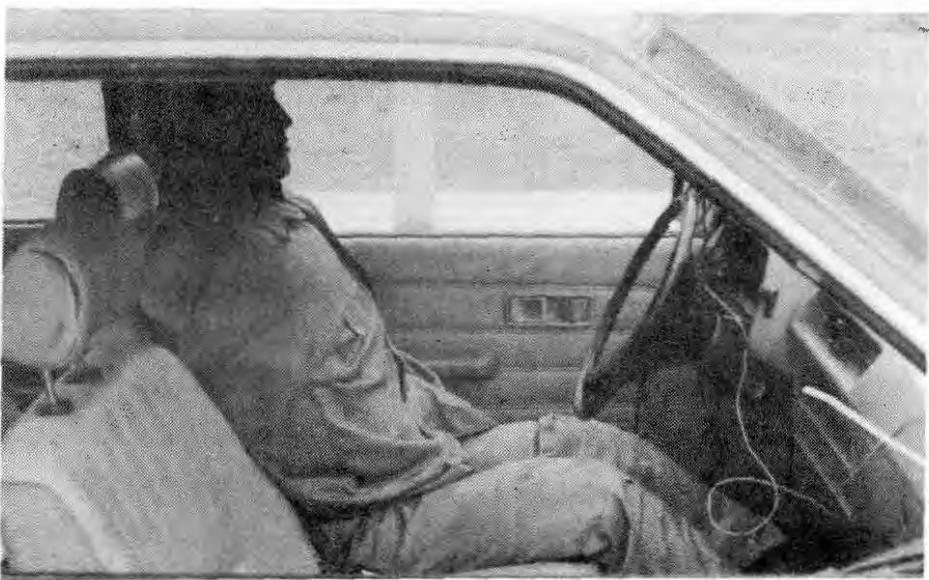
Figure 23. Pretest photographs of vehicle, test SI #1.

The test vehicle impacted at 29.36 mi/h (13.1 m/s) at a point on the left door in line with the occupant, 18 in (457.2 mm) behind the longitudinal location of the vehicle center of gravity as measured without the dummy in the vehicle. The vehicle had a 4° to 6° roll angle as it leaned toward the test pole, due to the side sliding forces acting on the tires. The maximum residual crush of the vehicle at the impact point was 10 in (254 mm). Pretest photographs of the vehicle and luminaire support are shown in figure 23.

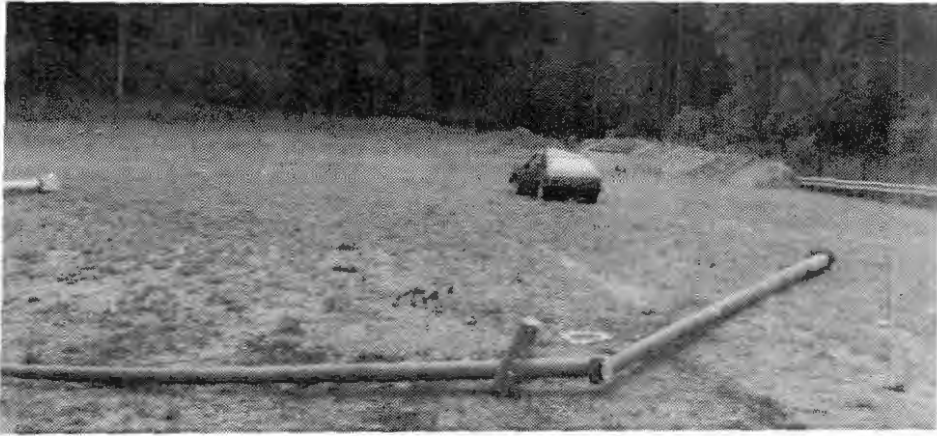
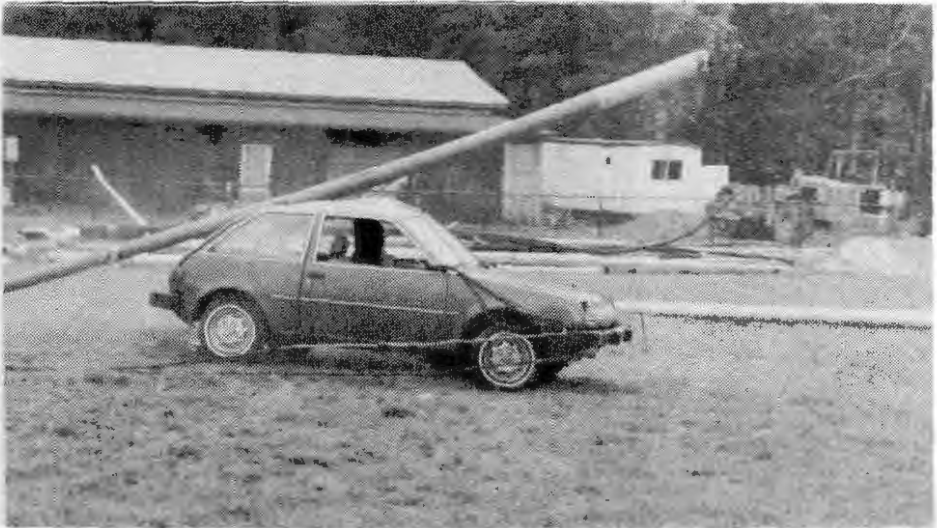
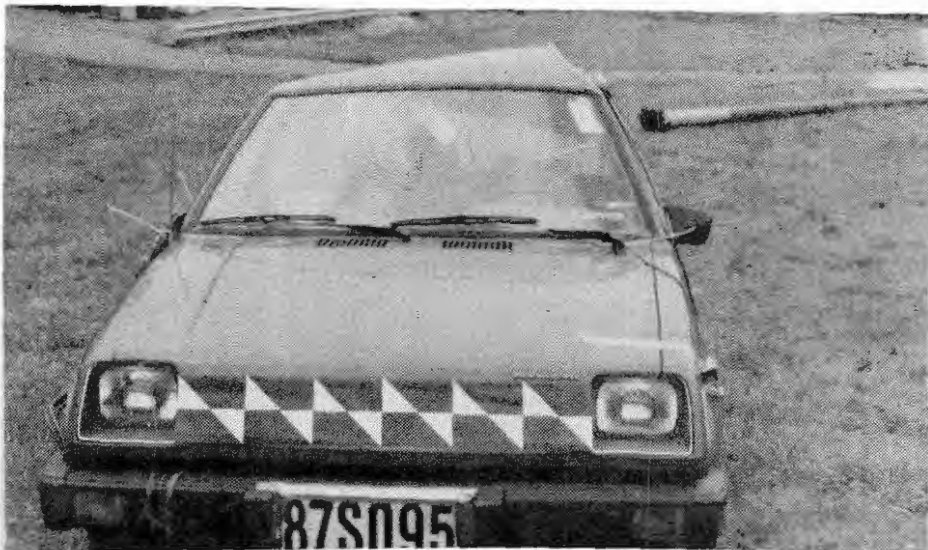
Figure 24. Posttest photographs of vehicle, test SI #1.

After the initial separation from the vehicle, the luminaire support translated forward at a speed of 13.7 ft/s (4.1 m/s) with a rotation rate of 1.59 rad/s. The luminaire support rotated up and over the test vehicle. The top of the pole hit the ground approximately 1.08 s after impact. Just prior to impact with the ground, the center portion of the pole landed on the left rear corner of the car. As the support rotated away, the vehicle yawed counter clockwise and rolled to its left. The maximum roll angle was about 5°, based on film observations. The vehicle then became stable and continued forward away from the impact area after yawing a total of about 90°. The vehicle did not pitch or roll much, but remained stable during this transition. The final resting position of the vehicle was about 70 ft (21.3 m) downstream and 10 ft (3 m) to the right of the impact point. Posttest photographs are shown in figure 24.

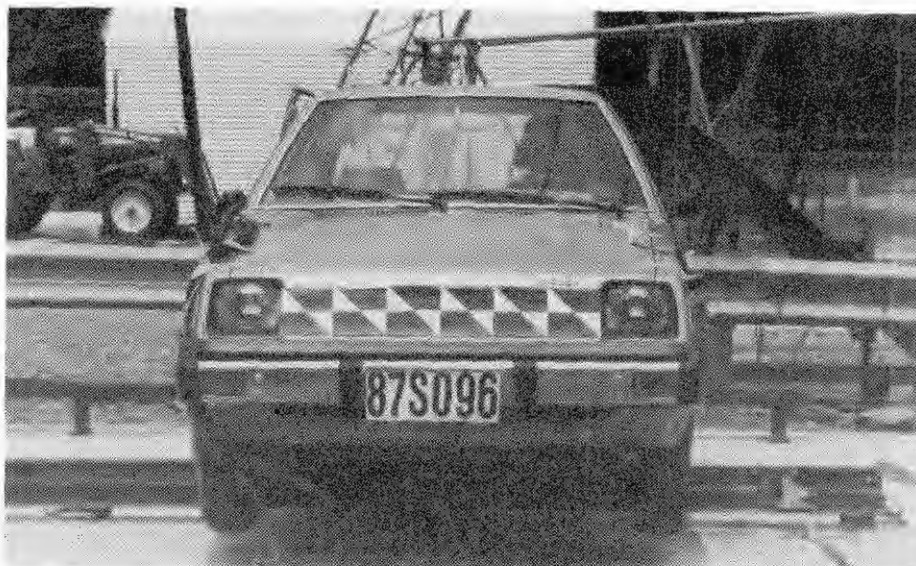
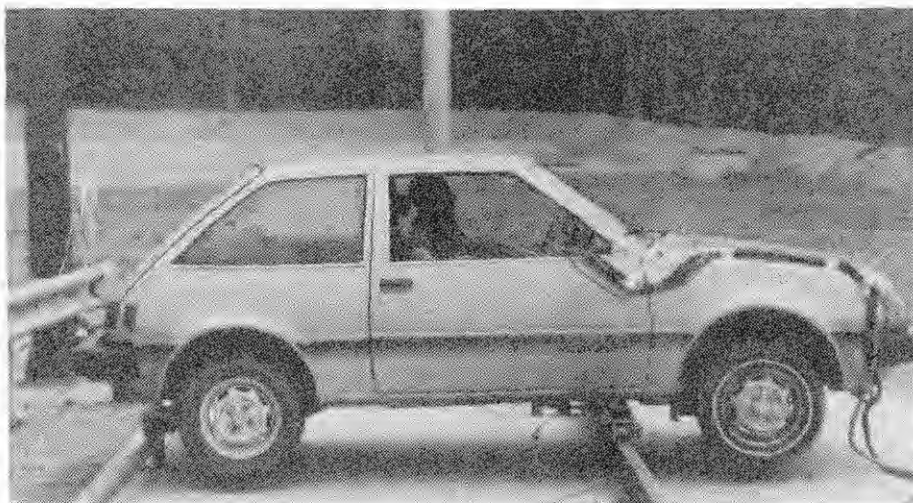
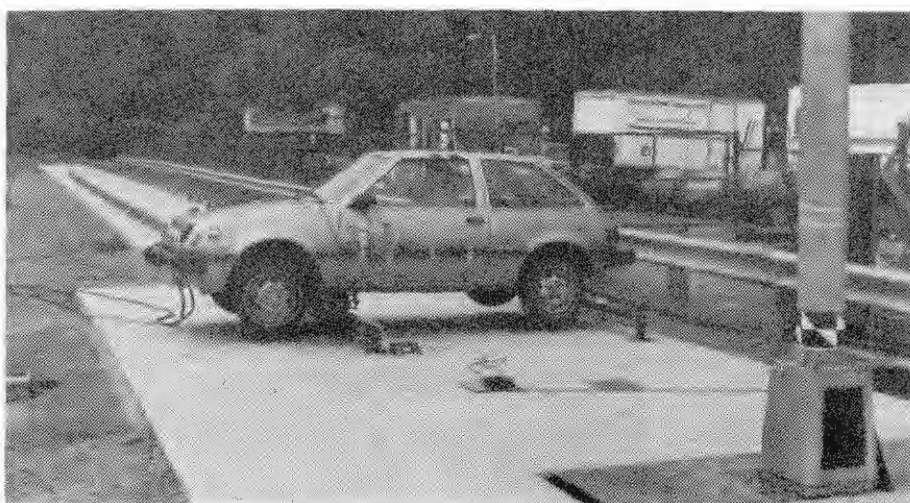
Figure 25. Pretest photos of vehicle & pole, test SI #2.

The test vehicle impacted at 28.64 mi/h (12.8 m/s) at a point on the left door in line, with the occupant 19 in (482.6 mm) behind the longitudinal location of the vehicle center of gravity as measured without the dummy in the vehicle. The vehicle had a 6.4° roll angle as it leaned toward the test pole, due to the side sliding forces acting on the tires. The maximum residual crush of the vehicle at the impact point was 26 in (660 mm). Pretest photographs of the vehicle and luminaire support are shown in figure 25.

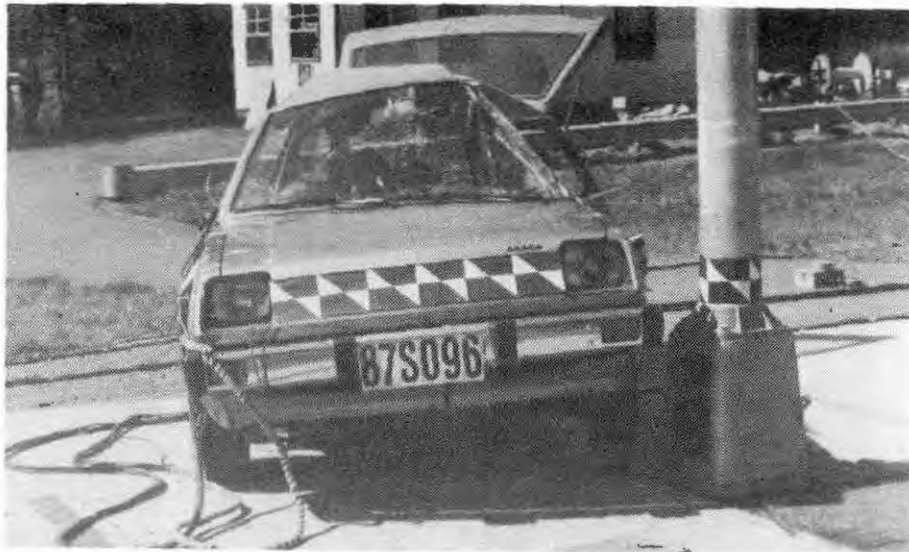
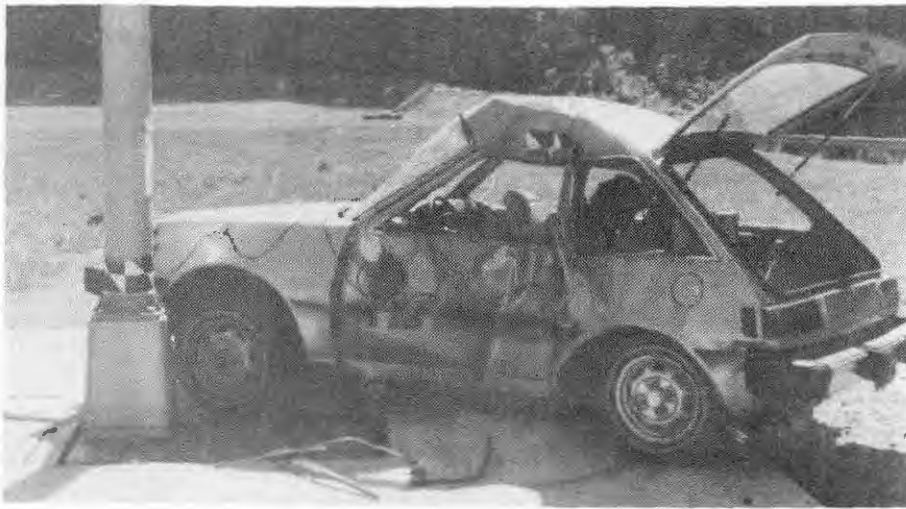
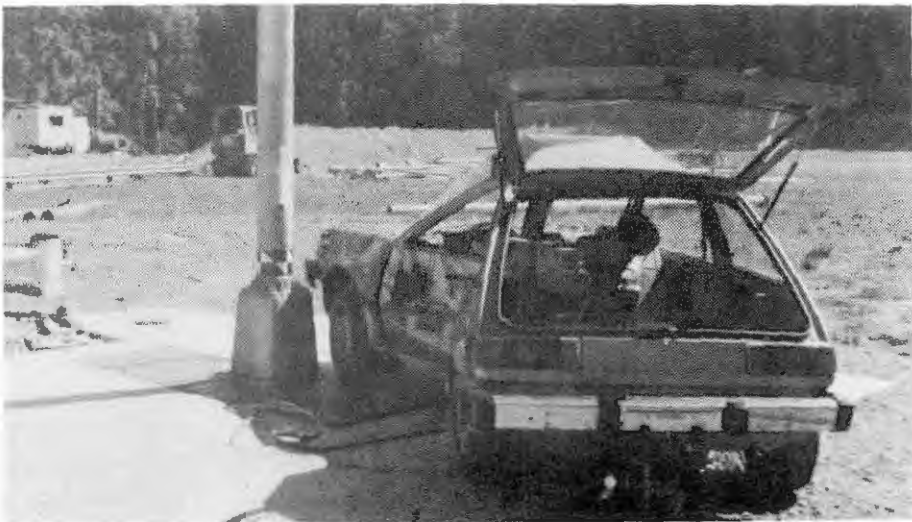
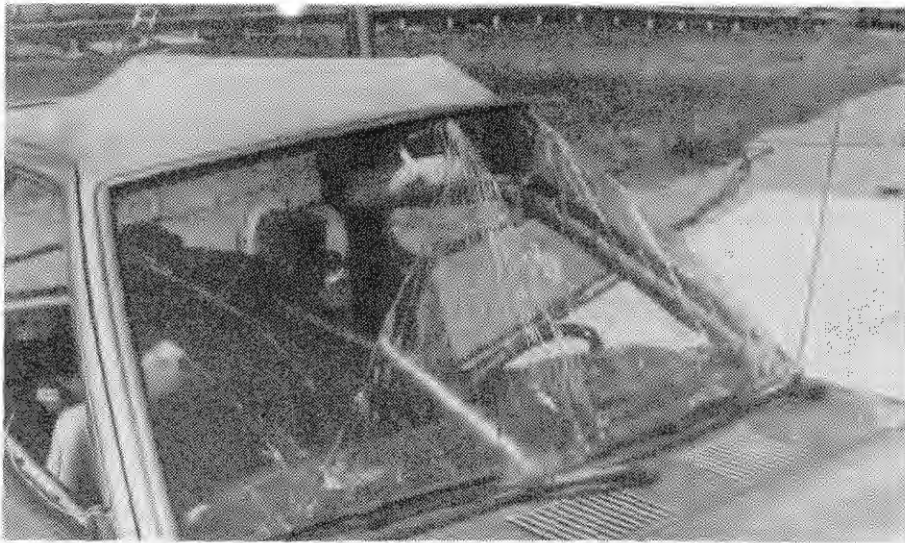
Figure 26. Posttest photographs of vehicle, test SI #2.

Figure 26. Posttest photographs of vehicle, test SI #2 (continued).

Upon impact, the vehicle began to crush followed by the dummy's head striking the pole. Shortly after impact the vehicle began to yaw counter clockwise around the pole. The transformer base pole combination did not break away, although the T-base did have several cracks around the bottom. The vehicle continued to yaw coming to a rest after about 153° of total rotation. The final resting position was approximately 2 ft (610 mm) to the right of the pole. The vehicle was bent about the impact point with the wheel base shortened almost 20 in (508 mm) on the impact side. Posttest photographs are shown in figure 26.

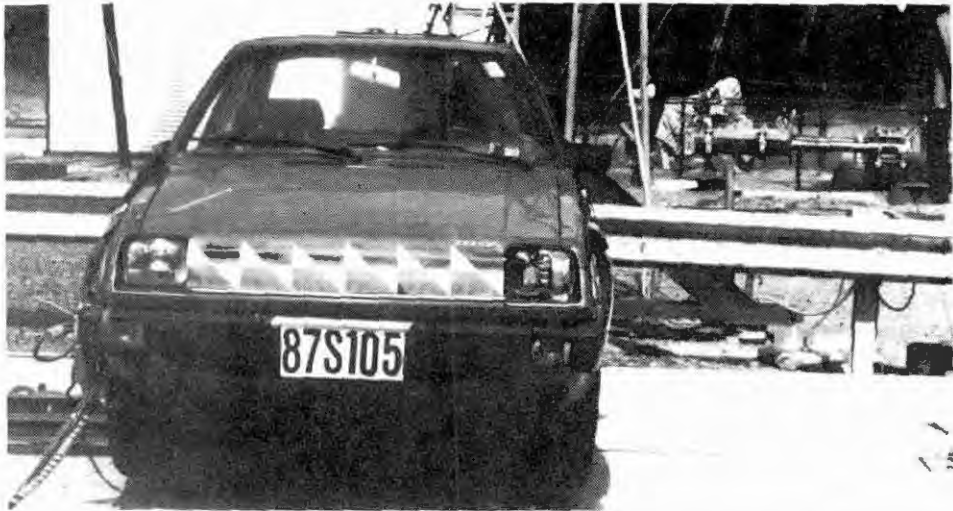
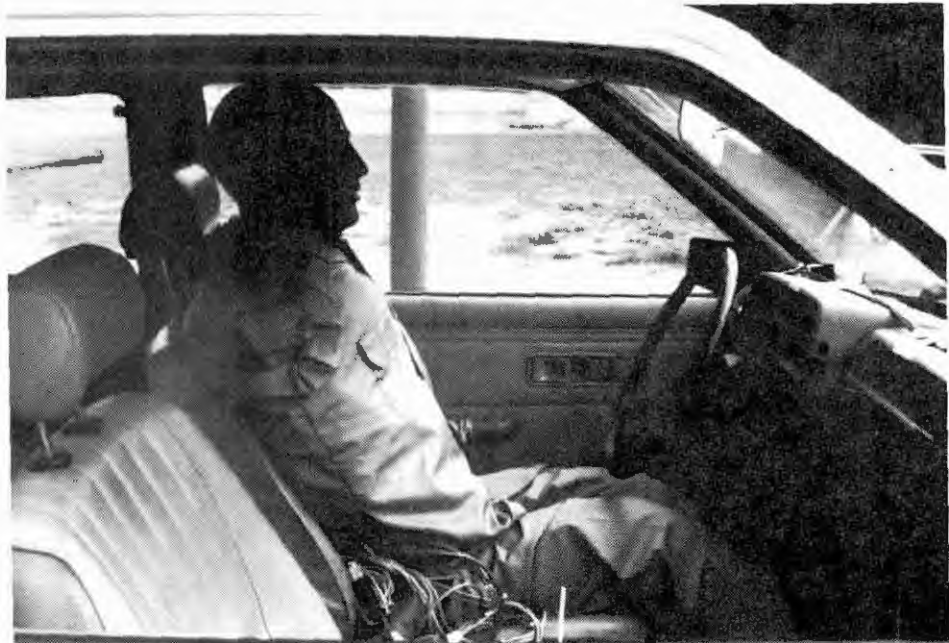
Figure 27. Pretest photographs of vehicle, test SI #3.

The test vehicle impacted at 30.5 m/h (13.6 m/s) at a point on the left door in line with the occupant, 28 in (711 mm) behind the longitudinal location of the vehicle center of gravity as measured without the dummy in the vehicle. The vehicle had a 4.9° roll angle as it leaned toward the test pole, due to the side sliding forces acting on the tires. The maximum residual crush of the vehicle at the impact point was 9.5 in (34.9 mm). Pretest photographs of the vehicle and luminaire support are shown in figure 27.

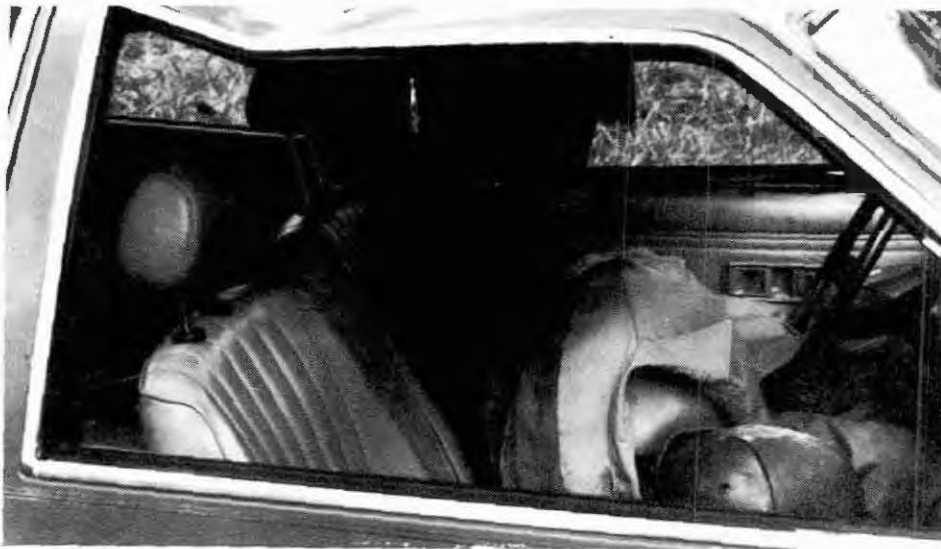
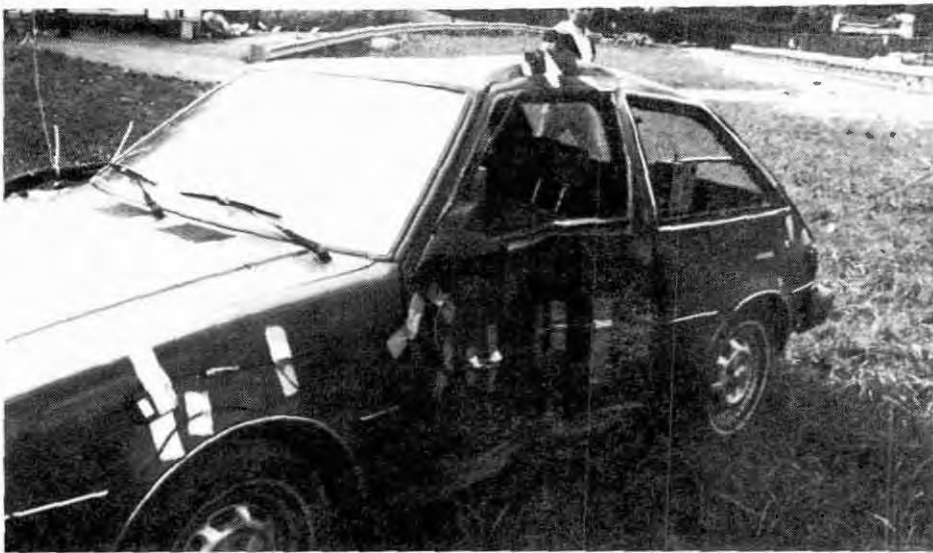
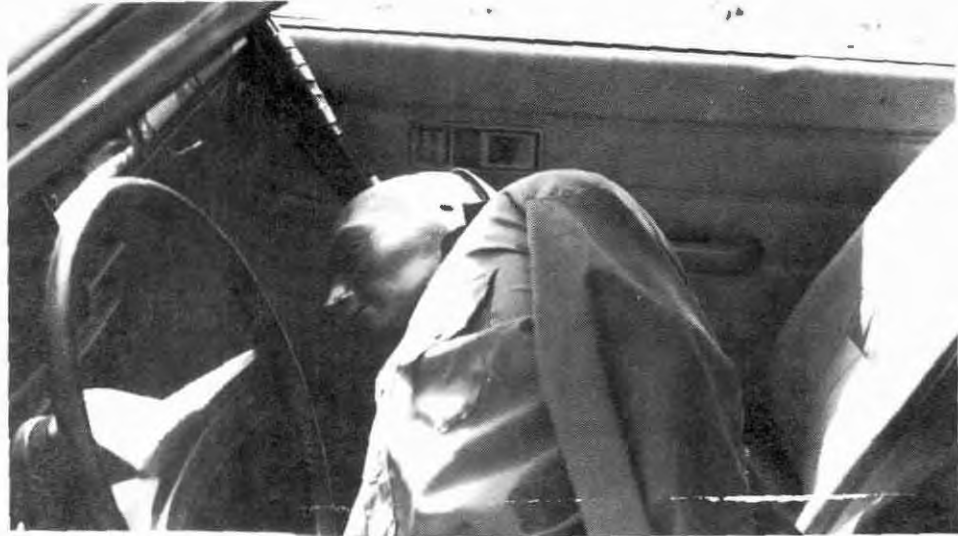
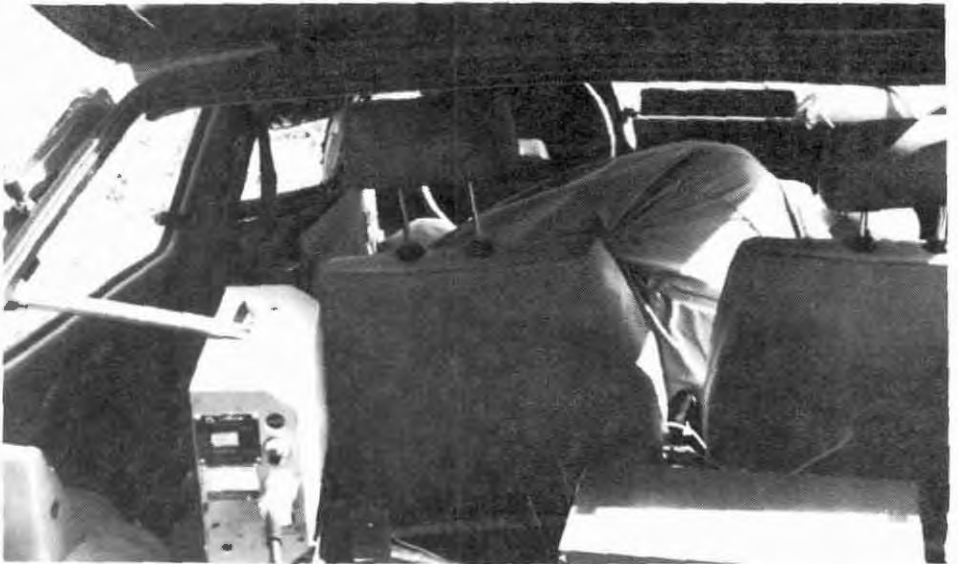
Figure 28. Posttest photographs of vehicle, test SI #3.

Figure 28. Posttest photographs of vehicle, test SI #3 (continued).

After the initial separation from the vehicle, the luminaire support translated forward and rotated up and over the test vehicle with the top of the pole hitting the ground about 1.1 s after impact. Just prior to impact with the ground, the center portion of the pole impacted on the left rear corner of the car. As the support rotated away, the vehicle yawed counter clockwise and rolled to its left. The maximum roll angle was about 5°, based on film observations. The vehicle then became stable and continued forward away from the impact area after yawing a total of about 60°. The vehicle did not pitch or roll very much, but remained stable during this transition. The final resting position of the vehicle was about 55 ft (16.7 m) downstream and 35 ft (10.6 m) to the right of the impact point. Posttest photographs are shown in figure 28.

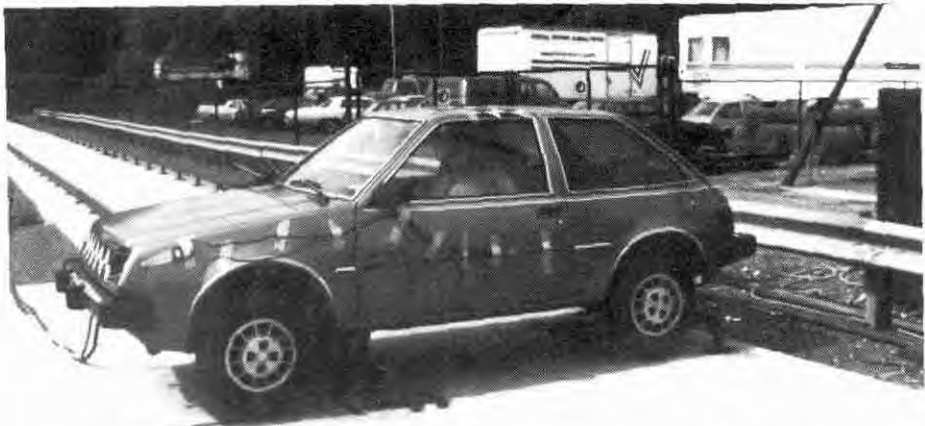
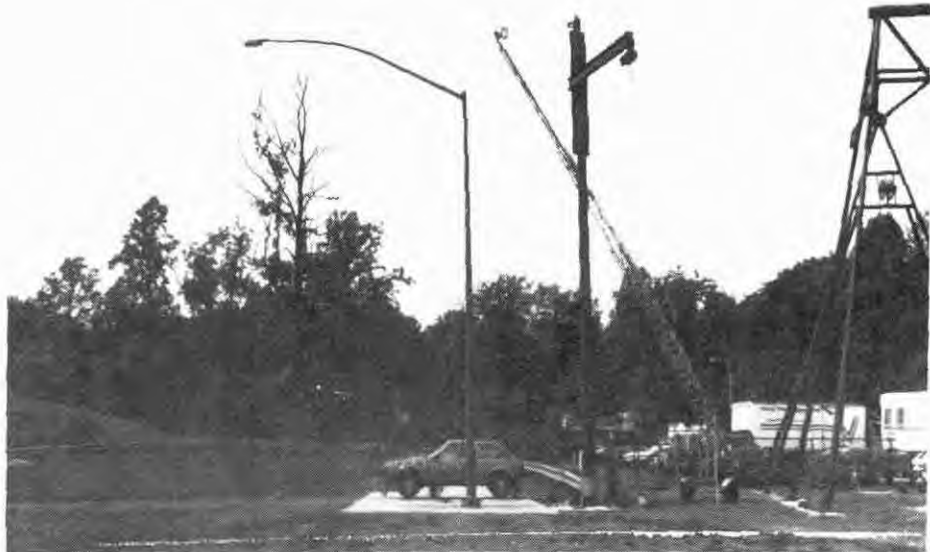
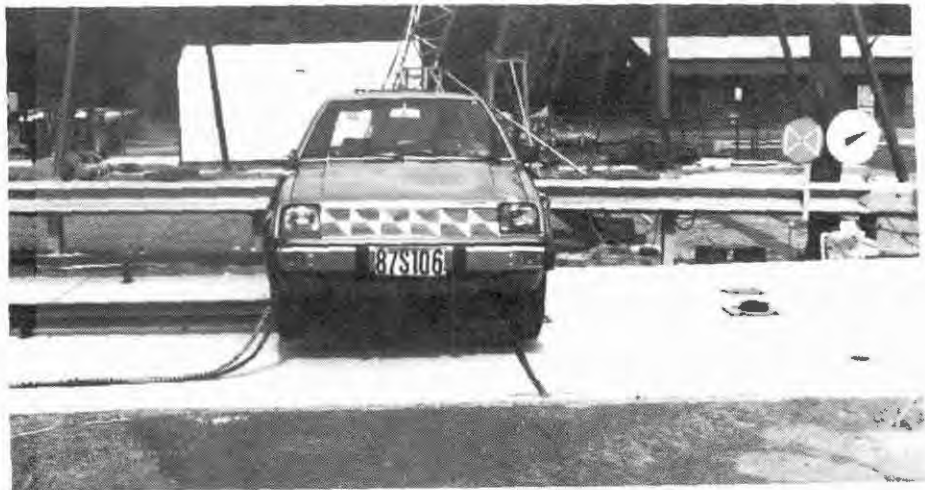
Figure 29. Pretest photographs of vehicle, test SI #4.

The test vehicle impacted at 29.45 mi/h (13.1 m/s) at a point on the left door in line with the occupant, 28 in (711 mm) behind the longitudinal location of the vehicle center of gravity as measured without the dummy in the vehicle. The vehicle had a 5.9° roll angle as it leaned toward the test pole, due to the side sliding forces acting on the tires. The maximum residual crush of the vehicle at the impact point was 10 in (254 mm). Pretest photographs of the vehicle and luminaire support are shown in figure 29.

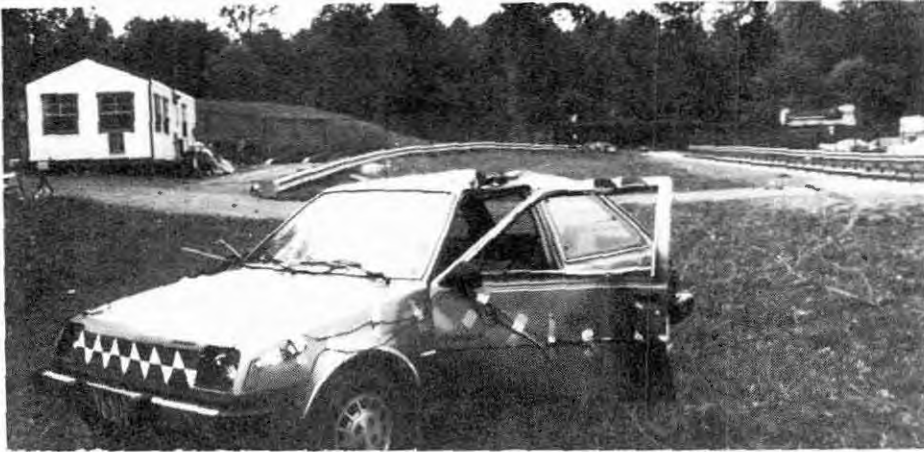
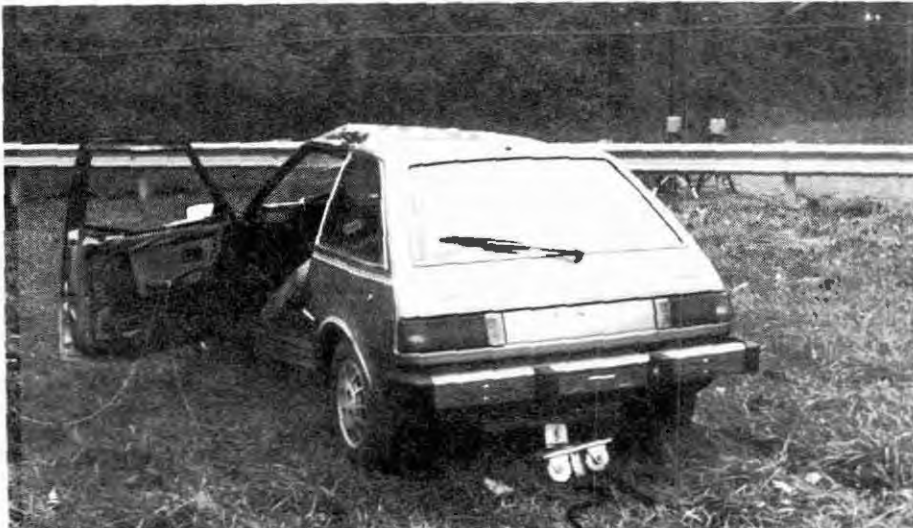
Figure 30. Posttest photographs of vehicle, test SI #4.

After the initial separation from the vehicle, the luminaire support translated forward at a speed of 6.9 ft/s (2.1 m/s) with a rotation rate of 1.94 rad/s. The luminaire support rotated up and over the test vehicle with the top of the pole hitting the ground about 1.1 s after impact. Just prior to impact with the ground, the center portion of the pole impacted on the left rear corner of the car. As the support rotated away, vehicle yawed counter clockwise and rolled to its left. The maximum roll angle was about 5°, based on film observations. The vehicle total yaw angle was approximately 60°. The vehicle did not pitch or roll very much but remained stable during this transition. The final resting position of the vehicle was about 55 ft (16.7 m) downstream and 35 ft (10.6 m) to the right of the impact point. Posttest photographs are shown in figure 30.

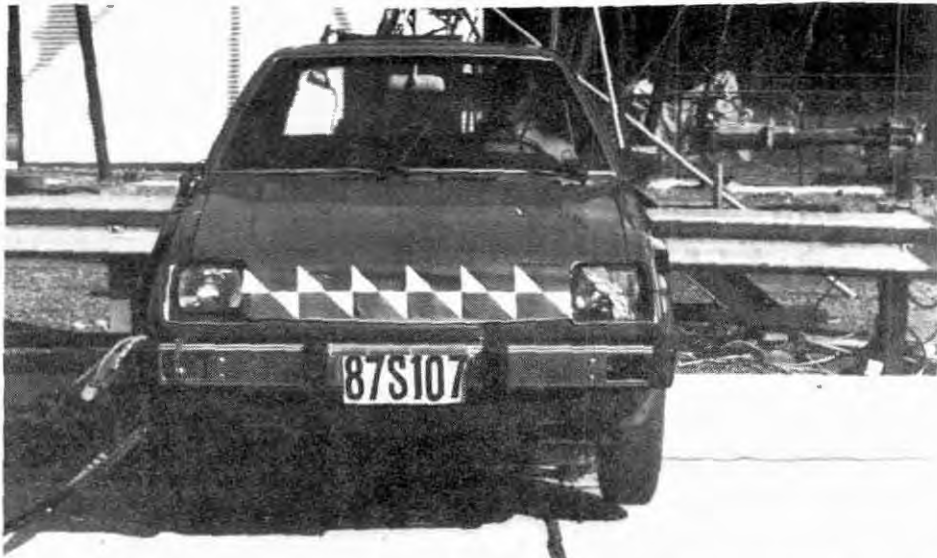
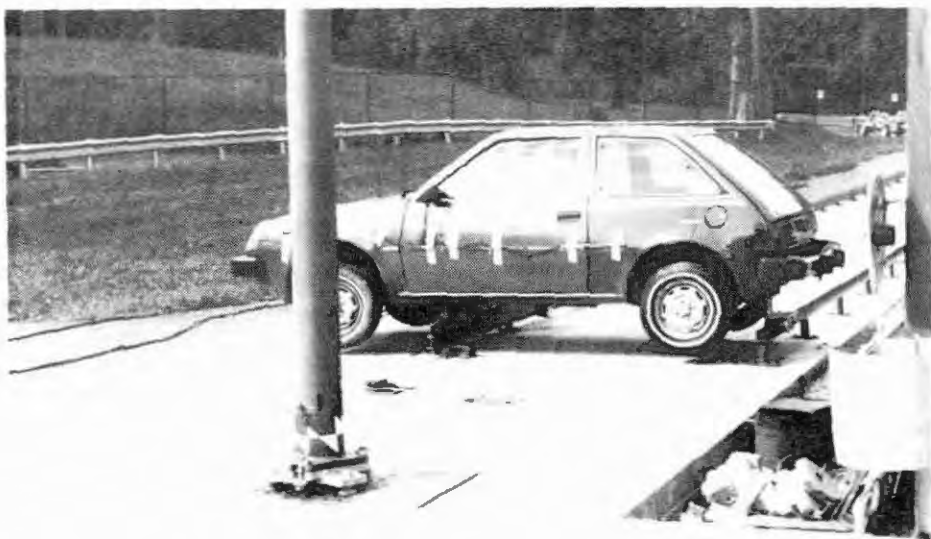
Figure 31. Pretest photographs of vehicle, test SI #5.

The test vehicle impacted at 29.7 mi/h (13.2 m/s) at a point on the left door 12 in (305 mm) behind the occupant, 40 in (1016 mm) behind the longitudinal location of the vehicle center of gravity as measured without the dummy in the vehicle. The vehicle had a 6.1° roll angle as it leaned toward the test pole due to the side sliding forces acting on the tires. The maximum residual crush of the vehicle at the impact point was 13 in (330 mm). Pretest photographs of the vehicle and luminaire support are shown in figure 31.

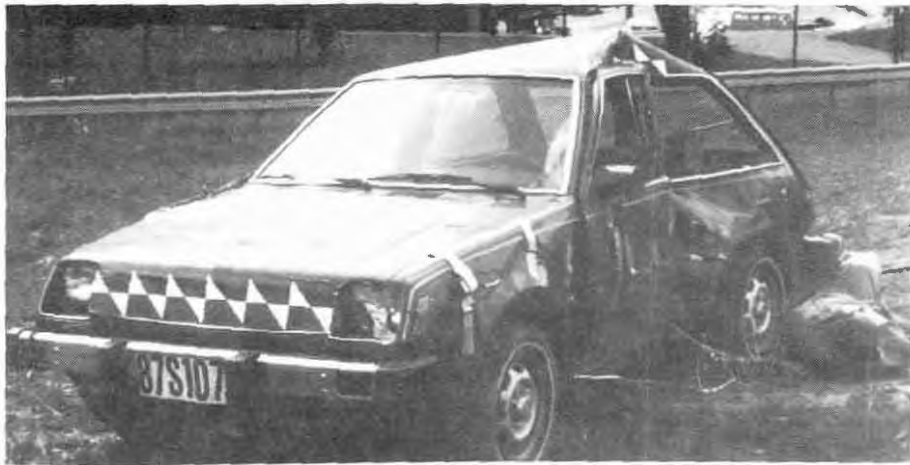
Figure 32. Posttest photographs of vehicle, test SI #5.

to impact with the ground, the center portion of the pole impacted on the left rear corner of the car. As the support rotated away, the vehicle yawed counter clockwise and rolled to its left. The vehicle then became stable and continued forward away from the impact area after yawing a total of about 90°. The vehicle did not pitch or roll very much but remained stable during this transition. The final resting position of the vehicle was about 60 ft (18.3 m) downstream and 15 ft (4.6 m) to the right of the impact point. During the impact, the driver's door latch area was deformed allowing the door to come open. As the vehicle left the impact area, the dummy slid out of the open door and fell to the ground. The dummy was then dragged along the ground by the dummy data cable. Posttest photographs are shown in figure 32.

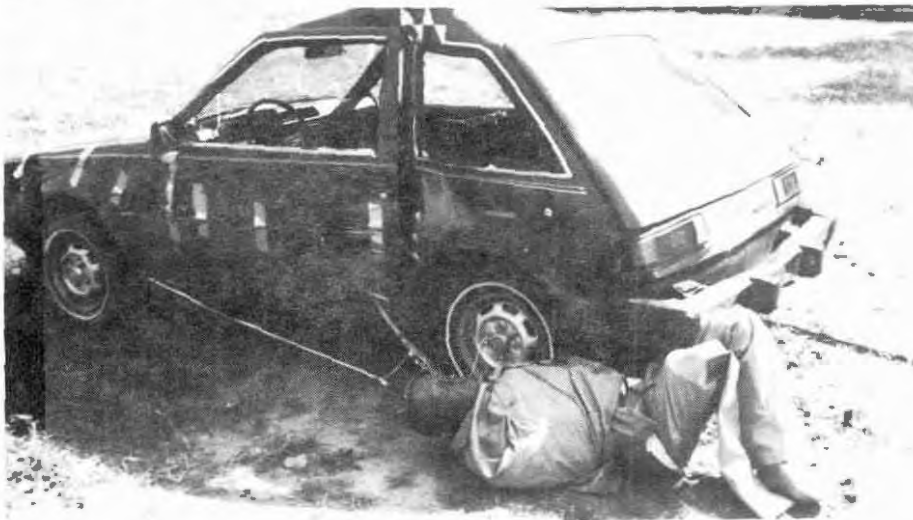
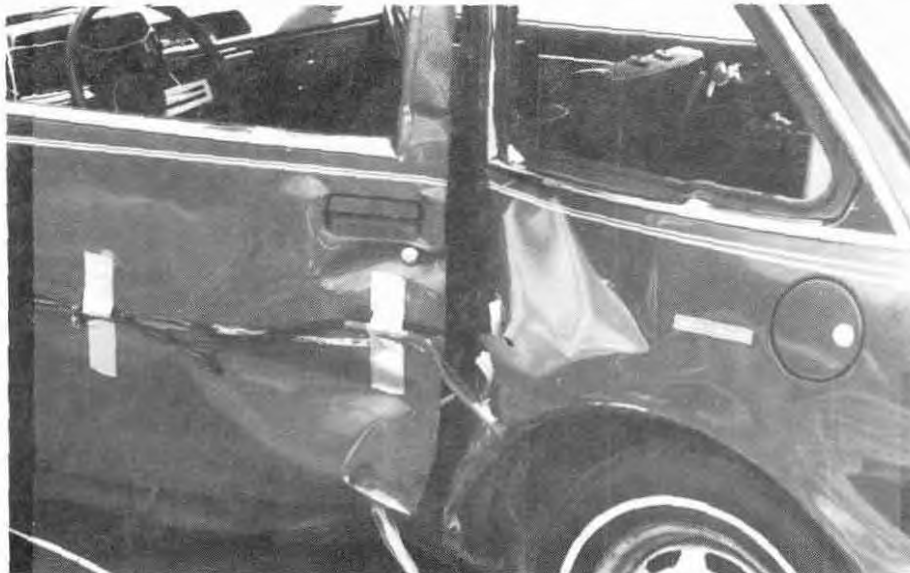
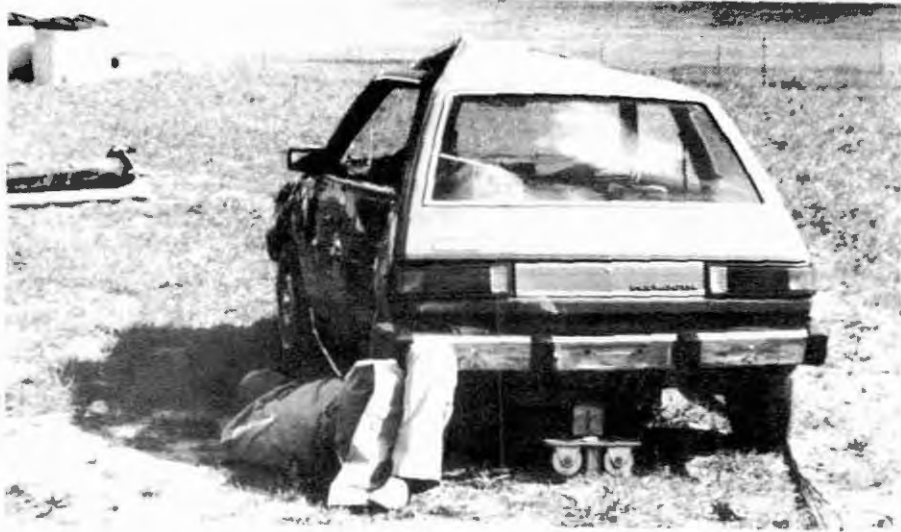
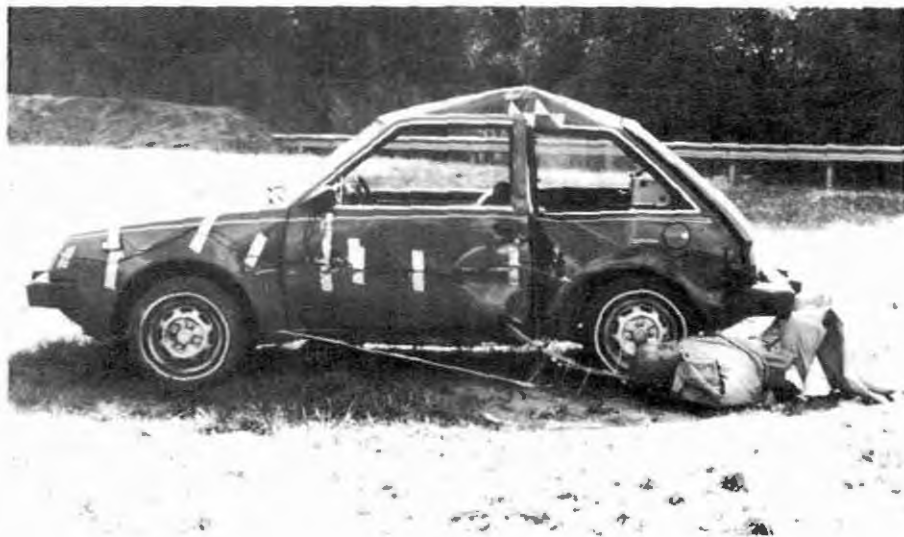
Figure 32. Posttest photographs of vehicle, test SI #5 (continued).
