Publication No. FHWA-RD-89-157

February 1989

Full-Scale Side Impact Testing

Federal Highway Administration

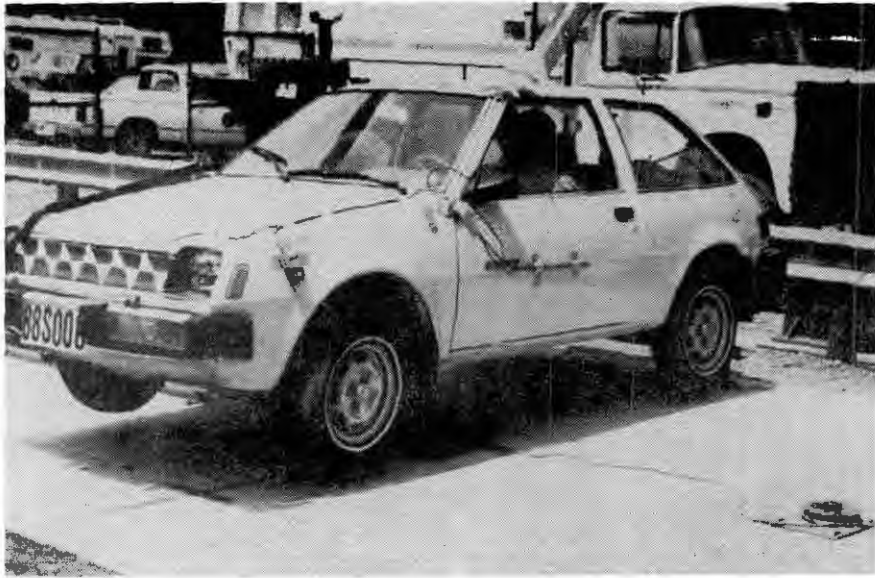
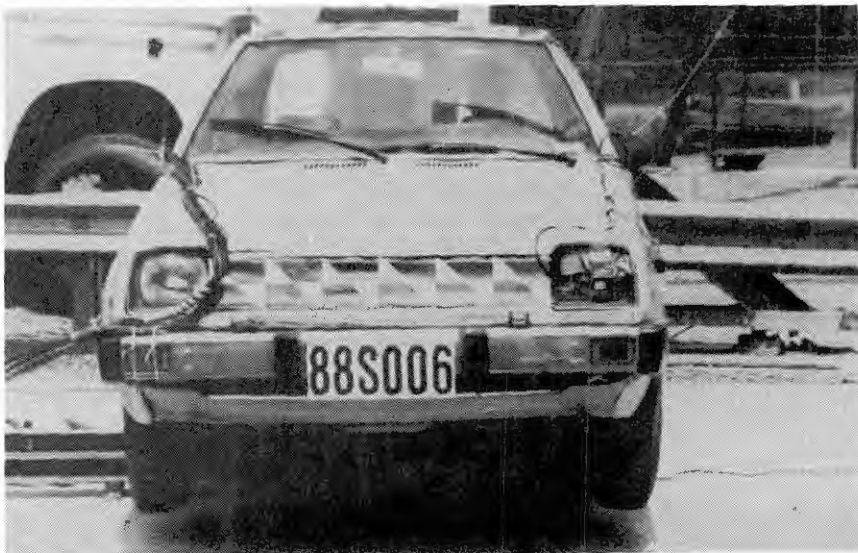
Figure 33. Pretest photographs of vehicle, test SI #6.

The test vehicle impacted at 28.25 mi/h (12.6 m/s) at a point on the left door 12 in (305 mm) forward of the occupant, 16 in (406 mm) behind the longitudinal location of the vehicle center of gravity as measured without the dummy in the vehicle. The vehicle had a 6.1° roll angle as it leaned toward the test pole due to the side sliding forces acting on the tires. The maximum residual crush of the vehicle at the impact point was 36 in (914 mm). Crush was measured from a straight line cord running from front bumper to rear bumper on the impact side. This was done because the vehicle was bent very severely. Pretest photographs of the vehicle and luminaire support are shown in figure 33.

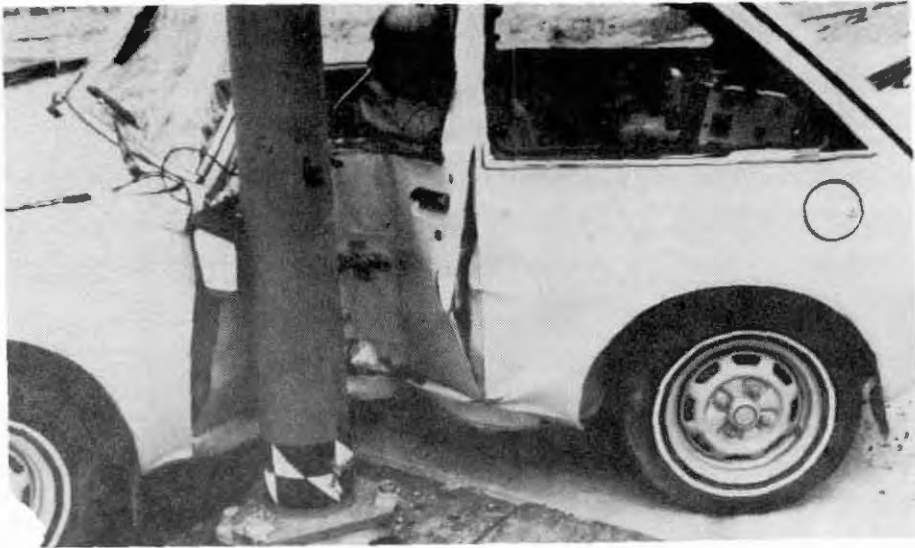
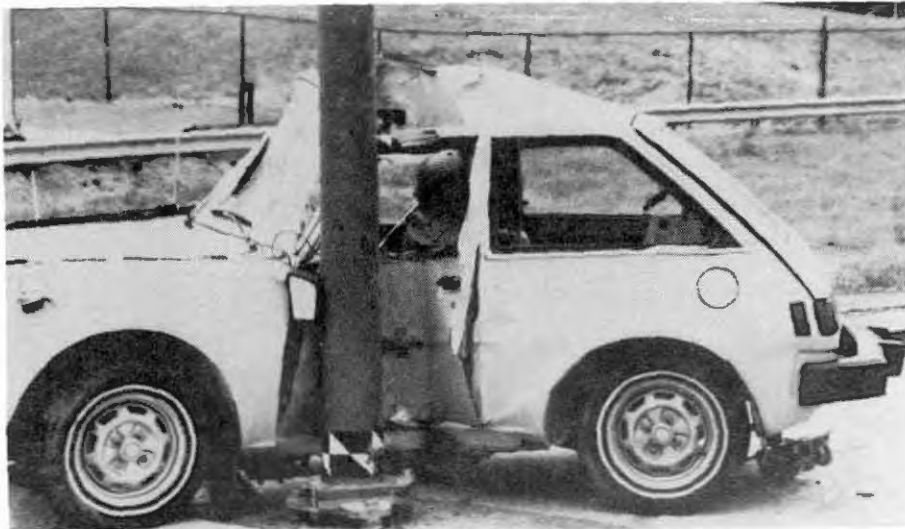
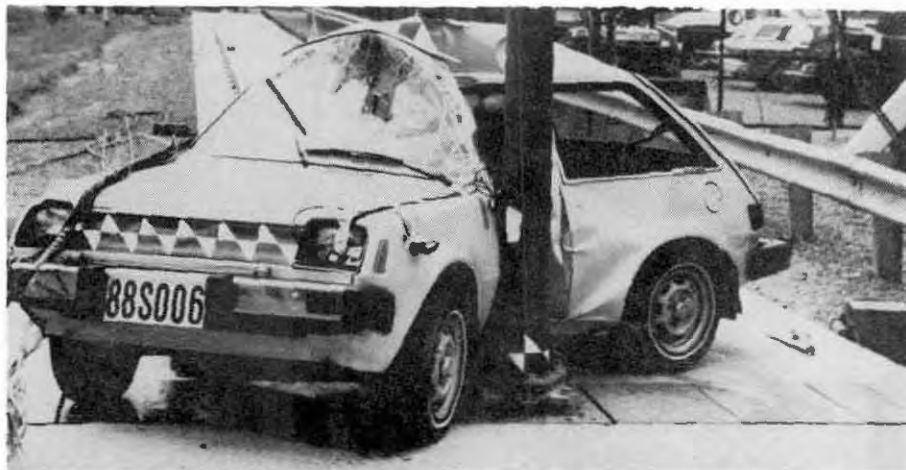
Figure 34. Posttest photographs of vehicle, test SI #6.

The vehicle impacted the pole in the desired location, 12 in (305 mm) forward of the driver's shoulder. The vehicle crushed inward as it slowed. The vehicle stopped without breaking away the pole, thus causing a very large deformation of the vehicle side. The vehicle yawed slightly as it came to a rest. Posttest photographs are shown in figure 34.

during test 6, indicating that design improvements may be warranted for this support. The reason for this failure may have been due to substantial engagement between the lower car sill and the fixed base of the luminaire support (which is only 3 in (76.2 mm) high). This hypothesis was never conclusively proved. As a result of this, it is felt that stub heights for side impact compatible supports may need to be lower than the currently required 4 in (101.6 mm). During all tests conducted directly in line with the dummy, substantial head contact and high HIC values occurred. Therefore, techniques to limit head contact or to mitigate head trauma will be required if such injuries are to be reduced or eliminated. Finally, techniques to minimize or reduce intrusion of the narrow support into the occupant compartment are needed.

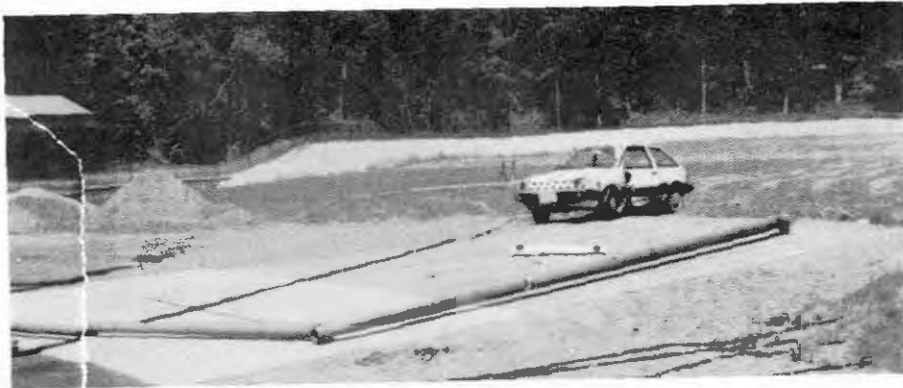
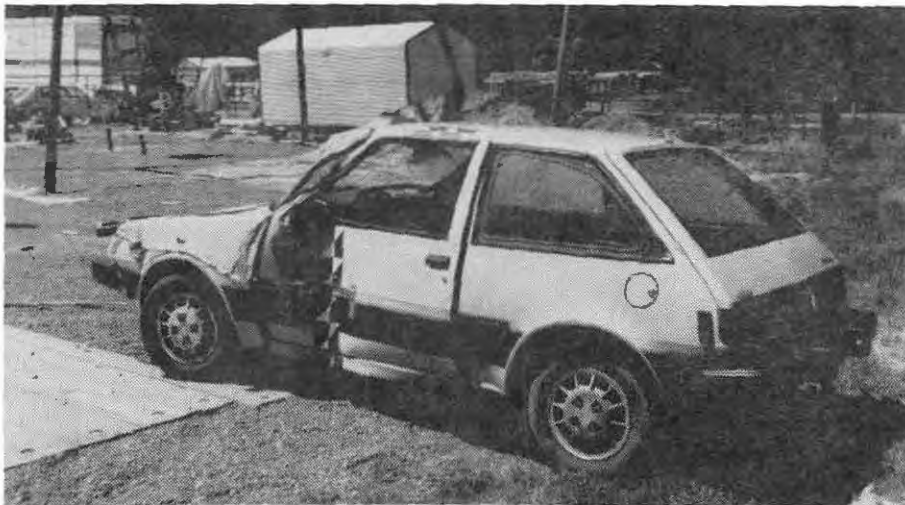
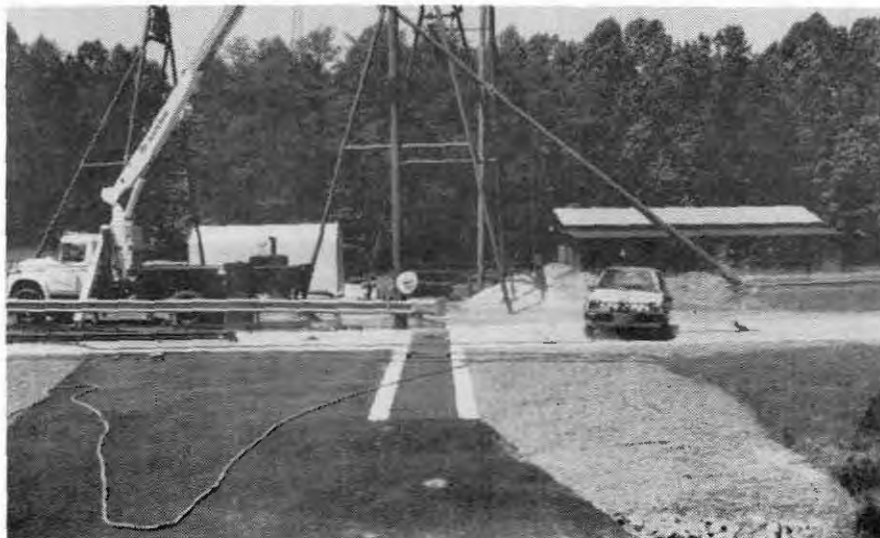
Figure 36. Posttest photographs of vehicle, test SI #7.

After the initial separation from the vehicle, the luminaire support translated forward at a speed of 24.7 ft/s (7.5 m/s) with a rotation rate of 1.84 rad/s. The luminaire support rotated up and over the test vehicle, with the top of the pole hitting the ground about 1.07 s after impact. Just prior to impact with the ground, the center portion of the pole impacted on the hood of the car. At the time of impact of the pole with the hood, the vehicle had yawed clockwise. It continued yawing for a total yaw angle of 90°. The vehicle did not pitch or roll very much, but remained stable during this transition. The final resting position of the vehicle was about 36 ft (11 m) downstream and 8 ft (2.4 m) to the left of the impact point. The post base ended up next to the vehicle with the top near the impact point. Posttest photographs are shown in figure 36.

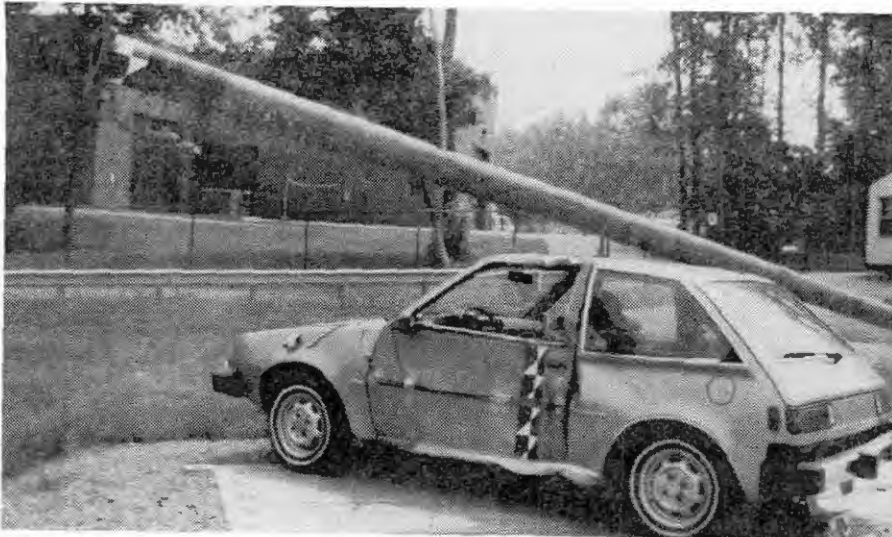
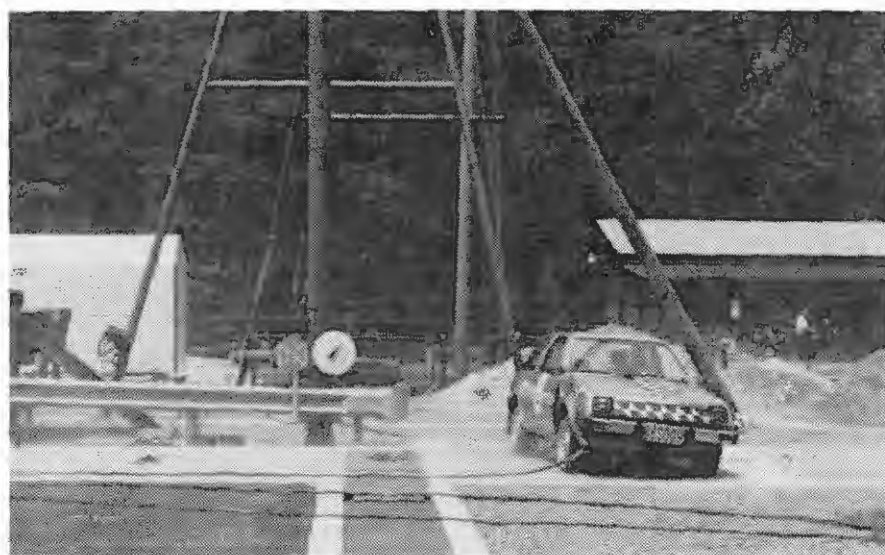
Figure 38. Posttest photographs of vehicle, test SI #8.

Figure 38. Posttest photographs of vehicle, test SI #8 (continued).

After the initial separation from the vehicle, the luminaire support rotated up and over the test vehicle with the top of the pole hitting the ground about 1.08 s after impact. Just prior to impact with the ground, the center portion of the pole impacted the roof of the car. As the support rotated away, vehicle yawed counter clockwise, continue forward away from the impact area after yawing a total of about 45°. The vehicle did not pitch or roll very much, but remained stable during this transition. The final resting position of the vehicle was about 36 ft (11 m) downstream and 8 ft (2.4 m) to the right of the impact point, with the pole resting on the roof. The top of

the pole was just past the end of the runway. Posttest photographs are shown in figure 38.
