# Trade-Off Between Delineation and Lighting on Freeway Interchanges

Publication No. FHWA-RD-88-223

August 1989

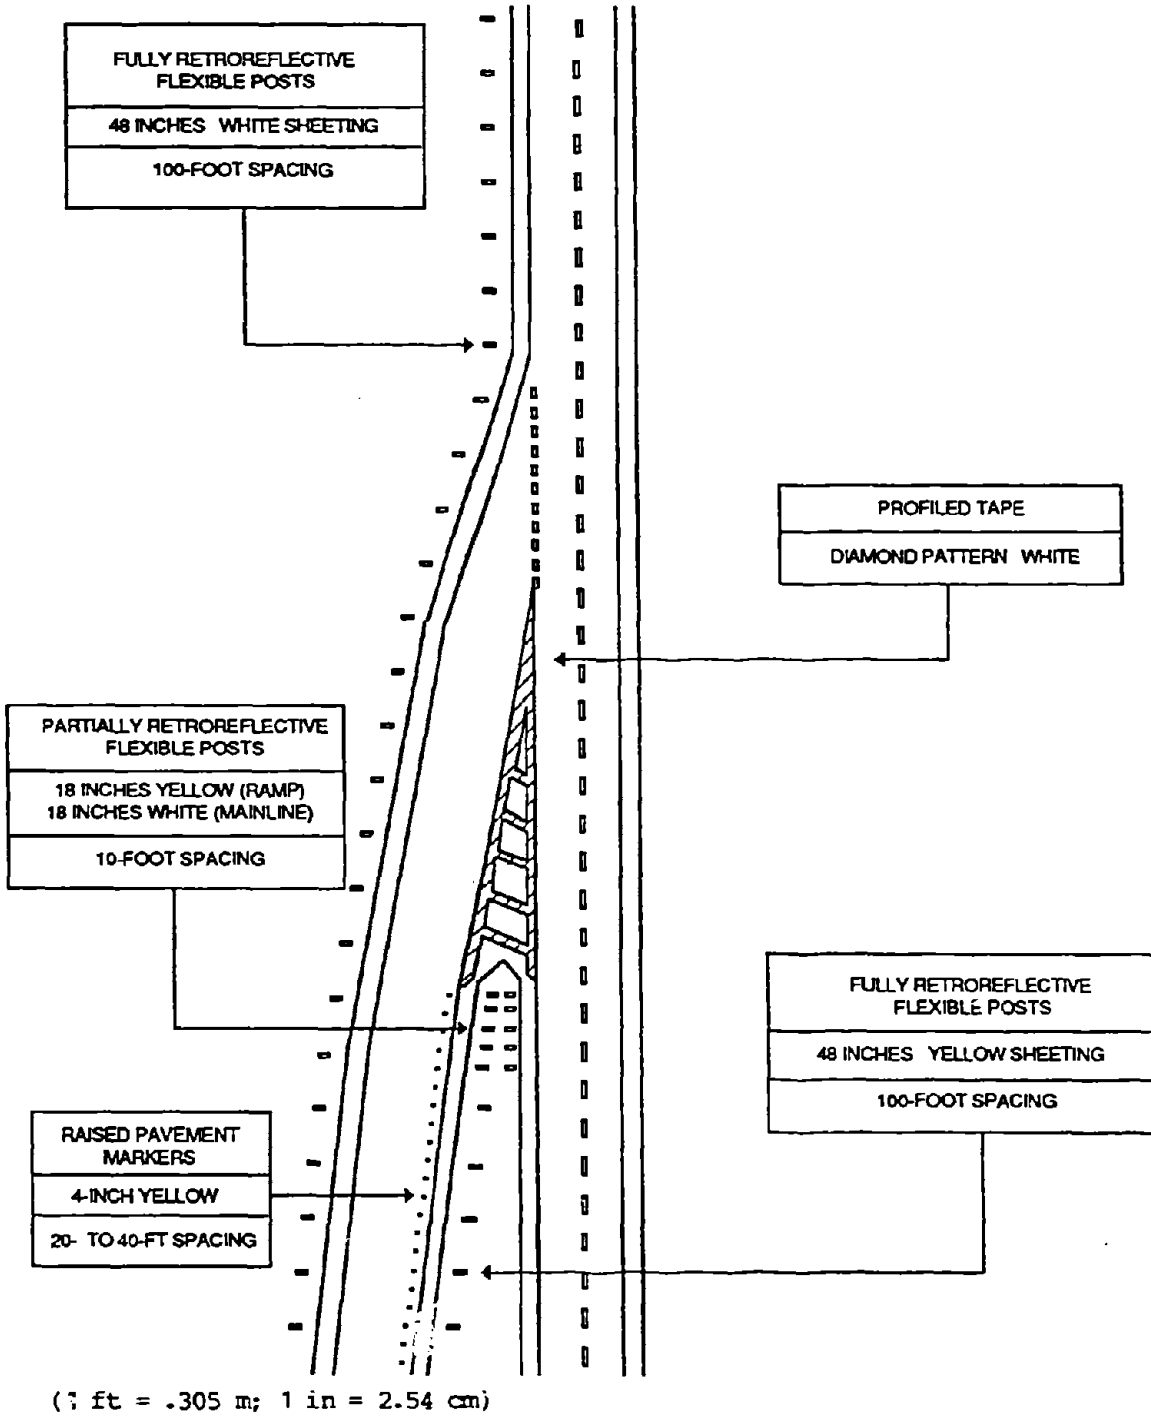
Figure 8. Delineation Upgrade 3.

Upgrade 3 replaced all Baseline system partially retroreflective posts with fully retroreflective posts except in the gore; used RPM's along the left ramp stripe; and used beaded, profiled tape containing a raised-diamond pattern for gore striping. The tape, applied without primer for quick installation and removal after data collection, was used because it would project above a film of water during rain like a heavy epoxy stripe containing glass beads. Figure 8 illustrates the Upgrade 3 configuration. As noted, details regarding the configuration of each delineation system tested are given in appendix B.

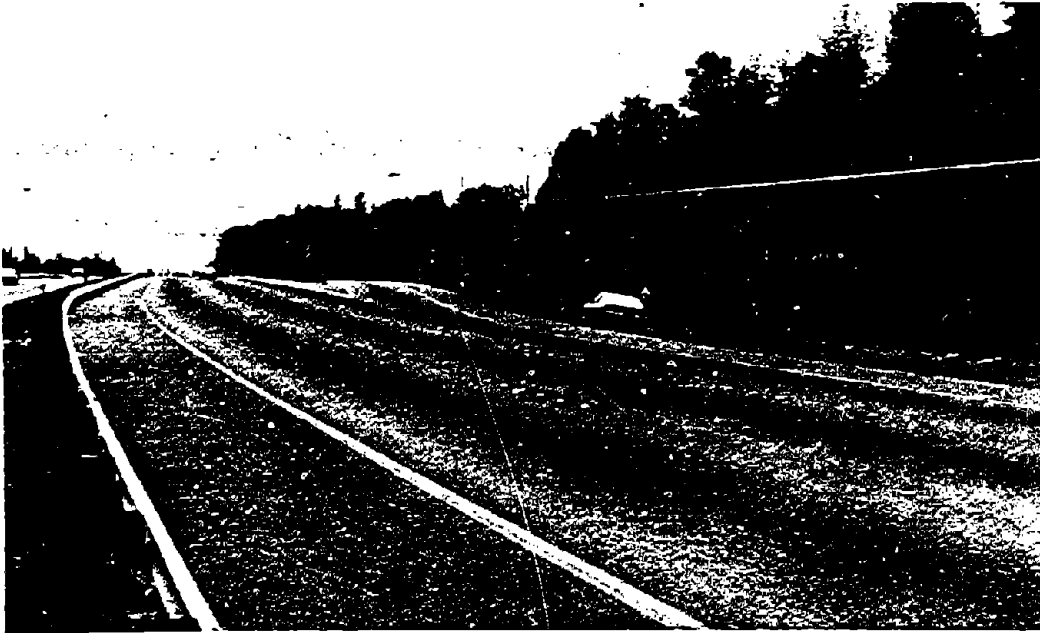
Figure 9. Site #1 photo.

Both sites selected for the field tests were diamond interchanges representative of the type of geometrics on which partial lighting is most frequently used. A primary advantage of the sites for the purposes of the research was that both were designed and built as fully lighted interchanges but were being operated in a partially lighted mode. Thus there were no problems in obtaining permission to operate under both full and partial lighting conditions during field testing. This made it possible to obtain comparisons of full lighting with nominal delineation and partial lighting with the same delineation and additional upgraded delineation systems. Further, the two sites were reasonably similar in geometric characteristics but differed with respect to the level of partial lighting used, i.e., one of the sites operated as a one-luminaire partial and the other as a three-luminaire partial. While the sites were not "matched" to the extent that direct statistical comparisons could be made, the general similarities provide some insights as to the potential effects of the two levels of partial lighting. For the site descriptions below, and for reference in describing the results, the one-luminaire site will be referred to as Site #1 and the three-luminaire site will be referred to as Site #2. Figures 9 and 10 show photographs of each site to depict the geometrics of the sites.

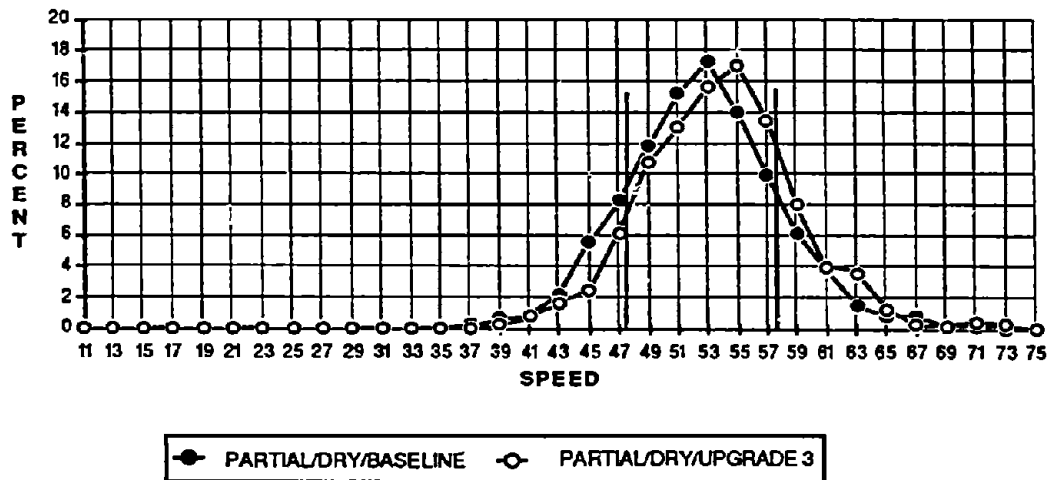
Figure 29. Site #2 Trap 3 speed distributions (Baseline vs. Upgrade 2, dry, partial lighting).

Figure 30. Site #2, Trap 4 speed distributions (Baseline vs. Upgrade 2, dry, partial lighting).

Figure 31. Site #2 Trap 5 speed distributions (Baseline vs. Upgrade 2, dry, partial lighting).

Figure 32. Site #2, Trap 3 speed distributions (Baseline vs. Upgrade 3, dry, partial lighting).

Figure 33. Site #2 Trap 4 speed distributions (Baseline vs. Upgrade 3, dry, partial lighting).

Figure 34. Site #2 Trap 5 speed distributions (Baseline vs. Upgrade 3, dry, partial lighting).

Under dry conditions at Site #2, the comparison of Baseline delineation with both Upgrade 2 and Upgrade 3 resulted in statistically significant differences; in this case at Traps 3, 4, and 5. The speed distributions for the significant comparisons are shown in figures 29 through 34. Greater differences were produced at the low end of the distributions, generally, than at the high end.

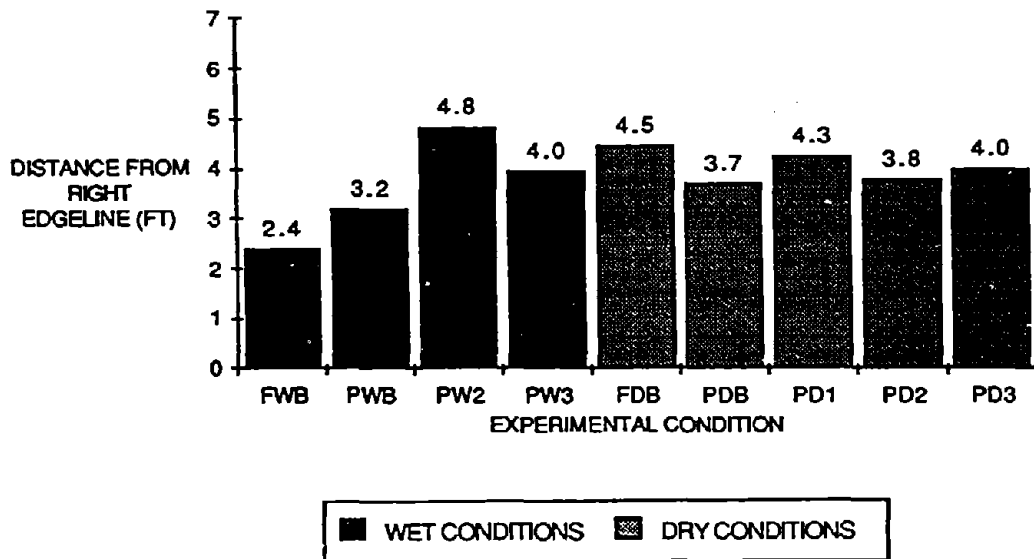
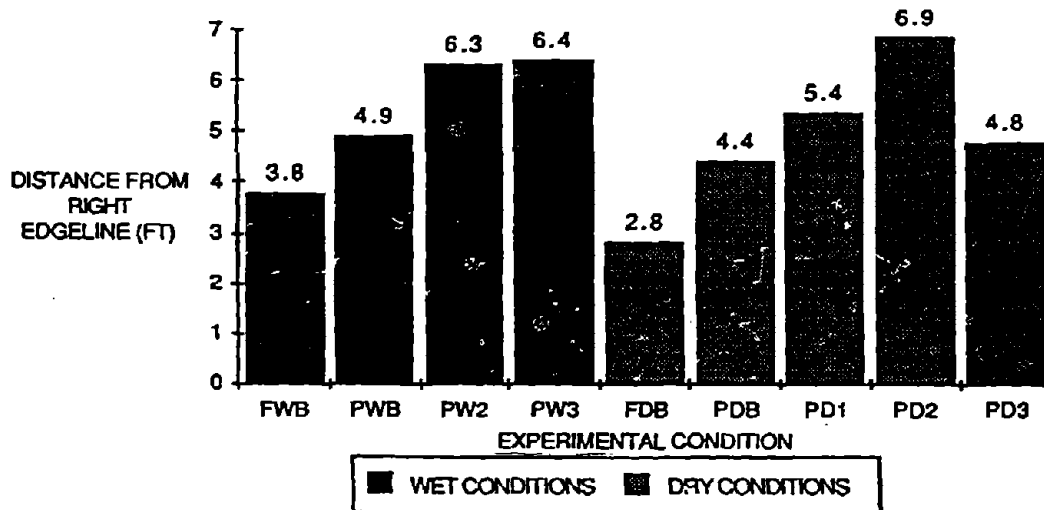
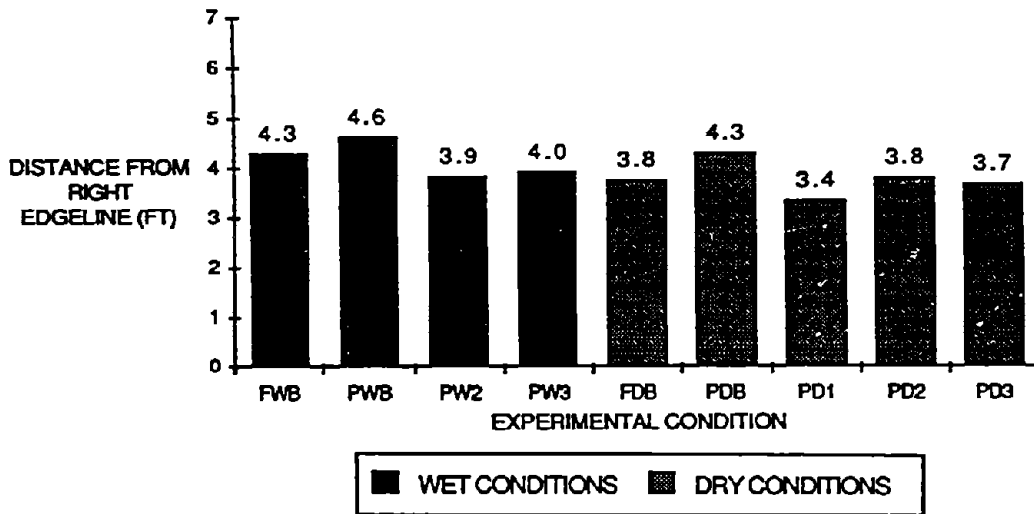
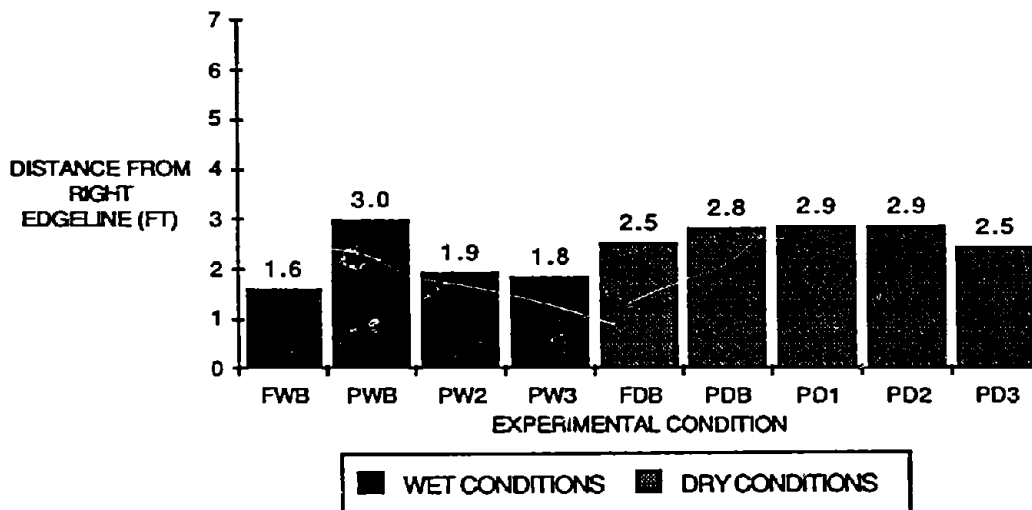
Figure 35. Lateral placement - Trap 4 - Site #1.

Figure 36. Lateral placement - Trap 5 - Site #1.

Figure 37. Lateral placement - Trap 6 - Site #1.

Figure 38. Lateral placement - Trap 4 - Site #2.

Figure 39. Lateral placement - Trap 5 - Site #2.

Figure 40. Lateral placement - Trap 6 - Site #2.

dry conditions. Trap 4 was located near the physical gore and Traps 5 and 6 were located downstream at approximately 100-ft (30.5 m) intervals. The means shown in the figures represent the distance from the right edgeline at which the vehicle broke the diagonal I/R beam. For both sites the lane width between the edgelines was approximately 14 ft (4.27 m). Thus a lateral position of 3.5 ft (1.07 m) would indicate a vehicle near the center of the lane.
