# SAFER BRIDGE RAILINGS VOLUME 1 SUMMARY REPORT

**Federal Highway  
Administration**

Report No.  
FHWA/RD-82/072

Final Report  
June 1984

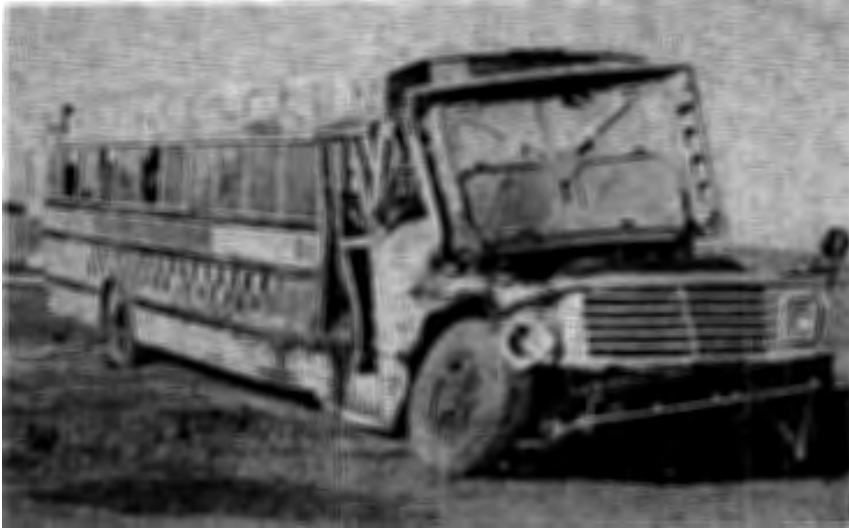
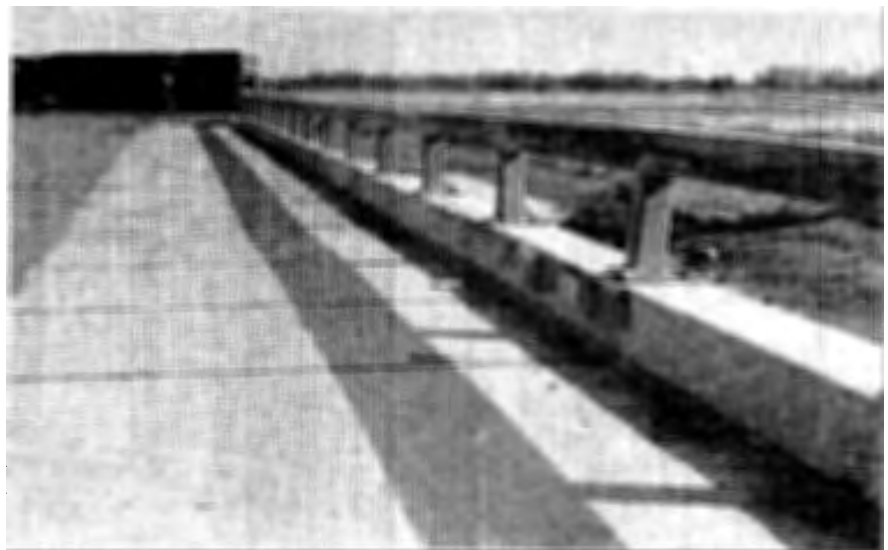
Figure 21. Photographs of Vehicle and Railing After Test 3451-4.

Bus after  
being  
uprighted

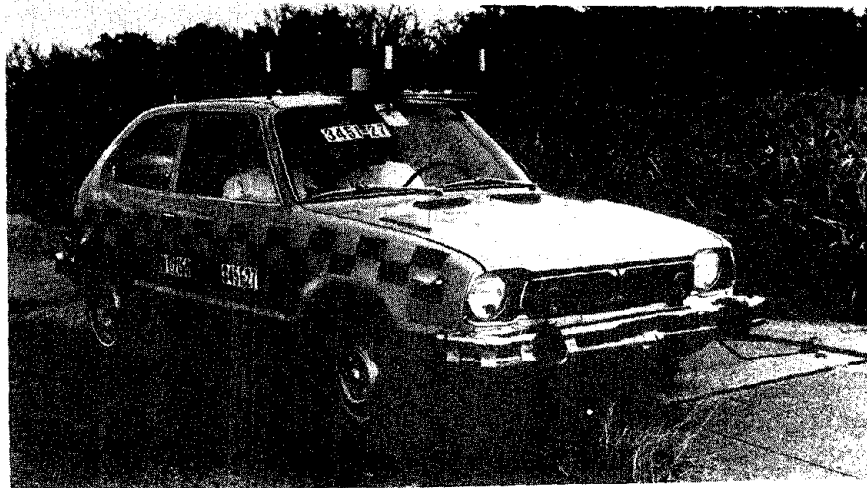
Figure 79. 1974 Honda.

1 lb = 0.454 kg
		1 in. = 0.025 m
Test Inertial Mass:	1,620 lb	
Dummy Mass:	330 lb	
Loose Ballast Mass:	0 lb	
Gross Static Mass:	1,950 lb	
Wheel Diameter:	21.5 in.	
Bumper Height:	16.5 in. to bottom	20.5 in. to top

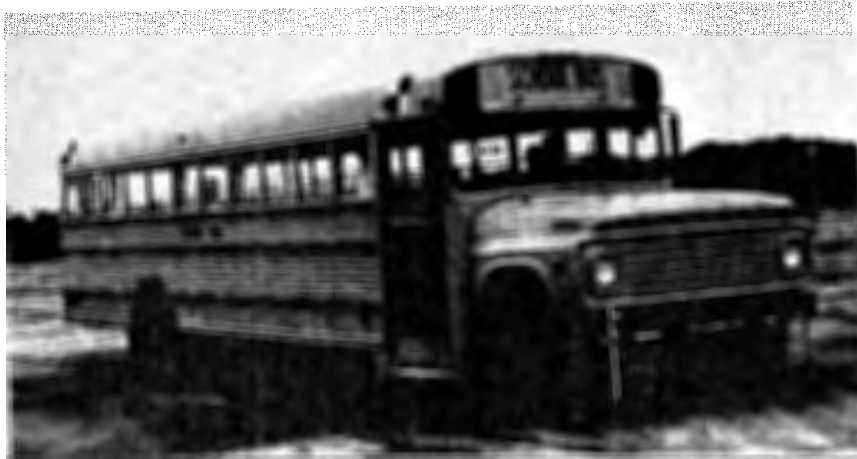
Figure 82 . 1970 Ford Sixty-Six Passenger School Bus.

Test Inertial Mass:	12,800 lb	1 lb = 0.454 kg
Dummy Mass:	495 lb	1 in. = 0.025 m
Loose Ballast Mass:	6,505 lb	
Gross Static Mass:	19,800 lb	
Wheel Diameter:	37 in.	
Bumper Height:	24.0 in. to bottom	32.0 in. to top

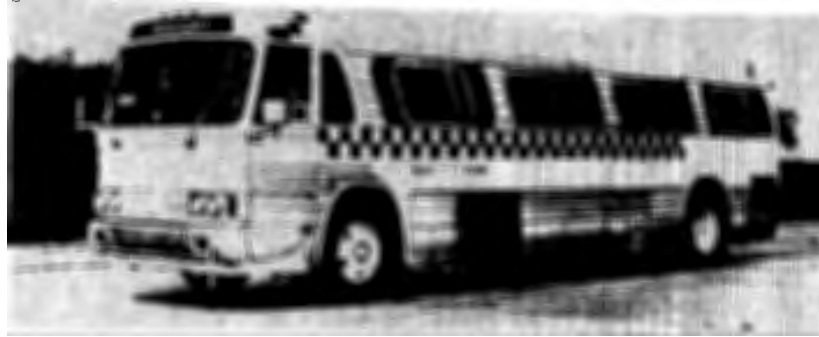
Figure 83 . 1962 GM PD4106 Coach.

Test Inertial Mass:	21,000 lb	1 lb = 0.454 kg
Dummy Mass:	495 lb	1 in. = 0.025 m
Loose Ballast Mass:	10,505 lb	
Gross Static Mass:	32,000 lb	
Wheel Diameter:	42 in.	
Bumper Height:	15.0 in. to bottom	27.0 in. to top
