1. Report No. FHWA/RD-87/049	2. Government Accession No. PB89 122576/AS	3. Recipient's Catalog No.													
4. Title and Subtitle BRIDGE RAIL DESIGNS AND PERFORMANCE STANDARDS Volume I: Research Report		5. Report Date February 1987													
		6. Performing Organization Code													
7. Author(s) M. E. Bronstad, J. D. Michie, L. R. Calcote, K. L. Hancock, J. B. Mayer, Jr.		8. Performing Organization Report No. 06-7908-1													
9. Performing Organization Name and Address Southwest Research Institute 6220 Culebra Road San Antonio, TX 78284		10. Work Unit No. 31T2-342													
		11. Contract or Grant No. DTFH61-84-C-00002													
12. Sponsoring Agency Name and Address Safety Design Division Federal Highway Administration 6300 Georgetown Pike McLean, VA 22101-2296		13. Type of Report and Period Covered Final Report Dec 1983 - Feb 1987													
		14. Sponsoring Agency Code													
15. Supplementary Notes FHWA Contract Manager (COTR): C. F. McDevitt (HSR-20)															
16. Abstract This project evaluated bridge railings. State bridge rail designs submitted to the Federal Highway Administration (FHWA) were rated and the best of each type were selecte

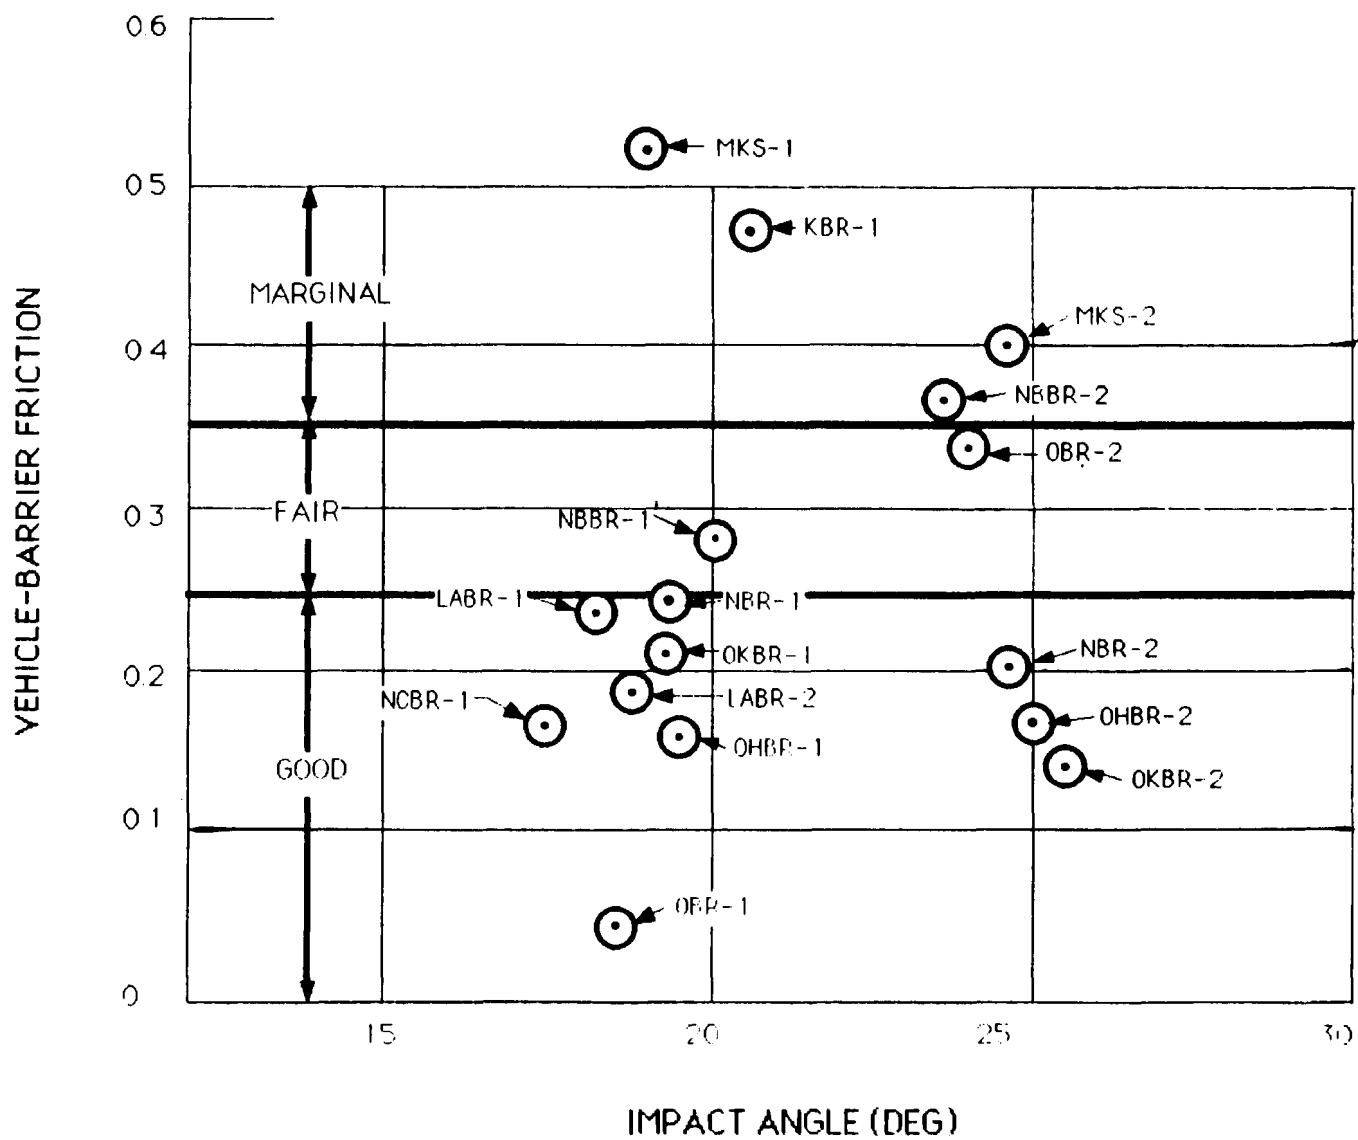
Figure 1. Vehicle-barrier friction.

$$(1) \quad \mu = \left[\frac{(\cos\theta - V_P/V_I)}{\sin\theta} \right]$$

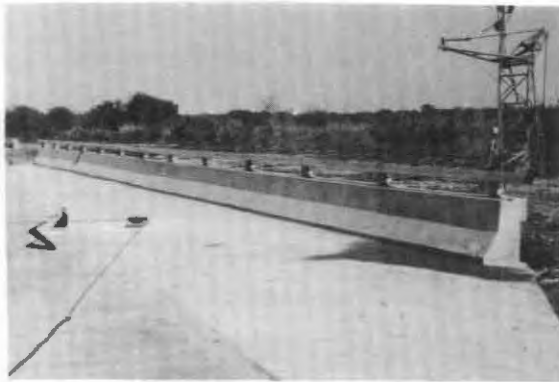
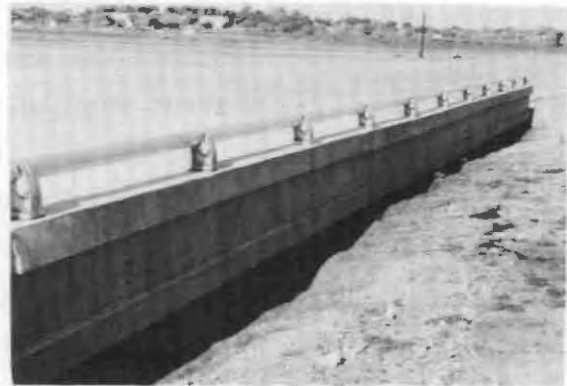
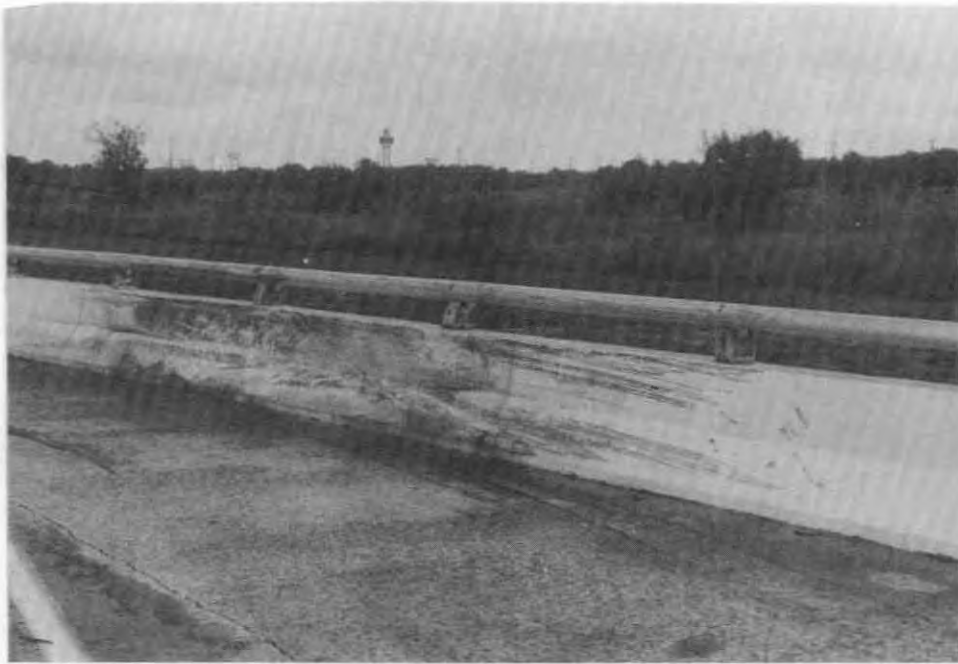
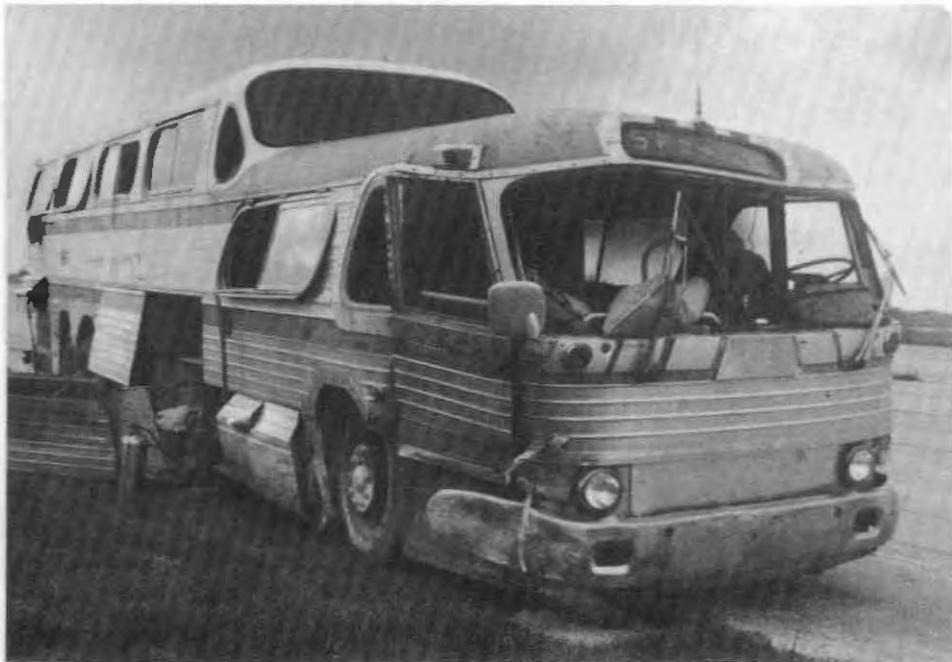
Figure 5. NBR series photographs.

After Test NBR-3.

NBR-3. The 40,000-lb (18,000-kg) intercity bus struck the barrier at 58.9 mph (94.8 km/h) and a 16.4-degree angle. As shown in figure 8, the vehicle rolled toward the barrier with a maximum angle of 55 degrees during the redirection. Although the bus lost contact with the concrete portion

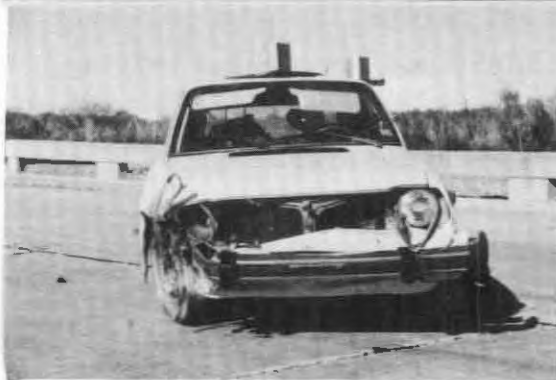
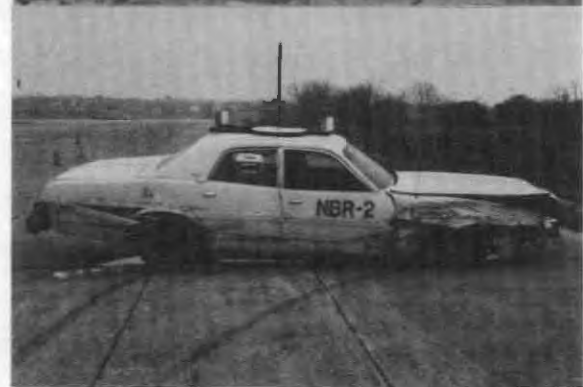
After Test NBR-1

After Test NBR-2

NBR-2. The 4650-lb (2109-kg) car struck the barrier at 61.4 mph (98.7 km/h) and a 24.9-degree impact angle as shown in figure 7. The vehicle remained in contact with the barrier for 11.6 ft (3.5 m) and the maximum roll angle was 9.5 degrees. As shown in figure 5, there was some vehicle contact with the upper railing although there was no railing damage.

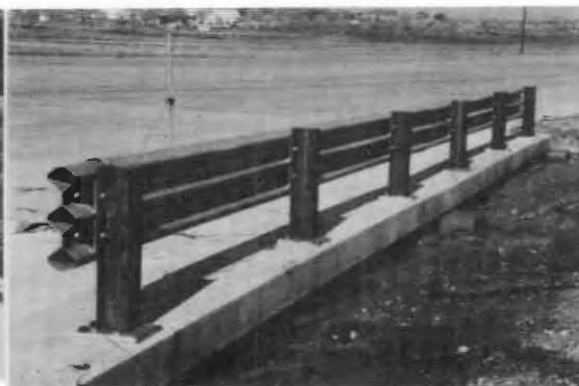
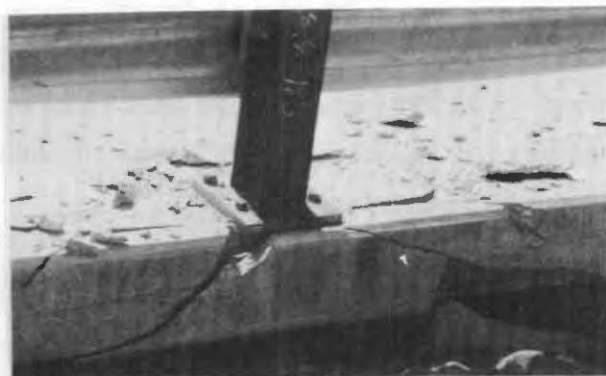
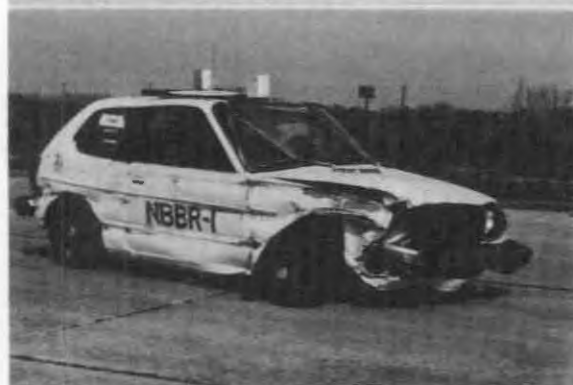
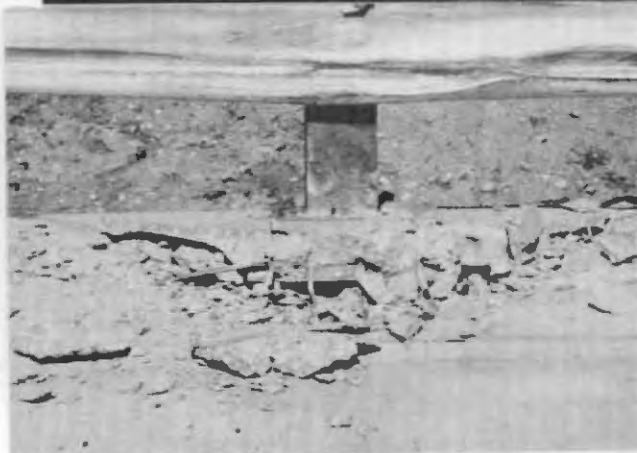
After Test NBBR-1

After Test NBBR-2

of the barrier after 30 ft (9.1 m), the side of the bus remained in contact with the aluminum railing from initial impact to the end of the system. Damage to the vehicle and barrier as shown in figure 5 included severe deformation of several posts with some permanent "set" in the railing.

NBBR-2. The 4700-lb (2132-kg) vehicle struck the barrier at 58.4 mph (94.0 km/h) and a 24.3-degree angle. The maximum dynamic deflection was 13 in (33 cm). The vehicle remained in contact with the barrier for 14.0 ft (4.3 m) before redirection as shown in figure 11. The vehicle maintained a smooth trajectory until a steep angle contact with another barrier system occurred. Damage to the barrier consisted of flattening and deformation of 2 sections of tubular thrie beam. The bridge deck anchorage was severely damaged as shown in figure 9.

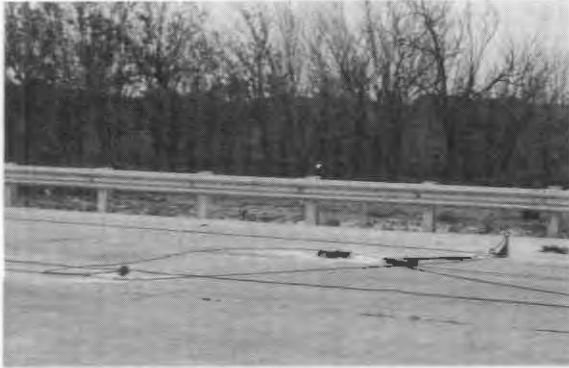
Figure 12. OHBR series photographs.

OHBR Test Installation

Two tests were conducted on the box beam/steel post system shown in figure 12. The 4x6 box beam is mounted on W6x25 posts spaced at 6-ft 3-in (1.9-m) centers, mounted on the deck edge. A standard W-beam is placed on the traffic side of the box beam.

OHBR-1. The 1980-lb (898-kg) vehicle struck the barrier at 60.6 mph (97.5 km/h) with a 19.6-degree angle as shown in figure 13. The vehicle remained in contact with the barrier for 7.8 ft (2.4 m) during redirection. One section of W-beam sustained minor deformation as shown in figure 12. Vehicle damage is also shown in figure 12.

OHBR-2. The 4790-lb (2172-kg) vehicle struck the barrier at 60 mph (97 km/h) and a 25-degree angle as shown in figure 14. The vehicle was in contact with the barrier for 12 ft (3.7 m) during redirection. One section of W-beam sustained deformation and the lower corrugation was torn as shown in figure 12. Some bridge deck damage occurred at post 4. Damage to the vehicle and barrier is shown in figure 12.

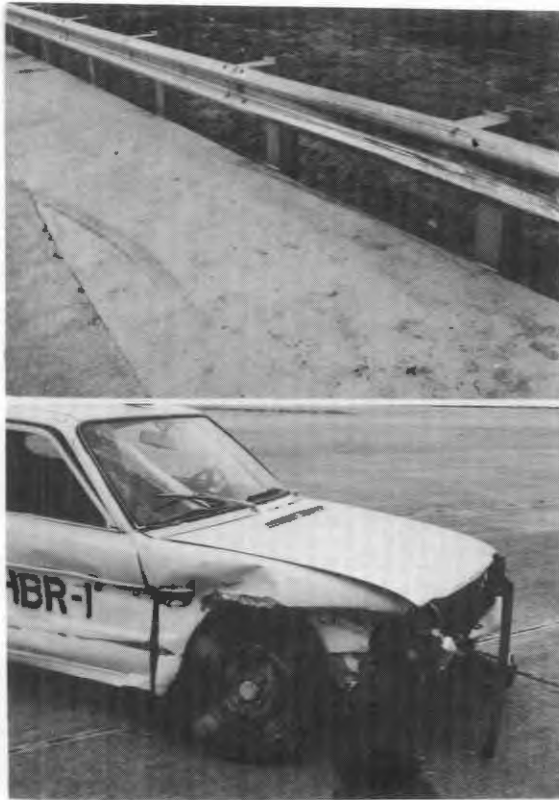
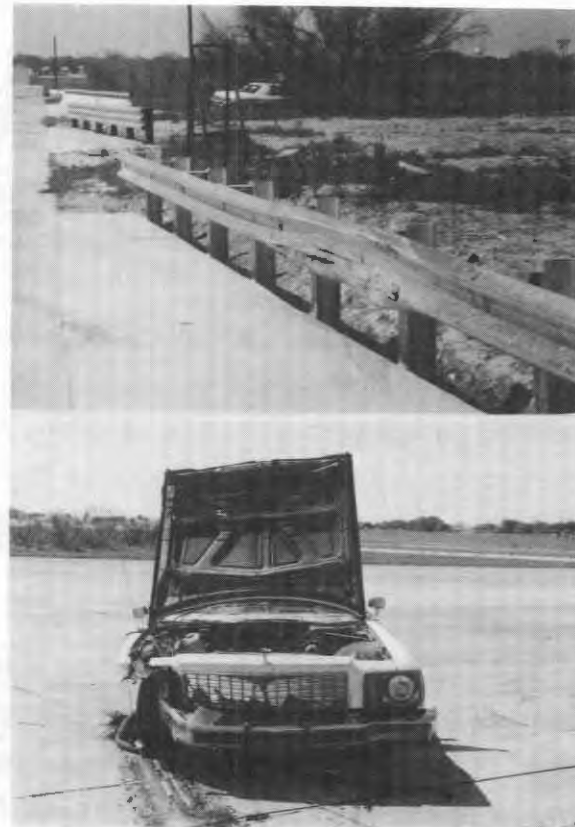
After Test OHBR-1

After Test OHBR-2

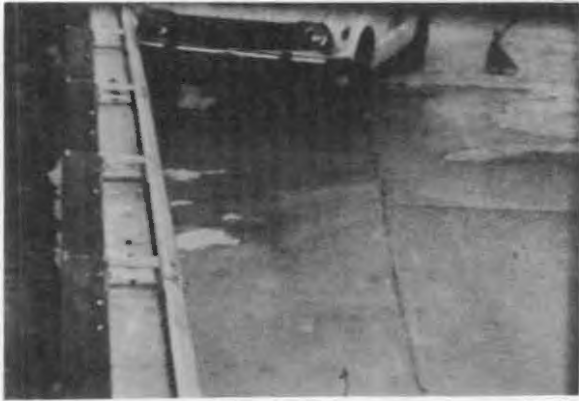
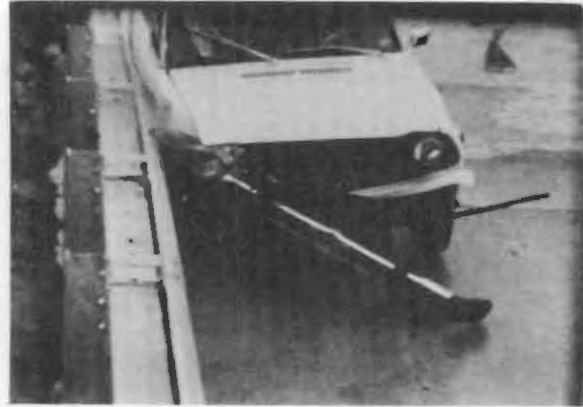
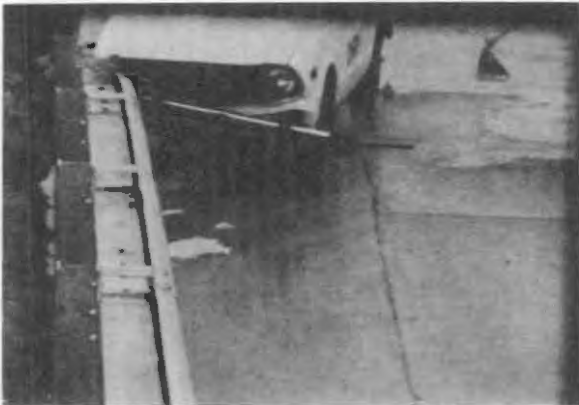
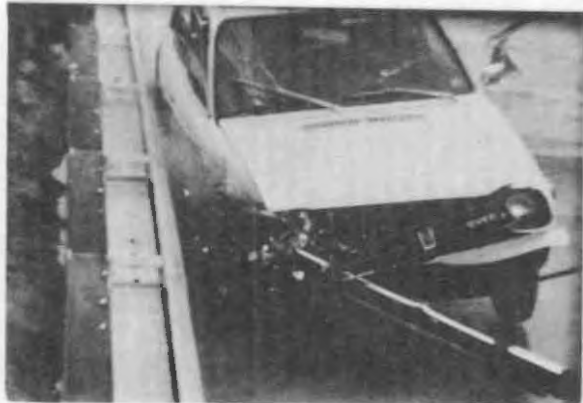
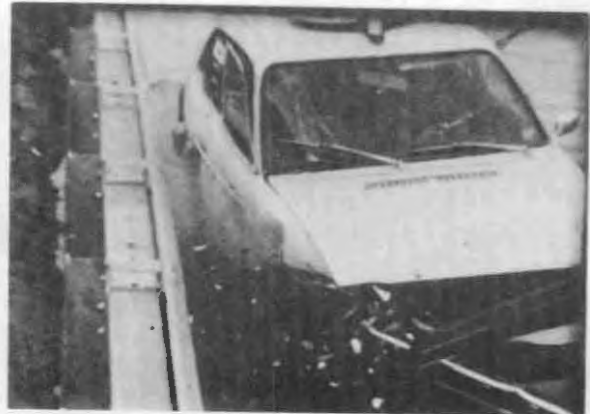
Figure 13. Sequential photographs, Test OHBR-1.

IMPACT

.15 sec

.05 sec

.20 sec

.25 sec

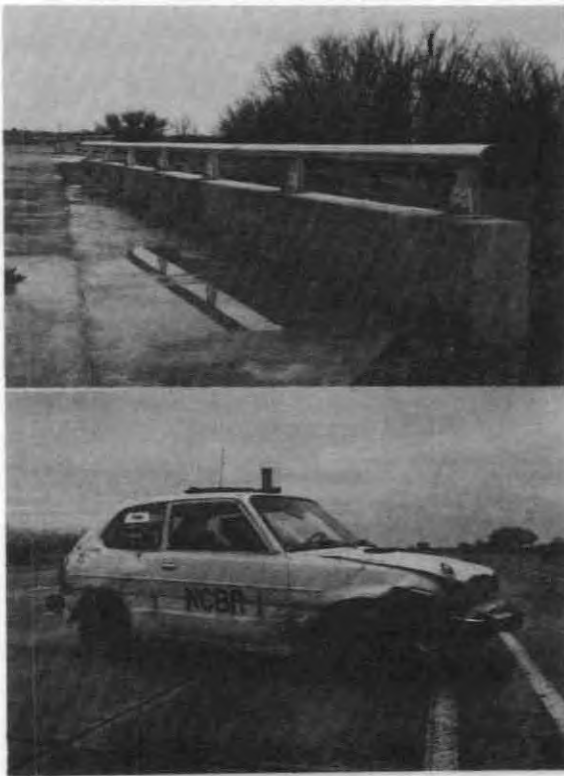
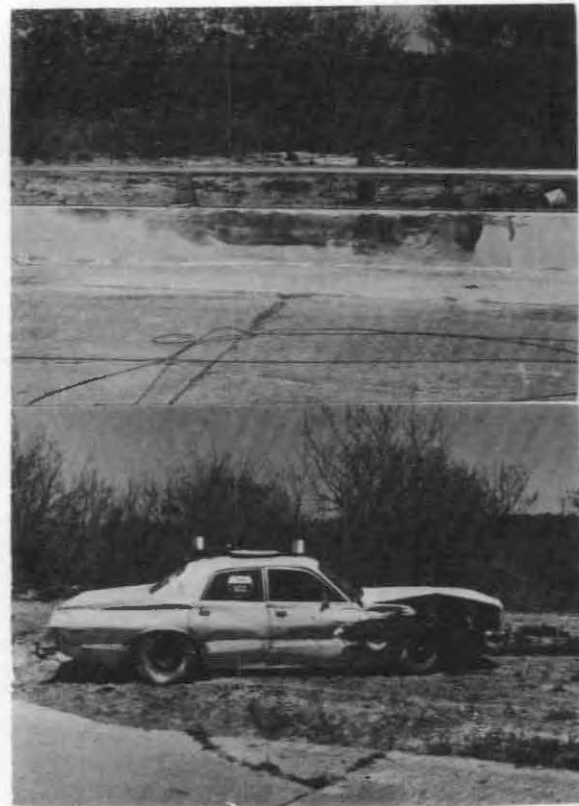
Figure 15. NCBR series photographs.

After Test NCBR-1

After Test NCBR-2.

NCBR-1. The 1990-lb (903-kg) vehicle struck the barrier at 59.7 mph (96.0 km/h) and an angle of 18 degrees as shown in figure 16. The vehicle remained in contact with the barrier for 7.5 ft (2.3 m) during redirection. There was no barrier deflection or damage as shown in figure 15. Vehicle damage is also shown in figure 15.

NCBR-2. The 4660-lb (2113-kg) vehicle struck the barrier at 60 mph (97 km/h) and a 25-degree angle as shown in figure 17. The vehicle remained in contact with the barrier for 12.6 ft (3.8 m) during redirection. There was no barrier deformation or damage as shown in figure 15. Vehicle damage is also shown in this figure.

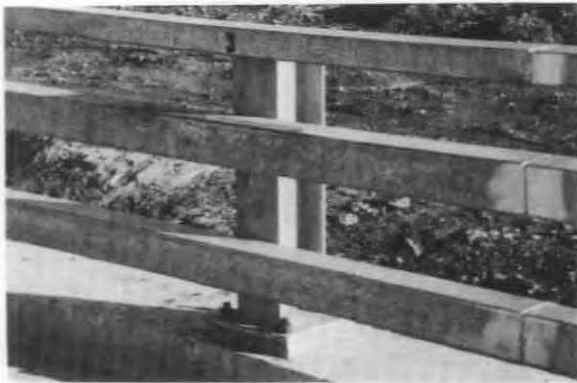
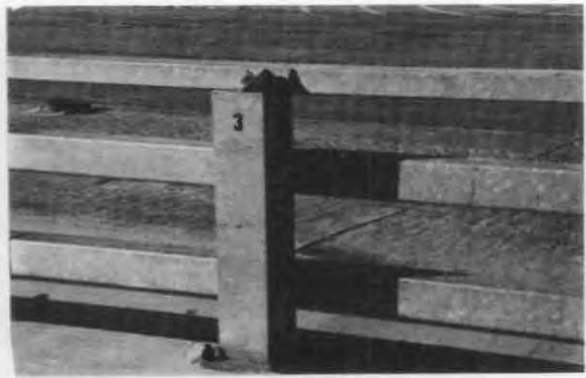
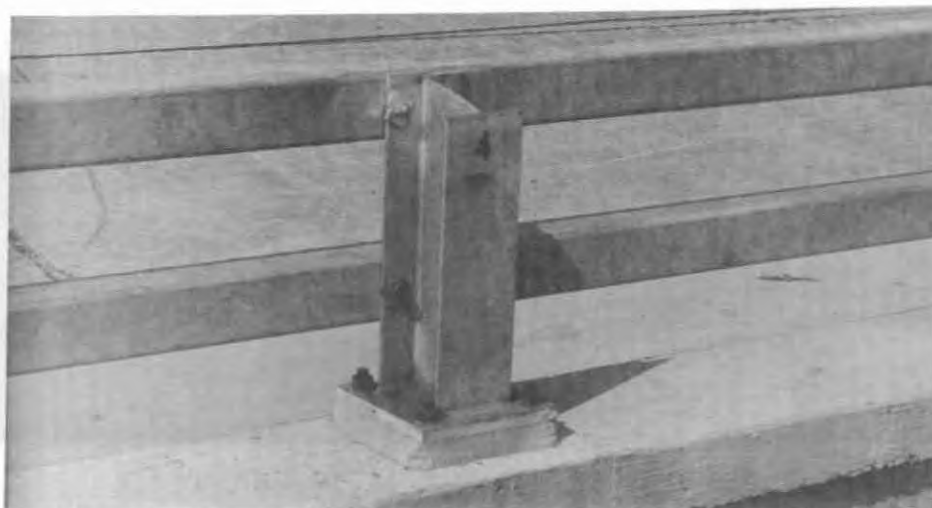
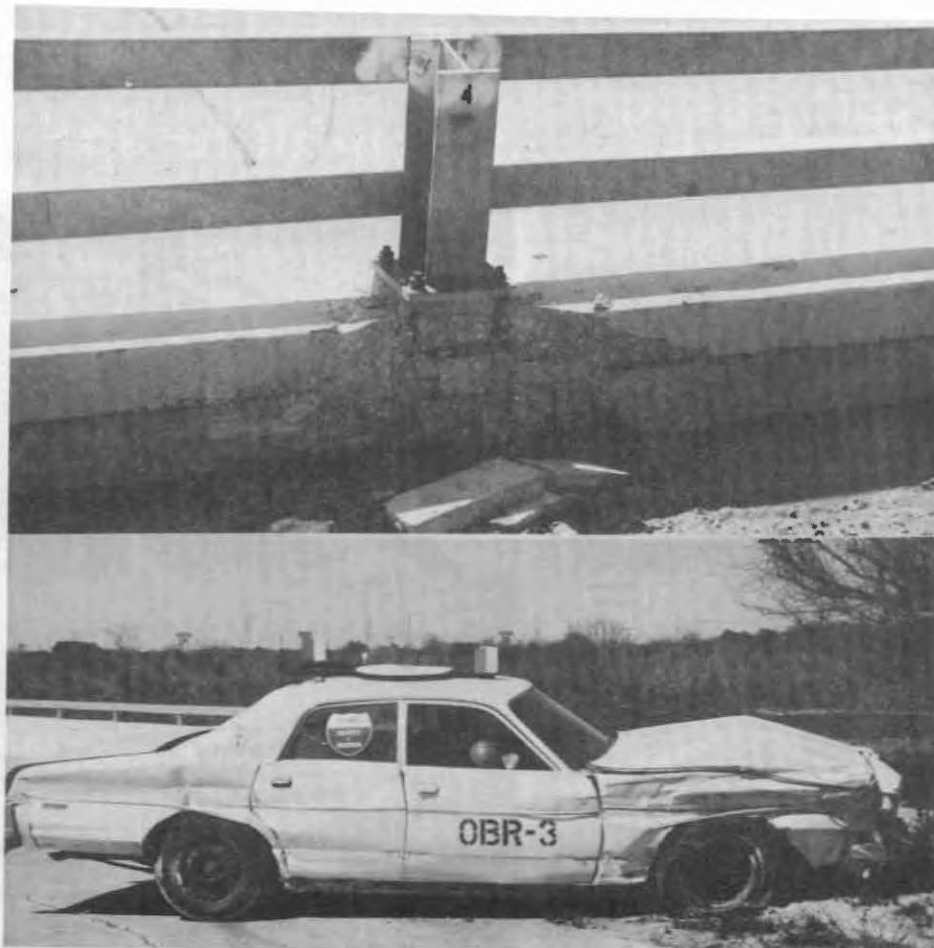
Figure 18. OBR series photographs.

OBR Test Installation

OBR-3 Test Installation

After Test OBR-3

OBR-2. The 4760-lb (2159-kg) vehicle struck the barrier at 60.8 mph (98.0 km/h) and a 24.3-degree impact angle as shown in figure 20. During the impact the hood snagged on post 3 between the upper and middle rails, causing detachment from the right hinge. The detachment allowed the hood to translate rearward and penetrate the windshield on the passenger side. The vehicle remained in contact with the barrier for 9.5 ft (2.9 m) during redirection. The maximum dynamic deflection was not obtained; the maximum permanent deflection was 5.5 in (14.0 cm) at the middle railing. The lower two railings were permanently deformed and the slab was extensively damaged at posts 2 and 3. The vehicle and barrier damage are shown in figure 18.

OBR-3. Based on the previous hood snagging results the top railing was removed and posts shortened for this test. The 4640-lb (2104-kg) vehicle struck the barrier at 60 mph (97 km/h) and a 25-degree impact angle as shown in figure 21. The vehicle remained in contact with the barrier for 11.3 ft (3.4 m) during redirection. The maximum dynamic deflection was not obtained, but the upper rail was permanently deformed 2.0 in (5.1 cm). Both rails were deformed in the impact area and the deck was fractured behind post 4 as shown in figure 18. Vehicle damage is shown in figure 18.

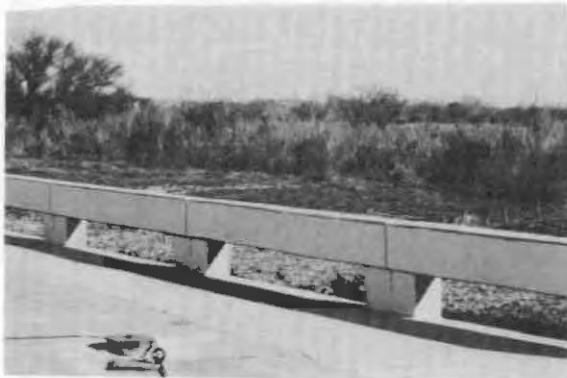
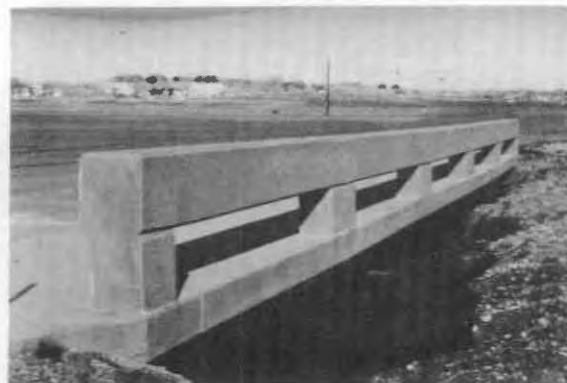
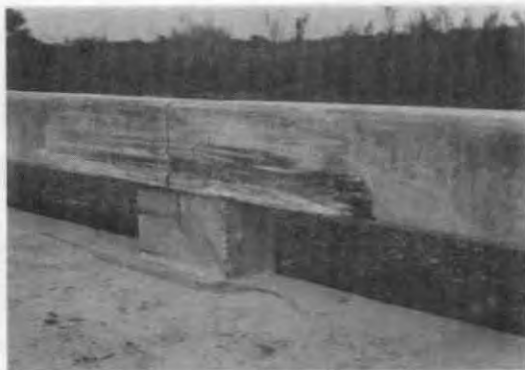
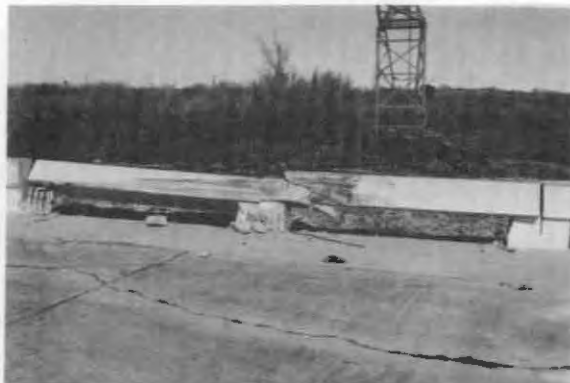
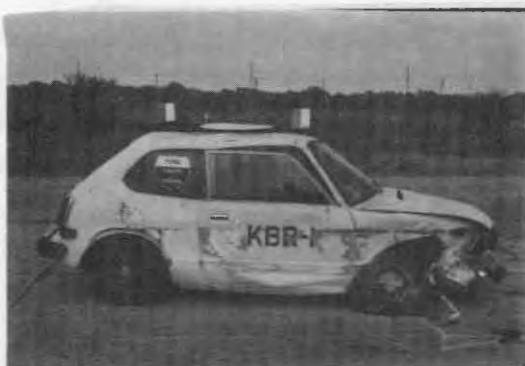
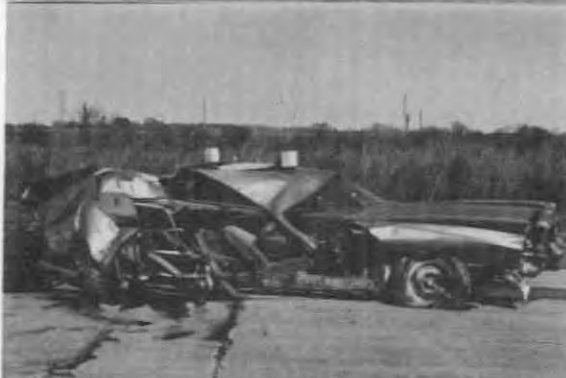
Figure 22. KBR series photographs.

KBR Test Installation

After Test KBR-1

After Test KBR-2

The system as shown in figure 22 is a concrete beam/post design. A unique feature of this design is the 0.5-in (1.3-cm) gap between post segments as shown. Two tests were conducted on this system.

KBR-1. The 1971-lb (894-kg) vehicle struck the barrier at 61.9 mph (99.5 km/h) and 20.3-degree impact angle as shown in figure 23. The vehicle remained in contact with the railing for 7.5 ft (2.3 m) during redirection. Front tire/wheel contact with the edge of post 5 was noted. Vehicle and barrier damage are shown in figure 22.

KBR-2. The 4660-lb (2113-kg) vehicle struck the barrier at 60.5 mph (97.3 km/h) and 24.0-degree impact angle as shown in figure 24. The concrete beam and posts 3A and 3B began to fracture at 0.07 seconds after impact. After these failures, the vehicle snagged on post 4B, causing the entire right side of the vehicle to be removed. This caused passenger compartment intrusion by the beam. The passenger dummy was ejected from the vehicle and decapitated. The vehicle initial contact was for 15.4 ft (4.7 m) and the vehicle recontacted the barrier at post 6 before coming to rest 9.5 ft (29 m) from the point of impact. As shown in figure 22, both vehicle and barrier were extensively damaged.

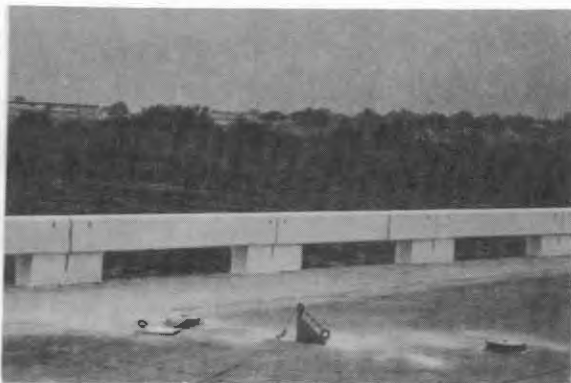
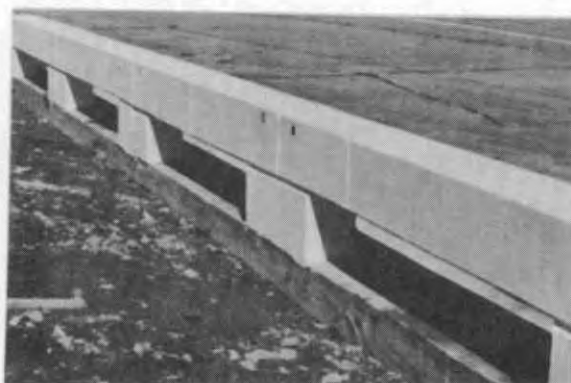
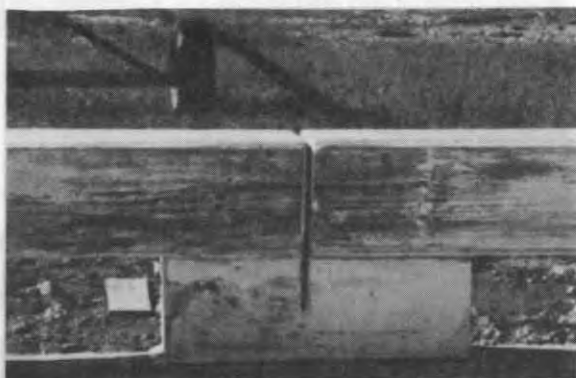
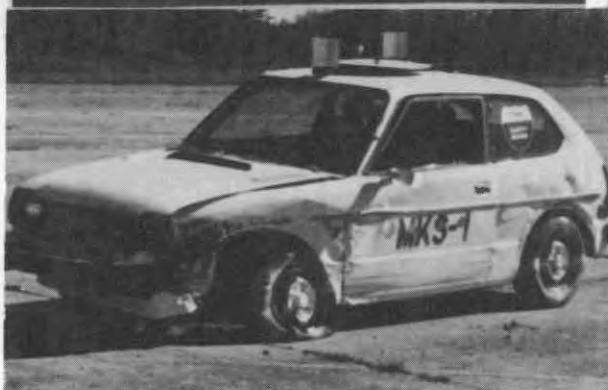
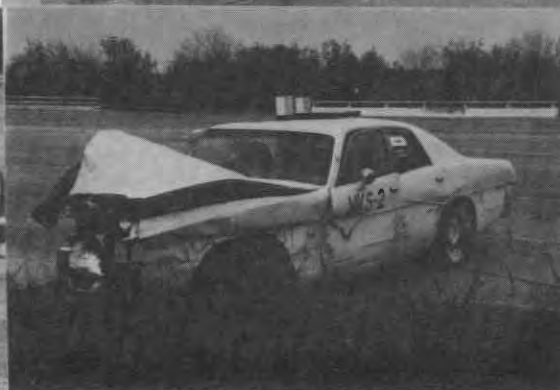
Figure 25. MKS series photographs.

MKS Test Installation

After Test MKS-1

After Test MKS-2

This design is a modification of the KS design which basically consisted of adding longitudinal beam steel and stirrups in both beam and posts. The 0.5 in (1.3 cm) gap remained a part of the design as shown in figure 25.

redirection. There was tire/wheel contact on the edge of post 4. There was no damage to the barrier. Vehicle damage is shown in figure 25.

MKS-2. The 4690-lb (2127-kg) vehicle struck the barrier at 59.2 mph (95.3 km/h) and 24.9-degree impact angle as shown in figure 27. The vehicle remained in contact with the barrier for 12.2 ft (3.7 m) during redirection. There was no evidence of wheel contact with a post edge. There was no significant damage to the barrier. Vehicle and barrier photographs after the test are in figure 25.

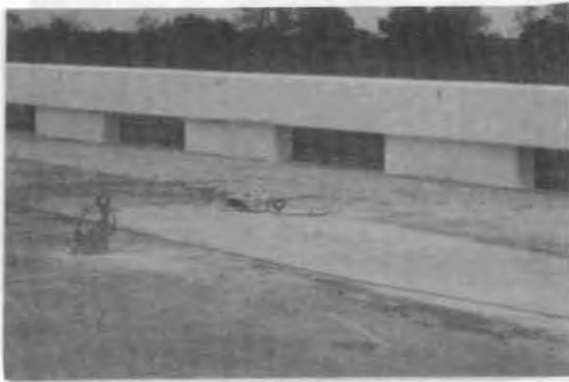
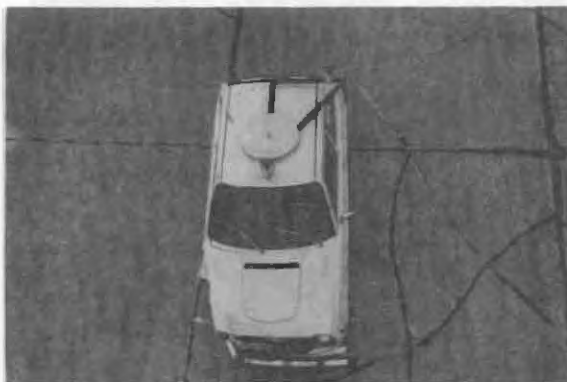
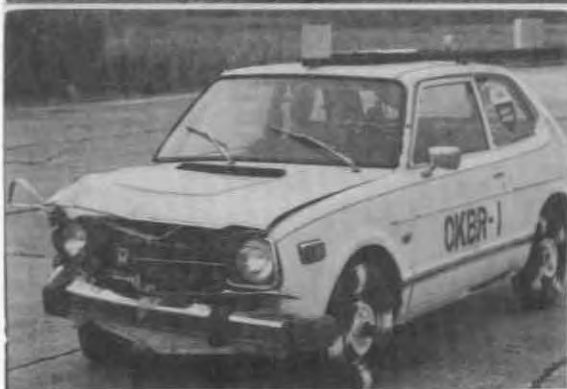
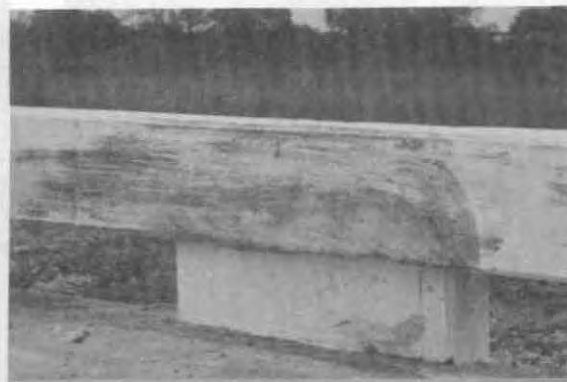
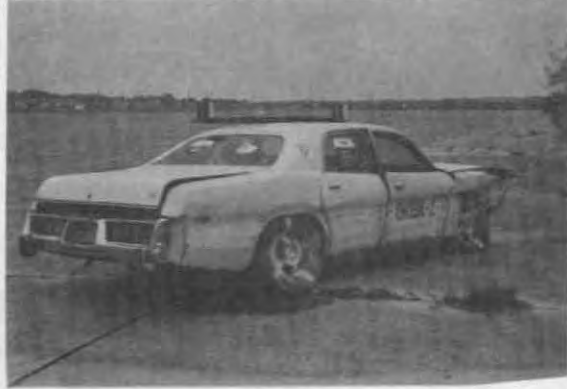
Figure 28. OKBR series photographs.

OKBR Test Installation

After Test OKBR-1

After Test OKBR-2

This series evaluated a concrete beam/post system shown in figure 28 which was similar to the KS and MKS in geometry, but with some significant differences:

OKBR-1. The 1980-lb (898-kg) vehicle struck the barrier at 58.7 mph (94.5 km/h) and 18.9-degree impact angle as shown in figure 29. The vehicle remained in contact with the barrier for 9.1 ft (2.8 m) during redirection. There was no evidence of tire/wheel contact with a post edge. There was no barrier damage; vehicle damage is shown in figure 28.

There were some hairline cracks on the backside of the beam and diagonal shear cracks were also noted in the deck from the front face of post 3 to the rear of the deck. Vehicle and barrier photographs after the test are in figure 28.

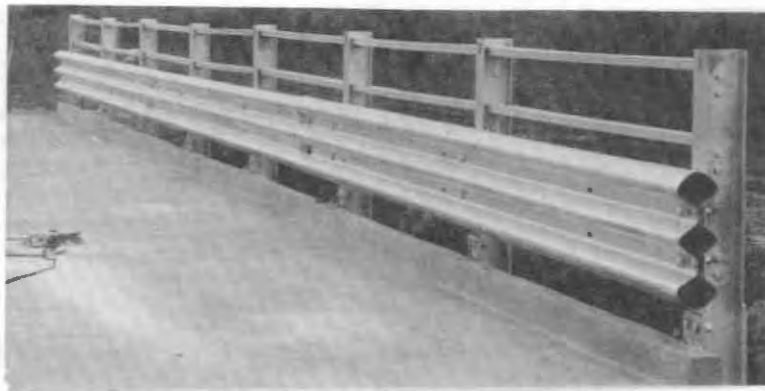
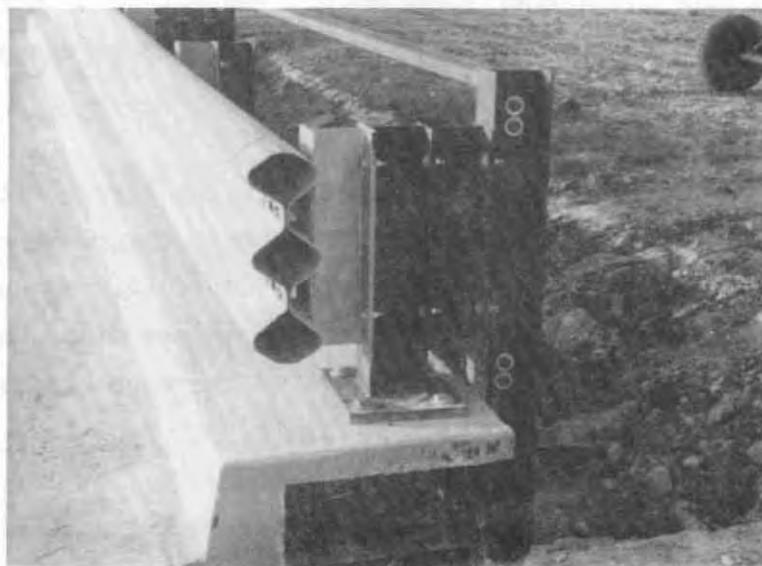
Figure 31. LABR series test installations.

LABR-1 & 2 Test Installation

LABR-3 Test Installation

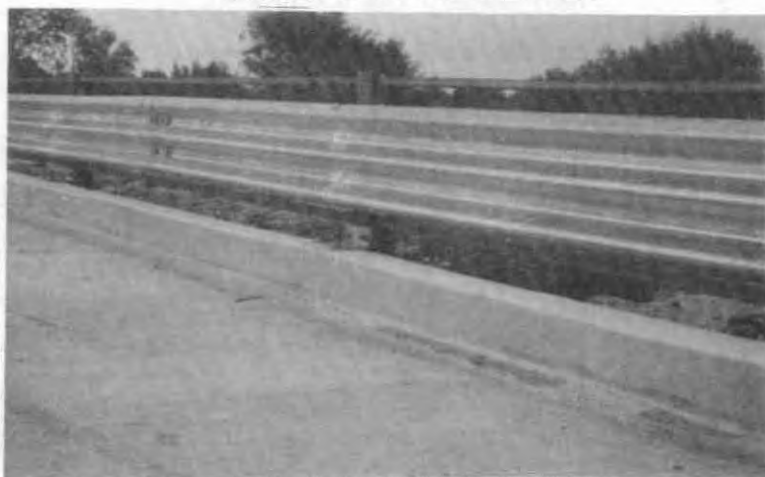
LABR-4 Test Installation

This series of tests evaluated three different barrier configurations involving a tubular thrie beam retrofit of an existing ballaster rail as shown in figure 31. The first configuration was evaluated for both minicar and full-size sedan impacts. The last two configurations were evaluated for minicar performance only.

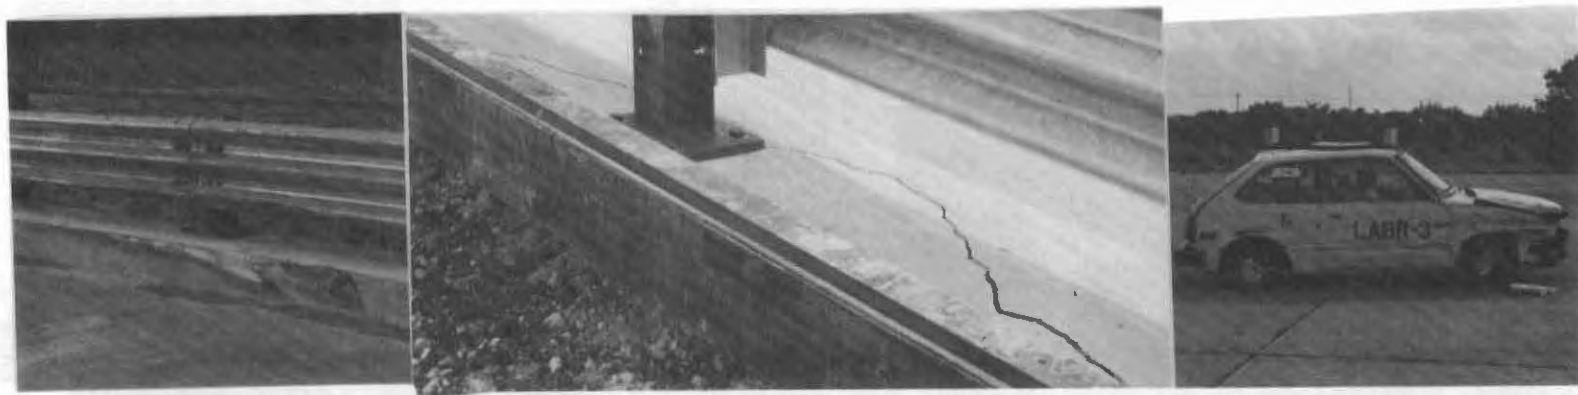
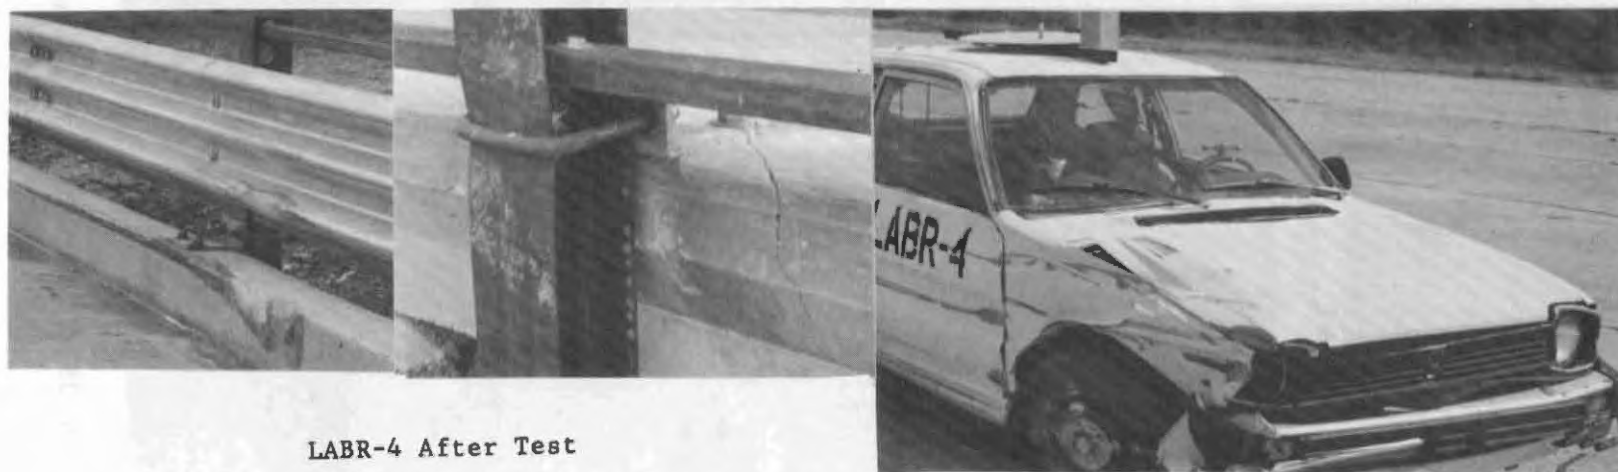
Figure 36. LABR-3 and LABR-4 series photographs.

LABR-3 After Test

LABR-4 After Test

LABR-3. This test evaluated the retrofit #2 installed with a safety walk. The 1990-lb (903-kg) vehicle struck the barrier at 59.7 mph (96.0 km/h) and an angle of 18.7 degrees. The vehicle was redirected as shown in figure 35 with a maximum barrier deflection of 3.0 in (7.6 cm). Damage to the retrofit system was minimal with the exception of significant cracking of the sidewalk as shown in figure 36.

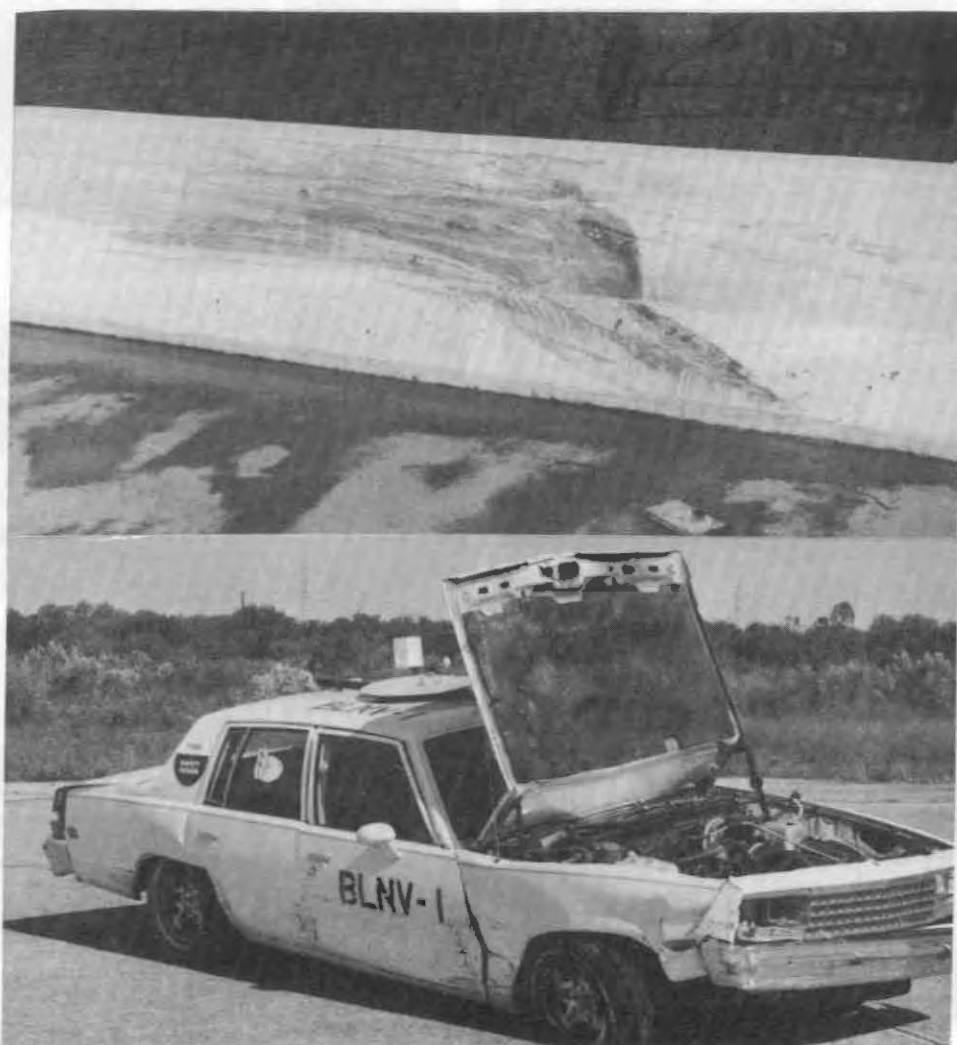
Figure 38. 3400-lb vehicle baseline series photographs.

BLNV Test Installation

BLNV-1 After Test

- BLNV-1. The aluminum railing from the NBR series was removed and the height of the concrete safety shape (New Jersey) increased to 32 in (80 cm) for the tests as shown in figure 38.

- The 3380-lb (1534-kg) vehicle struck the barrier at 62.3 mph (100.2 km/h) and a 19.6-degree impact angle as shown in figure 39. The vehicle remained in contact with the barrier for 10.5 ft (3.2 m) before smooth redirection at a 1.8-degree angle. The maximum vehicle roll angle was 12 degrees (away from the barrier). No damage occurred to the barrier; damage to the vehicle is shown in figure 38.

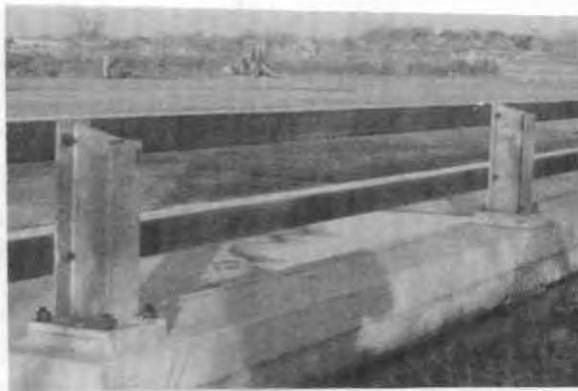
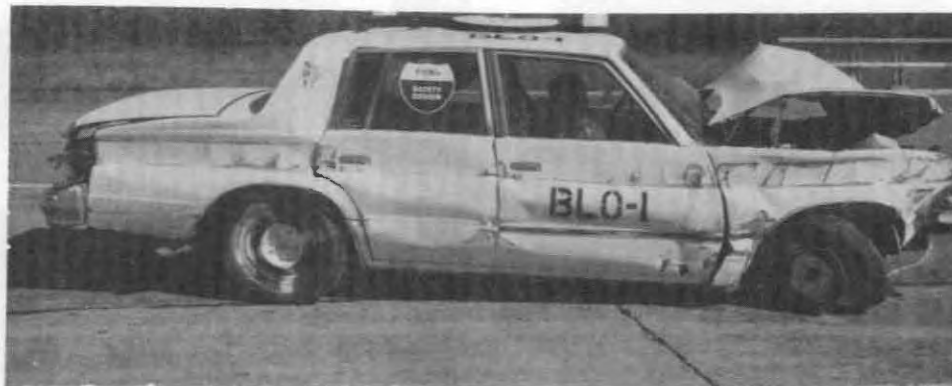
Figure 38. 3400-1b vehicle baseline series photographs (continued).

BLO After Test

- The 3450-lb (1566-kg) vehicle struck the barrier at 62.5 mph (100.6 km/h) and an angle of 20.7 degrees. As shown in figure 40, the vehicle was smoothly redirected after a maximum dynamic deflection of 3.9 in (10.0 cm). Damage to the vehicle and barrier are shown in figure 38.

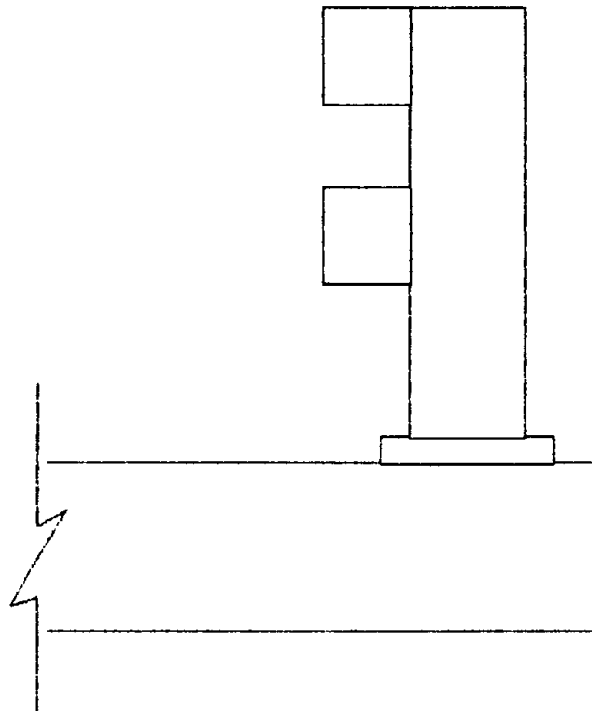
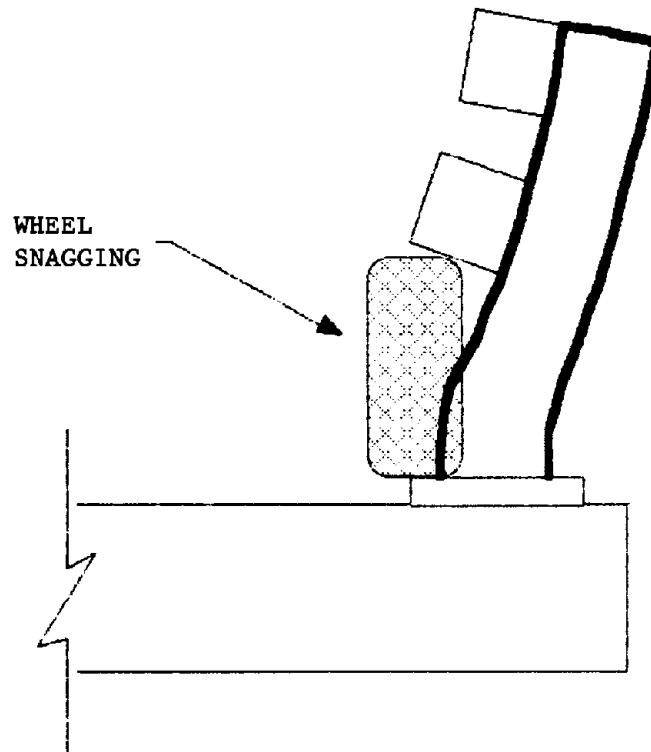
Figure 42. Flexible barrier considerations.
122

(a) Bridge rail system

(b) Ductile post resulting in reduction in setback distance

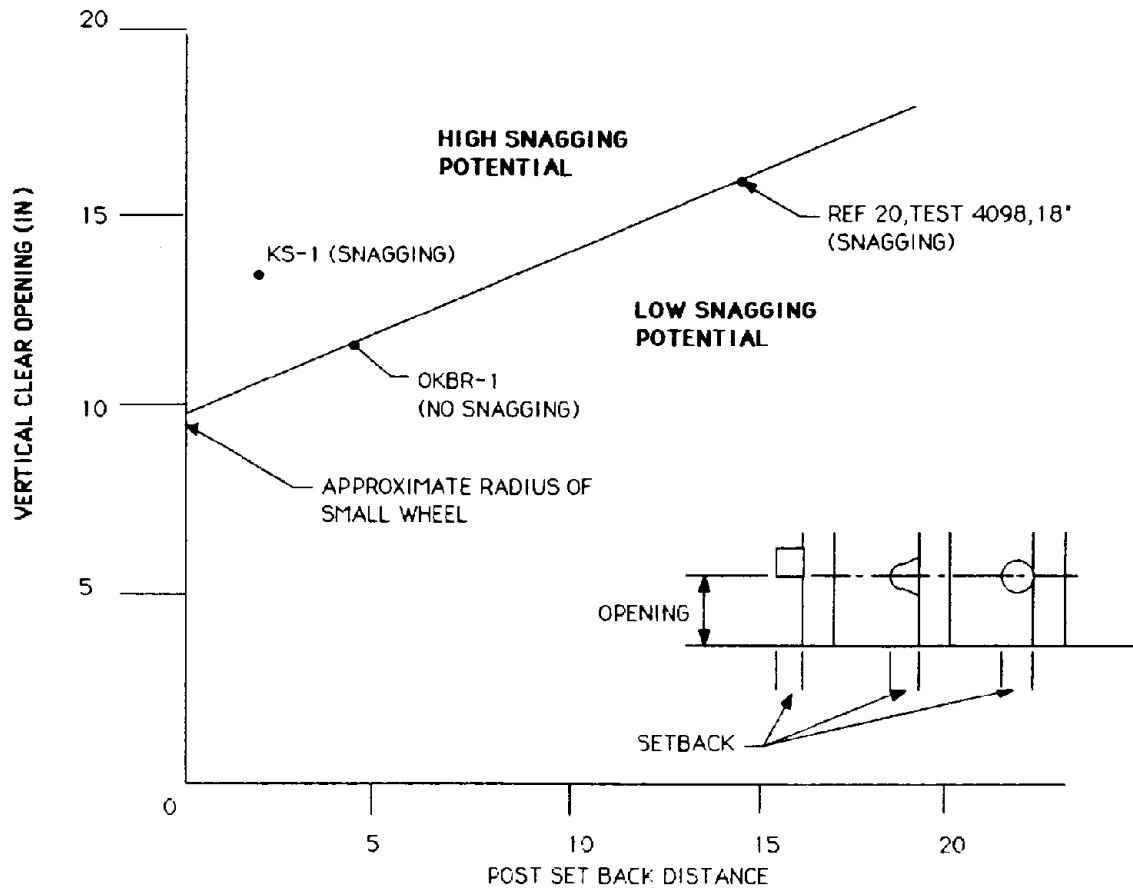
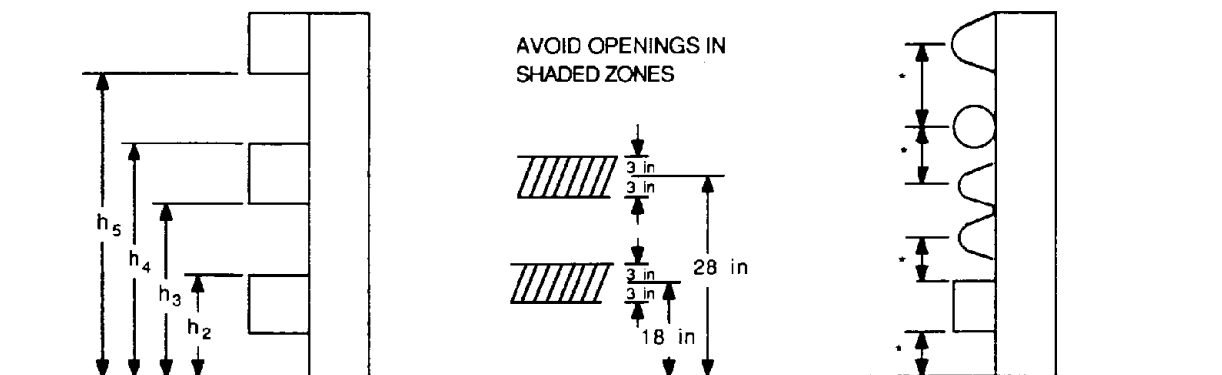
(a) Lower Opening Considerations (Based on Honda Civic Front Wheel for Test Conditions up to 60 mph [95 km/h] and 20 degrees)

NOTE: HOOD SNAGGING OBSERVED AT

$h_2 = 33$ in, $h_3 = 54$ in (TTR-8, Ref 21)
