RESEARCH REPORT

Long-term Performance of HES Class 50AF Concrete with Polypropylene Fibers as Field-Cast Connection between Deck Bulb-T Girders in SH-36 Bridge over Bear River

RP 288

September 2022

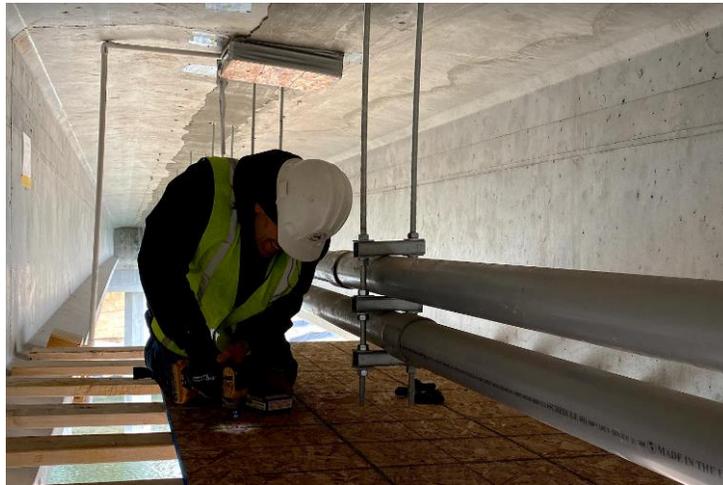
During the loading and data acquisition of Phase 2 of the project, the research team relied on the platforms installed by the contractor. For the current phase (Phase 3), since the contractor's platforms were removed, as shown in Figure 2-1 and Figure 2-2 in February 2020, new platforms were installed in order to have access to the instrumentation. Figure 2-1 also shows an instrumented box, where the steel bar strain gage wires exit below deck and where the concrete strain gages were located. There were four instrumented boxes, one in each closure pour. The boxes were located approximately 20 feet (ft) from the south abutment and directly above the middle of each 16-ft platform. The south abutment can be seen in Figure 2-2.

Figure 2-1 Access platform installation

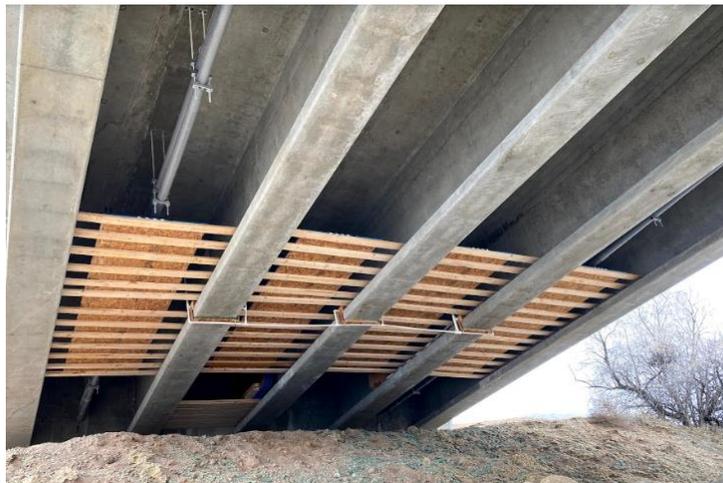
Figure 2-2 Installed access platform

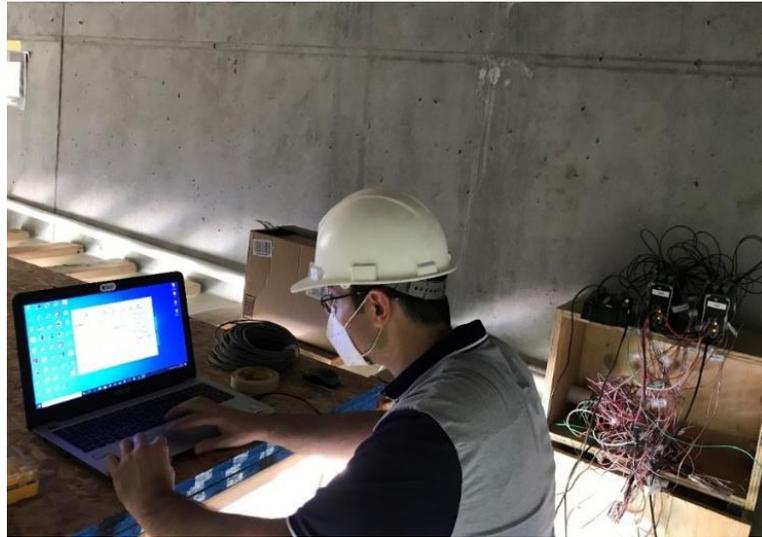
For each set of UBIT loading (i.e., while collecting data for Tests 1 to 6), the traffic was stopped on both directions. One person communicated with the person in charge of the data acquisition under the bridge (see Figure 2-7) and the person guiding the UBIT (see Figure 2-8). In order to place the front wheel of the UBIT on the instrumented part of the closure pours, these locations were marked on top of the bridge deck. One of these marks is shown in Figure 2-8.

Figure 2-7 Data acquisition system under the bridge

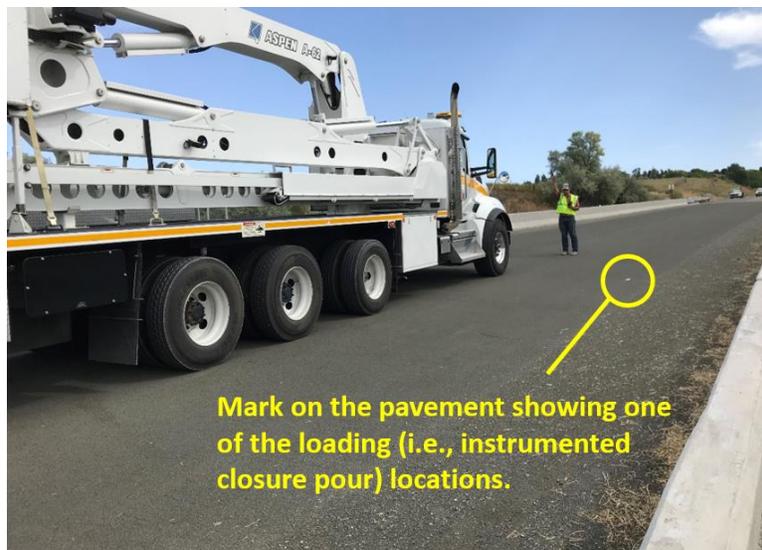
Figure 2-8 UBIT loading position for Test 3

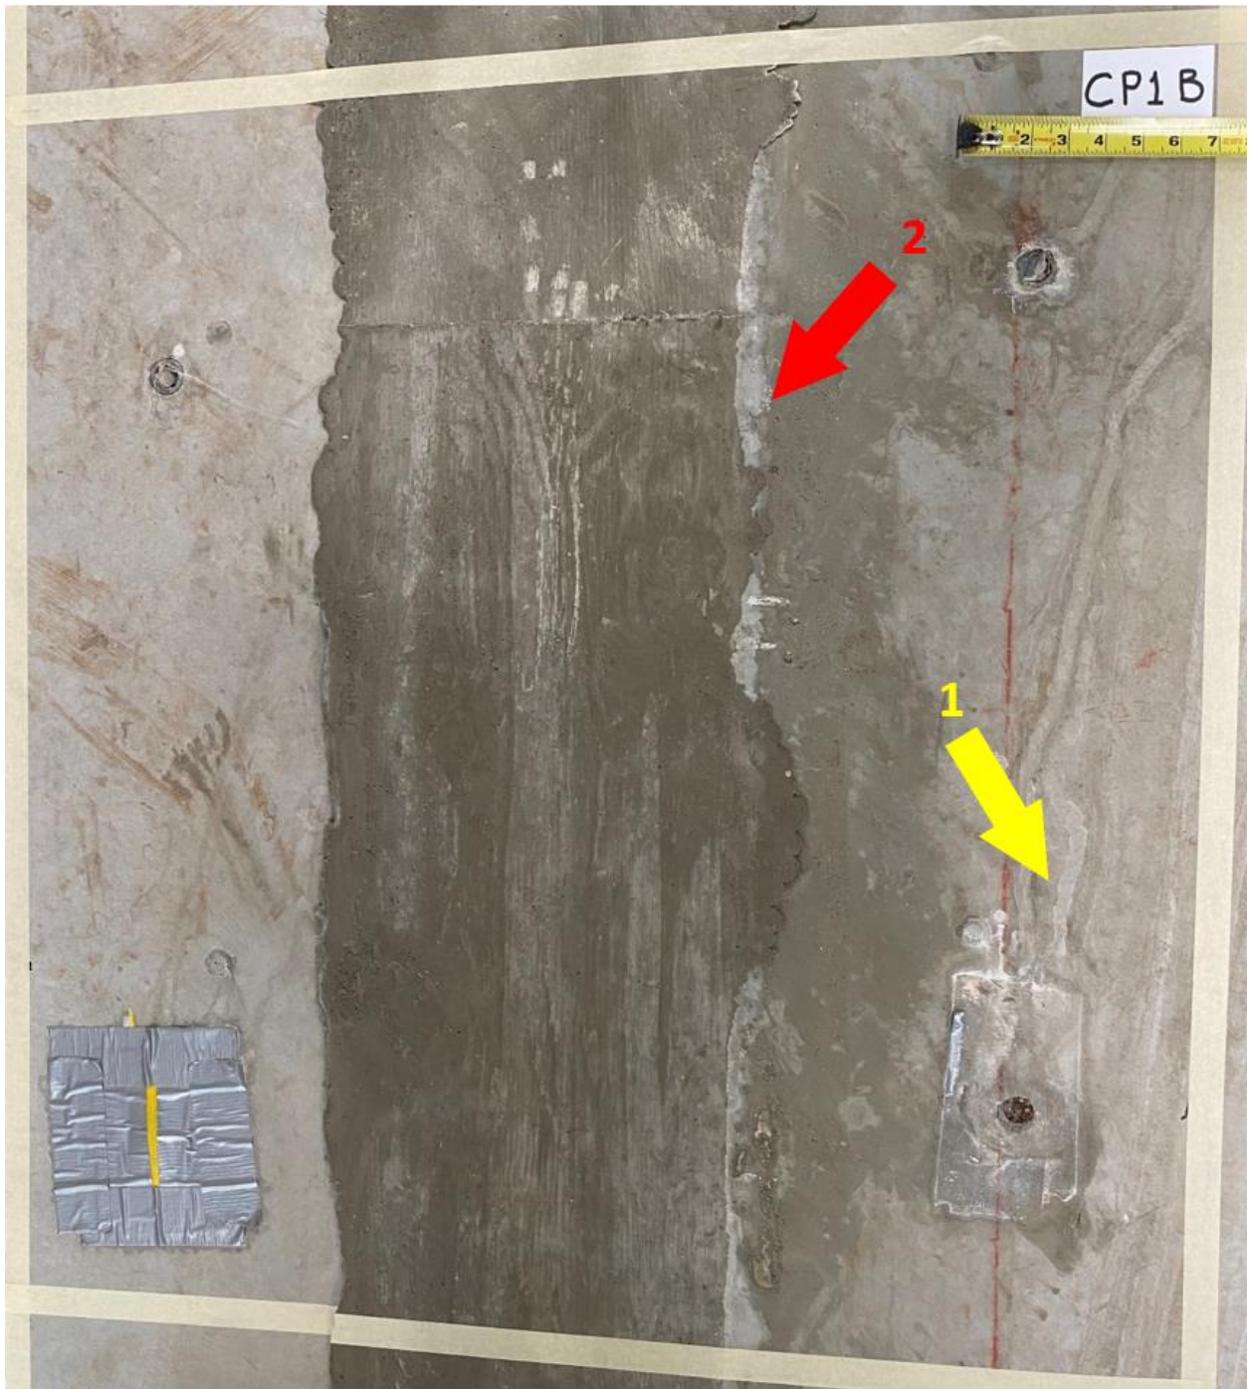
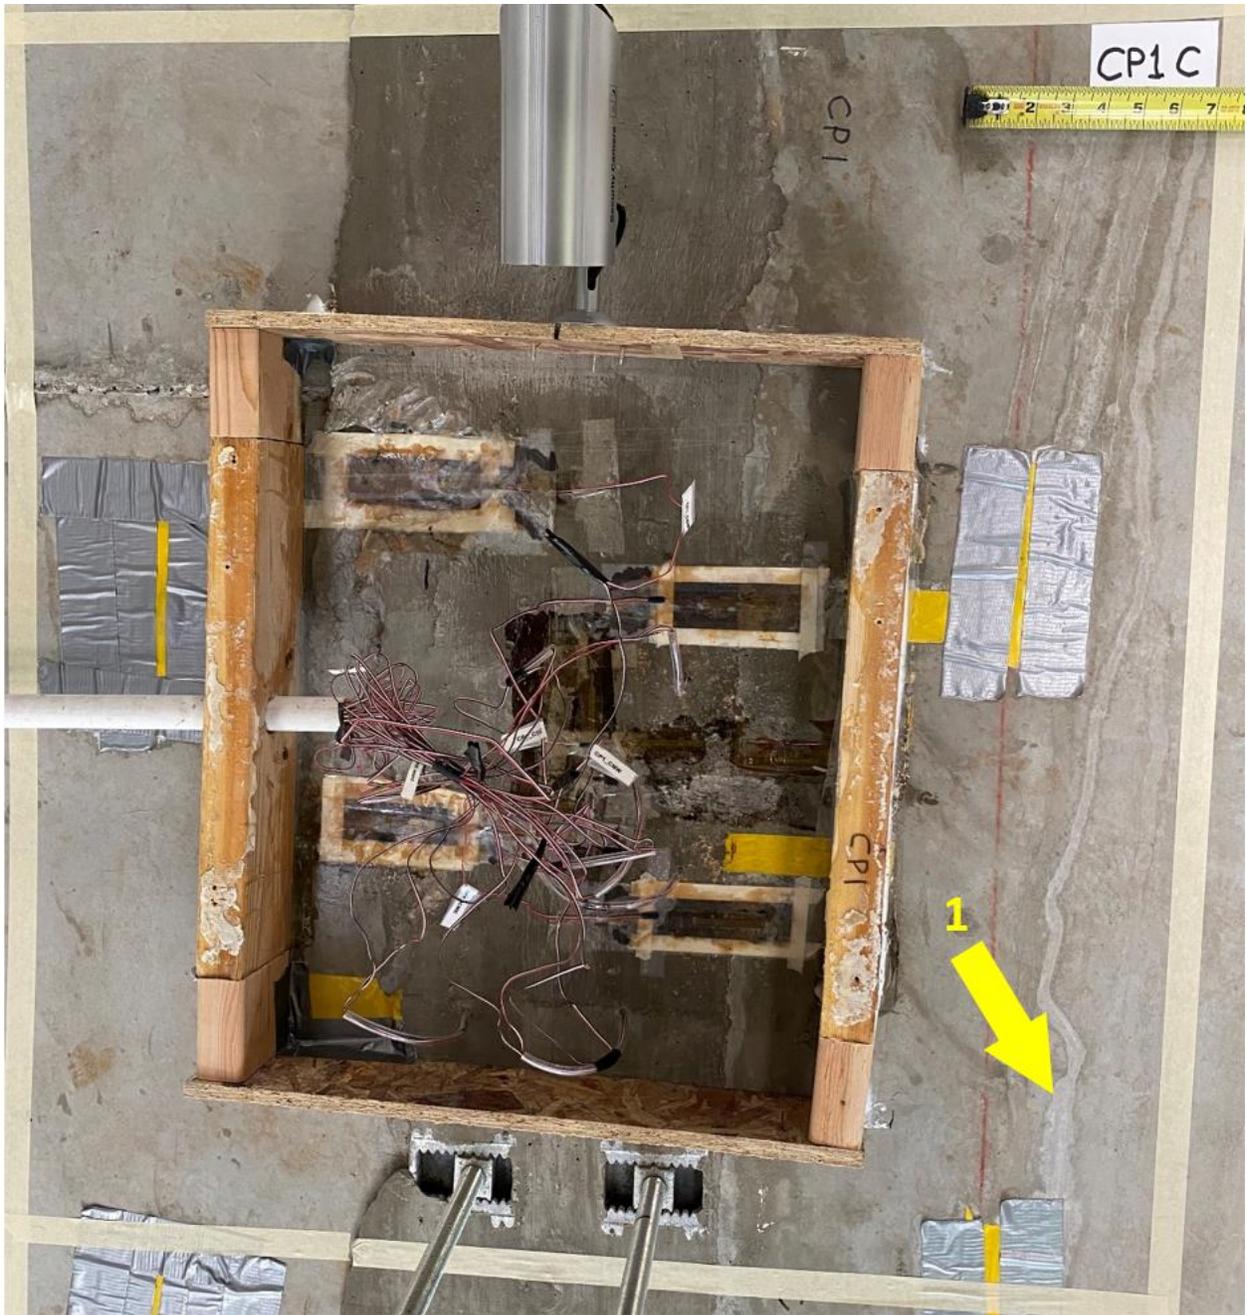
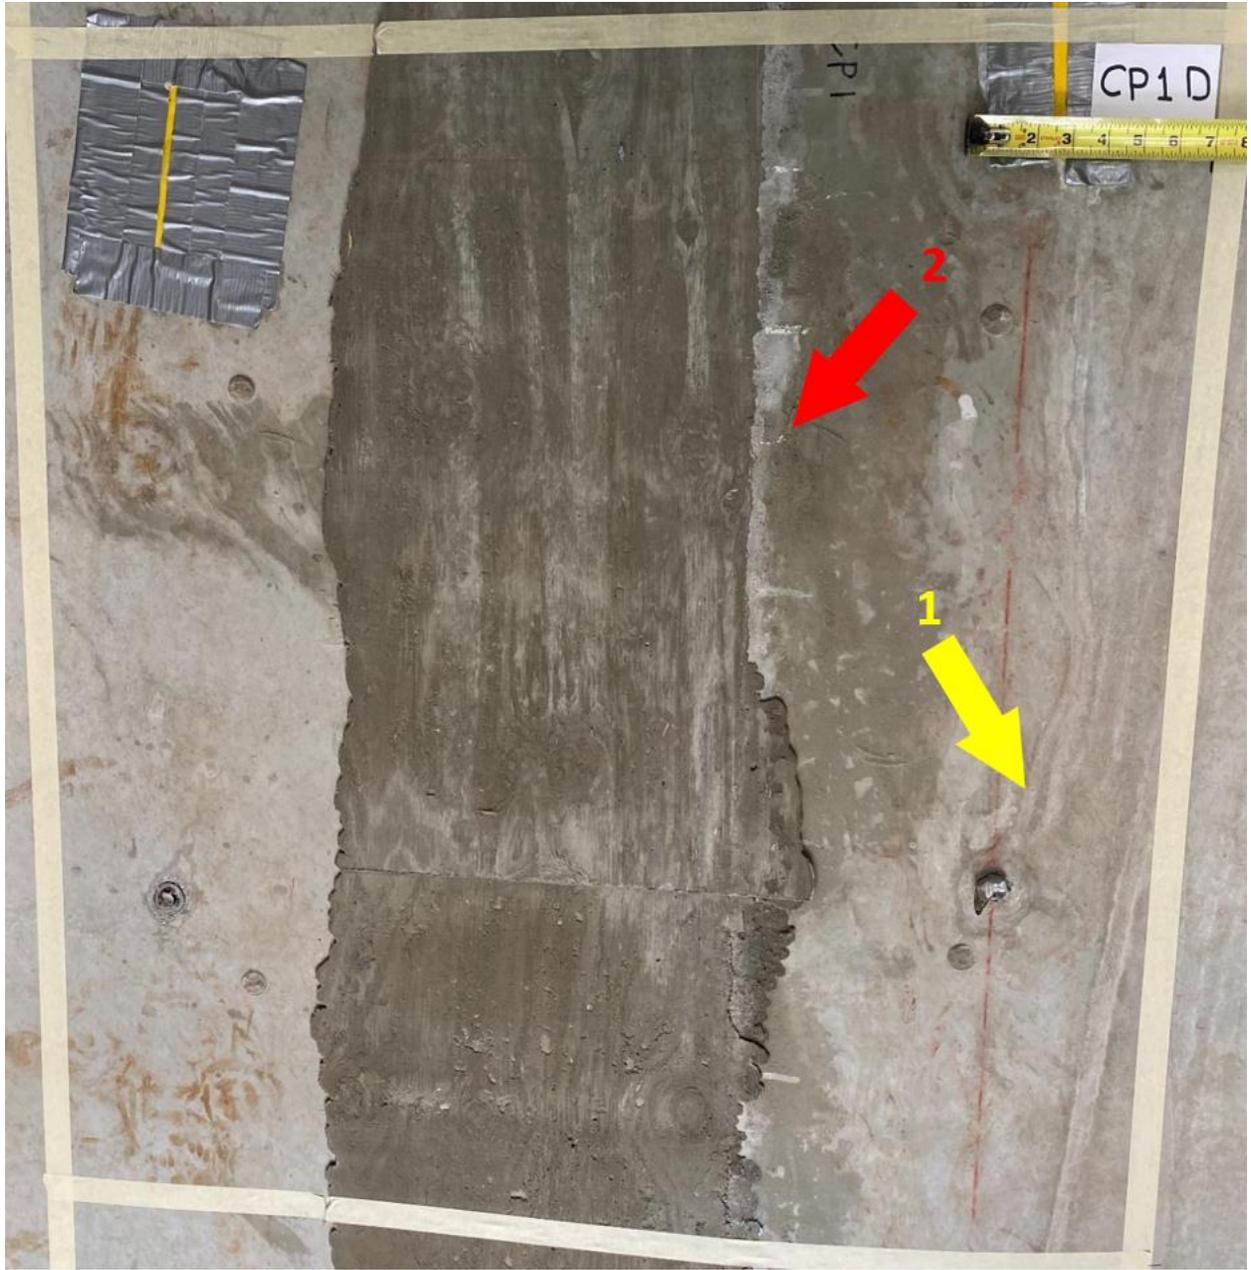
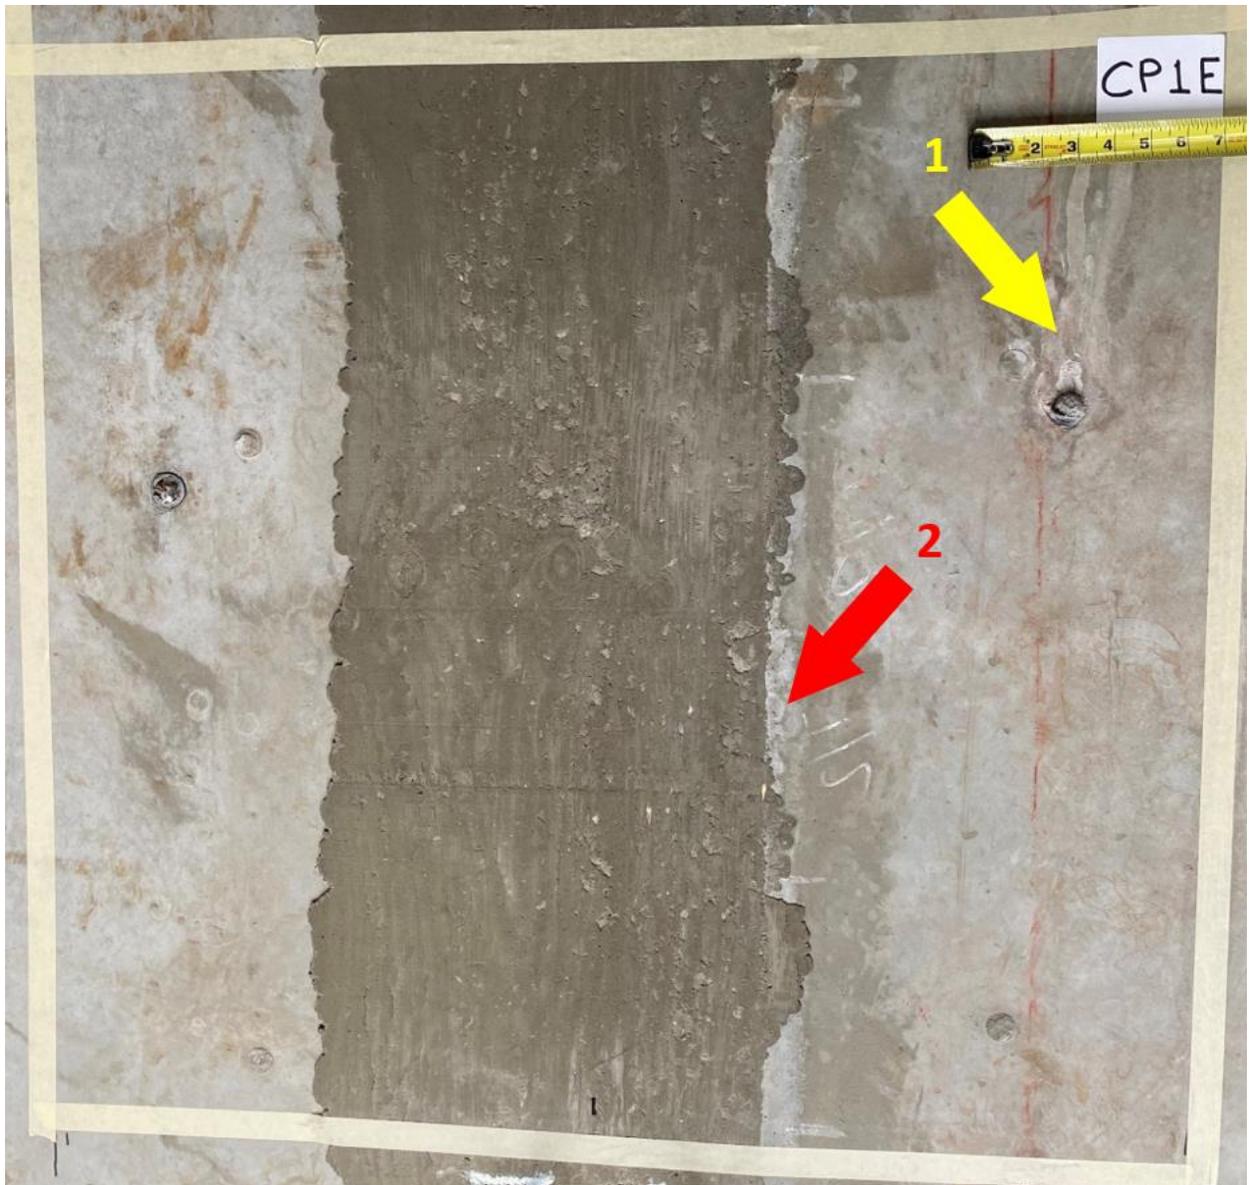
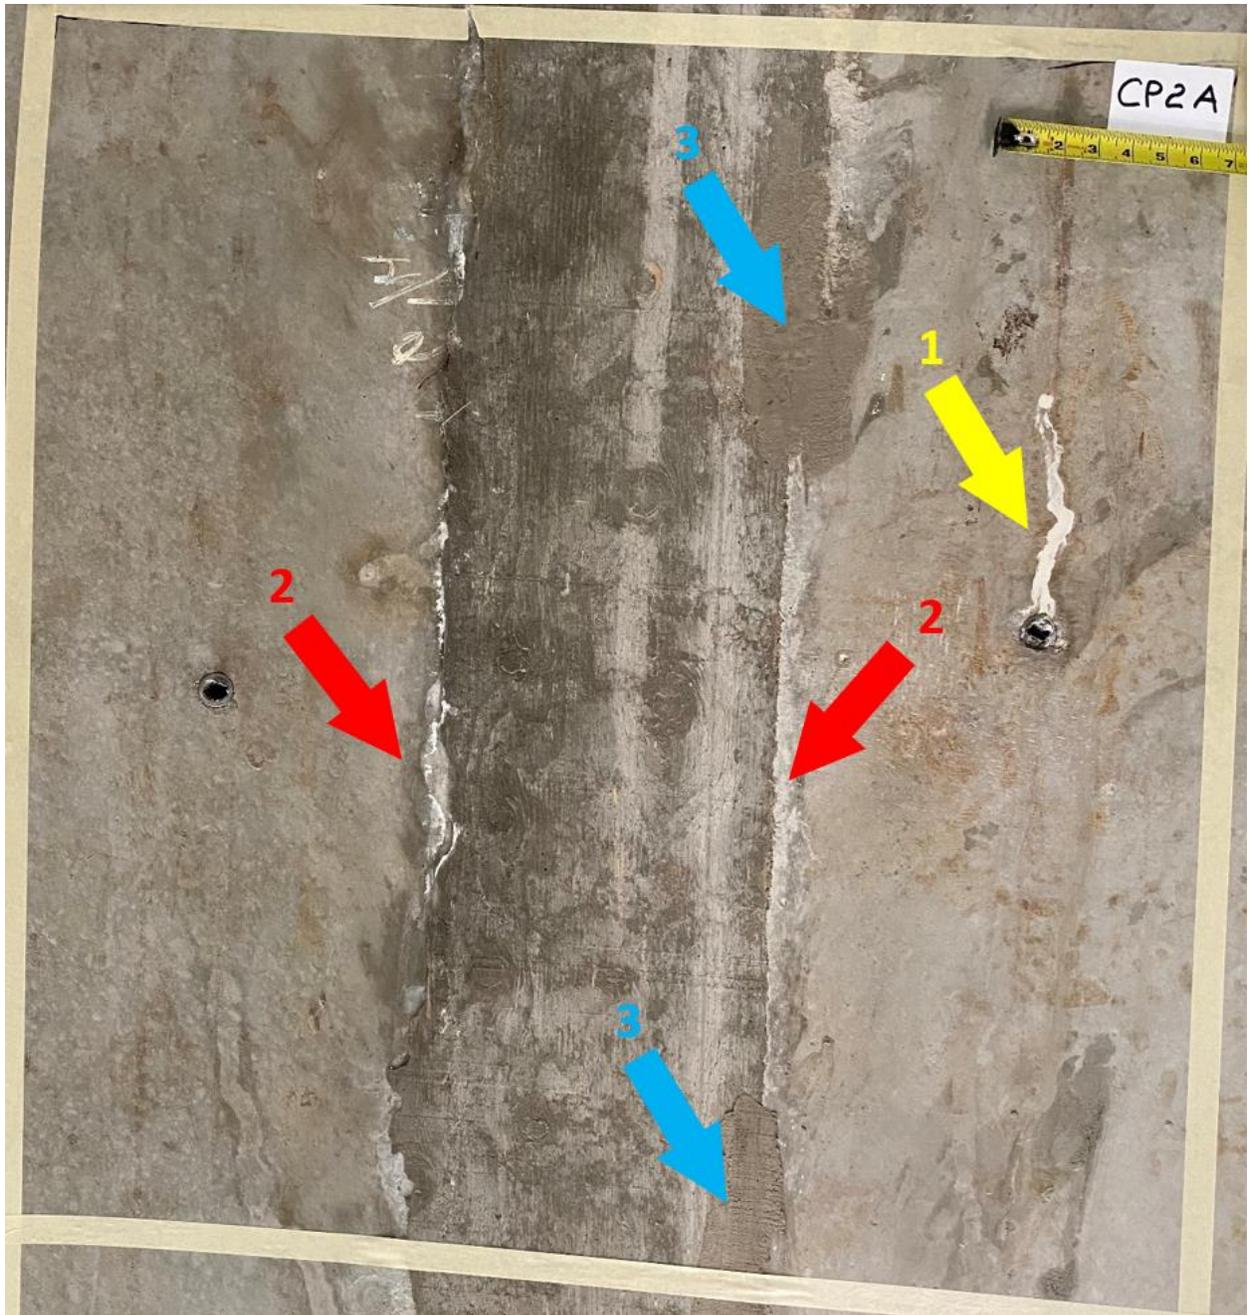
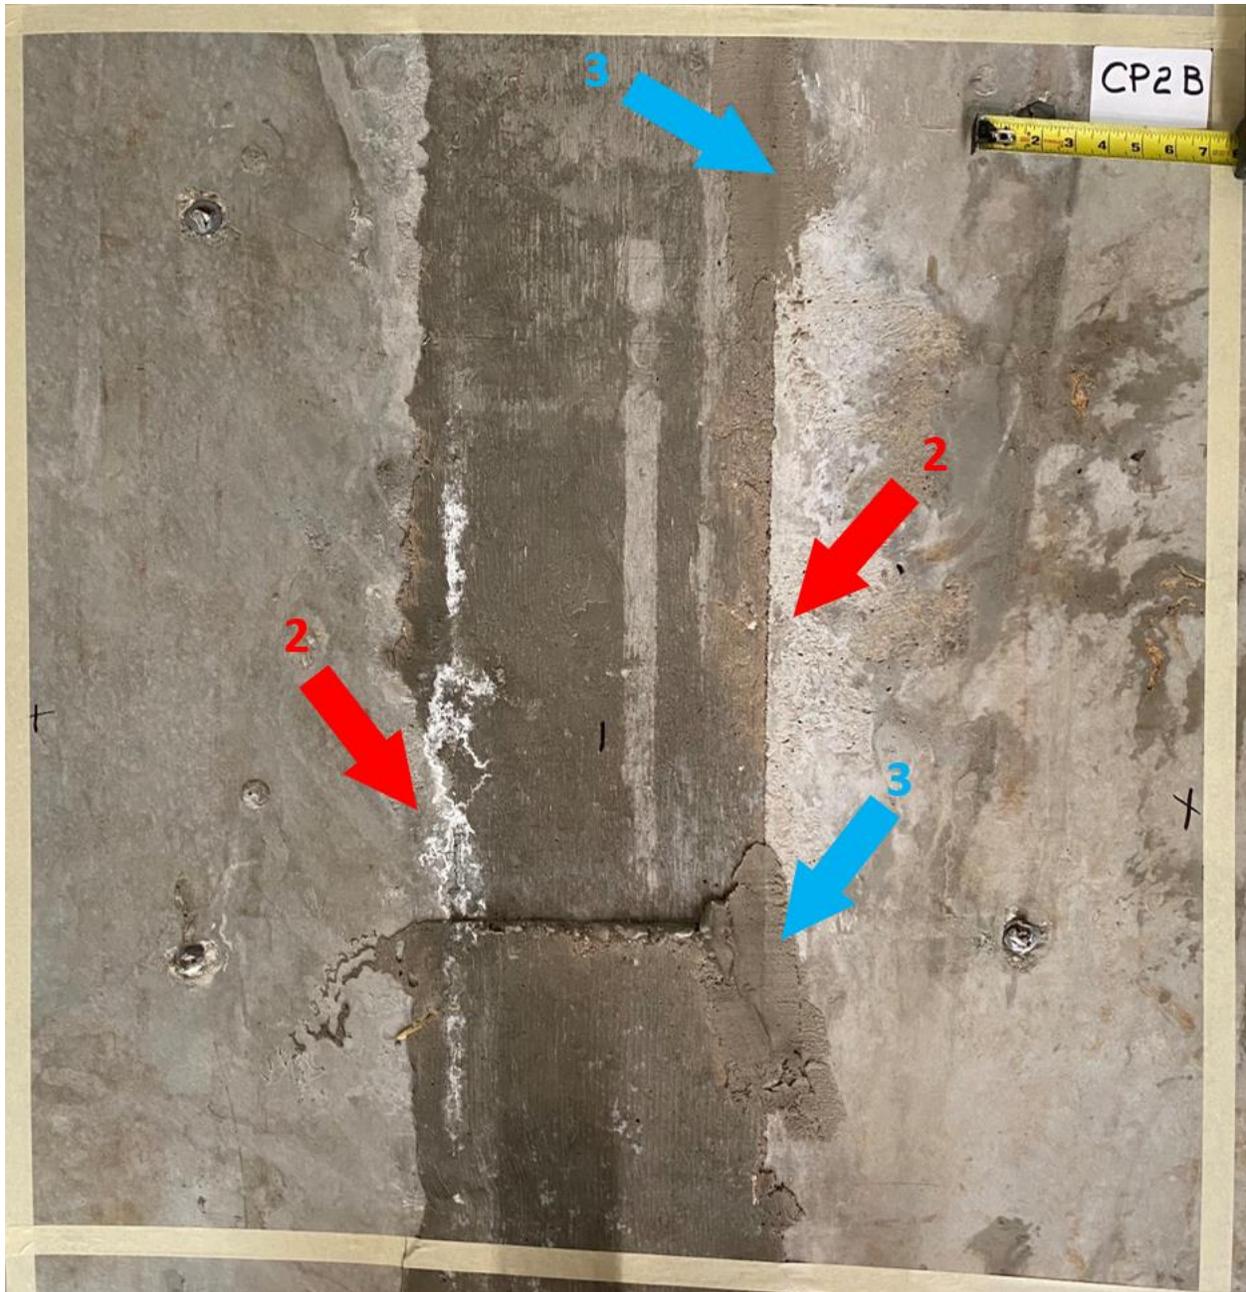
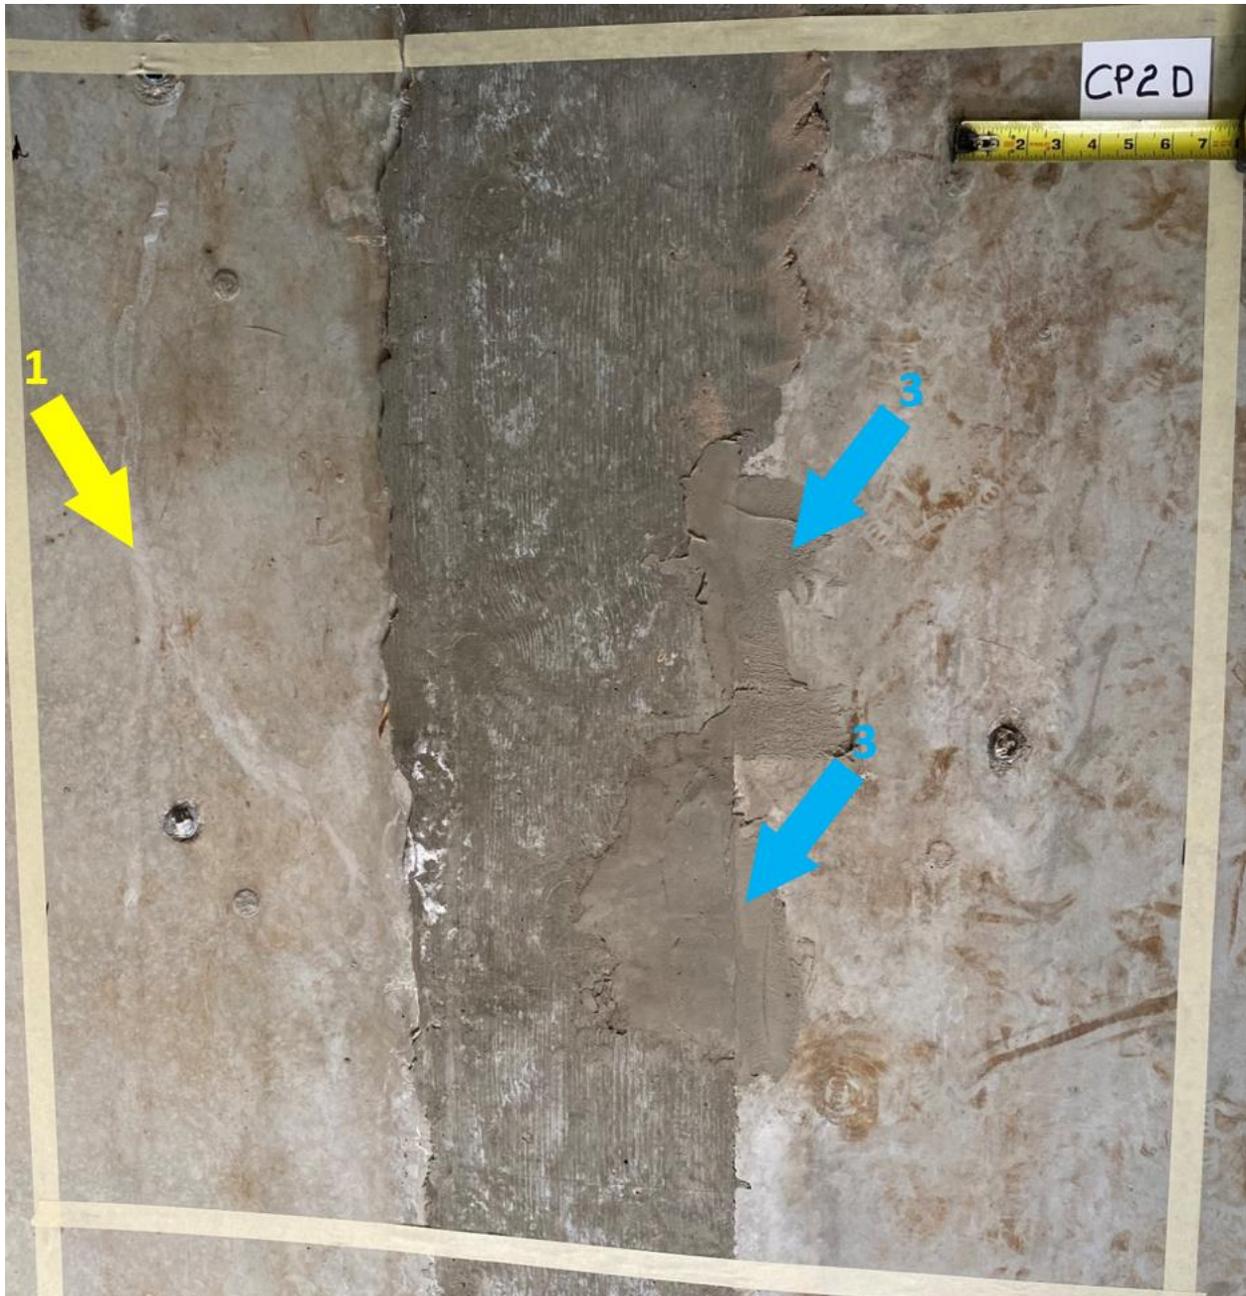
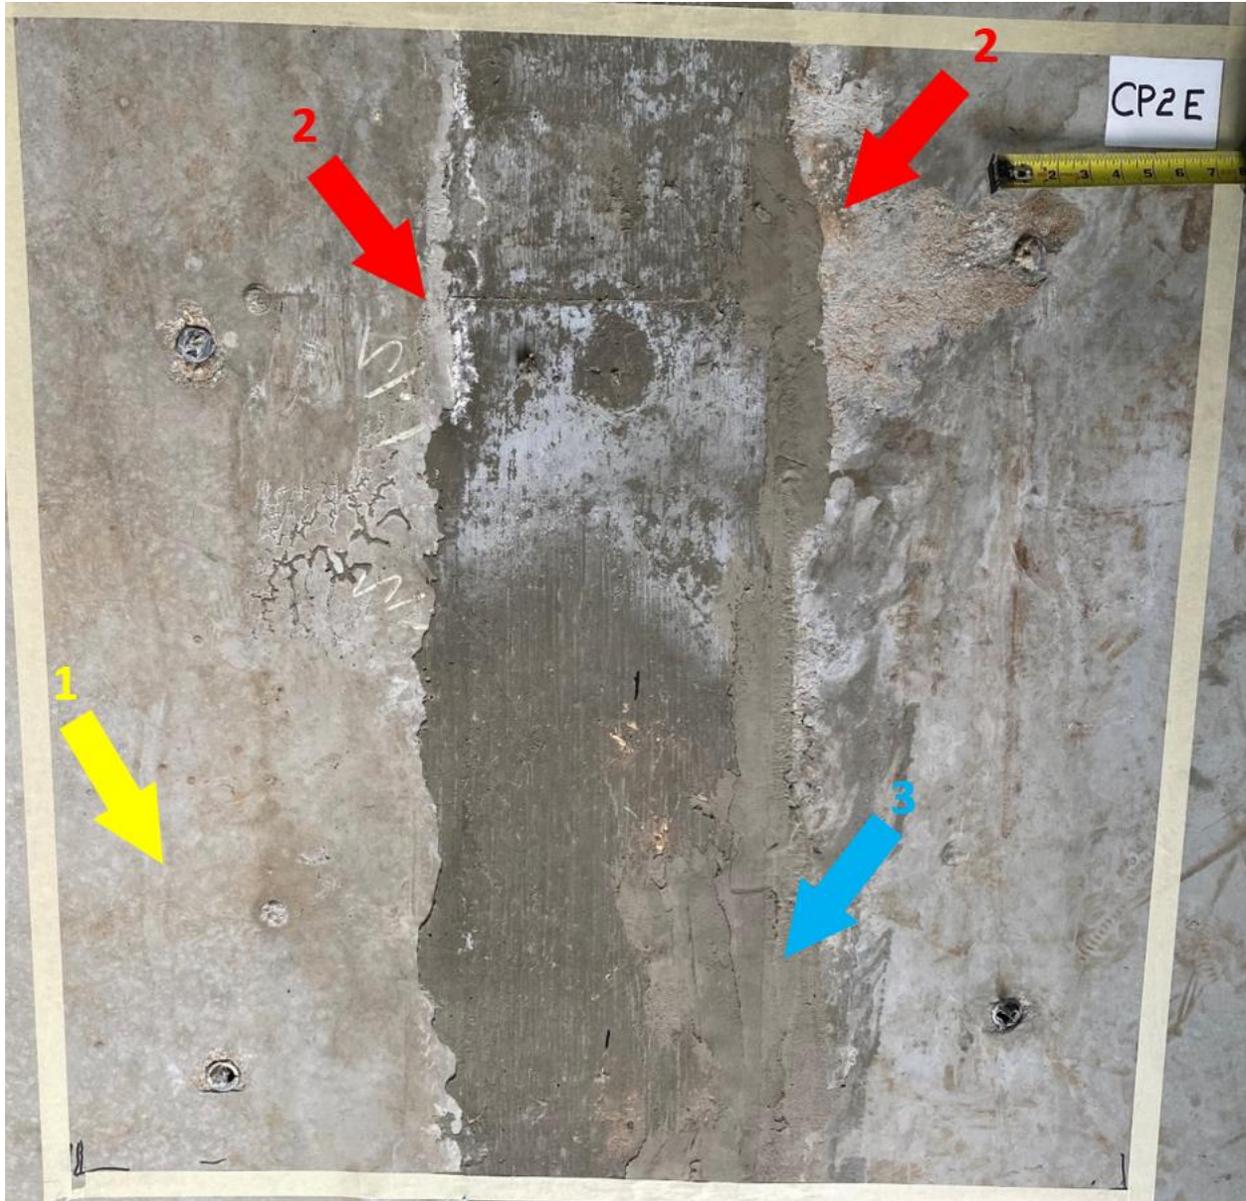
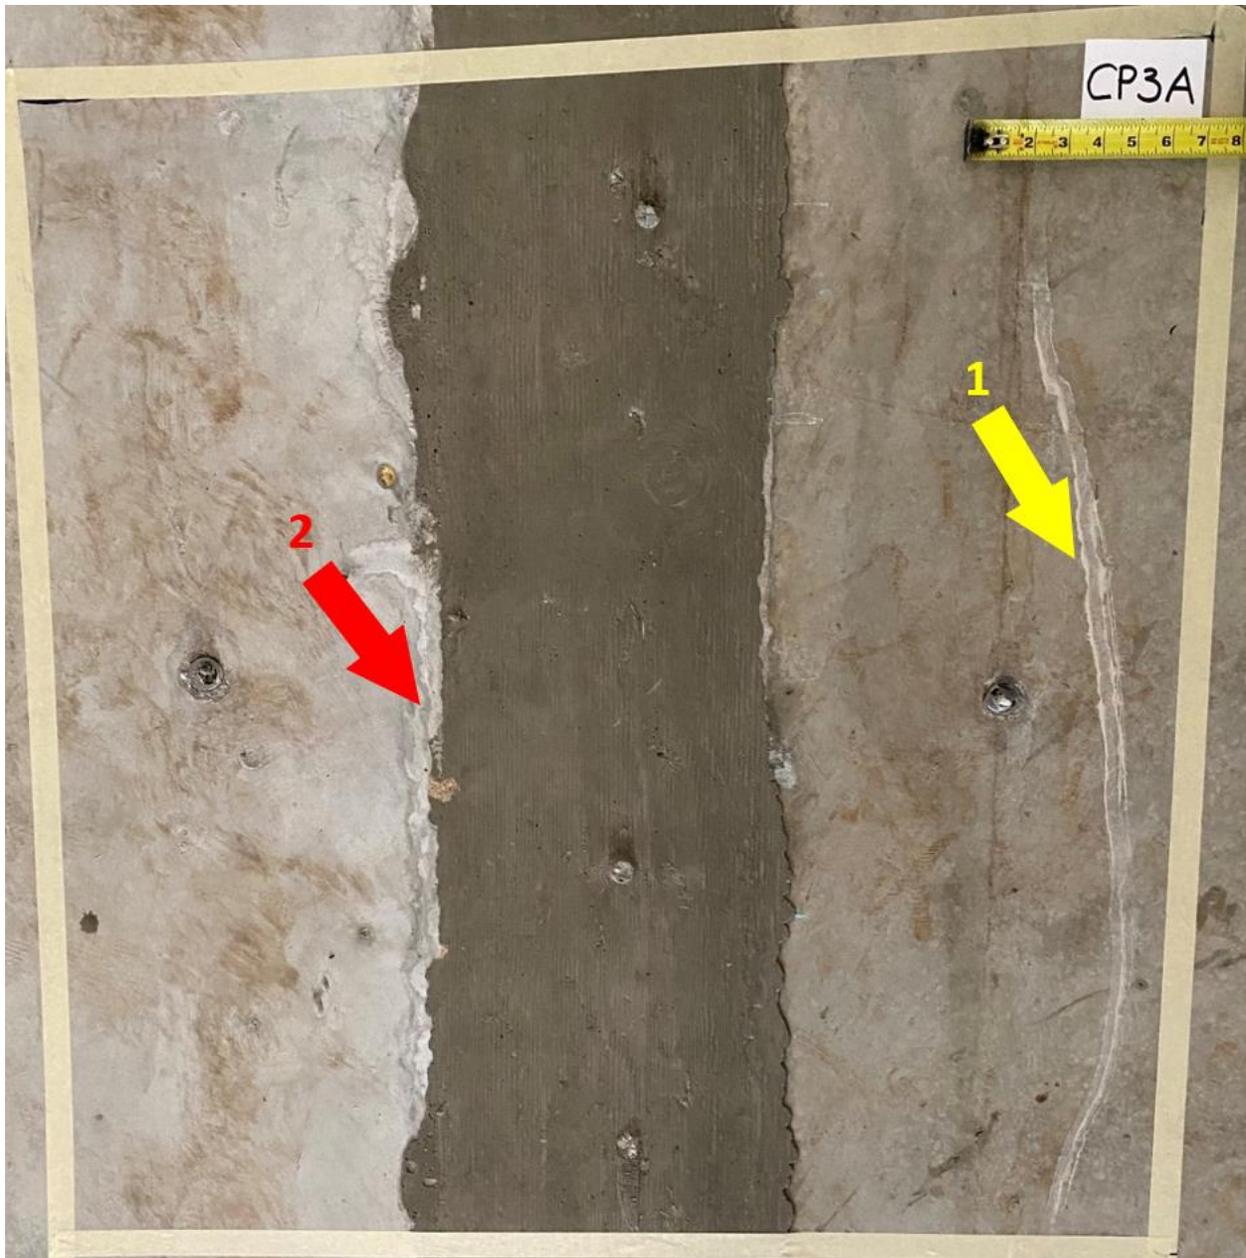
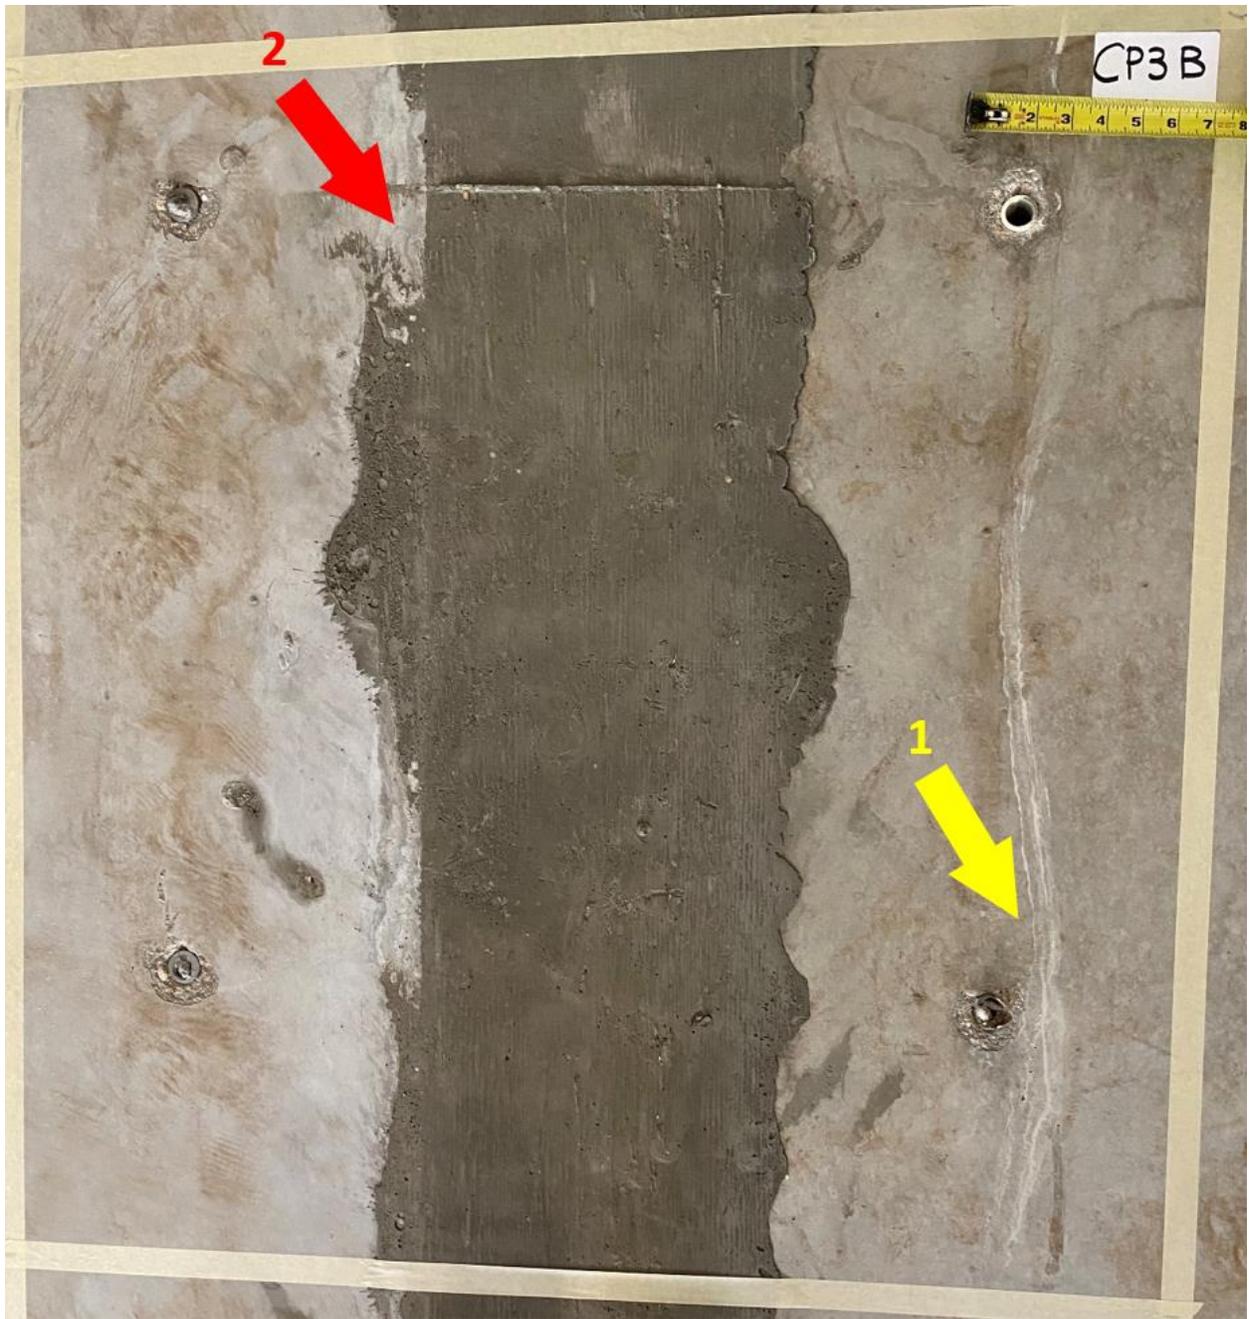
Figures C-1 to C-20 in Appendix C show the photographs of the sections. As recommended in the ACI 201.1R-08 Guide, in all photographs a scale is shown to indicate dimension (ACI Committee 201 2008). For the August 27, 2020, the following observations were made:

- There were no cracks observed in any of the closure pour concrete or at the interface of closure pour concrete and precast concrete that could be measured with the crack width ruler. However, the data clearly shows that under traffic load and the UBIT loads, the concrete strain exceeds the strain of the interface bond of 120 microstrain.

- Regularly placed holes (sleeves) with less than an inch in diameter were observed in the precast girders. Concrete is present in some of the holes; for example, see the close-up view in Figure C-8. But others are not completely filled with concrete and at some point, water from the top of the deck has penetrated through these holes, presumably before placement of the overlay. The water marks are shown with yellow arrows labeled with number 1 in most of the photographs of Figures Figure C-1 to Figure C-20.

- There were some water marks at the interface of the closure pour concrete and the precast concrete. It is possible that the same water from the sleeves has caused these water marks. Some of these water marks are shown with red arrows labeled with number 2 in Figures Figure C-1 to Figure C-20.
