RESEARCH REPORT

Long-term Performance of HES Class 50AF Concrete with Polypropylene Fibers as Field-Cast Connection between Deck Bulb-T Girders in SH-36 Bridge over Bear River

RP 288

September 2022

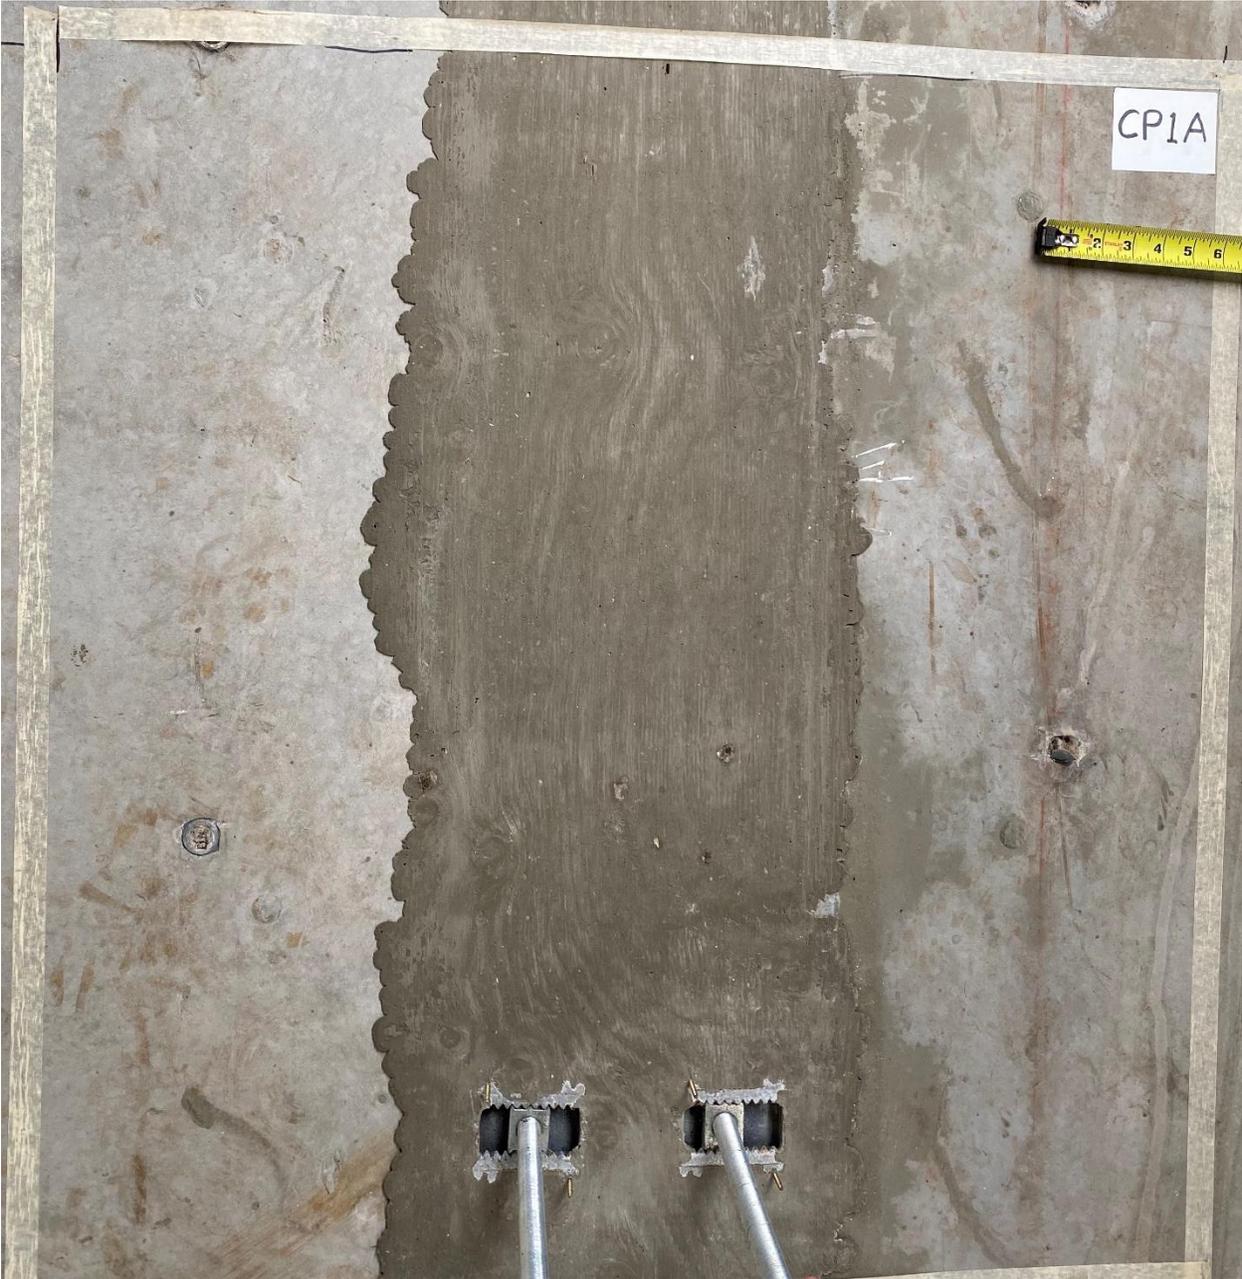
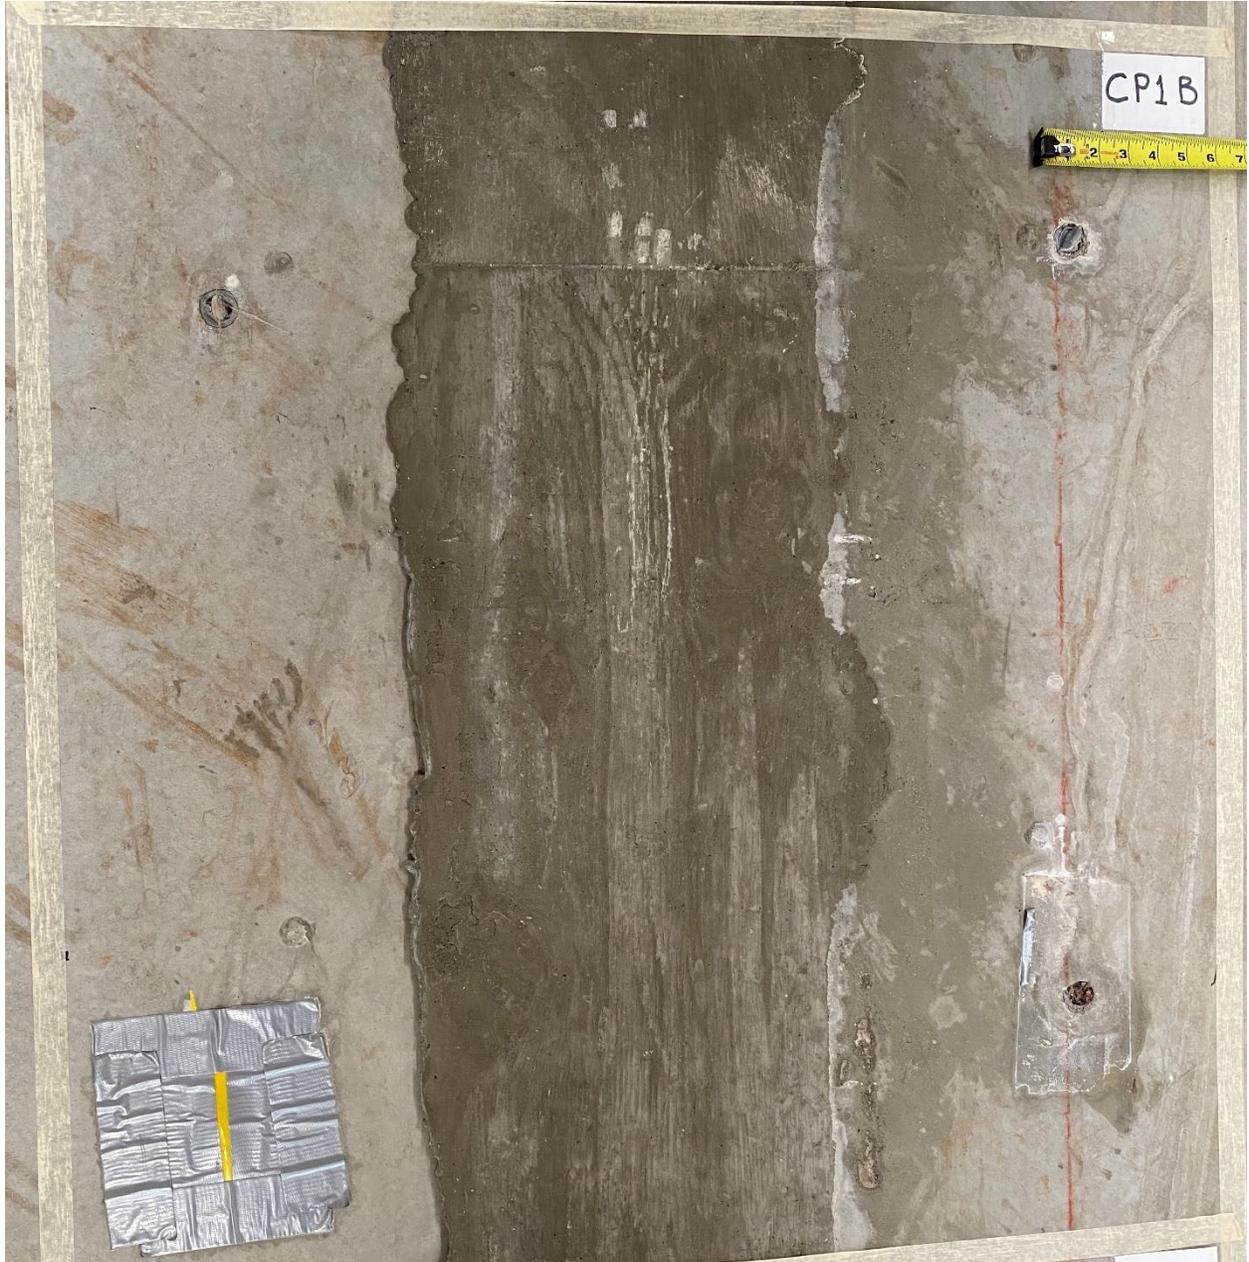
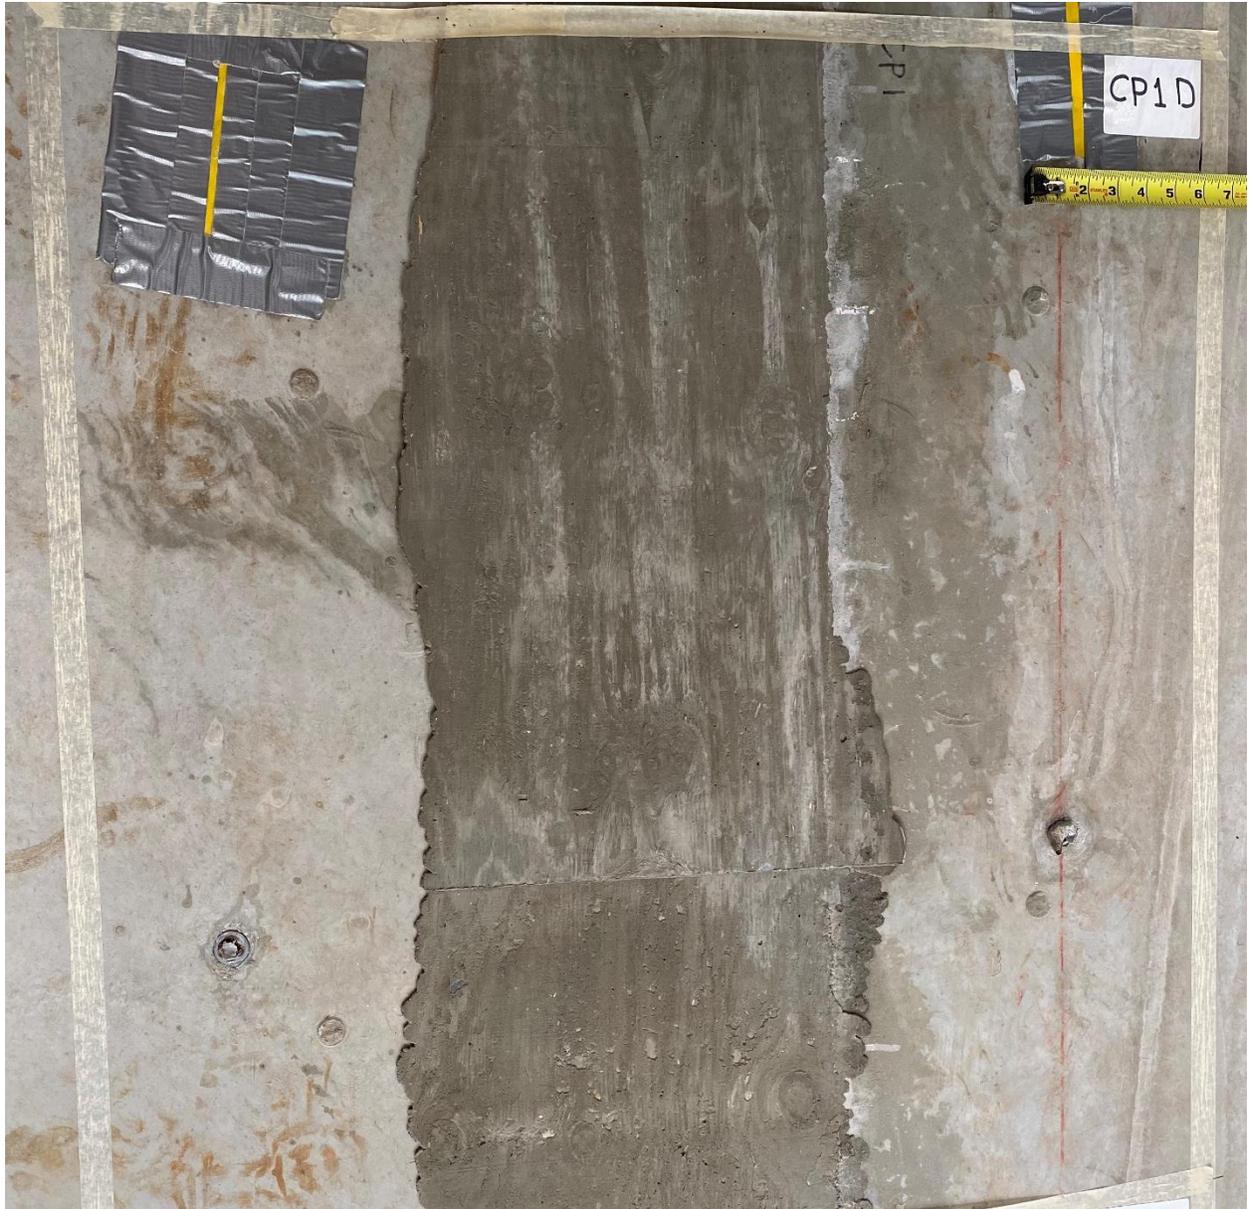
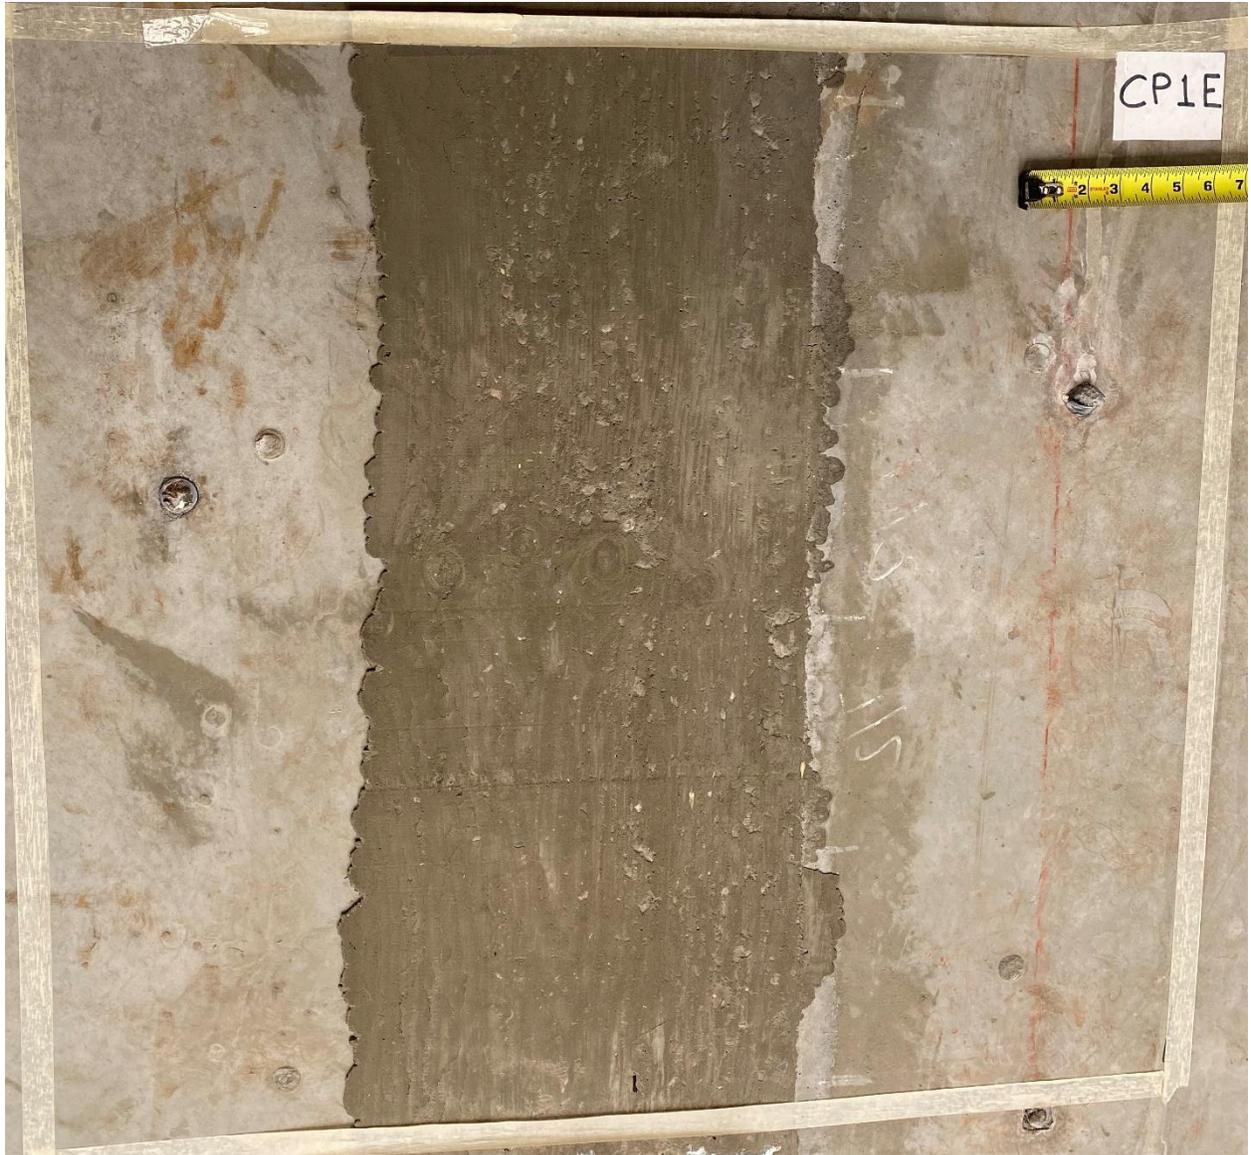
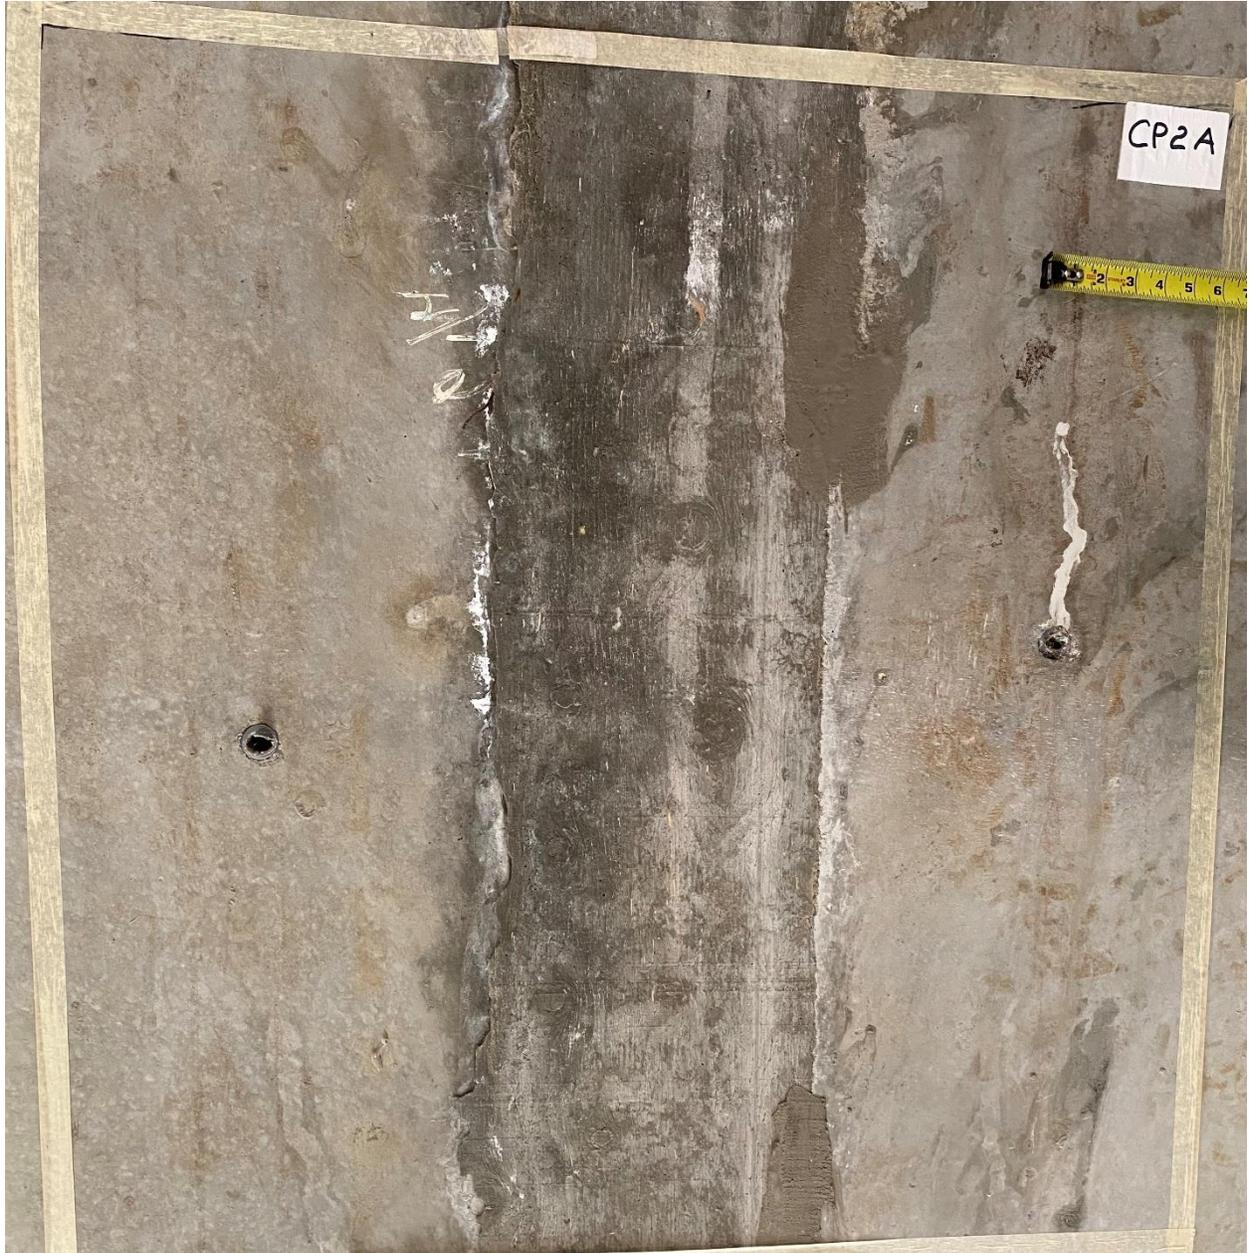
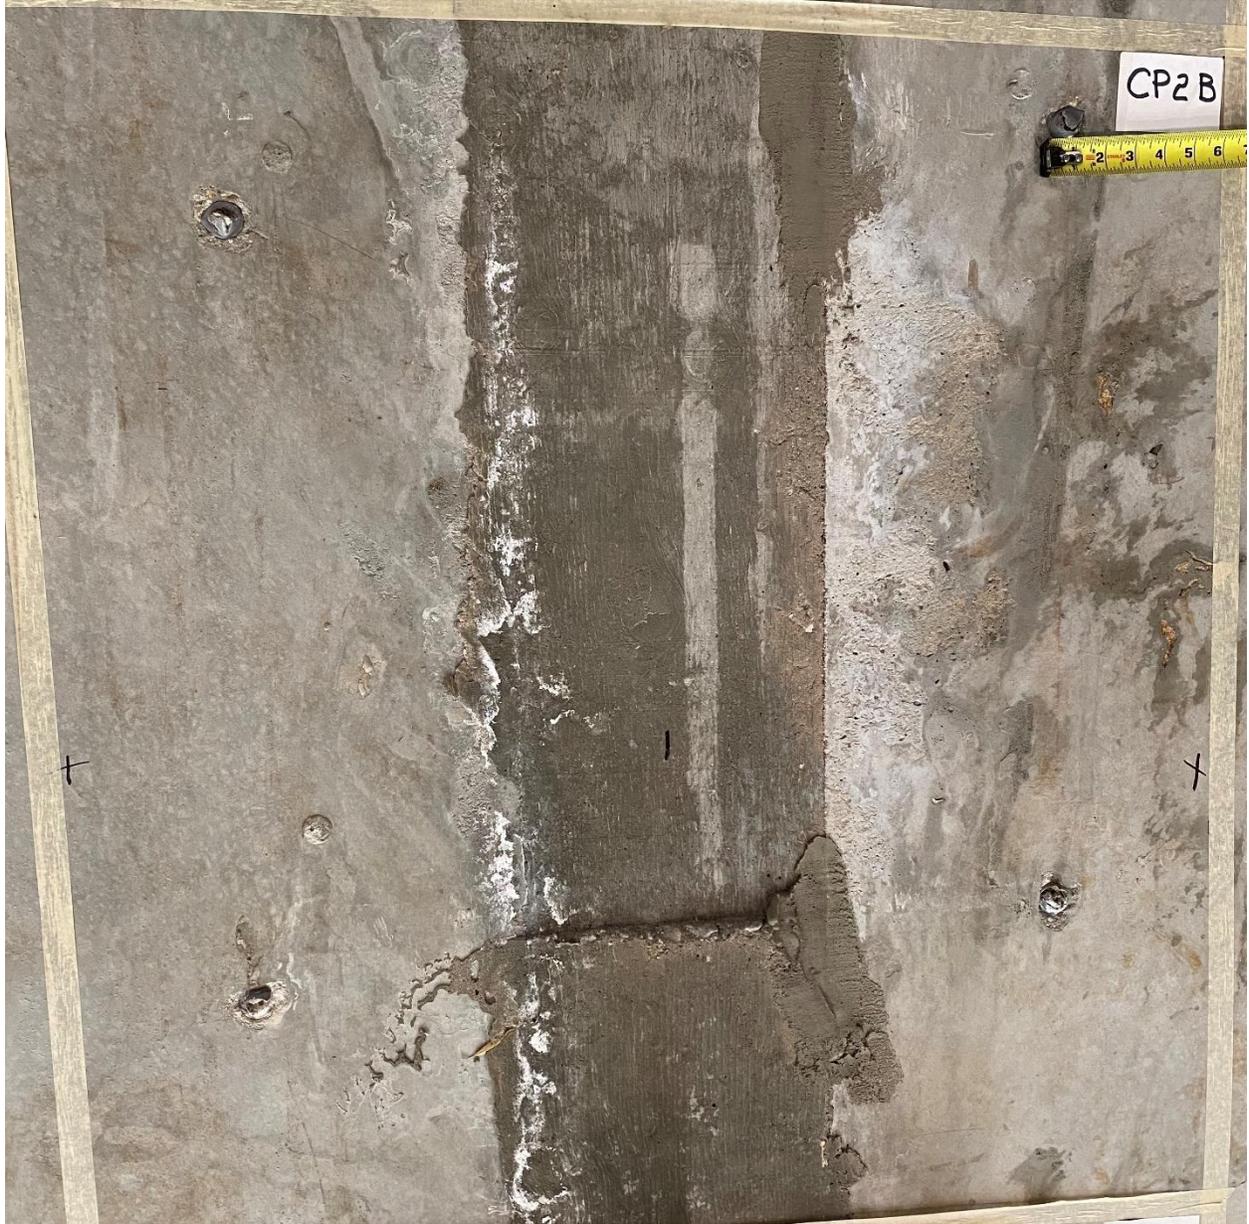
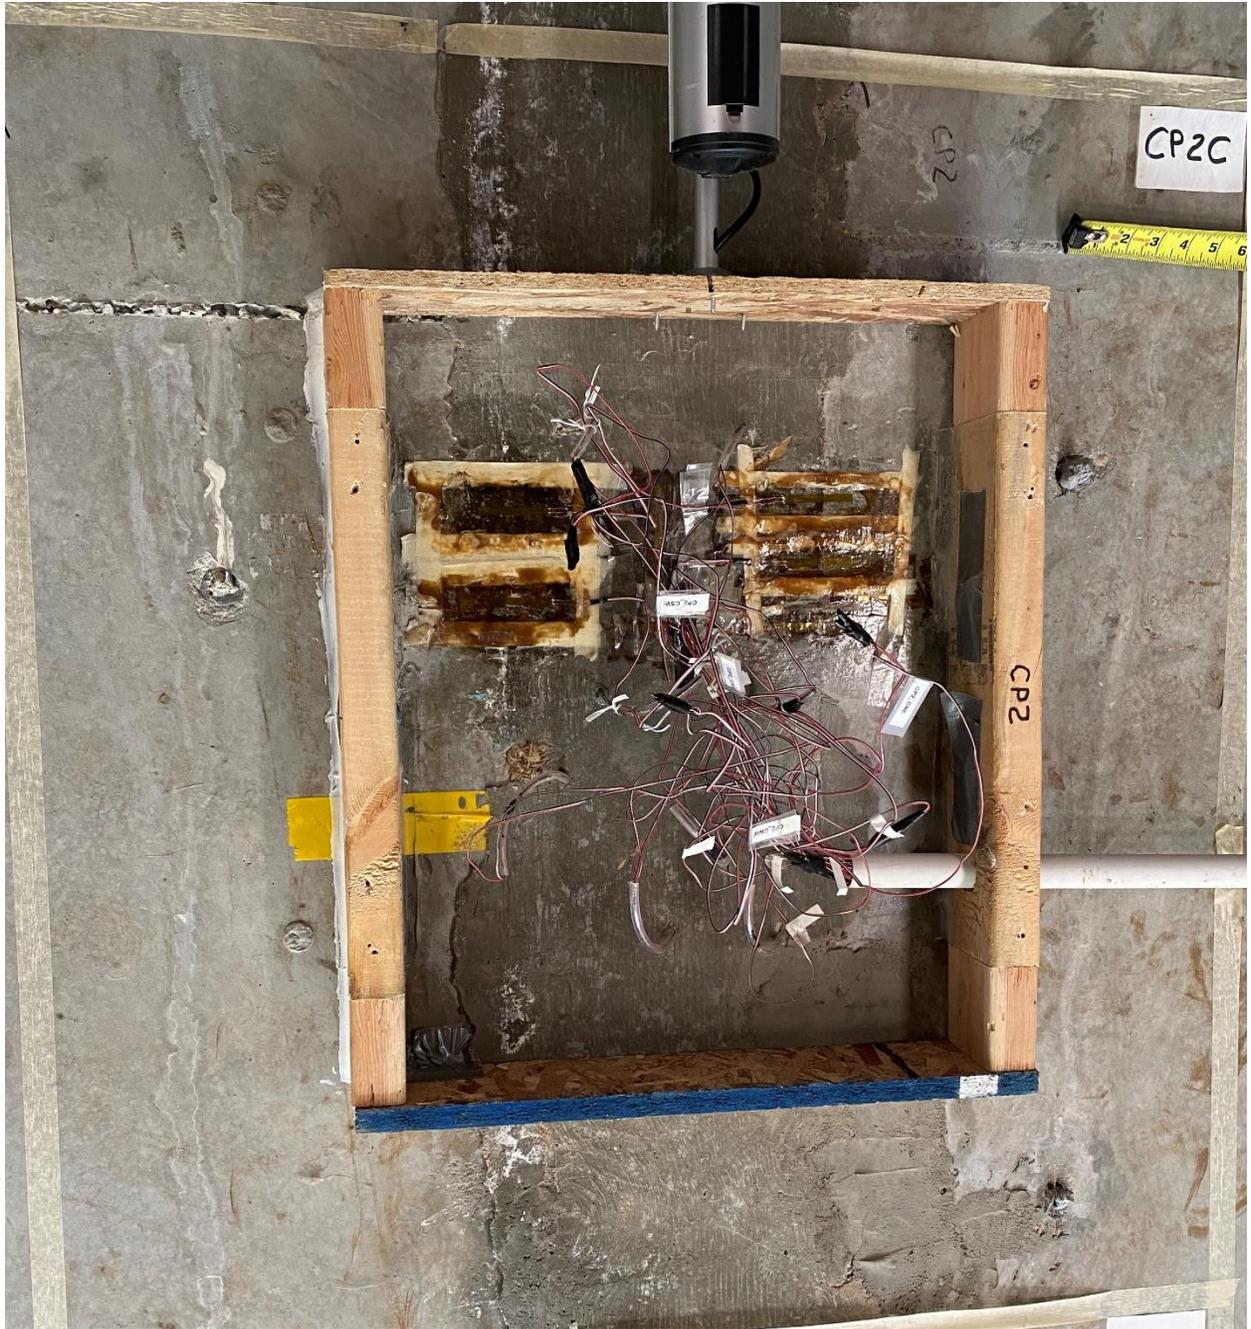
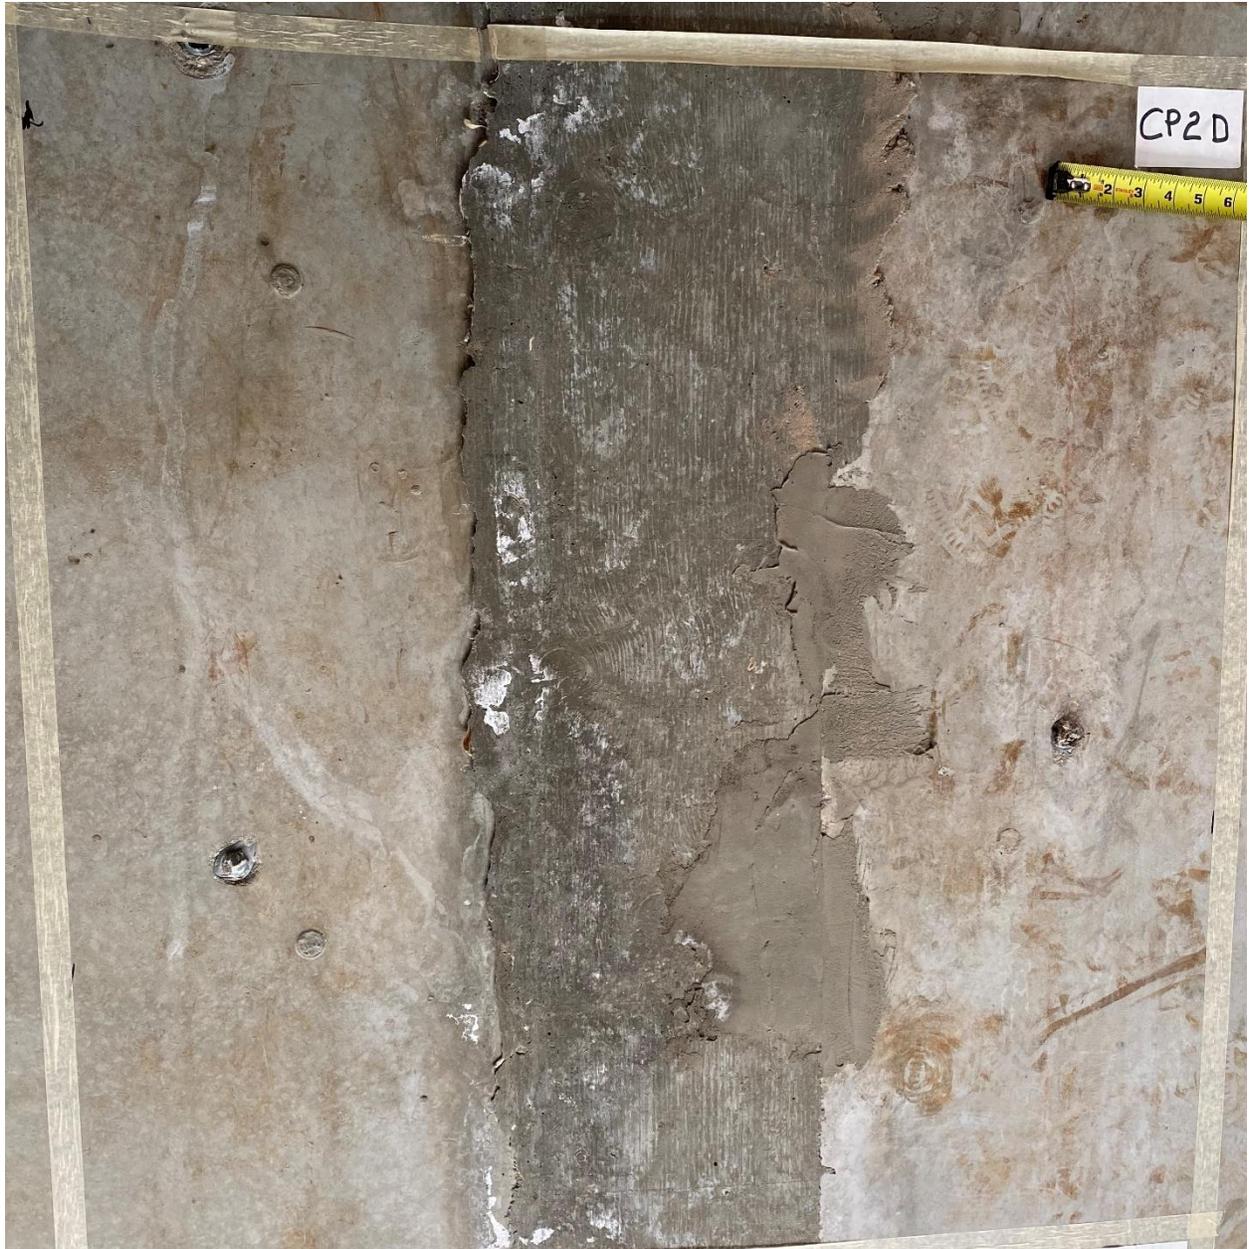
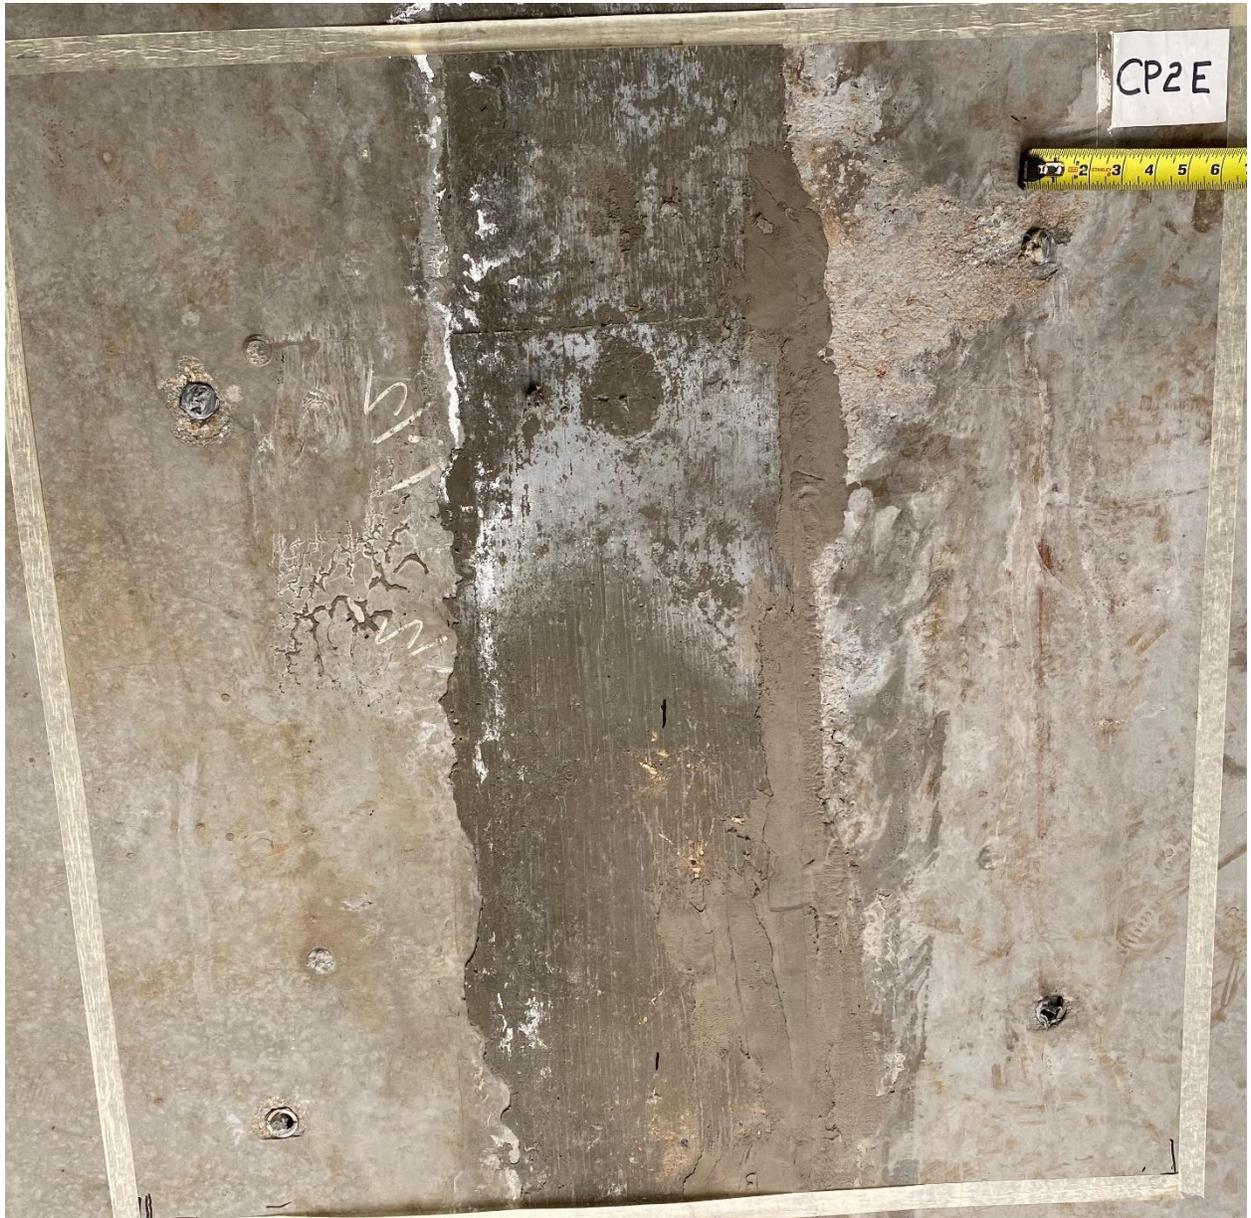
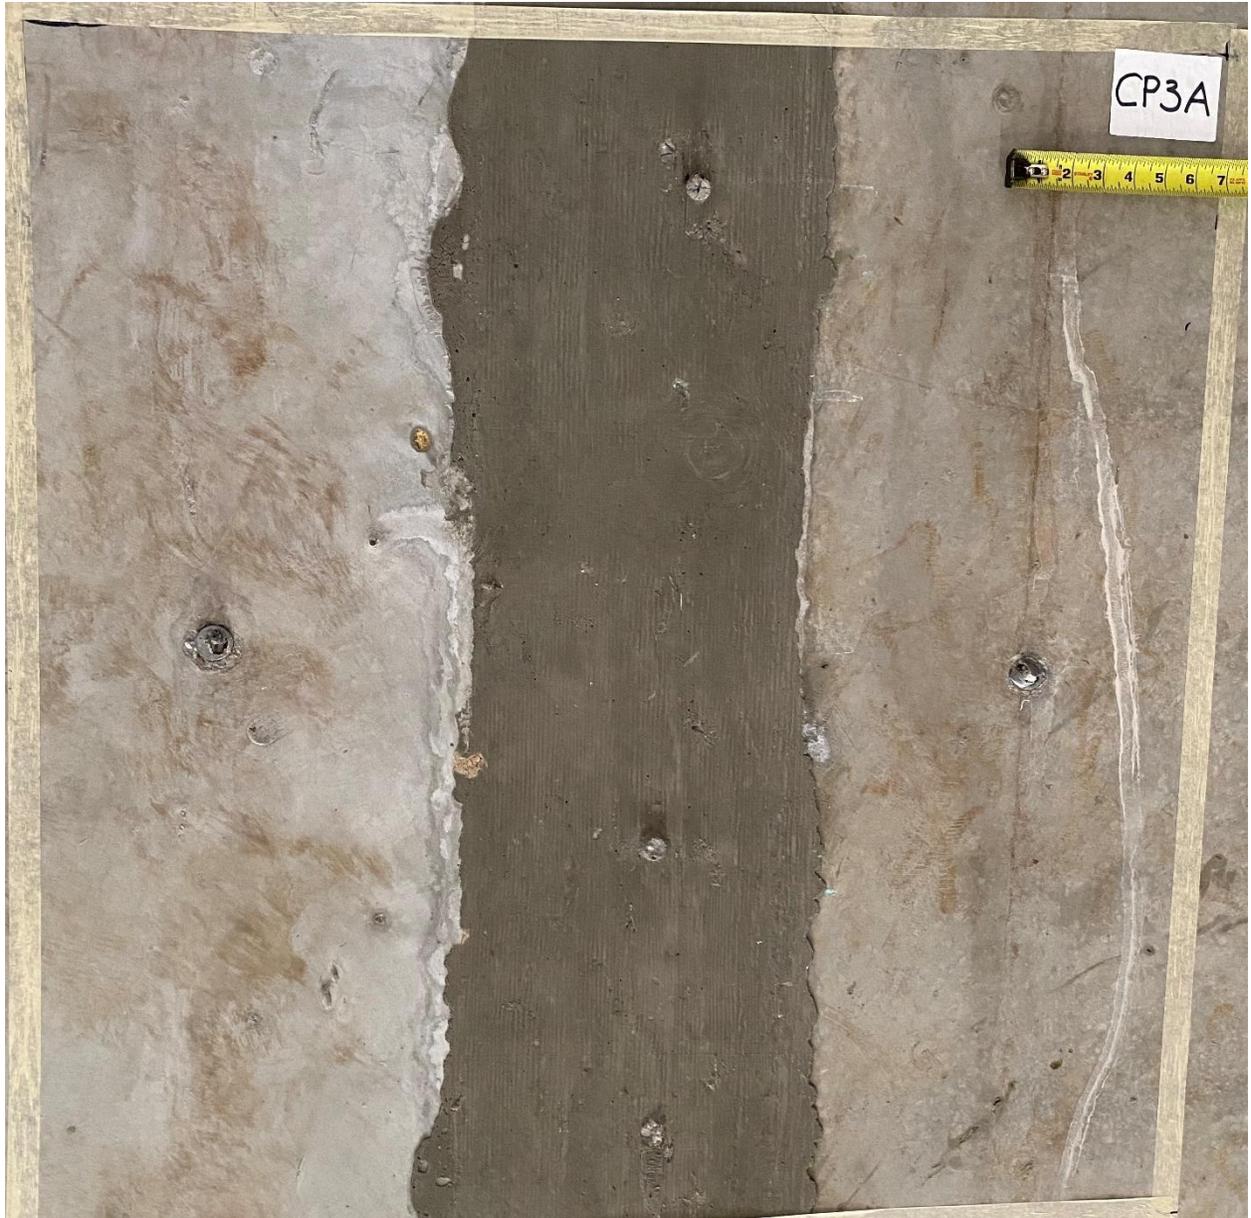
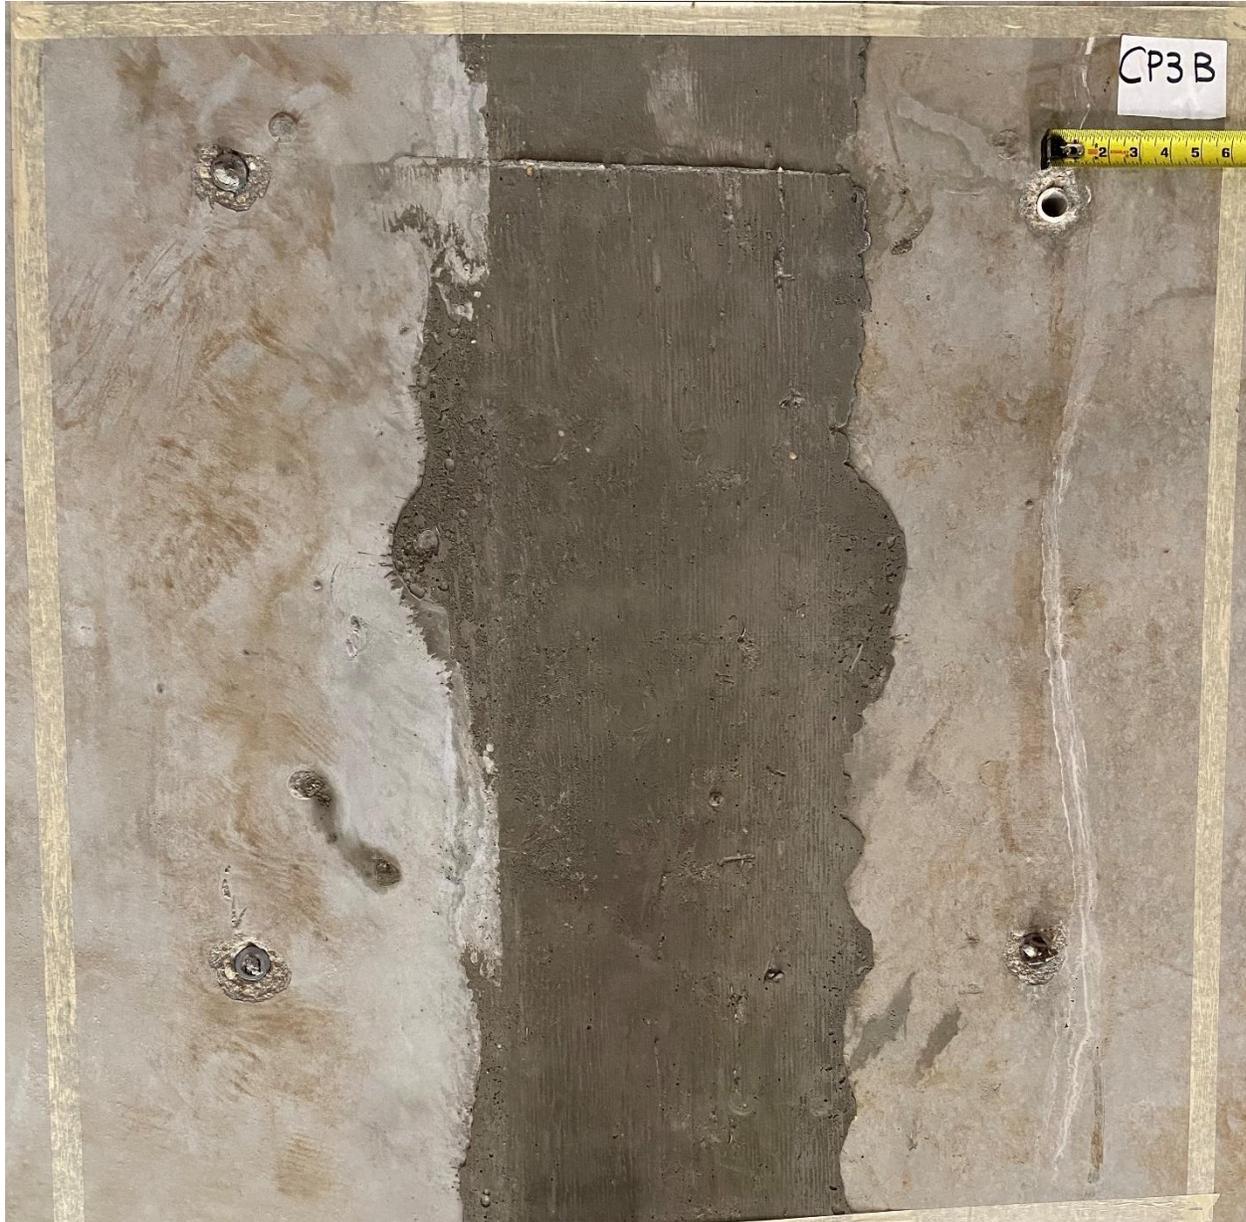
Four more sets of inspections were made approximately every four months at the same times the strain measurements were made. In December 2021, again moisture was present on the surface below the bridge deck. Although photos were taken in all the inspections, not all are presented in this report. In order to compare the first set of inspection photos with the last set, the photos for April 2022 are also included in Appendix C Figures Figure C-21 to Figure C-40. The arrows shown in the first set of inspection photos are not repeated. In all six inspections, no *visible* cracks were observed in any of the closure pour concrete, or at any of the interfaces of closure pour concrete and precast concrete.
