DOT/FAA/TC-23/50

Small Unmanned Aircraft System for Pavement Inspection

August 2023

Final Report

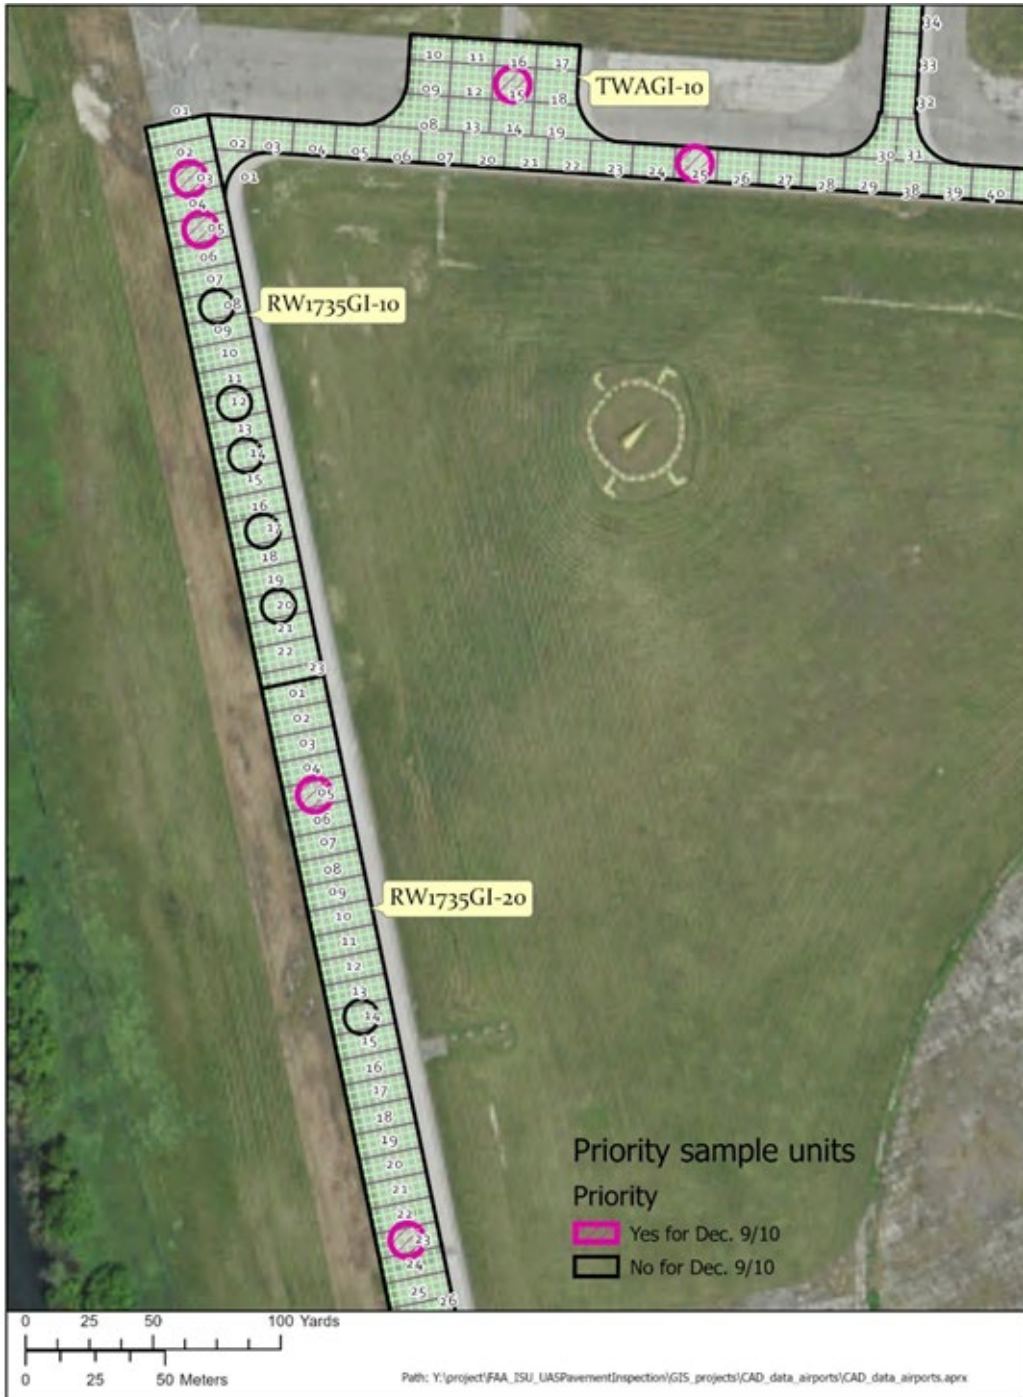
Figure 2. Focus Area for Data Collection with Six Selected Priority Sample Units Highlighted in Purple Circles

The research team traveled from MTRI in Ann Arbor, Michigan, to the nearby ONZ airport, to collect sUAS data from the target areas shown in Figure 2. Total travel distance was 69 kilometers (km). The team closely monitored the wind speed and temperature before conducting each sUAS flight. The temperature varied between 6 degrees Celsius (°C) and 9 °C and the wind speed ranged from 3 kilometers per hour (km/h) to 19 km/h. The team followed the safety plan outlined for this data collection to ensure safe sUAS operation. The safety plan included monitoring the air traffic during the flight operation, yielding right of way to all other aircraft, operating at least 76.2 meters (m) away from the operational runways and taxiways, and minimizing the team's presence on the runway and taxiway.

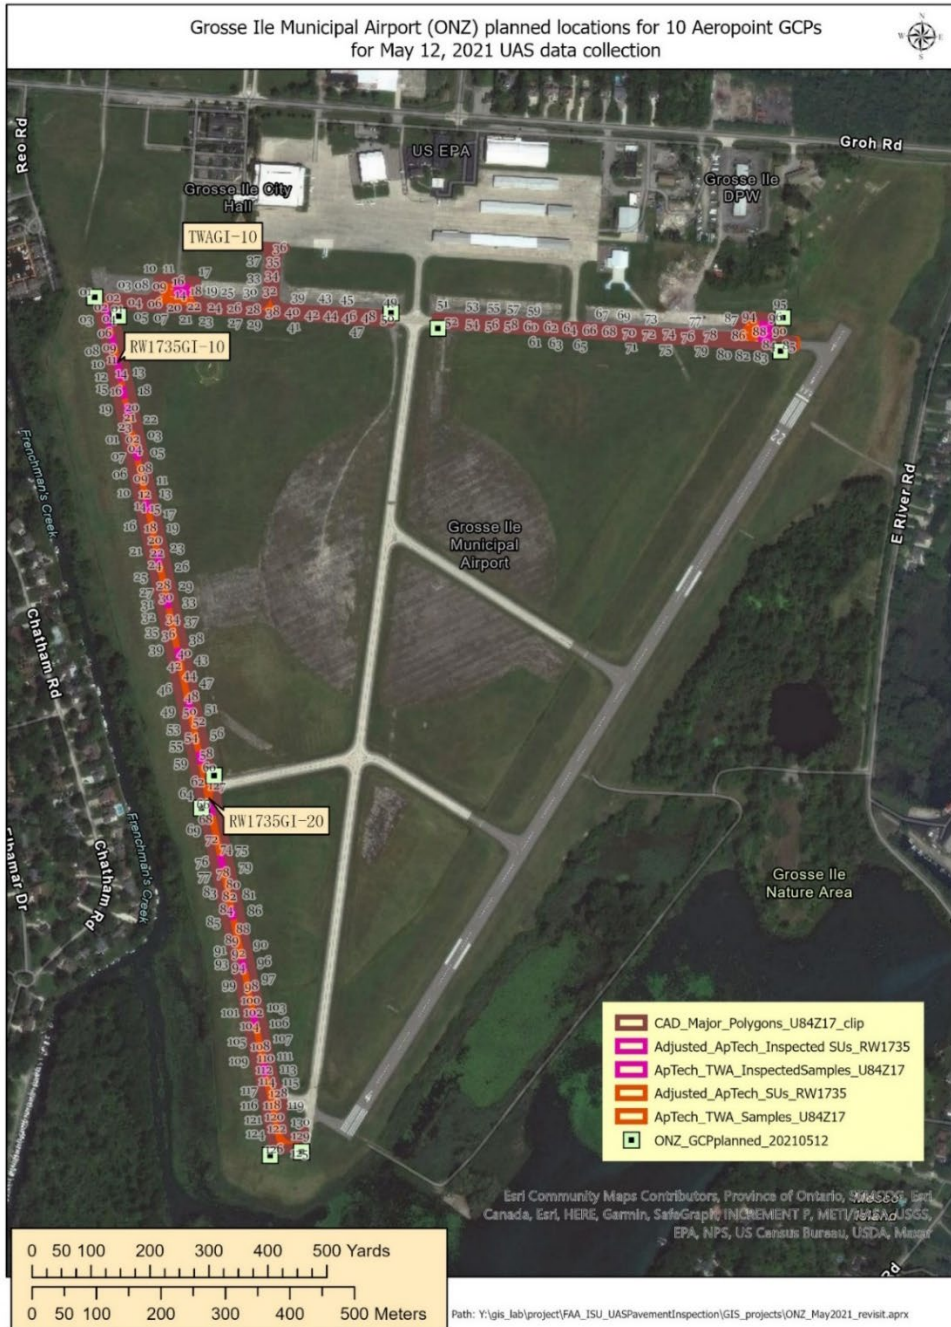
Figure 3. Location of the Ground Control Points at ONZ

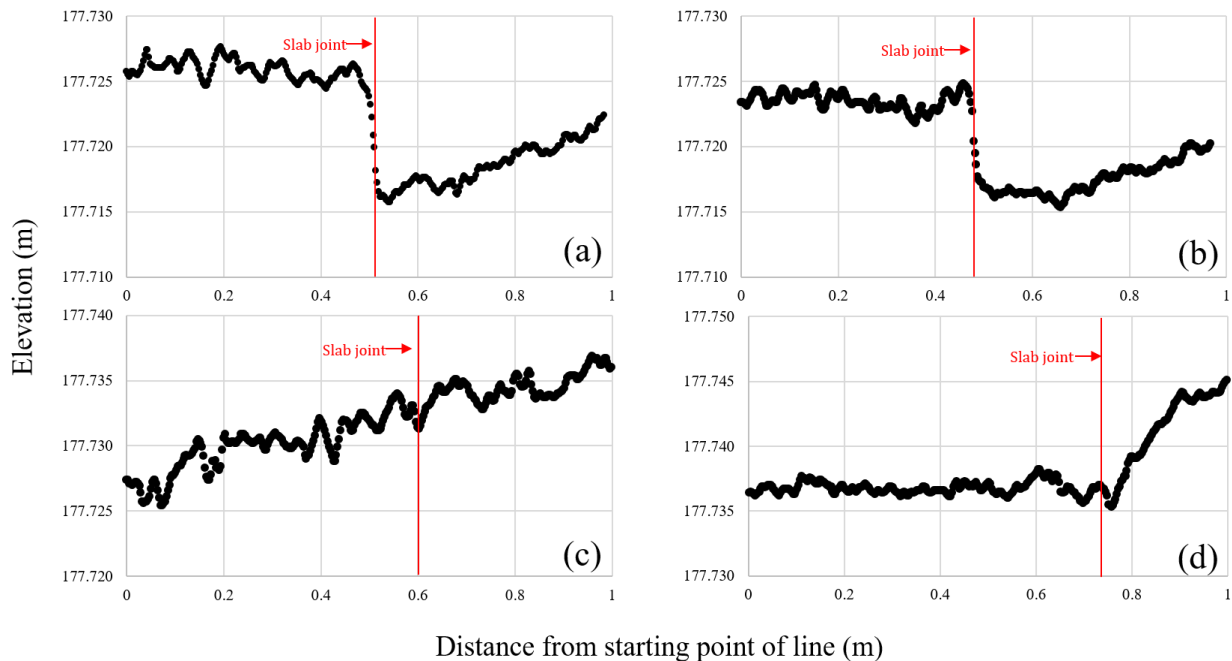
Figure 17. Faulting (M) Detection in 3-mm/pix DEM (a, b) Slab Joint with Faulting (M) Showing a 1-cm Sudden Drop in Elevation, (c, d) Slab Joint Without Faulting Showing No Elevation Drop

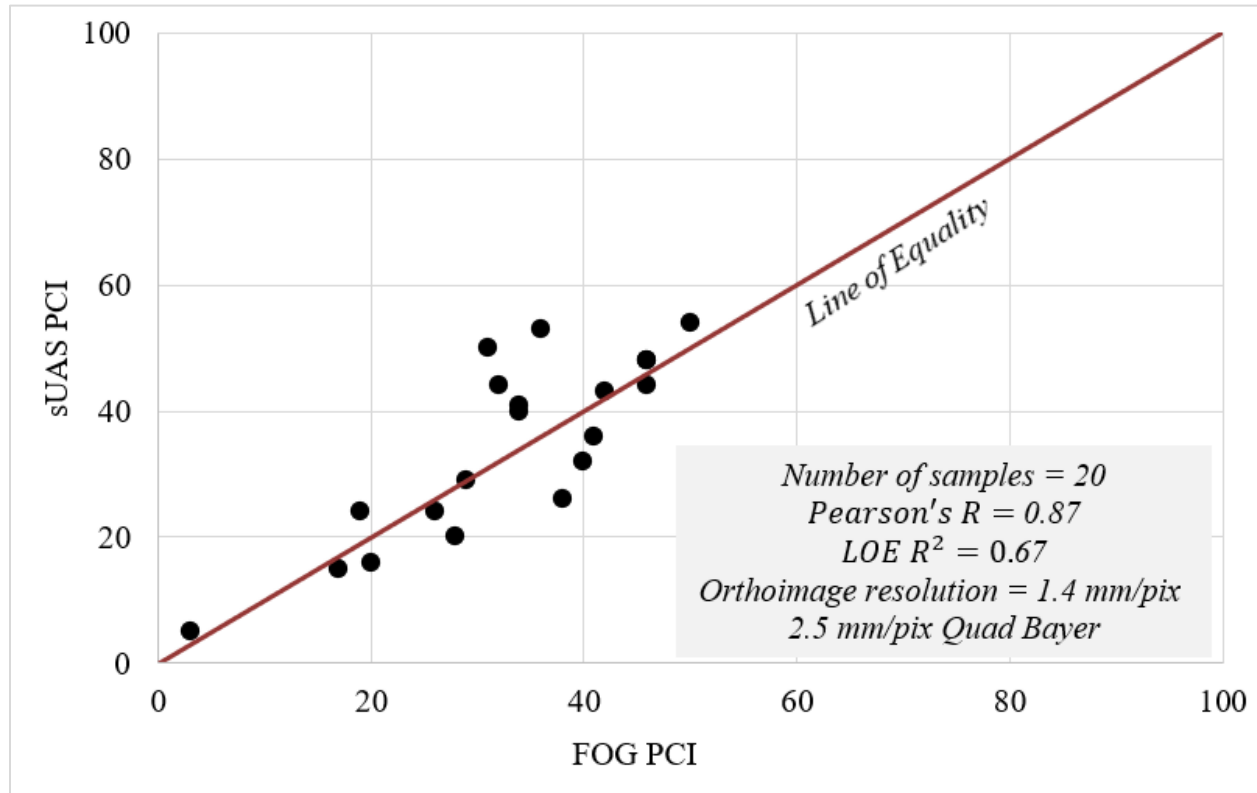
Figure 18. Comparison Between FOG PCI and sUAS PCI Calculated Using 1.4-mm/pix and 2.5-mm/pix Data from ONZ

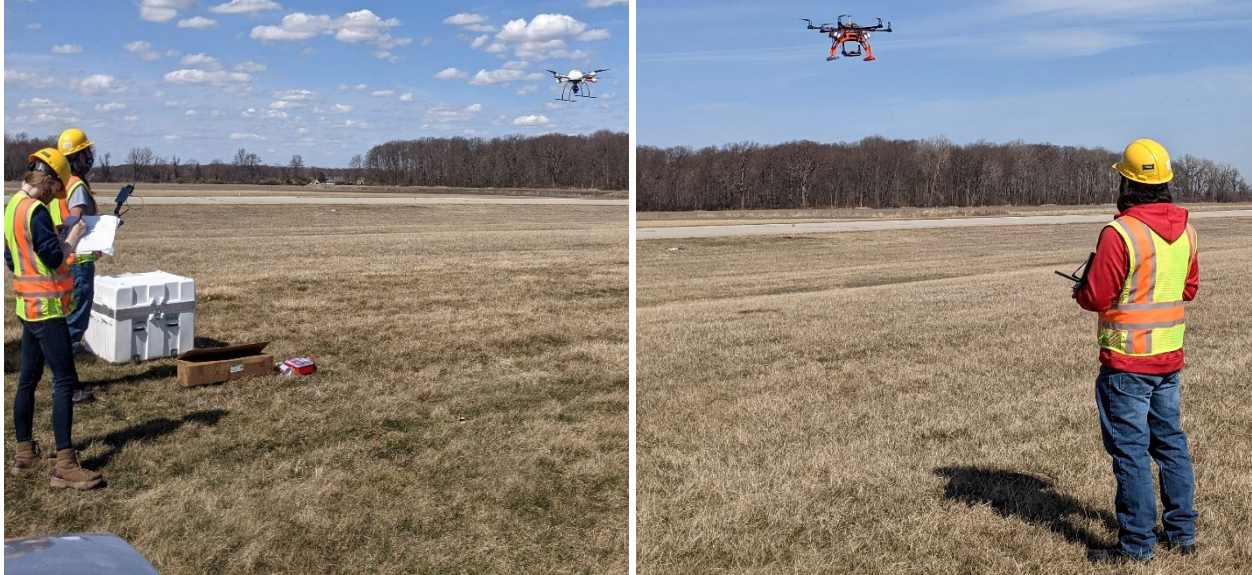
Figure 21. High-Resolution sUAS Data Collection with mdMapper1000+ and Bergen Hexacopter sUAS Platforms

The research team traveled from MTRI in Ann Arbor, Michigan to TTF on March 22, 2021, for a second sUAS data collection effort (Figure 21). The recorded temperature varied between 13 °C and 20 °C, whereas the recorded wind speed was from 4.8 km/h to 17.6 km/h with gusts up to 31.1 km/h in the afternoon, respectively. Five sUAS were successfully deployed to collect data on March 22, 2021: (a) a Mavic 2 Pro with its integrated 20-mp optical sensors, (b) a Bergen Hexacopter with Nikon D850 45.7-mp optical RGB Camera with 50-mm prime lens mounted, (c) a Bergen Hexacopter with a FLIR VUE Pro R 640x512 thermal sensor, (d) a Bergen Hexacopter with a Tetracam Micro-MCA6 multispectral camera, and (e) an mdMapper1000+ with a 42.4-mp optical RGB Sony RX1R-II. Table 8 provides the details of the focus area collected data type, sUAS platform, and sensors.

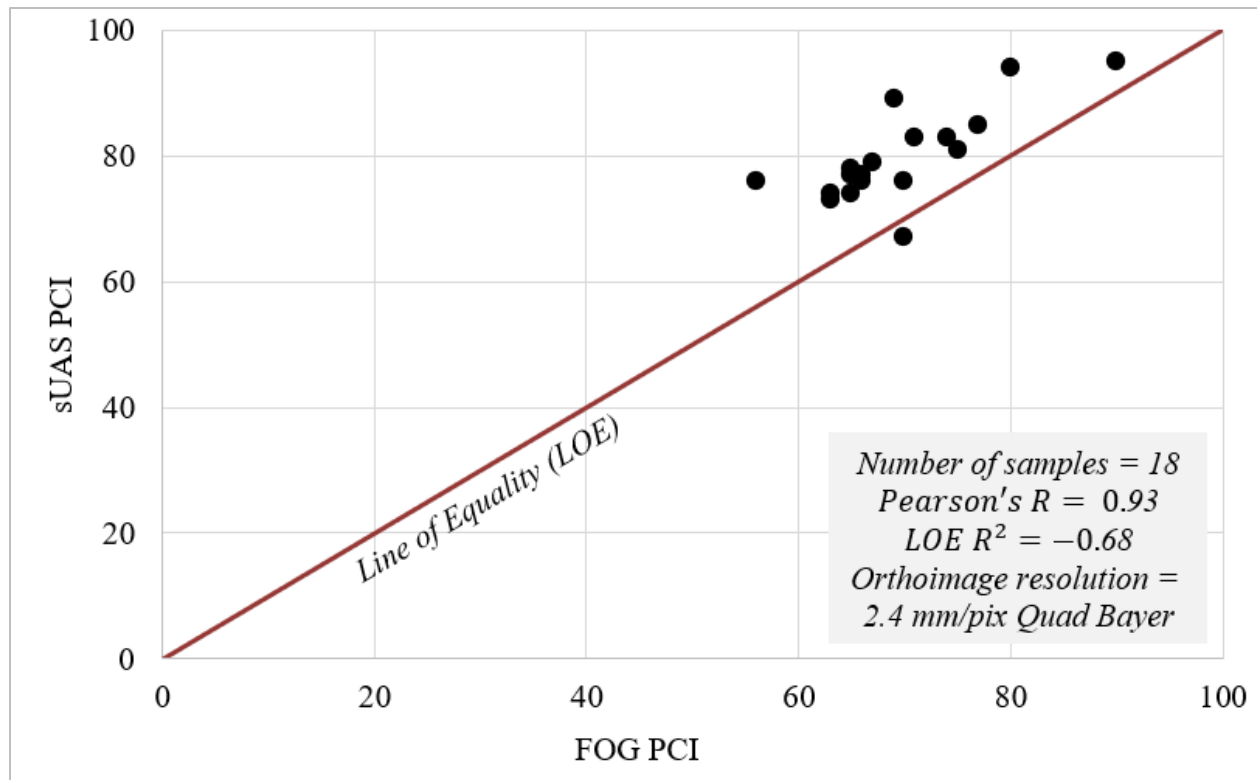
Figure 29. Comparison Between FOG PCI and sUAS PCI Calculated Using 2.4-mm/pix Data from TTF

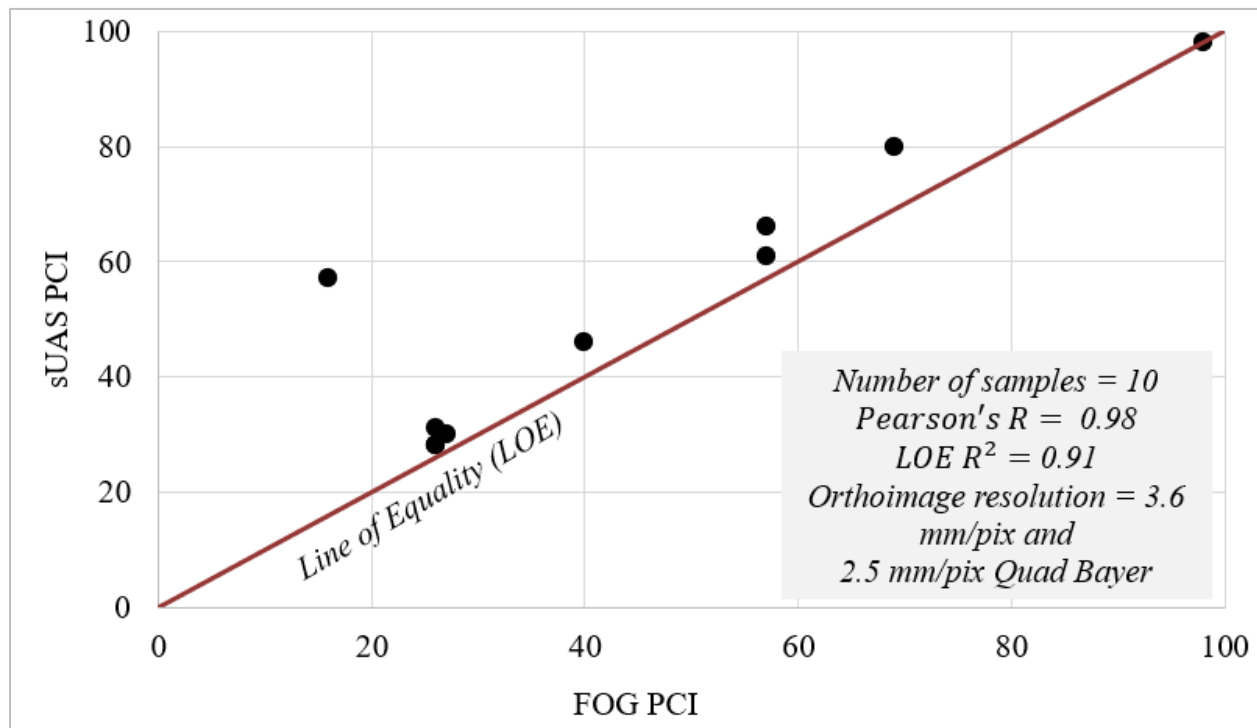
Figure 31. Comparison Between FOG PCI and sUAS PCI Calculated Using 2.5-mm/pix and 3.6-mm/pix Data from MTO

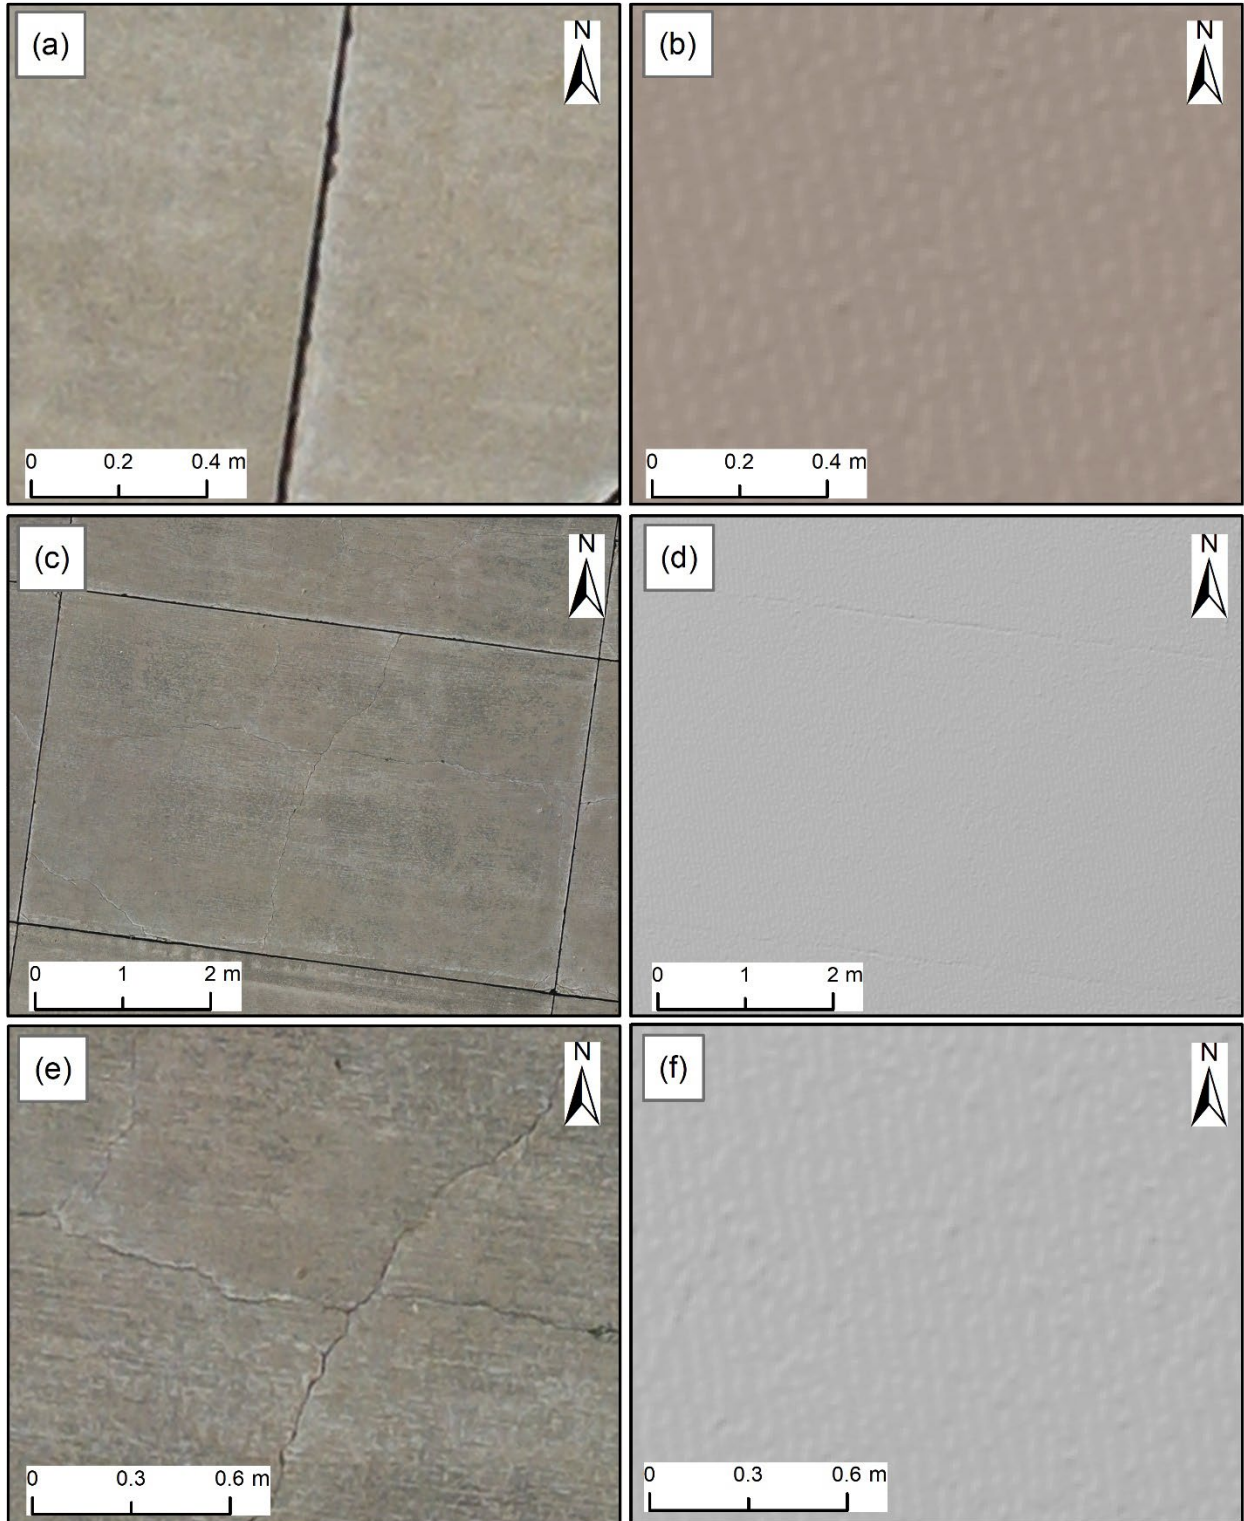
Figure 59. Faulting (L) in (a) 2.5-mm/pix Orthophoto and (b) 10-mm/pix DEM; and Shattered Slabs (M) in (c, e) 2.5-mm/pix Orthophoto and (d, f) 10-mm/pix DEM

difference, which could be used to confirm the suspected location of faulting in a slab (Figure 17 and Figure 59). Figure 98 illustrates the usefulness of high-resolution DEM data in detecting and verifying a change in elevation that indicates the presence of a distress. The two slabs where faulting exists at their edges show height differences of approximately 10 mm, as shown in parts Figure 17 (a) and (b); where there is no faulting, a rapid elevation drop is not present, as shown in Figure 17 (c) and (d). The usefulness of DEM data in the automated detection of elevation-based distresses without prior knowledge of their presence could be a topic for future research.

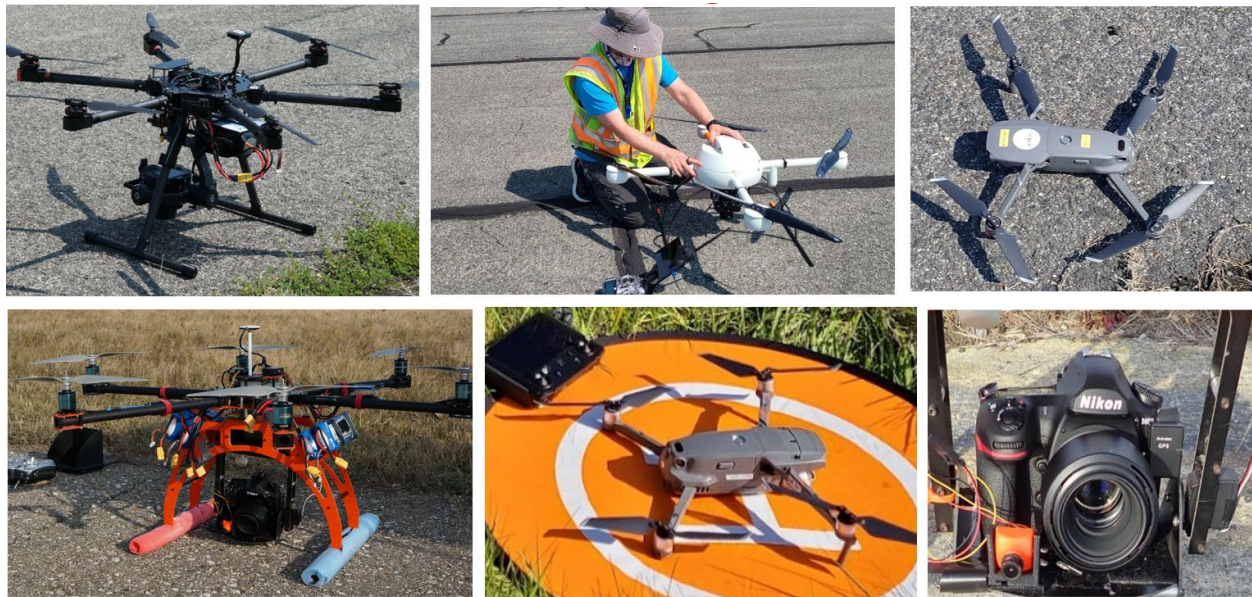
Figure 93. Examples of sUAS Platforms and Sensors Deployed
(Clockwise, from top left: Tarot X6 with Nikon D850, mdMapper1000+, Mavic 2 Pro, Nikon D850 camera, M2EA [on top of orange landing pad], Bergen Hexacopter with Nikon D850 ready for deployment)

Three small sUAS platforms were deployed at the data collection sites, all of which included integrated sensors: DJI Mavic 2 Pro, DJI M2EA, and DJI Mavic 2 Enterprise Dual. All three sUAS weighed about 1,100 gm each. They have a maximum expected flight time of 31 minutes, as reported by the manufacturer. However, they were flown back to the original take-off location when the battery had around 30% charge left for safe operation. It usually resulted in around 23 minutes of practical flight time. These sUAS showed better agility and maneuverability compared to the larger platforms. They can also perform better than the larger sUAS in adverse weather conditions; the M2EA and Mavic 2 Pro were deployed safely and successfully at TTF with up to 40 km/h wind gusts. Multiple successful flights were achieved at several airports using these platforms at wind gusts of more than 25 km/h. In addition, DJI provides and maintains flight assistant software for these sUAS, which was found to be reliable and easy to use (DJI Go 4 for the Mavic 2 Pro, DJI Pilot for the M2EA).

The research team deployed three relatively large sUAS platforms, weighing 6 kg to 10 kg with batteries on board. These sUAS platforms were mainly used for high-resolution sample unit data collections because of their ability to carry heavier, high-resolution cameras. The newer Tarot X6 North American-made platform from UAVSI (Figure 93, top-left) was used for complete data collection at WWD in August 2021, ONZ in November 2021, and TTF in November 2021. The latter two data collections were not part of the work presented in this report but were conducted for an additional FAA application. The platforms were versatile, and different sensors could be mounted based on the research need. The RGB optical cameras mounted on these platforms were full-frame and higher-resolution devices capable of capturing superior data compared to the smaller platforms' integrated, lower-resolution RGB optical sensors. Thus, these cameras mounted on larger platforms are recommended for higher-resolution data collection needing 2-mm/pix or better resolution RGB imagery with 6-mm/pix or better resolution DEM results for identification and rating of as many pavement distresses as possible.

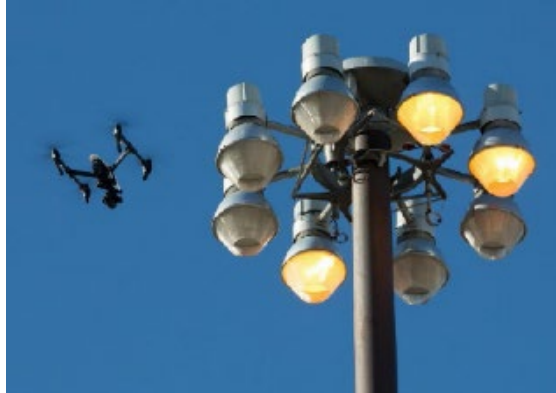
Figure A-7. Image of sUAS for High-Mast Lighting Pole Inspection by NJDOT (FHWA, 2018b)

The New Jersey Department of Transportation (NJDOT) started its sUAS program in 2016 and used it to inspect high-mast light poles (FHWA, 2018b). The plan was to examine 250 poles and, at the end of the program, 241 poles were inspected successfully (Figure A-7). NJDOT reported reduced lane closures and increased safety for both workers and the traveling public. NJDOT also reported a cost saving of 15% by using sUAS compared to conventional inspection methods. Using sUAS, it was possible to inspect six to seven poles per day, compared to traditional methodologies where only one or two poles were inspected per day.

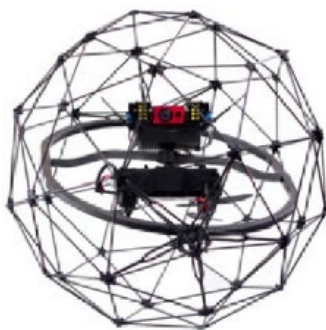
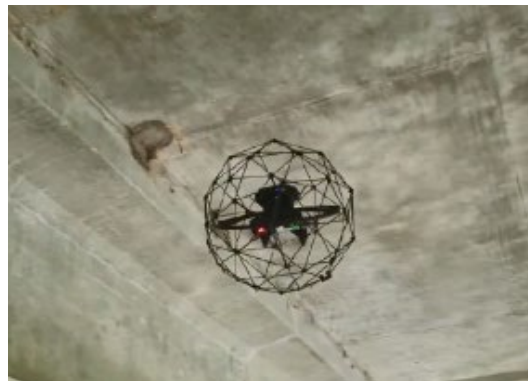
Figure A-10. Images of sUAS With Confinement Tested by MnDOT (FHWA, 2018a)

Since 2015, the Minnesota Department of Transportation (MnDOT) has been using sUAS for bridge inspection (FHWA, 2018a). MnDOT's sUAS capabilities are object sensing; 360-degree camera; and photo, video, and thermal imaging. The sUAS system uses a confinement cage to protect the system, as shown in Figure A-10. MnDOT reported a 40% cost savings by using sUAS for the structural inspection of bridges compared to conventional inspection methods. The report also indicates that close attention should be given to coordinate with the FAA and Aeronautics Office by providing the intended purpose and documentation for sUAS applications. The report also notes that inspection by sUAS does not need to entirely replace current inspection practices, and that further studies are required for future advancement.

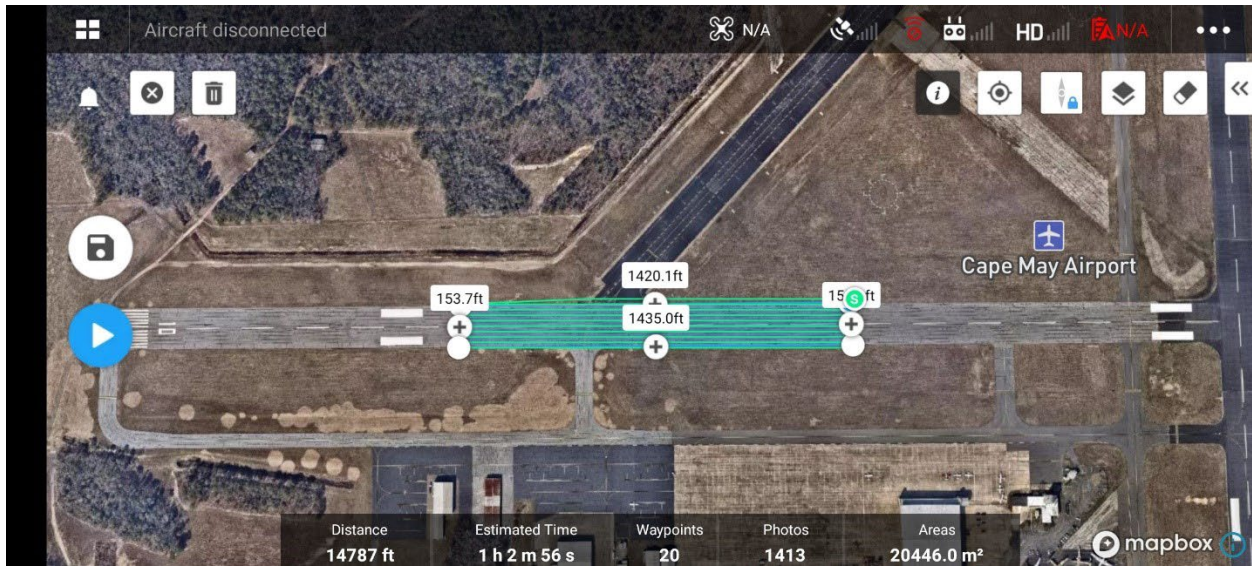
Figure B-5. Flight Plan for Stereo Thermal Data Collection with Mavic 2 Enterprise Advanced Over Part of Runway 10/28

Thermal imagery will be collected over Runway 10/28 section 10 and Apron Sections 30 and 40. Two M2EA units will be available, one with seven batteries and one with six batteries. Batteries can be recharged during the day with an available generator. The average flight time is estimated at 20 minutes per battery. The stereo thermal data are from 24.38 m AGL. The preplanned flights are shown in Figures B-5 and B-6.

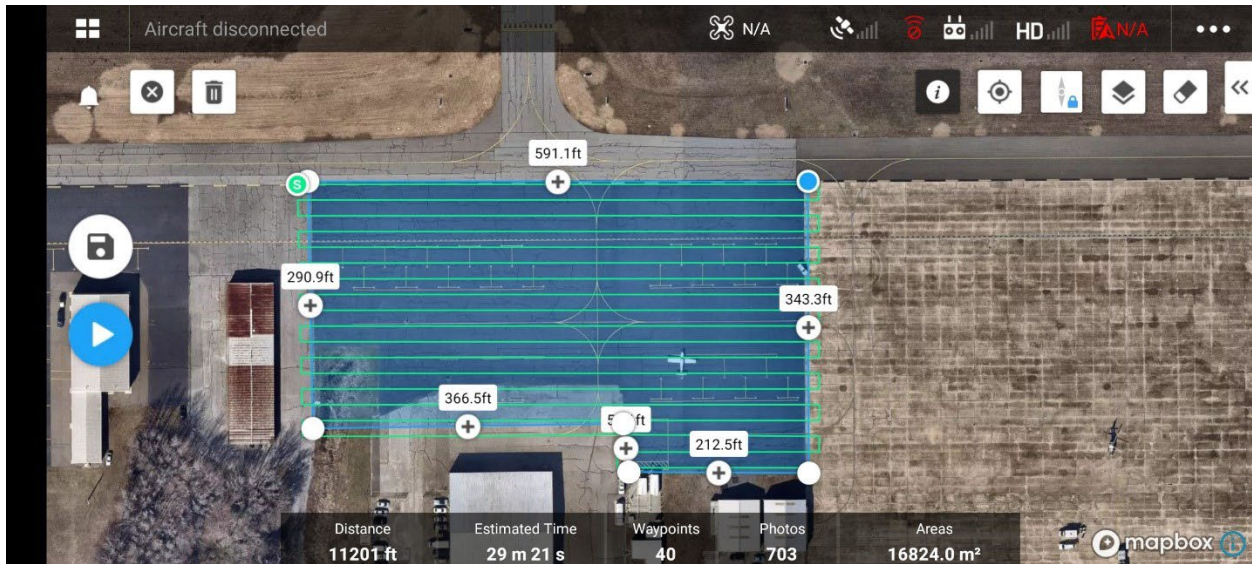
Figure B-6. Flight Plan for Stereo Thermal Data Collection with Mavic 2 Enterprise Advanced Over Apron 30
