MPC 22-466 | P. Romero

FIELD PERFORMANCE
OF ASPHALT MIXTURES
BASED ON FLEXIBILITY
INDEX RESULTS

Technical Report Documentation Page

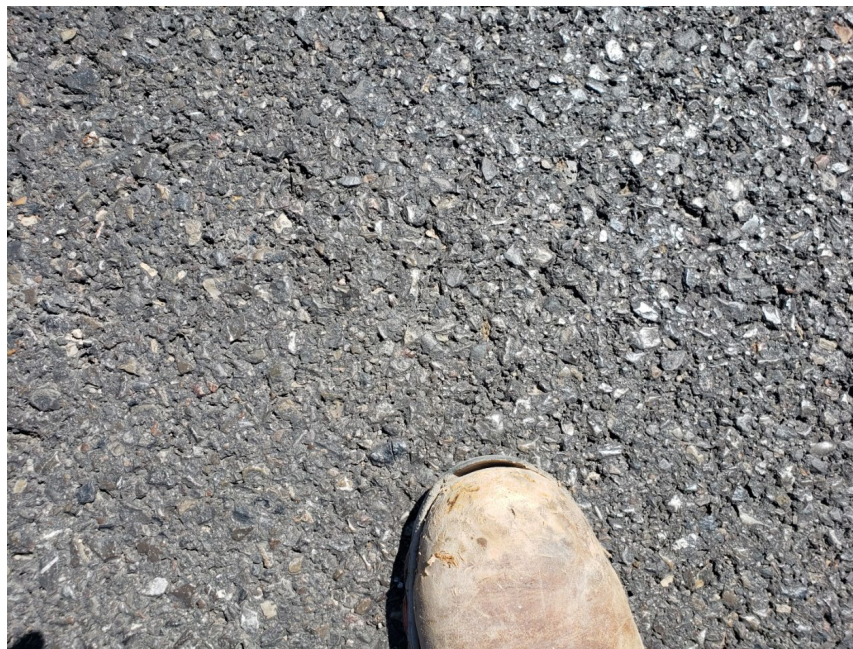
Figure 3.1 Section UT-02 showing fatigue cracking and raveling

This section is located in Tooele City, Skyline Drive, approximately 100 feet west of 200 East on the westbound travel lane (40°31'20.45"N 112°17'37.01"W). The pavement is not holding well; it shows sign of raveling and there is noticeable cracking observed in the section. This is shown in Figure 3.1.

The observations described in this chapter indicate that section UT-02 has not performed well as far as fatigue cracking distresses. This section had the most distresses after only two to three years of service. Section UT-03 showed significant thermal cracking. Section UT-05 shows some joint opening, which is considered a construction issue and not a materials issue. No distresses were seen in sections UT-04 or UT-07.

As previously discussed, FI values between 6 and 10 have been suggested as limits or thresholds in terms of performance, but no value has been specifically selected for Utah. The results shown in Table 2.2 indicate that section UT-02 is the only section with an FI value below 6 based on material sampled at both locations. Therefore, it is likely to be the worst performer of the group. As shown in the previous section, this was indeed the case, as this was the only section that showed signs of fatigue cracking.

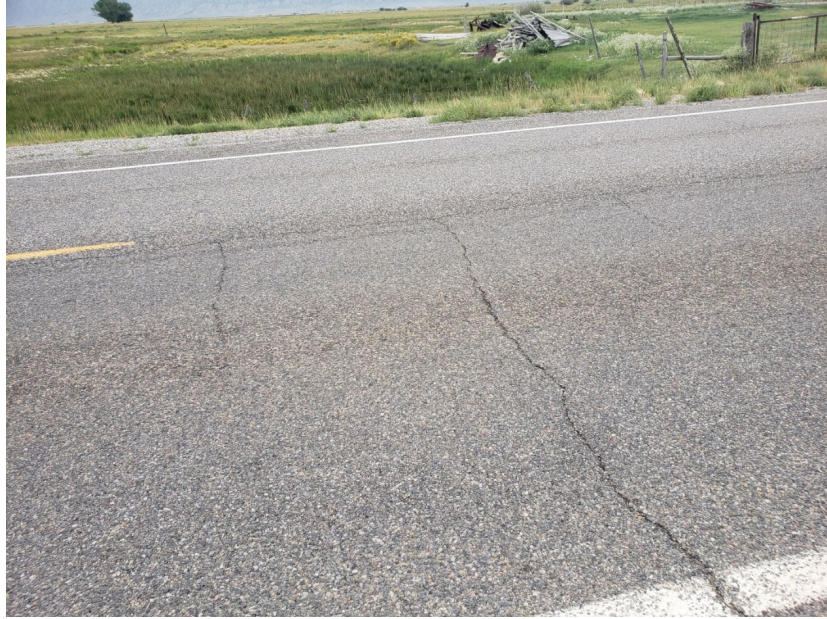
Figure 3.2 Section UT-03 showing thermal and reflective cracking

This section is located in Randolph, approximately 1.5 miles south of Church Street on the southbound travel lane (41°38'37.16"N 111°11'0.34"W). Randolph is at an elevation greater than 6,200 feet, and it is worth mentioning that Rich County, where this is located, has often set low temperature records for the state of Utah. Therefore, it is not surprising that Figure 3.2 shows severe thermal and reflective cracking.

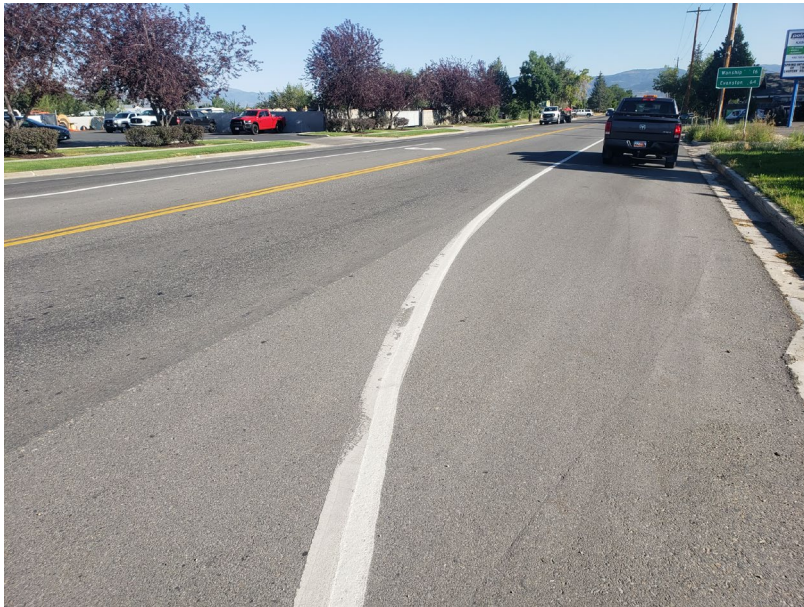
Figure 3.3 Section UT-04 Showing some joint opening

This section is part of SR 32 in Kamas. It is in the 200 North eastbound lane, in line with the east sidewalk ($40^{\circ}38'46.93''N$ $111^{\circ}16'50.26''W$). The section shows some longitudinal joint opening but no other distress. This is shown in Figure 3.3.

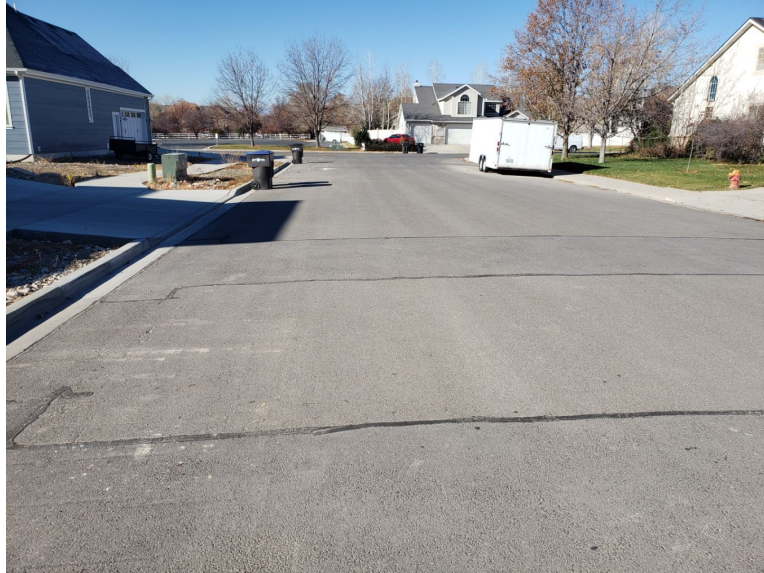
Figure 3.4 Section UT-05 used as a patch material

This section is located in a subdivision in Provo at 3550 N 180 E. The material was used as a patch and was sampled from a 17-hour-old stockpile for custom sales. The small size of the patch makes any performance evaluation meaningless. Figure 3.4 is a picture of the section.

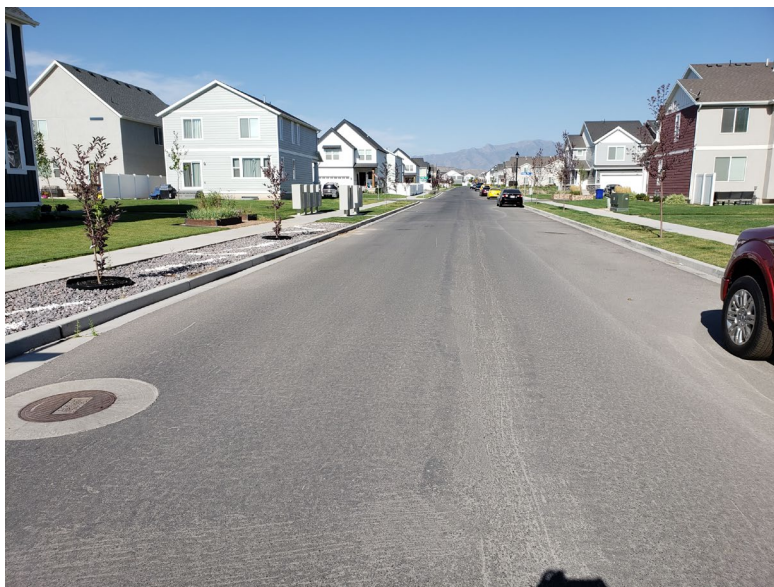
Figure 3.5 Section UT-07 showing no visible distresses

This section is located on Heartstone Lane in Saratoga Springs, between Valkyries and School House (40°21'9.41"N 111°54'33.27"W). As shown in Figure 3.5, the road is part of a residential area and shows no visible distresses.
