**DOT/FAA/TC-23/61**

# **Evaluation of Unmanned Aircraft Systems for Airport Obstacle Data Collection**

September 2023

Final Report

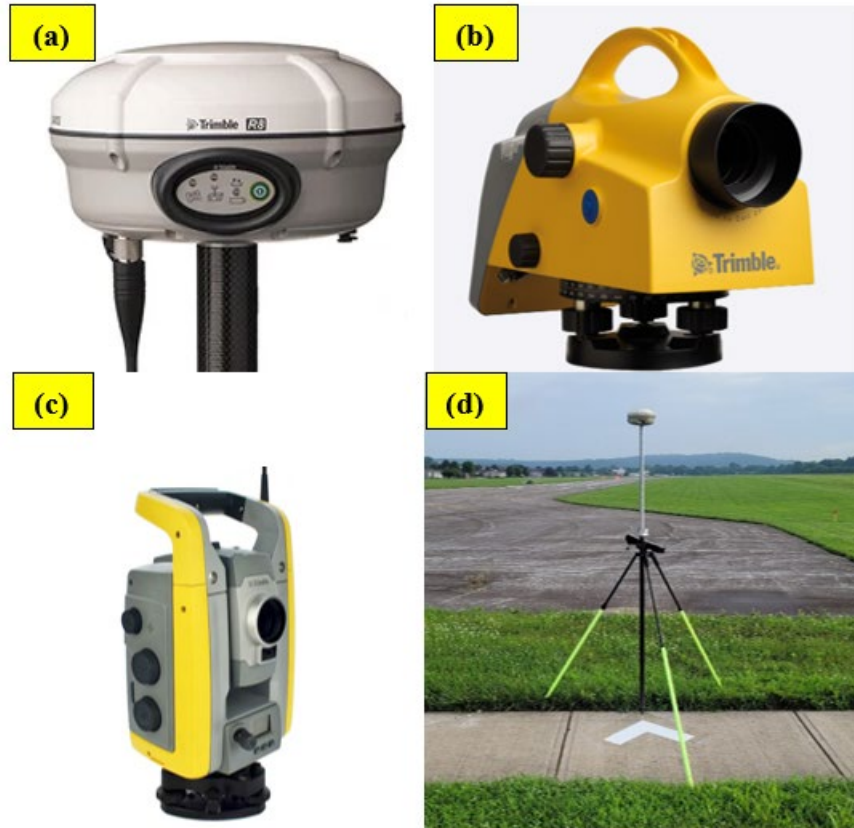
Figure 2. Survey Equipment: (a) Trimble R8 Model 3 GNSS Receiver, (b) Trimble S6 Robotic Total Station, (c) Trimble DiNi Digital Auto Level, and (d) Trimble Collapsible GPS Rover Rod with Tripod

Trimble Collapsible GPS Rover Rods™ with tripods, pictured in Figure 2(d), were used for all GNSS rover observations. The use of rods with fixed height increments prevents instrument height measurement errors while the locking bipods help ensure that the rover remains plumb for the duration of the observation.

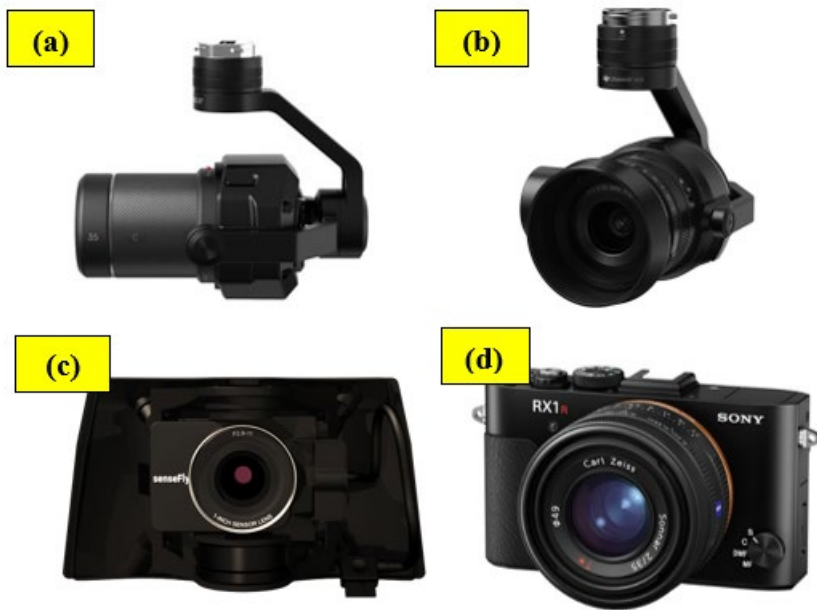
Figure 4. UAS Camera Payloads: (a) X7, (b) X5S, (c) S.O.D.A. 3D, and (d) RX1R-II

Table 2 presents a comparison of key specifications. Appendix B provides additional specifications for each camera payload.

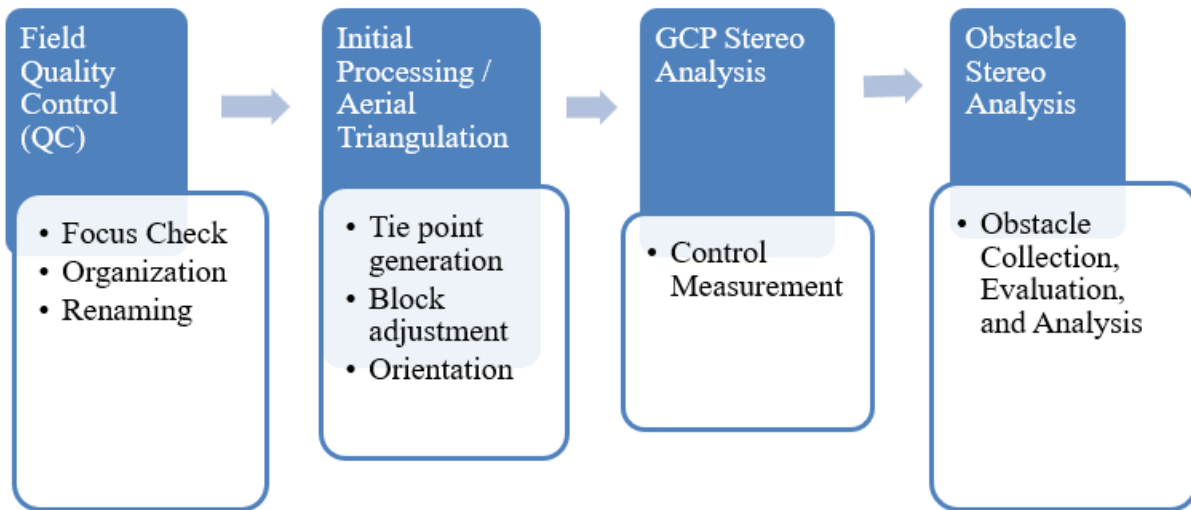
Figure 9. Unmanned Aircraft System Data Processing Workflow

Figure 9 presents a high-level overview of the UAS data processing workflow. Sections 2.3.1 through 2.3.5 describe the steps in the workflow and common issues that can arise during the process.

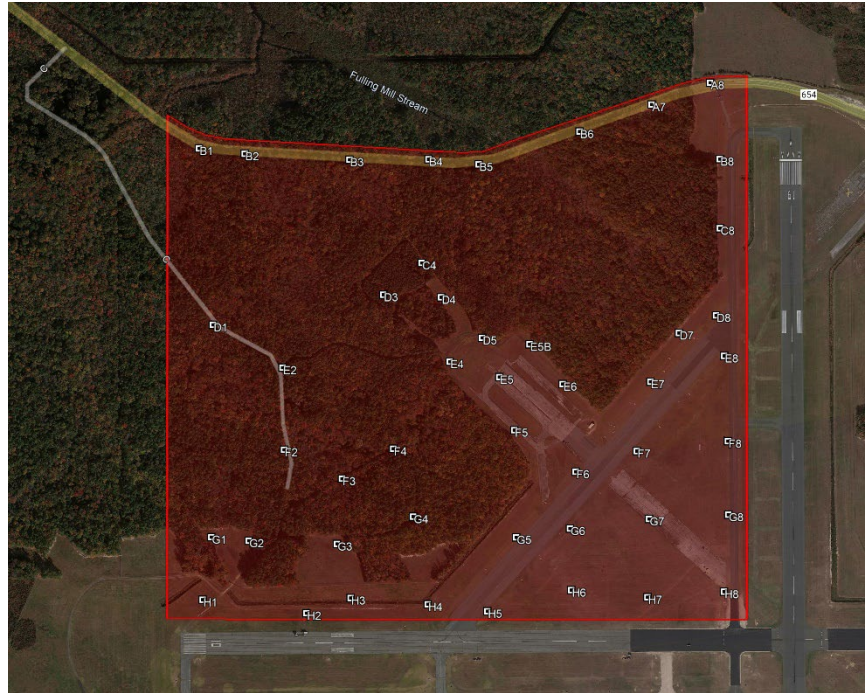
Figure 11. Cape May County Airport GCP Locations

Once on site, the vegetation in the study limits was found to be significantly denser than originally estimated. Because of this, the full grid could not be set as originally designed. As a result of the unexpected field conditions, a control layout containing only 47 of the intended 64 GCPs was established. Figure 11 depicts the final layout and the approximate locations of the 47 GCPs that were used as part of the data post-processing workflow.

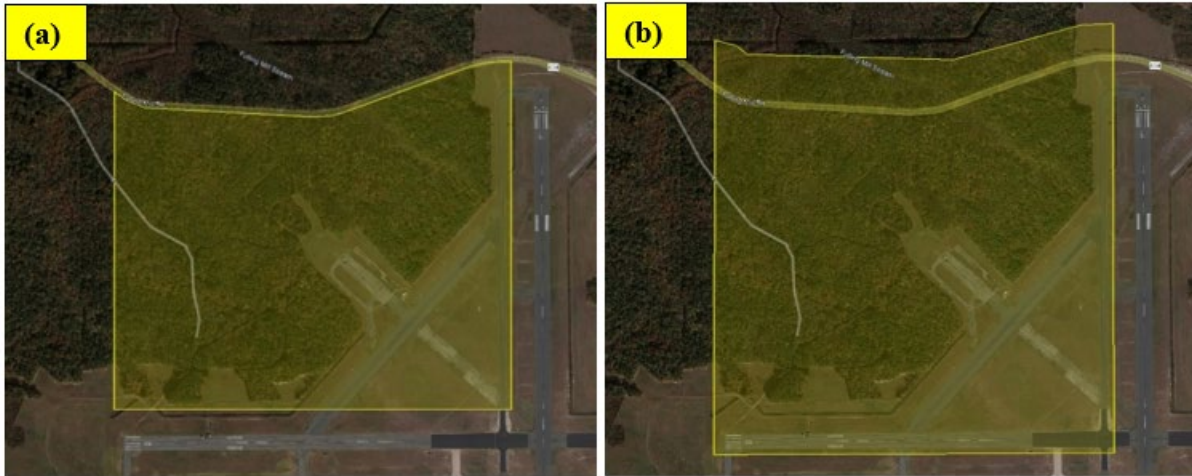
Figure 12. Cape May County Airport Operations Areas for (a) eBee and M210 and (b) WingtraOne

Due to challenges in generating acceptable AT solutions from the initial data sets collected with the M210 and eBee X, an additional data set was collected with the WingtraOne UAS. This UAS was selected due to its higher resolution camera, the Sony RXIR-II camera. The higher resolution of the camera payload produced a GSD of 0.5 in. when flying at a comparable altitude to other aerial surveys conducted at WWD. To further increase the likelihood of producing a valid and viable AT solution, the WingtraOne aerial surveys were conducted using a larger UAS operating area to help capture additional photos that included the GCPs along the road to the north and adjacent to Runway 10/28 to the south. Figure 12 compares the different UAS operating areas used during data collection at WWD.

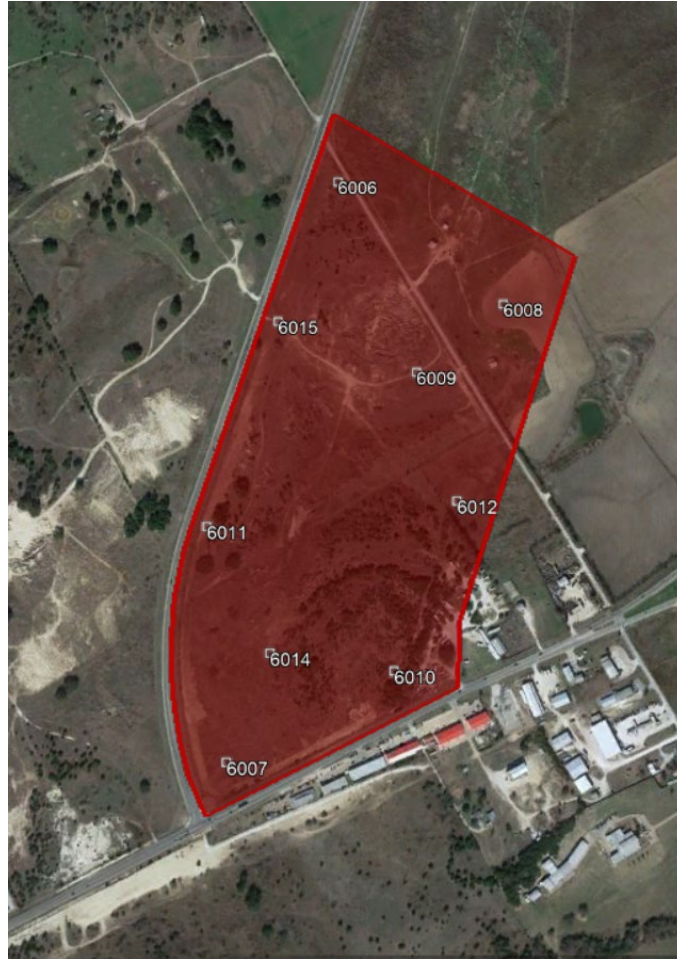
Figure 19. Granbury Regional Airport GCP Locations

Figure 19 depicts the approximate locations of the nine GCPs that were established at GDJ and used as part of the data post-processing workflow. No additional check points were set at GDJ due to unexpected construction occurring at the time of the survey, which limited ground access to a large central portion of the site. Inability to access the construction site limited the number of GCPs established, which resulted in all GCPs being used during processing, and none left over for use as check points. Flight operations were only conducted when the construction site was inactive and free from nonparticipants.

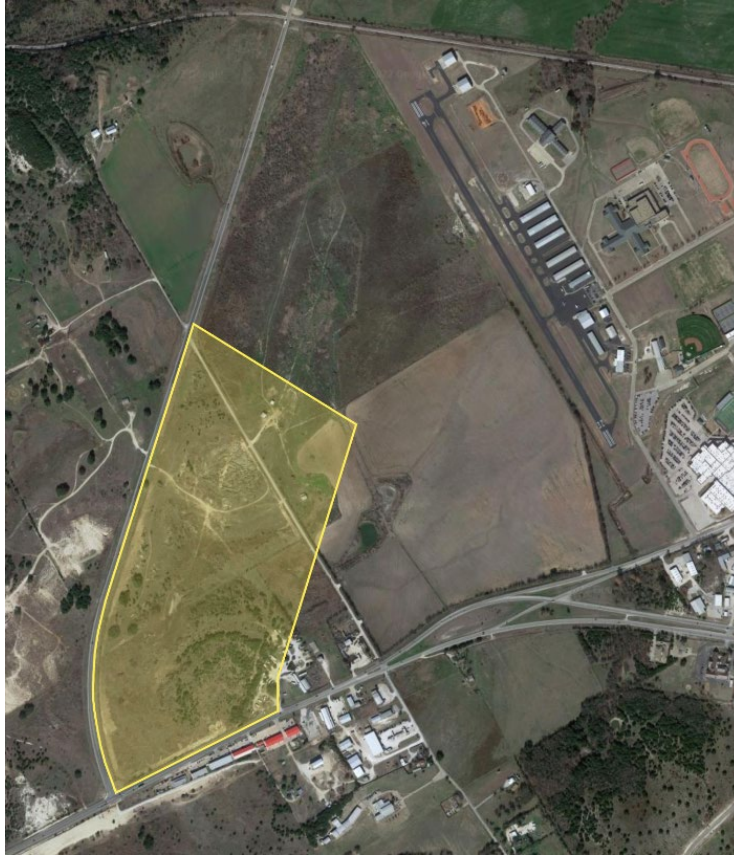
Figure 20. Granbury Regional Airport UAS Operations Area

Based on the finding from WWD showing that higher resolution imagery did not benefit the quality of data, a GSD of 1 in. was used for all flights. Regarding overlap, the 80%/60% forward and side settings used during the successful data set at WWD were replicated, as well as new minimum settings of 70%/60% forward and side overlap. Table 12 summarizes the collection parameters for each UAS aerial survey conducted at GDJ. Figure 20 depicts the UAS flight operations area.

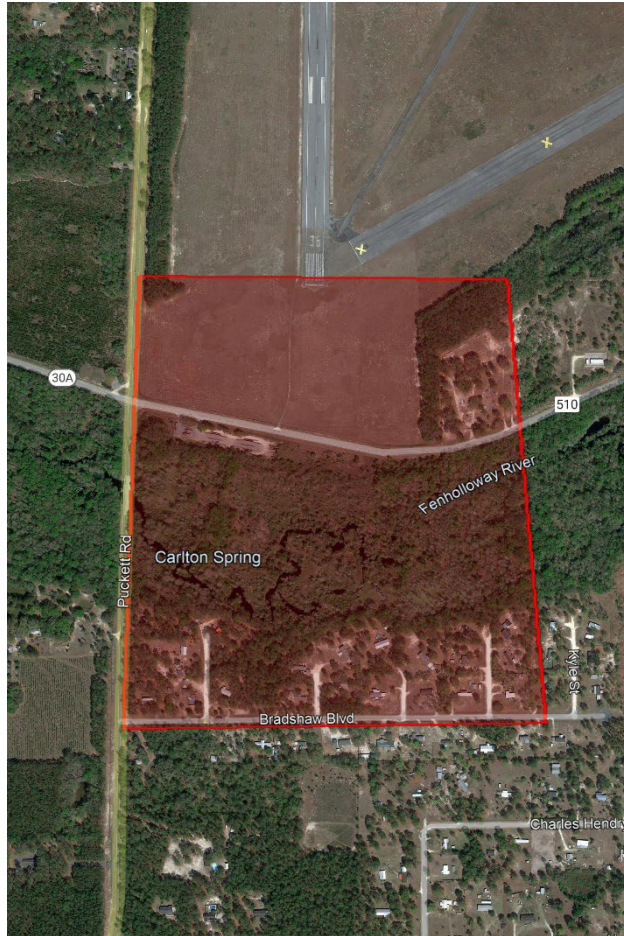
Figure 25. Perry-Foley Airport Study Limit

The study area at FPY was located on the south side of the airfield in the approach surface for Runway 36, as shown in the red-shaded area in Figure 25. A diverse range of obstacles were present in this area, including trees and man-made structures such as a building, fencing, a roadway, and airfield lights. Similar to WWD, the study area also included a substantial area of dense vegetation.

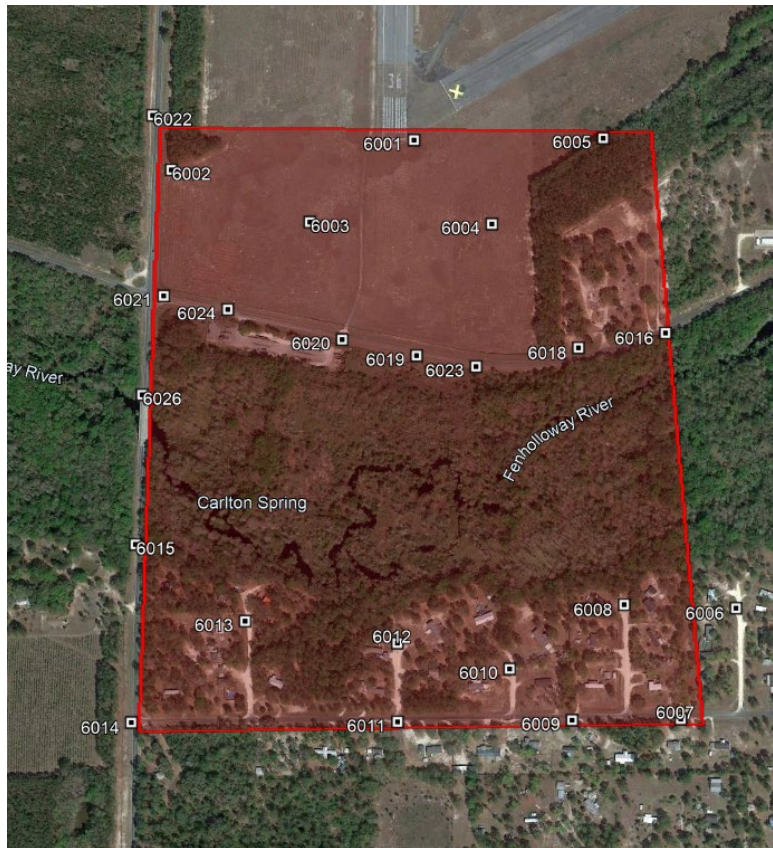
Figure 26. Perry-Foley Airport GCP Locations

Figure 26 depicts the approximate locations of the 24 GCPs that were established at FPY and used as part of the data post-processing workflow.

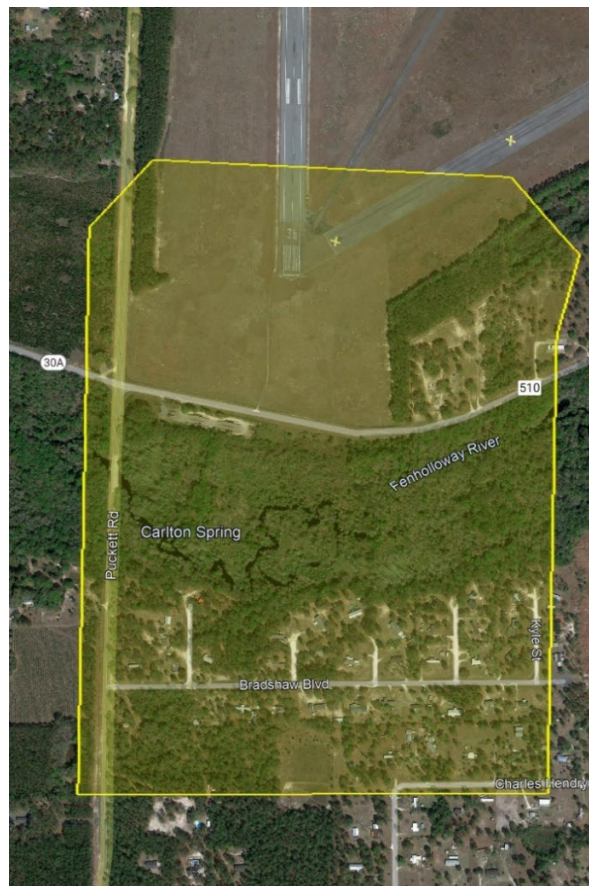
Figure 27. Perry-Foley Airport UAS Operations Area

to collect data at GDJ. Due to 14 CFR 107.51 restrictions (Operating Limitations for Small Unmanned Aircraft, 2016), the WingtraOne could not be flown high enough to achieve a 1 in. GSD, and instead collected data with a 0.5-in. GSD as it did during a successful data collection effort at WWD. In total, three UAS data sets were collected. Table 17 summarizes the collection parameters for each UAS aerial survey conducted at FPY. Figure 27 depicts the UAS flight operations.

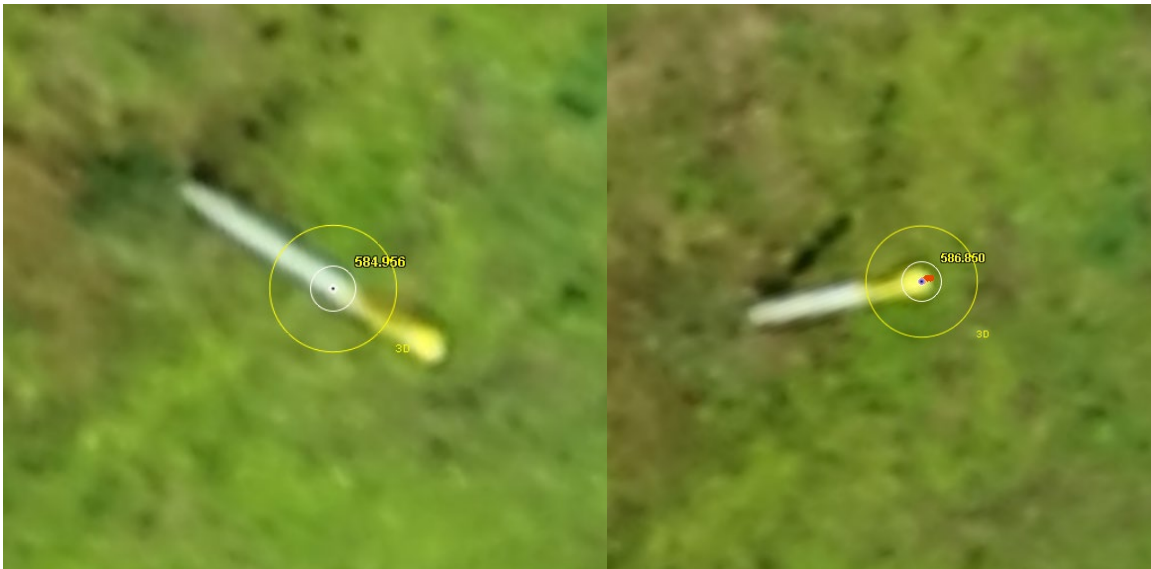
Figure 38. Flat Imagery Observed in Data from Test 4B

Tests 1A, 1B, 1C, 3A, and 3B produced valid AT solutions with unviable stereo imagery. Consistent parallax was observed in each of these data sets that manifested as extremely flat imagery. Flat imagery results in topography surrounding points that are close to the ground (such as a light or a utility pole) to appear flat or tilted, preventing the stereo analyst from fully measuring the image in 3D space. Figure 38 depicts examples of this phenomenon. During stereo analysis the yellow circle seen on these images moved horizontally (x, y) and vertically (z). The vertical movement of this cursor, seen in 3D in the stereo environment, is absent or diminished when the imagery appears flat.

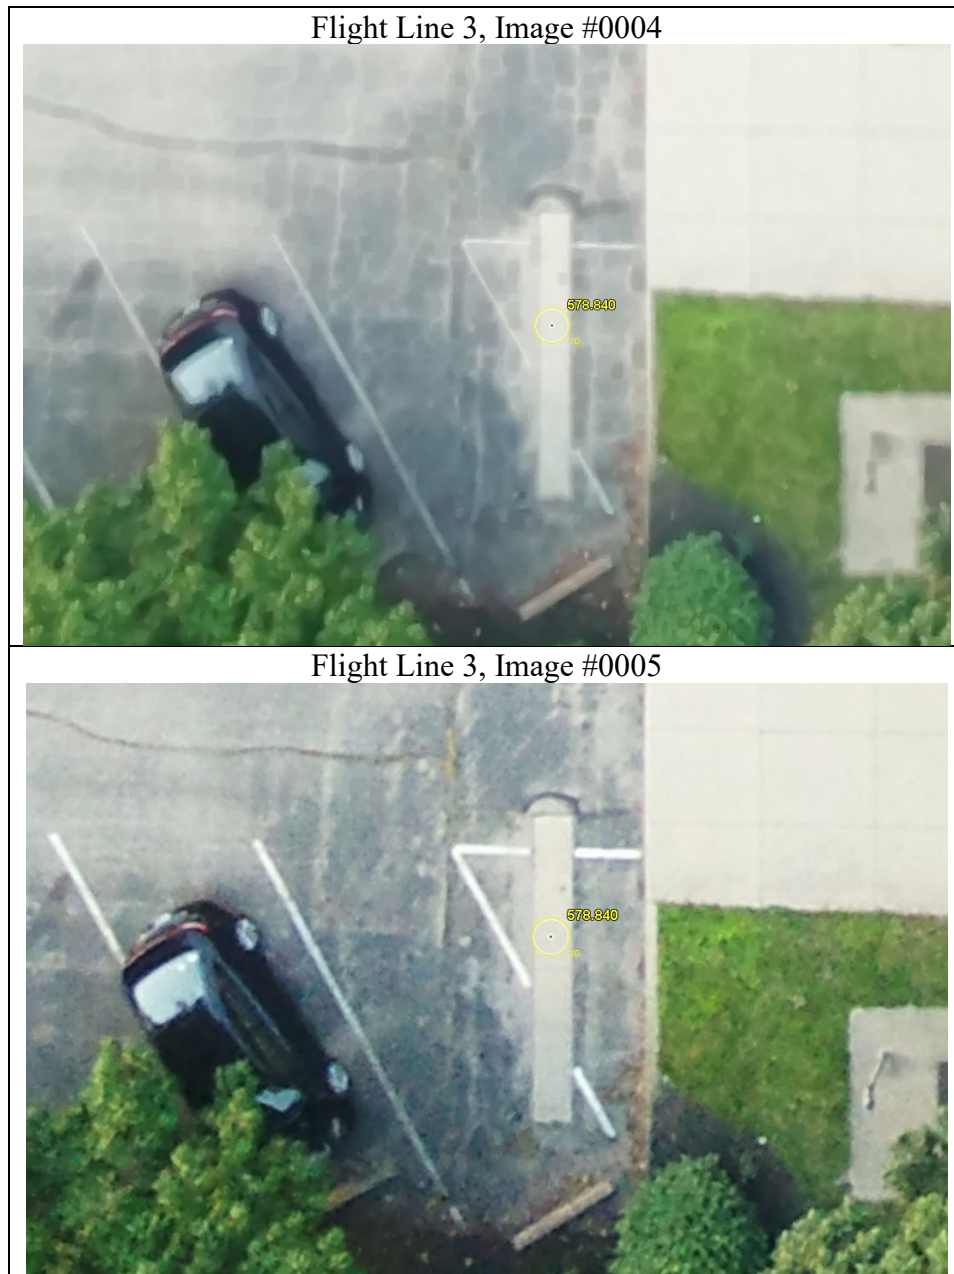
Figure 40. Example of Exposure and Texture Discrepancies from Flight 10

The inconsistency in image exposure and texture and the halo effect on some of the GCP chevrons were also present in this data set. The presence of these issues in both data sets indicates that the platform and payload are likely the cause, rather than the sun angle. The inconsistencies with exposure and texture are shown in Figure 40, which compares consecutive images from Test 10. The first image is blurred or “soft” around the car, treetop, and paint lines. In the next sequential image, this blurring effect is not present.

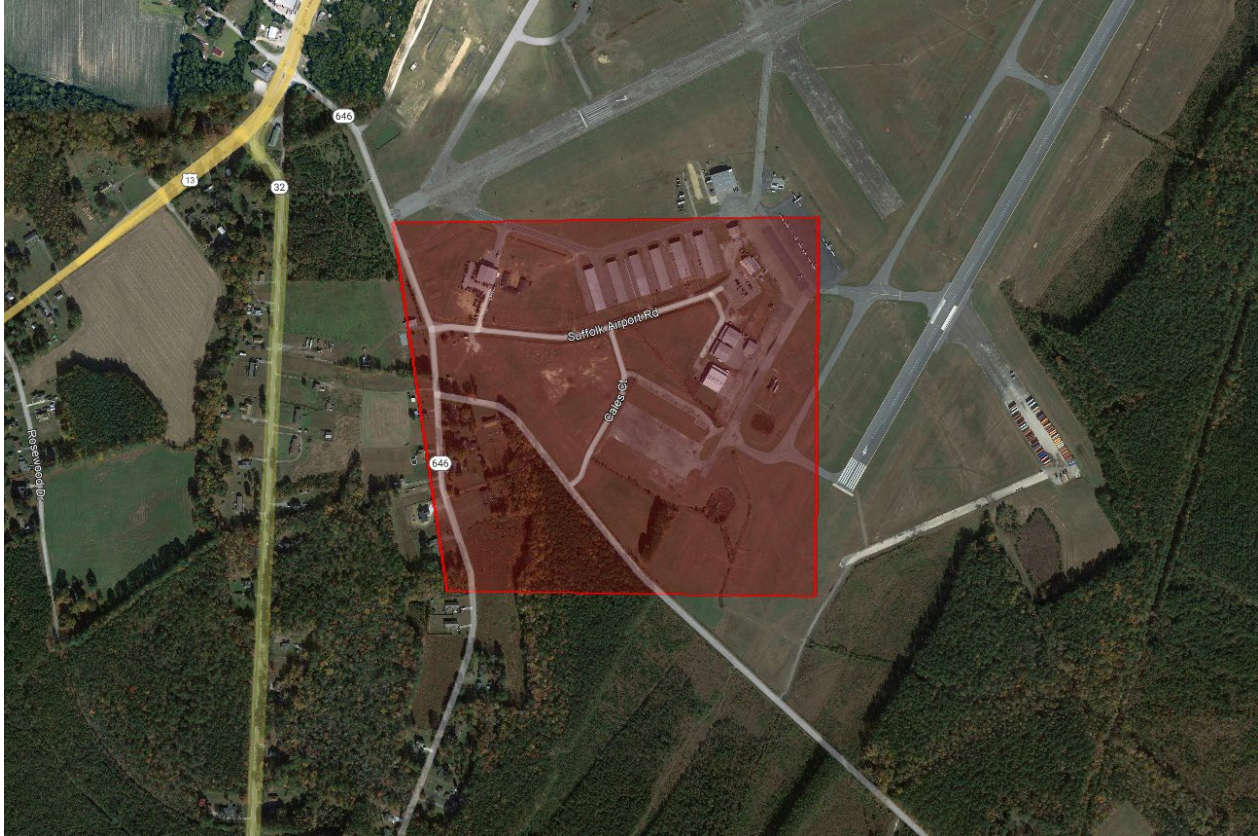
Figure 44. Suffolk Executive Airport Study Limit

The study area at SFQ was located on the southwest side of the airfield in and in between the approach surfaces for Runways 4 and 7, as shown in the red-shaded area in Figure 44. A diverse range of obstacles were present in this area, including natural obstacles such as trees and man-made structures such as buildings, fencing, and antennas.

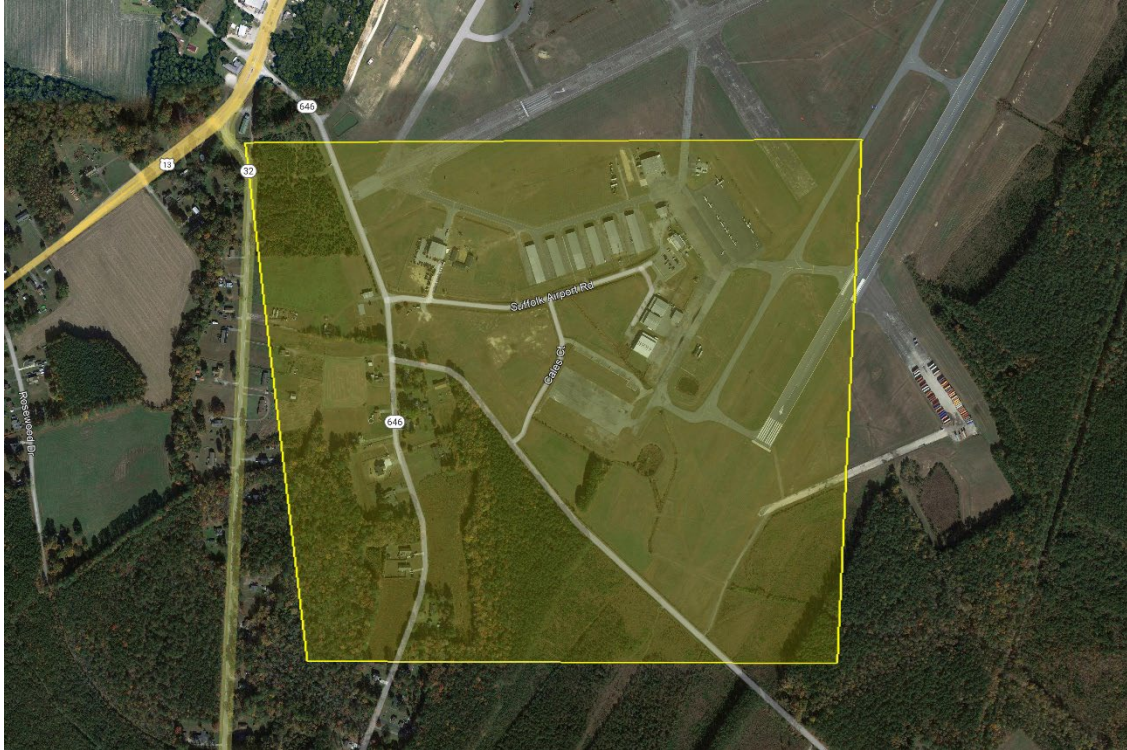
Figure 46. Suffolk Executive Airport UAS Operations Area

This test effort served as the final validation test during this research program and sought to provide the NGS with a single data set from each UAS used, including the M210, eBee X, and WingtraOne. Data collection parameters were selected that developed successful obstacle measurements in previous test efforts, including 80%/60% forward and side overlap settings, and a GSD value of 1 in. Due to 14 CFR 107.51 (Operating Limitations for Small Unmanned Aircraft, 2016), the WingtraOne could not be flown higher to achieve a 1 in. GSD, and instead collected imagery at 0.5 in. In total, three UAS data sets were collected. Table 72 summarizes the data collection parameters for each UAS data set collected at SFQ. Figure 46 depicts the UAS flight operations area.

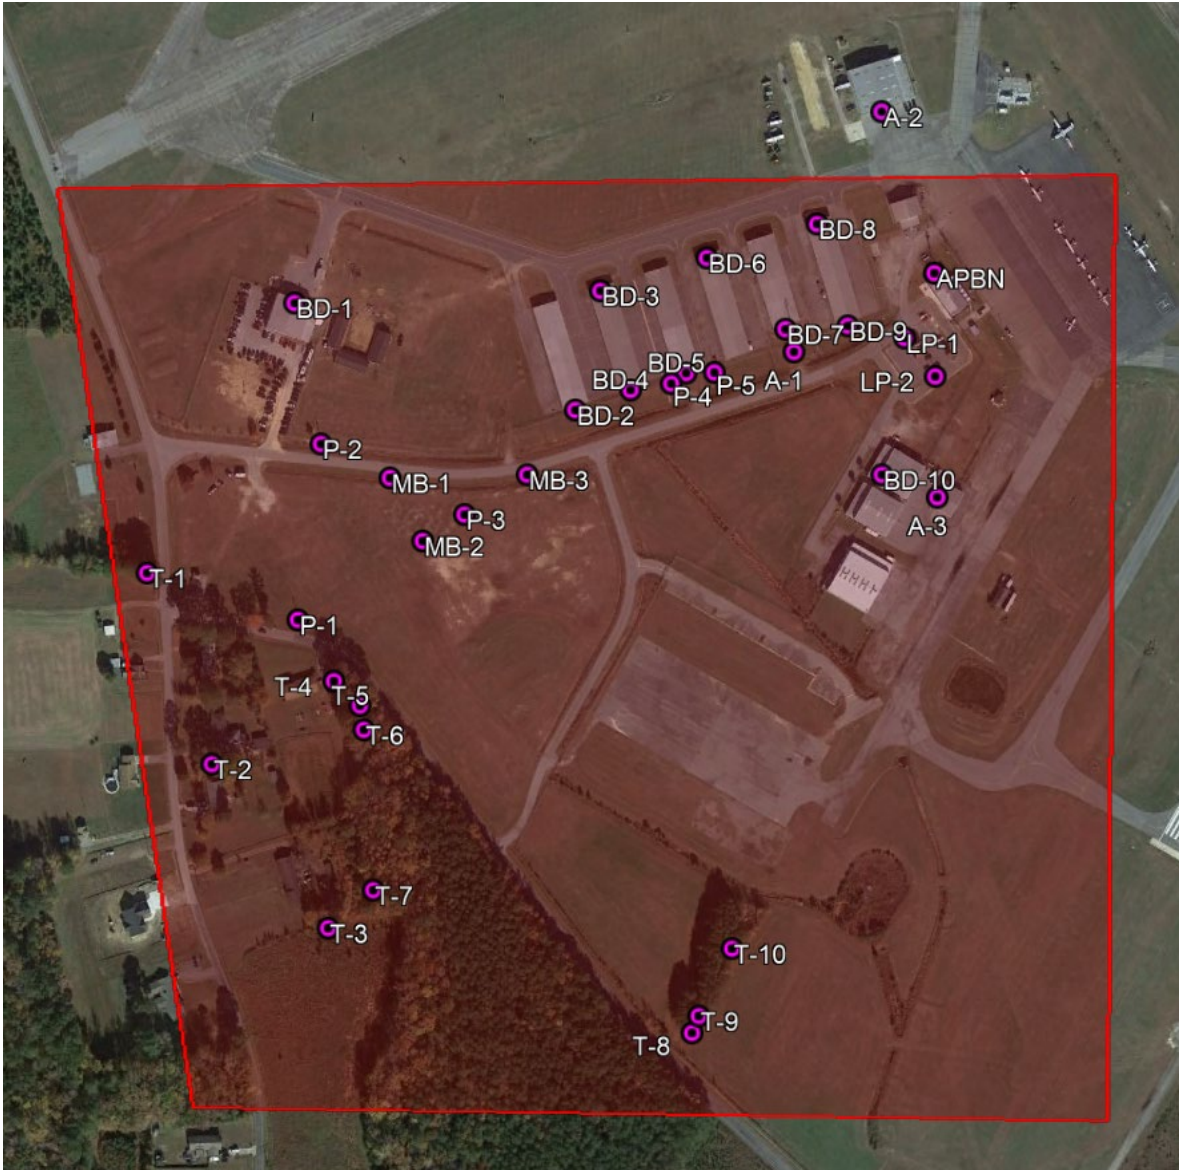
Figure 47. Suffolk Executive Airport Obstacle Locations

During their field obstacle data collection, the NGS identified 34 obstacles in the test area at SFQ that were used to assess the accuracy of UAS-collected data. Figure 47 shows the locations of these obstacles. The NGS did not disclose the locations of these obstacles prior to UAS data collection. Following data collection, the NGS provided a general vicinity map of the obstacles they requested be measured, along with annotated ground photographs of the features. This limited knowledge of the true position of obstacles ensured a fair test of the capability of UAS imagery to allow for the accurate collection of obstacle locations.

Once this information was received from the NGS, a stereo analysis effort was initiated to identify and measure each obstacle collected in the field survey using the UAS imagery. These measurements were provided to the NGS, who performed the comparison. The information in Tables 77 and 78 was provided by the NGS following their comparison. These tables are color-coded to indicate measurements that meet the most stringent obstacle requirements of AC 150/5300-18 (green), measurements that meet the requirements but are outliers (orange), and measurements that fall outside of the requirements (red).

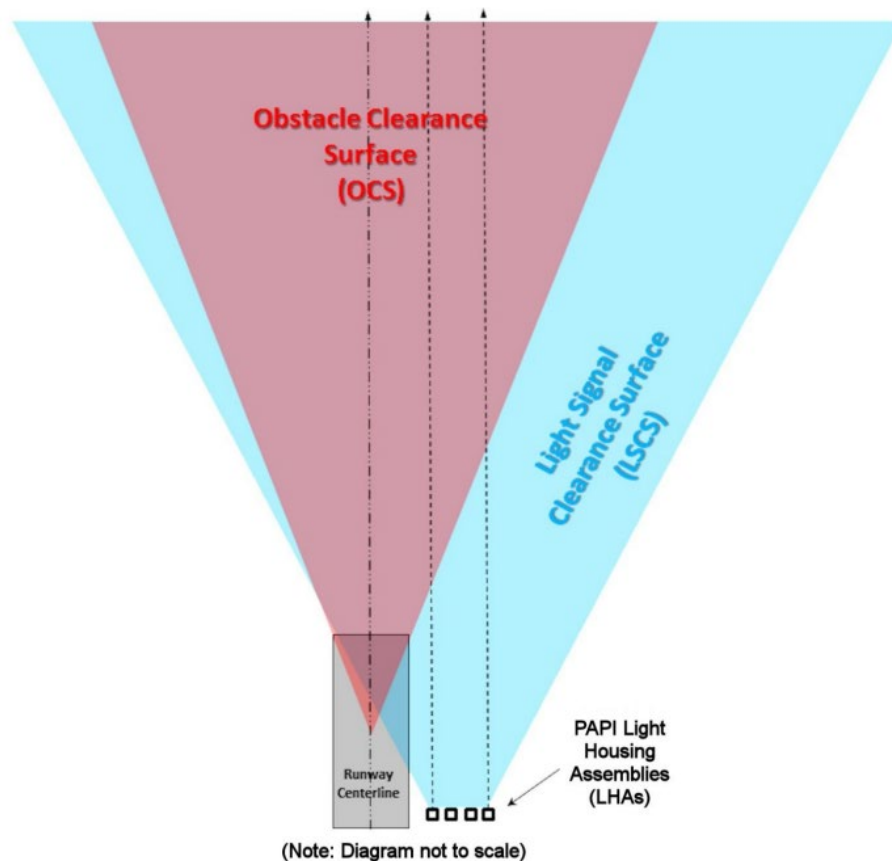
Figure 50. Precision Approach Path Indicator OCS and LSCS (FAA, 2017a)
