Emerging ISTD technology uses an innovative erosion head that more accurately measures soil erosion resistance, resulting in more cost-effective foundation designs and greater reliability and resiliency in bridge performance.

Recommended citation: Federal Highway Administration, *In-Situ Scour Testing Device (ISTD), State Demonstrations of Field Soil Tests, Lovelock, NV* (Washington, DC: 2023) <https://doi.org/10.21949/1521392>

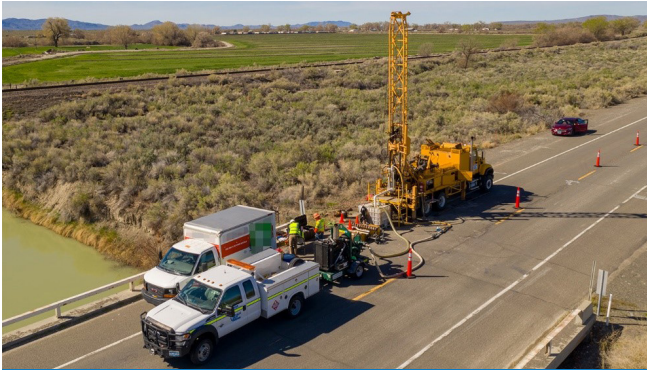
■ The ISTD demonstration site on State Route 396.

The Nevada Department of Transportation (NDOT) hosted the 10th ISTD field demonstration on State Route 396 at the bridge over the Humboldt River, located 2 mi north of Lovelock, which is about 90 mi northeast of Reno, NV. The demonstration was held on the south shoulder of the road at the west abutment. NDOT had scheduled the bridge for replacement due to its poor condition.

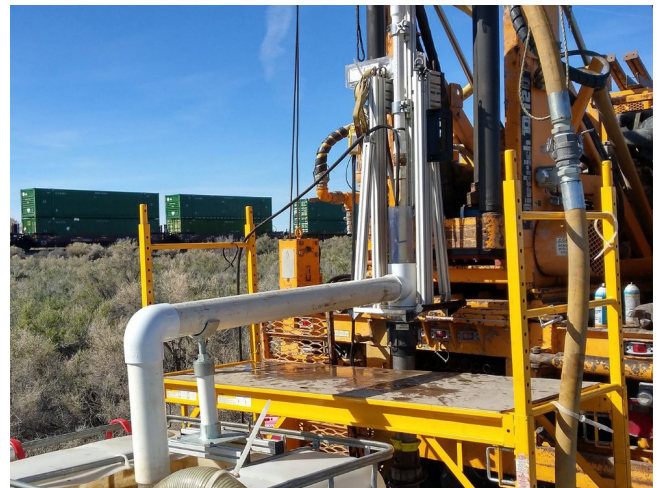
■ The ISTD equipment assembled in front of the drill rig.

The demonstration took place on April 17, 2019, but the drill crew and the hydraulics team arrived a day in advance to perform the SPTs and conduct as much ISTD field testing as possible in the two-day span. Because the test was held on the shoulder of an active roadway, NDOT organized traffic control to close the adjacent lane of traffic. The lane closure increased safety for the demonstration but reduced the available time to conduct testing. In addition, the rental pump was delivered from California and arrived without the proper adapter to connect the suction hose. Fortunately, an NDOT engineer found the correct adapter at a local construction site on an impromptu scouting trip, which saved a half-day of testing. The hydraulics team made a note to purchase a spare adapter to prevent future delays in a similar scenario. After mounting the adapter to the suction hose, the hydraulics team finished assembling the remaining equipment, including the linear drive, water tank, hoses, piping, and laptop. Having previously augered to a depth of 13 ft, the drill team lowered in the casing and pushed the Shelby tube 13 inches into the clay. The hydraulics team inserted the erosion head, connected all the equipment, and began the first test.
