**Emerging ISTD technology uses an innovative erosion head that more accurately measures soil erosion resistance, resulting in more cost-effective foundation designs and greater reliability and resiliency in bridge performance.**

The Kentucky Transportation Cabinet (KYTC) hosted the 11th ISTD field demonstration on State Route 62 at the bridge over Rolling Fork, KY, located 2 mi west of Boston, KY. The demonstration was held east of the river in the floodplain under the bridge. KYTC planned to replace the 13-span bridge, originally built in 1938, with a shorter, nine-span structure by lengthening the embankment on the eastern side.

Recommended citation: Federal Highway Administration, *In-Situ Scour Testing Device (ISTD), State Demonstrations of Field Soil Tests, Boston, KY* (Washington, DC: 2023) <https://doi.org/10.21949/1521393>

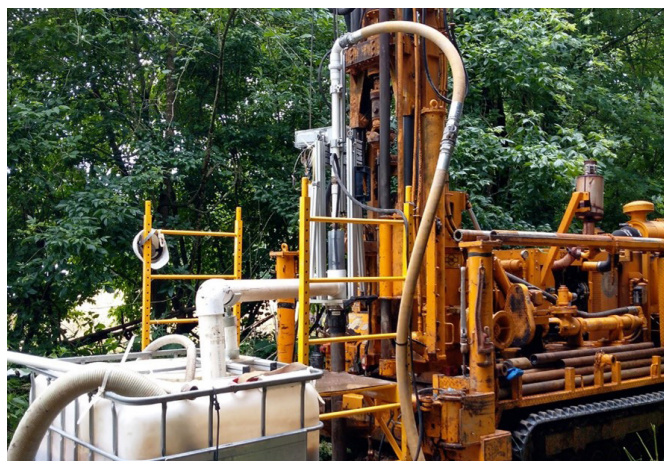
■ The ISTD equipment assembled in front of the drill rig.

The demonstration took place on May 30, 2019, but the drill crew and the hydraulics team arrived a day earlier to conduct as much ISTD field testing as possible in the two-day span. To access the floodplain area underneath the bridge deck, the crews used an access road entrance to a farm about 1,000 ft east of the bridge. When they arrived at the proposed drilling location, it was inaccessible because of brush overgrowth, so both groups agreed to move the test two span lengths closer to the east abutment. At this point, the weather took an unfortunate turn. Heavy rains fell at the site and continued over the two days of testing. The drill crew proposed positioning the rig under the bridge deck, but there was not enough clearance to raise the rig mast. Fortunately, they were able to position the rig adjacent to the deck to offer everyone some relief from the rainfall. The drillers ended up augering to a depth of 12 ft, a 5-ft segment past the targeted depth. The hydraulics team then assembled the remaining equipment, including the water tank, pump, piping, hoses, linear drive, and laptop to prepare for the first test.

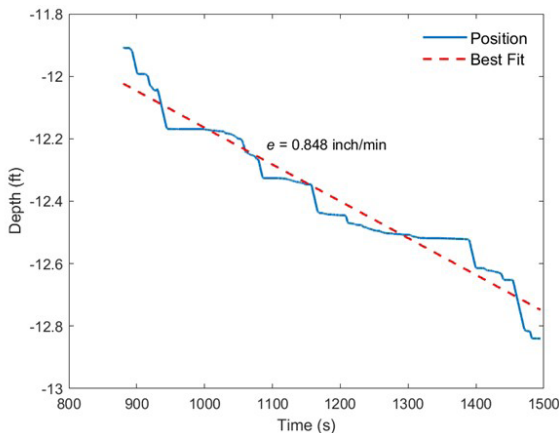
Soil layer's erosion rate (e) calculated from the slope of the best-fit line.

Despite some early difficulties with a stuck sensor and an instance where 10 inches of clay washed out quickly from the Shelby tube, the testing was very successful, obtaining a wide range of data points. With this data, FHWA identified nine different segments and extracted erosion rates using a best-fit line through each set of data. The corresponding mean flow rates were also calculated for each segment. The nine data points are detailed in the Summary of Results table. The erosion rates are plotted against flow rates, showing the correlation between the two values. With more data points, a nonlinear power curve can be fit to the data to extract the critical flow rate.
