JOINT TRANSPORTATION RESEARCH PROGRAM

Shear and Bearing Capacity of Corroded Steel Beam Bridges and the Effects on Load Rating

1. Report No. FHWA/IN/JTRP-2023/11	2. Government Accession No.	3. Recipient's Catalog No.	
4. Title and Subtitle Shear and Bearing Capacity of Corroded Steel Beam Bridges and the Effects on Load Rating	5. Report Date April 2023		6. Performing Organization Code

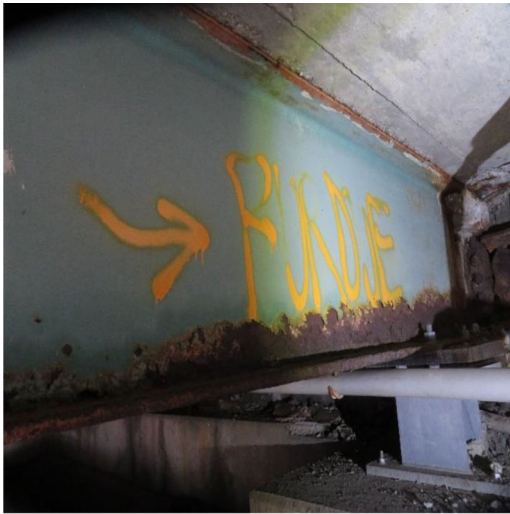
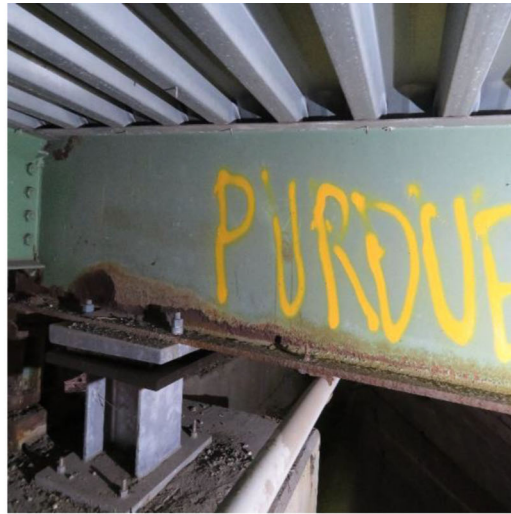
Figure 2.1 Corroded girders identification and marking.

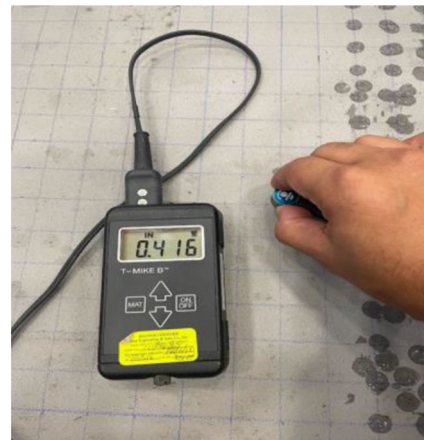
Figure 3.1 Section loss measurements using an ultrasonic thickness gauge.

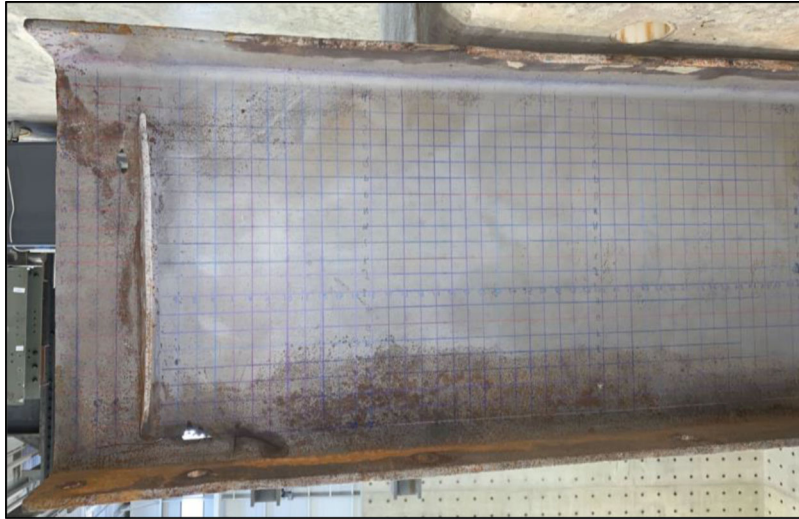
Figure 3.7 Specimen 3 and grids on the web where the remaining thickness is measured.

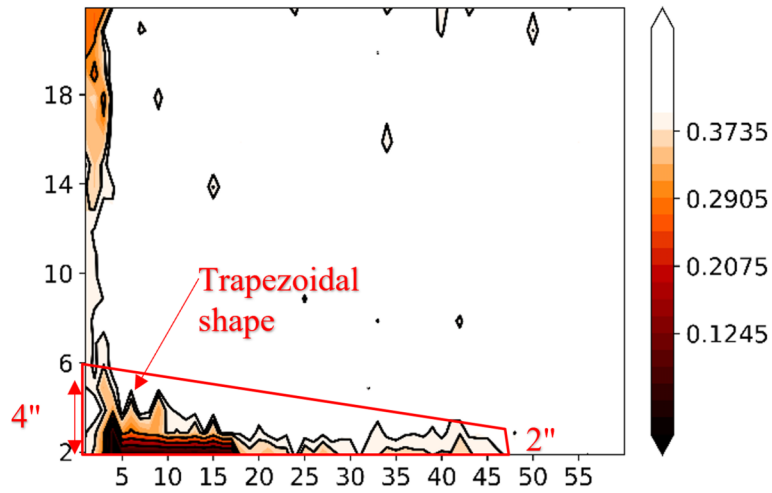
Figure 3.9 Specimen 2 contour plot of remaining thickness less than $0.9 t_{w_nominal}$.

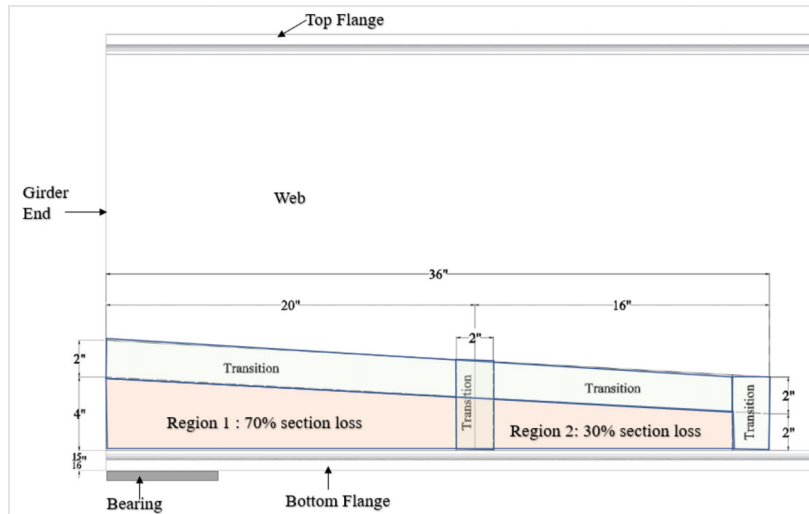
Figure 3.13 Section loss profile induced artificially in Specimens 4, 5, and 6.

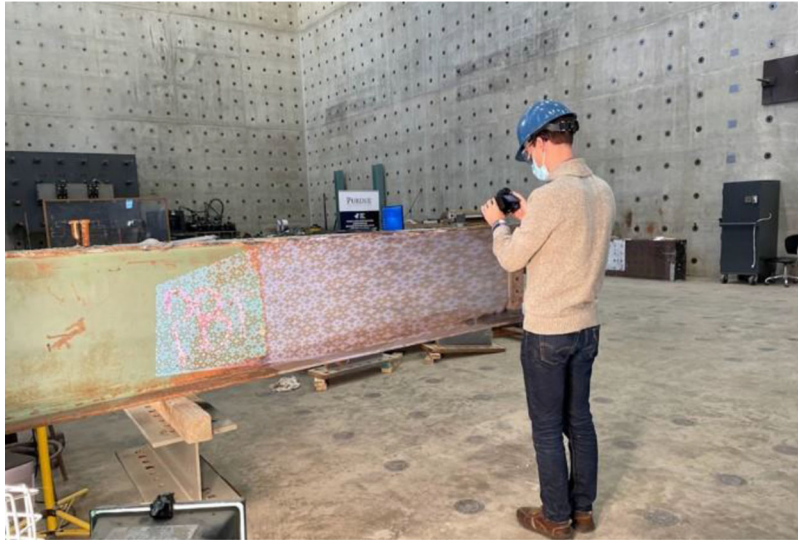
Figure 3.22 3D scanning of corroded girder.

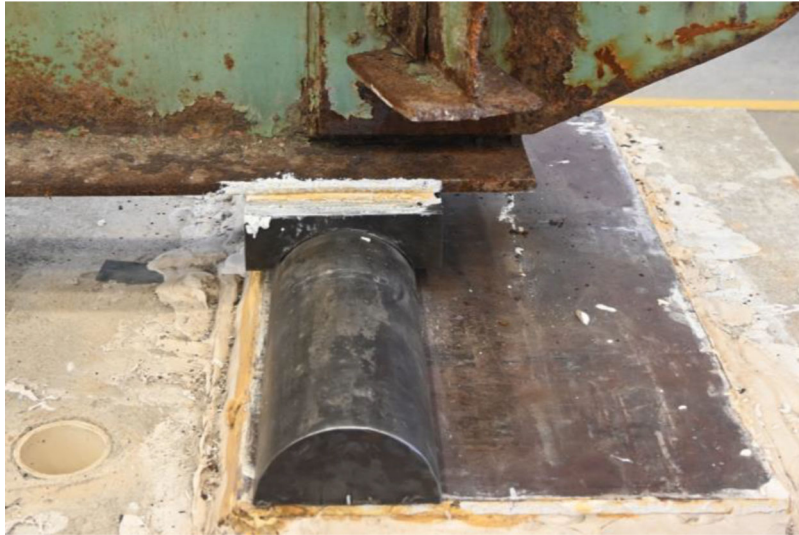
Figure 4.19 Simple support at the girder end.

Specimens were simply supported on an assembly of a half-cylindrical steel section and a steel block on top as shown in Figure 4.19. The width of the steel block was 8 in. and the half-cylindrical steel section on the bottom allowed rotation of the steel block and specimen on top during testing simulating a girder in actual

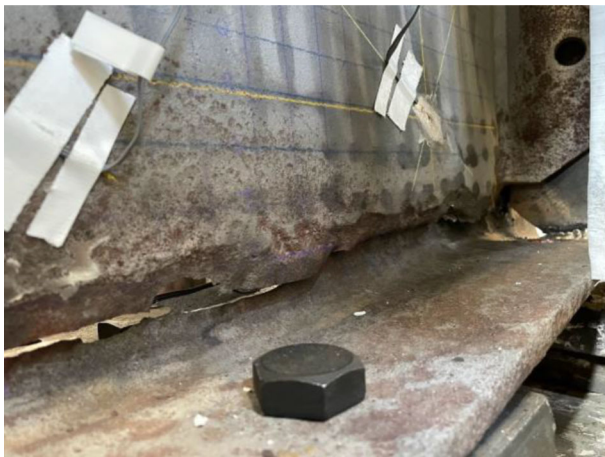
Figure 5.5 Specimen 2 shear rupture at the web bottom (East side).

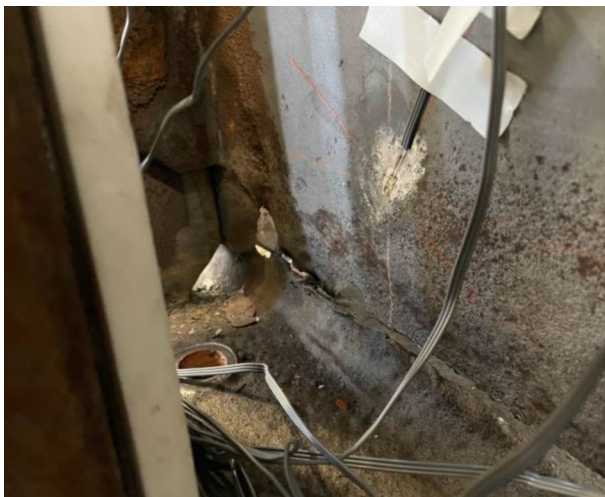
Figure 5.6 Specimen 2 shear rupture at the web bottom (West side).

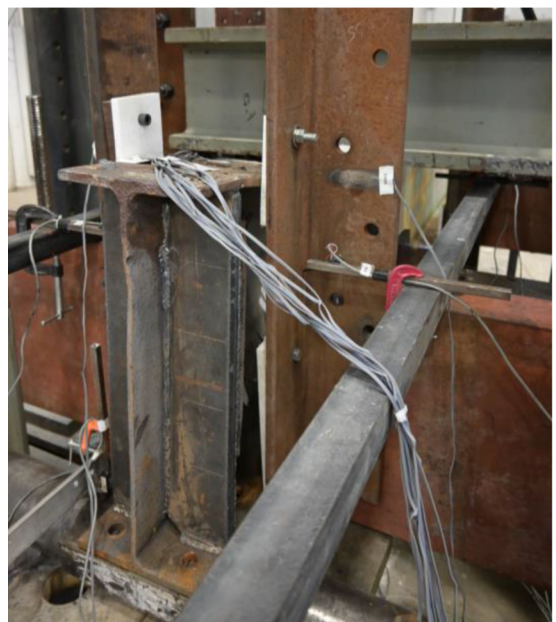
Figure 5.11 Specimen 3 web condition at the support.

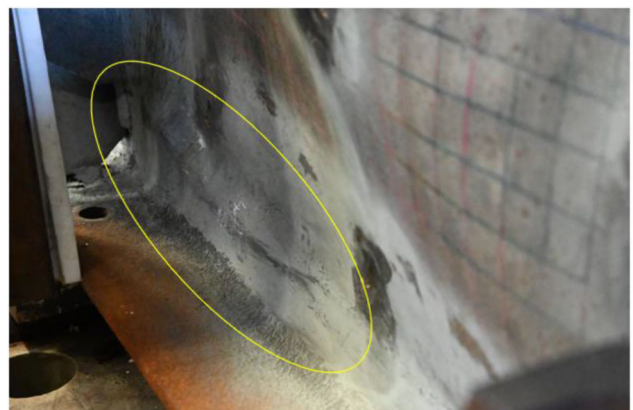
Figure 5.21 Specimen 6 OOP web displacement at the bottom (SP14).

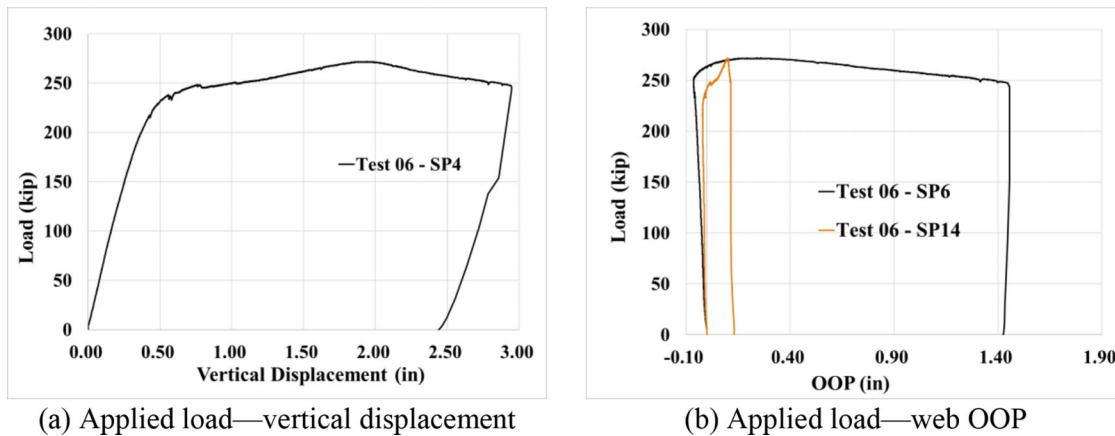
Figure 5.22 Specimen 6 load-displacement relationship.

From Figure 5.22(b), it was observed that Specimen 6 did not have any significant OOP displacement up to an applied load of 250 kips. The web began to buckle after the load exceeded 250 kips, as observed by the increase in the web OOP displacement. Large web OOP displacement occurred at the center of the web panel (SP6), as shown in Figure 5.20, in comparison to the bottom of the web just above the near-end support

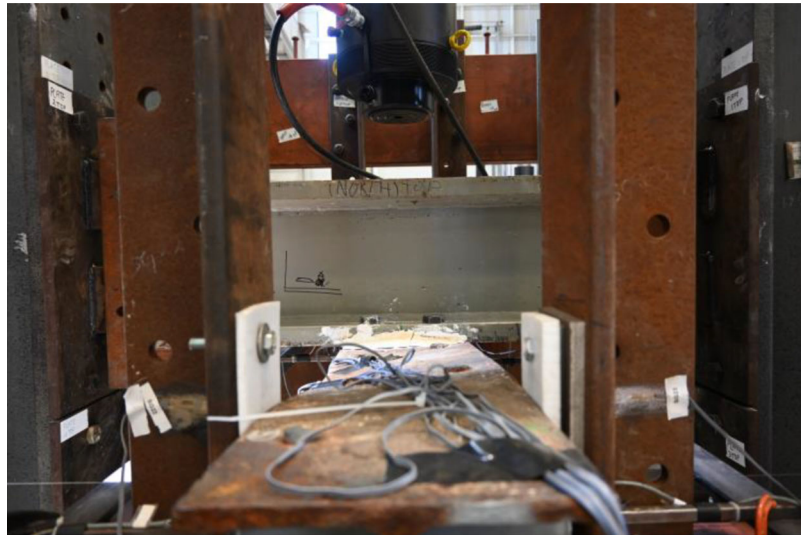
Figure 5.23 Tilting of top flange and spreader beam.

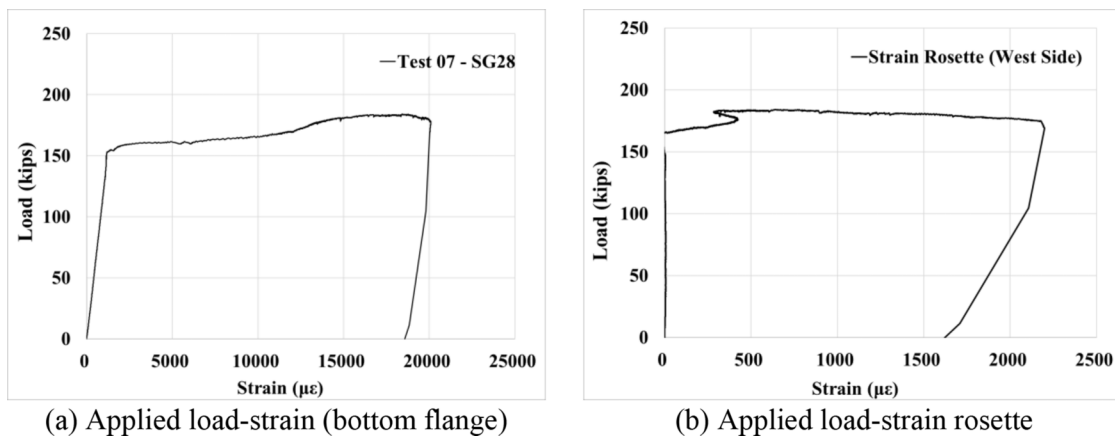
Figure 5.27 Specimen 7 load-strain relationship.

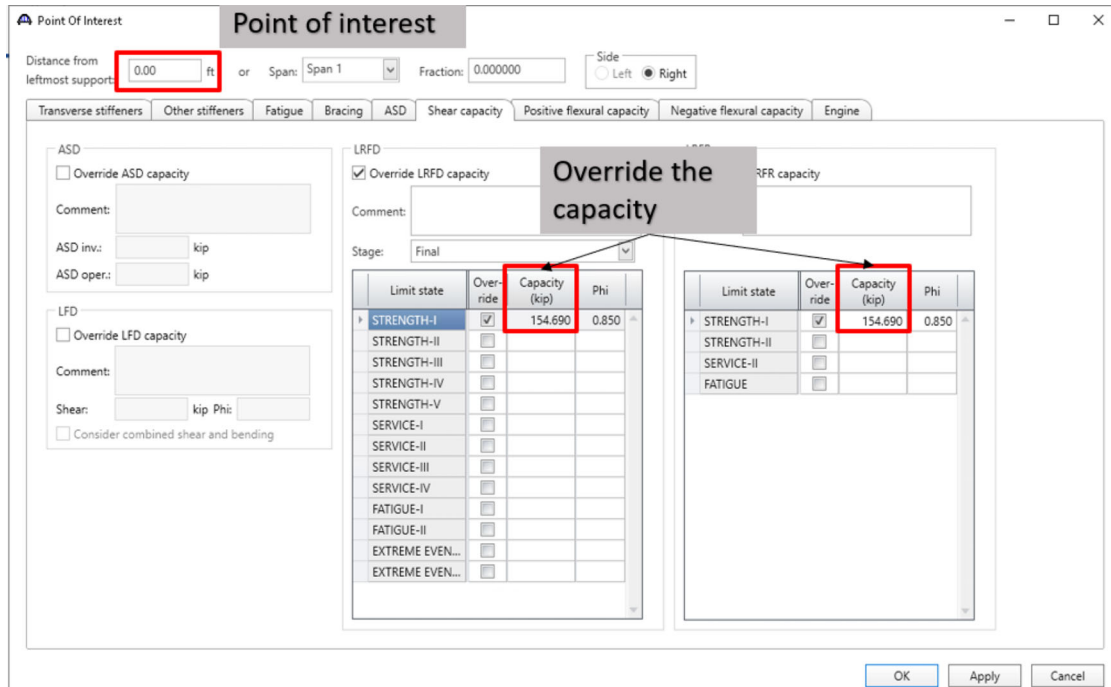
Figure 8.4 Example screenshot of overriding the nominal capacity at the point of interest in BrR software.
