GEORGIA DOT RESEARCH PROJECT 22-02

Final Report

**FIELD EVALUATION OF WIRELESS
ULTRASONIC THICKNESS MEASUREMENT
WITH STEEL BRIDGE MEMBERS**

October 2023

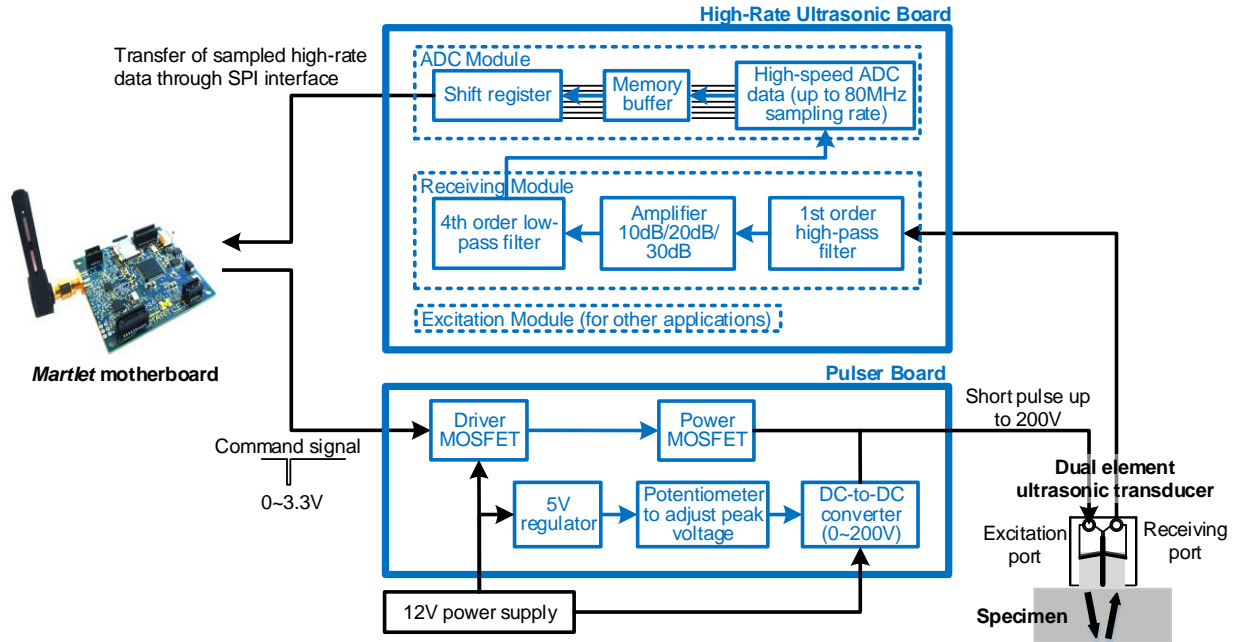
Figure 2. Diagram. Functional diagram of the *Martlet* ultrasonic thickness measurement device.

This section describes the *Martlet* ultrasonic thickness measurement device. Figure 2 shows the functional diagram. The *Martlet* wireless sensing system is a low-cost platform for intelligent infrastructure monitoring.^[2] As shown in figure 2, the *Martlet* motherboard incorporates a dual-core Texas Instruments Piccolo microcontroller, which can run up to 90 MHz. A Zigbee radio transmits data at rates up to 250 kbps. With *Martlet*'s modular design, researchers have developed a variety of stackable daughterboards to interface with various sensors used in structural health monitoring.^[3-7] Recently, the authors and collaborators have developed two daughterboards for ultrasonic thickness measurement: the high-rate ultrasonic board and the pulser board.^[6, 8] These two daughterboards, together with the *Martlet* motherboard, form a *Martlet* ultrasonic thickness measurement device.

The high-rate ultrasonic board consists of three modules: the excitation module, the receiving module, and the analog-to-digital converter (ADC) module. The excitation module was designed for launching surface waves and is not utilized in this study for thickness measurement. Instead, the pulser board serves as the transducer excitation source for measuring specimen thickness. The receiving module conditions the signal from a transducer through a first-order high-pass filter, amplitude amplification (10dB/20dB/30dB), and a fourth-order low-pass filter. Among the commonly used standard filter types, Bessel is selected for the fourth-order low-pass filter that is critical for the signal conditioning performance. Bessel filters offer a linear phase performance and help maintain the signal waveform in the time domain, which assists in accurately identifying the ToF of the received signal.^[9] The high-speed ADC module samples the filtered and amplified signal with a sampling frequency up to 80 MHz. The sampled data are transferred to the *Martlet*

motherboard through a serial peripheral interface (SPI) connection. Ultimately, the *Martlet* motherboard wirelessly sends the data to a base station connected to a personal computer (PC).

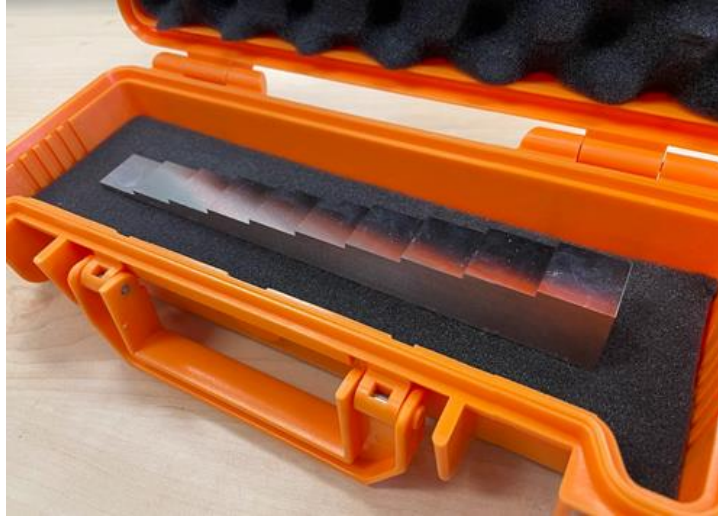
Figure 4. Photograph. Steel calibration block from 0.1- to 1.0-inch thicknesses.

Generally, it is necessary to calibrate thickness measurement values to identify the offset value specific to the instrument, transducer type, and ultrasonic characteristics. This procedure, known as calibration, is crucial for achieving accurate ultrasonic thickness measurements. Most commercial thickness measurement devices have built-in calibration features to improve the accuracy of measurements. To establish a calibration function for the *Martlet* ultrasonic device, we conduct thickness measurements on a 10-step steel calibration block. The block encompasses a range of thickness values from 0.1 to 1.0 inch, as shown in figure 4.

The calibration block is made of 1018 steel, for which the nominal velocity is set as $0.2330 \text{ inch}/\mu\text{s}$.^[10] With the fixed velocity value, the calibration function is derived for the measured ToF values. Specifically, we compare the true ToF (true thickness divided by $0.2330 \text{ inch}/\mu\text{s}$) and the ToF measured by the *Martlet* ultrasonic device. Table 1 summarizes the comparison of ToFs for each of the 10 thickness values.

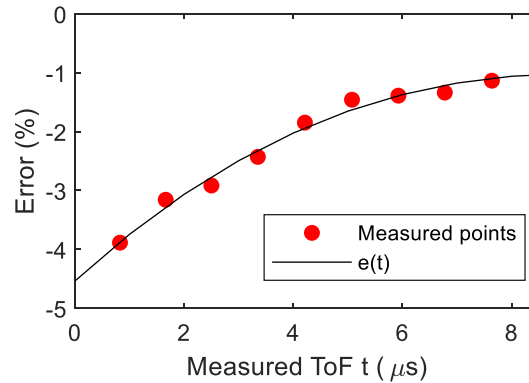
Figure 5. Graph. Measured ToF vs error (without calibration).

Figure 5 plots error percentages obtained from table 1. It is evident that the error percentage is more significant for smaller ToFs corresponding to thinner thicknesses (less than 0.4 inch). This observation can be attributed to the 2.25 MHz frequency of the transducer. In general, higher frequency transducers offer better resolution and can lead to smaller errors. However, it is important to note that higher frequency transducers are limited in their ability to penetrate thicker specimens. Given the practical thickness range of actual bridge members, which falls between 0.4 and 1.0 inch, the transducer with a frequency of 2.25 MHz was selected for this study.

Based on data in figure 5, the error percentage function is assumed to be a third-degree polynomial.

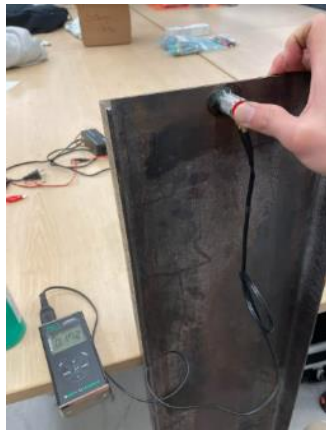
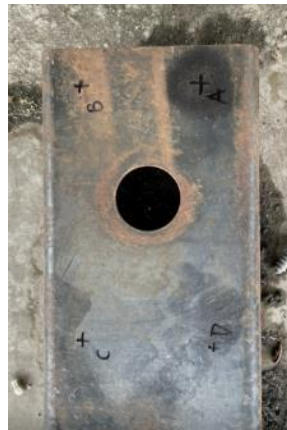
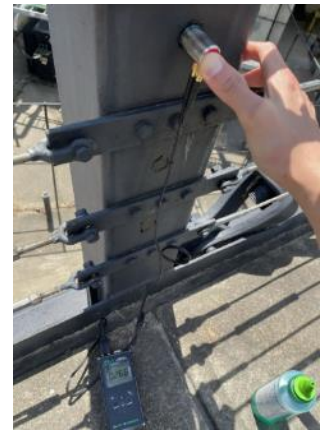
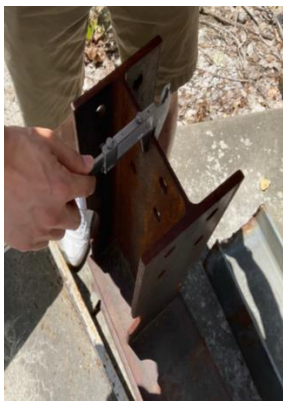
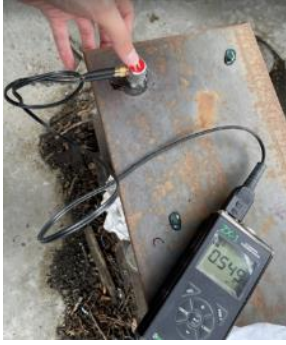
**Figure 6. Photographs. Steel specimens collected from the Structures Lab at Georgia Tech.
(Continued on the next page)**

Measurements obtained from the two devices were compared using steel plates with various thickness values. We prepared 14 different sizes of structural steel at the Georgia Institute of Technology (Georgia Tech) Structural Engineering and Materials Laboratory (Structures Lab) (figure 6). All the specimens are made of carbon steel, with a nominal velocity of 0.2339 inch/ μ s

and thicknesses ranging 0.175 to 0.1027 inch.^[11] Before conducting measurements, we sanded the measurement surface to ensure smoothness. Each thickness was first measured using a caliper to obtain a reference value for the true thickness. Subsequently, thickness measurements were performed using the *Martlet* ultrasonic device with the calibrated ToF and the handheld device.

Table 4 summarizes the thickness measurement results from the caliper (“True” column), *Martlet* ultrasonic device, and the commercial handheld device. For 10 of 14 specimens, the *Martlet*

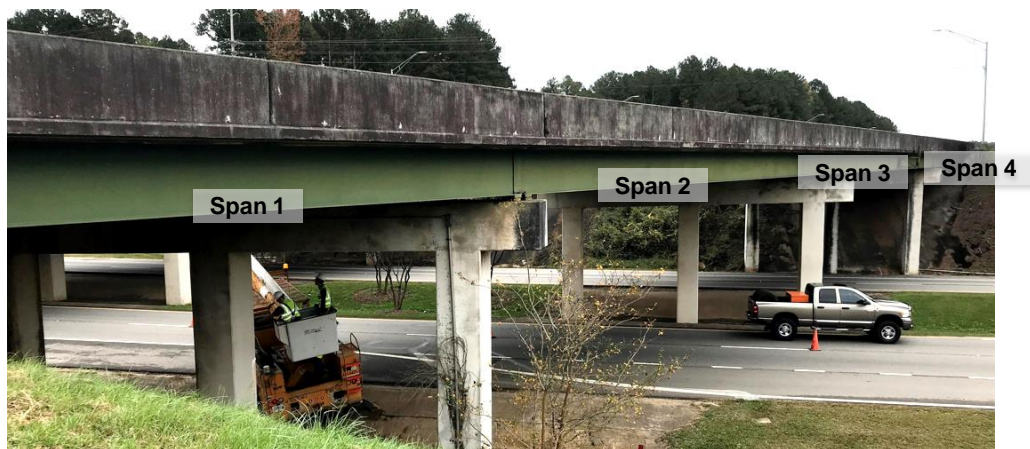
Figure 7. Photograph and diagram. Overview of the bridge in LaGrange, GA.

Figure 7 shows the overview (figure 7a), and the elevation (figure 7b) of the first testbed bridge (Structure ID – 285-0067-0) investigated in this study. The bridge was built in 1977 and is located in LaGrange, GA. The condition rating by the National Bridge Inventory for this bridge is 7 – Good Condition. The bridge superstructure consists of six steel beams and a reinforced concrete deck. The bridge has four spans: two simply supported end spans and two continuous middle spans.

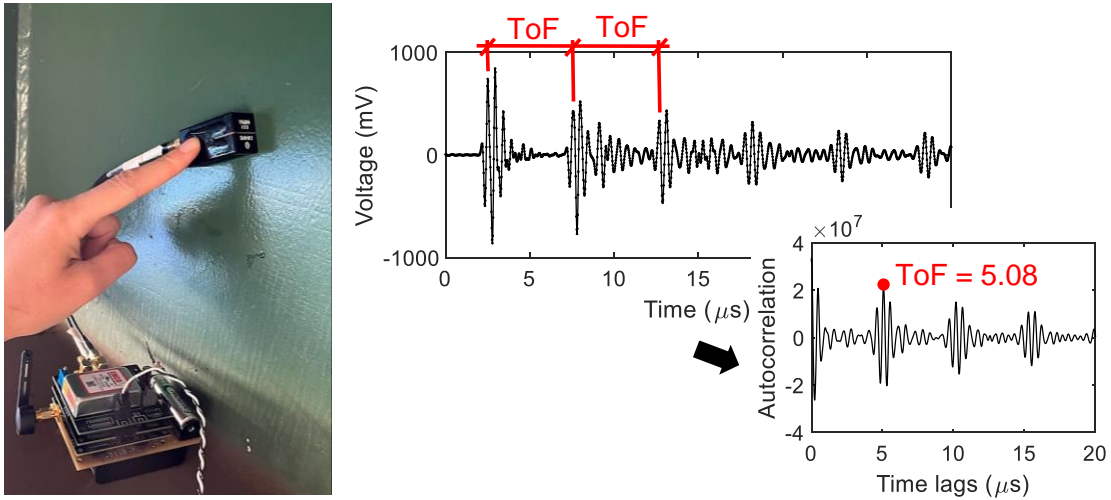
a. 0.60-inch-thick web with clean surface

Figure 8a shows the received signals of the 2.25 MHz dual-element transducer sampled by the high-rate ultrasonic board for the 0.60-inch-thick web with a clean surface. The received signal includes a sequence of echoes, which are the reflections of the ultrasonic waves created by the transducer. The time interval between the neighboring echoes is the ToF. To accurately obtain the ToF, we calculate the autocorrelation function of the received signal using the following equation:

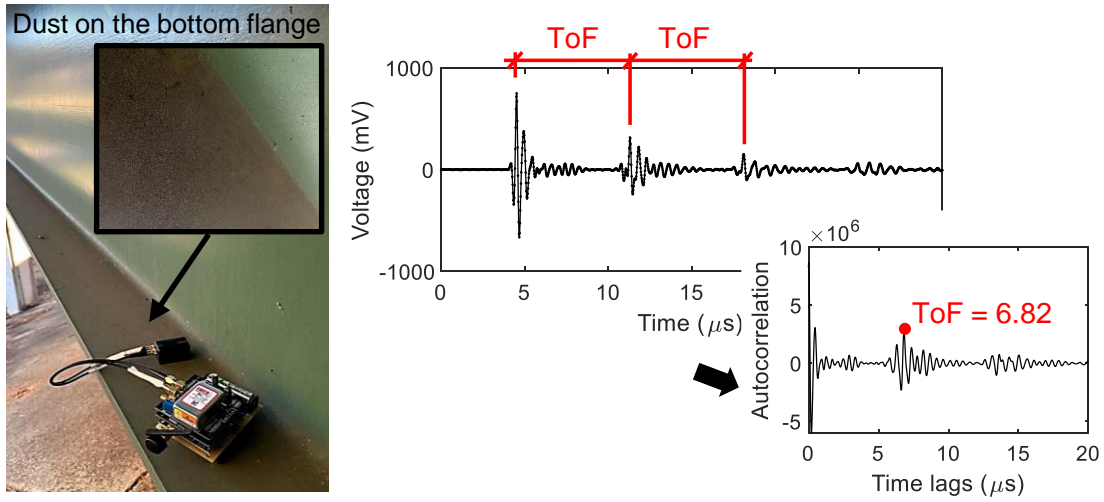
b. 0.80-inch-thick bottom flange with dusty surface

Similarly, figure 8b shows the received signals and autocorrelation function for the 0.80-inch-thick bottom flange with a dusty surface. Note that we did not clean the dust on the bottom flange. Therefore, autocorrelation waveforms are slightly distorted compared to the web due to the layer of dust. However, the peak is clearly identified at 6.82 μs .

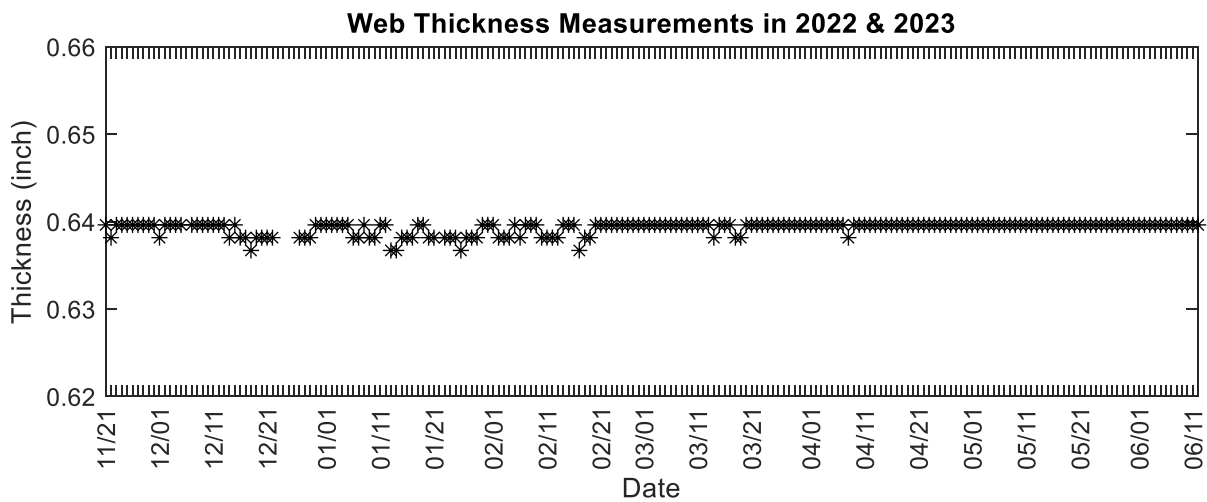
Figure 10. Plot. Daily history of the web thickness measurements on the bridge in LaGrange, GA

The thickness measurements are taken at scheduled time intervals for long-term monitoring. Figure 10 shows the daily thickness values recorded from November 21, 2022, to June 13, 2023. Overall, stable measurements are obtained around 0.64 inch, close to the 0.625-inch nominal thickness. The ultrasonic measurement system has a resolution of 0.0015 inch. Minor fluctuations in the measured thickness values, either slightly higher or lower by 0.0015 inch, are observed from December 2022 to February 2023. These variations could be attributed to the influence of cold

weather conditions on the couplant during the winter months or the couplant material taking time to reach a stable state until February 2023. Over the subsequent three months, the measurement values have remained stable, indicating the successful operation of the long-term thickness measurement system. This field testing validates the long-term ultrasonic thickness measurement system on a regular highway bridge and serves as the preliminary validation. Chapter 4 describes installation of the system to a second testbed bridge with corrosion.

- On the bridge in LaGrange, thickness values were recorded over about seven months. Although the measurements stabilized in the last three months, we observed slight variations for the first few months of installation. These variations could be attributed to cold weather conditions during the winter months or the couplant material requiring time to achieve a stable state.

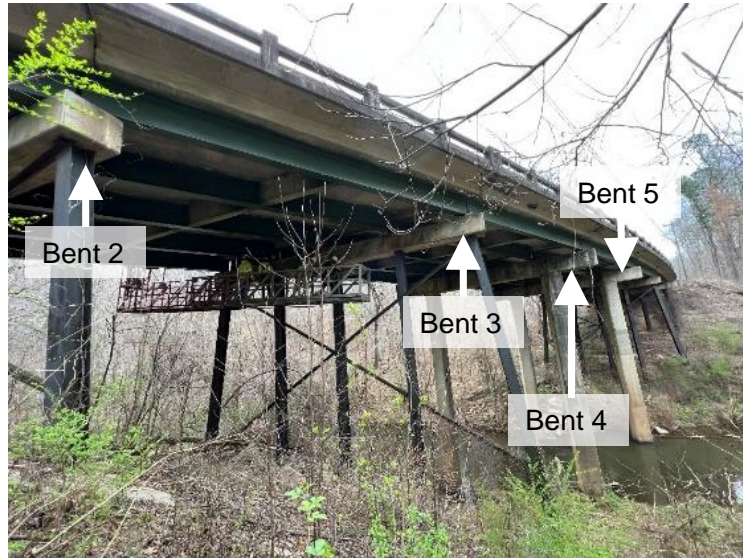
Figure 11. Photograph and drawing. Overview of the bridge in Douglas County, GA.

Figure 11 provides an overview of the bridge located in Douglas County, GA. The bridge consists of eight bents and five beams, forming a composite structure with a reinforced concrete deck. The middle two bents, Bents 4 and 5, are positioned above the river from the Bear Creek Reservoir, close to the bridge. These two middle columns (supporting Bents 4 and 5) are made of concrete, whereas other columns are made of wide flange steel sections. The bridge (Structure ID # 097-0013-0) was constructed in 1957, making it 20 years older than the bridge investigated in chapter 3. The National Bridge Inventory condition rating for this bridge is 5 – Fair Condition.
