Test Report No. 440862-03 3-4

**EVALUATION OF ALLOWABLE TAPER RATES OF FREESTANDING
SINGLE-SLOPE CONCRETE BARRIERS**

Texas Department of Transportation
<https://tti.tamu.edu/documents/0-7086-R2.pdf>

TEXAS A&M TRANSPORTATION INSTITUTE PROVING GROUND

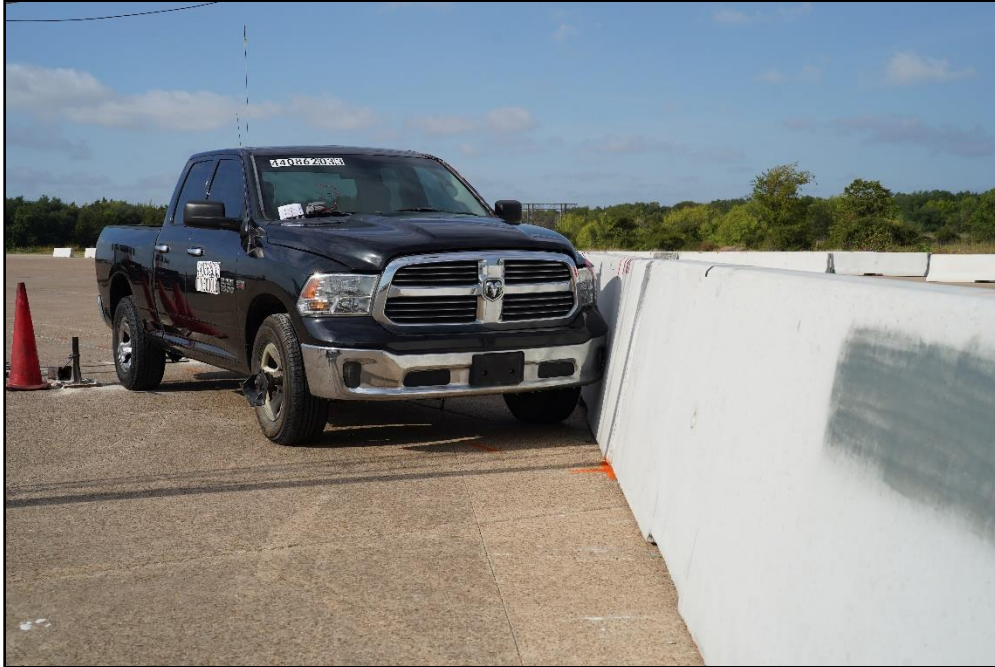
Figure 6.1. Flared Single-Slope Portable Concrete Barriers/Test Vehicle Geometrics for Test 440862-03-3.

See Table 6.1 for details on the *MASH* impact conditions and Table 6.2 for the exit parameters of Test 440862-03-3. Figure 6.1 and Figure 6.2 depict the target impact setup.

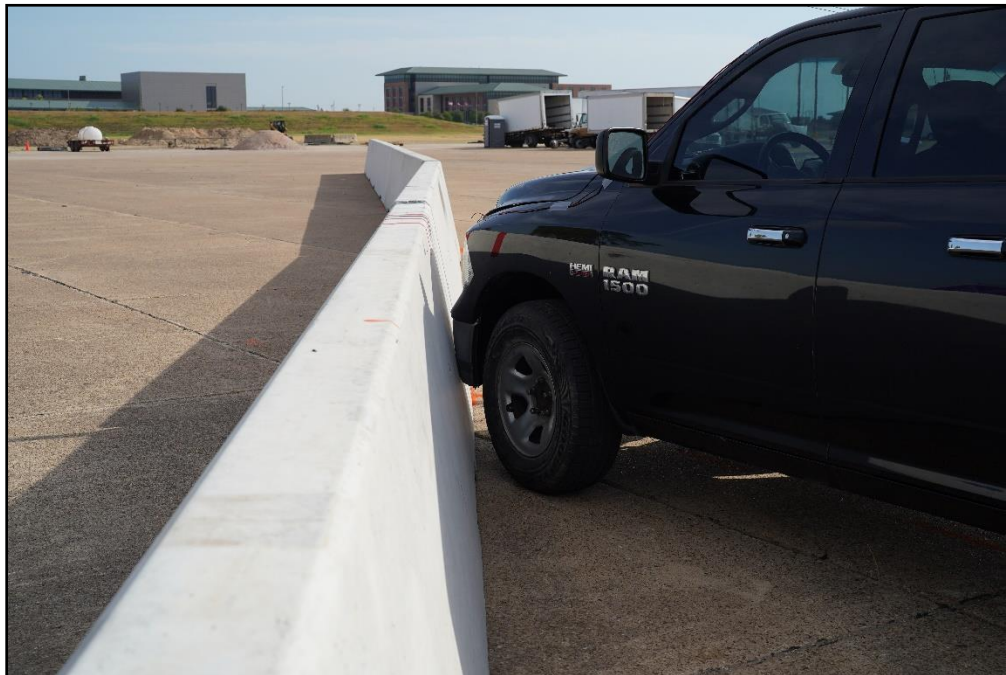
Figure 6.2. Flared Single-Slope Portable Concrete Barriers/Test Vehicle Impact Location for Test 440862-03-3.

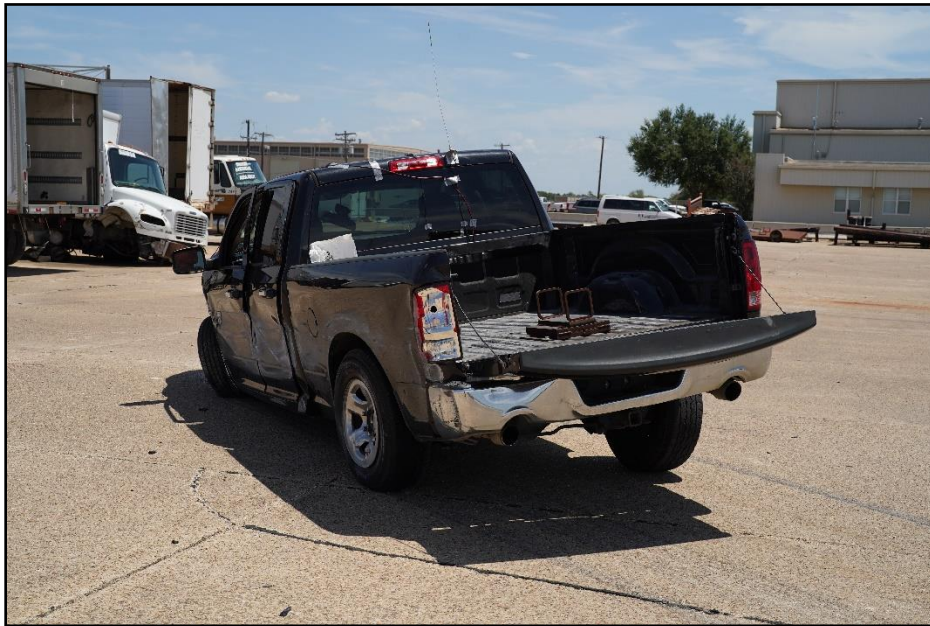
Figure 6.8. Rear Impact Side of Test Vehicle after Test 440862-03-3.

Figure 6.7 and Figure 6.8 show the damage sustained by the vehicle. Figure 6.9 and Figure 6.10 show the interior of the test vehicle. Table 6.8 and Table 6.9 provide details on the occupant compartment deformation and exterior vehicle damage. Figures B.2 and B.3 in Appendix B.1 provide exterior crush and occupant compartment measurements.

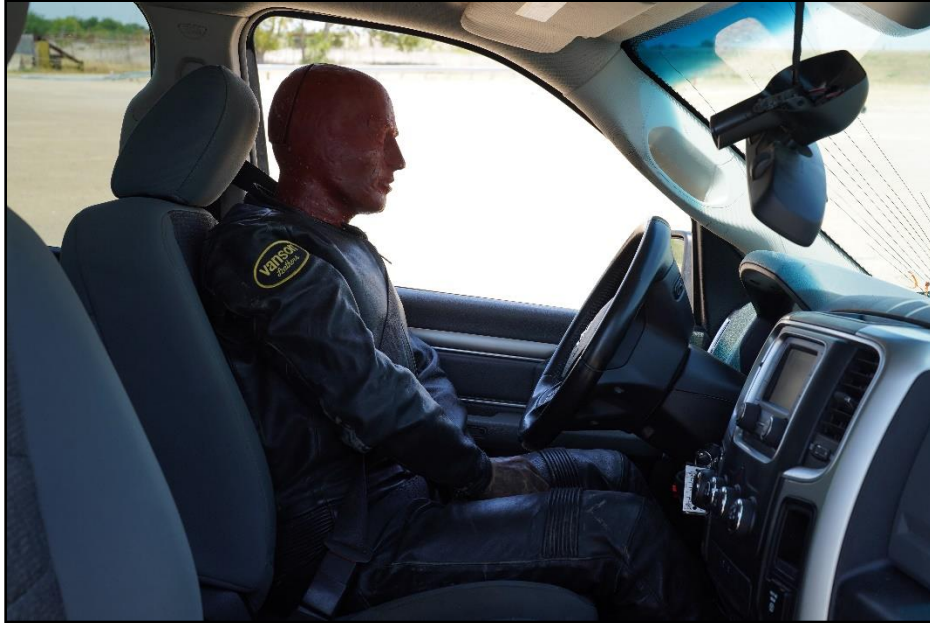
Figure 6.9. Overall Interior of Test Vehicle after Test 440862-03-3.

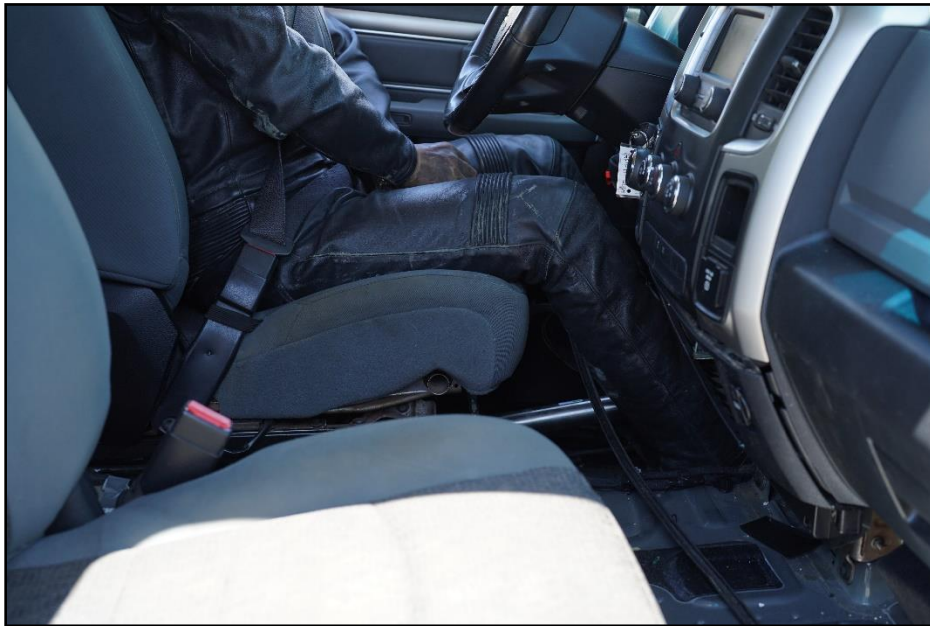
Figure 6.10. Interior of Test Vehicle on Impact Side after Test 440862-03-3.

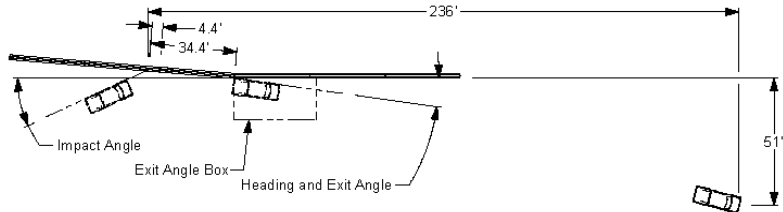
Exit Box Criteria	Vehicle crossed 71 ft downstream from loss of contact					
	Stopping Distance	236 ft downstream of impact point 51 ft to the traffic side					
	TEST ARTICLE DEFLECTIONS						
	Dynamic (inches)	58.7					
	Permanent (inches)	58.0					
	Working Width/Height (inches)	82.7/1					
	VEHICLE DAMAGE						
	VDS	11LFQ4					
	CDC	11FLEW5					
	Max. Ext. Deformation	9 inches					
	Max. Occupant Compartment Deformation	2 inches in the toe pan					
OCCUPANT RISK VALUES							
Long. OIV (ft/s)	18.0	Long. Ridedown (g)	4.3	Max. 50-ms Long. (g)	-8.7	Max. Roll (deg)	12
Lat. OIV (ft/s)	23.0	Lat. Ridedown (g)	14.1	Max. 50-ms Lat. (g)	12.6	Max. Pitch (deg)	7
THIV (m/s)	8.9	ASI	1.7	Max. 50-ms Vert. (g)	-3.7	Max. Yaw (deg)	39

Figure 6.11. Summary of Results for MASH Test 3-11 on Flared Single-Slope Portable Concrete Barriers.

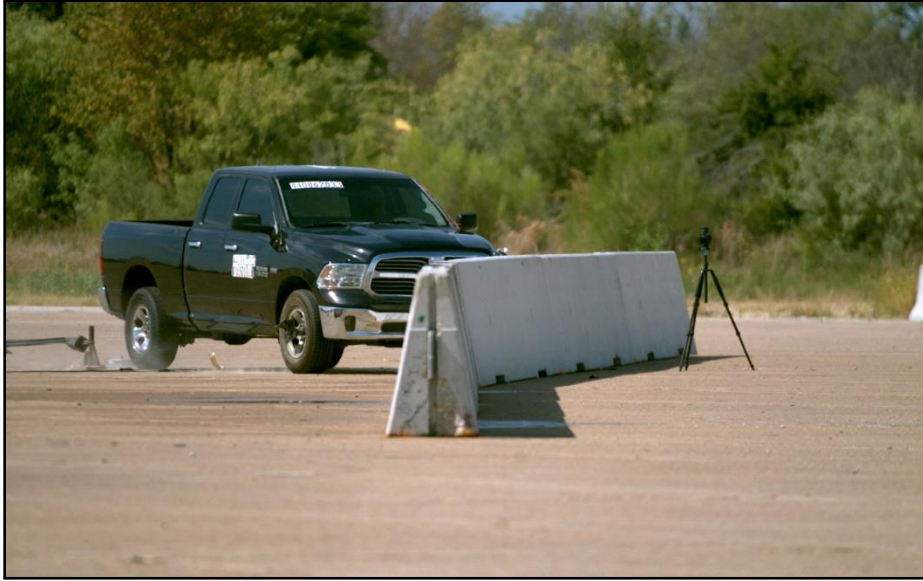
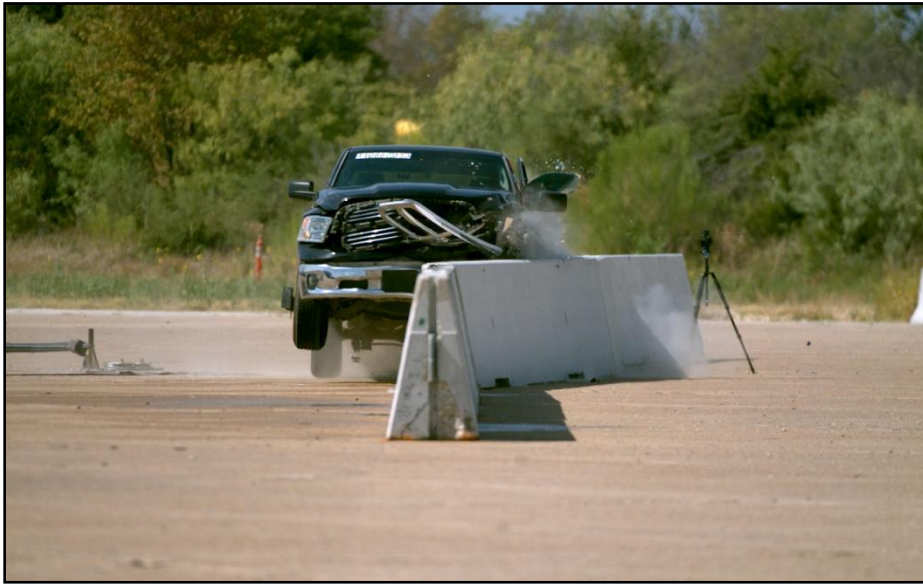
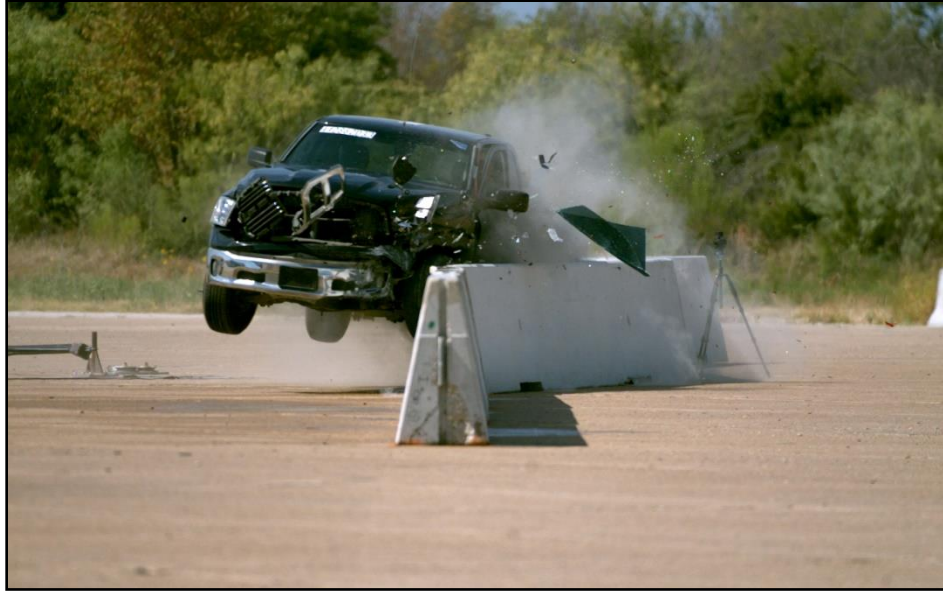
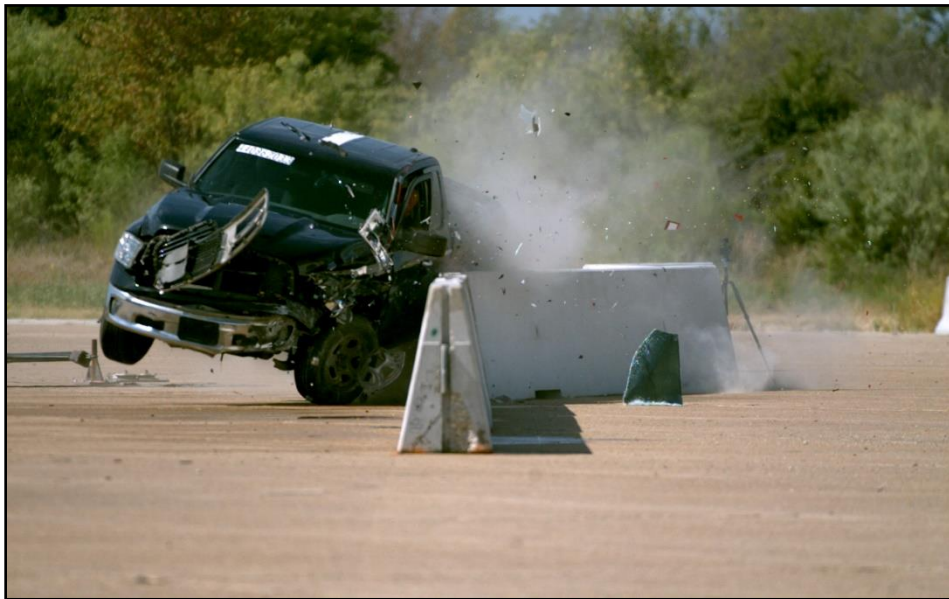
Figure 6.12. Summary of Results for Test 440862-03-3, Sequential Test Pictures.

Figure 6.12. Summary of Results for Test 440862-03-3, Sequential Test Pictures (Continued).

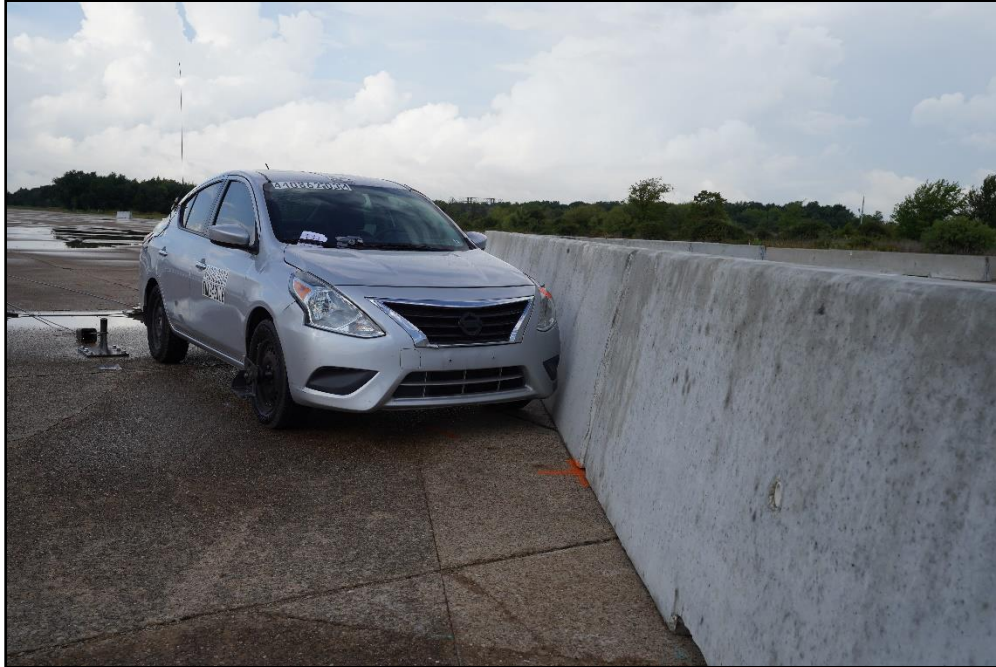
Figure 7.1. Flared Single-Slope Portable Concrete Barriers/Test Vehicle Geometrics for Test 440862-03-4.

See Table 7.1 for details on the *MASH* impact conditions and Table 7.2 for the exit parameters for Test 440862-03-4. Figure 7.1 and Figure 7.2 depict the target impact setup.

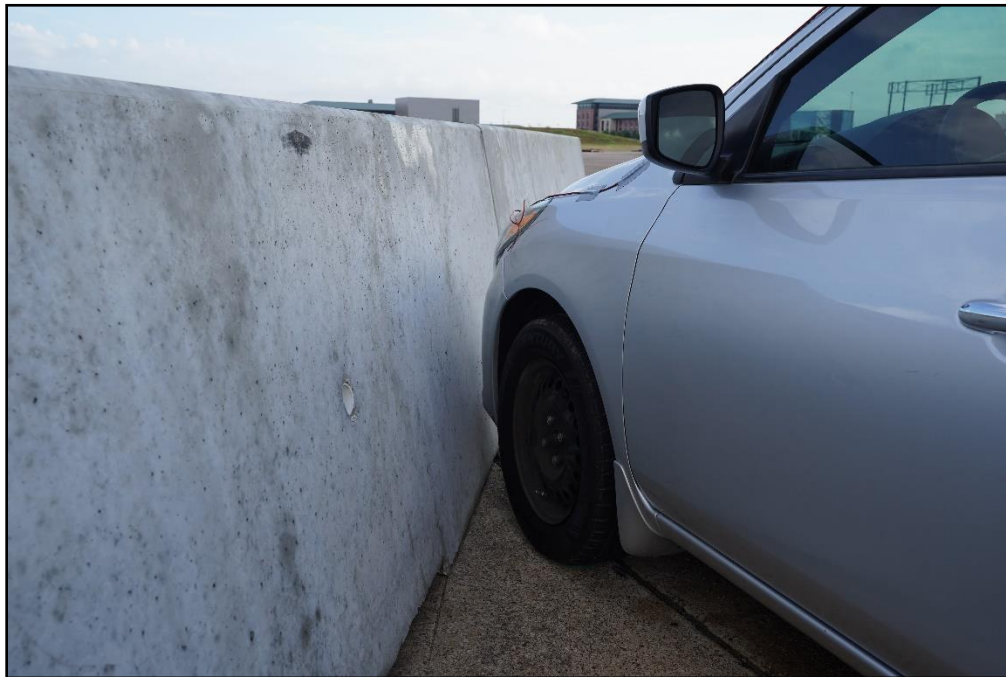
Figure 7.2. Flared Single-Slope Portable Concrete Barriers/Test Vehicle Impact Location for Test 440862-03-4.

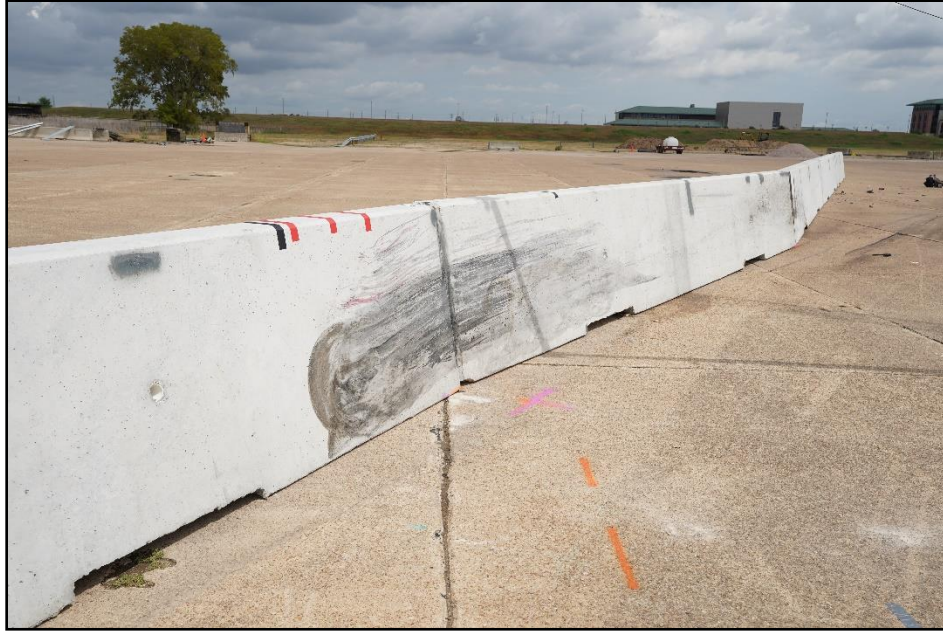
There was minor gouging and scuffing at impact, as well as a small crack on the downstream end of barrier 2 and the upstream end of barrier 3 at the top on the field side.

Figure 7.5. Flared Single-Slope Portable Concrete Barriers after Test at Impact Location, Test 440862-03-4.

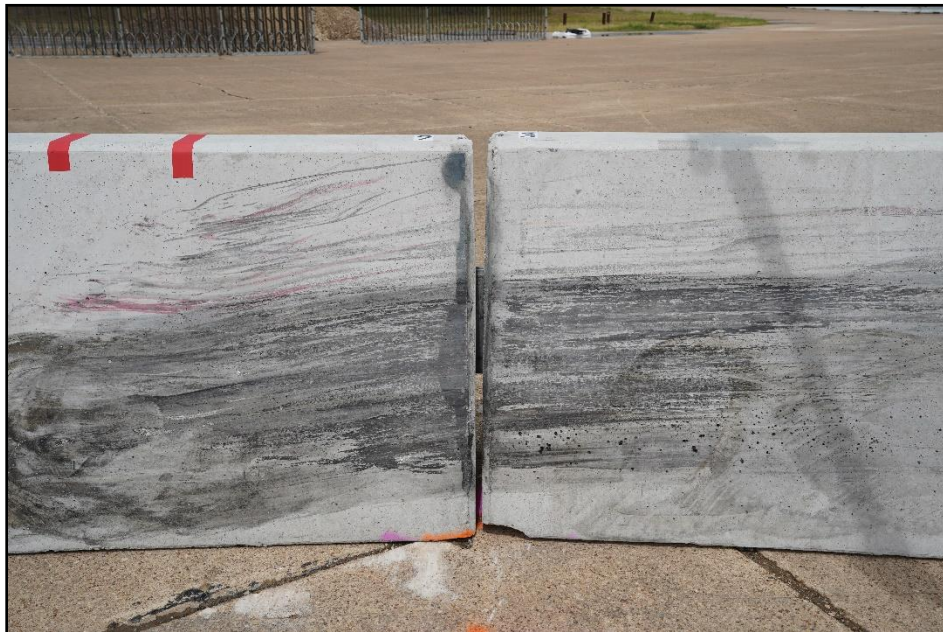
Figure 7.6. Flared Single-Slope Portable Concrete Barriers after Test at the Joint of Barriers 2 and 3, Test 440862-03-4.

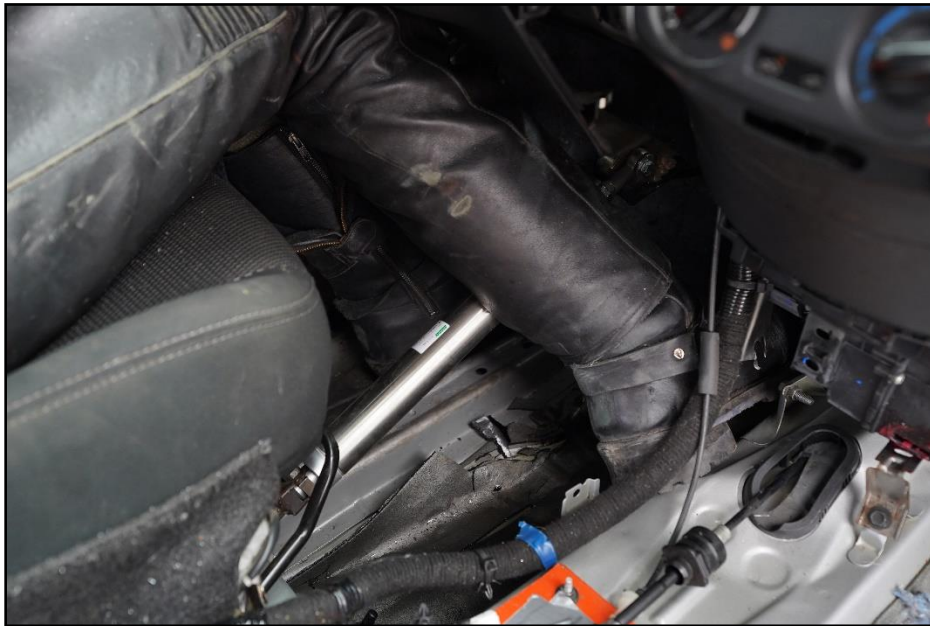
Figure 7.10. Interior of Test Vehicle on Impact Side after Test 440862-03-4.

Figure 7.7 and Figure 7.8 show the damage sustained by the vehicle. Figure 7.9 and Figure 7.10 show the interior of the test vehicle. Table 7.8 and Table 7.9 provide details on the occupant compartment deformation and exterior vehicle damage. Figures C.2 and C.3 in Appendix C.1 provide exterior crush and occupant compartment measurements.

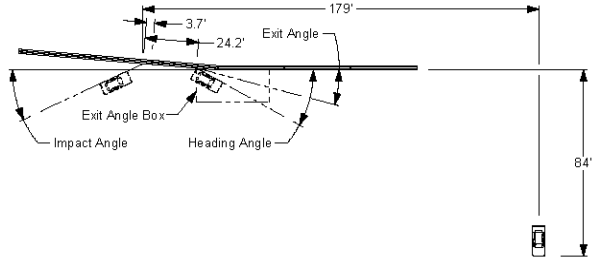
Exit Box Criteria	Vehicle crossed 40 ft downstream from loss of contact							
Stopping Distance	179 ft downstream of impact point 84 ft to the traffic side							
TEST ARTICLE DEFLECTIONS								
Dynamic (inches)	17.8							
Permanent (inches)	17.0							
Working Width/Height (inches)	41.8/1							
VEHICLE DAMAGE								
VDS	11LFQ5							
CDC	11FLEW5							
Max. Ext. Deformation	12 inches							
Max. Occupant Compartment Deformation	4 inches in side front panel							
OCCUPANT RISK VALUES								
Long. OIV (ft/s)	22.0	Long. Ridedown (g)	4.2	Max. 50-ms Long. (g)	-12.8	Max. Roll (deg)	21	
Lat. OIV (ft/s)	29.7	Lat. Ridedown (g)	14.3	Max. 50-ms Lat. (g)	18.0	Max. Pitch (deg)	7	
THIV (m/s)	11.3	ASI	2.6	Max. 50-ms Vert. (g)	-9.3	Max. Yaw (deg)	58

Figure 7.11. Summary of Results for MASH Test 3-10 on Flared Single-Slope Portable Concrete Barriers.

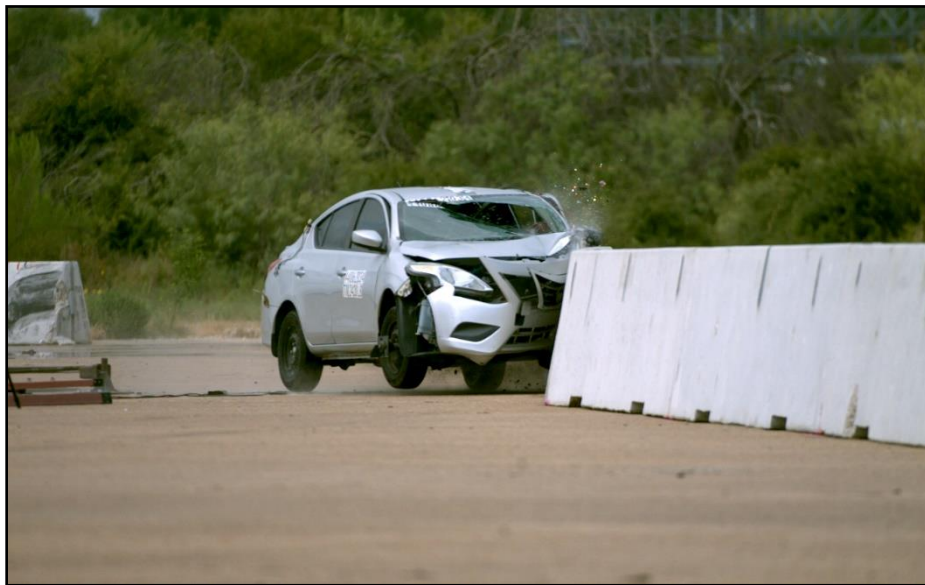
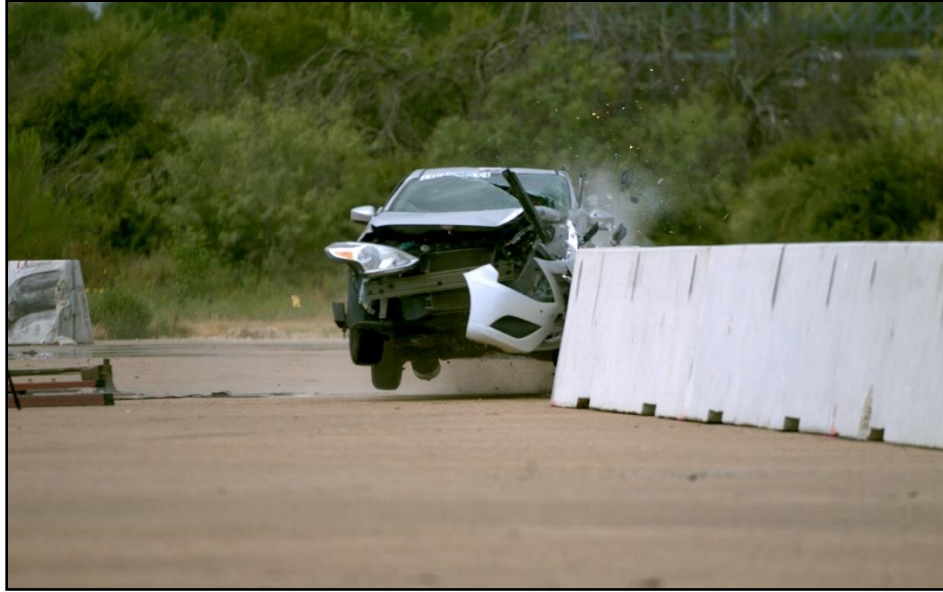
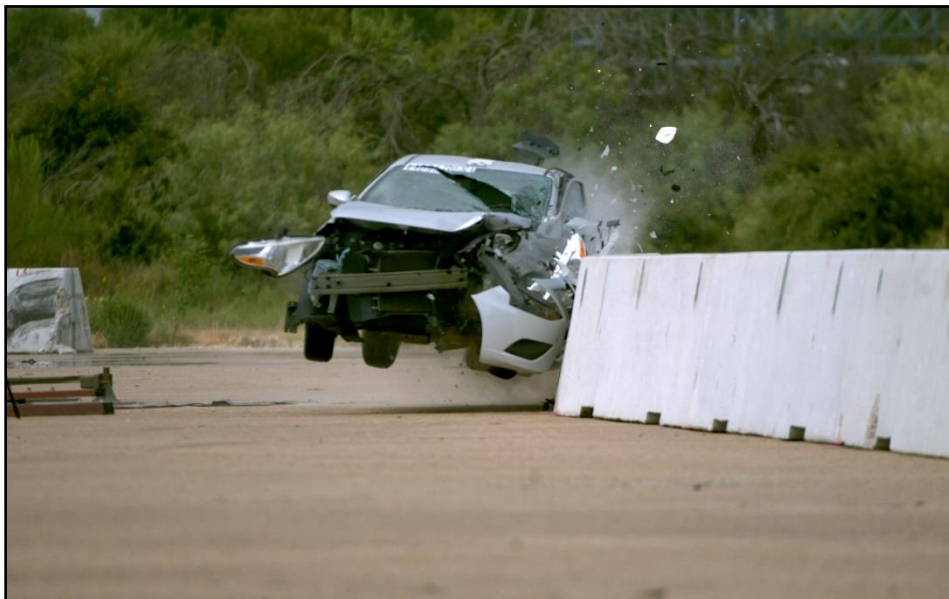
Figure 7.12. Summary of Results for Test 440862-03-4, Sequential Test Pictures.

Figure 7.12. Summary of Results for Test 440862-03-4, Sequential Test Pictures (Continued).
