Traffic Control Device Analysis, Testing, and Evaluation Program: FY2022 Activities

Technical Report 0-7096-R2

TEXAS A&M TRANSPORTATION INSTITUTE
COLLEGE STATION, TEXAS

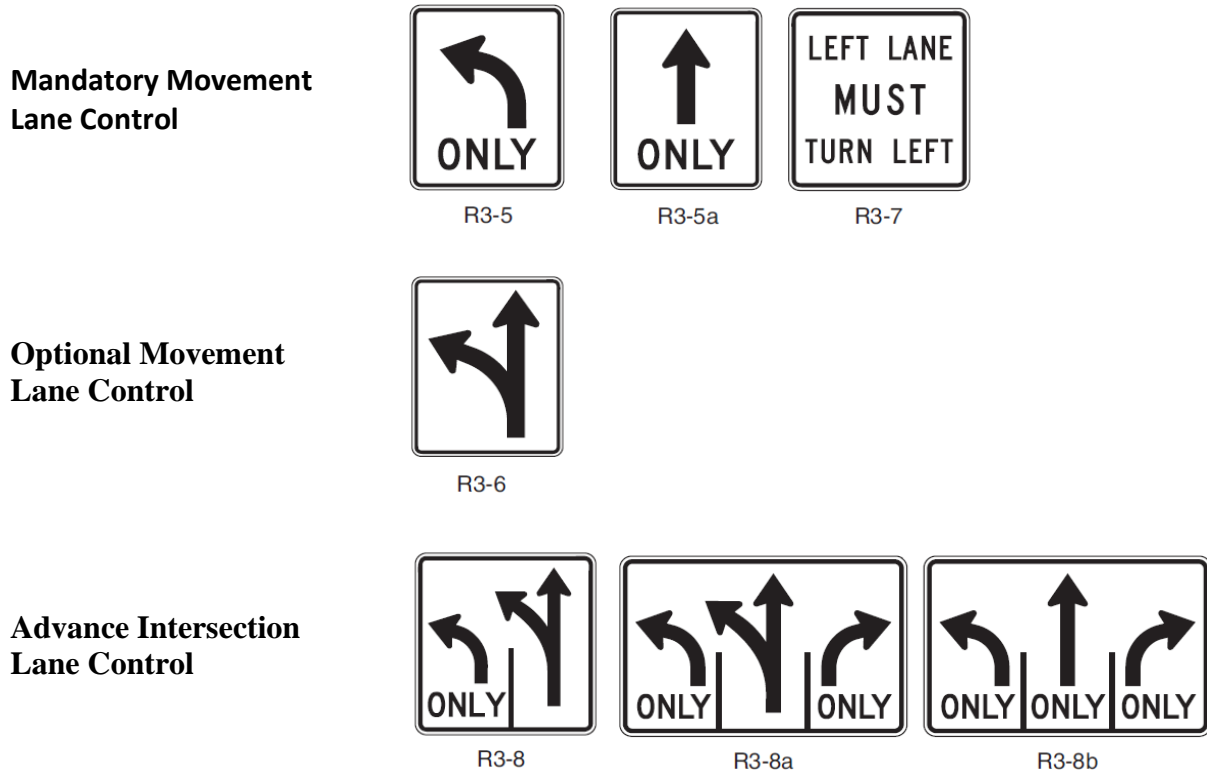
Figure 1. Example TMUTCD Intersection Lane Control Signs (Adapted from 1).

Examples of each type of TMUTCD Intersection Lane Control signing can be found in Figure 1. Guidance from Section 2B.19 states that when Intersection Lane Control signs are mounted overhead, each sign should be placed over the lane to which it applies. At signals where through lanes become turn lanes, multi-lane turns that include shared movements, or with other unexpected lane-use regulations, OLCS should be installed over the lanes at the intersection and in advance of the intersection over the appropriate lanes. Only where OLCS are impractical should roadside lane control signing be employed. However, the use of an overhead sign for one approach lane does not require the installation of overhead signs for the other lanes of that approach. For narrower approaches (i.e., two lanes or less), the Intersection Lane Control signs (R3-5, R3-6, or R3-8) may be overhead or (roadside) post-mounted.

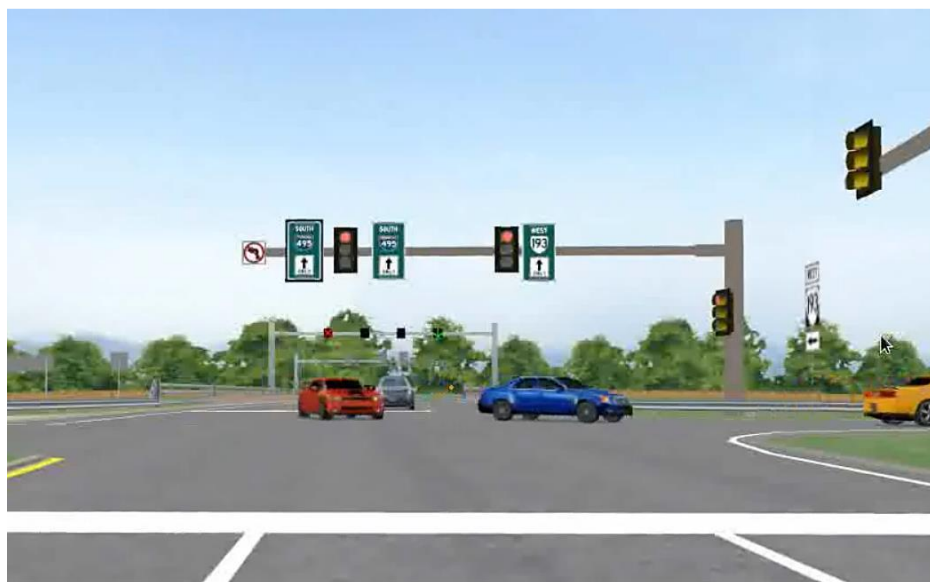
Figure 4. OLCS and Route Signing in Driving Simulator (Adapted from 12).

Recent research into innovative interchange design and management utilized a driving simulator to examine and analyze driver behavior in cases where arterial contraflow lanes were used within a dynamic reversible left-turn (DRLT) diamond interchange and on the approach to a contraflow left-turn (CLT) intersection (12). In both cases, versions of OLCS were used to inform drivers of downstream lane control (Figure 4). Despite the unusual interchange approach configuration—where drivers approaching a stop bar could be facing opposing traffic across the intersection—the driver comprehension rate for overhead signing was about 95 percent.

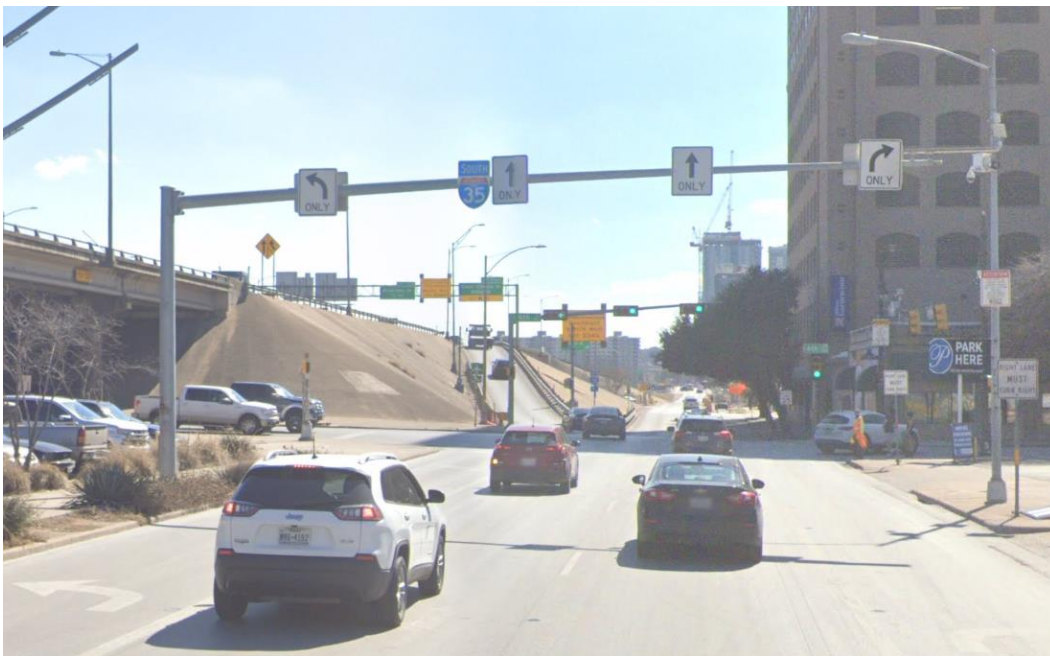
Figure 5. Frontage Road OLCS, IH 35 Southbound at E. 6th Street, Austin, Texas.

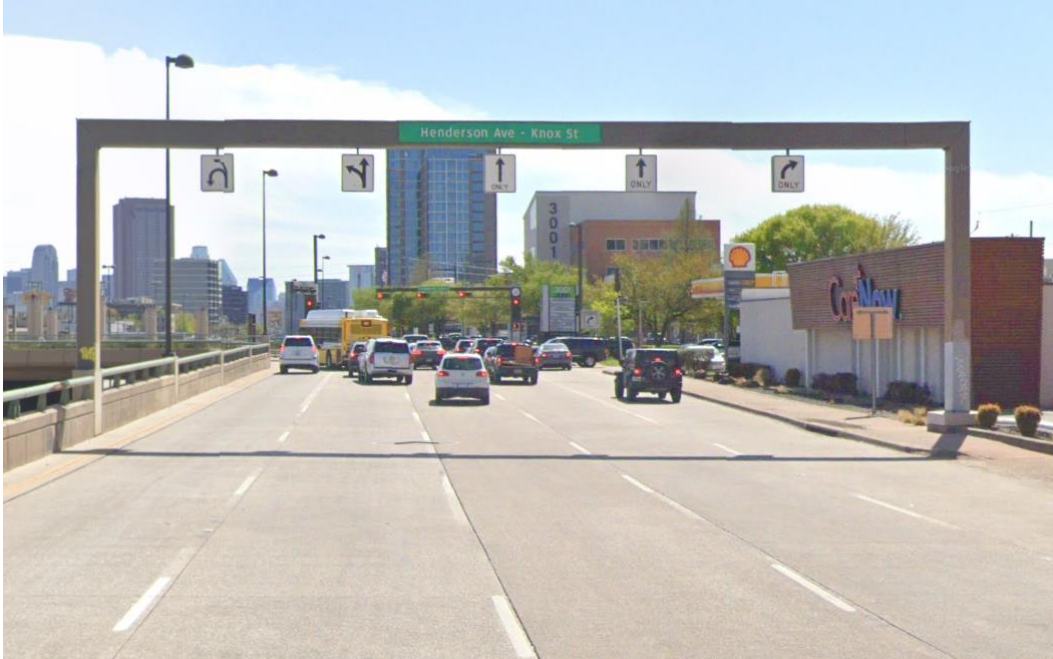
Figure 6. Frontage Road OLCS, US 75 Southbound at Henderson Avenue, Dallas, Texas.

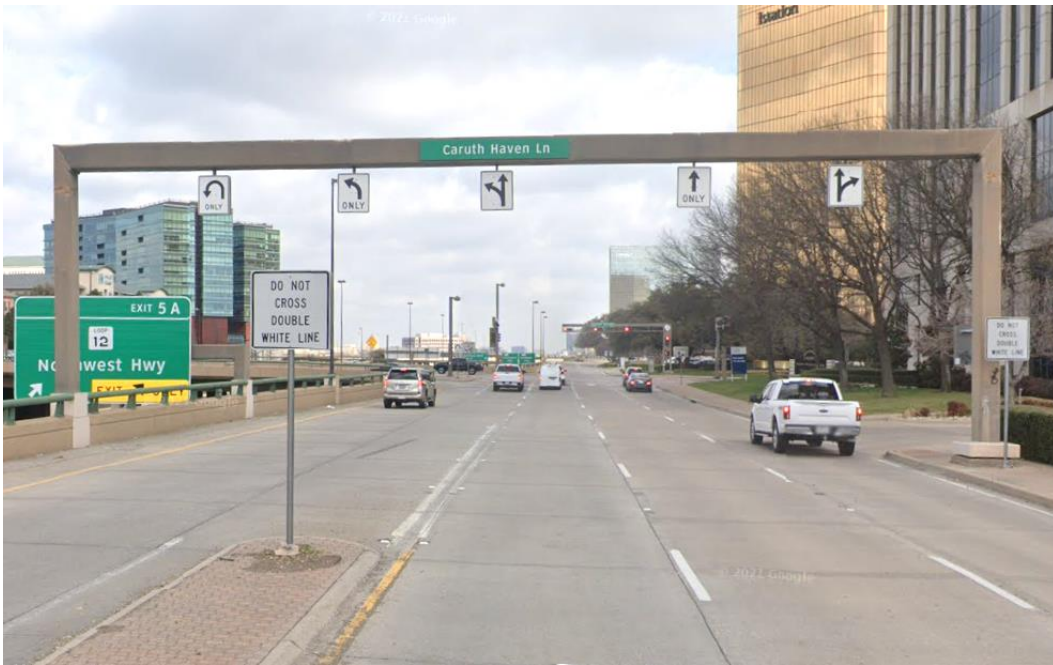
Figure 7. Frontage Road OLCS, US 75 Northbound at Caruth Haven Lane, Dallas, Texas.

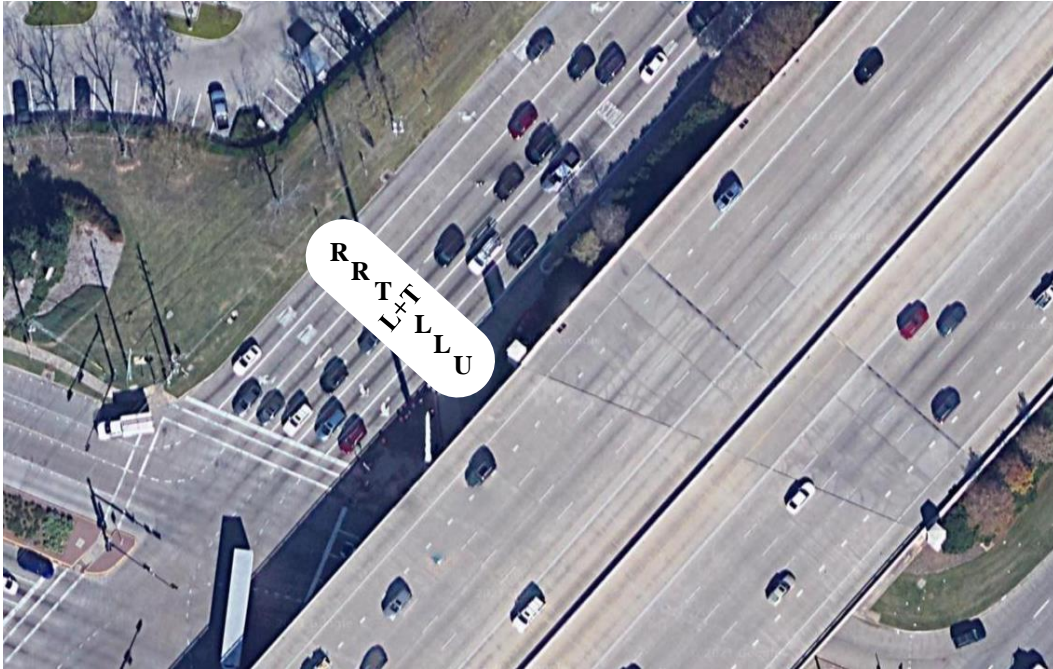
Figure 8. Frontage Lane Use, IH 69 Southbound at SH 6, Houston, Texas.

To provide a better understanding of how OLCS are used on frontage roads throughout Texas, TTI researchers identified real-world examples in metropolitan areas across the state. Structures for supporting signs vary from poles with mast arms to custom-designed monotube OSB structures. In some cases, route signing is combined with the individual lane control signs to clarify the relationship between lane selection and target route. Figure 2 provides a San Antonio example with a substantial pole and mast arm to provide individual OLCS across five frontage lanes. Figure 5 through Figure 7 contain other samples found in Austin and Dallas. A unique overhead dynamic message sign (DMS) form of lane control signing was found in Houston and is detailed in Figure 8 through Figure 10.

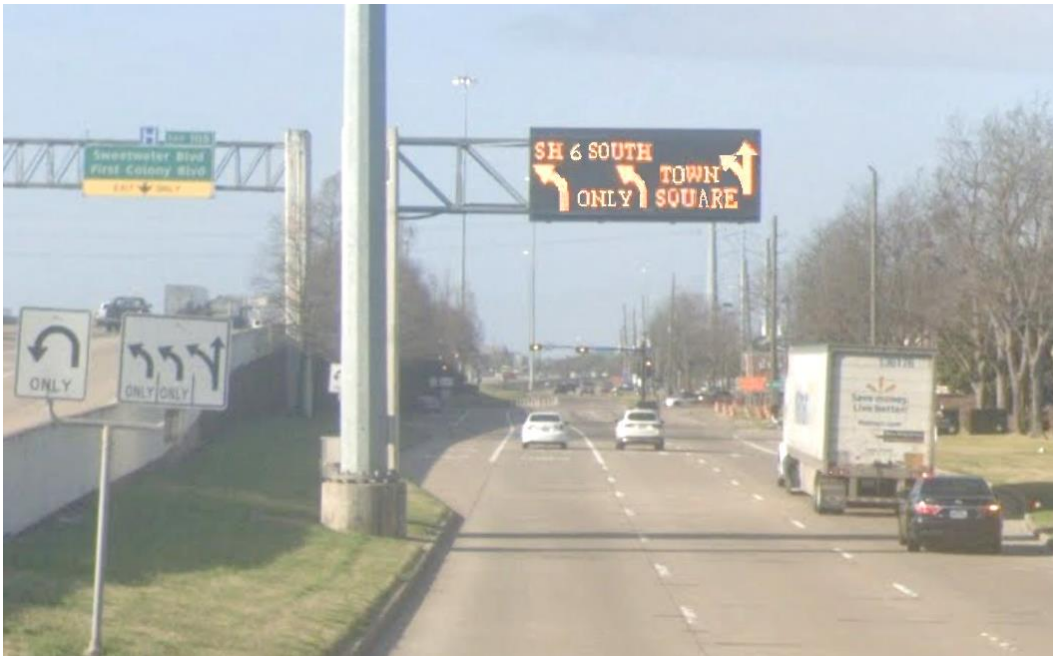
Figure 9. Lane Use DMS, IH 69 Southbound Frontage at SH 6, Houston, Texas.

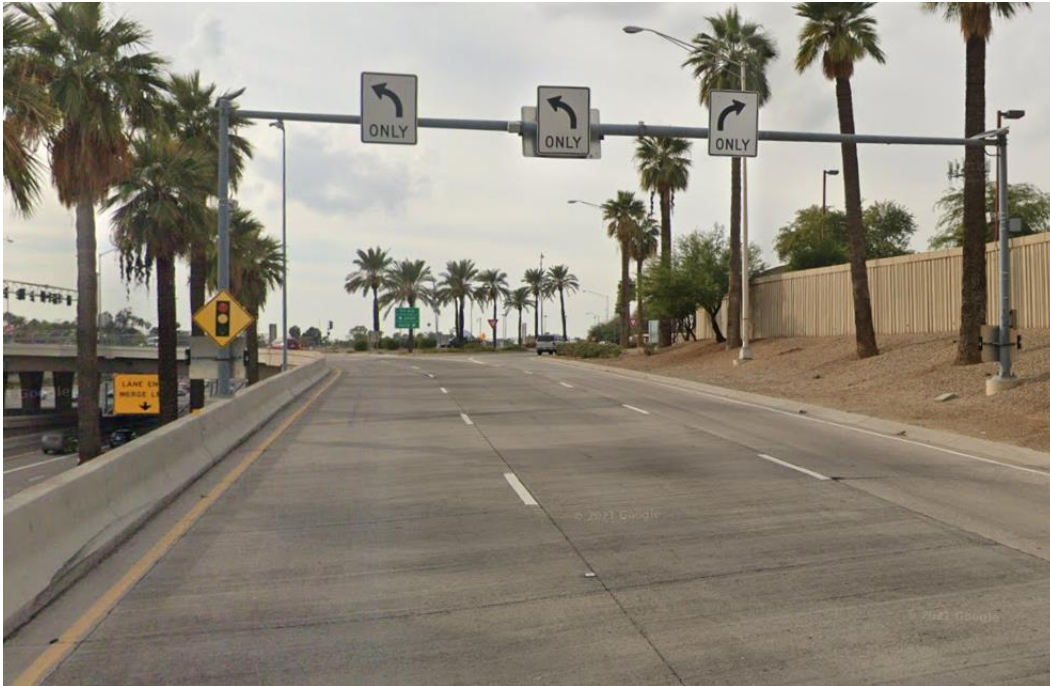
Figure 11. Ramp OLCS, Westbound IH 10 at N. 7th Avenue, Phoenix, Arizona.

Figure 11 through Figure 20 show these OLCS applications and in some cases demonstrate unique support methods or signing combinations not found in Texas. Figure 11 and Figure 12 demonstrate OLCS mounting methods from Arizona showing an example of an overhead “mast arm bridge” and a large pole with a unique mast arm that helps provide a clear zone along the frontage road. In Georgia, TTI researchers found examples of OLCS supported on span wire (see Figure 13 and Figure 14). Unique monotube cantilever and overhead sign bridges were found in Albuquerque, New Mexico (see Figure 15 and Figure 16).

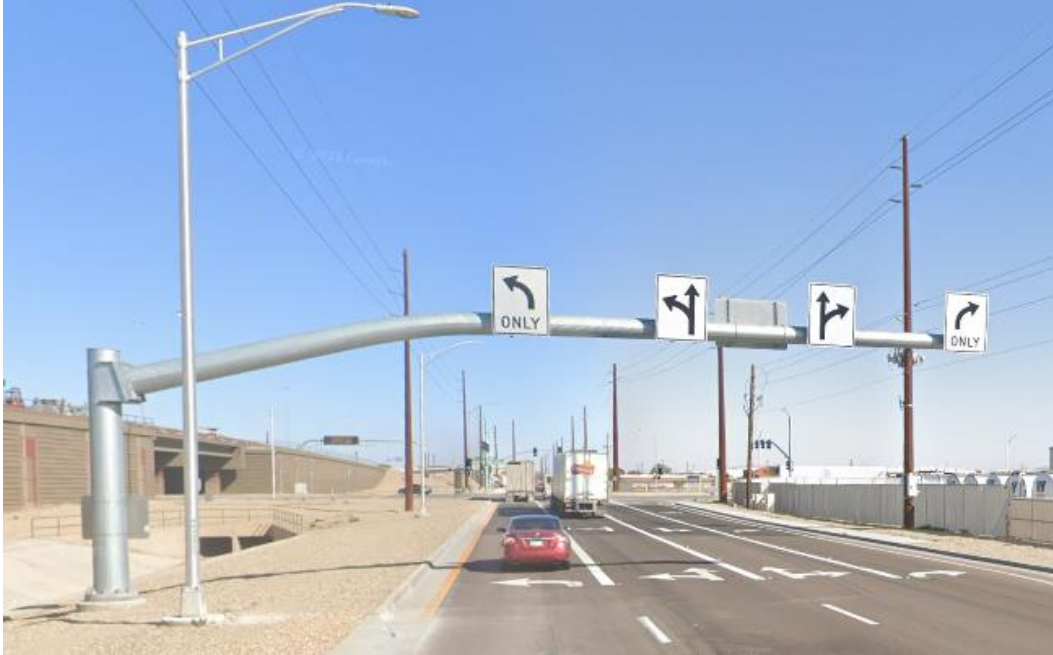
Figure 12. Frontage OLCS, Northbound El Pastor Freeway at W. Buckeye Road, Phoenix, Arizona.

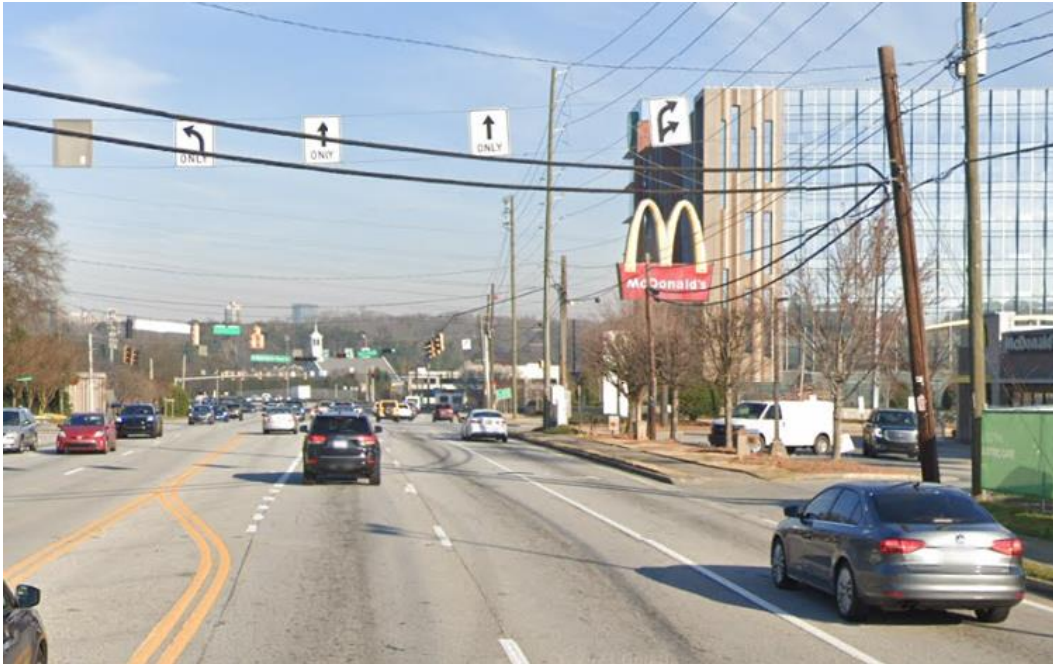
Figure 13. Arterial OLCS, Northbound N. Druid Hills Road at Tullie Road, Atlanta, Georgia.

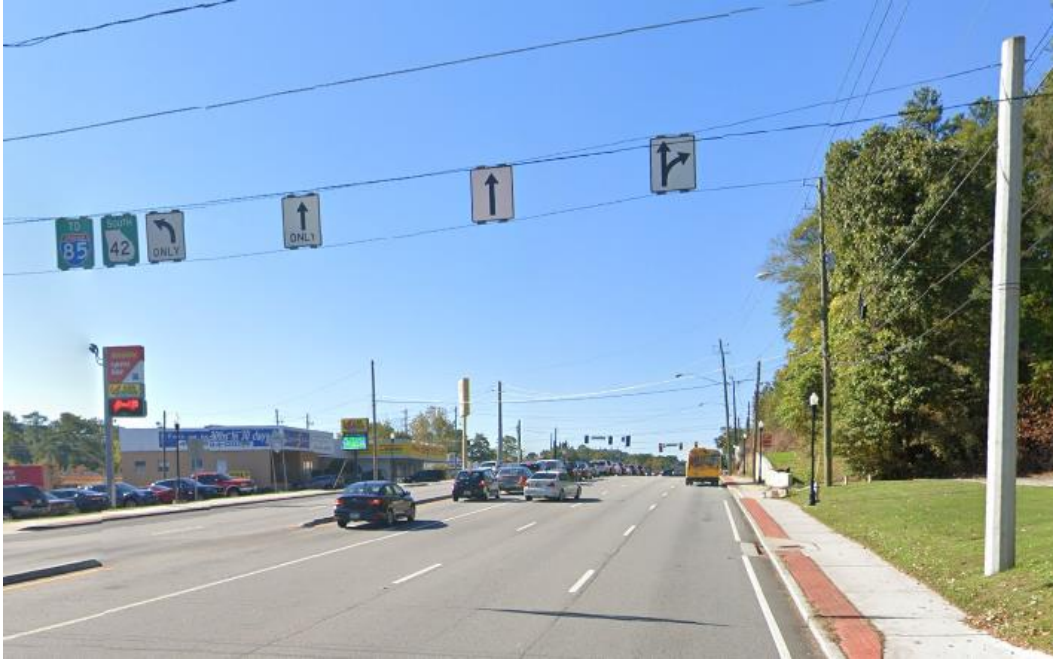
Figure 14. Arterial OLCS, Westbound Buford Highway NE at N. Druid Hills Road, Atlanta, Georgia.

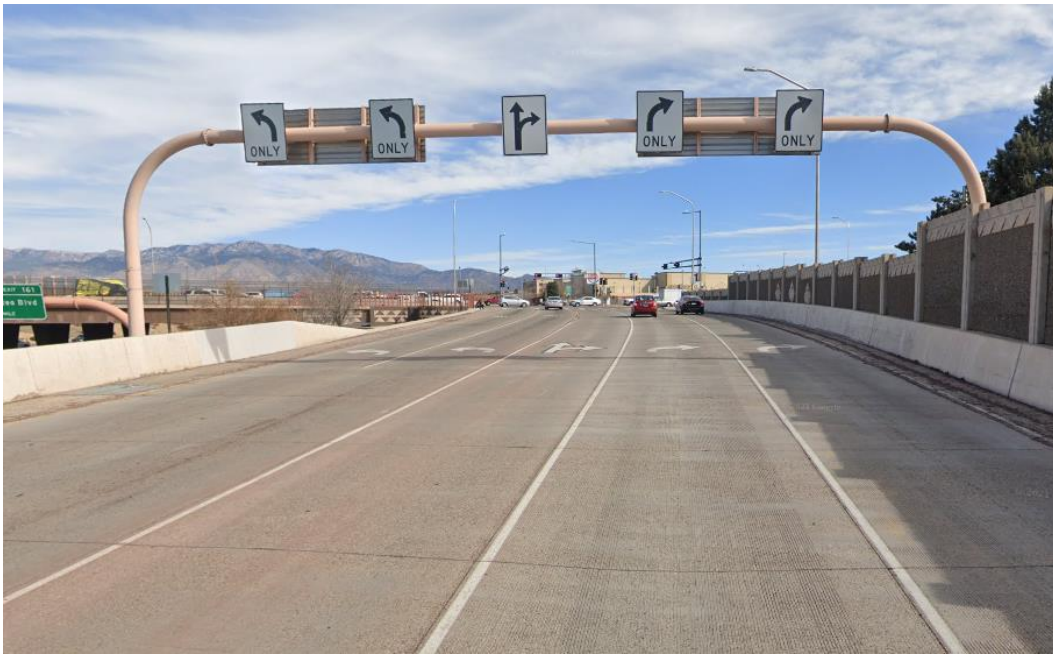
Figure 15. Ramp OLCS, Eastbound IH 40 at Carlisle Boulevard, Albuquerque, New Mexico.

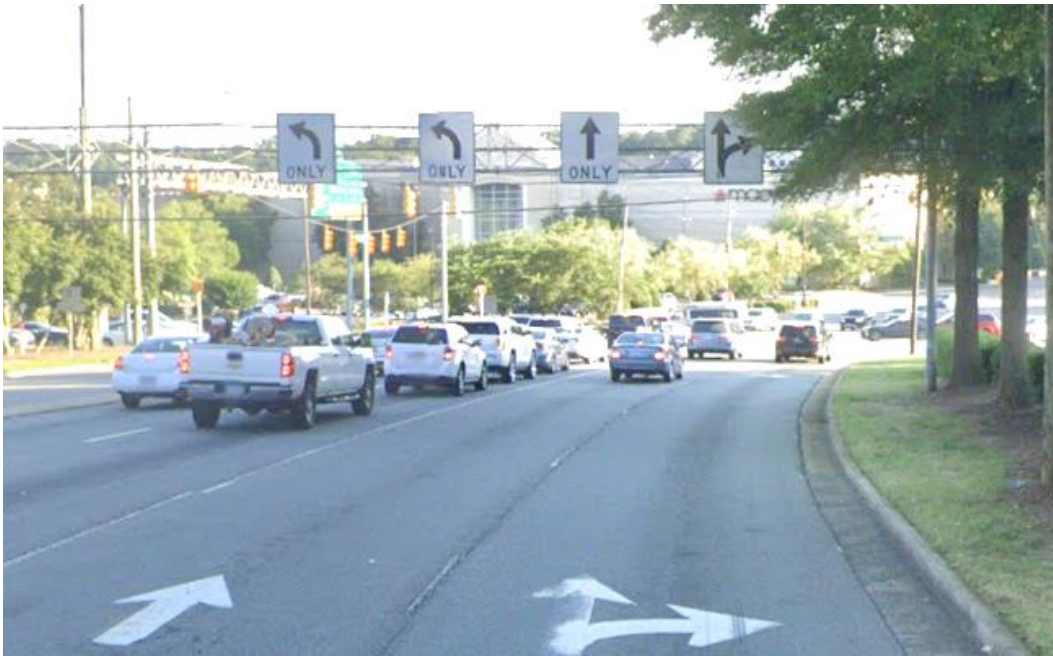
Figure 18. Arterial OLCS, Southbound SH 50 at US 70, Raleigh, North Carolina.

In North Carolina, OLCS examples were supported on truss OSBs (see Figure 17 through Figure 19). One of the North Carolina examples (see Figure 19) also includes route guide signing in combination with OLCS, expediting driver understanding of the route choice implications of lane choice approaching the interchange. An Ohio example (see Figure 20) of OLCS also combines route choice and lane use signing by lane to aid drivers in selecting the correct intersection approach lane to access or remain on their preferred route. The combination of lane control and route guide signing minimizes last-minute lane changing on the approach to a (very) nearby diamond interchange.

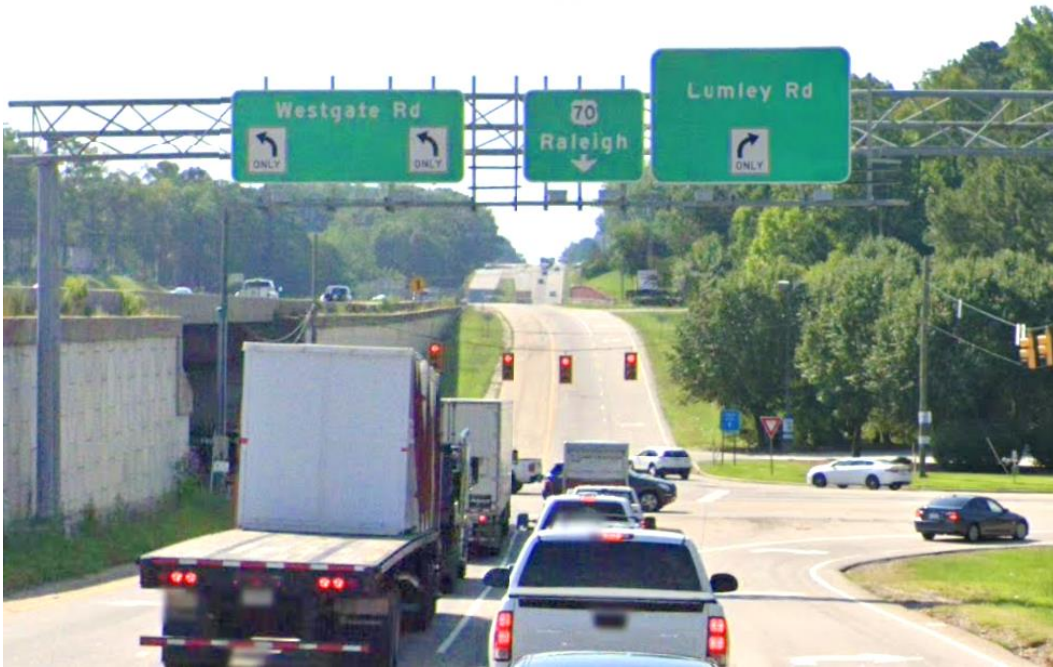
Figure 19. Ramp OLCS, Eastbound US 70 at Westgate/Lumley Road, Morrisville, North Carolina.

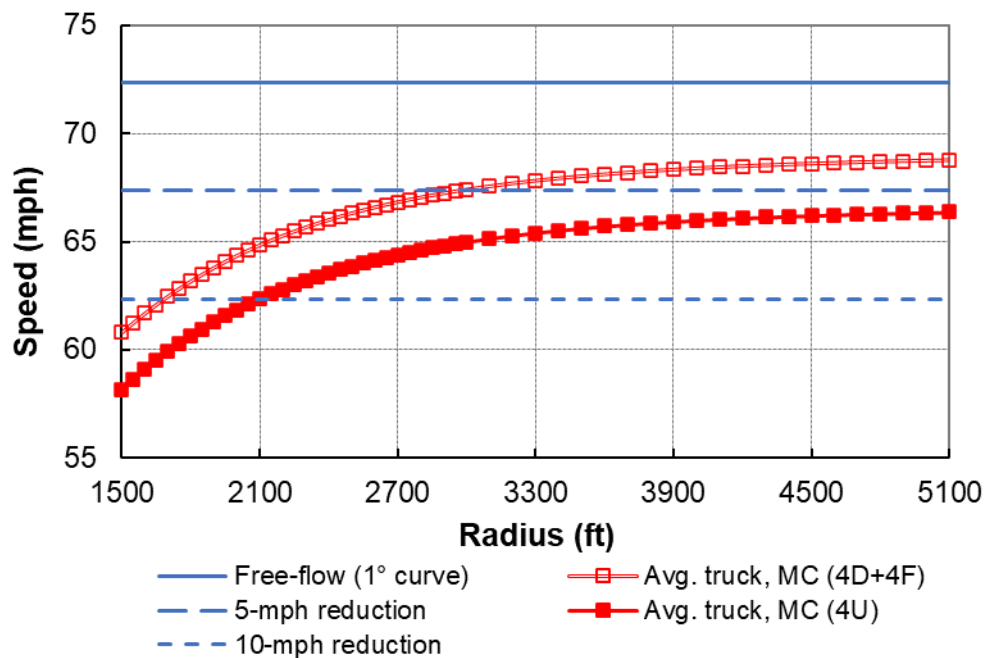
- On 4U roadways, the average truck speed is more than 10 mph below the free-flow speed on all curves with a radius less than about 2100 ft.

Figure 22. Speed Trends on Four-Lane Rural Highway Curves, 75 mph Speed Limit.

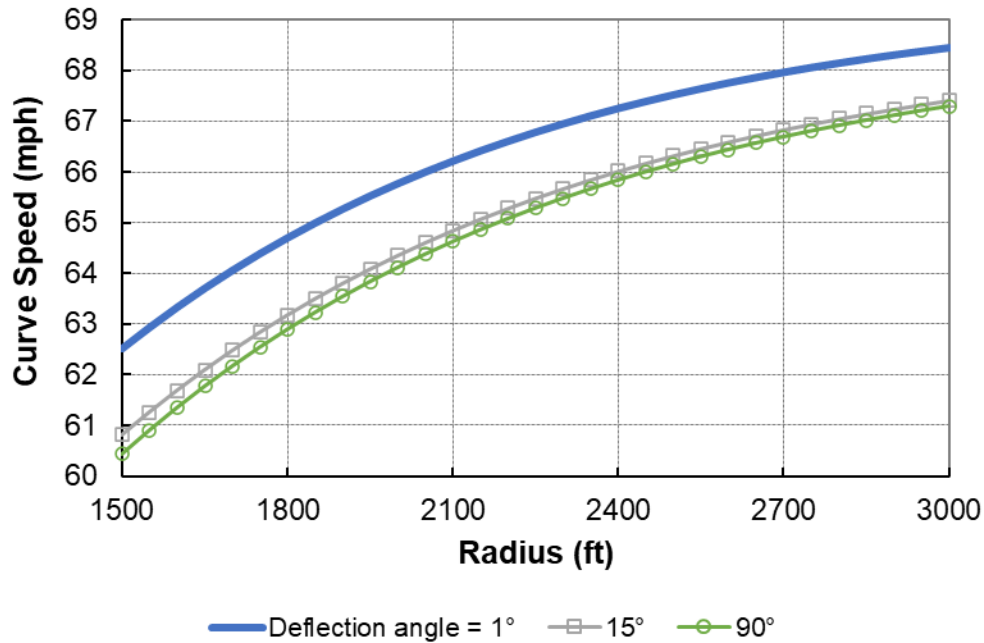
Figure 24. MC Speeds for Average Truck and 2-Percent Superelevation (4D or 4F Rural Highway, 75-mph Regulatory Speed Limit).

- Overall, drivers adopt lower speeds on 4D and 4F rural highways than on 2U rural highways, given the same regulatory speed limit (75 mph), radius, and superelevation rate (2 percent). This trend is apparent from the different y-axis ranges for the two graphs.
- On 4D and 4F rural highways, drivers appear to decelerate for curves even with more gradual radii (e.g., more than 2850 ft, roughly equating to curves with degree of curve values of 2 or less). However, the magnitude of speed reduction on these gradual curves is small. This trend is apparent by noting that Figure 23 has “knees” where curve speeds do not begin to decrease by more than a nominal amount until the radius decreases to a value in the range of 2000 to 2300 ft (depending on deflection angle), while Figure 24 has no such “knees.”

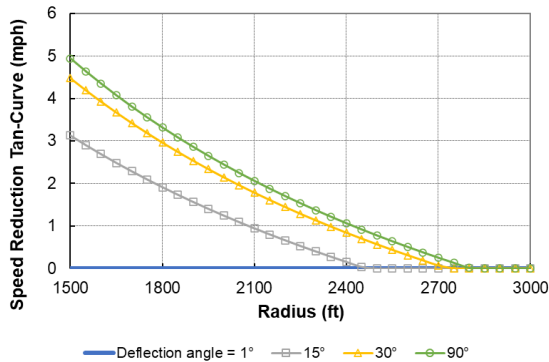
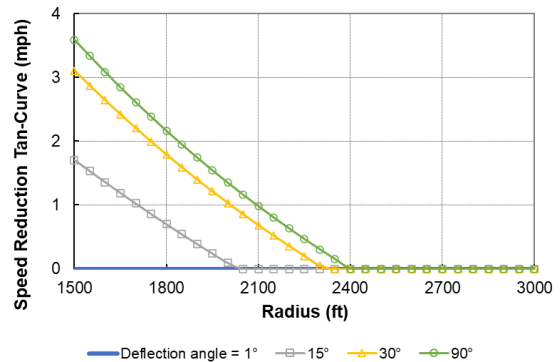
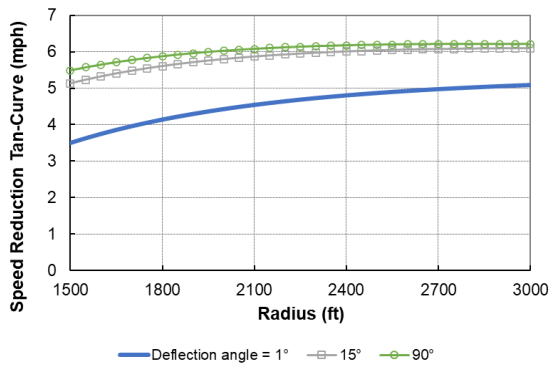
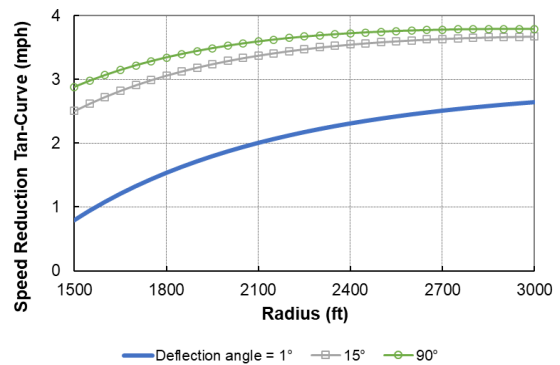
estimated by computing the tangent speed for a curve with a radius of 5730 ft (or degree of curve = 1), and the tangent (Tan) speed is computed for the range of curve radii on the x-axis.

a. 2U, 70-mph Regulatory Speed Limit.

b. 2U, 75-mph Regulatory Speed Limit.

c. 4U, 75-mph Regulatory Speed Limit.

d. 4D or 4F, 75-mph Regulatory Speed Limit.

- Drivers decelerate more for the curve if the curve is on a highway with a lower regulatory speed limit (e.g., compare Figure 25a and Figure 25b). This trend has been noted elsewhere (16, 18).
- Drivers decelerate more for curves on 4U rural highways than curves on 4D or 4F rural highways (see Figure 25c and Figure 25d).
- Speed reduction (as measured between approach tangent and MC) increases with decreasing radius on two-lane highways but decreases with decreasing radius on four-lane highways.

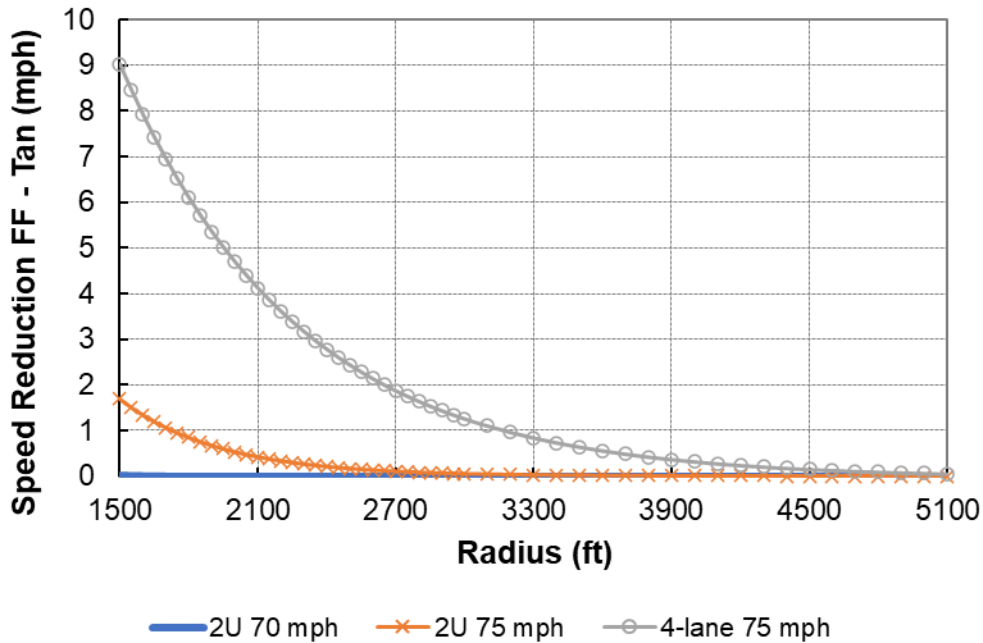
Figure 26. Speed Reduction Trends (Free-Flow—Tangent), 2-Percent Superelevation Rate.

With this rationale in mind, and considering the speed reduction trends that have been observed on the approach tangents to curves on four-lane rural highways (see Figure 26), the researchers suggest the following revisions to curve evaluation procedures *for four-lane rural highways*:

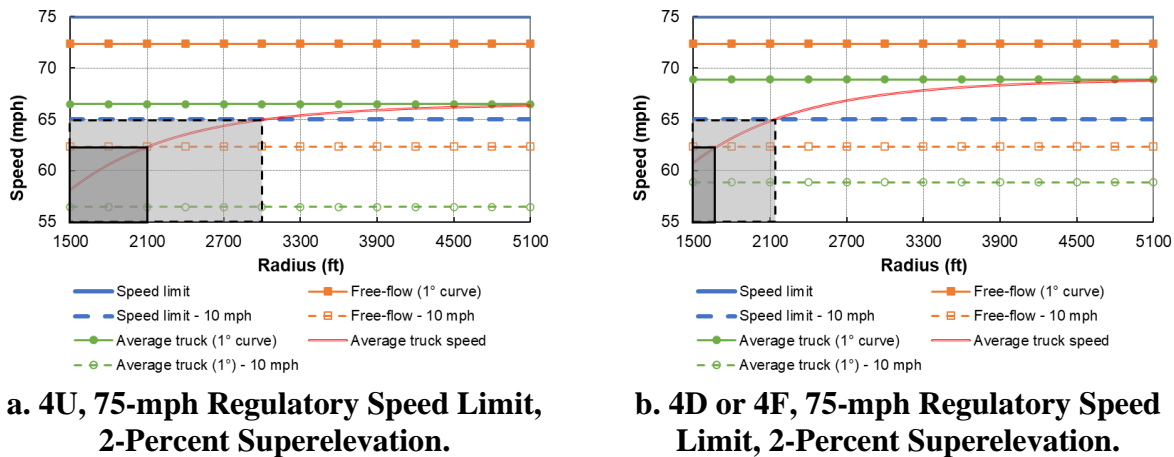
Figure 27. Illustration of Candidate Procedure Revisions.

Figure 27 shows the effect of these revisions on the aforementioned example curves with a 2-percent superelevation rate and 15-degree deflection angle. The lighter shaded regions with the dashed lines represent curves where a horizontal alignment sign alone may be posted, and the darker shaded regions with the solid lines represent curves where a horizontal alignment sign and an Advisory Speed plaque shall be posted.

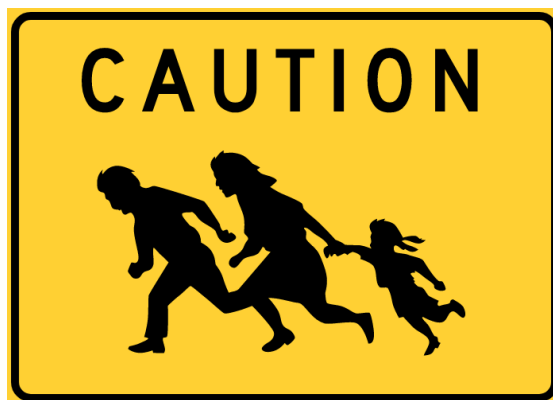
Figure 29. Rectangular Symbol Sign.

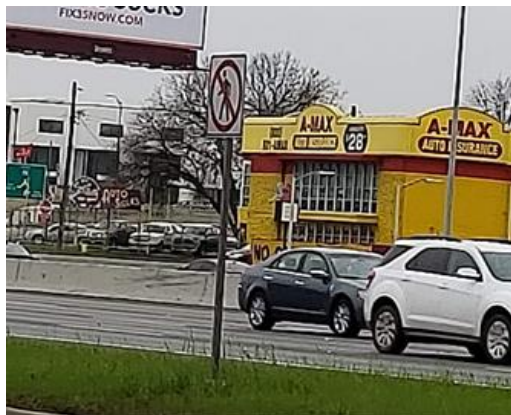
Figure 31. No Pedestrian Crossing Sign on IH 35 in Austin.

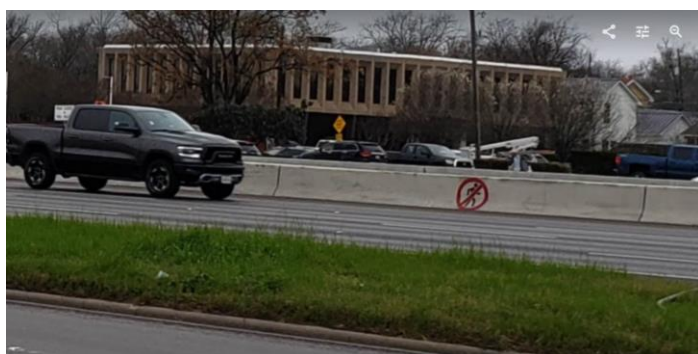
Figure 32. No Pedestrian Crossing Stencil and Signs on IH 35 in Austin.

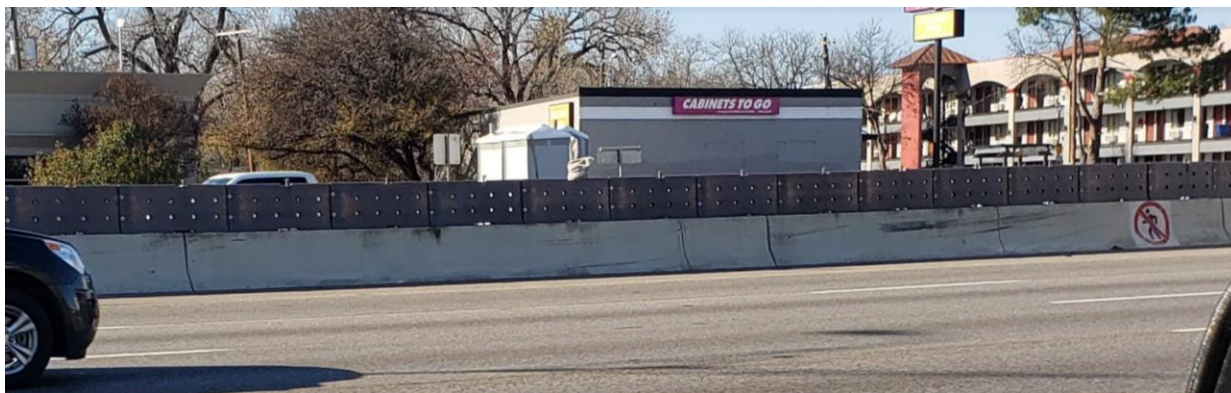
Figure 33. Stencil and Barrier on Top of Center Median on IH 35 in Austin.

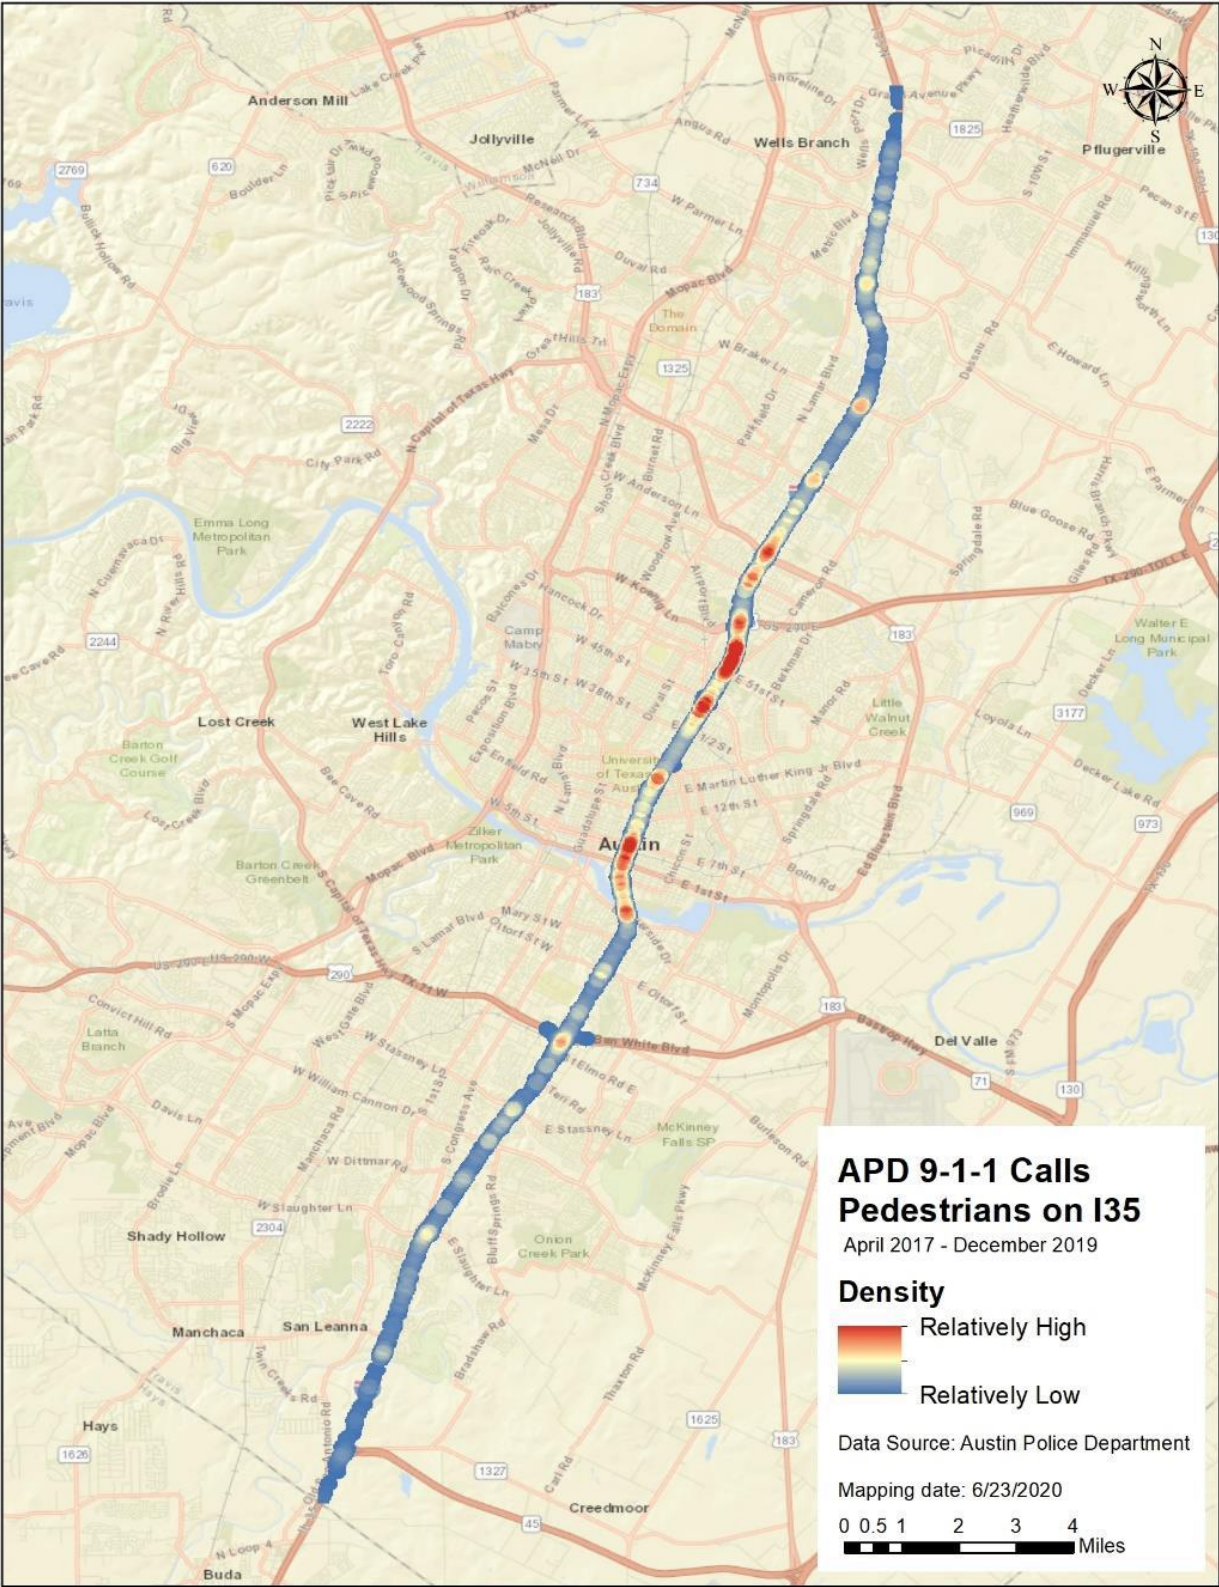
Figure 34. 9-1-1 Call Data Heat Map on IH 35 in the City of Austin Limits.

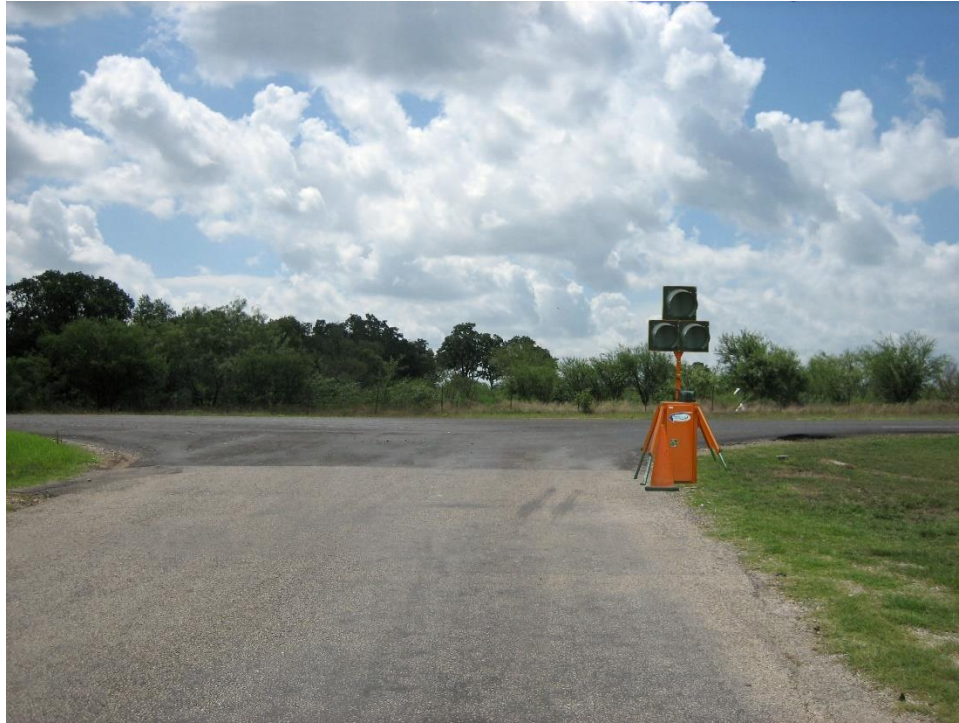
Figure 37. Mock Prototype DAD.

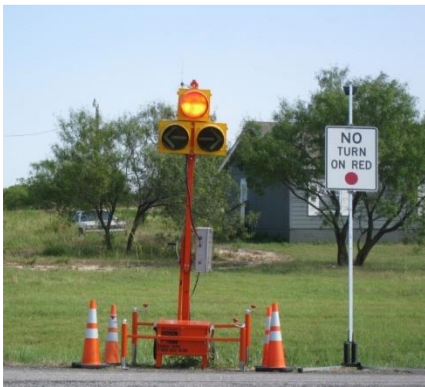
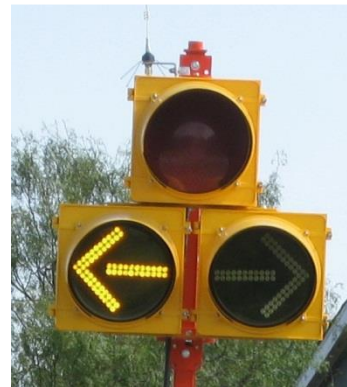
Based on these findings, researchers designed the three-section doghouse DAD in Figure 38. This device uses a 12-inch steady circular red indication and 12-inch flashing yellow arrows to control traffic. The steady circular red indication is shown when the minor approach traffic must stop and remain stopped. Since drivers facing a steady circular red indication may turn right after stopping when no other traffic control device is in place prohibiting a turn on red, a NO TURN ON RED sign (R10-11) was also displayed. The flashing yellow arrows indicate that the minor approach traffic is permitted to cautiously enter the roadway only in the direction of the arrow.

a. Steady Stop Indication.

b. Flashing Proceed Indication.

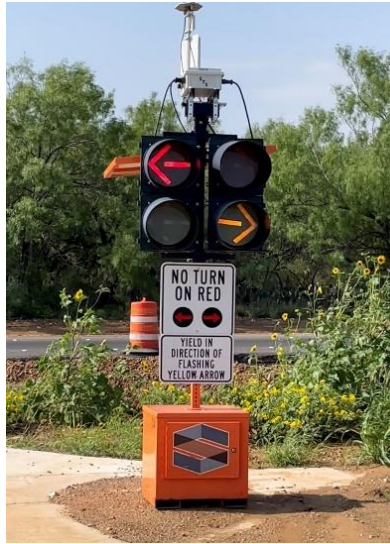
Figure 39. Example of Four-Section Stacked DAD.

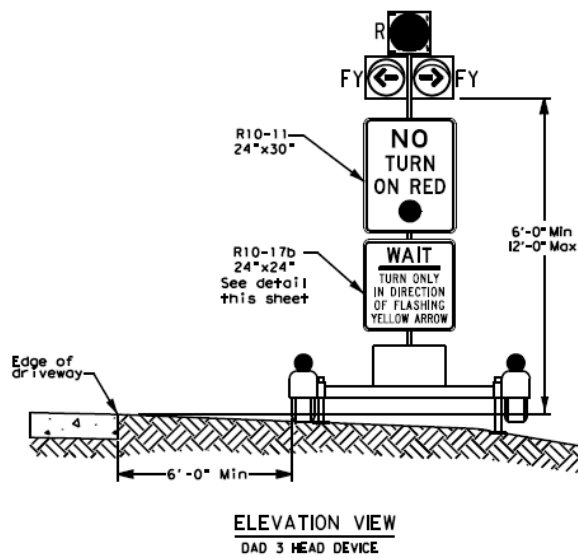
Figure 40. TxDOT Three-Section Doghouse DAD Design.

Currently, TxDOT allows the two DAD designs in Figure 40 and Figure 41 to be used and evaluated in Texas with prior approval from the TxDOT Traffic Safety Division.

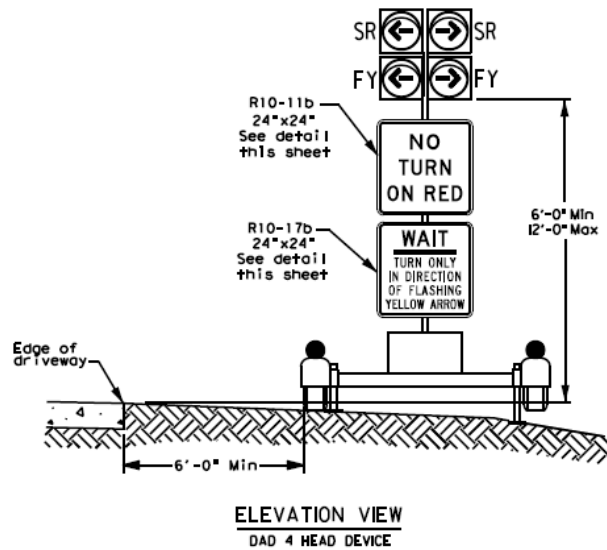
Figure 41. TxDOT Four-Section Stacked DAD Design.

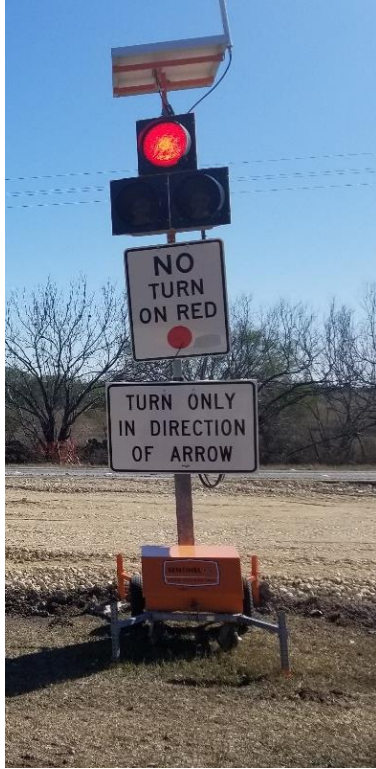
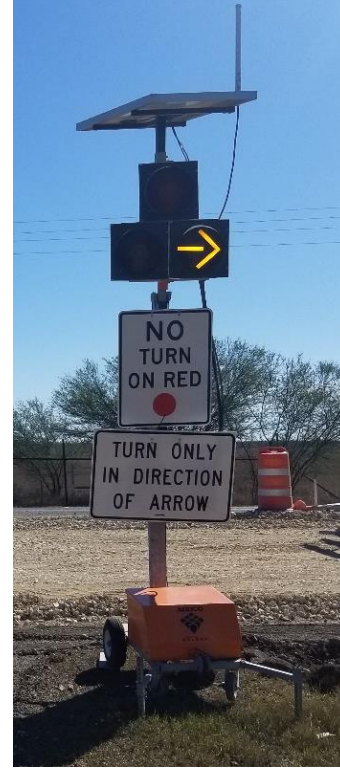
a. Steady Stop Indication.

b. Flashing Proceed Indication.

Project 1 involved the rehabilitation of US 83 in Uvalde County from FM 1435 to the Zavala County Line (see Figure 42). The construction sequence included seven sections where the two-lane, two-way roadway would be reduced to one lane. Work began near the Zavala County Line and progressed north toward Uvalde. The one-lane sections ranged in length from approximately 0.5 mile to 2 miles. The contractor used PTSs at both ends of the one-lane section to control the flow of traffic on the main road. The planned one-lane sections included intersections with three county roads, 45 private driveways (e.g., gated residential, oil field, and utility access), and six business or multi-home residential driveways (see yellow pins with circles in Figure 42). Since the three county roads were interconnected, the construction was sequenced such that only one county road intersection was within a one-lane section, and that intersection was closed during construction. The contractor used the three-section doghouse DAD with a R10-11 sign and a TURN ONLY IN DIRECTION OF ARROW sign (see Figure 43).

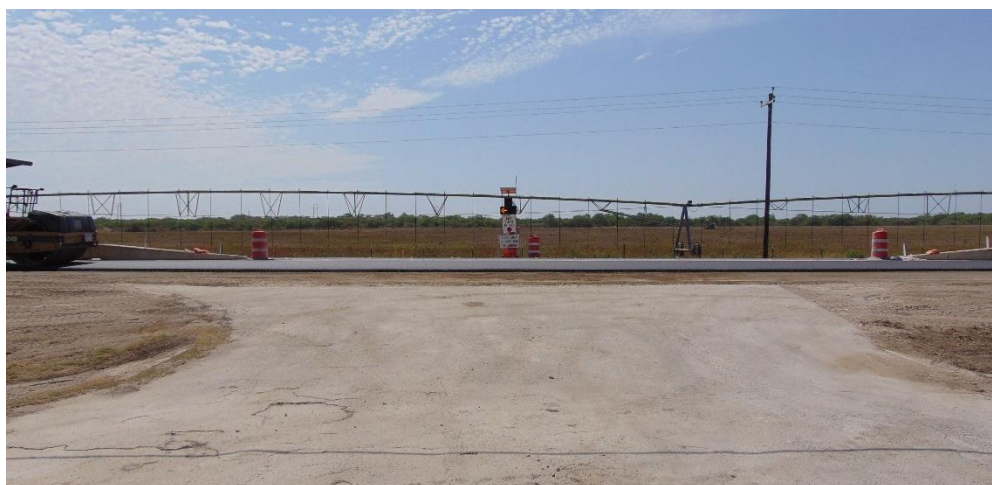
Figure 47. Project 1 DAD at Business Driveway SB-33.

On July 14–15, 2020, TTI researchers observed traffic exiting a convenience store driveway (SB-33) in Section 5 (see Figure 46). The DAD was located directly across the main road from the driveway since construction was occurring in the SB lanes (see Figure 47). Data collection began around 11:00 a.m. on Tuesday, July 14, and ended around 8:00 a.m. on Wednesday, July 15. The average phase duration for the DAD (i.e., red and flashing yellow arrow indications for one direction of travel) was approximately four minutes with a two-minute red clearance interval. The total DAD cycle length was about eight minutes. Due to the pandemic, traffic volume at the store was much lower than initially expected.

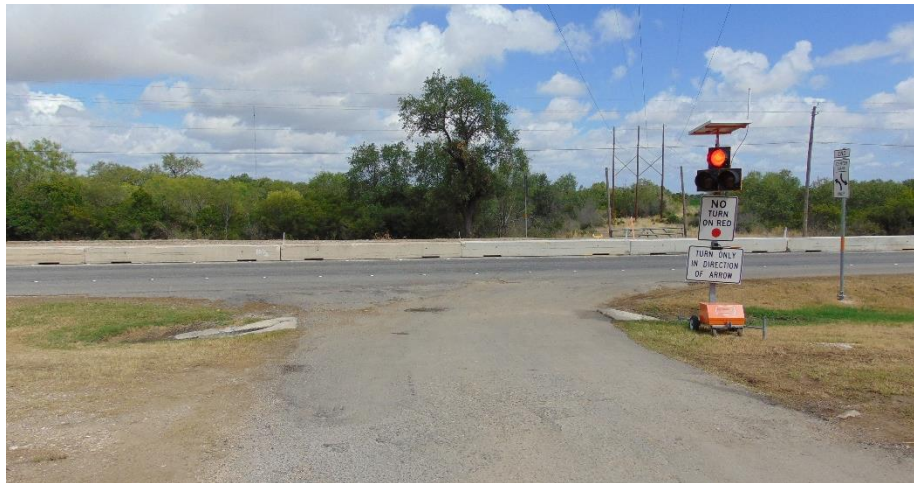
Figure 49. Project 1 DAD at Residential Driveway NB-12.

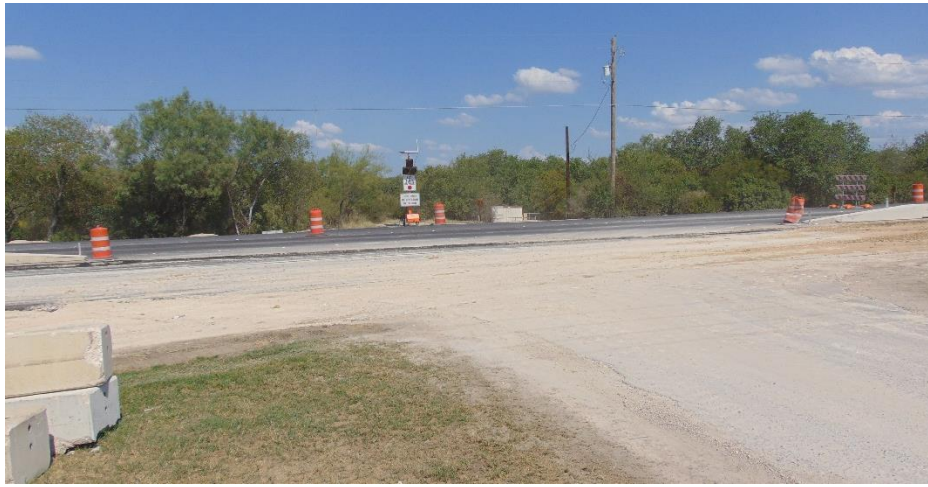
Figure 50. Project 1 DAD at Residential Driveway NB-11.
