Traffic Control Device Analysis, Testing, and Evaluation Program: FY2022 Activities

Technical Report 0-7096-R2

TEXAS A&M TRANSPORTATION INSTITUTE
COLLEGE STATION, TEXAS

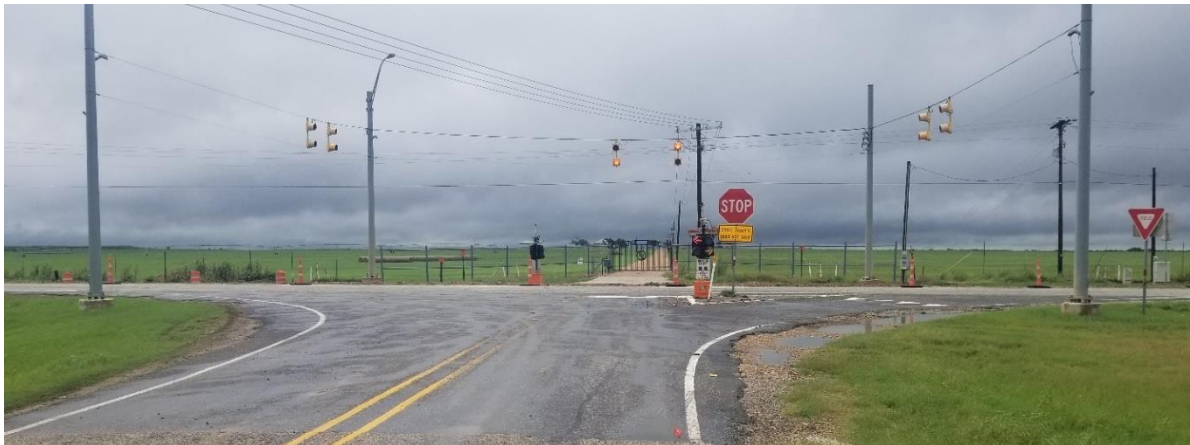
Figure 52. Project 2 DAD at Intersection of SH 85 and FM 1853.

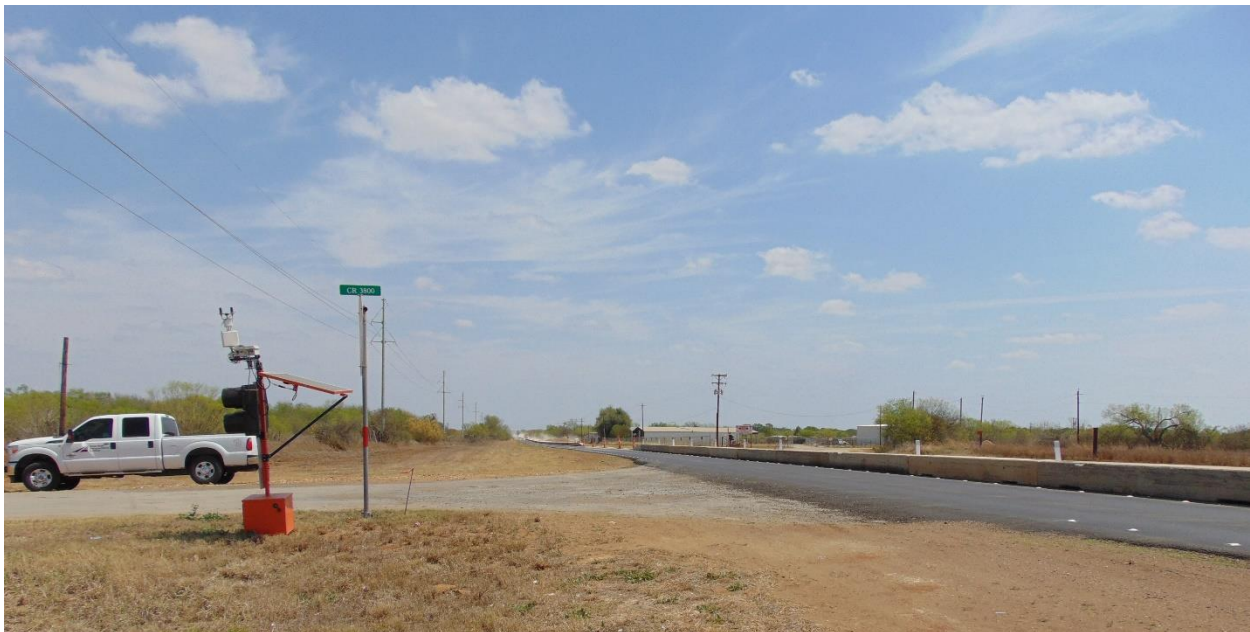
Figure 55. Project 2 DAD at Intersection of SH 85 and CR 3800—Looking East.

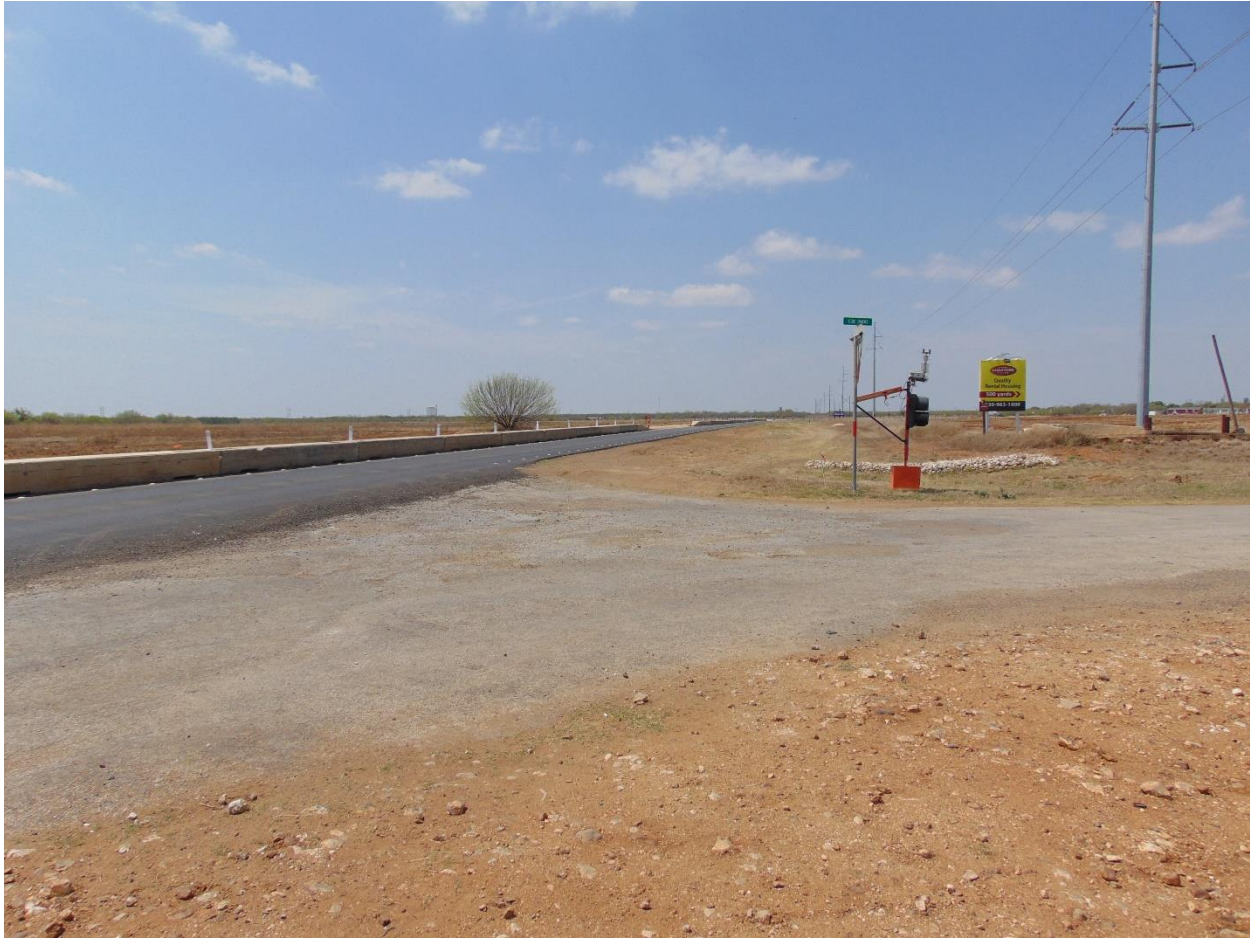
Figure 56. Project 2 DAD at Intersection of SH 85 and CR 3800—Looking West.

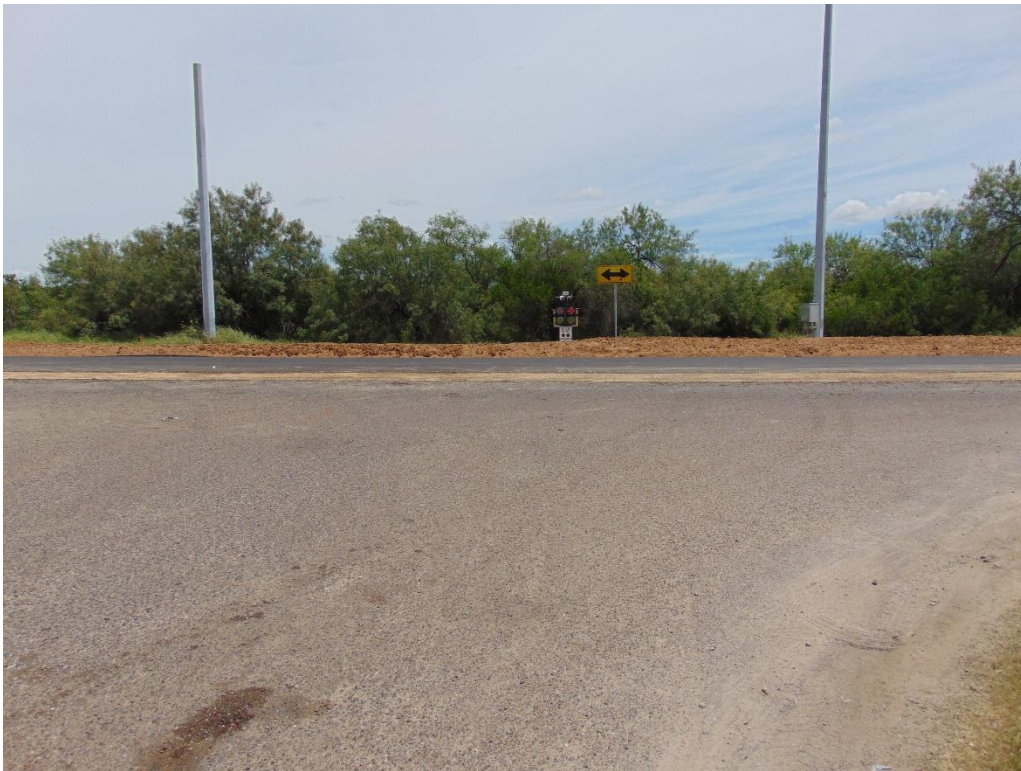
Figure 58. Project 3 DAD at Intersection of FM 3338 and Rancho Penitas Road.
