Using Surface Geometry to Identify Potential Hydroplaning Locations

Technical Report 0-7098-R1

Report 0-7098-R1
Project 0-7098

Project Title: Determine Drainage Basin Mapping and Estimation of Hydroplaning Potential

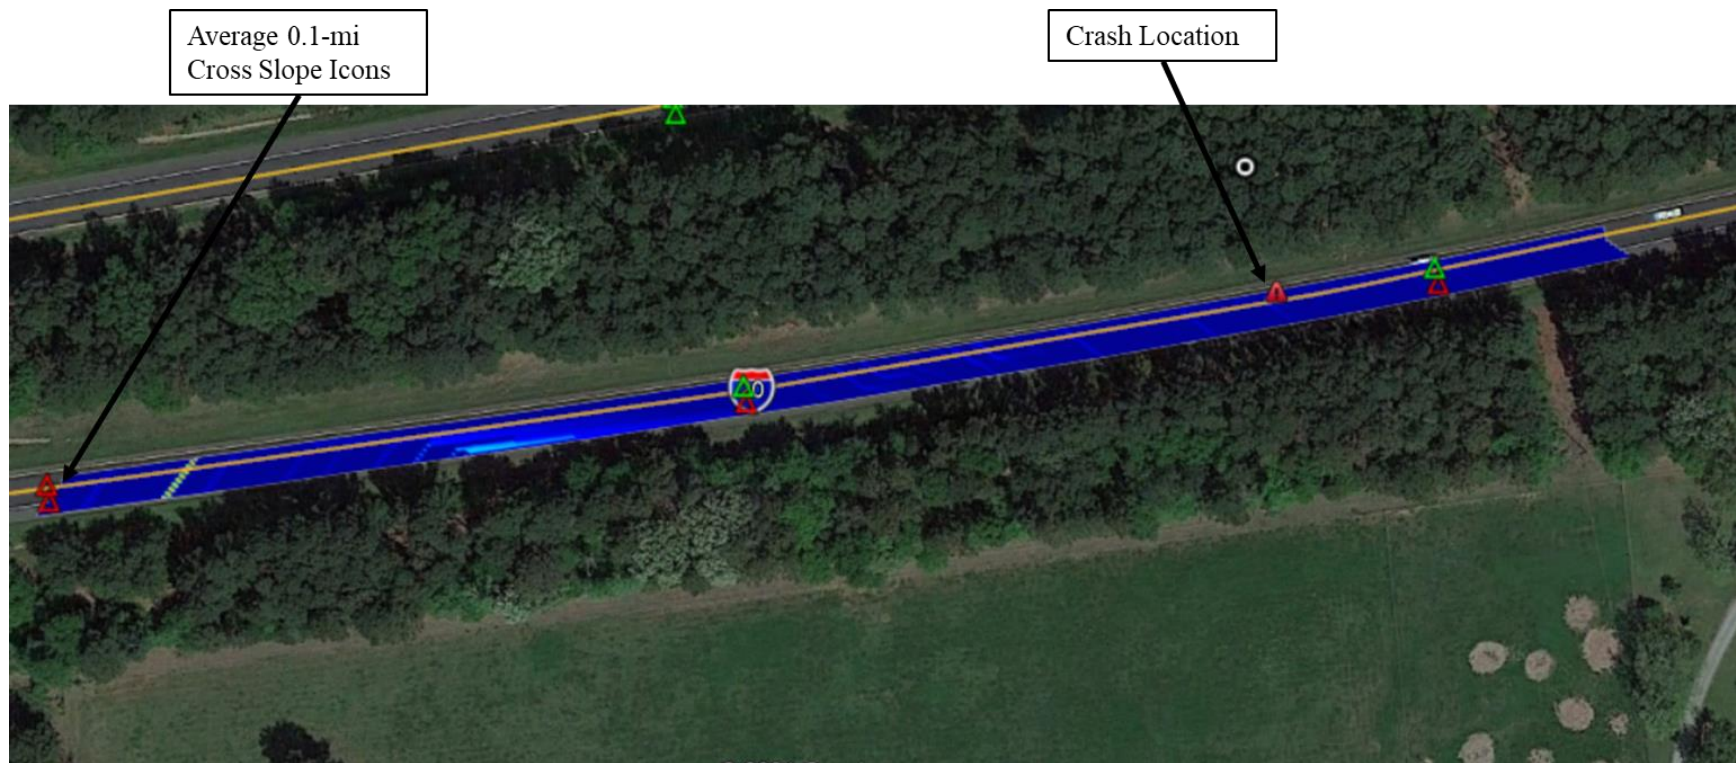
Figure 4. Zoomed Google Earth Location of Vulnerable Area.

Figure 3 through Figure 7 show examples of the visualization within Google Earth. Figure 3 shows the Google Earth window created when opening the .kmz file. Figure 4 is created in Google Earth by double-clicking on one of the vulnerable areas on the right side of Figure 3. Figure 4 provides a better view of the data visualized within the .kmz file. All icons in Figure 4 have additional information attached. Additional information can be displayed for each of these icons by clicking them within Google Earth. Figure 5 shows the additional data for cross-slope information obtained by clicking on a triangle, while Figure 6 shows crash record information obtained by clicking on the triangled exclamation mark. Finally, Figure 7 shows the pop-up window created in Google Earth by double-clicking on a vulnerable area. The table within Figure 7 provides additional information on the drainage basin.

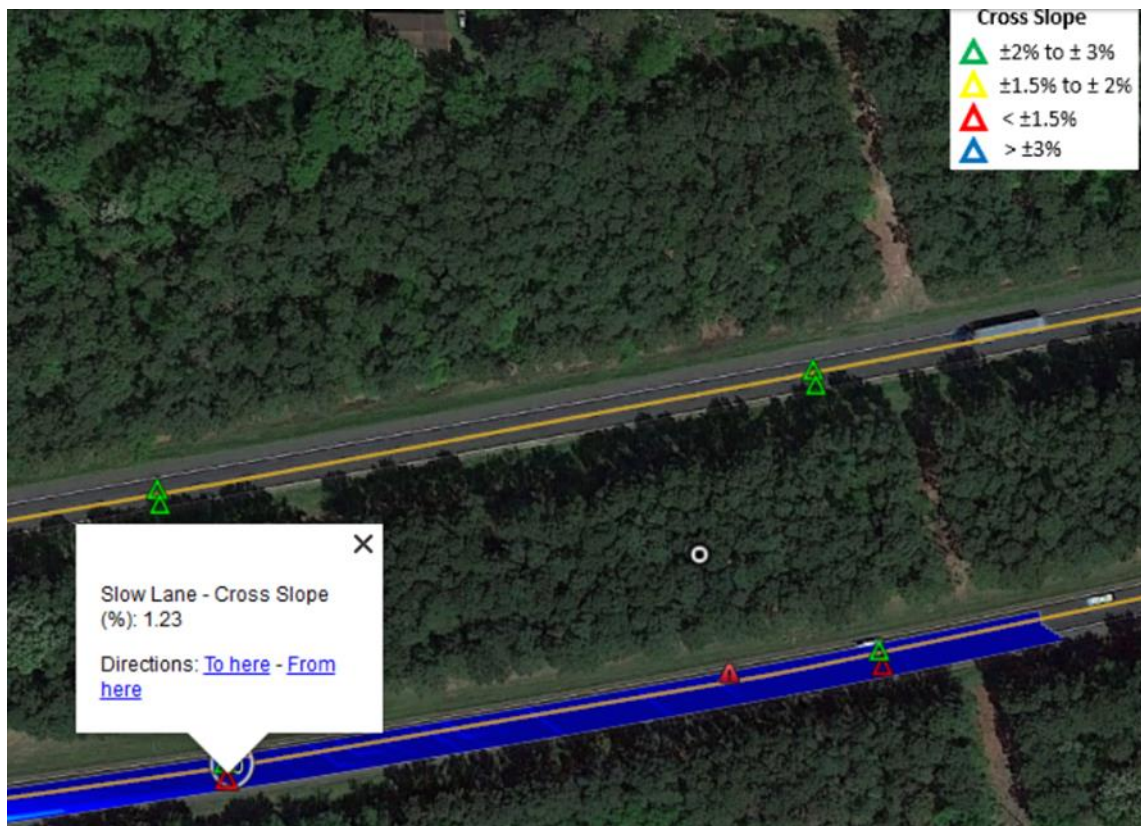
Figure 5. Visualization of Average Cross-Slope Data.
