Final Report WY-22004F Phase 2

Field Testing and Long-Term Monitoring of Selected High-Mast Lighting Towers (Phase 2)

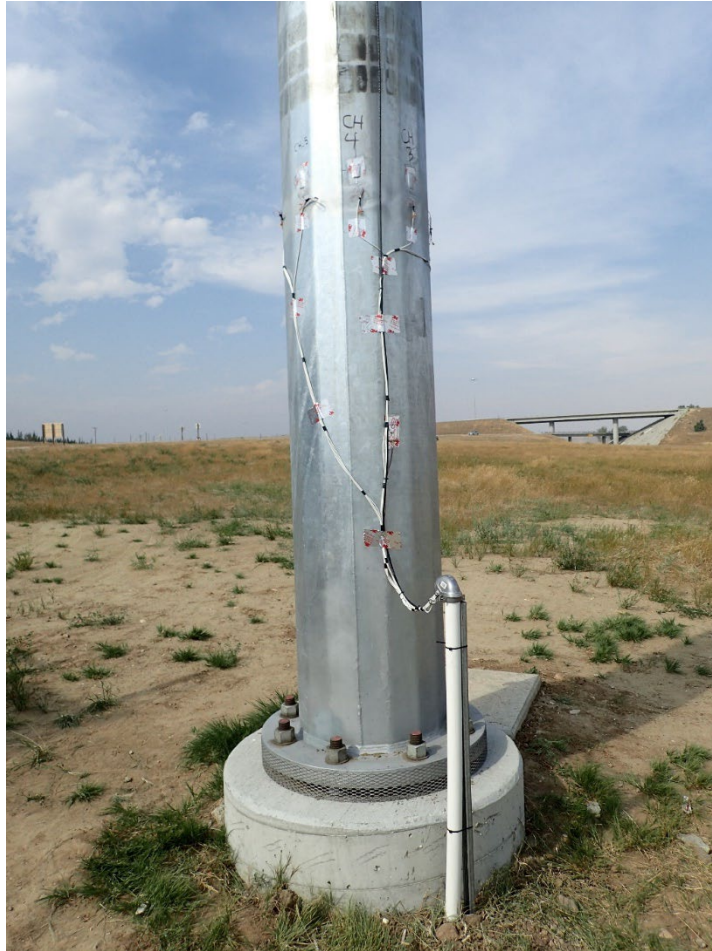
Figure 12. Example of underground conduit used to protect signal wires.

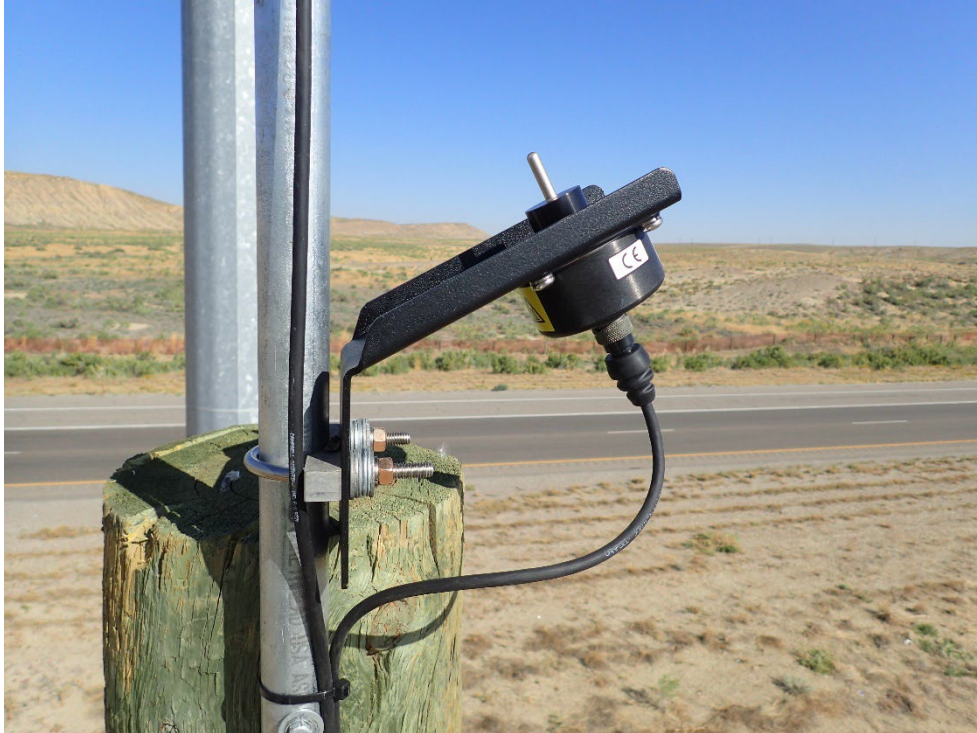
The freezing rain sensor is made by Rosemount Aerospace, Inc., Model 0871LH1. It detects the presence of icing conditions, or ice accumulation. The installation location can be seen in Figure 15, showing it mounted at the top of the temporary pole, below the anemometer, on the manufacturer-provided mounting bracket. The ice sensor operates using resonant frequencies of a nickel alloy probe. As ice collects on the probe, the added mass causes the resonant frequency to decrease. When the frequency decreases to about 130 Hz (resulting from a layer of ice of about 0.02 inches), the data logger logs an ice event and the ice sensor automatically defrosts the probe and begins the process again. When the pole at Dwyer Junction was removed at the conclusion of Phase 1 field monitoring, the WYDOT removal team decided to cut the cables to the ice sensor. This unfortunately caused internal damage to the electronics of the ice sensor. The Research Team investigated the feasibility of repairing or replacing the sensor, but ultimately the project team from WYDOT decided that it was not worth the expense. Instead, the ice sensor was removed from Baxter Interchange (this site was chosen due to being the least active site for wind events during Phase 1 testing) and relocated to Dwyer Junction on the newly instrumented pole. This proved to be a prudent decision because no wind events were observed at Baxter Interchange and Dwyer Junction continued to be one of the most active sites.

Figure 16. Freezing rain sensor and mounting kit

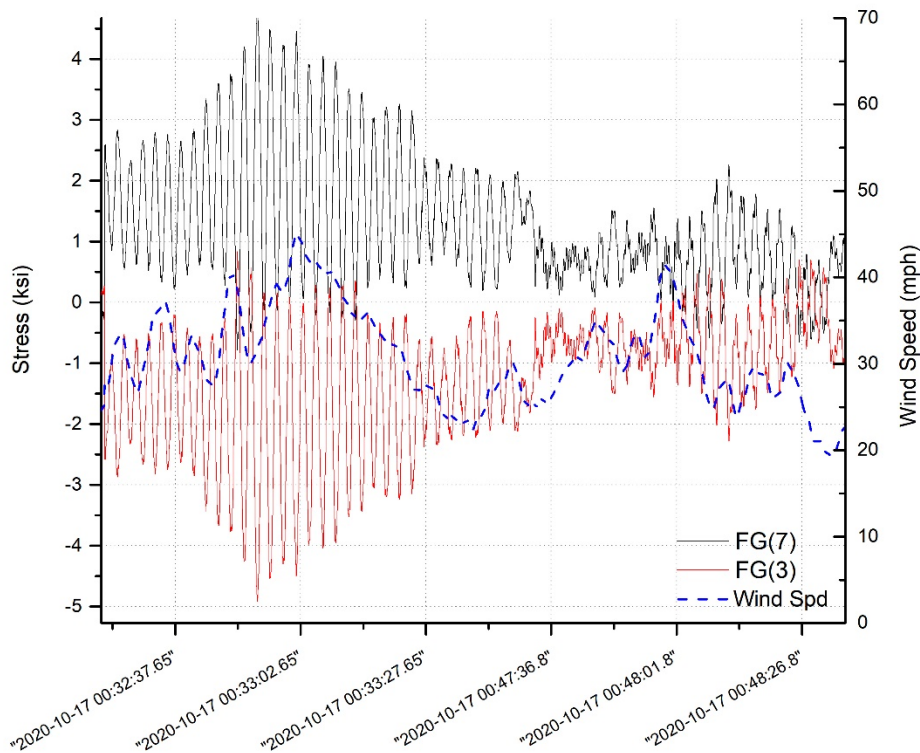
Figure 21. Data set from Buffalo Tri-Level representing typical along-wind response

Figure 21 displays a data set from the HMLT located at Buffalo Tri-level Interchange that was initiated by a Wind-40 trigger. This figure is a double-y plot with stress plotted along the vertical

The strain gages measuring the largest stress ranges were therefore positioned along an axis nearly parallel to the direction of wind, meaning that the oscillations were mostly along-wind. However, in this particular case the wind heading was about 30 degrees off parallel alignment with these strain gages. This is not unexpected since in addition to the flexural response, the poles can also experience torsional effects caused by the wind. The stress ranges for this event were not much more than about 5 ksi. And as can be seen in the figure, FG(3) mostly measured tensile stress and FG(7) mostly measured compressive stress for this event, indicating that the pole was being bent in a similar direction as the wind heading such that it was a buffeting wind that pushed the HMLT nearly parallel to its path while simultaneously inducing smaller amplitude vibrations. Although along-wind response was not uncommon, it was rarer than across-wind vibrations. The deflection from the event plotted in Figure 21 would have been unremarkable to an observer in the area: taking the mean stress of each gage of about 1.75 ksi results in a calculated tip displacement of approximately 4.5 inches with vibrations resulting in $\pm 3 - 8$ inches.

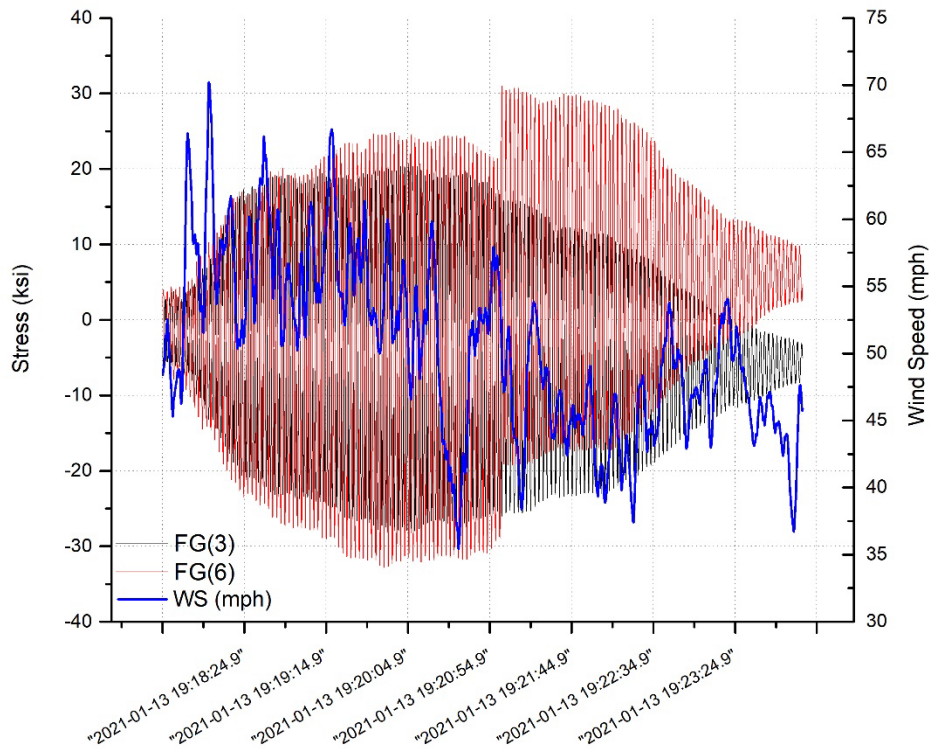
Figure 26. Large oscillation data set for Dwyer Junction captured a Wind-40 trigger

The two final triggered events to be discussed herein contained the largest amplitude oscillations observed throughout monitoring. Both events occurred at the Dwyer Junction location, which was also the location of the largest recorded event during Phase 1 monitoring, albeit a different pole. The first event was initiated on a wind-40 trigger and is plotted in Figure 26. This figure plots stress along the vertical left axis against the data time stamps on the horizontal axis. Data from two foil resistance strain gages, FG(3) and FG(6), are shown representing the largest stress ranges measured in the pole during this event. FG(3) was installed on the flat that faces approximately magnetic east and FG(6) was installed facing west-southwest. The wind speed has

While Figure 26 indicates notable wind speed variability, smaller segments of time, such as shown in Figure 27, reveal that the wind speed remained relatively constant over sufficient periods to energize the structural oscillation. Within a few hours of the recorded event shown in Figure 26, a WYDOT employee visited the pole location and took a photograph of the pole with ice accumulation on one side. This is shown in Figure 28. Temperature of the steel was shown to have dropped 20° F over the course of 25 minutes to about 30° F, making the ice build-up possible. Since the peak stress range measurements observed during the event were consistently seen for FG(3) and FG(6), it can be said that the direction of displacement did not vary

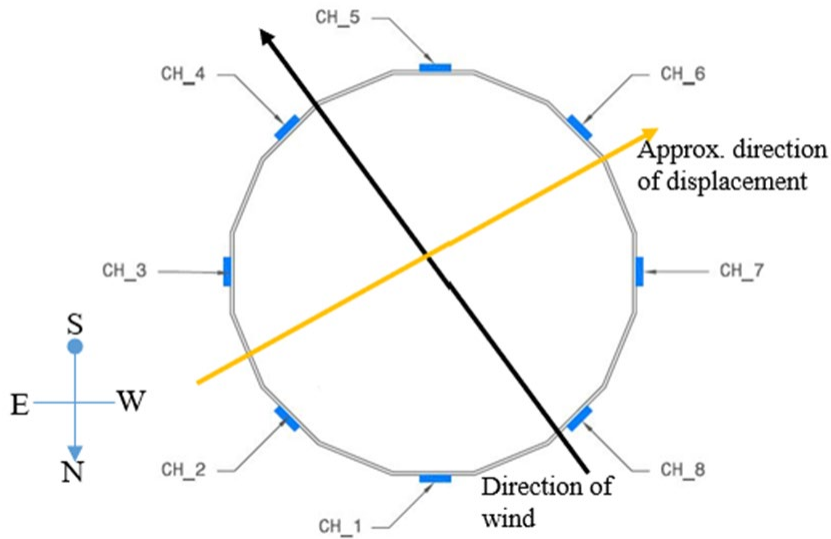
significantly. It also indicates that the pole was oscillating along the approximate axis between these two strain gages, as labeled in Figure 29 with the golden arrow. The arrow is meant only to approximate the direction of motion of the pole. Wind direction has also been labeled on the figure using a black arrow, which was taken from wind direction data recorded from the anemometer during the event. Wind direction varied up and down a few degrees, remaining relatively consistent out of the west-northwest direction and heading east-southeast (or approximately 320 degrees). The wind direction corresponded with the peak stress measurements in FG(3) and FG(6) for cross-wind vibration. A minor difference for this event can be seen Figure 30 where buffeting of the pole is also indicated in strain gages FG(4) and FG(8). This behavior is most obvious at the beginning of the data set when the sudden burst of 70 mph wind gusts impacted the pole. FG(8) measured small cycles in tension at the same time that FG(4) measured small cycles in compression without making full reversals (i.e., mean stress was not near zero). FG(4) and FG(8) measured stress ranges of about 18 ksi, each with a mean stress that was opposite each other in sign. Hence, the data suggests that the pole was pushed in flexure, aligned with the direction of wind, while it began to oscillate orthogonally to the wind vector, resulting in a combination of buffeting and vortex shedding. This is most likely why the peak stress ranges are being measured by two gages that are not directly across from each other.

Figure 29. Planview diagram of the large amplitude event at Dwyer Jct HMLT Jan 13, 2021

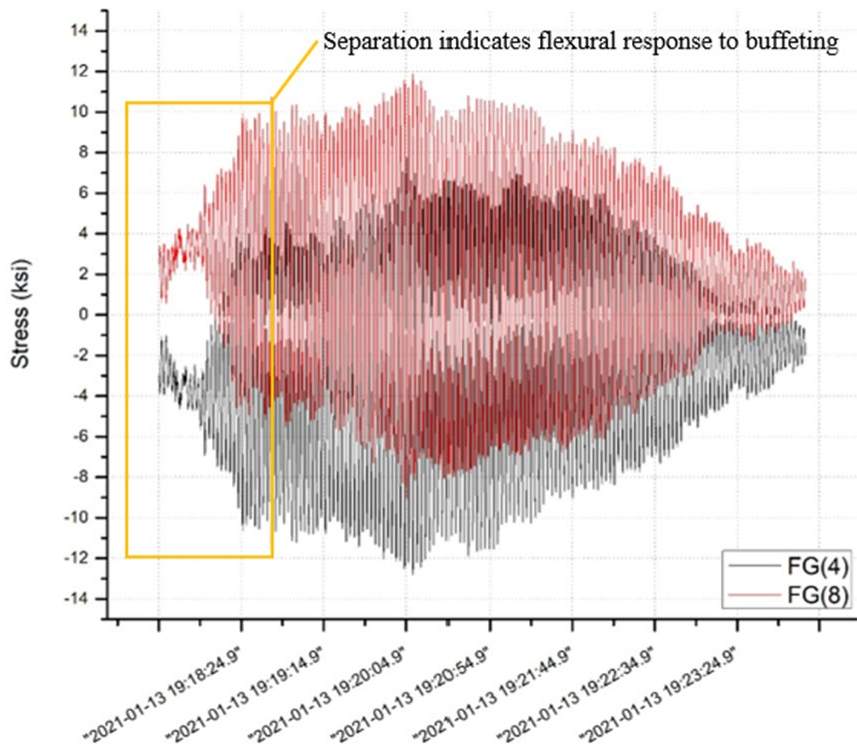
Figure 30. Large oscillation data set for Dwyer Junction showing indications of buffeting

The second of the two large-amplitude events observed during Phase 2 monitoring also occurred at the Dwyer Junction location. On March 29, 2022, a winter storm blew through the area-exciting mode I large-amplitude resonance in several HMLTs in the vicinity of Dwyer Junction.

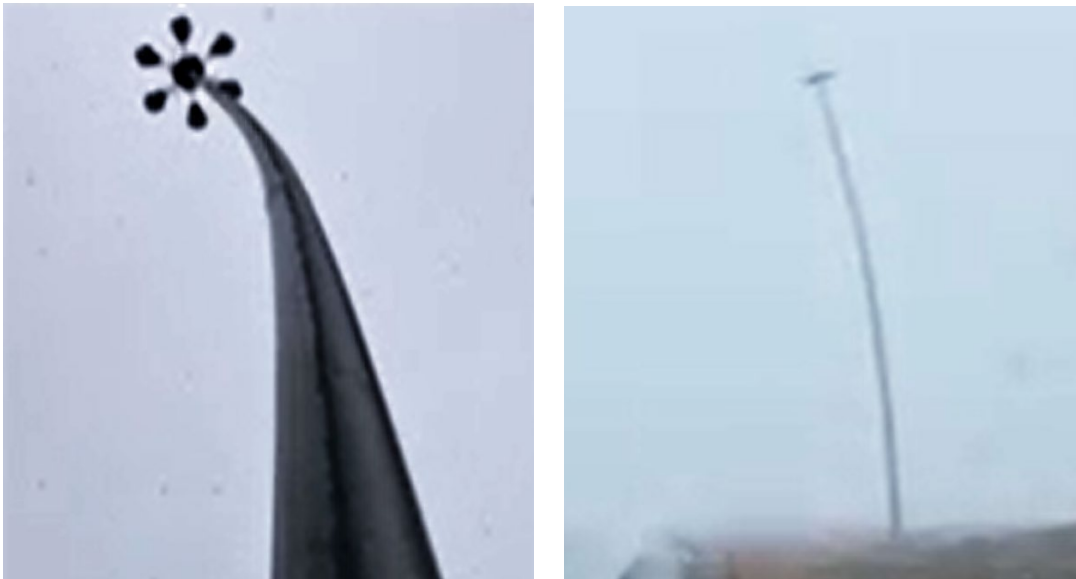
Data was only being collected on one pole; however, a WYDOT employee was also in the area and captured cell phone video footage of other poles experiencing large amplitude vibration from the same storm. Figure 31 contains two still images taken from the amateur video at the approximate moment of largest deflections of the two poles. A crude estimate of the top deflection appears consistent with calculations based on maximum stress measurements recorded on the monitored pole (i.e., ± 74 inches). Additionally, the pole on the left side of the figure shows an accumulation of snow. Ice accumulation was not reported by the monitoring system.

Figure 31. Images from cell phone footage showing deflection of two poles

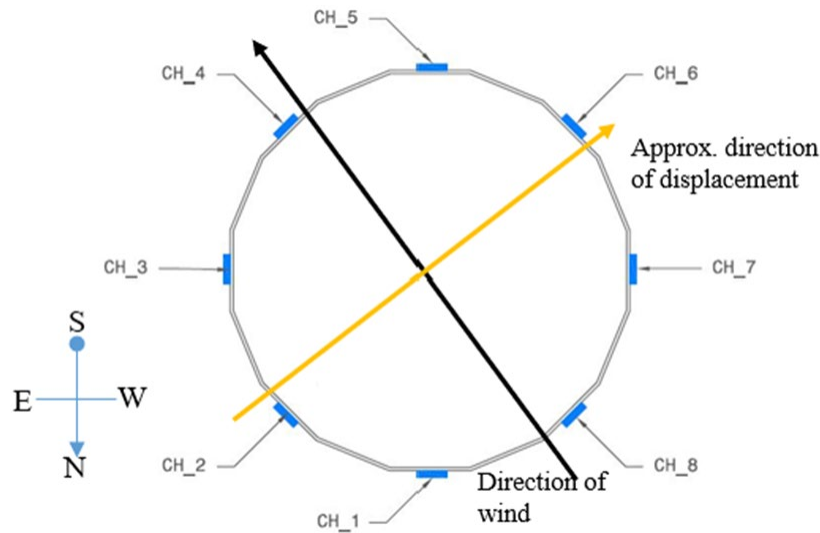
The pole was oscillating along the approximate axis between gages FG(2) and FG(6), as labeled in Figure 32 with the golden arrow. The arrow is meant only to approximate the direction of motion of the pole. Wind direction has also been labeled on the figure using a black arrow, which was taken from wind direction data recorded from the anemometer during the event. Figure 33 plots the entire data set captured for the March 29, 2022, event, which was initiated on a wind-40 trigger. This figure plots stress along the vertical left axis against the data time stamps on the horizontal axis. Data from one foil resistance strain gage, FG(6), are shown representing the largest stress ranges measured in the pole during this event. FG(6) was installed facing west-southwest. The wind speed has also been included in Figure 33 where it can be seen that wind speed varied 22 mph between the low of 29 mph and high of 51 mph. The average wind speed over this period was 37 mph, and the average direction was approximately 338 degrees, or a heading of south-southeast. Wind direction varied up and down a few degrees, remaining relatively consistent. The wind direction corresponded with the peak stress measurements in FG(2) and FG(6) for crosswind vibration. The vibration was across-wind motion at approximately 0.4 Hz, which matches the calculated mode I resonant frequency for Dwyer Junction, as reported in Phase 1. A calculation of tip displacement for the 28 ksi maximum stress is approximately ± 74 inches (or a full range of motion of 148 inches, which is equal to approximately 12 ft.).

Figure 32. Planview diagram of the large amplitude event at Dwyer Jct HMLT Jan 13, 2021

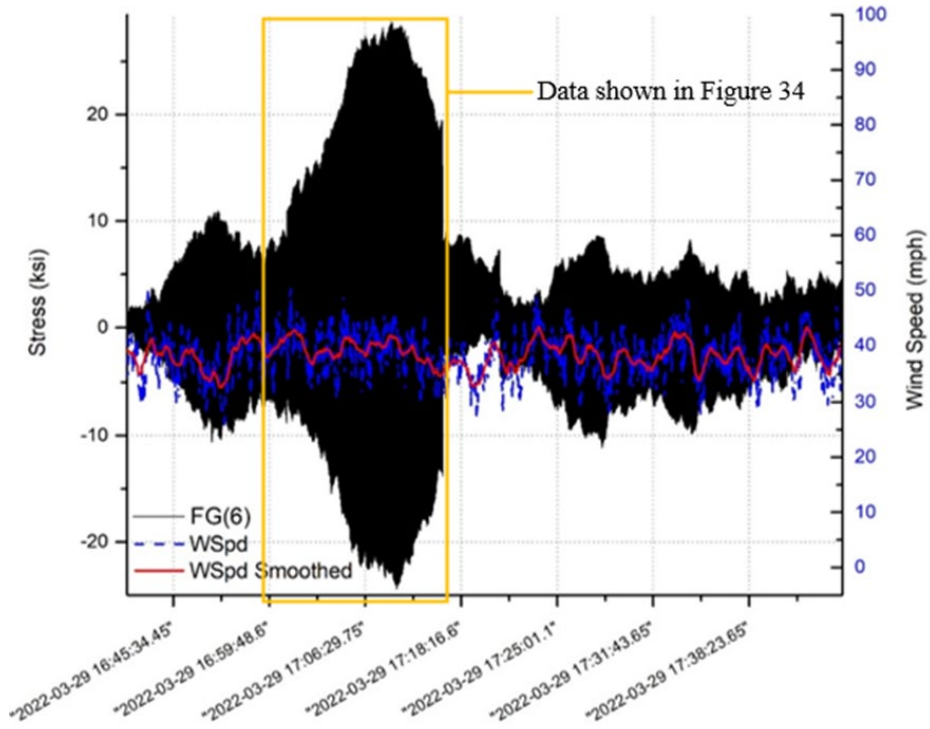
Figure 33 is nearly a continuous data set, with some minimal time gaps between trigger events. Several small chronological gaps in the data do exist. This is due to the parameters of the trigger programmed into the data logger combined with the frequency of 40 mph gust occurrences. As the event continued, the data logger would complete the required number of records for a single event before a logic test on buffered data sampling could trigger recording again. Thus, if the time that elapsed between the completion of a trigger record and a new trigger (i.e., another wind speed measurement greater than or equal to 40 mph) exceeded 10 seconds, a gap in the timeline would occur. This does not result in a significant loss of information but understanding this helps explain any abrupt changes in oscillations, such as can be seen at the end of the data set shown in Figure 34. Due to the density of the data at the scale plotted in Figure 34, a smaller subset of data are plotted in Figure 35. In this figure it can be seen that the maximum stress range measured for FG(6) was about 53 ksi (maximum stress of 28.7 ksi and minimum stress of -24.3 ksi). Additionally, at this plot scale it can be observed that the wind was relatively constant at about 40 mph, which is consistent with the measured average of 37 mph.

Figure 33. Stress-time data set for Dwyer Junction from March 29, 2022, storm

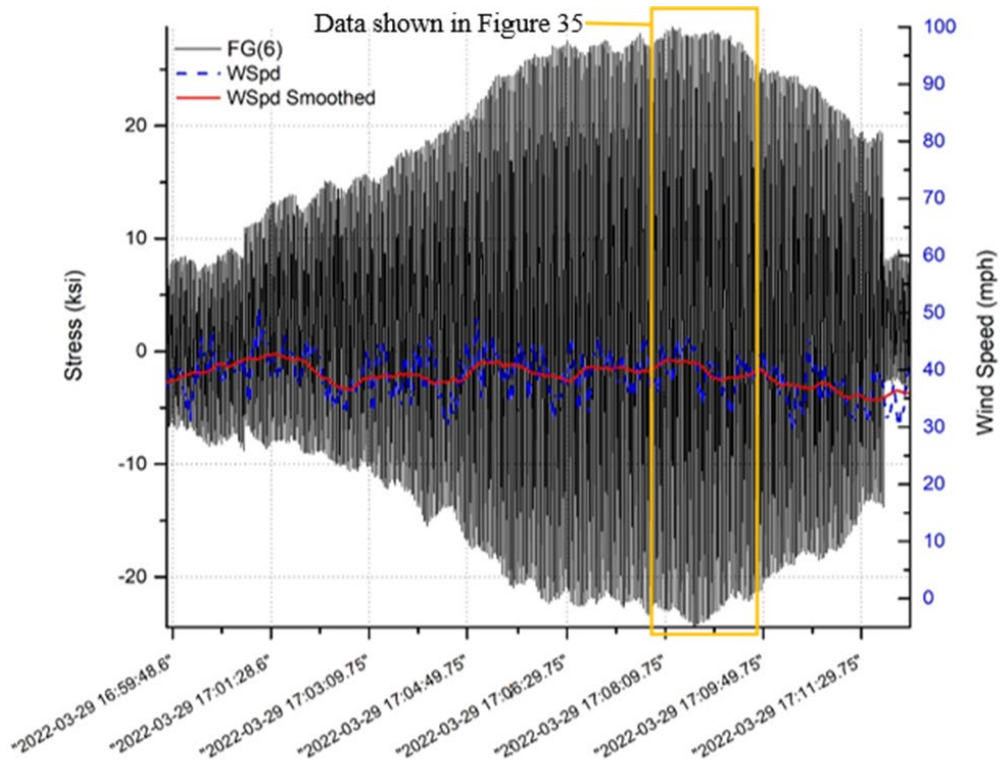
Figure 34. Large oscillation data set for Dwyer Junction captured a Wind-40 trigger

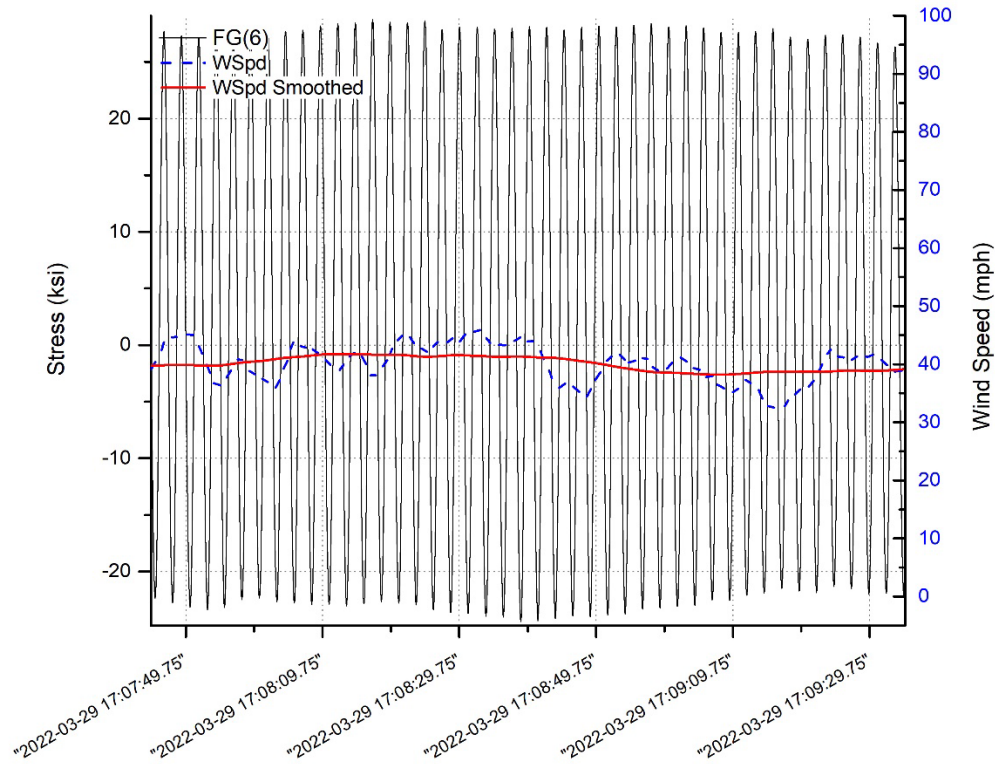
Figure 35. Zoom-in of large amplitude data for March 29 Dwyer Junction event
