**MPC 23-498** | H. Burns, E. Lawton, and P. Romero

FORENSIC EVALUATION  
OF GEOGRID-REINFORCED  
FLEXIBLE PAVEMENT  
SECTIONS ON SR-10 NEAR  
EMERY, UTAH

The purpose of this research project was to investigate and determine the reasons for premature deterioration of the geogrid-reinforced pavement system on the section of SR-10 between Muddy Creek and Emery, Utah.

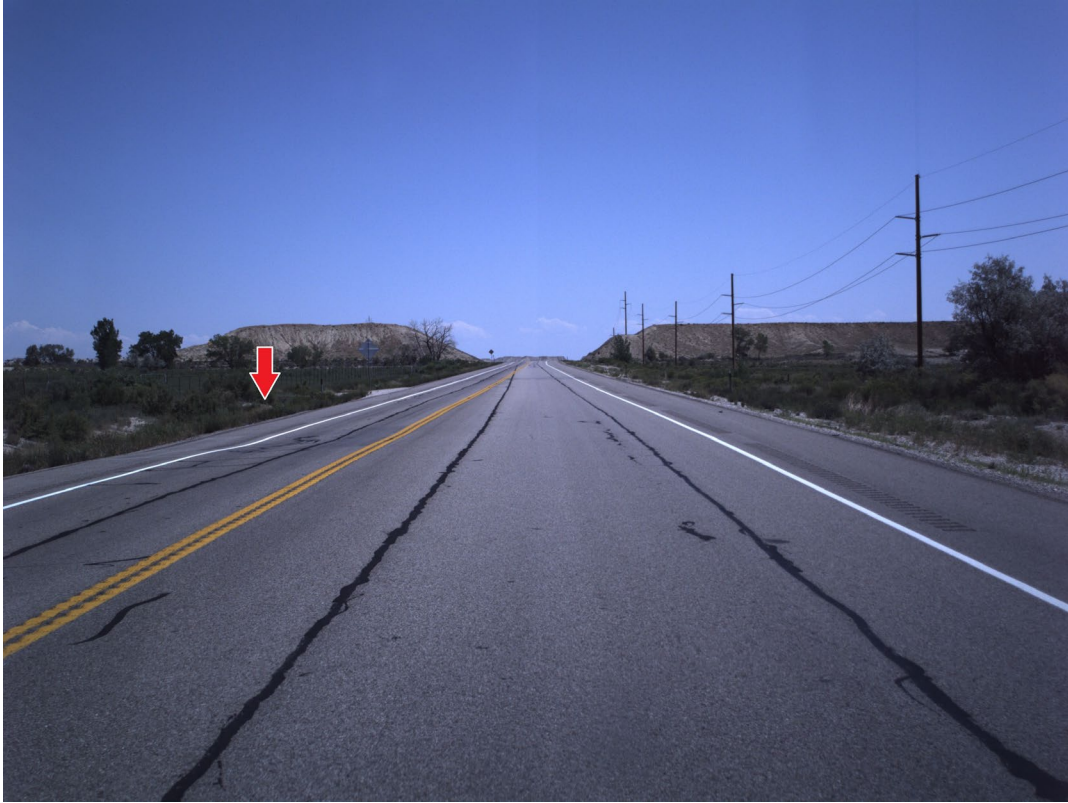
**Figure 1.1** Photograph Showing a Visible “Dip” in the Negative Direction of Travel as Indicated by the Red Arrow (Courtesy of UDOT/Mandli Communications)

In terms of the ride quality, the pavement system was in worse condition in the negative (southbound) direction compared with the positive (northbound) direction. The poor ride quality was observed during the first field visit, as well as a subsequent visit on July 5, 2019, to obtain samples of native soils that were likely used as fill material beneath the pavement system. Severe longitudinal surface deformations were noticeable when traveling in the negative direction at highway speeds. UDOT officials also highlighted the poor ride quality in the southbound lane. "Dips" of varying severity were present in the negative direction of travel. A longitudinal surface deformation is visible near the wheel-path closest to the shoulder on the left side of Figure 1.1, as indicated by the red arrow.

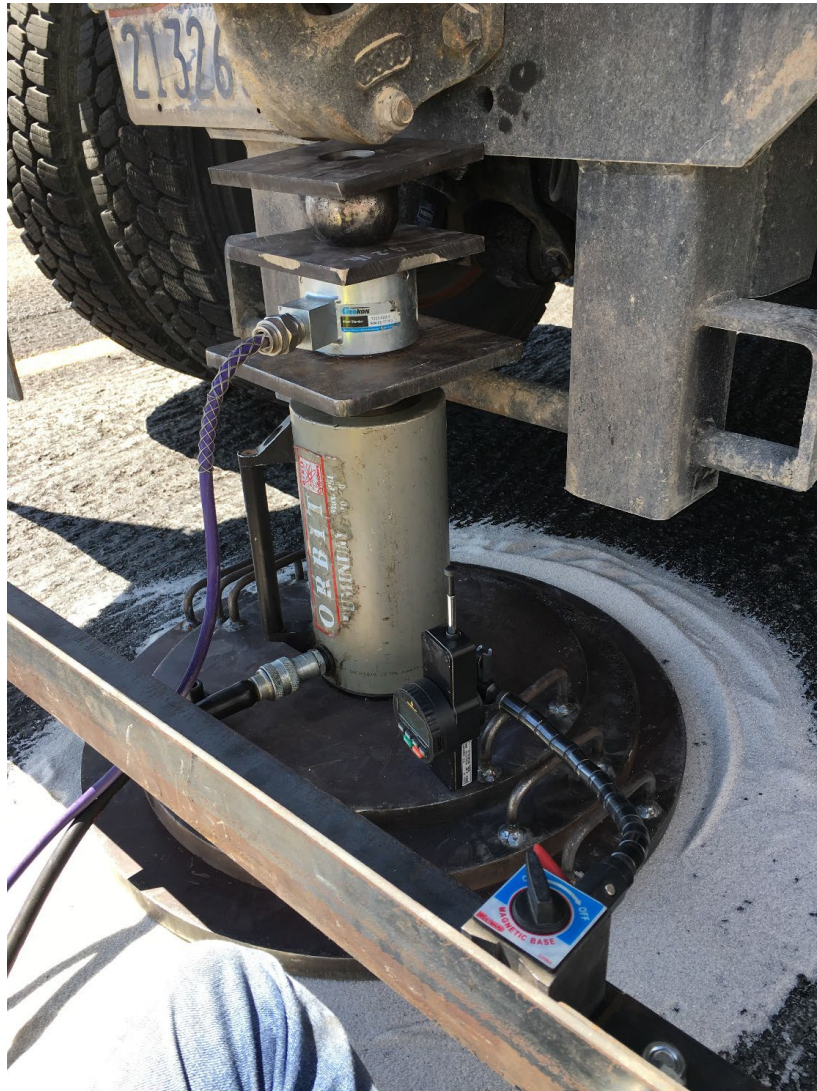
The Repetitive Static Plate Load Test (RSPLT) is a non-destructive test typically used to assess the bearing capacity of a pavement system or compacted fill. The test is carried out by loading a set of stacked steel plates with a diameter of 24 to 30 inches and measuring the deflection with either digital or analog dials. A 24-inch plate was used in this investigation with a combination of digital and analog dial gauges. The load was generated by jacking against a dump truck provided by UDOT. Ottawa sand was placed beneath the plate to create a uniform bearing pressure on the pavement surface. A picture of the

**Figure 2.2** Plate Load Test Setup

test setup is shown in Figure 2.2. The modulus of subgrade reaction can be determined by plotting a stress-displacement curve, as shown in Figure 2.3.

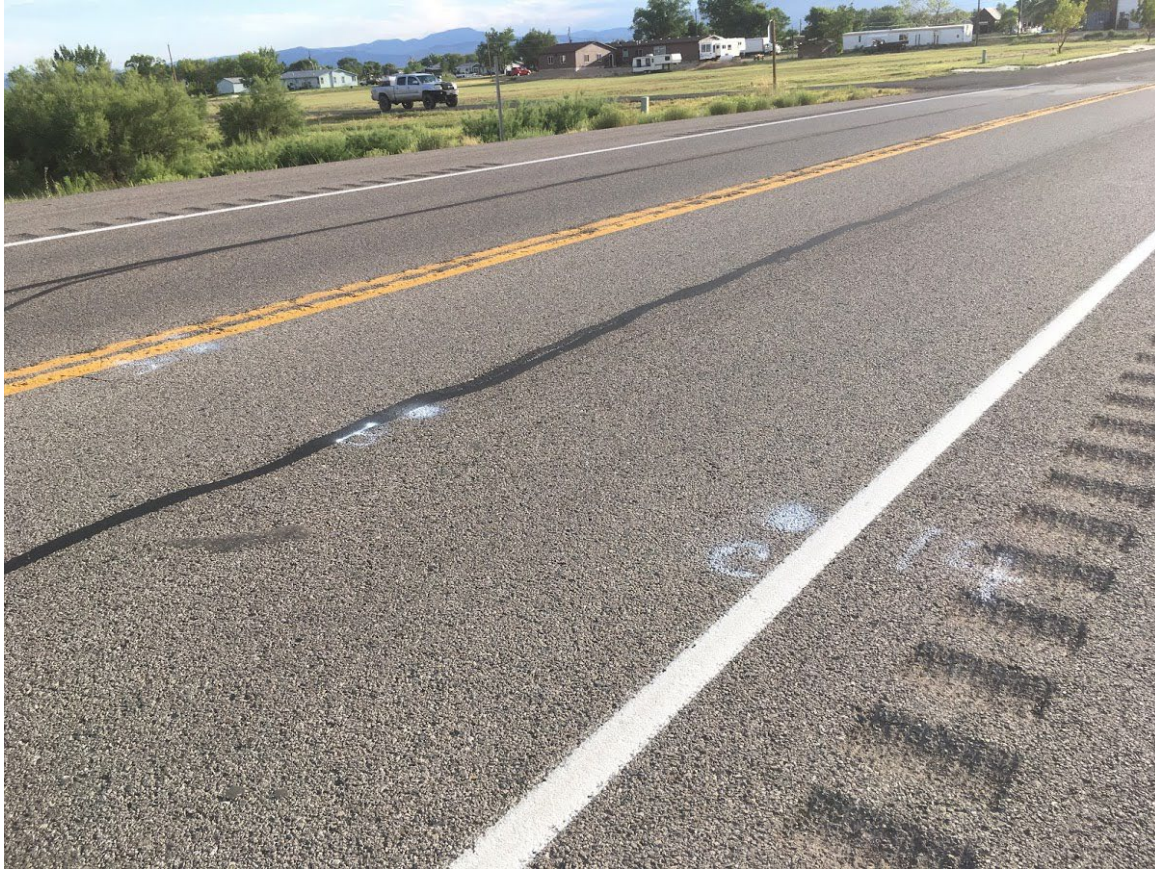
**Figure 2.8** Sampling Layout for All Locations

Asphalt-concrete cores were marked with a location number and letter indicating the location with respect to the transverse direction of the roadway.

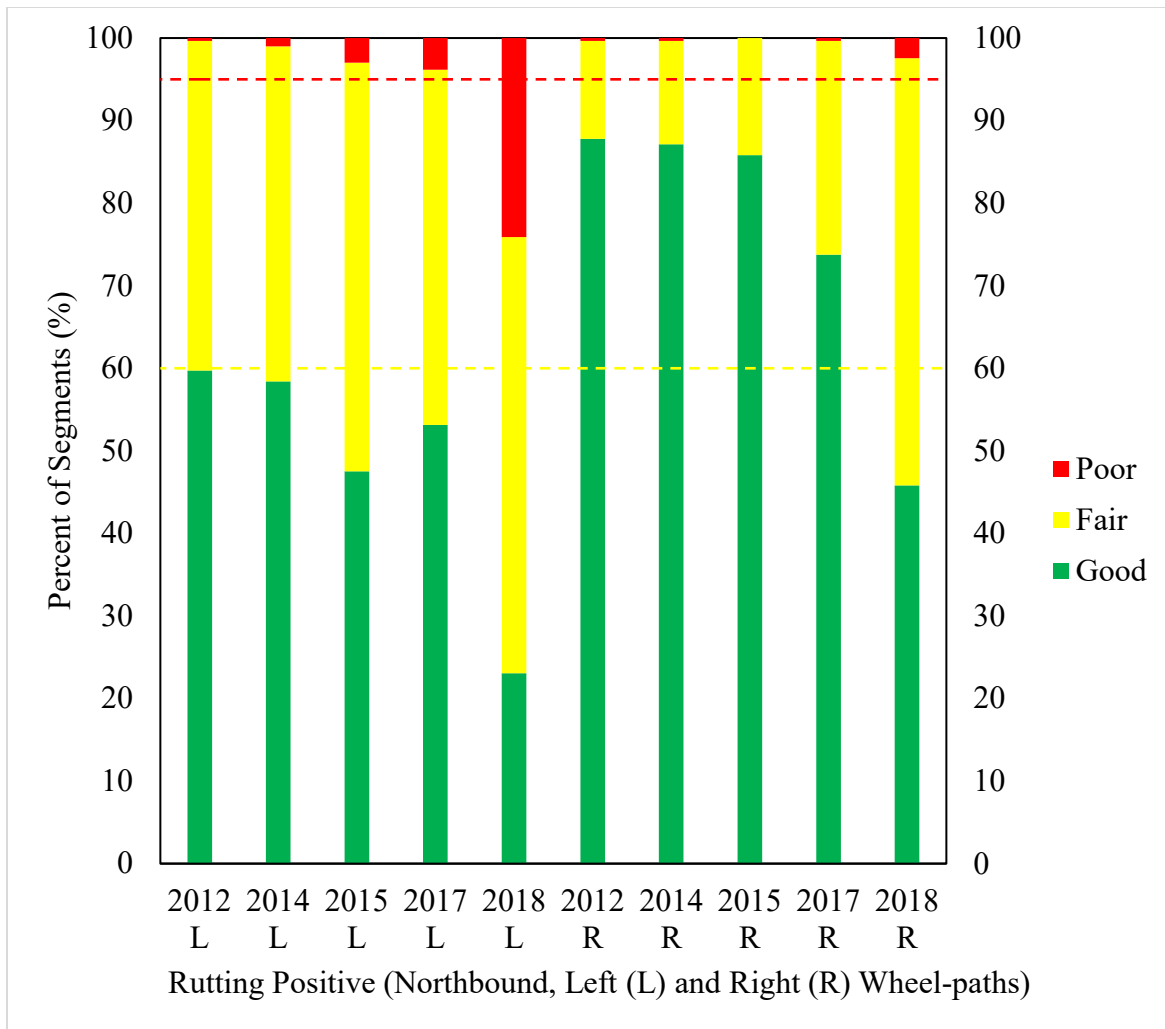
**Figure 3.8** Comparison of Right and Left Wheel-Path Rutting for the Positive Direction

The roadway plans show that the new alignment and lane widening required building most of the road over native subgrade and embankment fill. The rightmost side of the positive lane of travel was partially built over the existing roadway, while the rest of the roadway was built over native subgrade. The fact that the rightmost side of the positive direction was built over the existing alignment likely explains why the right wheel-path had less rutting than the left wheel-path in the positive direction. A similar trend is apparent by comparing each IRI wheel-path distress. In Figure 3.9, the distresses are displayed in the order of the wheel-paths, as they would appear in the up-station (positive, northbound) direction.

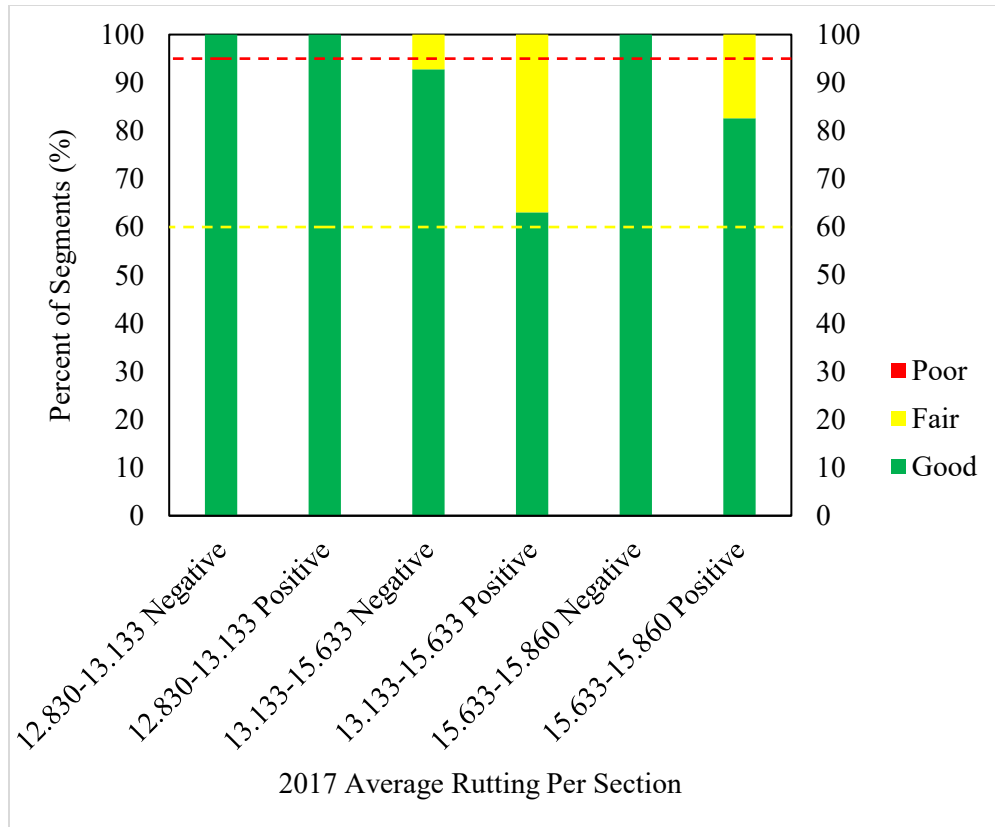
**Figure 4.5** Comparison of 2017 Negative and Positive Direction Rutting by Roadway Section

The section between mileposts 12.830 and 13.133 has performed better than the section between mileposts 13.133 and 15.633. This difference is likely because the first section was built over the old alignment while the second section was built on native subgrade or fills of varying depth composed of native soils. The section between 15.633 and 15.860 also appears to have been built on the old alignment but is performing worse than the test section. This difference may be because this section is the approach to the bridge at Muddy Creek.

The section of roadway that overlaps with the old alignment is approximately between mileposts 12.83 (Station 105) and 13.13 (Station 121) and between mileposts 15.63 (Station 253) and 15.86 (Station 265). In Figures 4.4 and 4.5, comparisons of distress ratings between the sections that overlap with the existing alignment and those that do not are provided.

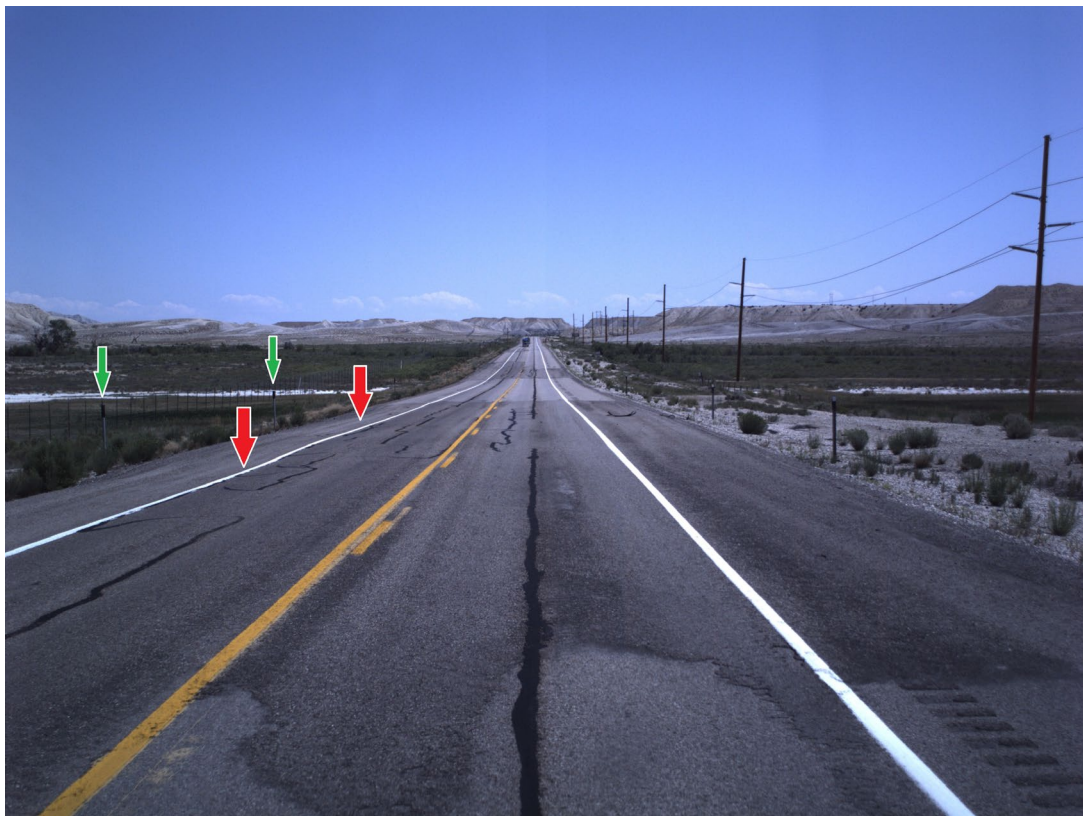
Without doing a hydrological analysis of the surrounding topography, the location of culverts can be used to indicate the presence of seasonal surface water flow. If culverts were not draining properly, it could lead to nearby embankment fill being saturated. The saturation of embankment fill could lead to wetting-induced volume changes, especially if the soil were fine-grained and cohesive. Additionally, it is possible that differential settlements would occur given that the granular backfill (UTBC) used around the culvert is less vulnerable to wetting-induced volume changes. Of particular importance are the spikes in IRI between mileposts 13.5 and 13.9, where cross-sections with deep embankment fill beneath the negative direction of travel were common. A photograph of a patch area with a visible IRI undulation in the negative direction of travel is provided in Figure 4.13. Note the presence of culvert markers next to the undulation.

**Figure 4.13** Photograph Looking Northbound (Positive Direction) of Patch Area with IRI Undulation in the Negative Direction of Travel Indicated by Red Arrows. Culvert Markers are Indicated by Green Arrows. (Courtesy of UDOT/Mandli Communications)

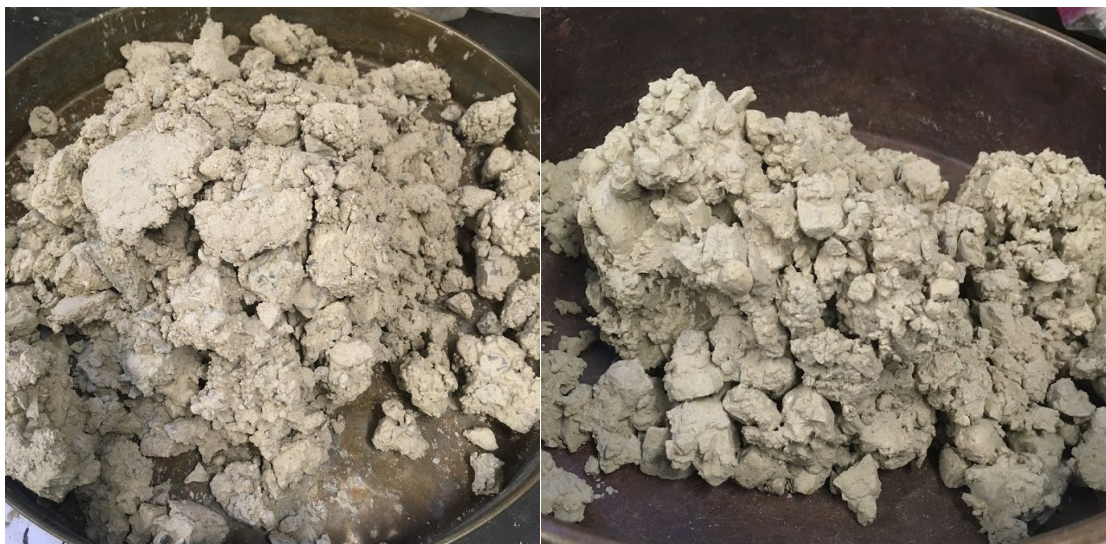
The presence of clay in the samples was noticeable after samples were air-dried in preparation for processing, as shown in Figure 5.1. A hammer was needed to break down the sample due to extensive bonding between cohesive and granular particles. The presence of plastic fines in the pavement system may be attributed to one or more of the following factors:

- Plastic fines not screened out at the source (gravel pit).
- Plastic fines introduced into the pavement system during the construction phase by, for example, driving heavy equipment over inadequately compacted layers, thereby churning the GB into the subgrade.
- Inadequate control of the UTBC and GB stockpiles to prevent contamination with other soils, or mixing of the UTBC or GB with subgrade soils during placement
- Plastic fines migrated into the pavement system during the service life.

**Figure 5.1** Air-Dried Samples of UTBC from Location 7 and GB from Location 8, Respectively.

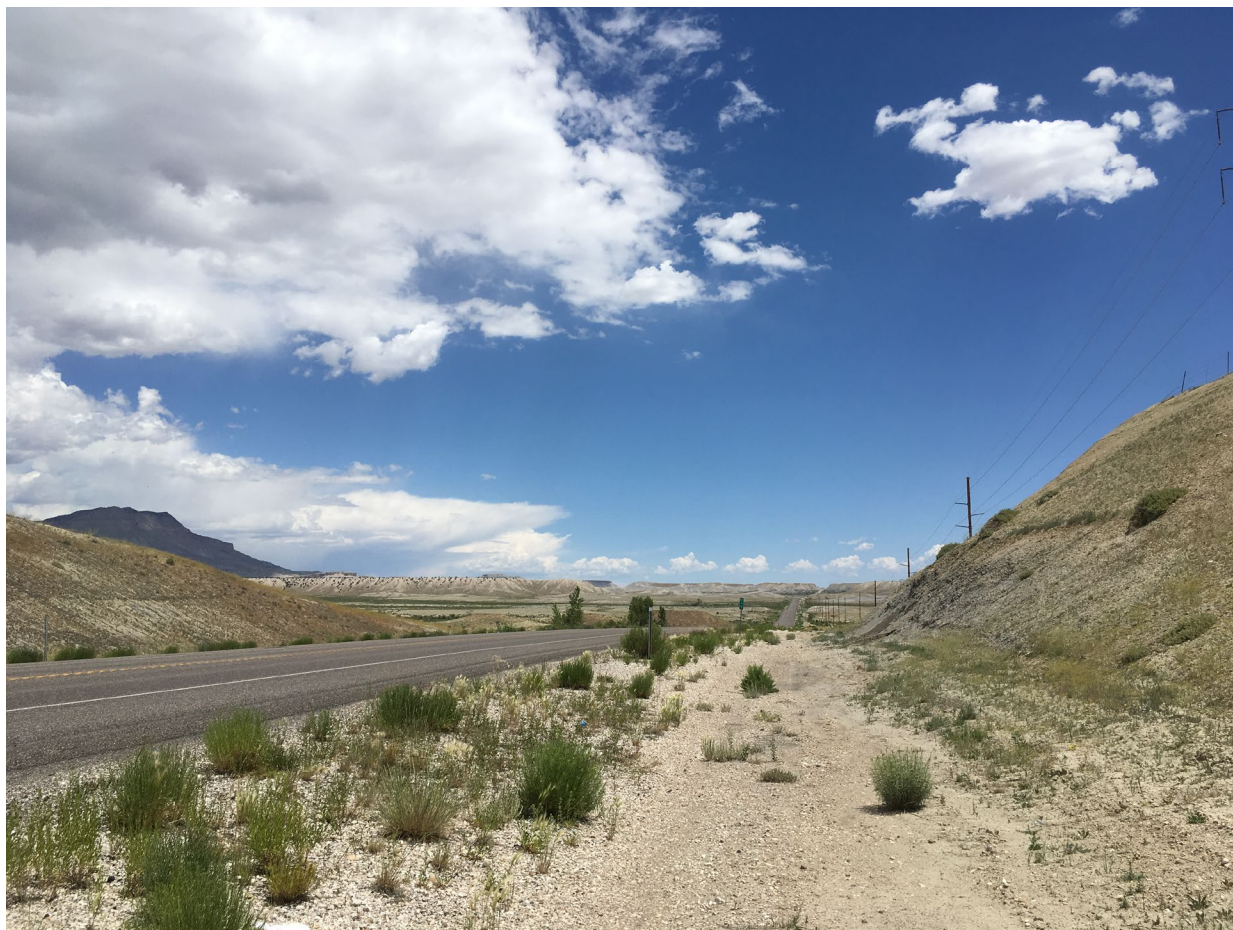
Sampling was carried out at two primary locations. TP-1 was located at milepost 14.012. TP-2 was located at milepost 14.707. Both sampling locations were done in cut areas, as shown in Figure 5.5. The photograph in Figure 5.5 was taken at the sampling location of TP-1, which was close to field test Location 6. TP-2 was taken from a cut section adjacent to field test Locations 3 and 4, as shown in Figure 5.6.

**Figure 5.5** Photograph of Sampling Location for TP-1

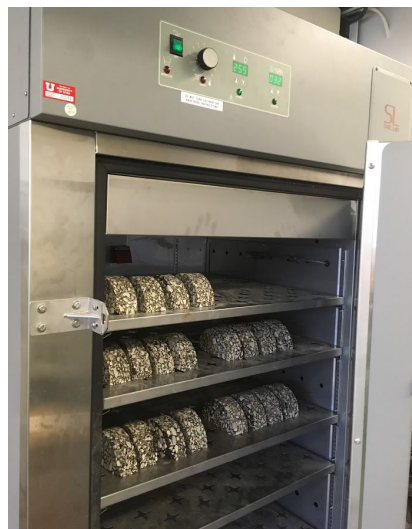
Each 50-mm puck was cut exactly in half to produce two half-disc specimens each, for a total of four specimens to be tested per sample. A 15-mm (+/- 1 mm) notch was cut down the middle of each half-disc specimen. The geometry of each specimen was recorded by measuring the radius, thickness, and length of the notch. Each specimen was cured in an environmental chamber at the standard testing temperature of 25°C (77 °F) for 24 hours before testing, as shown in Figure 5.12.

**Figure 5.12** Half-Disc Specimens Curing in the Environmental Chamber
