# **Performance of Asphalt Concrete Crack Sealants in South Dakota**

**SD2016-03  
Final Report**

**Prepared by:  
Damon Fick  
Western Transportation Institute  
Montana State University**

**October 31, 2020**

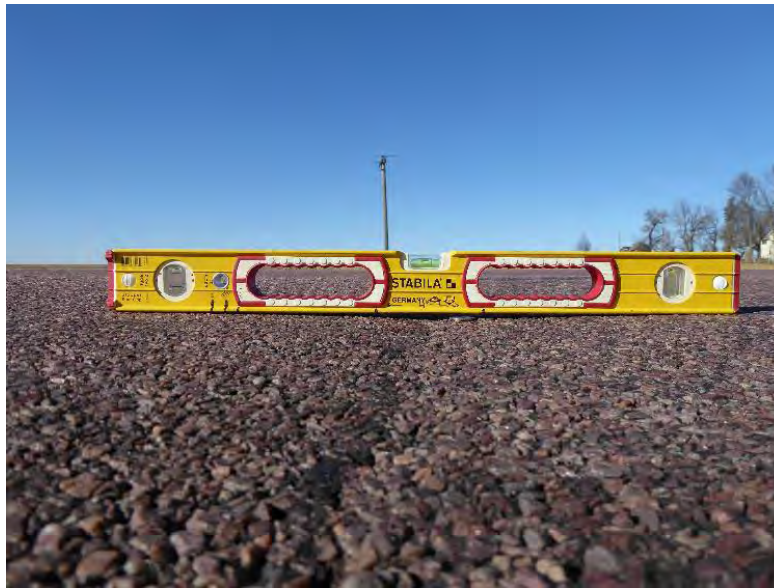
**Figure 4 Evidence of subsidence near the crack, Highway 11 – winter 2016.**

Photos during the winter reveal full adhesion failures along the sidewalls of many of the sealed cracks. In some cases, the unsealed gap was greater than  $\frac{3}{4}$  in. wide (MRM100, 102). In most of the cracks, the sealant did not seem to stretch at all as the gap widened with cooler temperatures. The asphalt in the area is approximately 10-12 years old. Based on personal conversations with Mr. Vandam, there were water issues during the installation process. Specifically, water was being held in the pore structure of the pavements and coming up from the bottom of the crack, making it difficult to dry them out prior to installation of the sealant. Part of this pavement was fog sealed in 2016. Subsidence of the cracked area was evident in many of the cracks. An example of this subsidence is shown in Figure 4.

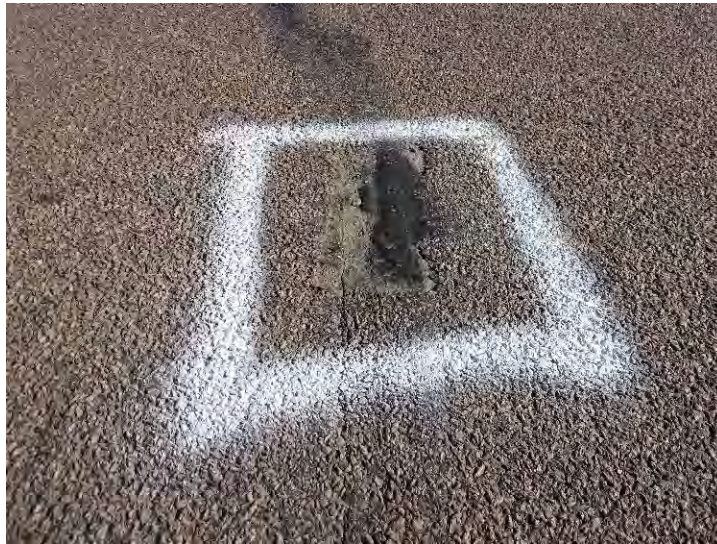
**Figure 7 Exposed crack sealant on HWY 13, MRM 110 – winter 2016**

cracking. A site visit during winter 2016 after chip sealing showed cracking in many areas through the chip seal. It is unknown whether the cracking extends through the underlying crack sealant. SDDOT maintenance personnel had recently re-sealed some of the cracks in this area.

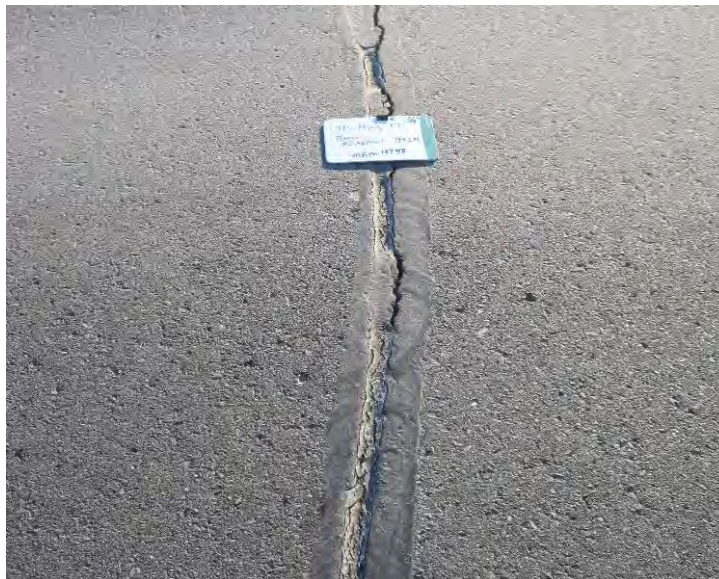
**Figure 8 Crack sealant on Highway 17, MRM 47.48 – winter 2013.**

distress, although there is also evidence of cohesive failure in the sealant surface (example shown in Figure 8 ). The photos also indicate that there was extensive movement of the pavement at these locations (more than a half inch in some locations). This site was not visited during winter 2016.

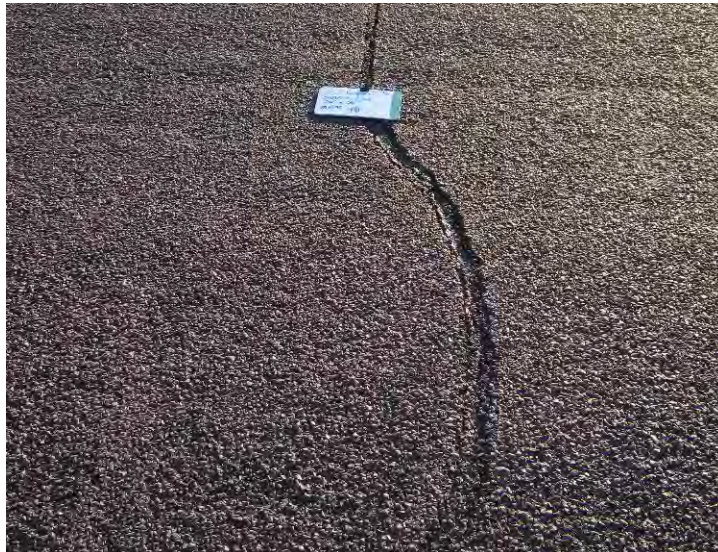
**Figure 12 Recession of the crack reservoir on Highway 81, MRM 98 – winter 2013.**

Failures in Crafc0 522 at this location indicate recession of the sealant in the reservoir (refer to Figure 12). There is also a lot of adhesive failures at this location that extend into the crack sealant and not just in the chip seal. Many areas experienced double adhesion failures where the crack sealant failed along both sides of the reservoir. A representative photo of the typical distresses at this location is shown in Figure 13.

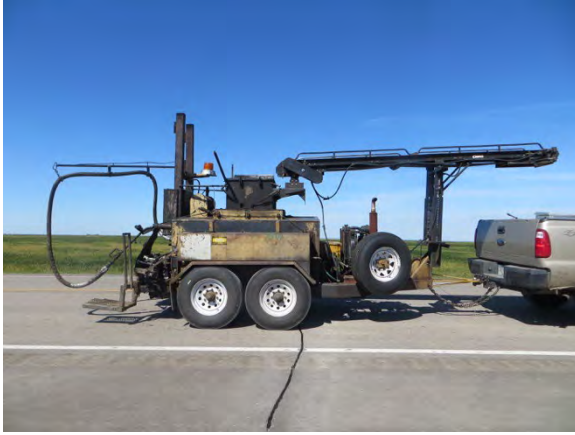
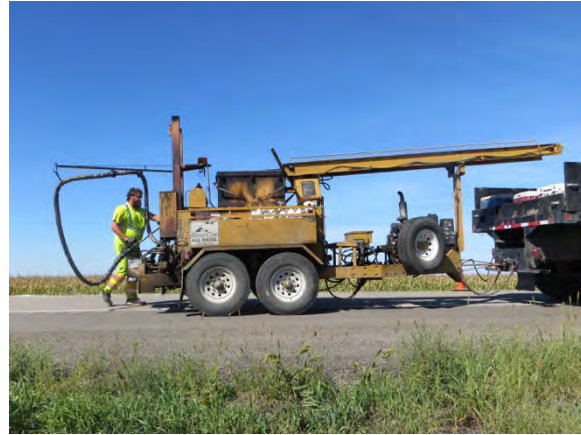
**Figure 18 Kettles used by Asphalt Technologies Corp. for heating and installing crack sealants**

Asphalt Surface Technologies Corp. (ASTECH), Saint Joseph, MN, performed all crack routing, cleaning, and sealant installations for both the Highmore and Yankton sites on 9/6/2017 and 9/7/2017, respectively. Approximately 500 to 700 lbs. of each sealant (Figure 17) were installed at each test section. The installations at both sites were performed in a continuous manner, beginning with Test Section 1 (Figure 16), progressing to Test Section 2, through Test Section 8 using a single kettle for each test section. Two kettles were used by ASTECH so that material could be heated while a different crack sealant material was placed with the other kettle which are shown in Figure 18. Crafco Co, Inc. provided their own kettle that distributes material on demand (no recirculation) for the installation of Crafco products and is shown in Figure 19.

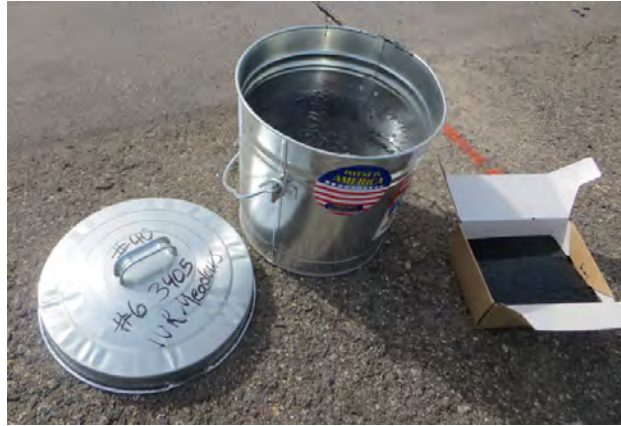
**Figure 20 Material samples taken at approximately midpoint of test sections**

infrared thermometer. Temperatures at the wand while filling the sample containers and pavement temperatures for each test section were recorded and are shown in Table 12.

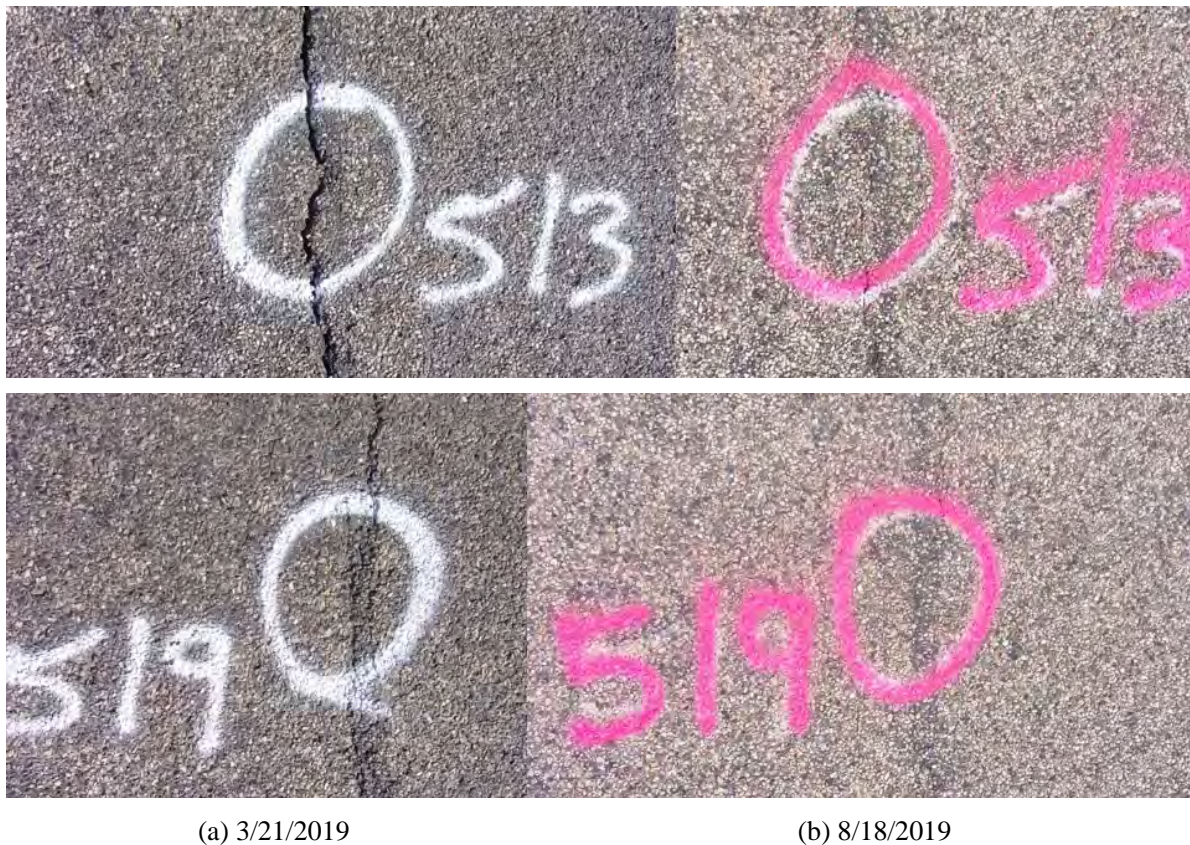
**Figure 25 Observed crack sealant condition during winter (a) and summer (b) inspections.**

The winter inspections (Table 14) provided the most revealing signs of sealant distress due to the pavement contraction, requiring the sealant to span a larger routed reservoir width. Representative differences in observable distress for two crack locations during winter (3/21/19) and summer (8/18/19) inspections are shown in Figure 25. Additional comparison photographs for the two winter inspections and summer inspection for the same crack at each test section at both test sites are included in Appendix E.

As shown in Figure 25 and Appendix E, sealant distress during the winter inspections are much more visible during the winter inspections, however confidently reporting these failures as adhesion, cohesion, or secondary cracking is not possible after the surface has been chip-sealed. An example of secondary cracking and cohesion failures observed during the winter inspection on 2/10/18 that become less apparent during the following year after chip-sealing is shown in Figure 26. The same areas of distress are identified next to the failure with a red line.

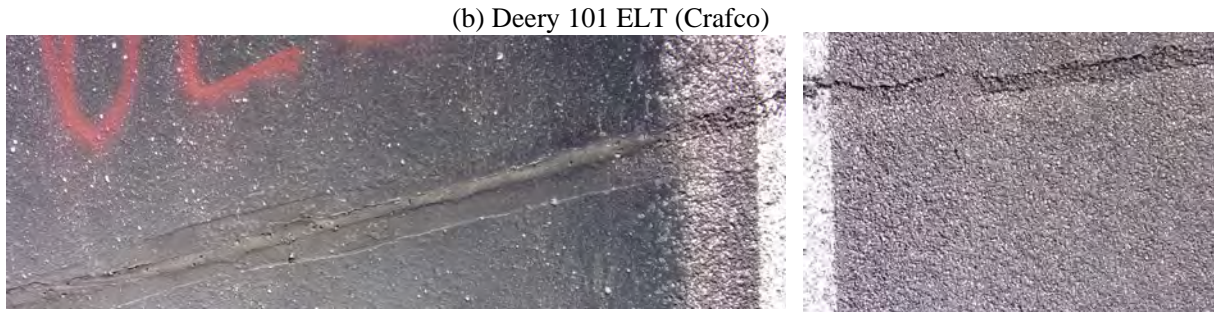
(c) Mod 4 3405 (Right Pointe)

From Appendix H, the three most significant adhesion failure/minor cracking sealant distresses were selected and are shown in Figure 35. The examples shown are not the most severe levels of adhesion failures or cracking observed at either test site. Without confidently knowing the penetration of the observed chip sealant distress, it is difficult to assess the sealants performance with and without the chip seal from the shoulder observations. The comparison photos in Figure 35, do however suggest the sealant extension is distributed over the routed reservoir dimension and are not concentrated at the edges of the reservoir and shown schematically in Figure 33.
