# **Development of Alternative Bridge Superstructures for South Dakota Local Roads**

**Study SD2014-14**

**Final Report**

**Prepared by**  
**South Dakota State University**  
**Brookings, SD 57007**

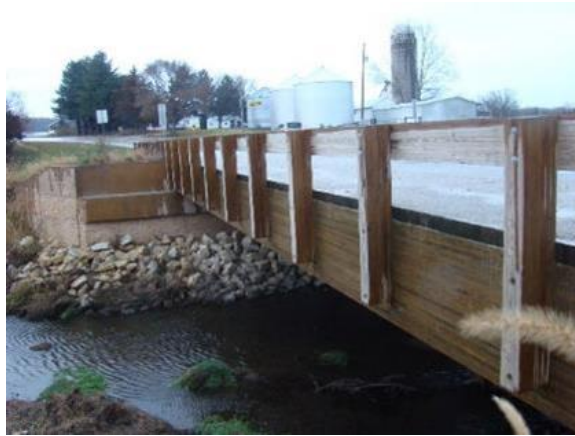
**Figure 5.16: Glulam Timber Bridge in Buchanan County, Iowa**

Glulam timber bridges (Figure 5.16) are constructed of glulam members manufactured from lumber laminations that are bonded together on their wide faces with waterproof structural adhesives. According to Ritter (1990), glulam is the most common material used for the fabrication of timber bridges because glulam members can be manufactured to any size and shape. In general, the span length of glulam bridges ranges from 20 to 80 ft, but construction of longer bridges with span lengths of 140 ft or longer is possible (Ritter, 1990). Important design and construction considerations such as design method, wearing surfaces, railing systems, and abutments are discussed in the following sections.

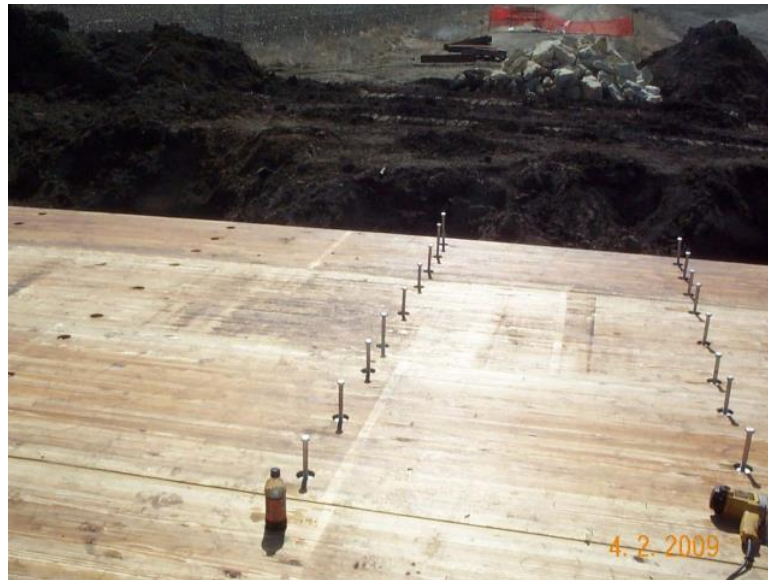
**Figure 5.21: Lag Bolt Deck-to-Stringer Connection for Timber Bridges**  
(after Hosteng, 2013)

Currently two methods are primarily used to connect deck panels to stringers. One method is to install lag bolts from the top of the deck through the entire panel into the top of the beam (Figure 5.21). One of the disadvantages of using lag bolts is their large size, requiring field boring for installation. Since it is impractical to drill lag bolt holes before the pressure treatment of the lumber, the bridge is more susceptible to decay due to water penetration. Furthermore, it is not possible to retighten these bolts if they loosen since the wearing surface will cover them.

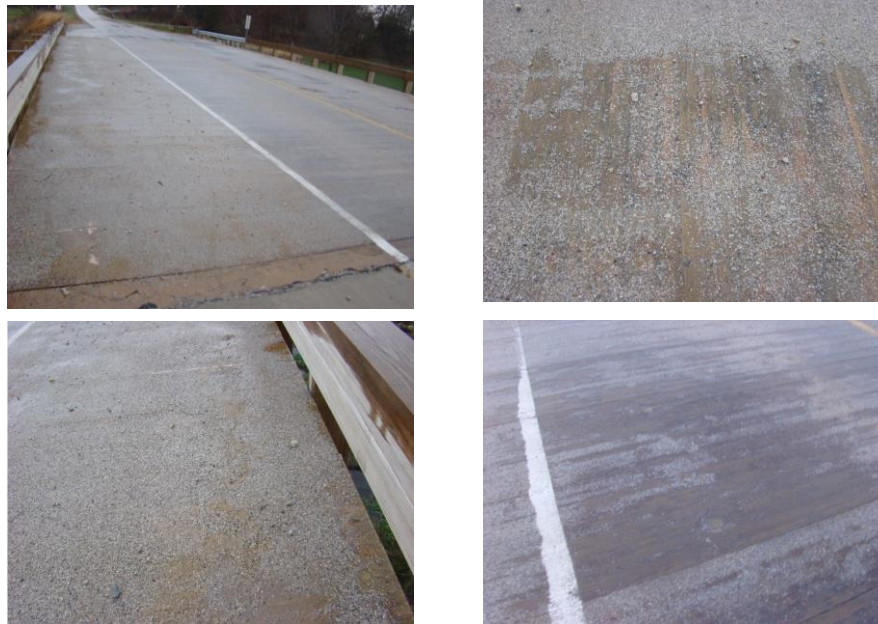
**Figure 5.29: Epoxy with Embedded Grit Wearing Surface for Glulam Timber Bridge in Buchanan County, Iowa**

A new wearing surface was recently used on the Cedar Rock Bridge in Buchanan County, Iowa (Figure 5.29). The bridge deck was flooded with epoxy to fill all the gaps in the wood. Then very small rocks were imbedded into the epoxy to improve traction. The epoxy is typically applied in three layers of 3/8-in thickness each. The life of the epoxy depends on its exposure. This wearing surface was applied in 2015, too recent for full performance evaluation.

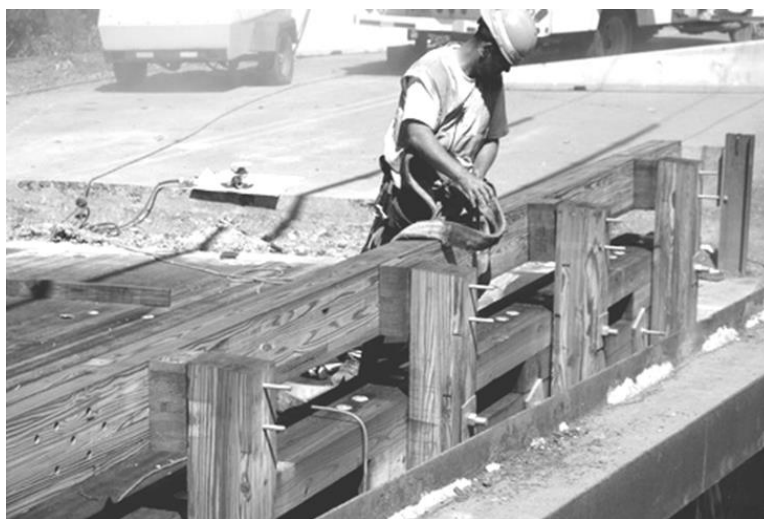
**Figure 5.30: Railing on a Glulam Bridge**  
(after laminatedconcepts.com)

A bridge railing system must be positioned to safely contain an impacting vehicle without allowing it to pass over, under, or through the rail elements. A proper railing system must be free of features that may catch on the vehicle or cause it to overturn or decelerate too rapidly. Any crash-tested railing configuration or any railing designed according to Section 13.7 of AASHTO LRFD (2013) can be used for timber bridges. The connecting components should be designed adequately. The rail material can be timber, metal, or concrete. One example of a timber railing is shown in Figure 5.30.

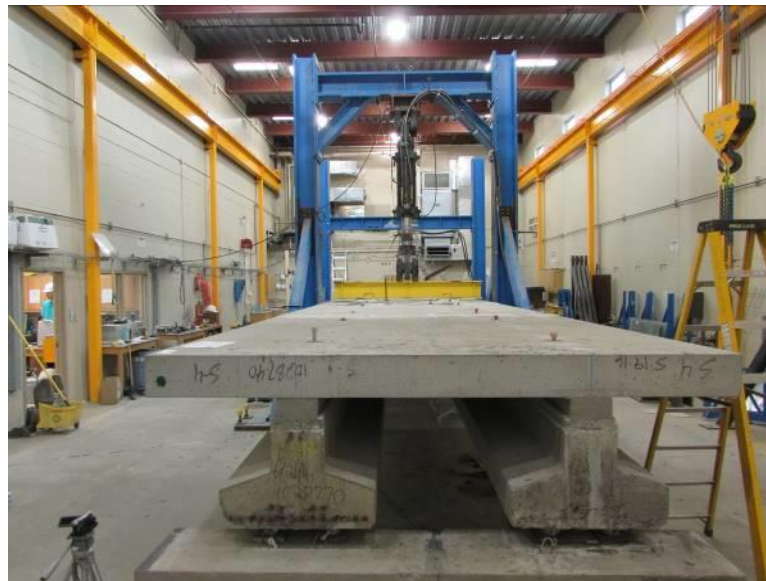
**Figure 6.16: Ultimate Test Setup for the Precast Bridge Specimen**

After the completion of the fatigue testing, an ultimate test was conducted using a 328-kip actuator. A W12x93 steel beam was used to spread the load over the two girder centerlines at the mid-span to avoid punching shear failure of the deck. Figure 6.16 shows the test setup for the strength test.

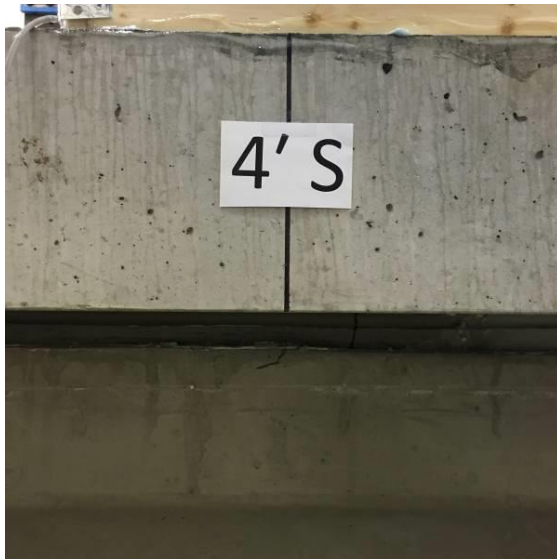
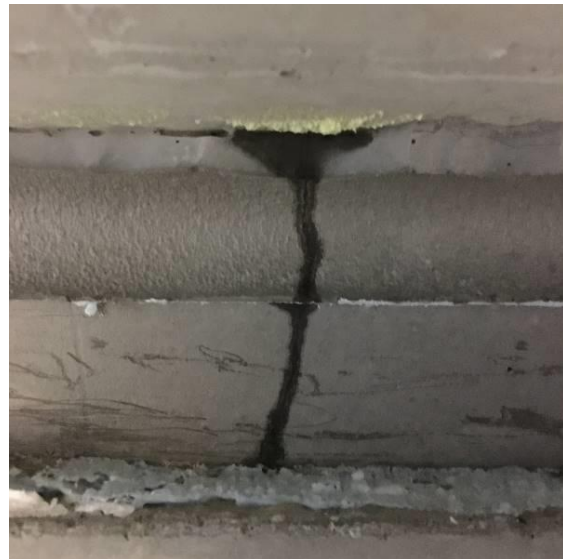
(a) Observed Crack at 25,000-Load Cycle

(b) Close Up of Crack

joints. One of the water ponds was on the top of this joint. Since (1) the crack width did not change over the entire fatigue test (Figure 6.19), (2) the pond did not lose water from this leak, and (3) this joint was the last joint filled with LMC (LMC sets in approximately 30 min.), it was concluded that the leak was because of construction issues but not structural degradation due to fatigue. Furthermore, there was no change in bridge overall stiffness due to this crack.

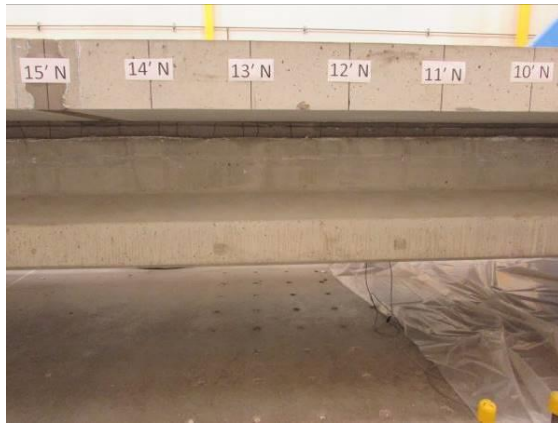
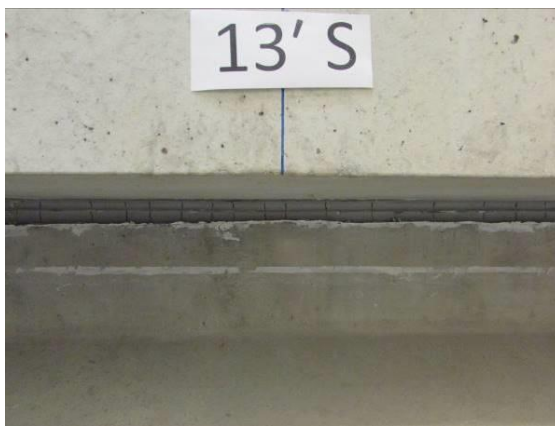
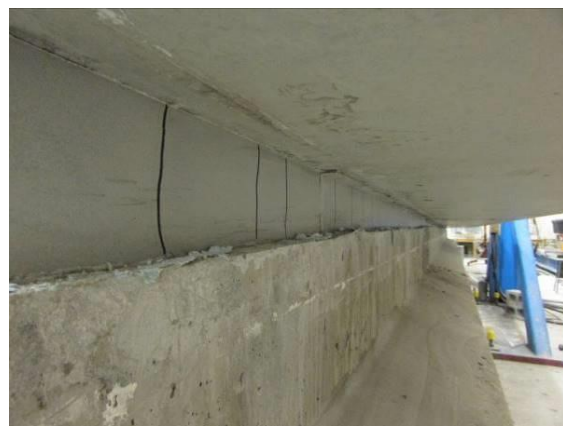
(a) Shrinkage Cracks in Haunch Region of Girder A Filled with Latex Modified Concrete

(b) Close Up of Girder A Haunch Region Filled with Latex Modified Concrete

(c) Shrinkage Cracks in Haunch Region of Girder B Filled with Non-Shrink Grout

(d) Close Up of Girder B Haunch Region Filled with Non-Shrink Grout

At 125,000 load cycles, which corresponds to 22.8 years of service, vertical hairline cracks were observed along the length of the grouted haunch of both girders approximately evenly spaced between 2 in. to 4 in. (Figure 6.20). Both the conventional non-shrink grout and the latex modified concrete exhibited vertical hairline cracking in the haunch area. Since the haunch region was in compression, it was concluded that these cracks were mainly shrinkage not flexural. Most likely, the fatigue loads made these shrinkage cracks wider and visible at this load cycle.

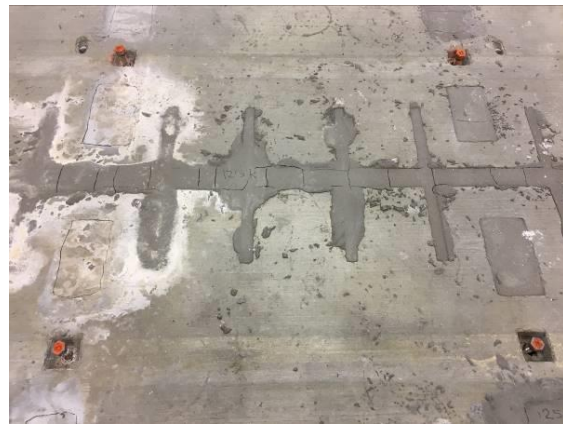
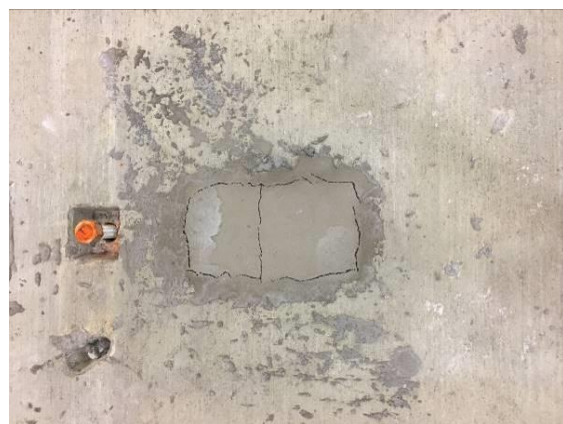
(a) Latex Modified Concrete at 125,000 Cycle

(b) Latex Modified Concrete at 650,000 Cycle

(c) Latex Modified Concrete at 125,000 Cycle

(d) Latex Modified Concrete at 650,000 Cycle

Also, hairline shallow cracks were observed in all transverse joints (Figure 6.21) and most shear pockets (Figure 6.22). Since (1) water did not leak through these cracks, (2) the crack width did not increase over time, and (3) there was no change in the bridge overall stiffness, it was concluded that these hairline cracks were caused by shrinkage, not fatigue loading.

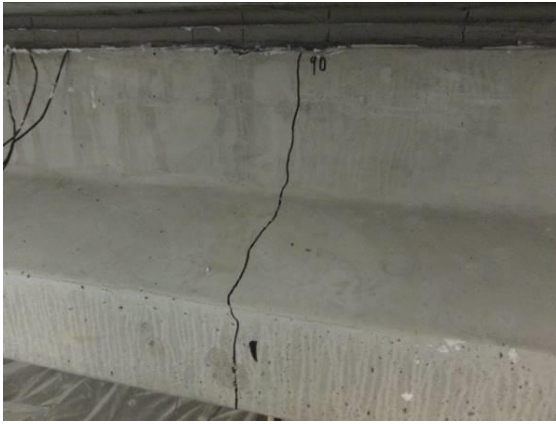
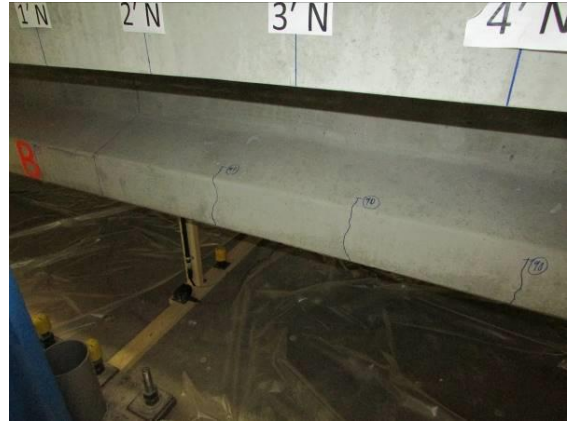
(a) First Crack, Mid-span of Girder A at P = 251 kips

(b) First Crack, Mid-span of Girder B at P = 251 kips

The first crack in the girder was observed at the mid-span at an actuator load of 149 kips (Figure 6.33a). Subsequently, more cracks were developed on both girders close to the mid-span at higher loads as shown in Figure 6.33b to Figure 6.33d.

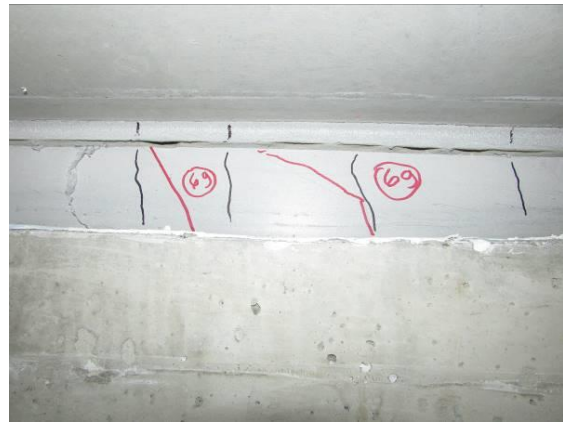
(a) 14-ft North of Mid-span (Girder A)

(b) 14-ft South of Mid-span (Girder A)

The first horizontal shear crack in the grouted haunch region of the precast bridge (Figure 6.34) was observed at an actuator load of 200 kips, which corresponds to a girder load of approximately 100 kips. However, horizontal shear stud strain gauge data suggests that cracking occurred at lower loads. Additional shear cracks appeared at an actuator load of 226 kips (Figure 6.35). Note that shear cracks did not form under an equivalent Strength I Limit State load for this bridge, which was 131.4 kips, indicating that the shear reinforcement detailing was sufficient.

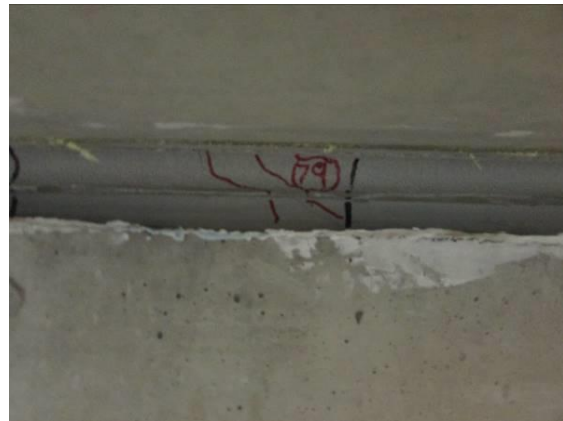
(b) 14-ft South of Mid-span (Girder B)

**Figure 6.35: Haunch Region Horizontal Shear Cracks at an Actuator Load of 226 kips During Strength Testing of the Precast Bridge Specimen**

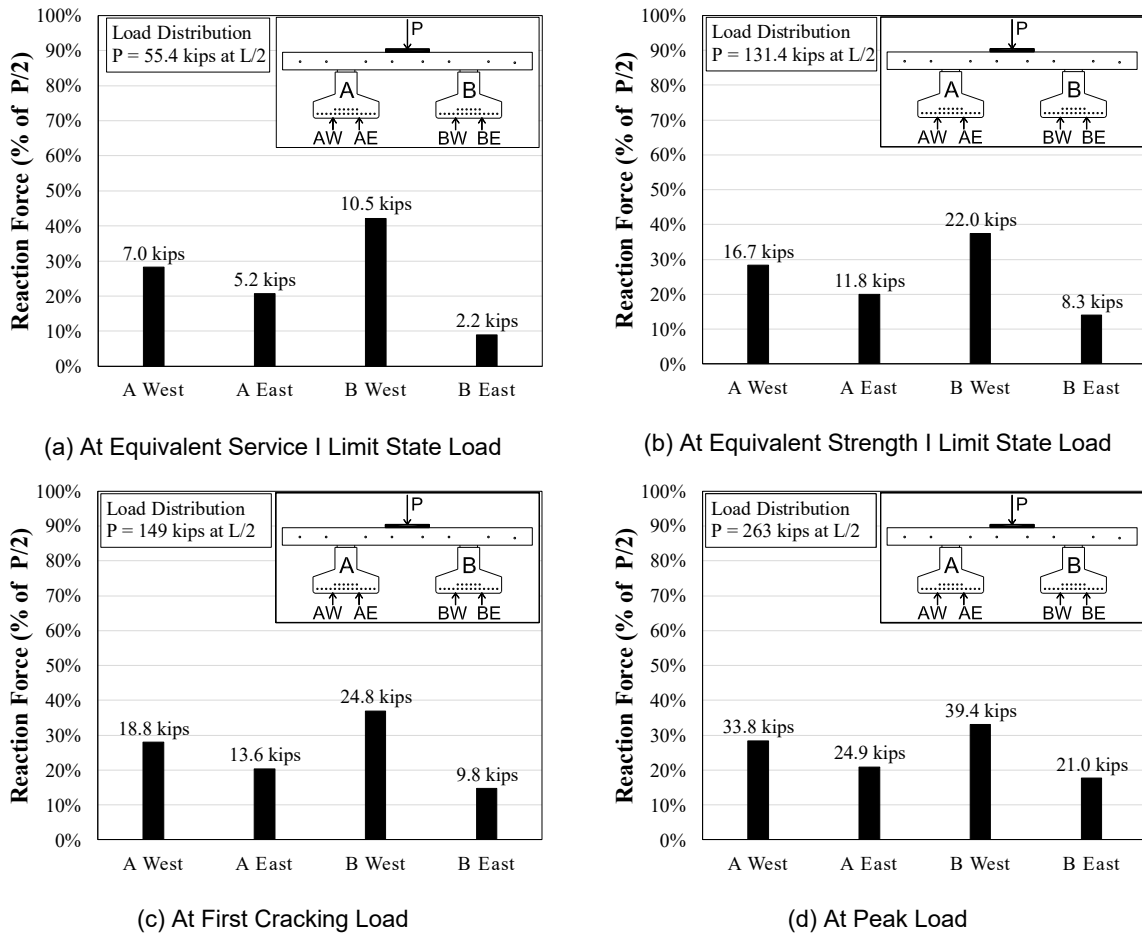
**Figure 6.37: Measured Girder End Reactions Under Strength Testing of the Precast Bridge Specimen**

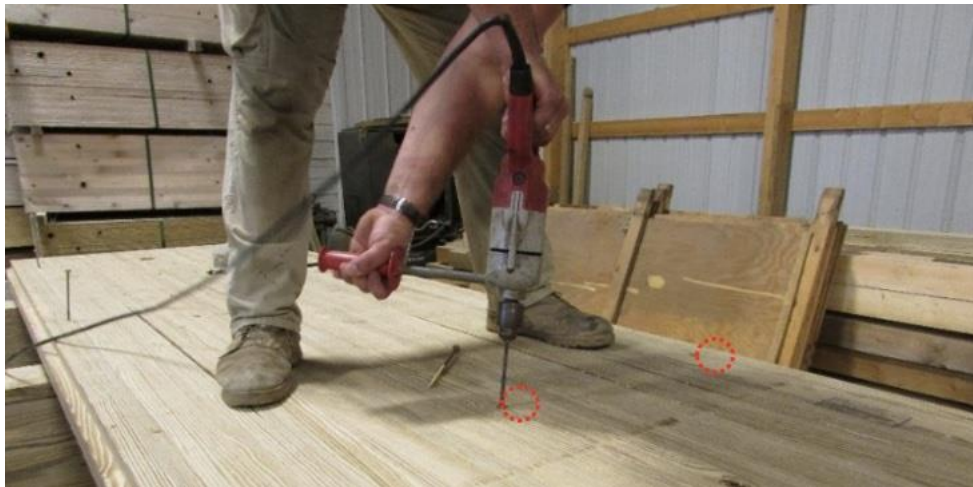
**Figure A.13: Deck-to-Girder Connections for Glulam Timber Girder Bridges**

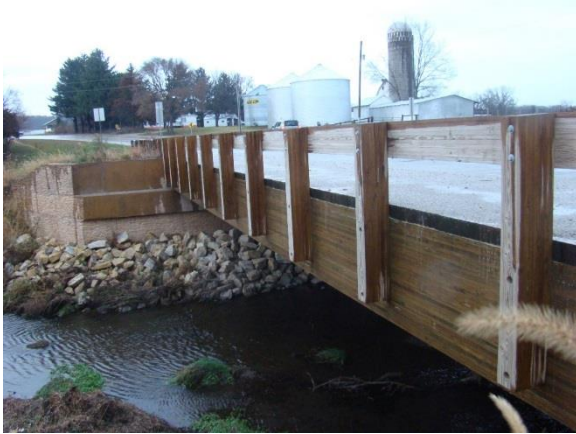
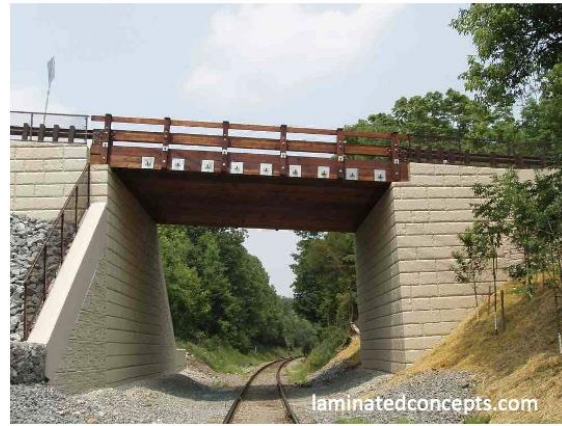
**Figure A.16: Timber Railing for Timber Bridges**

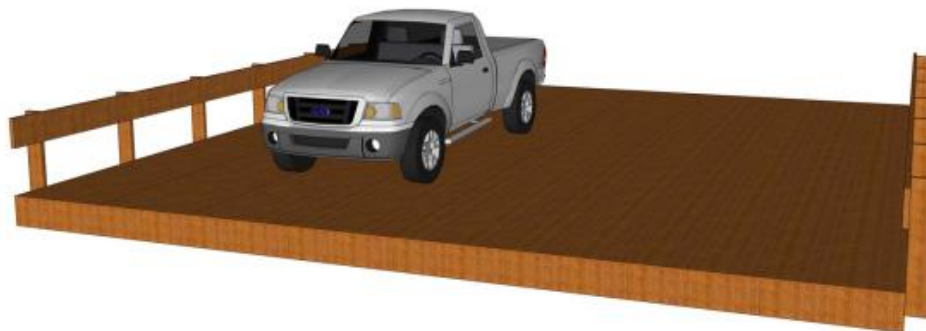
Figure A.18: Typical Glulam Timber Slab Bridge
