DEPARTMENT OF TRANSPORTATION

# Data Management, Mining, and Inference for Bridge Monitoring

FINAL REPORT

University of Pittsburgh

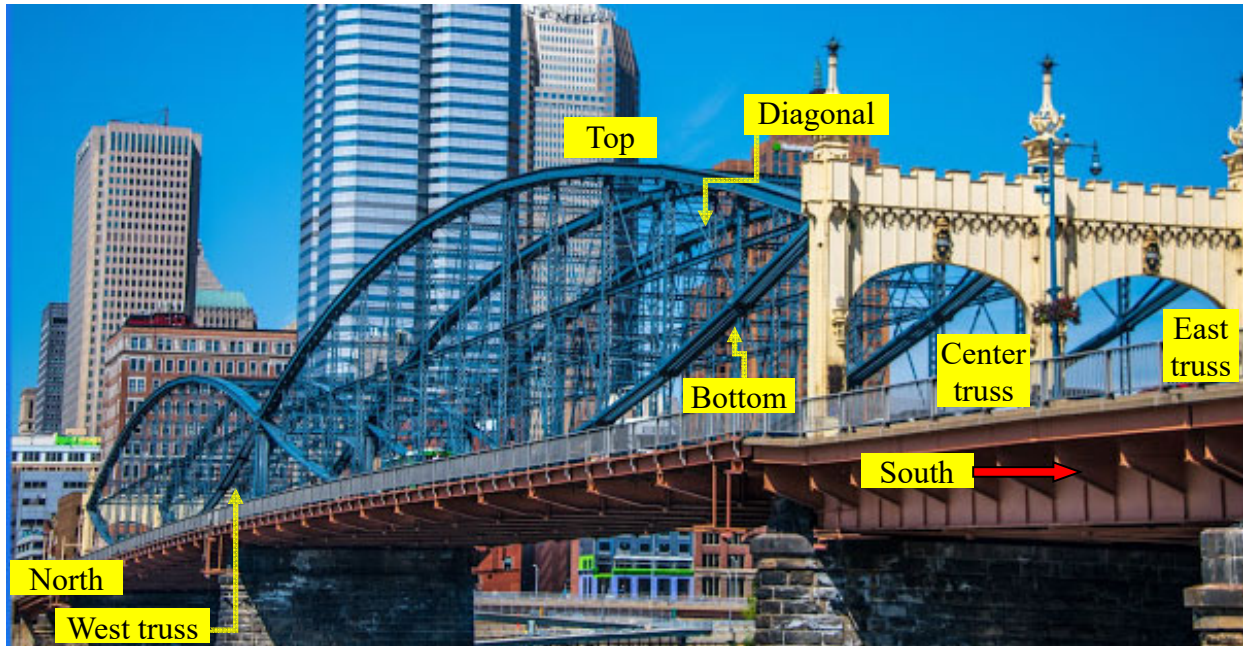
**Fig. 3.4** – The Smithfield bridge with directions and nomenclature. Span 3 is in the far end (North side).

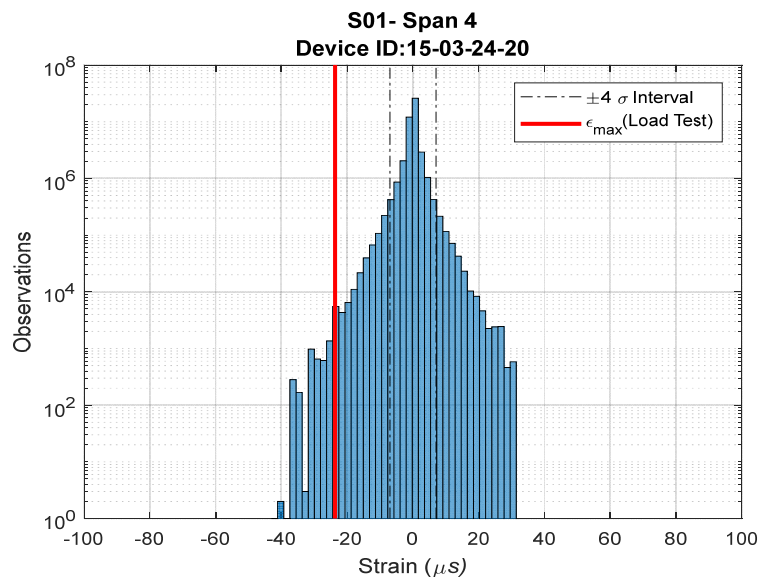
Fig. 4.6 – Example of counting the number of occurrences by computing how many times a certain strain was observed. The vertical red line represents the maximum value recorded by the given strain sensor during the truck load test. The dashed vertical lines bound the  $\pm 4\sigma$  interval. The strain in question was measured from one of the strain gages mounted on the Smithfield Bridge and the monitoring period in question spanned for 12 months, from 08/01/2019 to 07/31/2020.

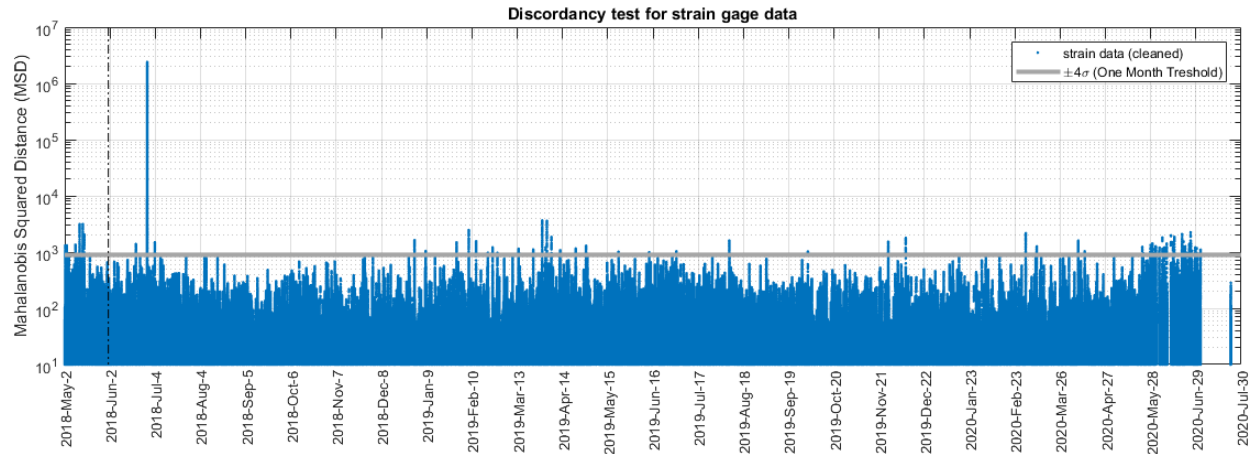
**Fig. 4.7** – Example of outlier analysis applied to true strain data collected from the 30 gages of the Somerset Bridge.

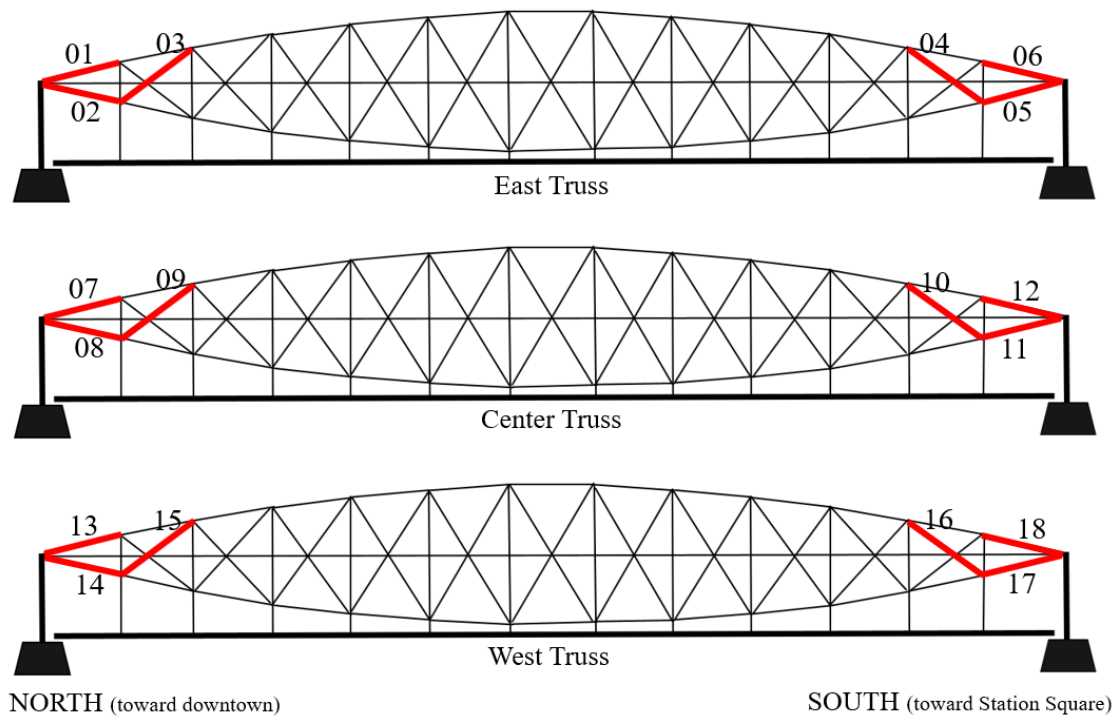
**Fig. 5.3** – Drawings of the East, Center and West trusses. The members instrumented with a wireless strain gage are labeled according to the gage number.

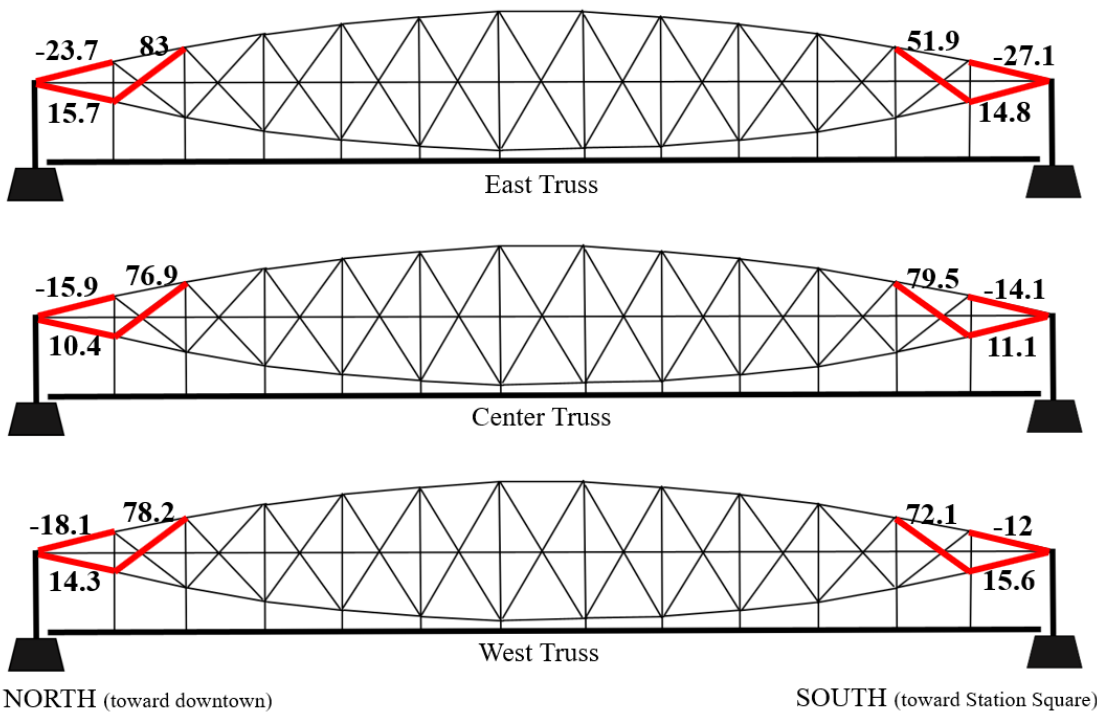
**Fig. 5.4** – Maximum strain increase during the truck test recorded at each of the instrumented members. Note that the sensors on the East truss face west, whereas the gages on the Center and West truss face east. The values are expressed in microstrains.

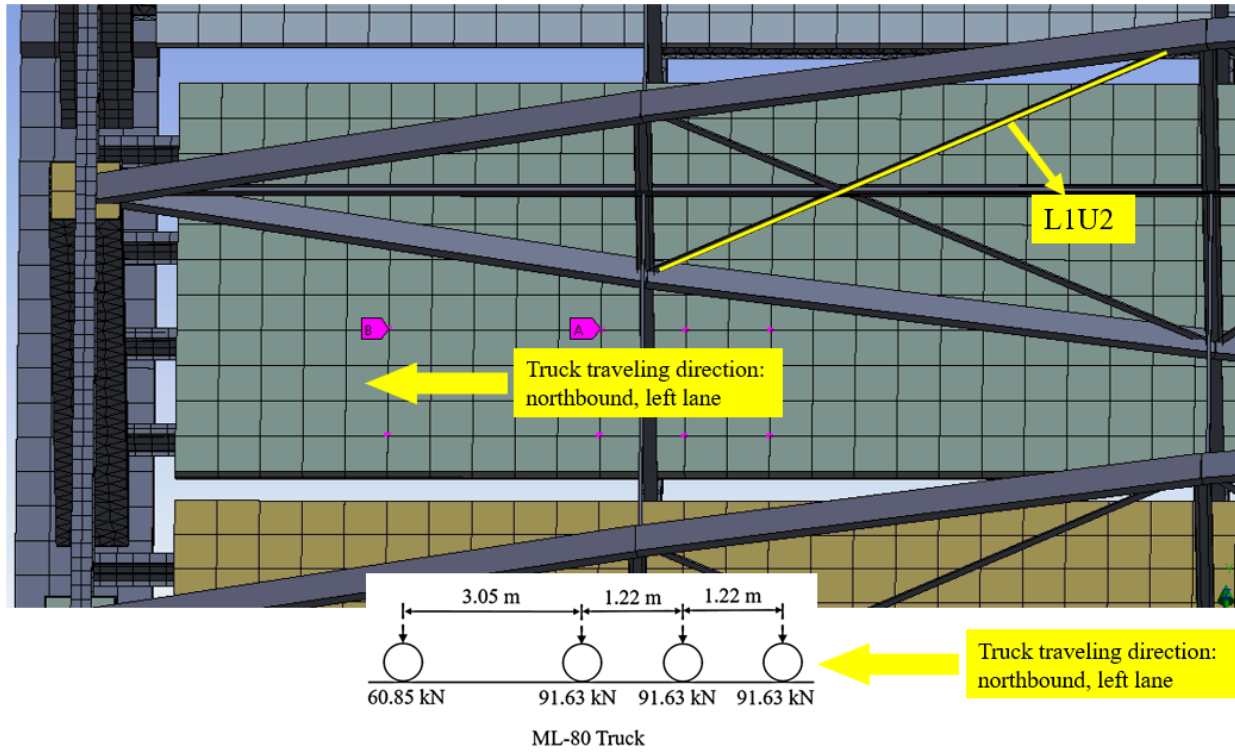
**Fig. 5.7** – Numerical setup relative to the analysis of the ML-80 AASHTO truck. The pink dots locate the position of the truck wheels.

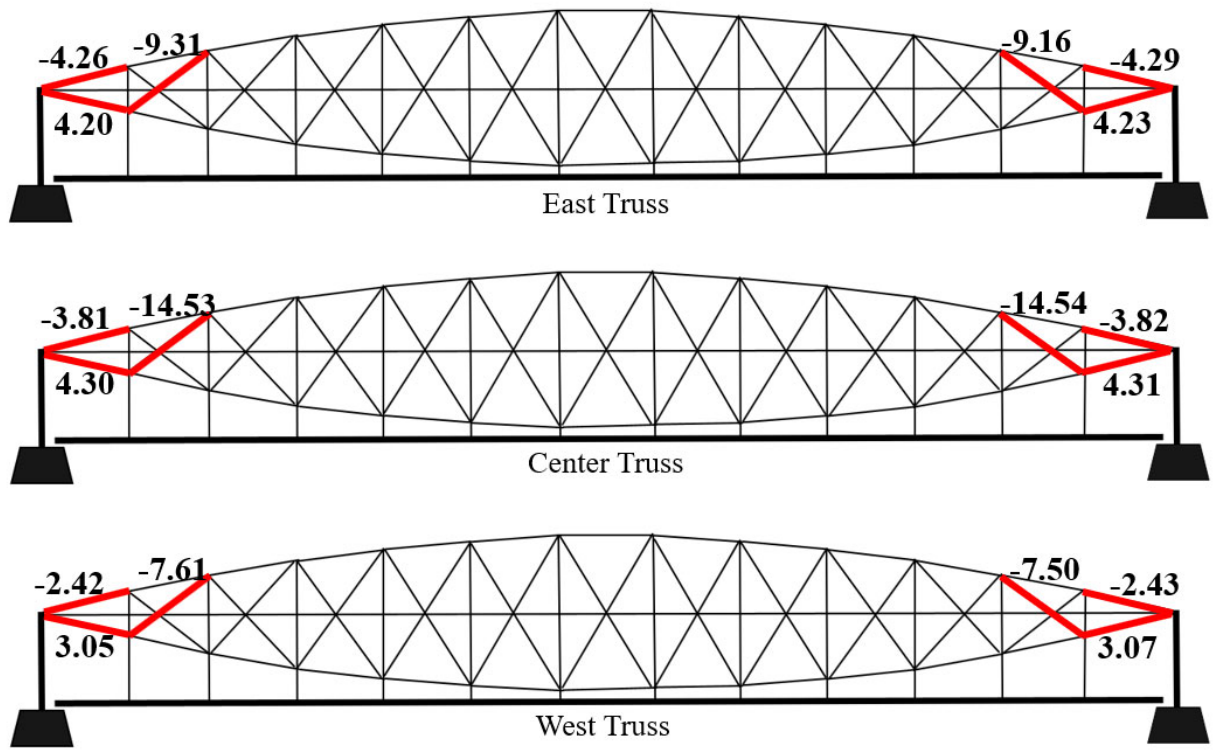
Fig. 5.8 – Numerical strains due to a simulated symmetric load. The values are expressed in microstrains.

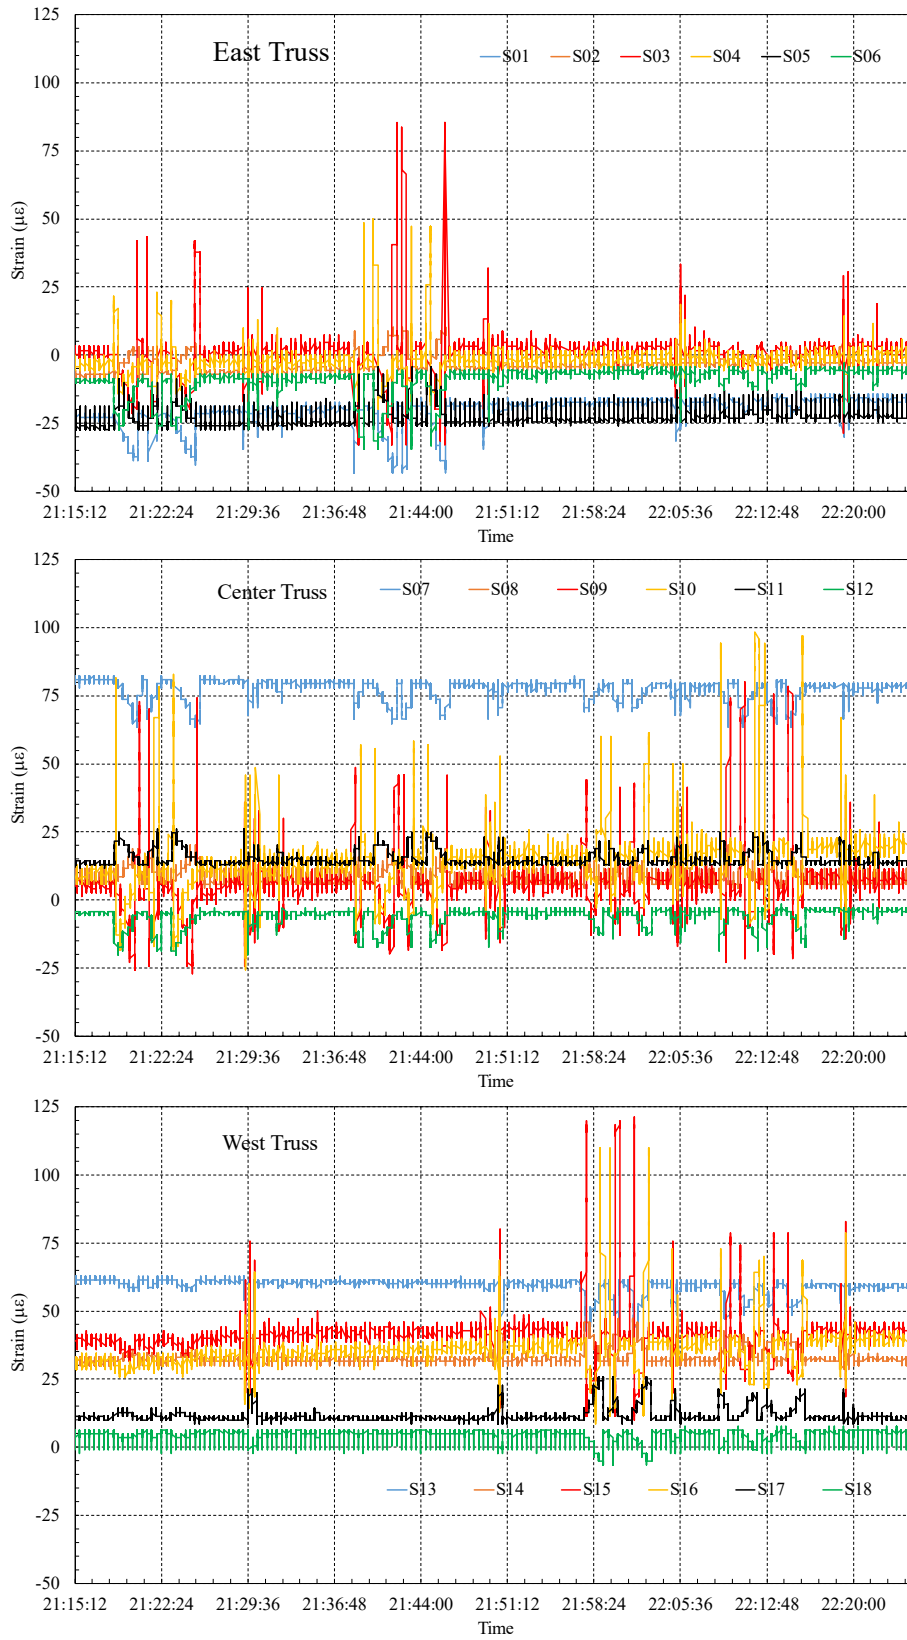
Fig. 5.9 – Strain measured during the truck test performed by Vendor.

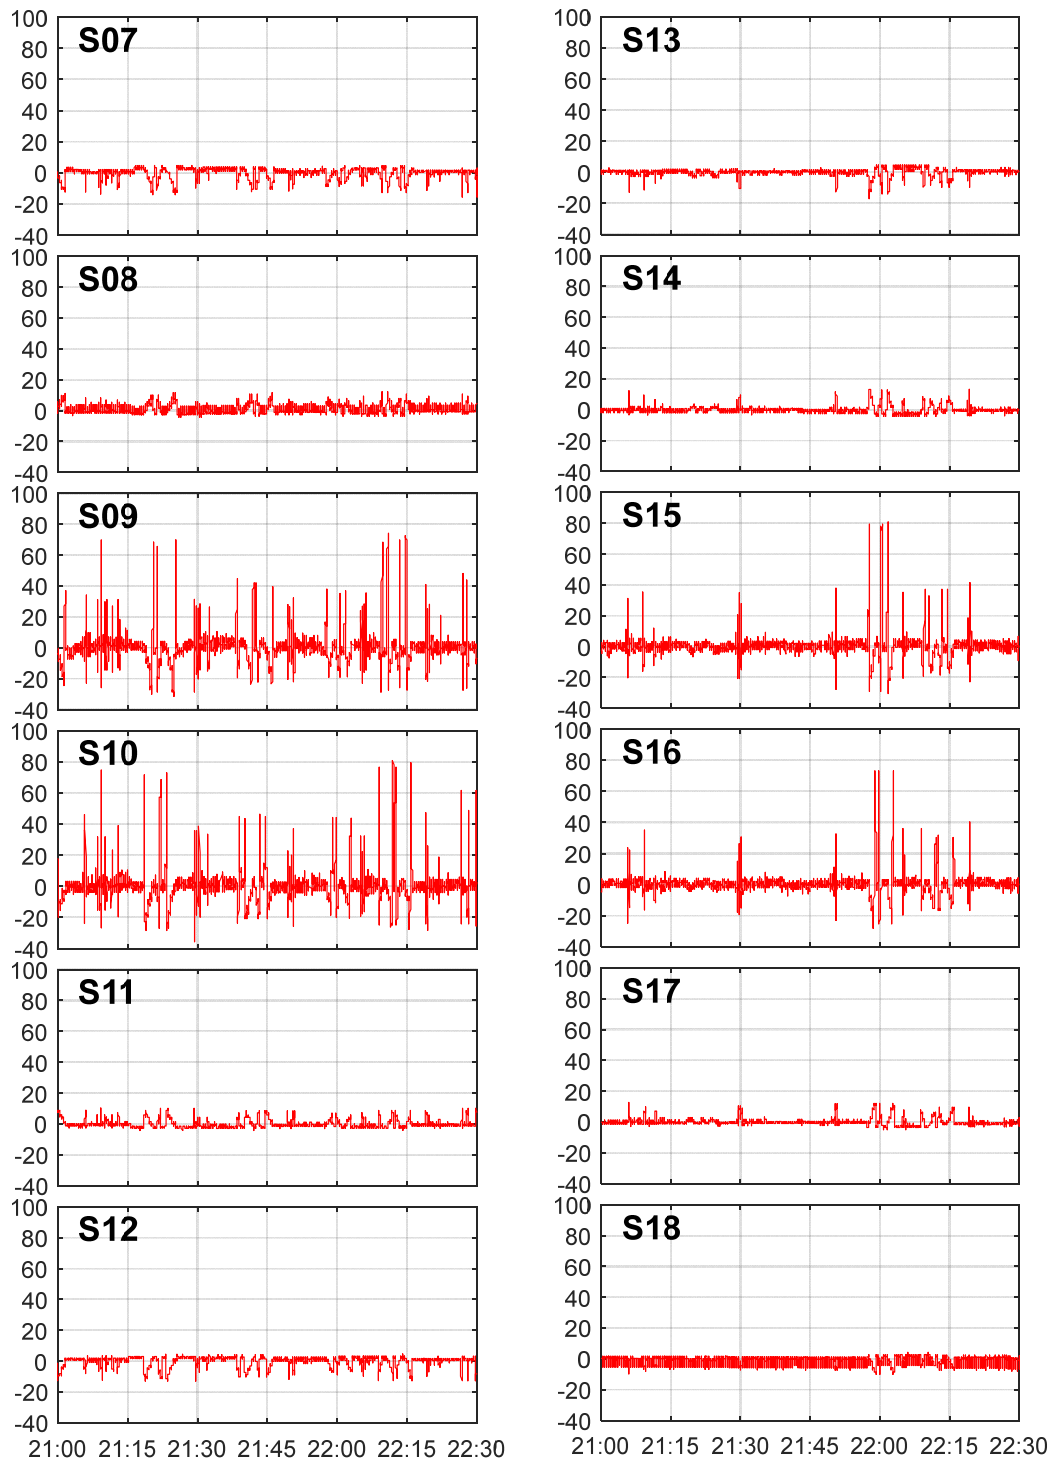
**Fig. 5.10** – True strains from gages S07 – S18 extracted from the raw strains stored during the controlled load truck test. (The values on the vertical axes indicate strains and are expressed in microstrains)

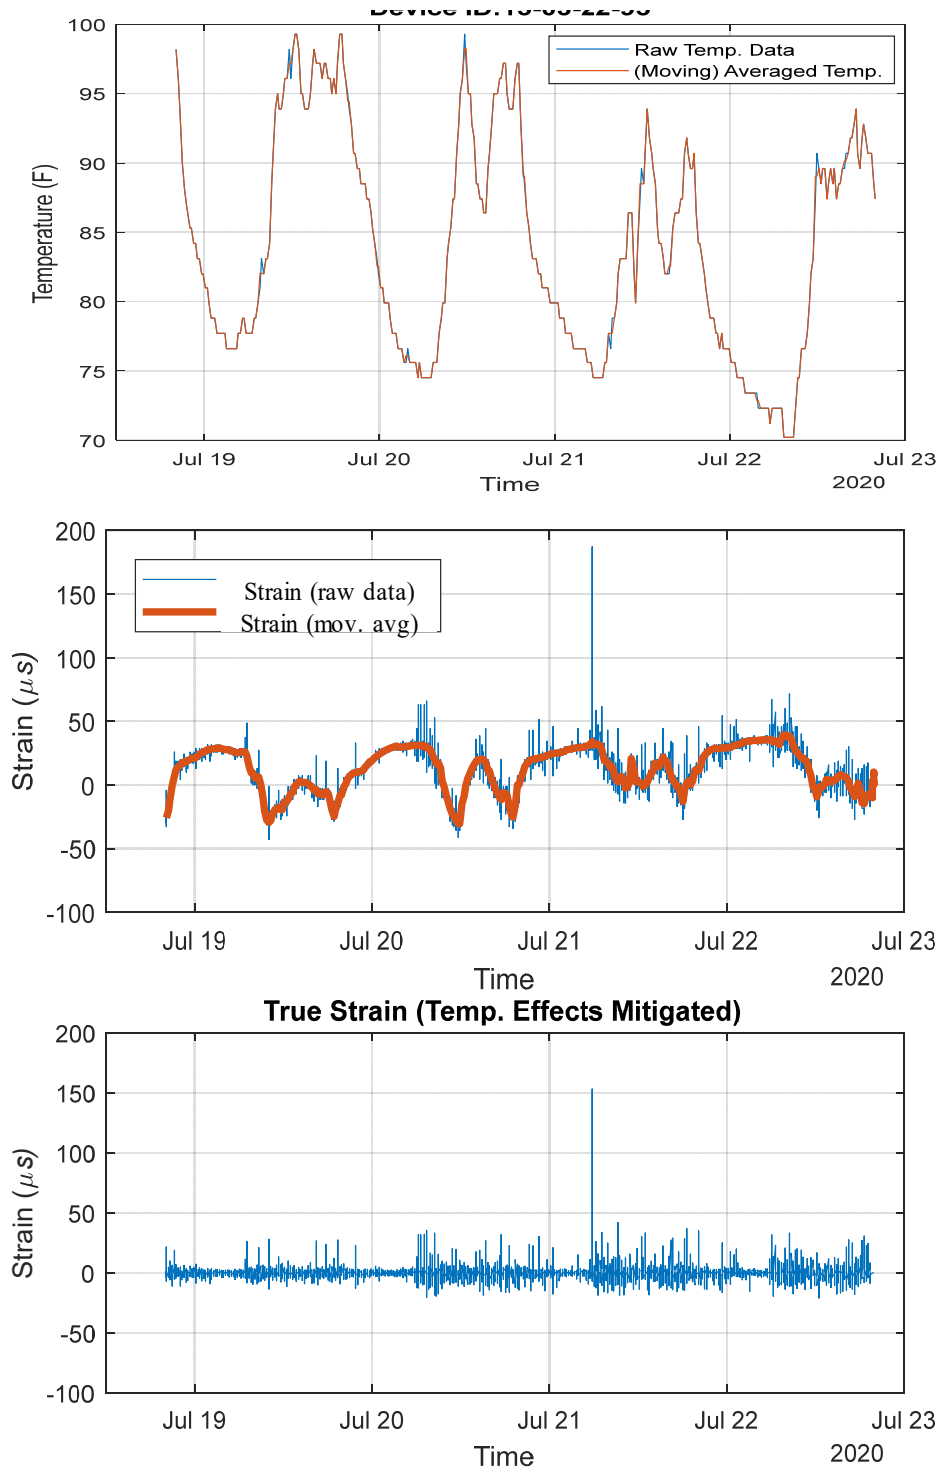
**Fig. 5.11** – (a) Top. Raw and 15-minutes moving average of the temperature data. (b) Center. Raw and 15-minutes moving average of the strain data. (c) Bottom. Live load strain.

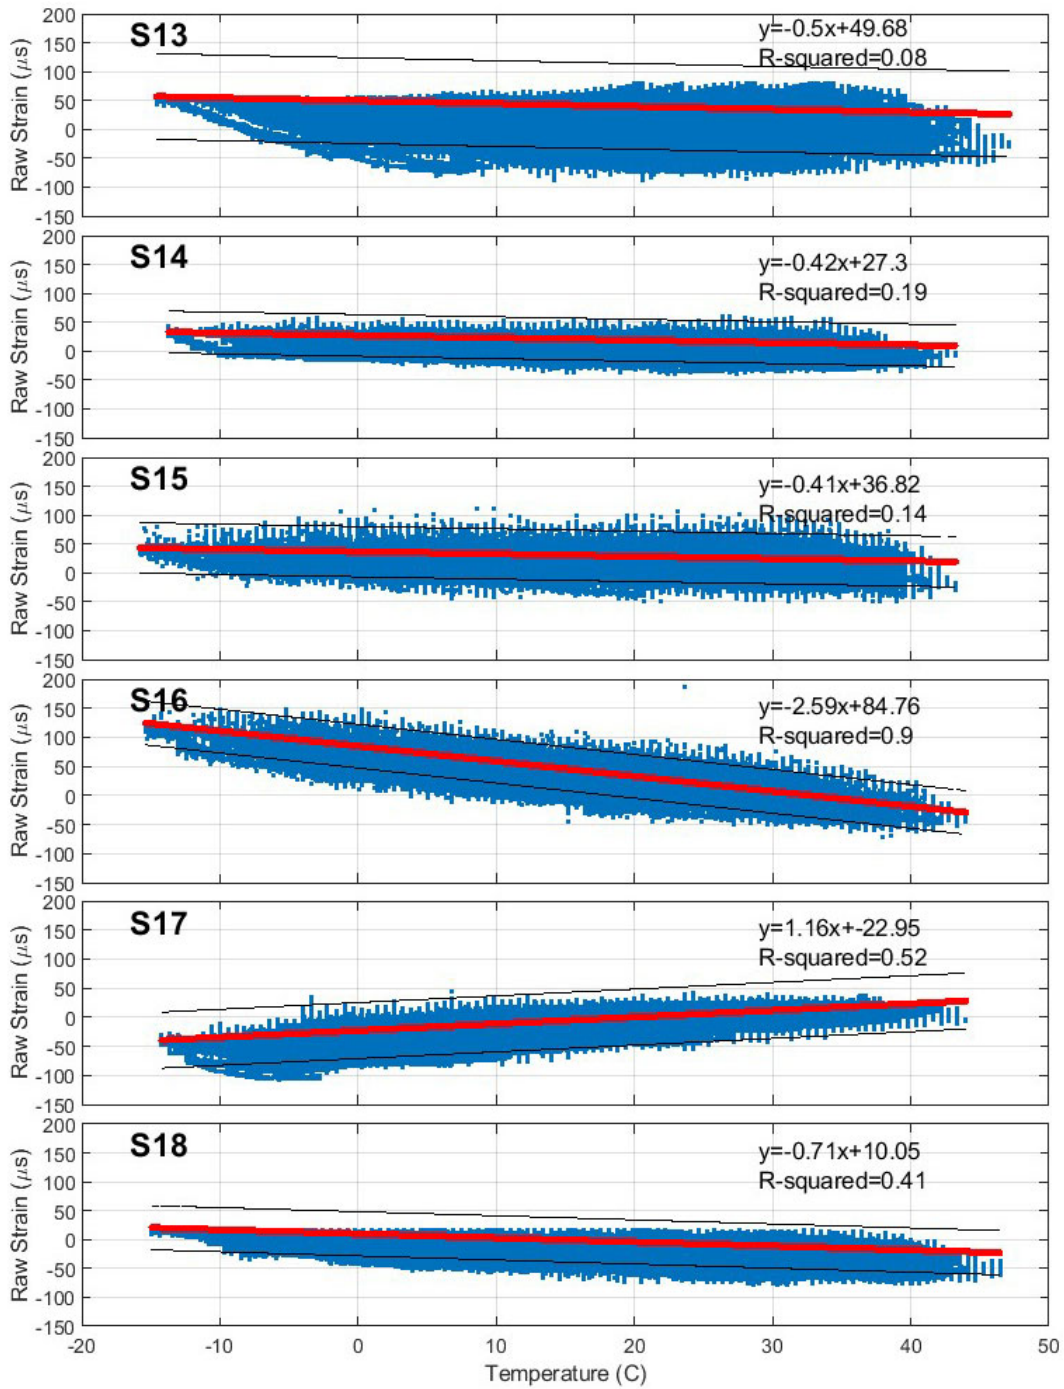
Fig. 5.13 – Raw strain vs raw temperature for all the strain gages.

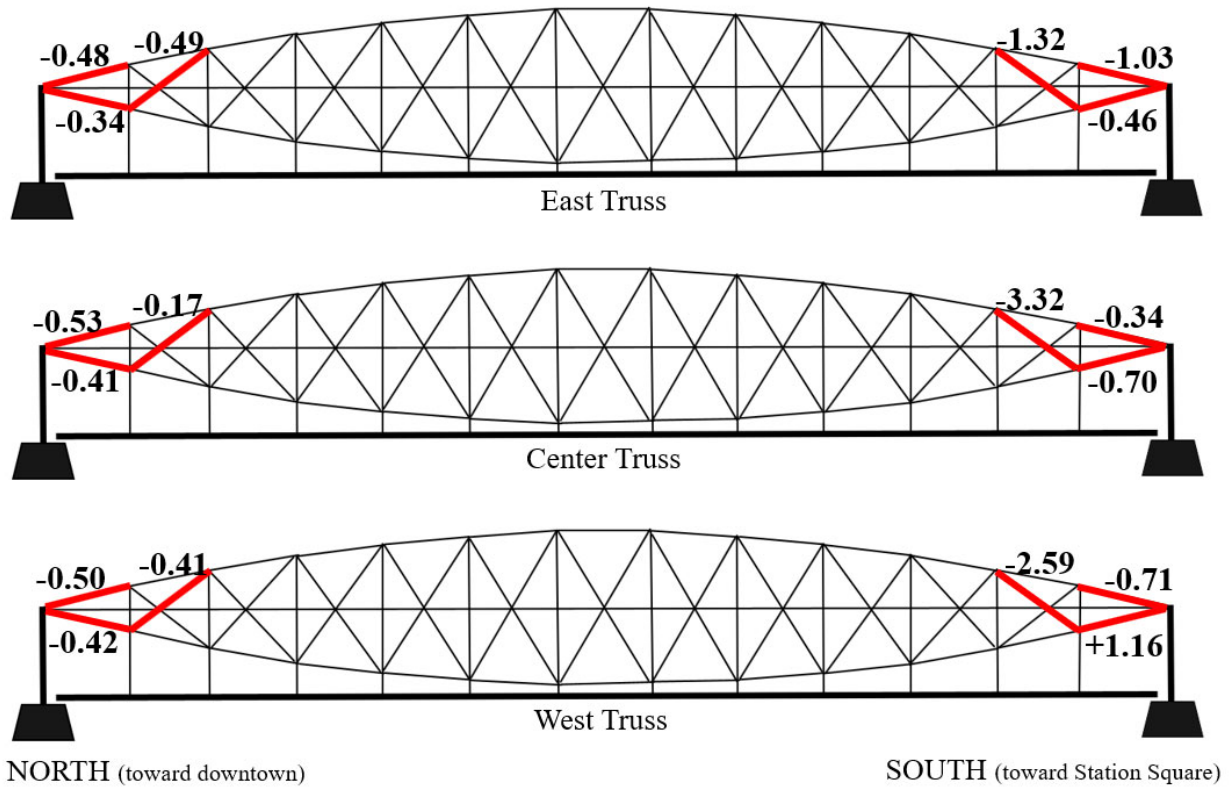
**Fig. 5.15** – Drawings of the east, center and west truss with the members instrumented and the corresponding strain rate expressed in  $\mu\epsilon/^\circ C$ .

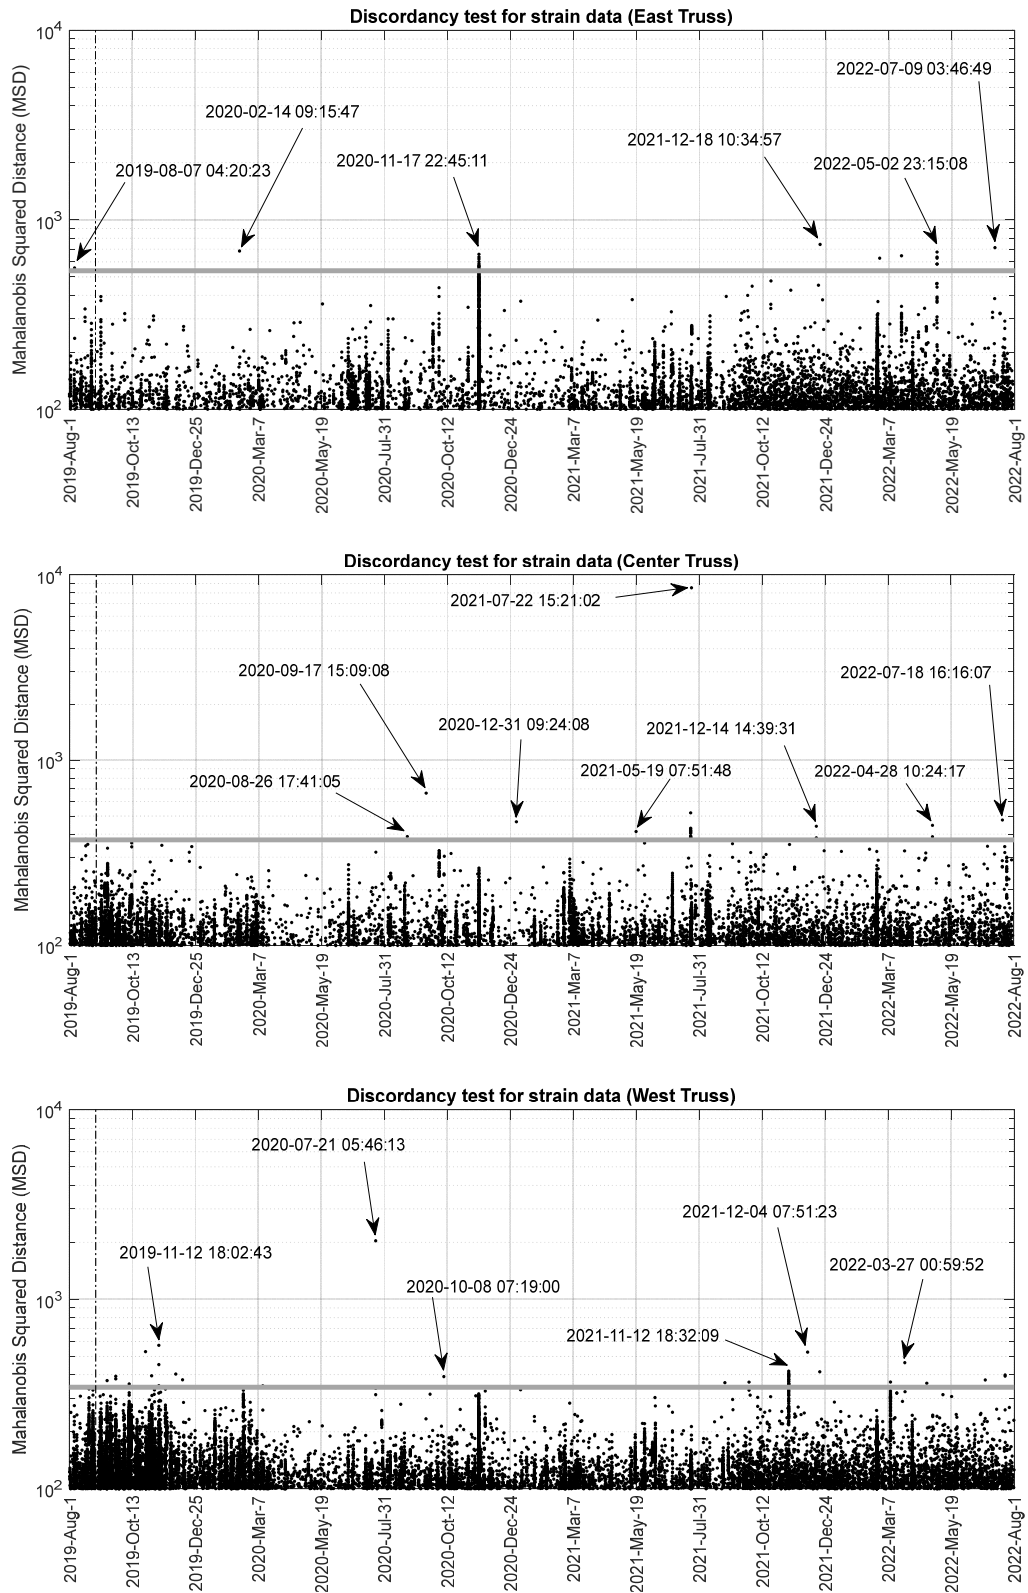
Fig. 5.18 – Mahalanobis squared distance applied to the strain gage data on the individual trusses.

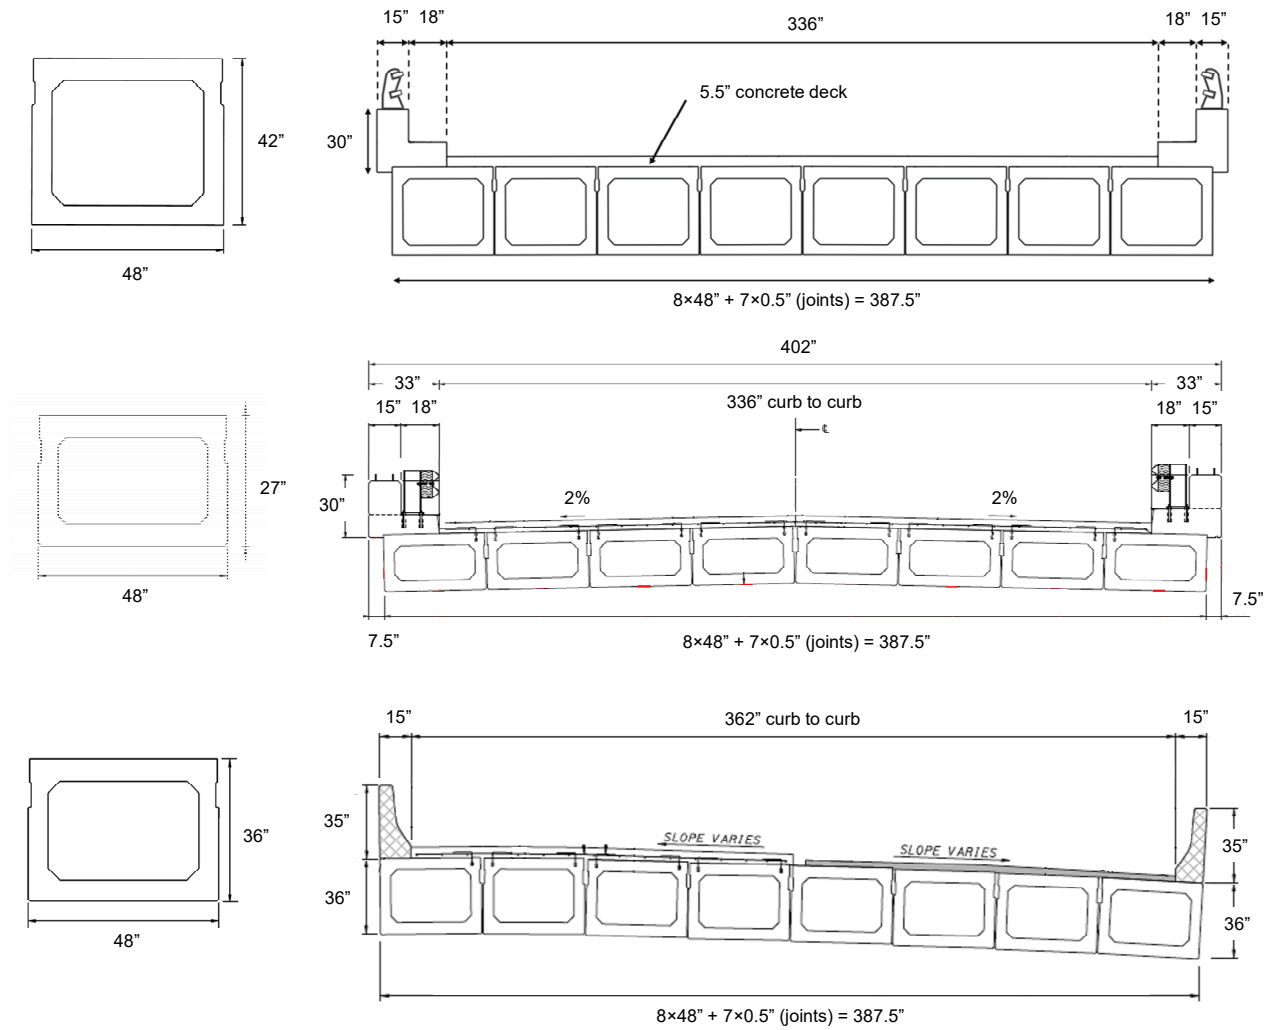
**Fig. 6.2.** Cross section of the (a) Somerset Bridge, (b) Cooks Mill Bridge, and (c) of the Tonolaway Creek Bridge. Units expressed in inches following the shop drawings provided to the authors.

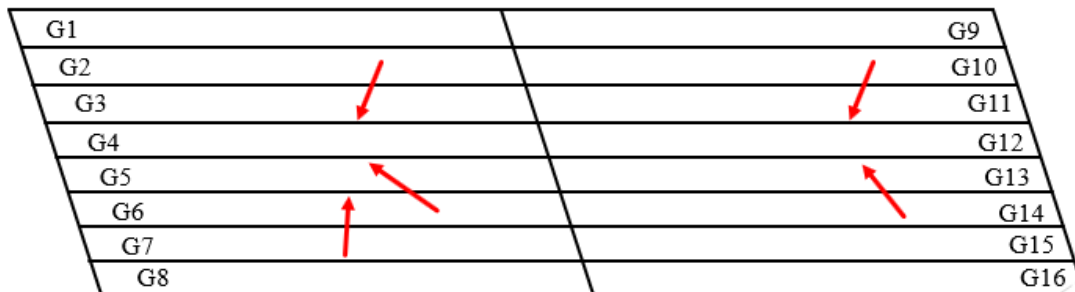
Fig. 6.10 – The shear keys at the Somerset Bridge that their contacts with the adjacent beams were changed to “No separation”

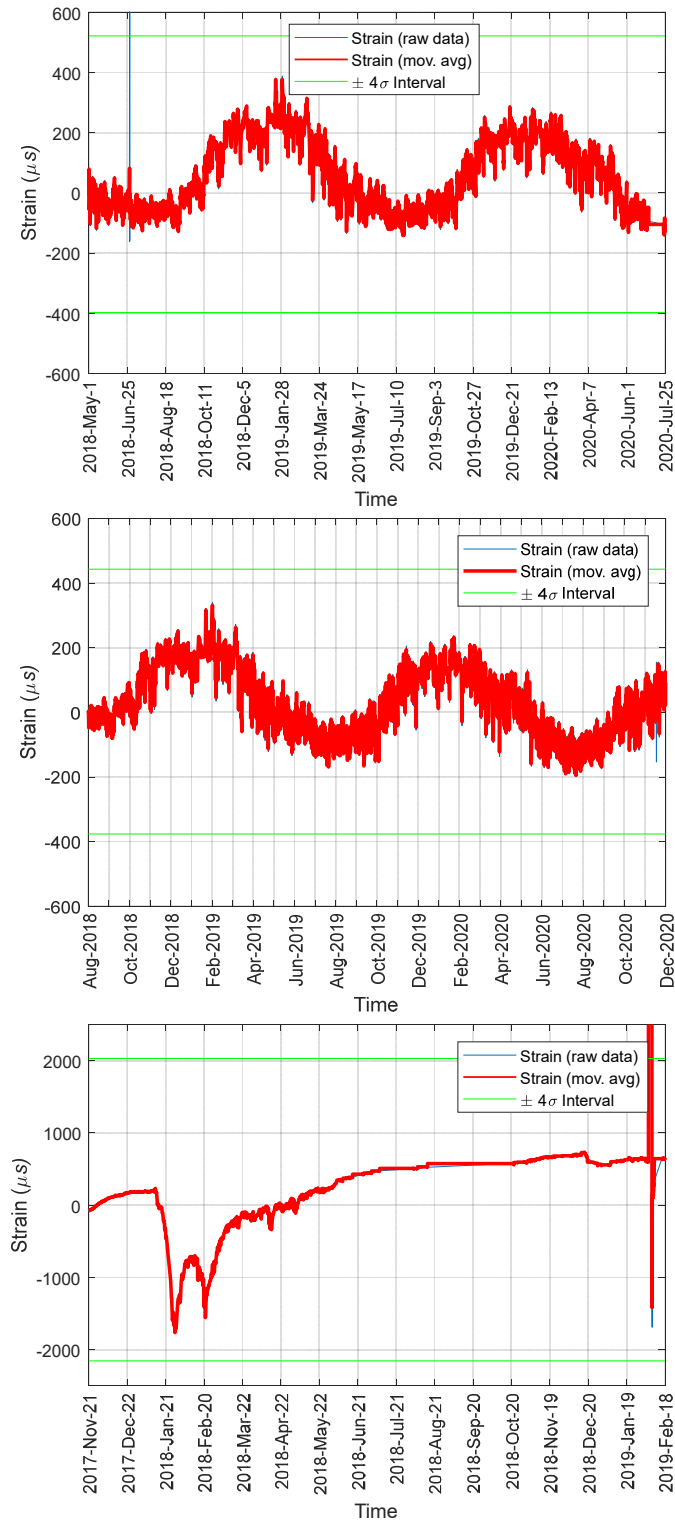
**Fig. 6.14.** Raw strain and corresponding 15-minutes average recorded by sensor 05 mounted on the (a) Somerset Bridge, (b) Cooks Mill Bridge, and (c) Tonolaway Bridge.

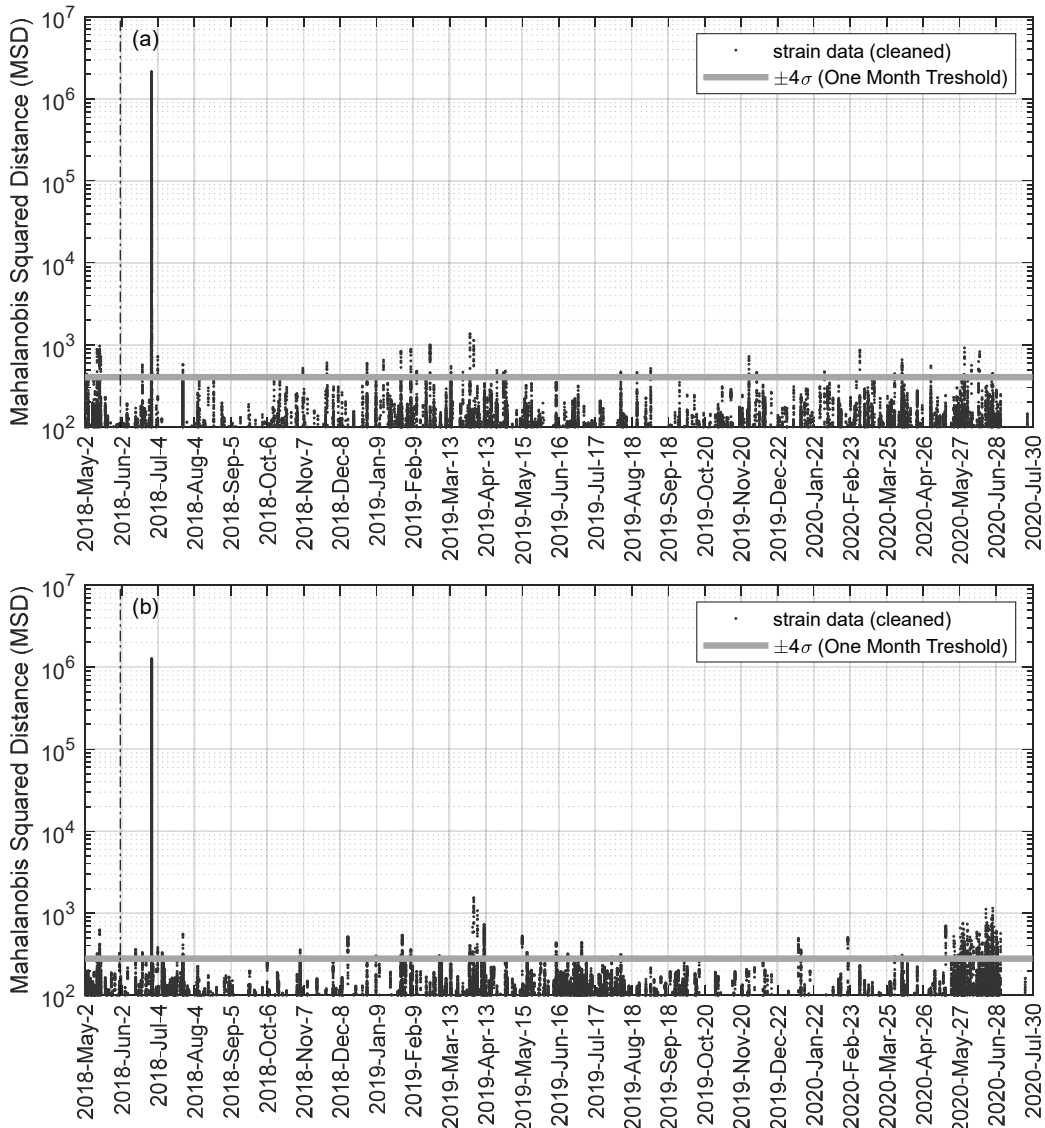
Fig. 6.21- Mahalanobis squared distance applied to the live strains from gages (a)-1 to 10 and (b)- 21 to 30.

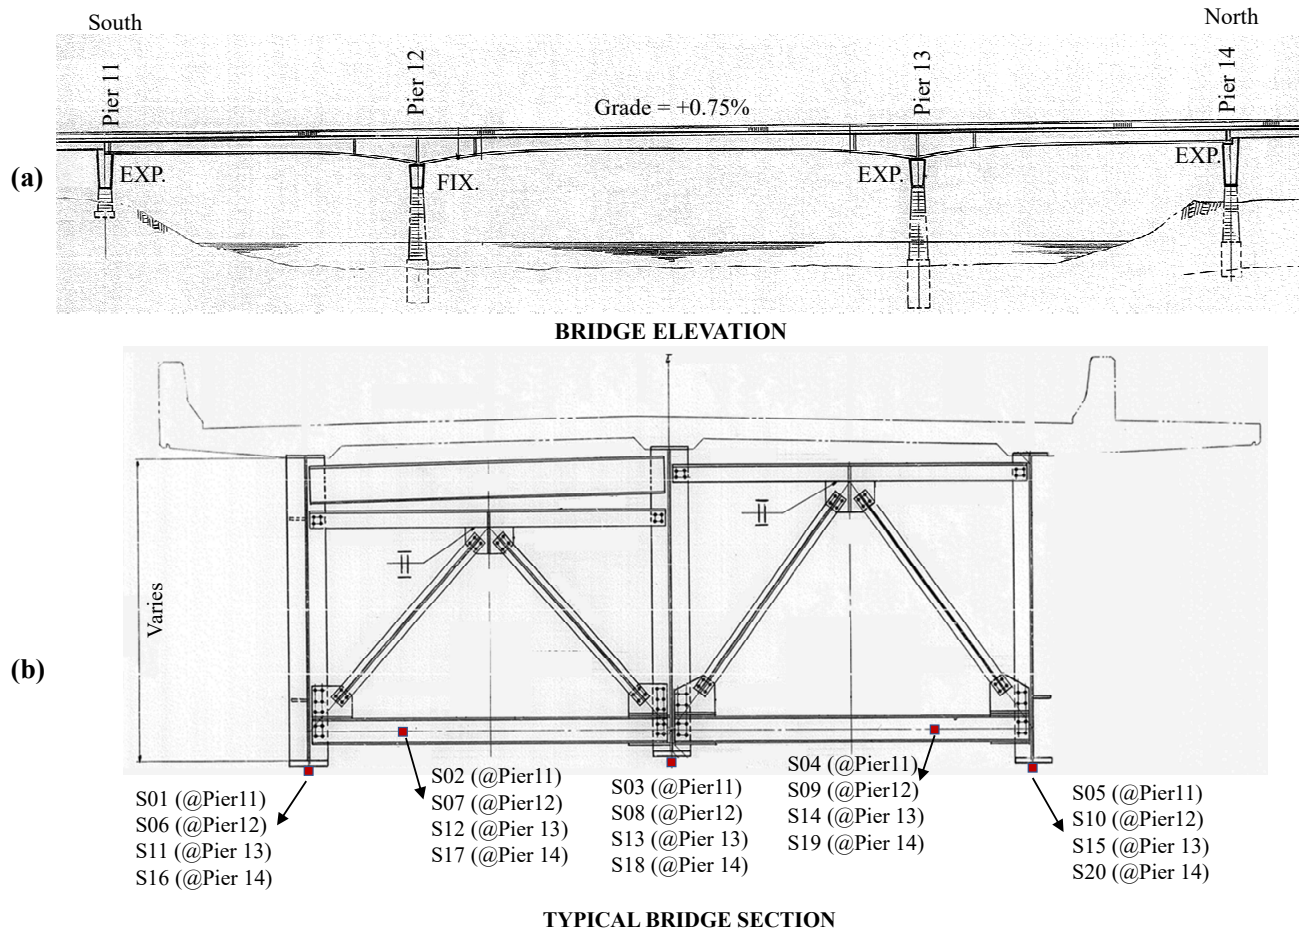
**Fig. 7.3** – Instrumentation plan of the Clairton Bridge.

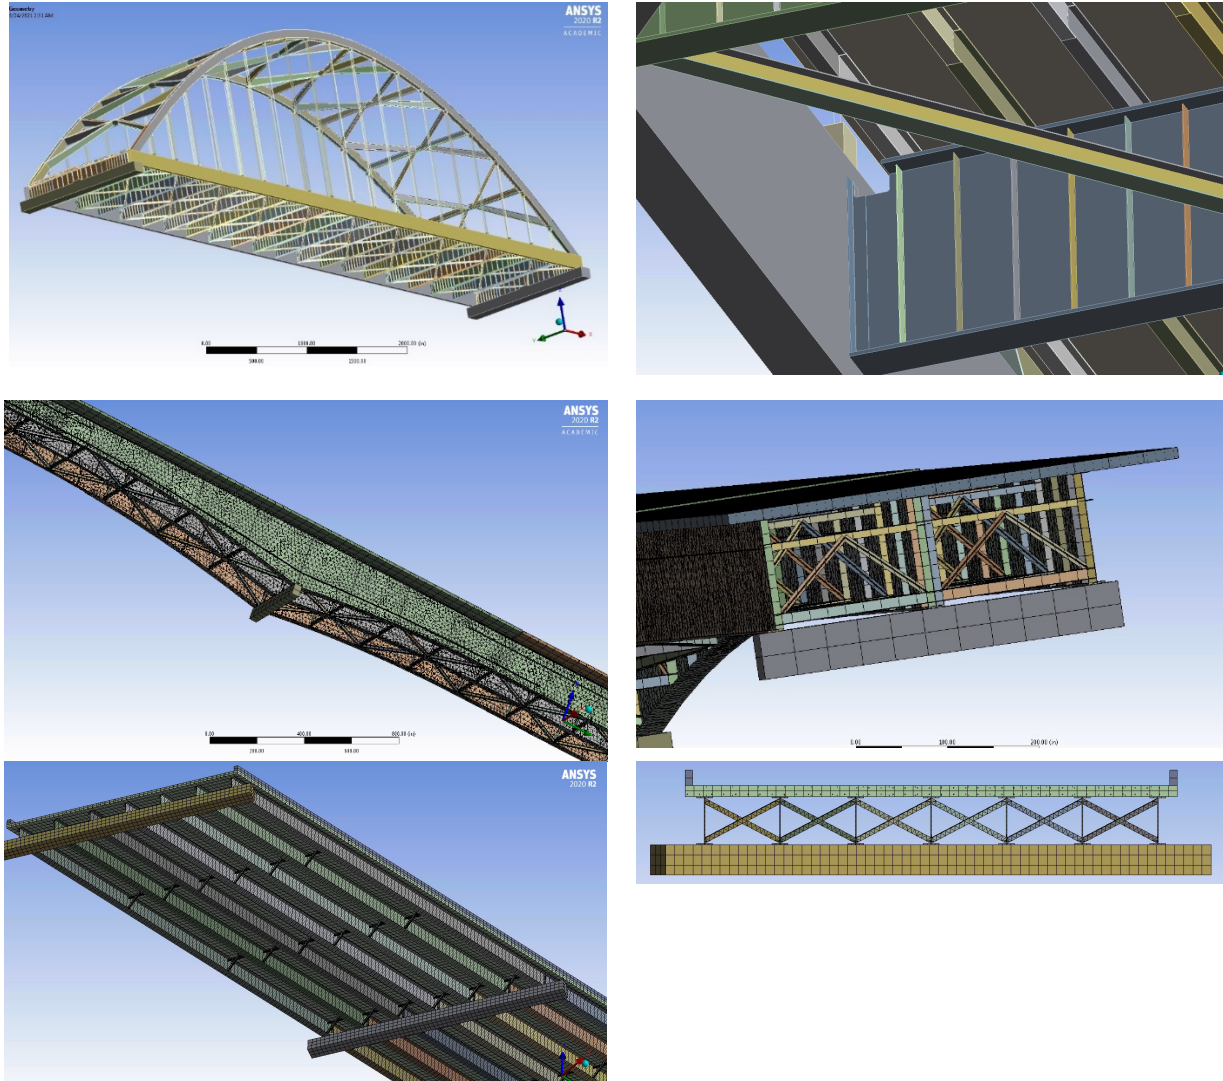
Fig. 7.5 – Snapshots of the digital replicas of the three bridges considered in this study

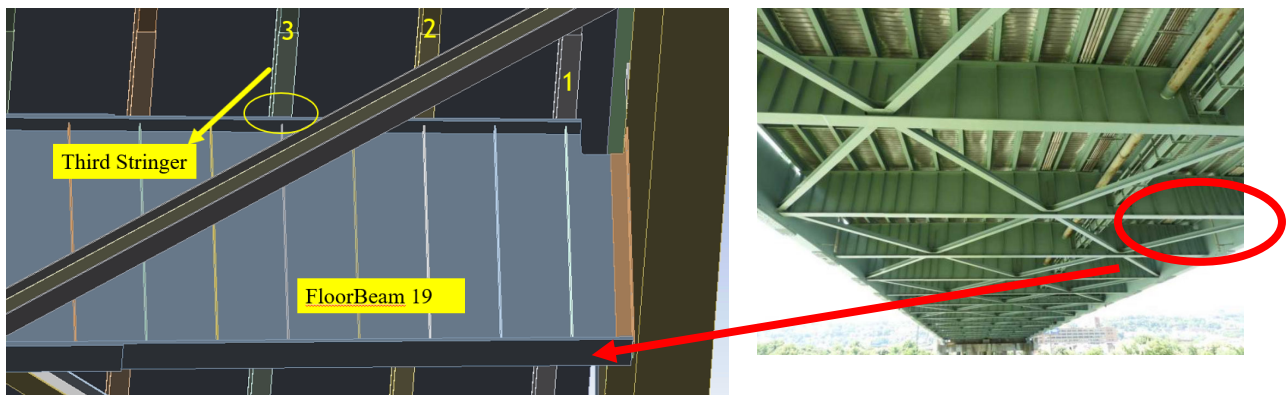
**Fig. 7.8** – The changed contacts of the third stringers for damage scenario 3.

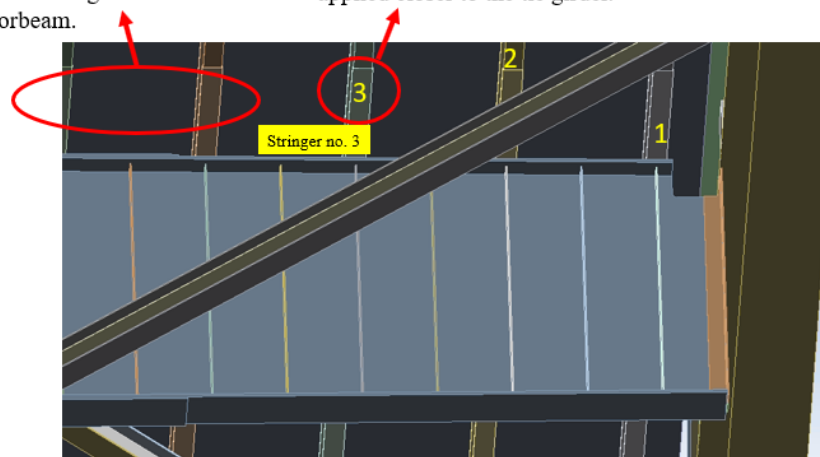
Fig. 7.9 – Load transfer mechanism between stringer 3 and FB19 under pristine and damage scenario 3.

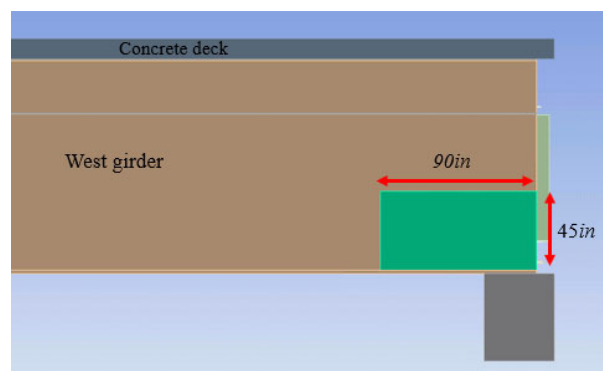
Fig. 7.11 – The added rectangular plate to the location of the fifth damage scenario.

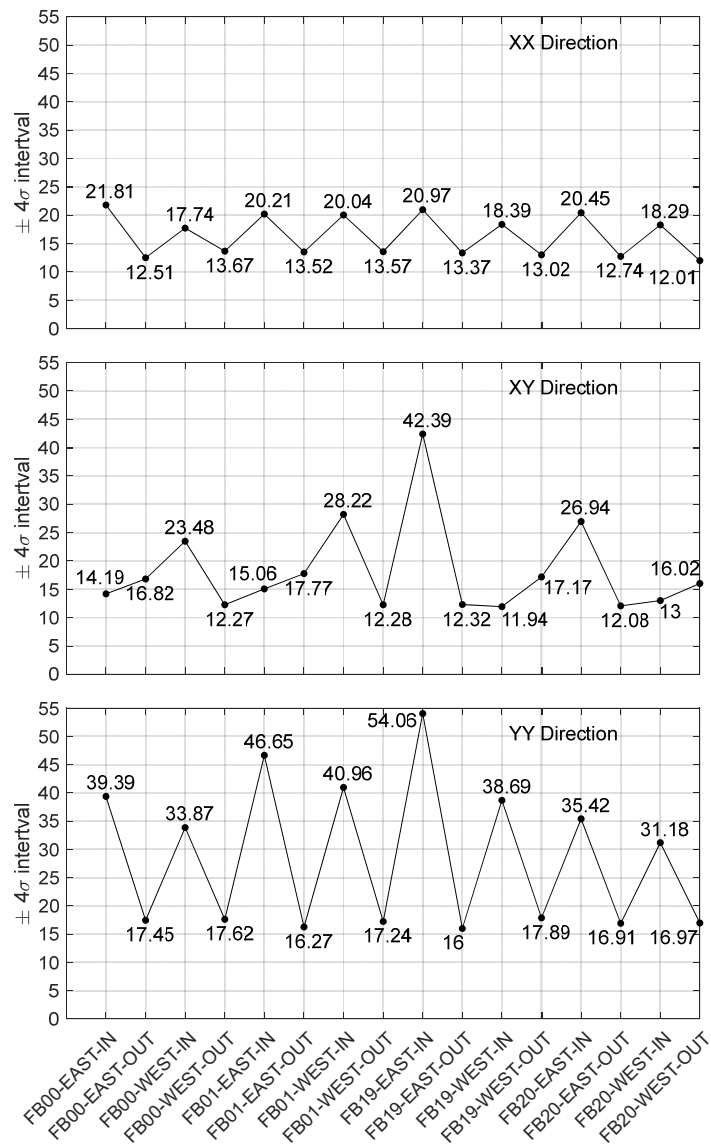
Fig. 7.22– Birmingham Bridge.  $4\pm\sigma$  interval associated with the cleansed true strains.
