DEPARTMENT OF TRANSPORTATION

# Data Management, Mining, and Inference for Bridge Monitoring

FINAL REPORT

University of Pittsburgh

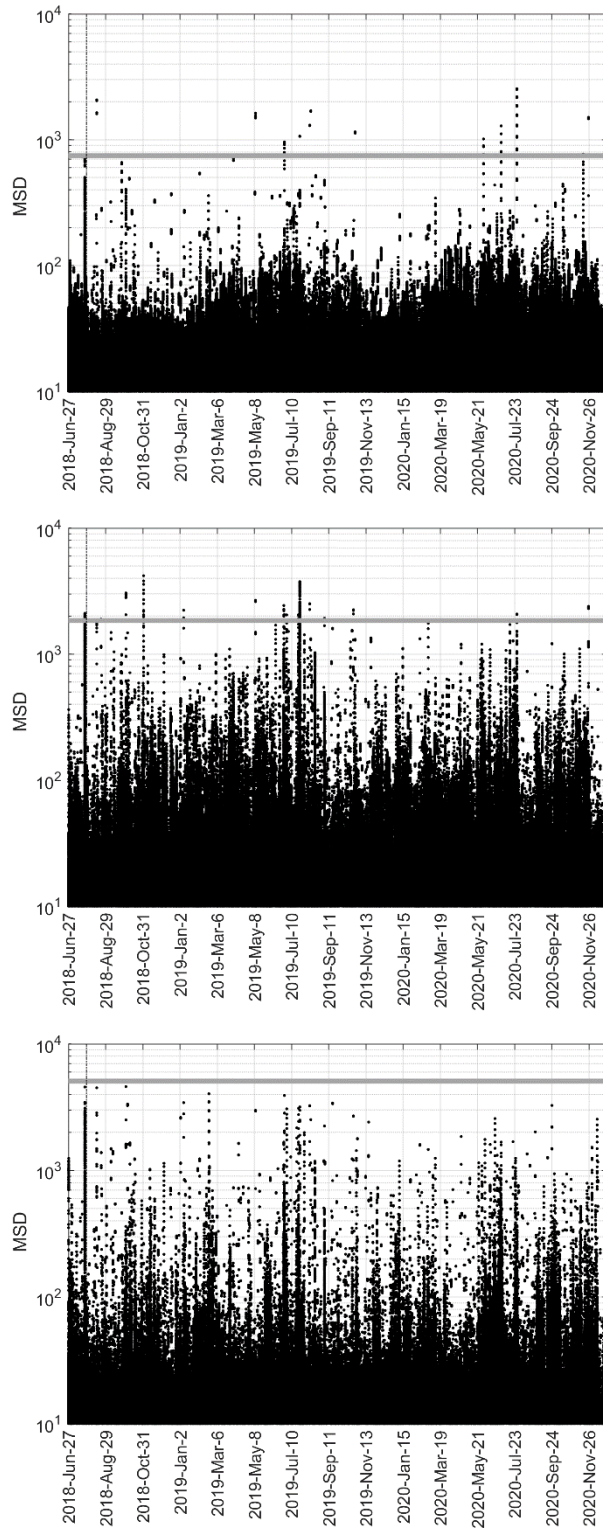
**Fig. 7.25** – Mahalanobis squared distance applied to the whole monitoring period. Top row: top flange. Middle row: web. Bottom row: Bottom flange. The threshold was computed by considering the data from the first month of operation without the truck test.

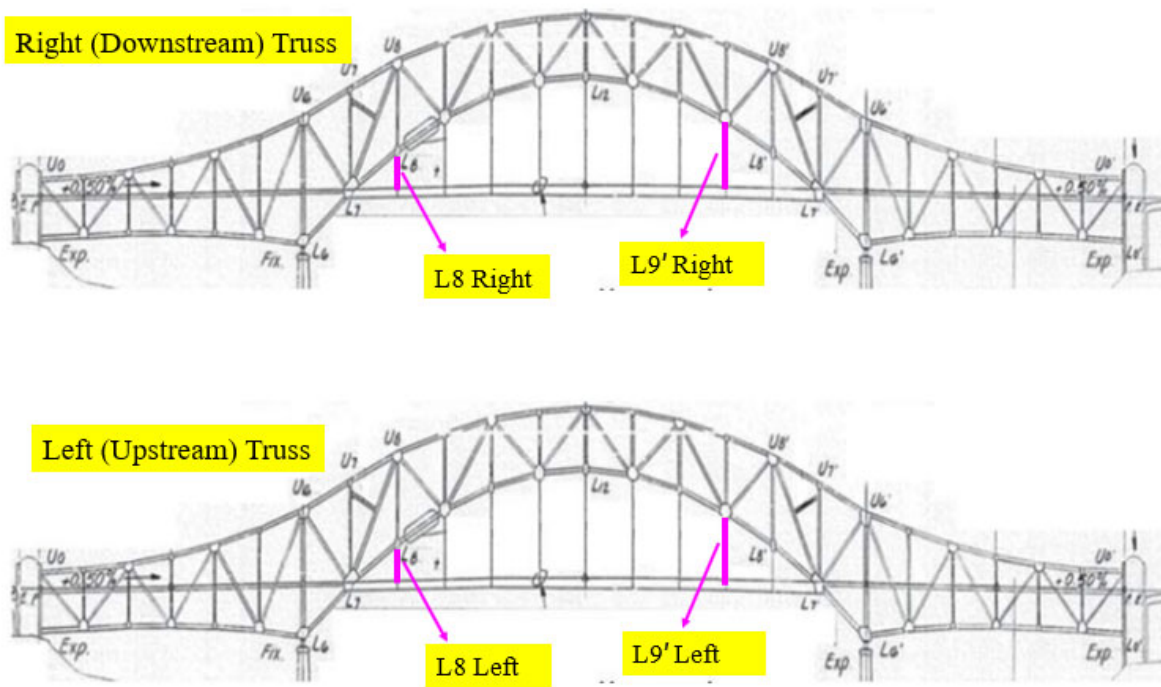
Fig. 8.1 – Cable gauges used for data comparison.

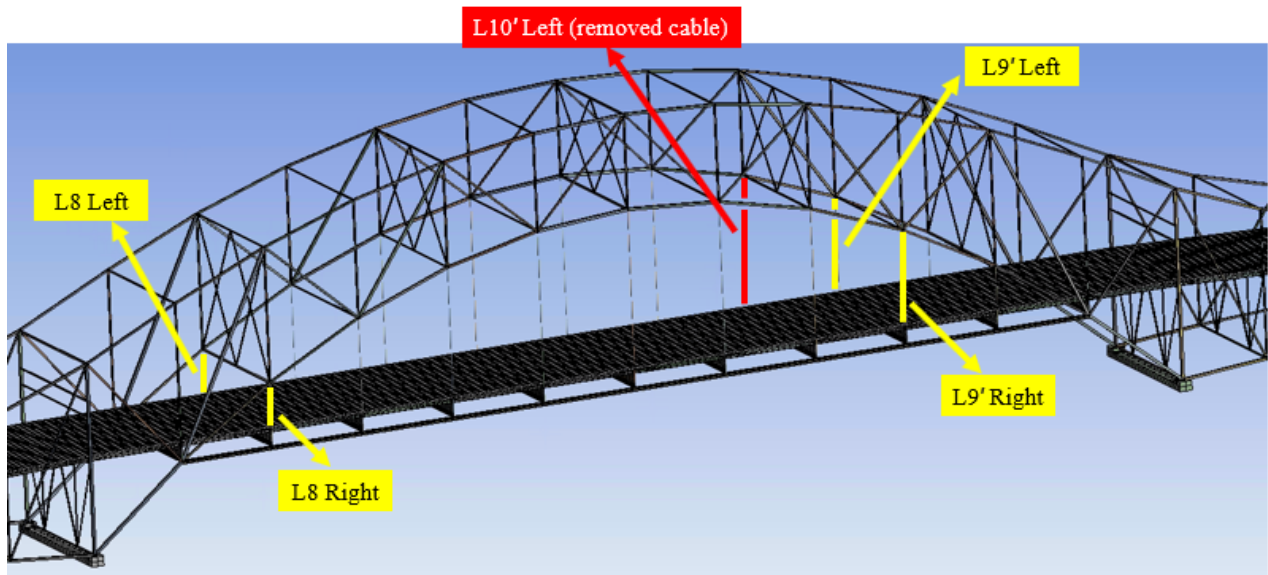
Fig. 8.2 – The location of the removed cable for damage scenario 3.

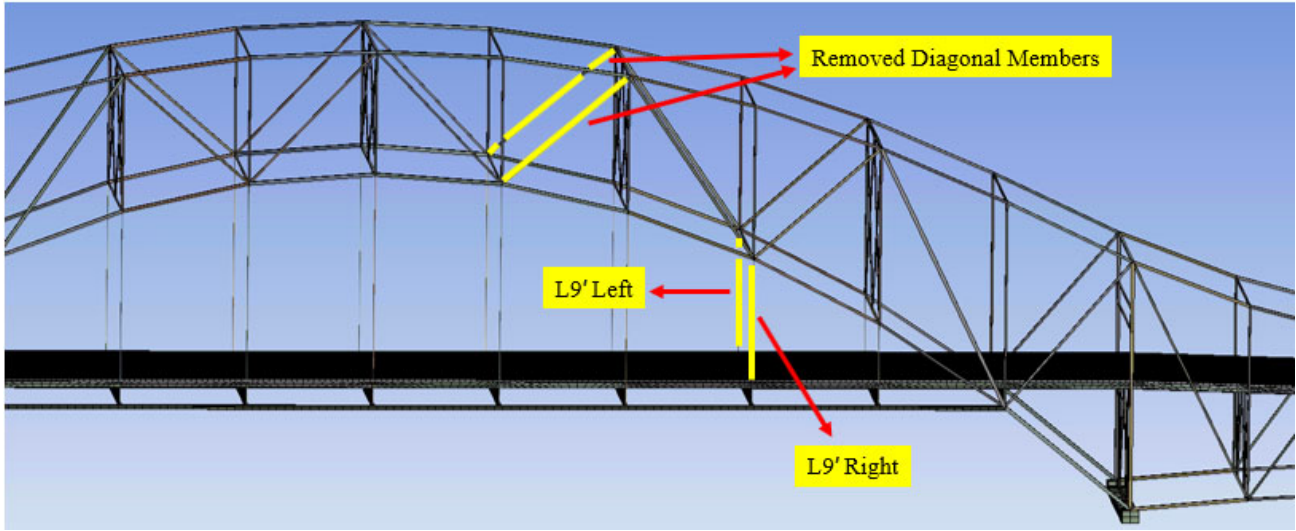
Fig. 8.3 – The location of the removed diagonal members for damage scenario 4.

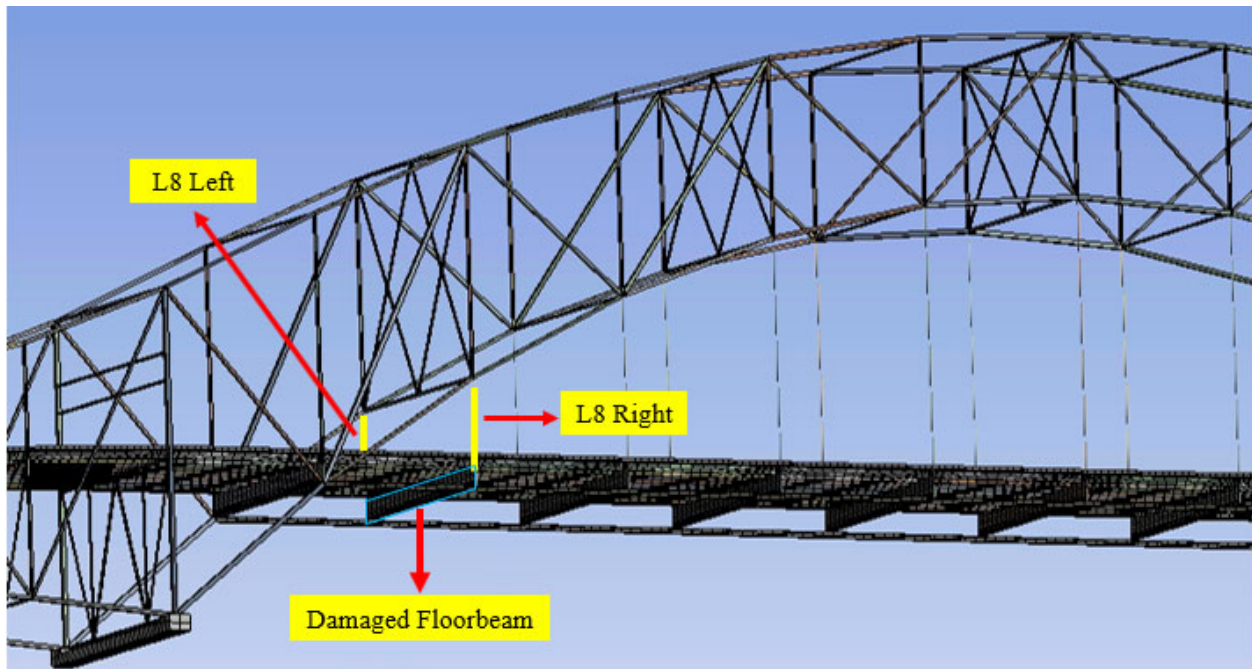
Fig. 8.4 – The location of the damaged floorbeam in damage scenario 5.

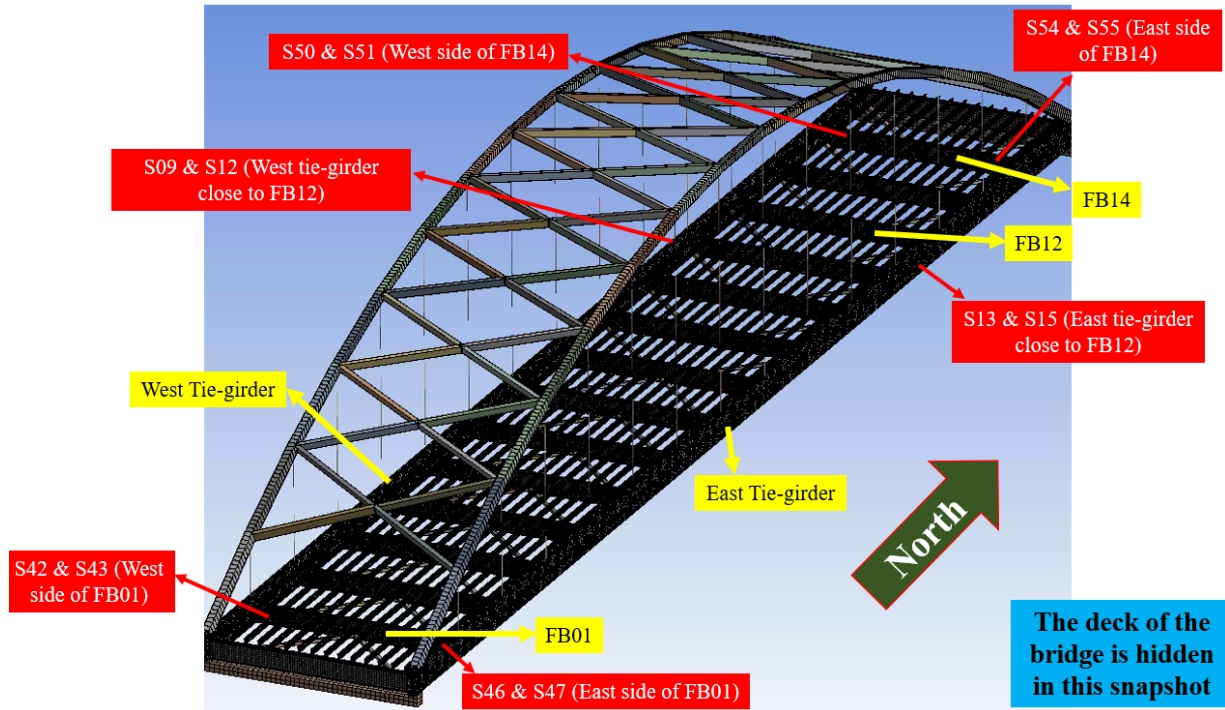
Fig. 9.1 – Location of the structural members and some of the installed sensors on the bridge The letter S means strain gage, the letters RR indicates resistance strain gage, FB means floorbeam, W indicates web, LT stands for left truss, and TP for top.

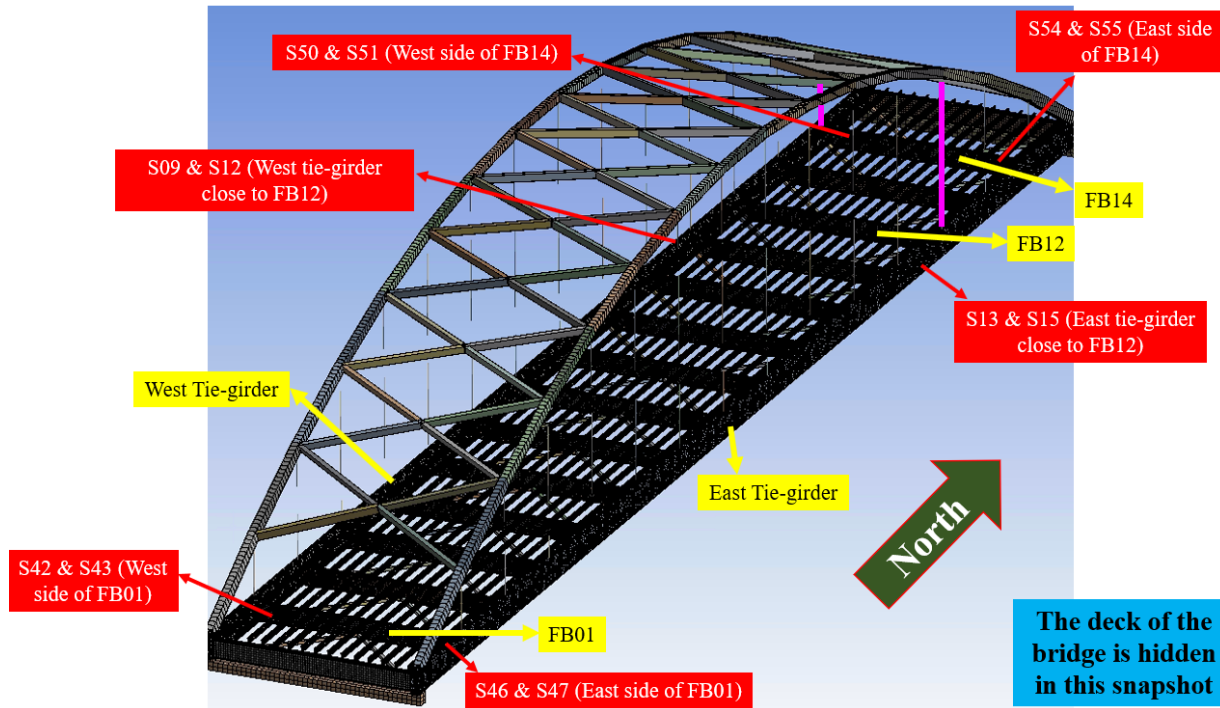
Fig. 9.2 – Removed cables from the East and West arches of the bridge (highlighted in pink).

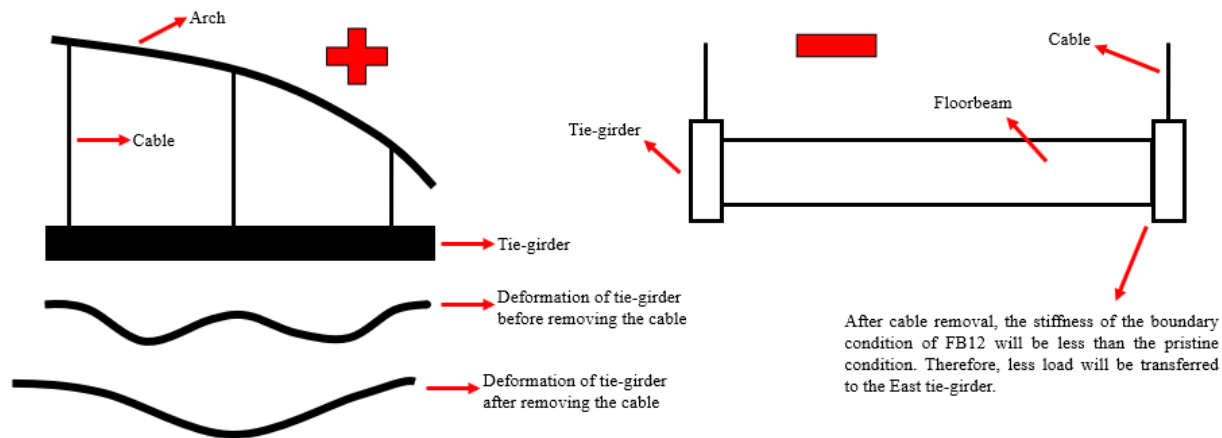
Fig. 9.3 – The factors affecting the predicted strain values under damage scenario 3 condition.

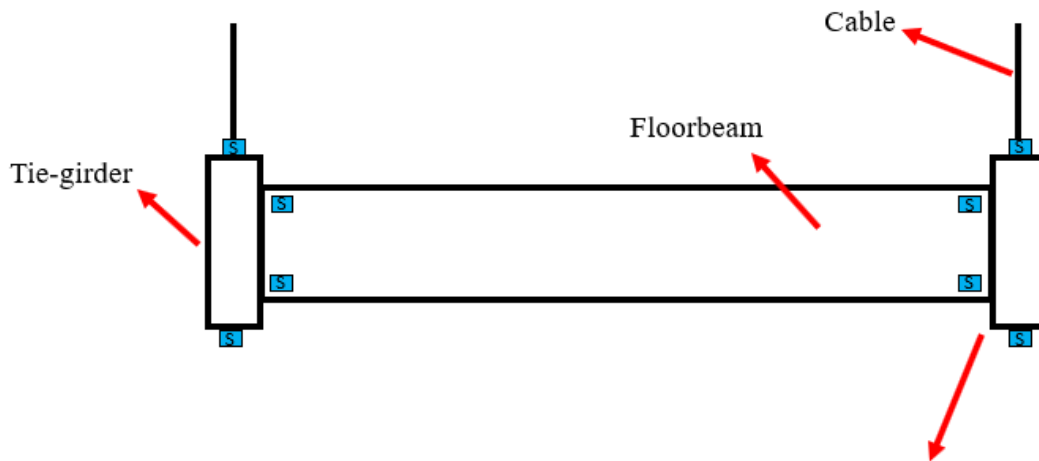
After simulating the corrosion, the stiffness of the boundary condition of floorbeams will be less than the pristine condition. Therefore, less load will be transferred to the East tie-girder.

Fig. 9.5 – The justification of the predicted strains under damage scenario 4 condition.

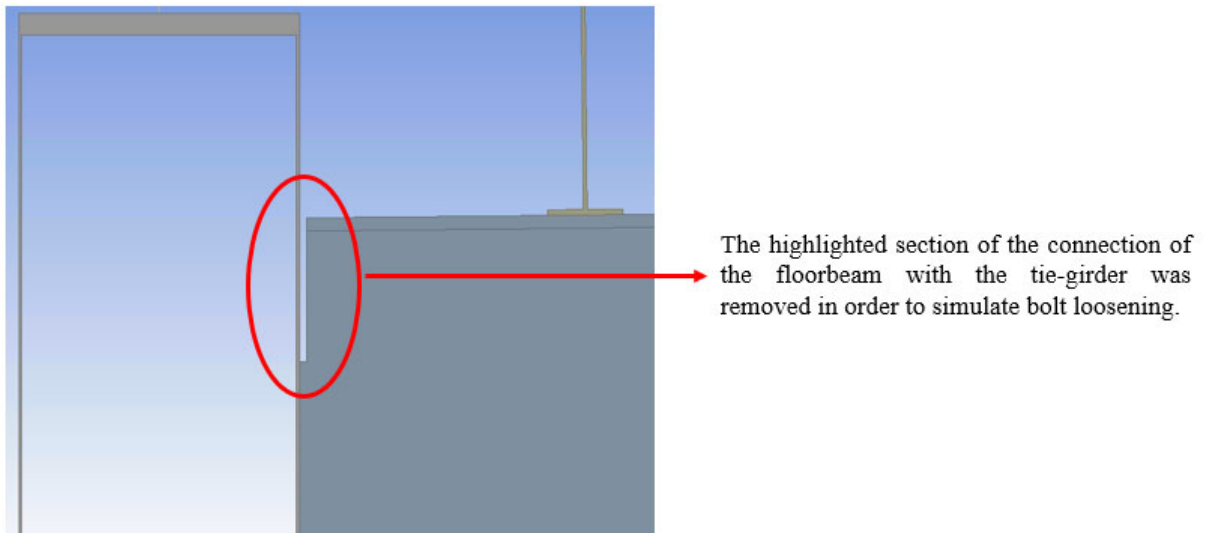
**Fig. 9.6** – Scheme of the damage scenario 5.

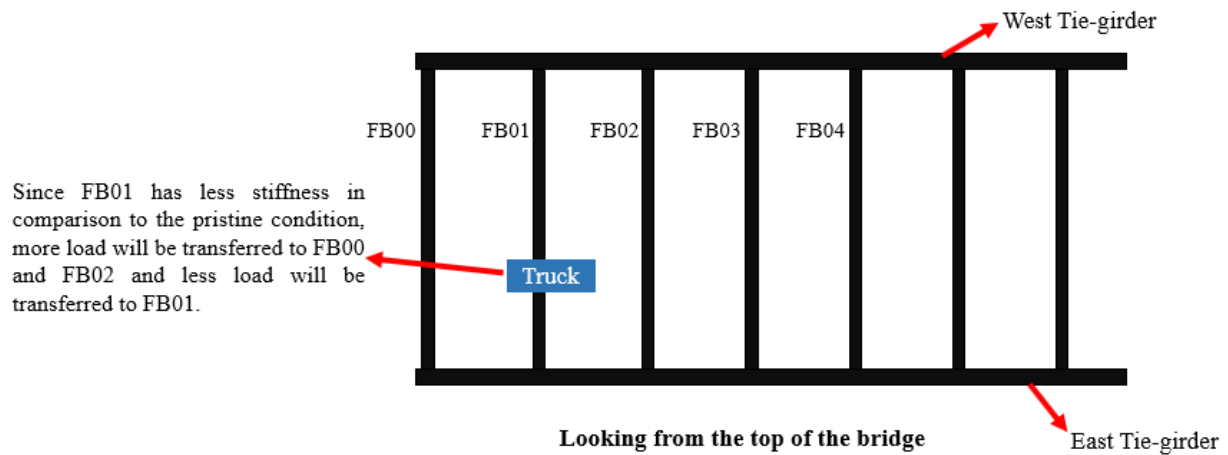
**Fig. 9.7** – The justification of the predicted strains under damage scenario 6.

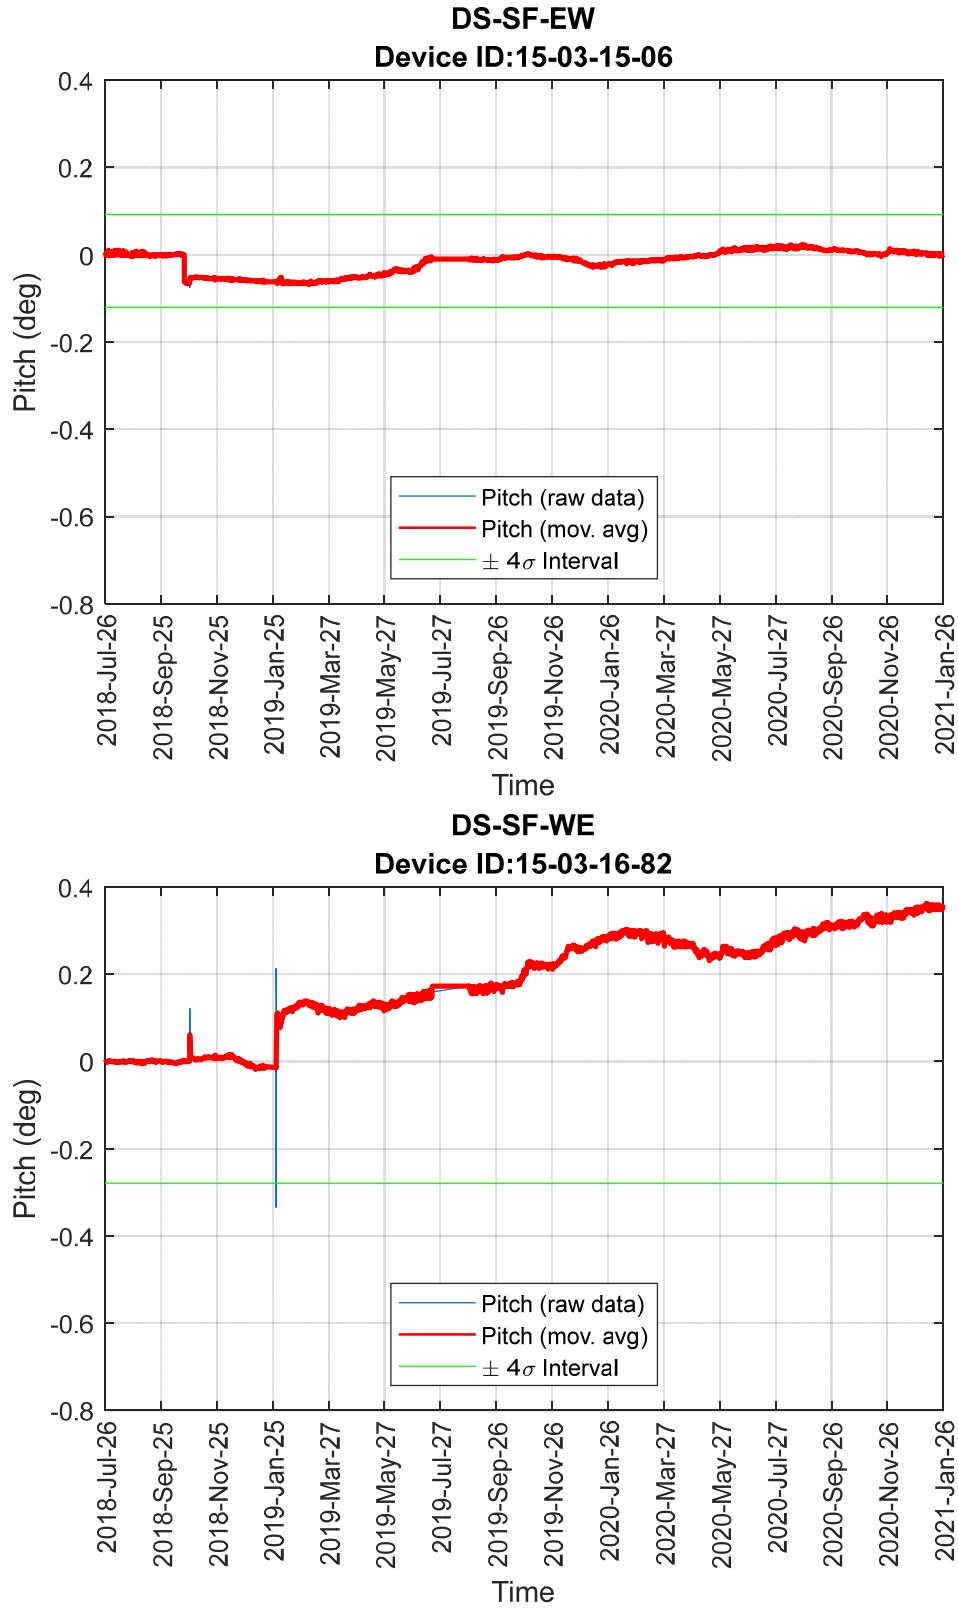
Fig. 10.1 – PITCH. Raw values and corresponding moving average associated with all 8 inclinometers.

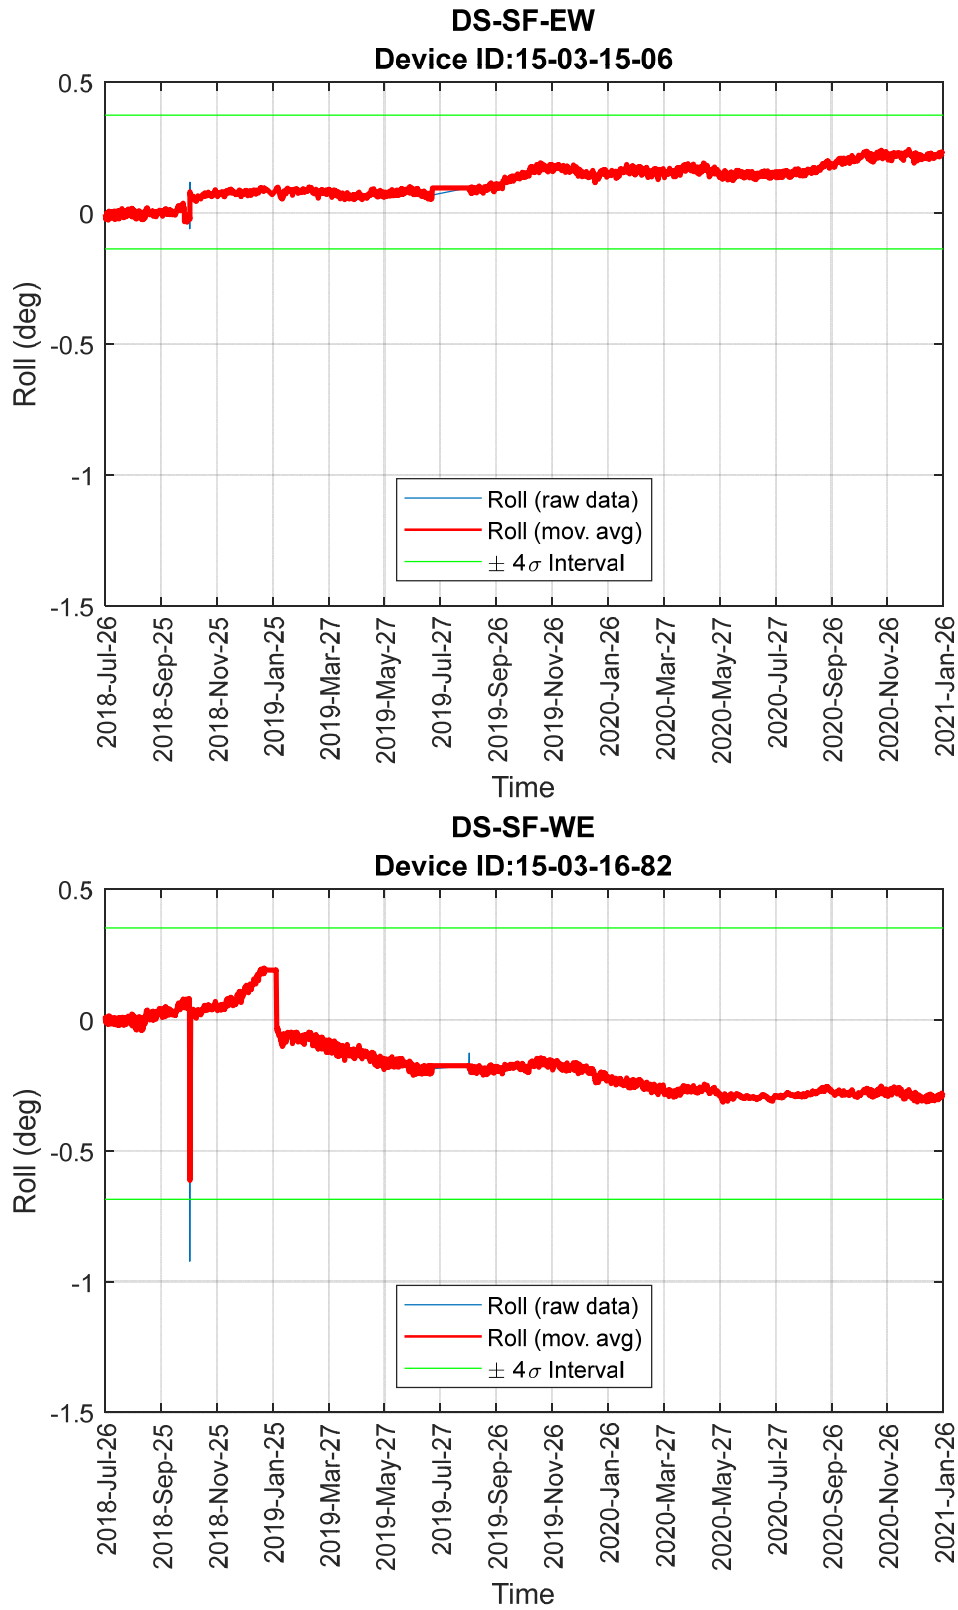
Fig. 10.2 – ROLL. Raw values and corresponding moving average associated with all 8 inclinometers.

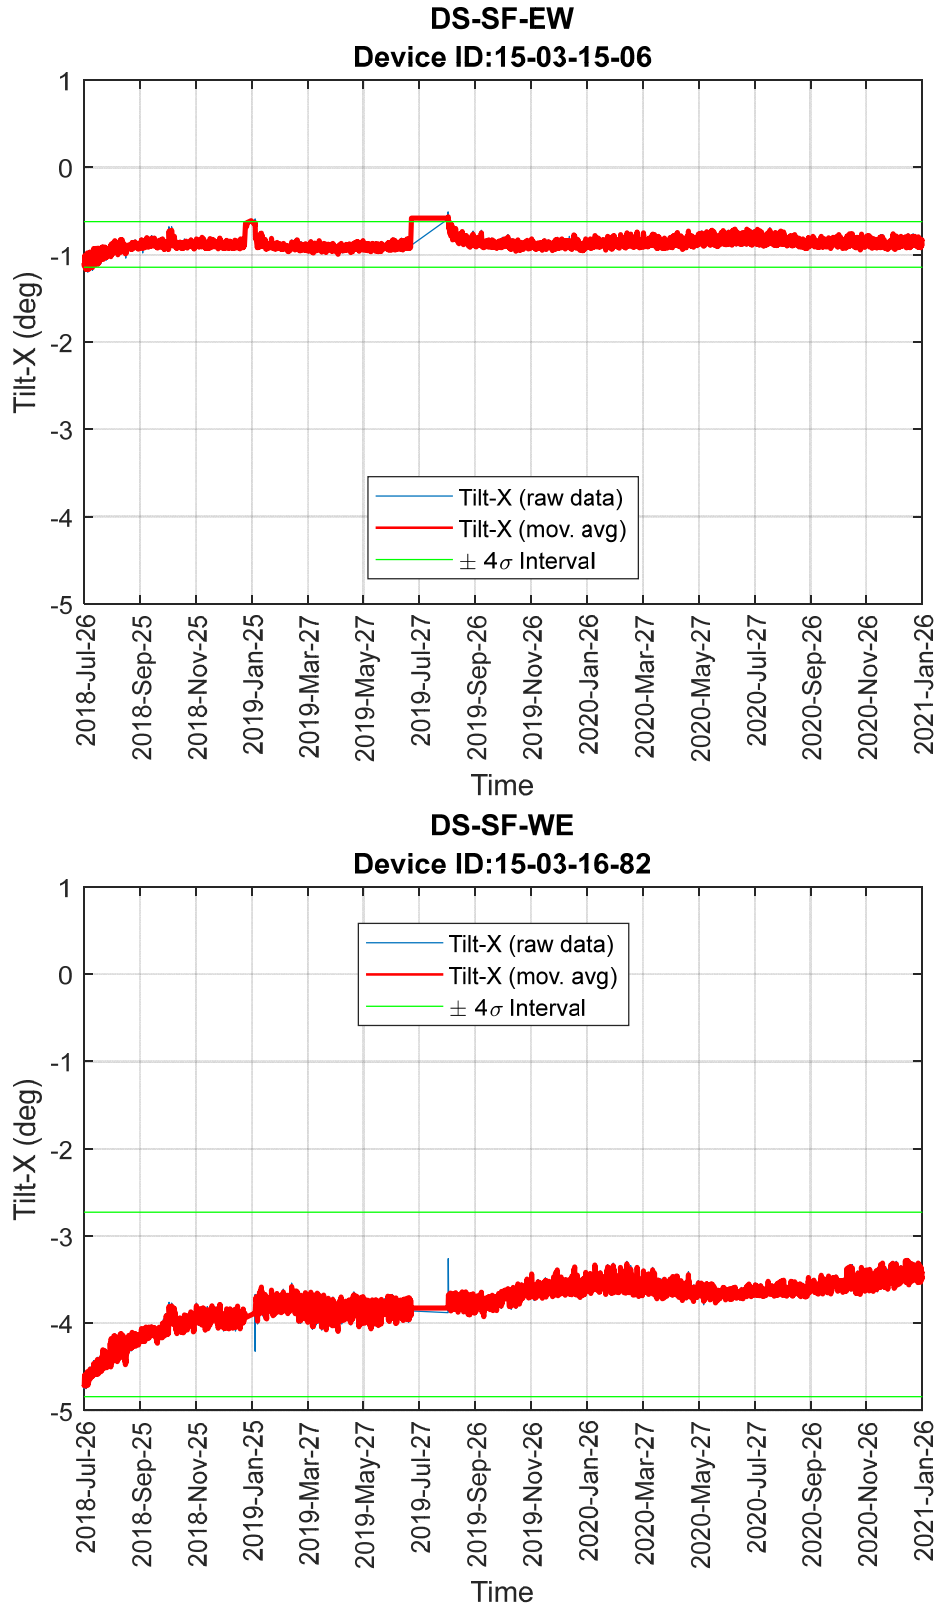
Fig. 10.3 – TILT X. Raw values and corresponding moving average associated with all 8 inclinometers.

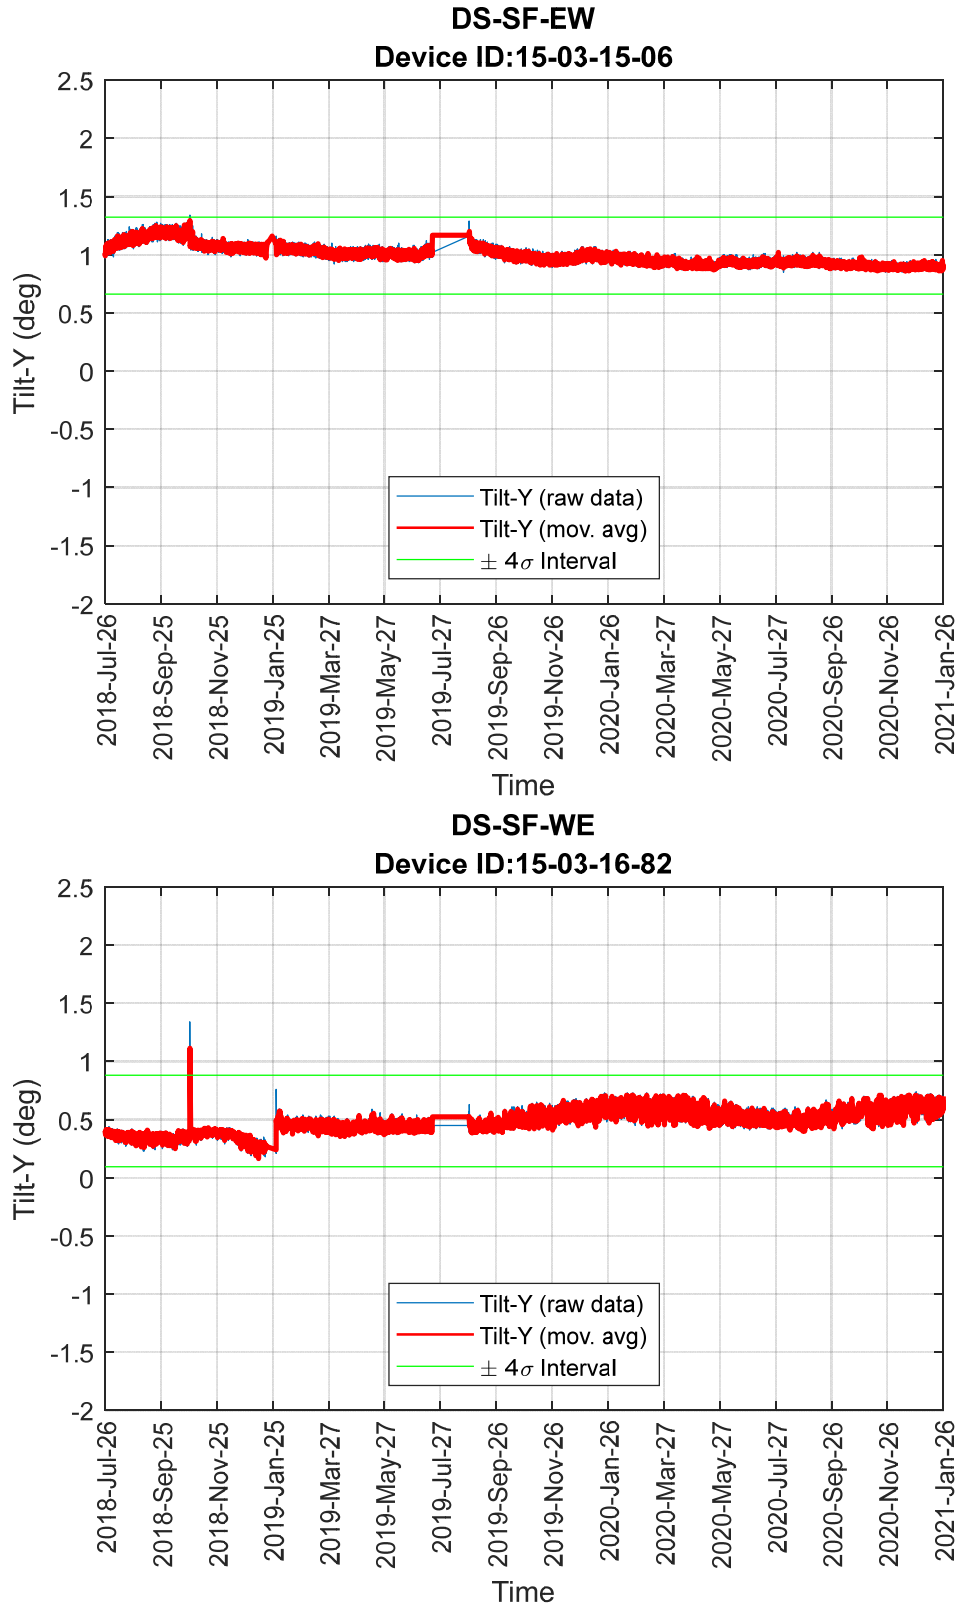
Fig. 10.4 – TILT Y. Raw values and corresponding moving average associated with all 8 inclinometers.

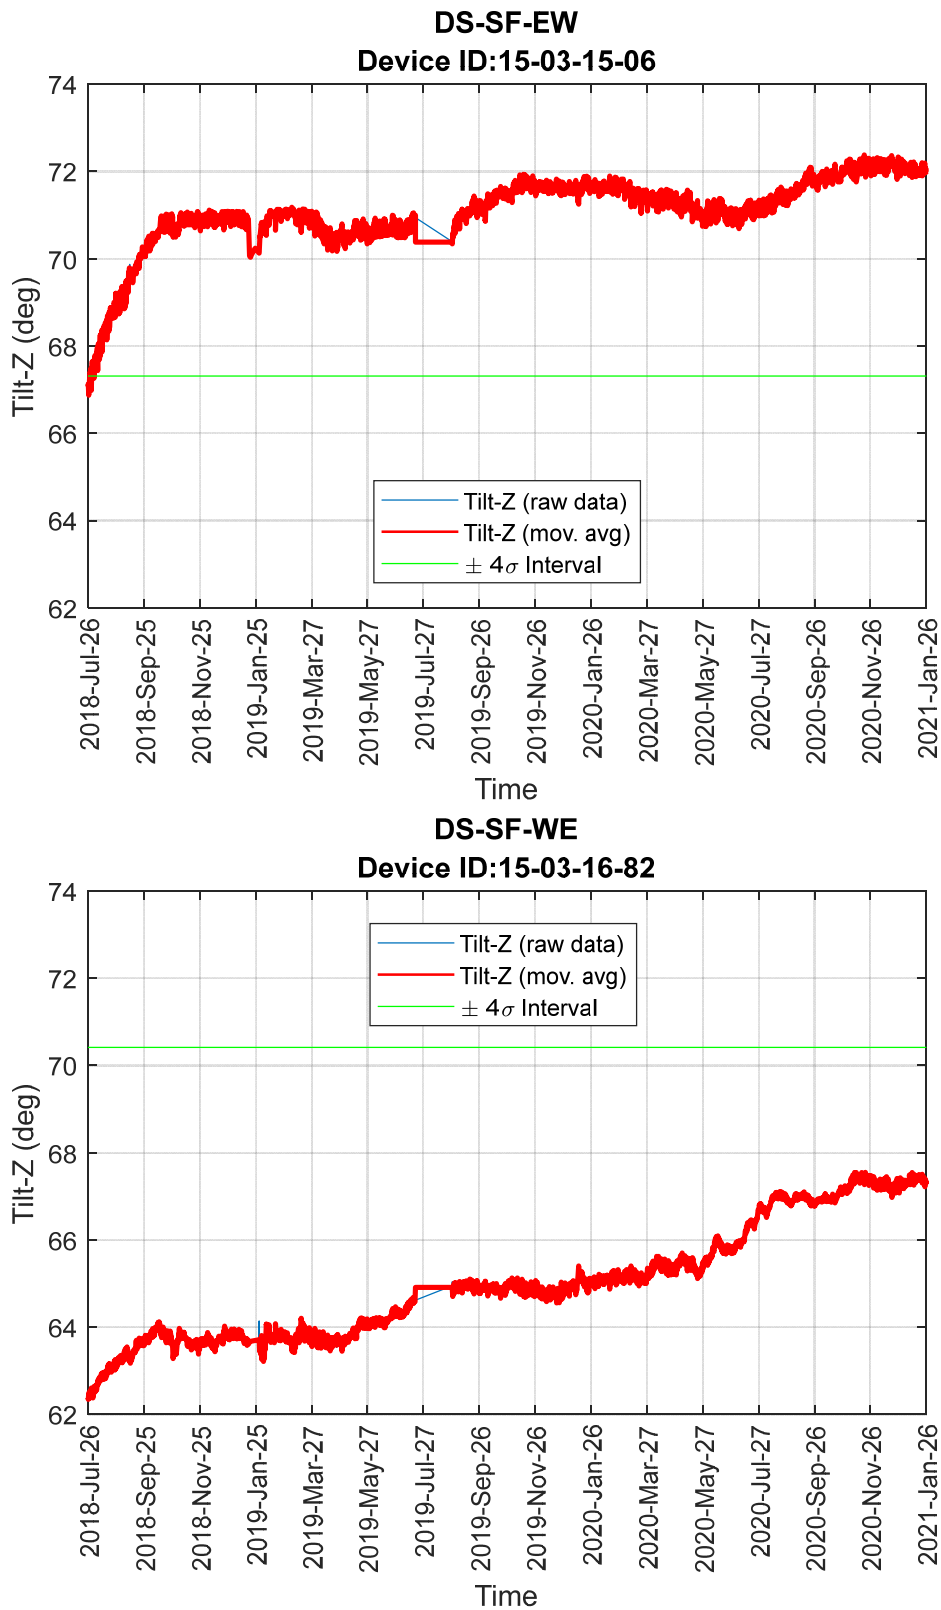
Fig. 10.5 – TILT Z. Raw values and corresponding moving average associated with all 8 inclinometers.

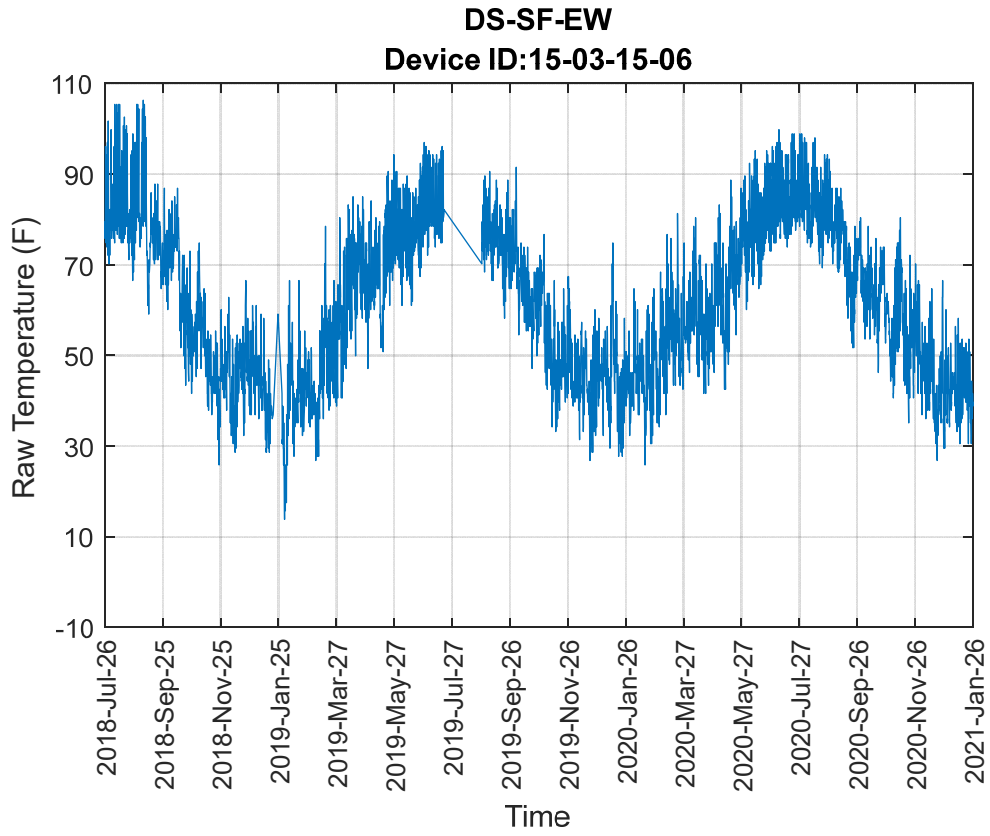
**Fig. 10.6** – Raw temperature from the 42 strain gages.

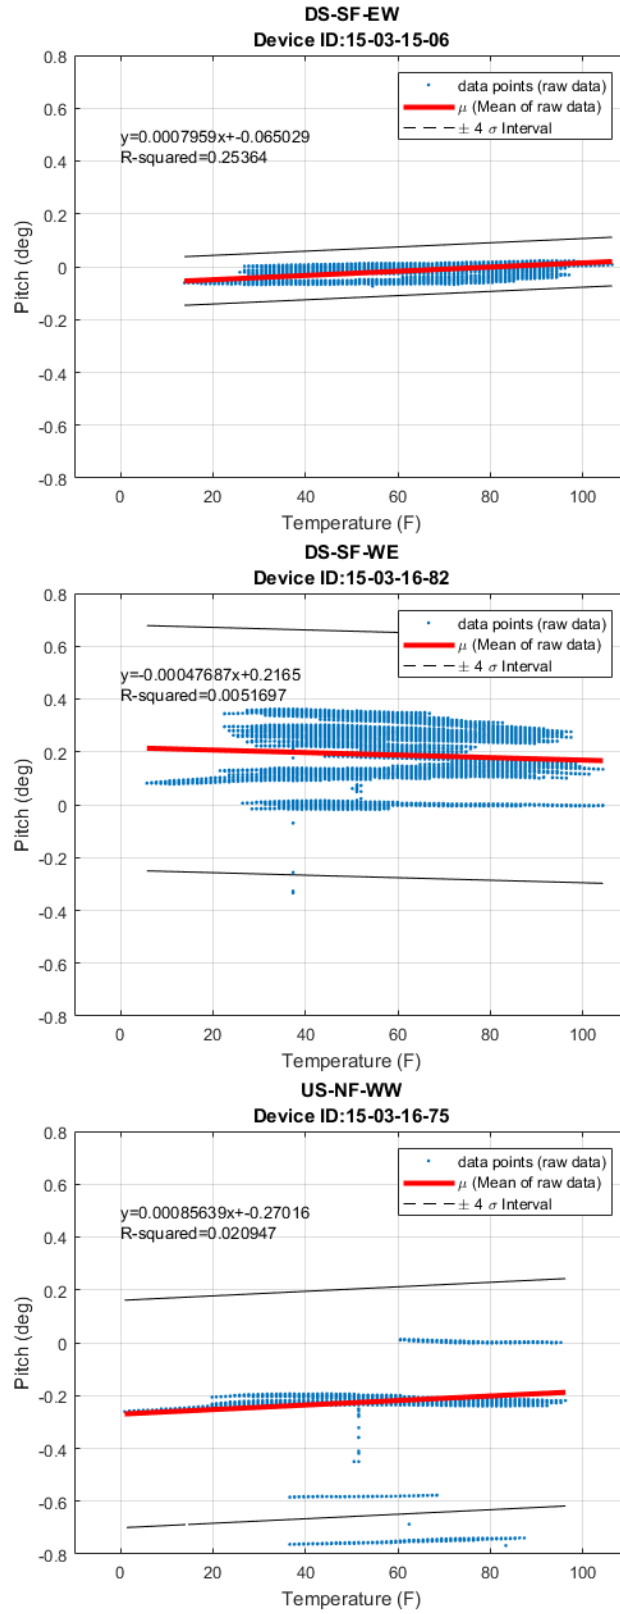
**Fig. 10.7 – PITCH.** Raw pitch vs temperature.

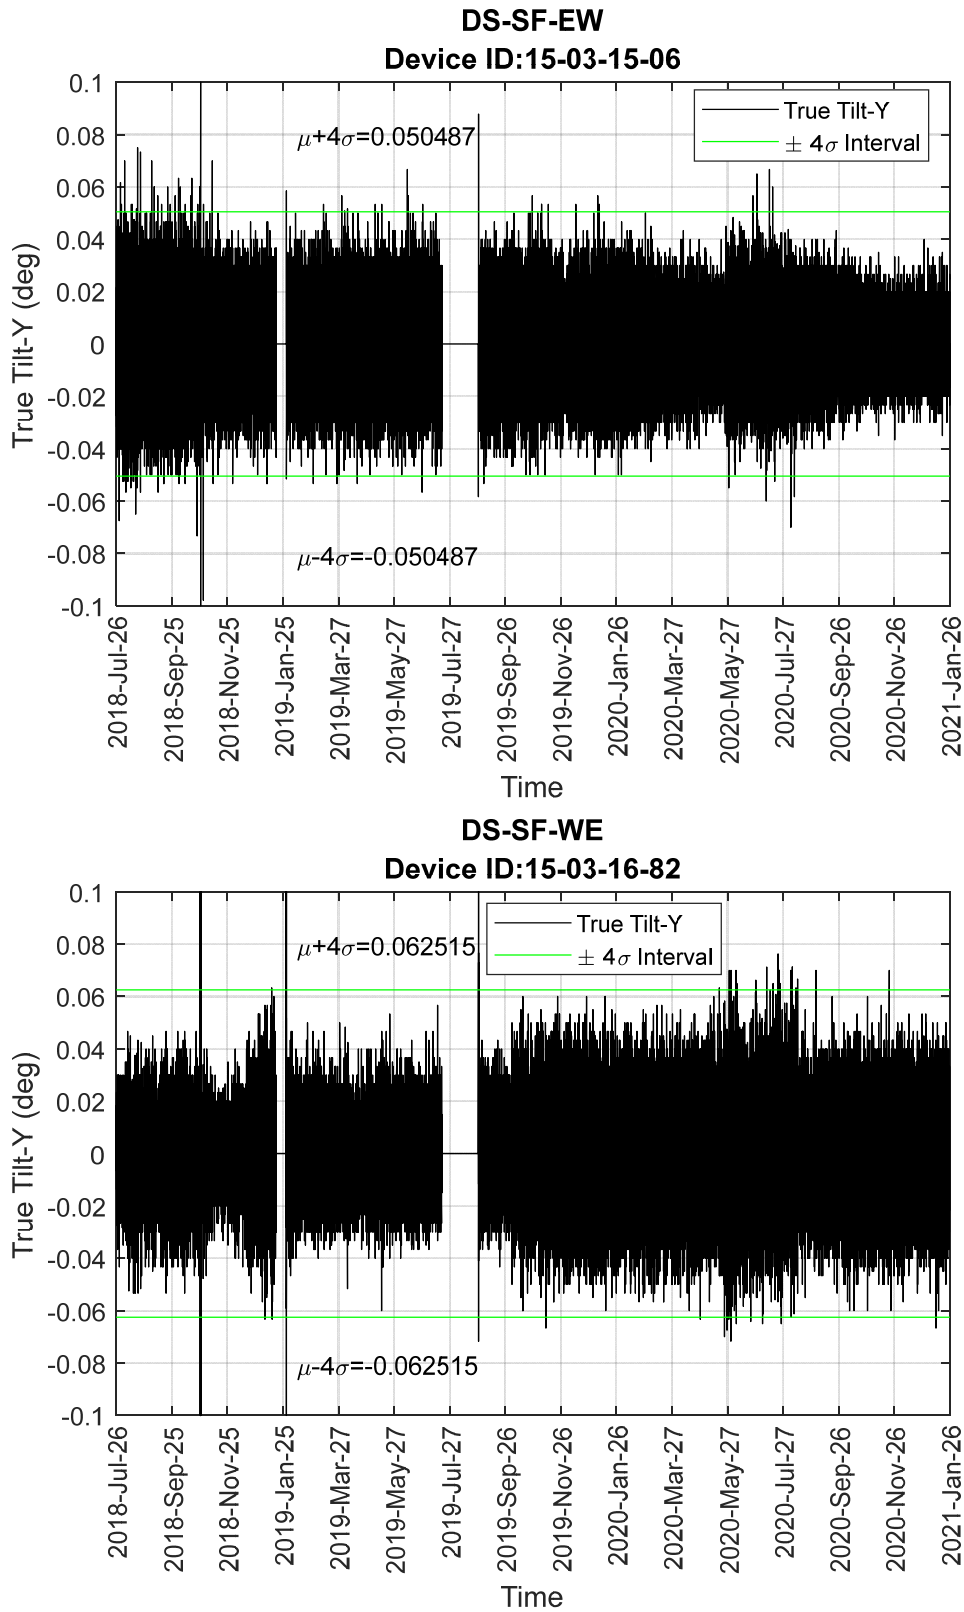
Fig. 10.9 – TILT-Y. True tilt-Y during the monitoring period.

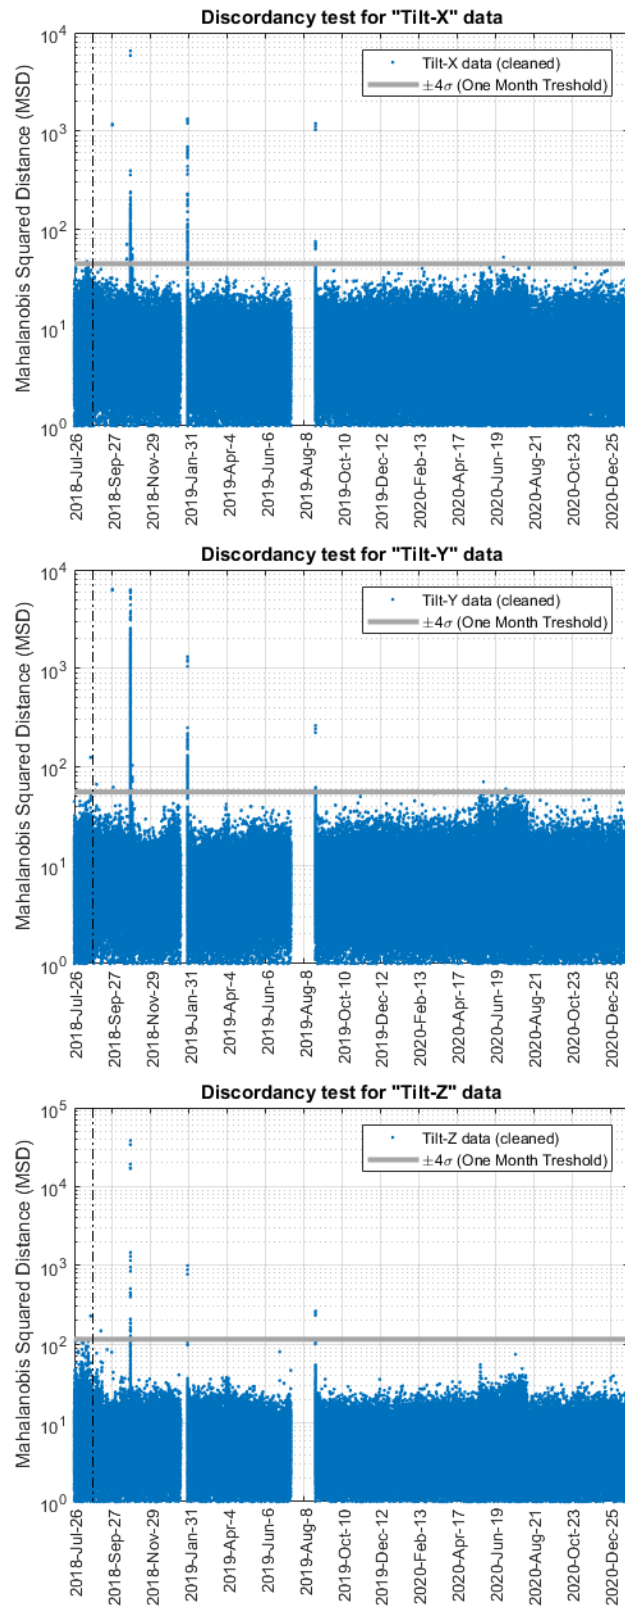
Fig. 10.11 – Mahalanobis squared distance applied to the Tilt data.
