PHASED CONSTRUCTION BRIDGES: MONITORING AND ANALYSIS FOR TRAFFIC-INDUCED VIBRATION

June 21, 2022

1. Report No. SPR-P1(20) M102	2. Government Accession No.	3. Recipient's Catalog No.	
4. Title and Subtitle Phased Construction Bridges: Monitoring and Analysis for Traffic-Induced Vibration		5. Report Date June 21, 2022

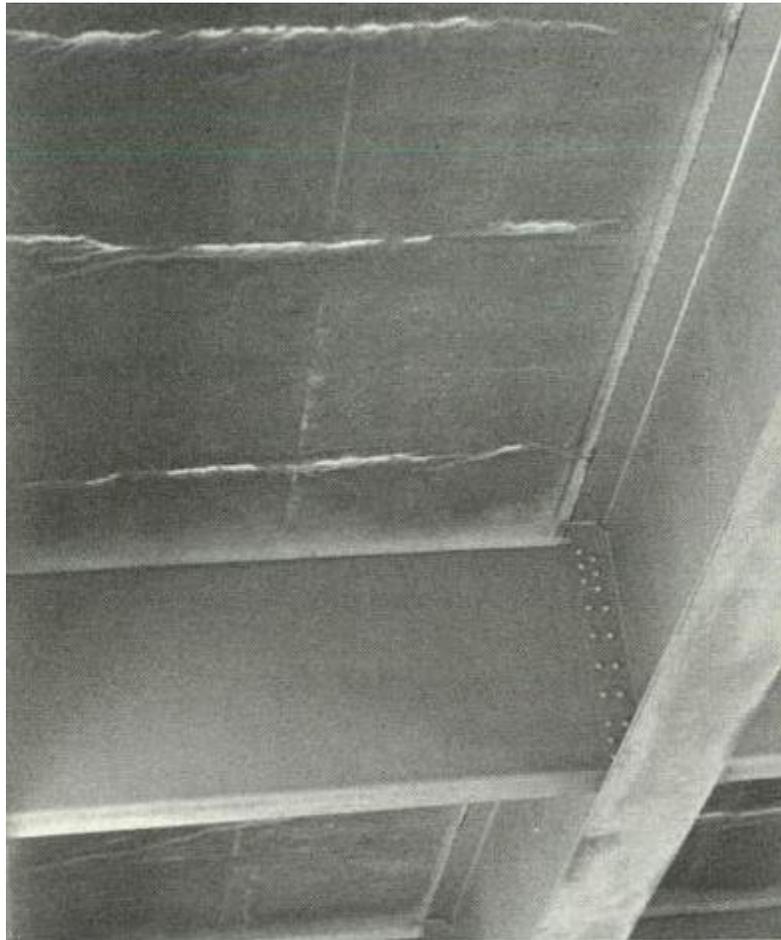
Figure 2. 1 Representative deck cracking on the underside of a deck slab (Manning 1981).

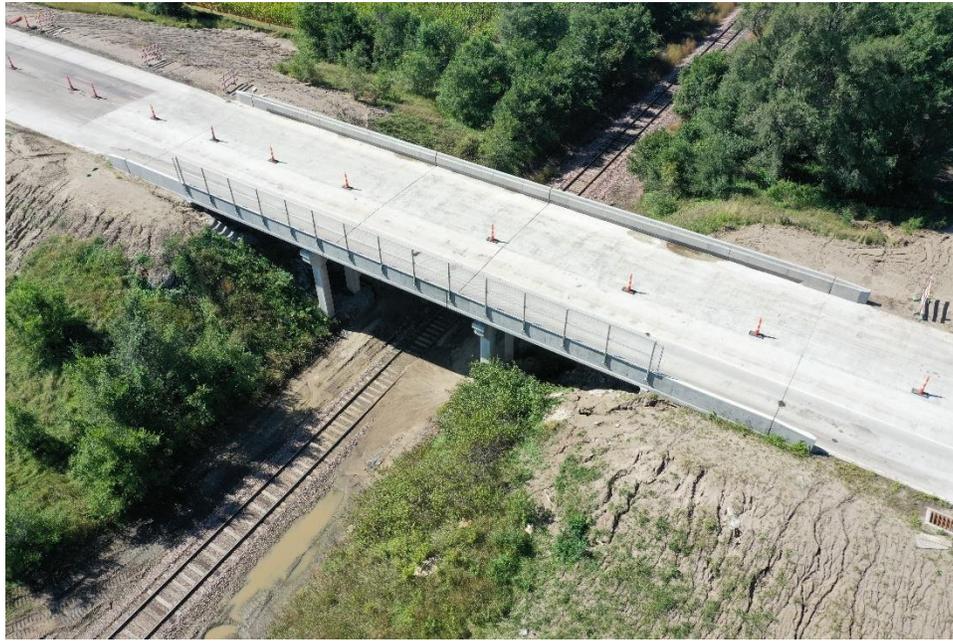
Figure 4. 2 Aerial photo of the Brunswick Viaduct Bridge (Bridge 1) after deck replacement and prior to asphalt overlay

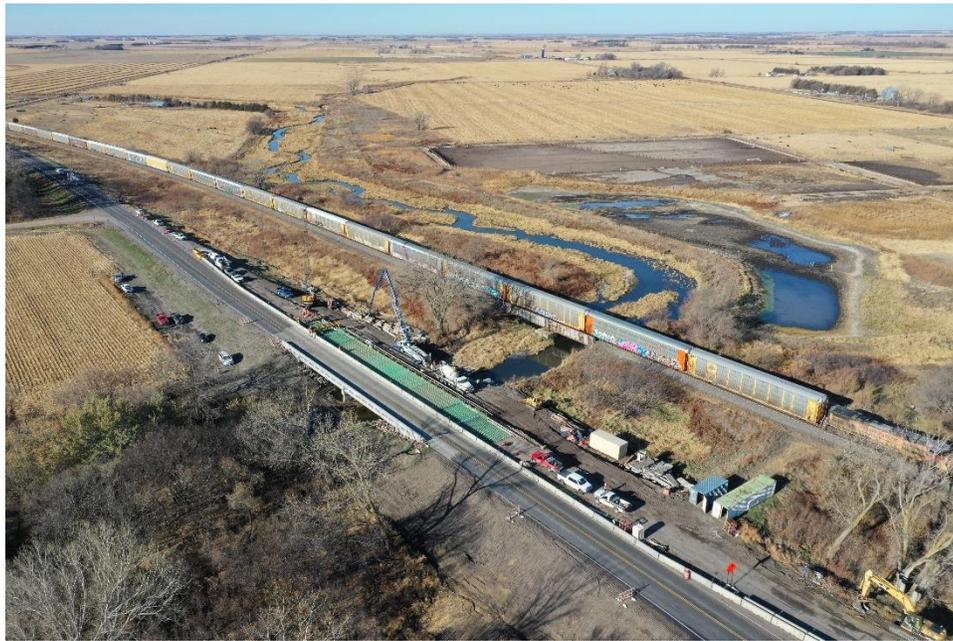
Figure 4. 4 Aerial photo of phase 2 deck pour at Silver Creek Bridge (Bridge 2)

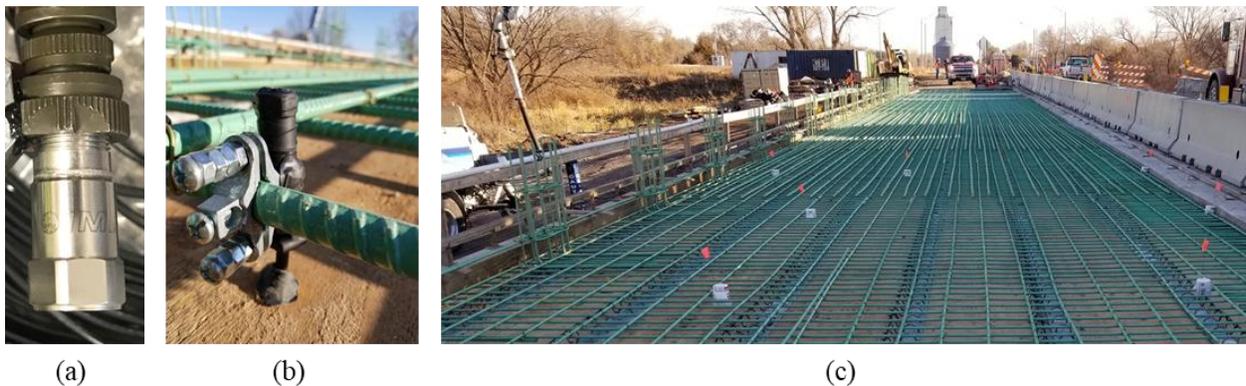
Figure 4. 5 (a) PCB 603C01 sensor; (b) waterproofed sensor fixed to rebar; and, (c) protected sensors fixed to rebar for T3-BR2.

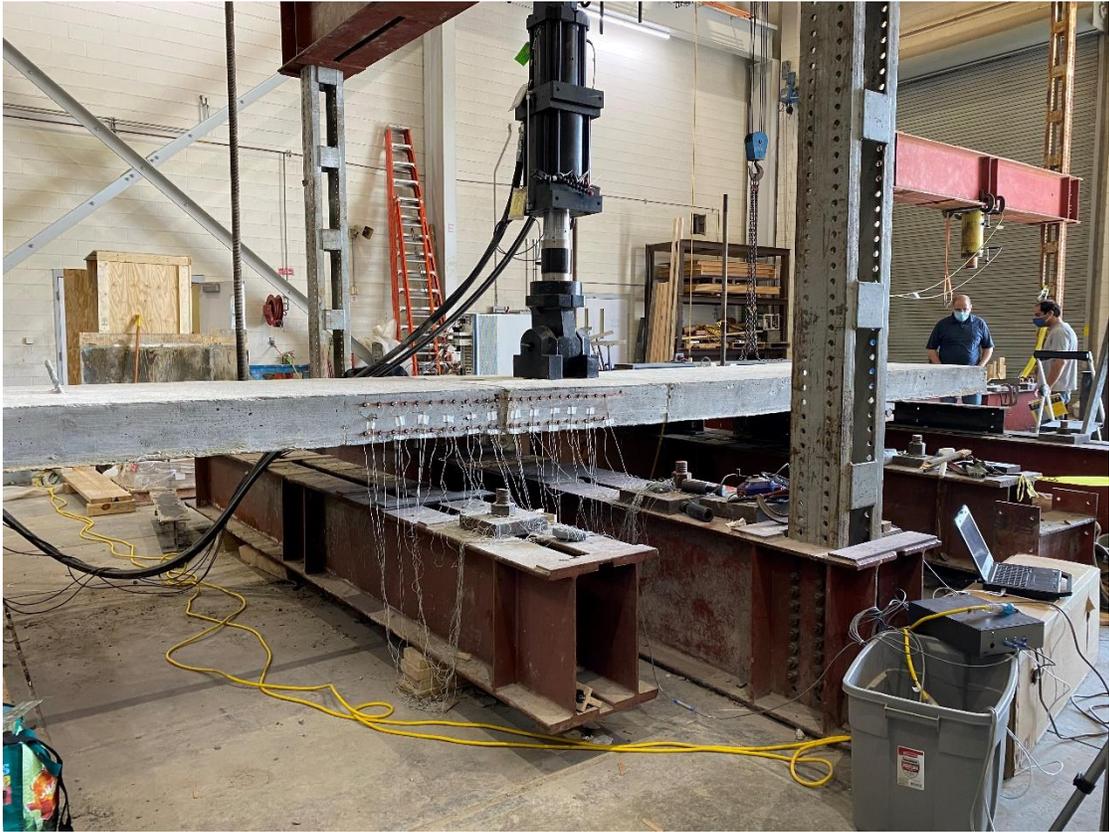
Figure 5. 7 Photograph of monotonic test
