TECHSUMMARY November 2023

State Project No. DOTLT1000216 | LTRC Project No. 18-1P

Exploration of Drone and Remote Sensing Technologies in Highway Embankment Monitoring and Management (Phase I)

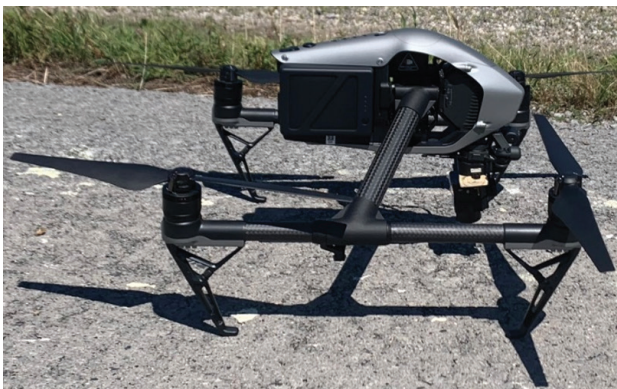
Figure 1. FLIR Vue Pro R thermal camera mounted on DJI Inspire 2

Two drone cameras were evaluated in this study: FLIR Vue Pro R, a radiometric thermal camera (Figure 1), and MicaSense RedEdge, a multispectral camera for precision agriculture (Figure 2). Specifically, they were evaluated both in laboratory and field settings for their accuracy, repeatability, and reliability.

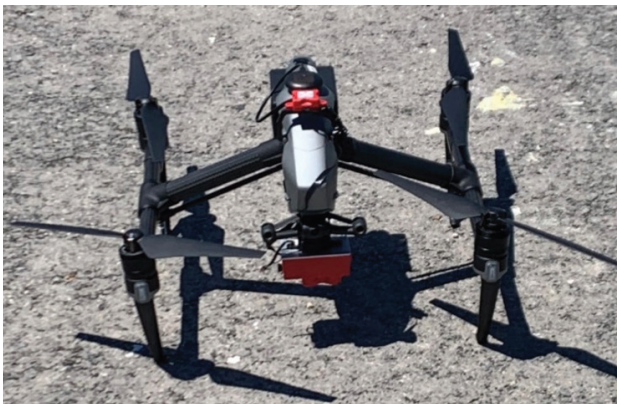
Figure 2. MicaSense RedEdge multispectral camera mounted on DJI Inspire 2
