TxDOT Report 5-7008-01-1

## **Implementation of Electrical Resistivity Imaging Manual**

Report Publication Date:	Submitted: August 2023 Published: November 2023
Project:	5-7008-01
Project Title:	Implementation of Electrical Resistivity Imaging Manual

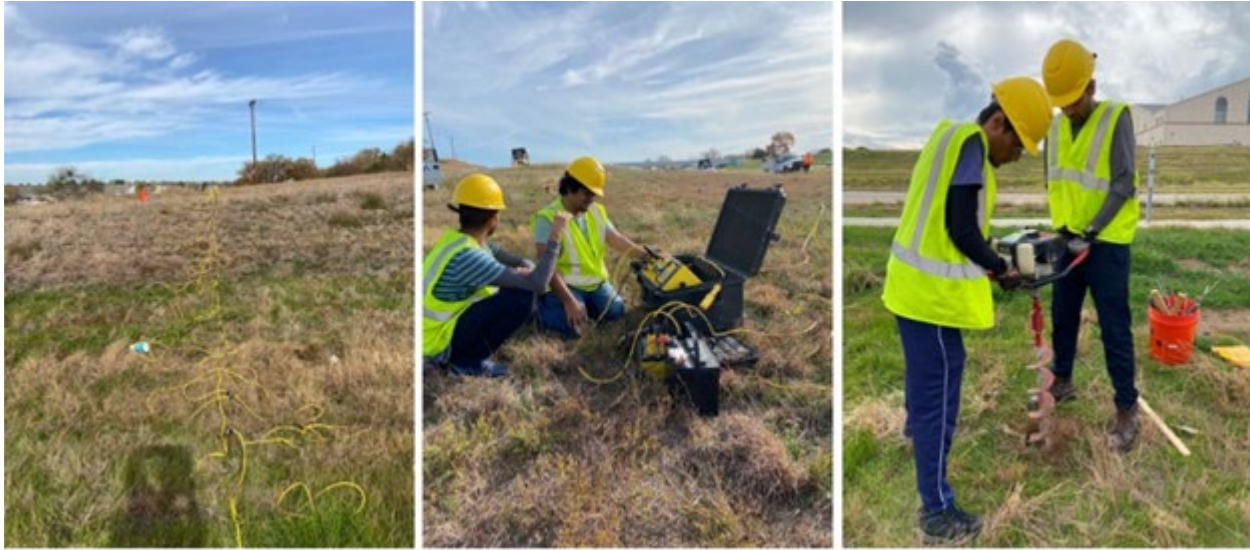
**Figure 2.3.** Implementation of ERI along highway US 67 and soil sample collection

In coordination with the Fort Worth district contacts, the research team implemented the ERI plan for US 67 project on December 2<sup>nd</sup> and 3<sup>rd</sup>, 2021. Twelve ERI surveys were conducted using 28 and 56 electrodes with 3-, 6-, and 8-foot spacings. In addition, six soil samples were collected from locations of high sulfate concentrations to be tested in the laboratory. Borings were advanced to a maximum depth of 2.5 feet using an electric hand auger. Figure 2.3 shows the implementation of ERI along highway US 67 and soil sample collection. Two days before conducting the ERI surveys, 0.33 inches of precipitation were recorded at the study area (Weather Underground 2022).

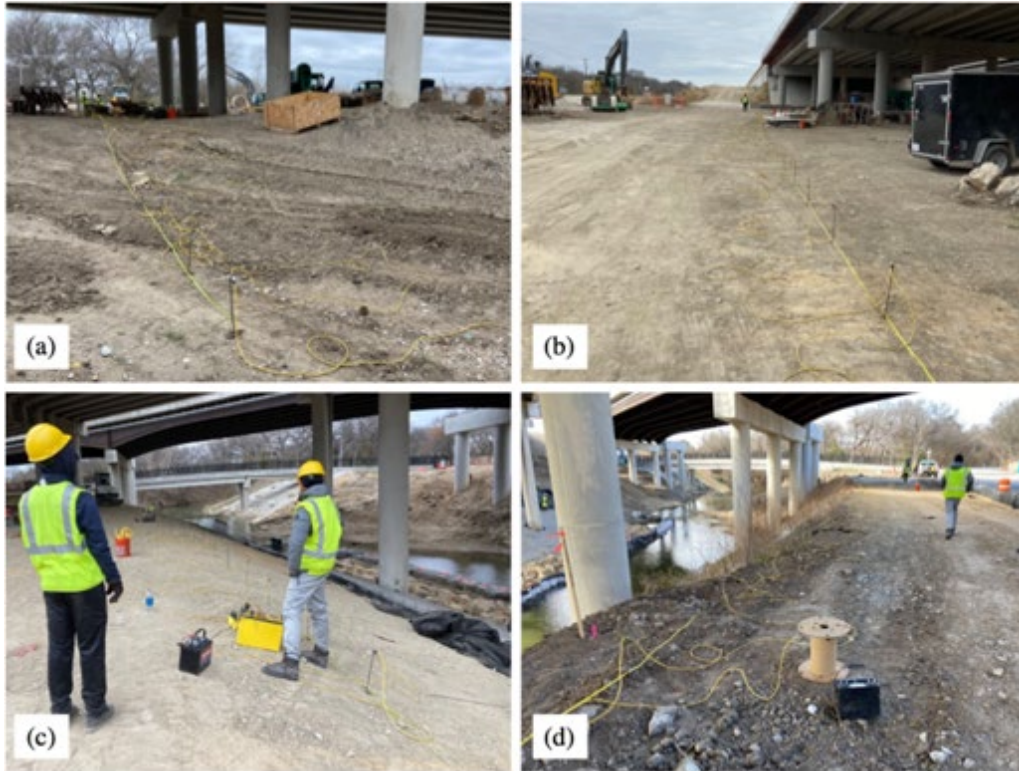
**Figure 2.12.** Implementation of ERI for IH 20 project; (a) on the crest of the slope at the river's West bank, (b) on the crest of the slope perpendicular to the river, (c) on the middle of the slope on the river's West bank, and (d) on the crest of the slope on the river's East bank.

In coordination with the Fort Worth district contacts, the research team implemented the ERI plan for IH 20 project on January 20<sup>th</sup>, 2022. Five ERI surveys were conducted using 28 electrodes with 4- and 6-foot spacings. Figure 2.12 shows the implementation of ERI for the IH 20 at Clear Fort Trinity River along Interstate 820 Loop. During 15 days before implementing the ERI surveys, no precipitation was observed at the study area (Weather Underground 2022).

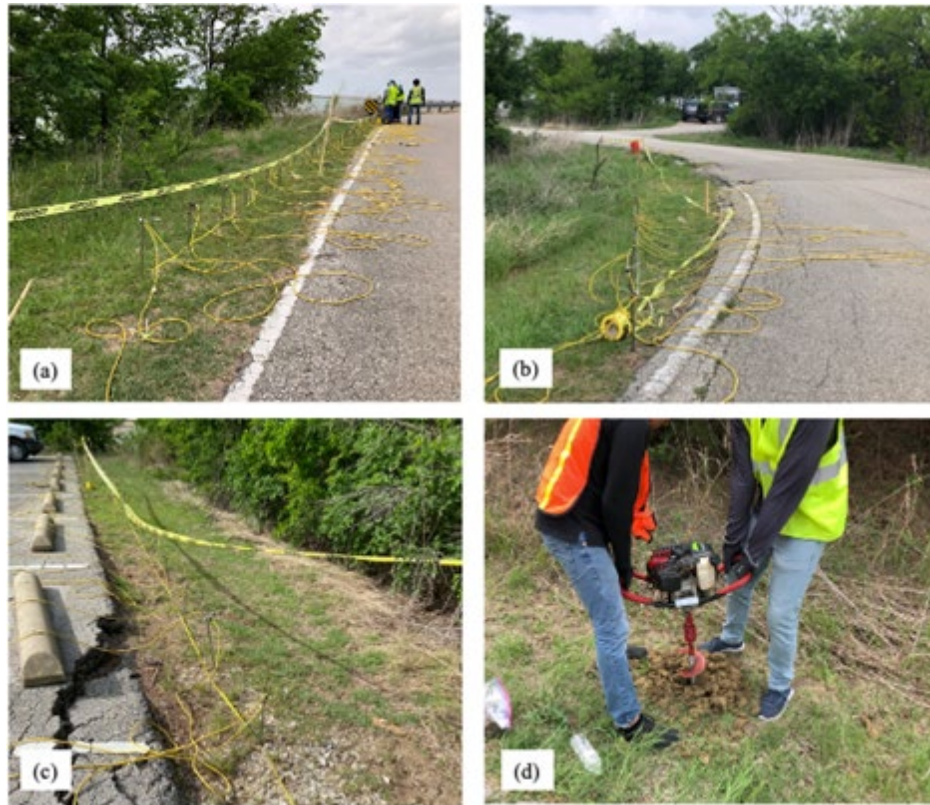
**Figure 2.17.** Implementation of ERI for Cedar Hill State Park; (a) Line 1 in Zone 1, (b) Line 2 in Zone 2, (c) Line 2 in Zone 2, and (d) soil sampling.

In coordination with the Dallas district contacts, the research team implemented the ERI plan for Cedar Hill State Park on April 21<sup>st</sup>, 2022. Eleven ERI surveys were conducted using 28 electrodes with 2- and 3-foot spacings. In addition, six soil samples were collected from multiple locations, as shown in Figure 2.16, to be tested in the laboratory. Borings were advanced to a maximum depth of 2.5 feet using an electric hand auger. Section 2.3.3 describes laboratory electrical resistivity tests and presents sulfate testing results. Figure 2.17 shows the implementation of the ERI at Cedar Hill State Park and soil sample collection. During 15 days before implementing the ERI surveys, no precipitation was observed at the study area (Weather Underground 2022).

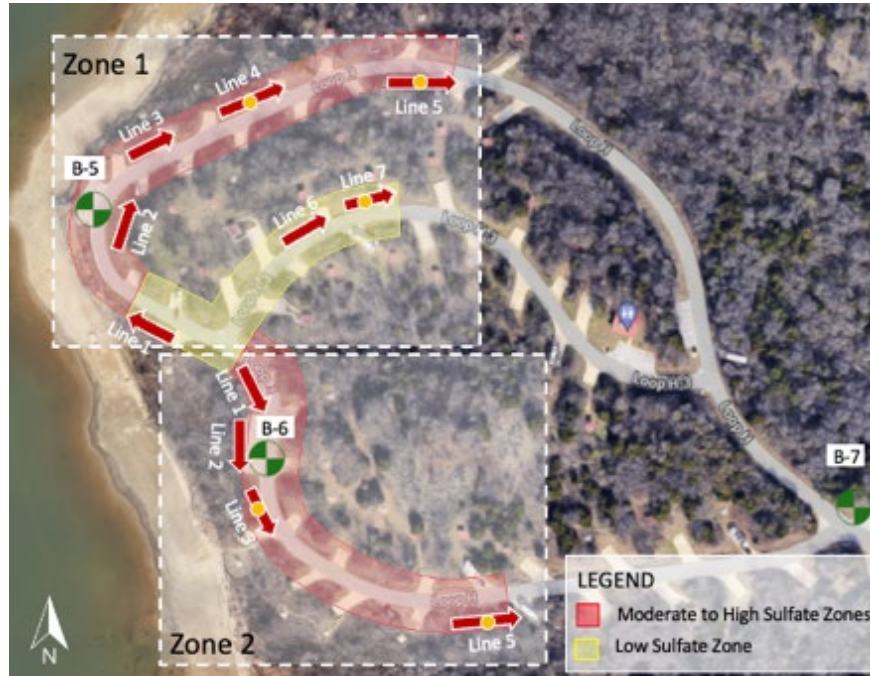
**Figure 2.21.** Overview of the extent of critical zones with the risk of sulfate-induced heaving

Figure 2.21 shows a comprehensive overview of the extent of critical zones with the risk of sulfate-induced heaving. As indicated in Figure 2.21, the extent of critical sulfate concentration zones along Loop H goes beyond zone 1 and 2 limits. However, there is a low risk of sulfate-induced heaving along Loop H-3.

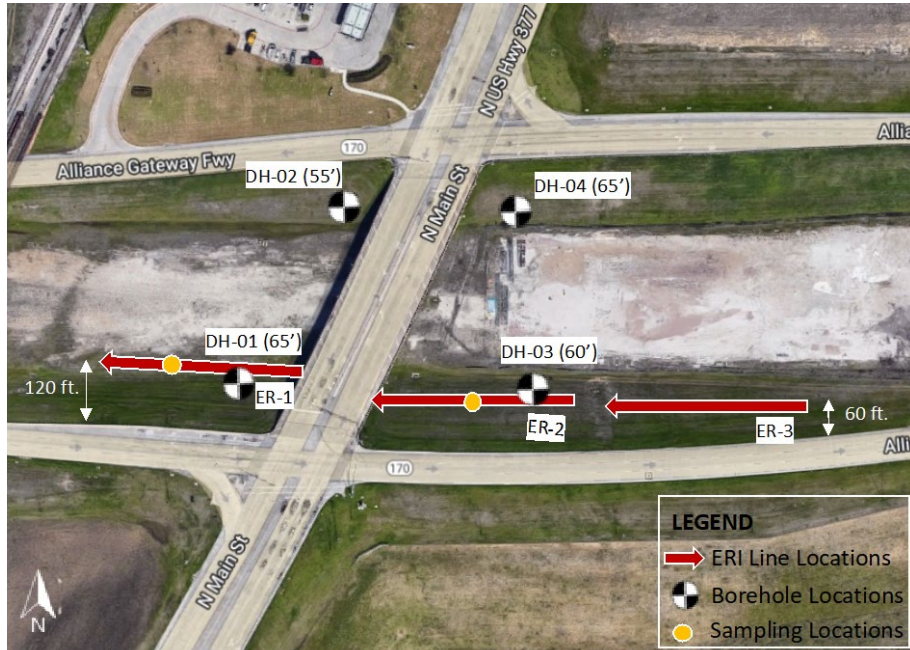
**Figure 2.28.** ERI data collection plan and borehole locations for SH 170 at N Main St

Figure 2.28 illustrates the ERI data collection plan and borehole locations for SH 170 at the N Main St project. This implementation aimed to assess the sulfate concentration levels at the study area and identify critical zones prone to sulfate-induced heaving.

Sulfate concentration was 5,680 ppm at a depth of approximately 4 feet at borehole DH-01.

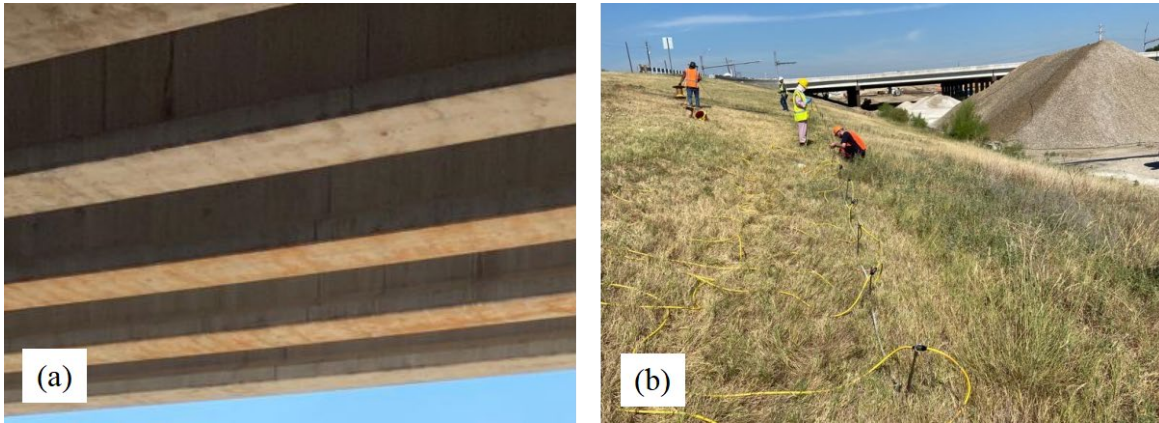
**Figure 2.29.** Subsurface resistivity images; (a) Line ER-1 and (b) Line ER-3

In coordination with the Fort Worth district contacts, the research team implemented the ERI plan for SH 170 at N Main St on July 12<sup>th</sup>, 2022. Three ERI surveys were conducted using 56 electrodes with 4- and 6-foot spacings. Line ER-1 was implemented within the road limit; however, ER-2 and ER-3 were implemented on the slope on the south side. In addition, two soil samples were collected from two locations, as shown in Figure 2.28, to be tested in the laboratory. The borings were advanced to a maximum depth of 1 foot using an electric hand auger. Section 2.5.3 describes the laboratory electrical resistivity tests and presents sulfate testing results. Figure 2.29 shows the implementation of the ERI at SH 170 at N Main St. During 15 days before implementing the ERI surveys, no precipitation was observed at the study area (Weather Underground 2022). The average maximum temperature for a week before implementation was about 100°F.

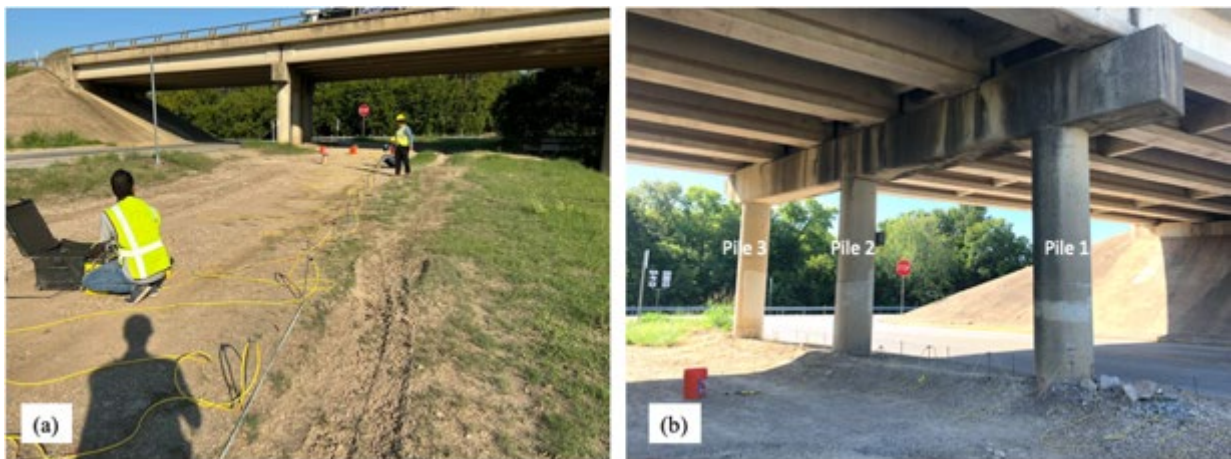
**Figure 2.34.** Implementation of the ERI along Mary's Creek; (a) ER-1 and (b) ER-2 within a small distance from the bridge piles

In coordination with the Fort Worth district contacts, the research team implemented the ERI plan for IH 30 project on September 16<sup>th</sup>, 2022. Three ERI surveys (ER-2 was performed in parallel and at the center of bridge piles) were conducted using 28 and 56 electrodes with 4- and 6-foot spacings. Figure 2.34 shows the implementation of the ERI along Mary's Creek. In the first week of September 2022, 2.68 inches of precipitation were recorded at the site (Weather Underground 2022).

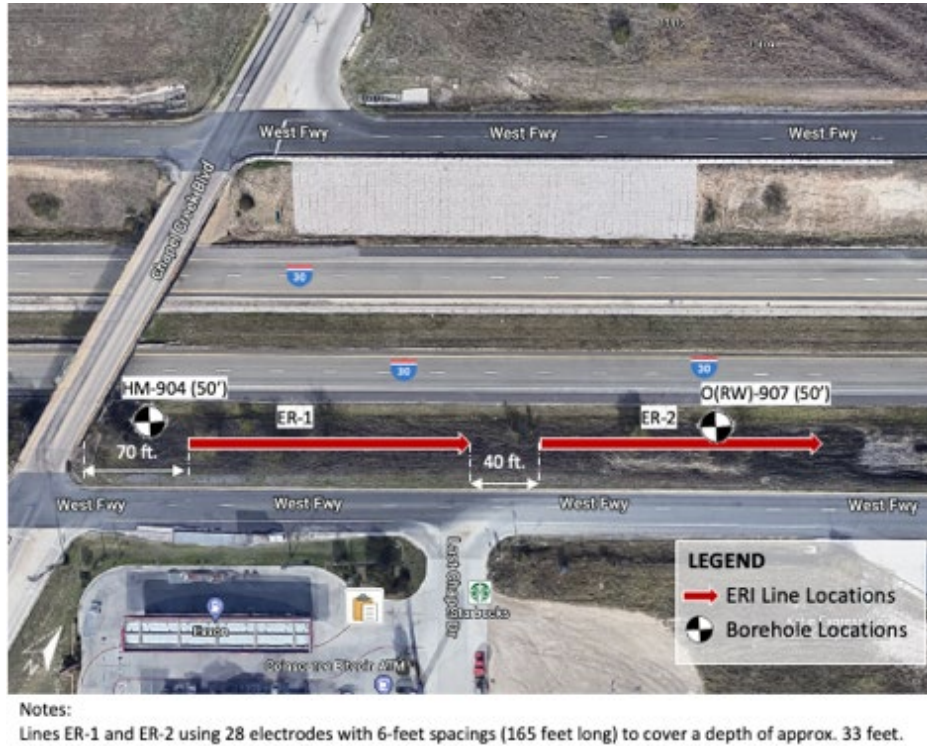
**Figure 2.38.** ERI data collection plan and borehole locations for IH 30 at Chapel Creek Blvd

Figure 2.38 illustrates the ERI data collection plan and borehole locations for IH 30 at Chapel Creek Blvd. This implementation aimed to identify the subsurface conditions behind the retaining wall (ER-1 in Figure 2.38) and assess the stability of the slope (ER-2 in Figure 2.38).

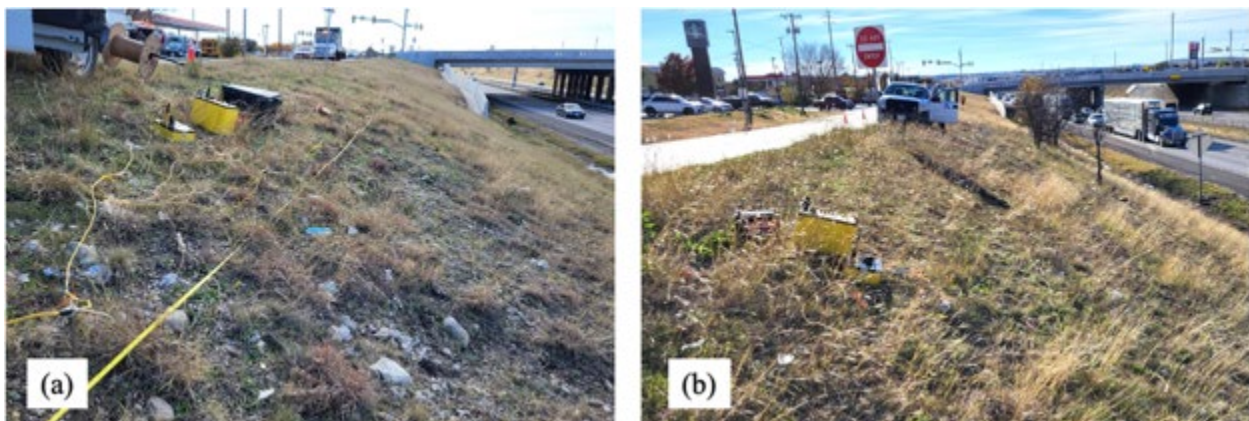
**Figure 2.39.** Implementation of the ERI along IH 30 at Chapel Creek Blvd; (a) Line ER-1 and (b) Line ER-2

In coordination with the Fort Worth district contacts, the research team implemented the ERI plan for IH 30 at Chapel Creek Blvd on December 2<sup>nd</sup>, 2022. Two ERI surveys were conducted using 28 electrodes with 2 feet spacings. Figure 2.39 shows the implementation of the ERI along IH 30 at Chapel Creek Blvd. In a week before the implementation, 0.49 inches of precipitation were recorded at the site (Weather Underground 2022).

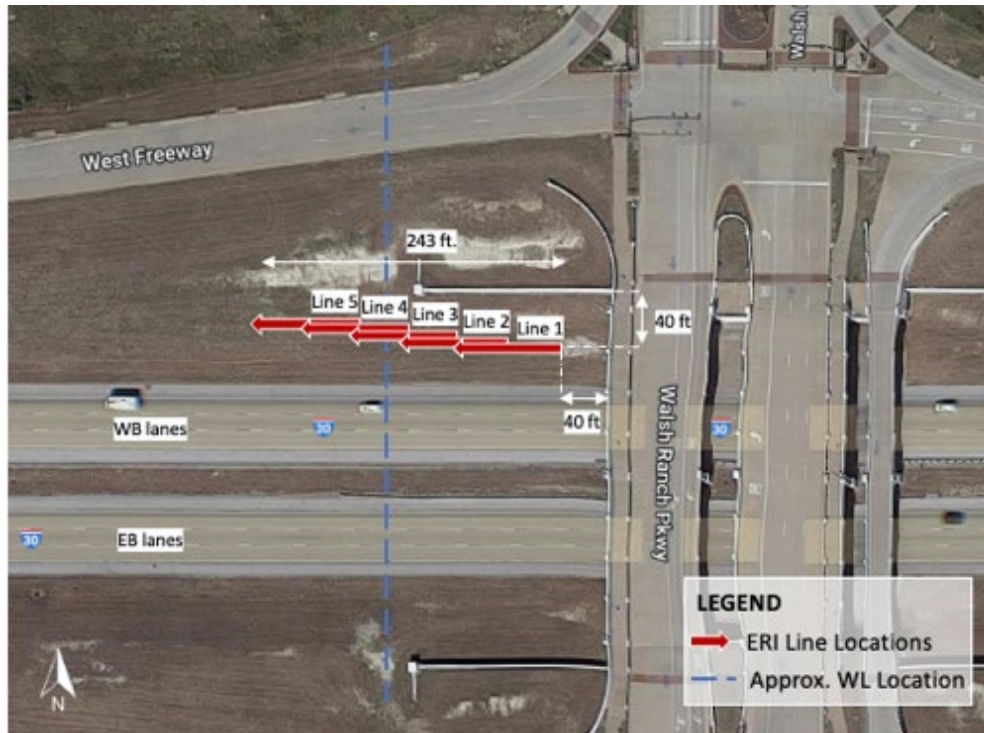
**Figure 2.43.** ERI data collection plan for IH 30 at Walsh Ranch Pkwy

Figure 2.43 illustrates the ERI data collection plan for IH 30 at Walsh Ranch Pkwy. This implementation aimed to locate an underground water pipe crossing the IH 30.

ER Lines 1 to 5 using 28 electrode with 3-feet spacings (81 feet long) to cover a depth of approx. 16 feet. 3-foot spacing is suitable for locating 18 inches diameter pipe size and larger pipes.

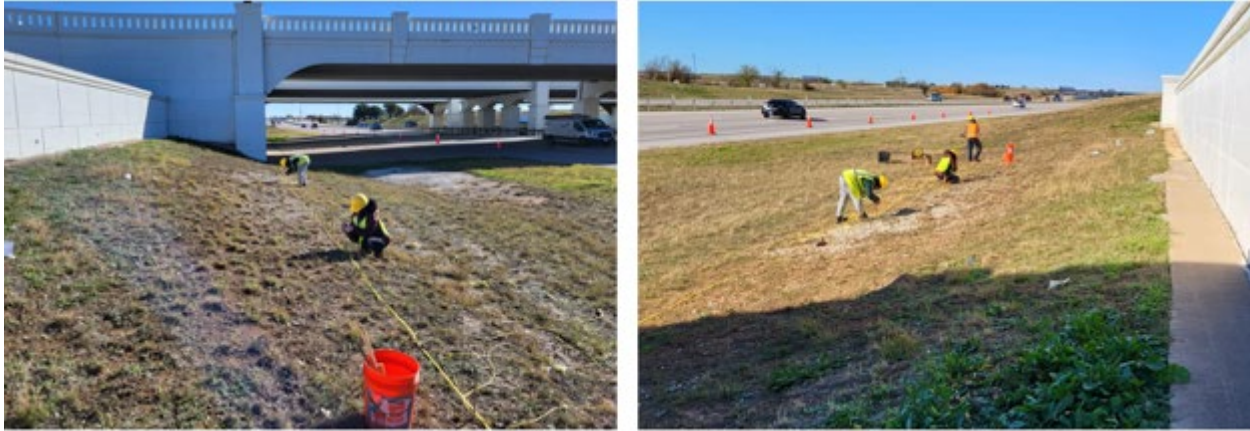
**Figure 2.44.** Implementation of the ERI along IH 30 at Walsh Ranch Pkwy

In coordination with the Fort Worth district contacts, the research team implemented the ERI plan for IH 30 project on November 30<sup>th</sup>, 2022. Five ERI surveys were conducted using 28 electrodes with 3 feet spacing. The ERI lines were performed continuously and overlapped with one another. Overlapping lines ensure no gaps between the lines, so the water line is unlikely to be missed. Additionally, it increases the confidence level of the ERI findings since two series of data are available for each location. Figure 2.44 shows the implementation of the ERI along IH 30 at Walsh Ranch Pkwy. In a week before the implementation, 1.97 inches of precipitation were recorded at the site (Weather Underground 2022).

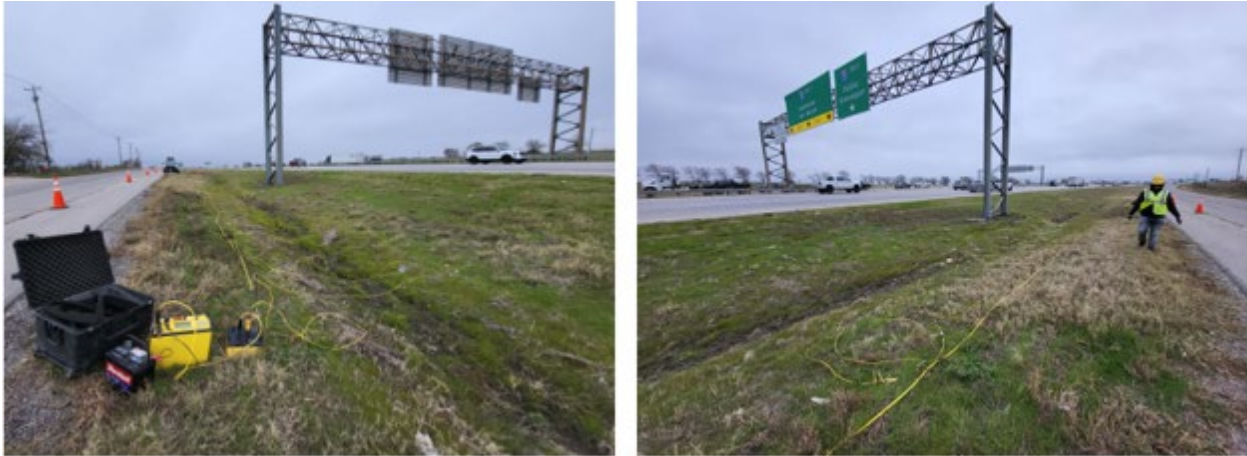
**Figure 2.48.** Implementation of the ERI along IH 20 at the east side of Farmer Rd

In coordination with the Fort Worth district contacts, the research team implemented the ERI plan for IH 20 project on December 2<sup>nd</sup>, 2022. Four ERI surveys were conducted using 28 electrodes with 3 feet spacings. The ERI lines were performed continuously and overlapped with one another. Overlapping lines ensure no gaps between the lines, so the water lines are unlikely to be missed. Additionally, it increases the confidence level of the ERI findings since there are two series of data available for each location. Figure 2.48 shows the implementation of the ERI along IH 20 east of Farmer Rd. In a week before implementation, 0.49 inches of precipitation were recorded at the site (Weather Underground 2022).

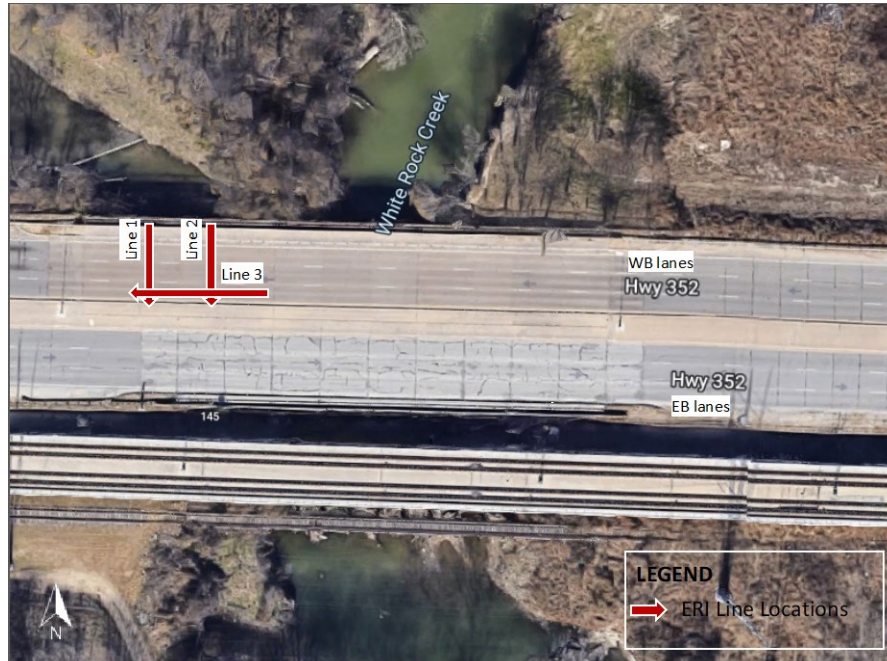
**Figure 2.51.** ERI data collection plan and borehole locations for SH 352 project

Figure 2.51 illustrates the ERI data collection plan for SH 352 project. This implementation aimed to determine the bridge pile's depth for the 2<sup>nd</sup> and 3<sup>rd</sup> bents from the west side of the bridge.

Notes:  
 ER Lines 1 and 2 using 28 electrode with 1.5-foot spacings (40.5 feet long) to cover a depth of approx. 8 feet.  
 ER Line 3 using 28 electrode with 2-foot spacings (54 feet long) to cover a depth of approx. 10 feet.

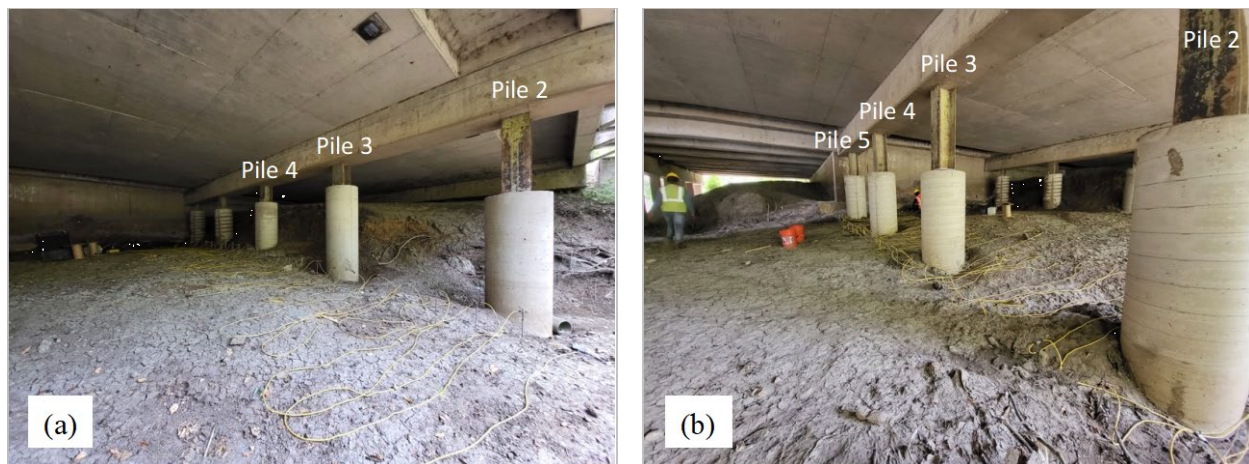
**Figure 2.52.** Implementation of ERI for SH 352 at White Rock Creek; (a) Line 1, (b) Line 2.

In coordination with the Dallas district contacts, the research team implemented the ERI plan for SH 352 project at White Rock Creek on October 7<sup>th</sup>, 2022. Three ERI surveys were conducted using 28 electrodes with 1.5- and 2-foot spacings. Figure 2.52 shows the implementation of the ERI for SH 352 at White Rock Creek. During 15 days before implementing the ERI surveys, no precipitation was observed at the study area (Weather Underground 2022).

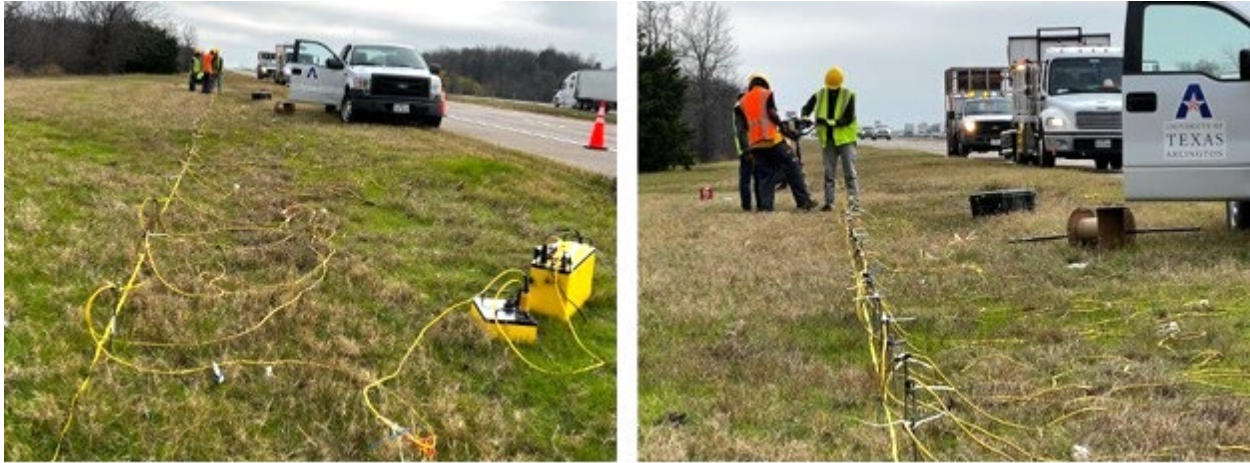
**Figure 2.60.** Implementation of the ERI along Ronald Reagan Memorial Hwy and soil sample collection

In coordination with the Fort Worth district contacts, the research team implemented the ERI plan for Site 1 along Ronald Reagan Memorial Hwy on December 9<sup>th</sup>, 2022. Three ERI surveys were conducted using 28 electrodes with 3 feet spacings. The ERI lines were performed continuously and overlapped with one another. In addition, five soil samples were collected from multiple locations, as shown in Figure 2.60, to be tested in the laboratory. The borings were advanced to a maximum depth of 1 foot using an electric hand auger. Figure 2.60 shows the implementation of the ERI along Ronald Reagan Memorial Hwy and soil sample collection. In the first week of December 2022, 0.08 inches of precipitation were recorded at the site (Weather Underground 2022).

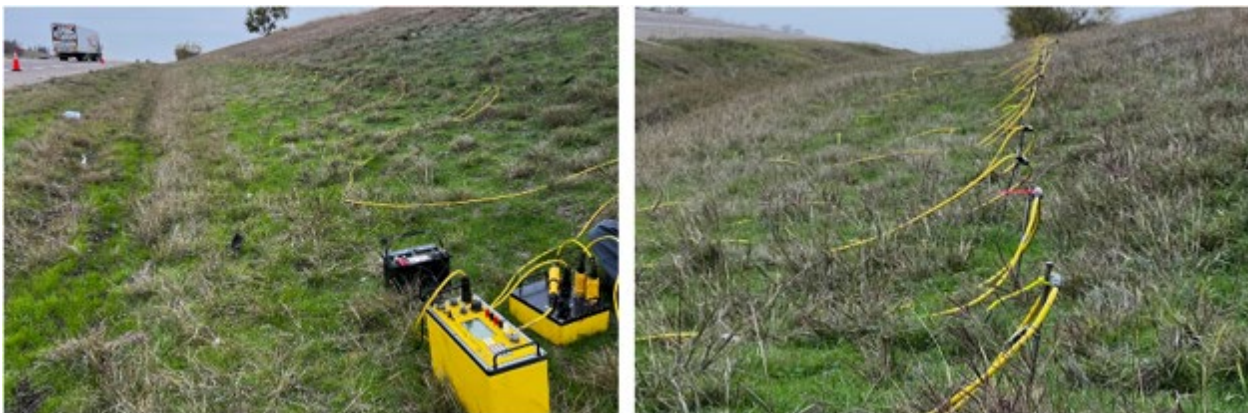
**Figure 2.64.** Implementation of the ERI for Site 2 along Ronald Reagan Memorial Hwy

In coordination with the Fort Worth district contacts, the research team implemented the ERI plan for Site 2 along Ronald Reagan Memorial Hwy on December 9<sup>th</sup>, 2022. One ERI survey was conducted using 56 electrodes with 8 feet spacing. Figure 2.64 shows the implementation of the ERI along Ronald Reagan Memorial Hwy. In the first week of December 2022, 0.08 inches of precipitation were recorded at the site (Weather Underground 2022).

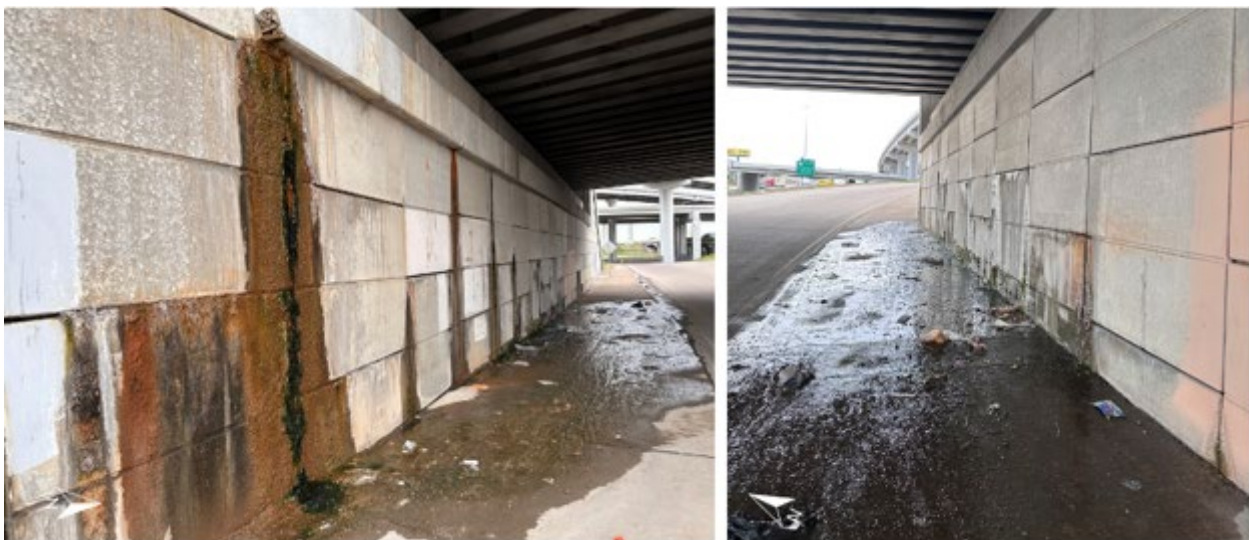
**Figure 2.67.** Current conditions of the retaining wall beneath the bridge

The study area is situated in a region mapped with Fort Worth Limestone and Duck Creek Formation with a thickness of 30 to 100 feet. Figure 2.67 shows the current conditions of the retaining wall beneath the bridge.

According to the resistivity profiles, the leakage from the retaining wall could be originated from the south side of the railroad due to the higher extent of less resistive zones in the south compared to the north side. Moreover, according to the depth of high moisture zones which are shallower on the south than on the north side, the water movement direction could be toward the north side.

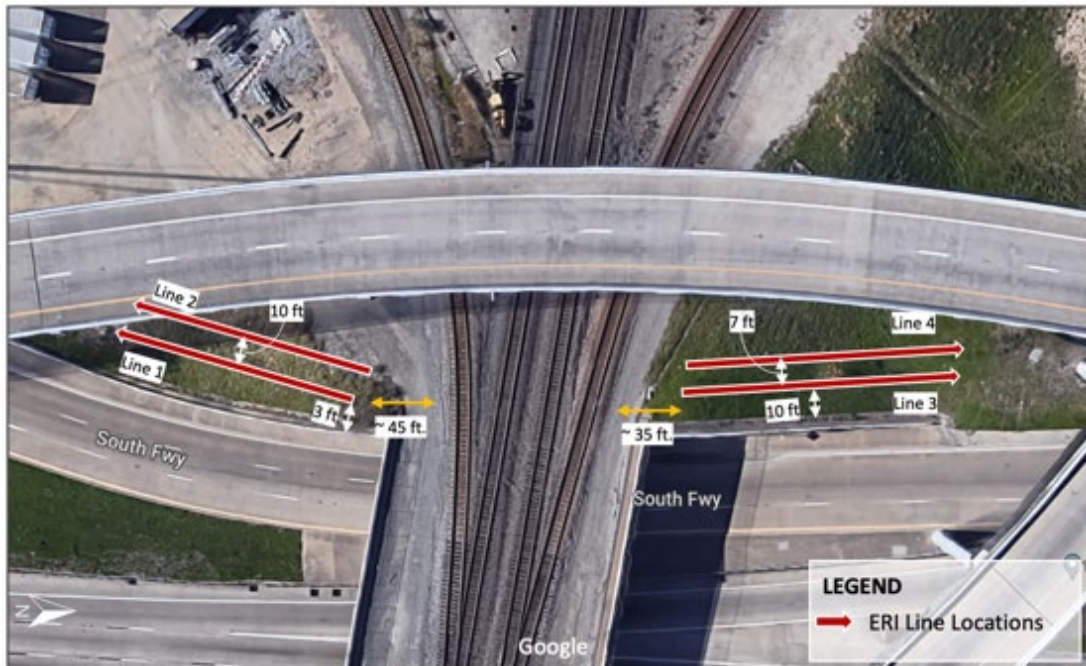
**Figure 2.68.** ERI data collection plan at IH 35W and railroad

Figure 2.68 illustrates the ERI data collection plan for IH 35W at the railroad bridge. This implementation aimed to identify the subsurface conditions behind the retaining wall under the bridge and assess the source of leakage from the wall.

ER Lines 1 to 2 using 28 electrode with 3-foot spacings (81 feet long) to cover a depth of approx. 16 feet.

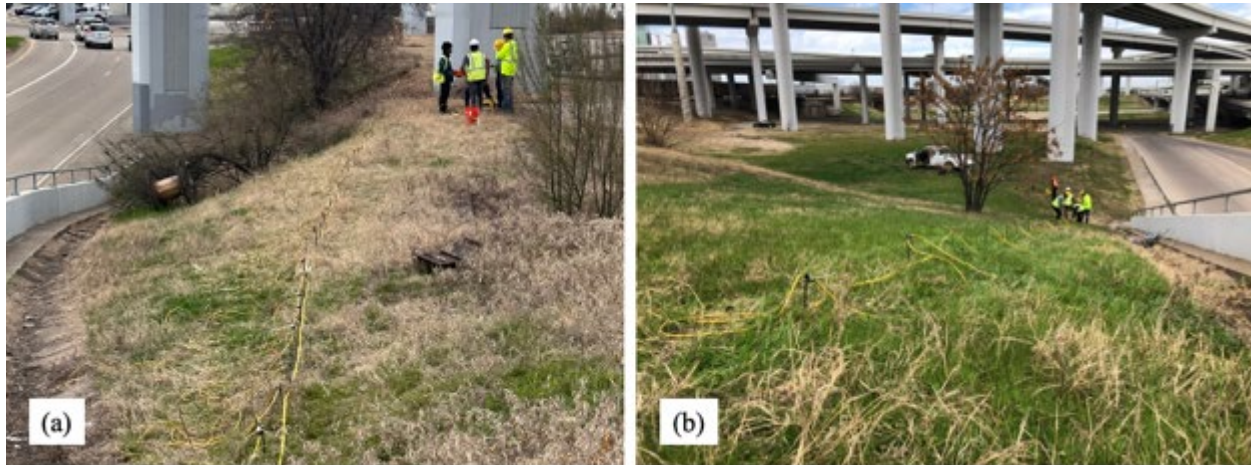
**Figure 2.69.** Implementation of the ERI at IH 35W and railroad; (a) Line 1 and (b) Line 3

In coordination with the Fort Worth district contacts, the research team implemented the ERI plan for IH 35W and the railroad on February 20<sup>th</sup>, 2023. Four ERI surveys were conducted using 28 electrodes with 3- and 4-foot spacings. Figure 2.69 shows the implementation of the ERI along the South Freeway. In a week before the ERI implementation, 0.66 inches of precipitation were recorded at the site (Weather Underground 2022).

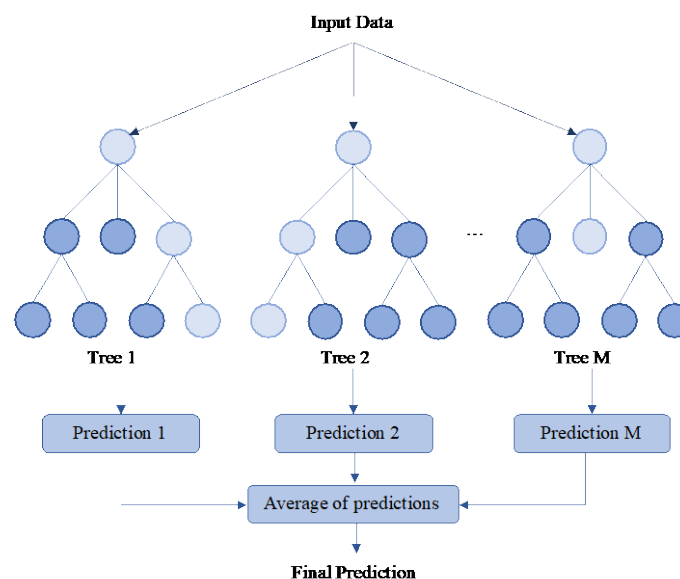
**Figure 2.73.** Random forest model structure

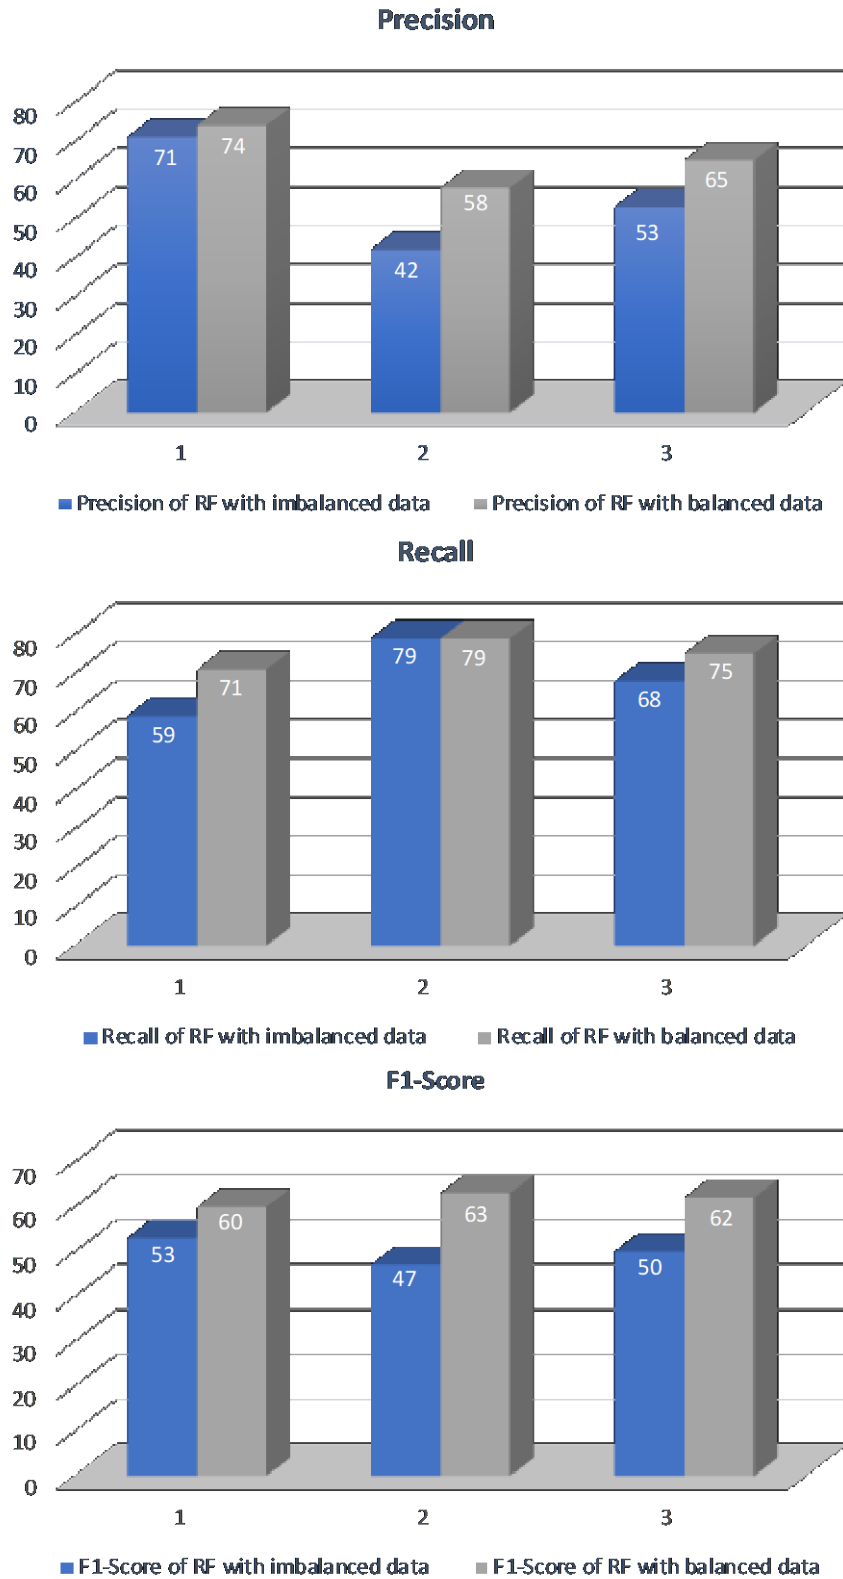
**Figure 2.74.** Comparison of performance metrics of random forest model with balanced and imbalanced class distributions of training datasets

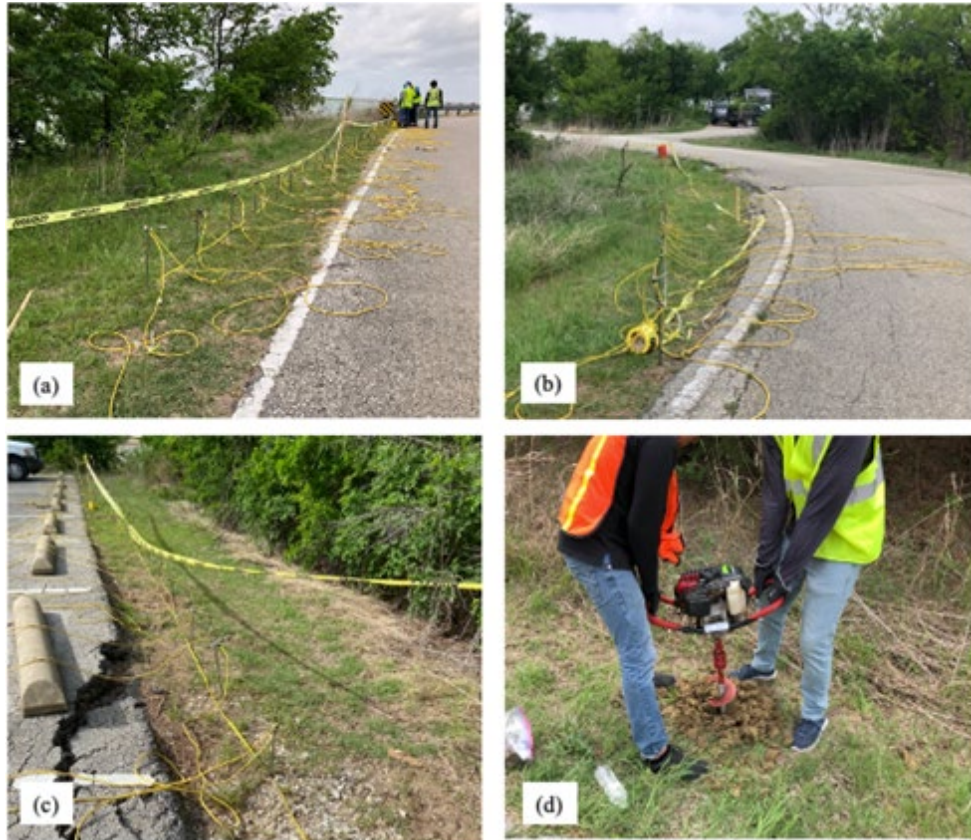
**Figure 4.2.** Implementation of ERI for Cedar Hill State Park; (a) Line 1 in Zone 1, (b) Line 2 in Zone 2, (c) Line 2 in Zone 2, and (d) soil sampling.

Figure 4.2 shows the implementation of the electrical resistivity imaging at Cedar Hill State Park and soil sample collection.

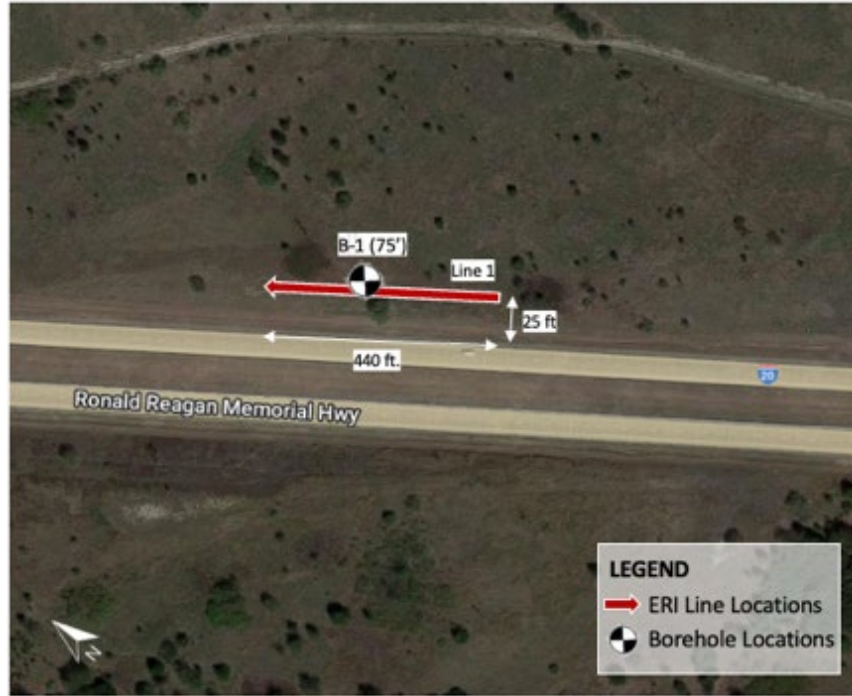
**Figure 4.6.** ERI data collection plan and borehole location along Ronald Reagan Memorial Hwy

One ERI survey was conducted using 56 electrodes with 8-foot spacings to penetrate to a depth of 88 feet. Figure 4.6 illustrates the ERI data collection plan and borehole location along Ronald Reagan Memorial Hwy.

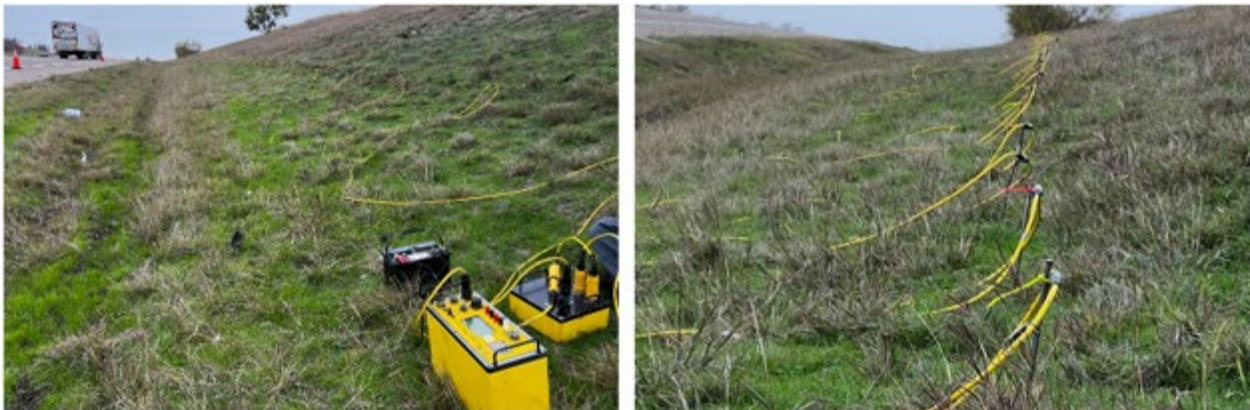
**Figure 4.7.** Implementation of the ERI along Ronald Reagan Memorial Hwy

Figure 4.7 shows the implementation of the electrical resistivity imaging along Ronald Reagan Memorial Hwy.

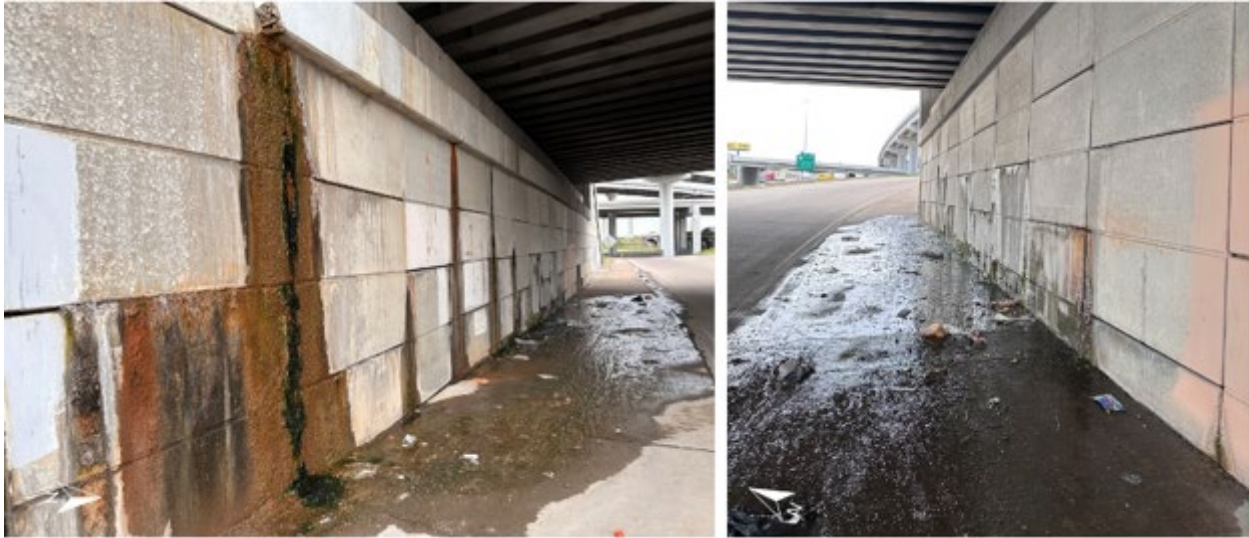
**Figure 4.9.** Conditions of the retaining wall beneath the bridge at the time of surveying

The study area is situated in a region mapped with Fort Worth Limestone and Duck Creek Formation with a thickness of 30 to 100 feet. Figure 4.9 shows the current conditions of the retaining wall beneath the railroad bridge. In a week before the ERI implementation, 0.66 inches of precipitation were recorded at the study area.

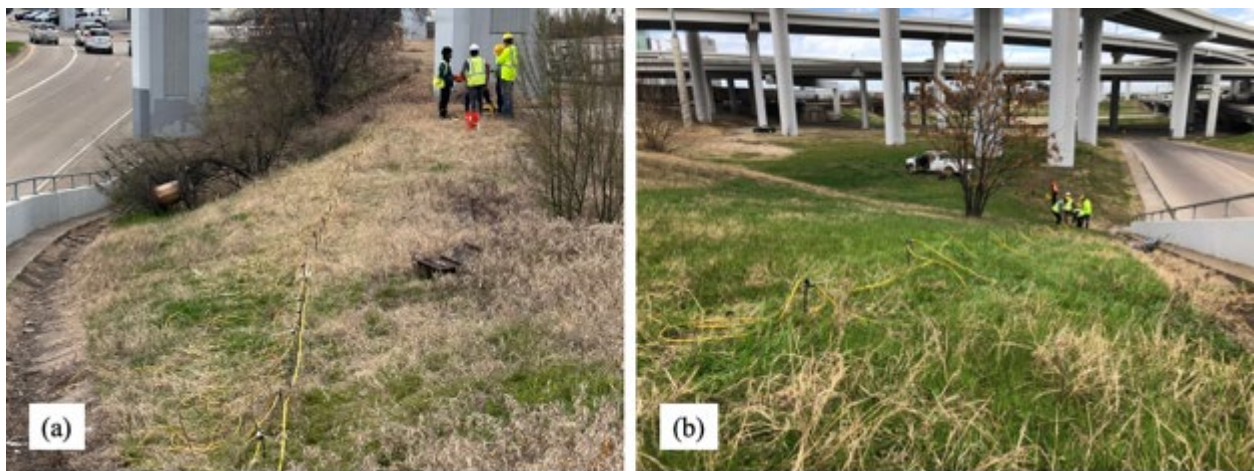
**Figure 4.11.** Implementation of the ERI at IH 35W and railroad; (a) Line 1 and (b) Line 3

Figure 4.11 shows the implementation of the electrical resistivity imaging along the South Freeway at the railroad.

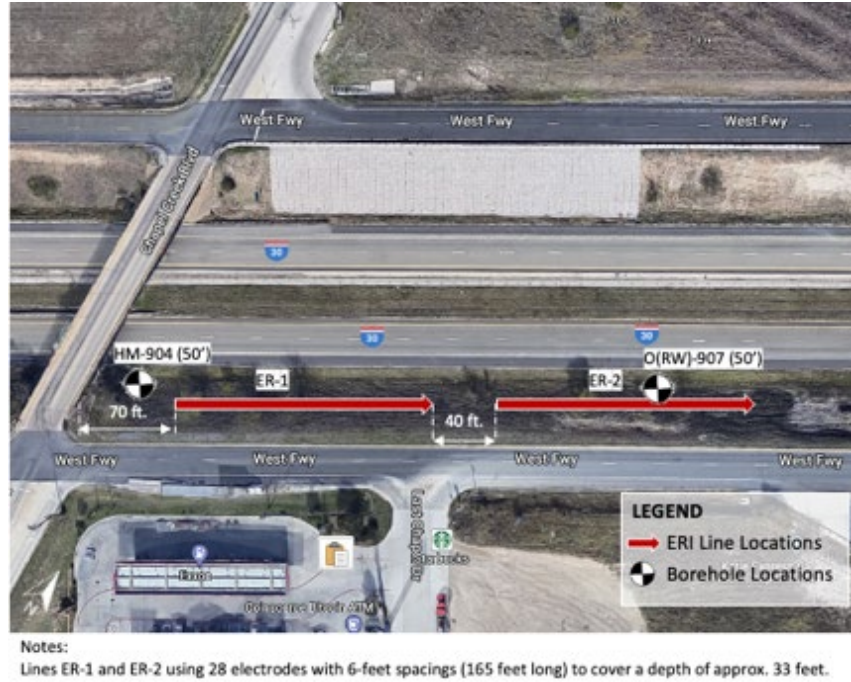
**Figure 4.14.** ERI data collection plan and borehole locations for IH 30 at Chapel Creek Blvd

Two ERI surveys were conducted using 28 electrodes with 6-foot spacings to penetrate to a depth of 33 feet. Figure 4.14 illustrates the ERI data collection plan and borehole locations for IH 30 at Chapel Creek Blvd.

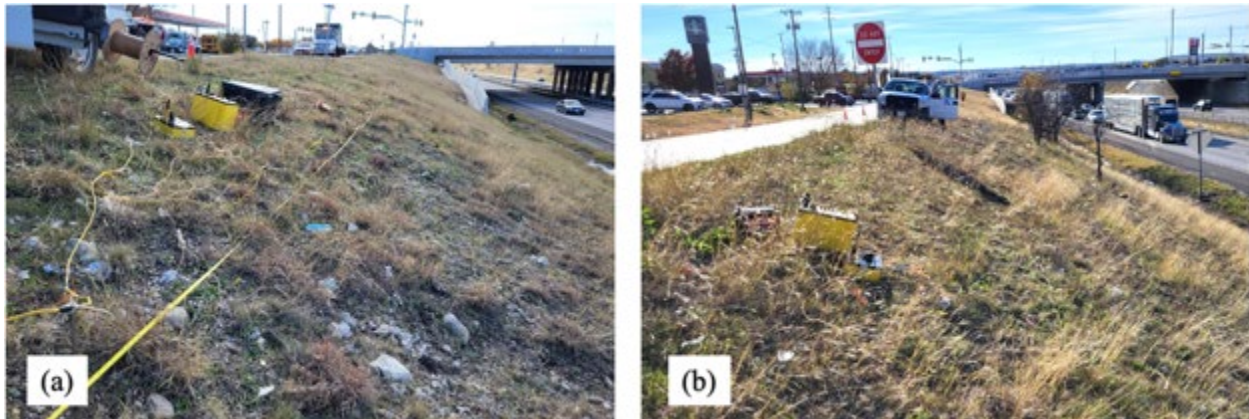
**Figure 4.15.** Implementation of the ERI along IH 30 at Chapel Creek Blvd; (a) Line ER-1 and (b) Line ER-2

Figure 4.15 shows the implementation of the electrical resistivity imaging along IH 30 at Chapel Creek Blvd.

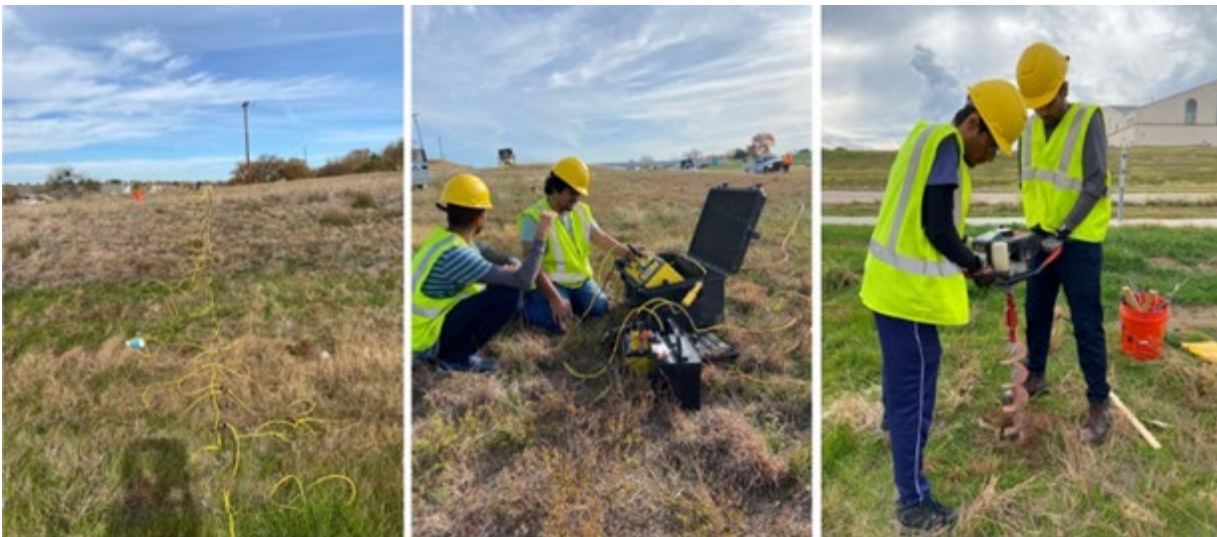
**Figure 4.19.** Implementation of ERI along Highway US 67 and soil sample collection

Figure 4.19 shows the implementation of electrical resistivity imaging along Highway US 67 and soil sample collection.
