TxDOT Report 5-7008-01-1

## **Implementation of Electrical Resistivity Imaging Manual**

Report Publication Date:	Submitted: August 2023 Published: November 2023
Project:	5-7008-01
Project Title:	Implementation of Electrical Resistivity Imaging Manual

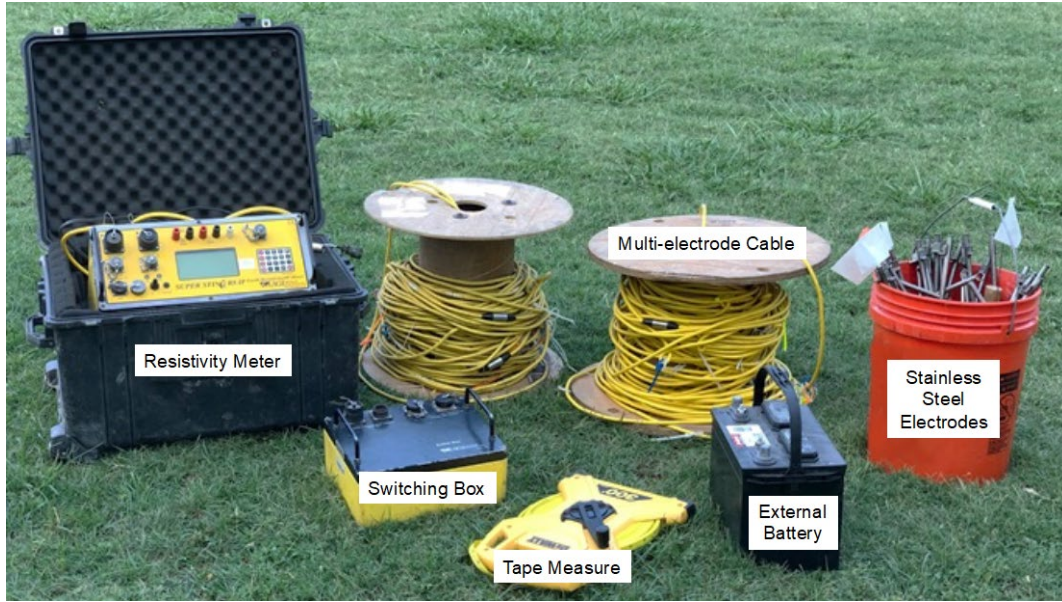
**Figure 6.1.** Required data acquisition equipment for the ERI implementation

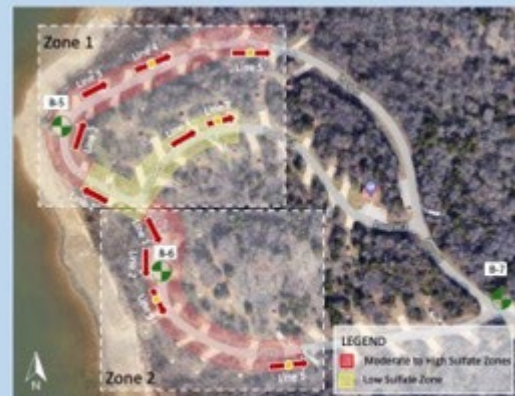
Generated Sulfate Concentration Map

- The ERI will assist TxDOT in determining roadway segments that are unlikely to suffer from sulfate-induced heaving as well as areas that may contain critical sulfate concentrations.
- Sulfate concentration maps can be generated based on the ERI results to help eliminate unnecessary site investigations that are costly and time-consuming.

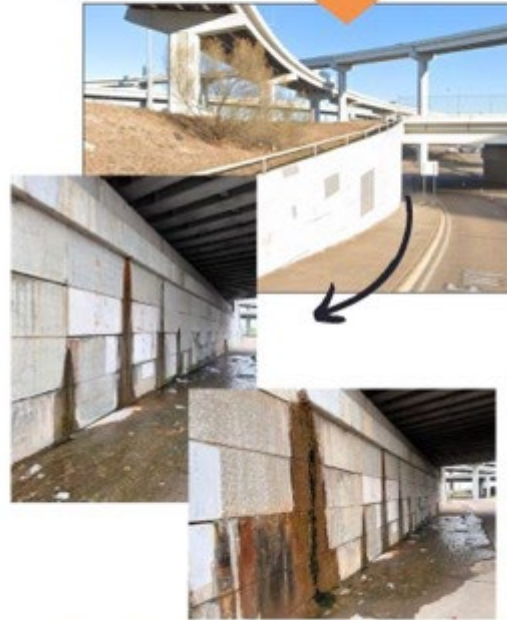
Drainage problem behind the wall.
