Vision Camera Data Collection & Traffic Analysis Enhancements

Final Report

Prepared for:
Grand Forks-East Grand Forks MPO

Prepared by:
Kshitij Sharma
Bradley Wentz
Advanced Traffic Analysis Center
Upper Great Plains Transportation Institute
North Dakota State University
Fargo, North Dakota

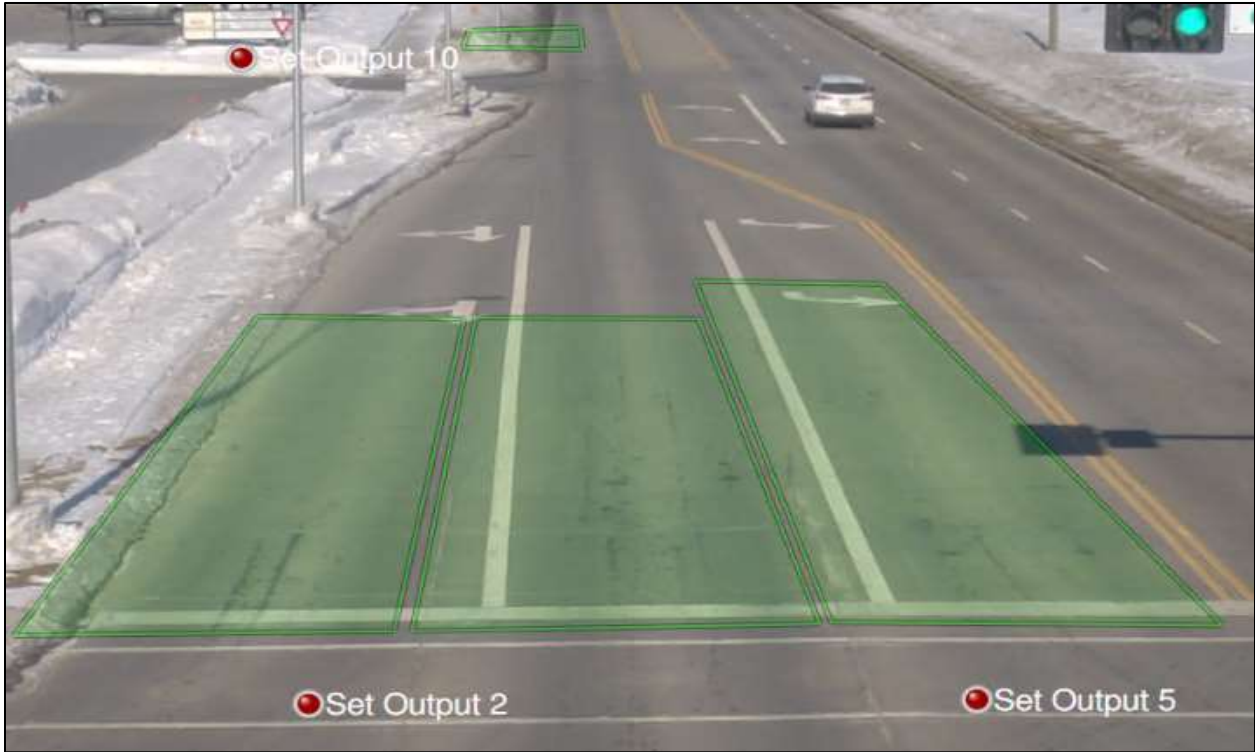
Figure 3. Existing zone setup for N 42nd St. at University Ave. southbound

Figure 3 shows the existing zone setup at the southbound approach at the intersection of N 42nd St. and University Ave. At this location, the zones were off center from their corresponding lanes. Figure 4 shows the adjustments made to the zone locations to better accommodate the lanes. This adjustment should reduce double-counting because of the mismatch between the pavement markings and the zone setup.

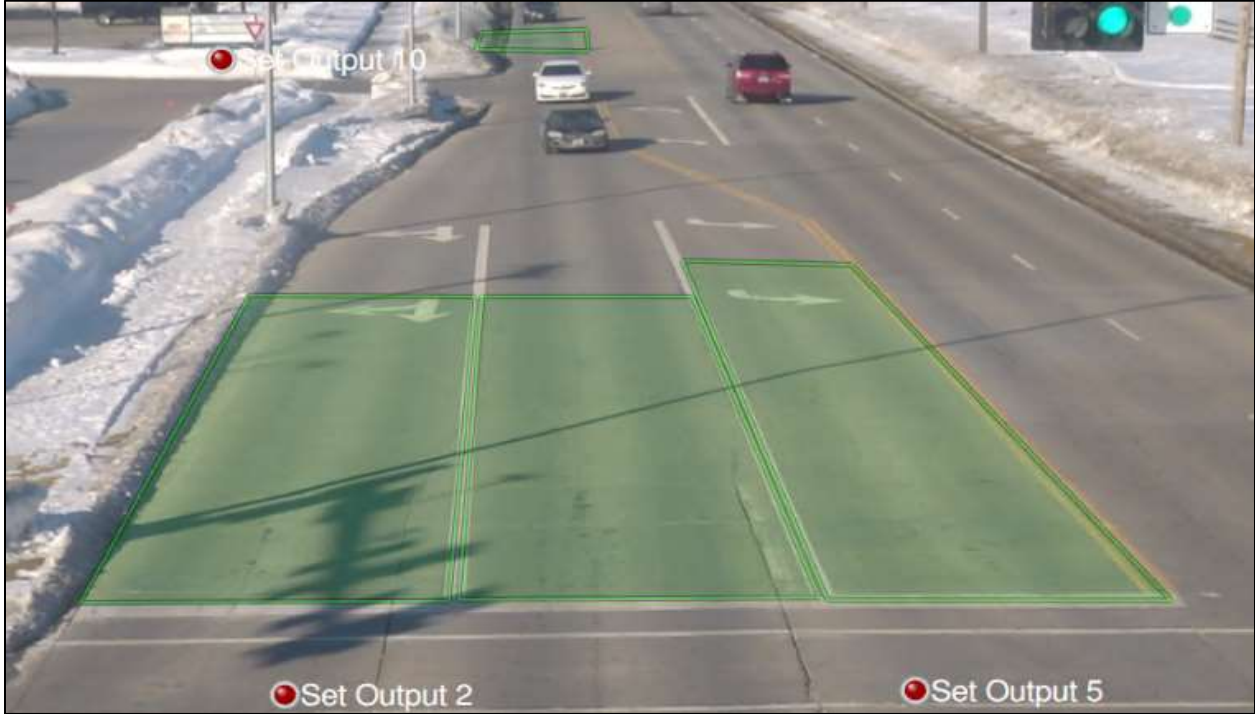
Figure 4. Updated zone setup for N 42nd St. at University Ave. southbound

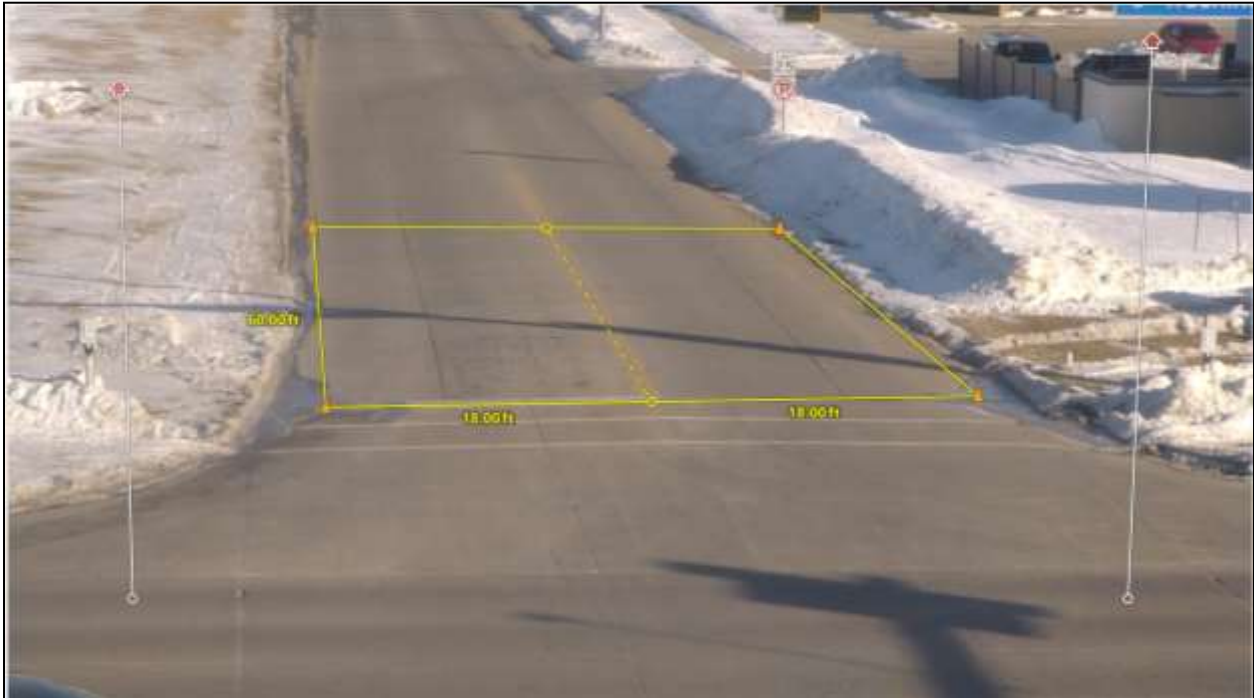
Figure 6. Updated calibration setup at Washington St. at 44th Ave. S WB approach

Figure 5 shows the existing calibration setup at the westbound approach at the intersection of Washington St. and 44th Ave. S. At this particular location, the calibrated lane widths were found to be incorrect. Figure 6 below shows the updated calibration at the same location. The improved calibration of these cameras is expected to improve the traffic counts as well as vehicle presence and passage detection.

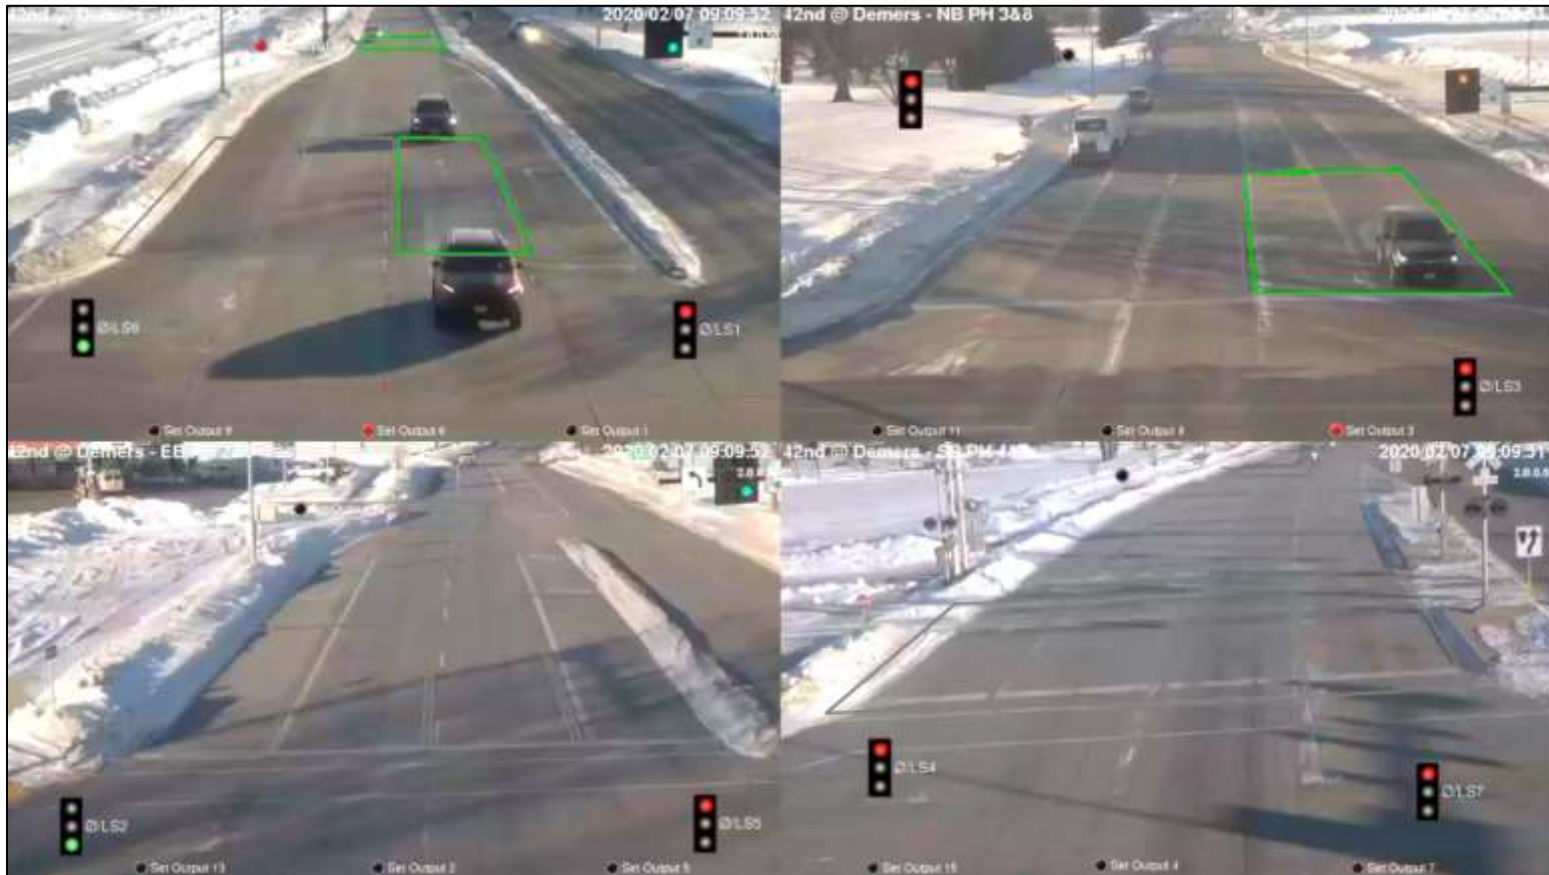
Figure 7. S 42nd St. at Demers Ave. EB camera in-and-out of low detail mode

Upon further investigation, it was found that the traffic data quality began to deteriorate during the mid- to late-winter months. This seemed to coincide with certain camera contrast-loss events registered in the operations log following the software/firmware update. These events are not considered severe errors and are marked as informational (e.g., entering/leaving low-detail mode). Figure 7 shows a typical intersection that may be entering low-detail mode. The specific intersection shown is S 42nd St. and Demers Ave. Five

out of the thirteen intersections audited thus far appear to have been impacted by the low-detail mode events. At these intersections, not every turning movement and not every camera was affected. Note that the direction of the camera did not appear to play a significant role. Figure 8 shows the operational log of the system entering low-detail mode. Note that vehicle detection for signal operations was not impacted by such events. Also, all of the data reported during the rest of the year is of exceptional quality. Further scrutiny is necessary in this matter. Recommendations and next steps in this regard are outlined in the corresponding section of the report.

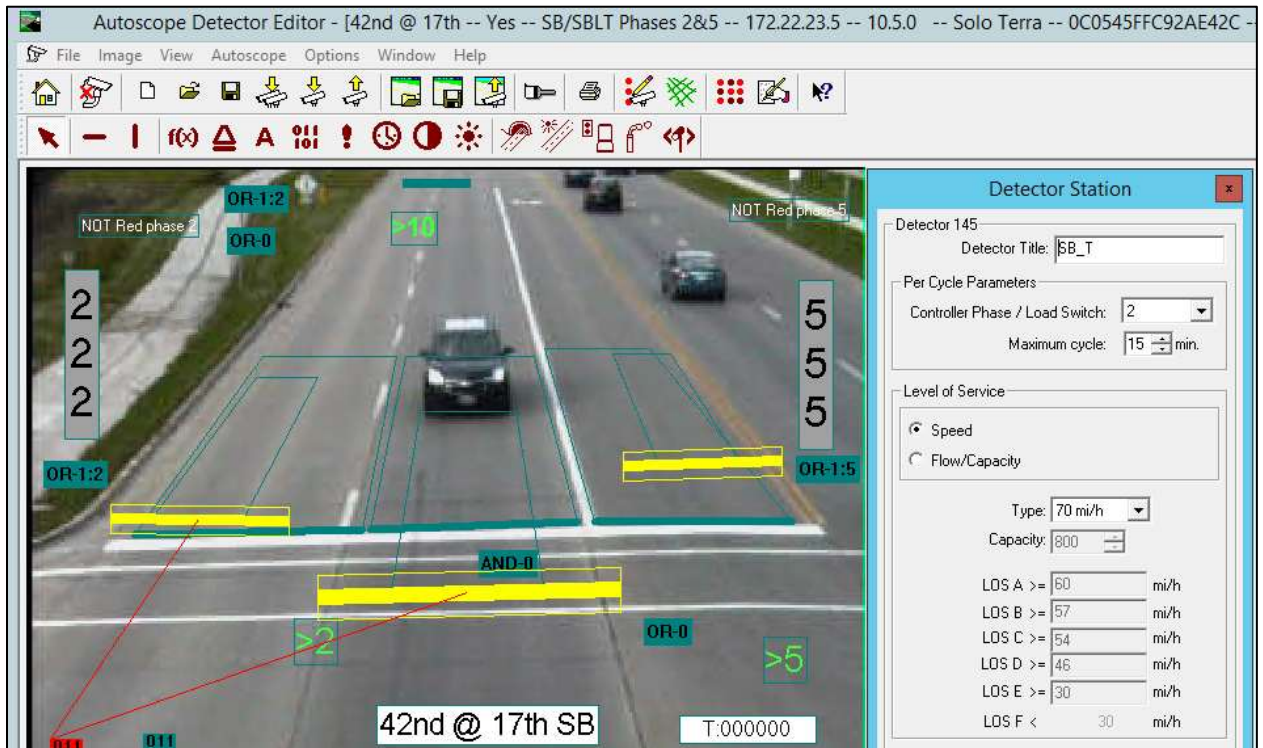
Figure 10. Level of service parameter settings as observed at southbound 42nd St. S at 17th Ave. S

The persistent data collection especially at the non-VISION intersections allows level of service estimation. Parameters for such estimation can be set to suggested or custom thresholds. However, during our investigation it was found that the setup at all of the cameras is not consistent as illustrated in Figures 9 and 10. Note that the level-of-service estimation criteria as well as threshold is different, rendering the level-of-service estimate data collected at these intersections unusable. Apparently, the estimation has wide applications as the criteria can be set to either speed or volume/capacity ratio. The speed criteria may be considered for freeway mainlines whereas the volume/capacity ratio criteria are more suited for signalized intersection approaches or midblock arterial locations. Consequently, it was determined that it is feasible to collect level-of-service estimate data from the signalized intersections outfitted with older-model cameras in Grand Forks. However, doing so would require resetting of the parameters of more than 180 devices.

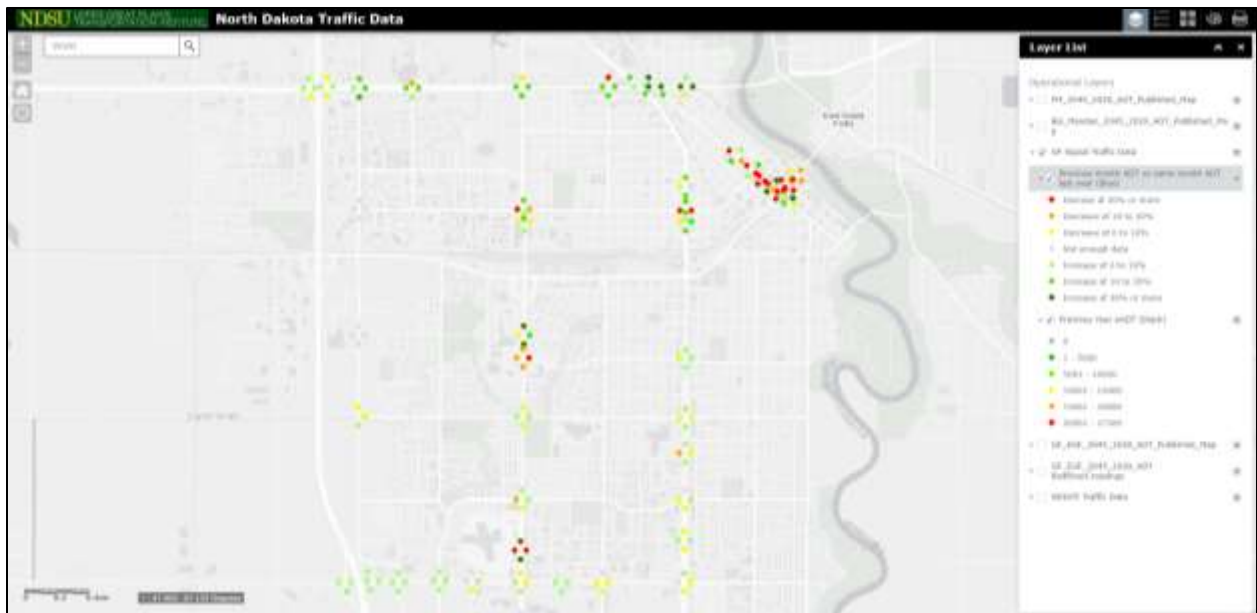
Figure 11. Sample of color-coded traffic changes at Grand Forks intersections on ND Traffic Data Portal

The ability to compare data in a timely and ongoing fashion affords stakeholders the ability to react to changes in travel demand and patterns in a much more appropriate manner. Currently, annual average daily traffic (AADT) values of the previous year can be compared to those of 2+ years ago. It is anticipated that soon the growth factor recalculation and web portal update will be carried out weekly, ensuring that weekly average daily traffic can be compared as well. The weekly factors will likely be divided into “weekday” and “weekend” categories. Figures 11 and 12 show a view of the web portal displaying MADT comparisons. Note that the colors and their shades depict growth (green) and decay (red) of traffic. The corresponding categories are:

- Dark green increase of 30% or more
- Medium green increase of 10% - 20%
- Light green increase of 0% - 10%
- Yellow decrease of 0% - 10%
- Orange decrease of 20% - 30%
- Red decrease of 30% or more

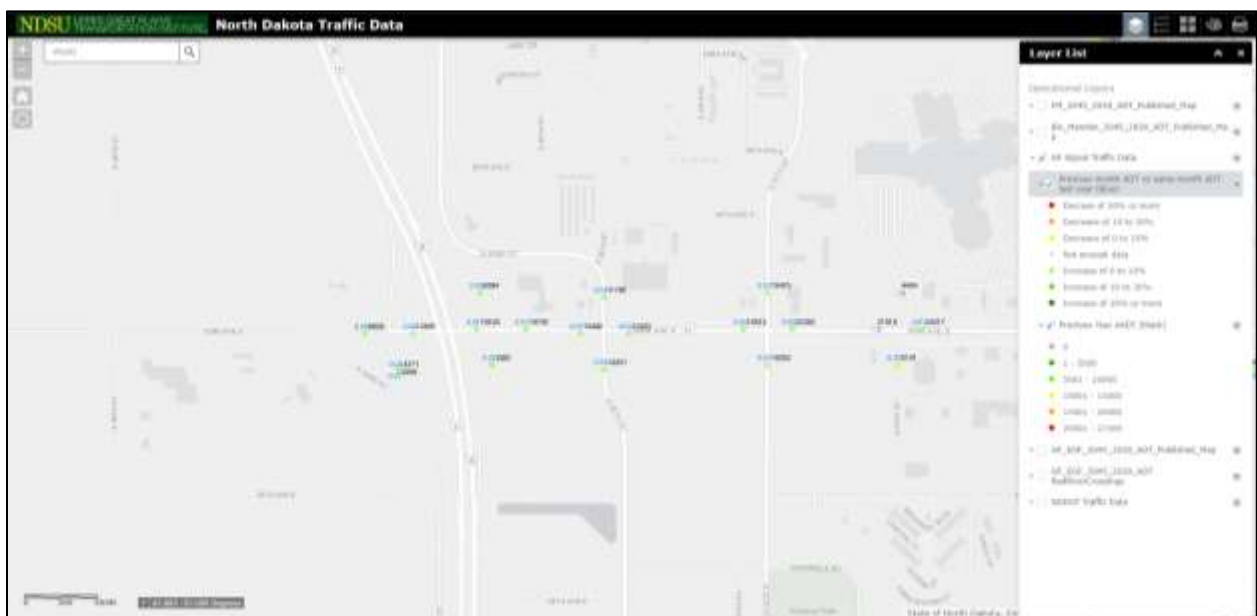
Figure 12. ND Traffic Data Portal showing last year's AADT and growth factors on selected Grand Forks intersections

The North Dakota Traffic Data Portal was created using the previous month's annual daily traffic (MADT) which can be compared to the same month of last year. This traffic growth factor calculation/comparison is done for all four (three – in case of T-intersections) legs of the Grand Forks intersections reporting traffic data.

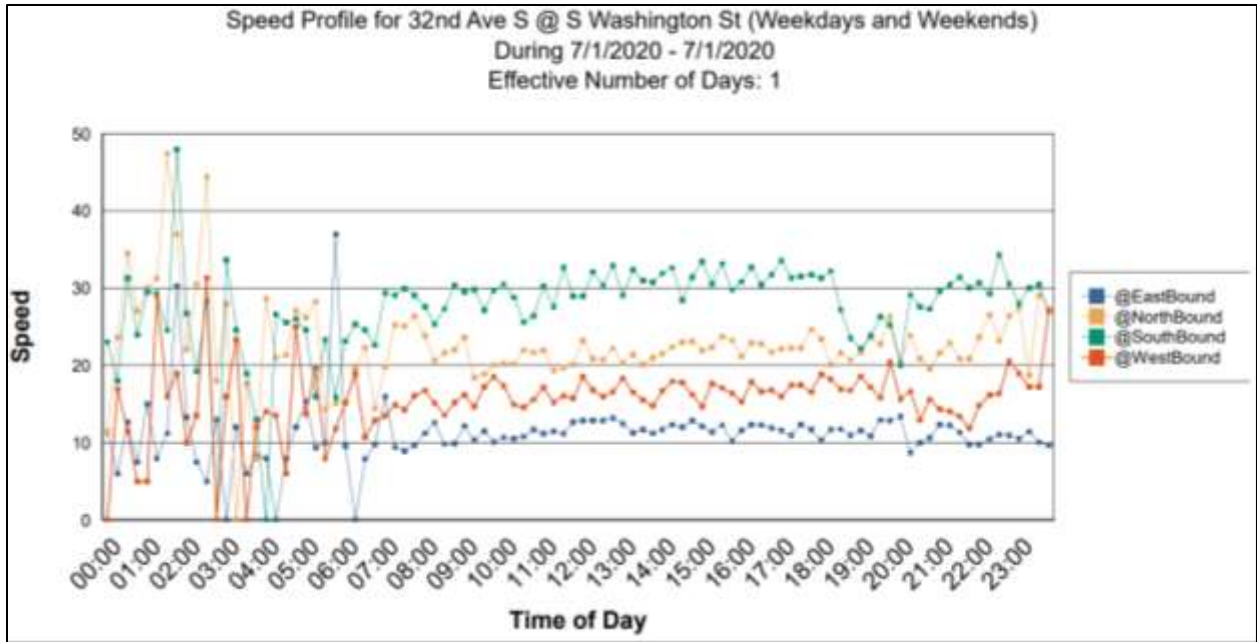
Figure 13. First plot of Speed Profile report showing trend lines for all approaches of the intersection

Figures 13, 14, and 15 show the three plots that constitute this report. The first plot has trend lines for all approaches of the intersection followed by the individual plots for the intersecting streets.

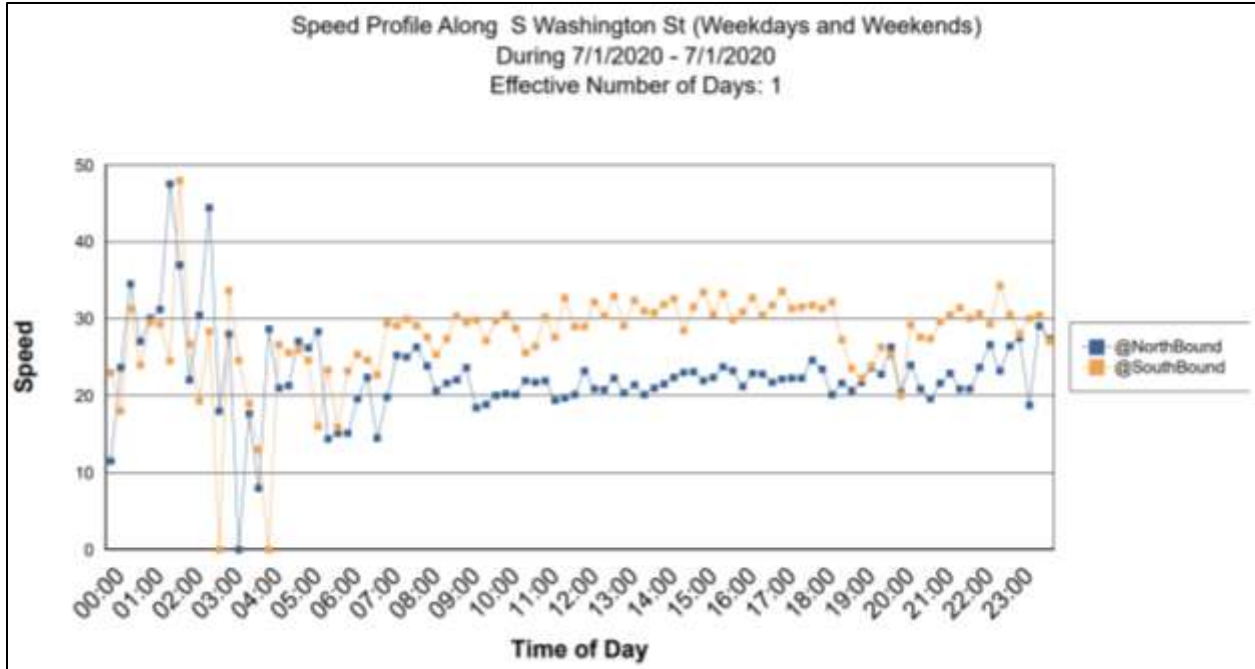
Figure 15. Third plot of Speed Profile report showing trend lines for the north-south corridor
