Rapid Replacement of Bridge Deck Expansion Joints Study – Phase I

Interim Report
December 2014

Sponsored by
Iowa Department of Transportation
Federal Highway Administration
(InTrans Project 13-451)

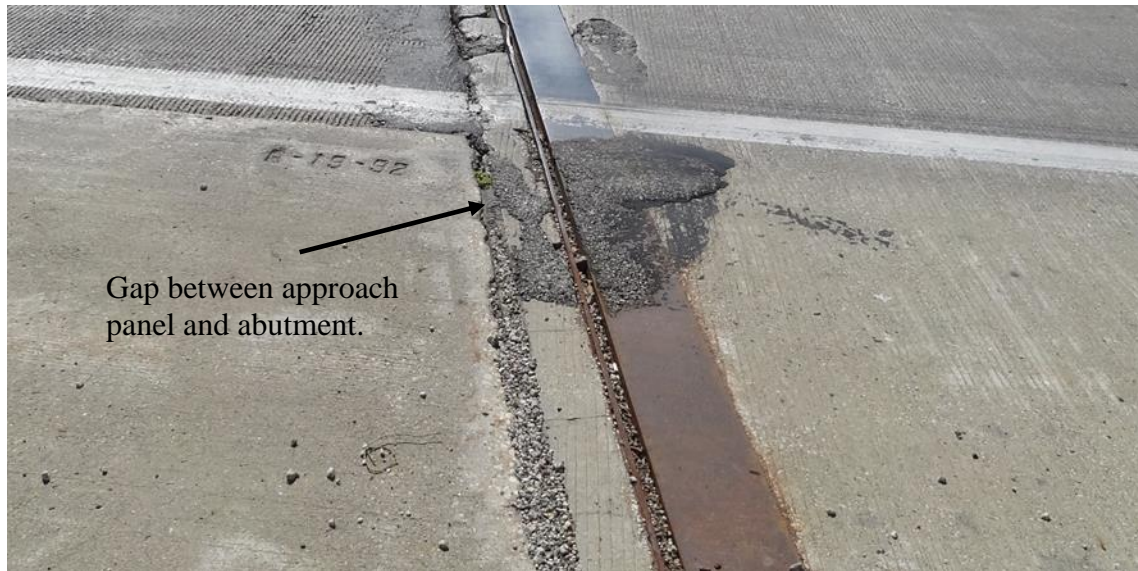
There are a few signs of an immobile joint that is pulling free from the abutment. The first sign is a gap gradually forming between the top of the abutment and the approach slab as shown in Figure 2.2.

Figure 2.2. Gap forming between top of abutment and approach panel on the I-80 over I-35 west abutment

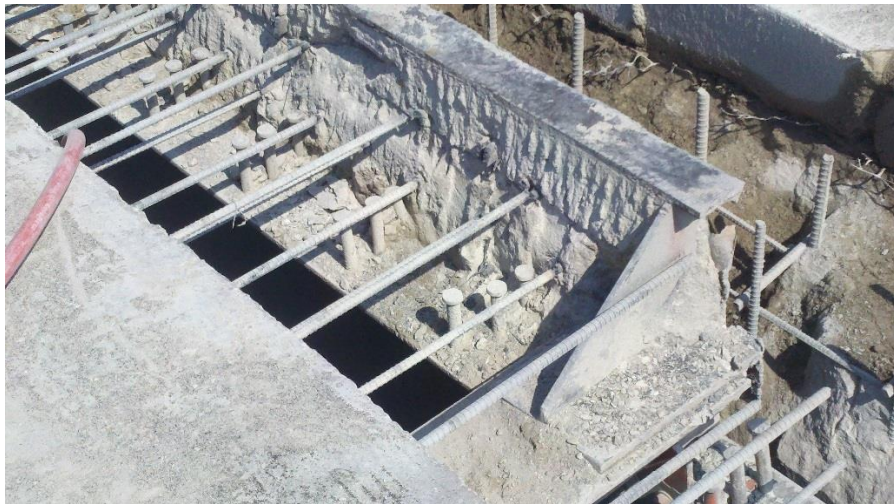
The aqua cutter had a demolition width of about 5 ft. After completing the removal between the required limits, the machine was moved to the side, realigned with the previous sections of demolition, and restarted. Hydrodemolition of Joint A took place for about 14 hours (see Figure 3.5).

Figure 3.5. Joint A after hydrodemolition
