# Rapid Replacement of Bridge Deck Expansion Joints – Phase II

**Final Report**  
**May 2017**

**IOWA STATE UNIVERSITY**  
**Institute for Transportation**

**Sponsored by**  
Federal Highway Administration  
Iowa Department of Transportation  
(InTrans Project 13-451)

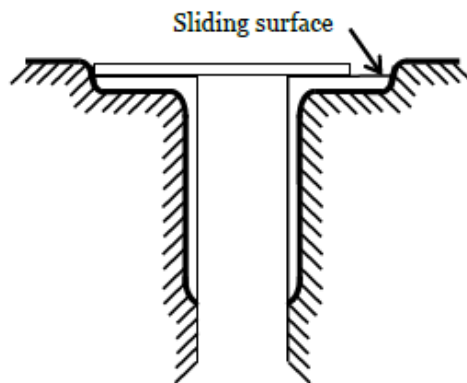
At one time, sliding plate joints, like the one depicted in Figure 2.1, were the predominant joint used on bridges by state highway agencies.

Over time, these joints develop issues because the sliding steel plates fatigue and come loose under traffic loading. Large pieces of loose plate can cause hazards to passing traffic. They also suffered from debris buildup, particularly in the gutter regions where runoff is typically concentrated.

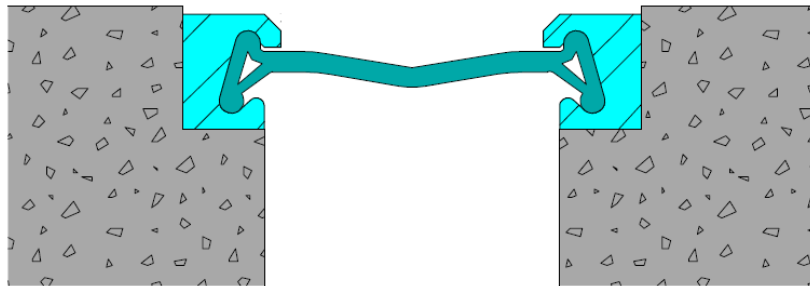
Strip seal expansion joints are increasingly popular with state highway agencies. As shown in Figure 2.2, a strip seal is an elastomeric, often neoprene, membrane held in place by a metal extrusion embedded in the concrete bridge deck.

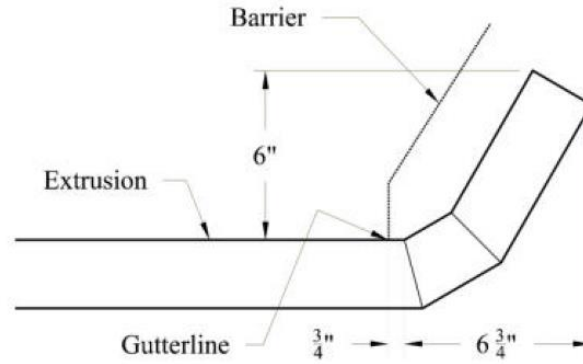
Another suggested way of reducing debris buildup in strip seals is to set the joint at a sufficient slope that the force of the draining water washes the debris down the seal, through the curb, and off of the bridge deck. Currently in Iowa, the strip seal end detail, shown in Figure 2.3, includes an upturned end at the curb to prevent runoff from leaving the bridge deck.

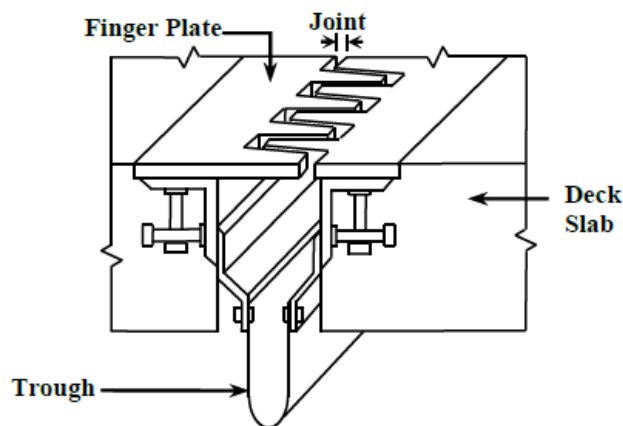
Finger joints are similar to sliding plate joints, and they are a type of joint that uses a set of interlocking plates to allow joint movement rather than using the plates that pass one on top of the other. These joints, which appear similar to the detail shown in Figure 2.4, are still often used for expansion distances greater than what can be achieved with a strip seal joint.

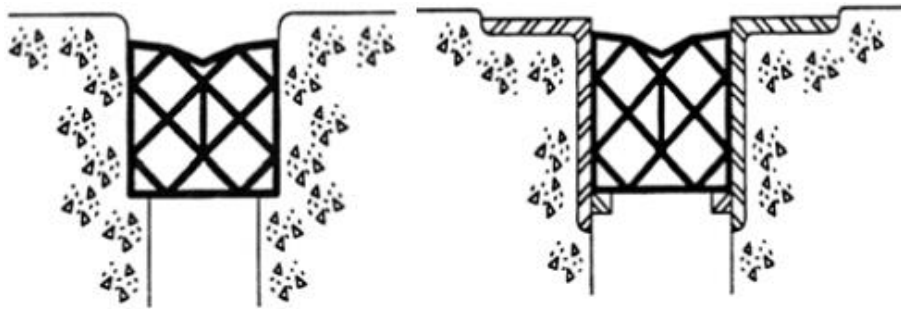
Compression seals are often used with or without steel armoring at the edge of the bridge deck, as shown in Figure 2.5.

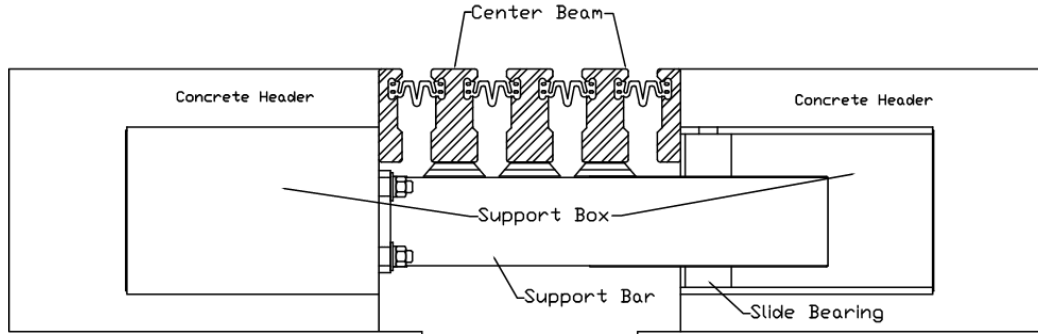
Modular bridge expansion joints (MBEJs) are, in essence, a series of strip seal expansion joints supported through an expansion gap by a support beam (see Figure 2.6).

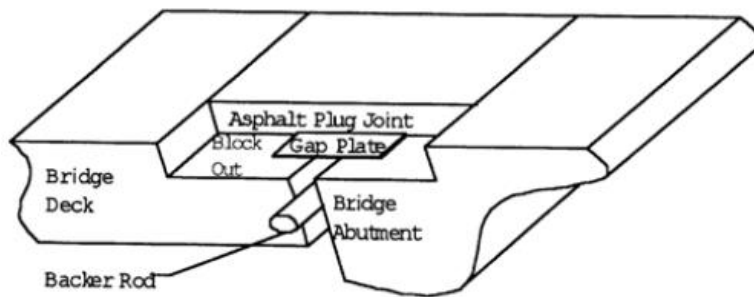
Plug seals are essentially a section of polymer-modified asphalt placed in the bridge deck as shown in Figure 2.7.

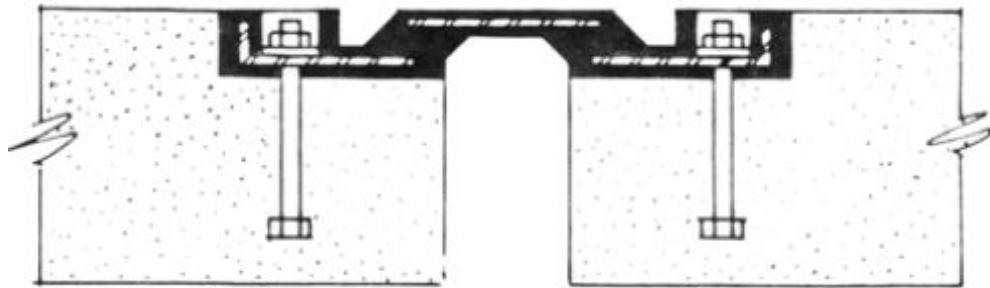
Cushion seals, also known as plank seals, use a steel-reinforced neoprene pad to provide the necessary bridge movement while maintaining a smooth deck. Figure 2.8 shows an example.

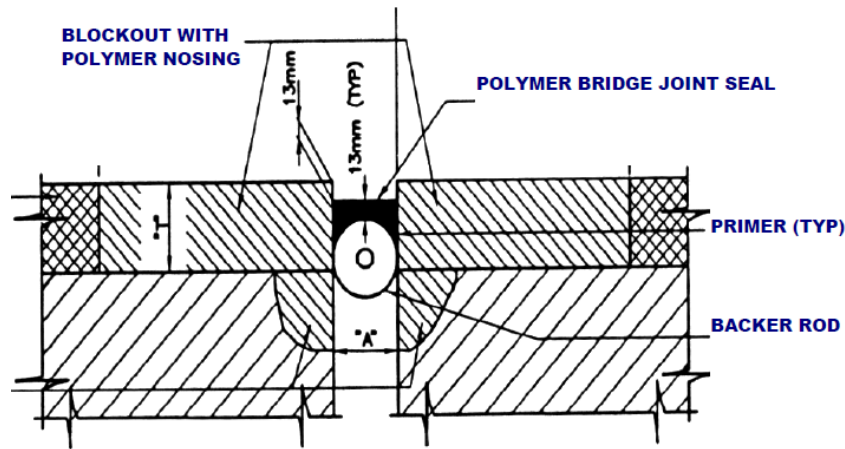
Poured silicone sealant is a joint material that has often been used for repairs of very small movement joints. These joints consist of a section of silicone, poured as a liquid into the expansion gap, that then sets and waterproofs the joint (see Figure 2.9).

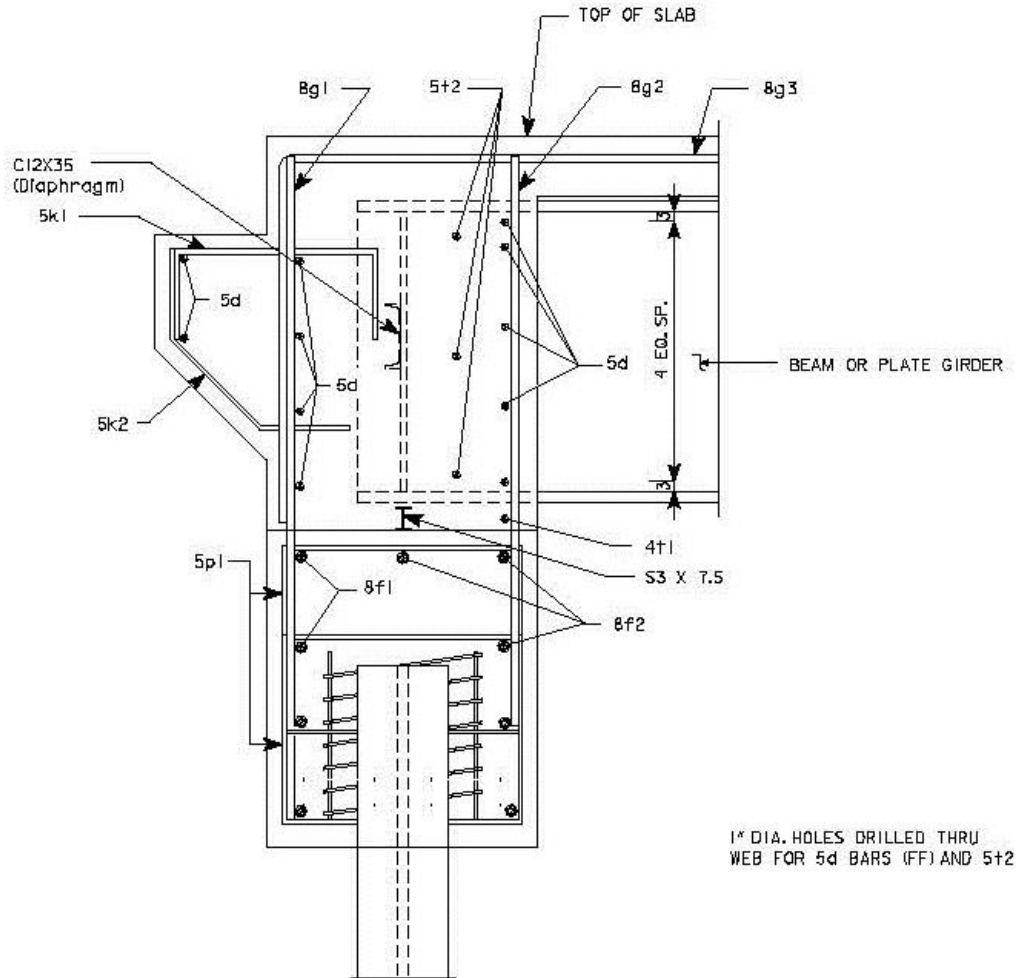
Few bridge decks are short enough to ignore expansion requirements altogether, although most bridge engineers would likely consider no expansion joint to be ideal. Thus, integral abutment bridges are becoming increasingly popular, because they accommodate expansion by allowing the bridge abutment to move with respect to the driven piles that support it and eliminate the need for a bridge deck expansion joint. This is accomplished by embedding the ends of the bridge girders in the abutment backwall and allowing the flexibility of the pile foundations to accommodate the necessary movement. Figure 2.10 shows a typical cross section.

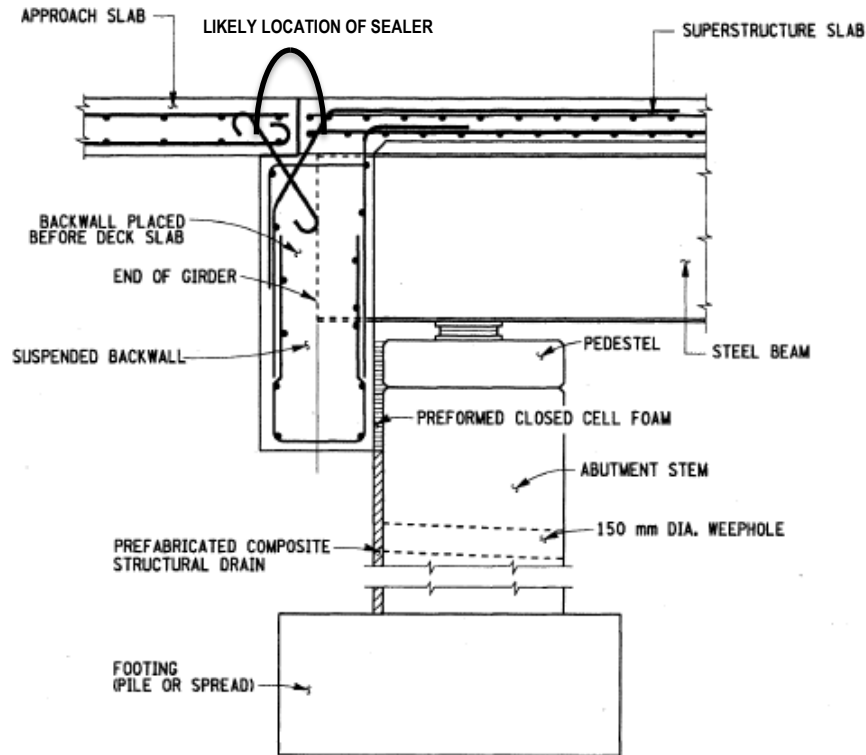
Semi-integral abutments are an alternative to integral abutments that function in much the same way. As seen in Figure 2.11, the girder ends are embedded in the backwall, but the entire backwall and girder system is situated on bearings that allow the backwall and girder system to slide over a fixed foundation.

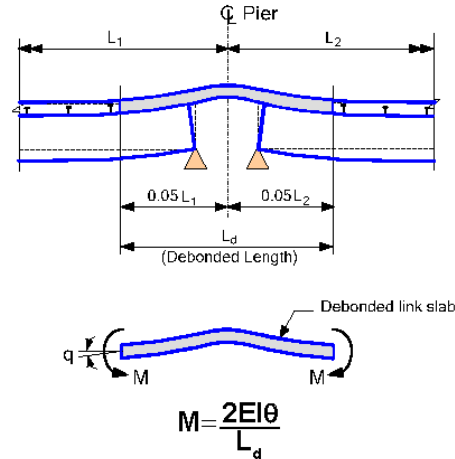
Link slabs are a method being increasingly tested for use in replacing expansion joints located over intermediate bridge piers. Link slabs are, in essence, a continuation of the bridge deck above the location that two girders meet over a pier as shown in Figure 2.12.

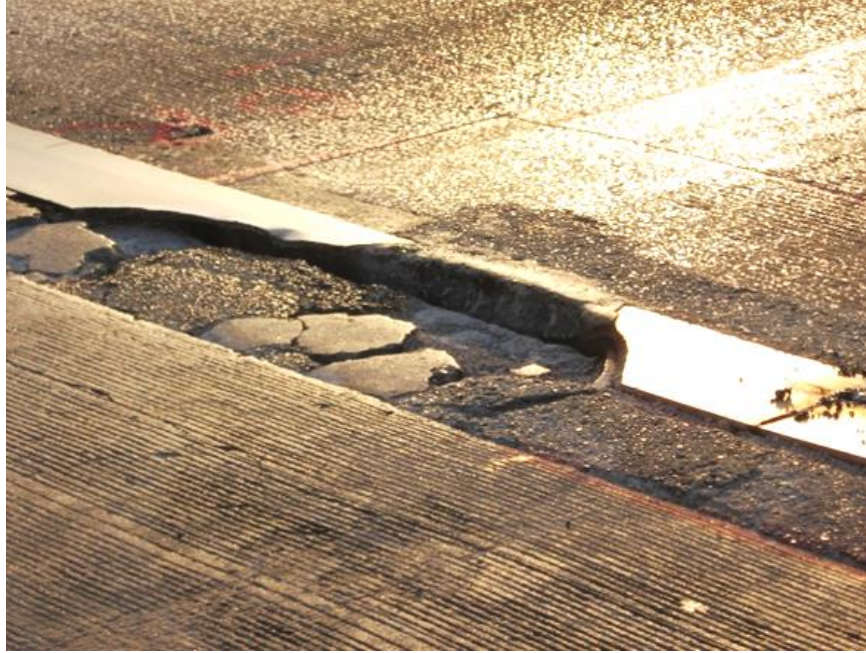
The combination of the plate losing structural section strength due to rust formation and the cyclical loads of heavy traffic eventually cause fatigue damage to the steel plate, and large sections of the plate may break loose as seen in Figure 3.1.

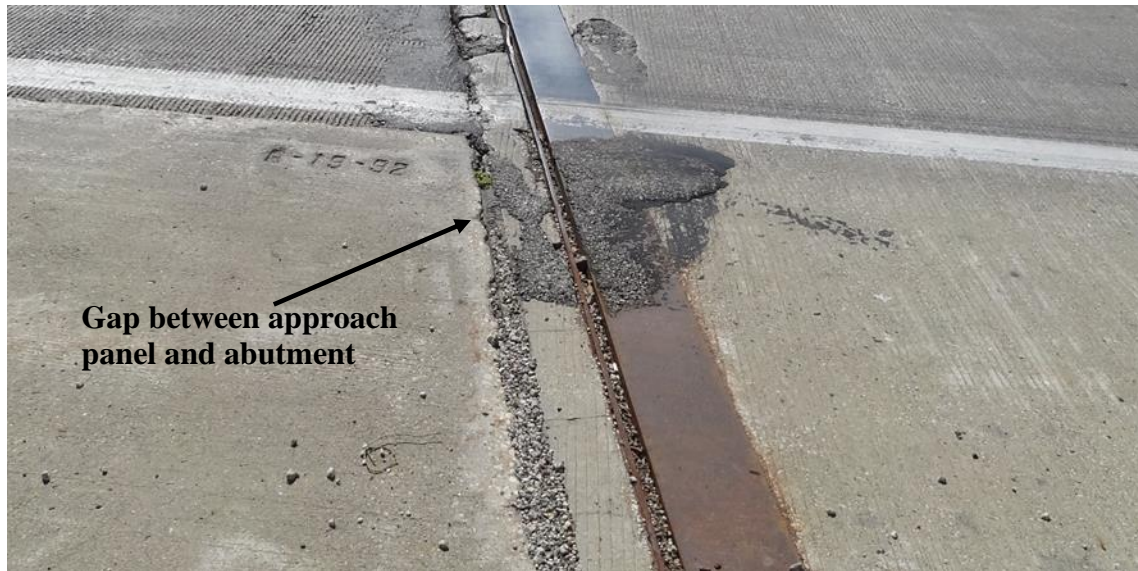
There are a few signs of an immobile joint that is pulling free from the abutment. The first sign is a gap gradually forming between the top of the abutment and the approach slab as shown in Figure 3.2.

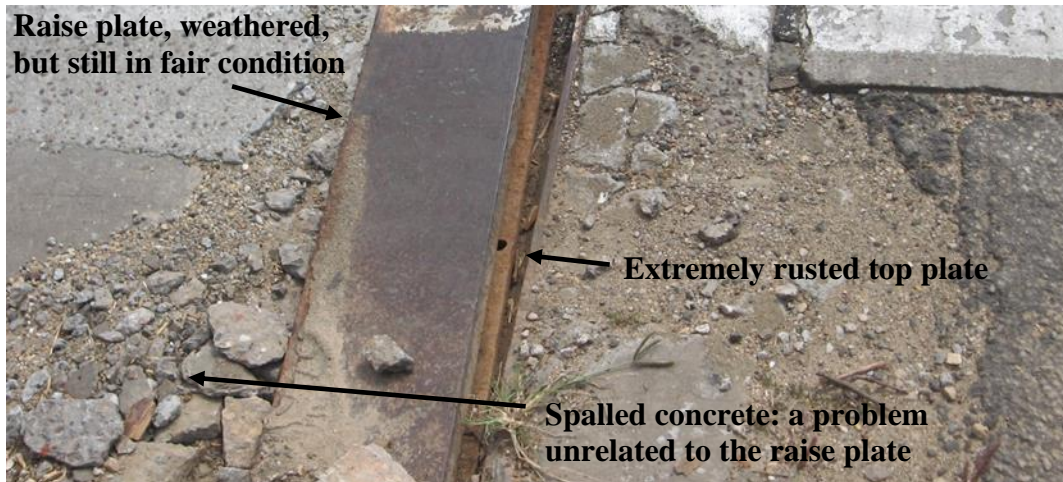
Years later, the original top plates are now beginning to fatigue, but the damage is hidden under a raise plate that usually appears to be in relatively good condition. This can be seen in Figure 3.3 (before replacement), where a badly rusted top plate can be viewed beneath a top plate showing relatively good conditions.

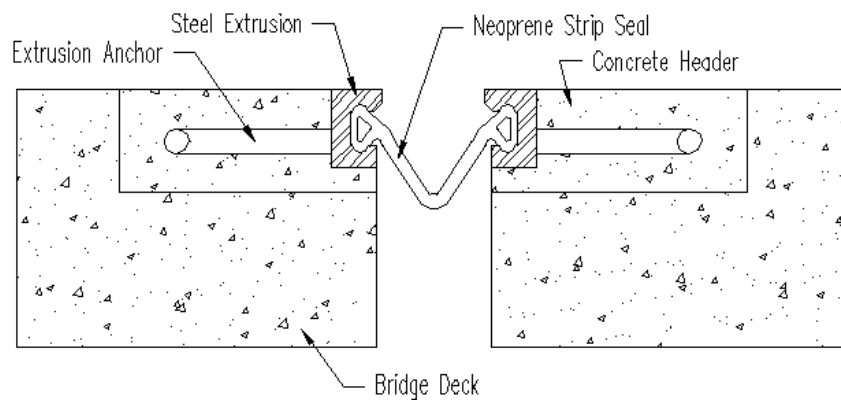
Strip seal and compression seal expansion joints are separate styles of joints that utilize a gland to prevent the passage of water through the expansion joint. In particular, a strip seal joint includes a gland, generally neoprene, that is mechanically locked in place through the use of steel extrusions embedded in the concrete header on either side of the expansion joint. Figure 3.5 shows an example of a strip seal joint.

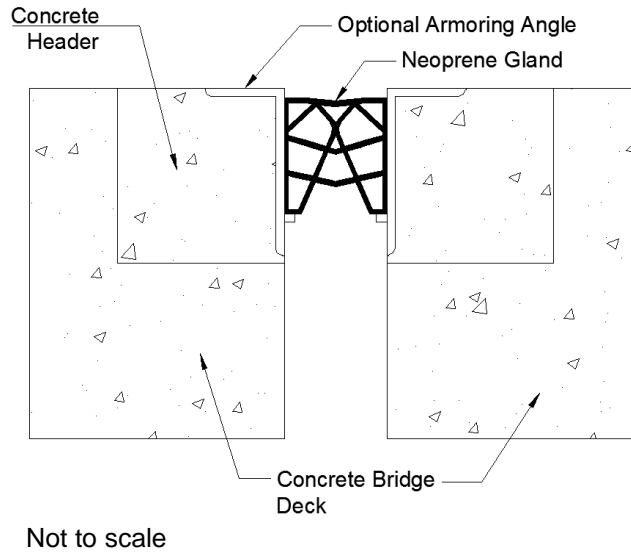
A compression seal is forced into place and uses the compressive force from the bridge deck to remain in place as shown in Figure 3.6.

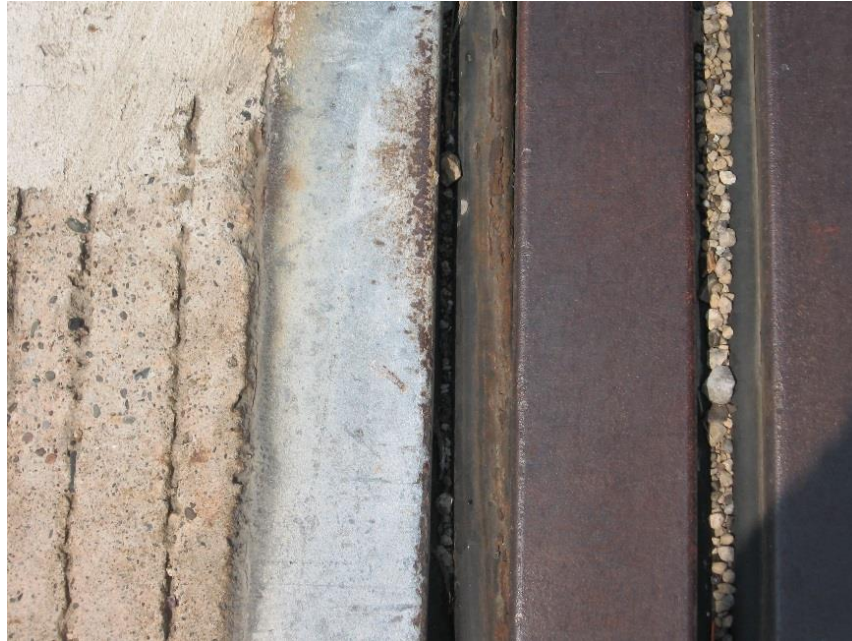
preventing the neoprene seal from being inserted. Rust inside the extrusion occurs nearly always in a seal that has served its useful life and already requires a replacement. This problem is essentially the same in modular joints (as shown in Figure 3.8).

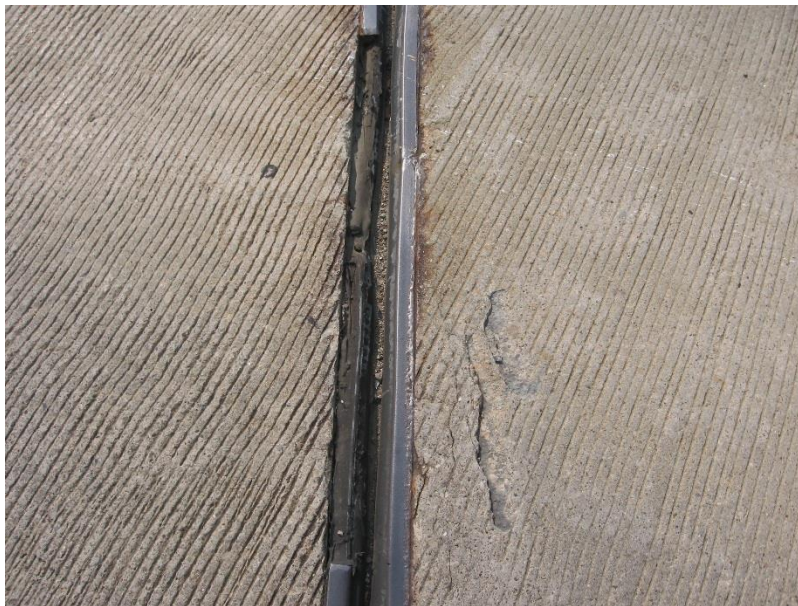
Several different repairs for extrusions were examined during this investigation. Figure 3.9 shows a strip seal joint with a missing section of the extrusion.

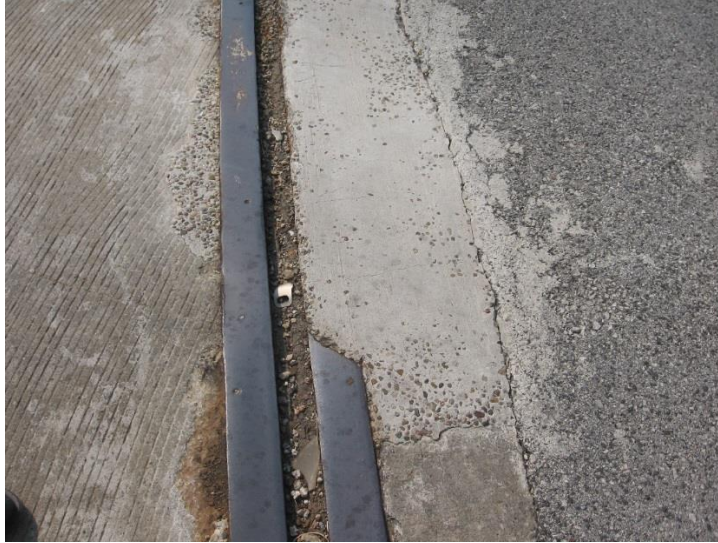
Broken sections of compression seal armoring are fixed much in the same way that sliding plate joints are fixed, by replacing the broken armoring and replacing any loose concrete with new concrete to provide a flat, smooth riding surface. Figure 3.10 shows this type of repair.

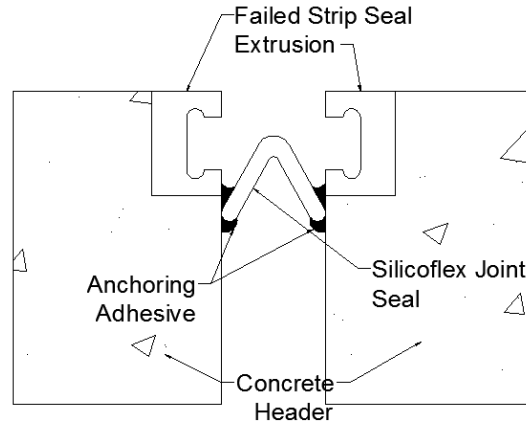
Recently, the Iowa DOT has been experimenting with the use of a Silicoflex joint sealing system from R.J. Watson, Inc. as a repair measure for damaged expansion joints. A Silicoflex seal is essentially an inverted strip seal held in place by an adhesive instead of an extrusion. The use of an adhesive makes Silicoflex ideal for joint repairs involving damaged strip seal extrusion sections. Figure 3.11 shows an example of a repair done with a Silicoflex joint.

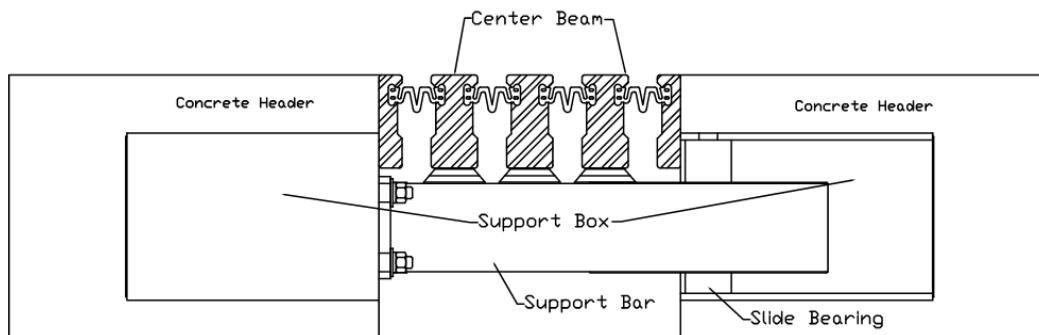
Finger joints and modular expansion joints are styles used by the Iowa DOT for large expansion distances, typically greater than 5 inches. Finger joints, as the name suggests, are designed as a series of interlocking steel fingers used to transfer traffic across the joint. Modular expansion joints are essentially a series of strip seal joints supported by reinforcing steel support bars placed parallel to traffic as shown in Figure 3.12.

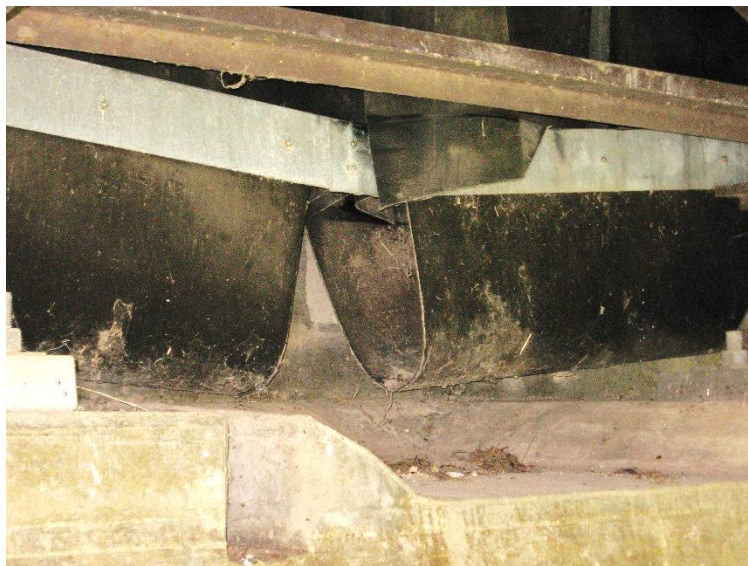
Another problem relating to these troughs is the flow of water. Where strip seals, compression seals, and modular joints prevent water from passing through the joint entirely, finger joints merely divert the water after it flows through the joint. Some troughs divert water away from the center of the abutment, while a neoprene trough below a finger expansion joint, as shown in Figure 3.13, diverts water to a catch basin at the center of the footing.

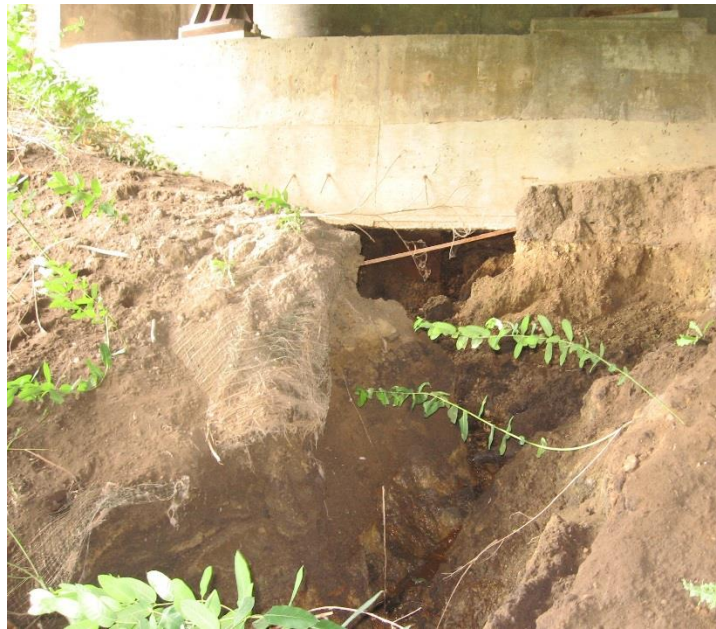
eventually erode away the slope exposing the steel piling as seen in Figure 3.14. At least two pilings were exposed when the image in Figure 3.14 was captured.

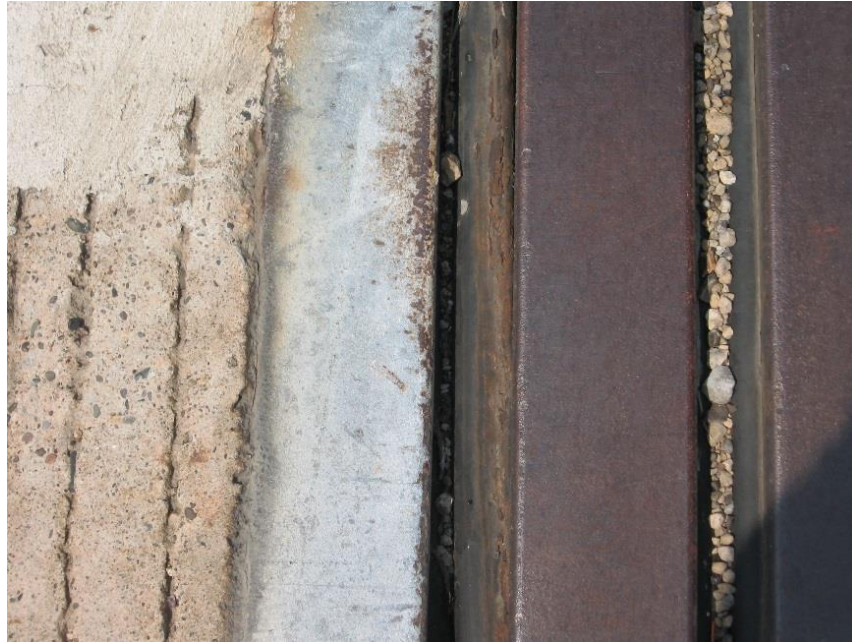
Modular expansion joints show many of the same problems that strip seal joints show. Neoprene glands again begin to fail at about year 15 and, as shown in Figure 3.15, incompressible debris collects in the joint.

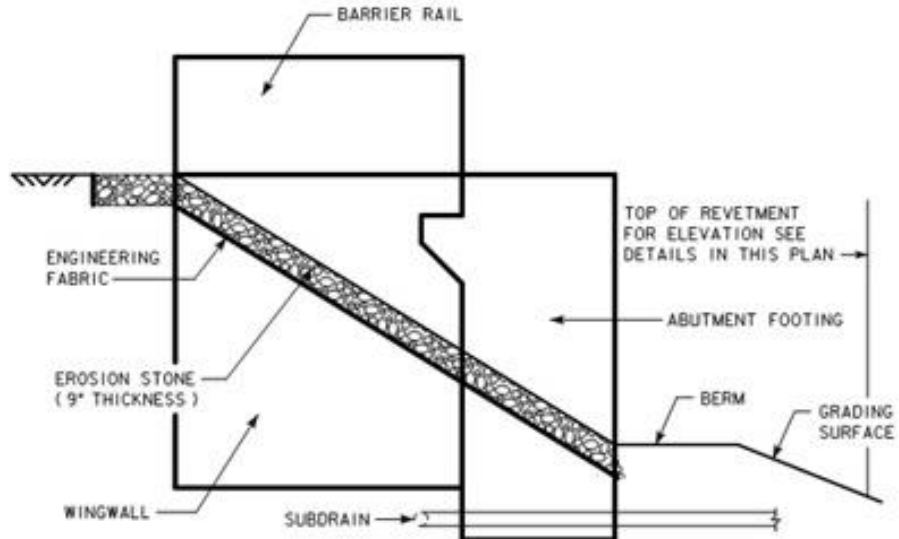
The detail for new bridges includes a bed of erosion stone atop a layer of engineering fabric atop the compacted subgrade and following the slope of the subgrade. This layer of stone should act as a drain allowing the runoff to quickly flow around the abutment and footing without eroding the supporting soils. Figure 3.16 shows a profile view of this new detail.

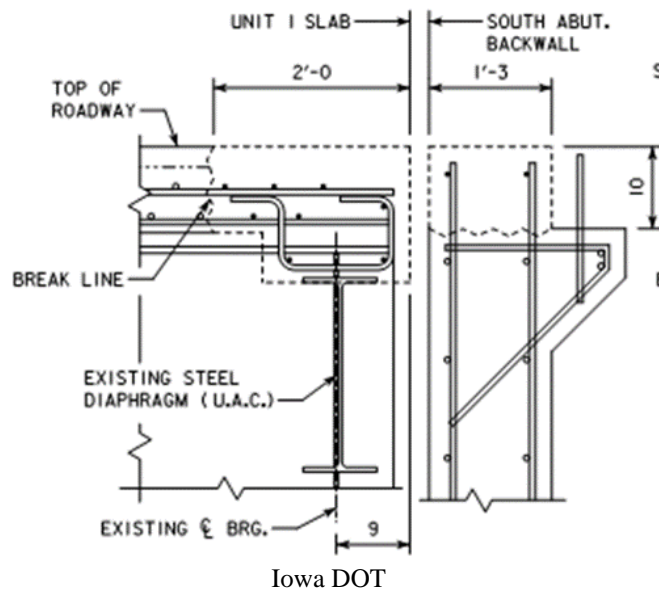
The old sliding plate joint was to be replaced with a new strip seal expansion joint. Concrete removal would consist of the top of the backwall from the existing riding surface to the top of the paving notch and the end two feet of roadway concrete (see Figure 4.3).

**Figure 4.3 Northbound I-380 project concrete removal cross section**

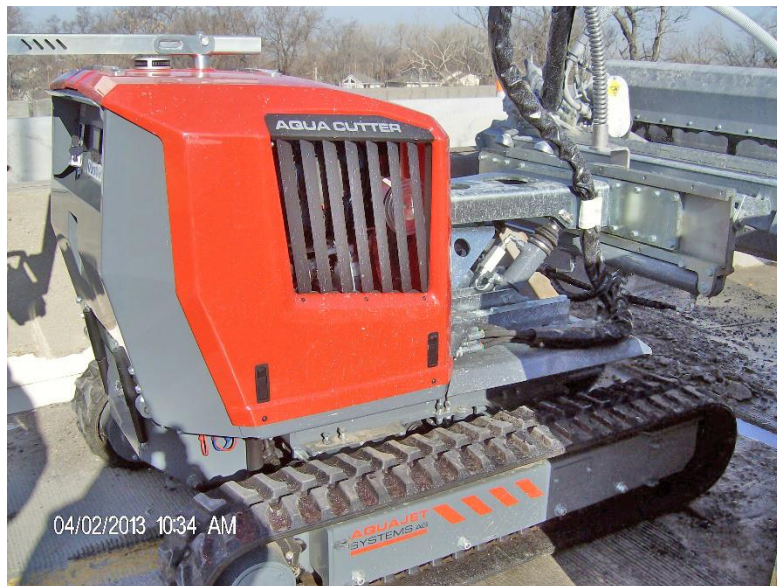
Equipment mobilization began shortly after traffic was completely rerouted, which was about an hour into the project. This job was unique in that the contractor utilized hydrodemolition for the majority of the concrete removal on Joint A. The contractor utilized an Aqua Cutter from Aquajet Systems AB, similar to the one shown in Figure 4.4.

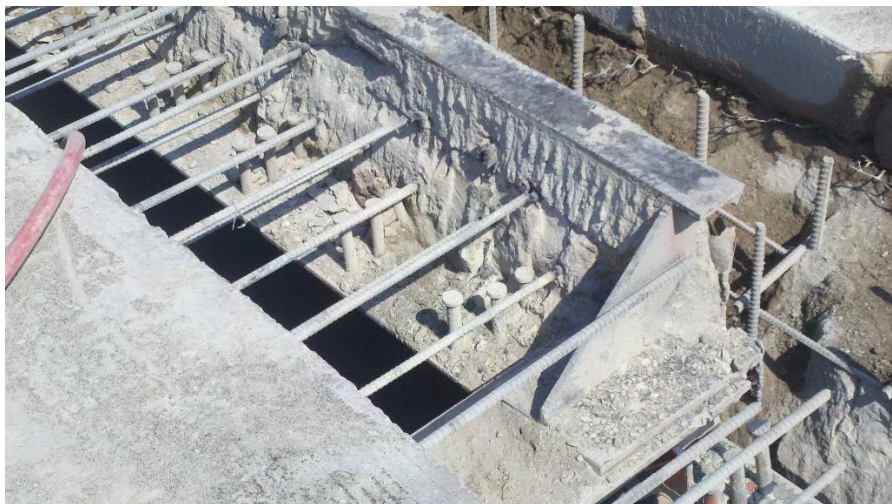
The aqua cutter had a demolition width of about 5 feet. After completing the removal between the required limits, the machine was moved to the side, realigned with the previous sections of demolition, and restarted. Hydrodemolition of Joint A took place for about 14 hours (see Figure 4.5).

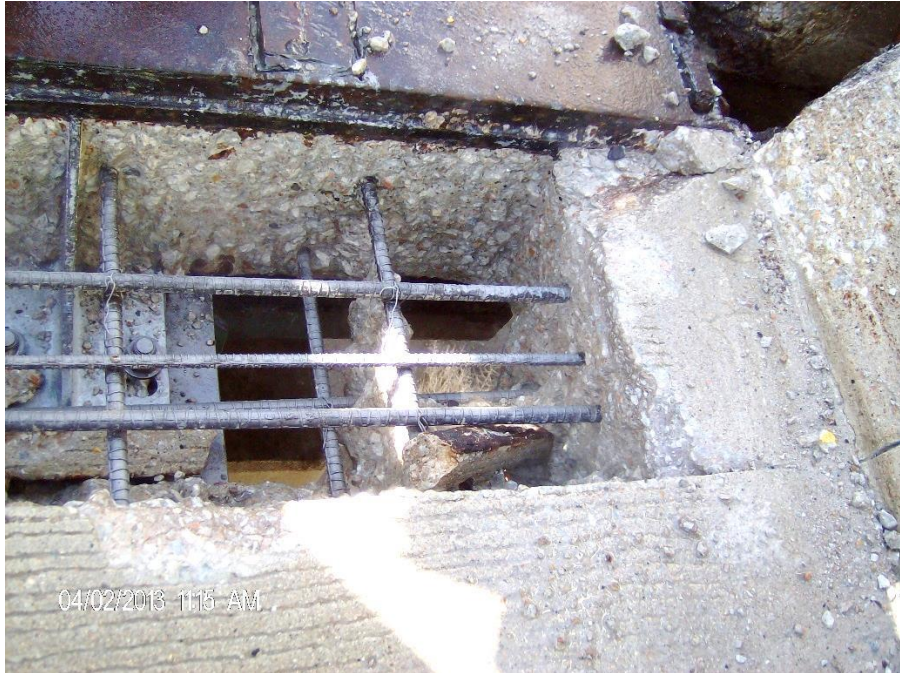
curb, as well as the curb itself. While not of concern to this project, this area near the curb may be larger if the joint is at a skew to the curb. A small section of concrete beneath the existing joint could not be removed with the aqua cutter (see Figure 4.6).

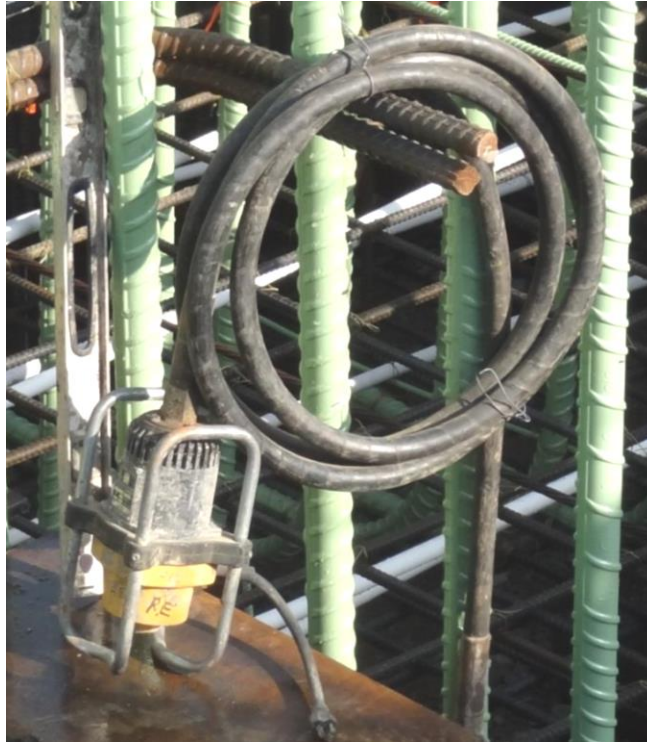
The concrete pour was much more organized than the rest of the project and the construction laborers appeared to be very experienced with concrete pours. Immediately before concrete was placed, a thin layer of grout was placed by hand on all existing concrete faces that would adjoin the new concrete. Concrete was then placed directly from the truck into the formwork and vibrated with a flexible shaft vibratory compactor as shown in Figure 4.7.

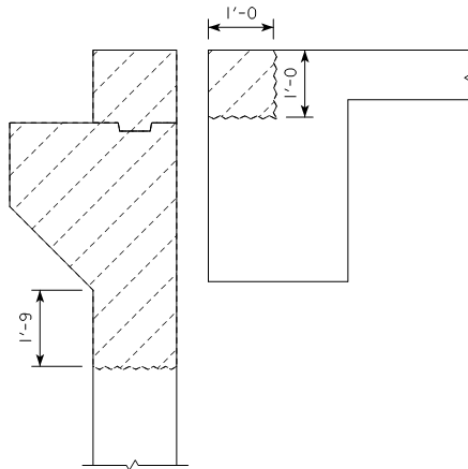
Concrete removal was to consist of a 1- by 1-foot square section of concrete on the deck side of the joint along with the removal of the backwall to 1 foot 9 inches below the bottom of the existing paving notch (see Figure 4.9).

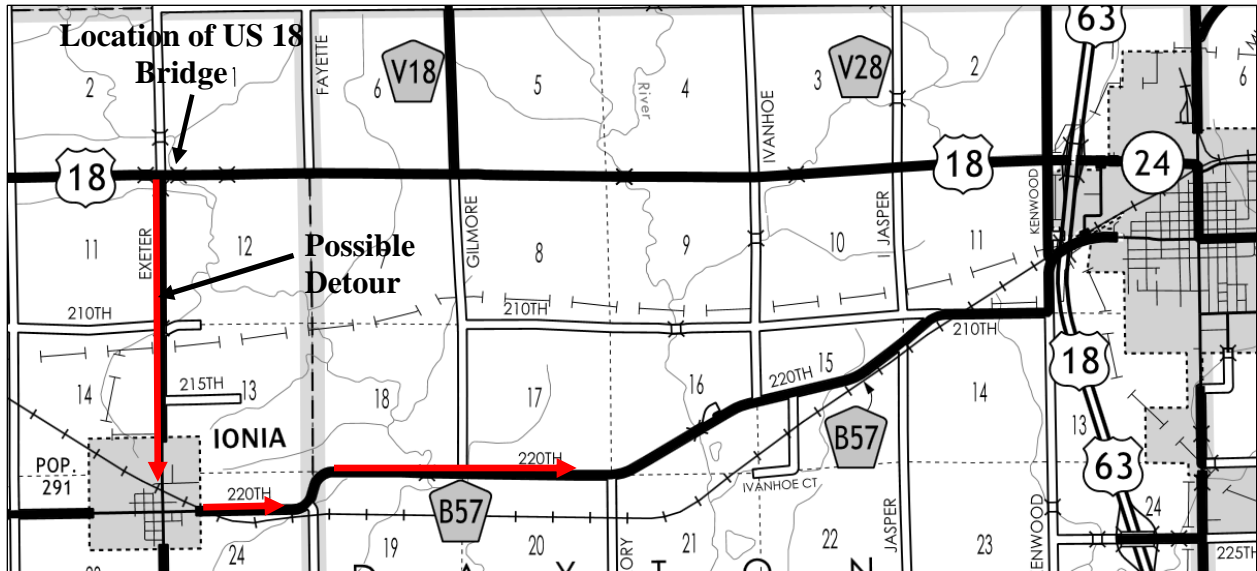
**Figure 4.11. US 18 over Wapsipinicon River project possible detour route**

One observation that the research team found key was the use of a staged project instead of a detour to complete the US 18 job. As seen in Figure 4.11, the bridge of interest was only a few hundred feet beyond the intersection of US 18 and County Road V-14 (Exeter Avenue). This would be about a 2.5-mile detour to County Road B-57 that would meet US 18 in New Hampton, Iowa.

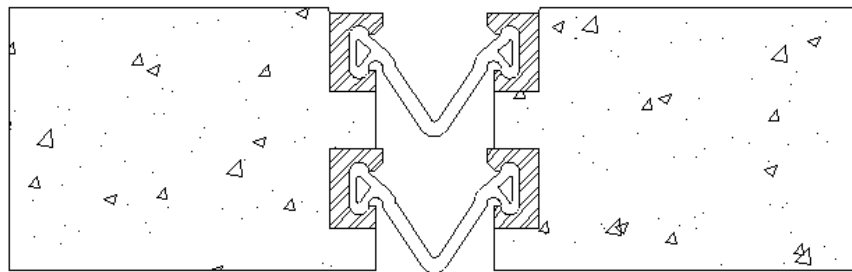
The second student-proposed concept involved stacking two strip seals on top of each other as shown in Figure 6.2.

**Figure 6.2. Stacked strip seals concept**

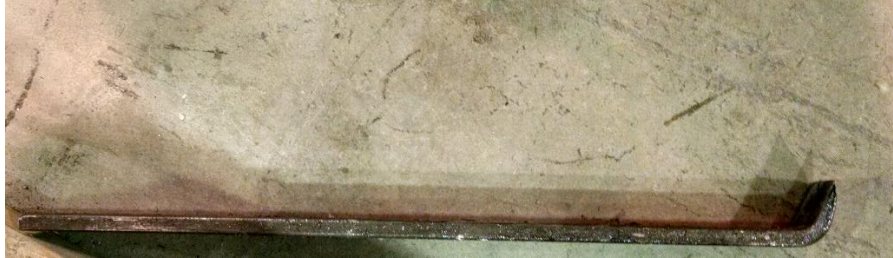
**Figure 6.3. Strip seal gland installation tool**

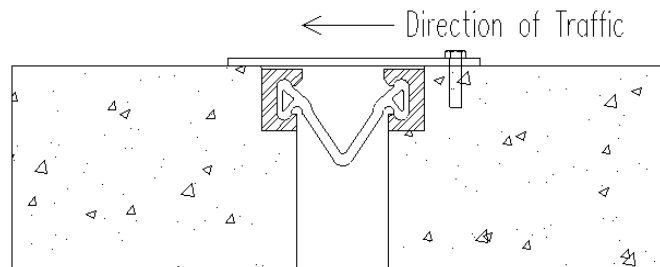
**Figure 6.4. Sliding plate concept**

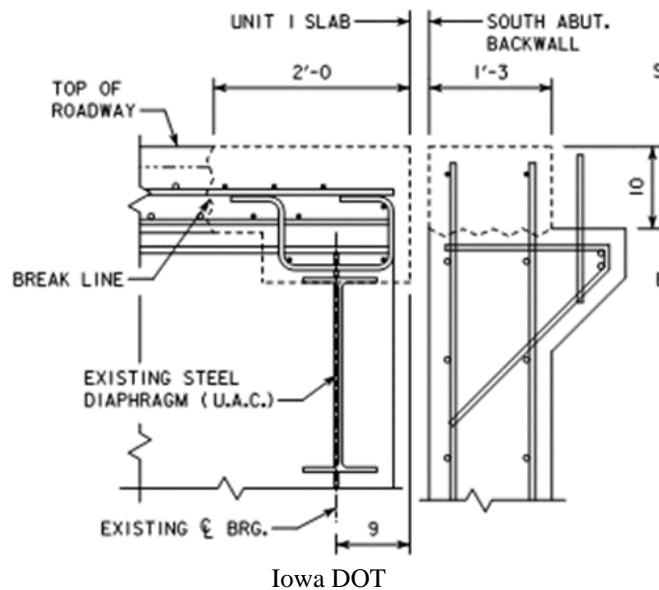
The participants were provided with a demolition plan similar to the one shown in Figure 6.5.

**Figure 6.5. Typical expansion joint replacement cross section**

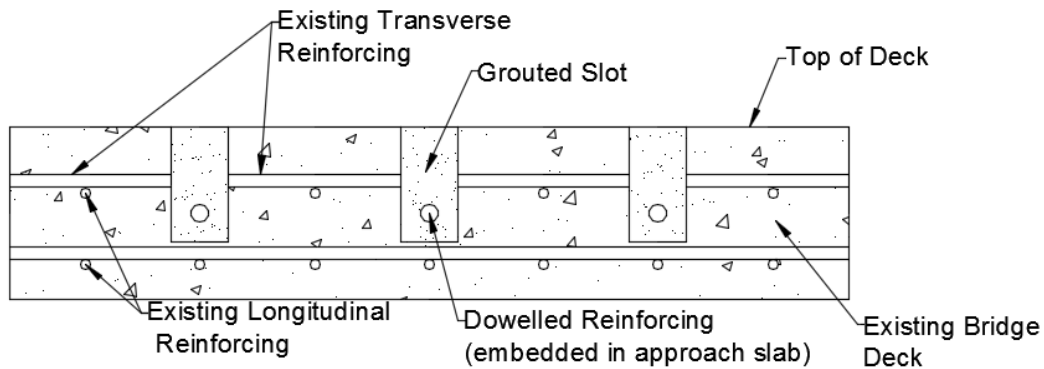
**Figure 6.7. Slotted dowel concept**

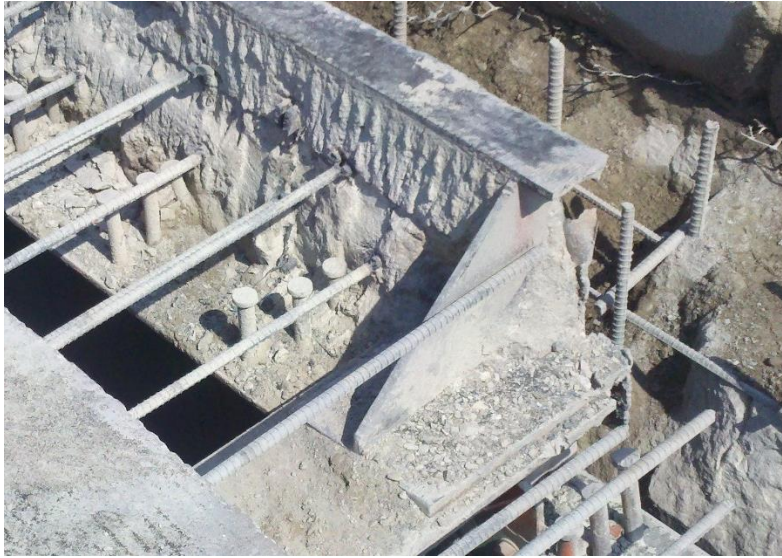
**Figure 6.8. Sliding plate joint anchorage during removal**

Existing joint anchorages take a great deal of work to remove. Sliding plate joint anchorages, in particular, are bolted to the top flange of the girder and require the removal of a considerable amount of concrete. The size and depth of these anchorages are shown in Figure 6.8 and Figure 6.9.

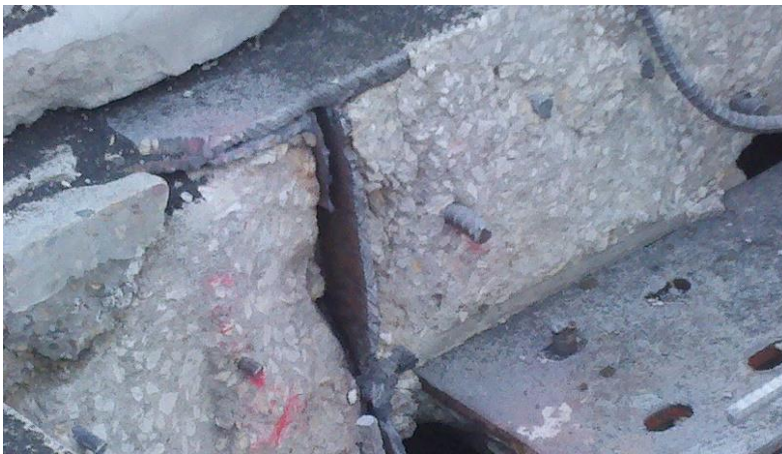
**Figure 6.9. Sliding plate joint cross section**

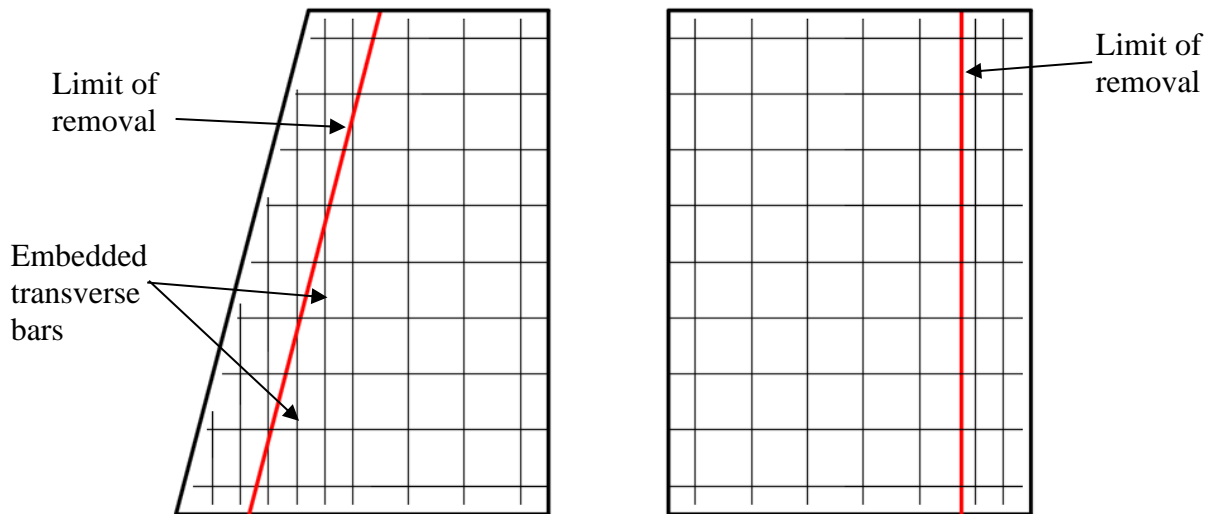
**Figure 6.10. Skewed bridge deck reinforcing (left) and non-skewed deck reinforcing (right)**

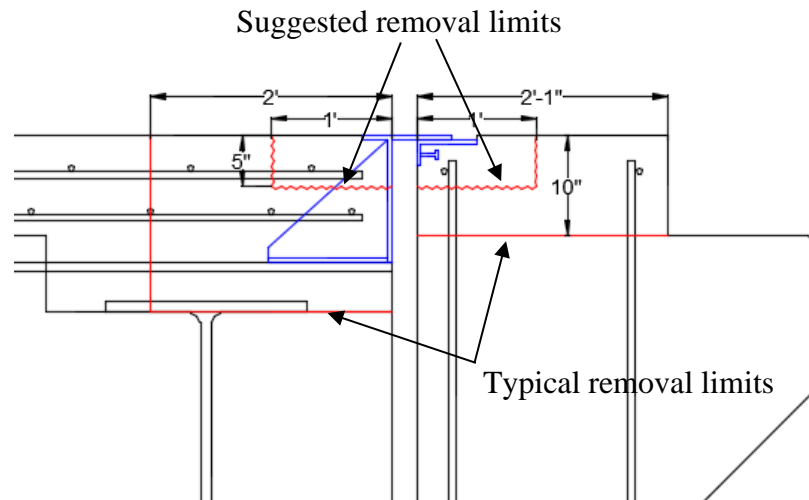
**Figure 6.11. Suggested demolition limits for partial-depth joint replacement concept**

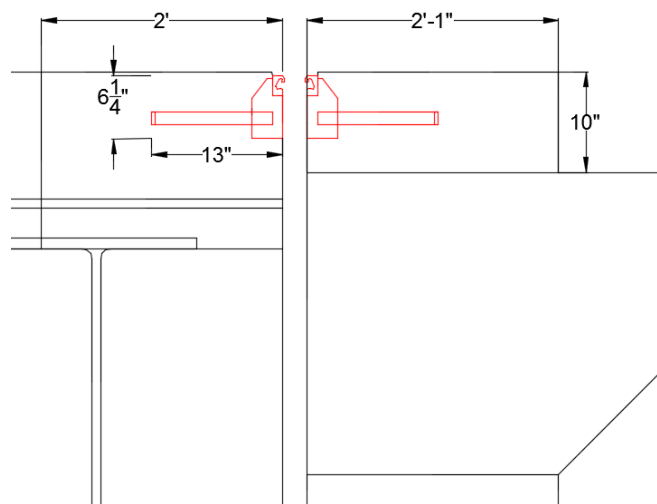
**Figure 6.12. Iowa DOT strip seal anchorage**

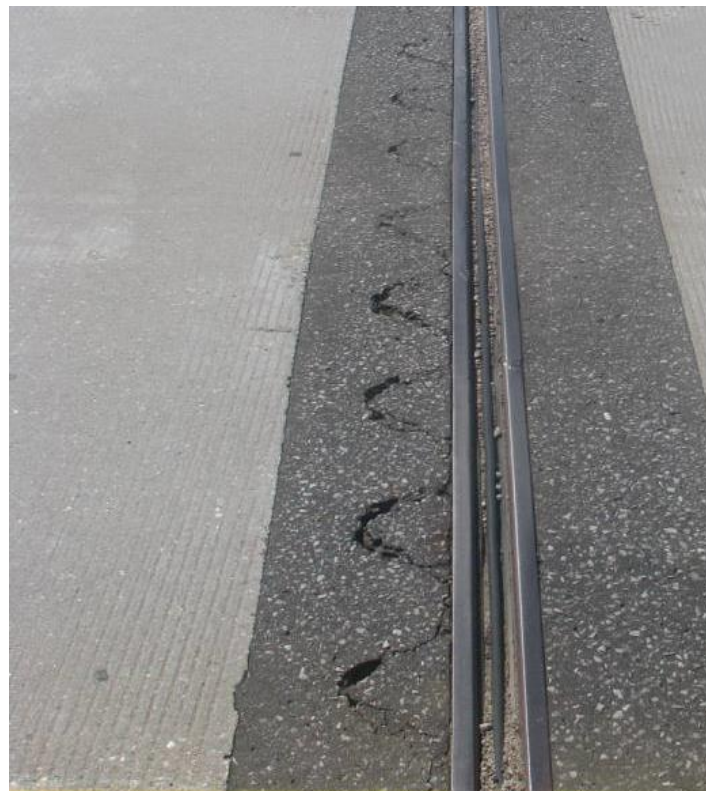
**Figure 7.1. Reflective cracking in elastomeric concrete header**

Prior to the report published in 2005, EC worked well as a header material for anchoring strip seal joints. These joints performed for a lifespan of more than 10 years; however, KDOT preferred a lifespan 15 years or longer for joints with these types of material and had numerous failures requiring repair or replacement in the last 7 to 8 years. The problem experienced by KDOT involved the joint developing cracking over the anchorages matching the shape of the anchorage; this can be observed in Figure 7.1.

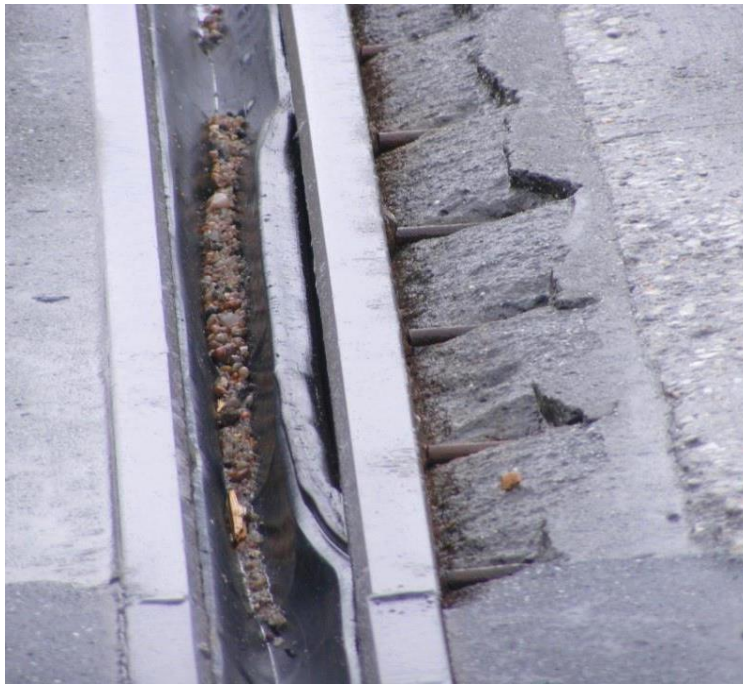
**Figure 7.2. Elastomeric concrete joint header with severe material loss**

Eventually, the cracking became severe enough that the header material was lost as shown in Figure 7.2.
