Final Report SPR-FY21(006)

WBS Report #
26-1122-0099-001

Performance of High Early-Strength Used in Concrete Bridge Repair

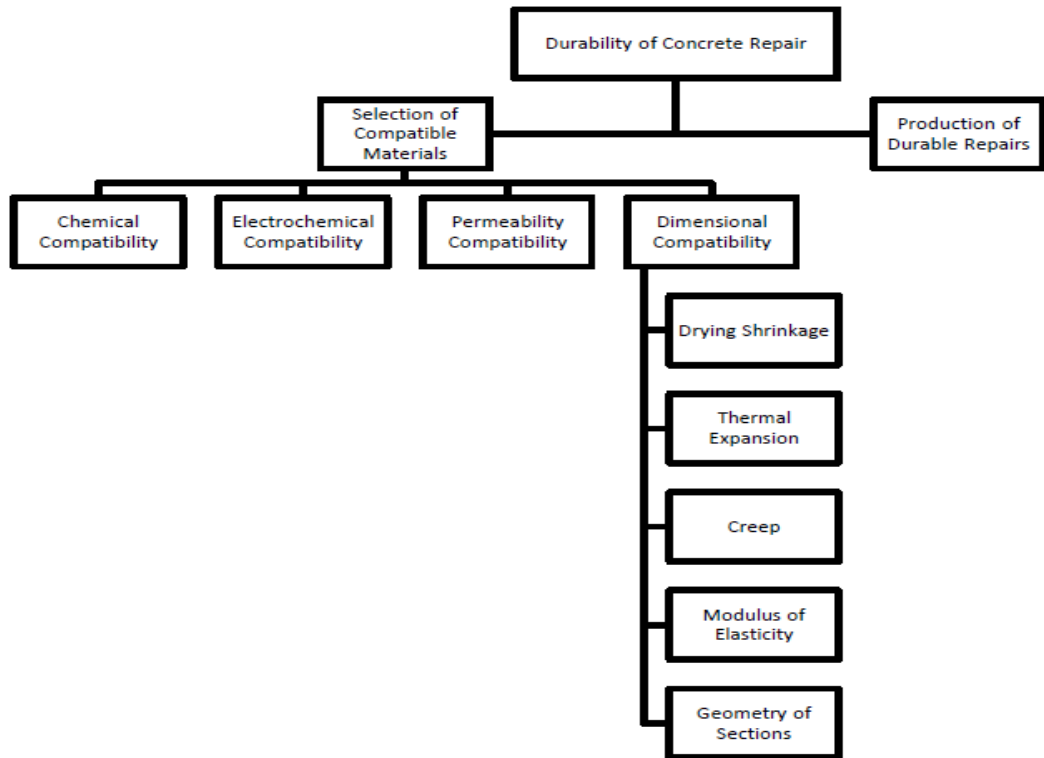
Figure Chapter 2.1 Factors affecting the durability of a concrete repair (Emmons et al., 1993)

Dimensional compatibility is considered the most significant factor affecting the durability of a concrete repair since it refers to the ability of a repair material to support applied

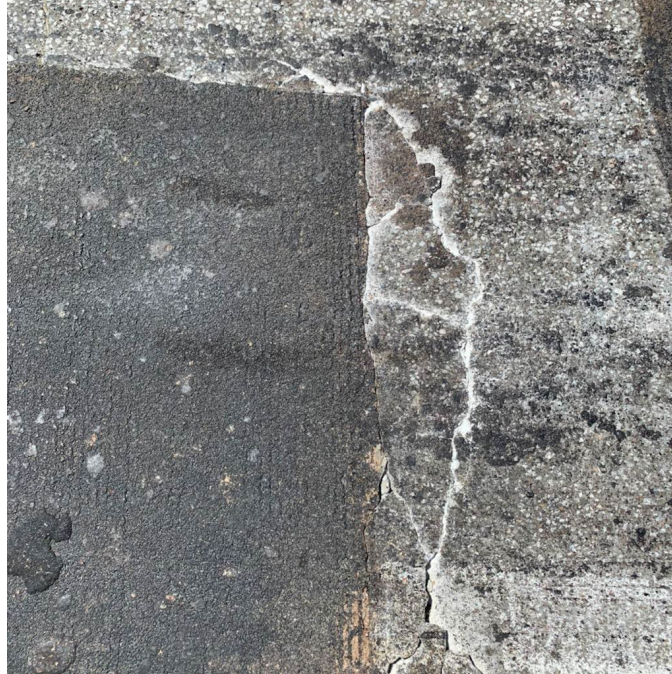
Figure Chapter 2.2 Early minor halo efflorescence on NDOT bridge polymer concrete repair

The “halo effect” is a corrosion phenomenon of special concern for deck patching and has been noted by NDOT personnel as a concern with HES bridge deck repair in the past (see HES polymer repair in Figure Chapter 2.2). The beginnings of some haloing (efflorescence around the patching interface) were potentially observed on a recent site visit by the research team. When a damaged area of concrete is repaired and the existing substrate is contaminated with chloride ions, a chloride gradient exists between the two materials, creating a large corrosion potential. This leads to rapid corrosion in the area around the repair (Whitmore, 2005).

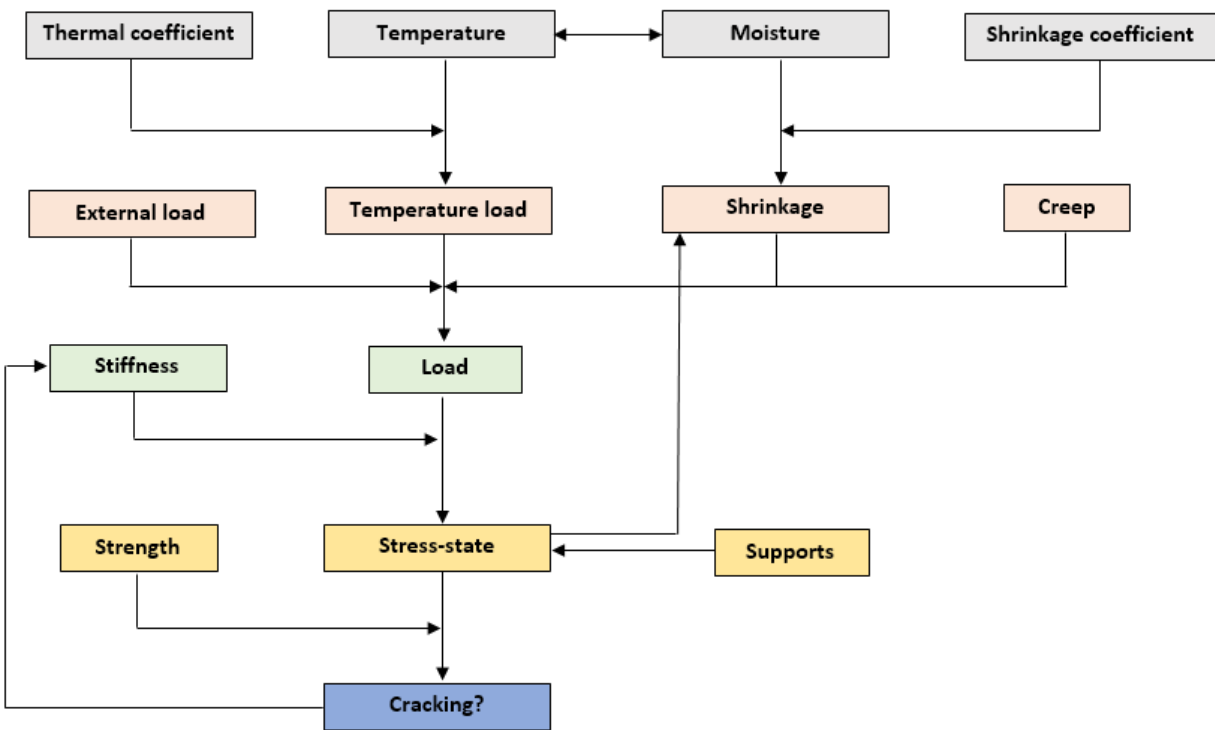
Figure Chapter 2.3 Flowchart for the analysis of early-age concrete behavior (redrawn and adapted from (Hauggaard et al., 1997))

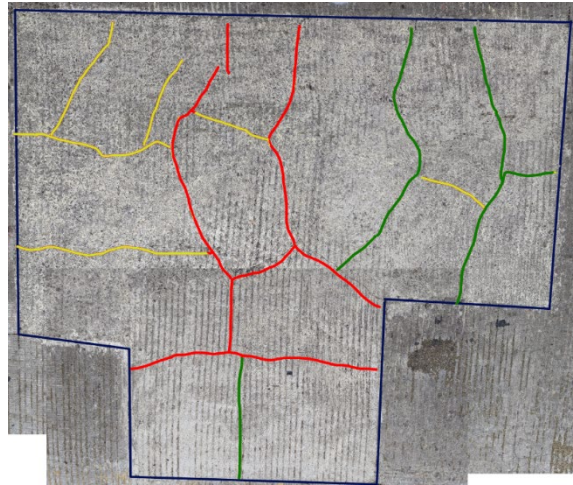
Figure Chapter 2.4 Example of field inspection of prebagged material in an ongoing study

Dimensional stability is a challenge for all HES materials. In a previous study by the authors on prebagged repair materials, there was no correlation between the observed early cracking in the field inspections (Figure Chapter 2.4) and standard tests such as the ring test, autogenous shrinkage, or drying shrinkage, all of which are commonly specified tests for HES repair material. It is likely that factors such as curing, workmanship, and environmental effects play a larger role in the behavior of HES materials than other materials. The factor that best predicted cracking performance over a 12-month period was compression strength. Note that all

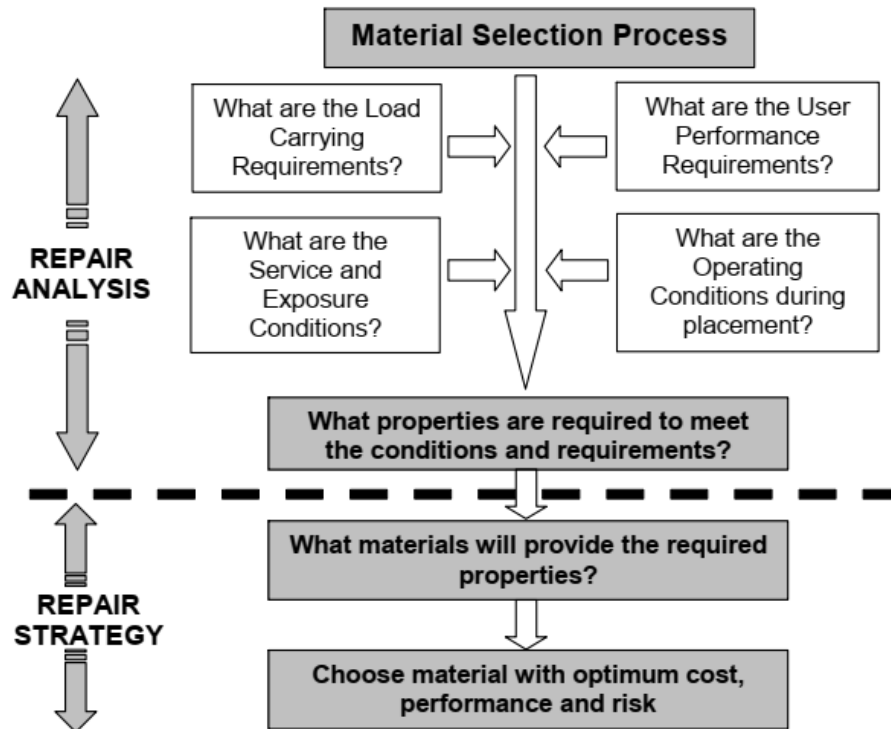
Figure Chapter 2.5 Material Selection Process (Barde et al., 2006)

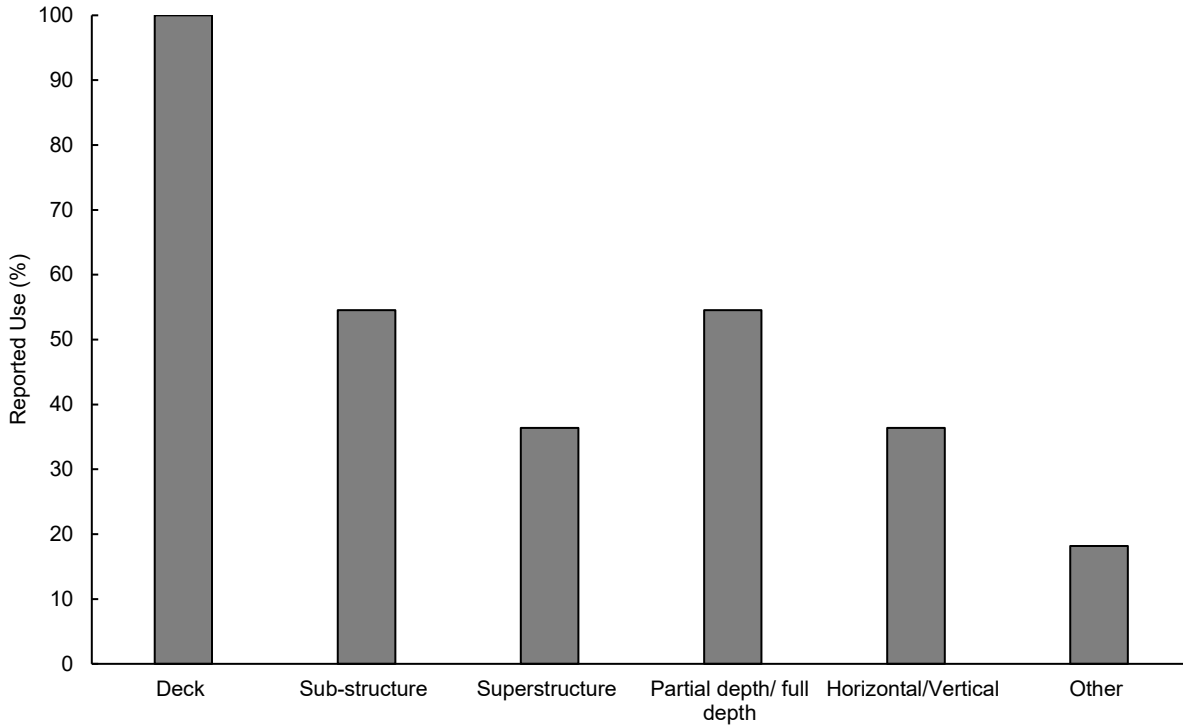
Figure Chapter 3.1 Utilization of HES materials for maintenance of different parts of the structures and different repair types

Based on the survey results, HES materials are typically used in bridge deck maintenance, as shown in Figure Chapter 3.1. Different types of HES materials are typically used in bridge maintenance projects. Portland cement-based HES repair materials are the most commonly used materials, followed by polymer concrete, magnesium phosphate, and sulfoaluminate repair materials. Challenges commonly encountered when using HES materials include short setting time, improper mixing and/or curing, testing, and opening traffic time. Most of the surveyed states have quality control specifications for HES materials, including specific material and experimental testing requirements. The HES quality control process is currently limited to the preselection and early post-installation phases.

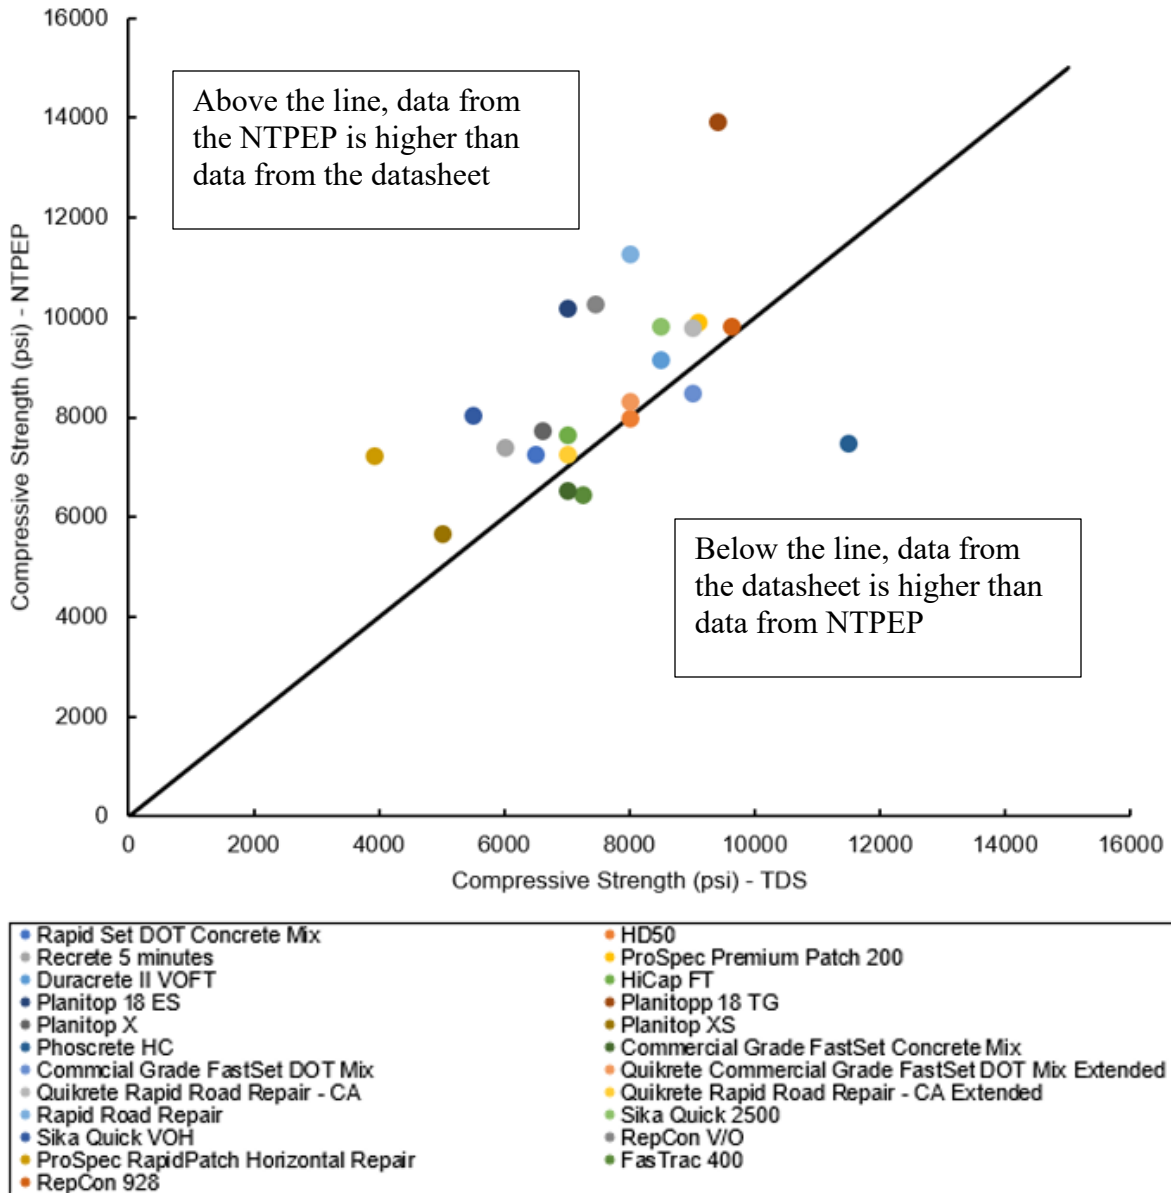
Figure Chapter 3.2 Comparison of the compressive strength data on the NTPEP and the material datasheet

The values of several properties of HES materials included on the APL and tested on the NTPEP were compared with those reported on each material's datasheet. These properties are compressive strength, shrinkage, and initial and final setting time. The results are shown in Figure Chapter 3.2 through Figure Chapter 3.6. In these graphs, the x-axis represents data obtained from the technical datasheet (TDS), the y-axis represents data obtained from the NTPEP, and the 45-degree line represents the ideal case where the NTPEP data match the data obtained from the TDS. As shown in the figures below, there is a significant difference between the data reported on the NTPEP and the data provided by the manufacturer.

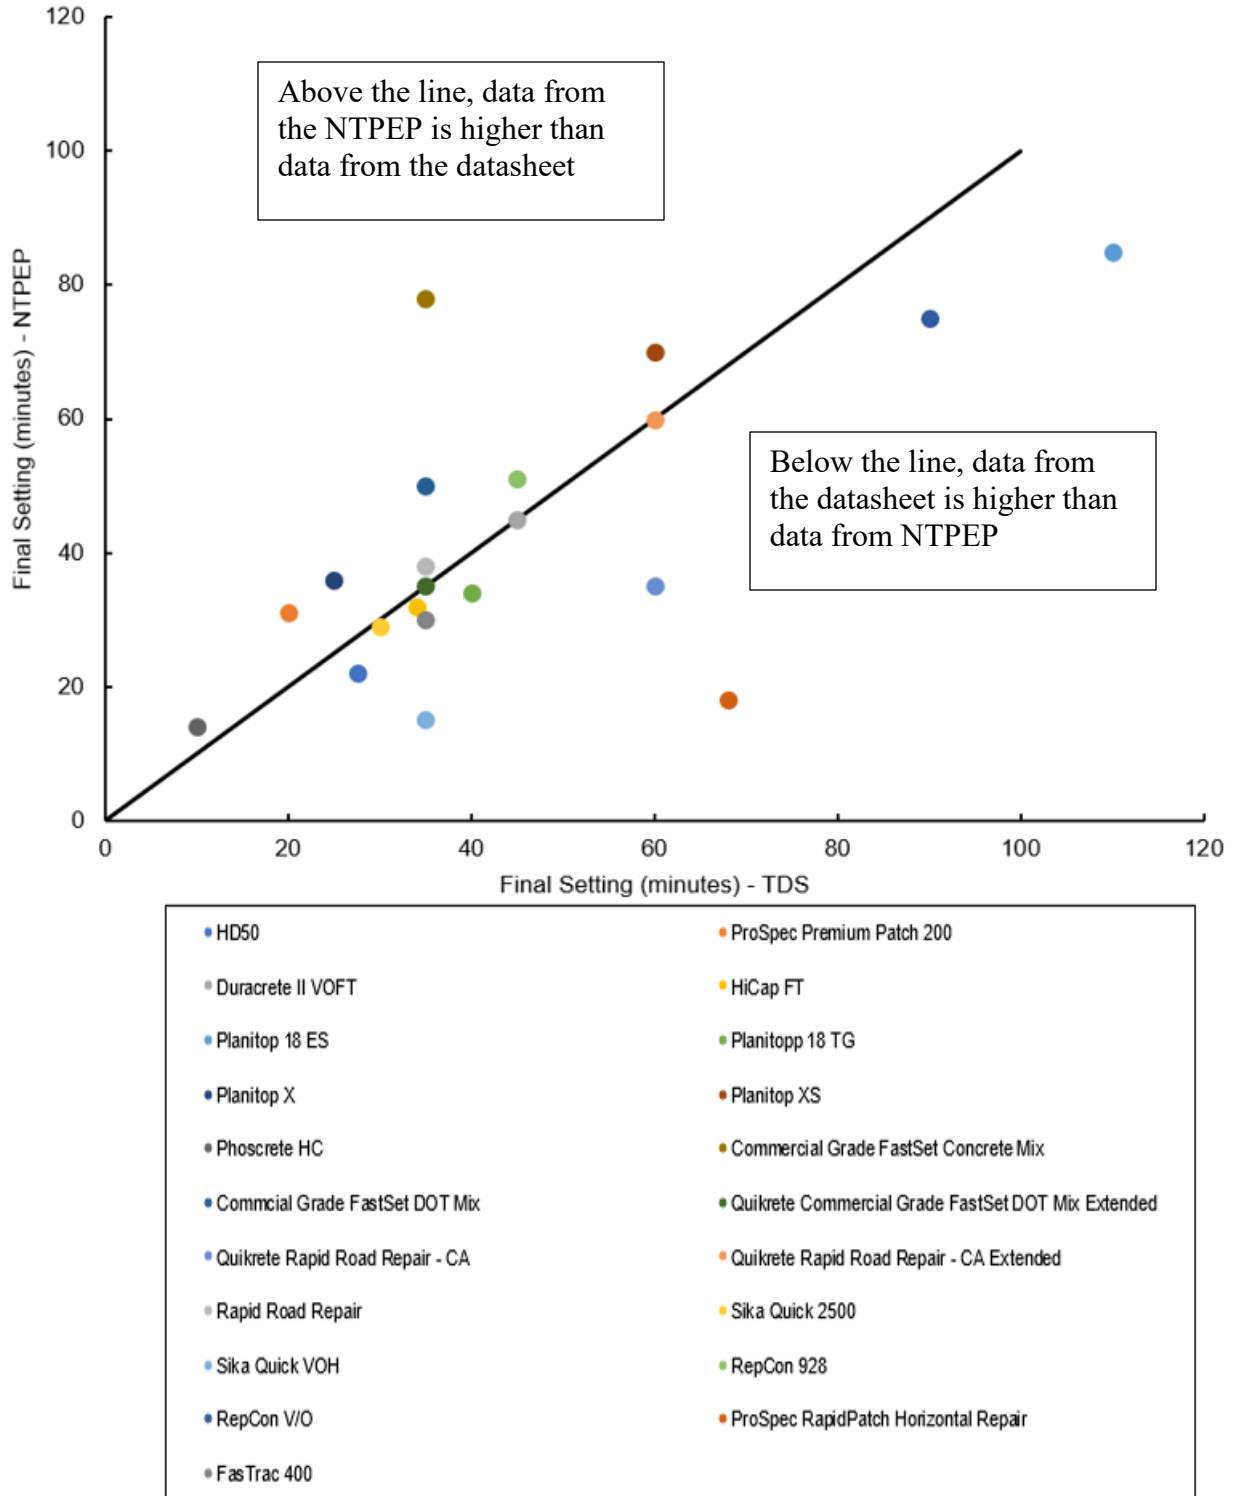
Figure Chapter 3.6 Comparison of the final setting data on the NTPEP and the material datasheet

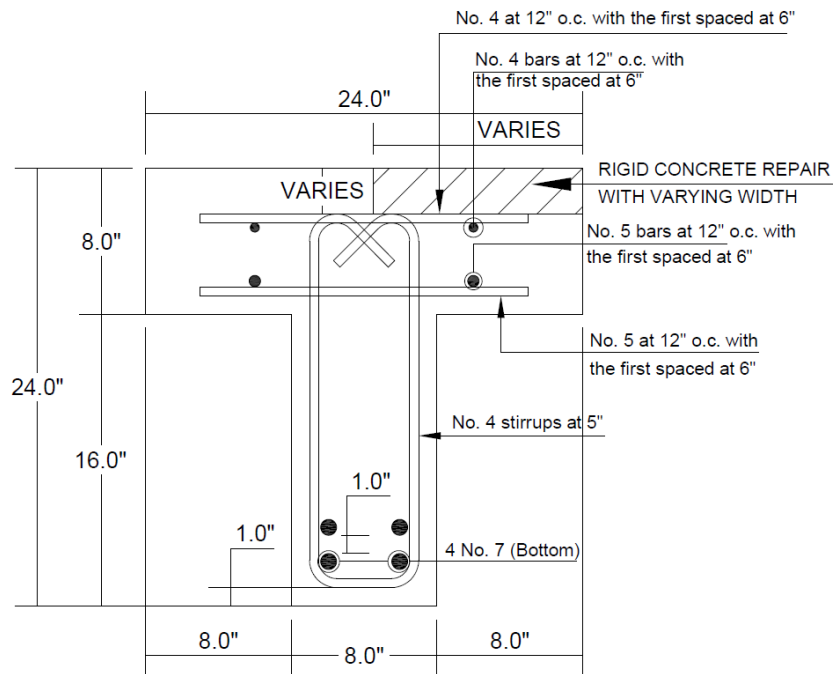
Figure Chapter 3.7 Cross-section of the T-beam used in the moment-curvature analysis

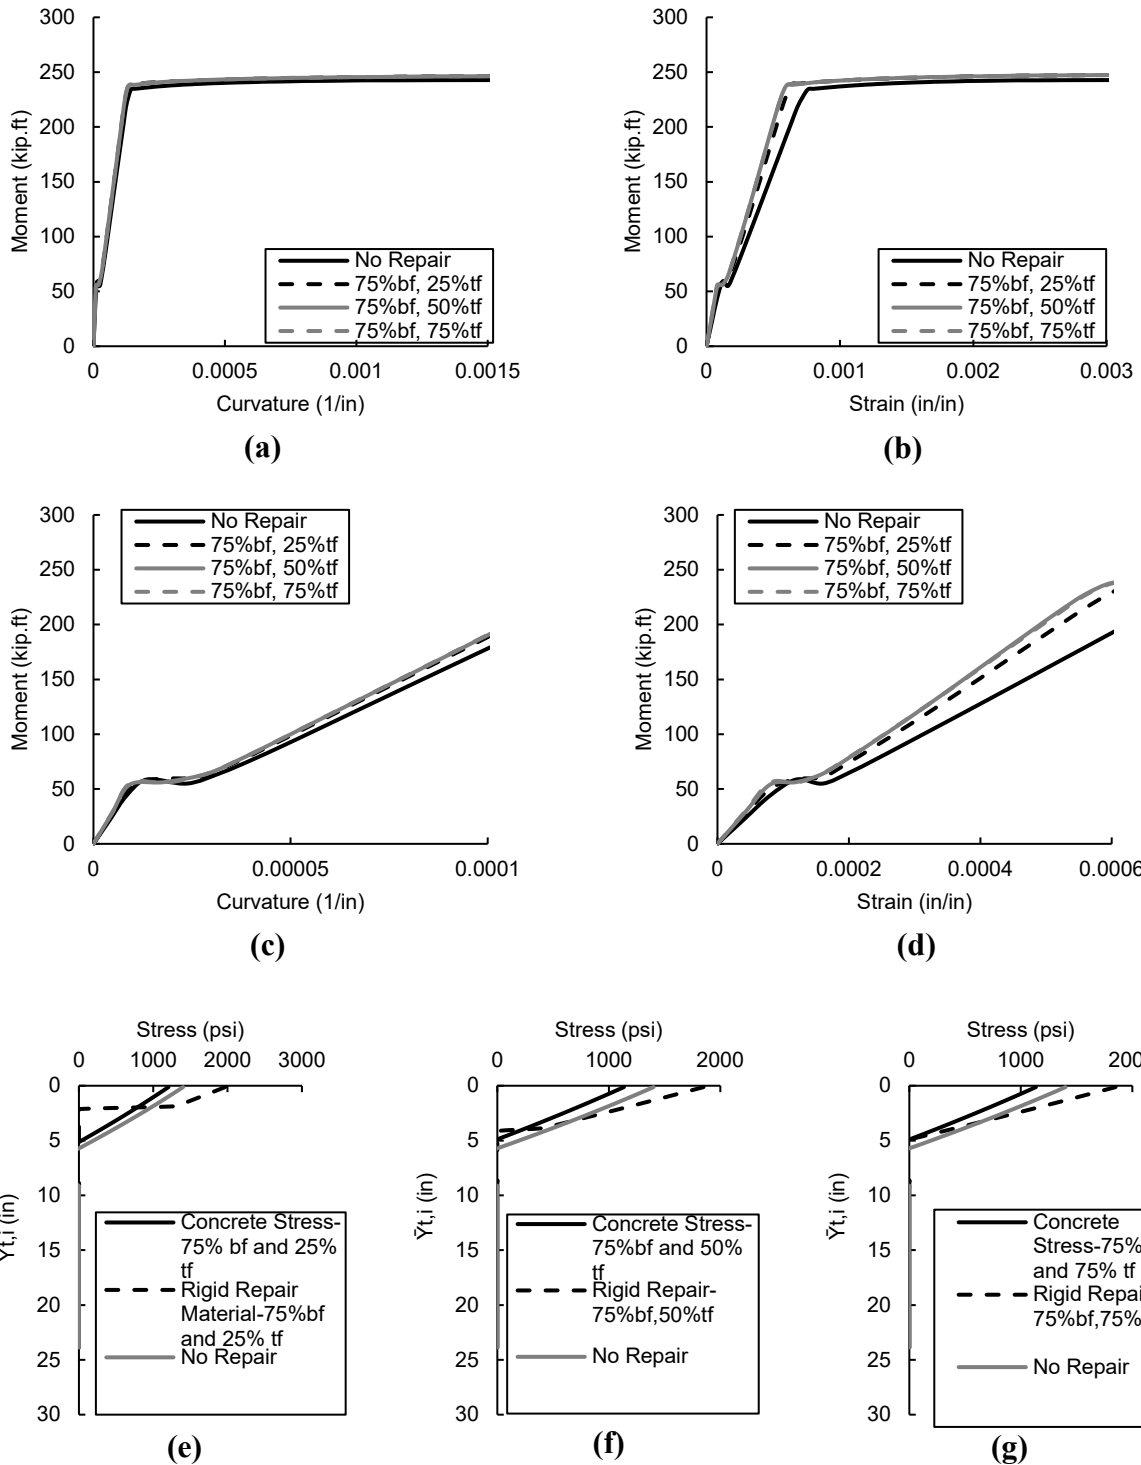
Figure Chapter 3.9 Effects of cement-based rigid repair materials on the flexural strength of a T-beam a) Complete moment-curvature curve and; b) moment-strain curve of a rigid repair material; c) elastic part of the moment-curvature curve; d) elastic part of the moment-strain curve; stress distribution in the concrete and the rigid repair material having a width equal to 75% of the width of the flange and e) 25%; f) 50%; and g) 75% of the flange thickness

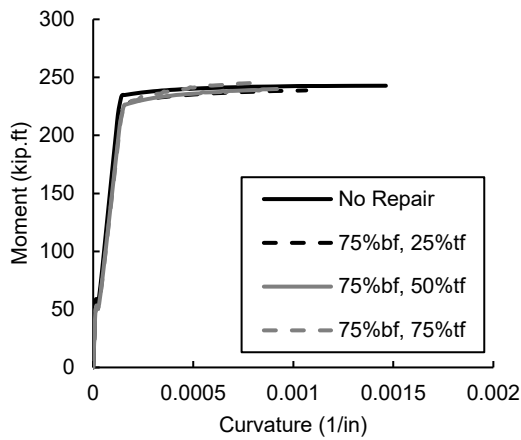
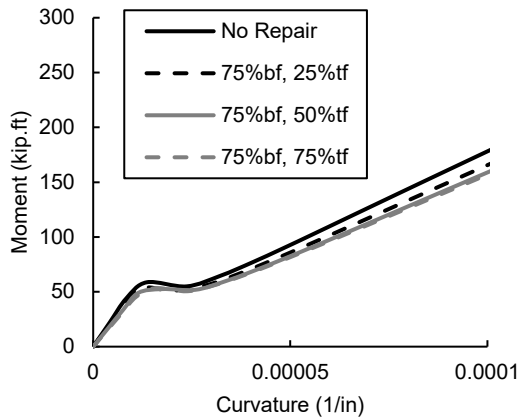
The moment-curvature and moment-top-fiber-strain curves for the repaired T-beam using cement-based HES material are shown in Figure Chapter 3.9-a through Figure Chapter 3.9. Figure Chapter 3.9-e through Figure Chapter 3.9-g illustrate the same moment (139 kip.ft) and the stress distribution in the post-cracking elastic range. This load was arbitrarily selected as it represents a service, load, and the relative stress changes in this preliminary investigation would hold at lower loads. Therefore, only the cases where the repair material is installed on 75% of the

flange width and having a depth equal to 25%, 50%, and 75% of the flange thickness are shown in Figure Chapter 3.9 and compared with the case where no repair is installed. The rest of the investigated cases can be found in Appendix B.

The results show that installing a cement-based HES that will typically have a higher strength than the substrate concrete will result in a slight percent increase in the beam's flexural capacity, which is proportional to the depth of the installed repair. As the repair depth increases, a higher strength gain is expected. However, similar strength gain is obtained when the depth of the installed repair is 50% and 75% of the flange depth. The stress distribution curves shown in Figure Chapter 3.9-e through Figure Chapter 3.9-g show that at the same amount of load, the stresses developed in the installed HES material are much higher than those developed in the substrate concrete. The stresses developed in the repaired beam were compared with those in the original, fully intact beam. The results show how the installation of HES repair material attracts more stress which may explain the early deterioration of many HES materials. In general, these results are as expected and are shown for context.

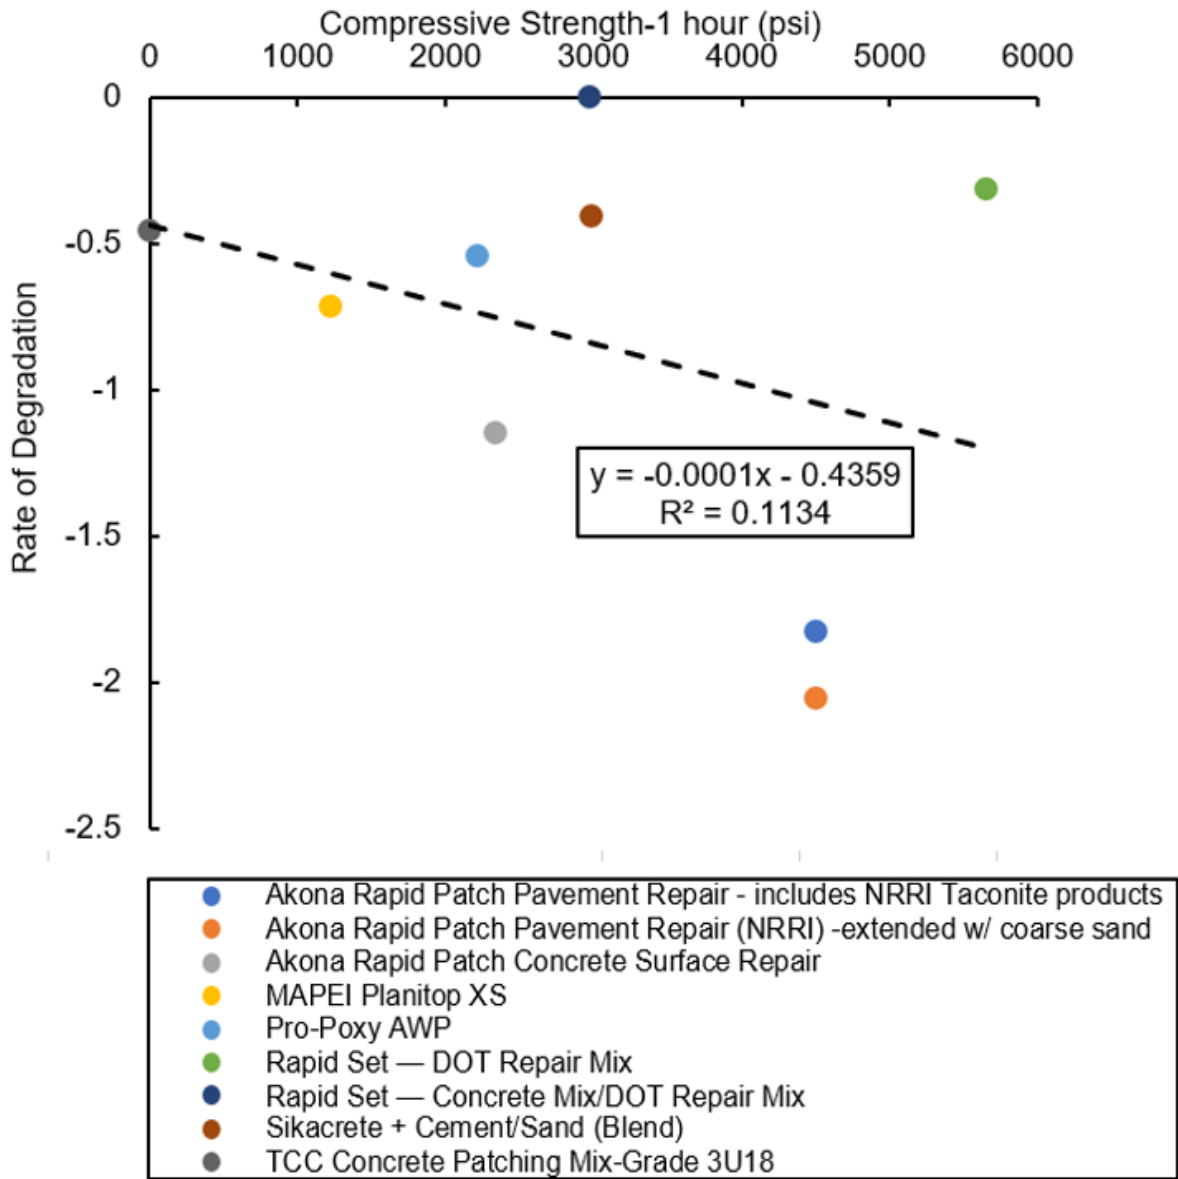
Figure Chapter 3.11 Early Compressive strength (1 hour) vs. the rate of degradation of field data collected by (Burnham et al., 2016)

slope of the curve of the condition rating data and the age of repair was calculated. The rate of degradation data was then plotted against the one-hour, 3-hour, and 28-day compressive strength in addition to length change (shrinkage data). The results are shown in Figure Chapter 3.11 through Figure Chapter 3.15, and show a weak correlation between the degradation rate and the early and 28-day compressive strength ($R^2_{1 \text{ hour}}=0.1134$, $R^2_{3 \text{ hours}}=0.1157$, $R^2_{28\text{-days}}= 0.0416$). The shrinkage data plotted against the rate of degradation show a low correlation between the length change data in air and the rate of degradation ($R^2=0.3035$). However, the length change in water data shows a possible relationship with the rate of degradation with a correlation coefficient (R^2) of 0.7211, but this seems to be heavily influenced by two points that dominate the R^2 weighting. The two materials, Akona NRRI and Akona NRRI with Taconite, seemed to affect the data disproportionately and strongly influenced the regression lines and R^2 values. The obtained results show that the relationship between the rate of degradation with different material properties is highly sensitive to the collected field data and the qualitative judgment of the evaluator on the repair condition.

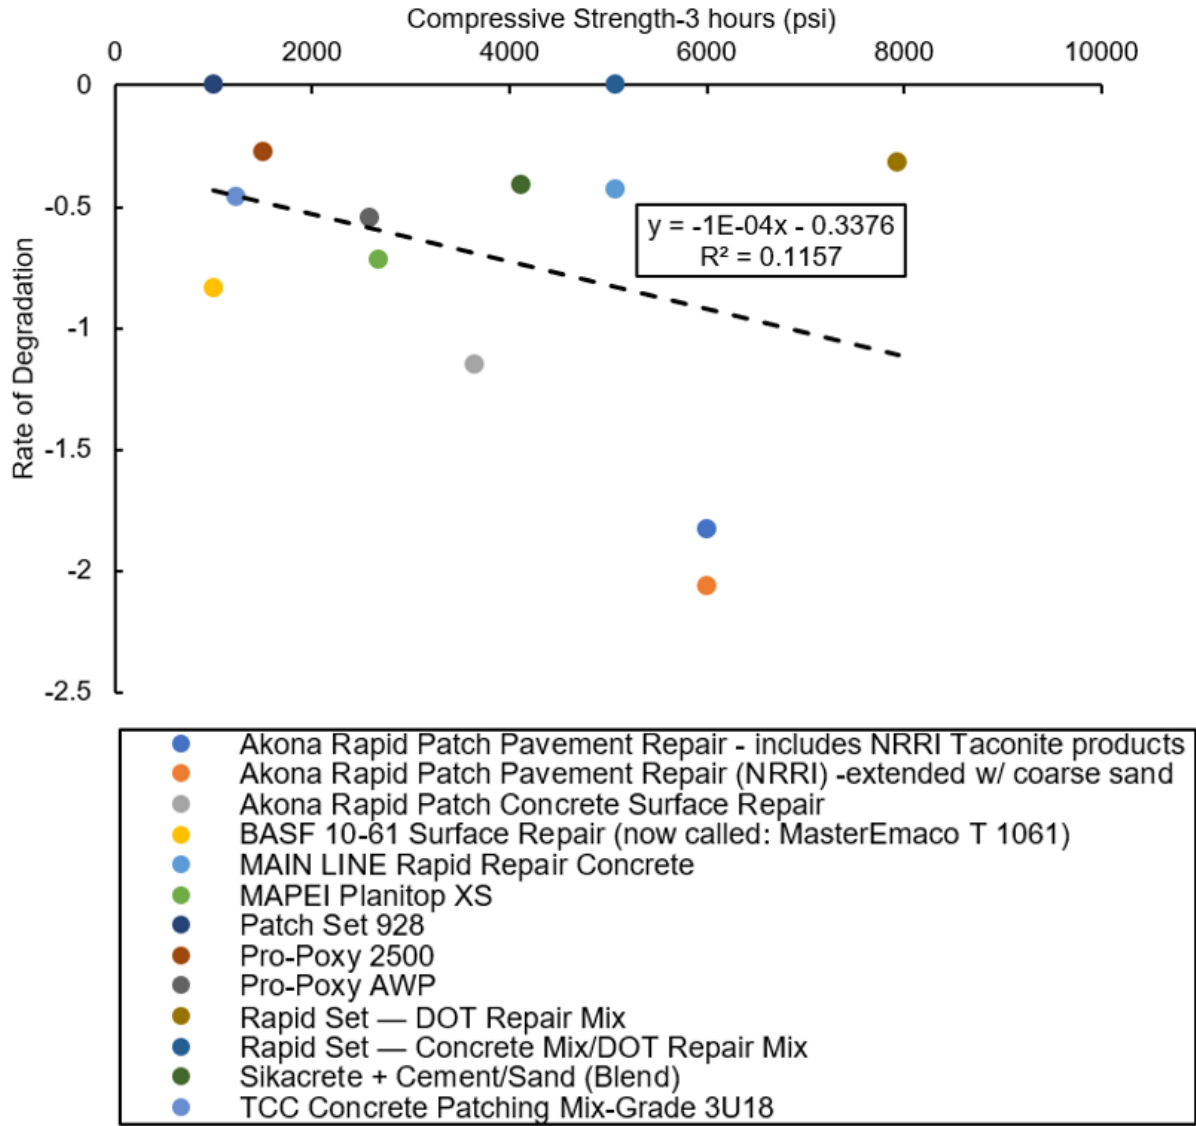
Figure Chapter 3.12 Early Compressive strength (3 hours) vs. the rate of degradation of field data collected by (Burnham et al., 2016)

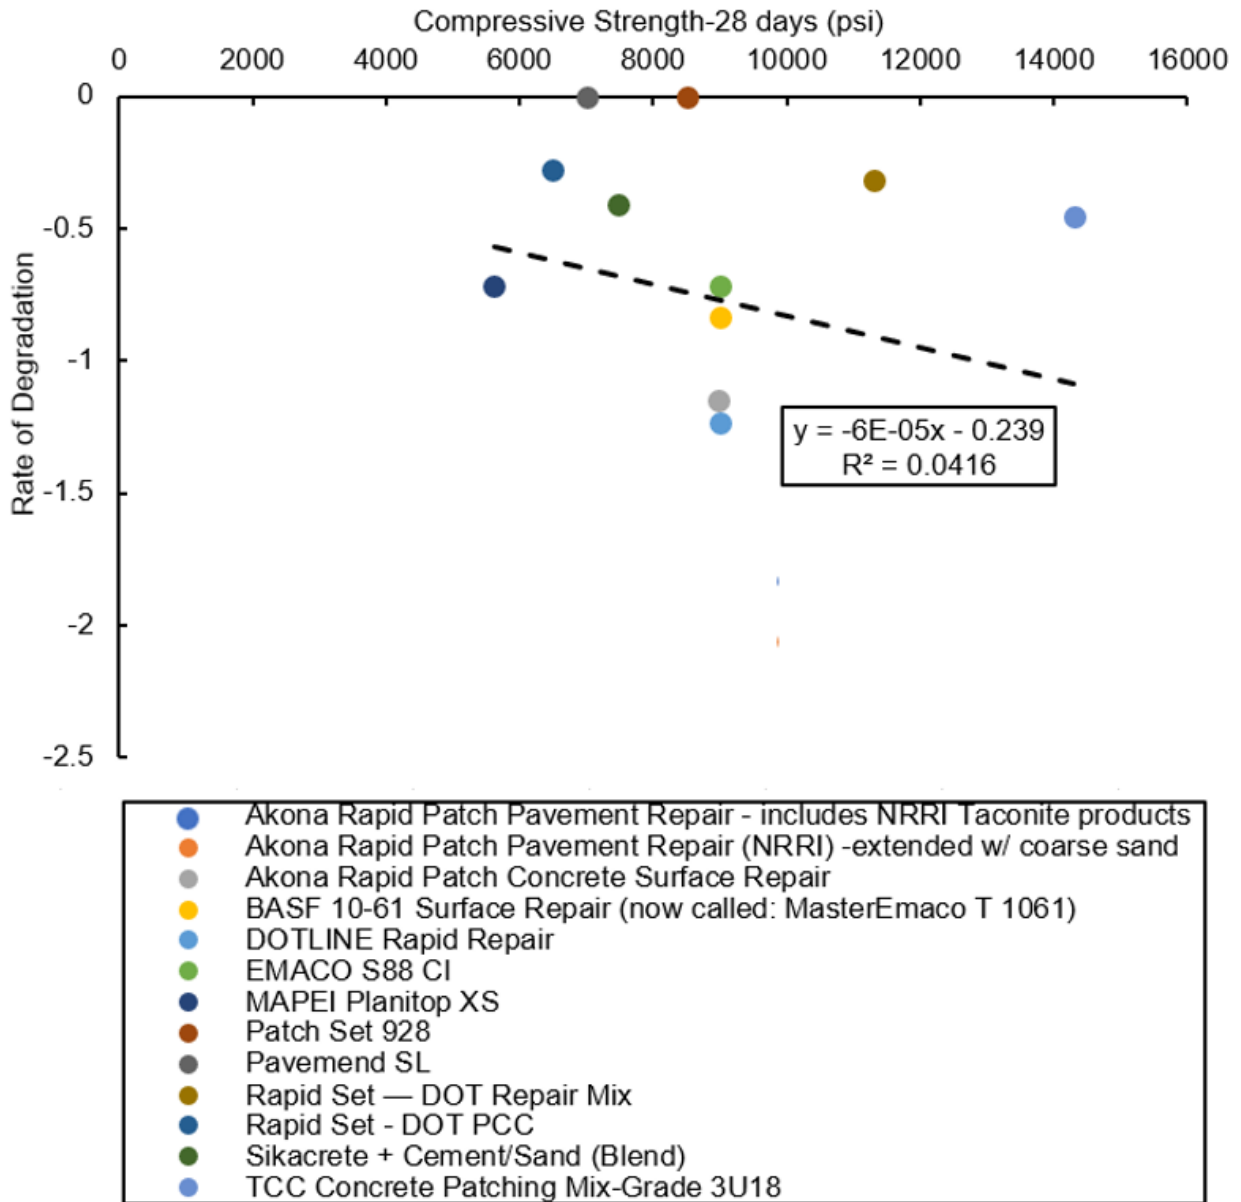
Figure Chapter 3.13 Compressive strength (28 days) vs. the rate of degradation of field data collected by (Burnham et al., 2016)

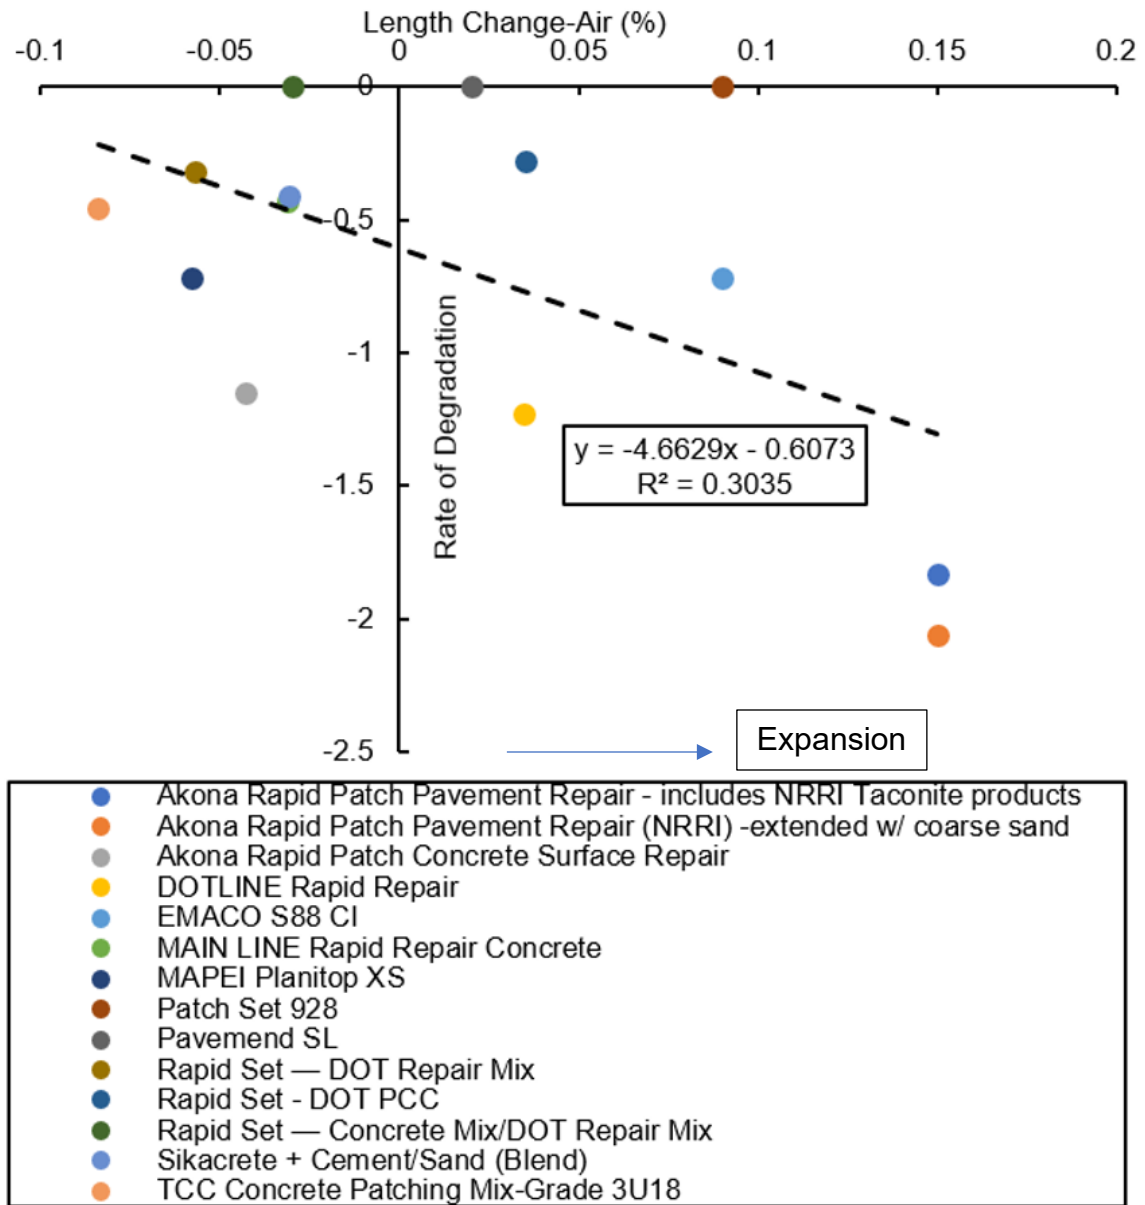
Figure Chapter 3.14 Length change in air vs. the rate of degradation of field data collected by (Burnham et al., 2016)

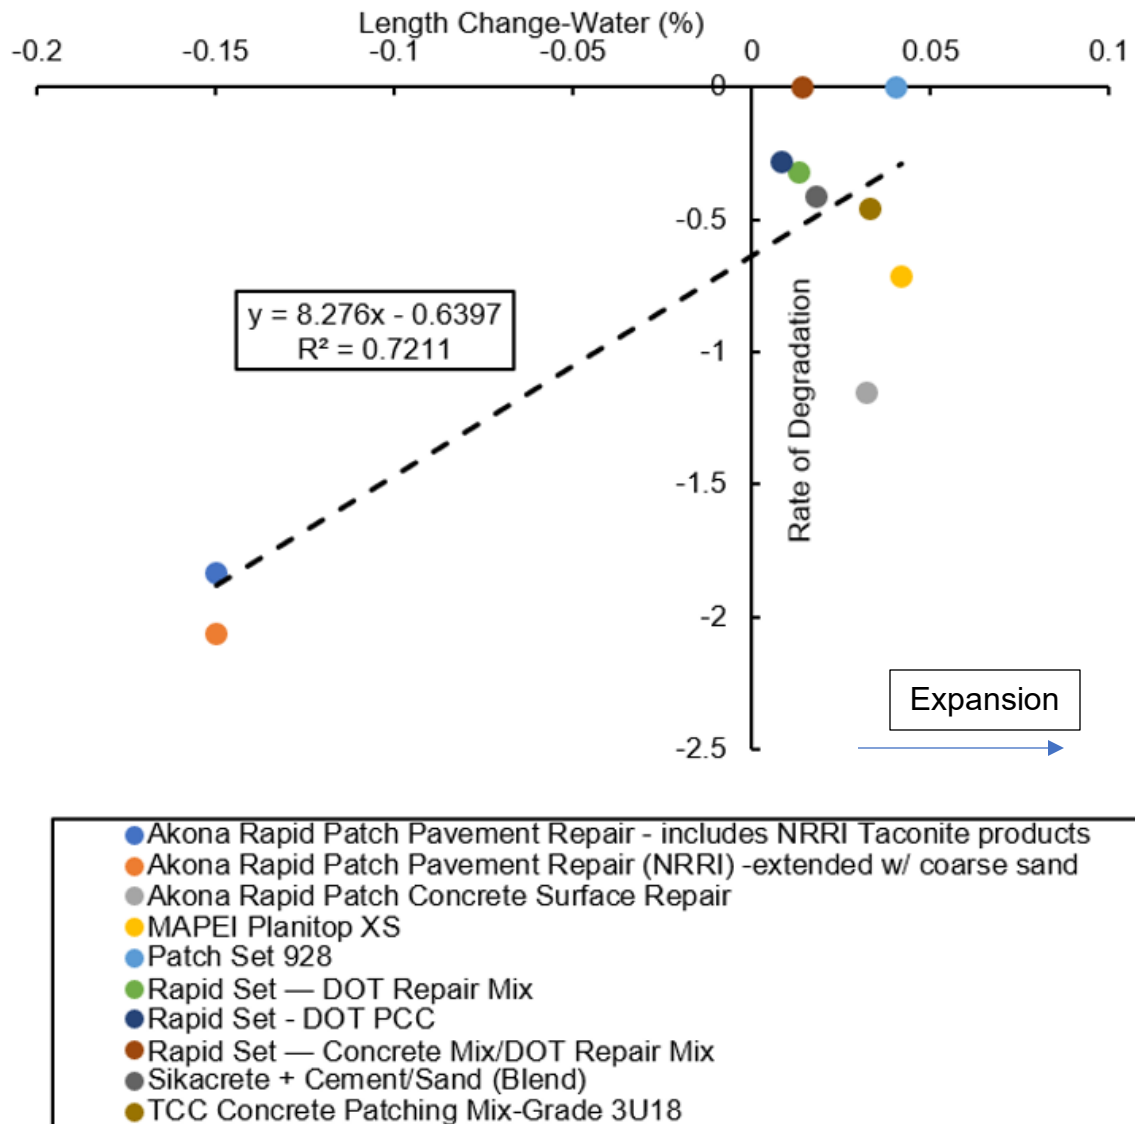
Figure Chapter 3.15 Length change in water vs. the rate of degradation of field data collected by (Burnham et al., 2016)

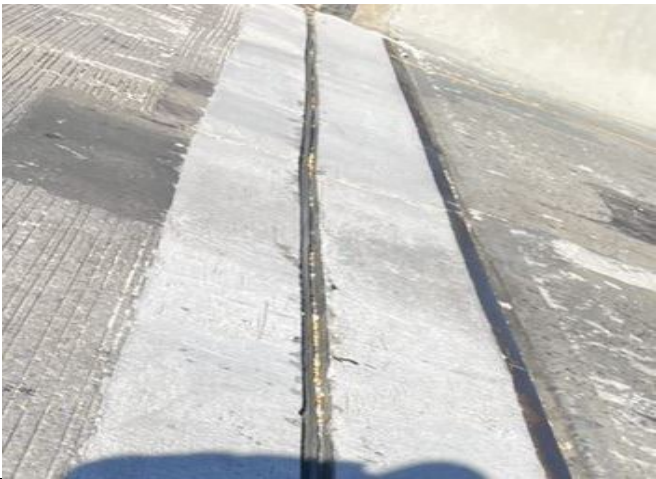
Item	Structure Number	Material	Time of Repair	Condition Rating	Approximate Repair Area (ft ²)	Average Crack Length (in.)	The current condition of the installed repair materials
1	508016	Phoscrete HC	July 2022	5	42	-

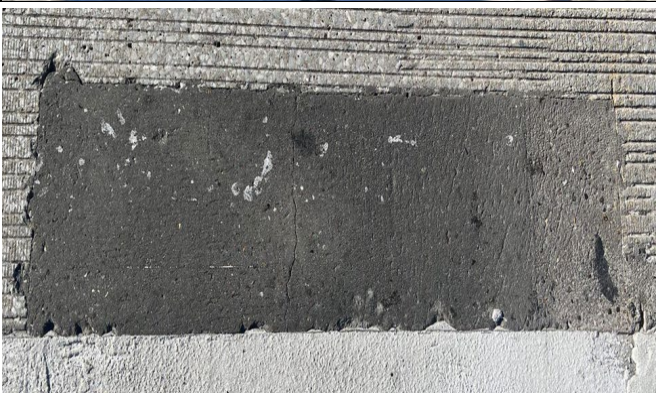
Master Emaco T 545	2017	2	1.5	8

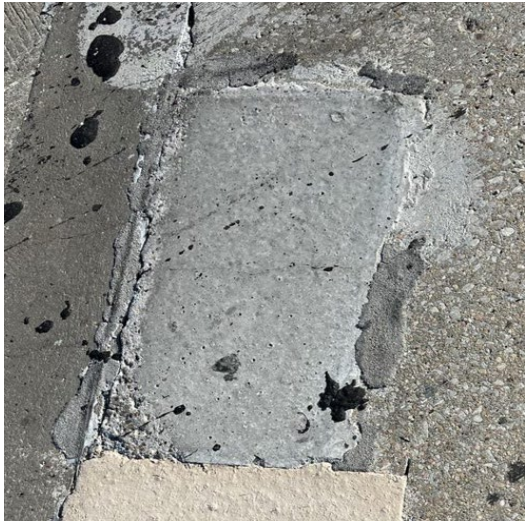
Item	Structure Number	Material	Time of Repair	Condition Rating	Approximate Repair Area (ft ²)	Average Crack Length (in.)	The current condition of the installed repair materials
2	48048	Master Emaco T 1060	2012	3	2	12

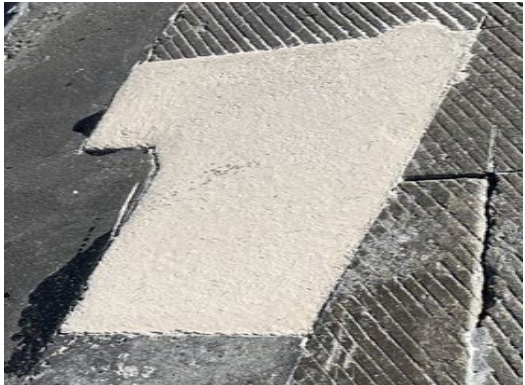
Phocrete HC	09/26/2022	5	2.7	-

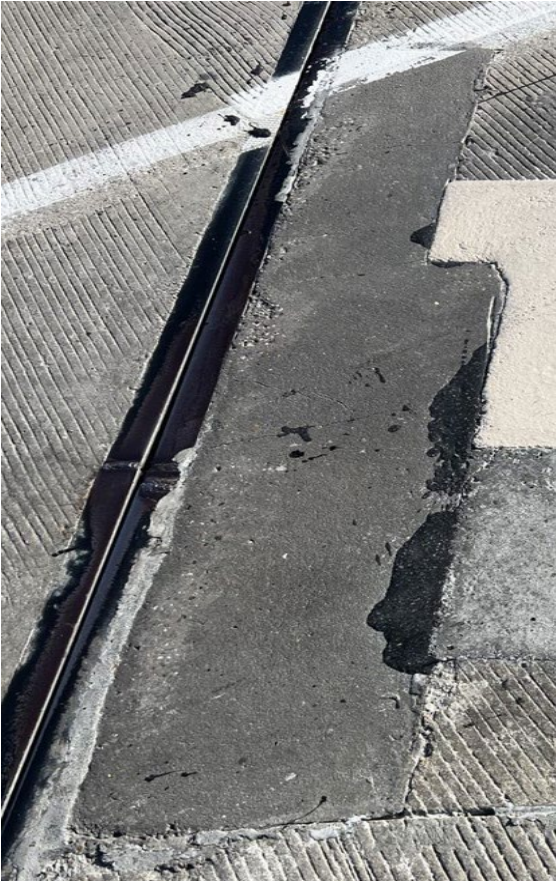
Item	Structure Number	Material	Time of Repair	Condition Rating	Approximate Repair Area (ft ²)	Average Crack Length (in.)	The current condition of the installed repair materials
2	48048	Master Emaco T 545	2017	2	5.83	14.2

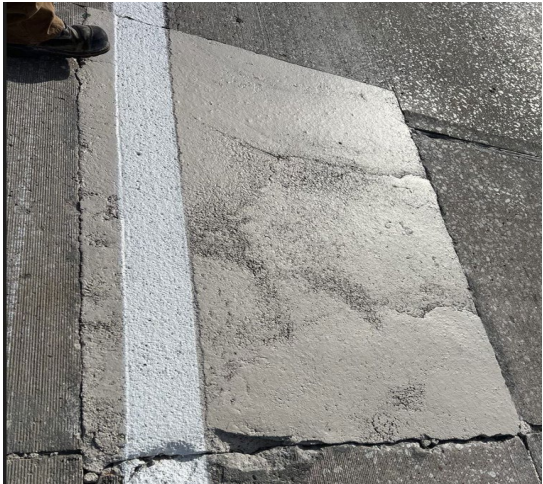
Item	Structure Number	Material	Time of Repair	Condition Rating	Approximate Repair Area (ft ²)	Average Crack Length (in.)	The current condition of the installed repair materials
3	49665	Phoscrete HC	09/27/2022	3	21	12

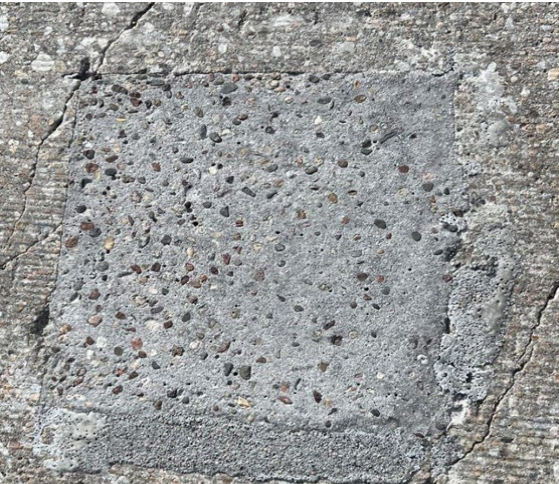
Master Emaco T 1060	-	5	2.6	-

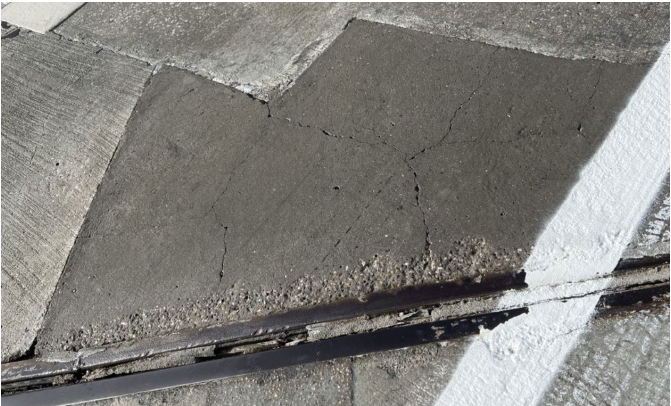
Item	Structure Number	Material	Time of Repair	Condition Rating	Approximate Repair Area (ft ²)	Average Crack Length (in.)	The current condition of the installed repair materials
3	49665	Master Emaco T 545	-	2	9.17	29

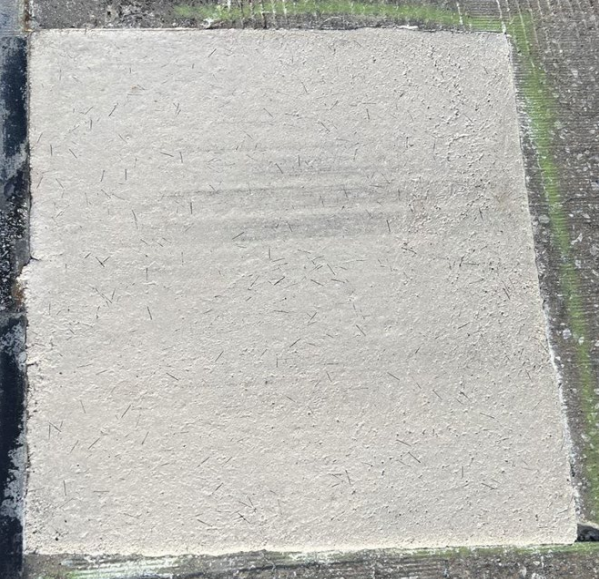
4	49626	Phoscrete HC	10/11/2022	5	7	7

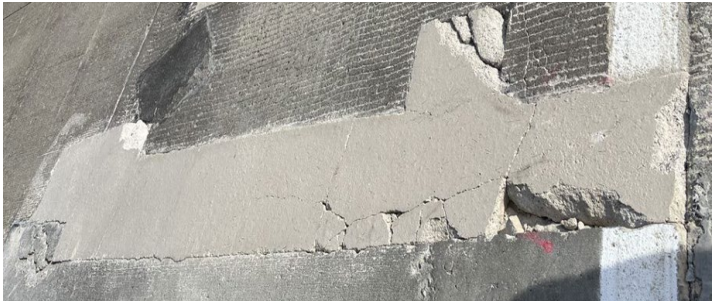
Item	Structure Number	Material	Time of Repair	Condition Rating	Approximate Repair Area (ft ²)	Average Crack Length (in.)	The current condition of the installed repair materials
5	49047	Phocrete HC	10/05/2022	1	14.2	17

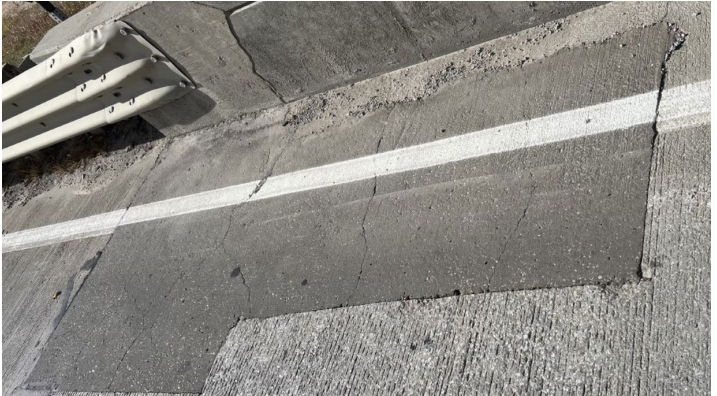
6	05428	Master Emaco T 1060	2017	3	42.5	30
