Final Report SPR-FY21(006)

WBS Report #
26-1122-0099-001

Performance of High Early-Strength Used in Concrete Bridge Repair

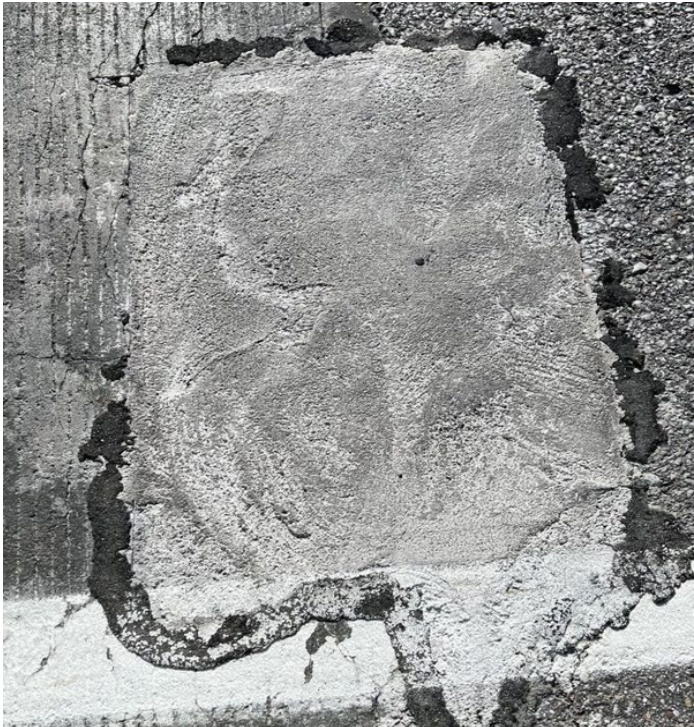
Item	Structure Number	Material	Time of Repair	Condition Rating	Approximate Repair Area (ft ²)	Average Crack Length (in.)	The current condition of the installed repair materials
7	35911	Phocrete HC	07/11/2022	4	4.4	-

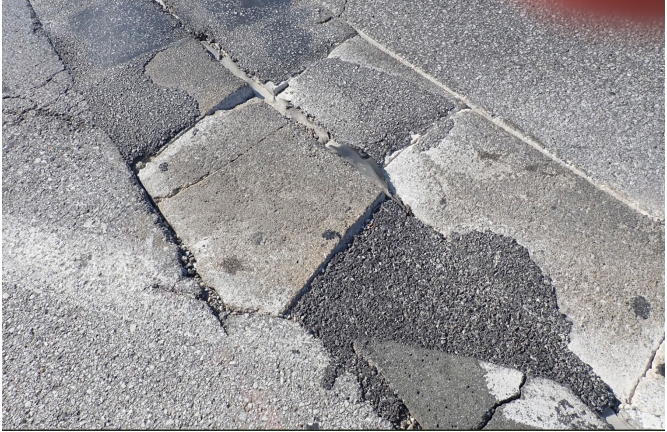
Item	Structure Number	Material	Time of Repair	Condition Rating	Approximate Repair Area (ft ²)	Average Crack Length (in.)	The current condition of the installed repair materials
1	44606	PPC 1121	2019	1	7.5	7.227

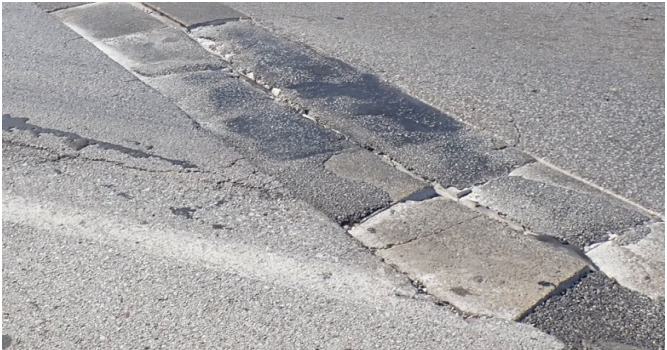
Undefined black material, Mastic	2019	1	7

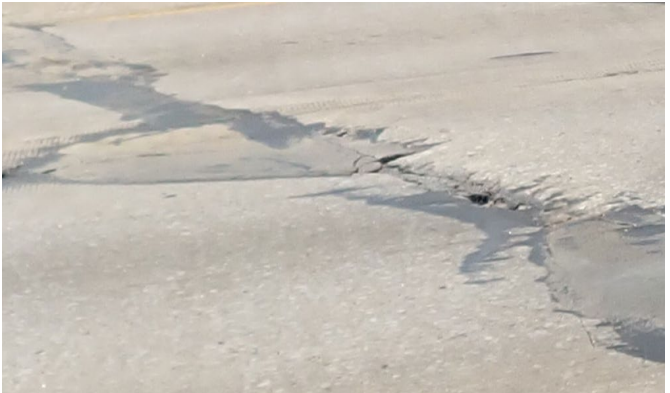
Item	Structure Number	Material	Time of Repair	Condition Rating	Approximate Repair Area (ft ²)	Average Crack Length (in.)	The current condition of the installed repair materials
2	44207 Westbound	PPC 1121	2020 or 2019	2	48	7

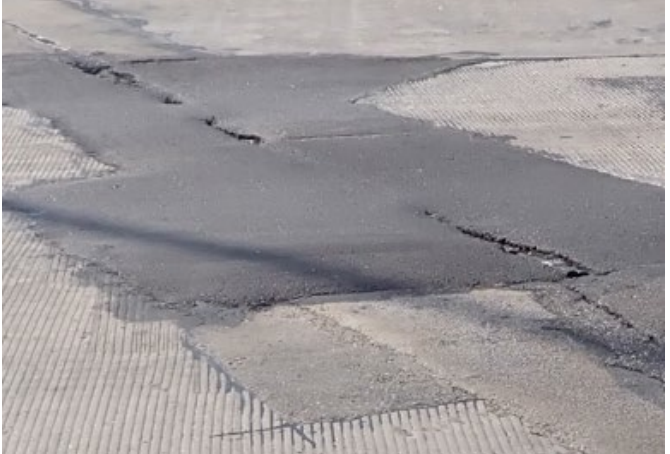
3	44207 East Bound	Hot mix and PPC 1121 (The hot mix seems to be placed on top of PPC 1121)	2021 (PPC 1121) 2022 (Hot mix)	1	144	7.393

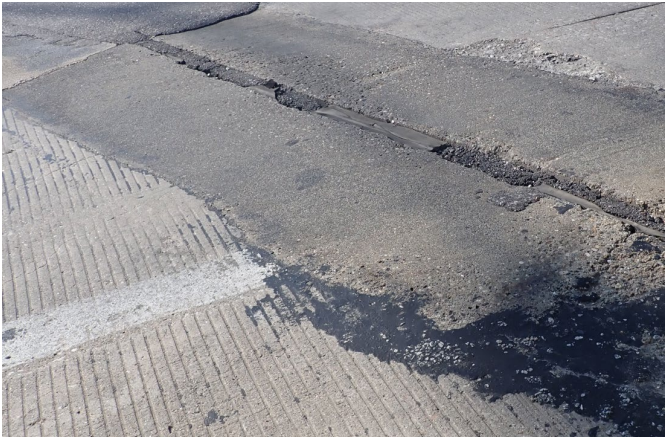
Item	Structure Number	Material	Time of Repair	Condition Rating	Approximate Repair Area (ft ²)	Average Crack Length (in.)	The Current condition of the installed repair materials
3	44207 East Bound	PPC 1121	2021	2	4	7.393

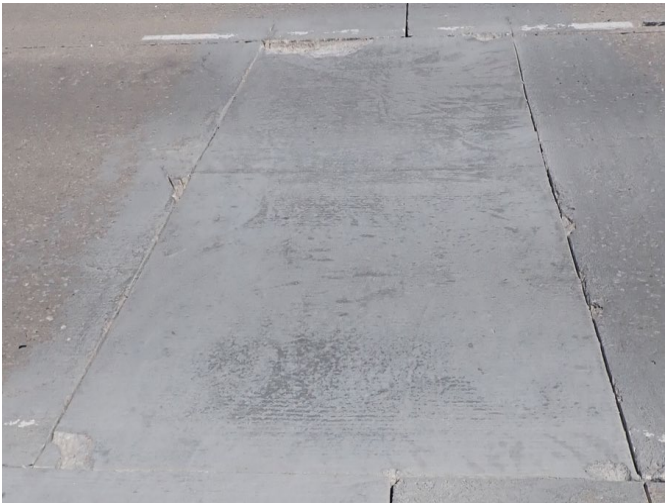
4	43922	47B-PR	Summer, 2021	3	36	3.8

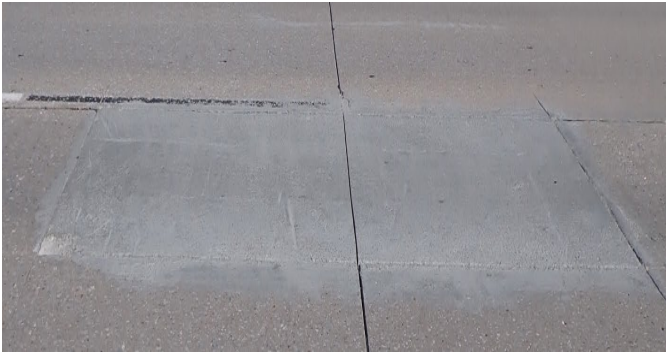
Item	Structure Number	Material	Time of Repair	Condition Rating	Approximate Repair Area (ft ²)	Average Crack Length (in.)	The Current condition of the installed repair materials
4	43922	47B-PR	Summer, 2021	4	50	3.8

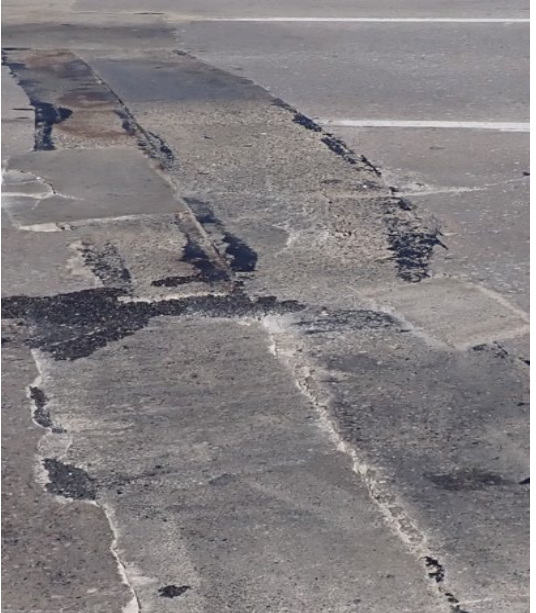
5	44207	PPC 1121 and hot mix	May 2021 (PPC 1121), July, 2022 (Hot mix)	1	74	5.31

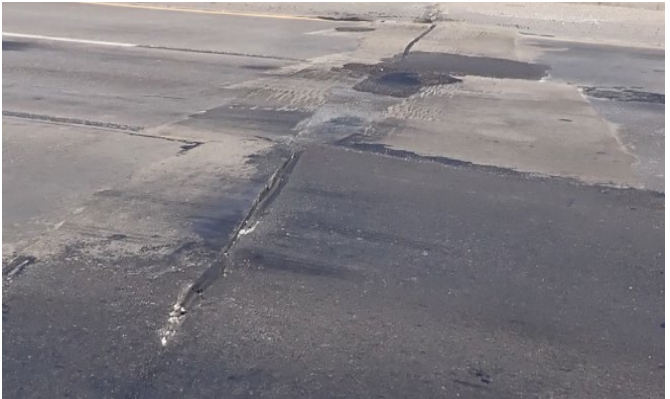
Item	Structure Number	Material	Time of Repair	Condition Rating	Approximate Repair Area (ft ²)	Average Crack Length (in.)	The Current condition of the installed repair materials
5	44207	PPC 1121 and hot mix	May 2021 (PPC 1121), July, 2022 (Hot mix)	1	148	5.31

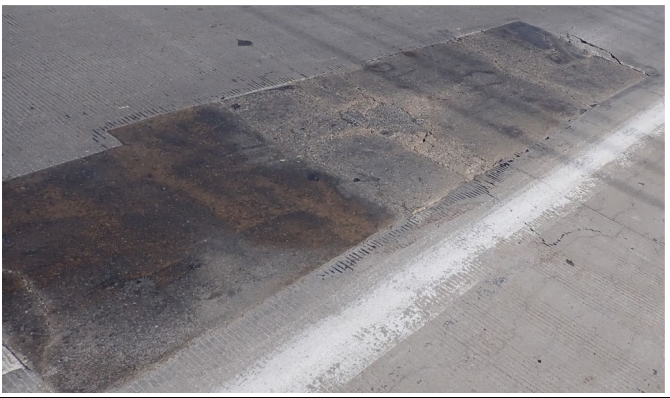
6	00604	PPC 1121, cold mix	2018 or 2017 (PPC 1121), 2019 (cold mix and second repair using PPC 1121)	1	17.5	6.9

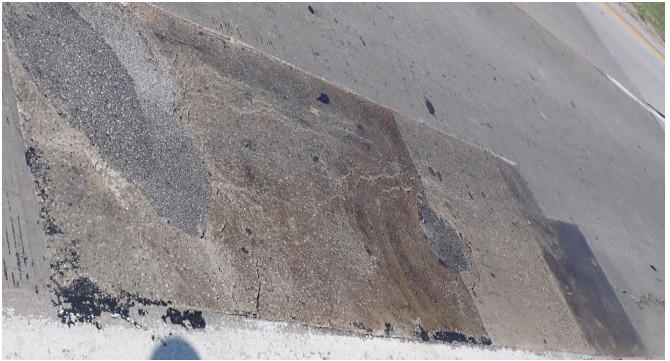
Item	Structure Number	Material	Time of Repair	Condition Rating	Approximate Repair Area (ft ²)	Average Crack Length (in.)	The Current condition of the installed repair materials
6	00604	PPC 1121, cold mix	2018 or 2017 (PPC 1121), 2019 (cold mix and second repair using PPC 1121)	1	24.5	6.9

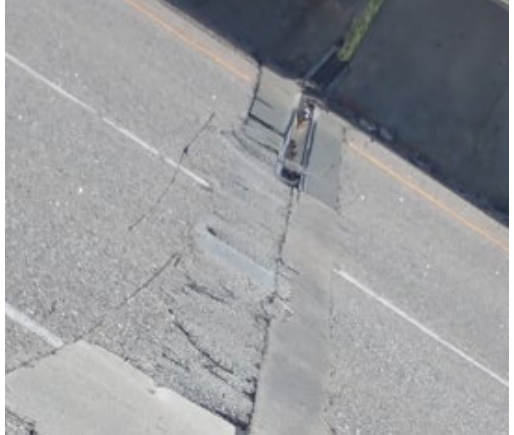
7	S080-44572	PPC 1121	2020	4	24	7

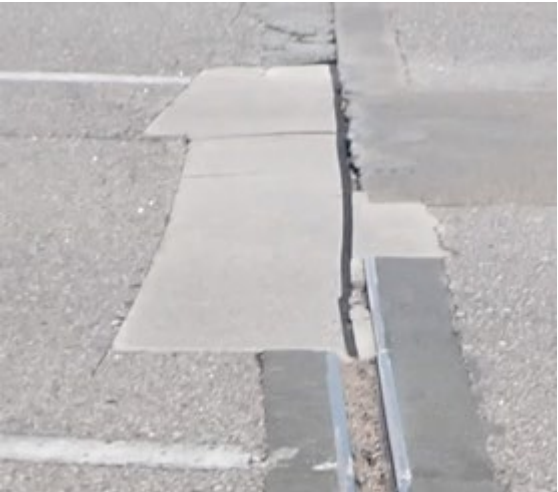
Item	Structure Number	Material	Time of Repair	Condition Rating	Approximate Repair Area (ft ²)	Average Crack Length (in.)	The Current condition of the installed repair materials
7	S080-44572	Phoscrete HC	2021	4	5	7

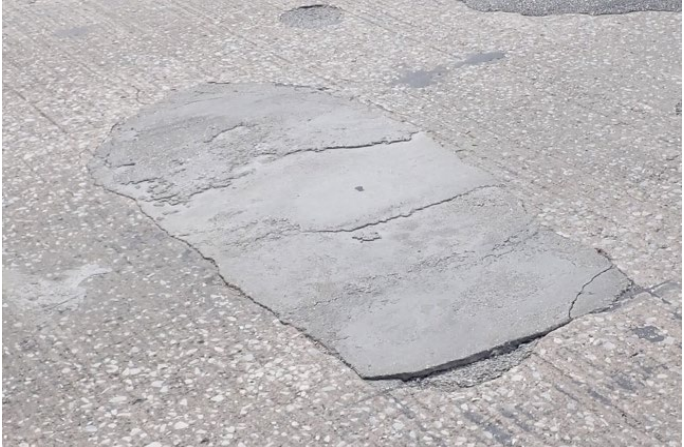
8	Highway 50-8762	Phoscrete HC	May, 2022	3	12	4.9

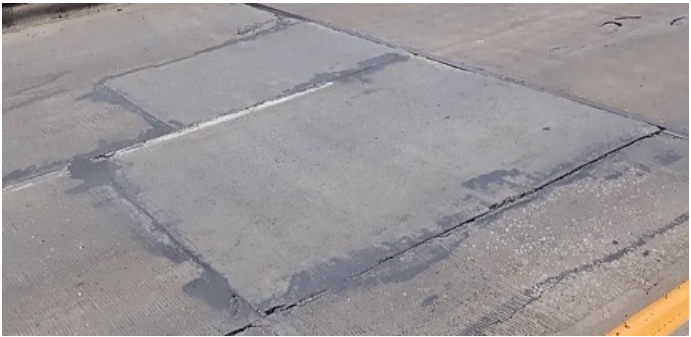
Item	Structure Number	Material	Time of Repair	Condition Rating	Approximate Repair Area (ft ²)	Average Crack Length (in.)	The Current condition of the installed repair materials
9	S050-08894	47B-PR	2020	3	216	5.4

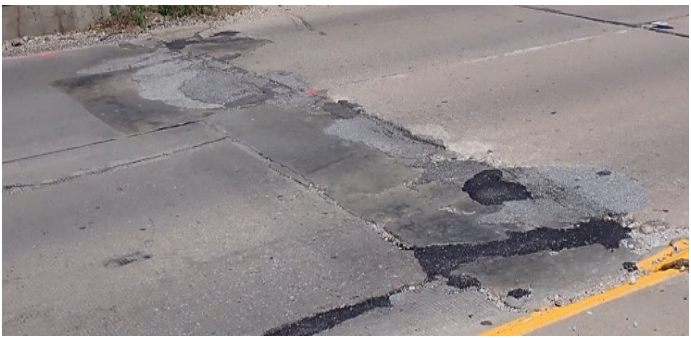
S050-08894	PPC 1121, hot mix	2019	1	24	5.4

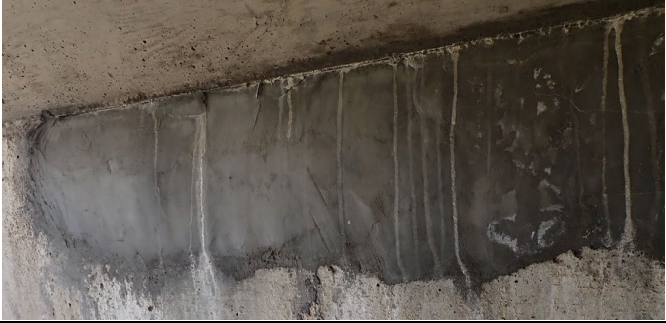
Item	Structure Number	Material	Time of Repair	Condition Rating	Approximate Repair Area (ft ²)	Average Crack Length (in.)	The Current condition of the installed repair materials
1	0578	Commercial -grade FastSet repair mortar	Started in 2020, and finished in 2021	4	6	8.4

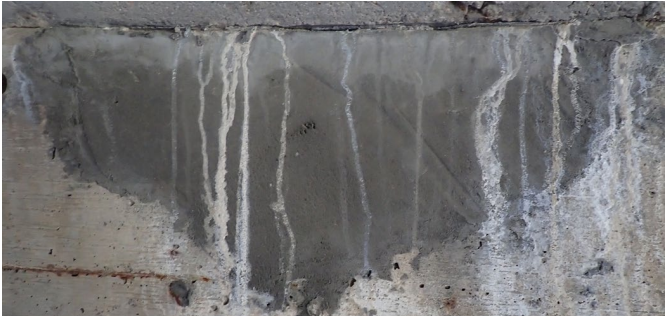
Commercial -grade FastSet repair mortar	Started in 2020, and finished in 2021	4	3

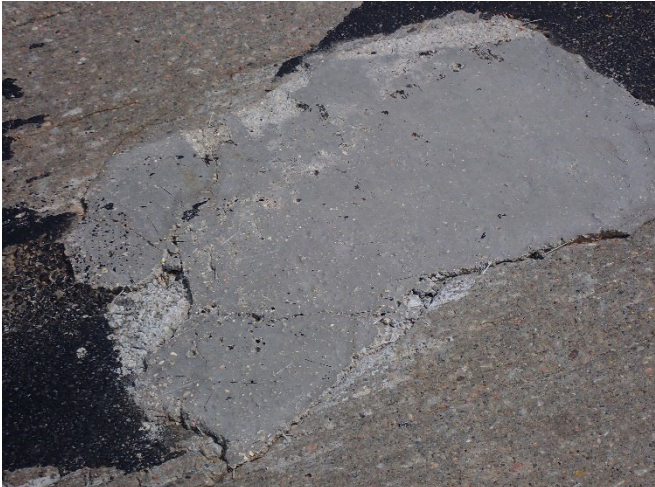
Item	Structure Number	Material	Time of Repair	Condition Rating	Approximate Repair Area (ft ²)	Average Crack Length (in.)	The Current condition of the installed repair materials
2	09667	Phoscrete HC and cold-patch.	2022	2	6 ^a	7.8

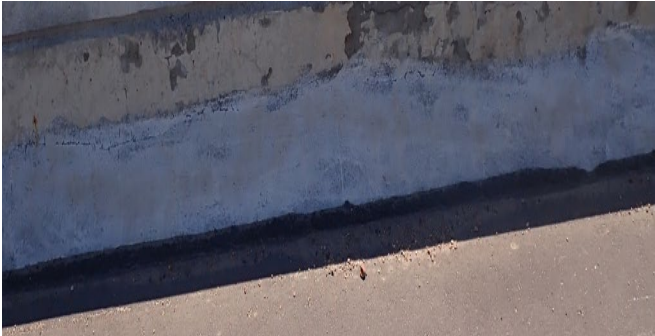
3	Rockville Ravenna North Highway 68	FastTrac VO	2020	4	45 ^b	8.2

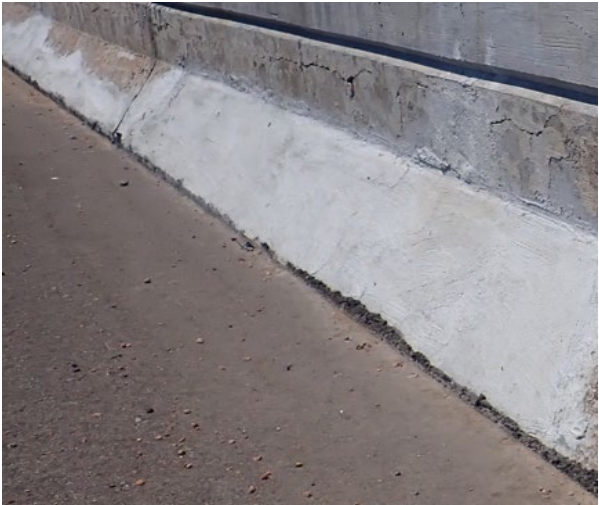
Item	Structure Number	Material	Time of Repair	Condition Rating	Approximate Repair Area (ft ²)	Average Crack Length (in.)	The Current condition of the installed repair materials
3	Rockville Ravenna North Highway 68	FastTrac VO	2020	4	15	8.2

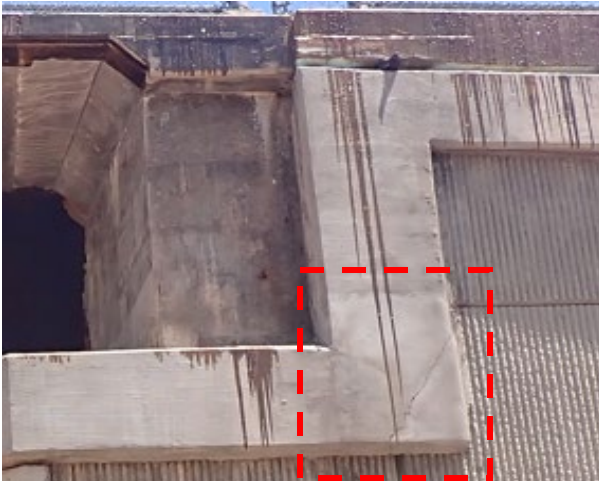
4	Gibbon link bridge over Highway 30	FasTrac VO	Oct,2021	4	NC	13.5

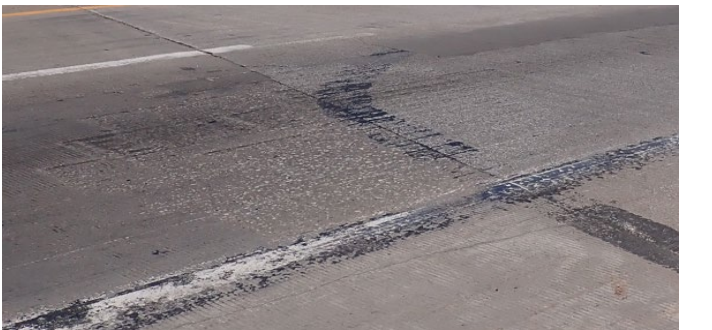
Item	Structure Number	Material	Time of Repair	Condition Rating	Approximate Repair Area (ft ²)	Average Crack Length (in.)	The Current condition of the installed repair materials
5	31263	Sikacrete 321 FS	2021	4	NC	NC

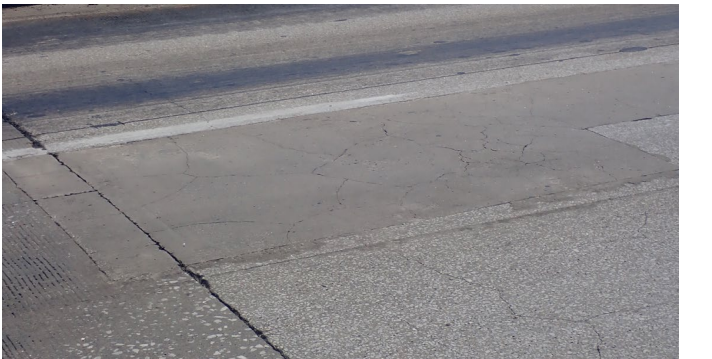
6	32815	Crete 120	2019	2	147	18.2

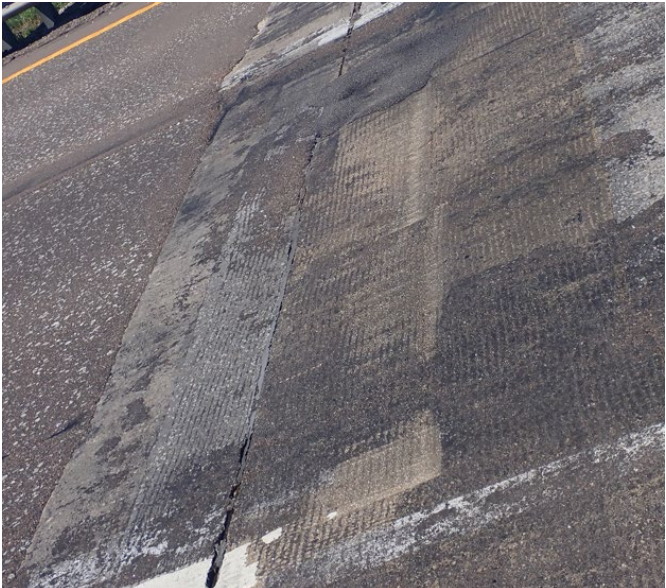
Item	Structure Number	Material	Time of Repair	Condition Rating	Approximate Repair Area (ft ²)	Average Crack Length (in.)	The Current condition of the installed repair materials
7	I-80 bridge Deck Aurora E&W	PPC 1121	Fall 2020	2	NC	11.75

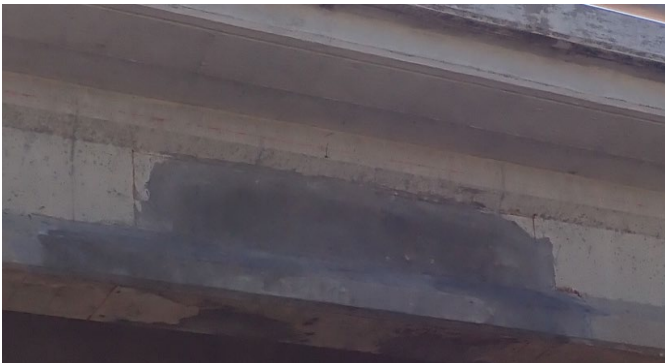
Item	Structure Number	Material	Time of Repair	Condition Rating	Approximate Repair Area (ft ²)	Average Crack Length (in.)	The Current condition of the installed repair materials
8	34413	RepCon V/O	Summer 2021	4	10	NC

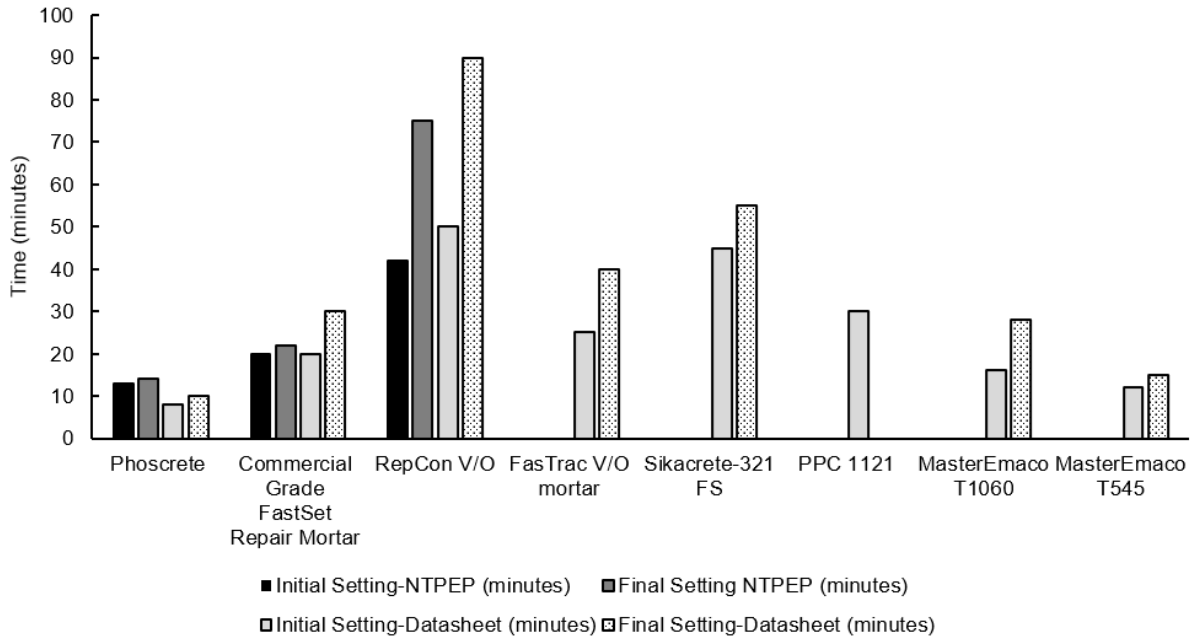
Figure Chapter 4.2 Setting time data of HES materials used in districts one, two, and four

To understand the performance of each material, data on different properties were tested and reported in the NTPEP database (AASHTO, 2023) for each repair material that was collected. Since some repair materials were not listed in the NTPEP database, their properties were obtained from the datasheet provided by the manufacturer of each material. For repair materials that have their properties tested and included on the NTPEP database and the manufacturer datasheet, the values of each property were compared between the two data sources. Figure Chapter 4.2 and Figure Chapter 4.3 show the data of two material properties that were tested and reported in both the NTPEP database and the datasheet of each repair material, namely, the setting time and the compressive strength. The data plotted on each of these figures indicate a variation between the data found in the NTPEP database and the data found in the datasheet of each repair material.

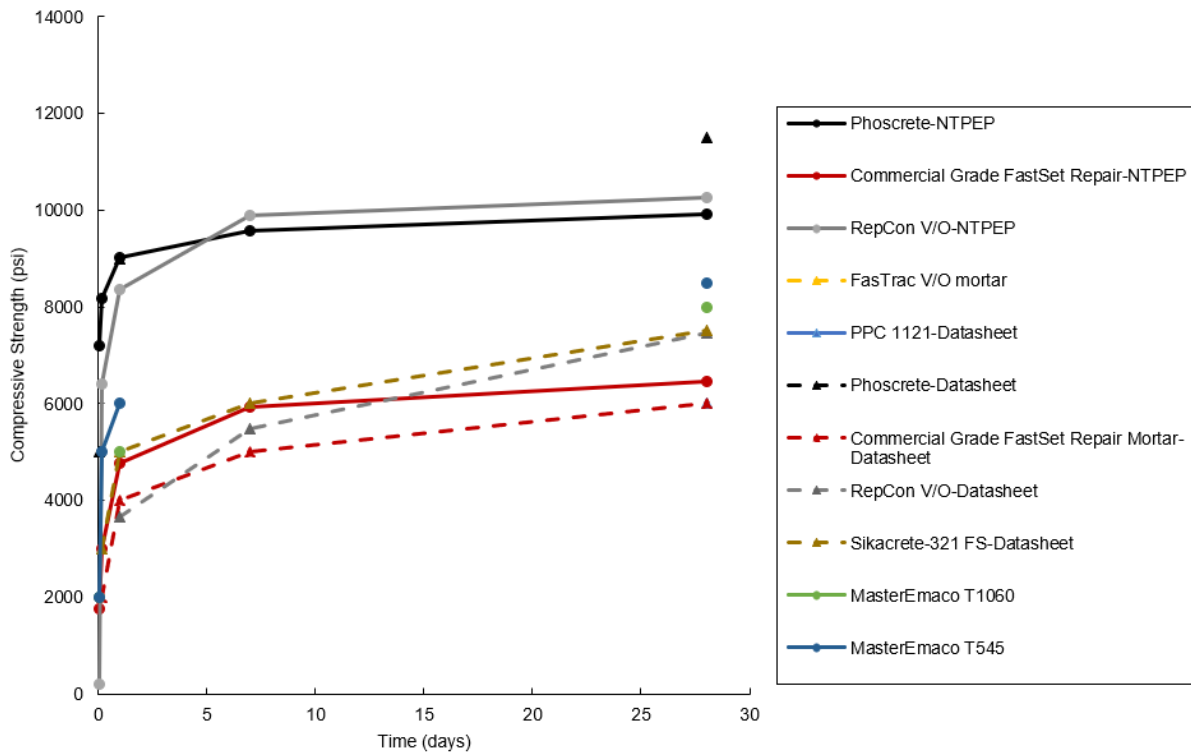
Figure Chapter 4.3 Compressive strength data of HES materials used in districts one, two, and four

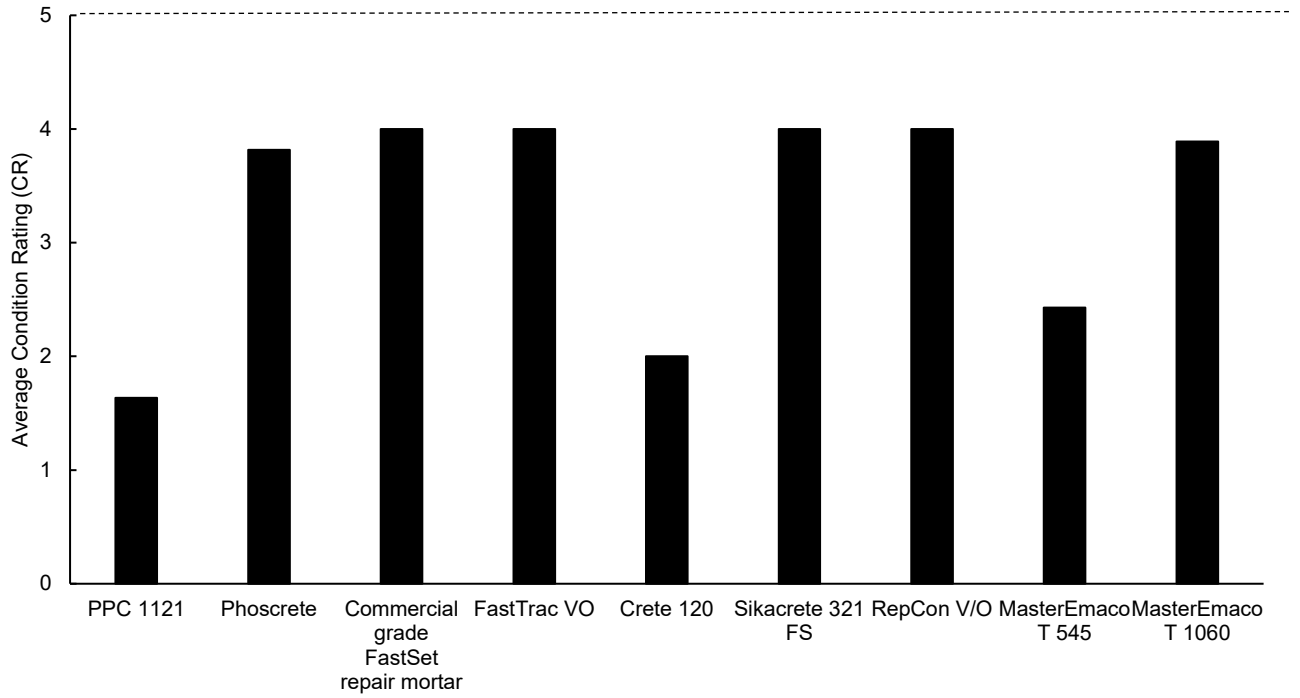
Figure Chapter 4.4 Average condition rating for HES materials used in districts one, two, and four

A qualitative condition rating was assigned for each repair inspected in Districts one, two, and four, and the average condition rating for each repair material used in each district was calculated and is shown in Figure Chapter 4.4. Note that this may not be a fair comparison because of the unequal numbers of repairs represented and the nonuniformity of the dataset. The results indicate that the highest condition rating was associated with locations that used Phoscrete HC, FastSet rapid mortar, FasTrac V/O, RepCon V/O, MasterEmaco T 1060, and Sikacrete 321 FS as repair materials. The repair material PPC 1121 had the lowest condition rating, which indicates that this repair material did not seem to perform as expected in the field. Based on the condition rating assigned for each repair inspected in the three districts, the rate of degradation was calculated, and the results are shown in Figure Chapter 4.5. The highest rate of degradation was associated with the Phoscrete HC material, followed by PPC 1121. District one reported good conditions of current repairs that used Phoscrete HC; however, all of these repairs were installed a few months ago (less than one year) and cannot be solely used to conclude the field performance of this material.

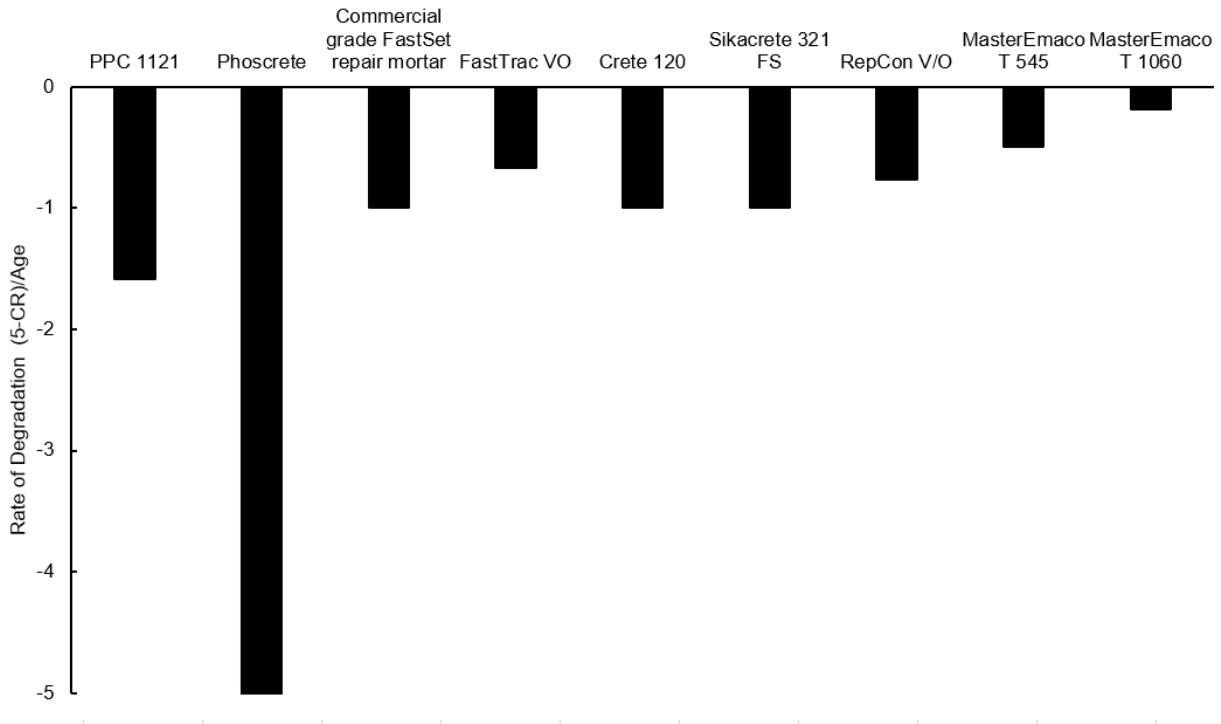
Figure Chapter 4.5 Average rate of degradation of HES materials used in districts one, two, and four

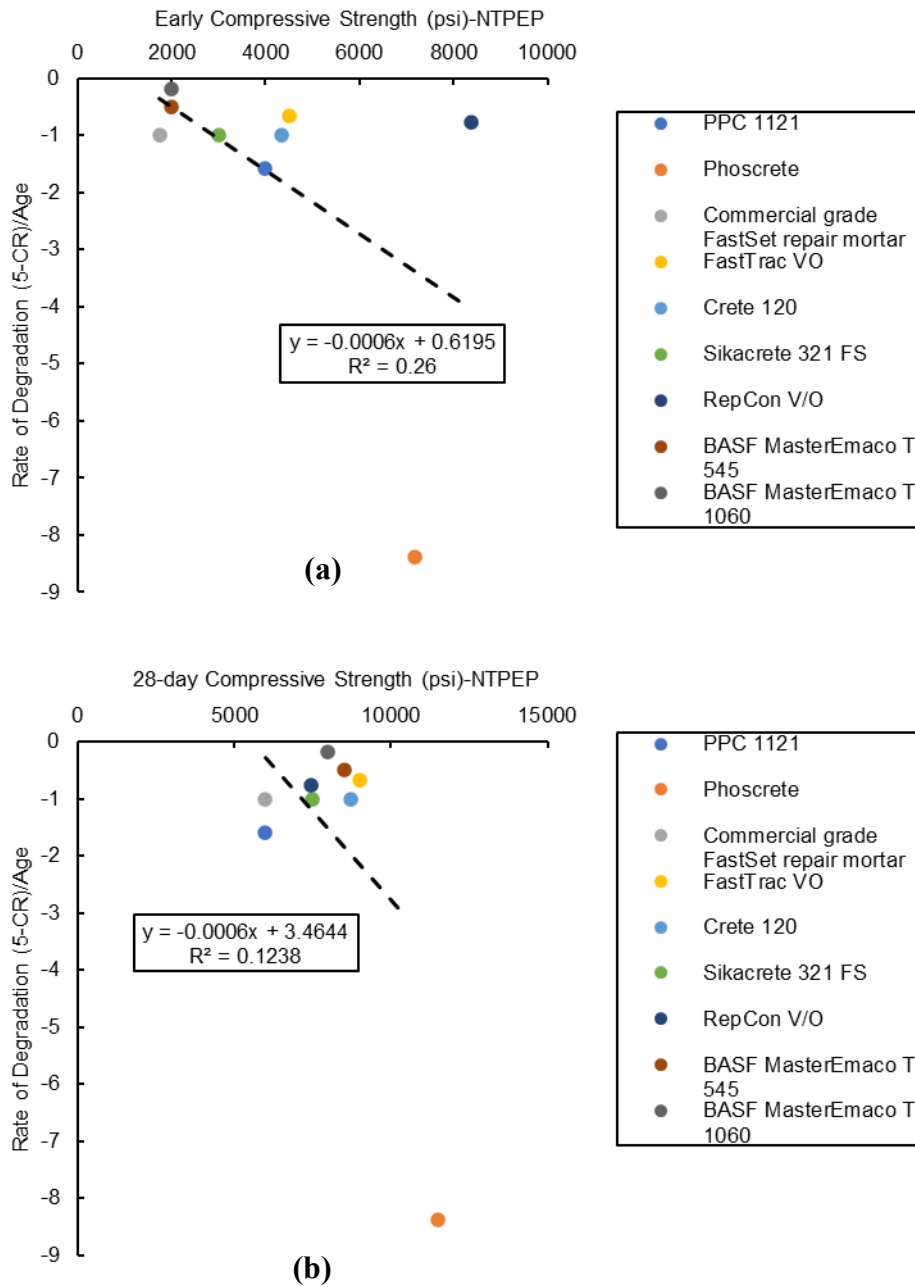
Figure Chapter 4.6 a) Rate of degradation vs. early compressive strength (psi); b) Rate of degradation vs. 28-day compressive strength (psi)

The main objective of this field investigation was to search for a possible correlation between a material's field performance and laboratory testing published on the NTPEP database or the datasheet provided (for materials not tested on NTPEP) by the manufacturer for each repair material. The early and 28-day compressive strength data were plotted with the rate of degradation data gathered from the field inspection, and the results are shown in Figure Chapter 4.6. The early and 28-day compressive strength did not seem to be correlated with the rate of degradation based on the available data obtained from the field inspection. The Phoscrete data represented by the solid orange circle in Figure Chapter 4.6 drove this relationship and may be too influential in a small dataset.

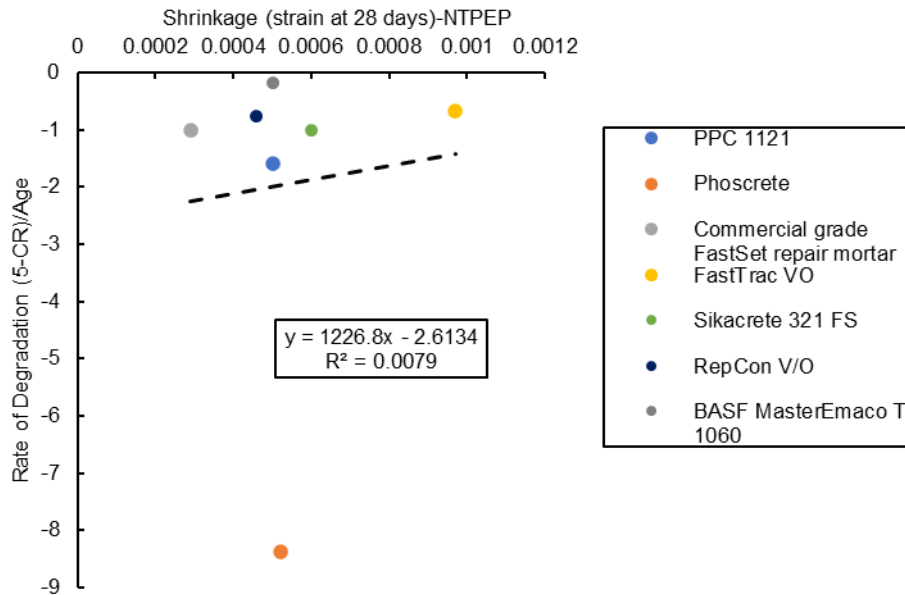
Figure Chapter 4.7 Shrinkage strain at 28 days vs. rate of degradation

corresponded to lower shrinkage values, except for FastTrac VO. In the NTPEP and datasheet data for these materials, it was unclear if they used a 24-hour demold time (per ASTM C157) or a 3-hour demold time, as is common for rapid-set materials.

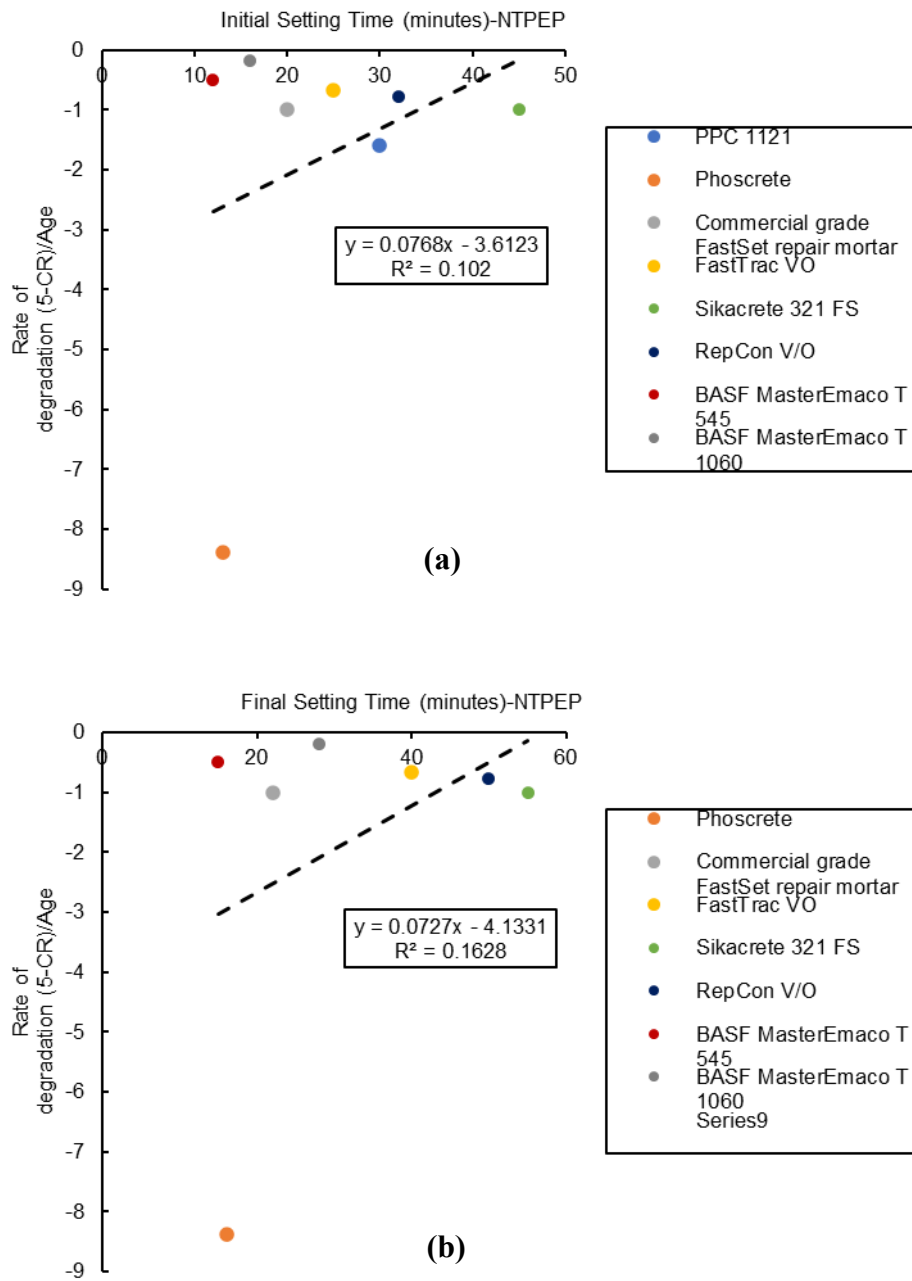
Figure Chapter 4.8 Rate of degradation vs. a) initial setting time; b) final setting time

setting time seemed to be as important a factor as found herein. Field inspection data for locations that incorporated Phoscrete had either a high or a low condition rating, which affected the final average rate of degradation and consequently affected potential relationships with the initial and final setting times.

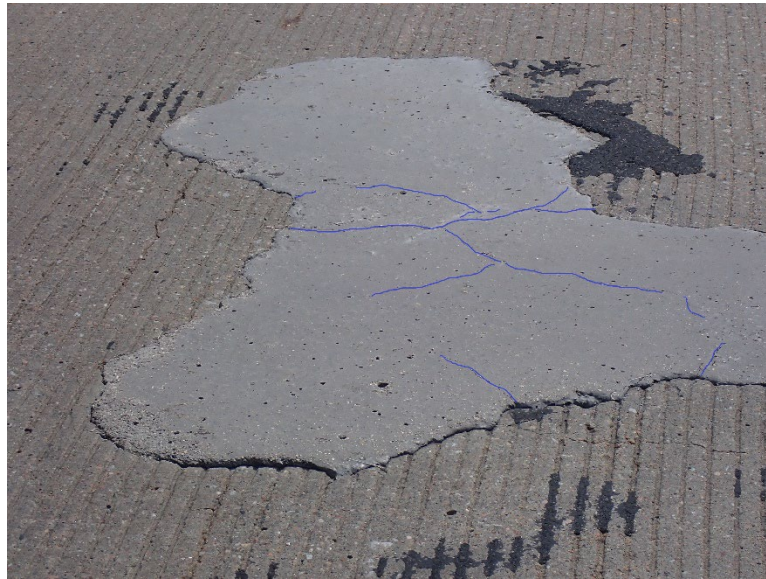
Figure Chapter 4.9 Highlighted cracks on one of the repair patches

The number of cracks and the estimated crack lengths within a field repair were estimated for each repair location based on the field inspection. Figure Chapter 4.9 displays an example of one of the repairs with the cracks highlighted for clarity.

The area of each repair was also measured and used to normalize the crack data by dividing the estimated total crack length by the estimated area of repair to obtain the normalized crack length (NCL). The NCL data were plotted against the early compression strength, 28-day compressive strength, 28-day shrinkage strain, and setting time data of each repair material. The laboratory test data were gathered from the NTPEP or datasheet if NTPEP data were not available. Based on the results shown in Figure Chapter 4.10, the experimental data of the early and 28-day compressive strength did not seem to be correlated with the NCL based on the current dataset. However, there may be a potential relationship between the early compressive

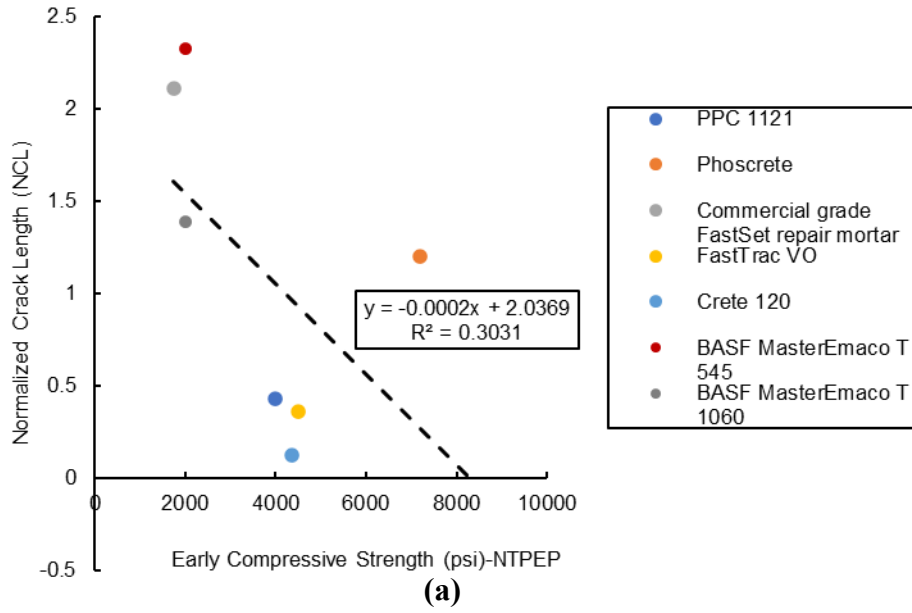
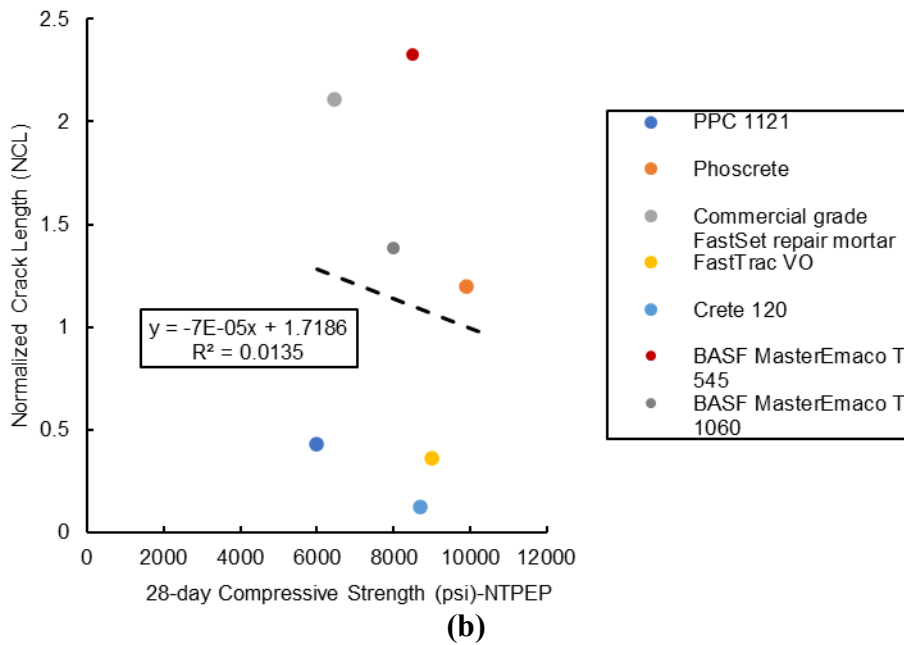
Figure Chapter 4.10 Normalized cracking length vs. a) early compressive strength (psi); b) 28-day compressive strength (psi)

strength and the NCL if a larger and more representative dataset is used. The shrinkage and setting time data showed a potential relationship with the NCL, as shown in Figure Chapter 4.11. Phoscrete data represented by a solid orange circle seemed to affect the relationship of the NCL with the different material properties investigated in this study. Since most of the Phoscrete data obtained from District one have been recently installed (less than a year in age), they seemed to negatively affect the relationship of the NCL with different material properties, especially the final setting time. The removal of Phoscrete data from the plot can improve the correlation up to an R^2 of 0.9701, as shown in Figure Chapter 4.12. This explains how sensitive the relationship between the NCL and different material properties was to factors such as the age of the repair, number of data points, condition rating, and number of cracks.

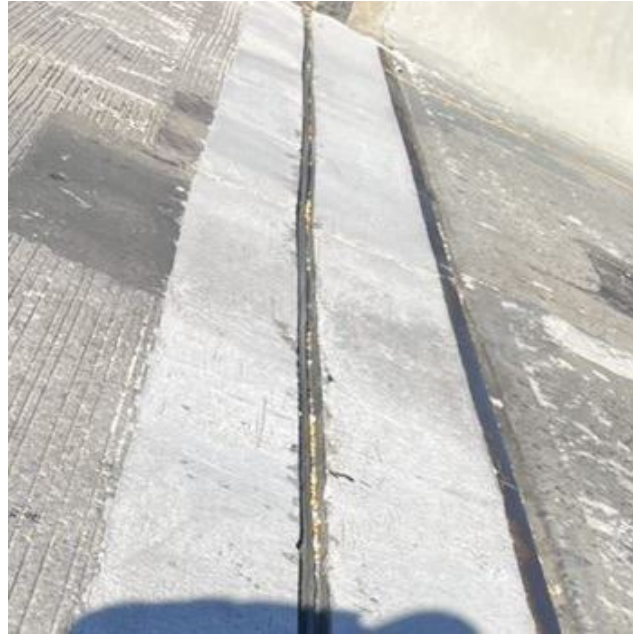
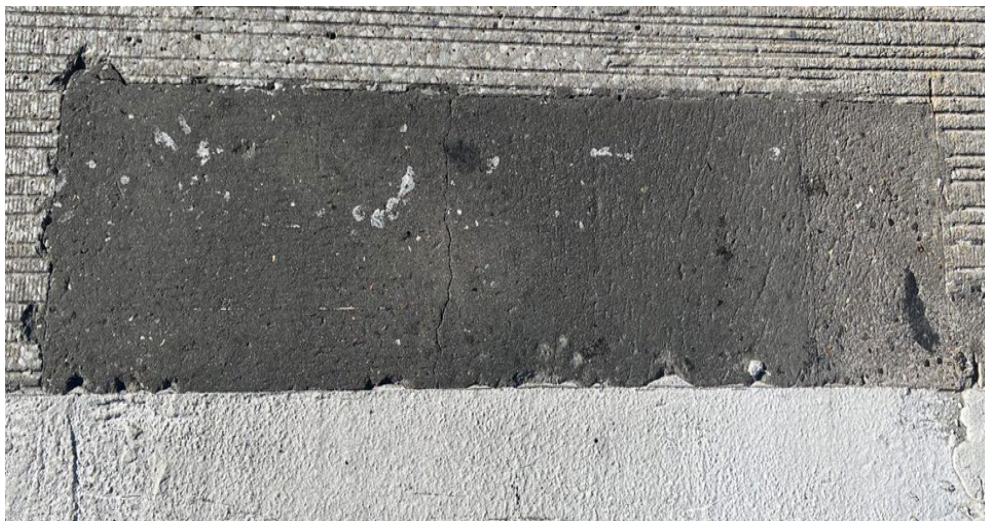
Figure Appendix A.1 Current state of repair material installed in location 1

Time of repair: July 2022 (Phoscrete HC), 2017 (MasterEmaco T 545)

Type of repair materials: Phoscrete HC, MasterEmaco T 545

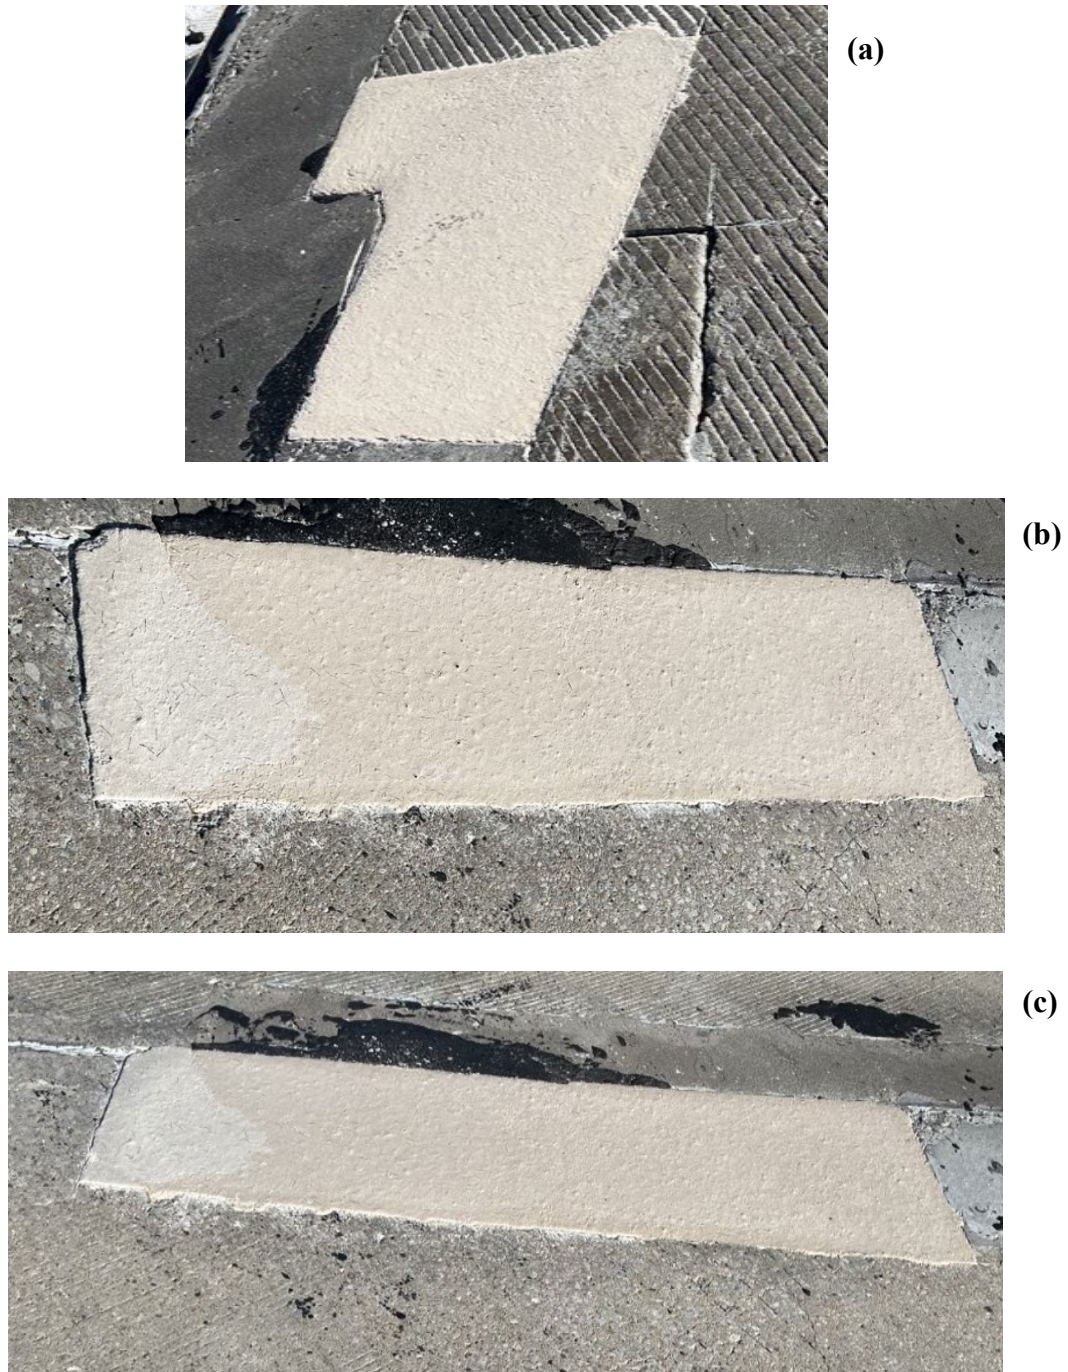
Type of repair materials: MasterEmaco, Phoscrete, MasterEmaco T 545

Figure Appendix A.2 Current state of repair material installed in location 2
