Final Report SPR-FY21(006)

WBS Report #
26-1122-0099-001

Performance of High Early-Strength Used in Concrete Bridge Repair

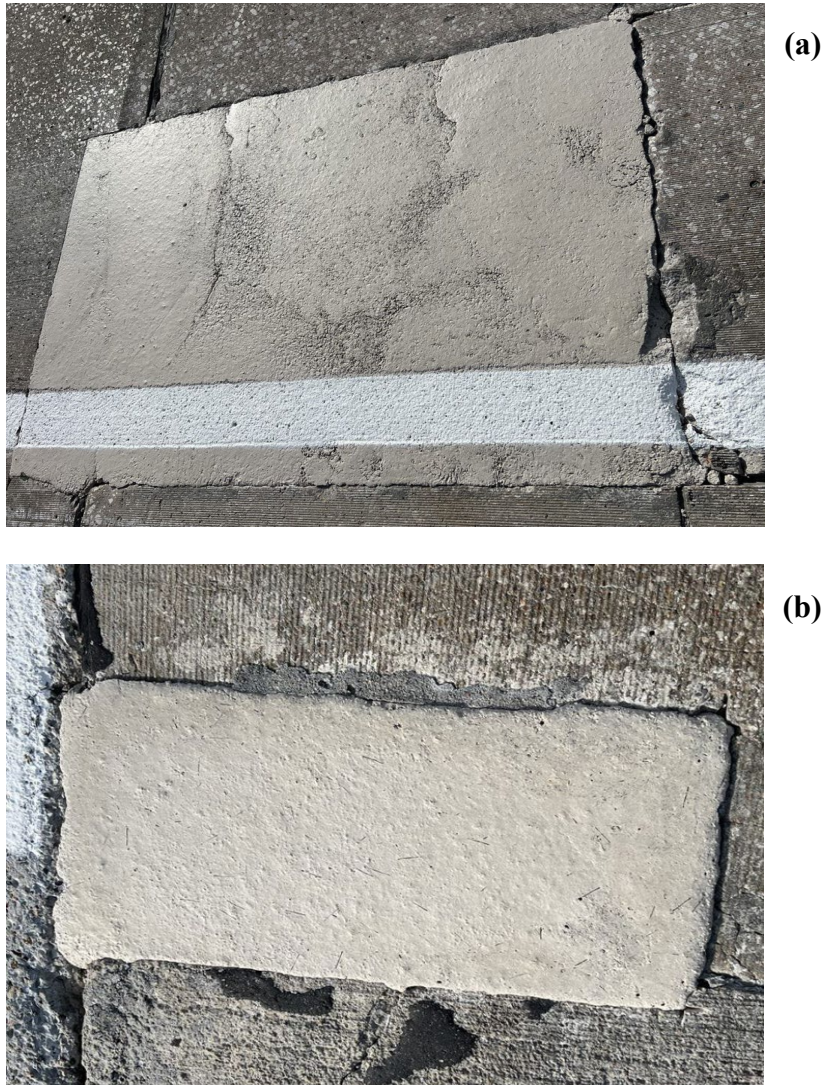
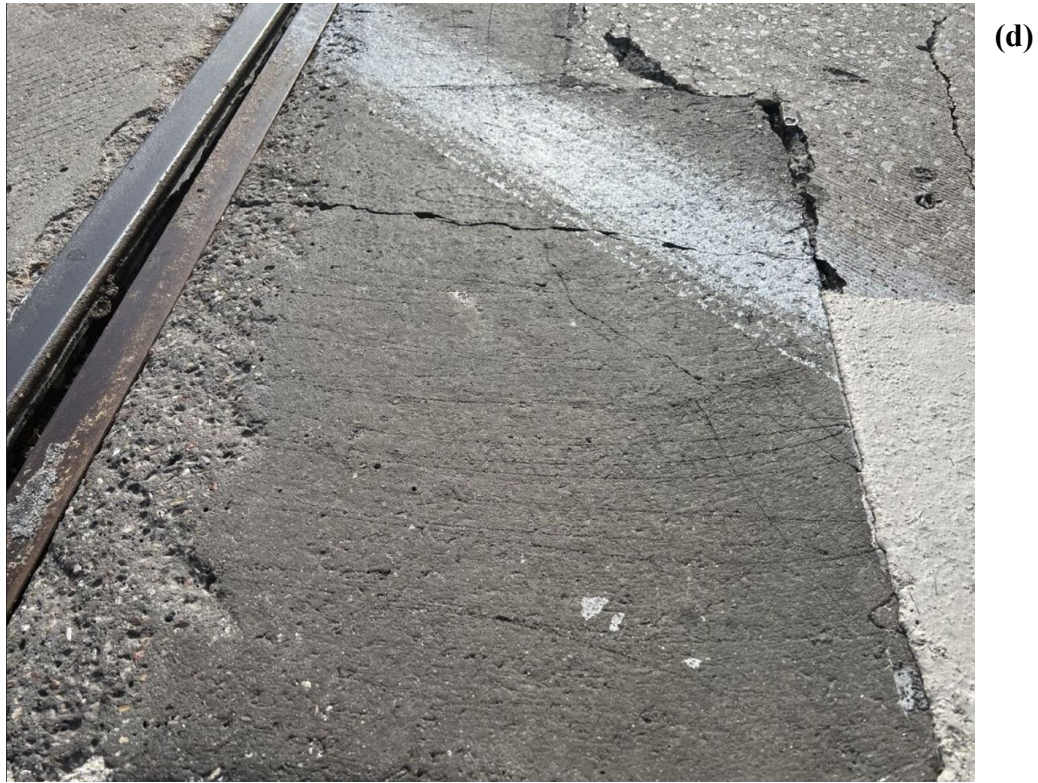
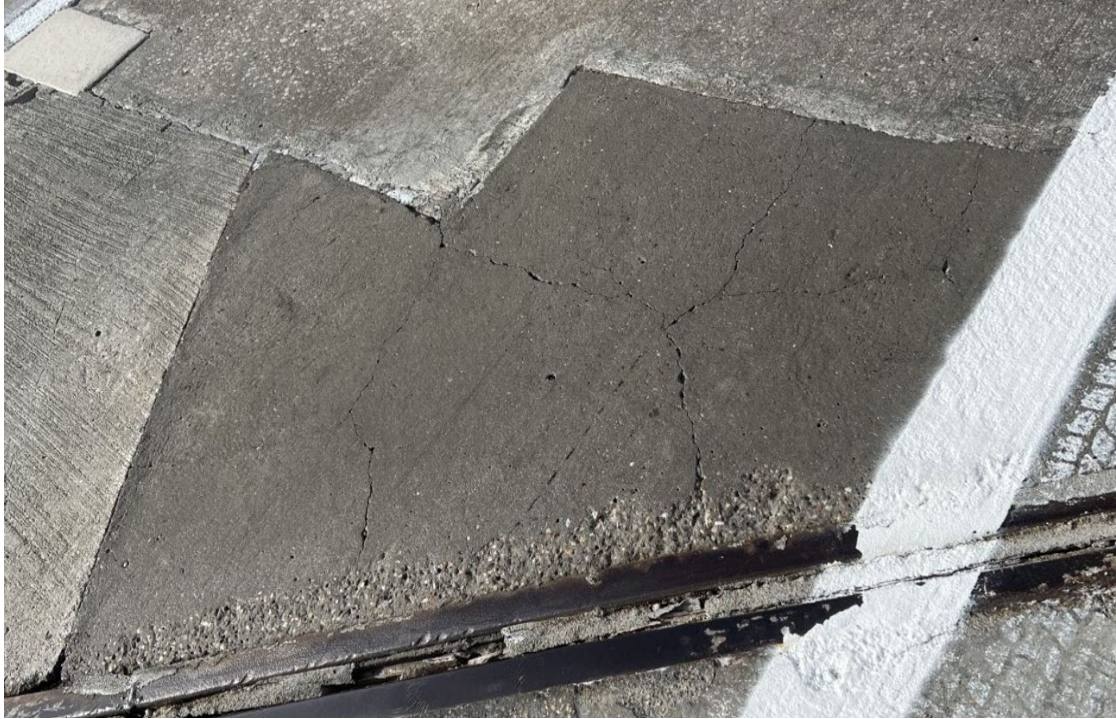
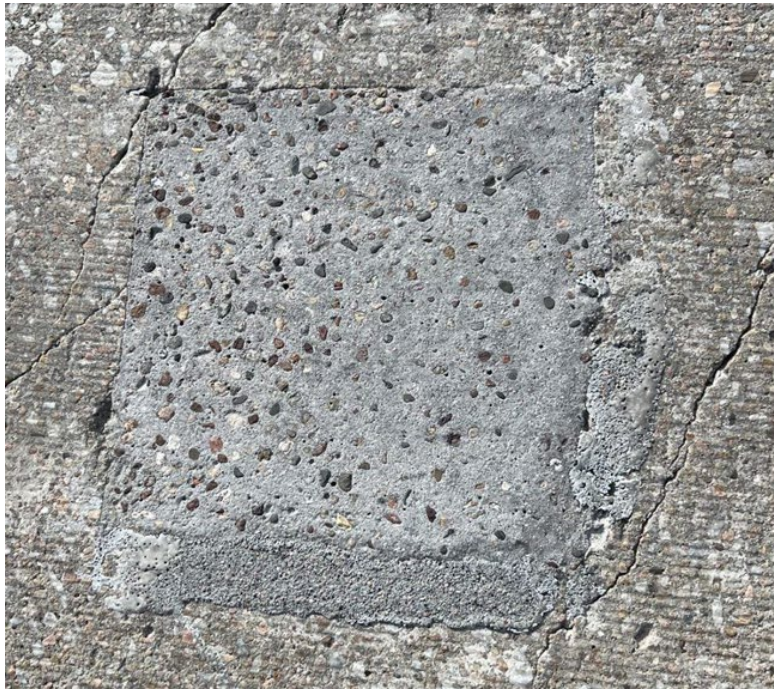
Type of repair materials: Phoscrete HC, MasterEmaco T 1060, MasterEmaco T 545

Figure Appendix A.3 Current state of repair material installed at location 3

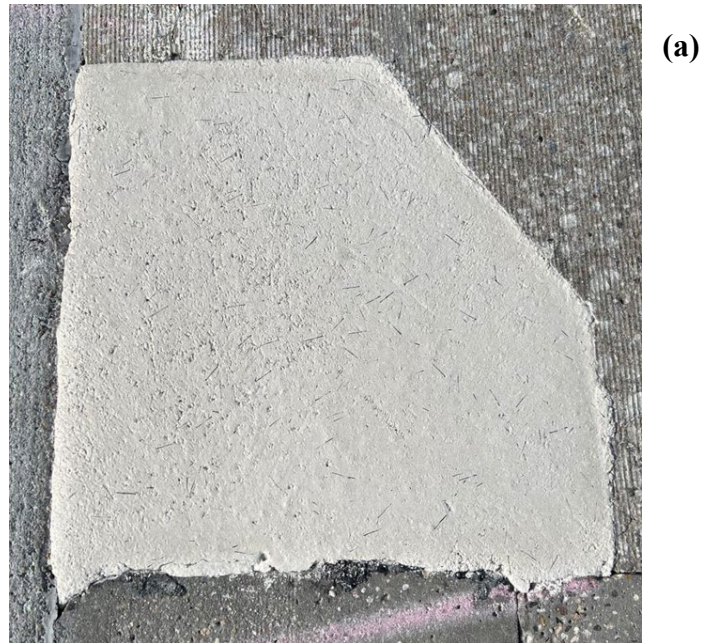
Figure Appendix A.4 Current state of repair material installed at location 4

Time of repair: 10/11/2022

Type of repair materials: Phoscrete HC

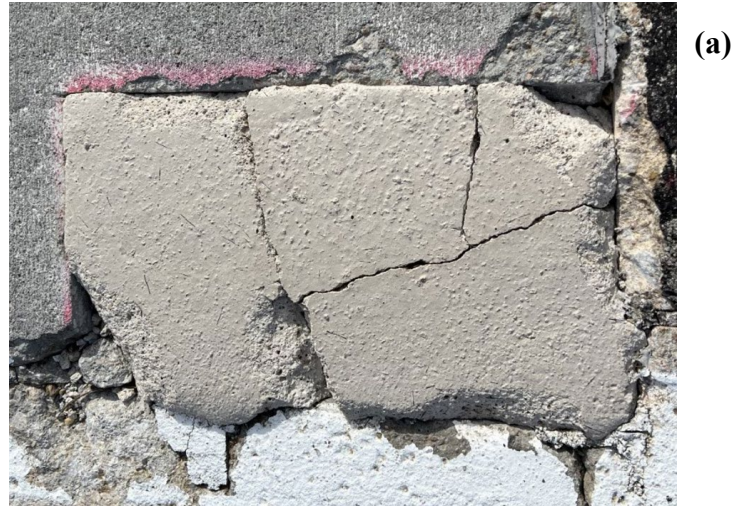
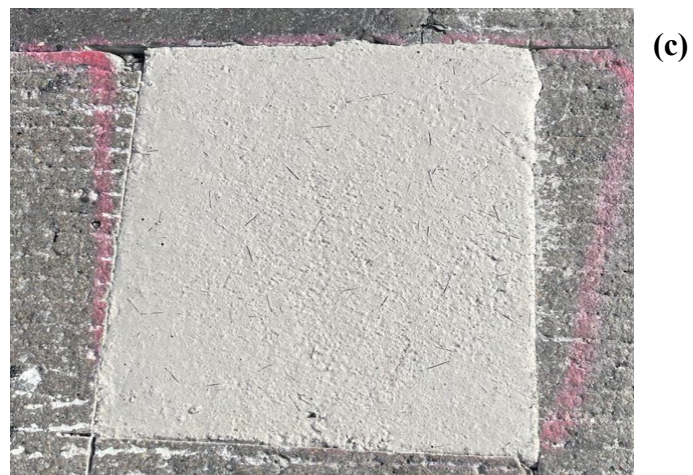
Figure Appendix A.5 Current state of repair material installed at location 5

Time of repair: 10/05/2022

Type of repair materials: Phoscrete HC

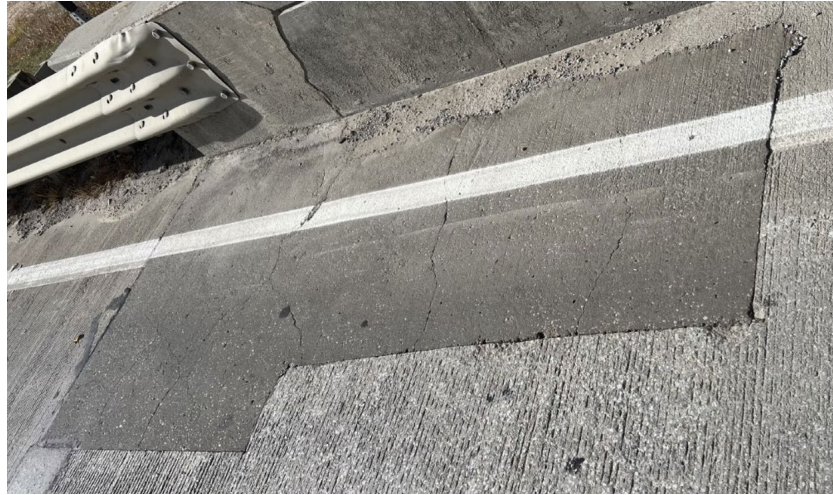
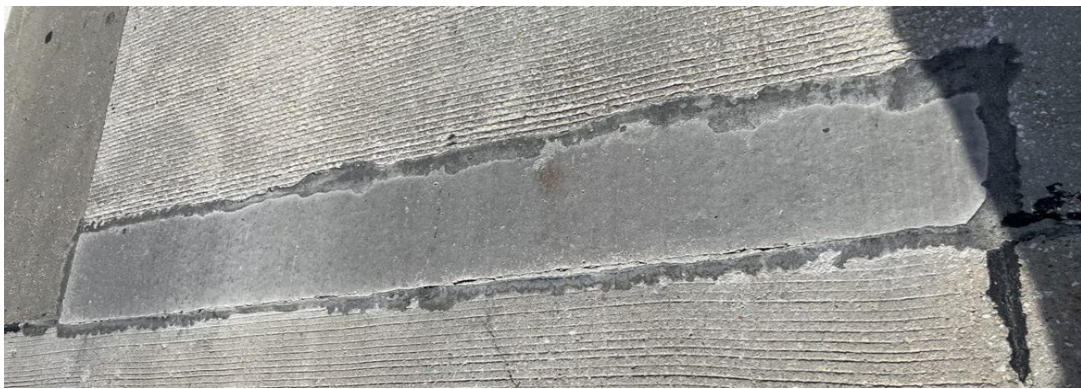
Figure Appendix A.6 Current state of repair material installed at location 6

Time of repair: 04/05/2022 (Phoscrete HC), 2017 (MasterEmaco T 1060)

Type of repair materials: Phoscrete HC, MasterEmaco T 1060

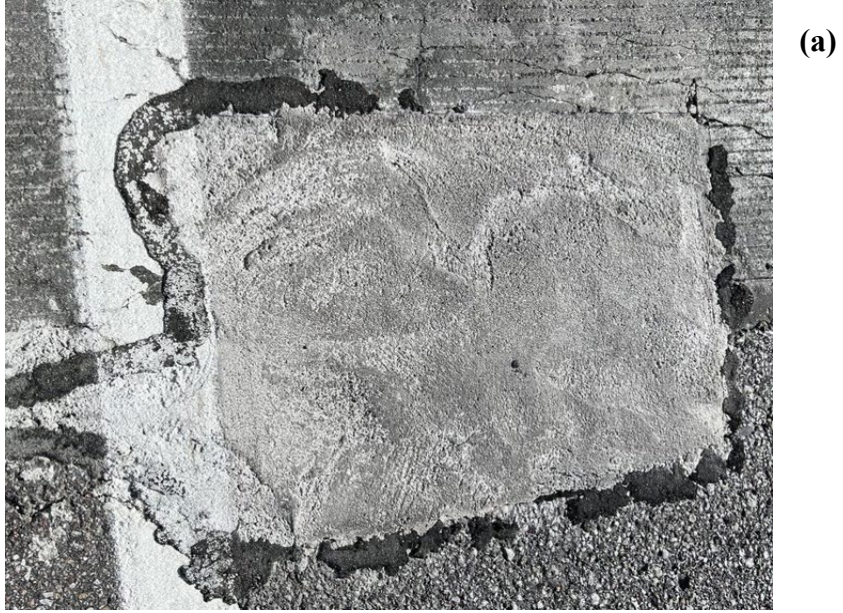
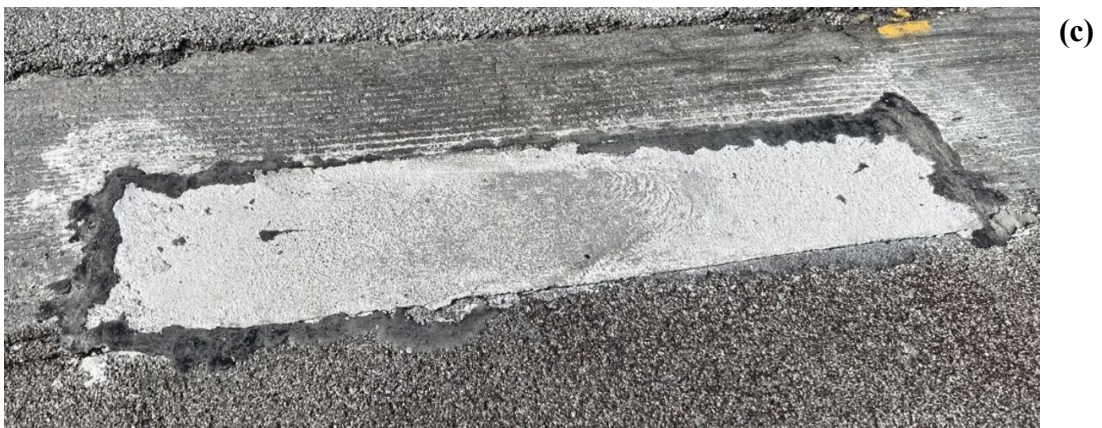
Type of repair materials: Phoscrete HC

Figure Appendix A.7 Current state of repair material installed at location 7

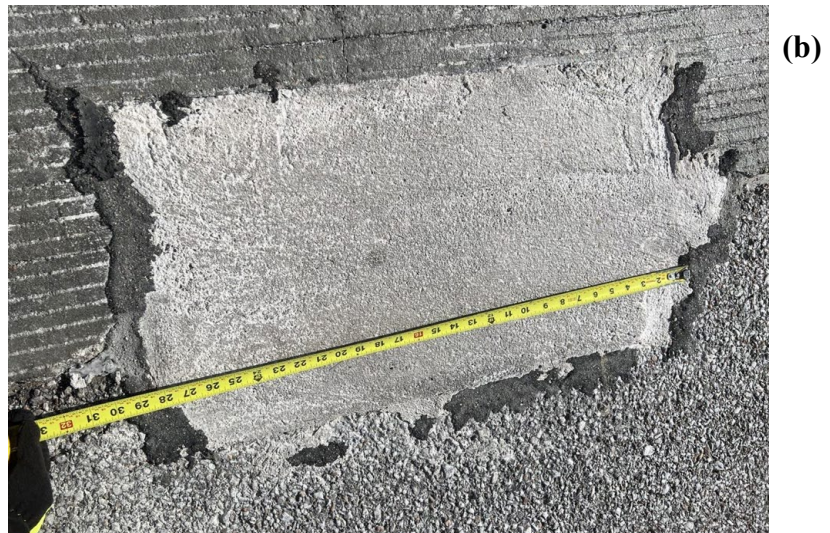
Time of repair: 07/11/2022

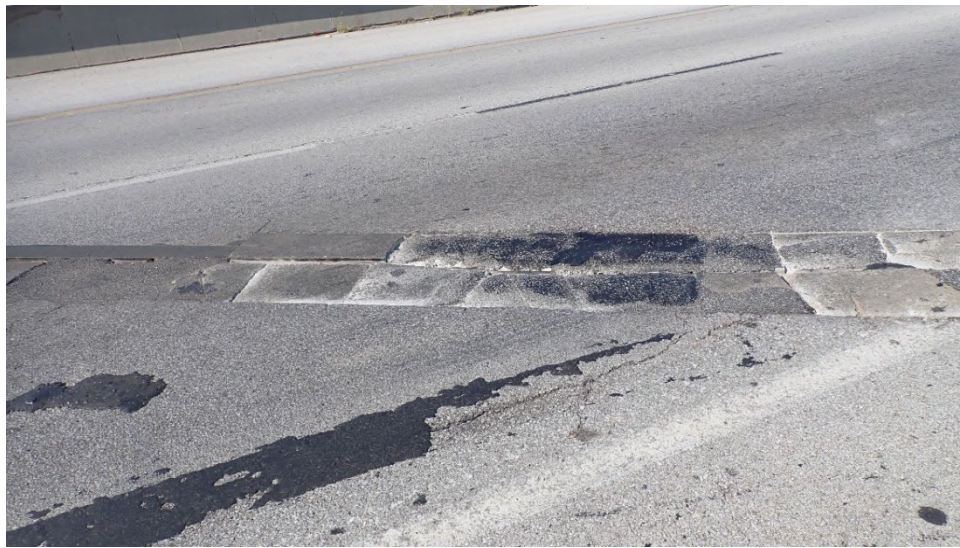
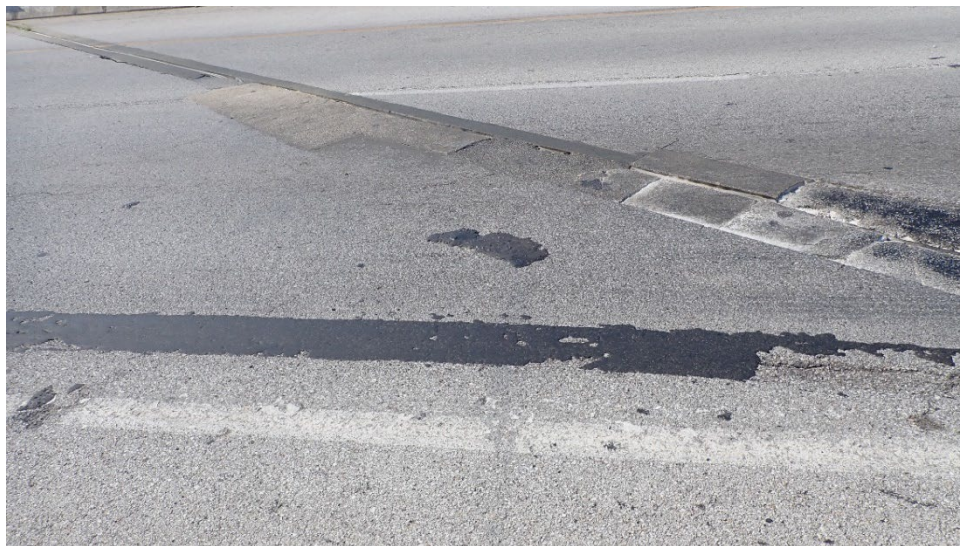
Figure Appendix A.8 Current state of repair material installed in location 1

Time of repair: 2019

Type of repair materials: mastic on the side, black material unknown (light porous or porous, not sure), Kwik bond on the side

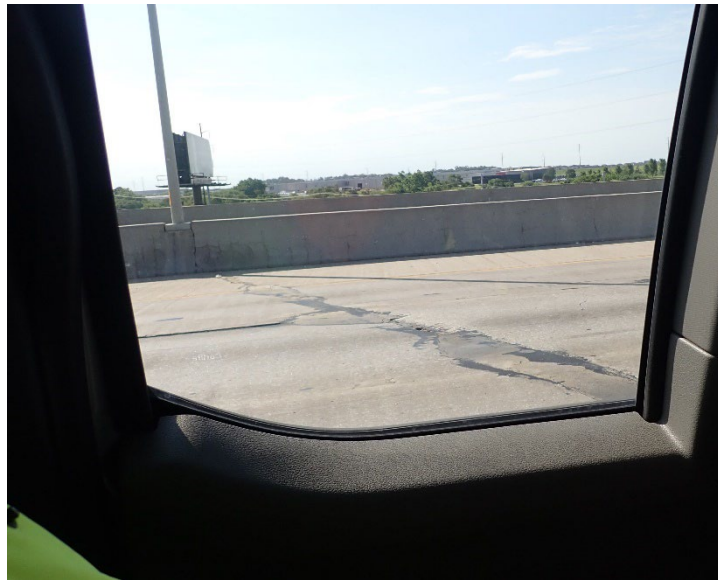
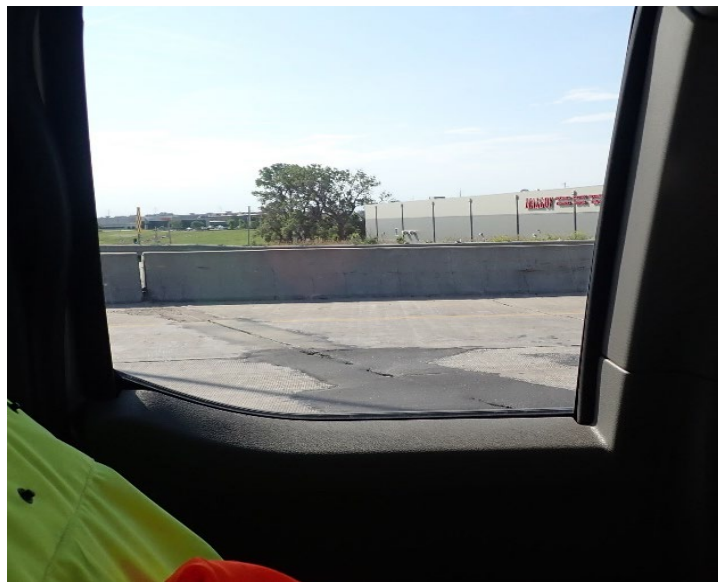
Figure Appendix A.9 Current state of repair material installed in location 2

Time of repair: 2019–2020

Type of repair materials: Kwik bond

Note: Photos were taken inside the car.

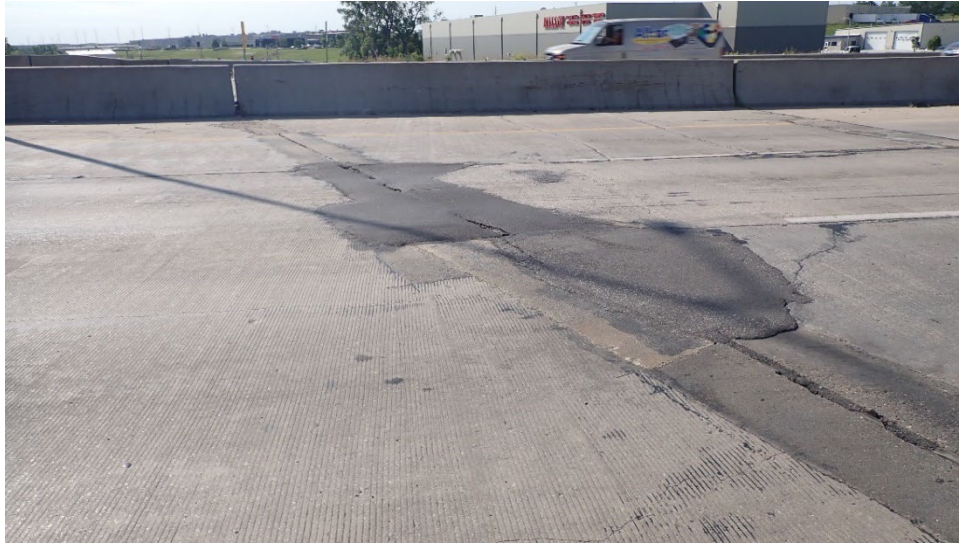
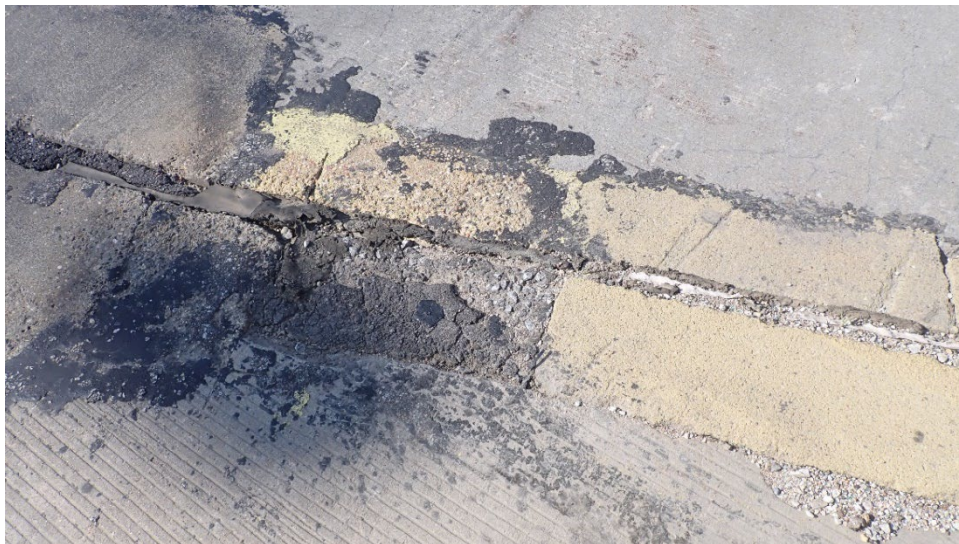
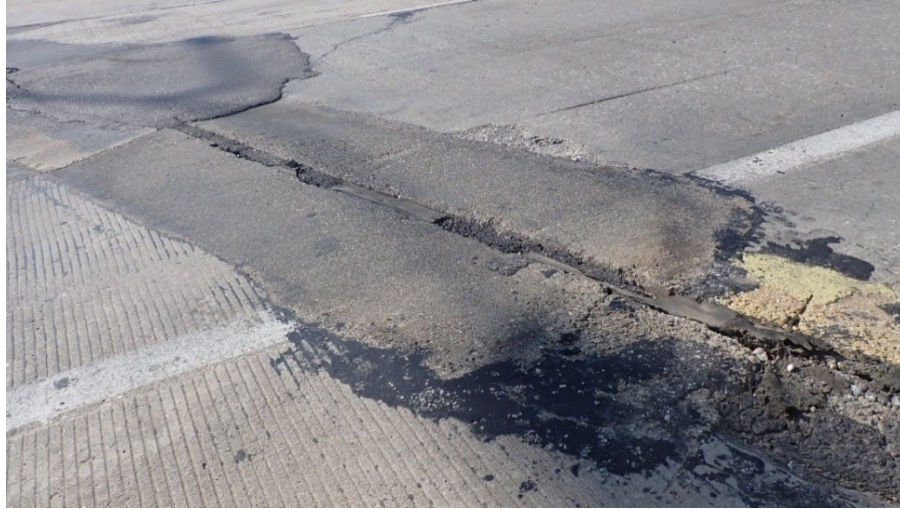
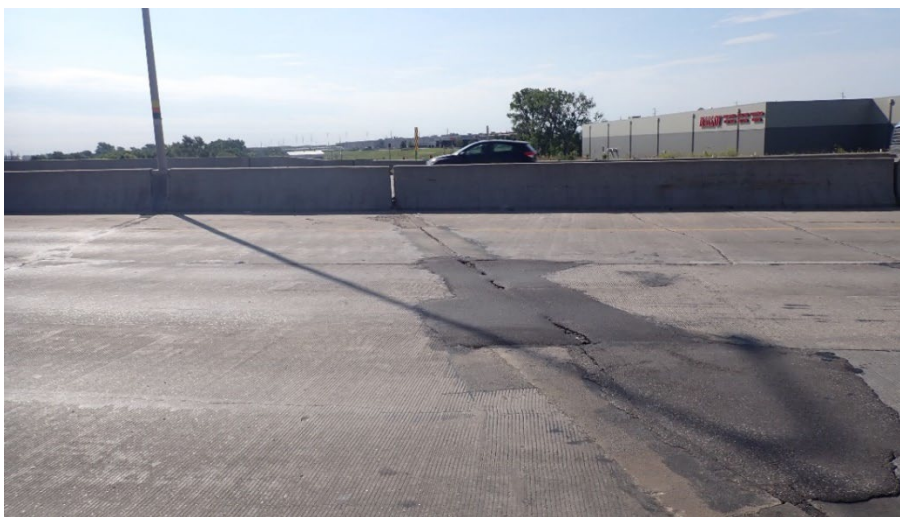
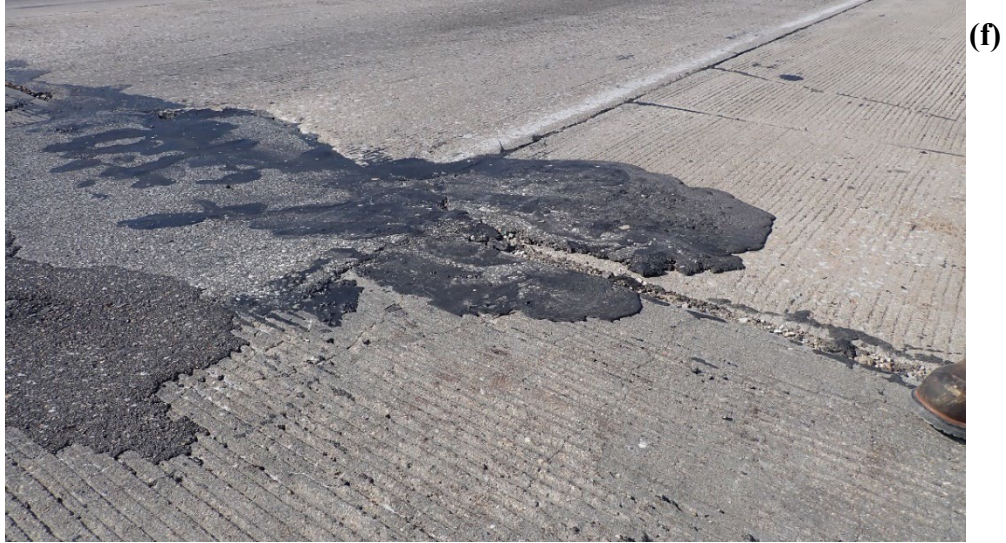
Type of repair materials: Kwik bond (2021) on the sides of the lane and hot mix (2022) in the middle

Figure Appendix A.10 Current state of repair material installed at location 3

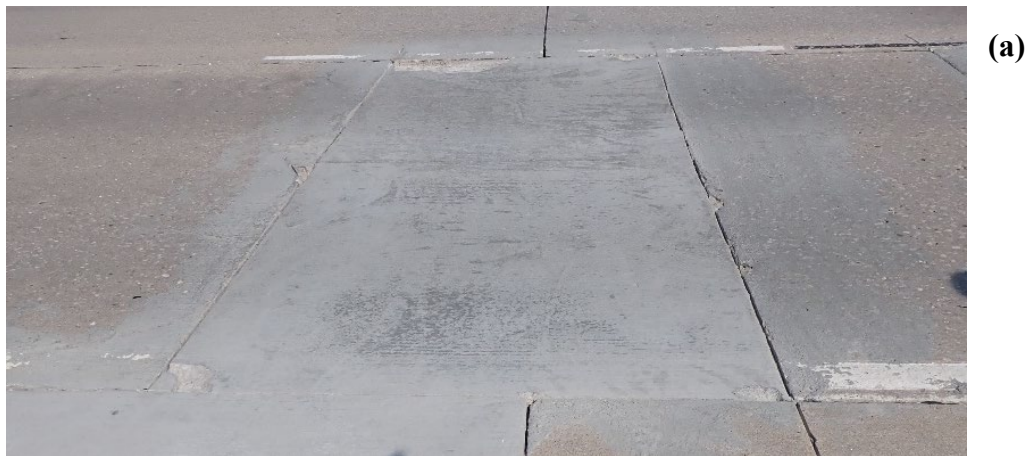
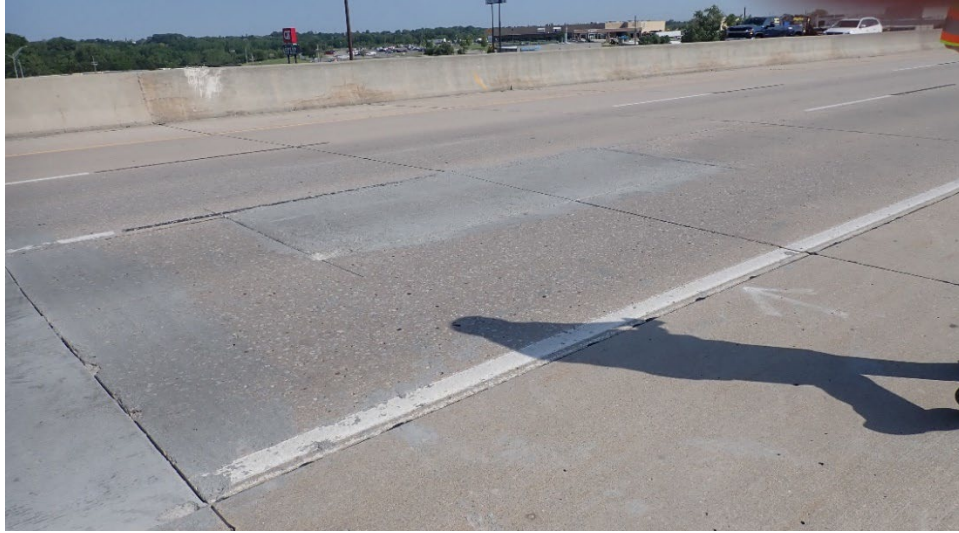
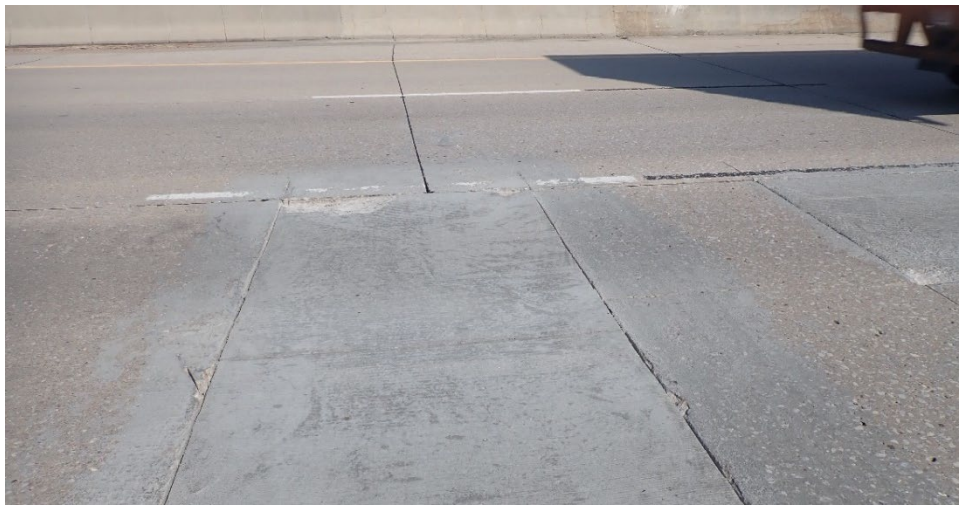
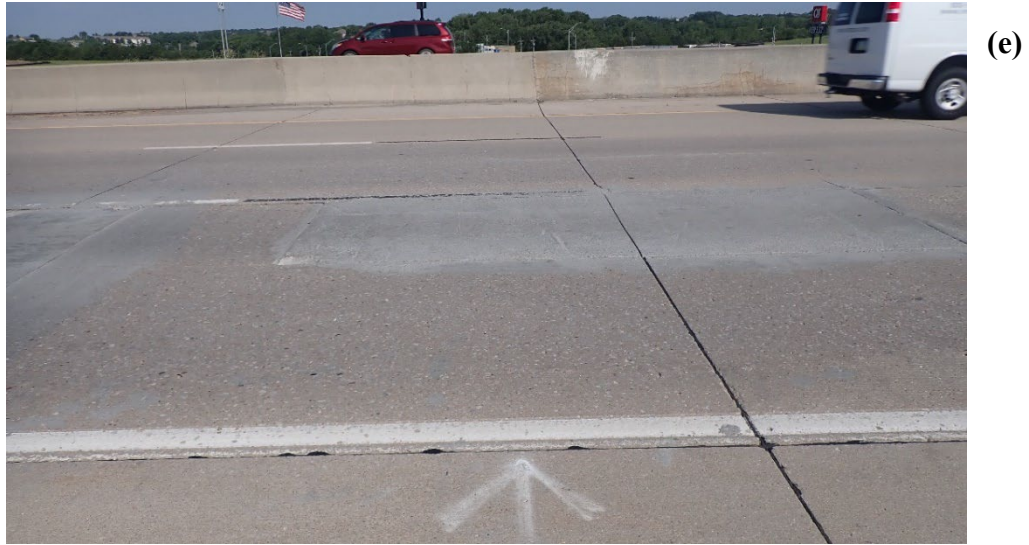
Type of repair materials: 47B-PR (done by contractor)

Figure Appendix A.11 Current state of repair material installed at location 4

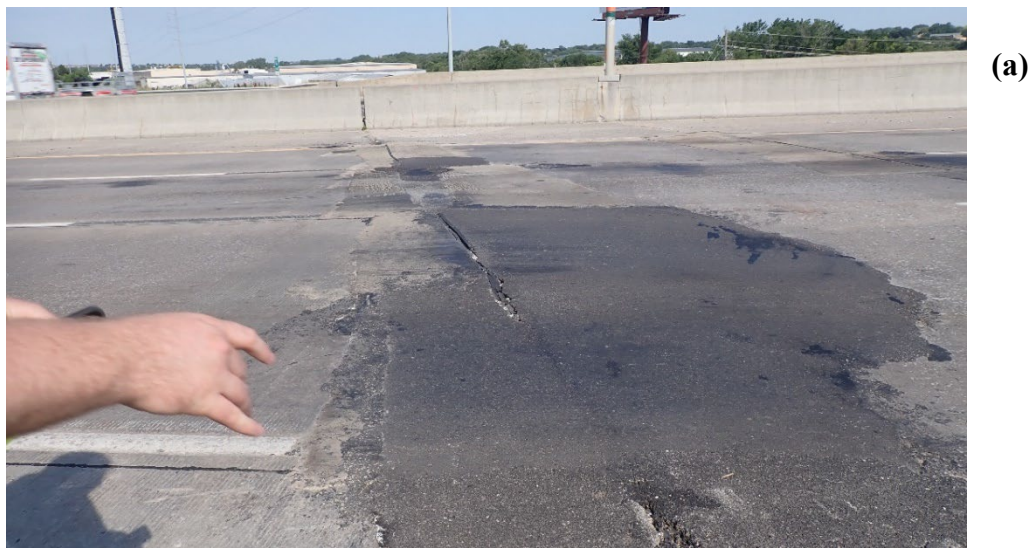
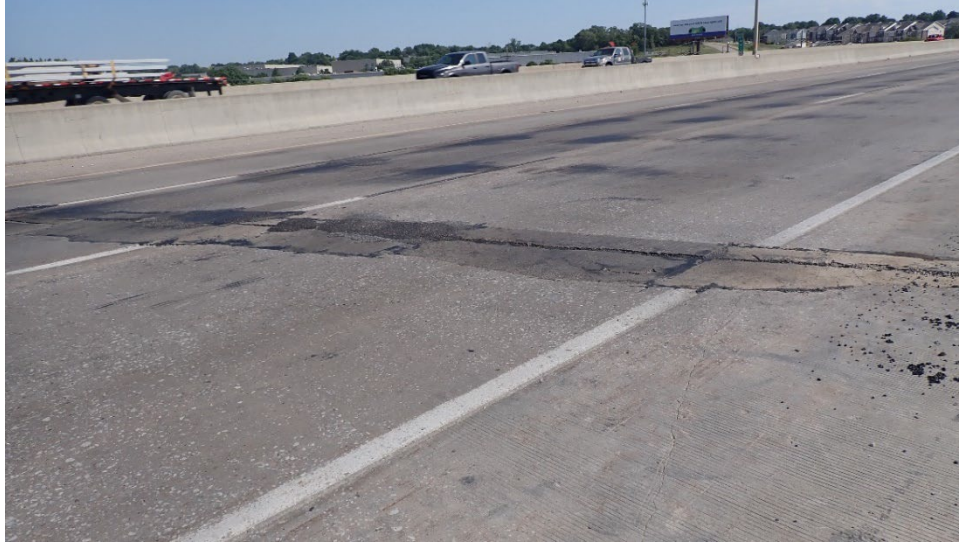
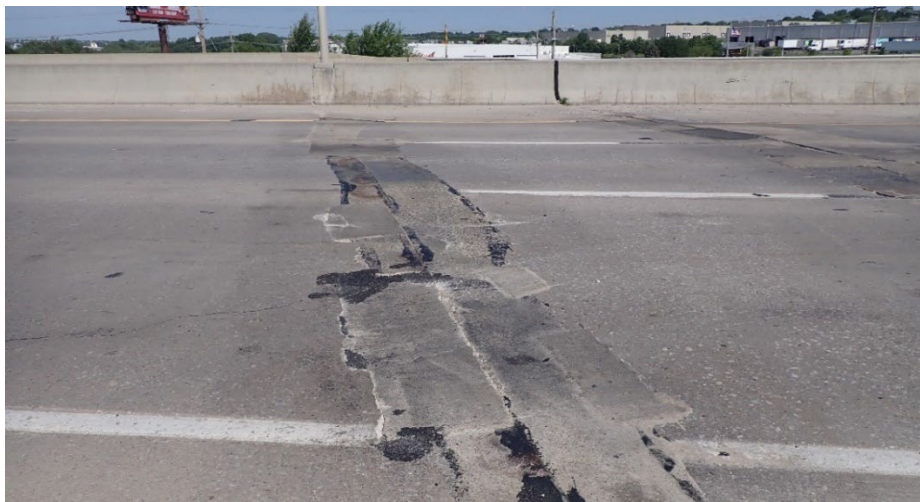
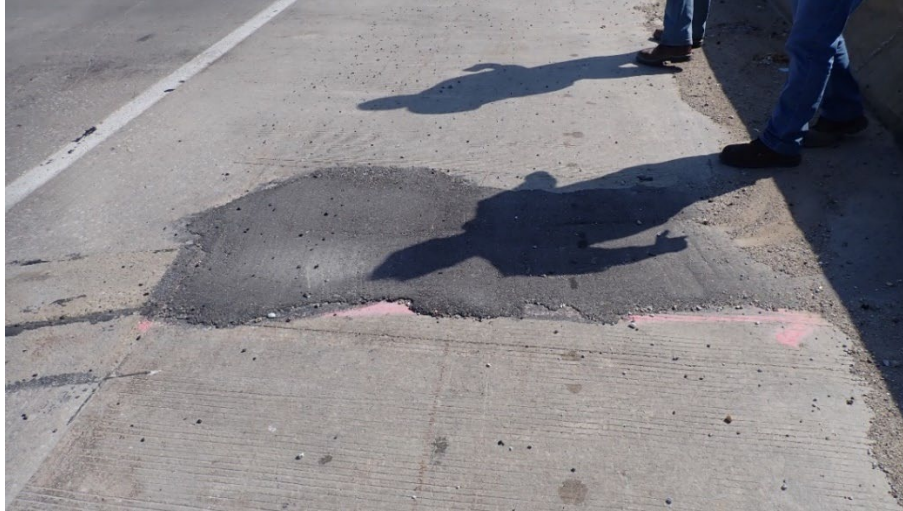
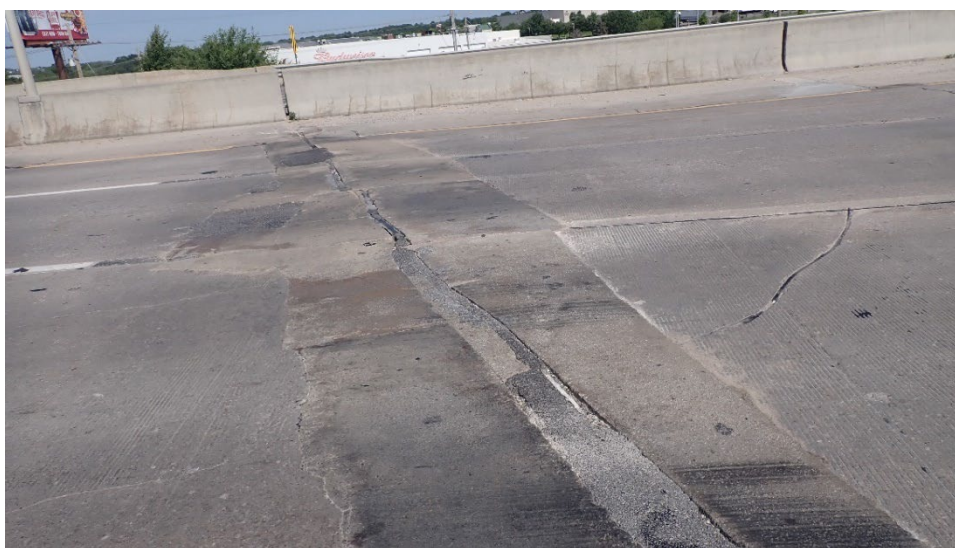
Type of repair materials: Kwik bond (NDOT) and hot mix asphalt

Figure Appendix A.12 Current state of repair material installed at location 5

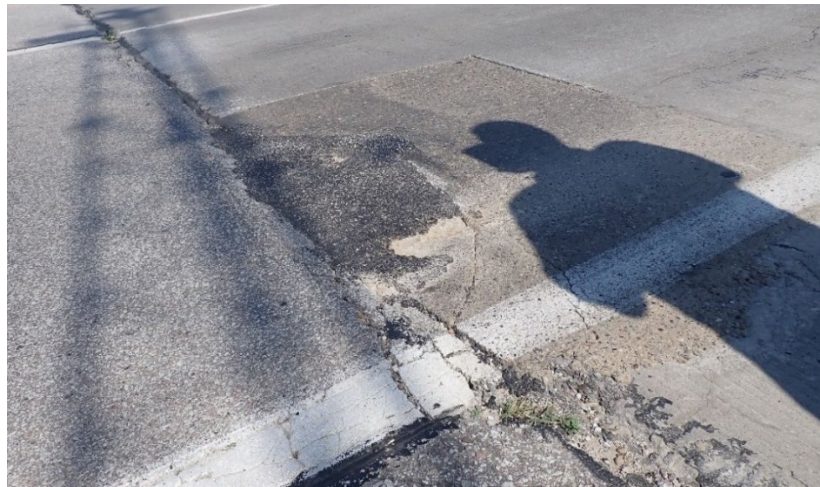
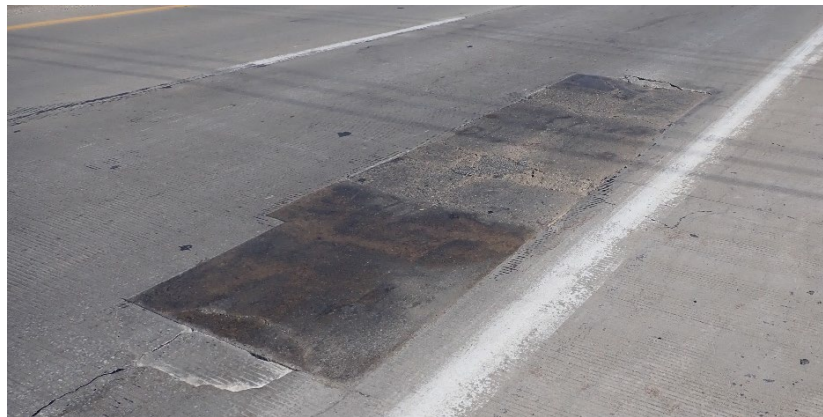
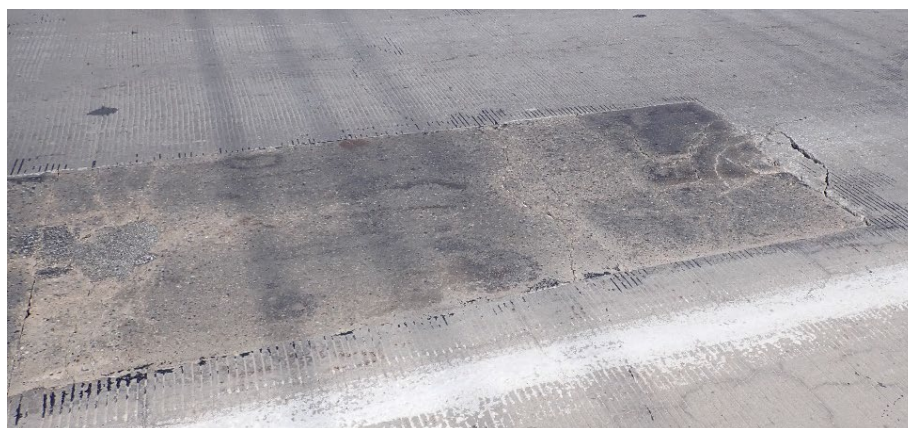
Figure Appendix A.13 Current state of repair material installed at location 6

Time of repair: 2017–2018 (Kwik bond), 2019 (cold mix), 2019 (Kwik bond)

Type of repair materials: Kwik bond and cold mix

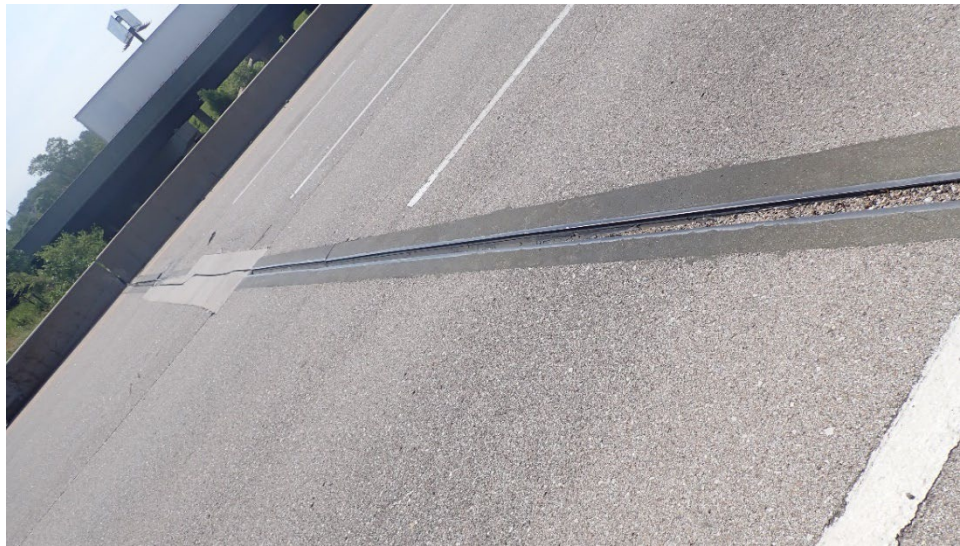
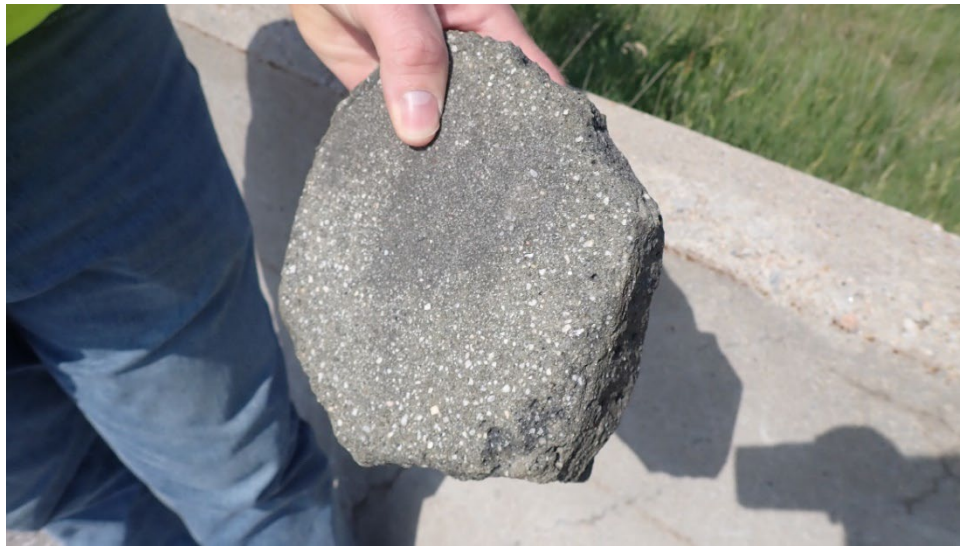
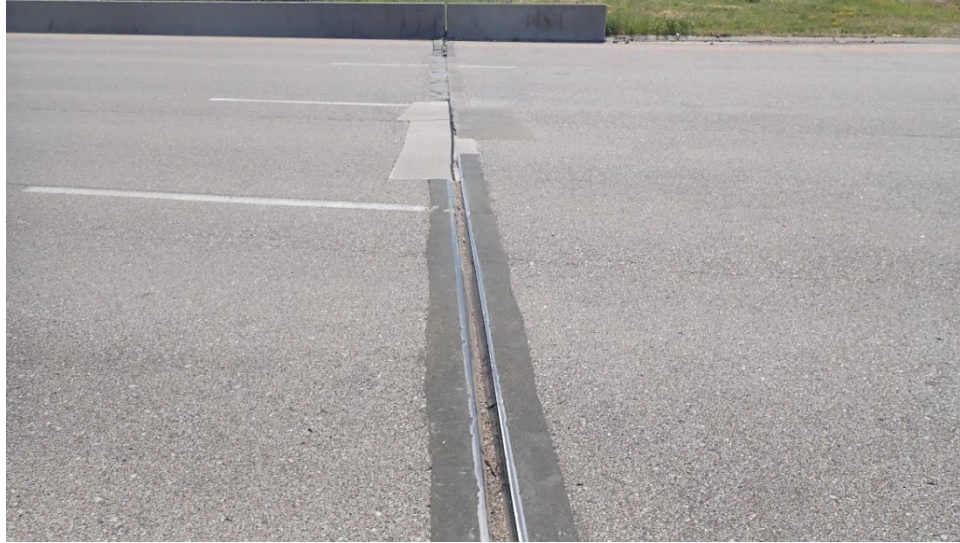
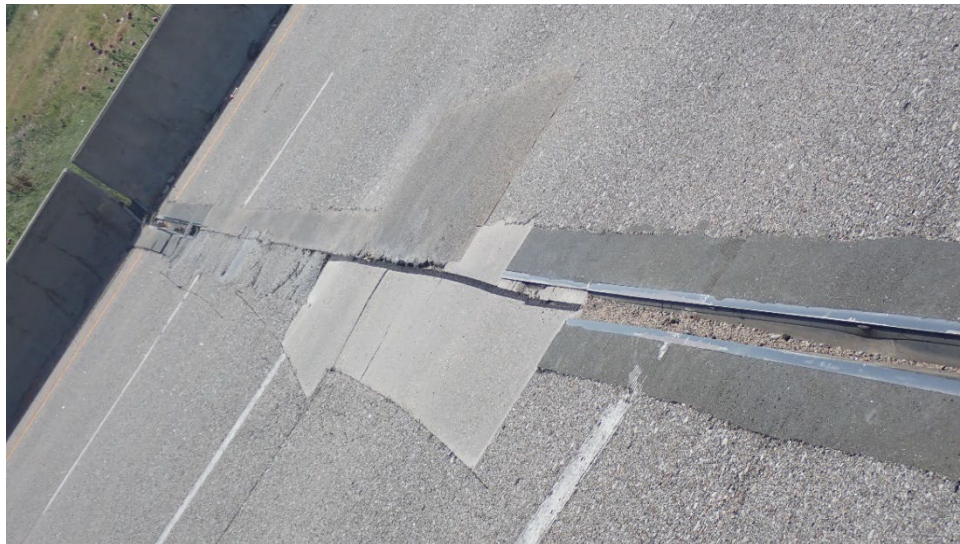
Type of repair materials: Kwik bond and Phocrete in the middle

Figure Appendix A.14 Current state of repair material installed at location 7

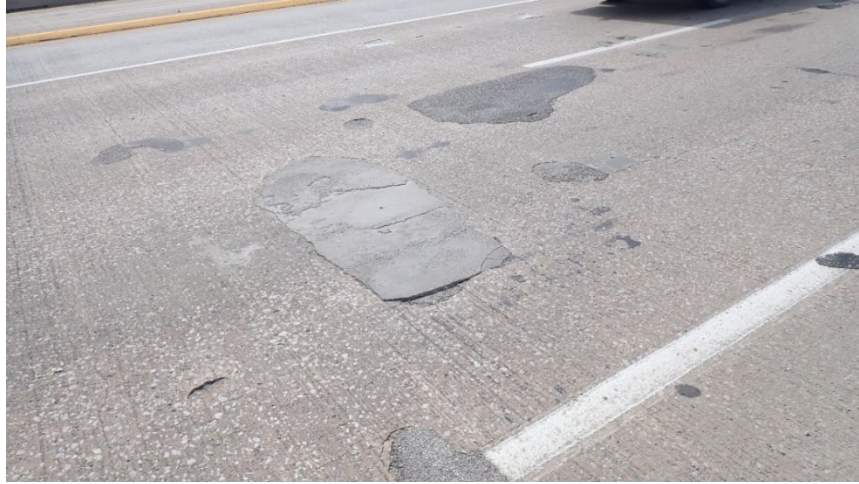
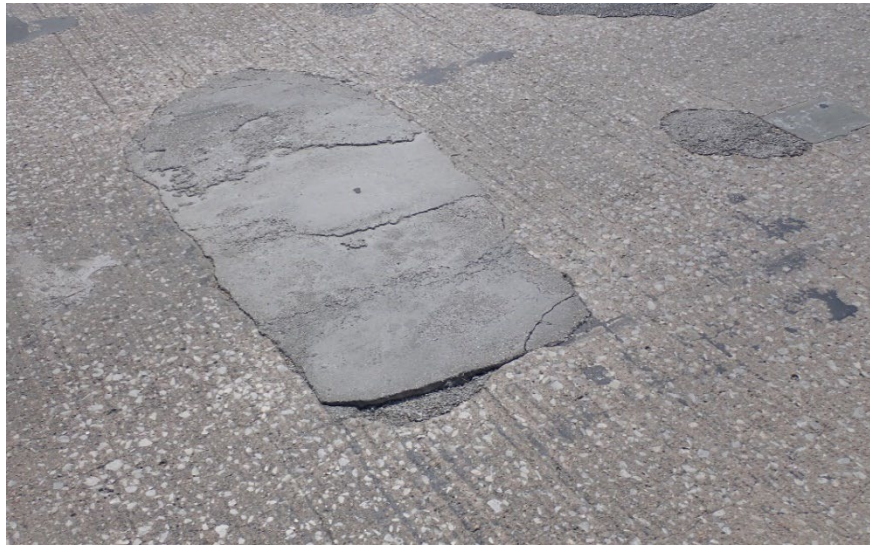
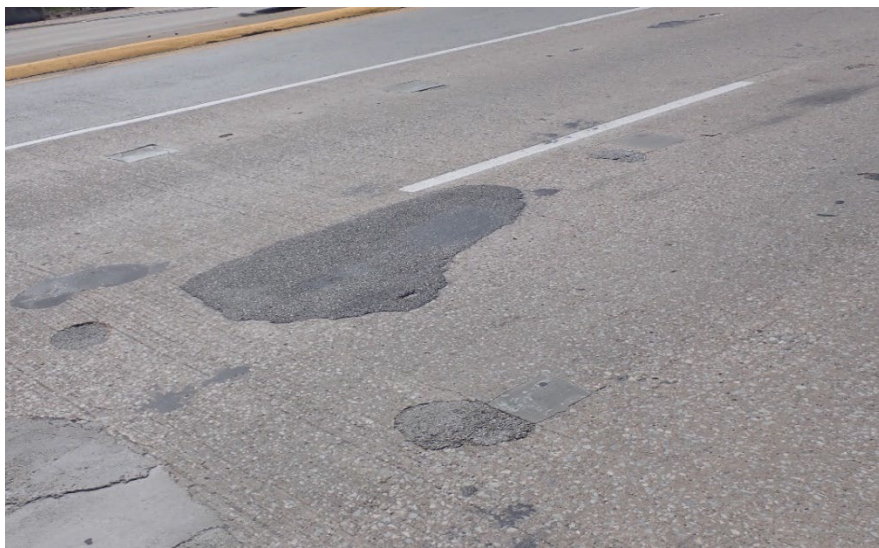
Figure Appendix A.15 Current state of repair material installed at location 8

Time of repair: May 2022

Type of repair materials: Phoscrete HC, hot mix

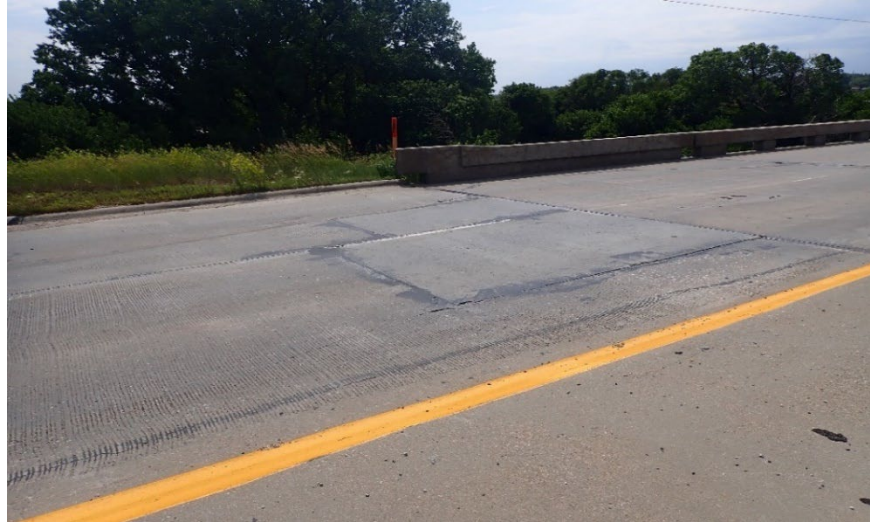
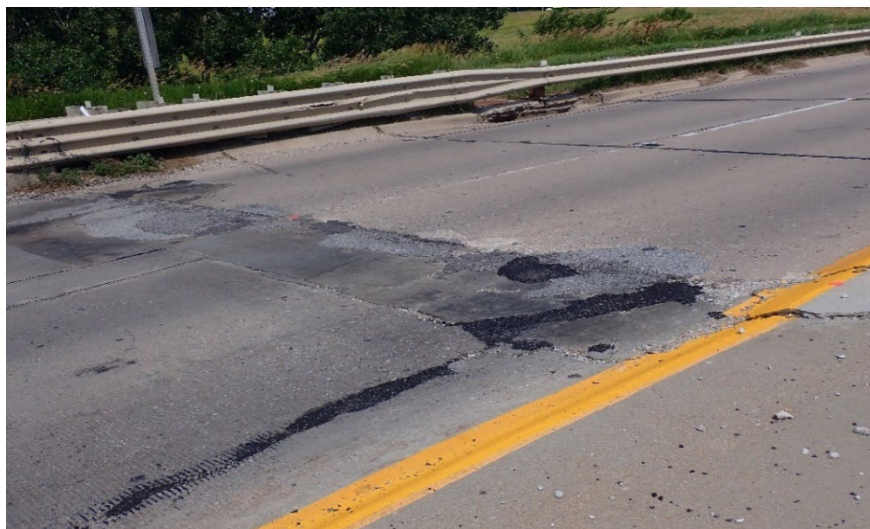
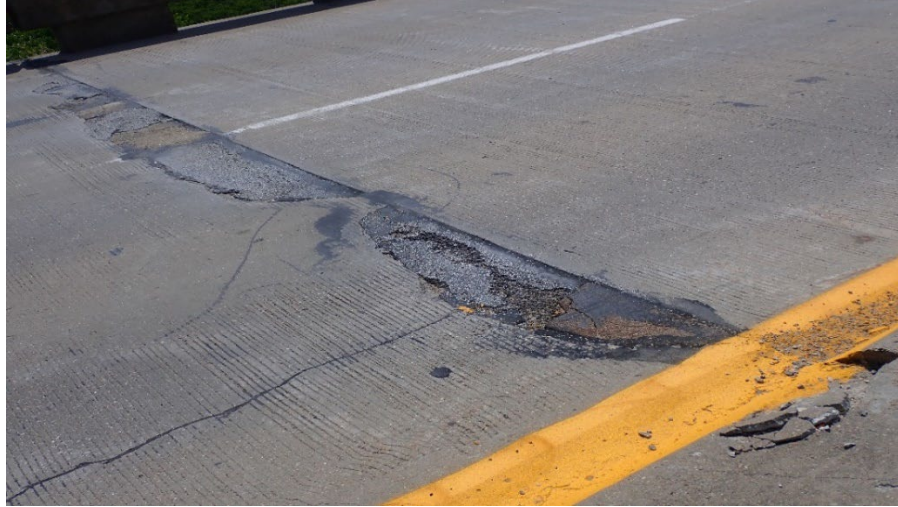
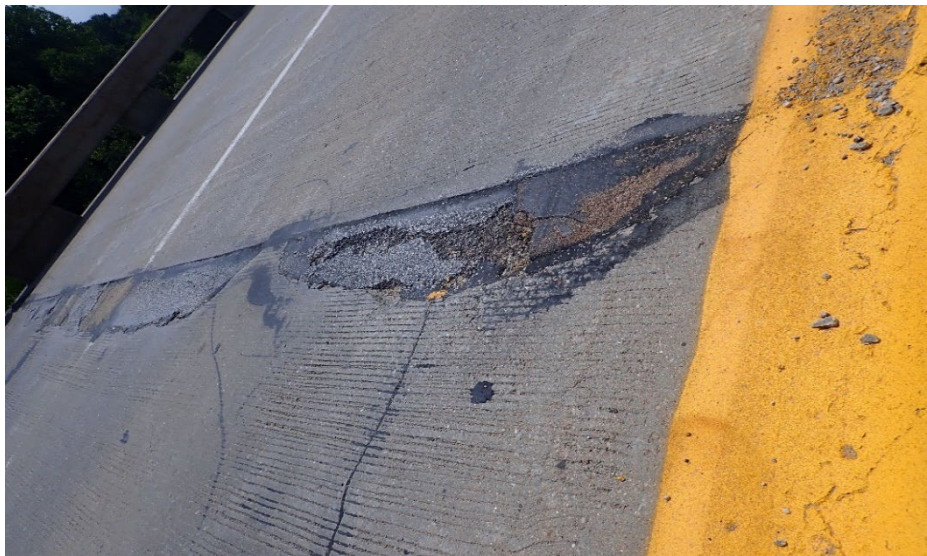
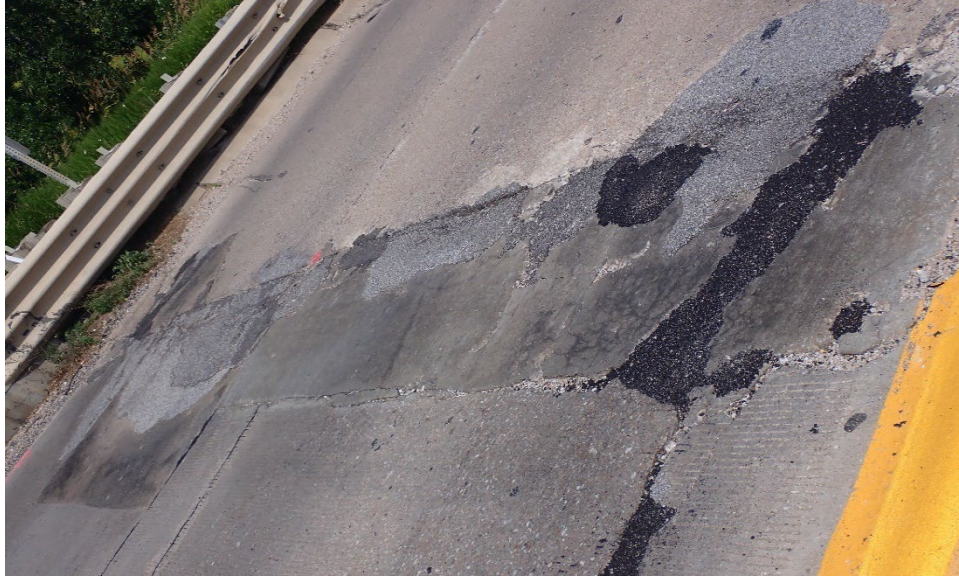
Note: It might have been patched in 2022 without removing the old material.

Figure Appendix A.16 Current state of repair material installed at location 9
