Final Report SPR-FY21(006)

WBS Report #
26-1122-0099-001

Performance of High Early-Strength Used in Concrete Bridge Repair

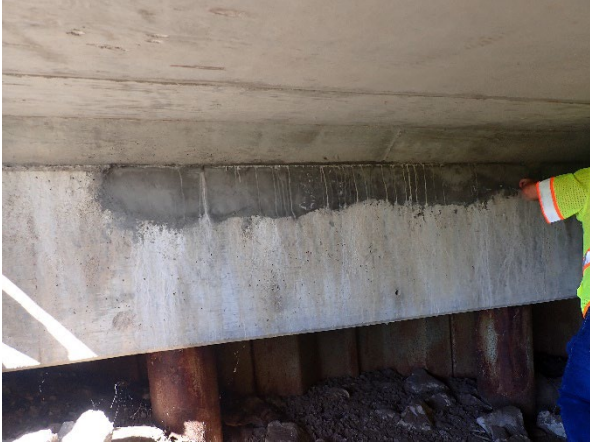
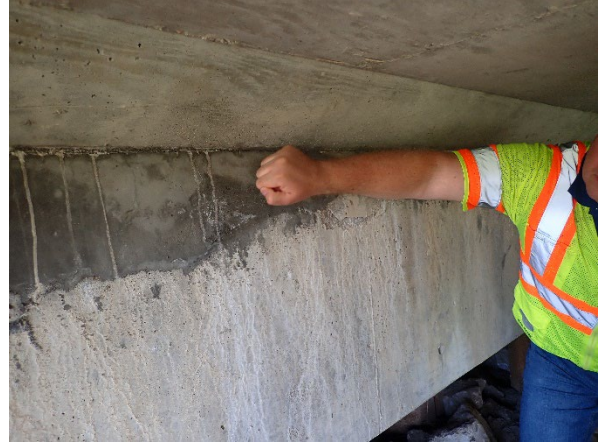
Type of repair materials: Commercial grade FastSet repair mortar

Notes: The repair was performed on the bottom of the bridge deck. It looked good. Some parts had an eco-sound.

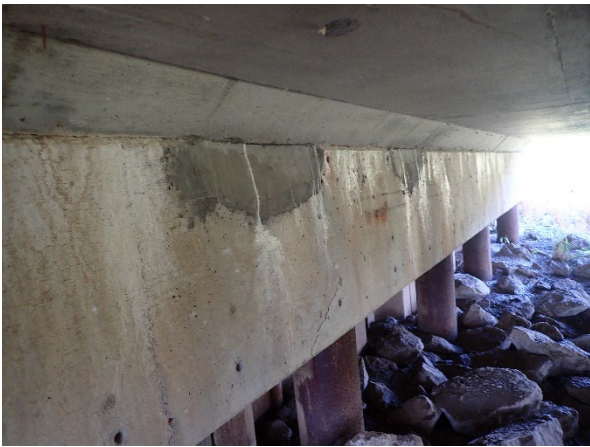
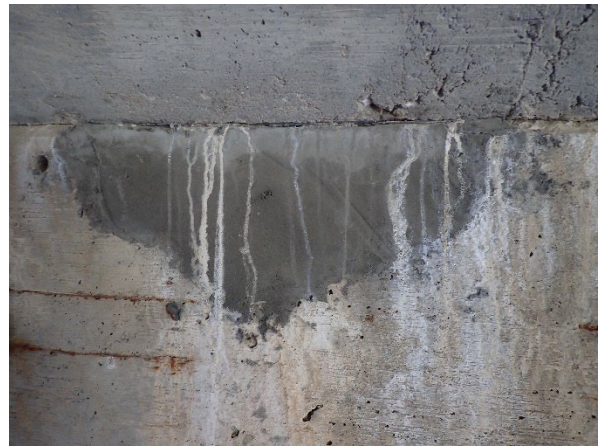
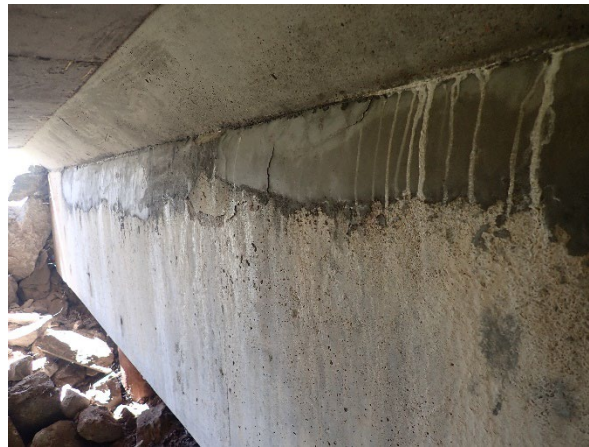
Figure Appendix A.17 Current state of the repair material installed at location 1

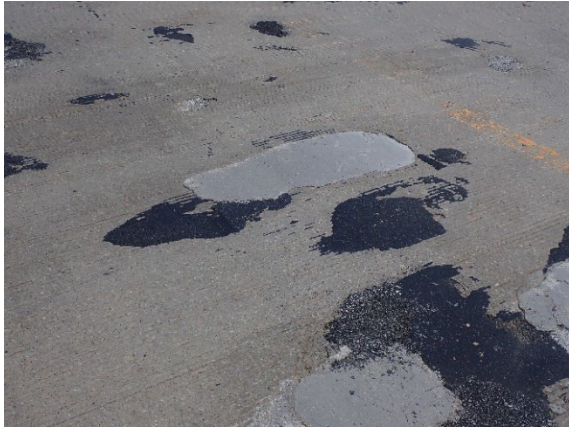
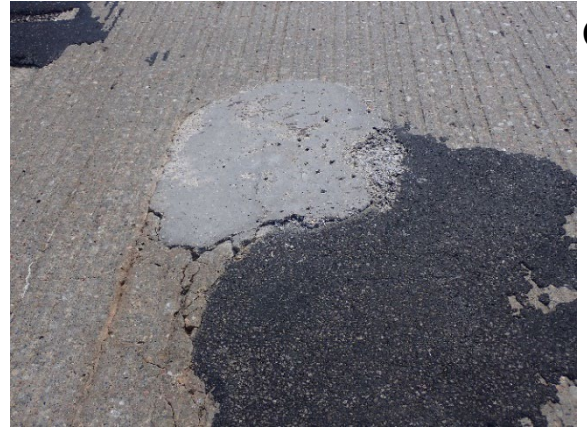
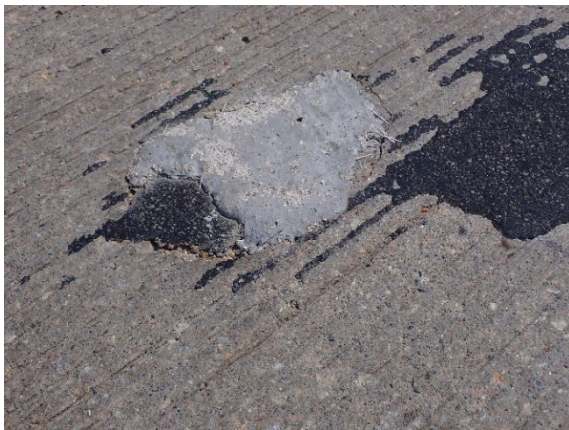
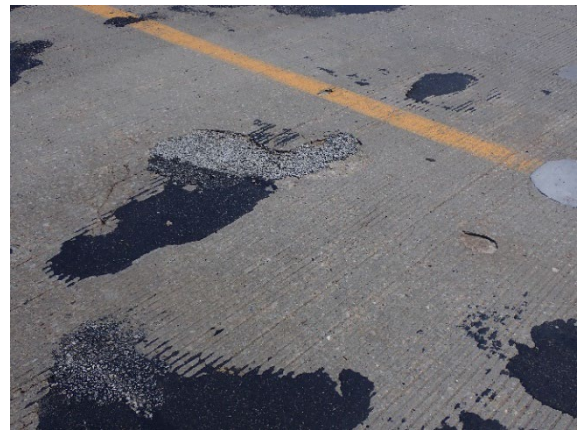
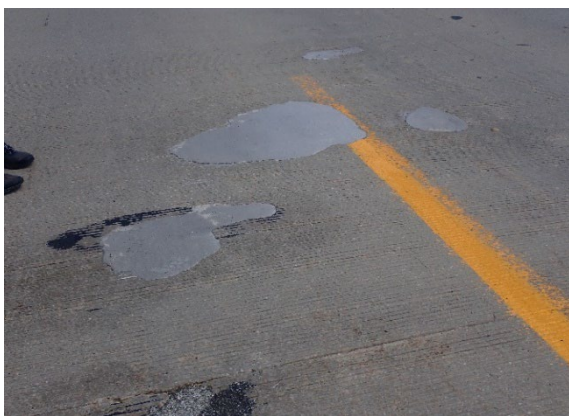
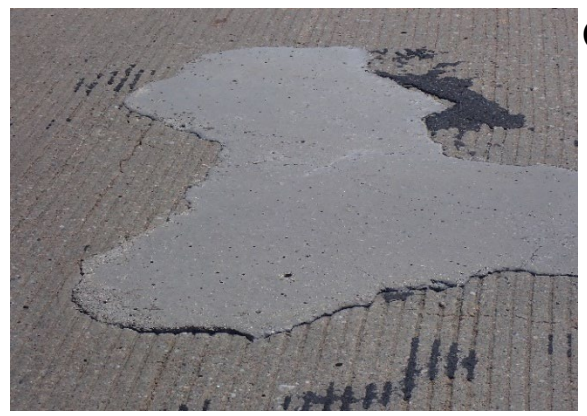
Time of repair: 2022

Type of repair material: a mixture between Phoscrete HC and cold-patch

Figure Appendix A.18 Current state of repair material installed in location 2

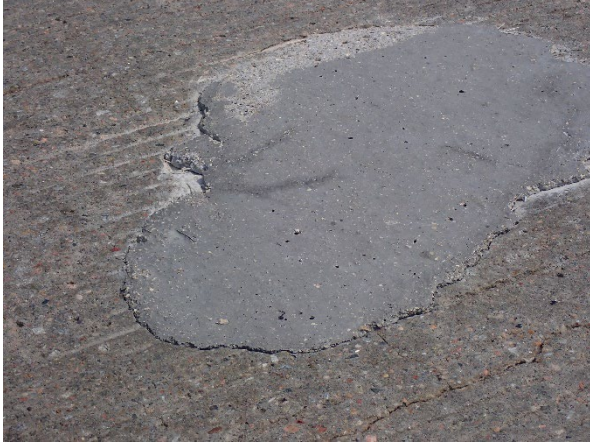
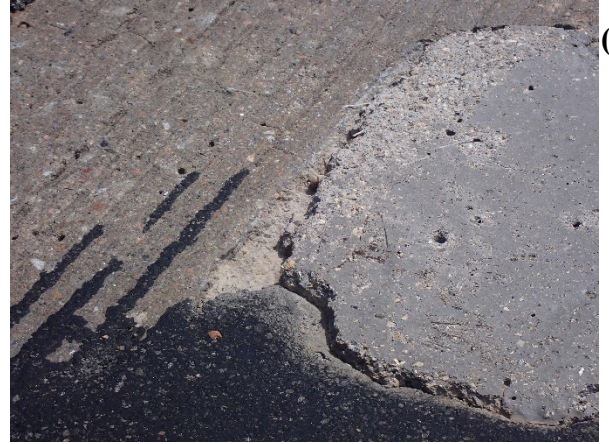
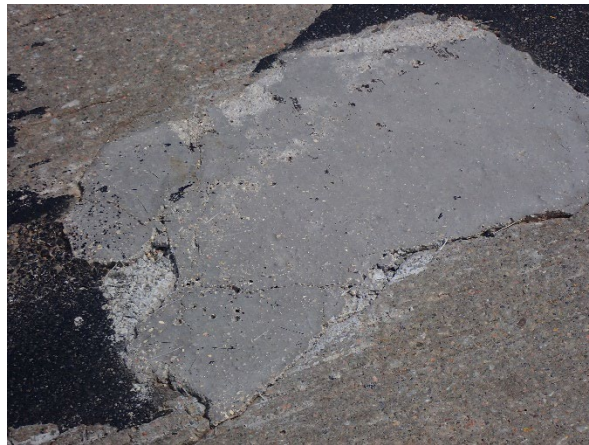
Figure A.18 (continued) Current state of repair materials installed at location 2

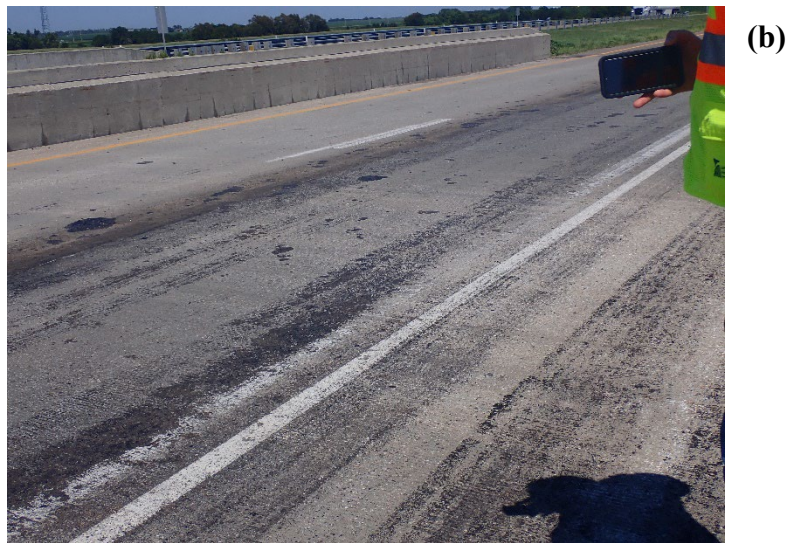
Time of repair: Fall 2020

Type of repair material: PPC 1121 (Polyester Polymer Concrete)

Figure Appendix A.23 Current state of repair material installed at location 7

Figure A.23 (continued) Current state of repair material installed at location 7

Figure A.23 (continued) Current state of the repair material used in location 7

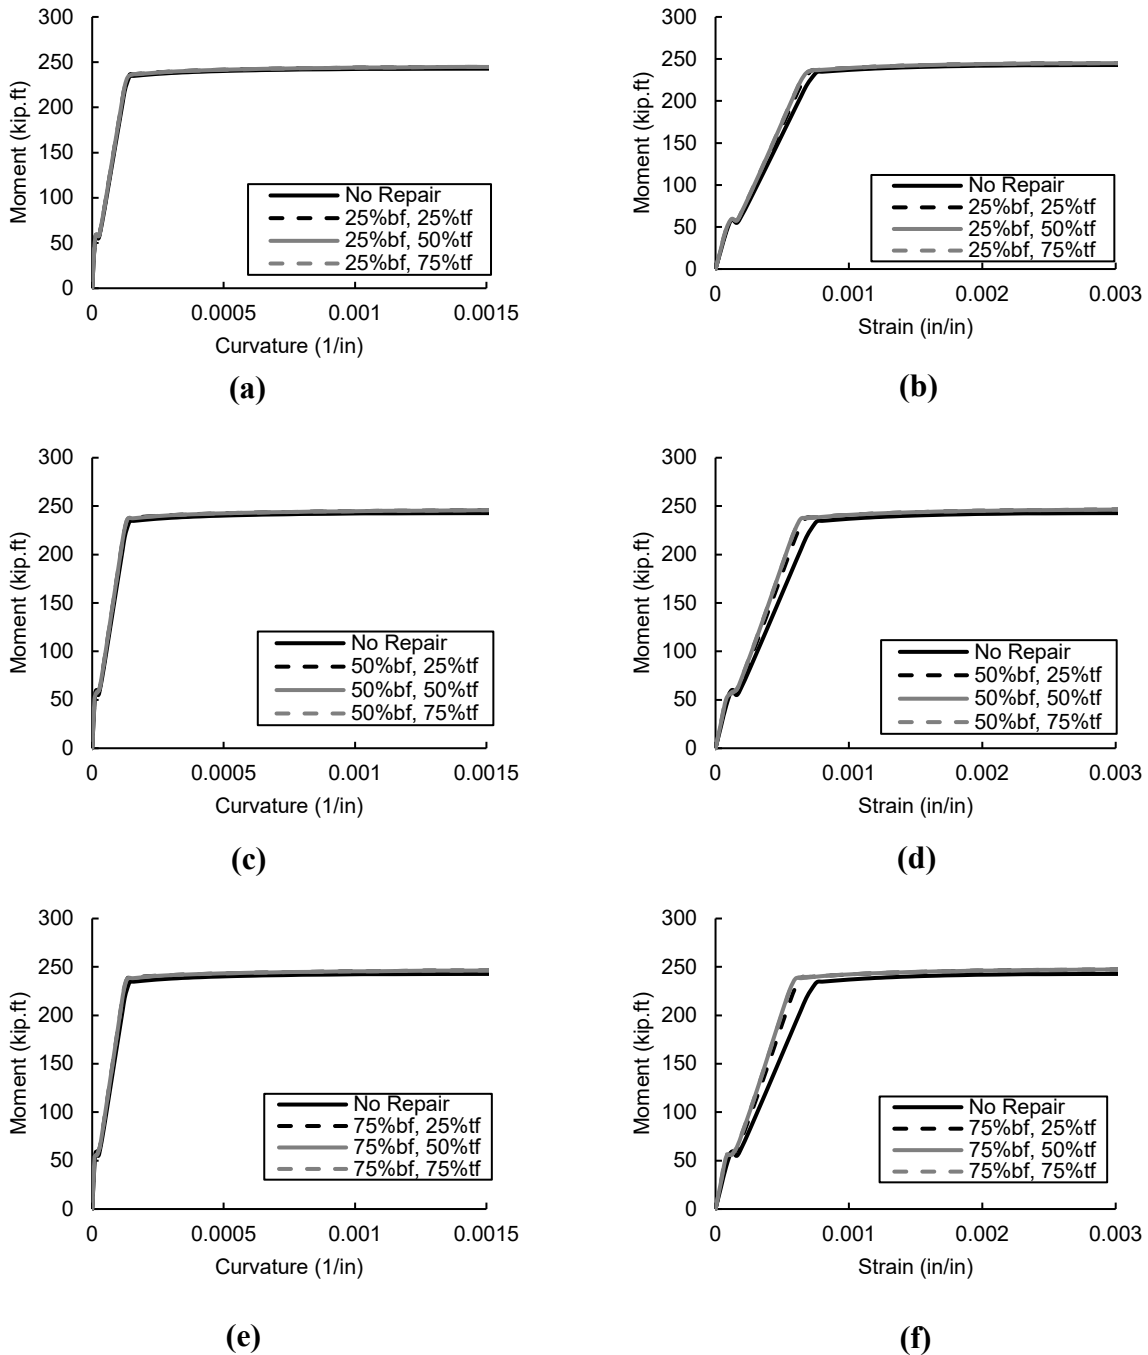
Figure B.1 Effects of cement-based rigid repair materials on the flexural strength of a T-beam
a) moment-curvature curve for a 25% b_f repair width; b) moment-strain curve for a 25% b_f repair width; c) moment-curvature curve for a 50% b_f repair width; d) moment-strain curve for a 50% b_f repair width; e) moment-curvature curve for a 75% b_f repair width; f) moment-strain curve for a 75% b_f repair width. Each case covers a certain width with a depth of 25%, 50%, and 75% t_f

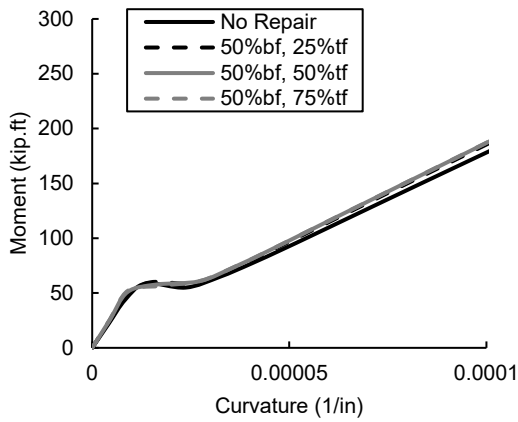
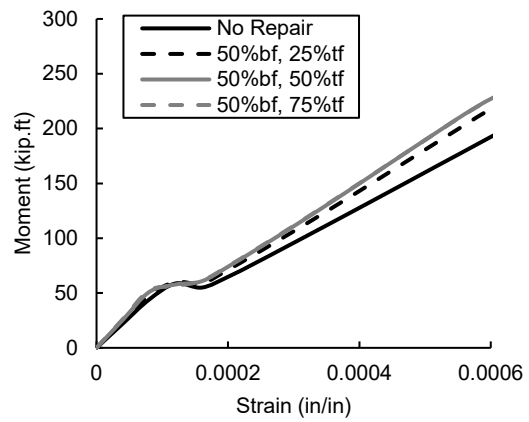
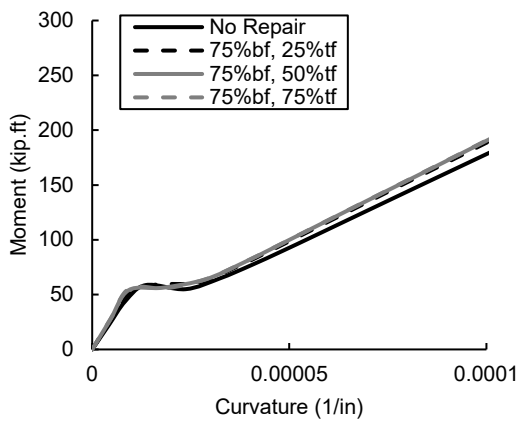
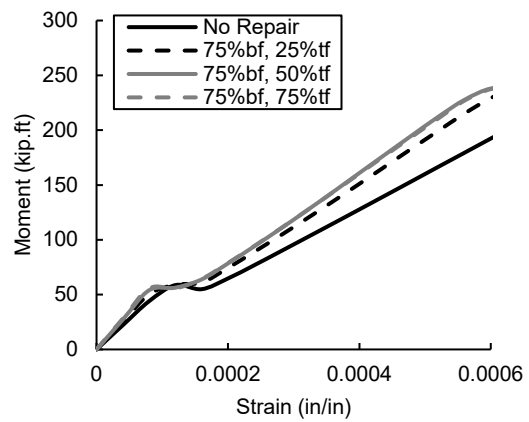
Figure B.2 The elastic part of a cement-based rigid repair material moment-curvature and moment-strain curves a) moment-curvature curve for a 25% b_f repair width; b) moment-strain curve for a 25% b_f repair width; c) moment-curvature curve for a 50% b_f repair width; d) moment-strain curve for a 50% b_f repair width; e) moment-curvature curve for a 75% b_f repair width; f) moment-strain curve for a 75% b_f repair width. Each case covers a certain width with a depth of 25%, 50%, and 75% t_f

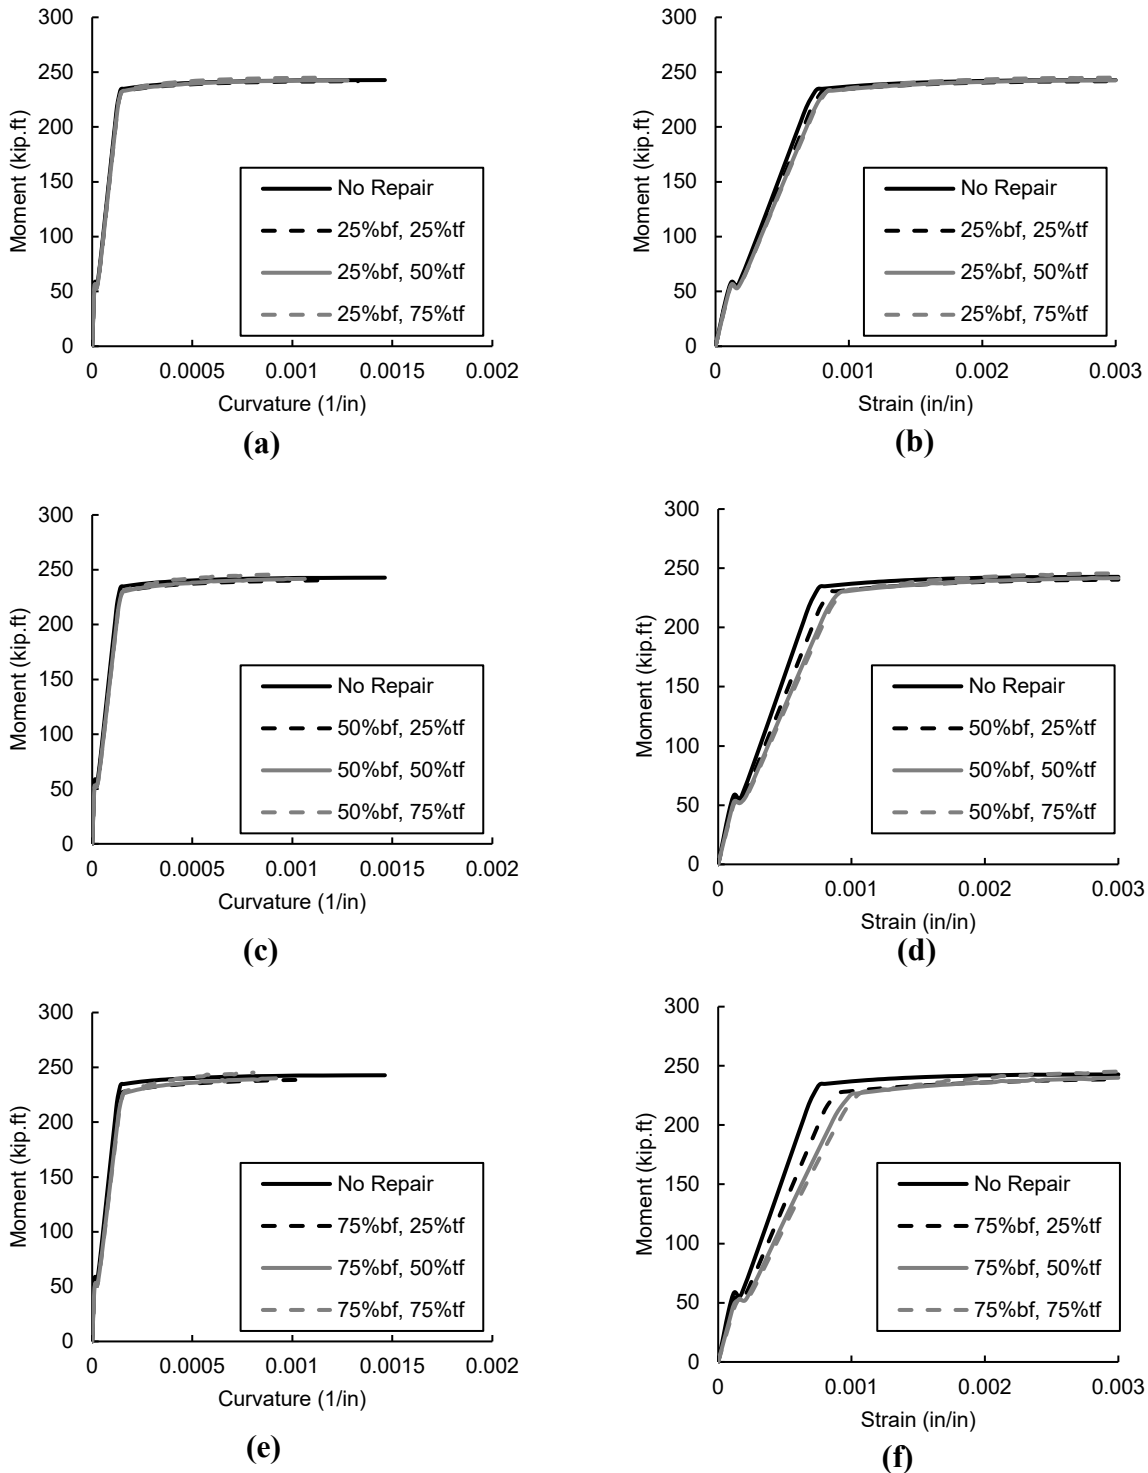
Figure B.3 Effects of polymer repair materials on the flexural strength of a T-beam a) moment-curvature curve for a 25% b_f repair width; b) moment-strain curve for a 25% b_f repair width; c) moment-curvature curve for a 50% b_f repair width; d) moment-strain curve for a 50% b_f repair width; e) moment-curvature curve for a 75% b_f repair width; f) moment-strain curve for a 75% b_f repair width. Each case covers a certain width with a depth of 25%, 50%, and 75% t_f

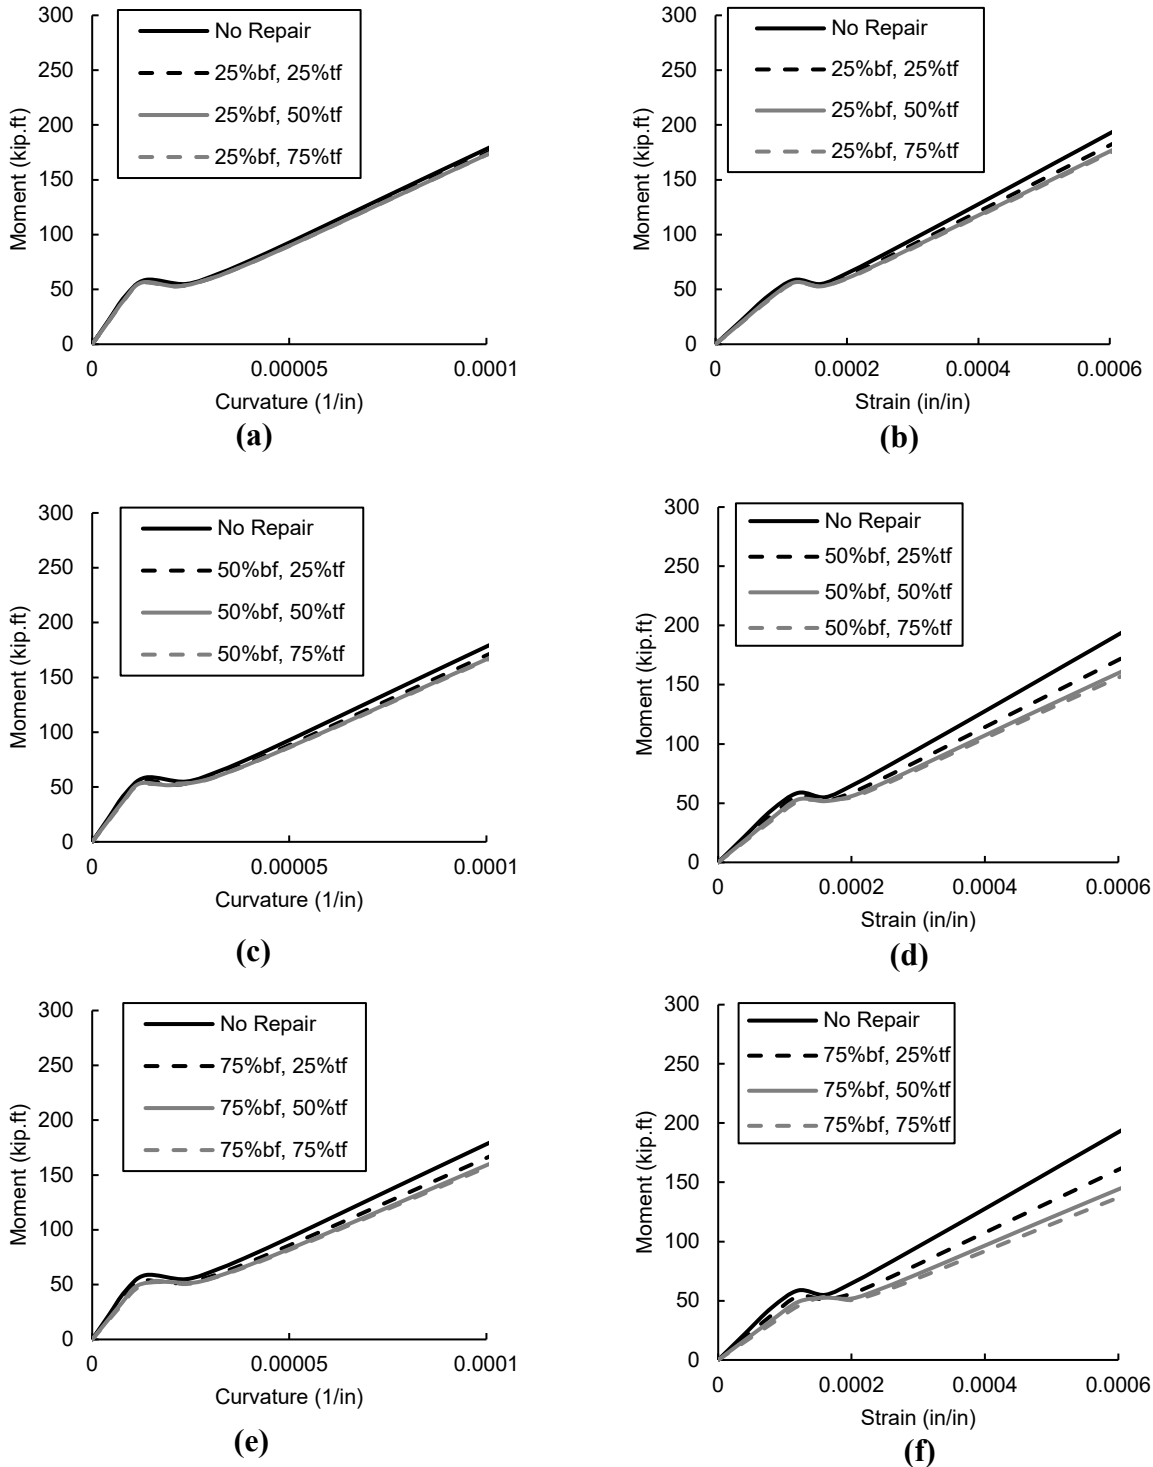
Figure B.4 The elastic part of a polymer-based HES material moment-curvature and moment-strain curves a) moment-curvature curve for a 25% b_f repair width; b) moment-strain curve for a 25% b_f repair width; c) moment-curvature curve for a 50% b_f repair width; d) moment-strain curve for a 50% b_f repair width; e) moment-curvature curve for a 75% b_f repair width; f) moment-strain curve for a 75% b_f repair width. Each case covers a certain width with a depth of 25%, 50%, and 75% t_f
