IDAHO TRANSPORTATION DEPARTMENT

RESEARCH REPORT

Experimental Validation of Repair Methods for Earthquake-Damaged Bridges Incorporating ITD's Precast Pier System

RP 302

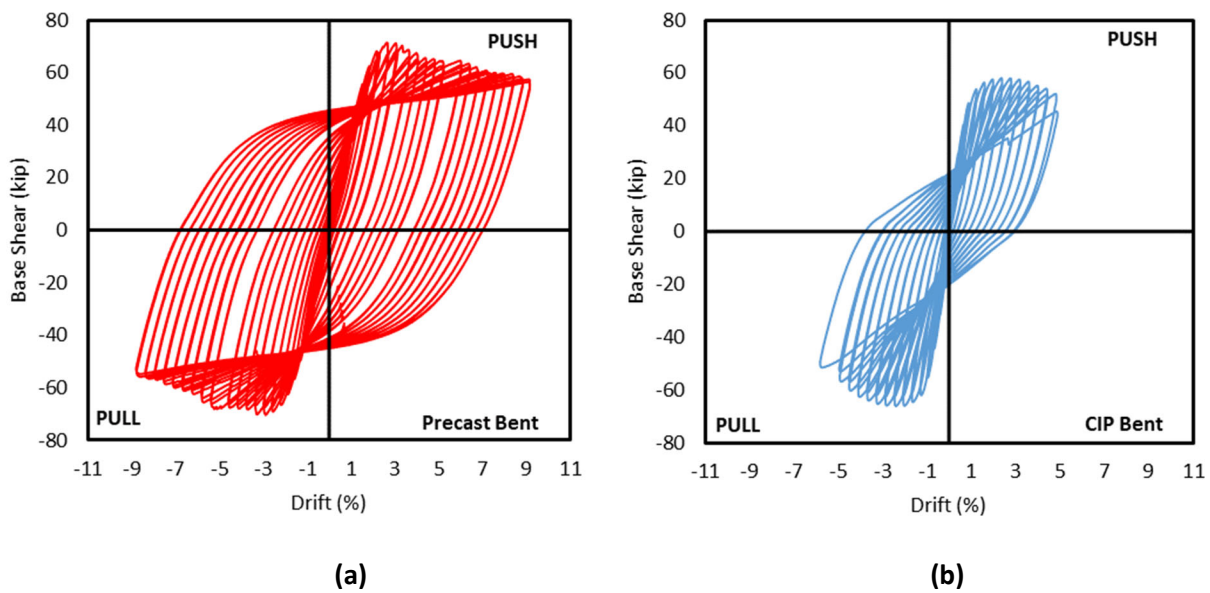
Figure 1.3 Bent Hysteresis: (a) Precast, (b) Cast-in-Place

In Phase I, both the CIP and Precast bents were designed identically in dimensions and performance capacities. Both bents were tested under quasi-static loading in the ISU SLAB using the same loading protocol. The two systems performed similarly during testing. Figure 1.3 gives the hysteresis from testing of the Precast and CIP bents. The Precast bent showed less overall damage than the CIP bent. The Precast bent also achieved a higher moment capacity, 498 kip-ft compared to the moment capacity of 468 kip-ft for the CIP bent. The Precast bent withstood 24 complete loading cycles, with an ultimate drift ratio of 9.15%. The CIP bent only withstood 15 loading cycles, resulting in an ultimate drift ratio of 4.94%. The Precast bent achieved maximum force 71.4 kip at 2.69% drift, while the CIP bent achieved maximum force 66 kip at 2.46% drift. Overall the Precast bent was able to dissipate more energy than the CIP bent. The Precast bent dissipated 2,125 kJ (1,567,320 ft-lb.), while the CIP bent dissipated 342 kJ (252,246 ft-lb.). Table 1.1 gives a summary of the comparison of the CIP bent with the Precast Bent.

- The Precast bent withstood small displacement without suffering hairline cracking due to the presence of the elastomeric bearing pad.
- The Precast bent displayed better confinement through reduced cracking observed throughout the experimental program.

- Buckling and tearing of the HSS pipe is observed during large drift ratios to be the failure mechanism of the proposed precast connection.
- The Precast pier demonstrates a reduced stiffness as it approached ultimate capacity than that of the CIP bent.

- The Precast bent also exhibited a higher yield displacement of 1.13% drift ratio compared to the 0.5% drift exhibited by the CIP bent.
- The precast bent displayed more energy dissipation than the CIP bent. The Precast bent displayed far less degradation than the CIP bent. The Precast bent was able to withstand additional cycles, compared to the CIP bent.

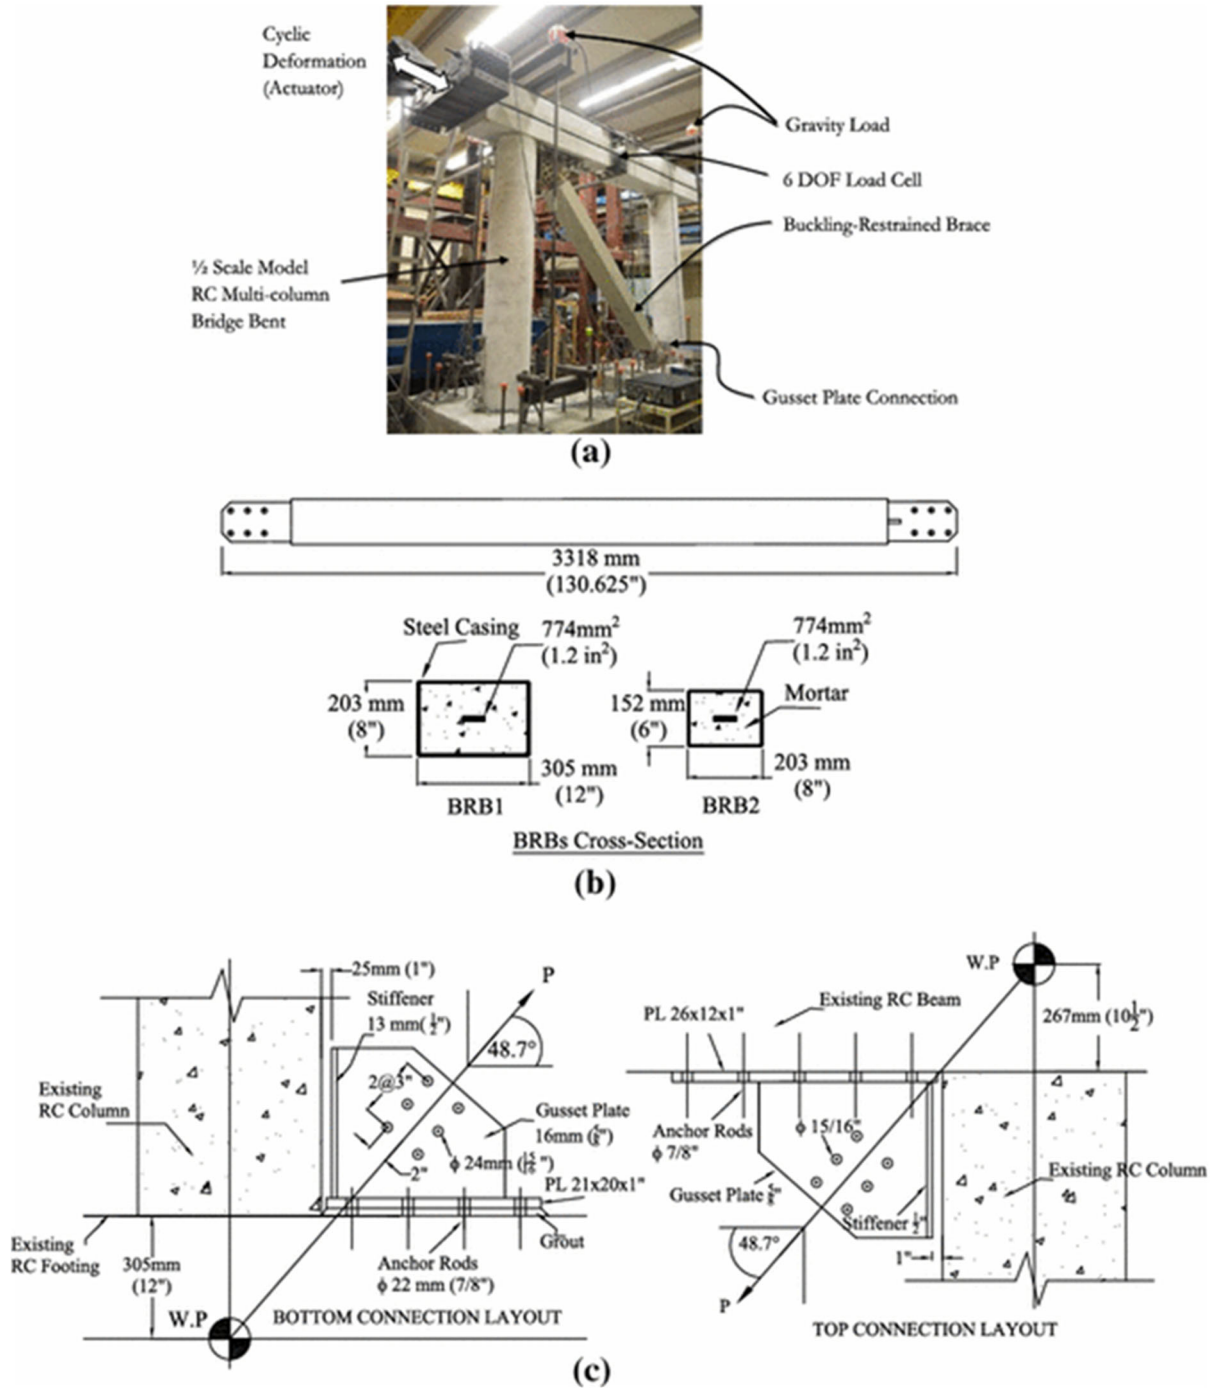
Figure 2.10 Bridge Retrofitting using BRBs (Bazaiez and Dusicka 2018)

the BRBs were effective in achieving both life-safety and operational performance levels for the retrofitted bent.

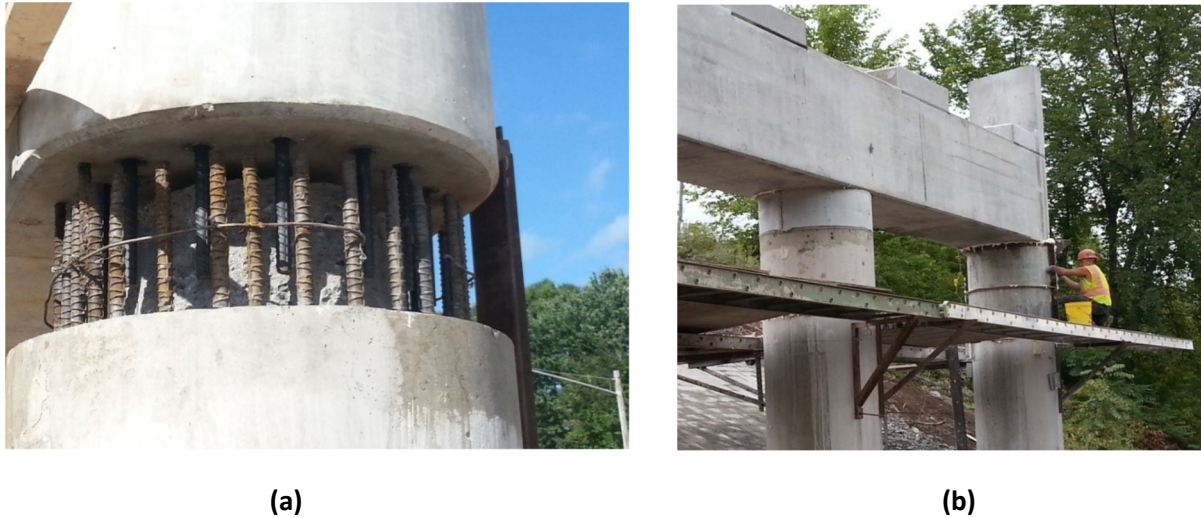
Figure 2.31 (a) Condition of Existing Rebars and New Dowels, (b) Completed Retrofit (Doiron 2016)

changes, reduced the need for two extra days, and removed uncertainty about misalignment. The project was completed within 21 days. Figure 2.31 shows the pier retrofit process.

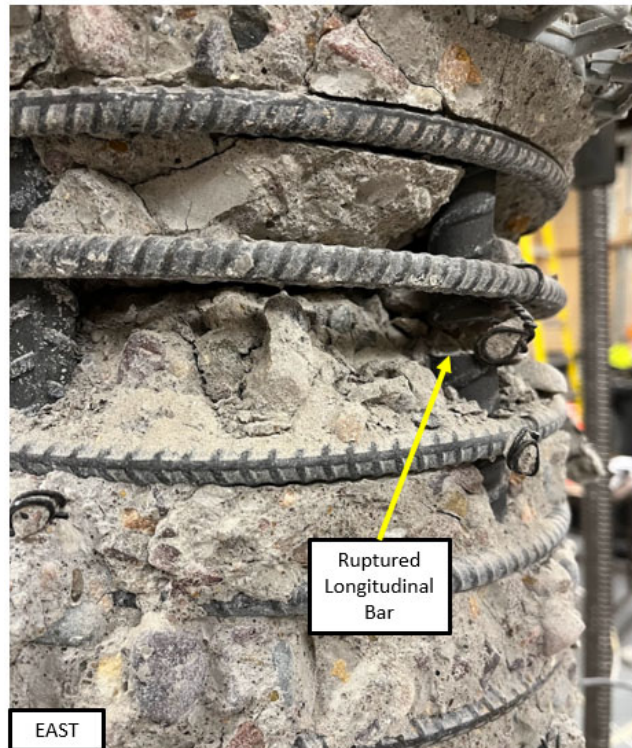
Figure 3.50 Precast 1 Ruptured Longitudinal Bar, East Face

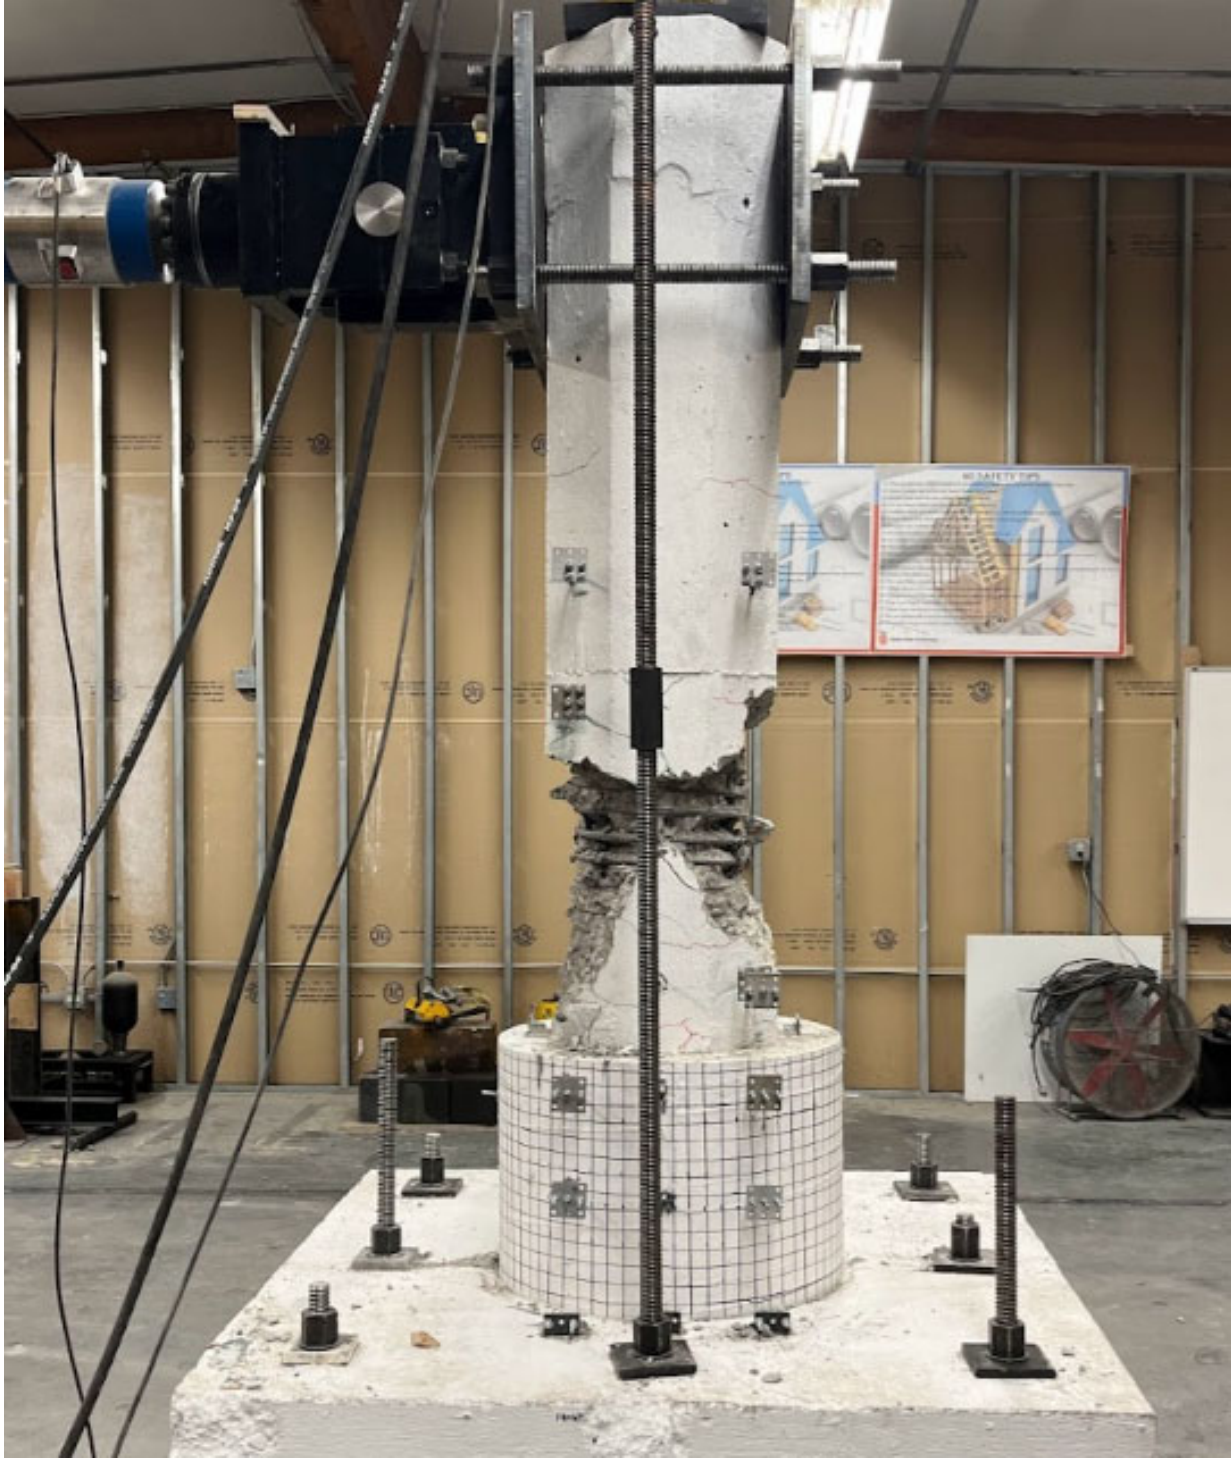
Figure 3.51 Precast 1 Post-Test

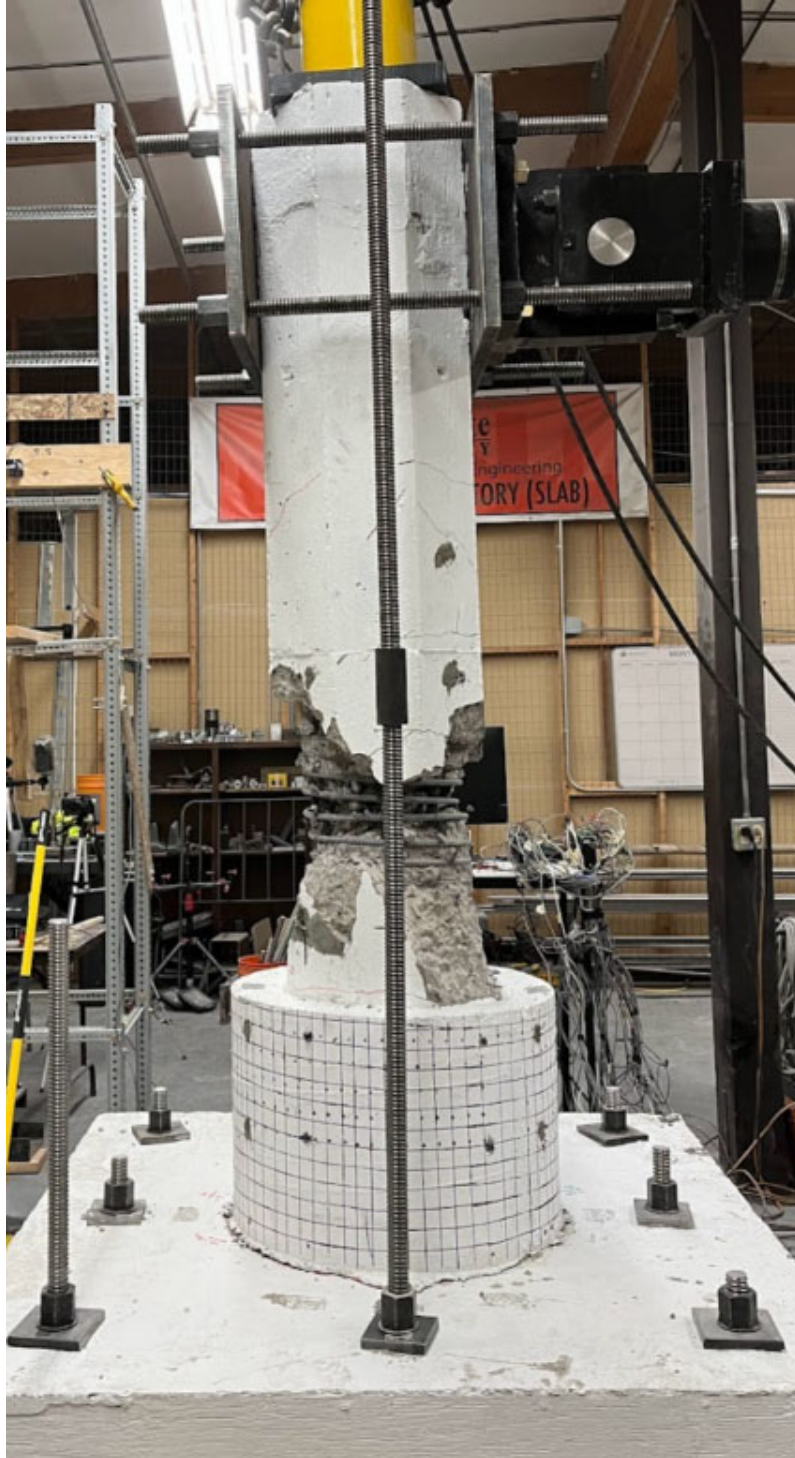
Figure 3.68 Precast 2 Post-Test

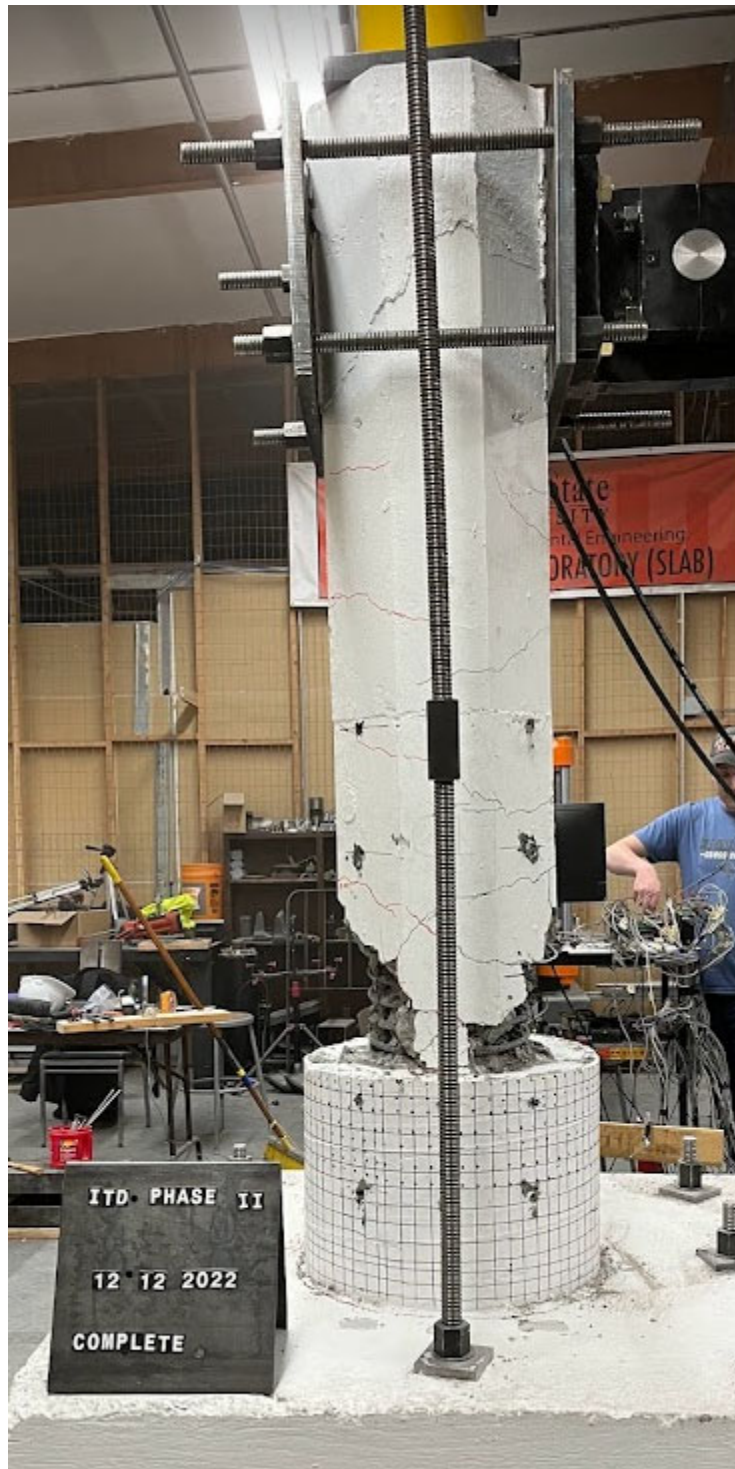
Figure 3.85 CIP 1 Post-Test

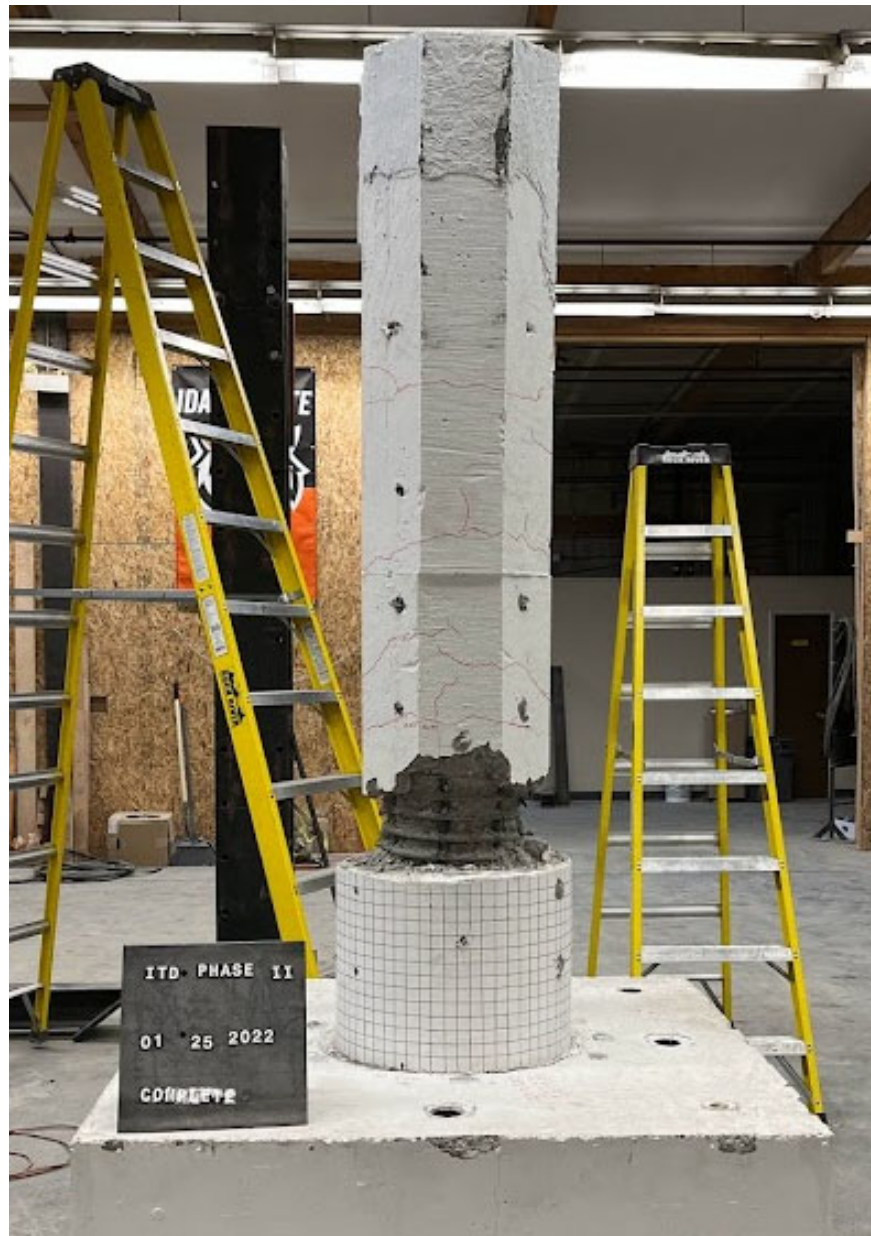
Figure 3.101 CIP 2 Post-Test
