# Emergency Relief Program Resilience Case Study – Alabama

## U.S. Highway 231 Landslide Repair Project

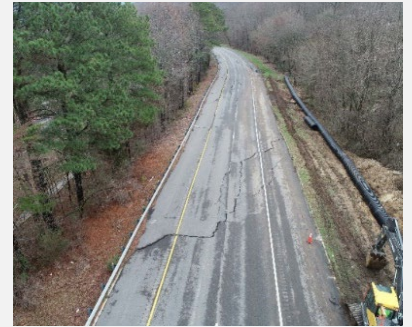
*Figure 1: Damage to the northbound lane of US 231 and the berm ALDOT first built along the roadway to minimize further damage and keep water away from the area. Source: ALDOT*

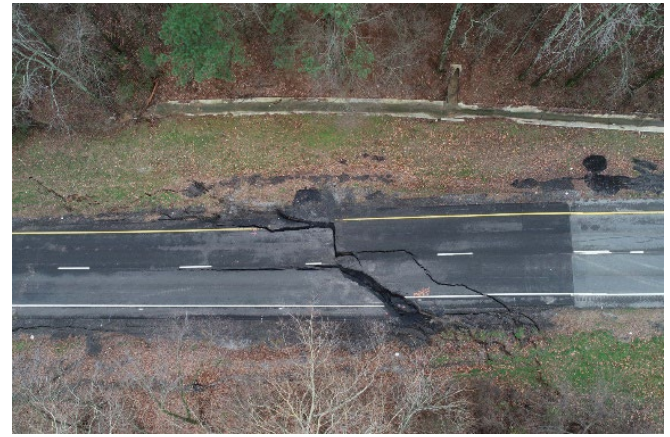
Figure 2: Damage to the southbound lane of US 231 following the February 2020 rainfall event. Source: ALDOT

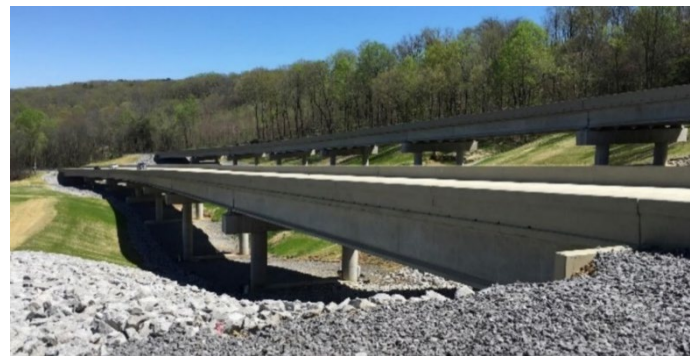
Figure 3: Side view of the completed US 231 bridges illustrating the colluvial deposit and elevation difference of the two roadways. Source: ALDOT

The two-bridge option provided the State of Alabama with a cost-effective and lasting solution to a location susceptible to damage with each rain event. The two-bridge option bridging the slide area effectively adapts to the site location by allowing movement of the slope beneath the bridges. Additionally, through the instrumentation plan, ALDOT is able to monitor the bridges and surrounding area to mitigate future damage and potentially avoid a similar event. Furthermore, through the AID grant, ALDOT can capture lessons learned from this project and further the approach to resilience for future use across the country. Alabama intends to look at landslides differently moving forward. The instrumentation plan for monitoring the area should generate ways to better address these types of events before they occur, and ultimately may make the State's infrastructure more resilient.
