**TECHNICAL REPORT 0-7042-1**  
TXDOT PROJECT NUMBER 0-7042

# Larger-Diameter Shear Studs for Composite Steel Bridges

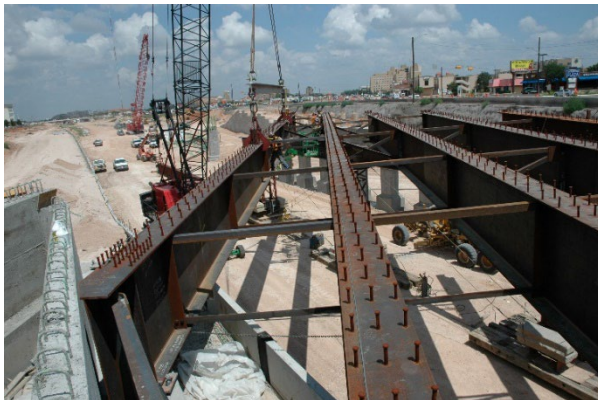
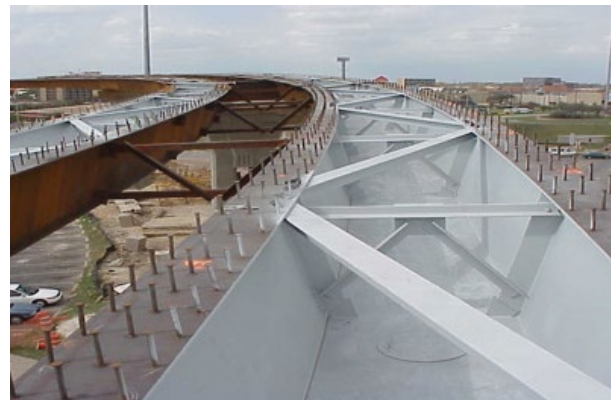
*Figure 1.1 - Steel Bridge Girders with Shear Studs*

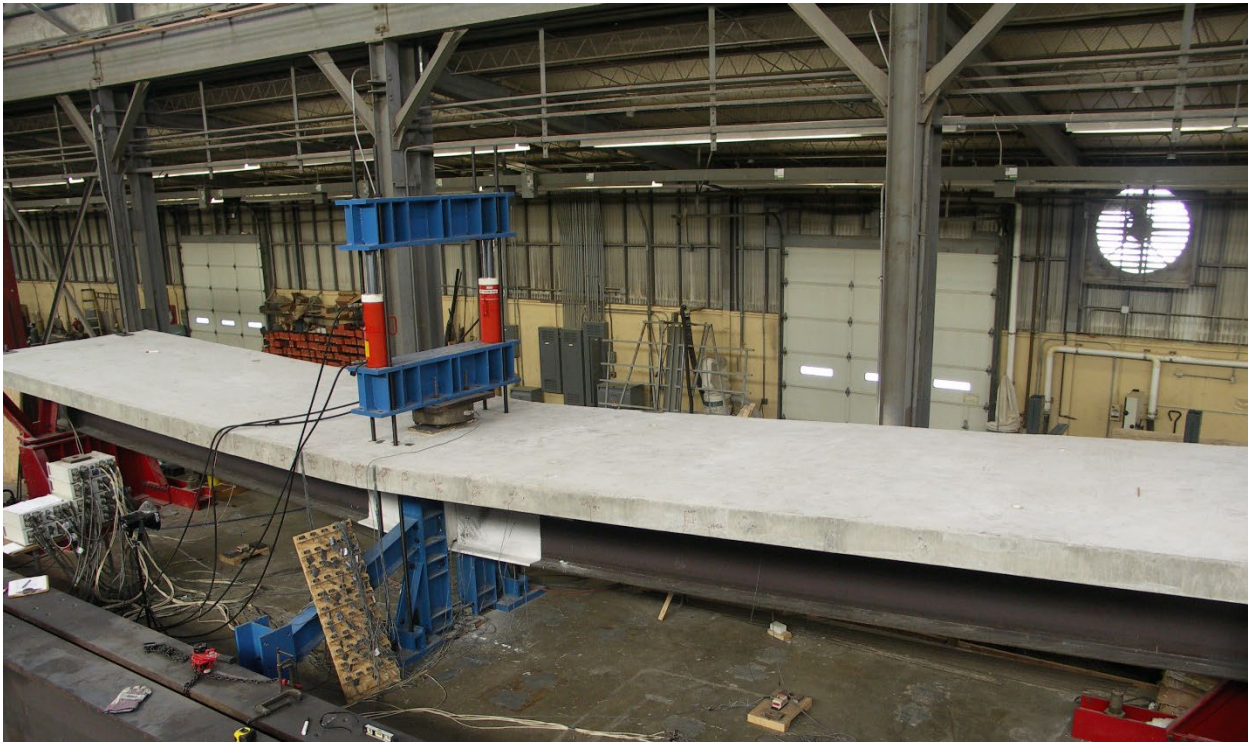
*Figure 2.4 - Example of Laboratory Test of a Composite Beam (Kwon, et al. 2007)*

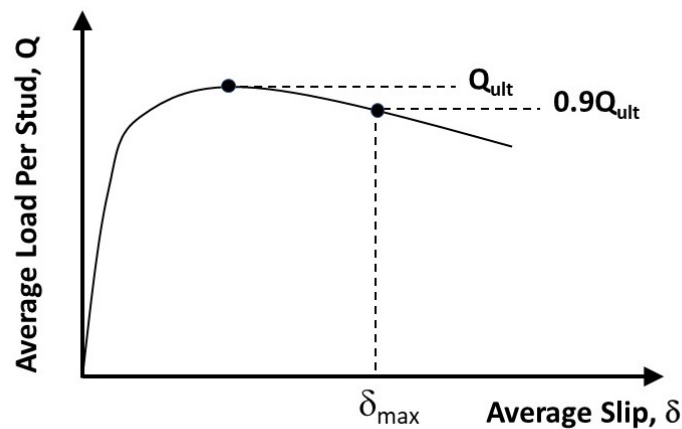
Figure 2.5 - Qualitative Load-Slip Curve from Push-out Test

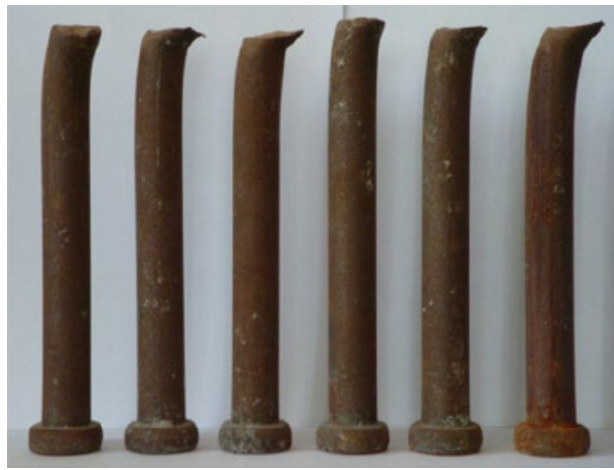
*Figure 2.6 - Example of Shear Stud Fracture in a Push-out Test (Xue, et al. 2012)*

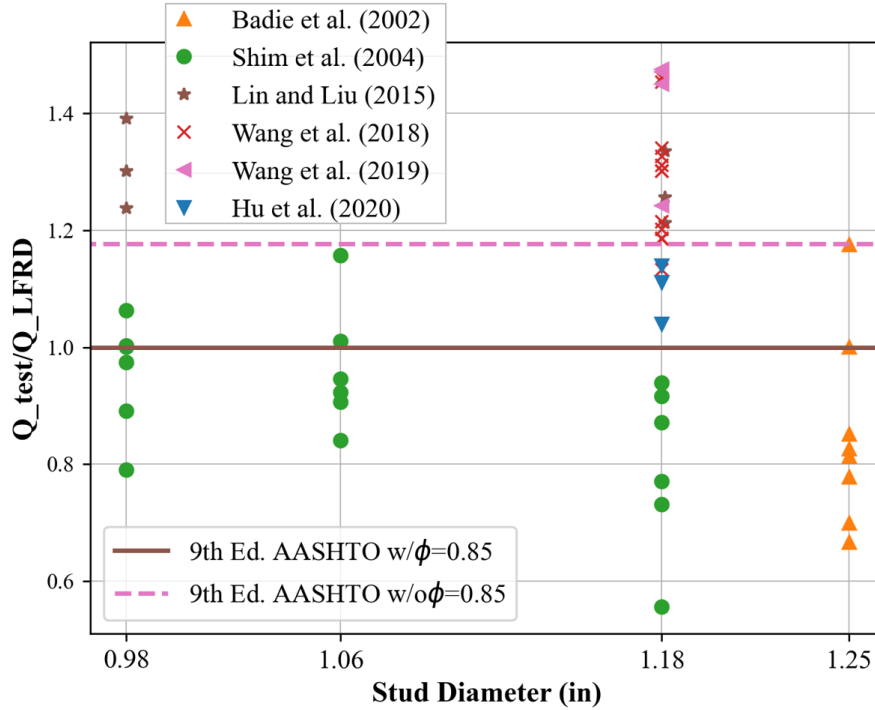
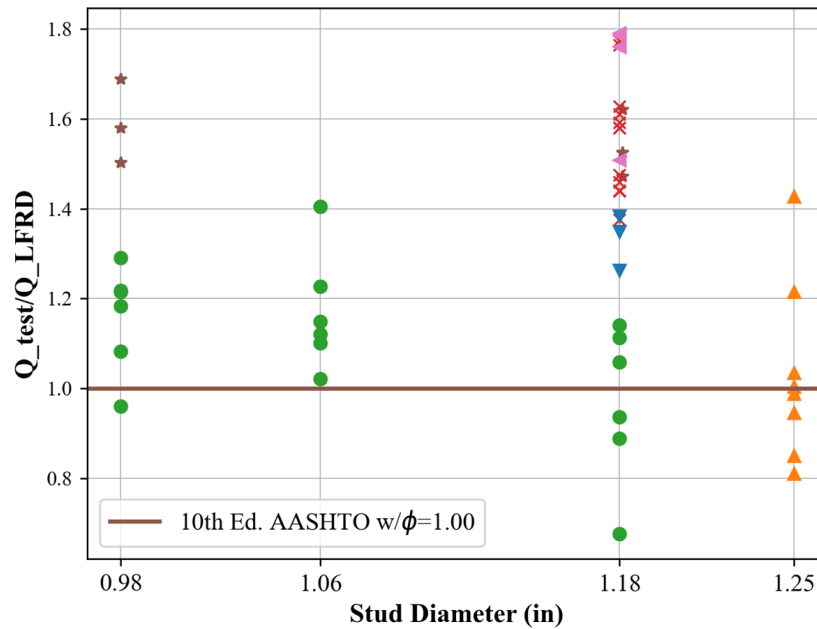
Figure 2.15 - Summary of static strength data for larger-diameter shear studs

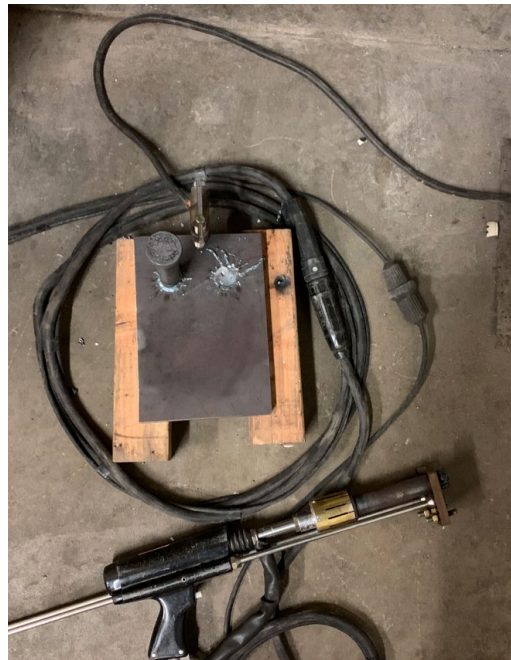
*Figure 4.7 - Cable Looping Around the Welding Point*

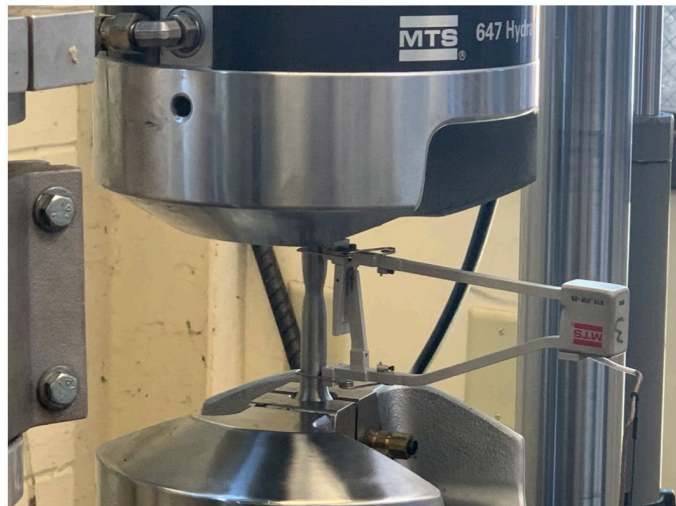
Figure 4.10 - Tension Coupon Test Setup

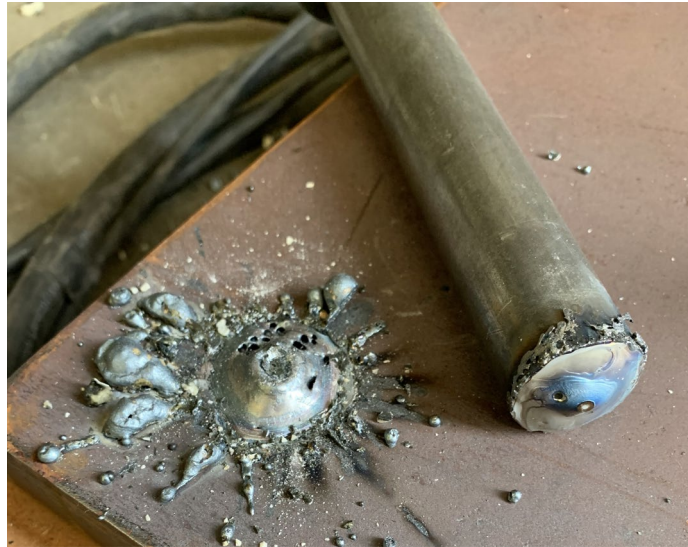
Figure 4.19 - Unsuccessful Stud Weld

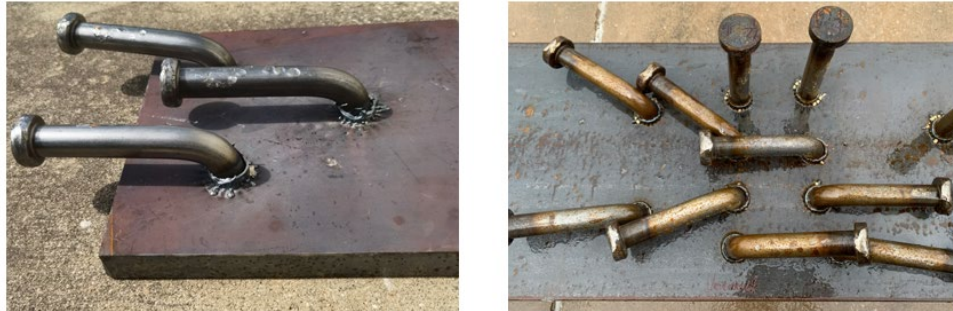
*Figure 4.20 - Shear Studs Passing 90° Bend Test*

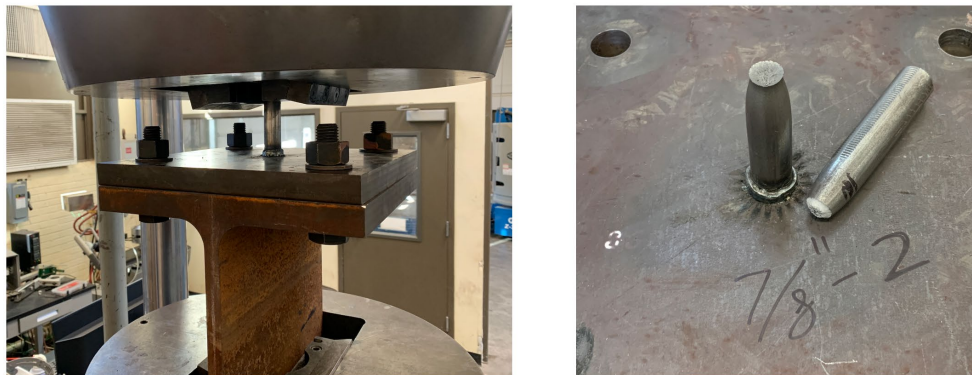
*Figure 4.21- Weld Tension Test Setup and a Successful Test*

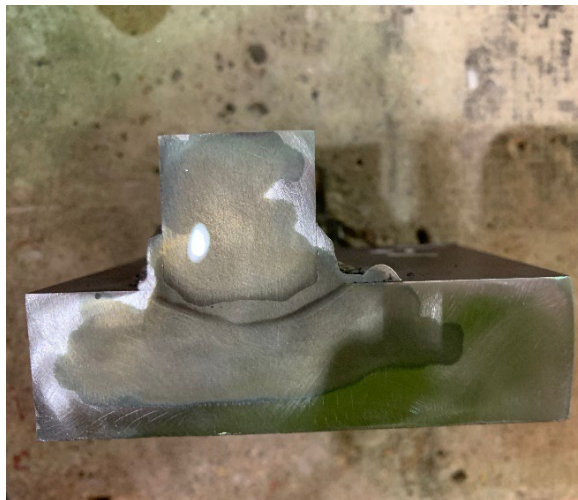
*Figure 4.30 - Macro Etch Weld Test for 1" Diameter Shear Stud Welded on 1" Thick Plate*

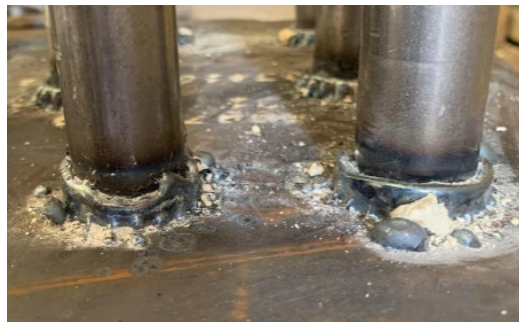
*Figure 4.31 - 1" Diameter Shear Stud Welded Without Surface Preparation*

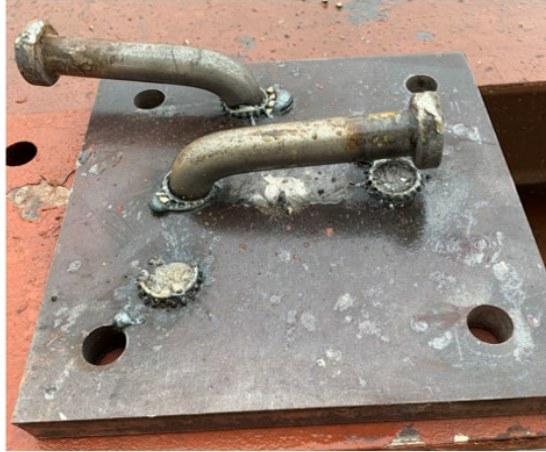
*Figure 4.38 - Failed Bend Test for 1-1/8" Studs Using Counterclockwise Cable Loop, Straight Polarity, and No Surface Preparation*

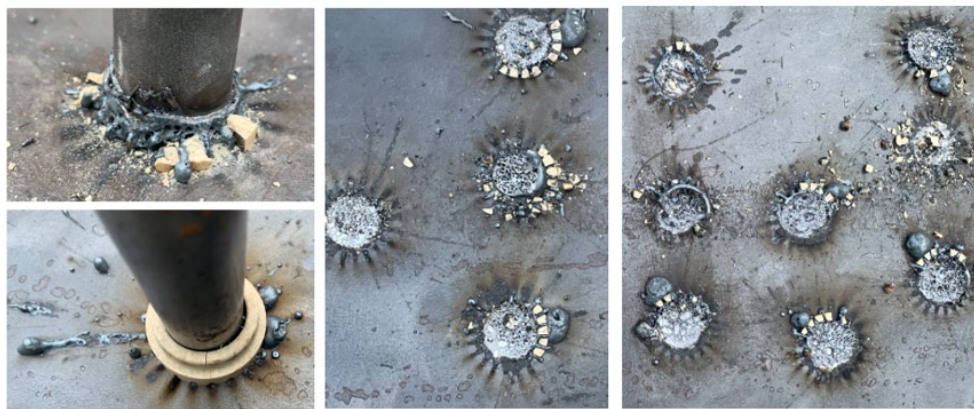
*Figure 4.40 - 1-1/8" Studs Welded Using 2050A, 1.3s, S Polarity, One Clockwise Loop, and Surface Preparation on a W14×132 Girder. Weld Collar (left photos) and Fracture Surfaces After Bend Test (center and right photos)*

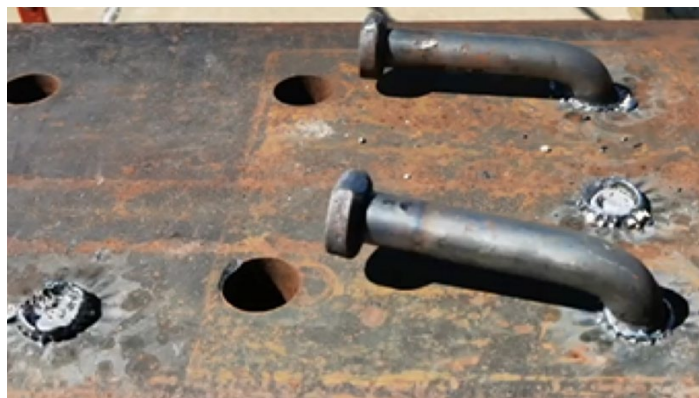
*Figure 4.42 - 1-1/8" Studs Welded Using 2150A, 1.4s, R Polarity, No Surface Preparation, No Cable Looping on a W14×500 Girder with 3-1/2" Thick Flange. 90° Bend Test Results*

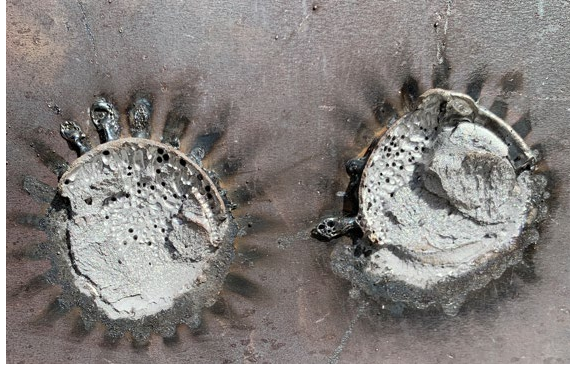
Figure 4.49 - 1-1/4" Studs Welded Using 2275A, 1.45s, S Polarity, Surface Preparation, One Clockwise Cable Looping on 1" Plate. Fracture Section of Failed Bend Tests.

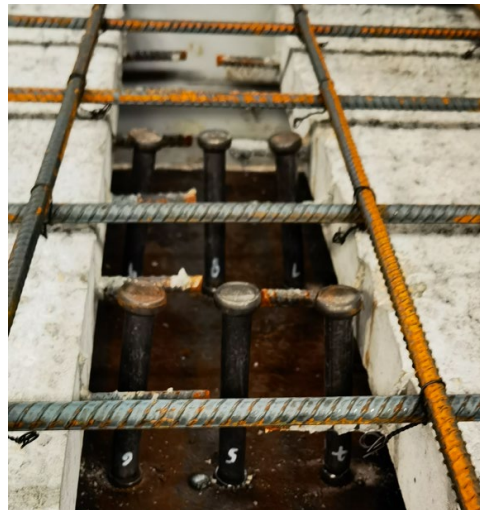
*Figure 5.8 - Shear Studs Bent Inward in Specimen No. 2*

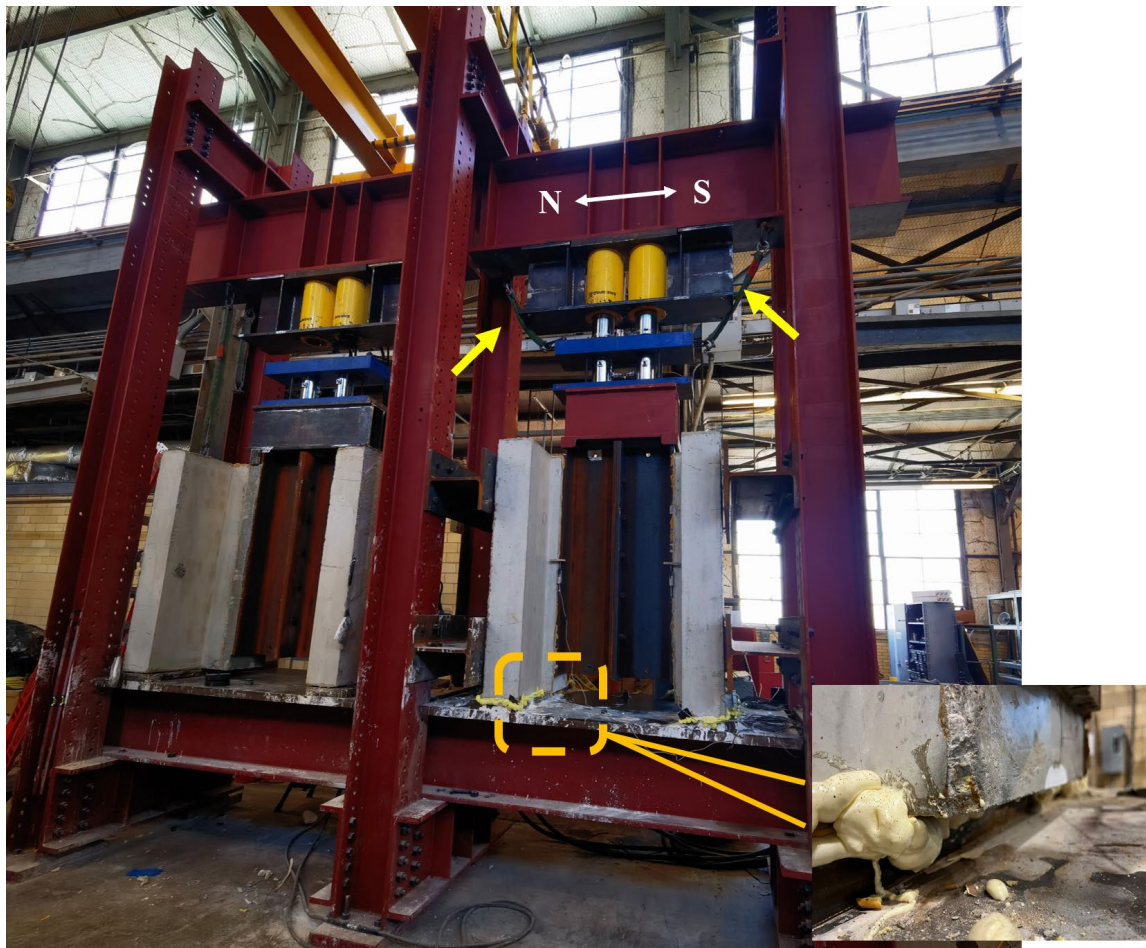
*Figure 5.21 - Photo of Specimens in the Test Setup with Enlarged View of the Haunch Bottom - Safety Measures for Load Assembly Can Be Seen (With Arrows) Between 4" Thick Load Spreader Plate and W30×211 Load Beam*

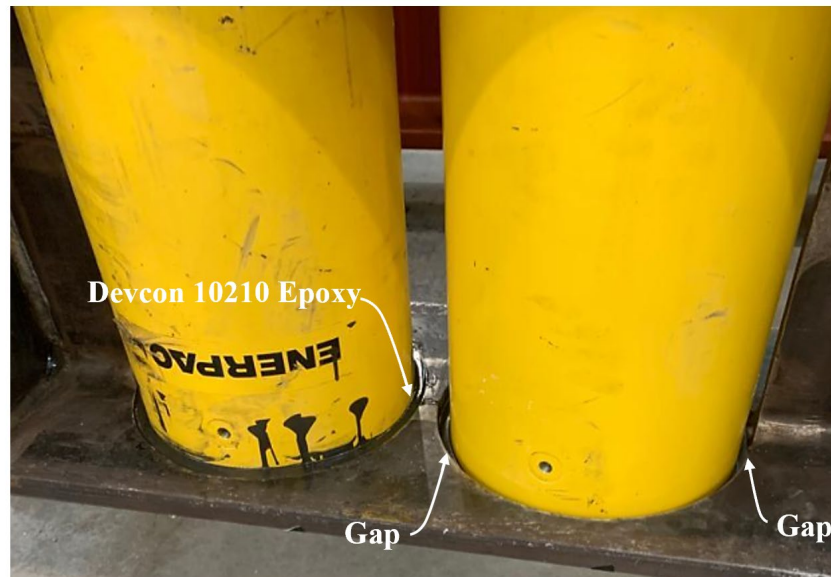
*Figure 5.22 - Epoxy is Used to Fill the Gap Between Actuators and Lateral Support*

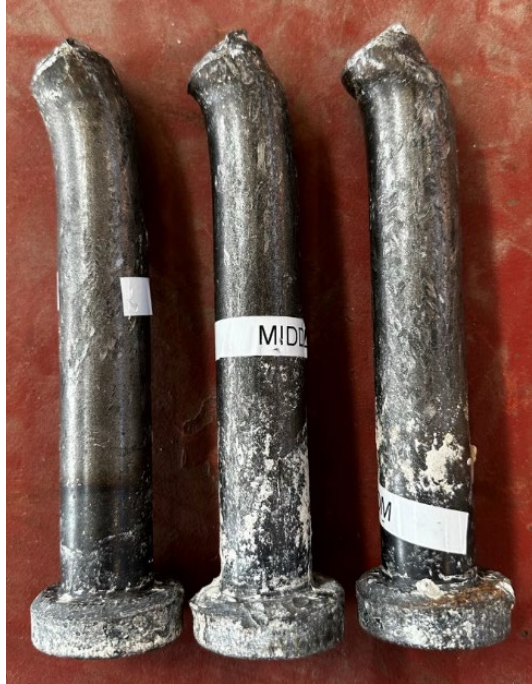
*Figure 5.60 – Deformation of Studs After Testing*

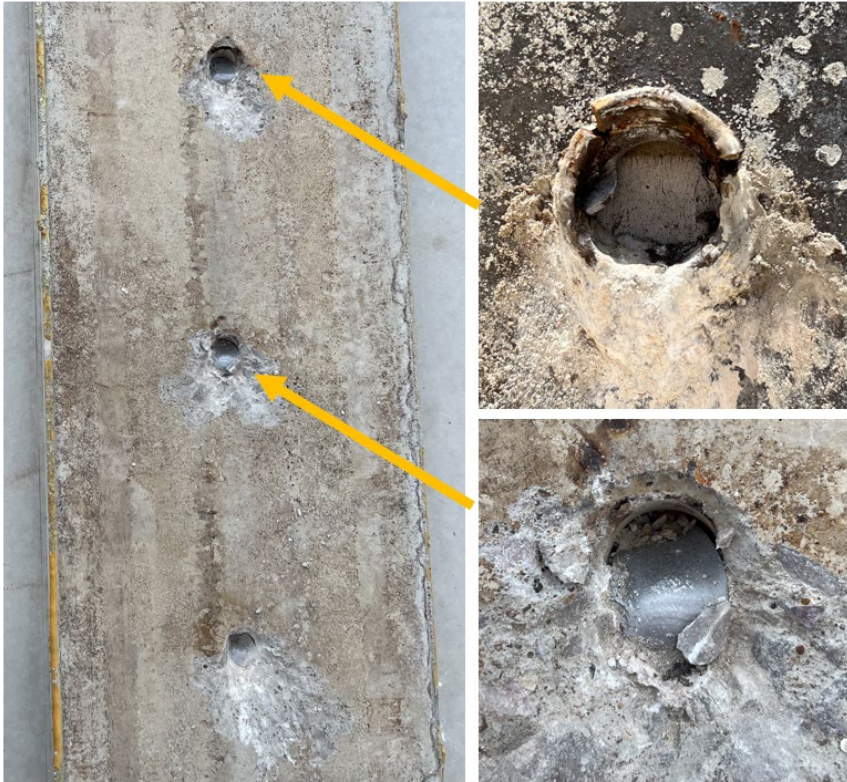
Figure 6.5 - Specimen No.2F: Concrete Deck After Failure with Enlarged Photos of Studs

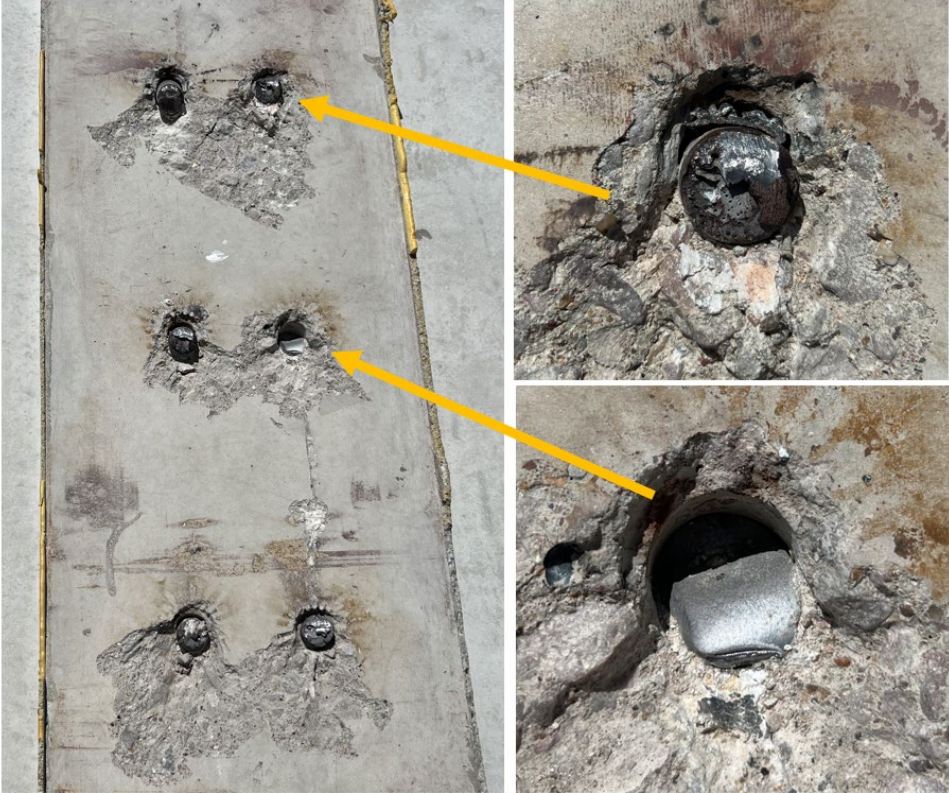
Figure 6.8 - Specimen No.4F: Concrete Deck After Failure with Enlarged Photos of Studs

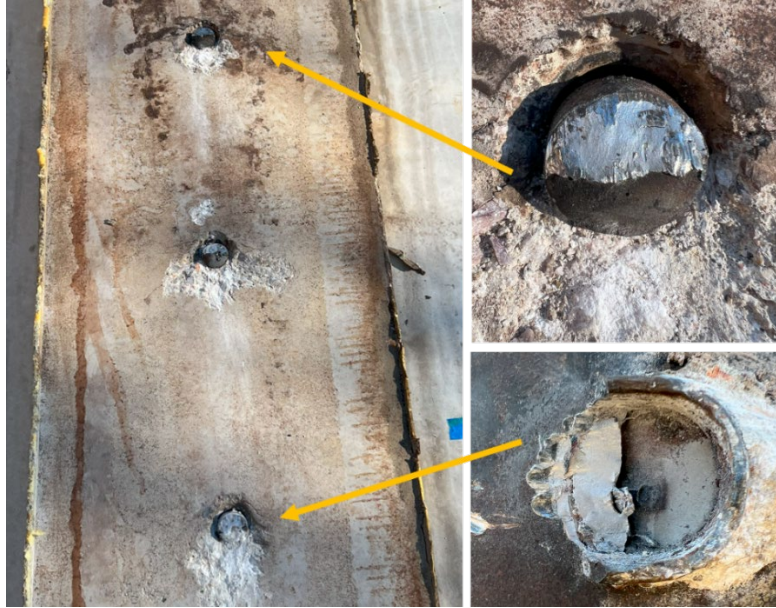
Figure 6.10 - Specimen No.1F: Concrete Deck After Failure Under Monotonic Loading with Enlarged Photos of Studs

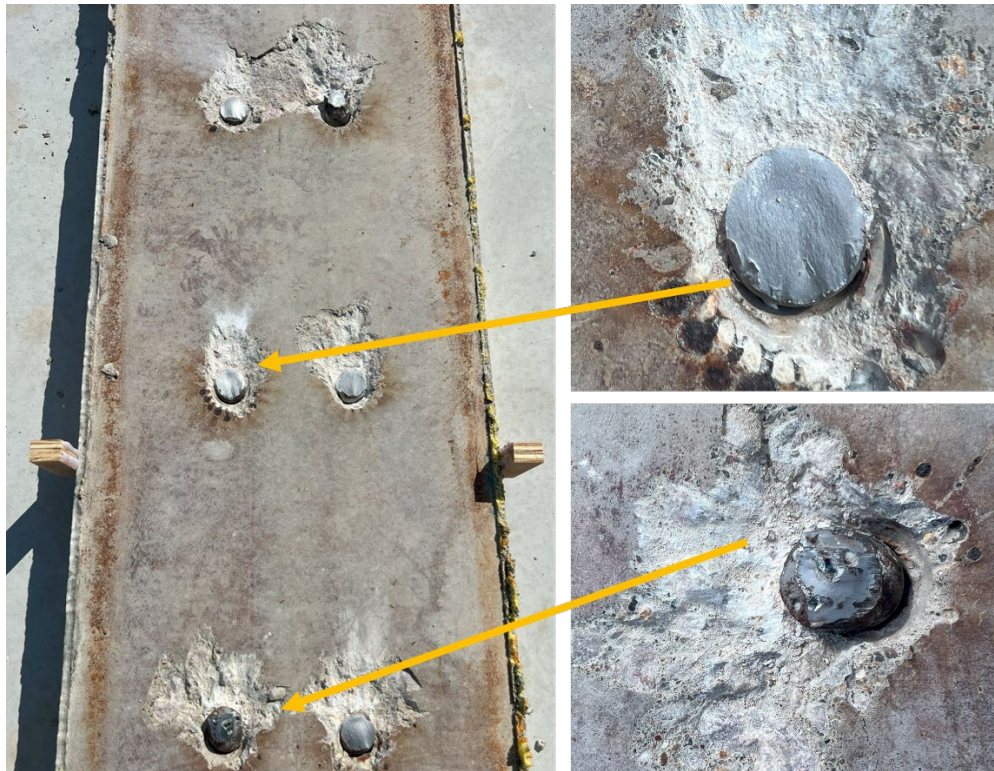
Figure 6.12 - Specimen No.3F: Concrete Deck After Failure with Enlarged Photos of Studs

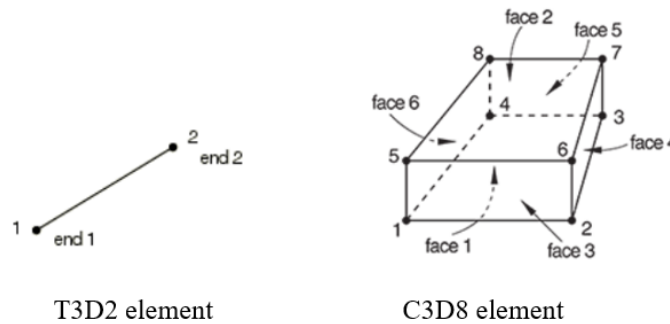
*Figure 7.21 - Abaqus Elements Used in FE Model (Abaqus 2016)*

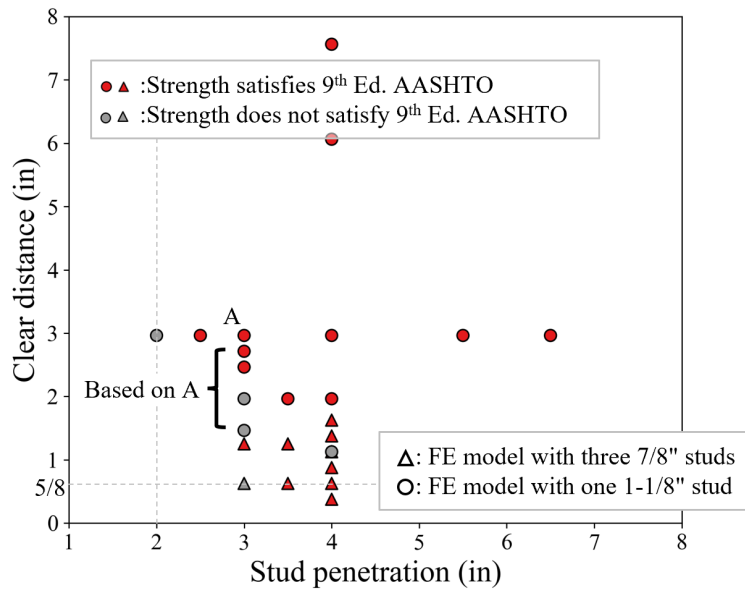
Figure 7.66 - Additional Parametric Study Results on Stud Penetration and Clear Distance

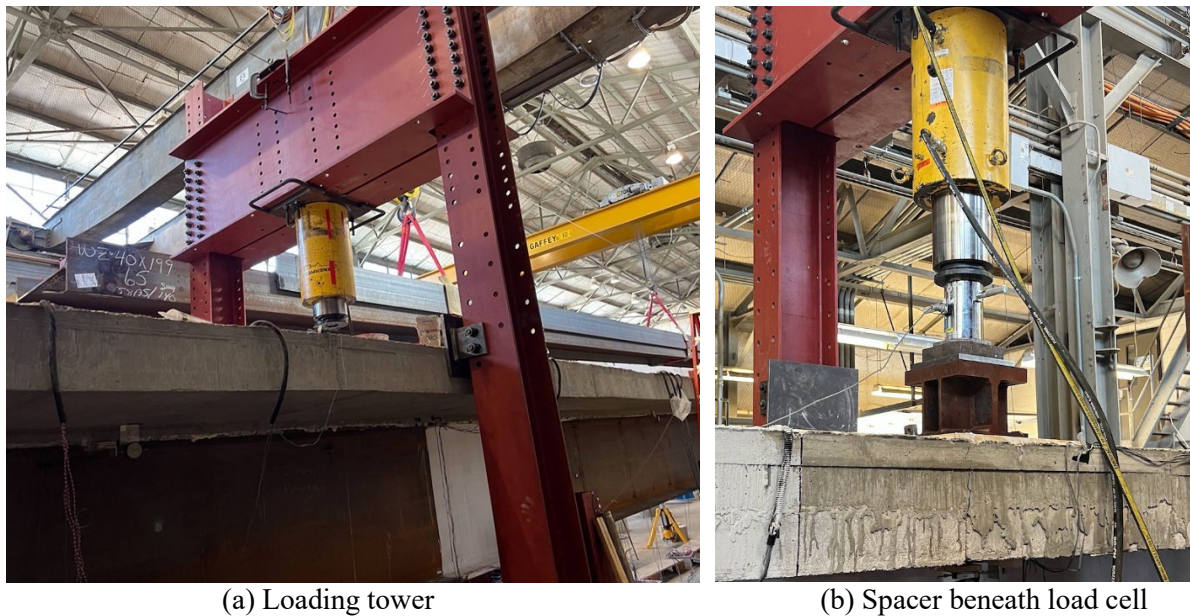
Figure 8.21 – Photos of Loading Tower

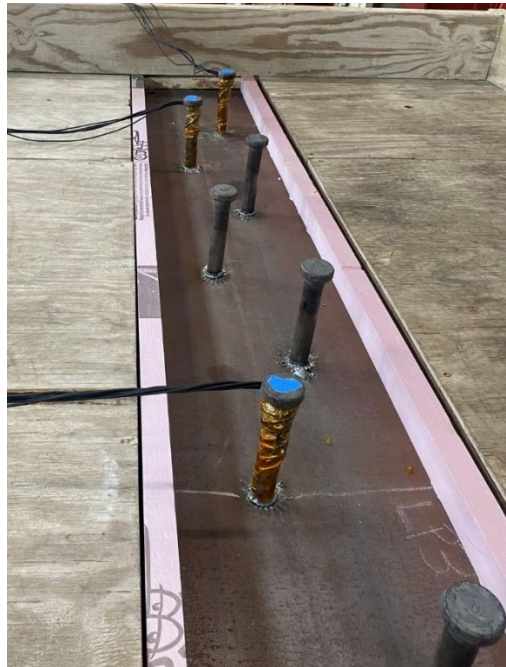
*Figure 8.41 – Foam Bedding Strips*

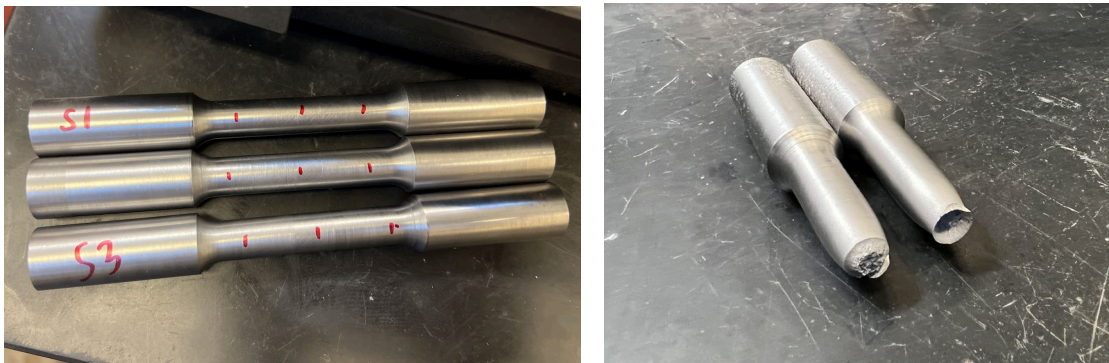
Figure 8.50 – Tensile Coupons from 1-1/8" Studs Before and After Testing

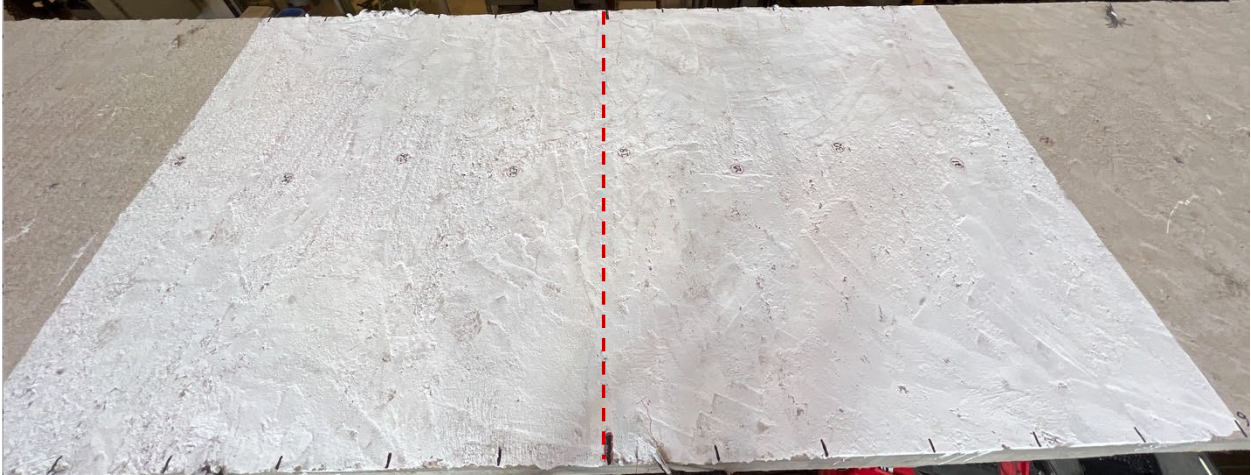
Figure 8.65 – Beam Specimen No. 1 - Portion of Deck over Interior Support Prepared for Tracking Cracks

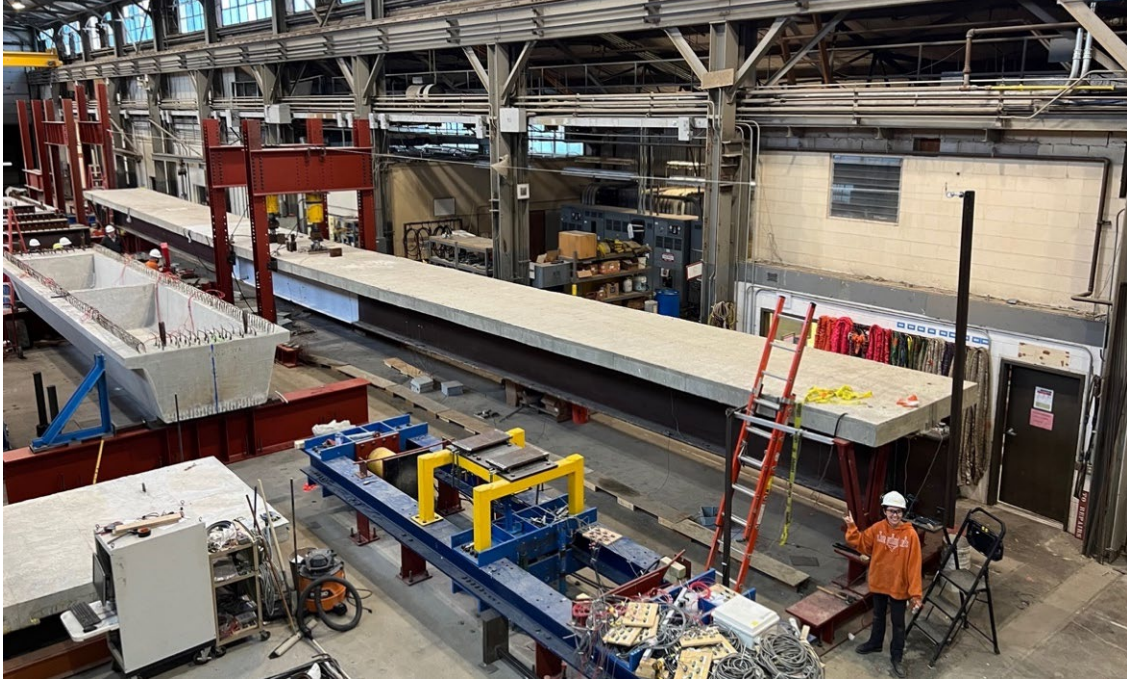
Figure 8.72 – Beam Specimen No. 1 Prior to Single-Span Test

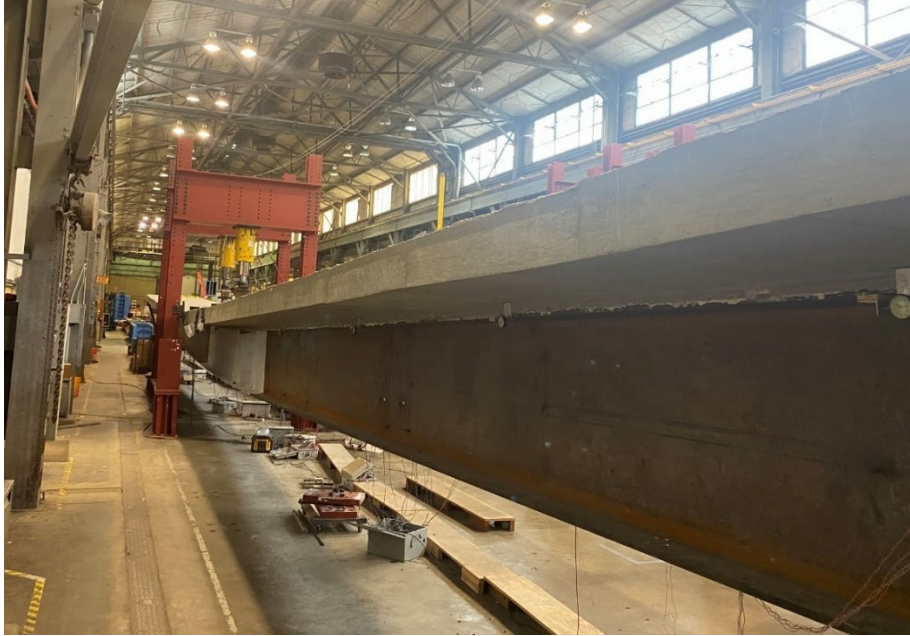
*Figure 8.74 – Beam Specimen No. 1 After Completion of Single-Span Test*

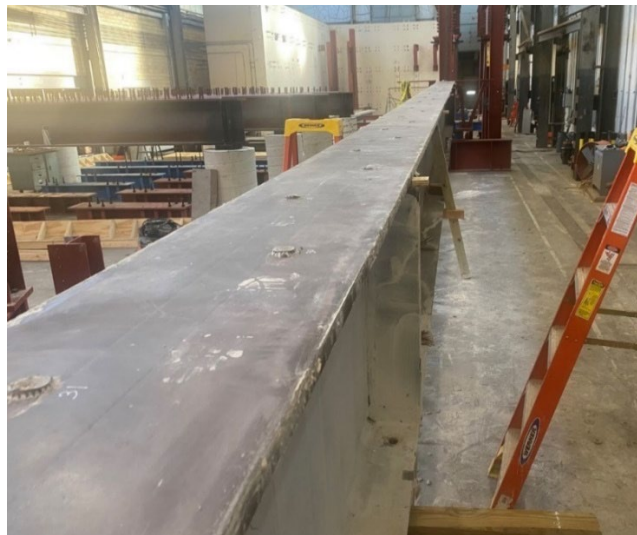
*Figure 8.75 – Beam Specimen No. 1 – View of Top Flange for South Half of the Girder After Removal of Concrete Deck*

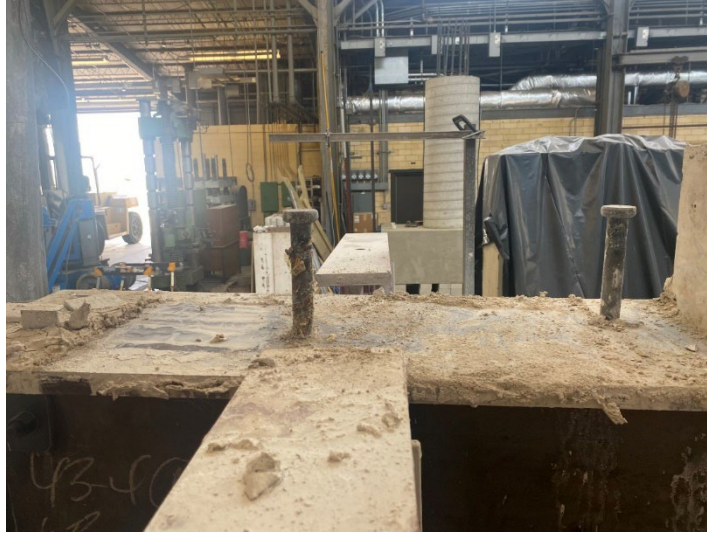
*Figure 8.76 – Beam Specimen No. 1 – Shear Studs on North Half of Beam After Removal of Concrete Deck*

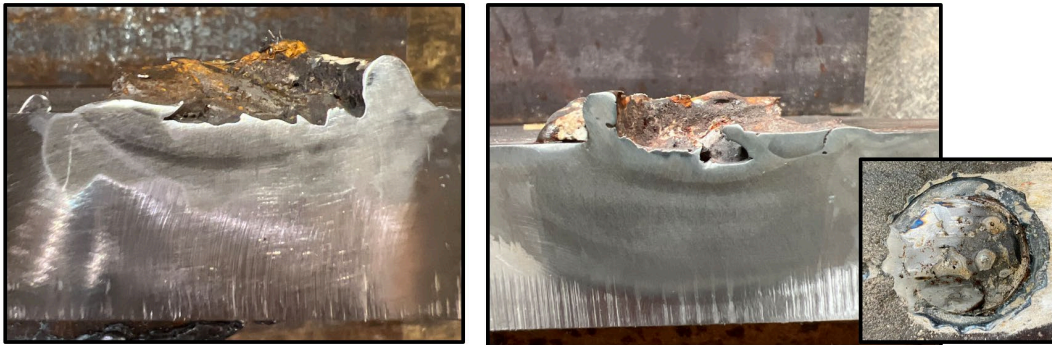
Fracture between heat affected zone(HAZ) & weld

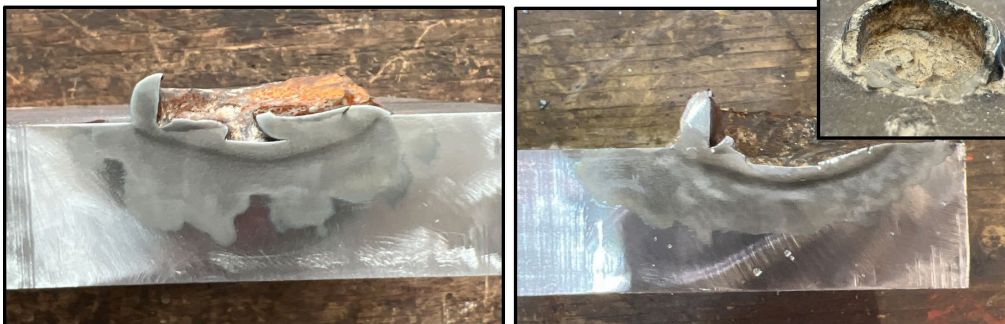
Fracture in the weld or in HAZ

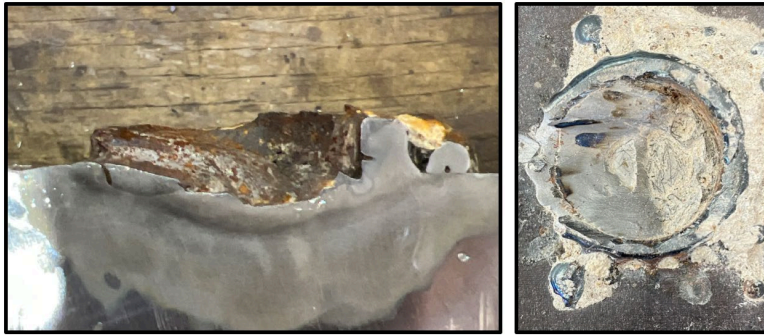
Fracture in the weld or between HAZ and weld 16th stud

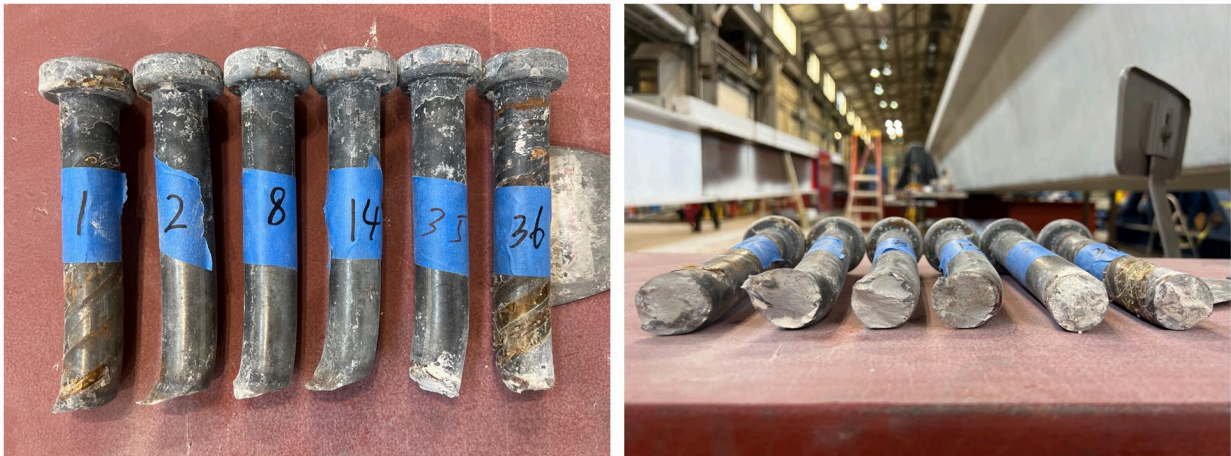
Figure 8.83 – Deformed Shape of Fractured Shear Studs

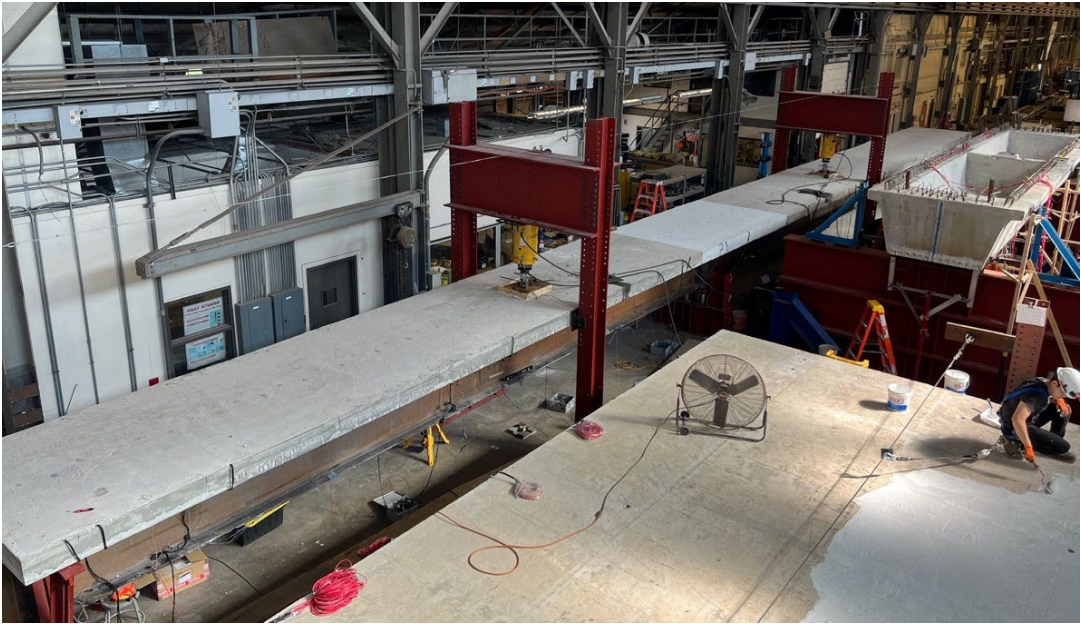
Figure 8.88 – Beam Specimen No. 2 Prior to Two-Span Test

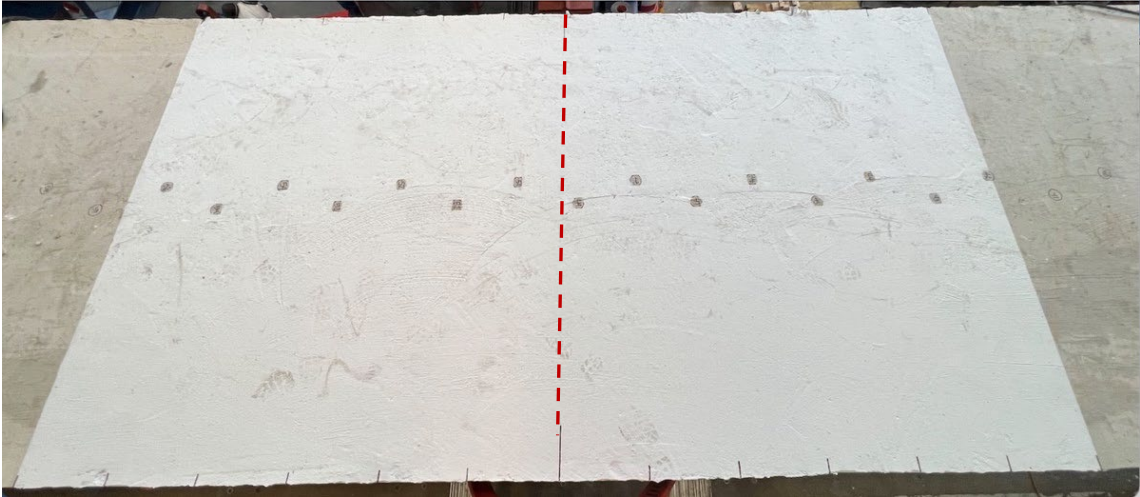
Figure 8.89 - Beam Specimen No. 2 - Portion of Deck over Interior Support Prepared for Tracking Cracks

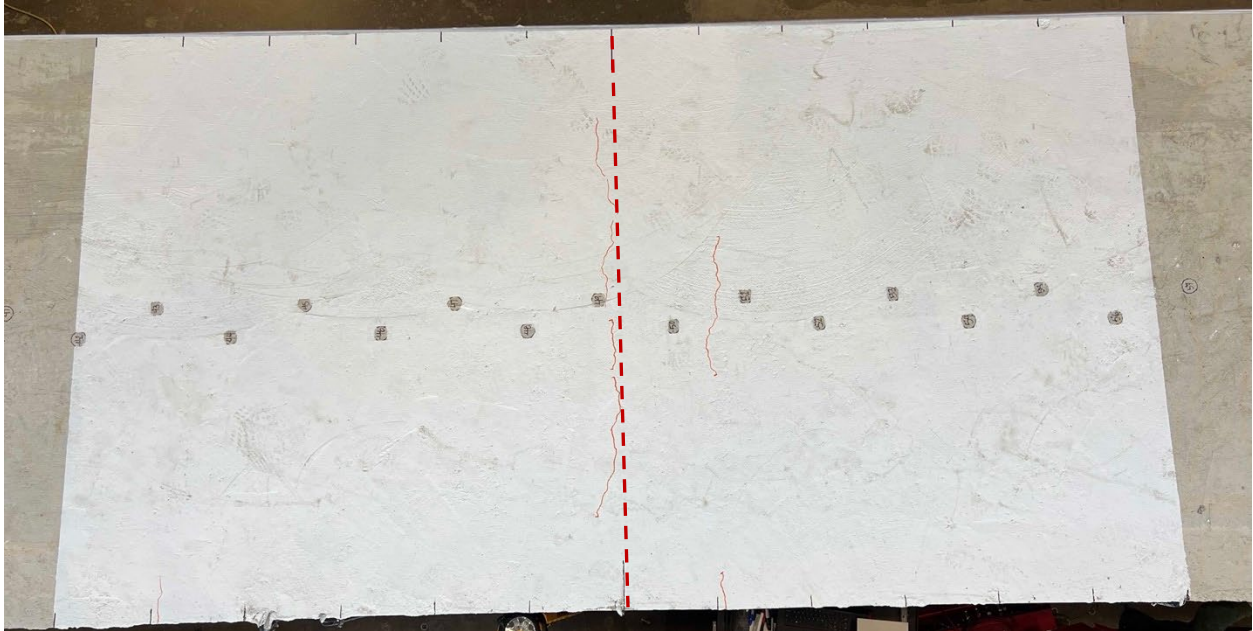
*Figure 8.90 – Beam Specimen No. 2 – Crack Distribution after 7 Cycles of 50 kips Load per Ram*

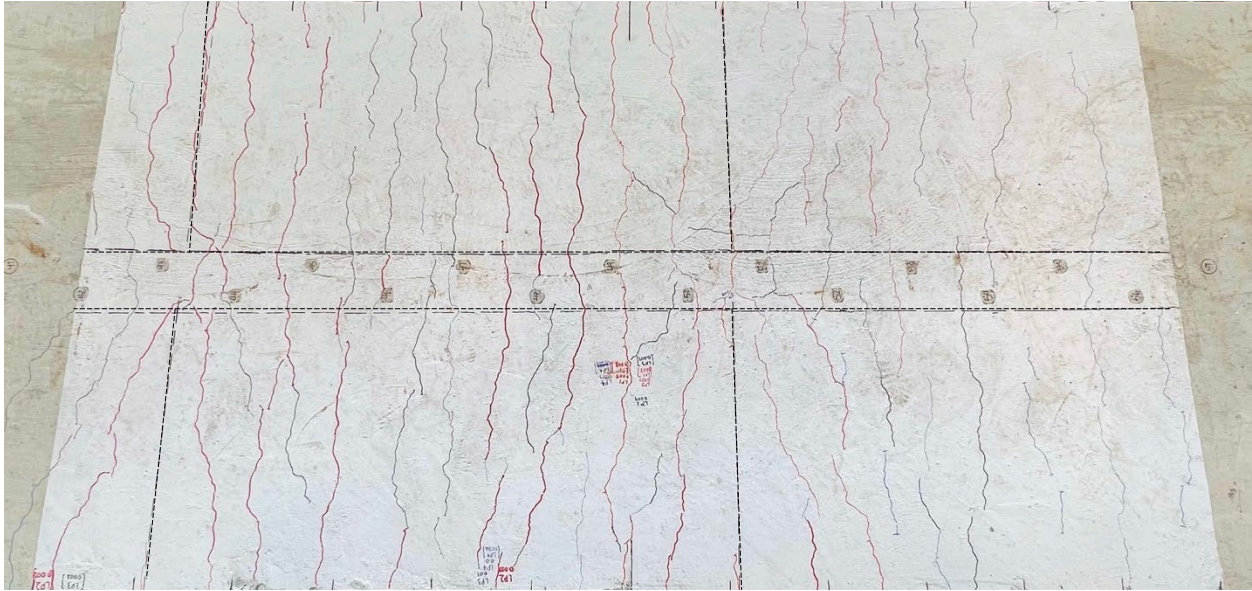
Figure 8.94 - Beam Specimen No. 2 - Crack Distribution After Completion of Two-Span Test and Boundaries of the PCPs

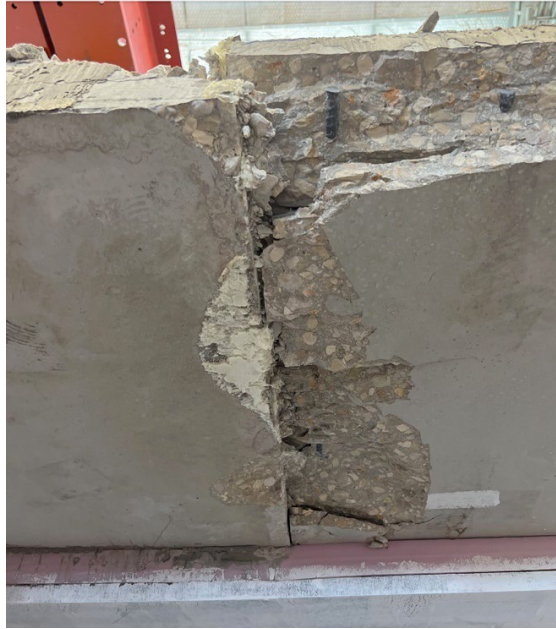
*Figure 8.101 – Beam Specimen No. 2 – View Looking Up at the Bottom Side of Deck Showing Crushing at Boundary of PCPs*

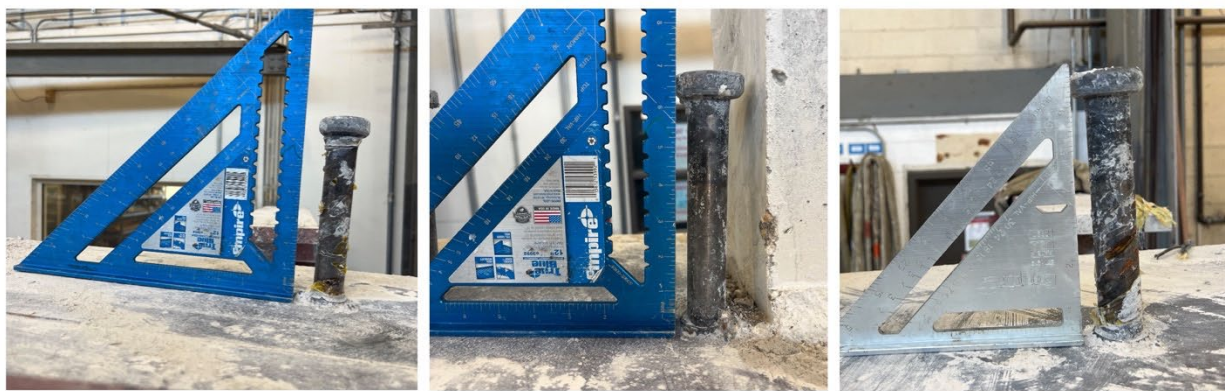
1st stud at south end

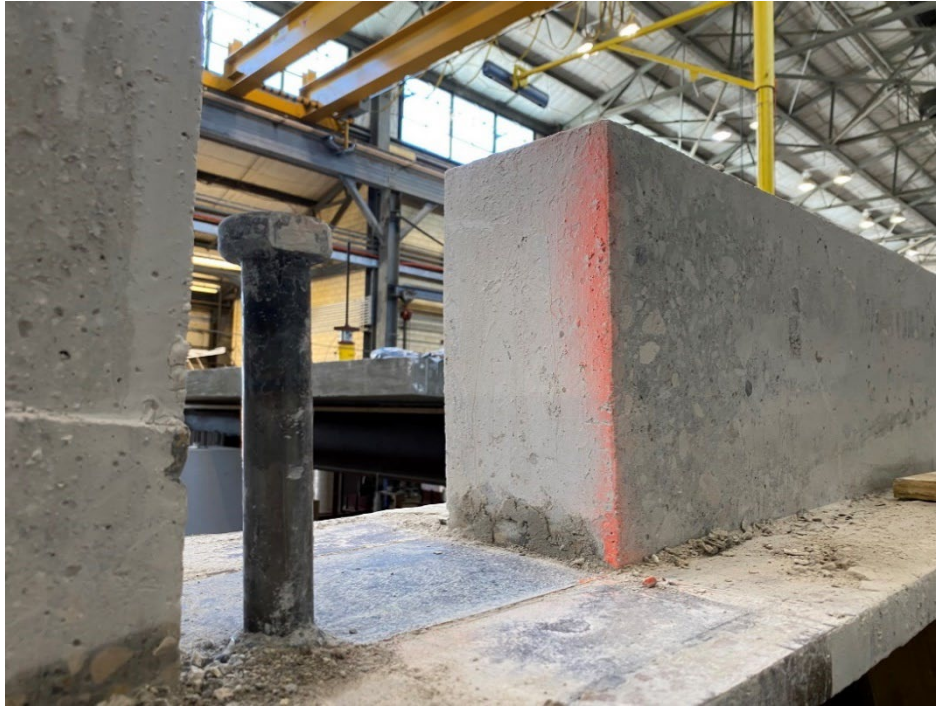
*Figure 8.103 – Beam Specimen No. 2 – Section Cut Through Slab Near Shear Stud*

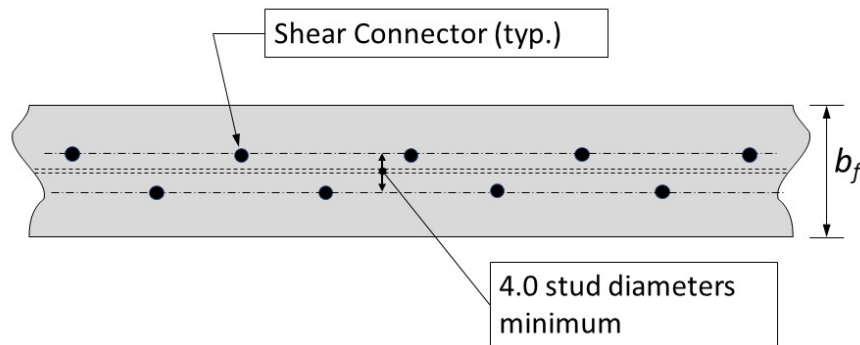
Figure C6.10.10.1.3.1 – Plan View of Top Flange of Girder with Staggered Shear Connector Layout
