Report No.611801-03 & -04

Development of Approach Transition from Box Beam Guardrail to Concrete Parapet

Final Report

Report Date: November 2023

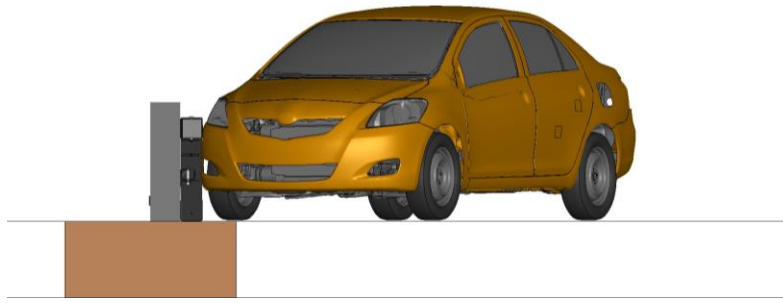
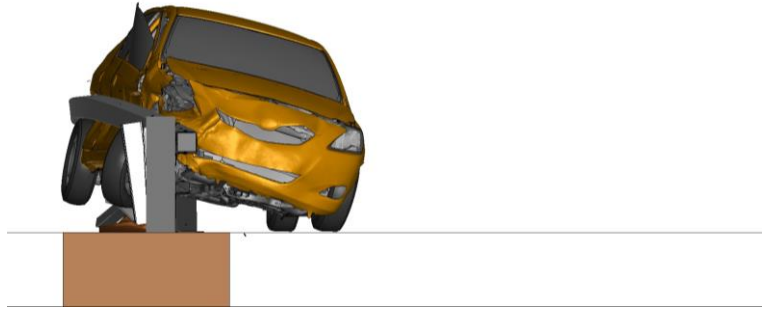
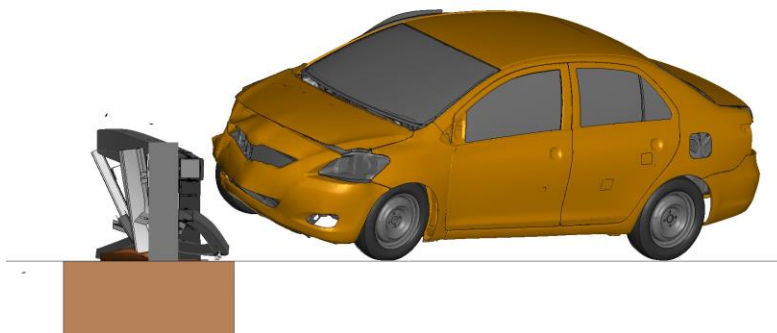
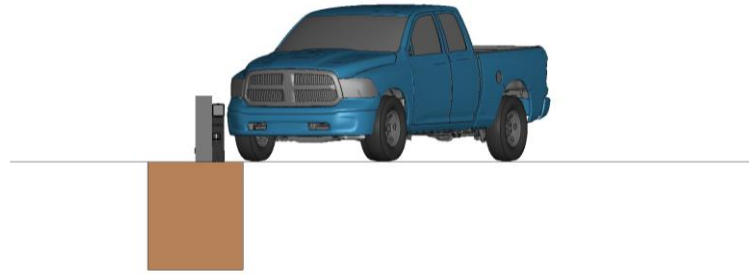
Figure 3.13. MASH 3-20 Simulation – Upstream Section with HSS4x3 Rubrail.

Figure 3.14 show sequential images for Test 3-20 and Test 3-21 impact simulations, respectively. The impact locations were the same as those conducted in the previous crash tests (2).

Consequently, a decision was made to evaluate the MASH impact performance of the upstream end of the transition with the HSS4x3 rubrail modification using computer simulation. MASH Test 3-20 and Test 3-21 computer simulations were performed on the upstream end of the transition system with the HSS4x3 rubrail and associated termination details.

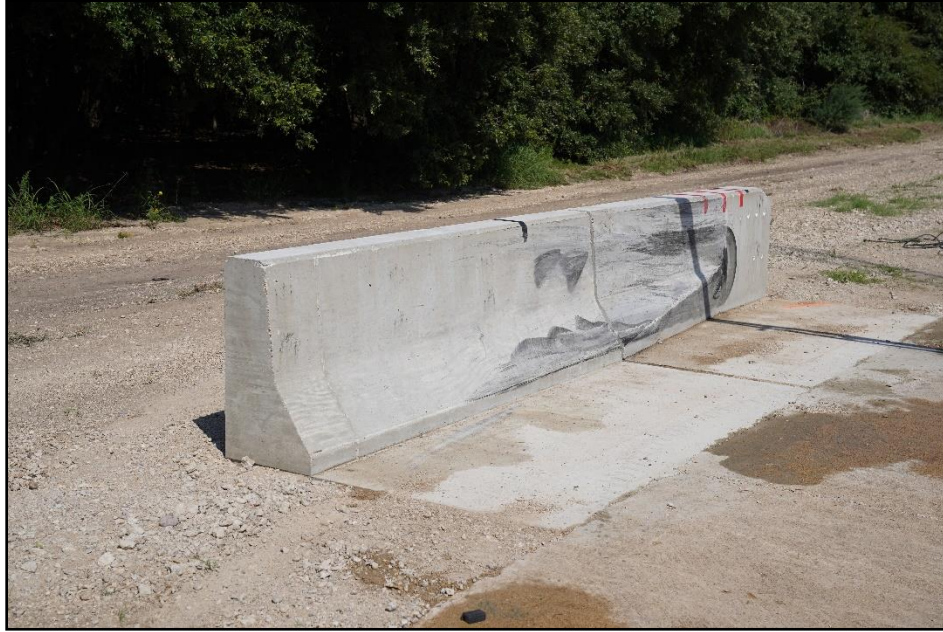
Figure 6.10. Concrete Parapet Shape Transition after Test at Impact Location 611801-03-1.

Test Parameter	Measured
Permanent Deflection/Location	¾ inches toward field side, at the parapet joint
Dynamic Deflection	1 inch toward field side
Working Width ^a and Height	21.6 inches, at a height of 36.6 inches

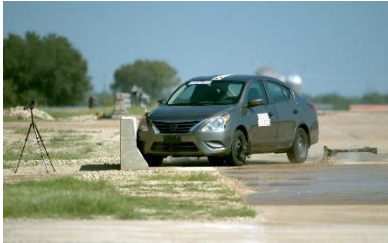
Figure 6.16. Summary of Results for MASH Test 3-20 on Concrete Parapet Shape Transition.

<p style="text-align: center;">0.000 s</p>	Test Agency		Texas A&M Transportation Institute (TTI)						
	Test Standard/Test No.		MASH 2016, Test 3-20						
	TTI Project No.		611801-03-1						
	Test Date		2022-09-15						
TEST ARTICLE									
		Type	Transition System						
		Name	Concrete Parapet Shape Transition						
		Length	18 feet						
		Key Materials	32-inch-high concrete parapet and 60-inch wide concrete deck

Figure 6.16 summarizes the results of MASH Test 611801-03-1.

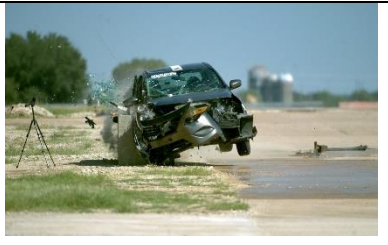
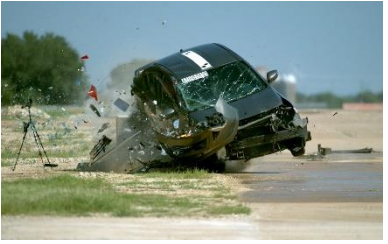
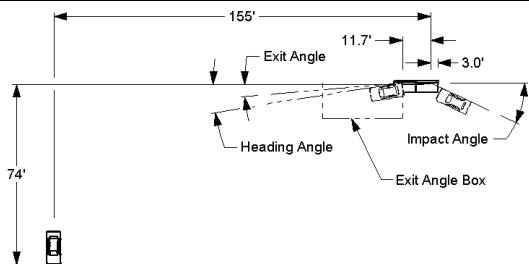
<p style="text-align: center;">0.200 s</p>	Soil Type and Condition		Concrete, damp						
	TEST VEHICLE								
			Type/Designation	1100 C					
			Year, Make and Model	2016 Nissan Versa					
		Inertial Weight (lb)	2437						
		Dummy (lb)	165						
		Gross Static (lb)	2602						
IMPACT CONDITIONS									
		Impact Speed (mi/h)	62.1						
		Impact Angle (deg)	24.9						
		Impact Location	36 inches downstream from the upstream end of the concrete parapet.						
		Impact Severity (kip-ft)	55.7

<p style="text-align: center;">0.400 s</p>	EXIT CONDITIONS								
			Exit Speed (mi/h)	52.7					
			Trajectory/Heading Angle (deg)	5 / 9					
			Exit Box Criteria	Vehicle crossed					
		Stopping Distance	155 ft downstream 74 ft to the traffic side						
TEST ARTICLE DEFLECTIONS									
		Dynamic (inches)	1						
		Permanent (inches)	3/8						
		Working Width / Height (inches)	21.6 / 36.6						
VEHICLE DAMAGE									
		VDS	01RFQ4						
		CDC	01FREW3						
		Max. Ext. Deformation	8						
		Max Occupant Compartment Deformation	5 inches at the side panel and in the door.						
OCCUPANT RISK VALUES									
Long. OIV (ft/s)	21.4	Long. Ridedown (g)	3.2	Max 50-ms Long. (g)	-12.2	Max Roll (deg)	20		
Lat. OIV (ft/s)	31.2	Lat. Ridedown (g)	9.0	Max 50-ms Lat. (g)	-19.5	Max Pitch (deg)	17		
THIV (m/s)	11.6	ASI	2.6	Max 50-ms Vert. (g)	3.5	Max Yaw (deg)	104

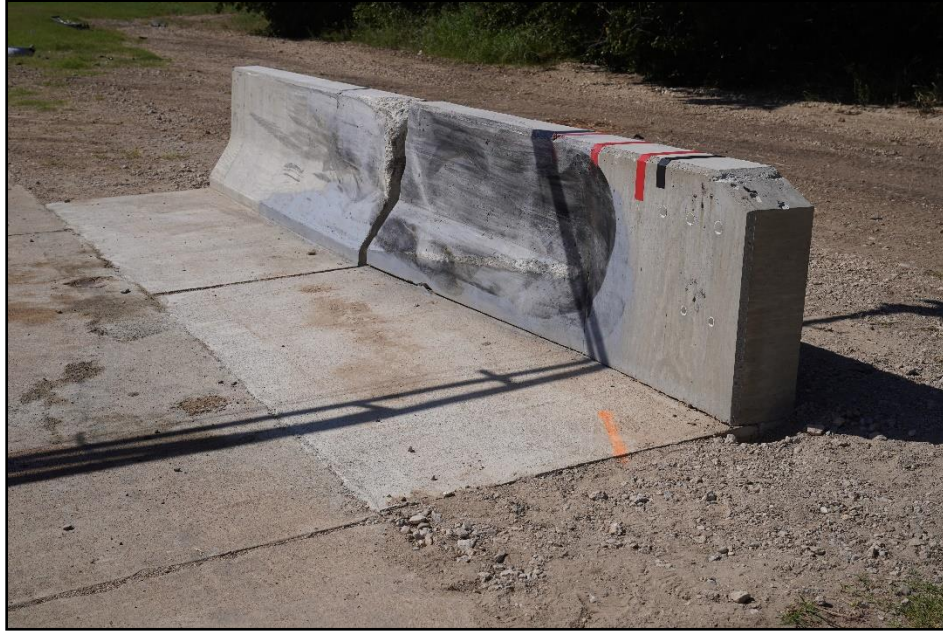
Figure 6.21. Concrete Parapet Shape Transition after Test at Impact Location 611801-03-2.

Test Parameter	Measured
Permanent Deflection/Location	2.25 inches toward field side, at the downstream end of the upstream parapet.
Dynamic Deflection	3.7 inches toward field side, at the downstream end of the upstream parapet.
Working Width ^a and Height	29.6 inches, at a height of 62.2 inches (corresponding to the right-side mirror of the vehicle)

Table 6.16 describes the damage to the Concrete Parapet Shape Transition. Figure 6.21 and Figure 6.22 show the damage to the Concrete Parapet Shape Transition.

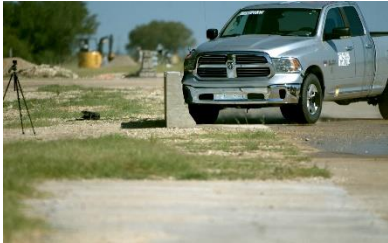
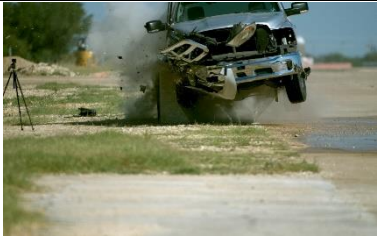
Figure 6.27. Summary of Results for MASH Test 3-21 on Concrete Parapet Shape Transition.

<p>0.000 s</p>	Test Agency		Texas A&M Transportation Institute (TTI)					
	Test Standard/Test No.		MASH 2016, Test 3-21					
	TTI Project No.		611801-03-2					
	Test Date		2022-09-28

<p>0.200 s</p>	TEST ARTICLE							
	Type		Transition System					
	Name		Concrete Parapet Shape Transition					
	Length		18

Figure 6.27 summarizes the results of *MASH* Test 611801-03-2.

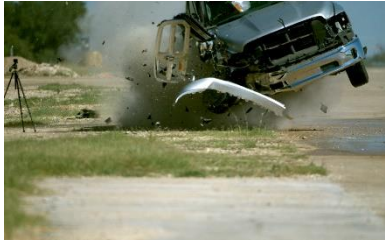
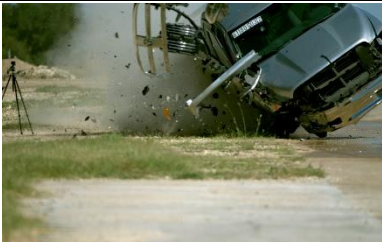
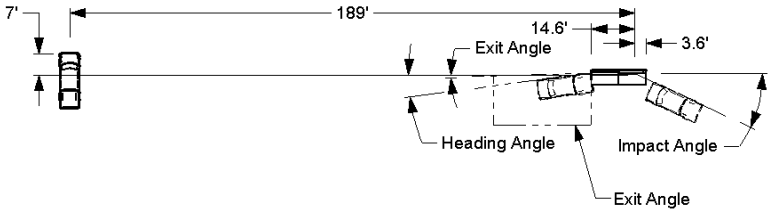
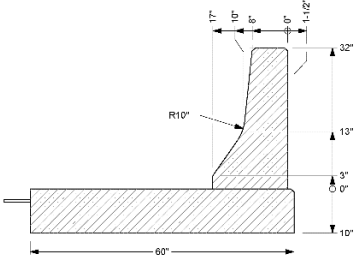
<p>0.400 s</p>	Key Materials		32-inch-high concrete parapet and 60-inch wide concrete deck					
	Soil Type and Condition		Concrete, damp					
	TEST VEHICLE							
	Type/Designation		2270 P

<p>0.600 s</p>	Year, Make and Model		2016 RAM 1500					
	Inertial Weight (lb)		5011					
	Dummy (lb)		N/A					
	Gross Static (lb)		5011					
IMPACT CONDITIONS								
Impact Speed (mi/h)		62.6						
Impact Angle (deg)		24.3						
Impact Location		43.2 inches downstream from the upstream end of the concrete parapet.						
Impact Severity (kip-ft)		111.2						
EXIT CONDITIONS								
Exit Speed (mi/h)		49.4

Trajectory/Heading Angle (deg)		2 / 7						
Exit Box Criteria		Crossed						
Stopping Distance		189 ft downstream 7 ft to the field side						
TEST ARTICLE DEFLECTIONS								
Dynamic (inches)		3.7						
Permanent (inches)		2¼						
Working Width / Height (inches)		29.6 / 62.2						
VEHICLE DAMAGE								
VDS		01RFQ4						
CDC		01FREW3						
Max. Ext. Deformation		12 inches						
Max Occupant Compartment Deformation		3 inches in the kick panel						
OCCUPANT RISK VALUES								
Long. OIV (ft/s)	23.9	Long. Ridedown (g)	4.4	Max 50-ms Long. (g)	-11.0	Max Roll (deg)	36	
Lat. OIV (ft/s)	25.2	Lat. Ridedown (g)	7.2	Max 50-ms Lat. (g)	-13.2	Max Pitch (deg)	10	
THIV (m/s)	9.7	ASI	1.8	Max 50-ms Vert. (g)	-2.6	Max Yaw (deg)	45

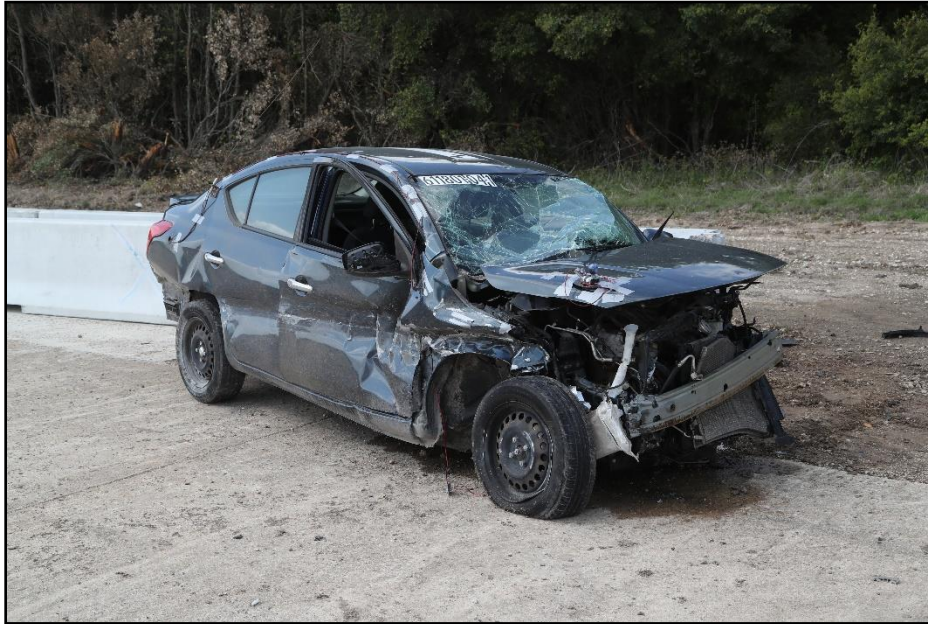
Figure 7.12. Impact Side of Test Vehicle after Test 611801-04-1.

Figure 7.12 and Figure 7.13 show the damage sustained by the vehicle. Figure 7.14 and Figure 7.15 show the interior of the test vehicle. Table 7.11 and Table 7.12 provide details on the occupant compartment deformation and exterior vehicle damage. Figures E.2 and E.3 in Appendix E.1 provide exterior crush and occupant compartment measurements.

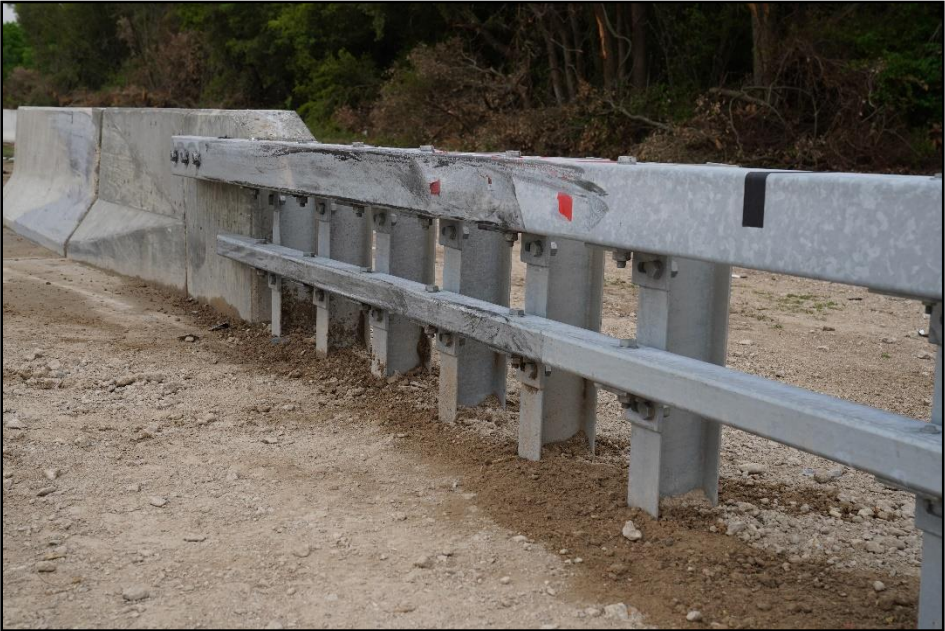
Figure 7.21. Box Beam to Concrete Barrier Transition at Impact Location after Test 611801-04-2.

The box-beam and rub rail were scuffed and deformed at the impact location. Table 7.19 describes the post soil gap and lean after the test. Table 7.20 describes the deflection and working width of the Box Beam to Concrete Barrier Transition. Figure 7.21 and Figure 7.22 show the damage to the Box Beam to Concrete Barrier Transition.

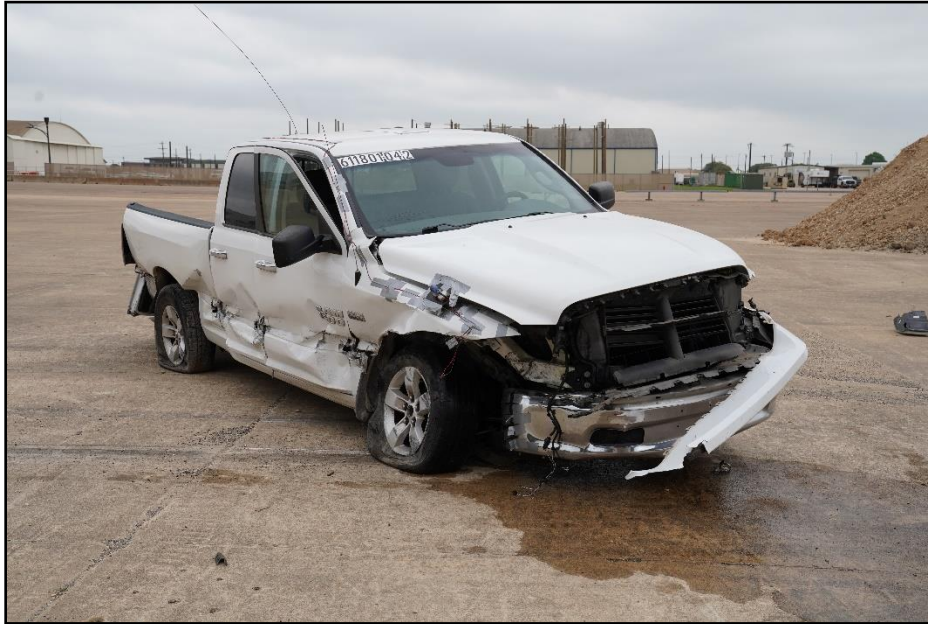
Figure 7.23. Impact Side of Test Vehicle after Test 611801-04-2.

Figure 7.23 and Figure 7.24 show the damage sustained by the vehicle. Figure 7.25 and Figure 7.26 show the interior of the test vehicle. Table 7.21 and Table 7.22 provide details on the occupant compartment deformation and exterior vehicle damage. Figures F.2 and F.3 in Appendix F.1 provide exterior crush and occupant compartment measurements.

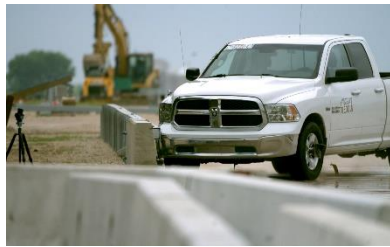
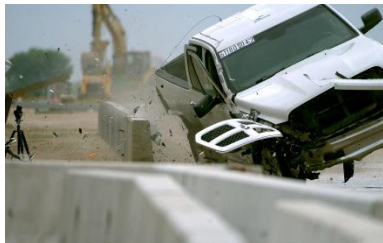
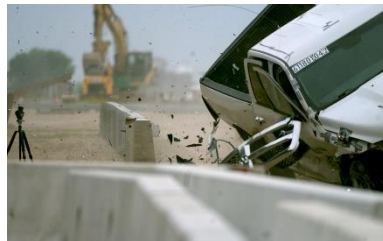
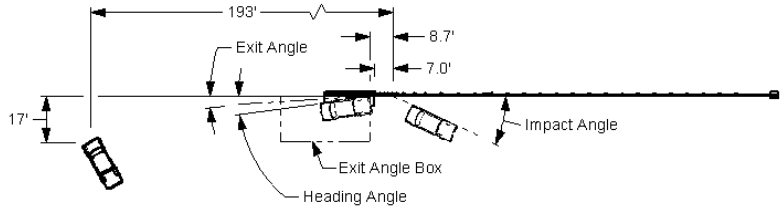
Figure 7.27. Summary of Results for MASH Test 3-21 on Box Beam to Concrete Barrier Transition.

<p>0.000 s</p>	Test Agency		Texas A&M Transportation Institute (TTI)					
	Test Standard/Test No.		MASH 2016, Test 3-21					
	TTI Project No.		611801-04-2					
Test Date		2023-03-30						
TEST ARTICLE								
Type		Transition System						
Name		Box Beam to Concrete Barrier Transition						
Length		165 ft 5 inches						
Key Materials		32-inch-high concrete parapet and 60-inch wide concrete deck. Steel box beam and rub rail. Steel transition posts						
Soil Type and Condition		AASHTO M147-17 Type 1 Grade D Crushed Concrete

<p>0.200 s</p>	TEST VEHICLE							
	Type/Designation		2270P					
	Year, Make and Model		2017 RAM 1500					
Inertial Weight (lb)		5051						
Dummy (lb)		N/A						
Gross Static (lb)		5051						
IMPACT CONDITIONS								
Impact Speed (mi/h)		62.1						
Impact Angle (deg)		25.0						
Impact Location		83.8 inches upstream from the end of the concrete parapet						
Impact Severity (kip-ft)		116.3

<p>0.400 s</p>	EXIT CONDITIONS							
	Exit Speed (mi/h)		52.1					
	Trajectory/Heading Angle (deg)		4.1 / 8.1					
Exit Box Criteria		Vehicle crossed the exit box 57 feet downstream from loss of contact						
Stopping Distance		193 ft downstream 17 ft to the traffic side

<p>0.600 s</p>	TEST ARTICLE DEFLECTIONS							
	Dynamic (inches)		2.5					
	Permanent (inches)		1					
Working Width / Height (inches)		22.4 / 49.0						
VEHICLE DAMAGE								
VDS		01RFQ4						
CDC		01FREW3						
Max. Ext. Deformation (inches)		14						
Max Occupant Compartment Deformation		3 inches in the right toe pan						
OCCUPANT RISK VALUES								
Long. OIV (ft/s)	16.4	Long. Ridedown (g)	5.0	Max 50-ms Long. (g)	-8.7	Max Roll (deg)	30.6	
Lat. OIV (ft/s)	31.8	Lat. Ridedown (g)	11.5	Max 50-ms Lat. (g)	-17.5	Max Pitch (deg)	4.1	
THIV (m/s)	10.9	ASI	2.2	Max 50-ms Vert. (g)	3.6	Max Yaw (deg)	49.4

Figure 7.27 summarizes the results of *MASH* Test 611801-04-2.

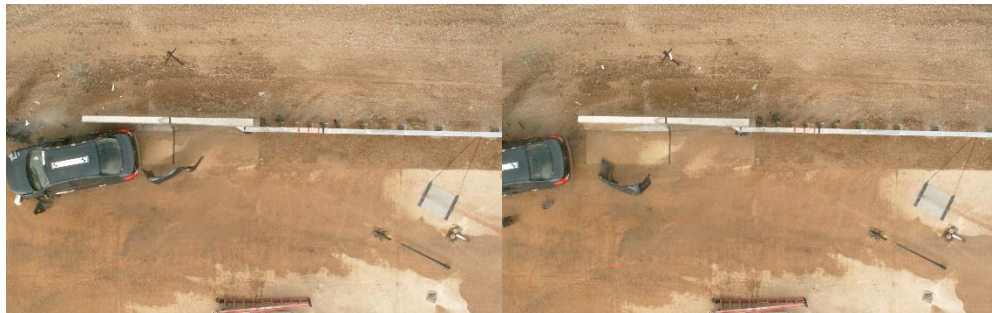
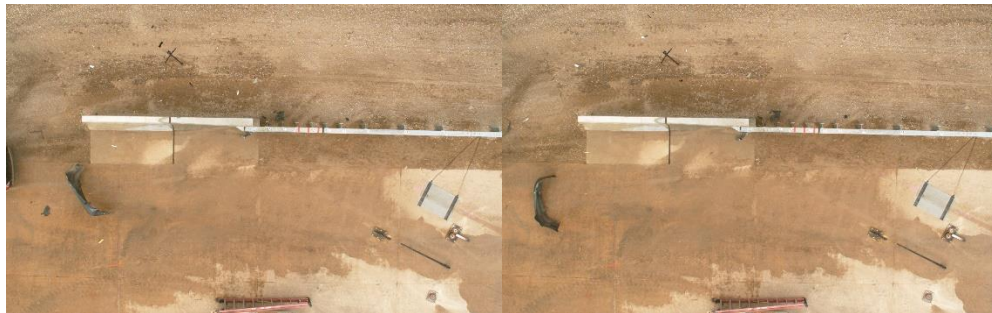
Figure E.4. Sequential Photographs for Test No. 611801-04-1 (Overhead Views).

(c) 0.200 s

(d) 0.300 s

(e) 0.400 s

(f) 0.500 s

(g) 0.600 s

(h) 0.700 s

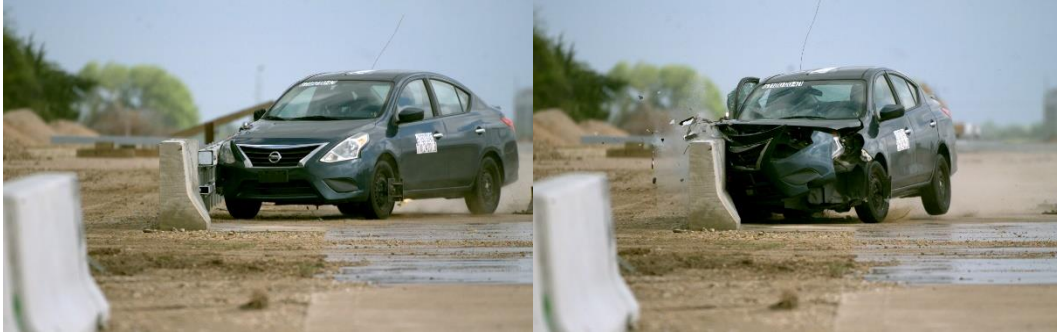
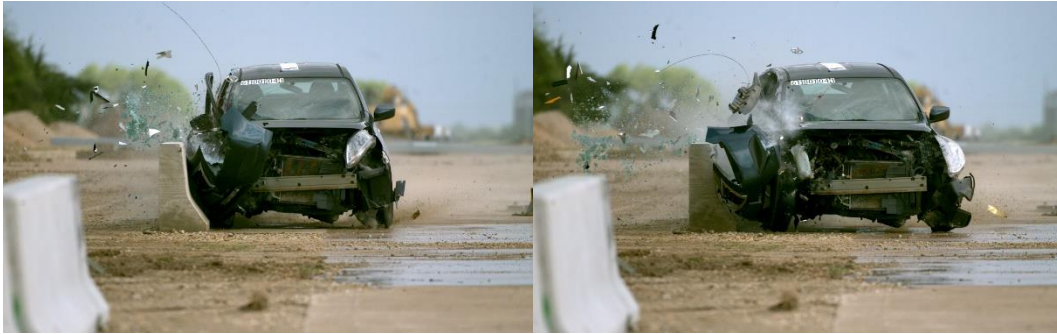
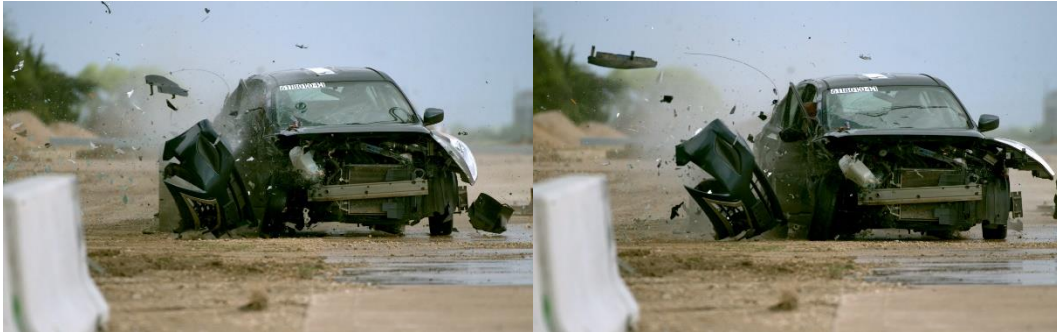
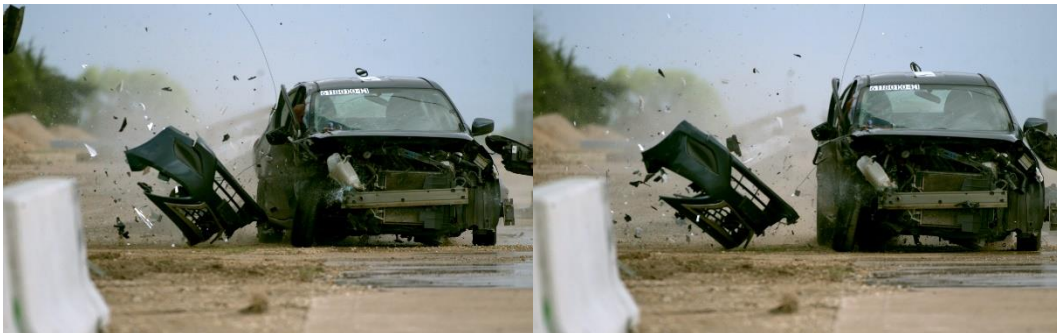
Figure E.5. Sequential Photographs for Test No. 611801-04-1 (Frontal Views).

(a) 0.000 s

(b) 0.100 s

(c) 0.200 s

(d) 0.300 s

(e) 0.400 s

(f) 0.500 s

(g) 0.600 s

(h) 0.700 s

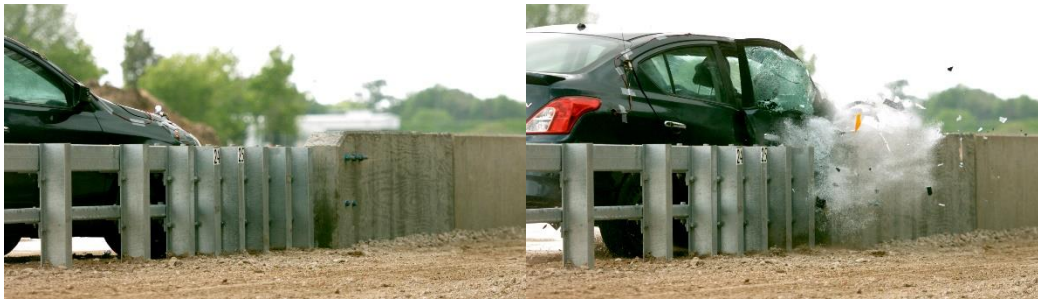
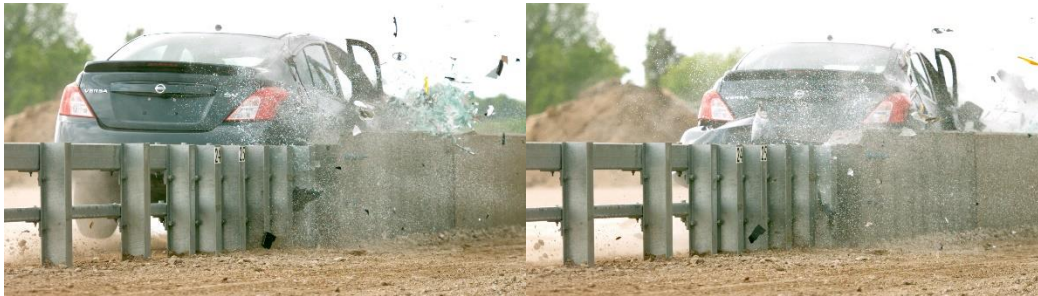
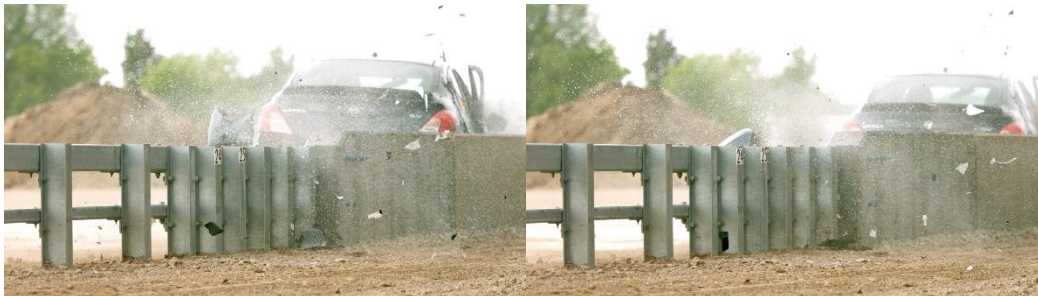
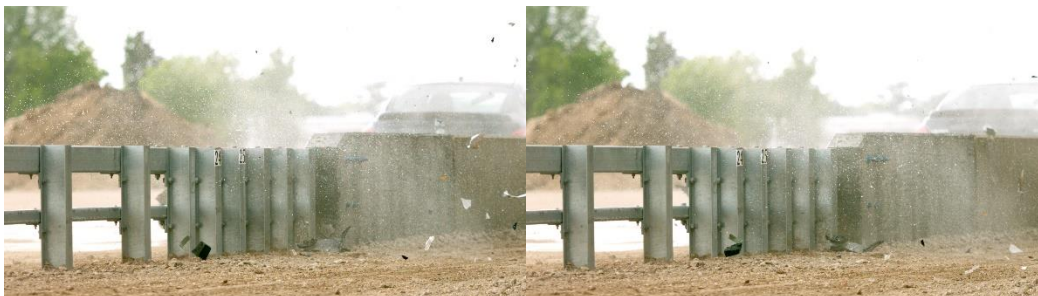
(a) 0.000 s

(b) 0.100 s

(c) 0.200 s

(d) 0.300 s

(e) 0.400 s

(f) 0.500 s

(g) 0.600 s

(h) 0.700 s

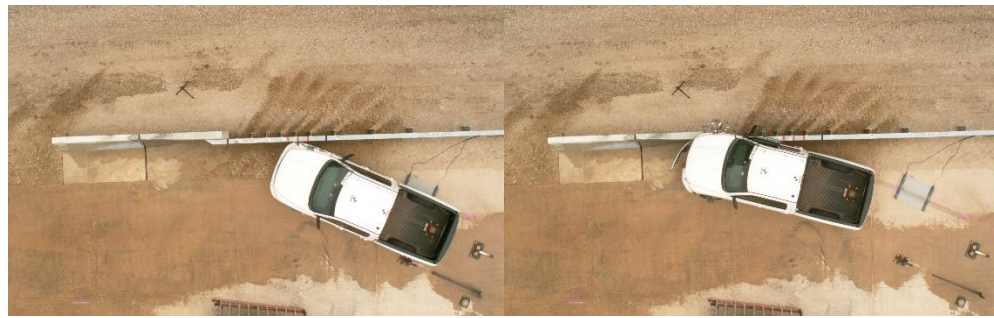
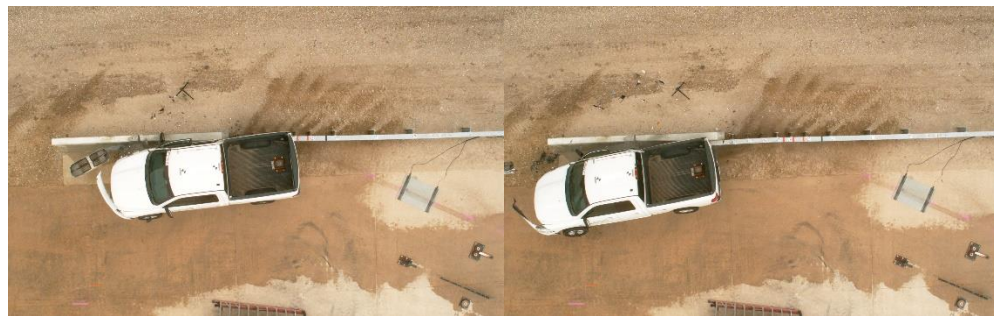
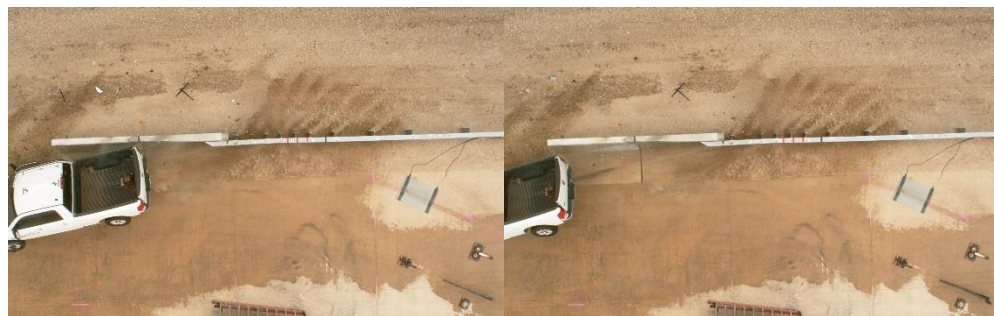
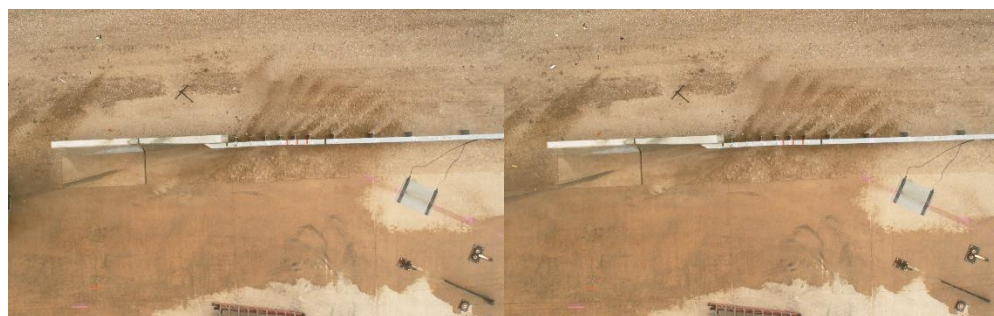
Figure F.4. Sequential Photographs for Test No. 611801-04-2 (Overhead Views).

(a) 0.000 s

(b) 0.100 s

(c) 0.200 s

(d) 0.300 s

(e) 0.400 s

(f) 0.500 s

(g) 0.600 s

(h) 0.700 s

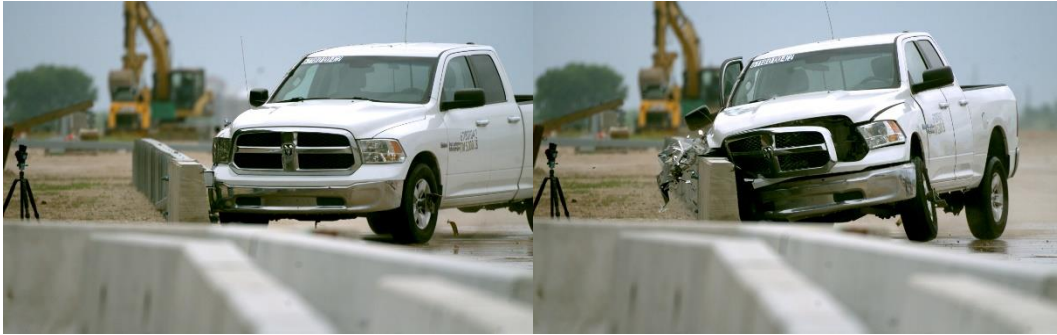
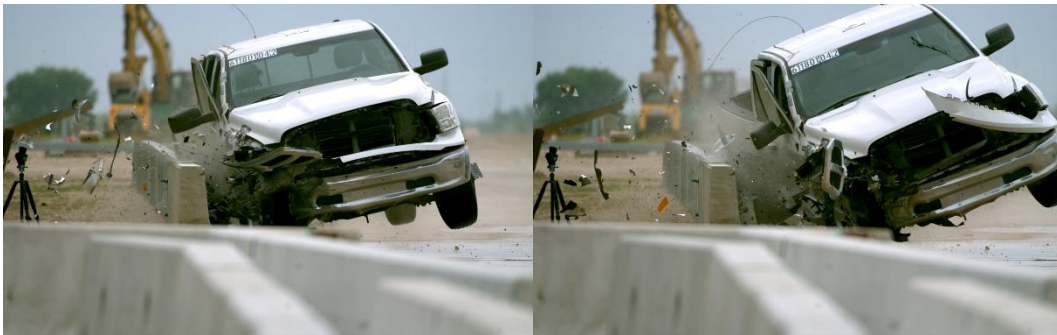
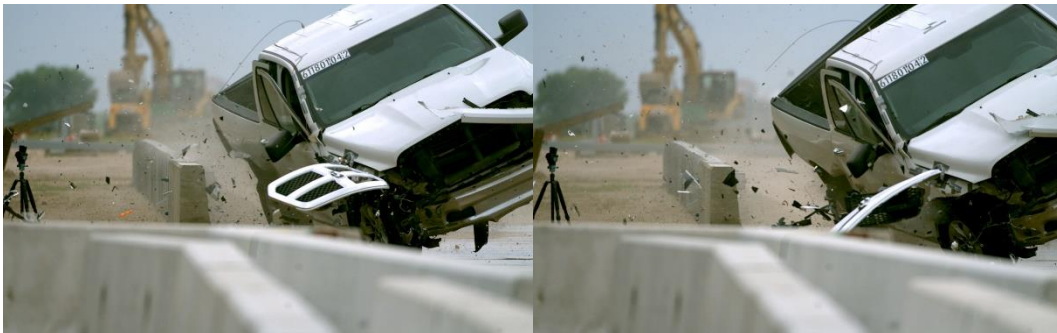
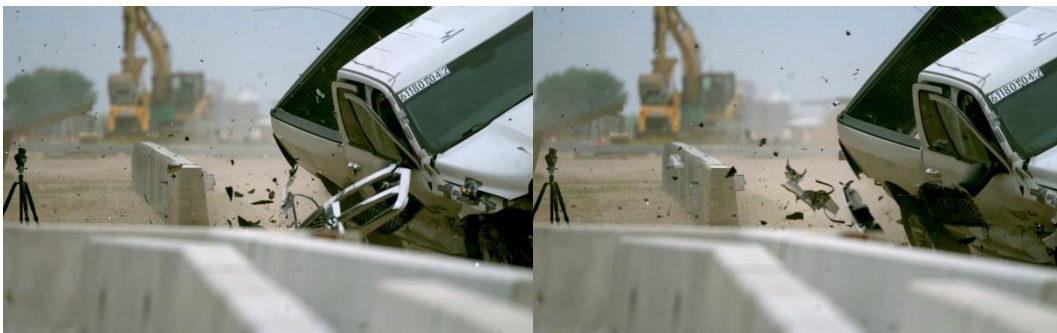
Figure F.5. Sequential Photographs for Test No. 611801-04-2 (Frontal Views).

(a) 0.000 s

(b) 0.100 s

(c) 0.200 s

(d) 0.300 s

(e) 0.400 s

(f) 0.500 s

(g) 0.600 s

(h) 0.700 s

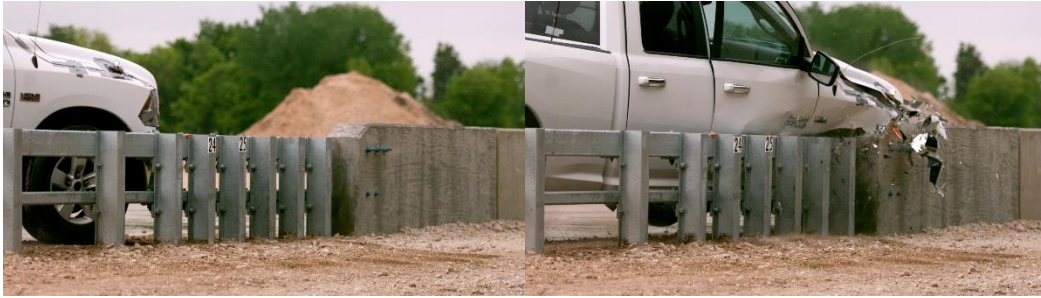
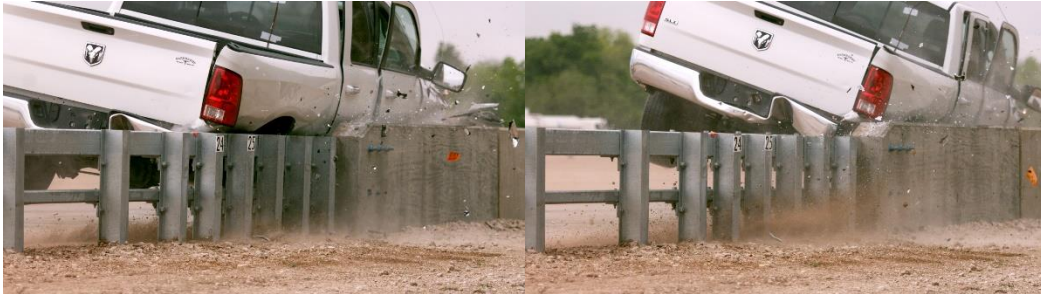
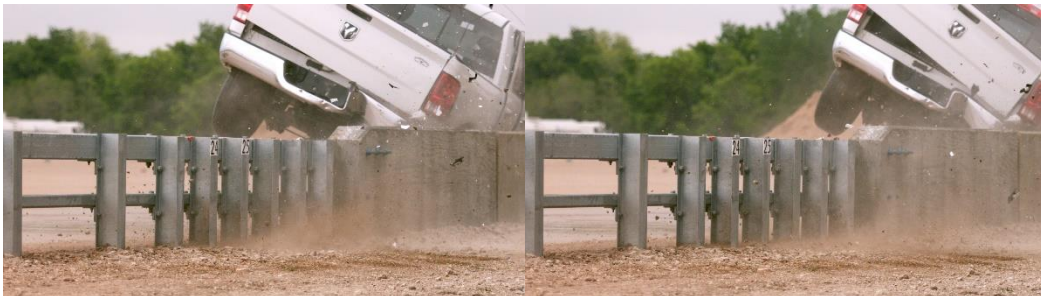
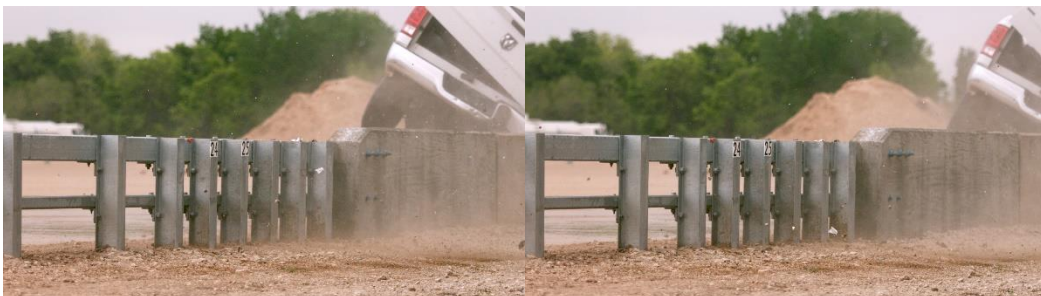
(a) 0.000 s

(b) 0.100 s

(c) 0.200 s

(d) 0.300 s

(e) 0.400 s

(f) 0.500 s

(g) 0.600 s

(h) 0.700 s
