GEORGIA DOT RESEARCH PROJECT 22-01

Final Report

**UAS-ASSISTED INSPECTION
OF BRIDGES FOR
CORROSION EFFECTS**

December 2023

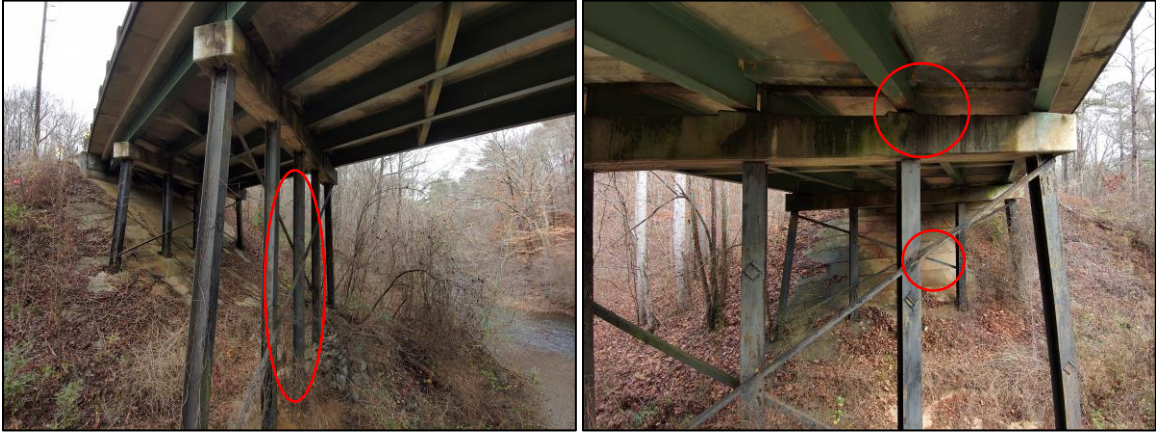
**Figure 3. Photographs. Bridge over Bear Creek, Douglasville.
Red circles = identified corrosion.**

Although figure 3 shows visible corrosion (red circles) in images taken on the site, the lighting variations limit the view in portions of the bridge that are out of focus in the image. For the piles and beams in the foreground of the image, the lighting is generally adequate for the human eye to view corrosion. These photographs were taken using automatic image capture while the drone was in motion at 2–10 mph speeds.

In these photographs, the majority of the image space is dedicated to the background, and the object of interest, i.e., the corrosion shown in the red circles, takes up a relatively small amount of image space. Further, because the photographs were taken in December, the leaves on the ground are a brown-red color that resembles corrosion more closely than foliage that would be present during spring or summer. This resemblance made automatic corrosion detection more difficult, especially for the image processing algorithms, as discussed in chapter 4.

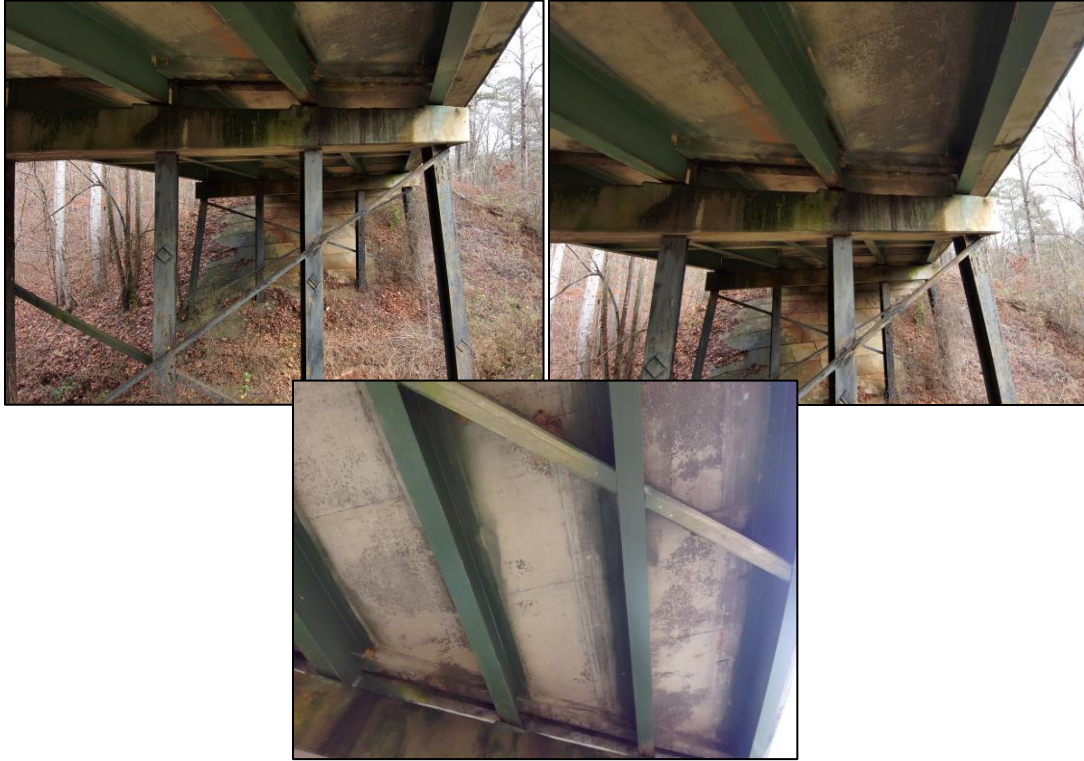
Figure 4. Photographs. Underside of the Bear Creek bridge deck at (a) 0° rotation (b) 50° rotation and (c) 80° rotation.

Figure 4 shows the underside of the bridge deck with different degrees of gimbal rotation. The Skydio 2+ drone is capable of collecting photographs that give a complete understanding of the underside of the bridge deck due to the 180-degree gimbal rotation feature. In these photographs, the lighting improves as the gimbal rotation increases because the lighting from the sky is in less of the photograph; the Skydio camera adjusts accordingly, leading to better visibility of the corroded areas.

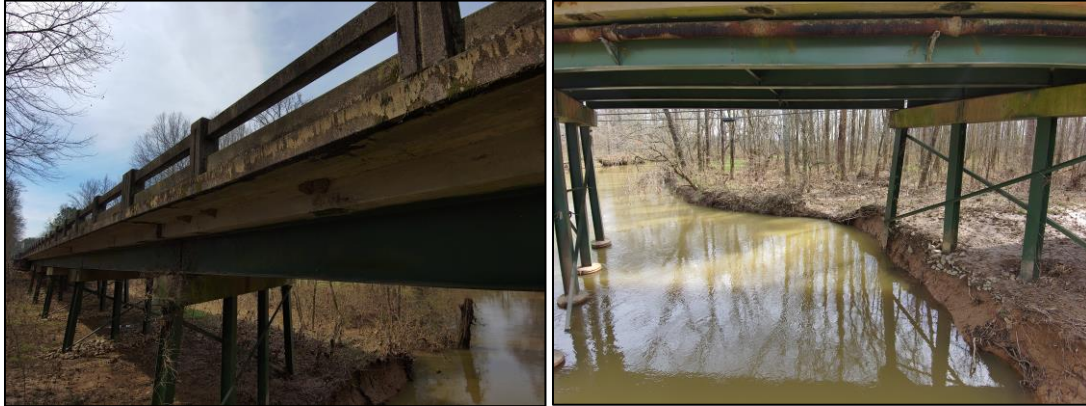
Figure 6. Photographs. Bridge over Salacoa Creek, Calhoun.

Similar to Bear Creek, many thin branches at this site limited where the drone could fly (see figure 6). These photographs are examples of the images taken during the inspection. As shown, the portion of the bridge that crossed dry land rather than the creek was almost entirely unreachable due to the thin trees and branches present. Therefore, the inspectors were only able to take images of the northern half of the bridge.

Figure 6 also shows the variable lighting that was present due to the weather conditions. In the photograph on the left, the majority of the bridge is covered in shadows, hiding most of the corrosion and rendering this photograph unusable for automatic corrosion detection. The photograph on the right shows an example where the lighting was better and corrosion is visible. These photographs were taken using automatic image capture while the drone was in flight at speeds ranging 2–10 mph.

Again, as seen in figure 6, the majority of the image space is dedicated to the background, so the object of interest, i.e., corrosion, takes up the least amount of image space. Although there was not as much foliage on the ground, the coloring of the soil at Salacoa Creek resembles corrosion more closely than the soil at Bear Creek, which caused confusion for the automatic corrosion detection algorithms, which will be discussed further in chapter 4.

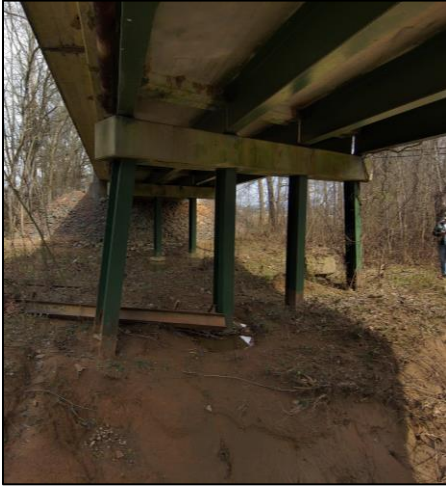
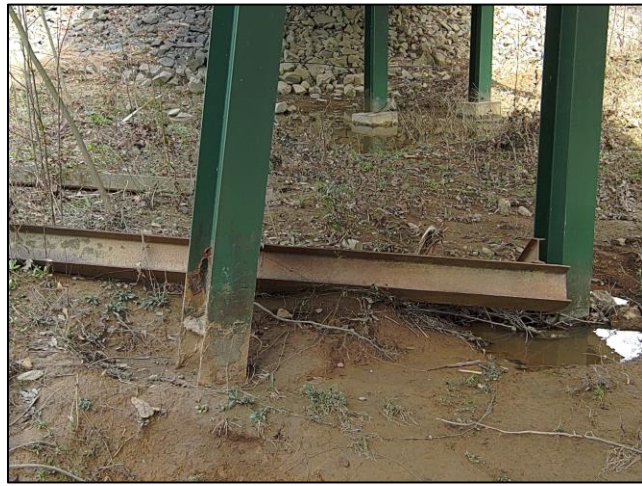
Figure 7. Photographs. (a) Standard and (b) zoomed view of corroded pile at Salacoa Creek.

Figure 7 shows the increased visibility in images taken with 3× zoom compared to images taken with standard magnification. In the standard image, it is difficult for humans to determine if the corrosion present on the left pile is actual corrosion or soil stuck on the structure. However, in the zoomed photograph, it is easier to determine that it is indeed corrosion. It is important to note, as well, how the lighting improves in the zoomed photograph versus the standard photograph. Because the Skydio 2+ automatically adjusts lighting according to the composition of the photograph, when less sky and other bright objects are present, the shadows become more uniform and the corroded areas are easier to observe.

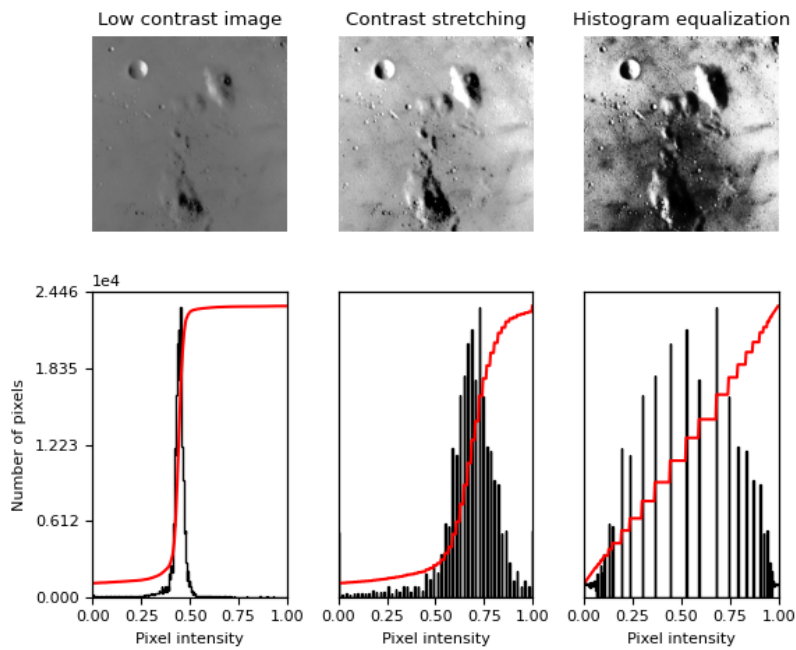
Figure 8. Photographs and charts. Histogram equalization (right) versus contrast stretching (center) on a low-contrast image (left).^[7]

Two potential methods to enhance the contrast in an image are histogram equalization and contrast stretching. Histogram equalization spreads out the most frequent intensity values in an

image so the cumulative distribution function of intensity in the image is roughly linear. However, this method can oftentimes yield unnatural results. Contrast stretching, on the other hand, stretches the range of intensity values linearly across a wider range. This method yields more natural results, but the intensity values are not as dispersed as with histogram equalization (see figure 8).^[7] When detecting corrosion from images, the intensity values of the pixels are more important than the visual appearance of the image. Therefore, histogram equalization was applied to images during texture thresholding. The results of corrosion detection with and without histogram equalization are shown and discussed in Texture Thresholding.

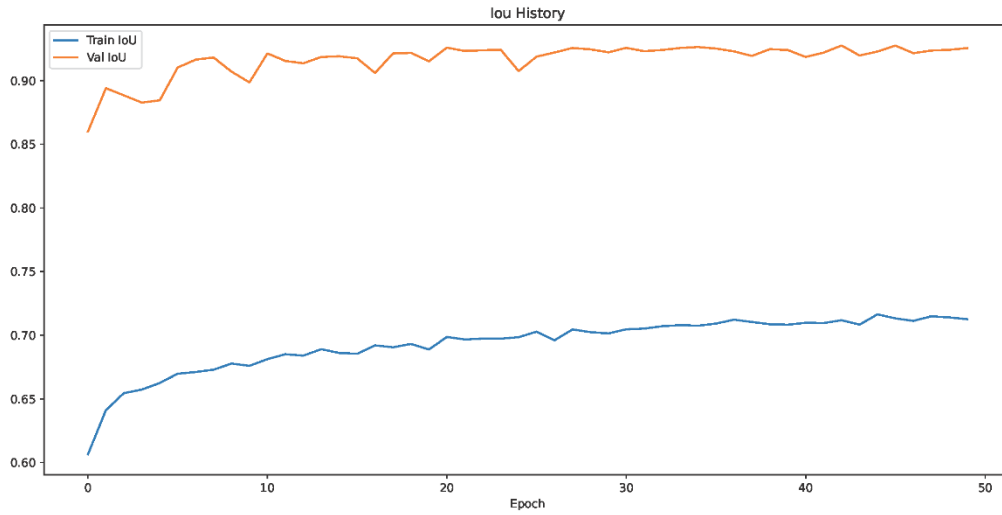
Figure 9. Graph. IoU history of background removal algorithm.

The background was removed using a deep learning algorithm. Although there are open-source background removal algorithms available, they are not trained on images of bridges and therefore do not perform well on the dataset. Therefore, the PyTorch implementation of the fully convolutional network (FCN) architecture was trained using the data collected at Bear Creek and Salacoa Creek. Once the algorithm is trained, it can remove the background from the images quickly and accurately. Figure 9 and figure 10 show the mean Intersection over Union (IoU) history and loss history as the algorithm is trained to remove the background from images of bridges. A perfect performance would be 1.00 IoU and 0.00 loss, and the algorithms were run until convergence.

The final IoU of this model was 0.721 on the training dataset and 0.925 on the validation dataset.

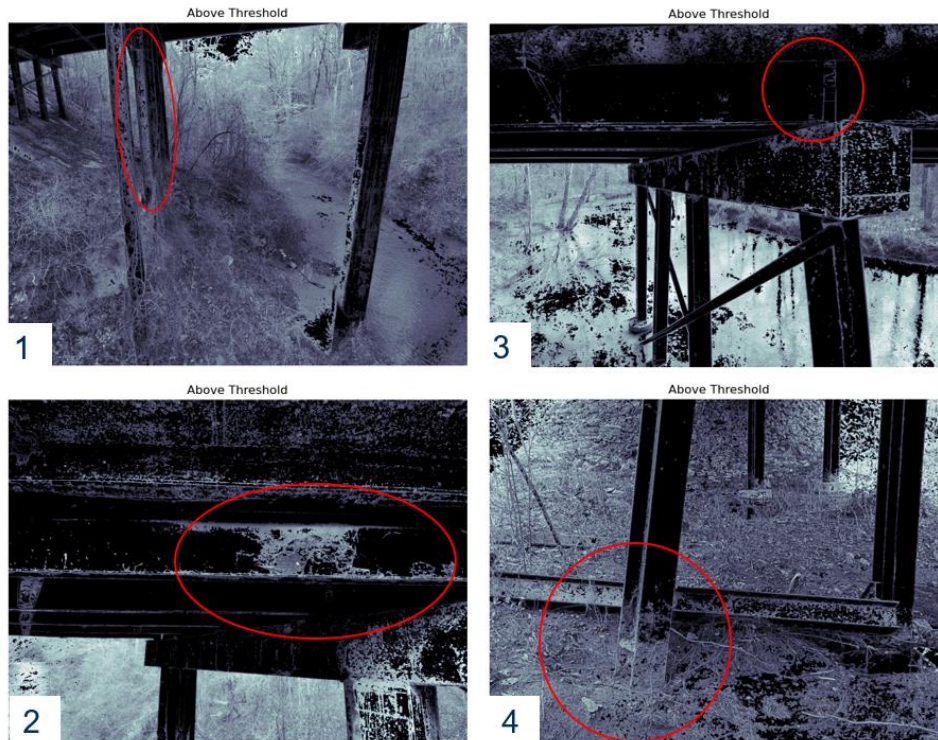
Figure 13. Photographs. Results of entropy thresholding. Circles = corrosion.

The threshold used to segment the image was determined by visual analysis. First, a group of four test images was segmented using different entropy thresholds to see at which value the corrosion was fully separated into one cluster. These thresholds ranged from 10 to 100 percent of the maximum entropy value in the image at intervals of 10 percent. After visual evaluation, it was determined that 65 percent of the maximum entropy value was the best corrosion segmentation threshold. The images were then separated into regions that were above this threshold and below it. Figure 13 shows the results of texture thresholding on four images from Bear Creek and Salacoa Creek.

As visible in figure 13, the amount of corrosion that has been completely segmented to the “textured” or “corrosion” segment of the image varies. In images 2 and 4 of figure 13, the corrosion on the bridge is almost completely segmented above the entropy threshold. However, in images 1 and 3, part of the corrosion has been falsely identified as background. In addition, it is important to note that the majority of the photograph that is labeled as “textured” or “corrosion” is background foliage. This result is unsurprising because the entropy is highest in the photographs where foliage is present. However, this results in a large number of false positives that make the inferences using this method alone inadequate for corrosion detection.

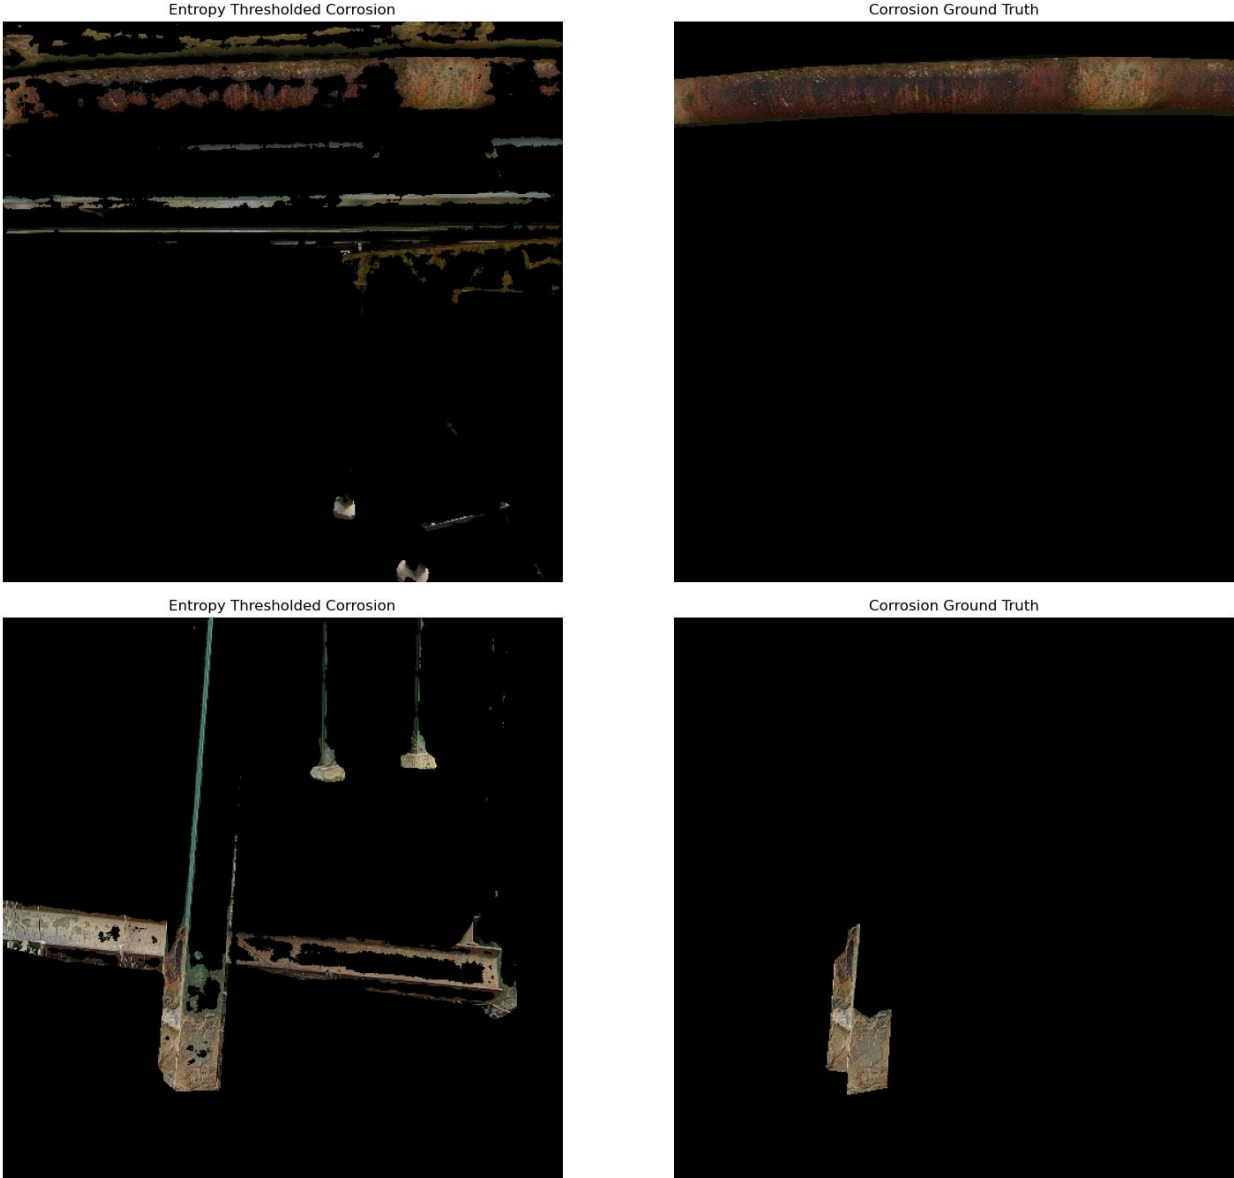
Figure 15. Photographs. Results of entropy thresholding on images with background removed using the labels.

was removed with no error. Figure 15 shows the results of texture thresholding when the background is removed using the ground truth labels.

As shown in figure 15, the results are improved to varying degrees when the background is removed with the ground truth labels. In the top photograph, the corrosion inferences are very

similar because the deep learning algorithm removed the background with low error. However, in the bottom photograph, the deep learning algorithm did not perform as well; however, the corrosion segmentation results are much improved from when the background is removed using the deep learning algorithm. Although the accuracy did not increase, the recall increased from 0.3324 to 0.4887, which is an increase of 47.0 percent. The results of texture thresholding with perfect background removal are shown in table 2.

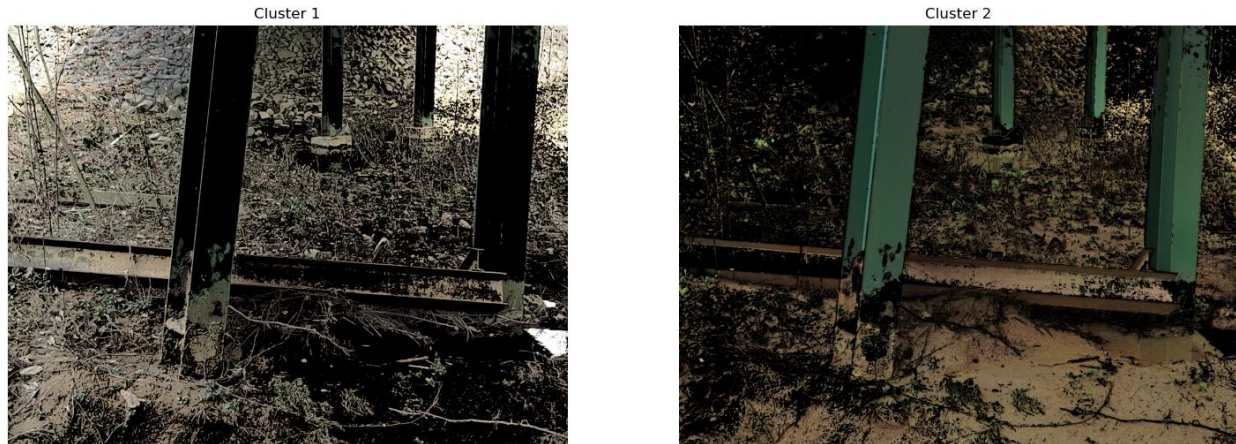
Figure 17. Photographs. Results of color thresholding in the HSV color space.

To follow the studies conducted by Petricca et al.^[11] and Bondada et al.,^[12] the HSV photographs were segmented using only the hue and saturation layers. Theoretically, removing the value layer from the photograph would reduce the impact of lighting. Although the lighting is not as impactful as it is for the RGB color space, the image seems to be segmented based on gray areas and colorful areas, as shown in figure 17. The large patch of corrosion present on the bottom of the pile has been split into both of the clusters, so this thresholding method was deemed inadequate to segment corrosion as well.

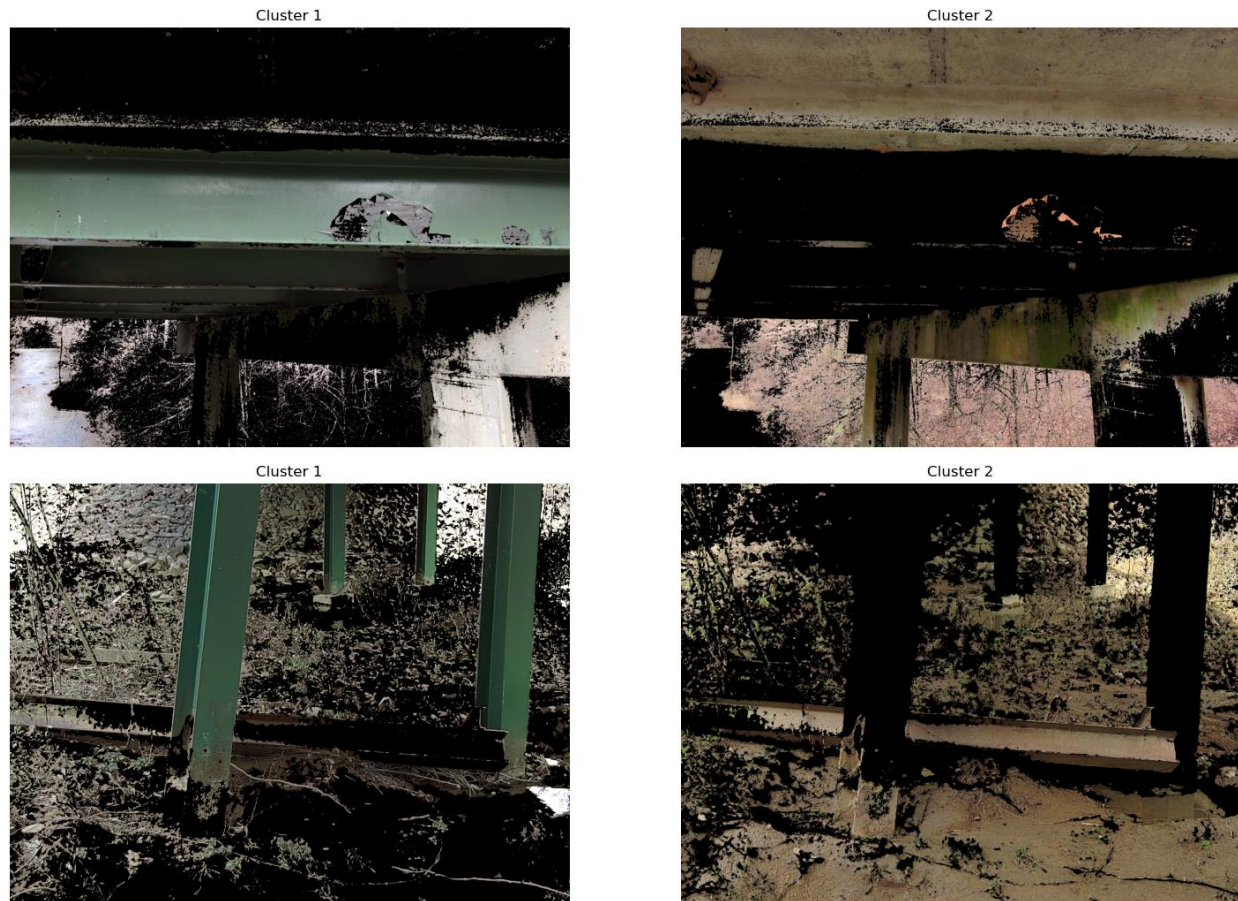
Figure 18. Photographs. Results of color thresholding in the L*ab color space.

In the L^*ab color space, the lightness layer was removed to reduce the impact of lighting. Therefore, the image was only segmented based on the pixel values of red-green and blue-yellow. The results of color thresholding in the L^*ab color space are shown in figure 18. From the results of this study, this color space performed the best. The clusters appear to be separated by color rather than lightness or saturation, and the corroded patches are more fully segmented into one cluster rather than being split between both of them. Therefore, thresholding using this color space was evaluated further.

As shown in figure 18, segmentation using this method resulted in many false positives in the background. Therefore, this method was tested on images with the background removed using deep learning in an attempt to reduce the false positives. The results are shown in figure 19. The corroded segment is shown on the left and the rest of the image is shown on the right.

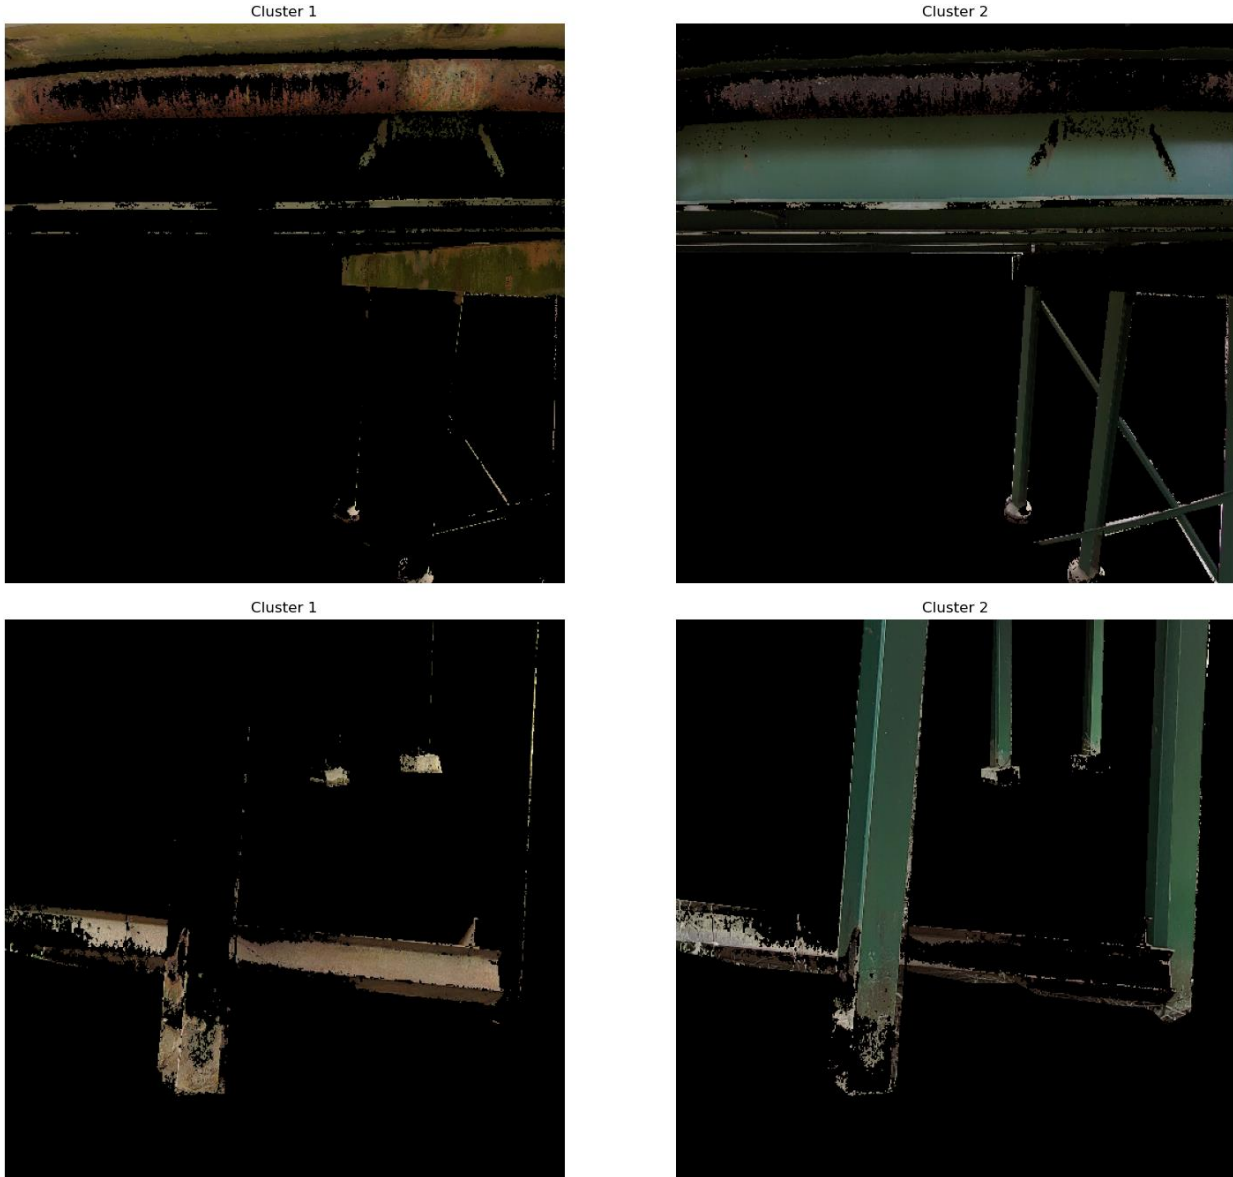
Figure 20. Photographs. Results of color thresholding on images with background removed using the ground truth.

As with texture thresholding, color thresholding resulted in performance with high accuracy but low precision and recall (table 4). Again, this is possible because the majority of the image represents uncorroded areas. Color thresholding was also tested on images with the background removed using the ground truth labels to see how it would perform in a perfect scenario. The results are shown in figure 20.

The performance improved slightly when the background was removed with no error. These results are summarized in table 5.

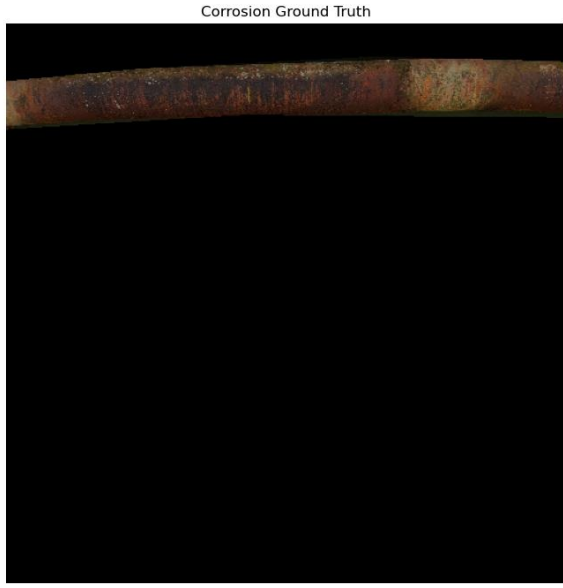
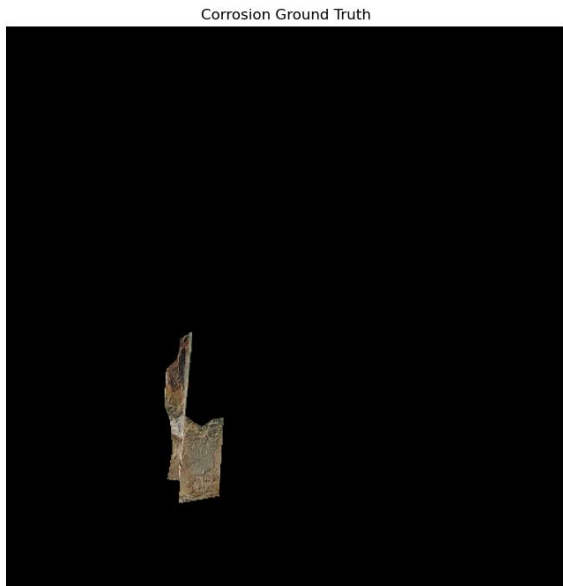
Figure 21. Photographs. Results of K-means on images with background removed using deep learning.

K-means was conducted with texture and color features with the background removed. First, this method was tested on images with the background removed using deep learning. Then, it was tested on images with the background removed using the ground truth. The results of the images with the background removed using deep learning are shown in figure 21.

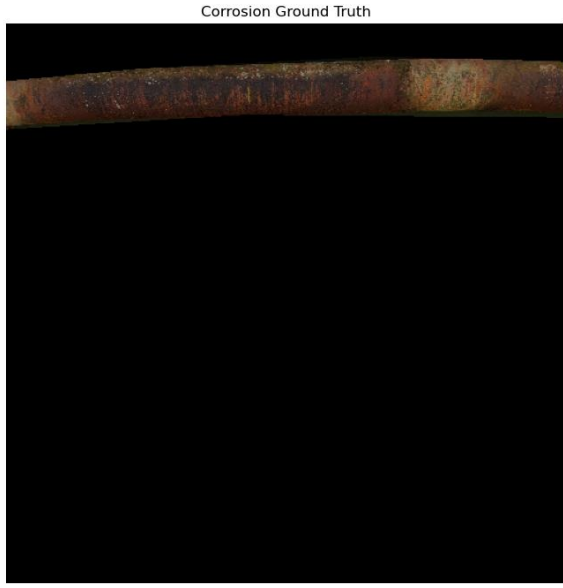
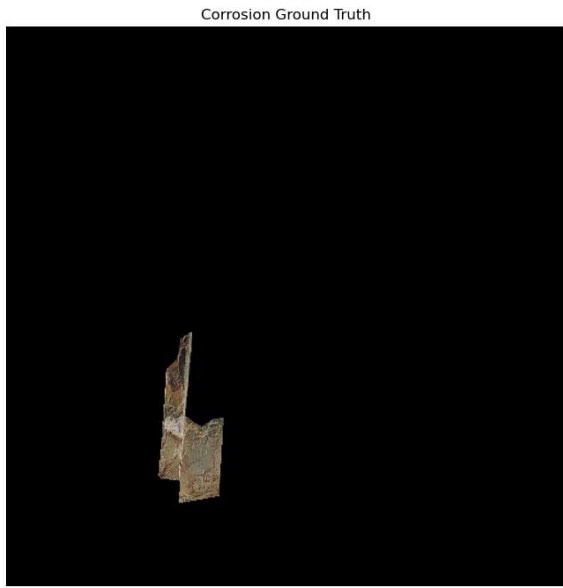
Figure 22. Photographs. Results of K-means on images with background removed using the ground truth.

Figure 22 shows the results of K-means when the background is removed using the ground truth labels.

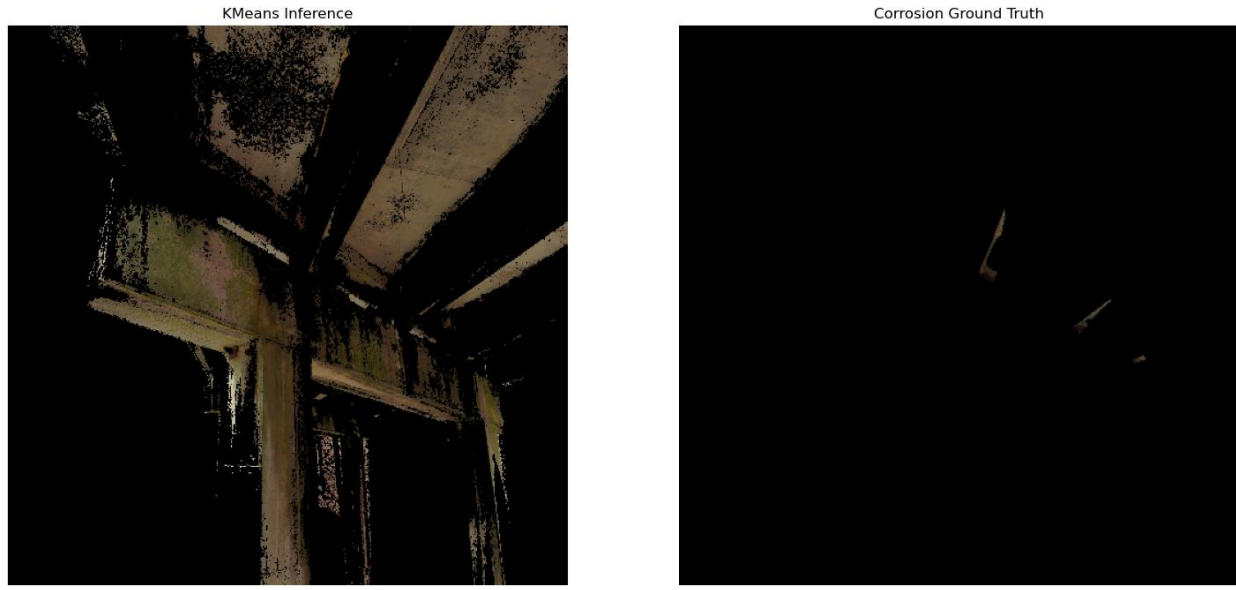
Figure 23. Photographs. K-means segmentation on an image with a small amount of corrosion.

It is important to note that the K-means methodology works better on images with larger portions of corrosion. It does not work on images where there is no corrosion present because it will always segment a portion of the image as corroded. This phenomenon is shown in figure 23. As seen in the ground truth, a small amount of corrosion is present in the image, but the K-means algorithm falsely detects more regions of the image as corroded.

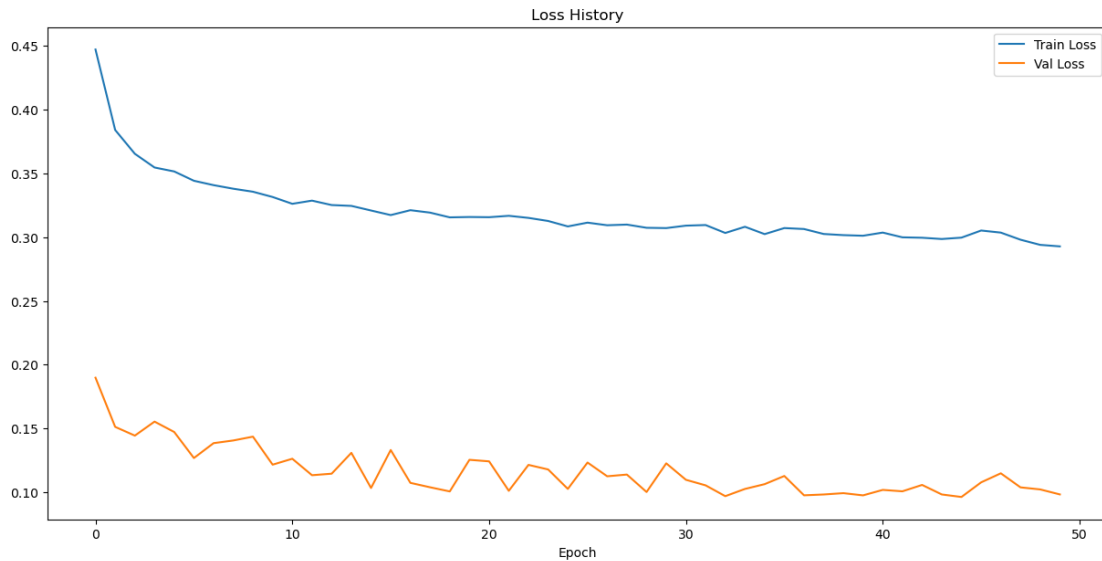
Figure 26. Graph. Loss history of FCN for corrosion segmentation.

shows the loss of the model throughout training. The final validation loss was 0.0963 and the final validation IoU was 0.9253. Once training was complete, the model could infer the dataset almost instantaneously.
