# Reducing the Environmental Impact of Road Construction

**NCDOT Project 2020-01  
FHWA/NC/2020-01 April  
2023**

North Carolina Department of Transportation

PROJECT AUTHORIZATION NO. RP-2020-01

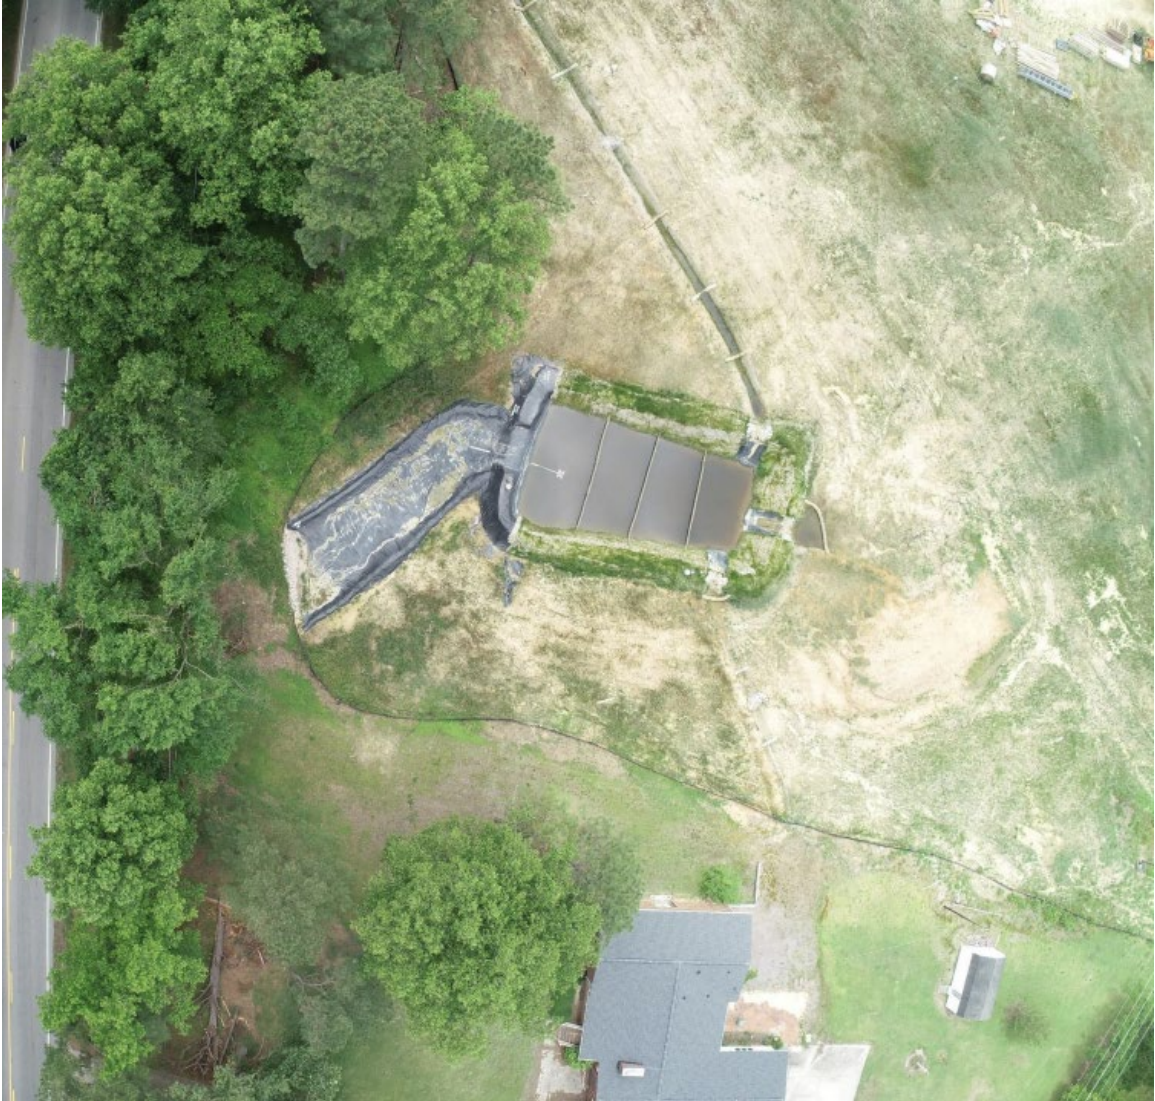
**Figure 4.** Drone image of basin 1 in April of 2020.

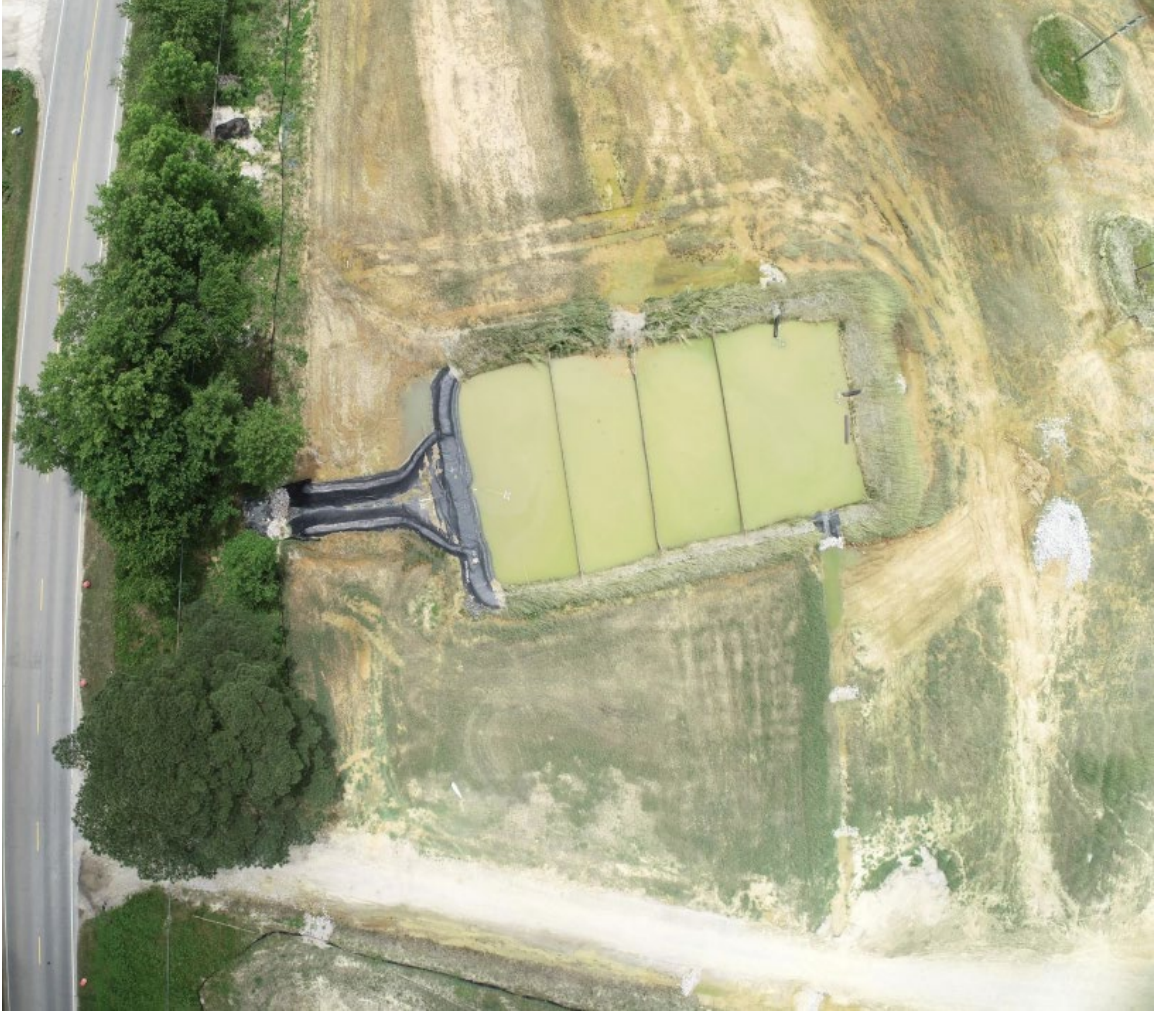
**Figure 5.** Drone image of basin 2 in April of 2020.

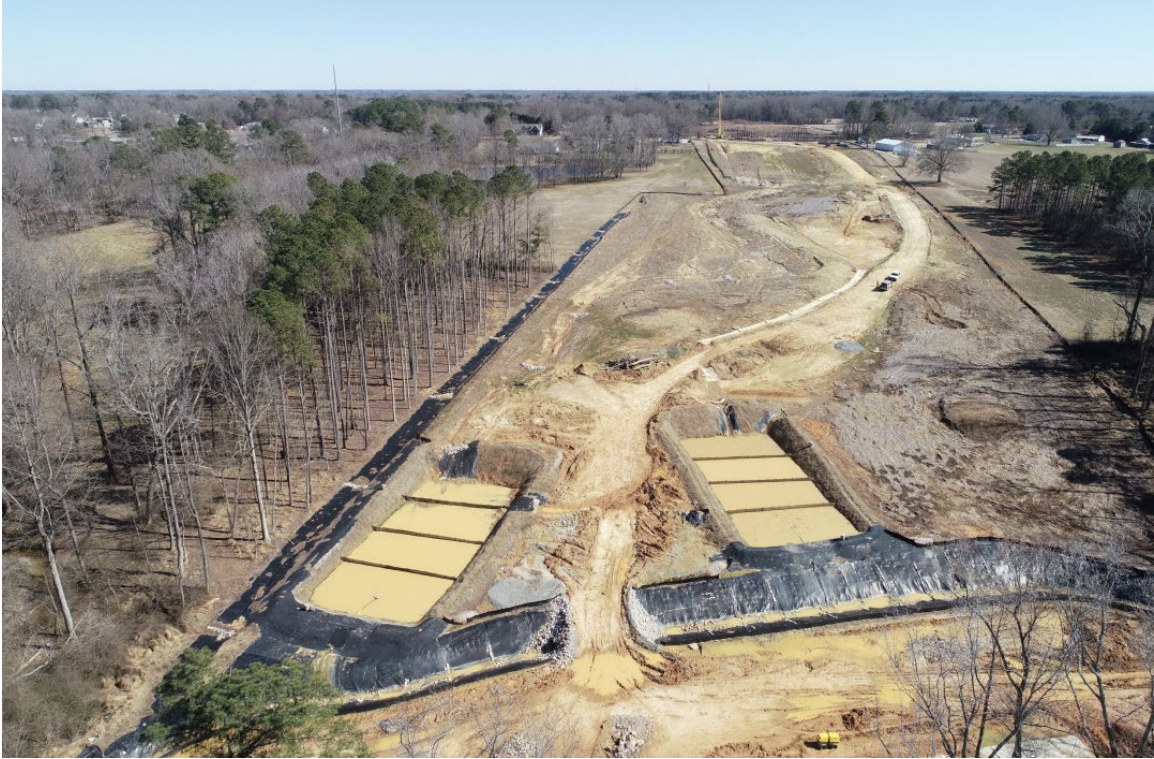
**Figure 8.** Drone image of basin 3 and 4 in January 2021.

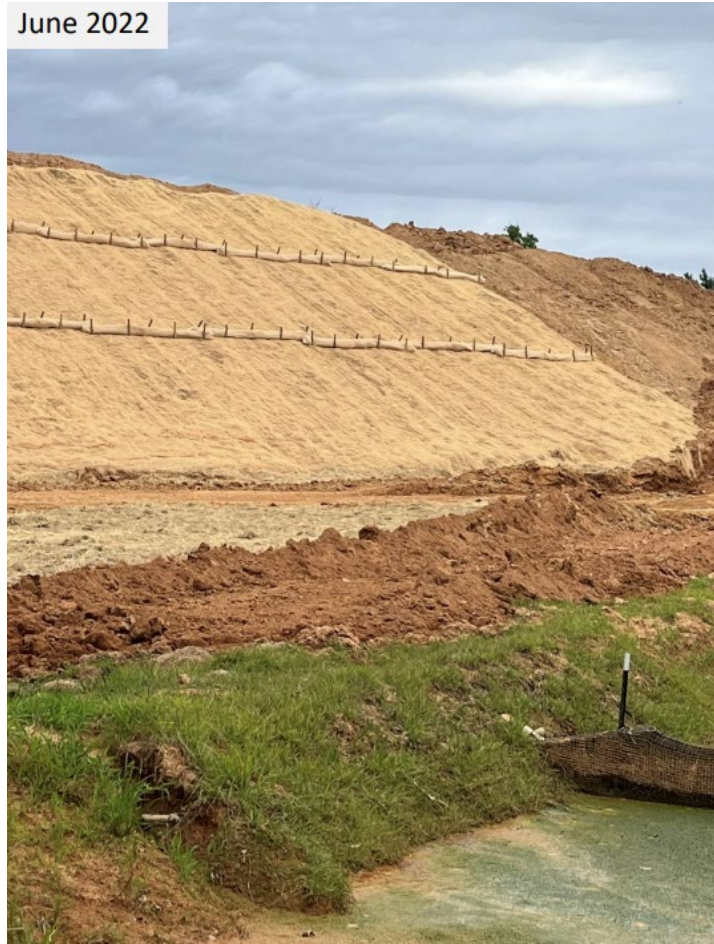
**Figure10.** Steep slope located next to basin 5.

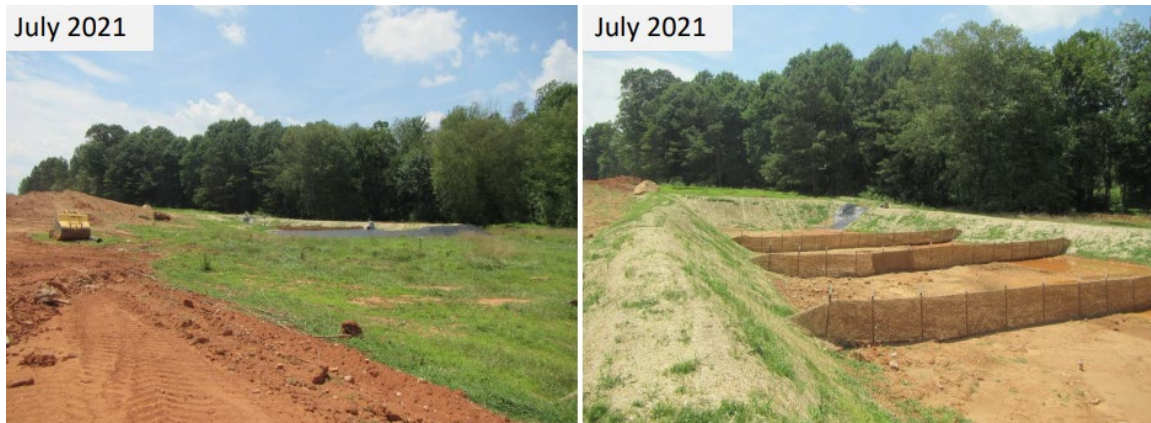
**Figure 11.** Basin 6 at the start (July 2021) of sample collection. Note there is no soil stockpile located next to the basin at this time.

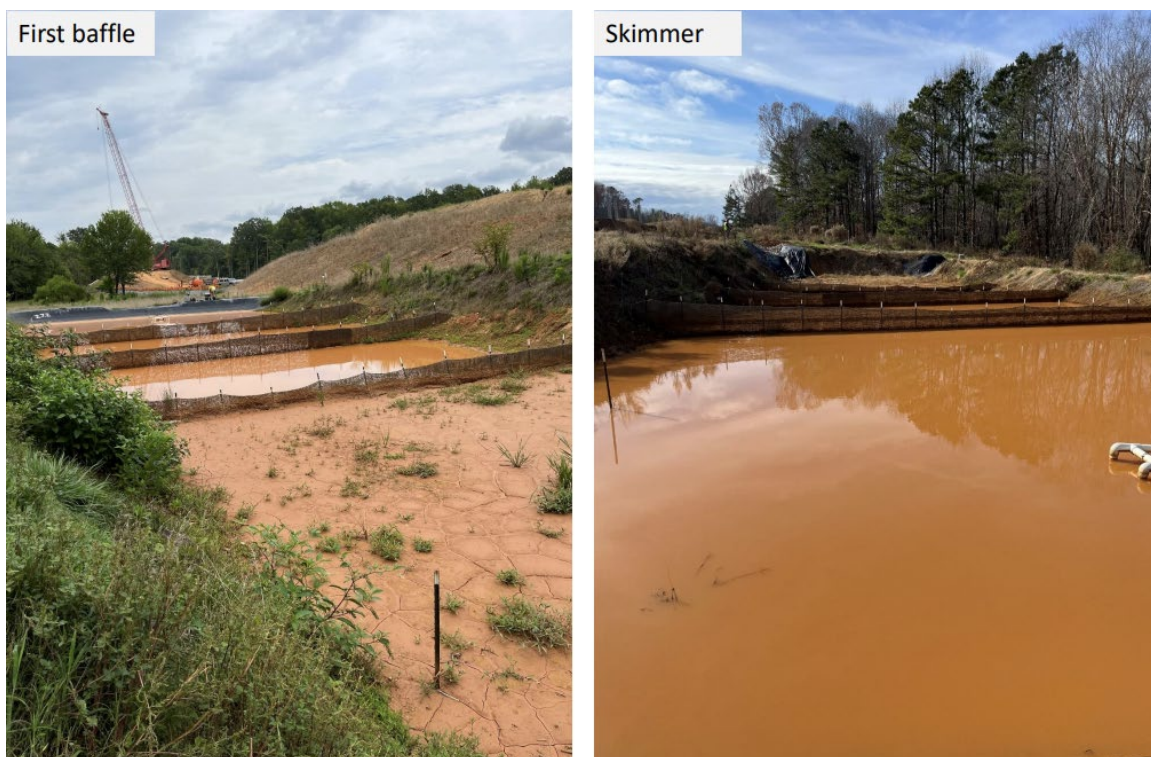
**Figure 12.** Basin 6 at the end (December 2022) of sample collection. (Left) Looking at the first baffle (first chamber), and (Right) looking at the skimmer (last chamber).

Basin 6 (Figure 11 & 12) and 7 (Figure 13) were the last set of basins monitored. Monitoring started July of 2021 and ended in March 2022 (basin 7) and December 2022 (basin 6). The basins were located off of the Benson Road construction entrance near the end of the construction site on either side of the construction road. Ditches leading to the basins did not receive PAM application by NCSU, and evidence of PAM was rarely seen in these basins. Standing water was rarely seen in the first chamber of basin 6 (Figure 12), suggesting there could have been high infiltration at that location. Basin 6 was a larger basin which was going to be converted to a stormwater detention basin, while basin 7 was a smaller temporary basin.

The TSS largely decreases from the first baffle to the skimmer, as can be seen in the negative change for basins (Figure 16). Basin 6 was the only basin to have a positive change, indicating the stormwater gained TSS as it moved through the basin (Figure A12). This basin was monitored for about 18 months. During this time, there were only two storm events that got samples from both the first baffle and skimmer. Basin 6 rarely had samples in the first chamber, indicating that the water was moving rapidly through the basin or infiltrating (Figure 12). Only very large storm events (hurricanes) allowed enough water to accumulate in the first chamber to get samples, which likely skewed the data in addition to the low number of comparisons.

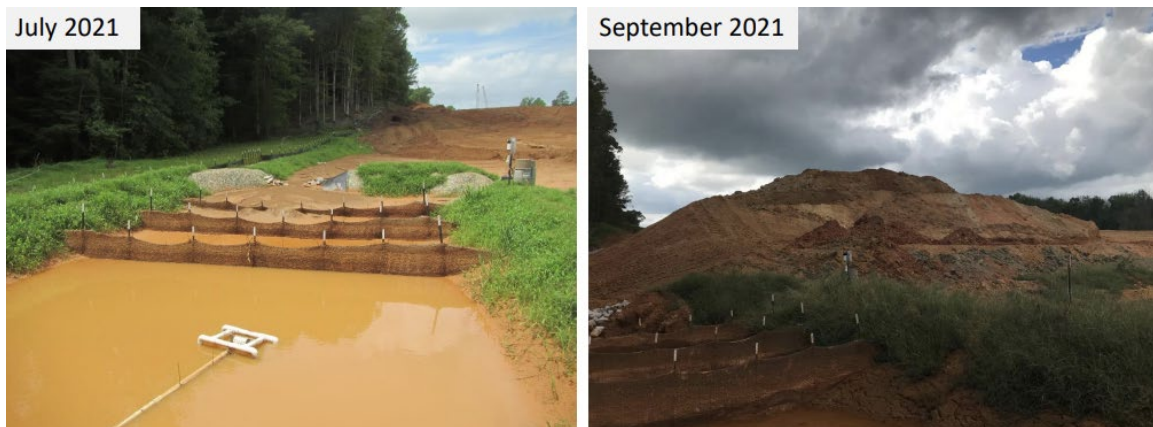
**Figure 14.** Basin 7 evolution of soil stockpile growing at the entrance of the basin.

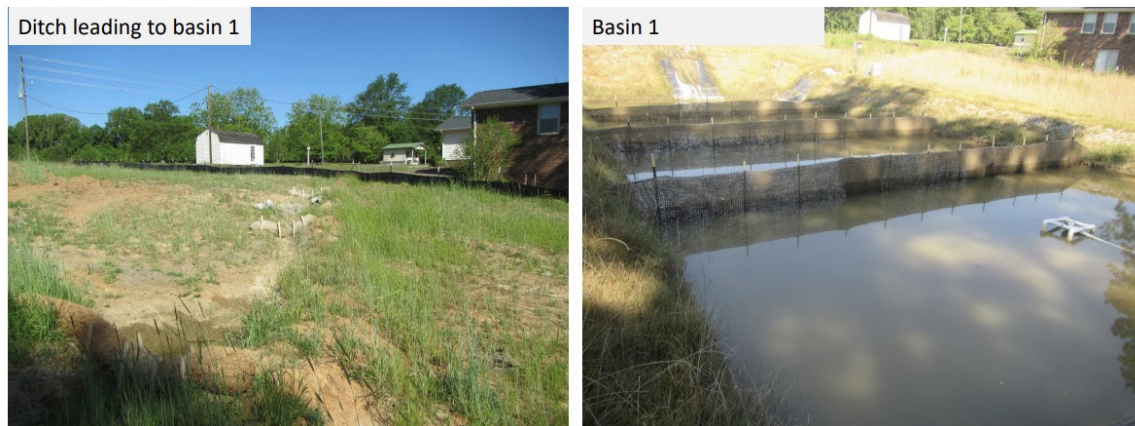
**Figure 17.** (Left) The ditch leading to basin 1, and (Right) basin 1.

Most of this part of the project was conducted during the construction I-540 near Raleigh, NC. Basin 1 was chosen as the chemical treatment basin (Figure 17). It was monitored from March 2020 to August 2020. The sediment basin was designed, constructed, and maintained by an NCDOT contractor.

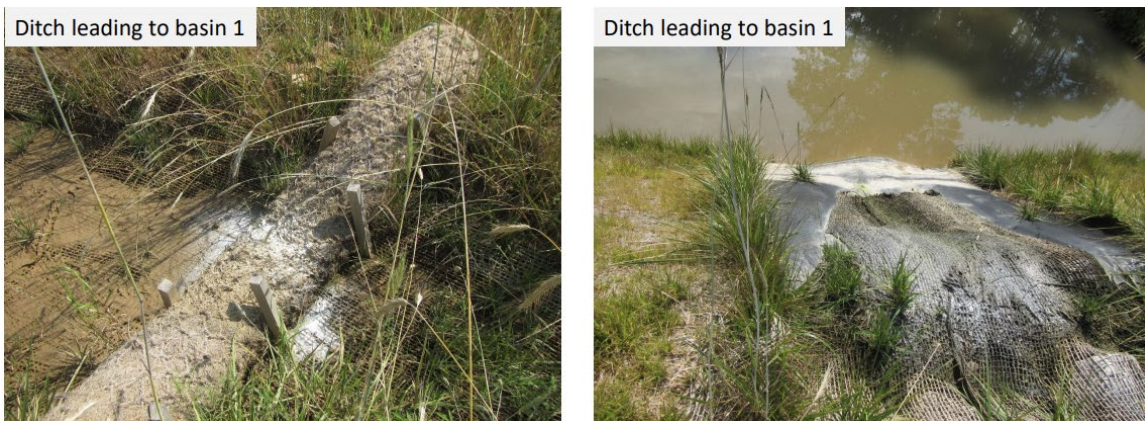
**Figure 18.** Polyacrylamide (PAM) application on wattles leading to basin 1.

PAM 705 (Applied Polymer Systems, Woodstock, GA) was used as the flocculating agent. A granular form of PAM was applied in 4 oz increments to each wattle in the ditches leading to basin 1 (Figure 18). The ditch and wattles were checked after each qualifying storm event to see if more PAM needed to be applied. For the NC86 site, PAM was also applied inside slope drains and on inlets to each basin.

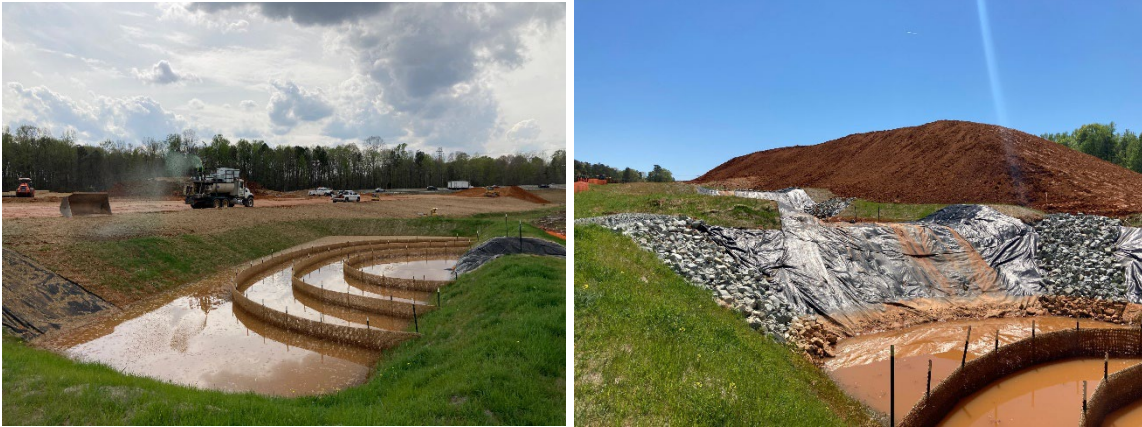
**Figure 19.** Basin A and Basin C-3 (tiered) at the I-40/NC86 site.

In general, this site was very well managed and the sediment control devices constructed properly (Figure 19). The first samples were obtained several days after a rain event on March 1, 2023 and the turbidity levels were similar to those found in the basins a week earlier (Table 2). NCSU staff applied PAM after that storm to check dams, basin inlets, and pipes, and turbidity levels dropped considerably over the subsequent storms even with the addition of stockpiles and other disturbances (Figure 20). This suggests that the combination of a well-managed site, good sediment control device construction, and distributed flocculent applications can reduce turbidity substantially.

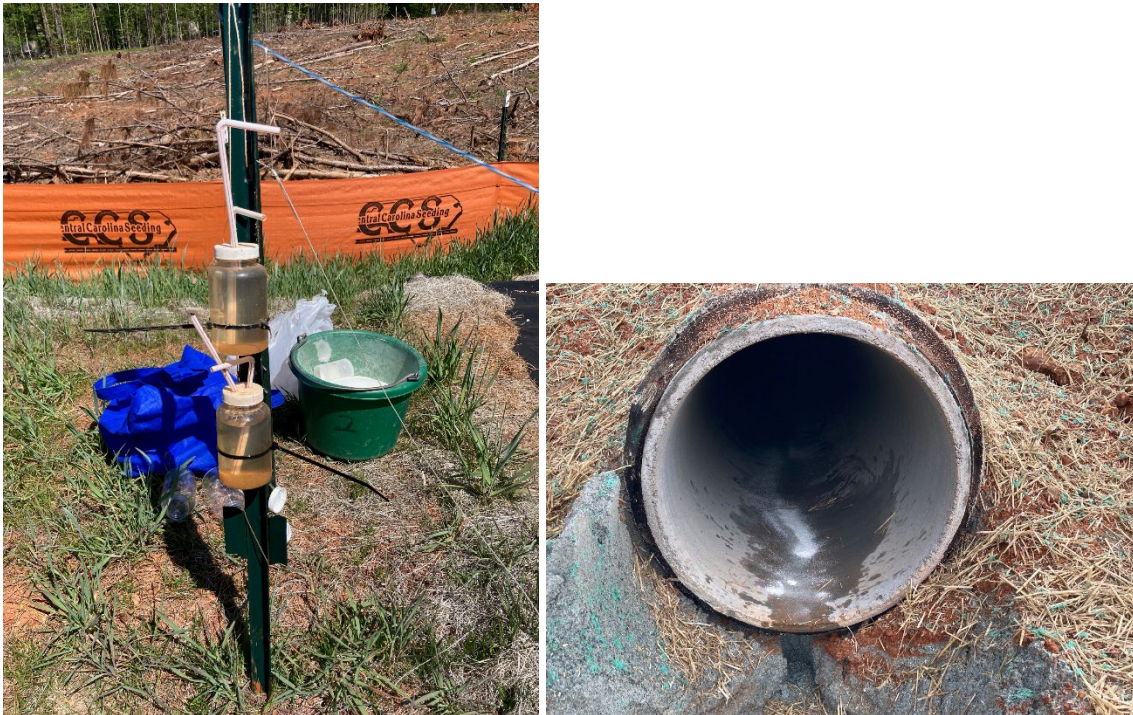
**Figure 20.** Stage samplers and example of PAM application in storm pipe at the I-40/NC86 site.

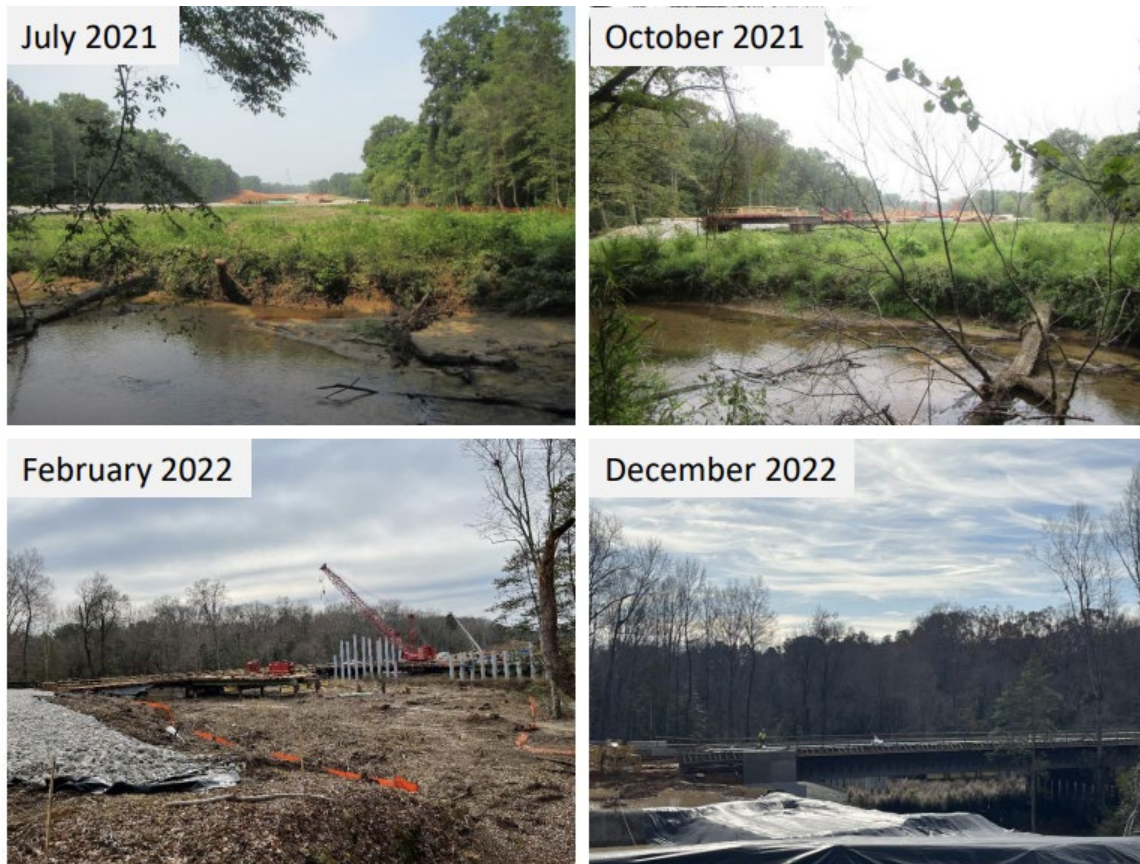
**Figure 24.** Construction progression of the bridge over Swift Creek.

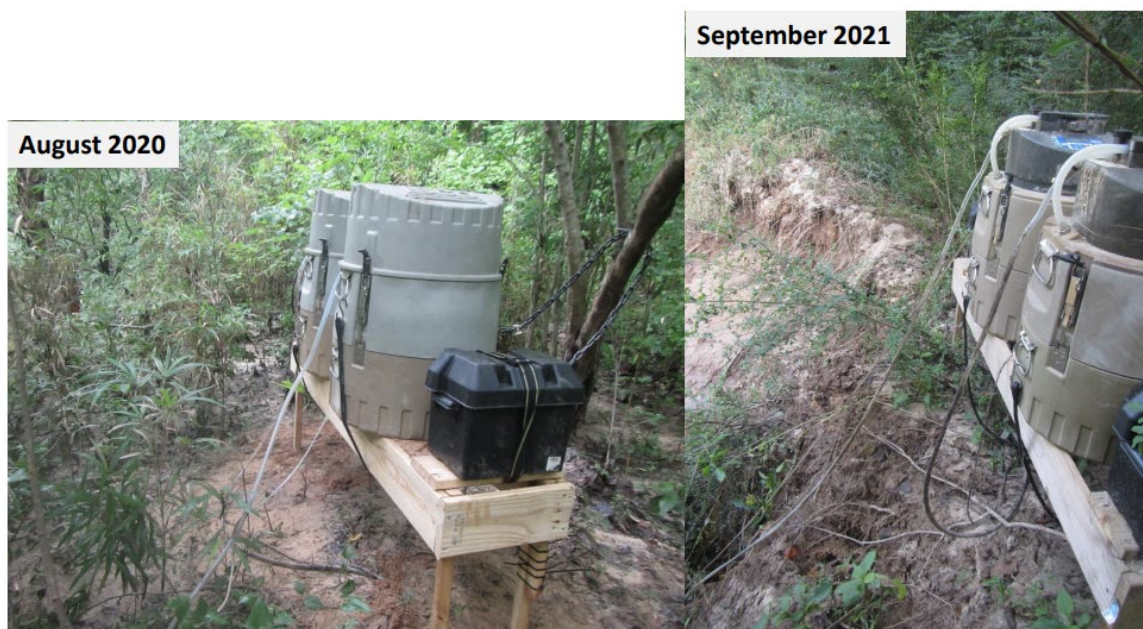
**Figure 25.** Stream bank erosion on Swift Creek upstream of the construction site.

During the monitoring of Swift Creek, other environmental pressures were found on the creek besides potential sediment loads from constructions. First, Swift Creek level changed a lot during storm events. This caused stream bank erosion to happen at all locations monitored. In particular, the upstream site had the most stream bank erosion

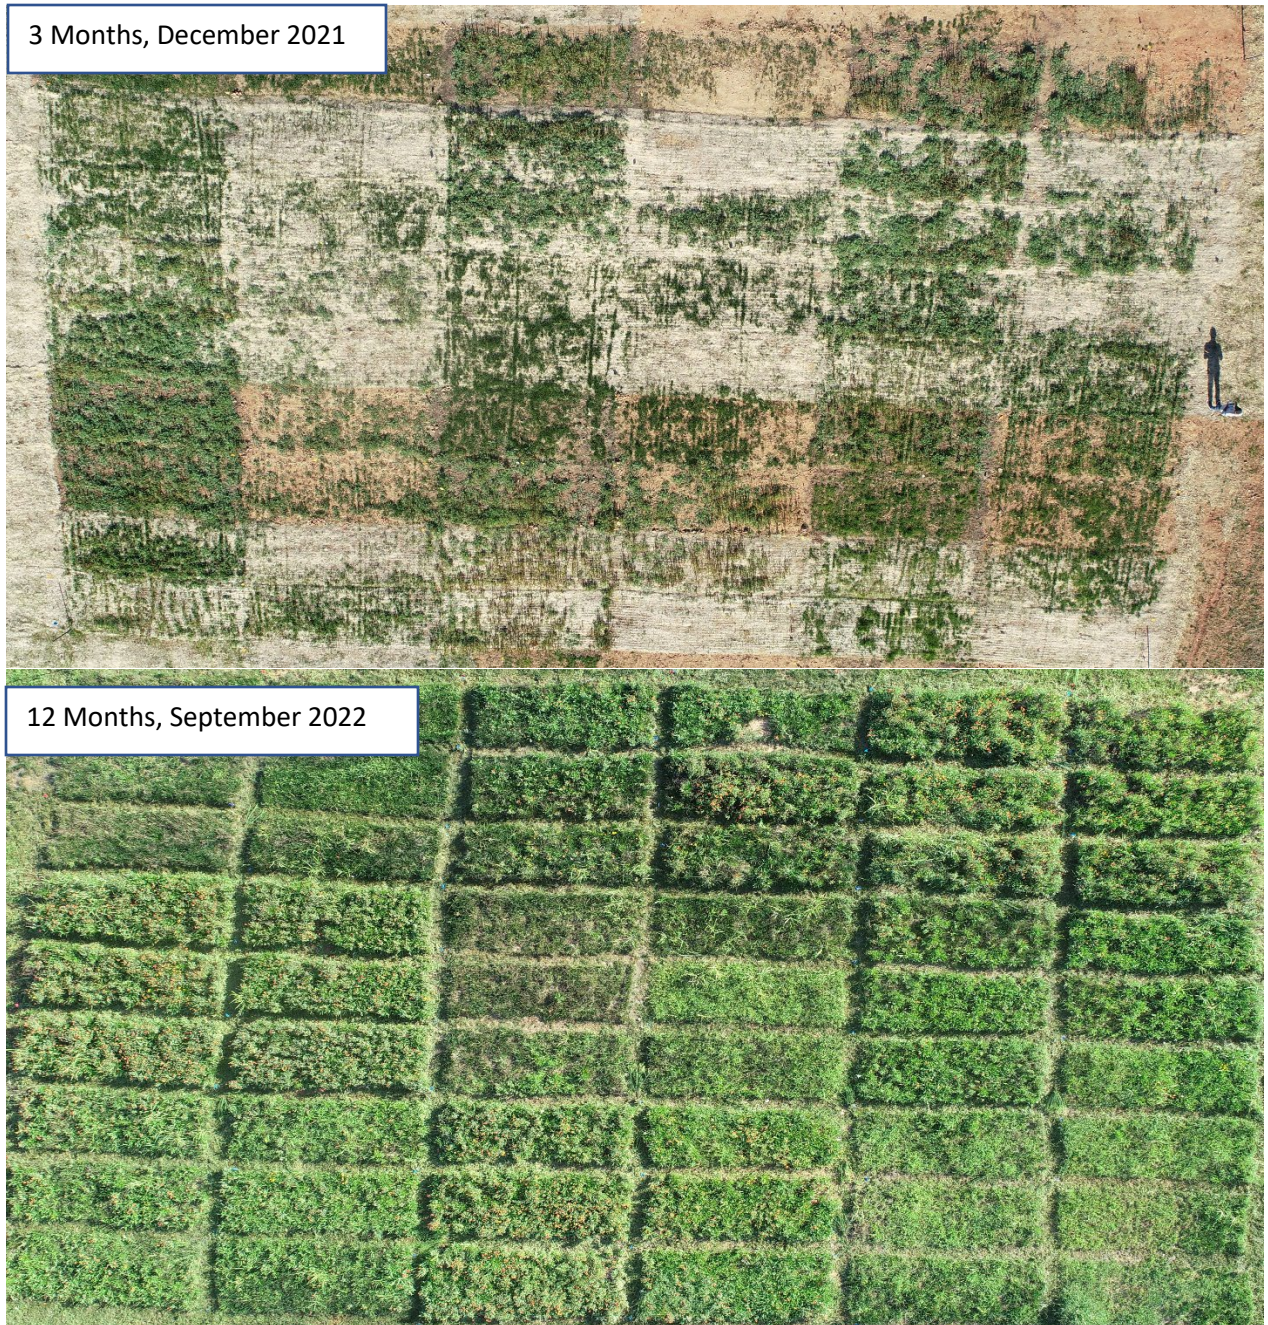
**Figure 27.** Vegetation cover at the established plot at 3 Months (December 2021) and 12 Months (September 2022).

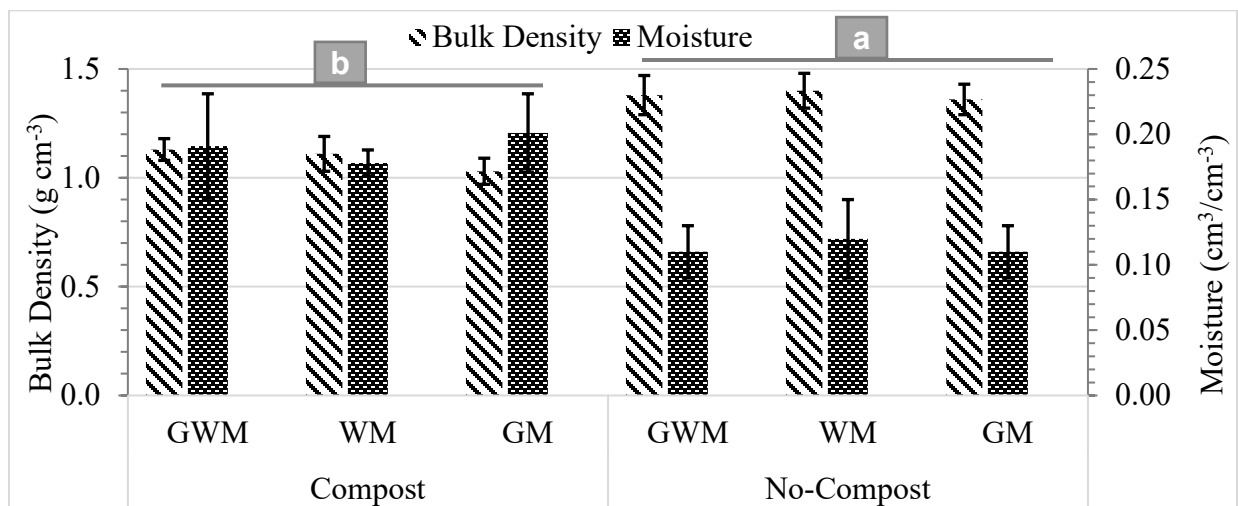
**Figure 31.** Soil bulk density and moisture content after 12 Months.

The 30 % compost incorporation significantly decreased soil bulk density and increased moisture content (Figure 31). There was an 18-25% decrease in bulk density and a 48-83% increase in moisture content. There were no statistical differences between vegetation types for bulk density or moisture content. Compost amendment seems to be the factor changing soil physical properties verses vegetation type in the short-term (< 1 year).

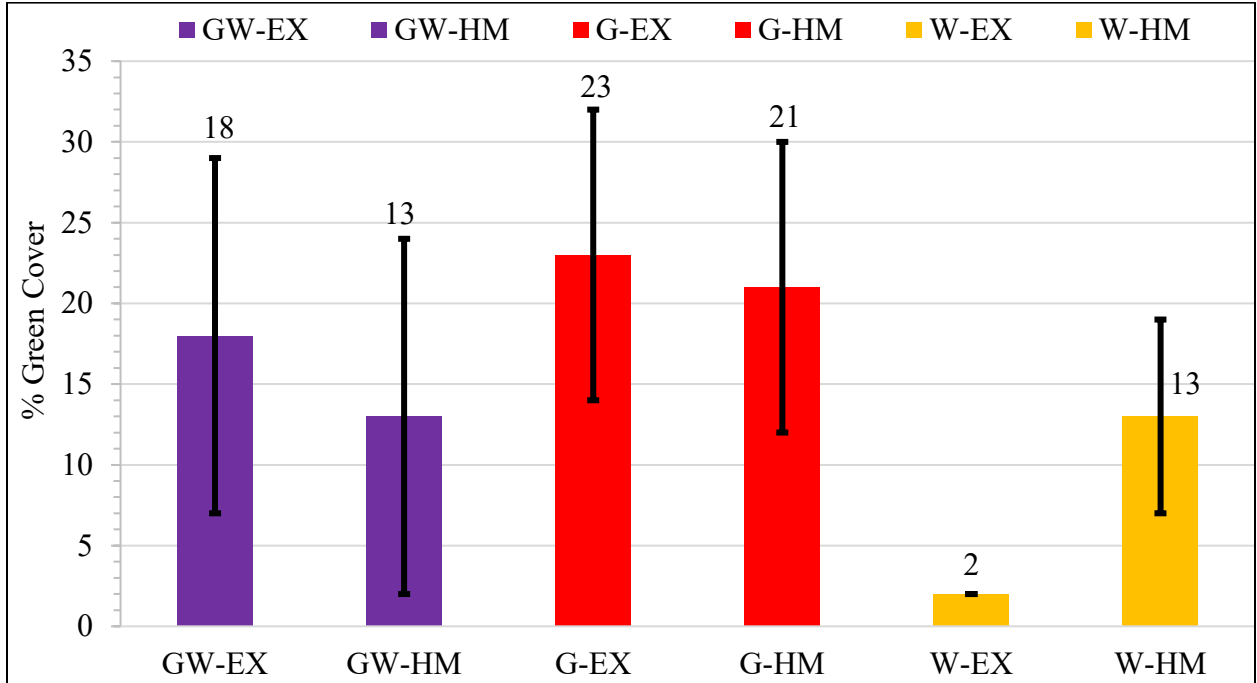
**Figure 36.** Green vegetation cover (%) after 1.5 months of plot establishment. Here, Ex is excelsior, and HM is hydro mulch covers.

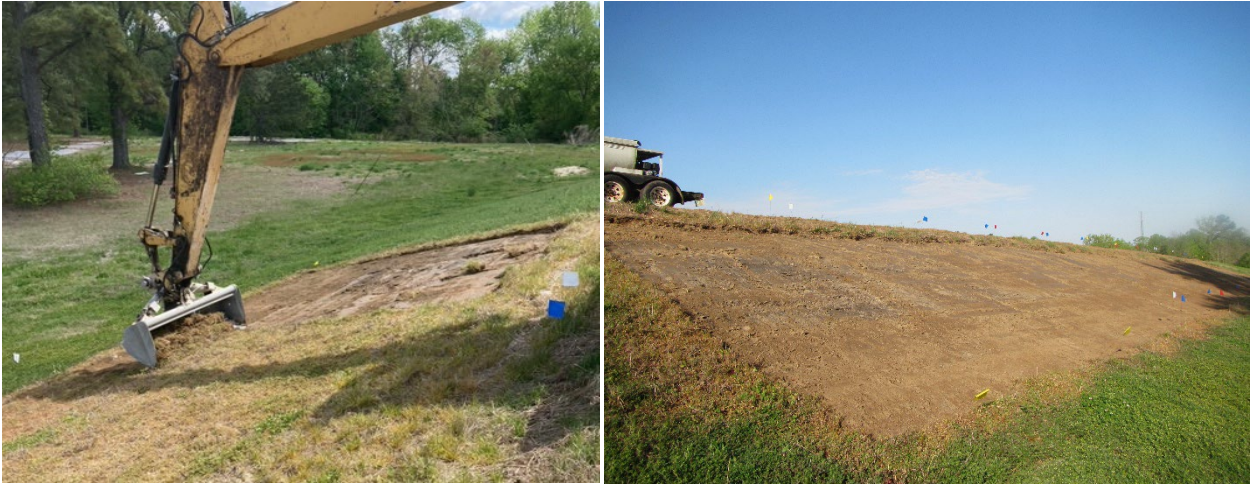
**Figure 37.** Location of plot in the Kingsboro Industrial Area. The existing vegetation was scraped off before installing the treatments.

This study site was in Tarboro, North Carolina, USA (35.930163, -77.650839), where a new industrial park was being established. The plots were established in April 2021 on a fill slope that was made as an entry road in that area (Figure 37). The plots areas were scraped to bare earth with an excavator before planting.

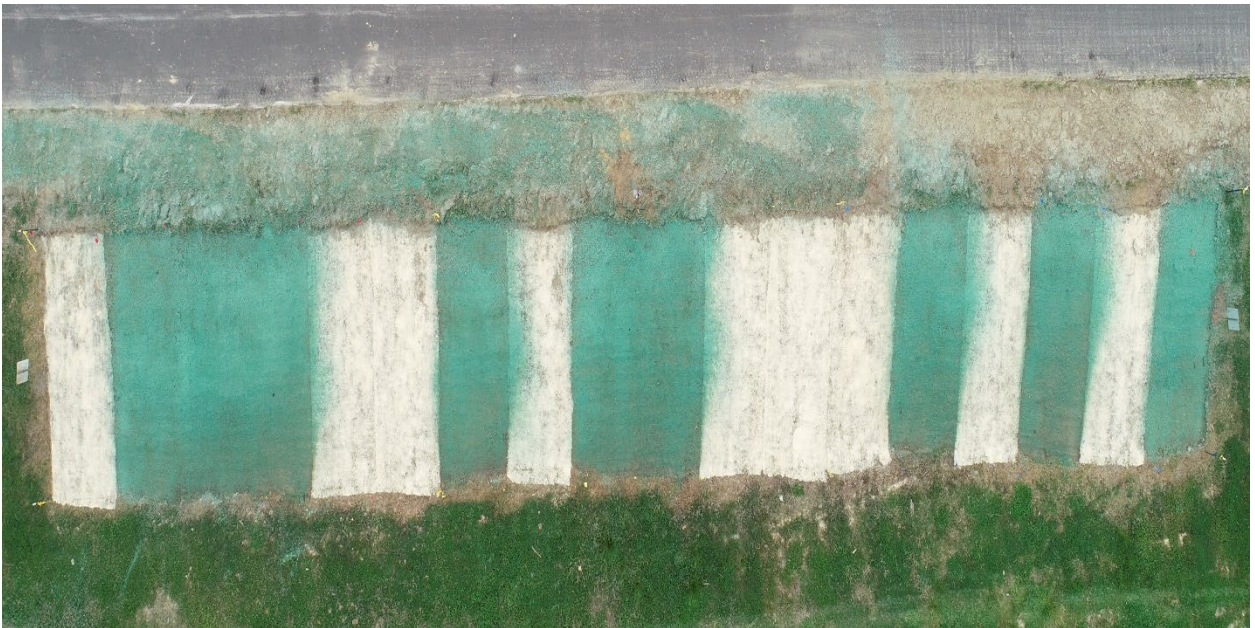
**Figure 38.** Drone image at plot establishment (16 April, 2021). The green strips are the hydromulch plots (actual color of the hydromulch).

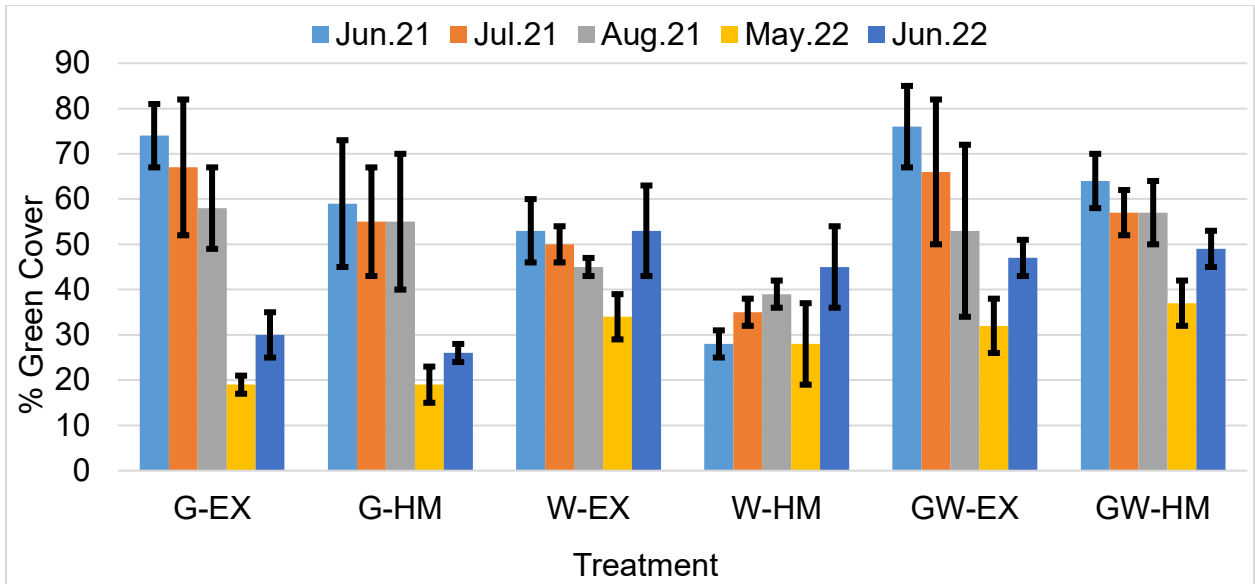
**Figure 39.** Green vegetation cover at Kingsboro; G: grass, W: wildflowers, EX: excelsior & HM: hydro-mulch.

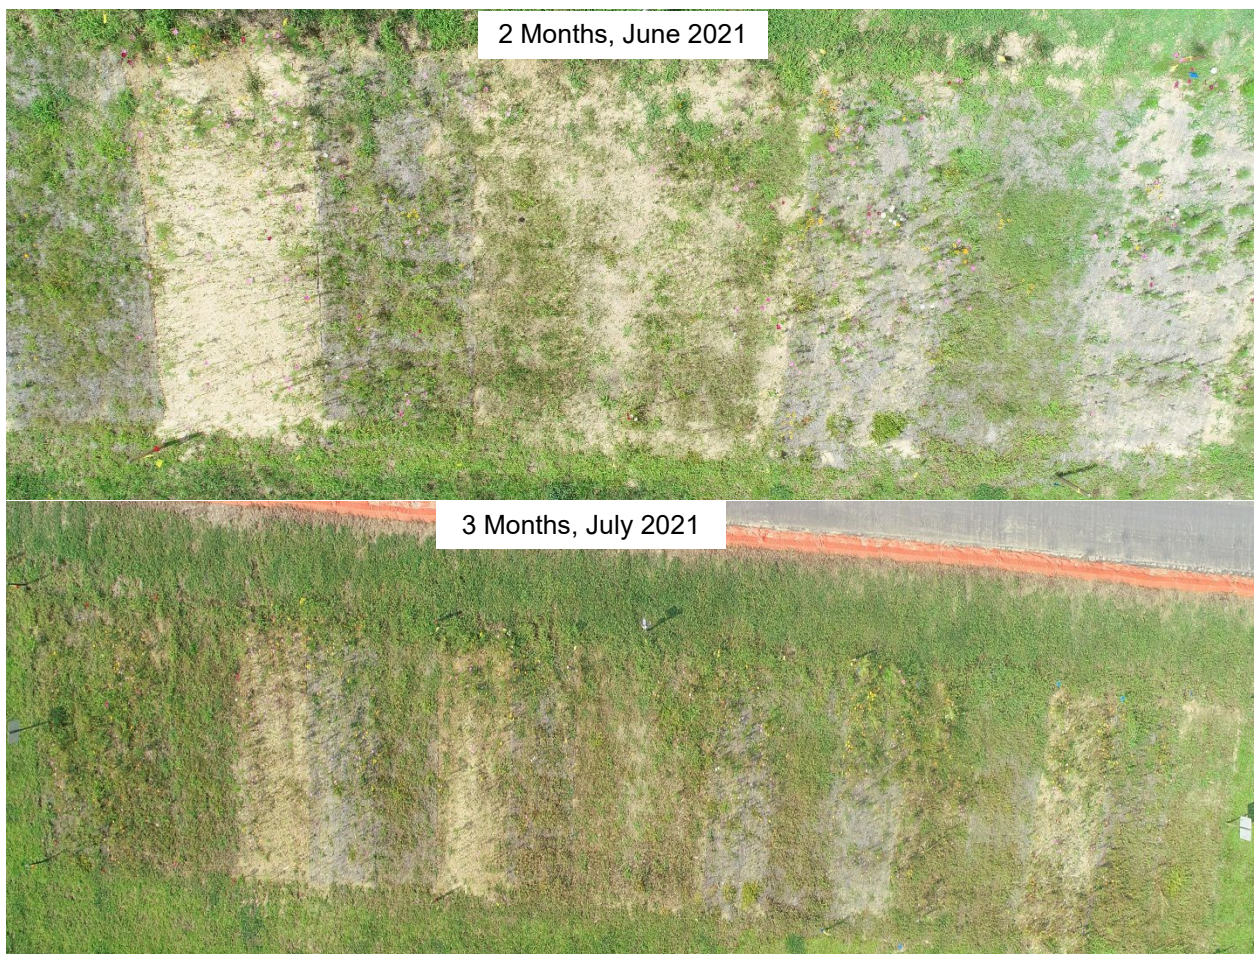
**Figure 40.** Green vegetation cover at Kingsboro 2 and 3 months after seeding.

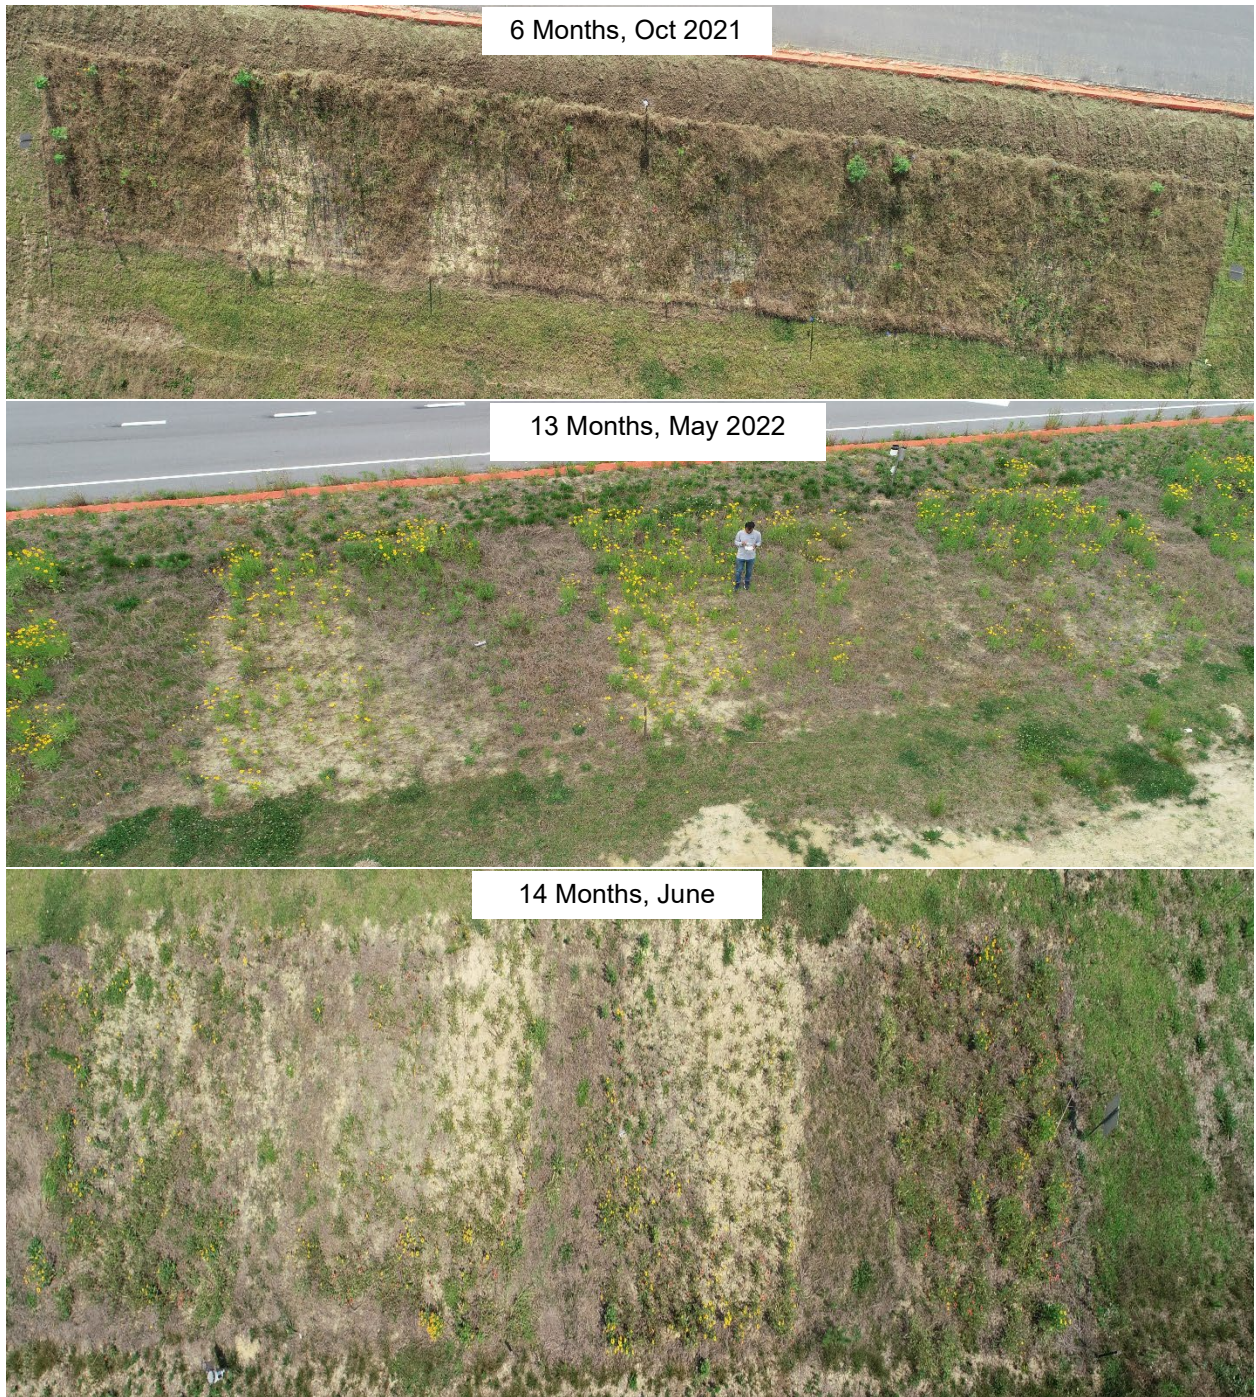
**Figure 41.** Green and brown vegetation cover at Kingsboro 6, 13, and 14 months after seeding.
