Division of Planning Research On-Call Task#8 - Assessment and Prioritization of Culverts for Enhanced Fish Passage

Project ID Number: 111440 (Task 8)

January 2022

Final Report

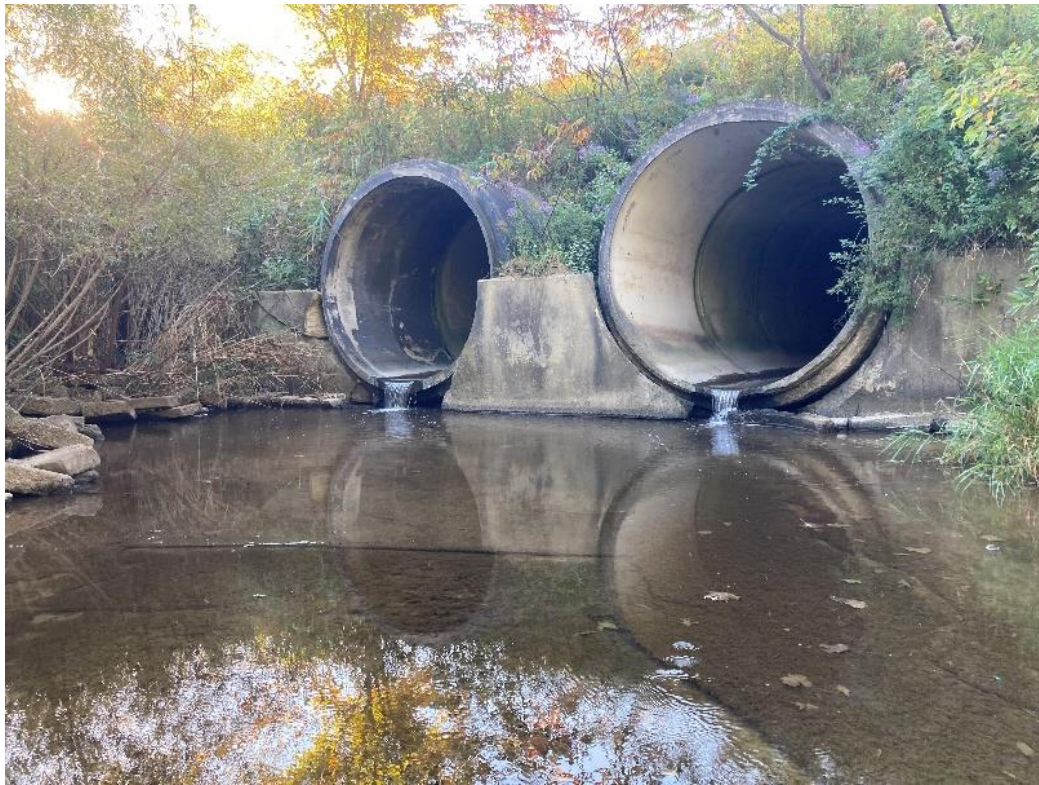
Brett Rodstrom with Western Reserve Land Conservancy provided a tour of this site. Red Brook is located on the site of a 150-acre golf course that closed in 2016 and was purchased by the Park District. The site visited is a double barrel perched culvert approximately 90 feet long, culverts are perched about one foot above the water level at base flow (Figure 3). During high flow larger fish may be able to manage passage through the culvert but not the small and medium size fish due to the high velocity through the culvert at high flow. Red Brook is a direct tributary to Lake Erie; Sea Lamprey are a risk to migrate from the lake upstream. The Park District is doing a stream restoration project on this site downstream of the culvert utilizing Great Lake Restoration Initiative (GLRI) funds.

Figure 3 Red Brook site in Ashtabula County.

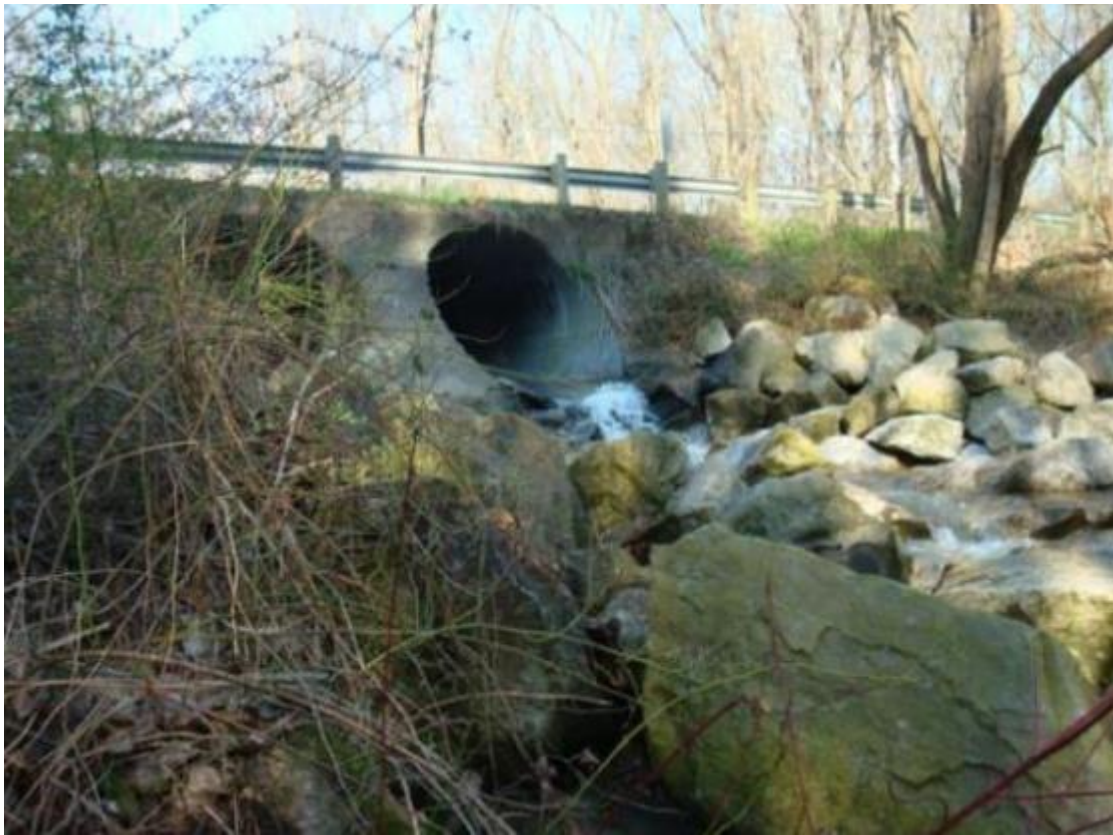
Figure 4 Perched culvert at Sperry Road Bridge. Photo Source: Chagrin River Watershed Partners – East Branch Chagrin.

Josh Meyers and Kevin Saracino with Chagrin River Watershed Partners provided an overview of this site. A large structure with a series of drops, this project is identified in the NPS-IS plan but no plans yet for implementation (Figure 4). The elevation difference from downstream to upstream is substantial, the project would require regrading and upgrading the culvert to a bridge structure. Sea Lamprey are not found in the Chagrin, they are not a risk or concern at this time. This section of stream meets Coldwater Habitat and Scenic Designation in sections. The upstream section could support Brook Trout habitat, however, no fish data has been collected upstream.

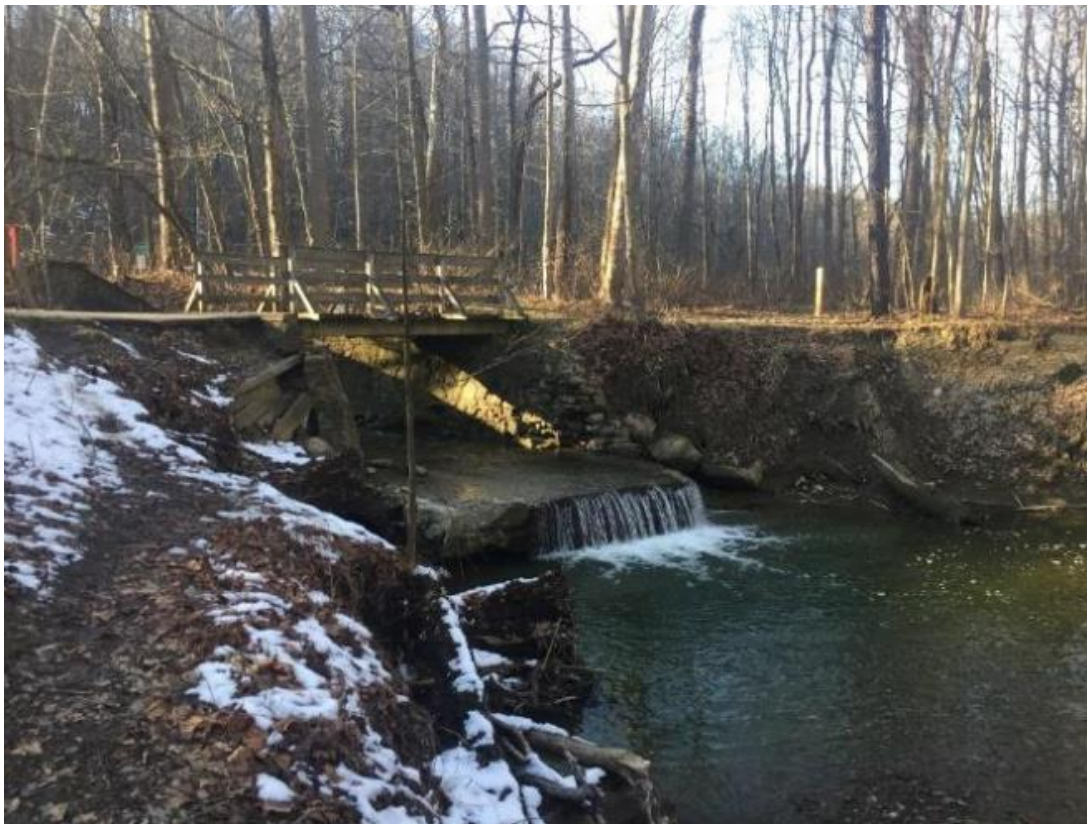
Figure 5 Pre-construction photo of drop-structure at Beechers Brook. Photo source: Chagrin River Watershed Partners – Griswold Creek.

Jenn Grieser and Josh Phillips with Cleveland Metroparks provided a site tour at Beecher's Brook a project located in the Cleveland Metropark. This is a completed project constructed in 2021. Implementation included bridge installation, stream restoration of five pools and riffles installed to grade, and streambank stabilization plantings. Previously this site was a large box culvert with a two-foot plunge pool and bank scour downstream (Figure 5). Upstream fish survey showed only one species (Creek Chub – very tolerant) and downstream showed 15 different species, representing good diversity. Migration was blocked at the drop structure from downstream to upstream. The goal for implementation was to address streambank erosion and fish passage. Beecher's Brook project was funded by Ohio EPA 319 grants and Northeast Ohio Regional Sewer District. There was not a concern of Sea Lamprey migration since they are not found in the Chagrin River. The post construction monitoring is scheduled for 2022.

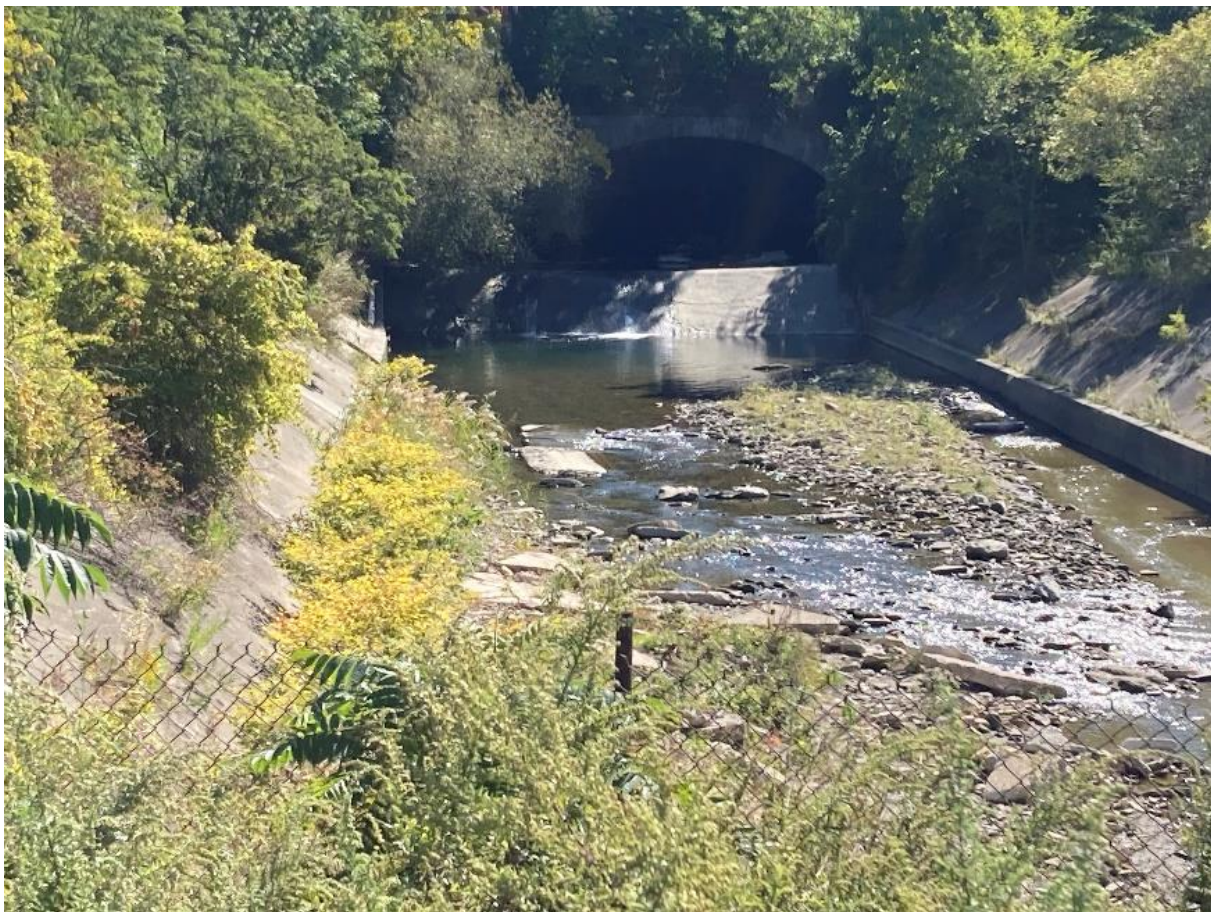
Paul Kovalick and Jon Brauer with Northeast Regional Sewer District (NEORS) provided a project overview. Jenn Grieser, Cleveland Metroparks, and Mark Carpenter, ODOT accompanied the tour visit. This site is a direct tributary to Lake Erie consisting of a 900 ft concrete channel and a drop culvert structure (Figure 6). NEORS partnered with the Army Corps of Engineers on a Feasibility Report for passage over the concrete culvert structure. This site has been identified as an 'Area of Concern' therefore allowing access to GLRI funds. NEORS is the local sponsor and will hold the easement with the railroad while Ohio EPA and Army Corps of Engineers partnership allows access to GLRI funds. The goal is to allow fish connectivity upstream and downstream of this blockage. Timeline for this project is 60% design by spring 2022. Easements will be secured after 50% design is complete. Note: NEORS inventories 450 miles of stream and 4000 crossings, focusing on flooding, erosion, and water quality.

Figure 6 Euclid Creek Project under design with partners.

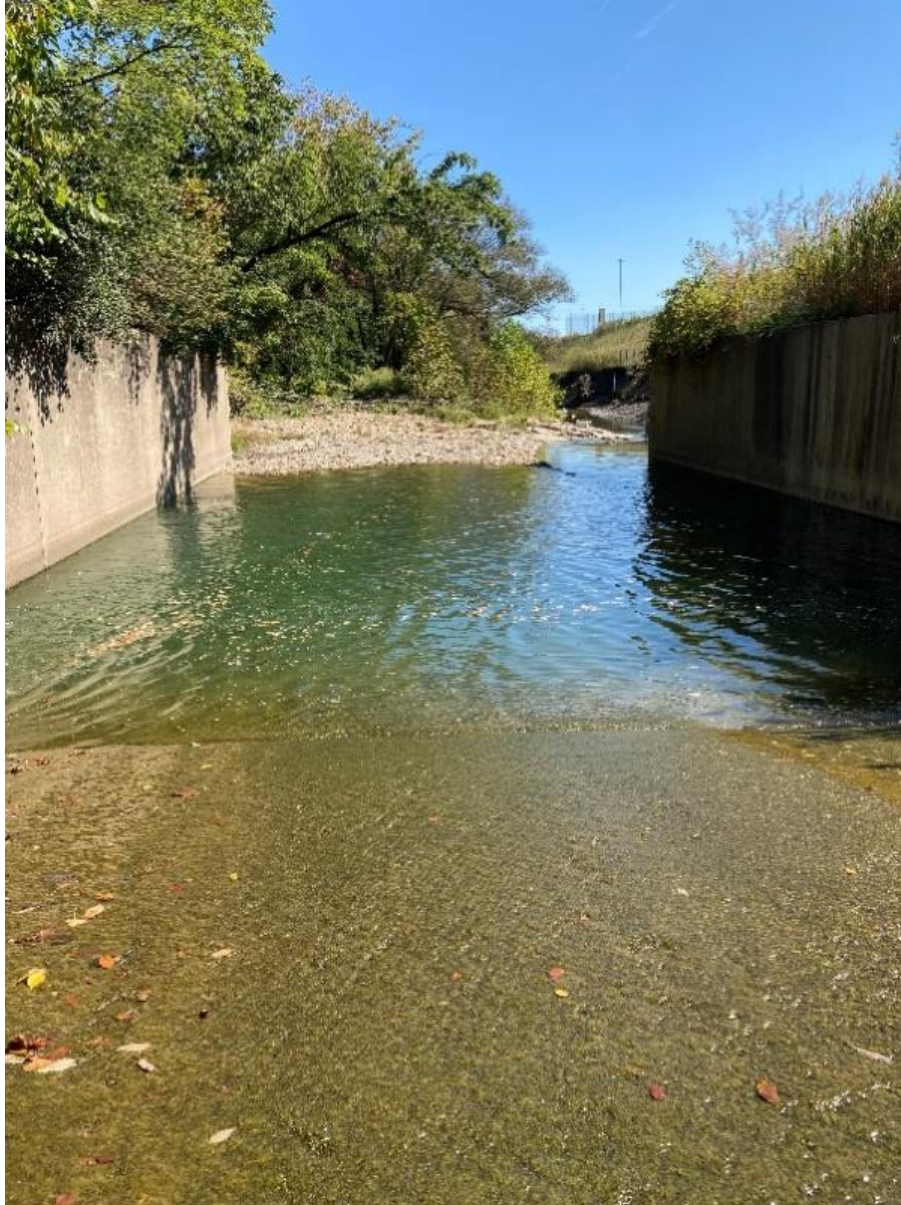
Figure 7 West Creek Project site under design with partners.

Ivan Valentic and Jon Brauer, NEORS provided a project overview. Jenn Grieser, Cleveland Metropark, and Mark Carpenter, ODOT accompanied the tour. The planned project site consists of a 6,500 ft long channel restoration along I-77, with the removal of a 1,000 ft long concrete 'flume' (Figure

7). West Creek has been historically moved, filled, channelized, stripped of riparian corridor, and reinforced with concrete to control the lateral migration of the creek within this urbanized area. The goals of this restoration project are to improve habitat, water quality, and fish passage and protect infrastructure of I-77. The approach is to raise the grade (4-5 ft), reconnection to the floodplain, create a large cross-sectional area, install woody debris, remove the concrete walls and flume, and replant the riparian corridor. Many partners including Ohio Regional Sewer District and ODOT are involved in this project estimated to cost \$15-16M and to be completed in 2024 (ODOT PID 113210, March 2020).

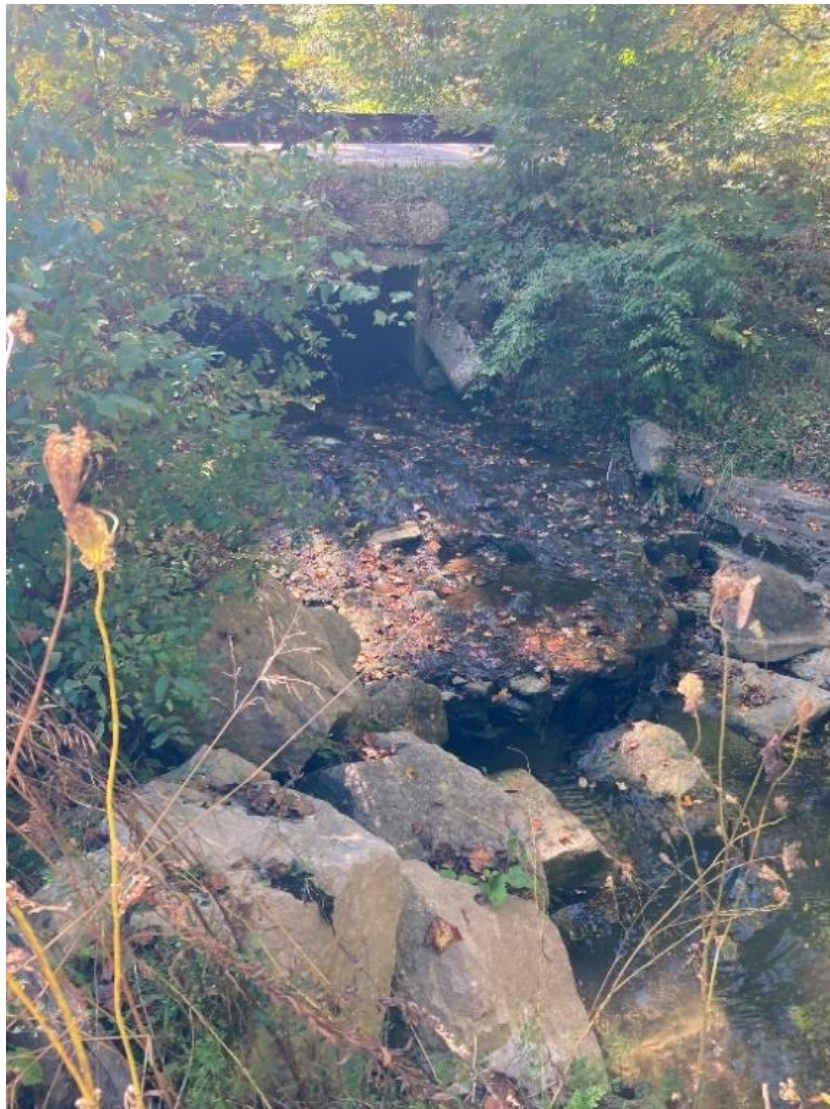
Figure 9 Johnsons Creek downstream of the culvert.

Jenn Grieser and Mike Duralet with Cleveland Metropark provided a site visit. Mike Johnson with Summit Metro Park accompanied the tour. This site located in the Cleveland Metropark- Hinckley Reservation, consists of a box culvert blocking fish passage from downstream (Figure 9) to upstream (Figure 10). The creek sustained a large precipitation event that created a substantial 'down cut' in 2014, causing lateral migration and disconnection of upstream and downstream portions of the creek at the culvert. According to data Michael Durkalec with the Cleveland Metropark shared the upstream portion only had 3 species of fish while downstream had higher species diversity (15 species) and four times the biomass. This project goal is to restore fish passage, reduce erosion, and fix the culvert that failed inspection. The approach is to replace the culvert with a 4-sided box culvert with the bottom buried by one foot of natural substrate. The project is funded by Ohio EPA 319 and has 30% design complete and the culvert replacement will be constructed and surrounding area revegetated in 2022.

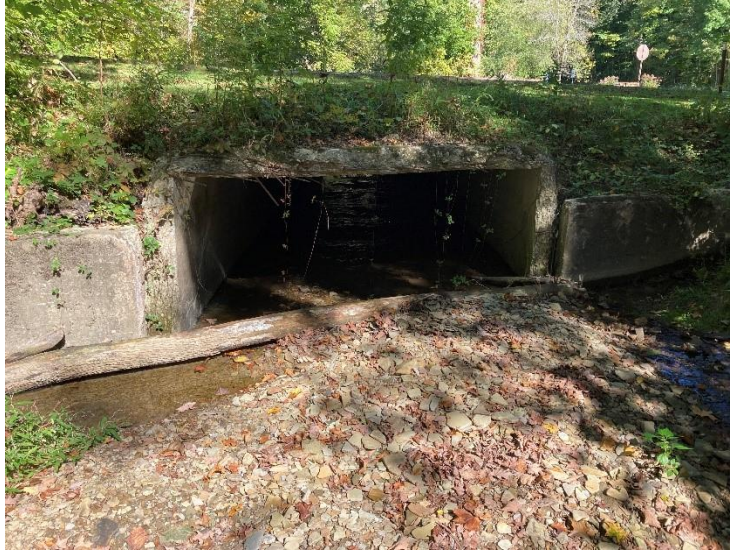
Figure 10 Johnsons Creek upstream of the culvert.

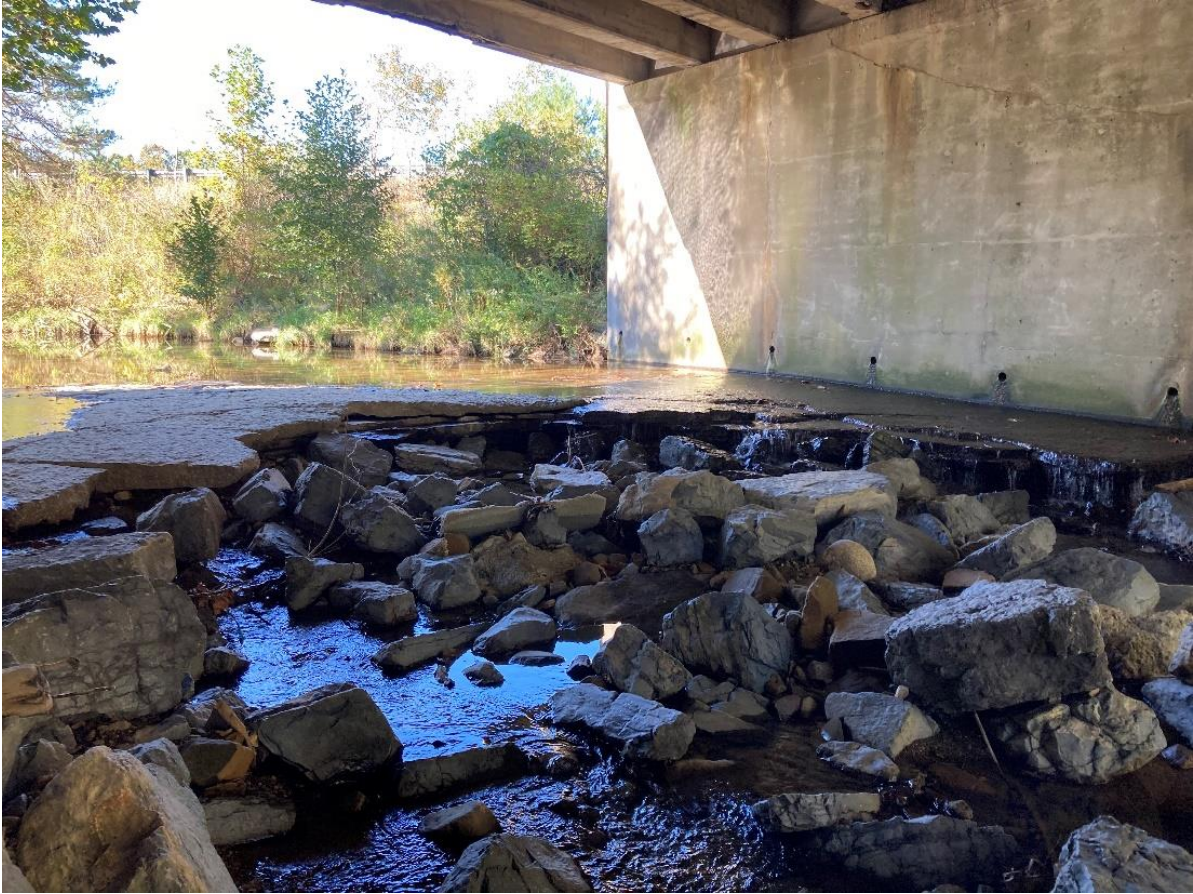
Figure 11 Furnace Run Project in the Summit Metro Park.

Mike Johnson, Summit Metro Park, provided a tour of the Furnace Run previously constructed project. Furnace Run is a tributary to the Cuyahoga River. At low flow no fish can migrate upstream, although at high flow this one-foot elevation difference is passable. Six grade control structures were installed downstream to raise the grade up to the upstream bed elevation as shown in the Figure 11. This project was funded by Ohio EPA 319 grant in 2014. No post construction monitoring has been conducted.

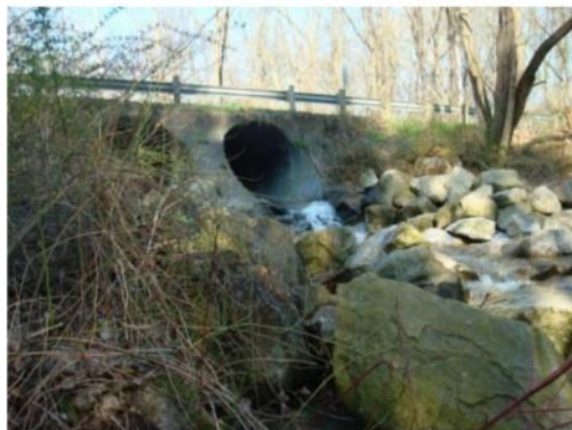
Figure 36: Unnamed tributary to East Branch at RM 15.35 is impaired by a perched culvert that acts as a fish barrier.

An unnamed tributary to East Branch at RM 15.35 is in partial/full attainment of its CWH/EWH designation. Sampling by Ohio EPA in 2003 – 2004 indicated the causes of impairment at this site as habitat alteration, flow alteration, and sedimentation. Nonpoint sources of impairment included a bridge on Sperry Road with a perched culvert that acts as a barrier to fish migration to upstream portions of this stream. Rip-rap was added to this structure in 2006 – 2007.

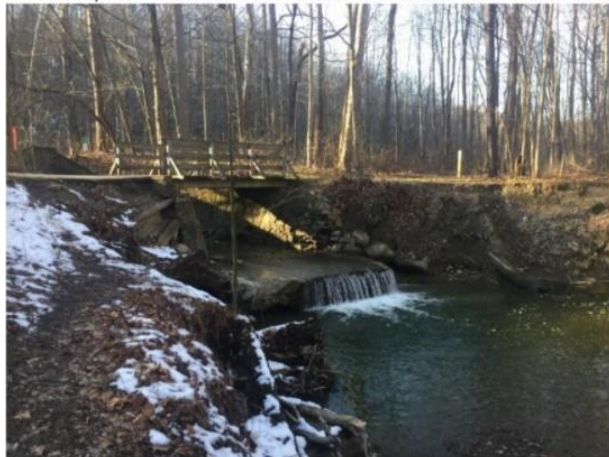
Figure 24: Drop structure acting as fish migration barrier at Beecher's Brook near Wilson Mills trailhead at North Chagrin Reservation

Some of the tributaries in this critical area also have dam structures or other barriers that impede fish migration. At Beecher's Brook near Wilson Mills trailhead, the drop-off structure does not allow for fish to migrate upstream. In addition, near vertical banks contribute to in-stream sedimentation and water quality degradation.
