Cost-effective Bridge Decks for Improved Durability and Extended Service Life – Experimental Testing and Performance Analysis of a Corrugated Core Bridge Deck with Structural Adhesive Bonding

FINAL REPORT

June 2023

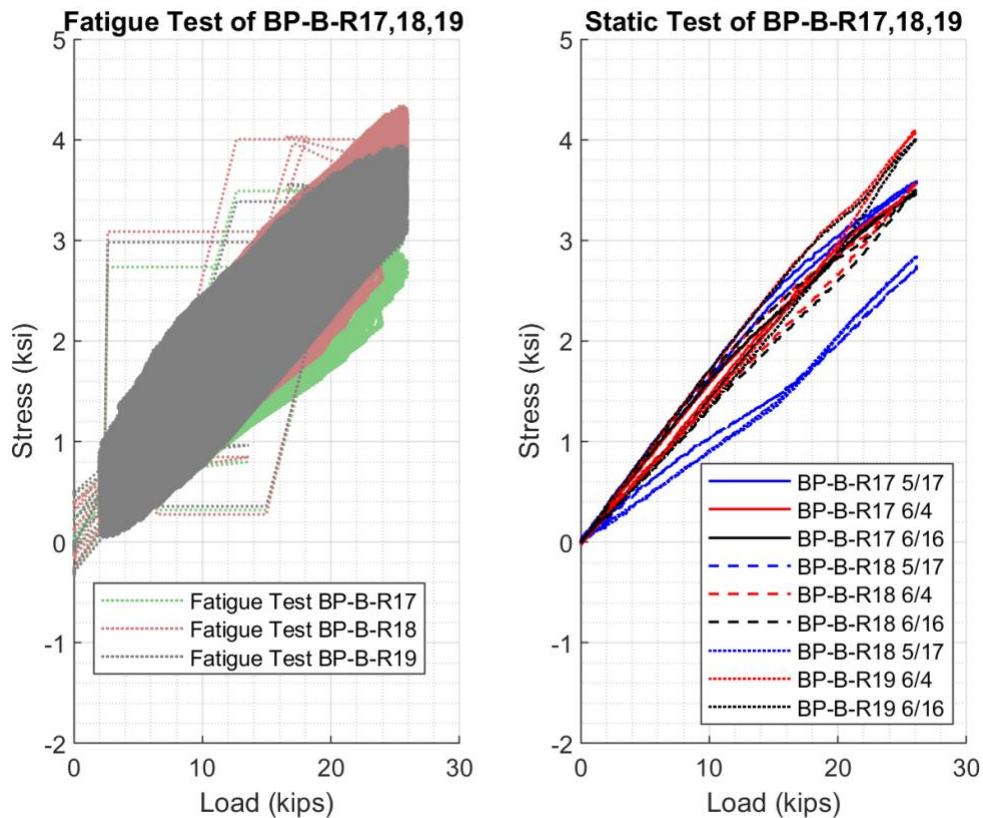
Figure 23 illustrates the responses of the gauge BP_B_R17,18,19, positioned beneath the second corrugation on the underside of the bottom plate. This gauge was installed in situ and accordingly was not disturbed by the fabrication process. Arm R17 was aligned longitudinally along the deck, while the arm R19 was oriented transversely. Arm R18 was situated diagonally between R17 and R19.

Figure 23 Fatigue and static test results of BP_B_R17,18,19

The results depicted in the graph exhibit a linear response, without any notable variation among the tests. The stress in the transverse direction during the first test was slightly lower than the other two tests, although the difference was not significant. Unlike the gauges located near adhesive connections, this particular gauge was positioned beneath a welded connection, which likely remained unaffected by the fatigue testing. The increase in the gauge response between the initial and subsequent static tests was likely due to the degradation of the adhesive connections at the deck plate, rather than the adjacent welded connection.
