# Deployment of a Snowplow Driver-Assist System

**JUNE 2023**

Research Project  
Final Report 2023-27

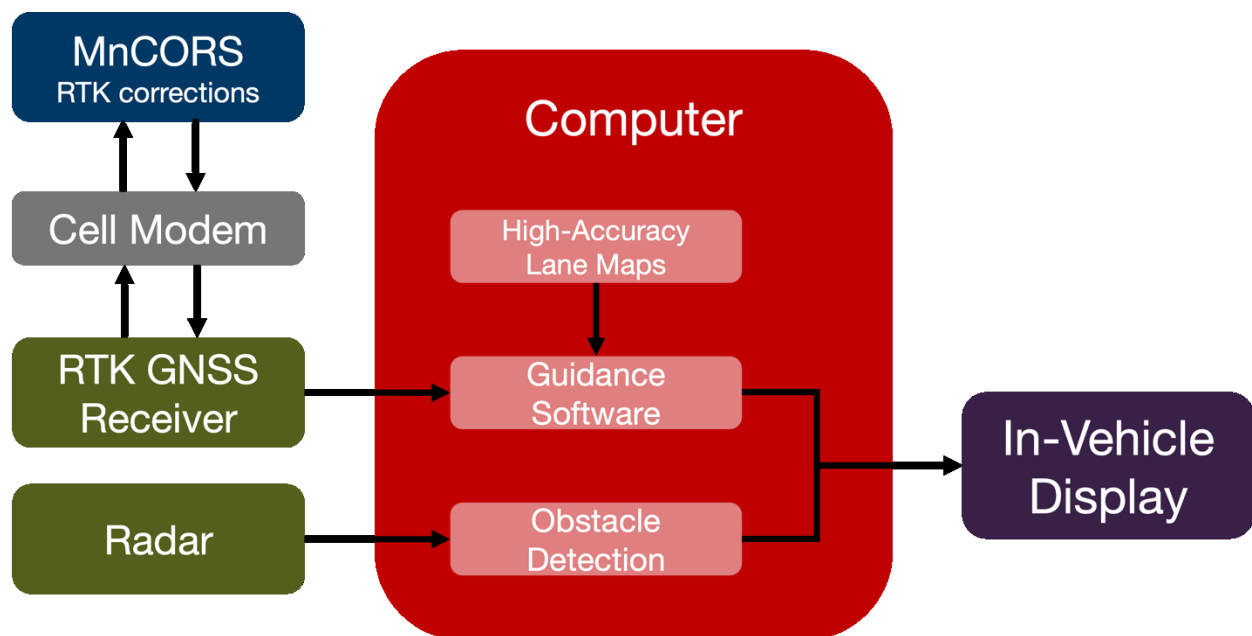
Figure 2.1 Snowplow DAS Overview Diagram

The lane-guidance system incorporates high-accuracy digital maps and an RTK GNSS receiver to determine the vehicle's position within the lane. The receiver uses a cellular modem to receive GNSS corrections data from a continually operating reference station (CORS) network. The forward-obstacle-detection system uses a forward-facing radar mounted on the top of the snowplow to identify potential hazards in the snowplow's path. This information is provided to the operator through an LCD screen mounted on the dashboard and a speaker mounted behind or next to the operator. Figure 2.1 illustrates the major system components.

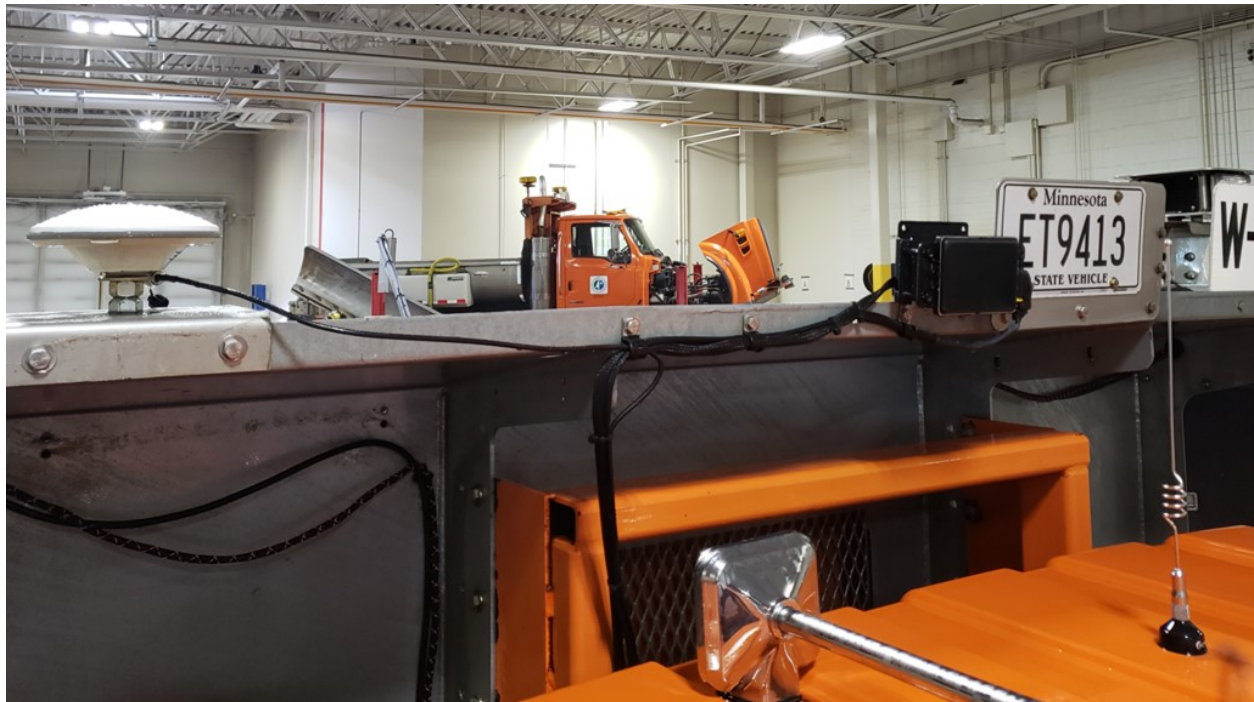
**Figure 2.2 GNSS antenna and radar mounted on top of snowplow**

The RTK GNSS receiver is the key hardware component in the lane-guidance system. Current deployments use a Swift Navigation Duro Inertial GNSS receiver (Swift Navigation, 2023). This receiver communicates with the Minnesota Continually Operating Reference Station (MnCORS) Network (MnDOT, 2023) through a cellular modem providing internet connectivity. This allows the receiver to determine the snowplow's position with an approximate accuracy of 1-3 cm. The receiver also provides measures of the vehicle's speed, the quality of the position fix, and the vehicle's heading as determined by its movement history. Position fixes are provided by the receiver at a 10 Hz update frequency. The receiver is mounted inside the snowplow's cab behind or next to the driver and its antenna is mounted on the roof of the snowplow cab. Figure 2.2 shows the GNSS antenna as well as the radar mounted on top of the snowplow.

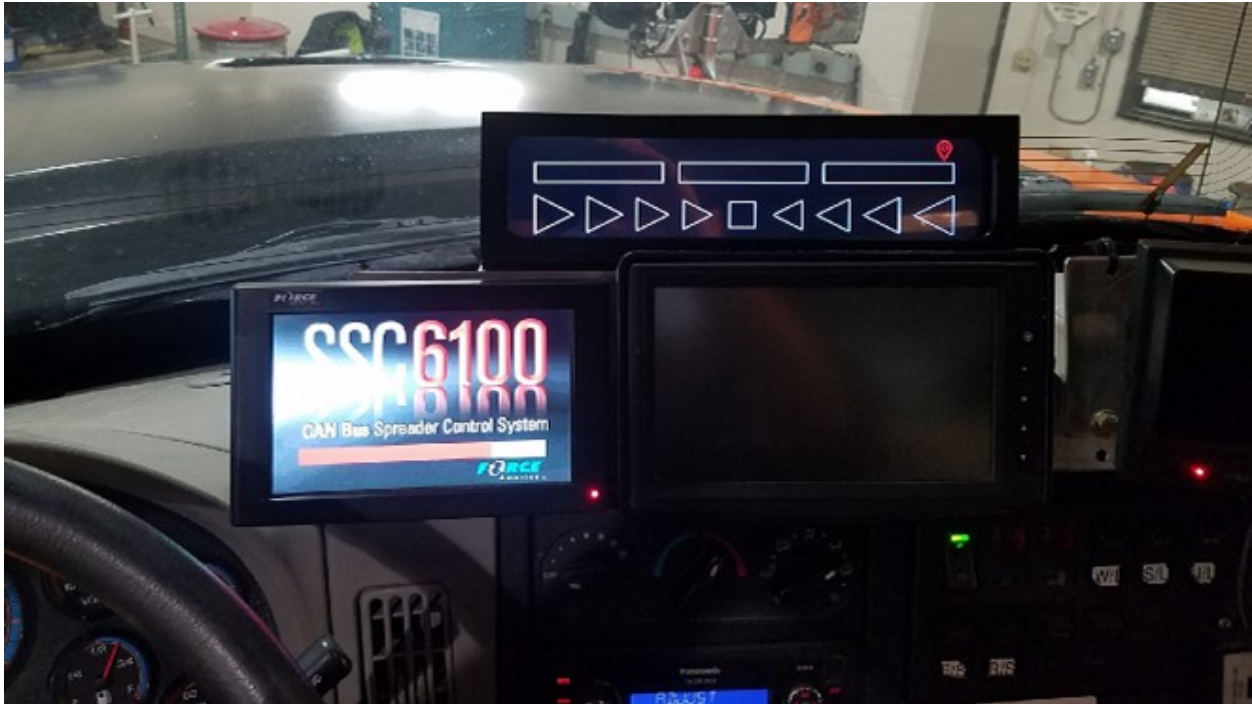
Figure 2.3 Driver display mounted on dashboard

the display mounted on the dashboard and Figure 2.4 shows an illustration of the display with all shapes lit up.

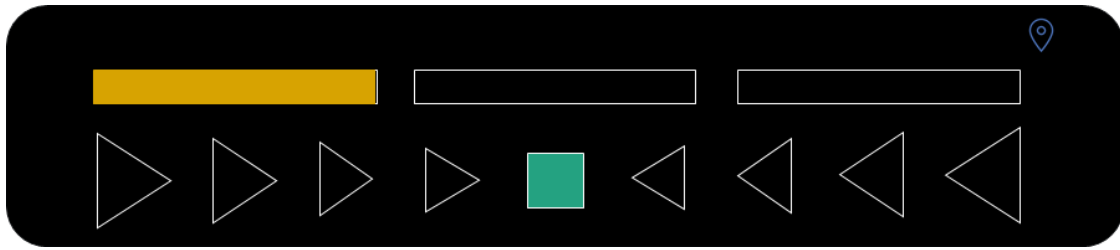
Figure 2.5 Display when snowplow is centered within lane

Figure 2.5 through Figure 2.9 illustrate how the display would indicate the snowplow's lateral position within the lane as it moves from centered to 4 ft to the left of center. Lateral deviations to the right of the lane centerline would have similar, although mirrored, indications. All these figures show the hazard warning bar turned on as if a hazard is detected to the left of the plow.

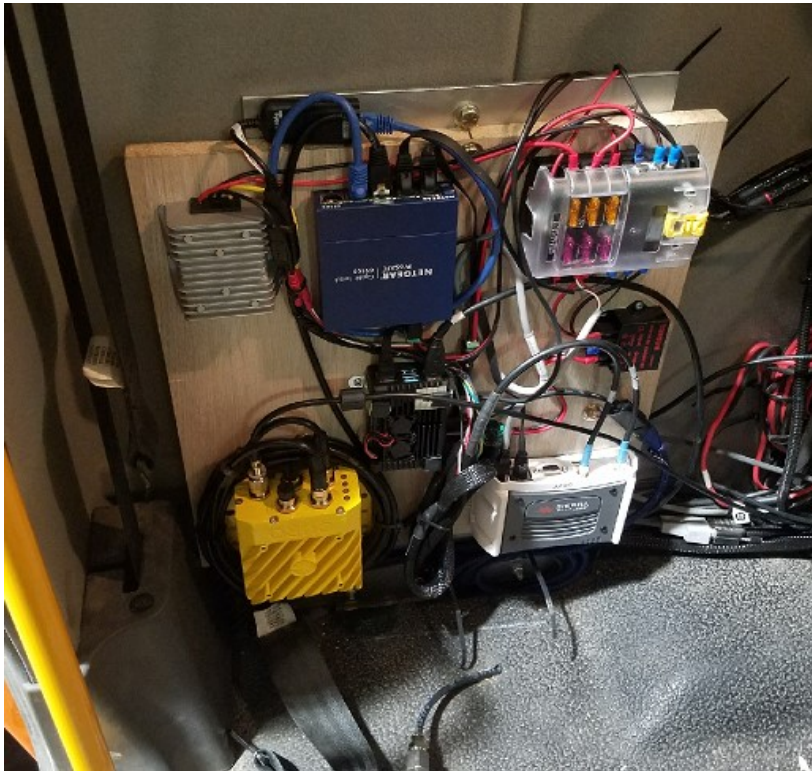
Figure 2.10 Interior System Components

The interior system components include the GNSS receiver, a cellular modem, a networking switch, and various power supply and distribution components. Additionally, the system's Raspberry Pi 4 computer is mounted here. Figure 2.10 shows the components mounted inside the cab.

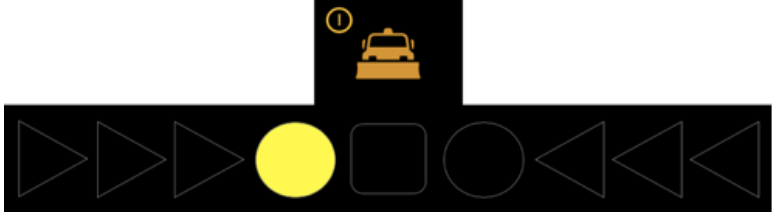
Snowplow Indicator Above Lane Guidance

Location Bar Indicator Above Lane Guidance

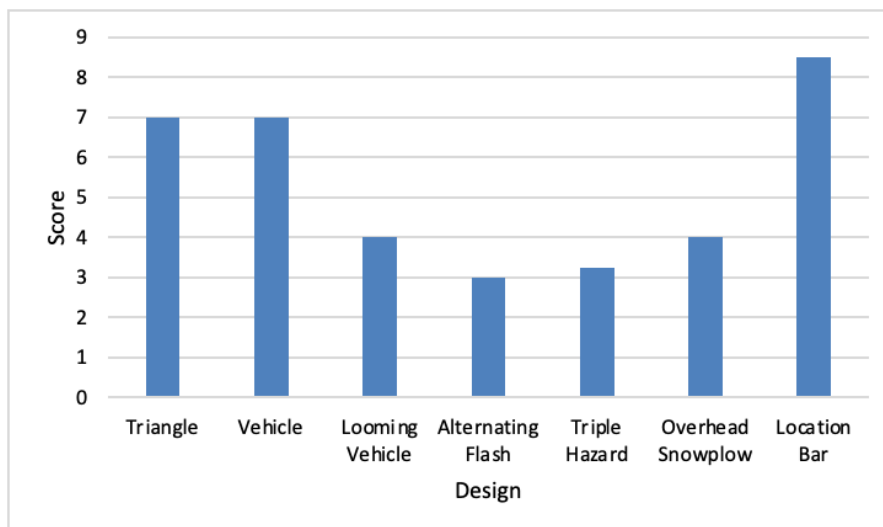
**Figure 3.1 User Preference Scores for Initial User Interviews**

Designs were scored based on participant rankings where a design ranked 1<sup>st</sup> place would receive 3 points, 2 points for 2<sup>nd</sup> place, 1 point for 3<sup>rd</sup> place, 0.5 points for 4<sup>th</sup> place, and 0.25 points for 5<sup>th</sup> place. Note that not all participants elected to rank the 4<sup>th</sup> and 5<sup>th</sup> place ranking. Scores were then added together across all participants. Participants consistently reported a preference for three designs: Location Bar Indicator (8.5 points), Triangle Indicator (7 points), and Vehicle Indicator (7 points).

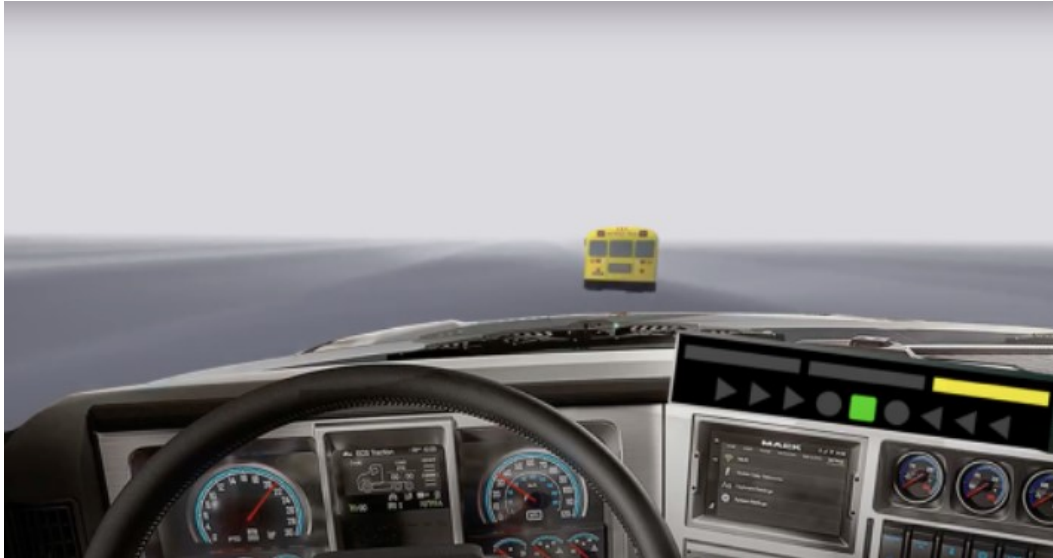
Figure 3.2 Screenshot of right warning indicator

For each of the warning designs, three videos were created which presented a stalled vehicle directly in front of the plow, to the left of the plow, and to the right of the plow. During the simulation, the forward obstacle warning indicator flashed according to the stalled vehicle position (i.e., front, left, or right) and played a sound alert that increased in frequency as the plow approached the obstacle. Figure 3.2 through Figure 3.4 show sample screenshots of the videos demonstrating the different warning interface designs. Appendix B presents screenshots of each video design with warning indicators and the corresponding stalled vehicle position (i.e., front, left, or right).

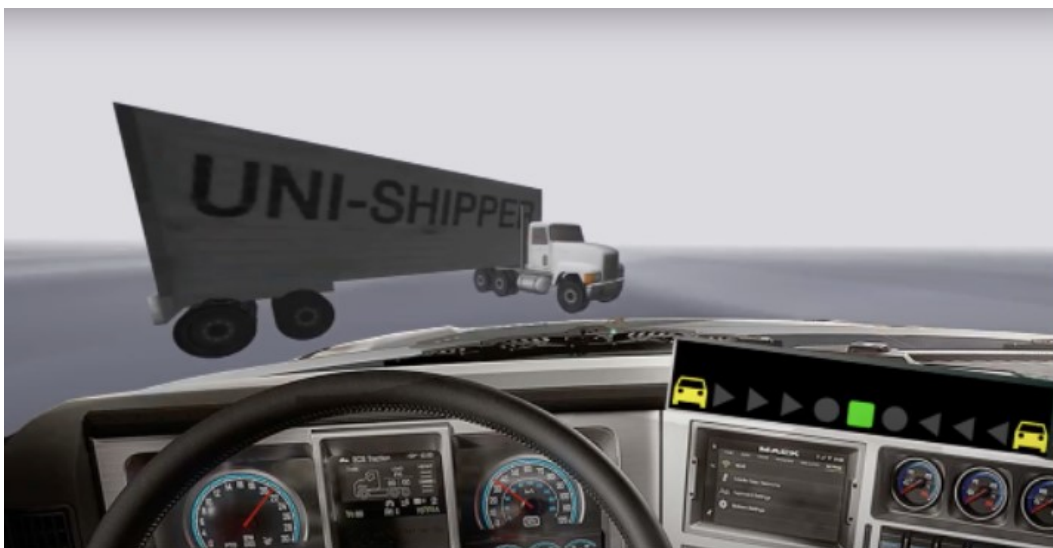
Figure 3.3 Screenshot of center warning indicator

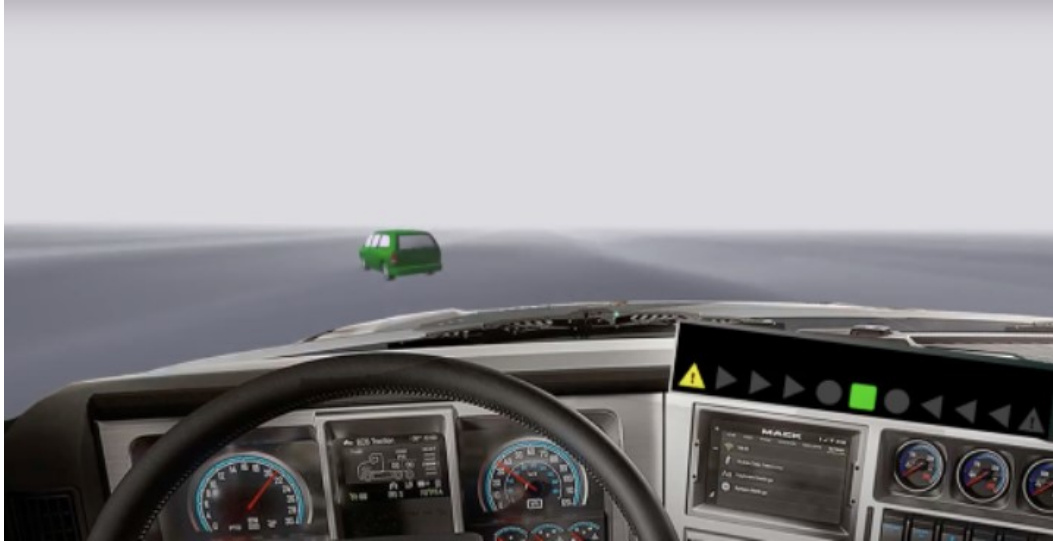
**Figure 3.4 Screenshot of left warning indicator**

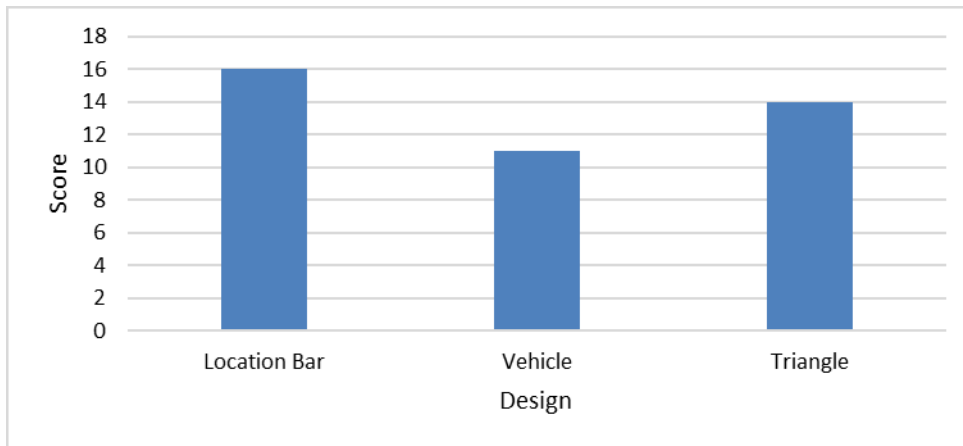
**Figure 3.5 User Preference Scores for Final User Testing**

Participants were asked to rank the three designs in order of preference. Each design received a score based on the participants' preference rankings with 1<sup>st</sup> place receiving 3 points, 2 points for 2<sup>nd</sup> place, and 1 point for 3<sup>rd</sup> place. There was strong support for the Location Bar Indicator, receiving a score of 16, compared to the triangle and vehicle indicators, receiving scores of 14 and 11, respectively, see Figure 3.5.

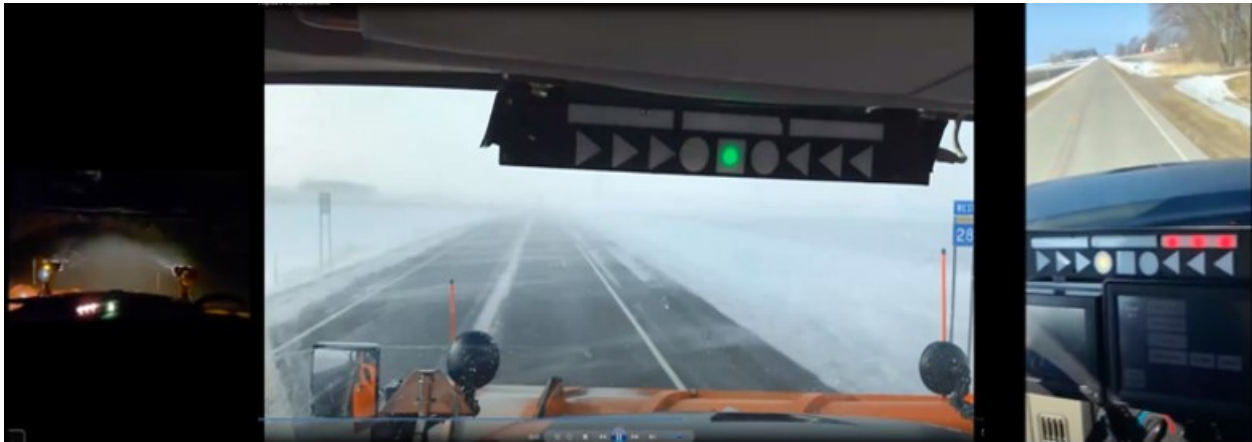
**Figure 5.1** Screenshots of recorded video footage reviewed during interviews

Once video footage was collected, researchers met with operators over Zoom conference software to review the video footage and conducted a semi-structured interview. Operators were asked to walk through their experiences in the video and describe things they liked or disliked, points of frustration or confusion, and provide recommendations for improvement. The video footage reviewed during interviews with operators included video footage of various weather (e.g., blowing snow, windstorm, during snow fall) and lighting conditions (e.g., overcast day, nighttime). Figure 5.1 shows screenshots of reviewed video footage. The total time to complete the video review and interview was approximately 30 minutes.

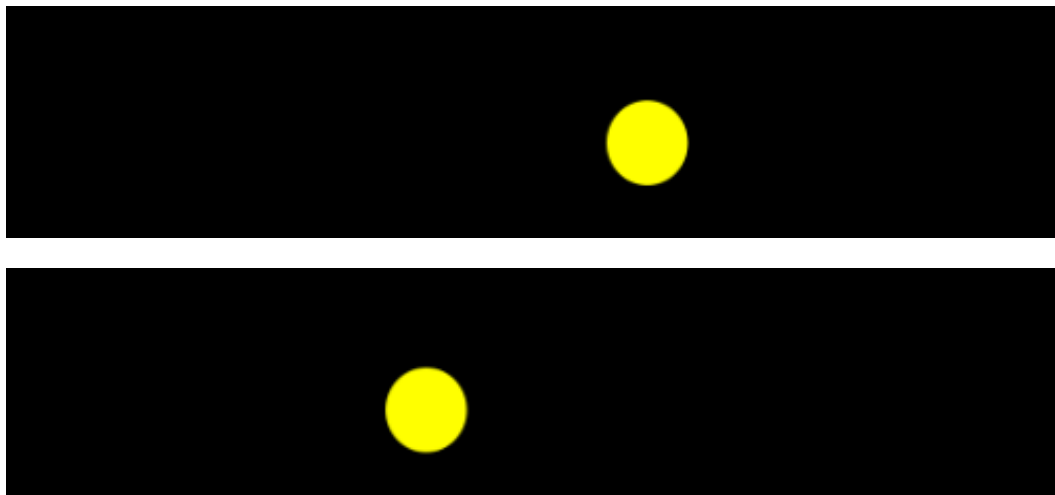
Figure 5.2 Example of lane-guidance indicator showing single yellow circle in total darkness

This is problematic because the left side and right-side yellow circles (i.e.,  $\pm 1$  foot from centerline) would be indistinguishable when only blackness surrounds the display (see Figure 5.2). Further, the three inward-facing triangles would lose their specificity from one another until greater than four feet out of center had been reached. Other operators were contacted to determine if this was a problem experienced by others, but no other operators reported using the system under this extremely low ambient lighting condition.

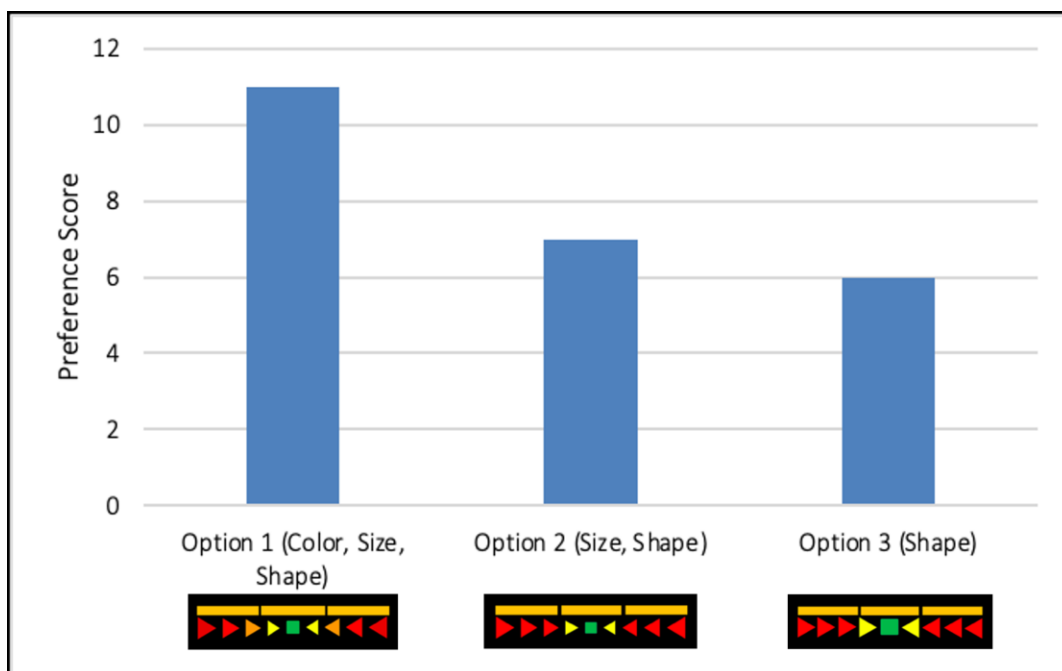
Figure 5.3 Option Preferences for Lane-Guidance Modification

Participants were asked to rank their preferred design modification. Each design received a score based on participant preference, which allowed for summation of votes for 1st place (3 pts), 2nd place (2pts), and 3rd place (1 pt). Participants reported strong support for Option 1, receiving a score of 11, compared to Option 2 and Option 3, receiving scores of 7 and 6, respectively, see Figure 5.3. Participants showed strong support for a design that included both changes in color and size. Additionally, participants indicated that they would prefer an even stronger contrast between the colors, thought the smaller size of the position indicators would be particularly helpful at night or in low illumination conditions, and suggested that it would be useful to increase the spacing between the each of the position indicators.

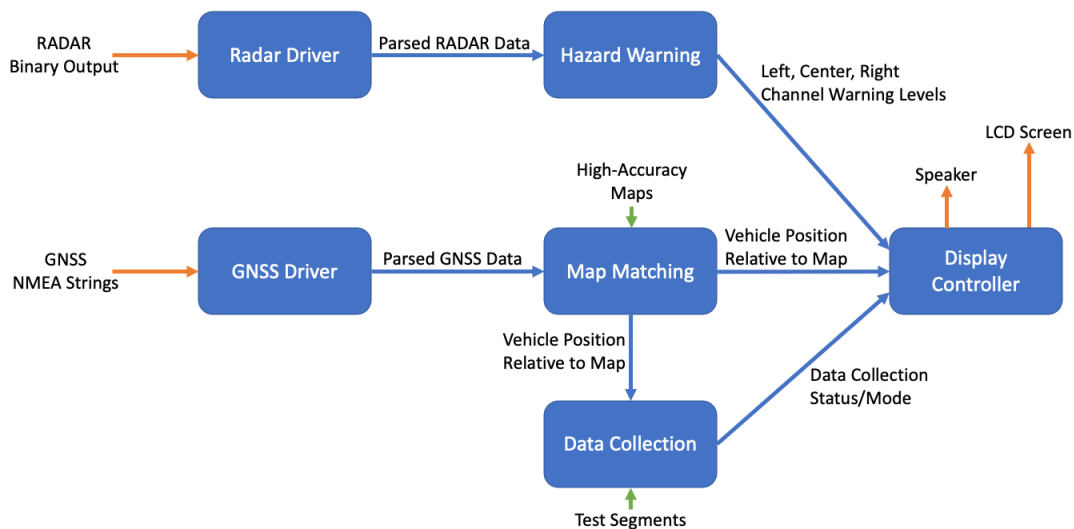
Figure 6.1 Snowplow Driver-Assist System Software Diagram

The snowplow driver-assist system software is organized into a number of modular components written in Python which each implementing a single, small piece of the system’s functionality. These components read input either directly from hardware devices (e.g., GNSS, radar, etc.) or from other components, process this input, and then pass their output to the next components that need it. This inter-process communication (IPC) is performed by a Redis (Redis Ltd., 2023) instance that runs on the Raspberry Pi computer. Figure 6.1 shows an illustration of the system components and the information shared between them.

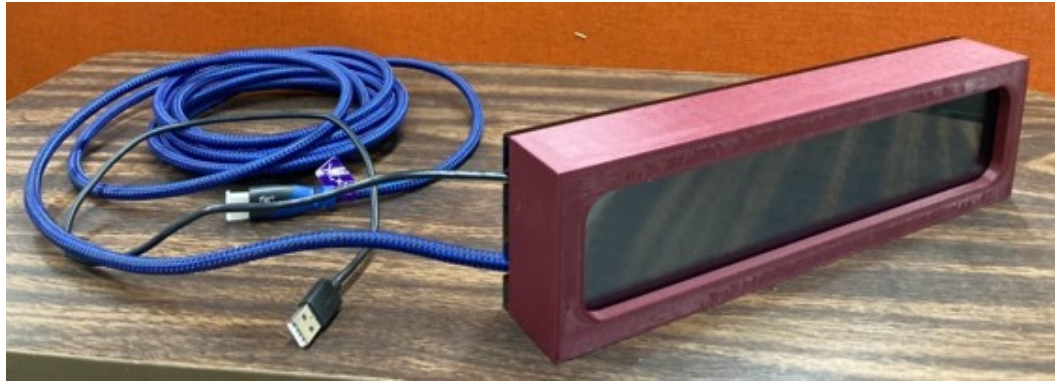
Figure 6.3 LCD screen in a custom designed prototype enclosure

snowplow cab. Figure 6.3 shows the display in its enclosure. 3D printing was used to produce a custom display enclosure. The blue cable shown is an HDMI cable that connects to the Raspberry Pi computer. The black cable shown is a USB cable that provides power to the display. A rear view of the enclosure is shown with the backplate removed in Figure 6.4. This view shows the display electronics inserted into the display enclosure design.

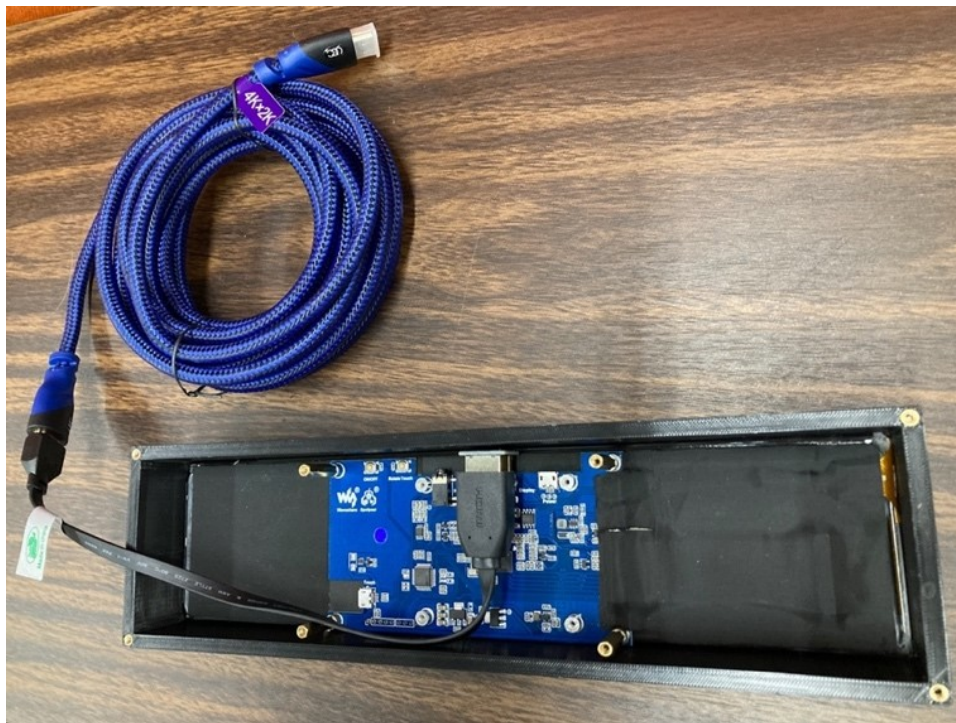
Figure 6.4 Display electronics in enclosure without backplate

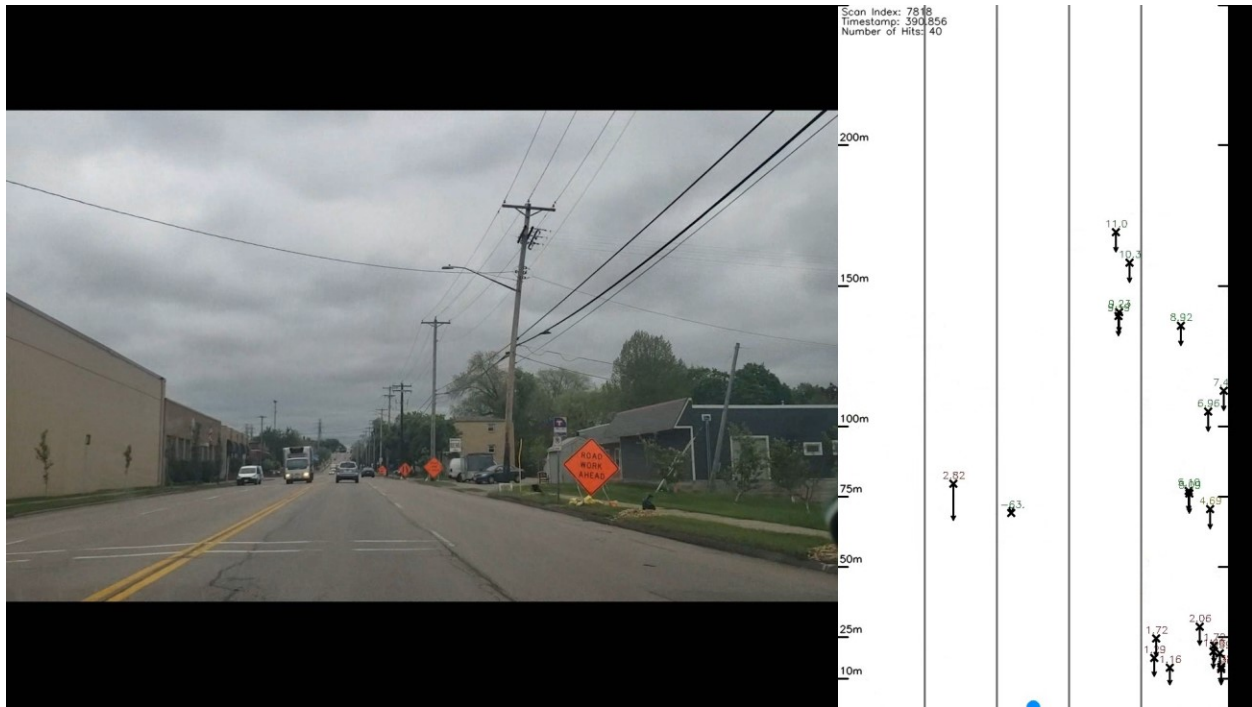
**Figure 6.7 Sample frame from visualization software**

To support this work, sample data was collected simultaneously from the radar as well as a video camera such that the radar data and video data could be synchronized in post processing. Visualization software was created to display a top-down, 2D representation of the radar data alongside a forward-facing video. The data visualization includes markers to indicate longitudinal and lateral distance from the radar. Individual radar returns are shown in the visualization with arrows indicating their speed relative to the radar and numbers indicating either the time to collision or the strength of the return. Figure 6.7 shows a sample frame from the software showing the video on the left and the top-down, 2D representation on the right.

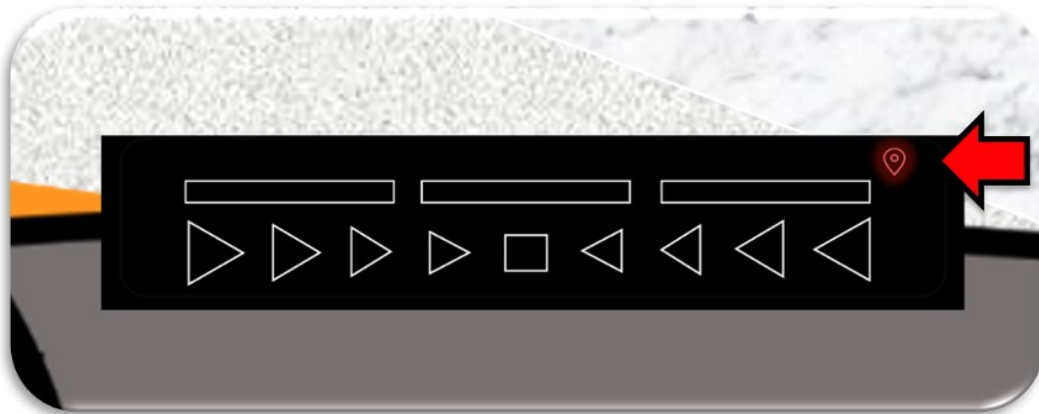
Figure 7.2 Screenshot of tutorial demonstrating loss of GPS signal

An updated snowplow driver-assist system tutorial PDF was created to provide operators with a brief overview of the revised lane-guidance system and forward-obstacle-detection system. The seven-page PDF tutorial describes the benefits of the system (i.e., better decision-making, increased safety) and provides information about how to interpret the system's display. See Appendix E. Lastly, the tutorial includes updated information about how the system will respond to cases of temporary loss of GPS signal or roads that are not digitally mapped. Figure 7.2 shows a sample screenshot from the tutorial showing the icon indicating a loss of GPS signal.

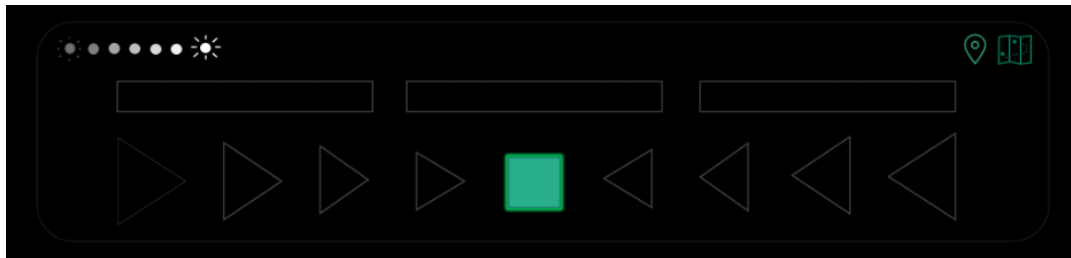
*GPS and Mapping Icons.* Two icons were initially selected to indicate when GPS and Mapping features of the system were available. The icons are placed at the top right corner of the display. The icons are illuminated in green to indicate that GPS and Mapping features were functional. Additionally, several icon designs were developed to indicate the GPS and Mapping features were not functional by modifying the GPS and Mapping icons. The non-functional design options included changing the icon color from green to red and adding a red slash diagonally through the GPS and mapping icons. See Figure 8.1 and Figure 8.2.

Figure 8.1 Screenshot the five brightness levels (see top left corner) and of GPS and Mapping icons indicating GPS and mapping are available (the icons are in the upper right corner)

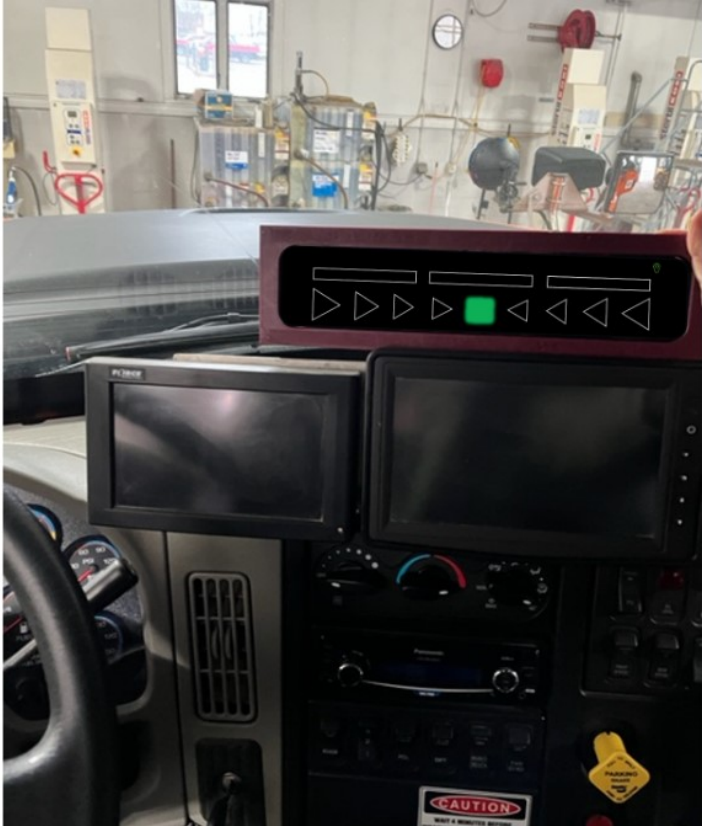
Figure 8.3 Preferred Placement for the Lane Boundary Guidance System

Several options were reviewed for placement of the Lane Boundary Guidance System on the truck. The majority of operators thought the system would be best suited to be placed in the center of the dash, to the right of the steering wheel above the Force America/AVL systems. See Figure 8.3. Additionally, operators did not feel that the extra height of the new system would be an issue while plowing. However, a few operators expressed concern about placing the system in the center of the dash, because they felt other systems in their truck would distract them from focusing on the Lane Boundary Guidance System. These operators felt the system would be better placed over the steering wheel so that it was directly in front of them.

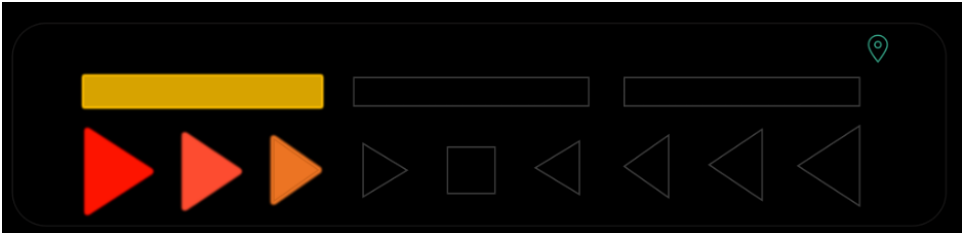
Figure 8.4 Image of Final Design at 4 feet to the left of the centerline

*Overall Design.* The purpose of display user testing was to evaluate the revised Lane Boundary Guidance System through a series of user testing. The outcome of this work resulted in a final design recommendation of the revised Lane Boundary Guidance System that was recommended for implementation. Overall, operators showed strong support for the system and preferred a design that used size, shape, and color (i.e., Design B) to provide lane position feedback. See Figure 8.4 for an example of the final design recommendation. See Appendix F for additional images of the final design.

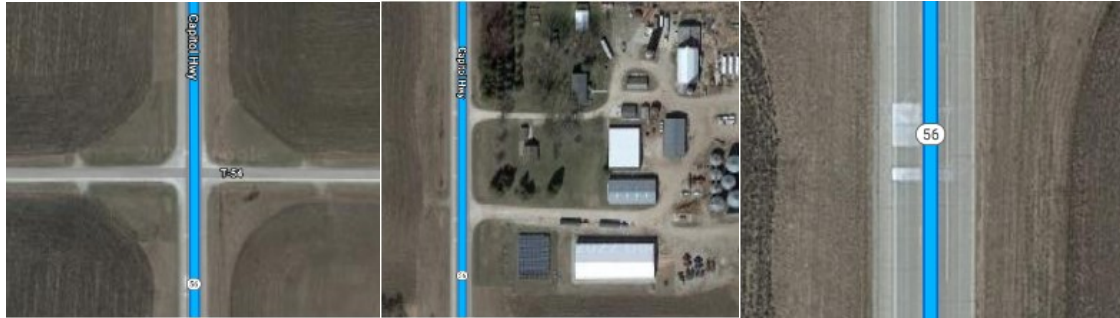
Roadway characteristics were documented for each three-mile segment using Google Maps. Roadway characteristics included the number of intersections along the three-mile route, the number of driveways leading to homes or businesses along the route, and the number of right turn lanes present within each three-mile route. See Figure 8.6.

Figure 8.5 Three Google Maps images of intersections, driveways, and right turn lanes along routes

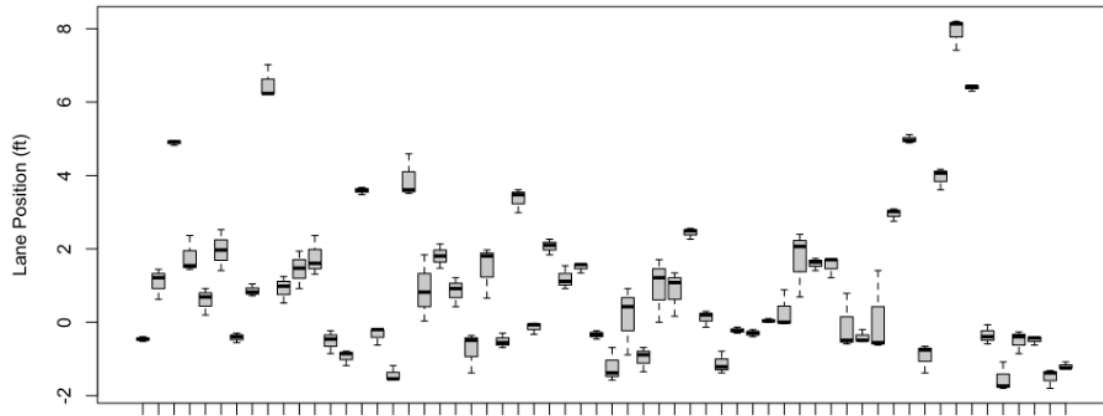
Figure 8.6 Boxplot of lane position (ft) by individual run ( $N = 60$ ). Positive is to the right of the centerline

Although data was initially collected from seven truck stations, not all test runs contained complete data sufficient for analysis. Thus, after data cleaning, 10 runs were removed because of incomplete data and the final sample size consisted of 60 completed runs from five truck stations. Twenty percent (12) of the runs were from District 2, 10% (6) of the runs were from District 3, 46.7% (28) of the runs were from District 4, 13.3% (8) of the runs were from District 6 and 10% (6) of the runs were from District 7. Overall, there was considerable variation in both lane position and average truck speed observed across the 60 completed runs. See Figure 8.6 and Figure 8.7.

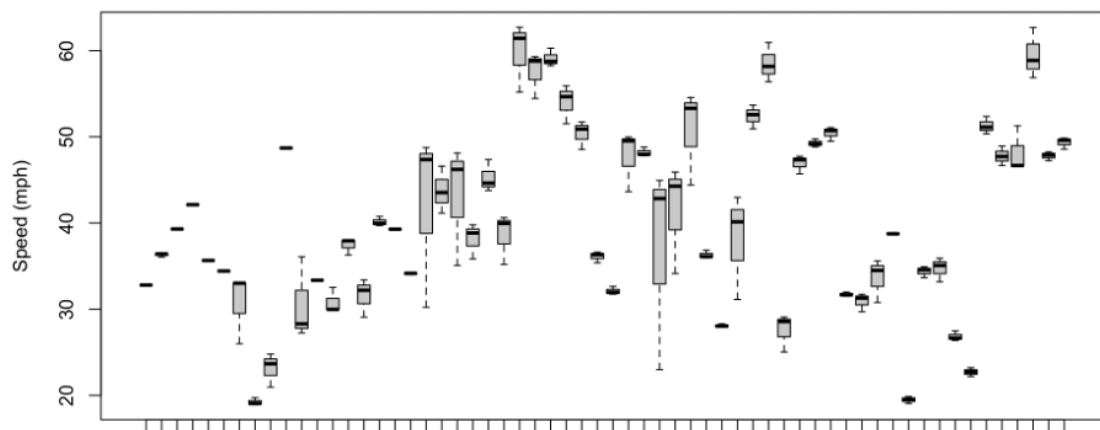
Figure 8.7 Boxplot of truck speed (mph) by individual run ( $N = 60$ ).

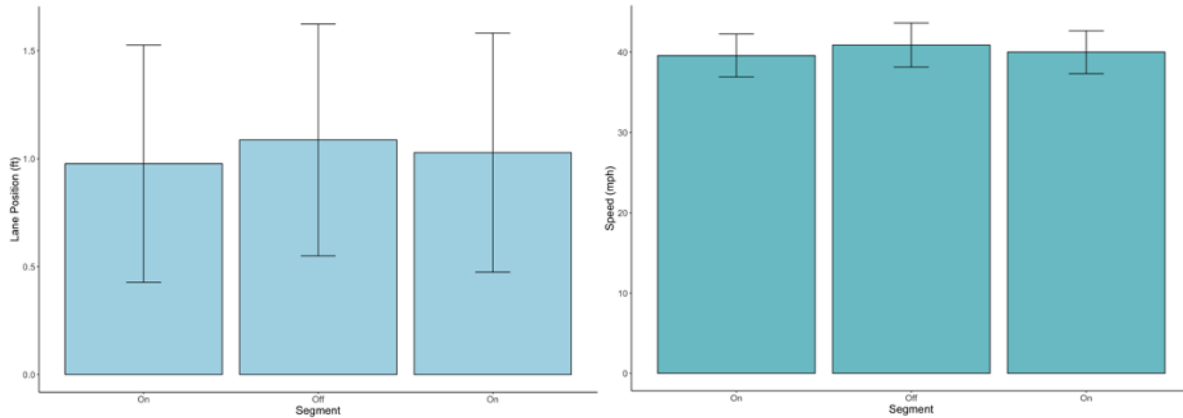
**Figure 8.8** Bar graphs of mean lane position (ft) with positive to the right of the centerline, and mean speed (mph) by BAB segment for all runs ( $N = 60$ ).

feedback changed from on to off, and then decreased when the display feedback was turned back on in Mile 3 ( $M = 39.99$ ,  $SD = 10.32$ ). This suggests that the change in the system display mode influenced operator speed; however, more data may be needed to show statistically significant differences. See Figure 8.8.

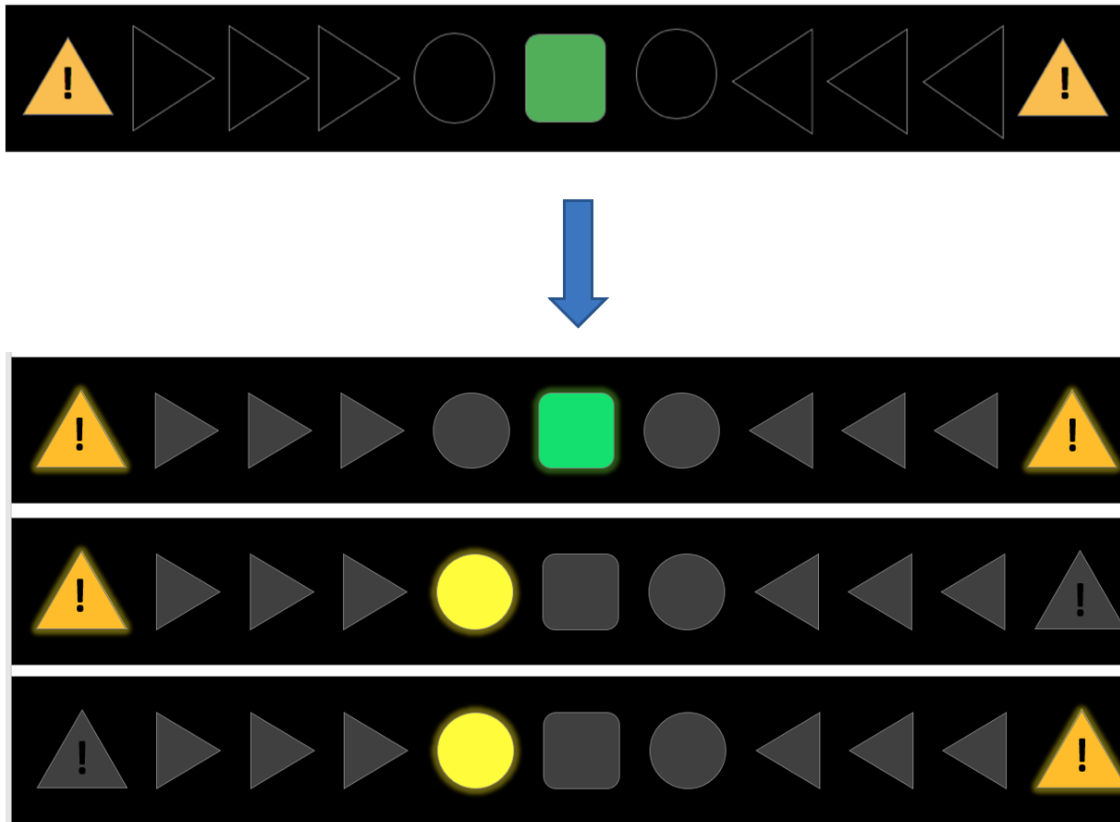
*Note: Design changes were made to demonstrate glowing functions and to demonstrate hazard position through center (left and right triangles illuminated together), left (left triangle illuminated), and right (right triangle illuminated) hazard locations relative to plow.*

Figure A-1 Triangle indicator on outer edges iteration

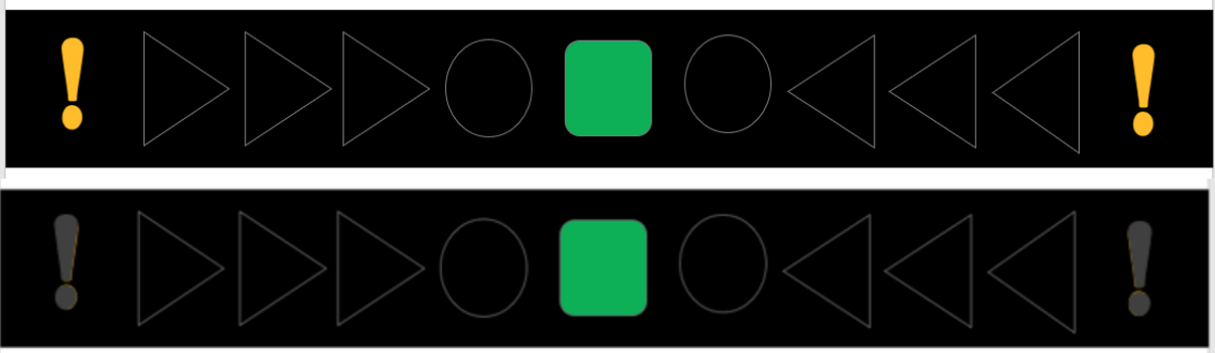
*Note: Design was tested to include still or flashing functions and was eliminated from consideration during testing.*

Figure A-2 Exclamation indicator on outer edges flashing/still

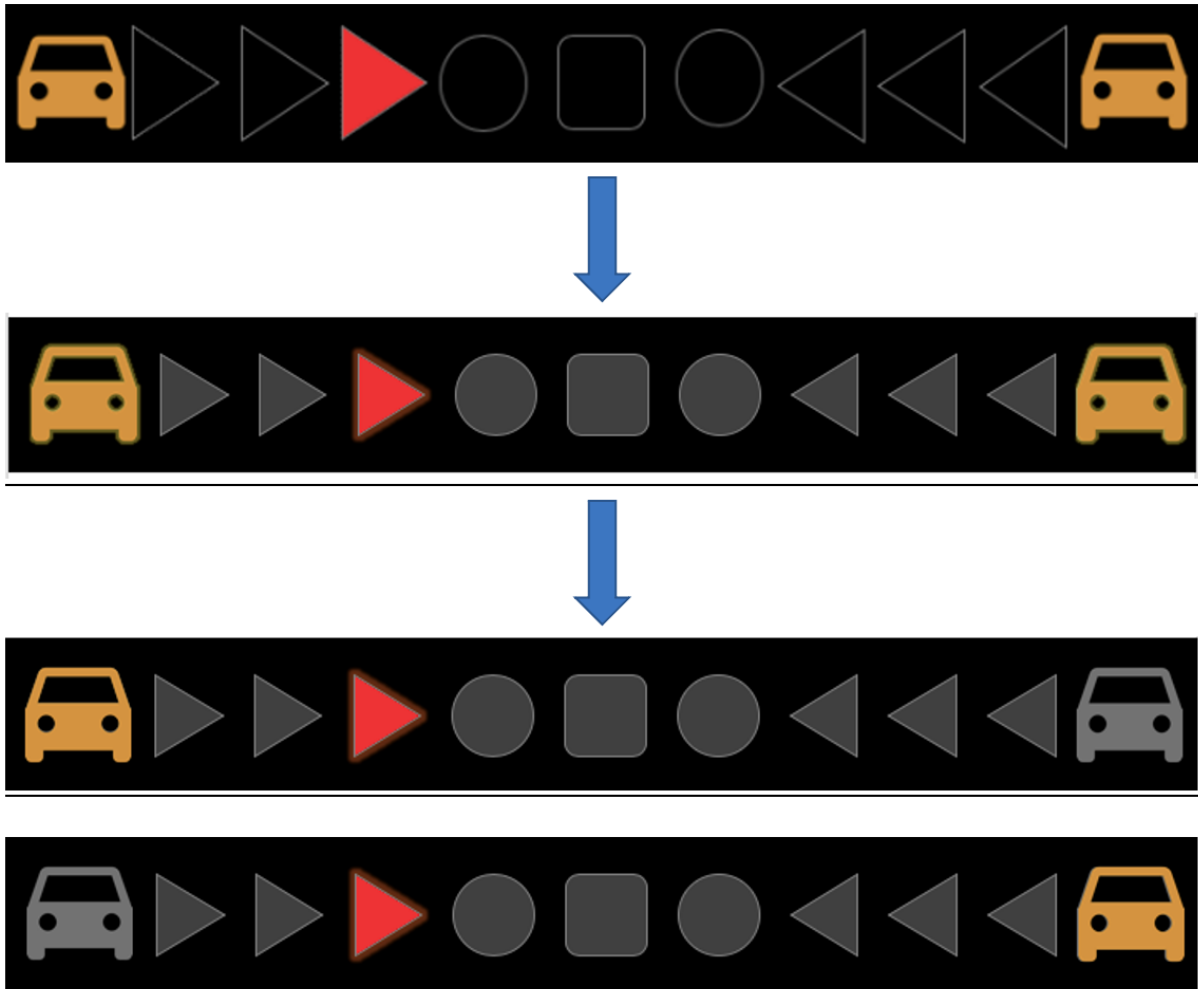
*Note: Design changes were made to demonstrate glowing functions and to demonstrate hazard position through center (left and right cars illuminated), left (left car illuminated), and right (right car illuminated) hazard locations relative to plow.*

Figure A-5 Flashing vehicle indicator on outer edges iteration and right/left hazard position

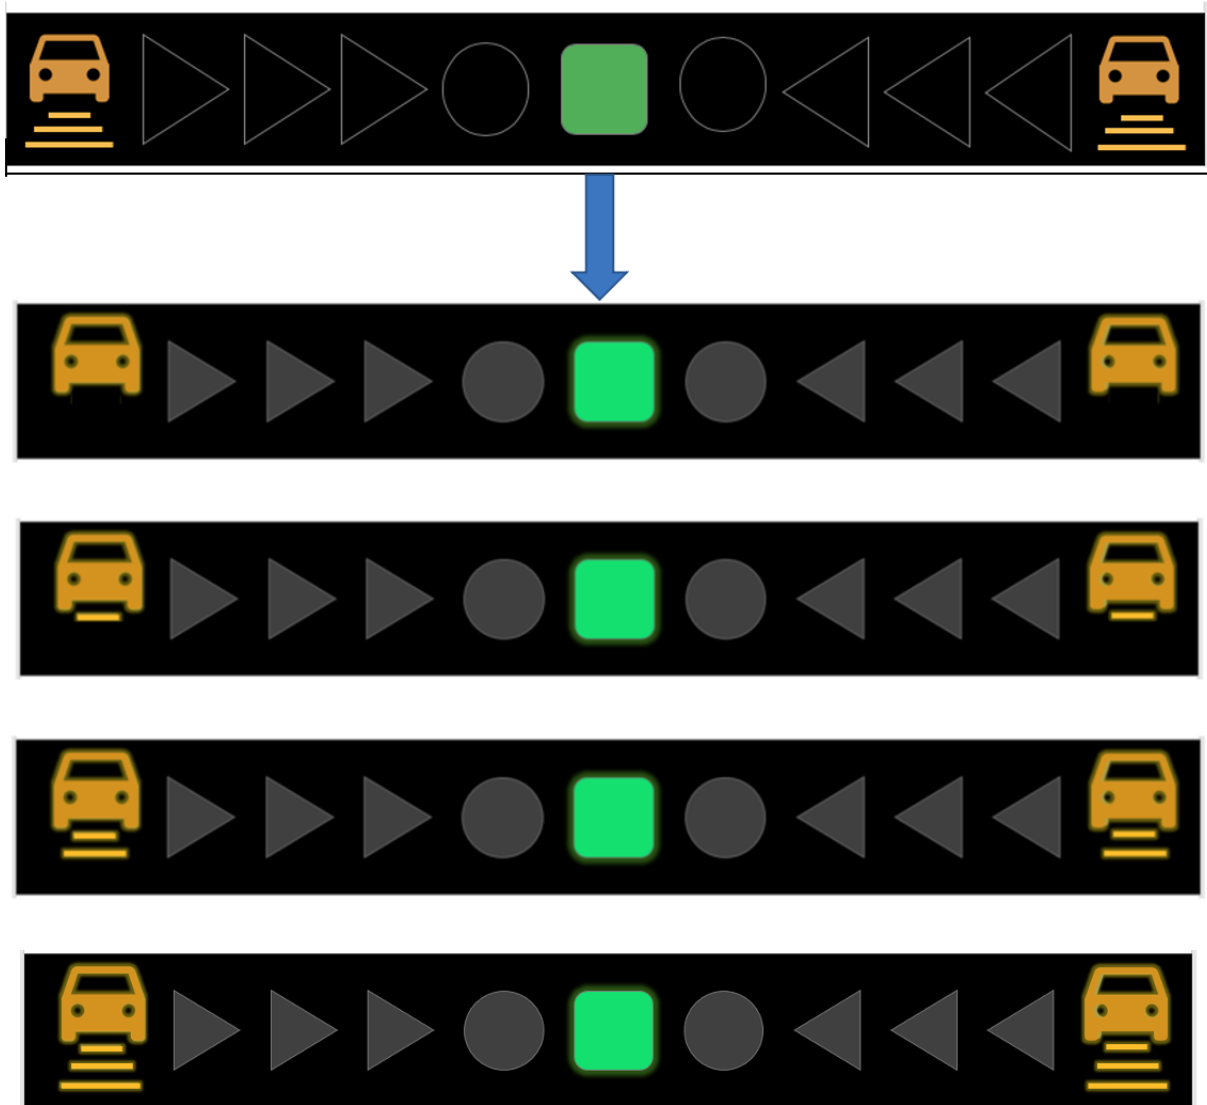
*Note: Design changes were made to demonstrate glowing functions and remaining images demonstrate the multiple states of the design (with glowing functions) as the hazard approaches plow.*

Figure A-6 Vehicle with looming bars on outer edges (Additional looming bars appear as hazard approaches)
