# Deployment of a Snowplow Driver-Assist System

**JUNE 2023**

Research Project  
Final Report 2023-27

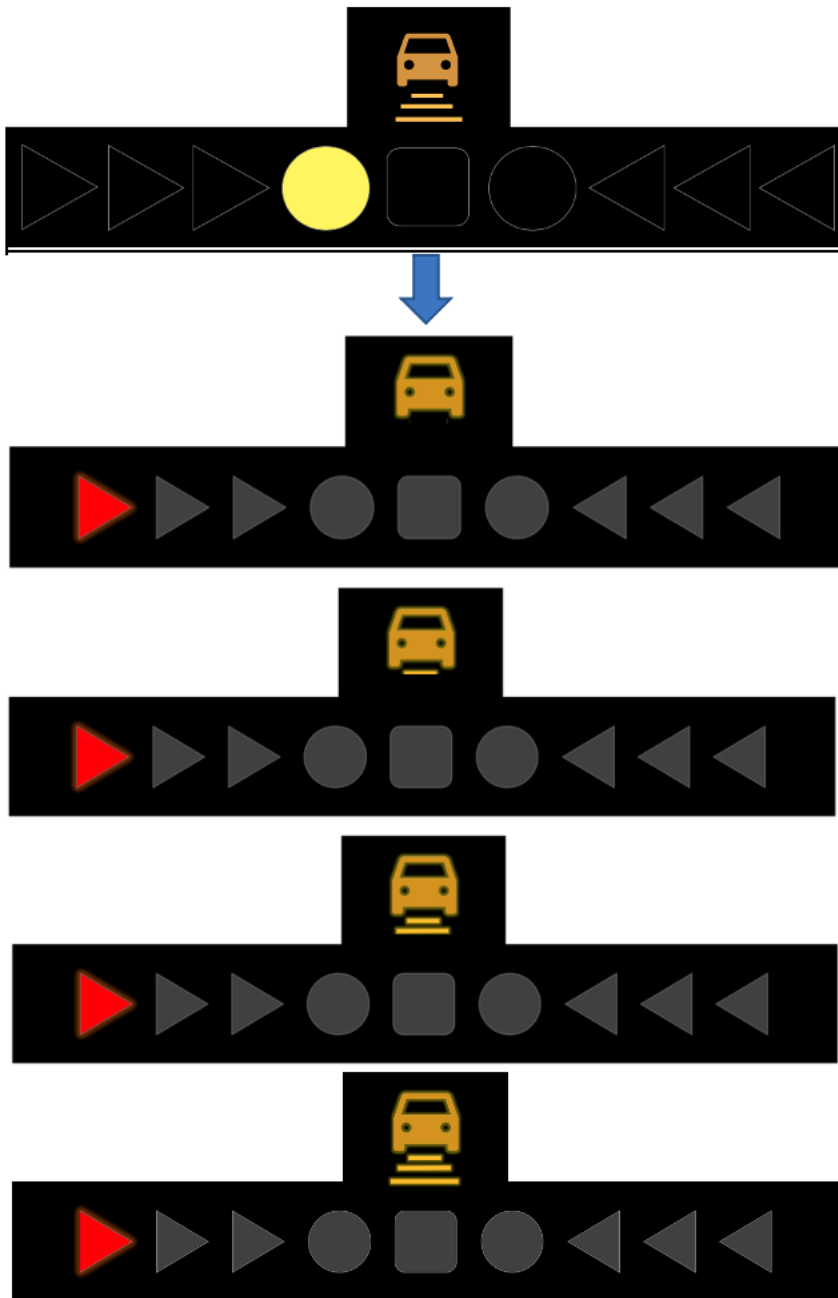
*Note: Design changes were made to demonstrate glowing functions and remaining images demonstrate the multiple states of the design (with glowing functions) as the hazard approaches plow.*

Figure A-7 Overhead vehicle indicator with additional bars appearing as hazard approaches

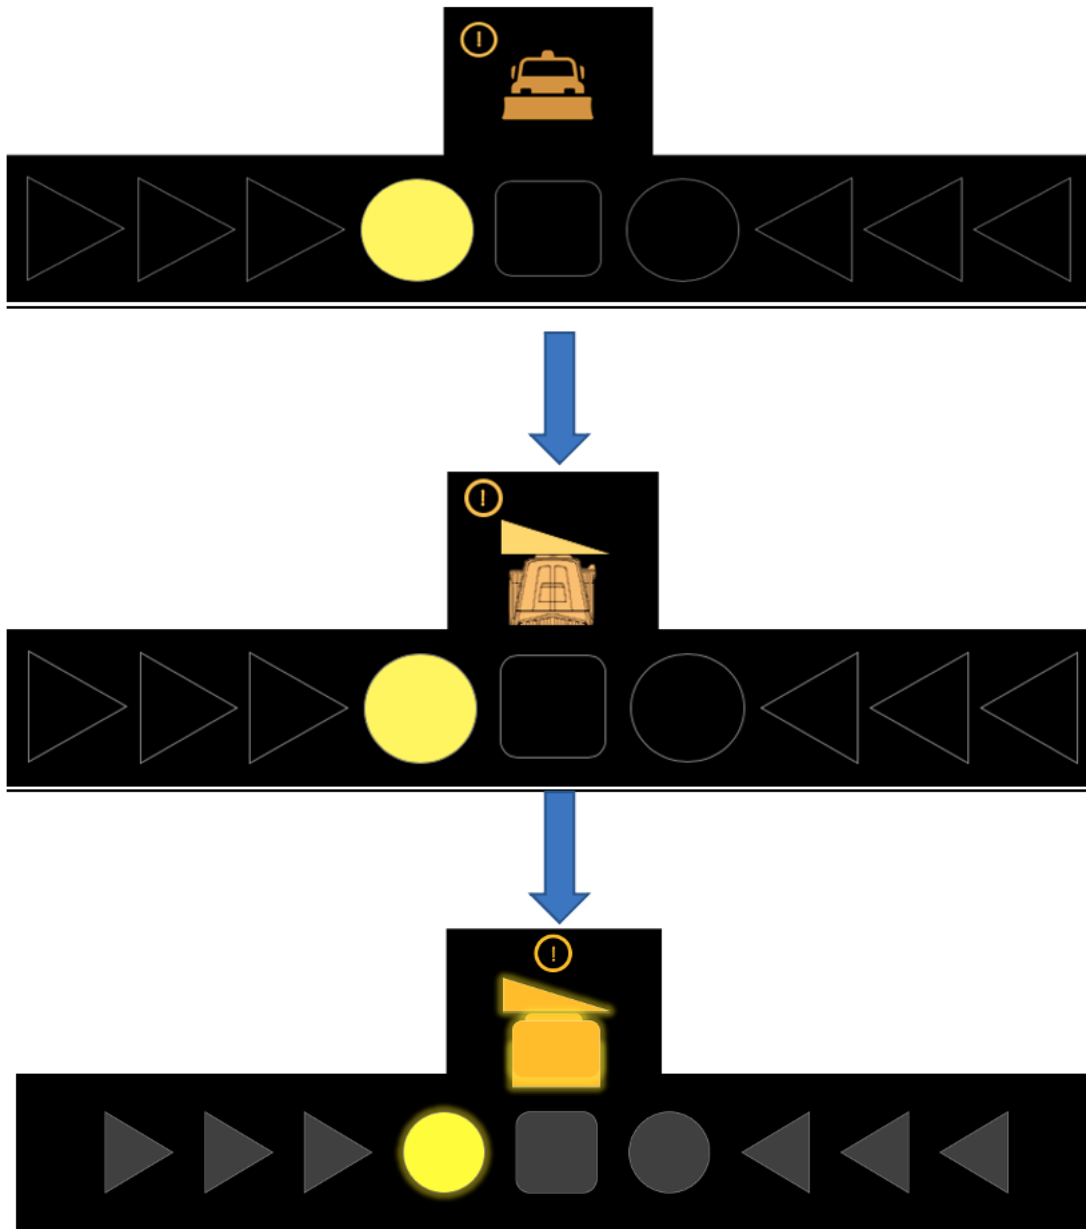
*Note: Design changes were made to present a bird's eye of the snowplow and additional changes were made to demonstrate glowing function.*

Figure A-8 Overhead snowplow indicator iteration (Exclamation above snowplow indicates lateral location)

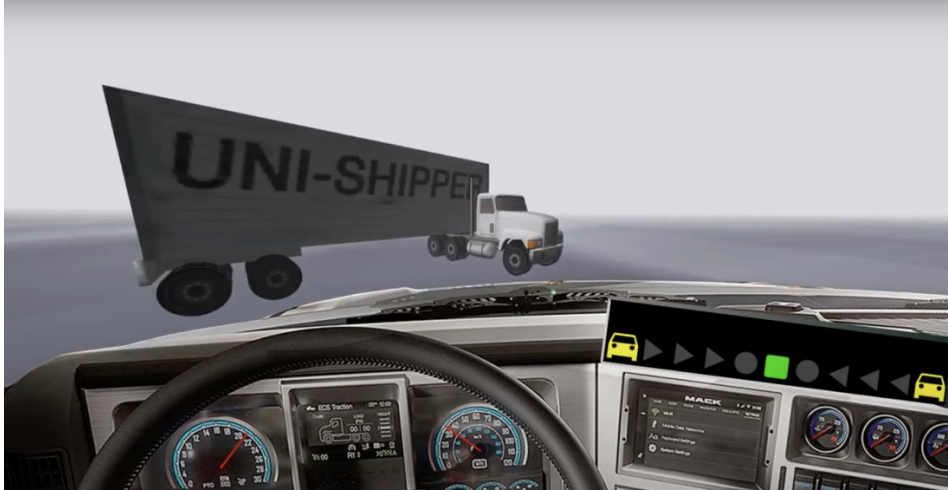
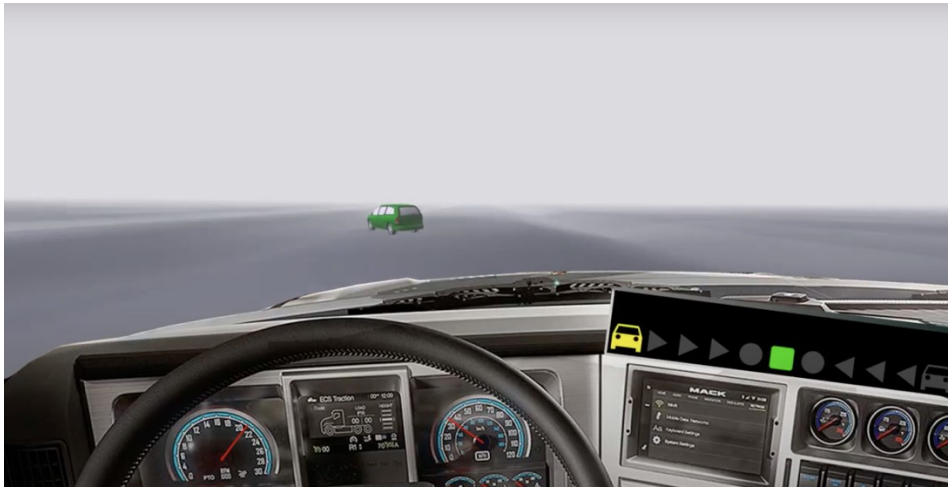
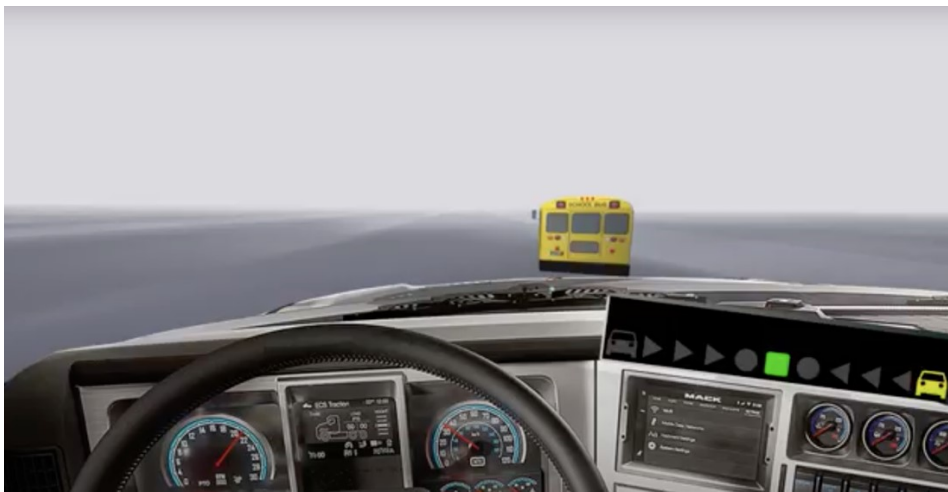
Figure B-1 Three screen shots of flashing vehicle indicator for center, left and right hazard

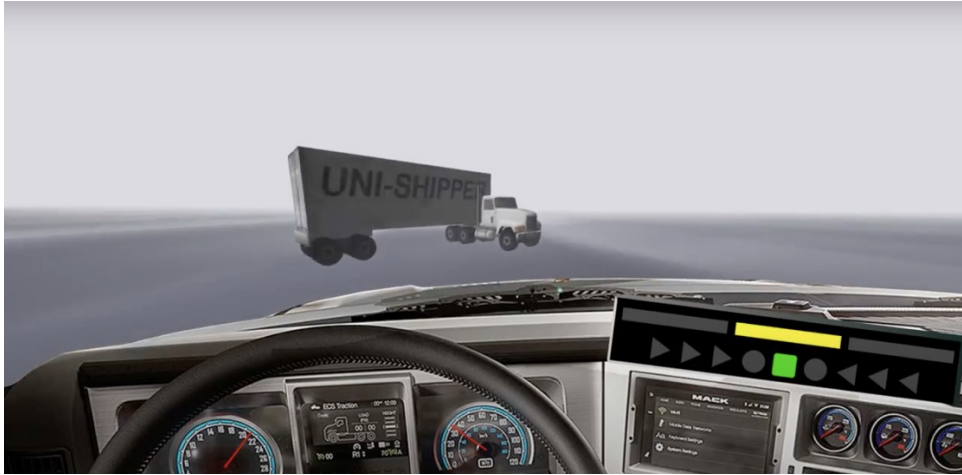
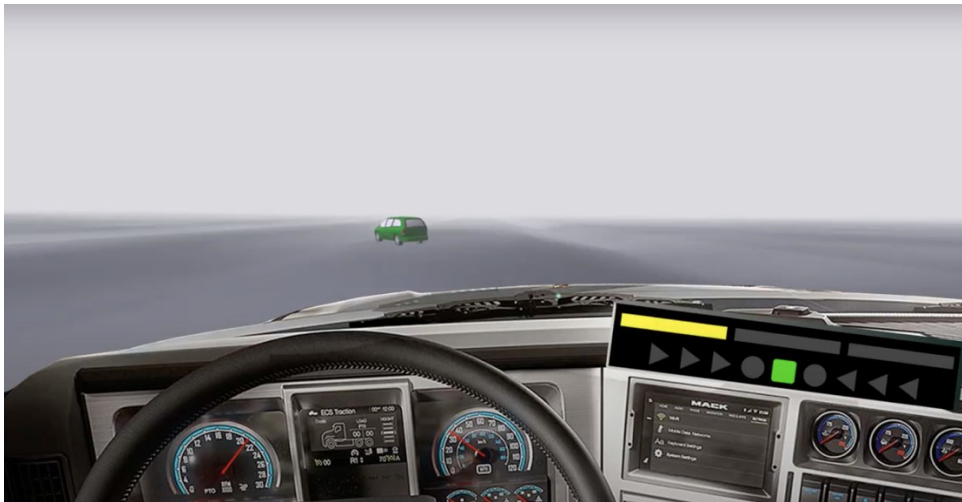
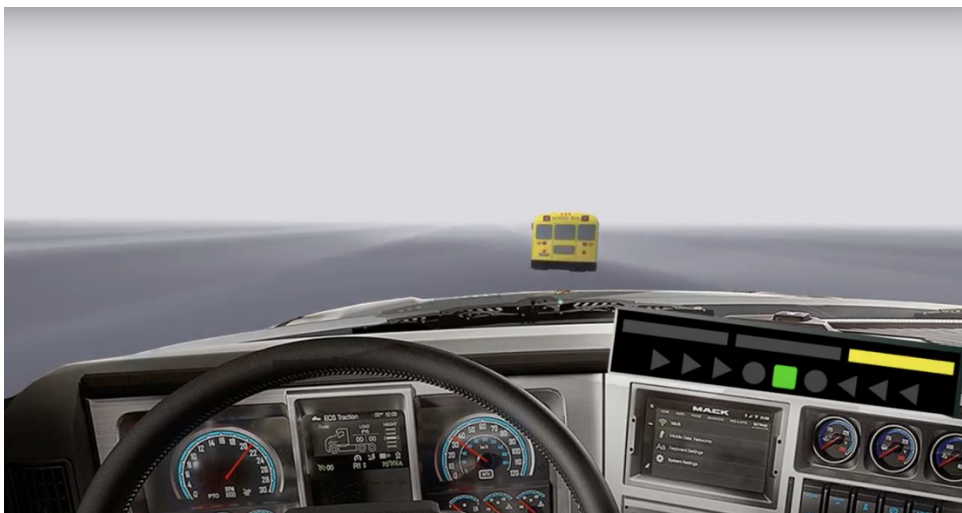
Figure B-2 Three screen shots of Flashing Location Bar indicator for center, left, and right hazard

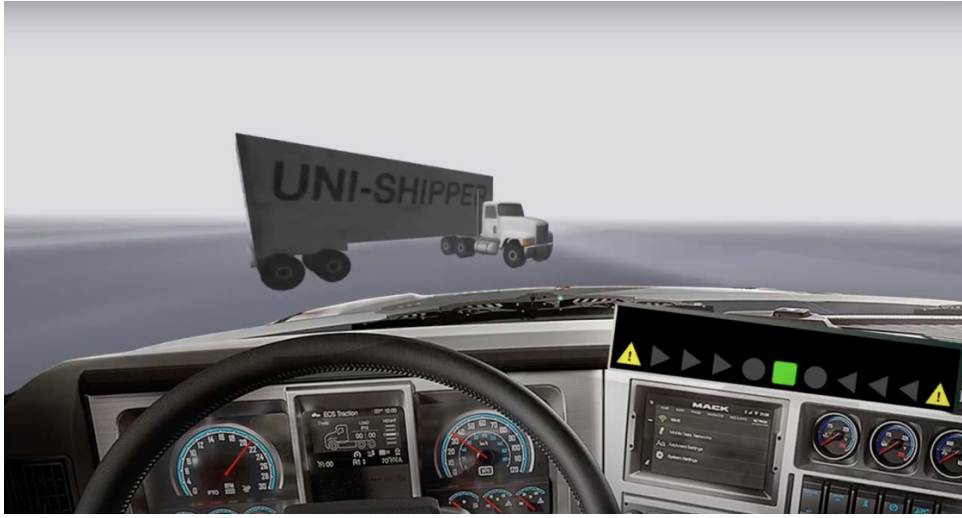
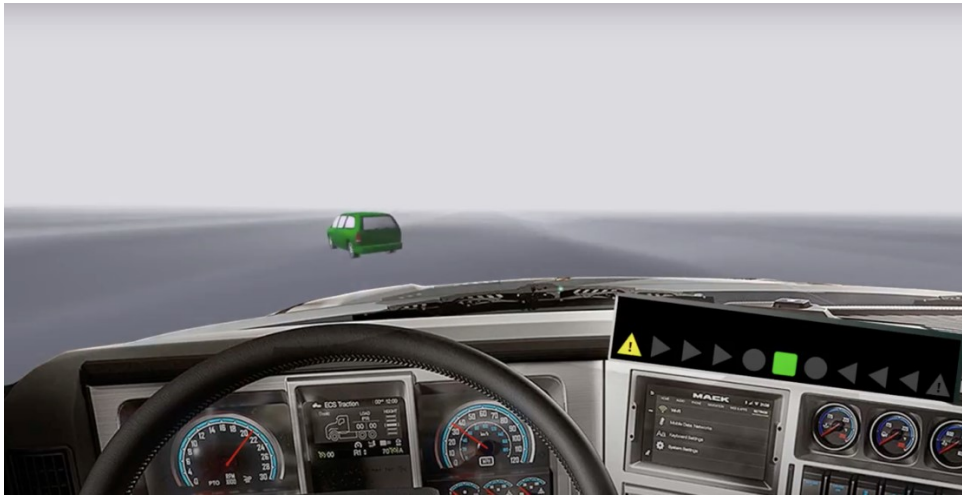
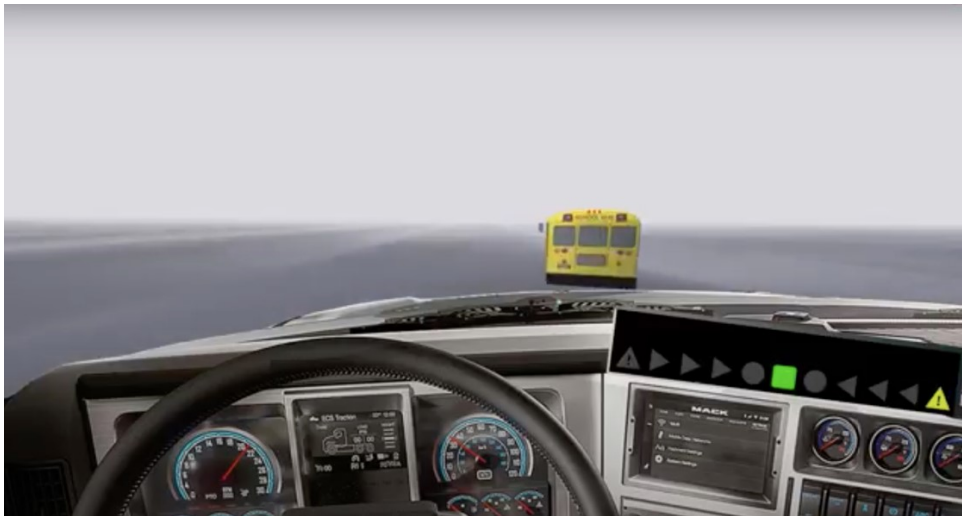
Figure B-3 Three screen shots of flashing triangle indicator for center, left, and right hazards

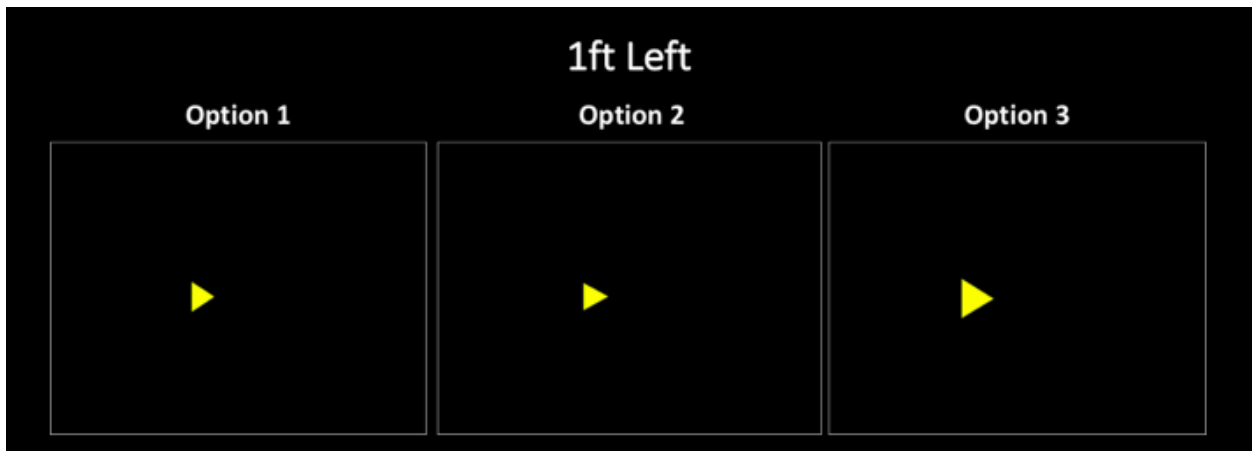
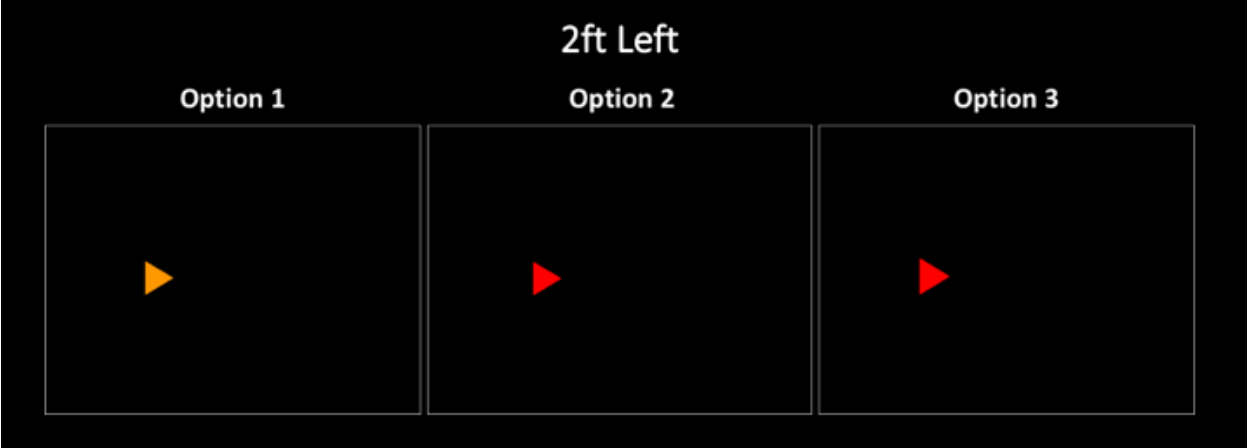
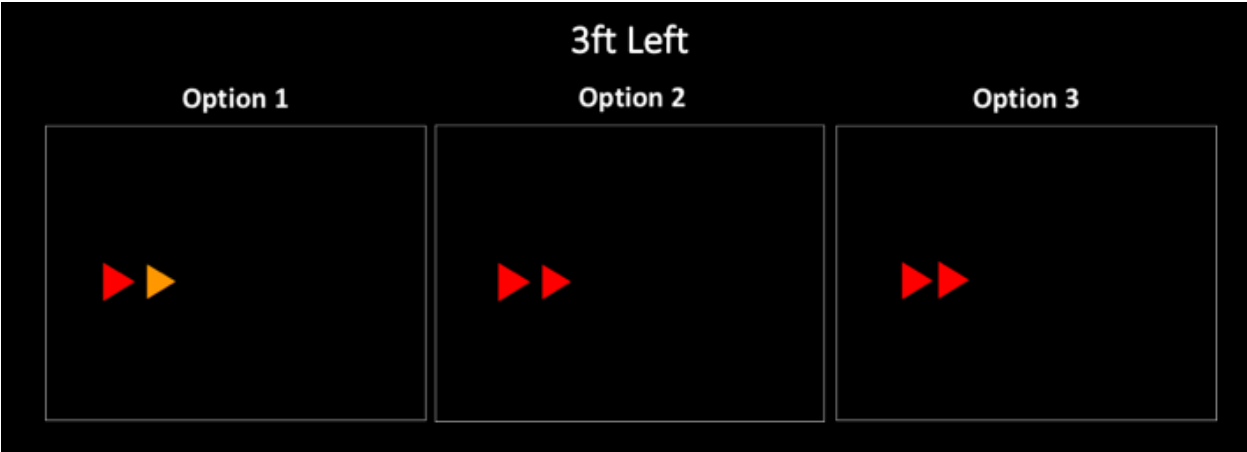
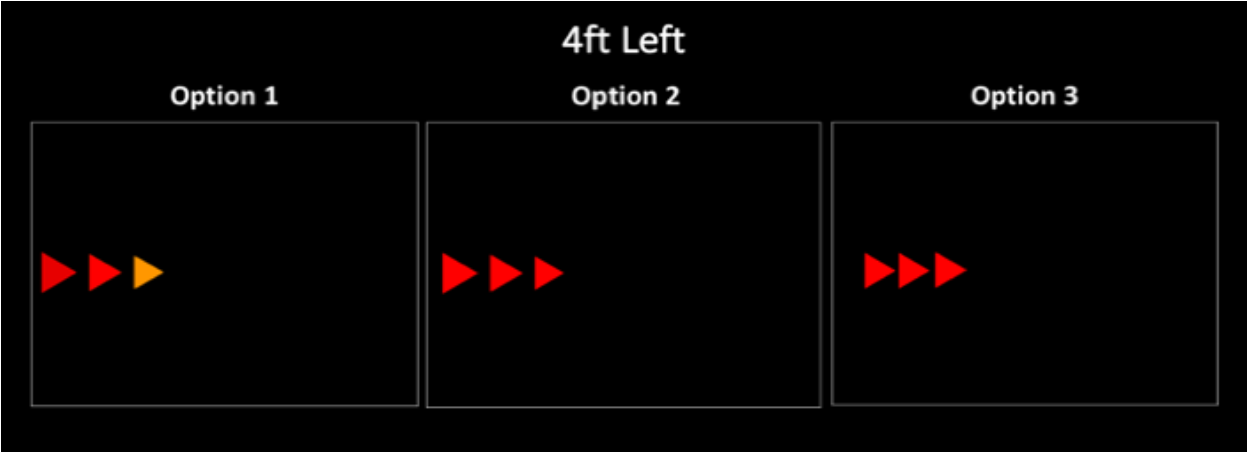
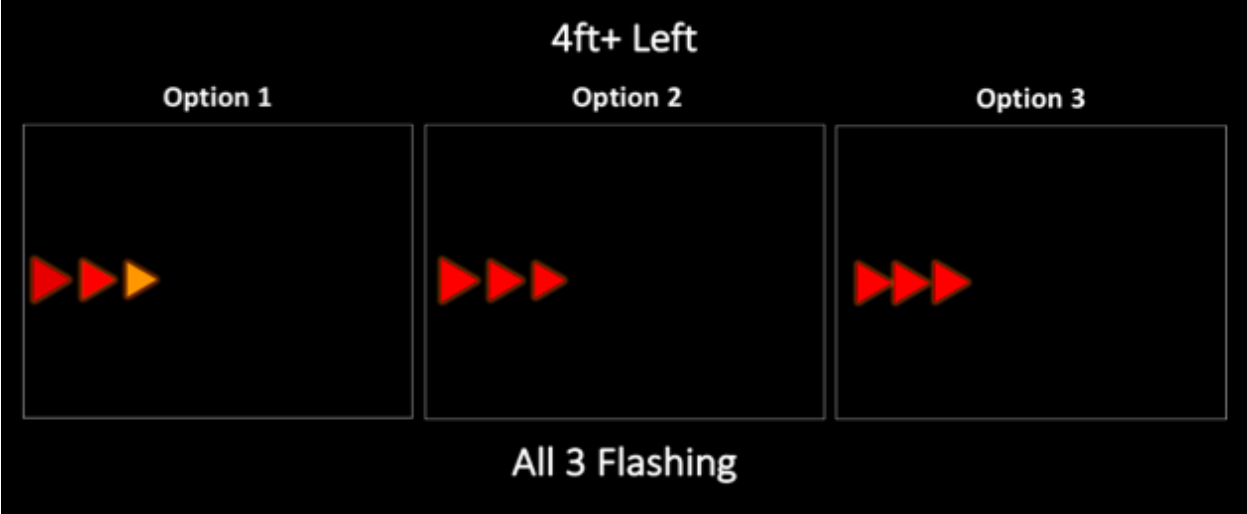
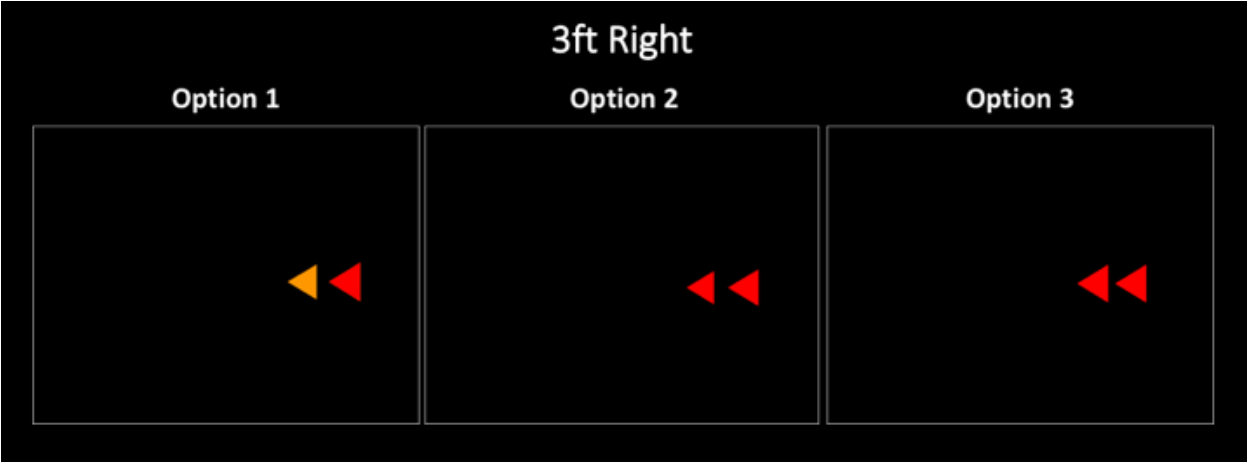
The videos began by presenting the full design modifications (i.e., with all position indicators illuminated) and then demonstrated the entire sequence of the lane-guidance system (i.e., each position indicator). After the sequence was displayed, a final slide presented the full modifications. Each column represents what the operator would see on the video for each of the design options (i.e., Option 1, Option 2, and Option 3), moving from the center line, one foot to the left, two feet to the left, three feet to the left, four feet to the left, more than four feet to the left, the center line, one foot to the right, two feet to the right, three feet to the right, four feet to the right, and more than four feet from the right.

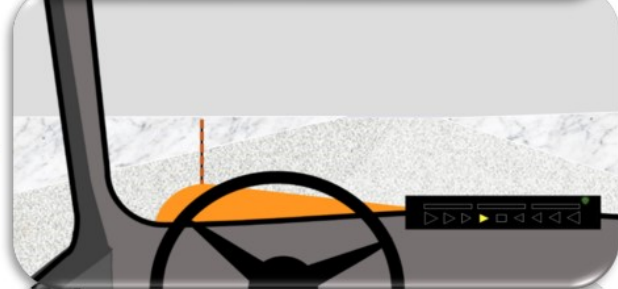
A **yellow triangle** indicates the left plow edge is *1 foot* to the *right* or the *left* of the centerline

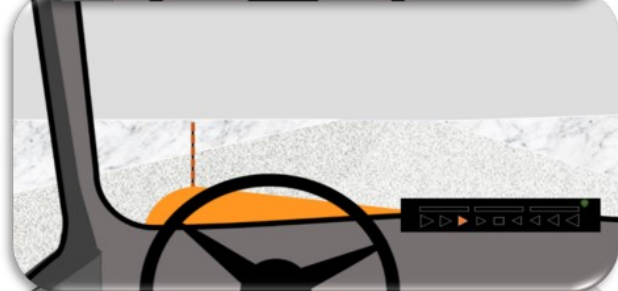
An **orange triangle** indicates the left plow edge is *2 feet* to the *right* or the *left* of the centerline

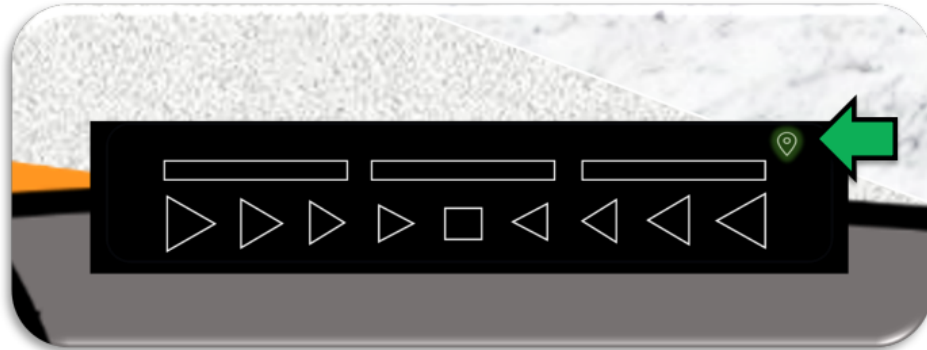
A map position icon is located on the upper right corner of the display.

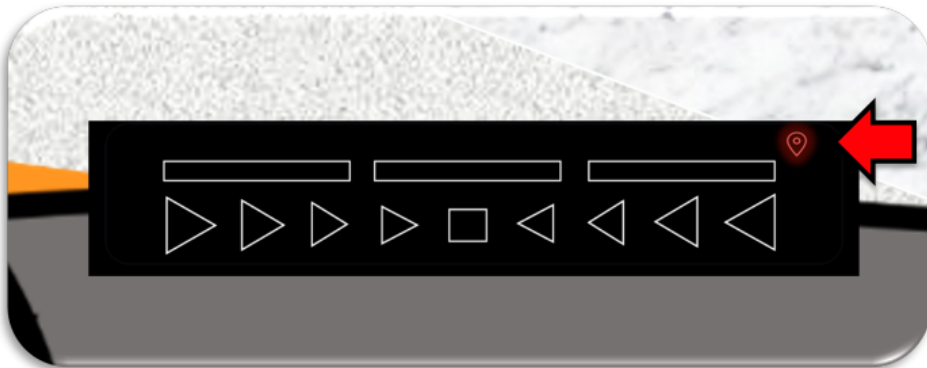
When the **map position icon** indicator is colored **red**, there is *no map available* for the roadway. This may be due to temporary loss of GPS signal or because the current roadway has not been digitally mapped.

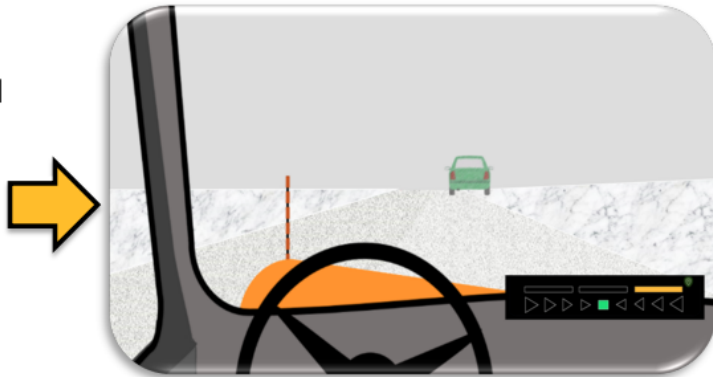
The hazard warning **bars will turn red** and an audible **alert will sound** when the *object* is 3 to 2 seconds away from the plow.

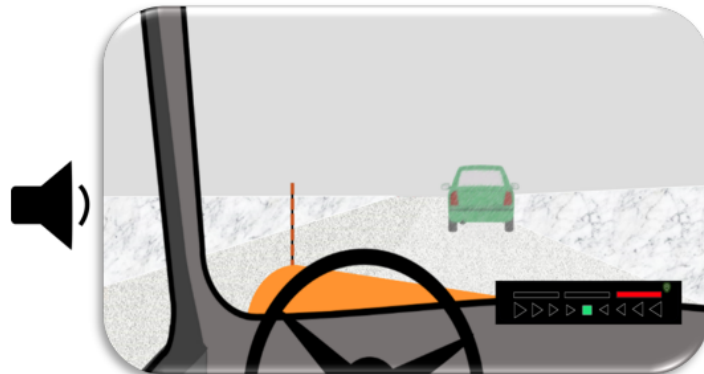
When the *hazard* is within 2 seconds or less to the plow, the hazard warning **will flash red** and an audible **alert will increase in intensity**.

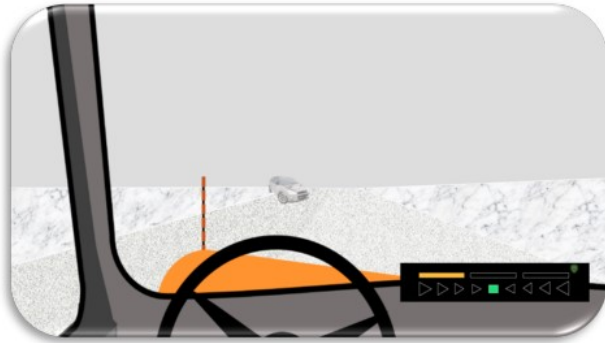
The audible alert will not sound for any hazards detected to the left of the plow.

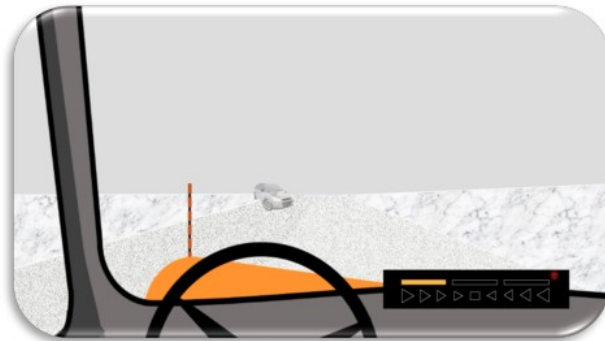
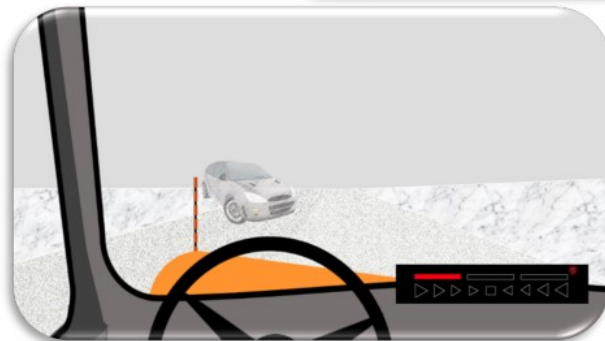
Additionally, the hazard warning system will still operate even when there is no GPS information available.

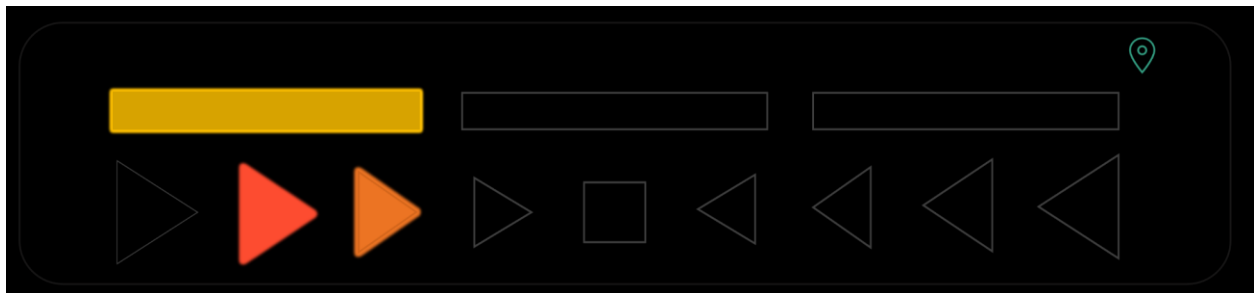
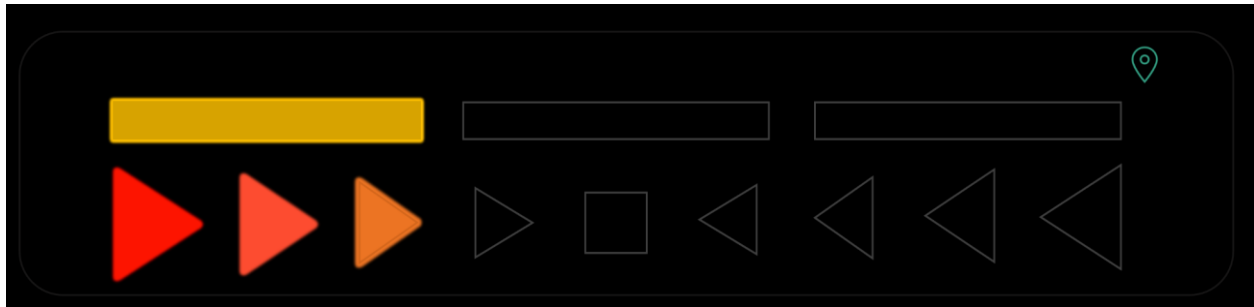
The final design of the lateral position information is sequenced as follows: A single indicator indicates the position of the left plow edge relative to the centerline when the left plow edge is on the centerline (green square), one foot to the right or left of the centerline (yellow triangle), and two feet to the right or the left of the centerline (orange triangle).

However, when the left plow edge is three feet to the right or the left of the centerline, the two-foot indicator (i.e., orange triangle) and the three-foot indicator (i.e., red-orange triangle) were displayed. Similarly, when the left plow edge was four feet from the centerline, the two-foot, three-foot, and four-foot (i.e., red triangle) indicators are displayed. Finally, when the left plow edge is greater than four feet to the right or the left of the centerline, the two-foot, three-foot, and four-foot indicators flash simultaneously.
