**AN RAI OF DATA  
GENERALIZING THE DATA-DRIVEN ROCKFALL ACTIVITY INDEX  
(RAI) BASED ON LONG-TERM OBSERVATIONS OF WELL-  
CHARACTERIZED SLOPES**

**FINAL PROJECT REPORT**

Margaret M. Darrow  
Daisy M. Herrman  
University of Alaska Fairbanks

Ben Leshchinsky  
Michael J. Olsen  
Oregon State University

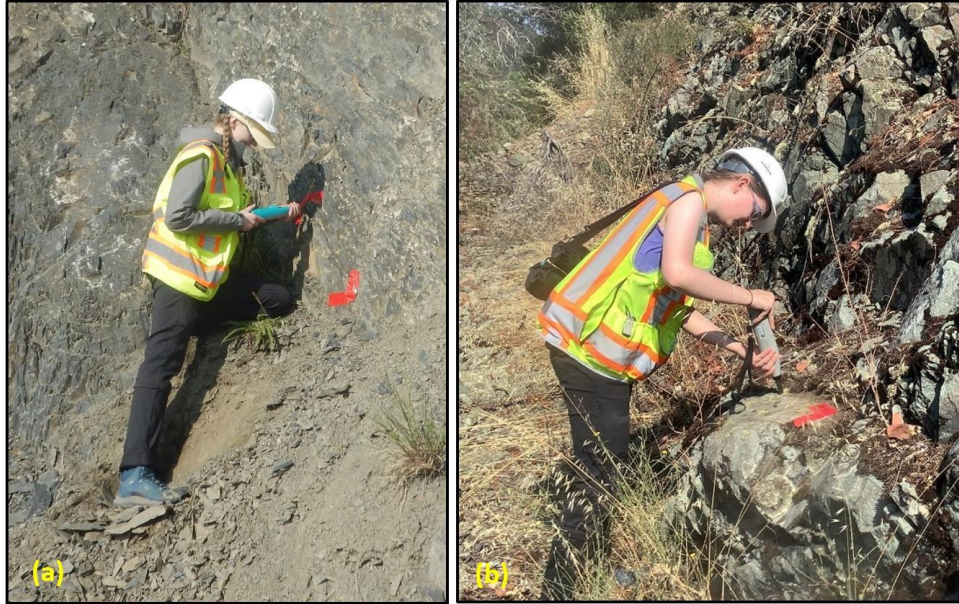
**Figure 2.2** Acquisition of Schmidt hammer (SH) readings at sites in (a) Alaska and (b) Oregon.

At each site, we identified a minimum of ten SH testing locations along the rock slope face; all SH measurement locations were georeferenced. At each location, we constructed a grid of ten points within a 1-m<sup>2</sup> area. We developed an additional testing grid of ten points for locations where two individuals alternated taking measurements. The distance between each testing point on the grid was greater than 6 cm (2.36 in.) to prevent any overlap of deformation on the rock face. We took a measurement with each hammer type at each point, alternating which hammer type was used first at the different sites. If applicable, we noted the orientation to foliation or bedding because this can impact rebound values. For data analysis, we averaged all of the SH readings for each site, an approach that included effects of discontinuities in the rock mass. We also followed the ASTM D5873-14 standard, by averaging ten readings from a site, removing rebound values that differed from the average by seven or more, and then averaging the remaining values (ASTM 2014). Results from both approaches are included in this report.

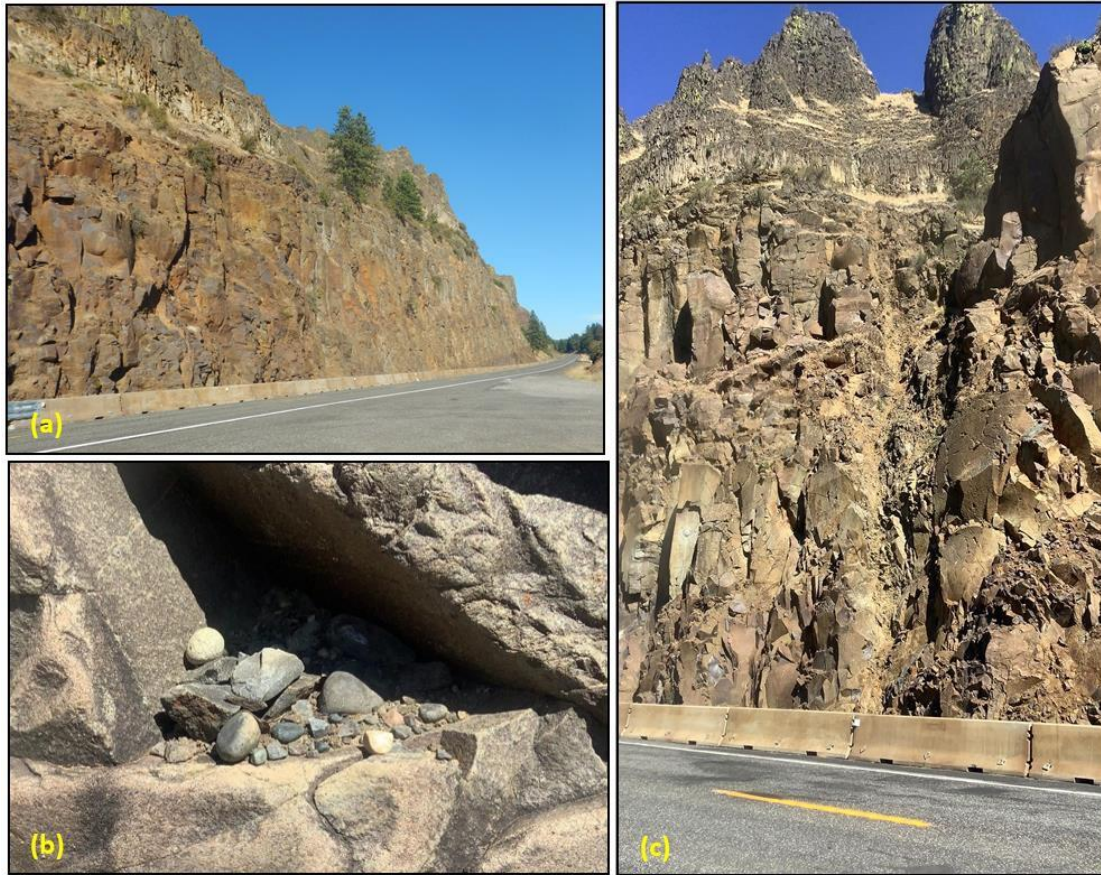
**Figure 2.3** Views of the Hewett Lake (SR 14) research site: (a) view to the east along the highway; (b) example of the interpreted Missoula flood deposits nestled under an overhanging block; (c) example of a high-angle fault.

We conducted SH readings using both hammer types at ten locations at this site (see Table 2.1 for average results). We also made 214 measurements of discontinuities, including faults and joints (Figure 2.4). The road cut stands up to 80 m high at an ~80° maximum slope angle (facing ~200°). We noted the presence of several high angle faults (with average dip and dip direction of 86° and 99°, respectively), some of which we were able to estimate at 1.5 to 2 m of separation (Figure 2.3c, Figure 2.4).

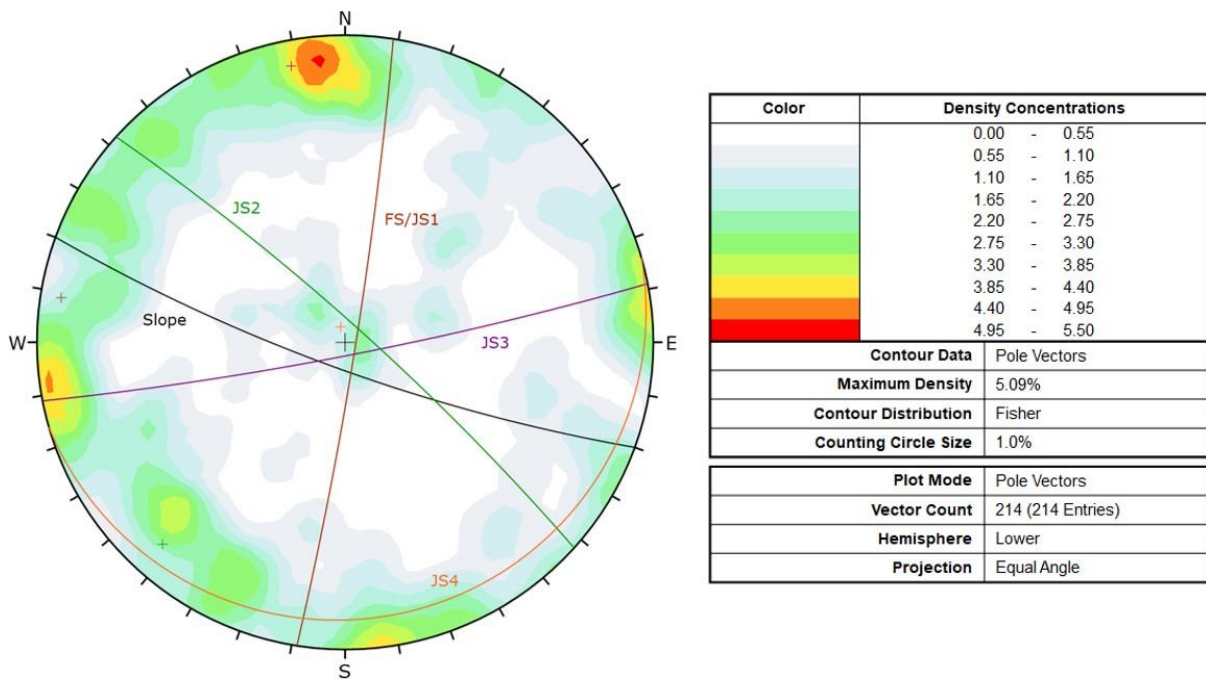
**Figure 2.4** Stereonet for Hewett Lake, Washington (SR 14).

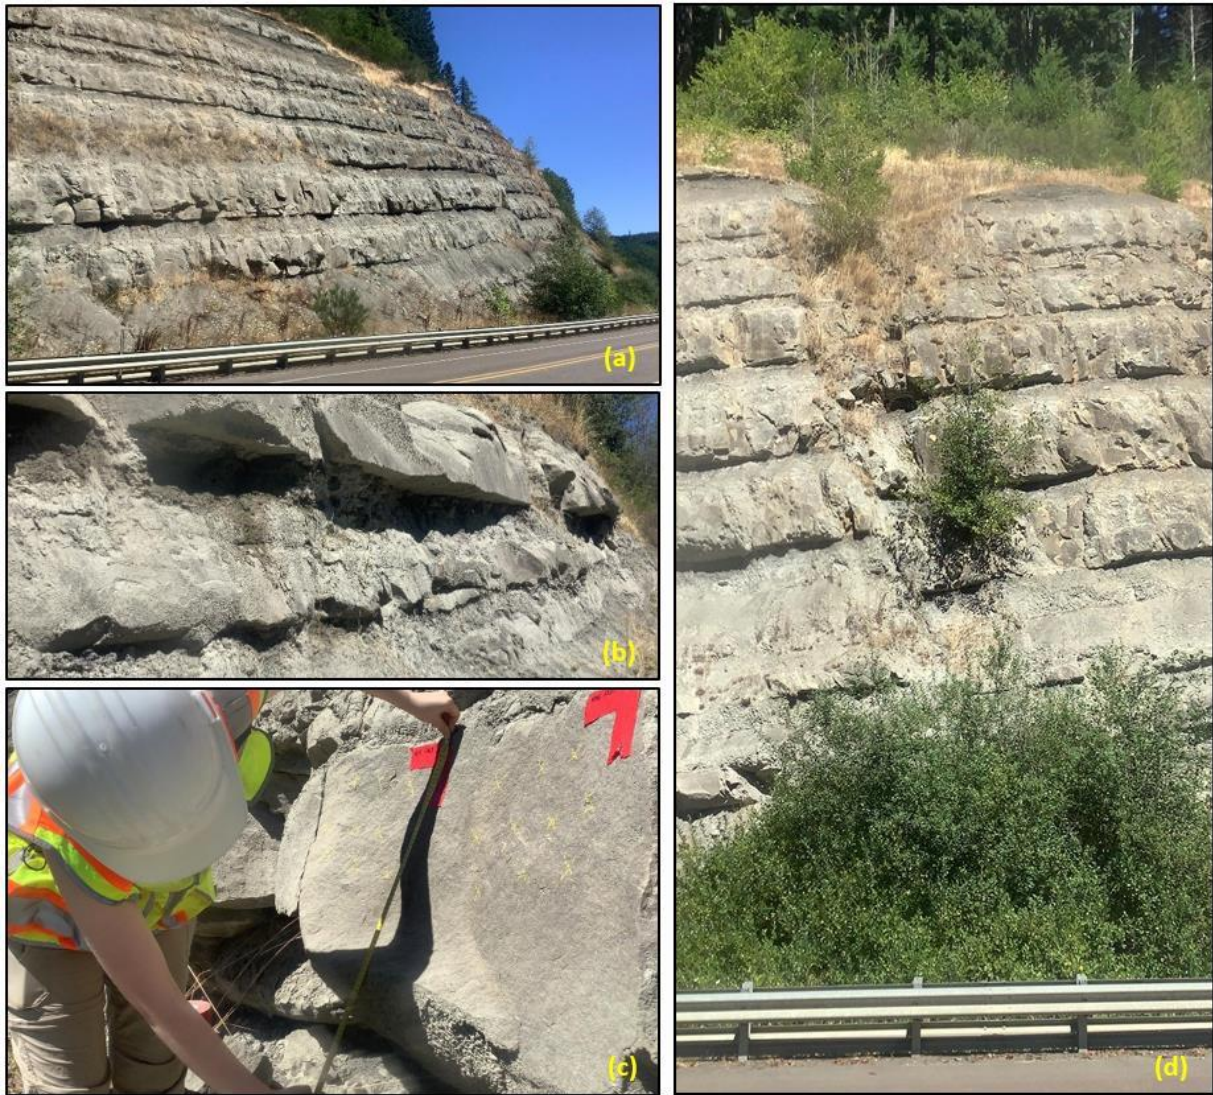
**Figure 2.5** Photographs of the geology at the Eddyville research site: (a) view to the east along the highway; (b) example of overhanging greywacke underlain by siltstone with evidence of water seepage; (c) measuring bed thickness at an SH measurement site; (d) high-angle, normal fault with vegetation.

We took 31 measurements of bedding, joints, and faults. The high-angle normal faults form notable drainages in the topography above the rock cut, providing preferential flow paths for water, with larger debris piles forming at their base. Some of these faults were obscured with vegetation, which was likely growing where there was more available water (Figure 2.5d). Measured displacements ranged from only 1 cm to 0.7 m offset, with some faults containing black gouge and iron staining. One fault demonstrated apparent strike-slip movement based on the orientation of slickens on the fault surface. Figure 2.6 is the stereonet for this location, displaying the consistent bedding (avg. dip and dip direction of  $14^{\circ}/335^{\circ}$ ) and predominate fault/joint set (avg. dip and dip direction of  $82^{\circ}/88^{\circ}$ ). We also conducted SH readings using both hammer types at 12 locations for the graywacke parallel with bedding, and at two locations for the siltstone parallel with bedding (see Table 2.1 for average results). The values presented in Table 2.1 for siltstone represent one non-zero reading for the N-type SH; all other readings for the siltstone were 0. These results agreed with the visual observations of the siltstone being the weaker of the two types of rock exposed.

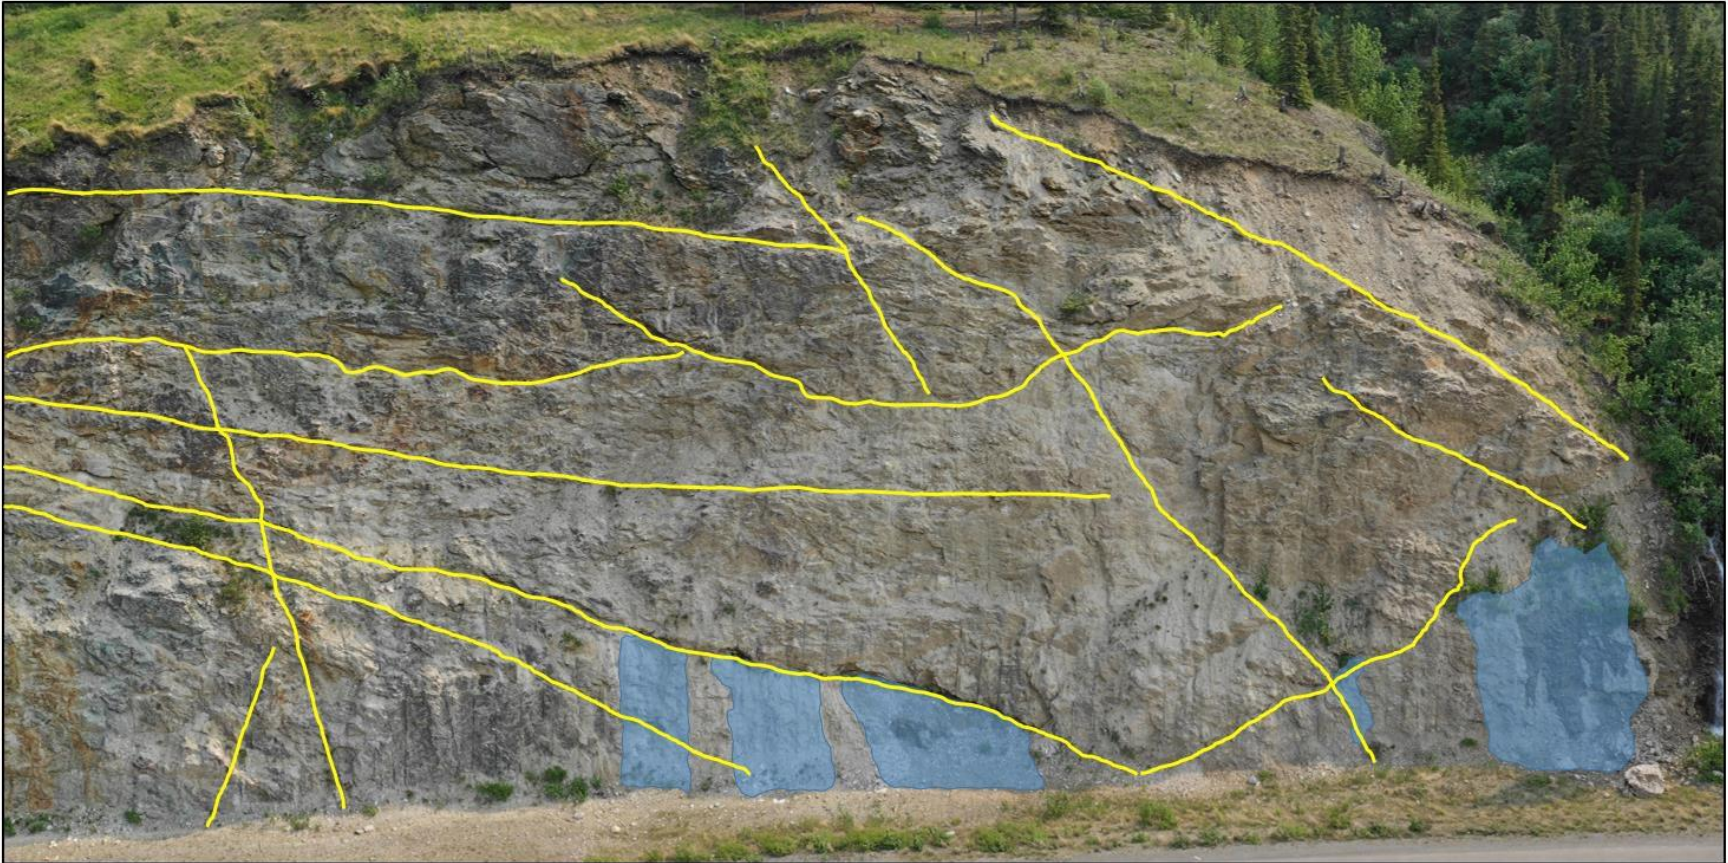
**Figure 2.13** Nenana Canyon (MP 241), Alaska, south section: major discontinuities (yellow) and water seepage areas (blue) in micaceous quartzite and muscovite/sericite quartz schist.

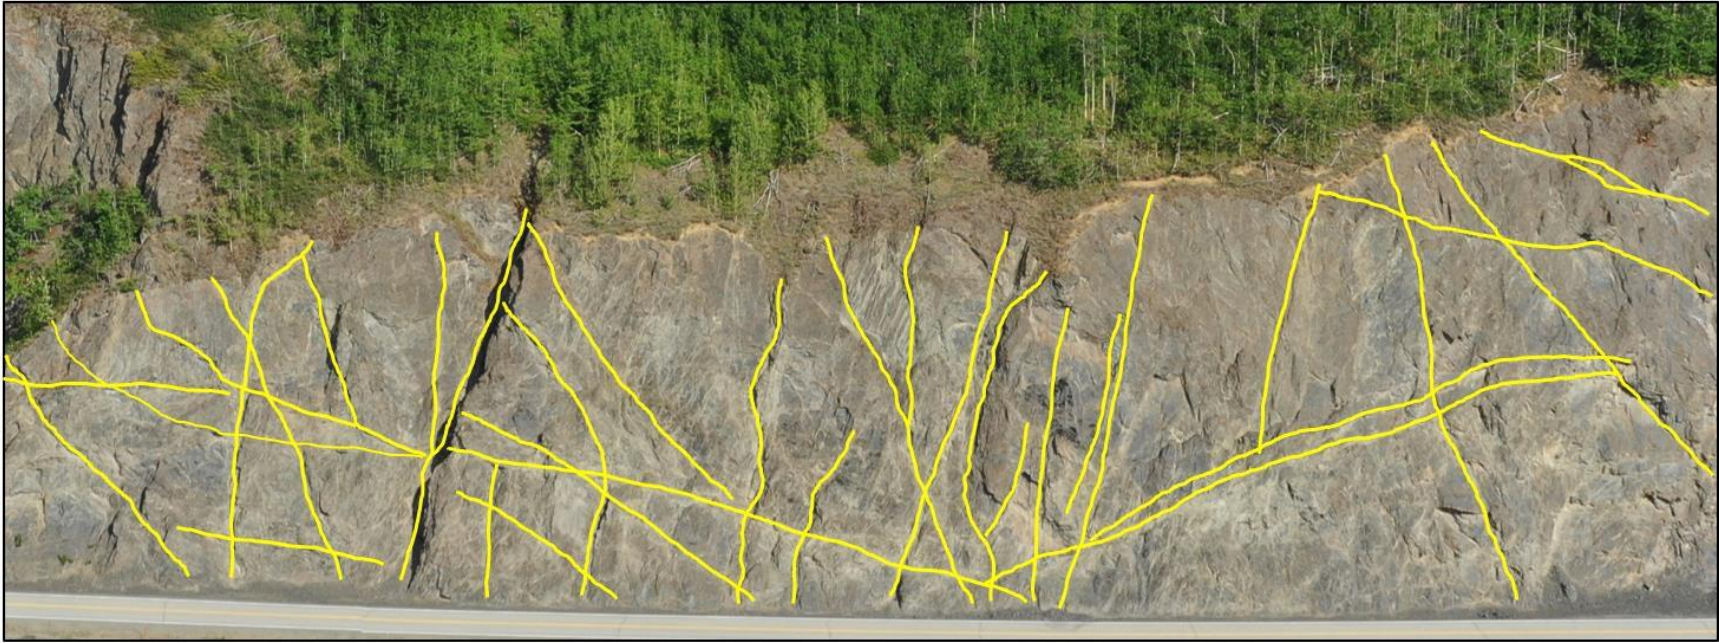
**Figure 2.14** Long Lake (MP 71), Alaska, west section: major discontinuities (yellow) in mudstone.

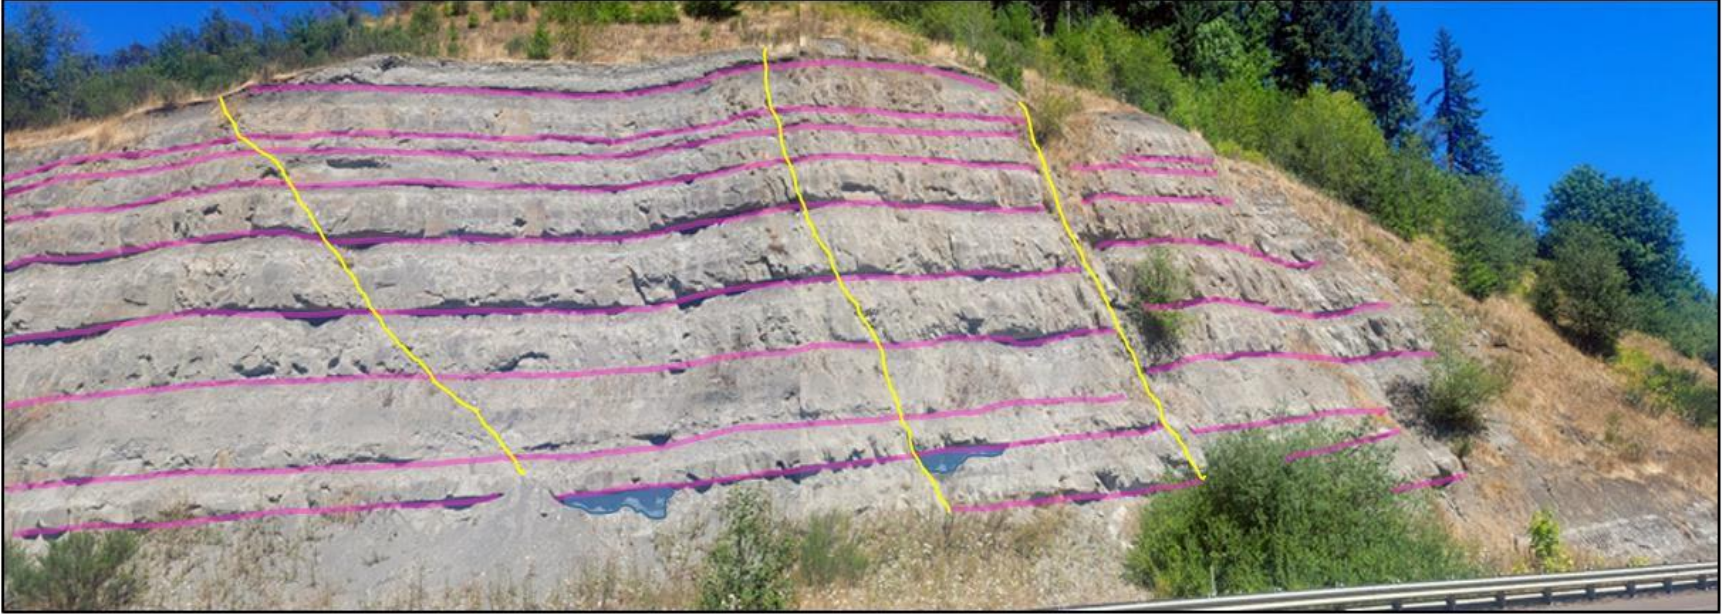
**Figure 2.16** Eddyville, Oregon: major discontinuities (yellow) and water seepage areas (blue) in alternating beds of greywacke and siltstone (rose lines mark the bottom of each greywacke bed). Note that this image covers only the extreme east end of the site.
