EFFECTIVE WILDLIFE FENCES THROUGH BETTER FUNCTIONING BARRIERS AT ACCESS ROADS AND JUMP-OUTS

FHWA/MT-23-005/9923-808

Electrified Barriers Installed on Top of Wildlife Guards to Help Keep Large Wild Mammals Out of a Fenced Road Corridor - Interim Report

Electrified Barriers Installed on Top of Wildlife Guards to Help Keep Large Wild Mammals Out of a Fenced Road Corridor

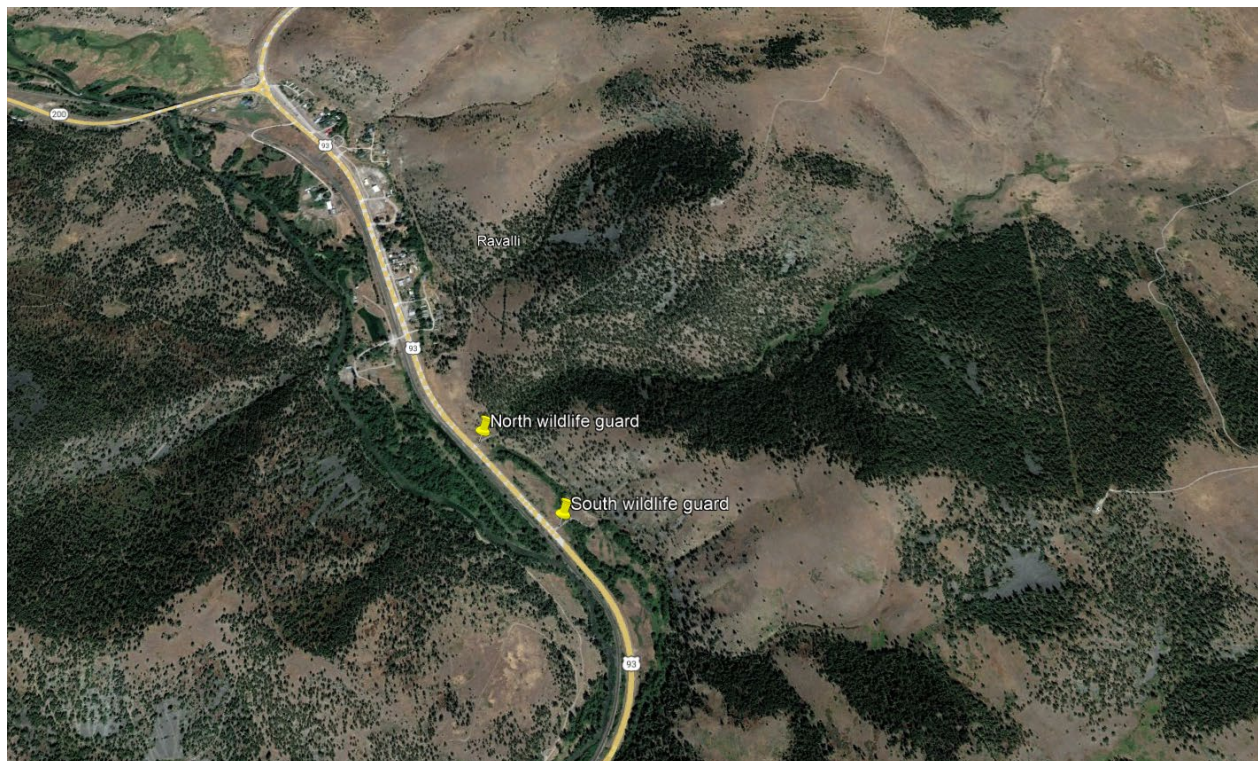
Figure 1: The two locations selected for the installation of an electrified mat on top of an existing wildlife guard, just south of Ravalli, Montana. Note that these are the same two sites that were part of the study by Allen et al. (2013).

Two locations were selected for the installation of electrified barriers on top of existing wildlife guards (Figure 1). These two locations meet the following criteria:

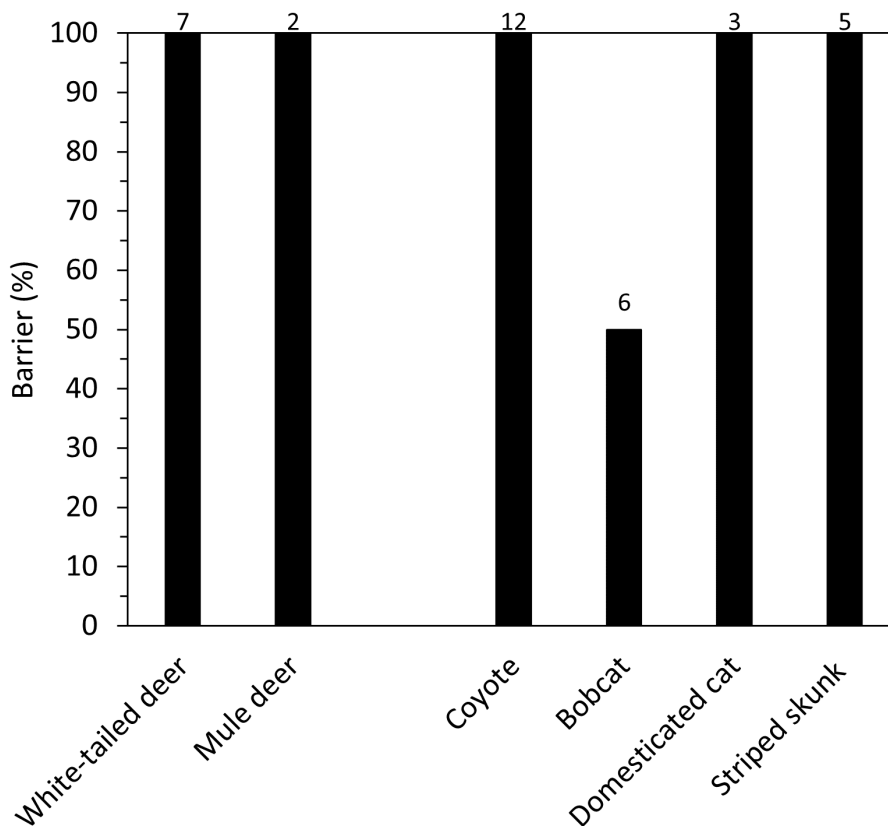
Figure 10: The barrier effect (%) for the different ungulate species (left) and species with paws (right) that approached the wildlife guard (without an electrified barrier) within 2 meters on the habitat side. The numbers on top of the bars are the sample size (i.e., the total number of animals that approached the wildlife guard on the habitat side and that came within 2 m of the wildlife guard).

None of the white-tailed deer and mule deer that approached the wildlife guard on the habitat side and that came within 2 m of the wildlife guard crossed into the fenced road corridor (Figure 10). The wildlife guard was also an absolute barrier for coyotes, domesticated cats, and striped skunks. However, 50% of the 6 bobcats that approached the wildlife guard entered the fenced road corridor. All three bobcats that entered the fenced road corridor did so by walking on the exposed concrete edge of the pit (Figure 11).

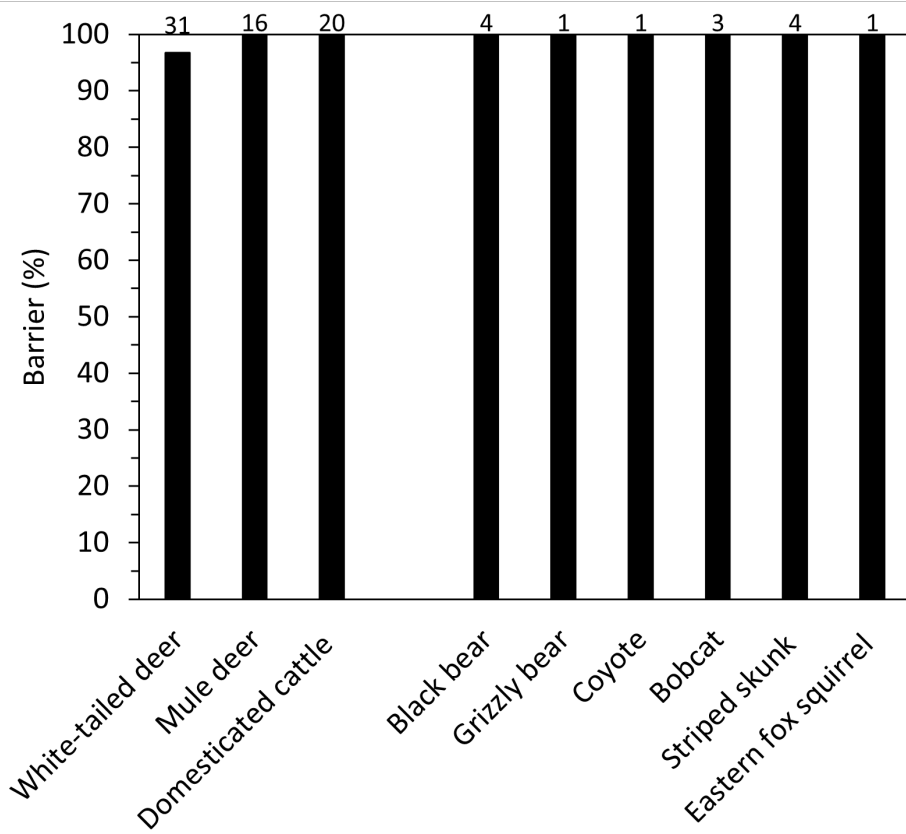
Figure 12: The barrier effect (%) for the different ungulate species (left) and species with paws (right) that approached the two wildlife guards and electrified mats (both Crosstek and BS Fabrications combined) within 2 meters on the habitat side. The numbers on top of the bars are the sample size (i.e., the total number of animals that approached the two wildlife guards and electrified mats on the habitat side and that came within 2 m of the edge of the wildlife guard).

One of the 31 white-tailed deer but none of the 16 mule deer that approached the 2 wildlife guards on the habitat side and that came within 2 m of the electrified wildlife guards crossed into the fenced road corridor (Figure 12) (96.8% barrier for white-tailed deer, 100% barrier for mule deer, 97.9% barrier for the 2 deer species combined). The northern barrier (Crosstek) had 7 white-tailed deer and 2 mule deer approach the wildlife guard on the habitat side within 2 m. None of these animals crossed into the fenced road corridor (100% barrier for both deer species). The southern barrier (BS Fabrications) had 24 white-tailed deer and 14 mule deer approach the wildlife guard on the habitat side within 2 m. One white-tailed deer but none of the mule deer crossed into the fenced road corridor (95.8% barrier for white-tailed deer, 100% barrier for mule deer). Based on the images, the one white-tailed deer that entered the fenced road corridor still got shocked, but there seems to have been a delay because of the snow, likely contributing to the animal jumping forward rather than backing off (Figure 13).

The electrified wildlife guards were an absolute barrier (100%) for domesticated cattle, black bears, grizzly bears, coyotes, bobcats, striped skunks, and eastern fox squirrel. Based on the images, at least 2 of the 4 black bears were shocked (Figure 14), and the one grizzly bear was also shocked (Figure 15). There was one additional black bear on 25 April 2022 (outside of the formal evaluation period) that started crossing the wildlife guard with an electrified mat by BS Fabrications. Based on the images, this black bear was shocked as well and ran back to the habitat side. Thus, if it was not for the electrified barriers, likely at least 3 black bears and 1 grizzly bear would have crossed into the fenced road corridor where they would have been exposed to vehicles.

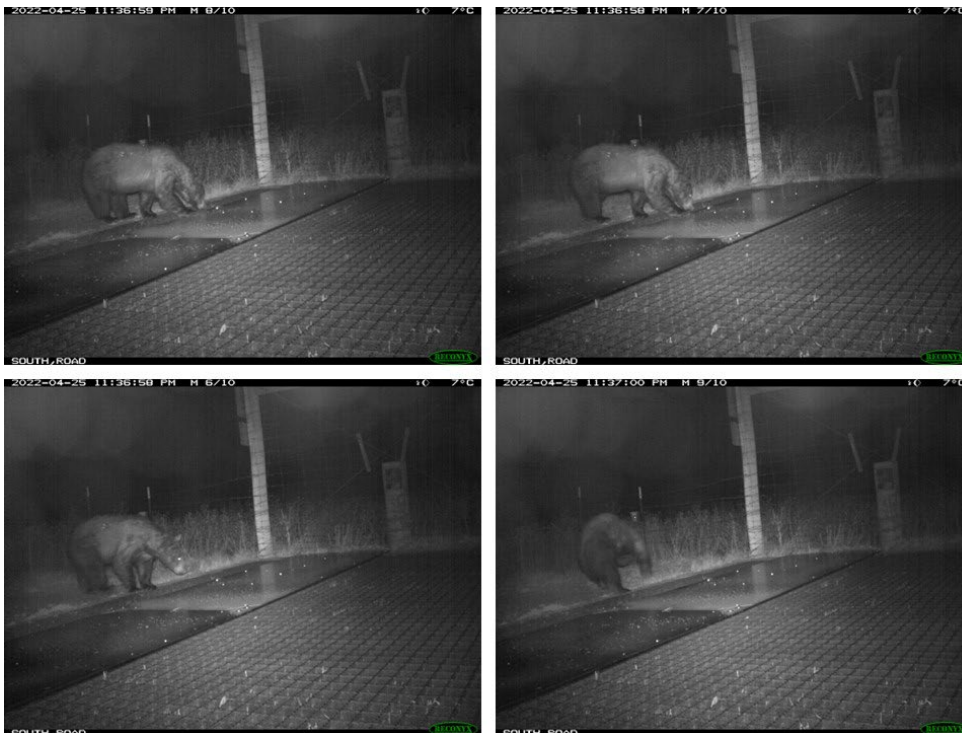
Figure 14: A black bear approached the wildlife guard and electrified barrier (BS Fabrications). Based on the images, this animal was shocked and ran back to the habitat side.

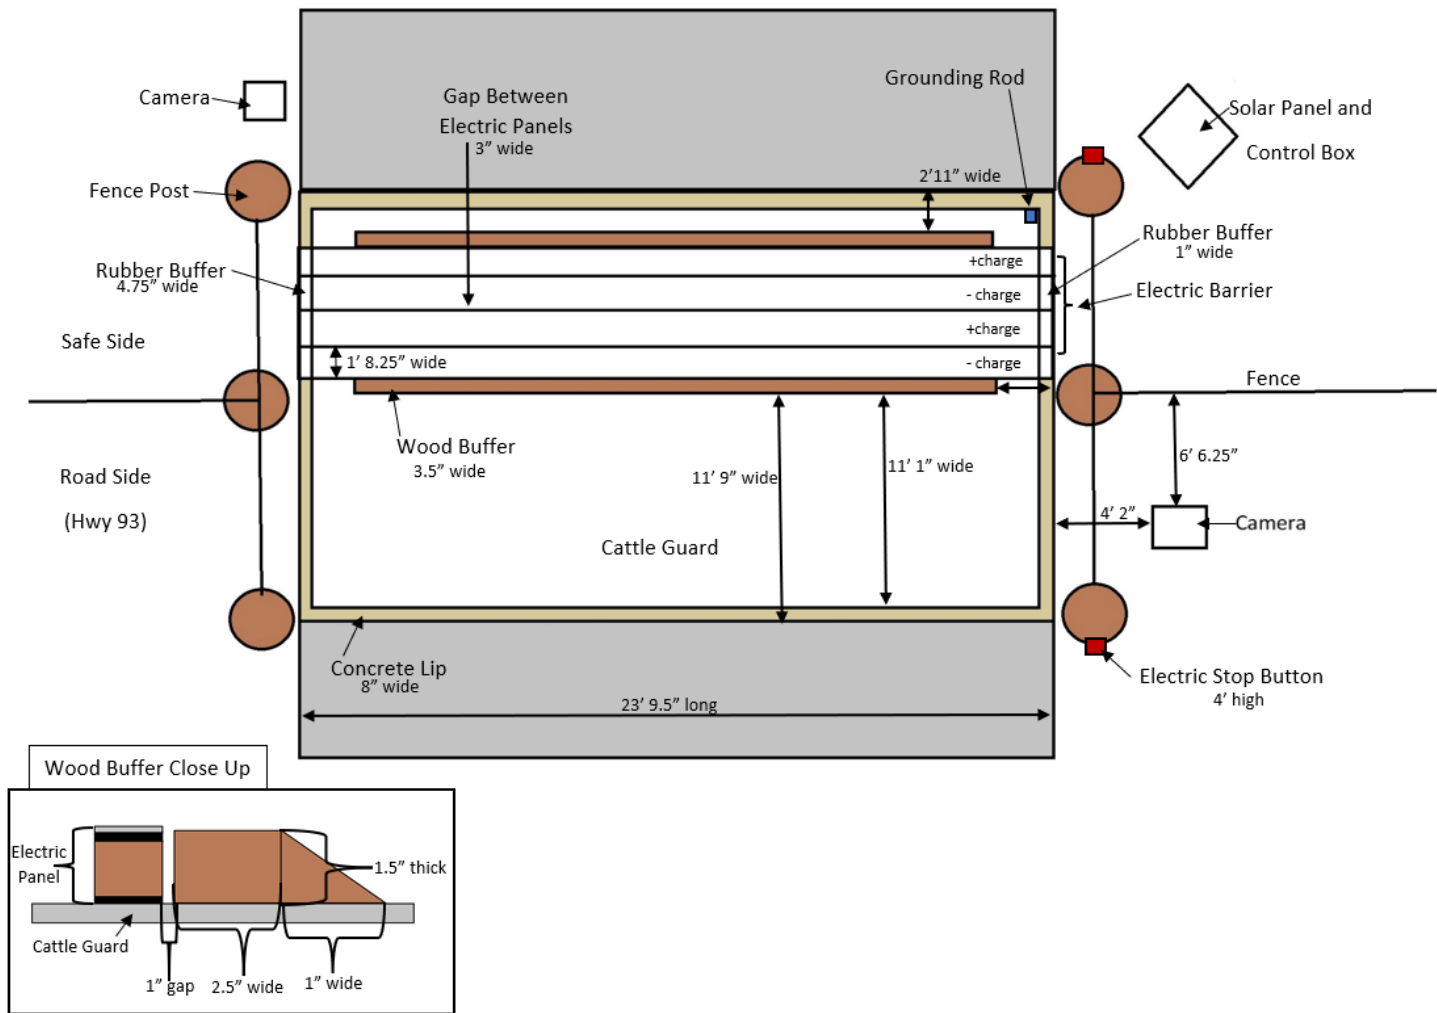
Figure 16: Technical drawing of the Crosstek electrified mat. Note: for "proof of concept" for this project, CrossTek determined inclusion of wood materials was adequate given the expected short study length and low traffic volume. CrossTek uses a variety of very long life and highly durable materials including composites and concrete where necessary, designed for and matched to individual site conditions.

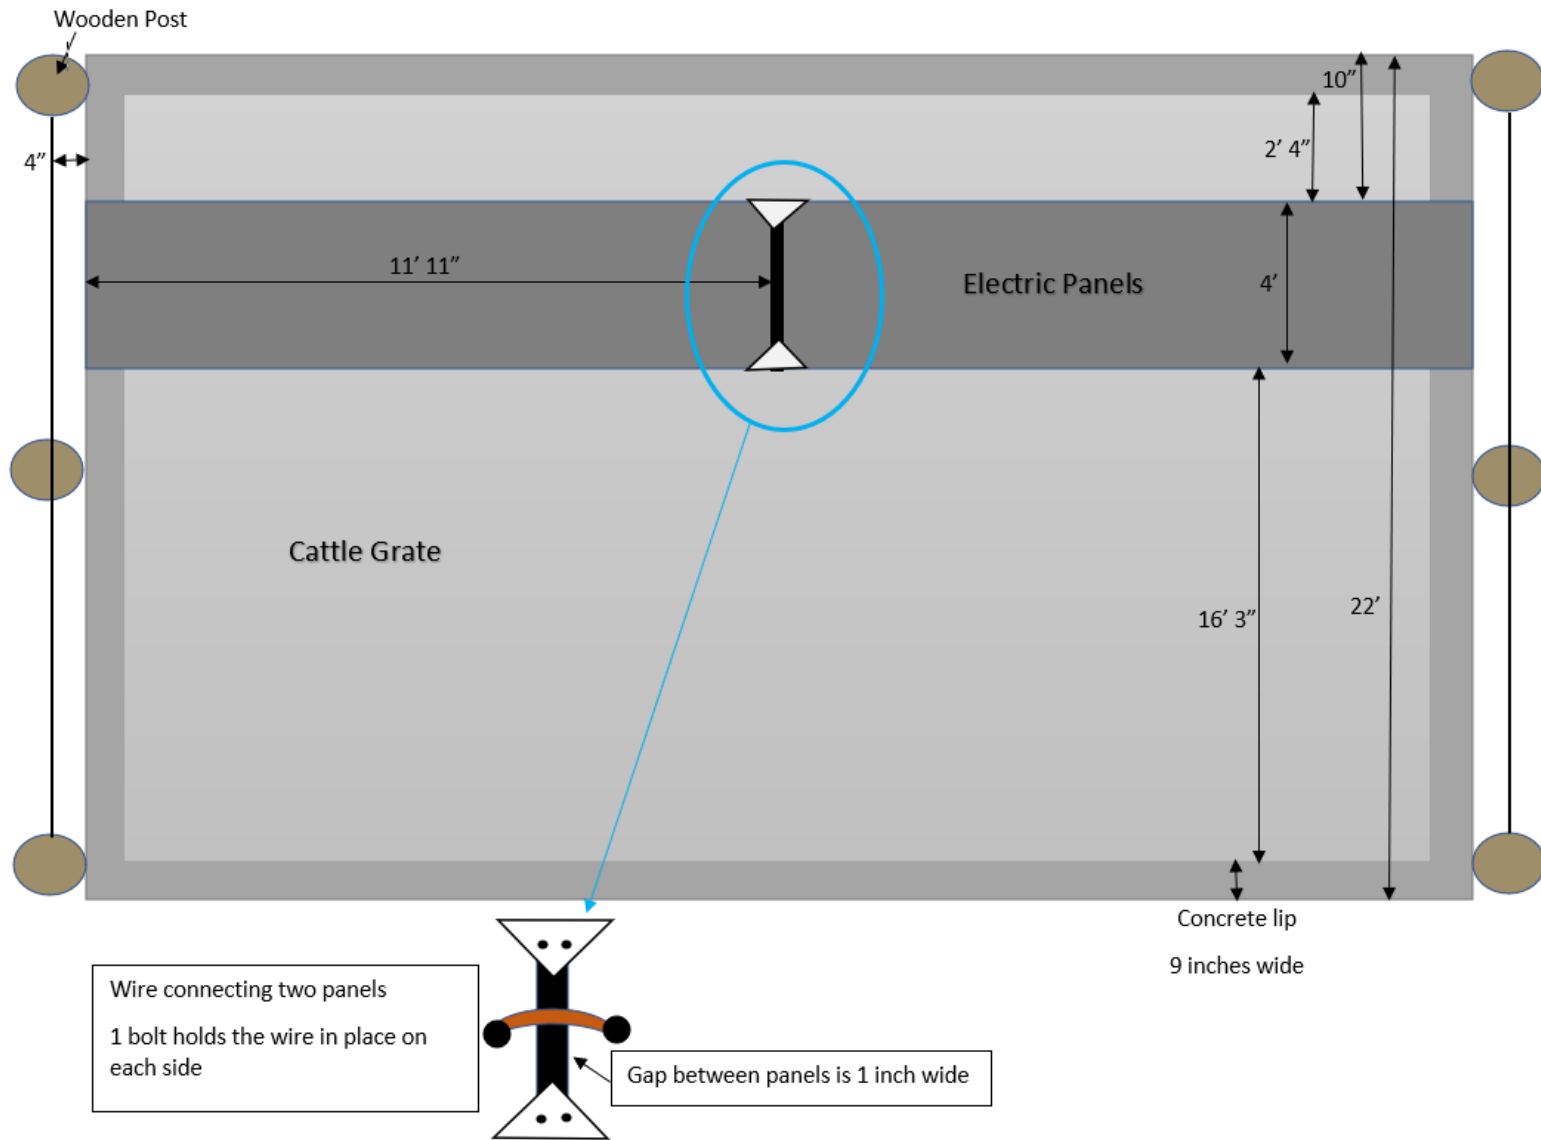
Specifications electrified mat by BS Fabrications (Figure 17)

Figure 17: Technical drawing of the BS Fabrications electrified mat.
