# **Interstate and Primary PCC Pavement Overlays Review**

**Final Report  
for  
MLR-23-01**

December 2023  
Construction & Materials Bureau

Construction & Materials Bureau  
Iowa Department of Transportation  
Ames, Iowa 50010

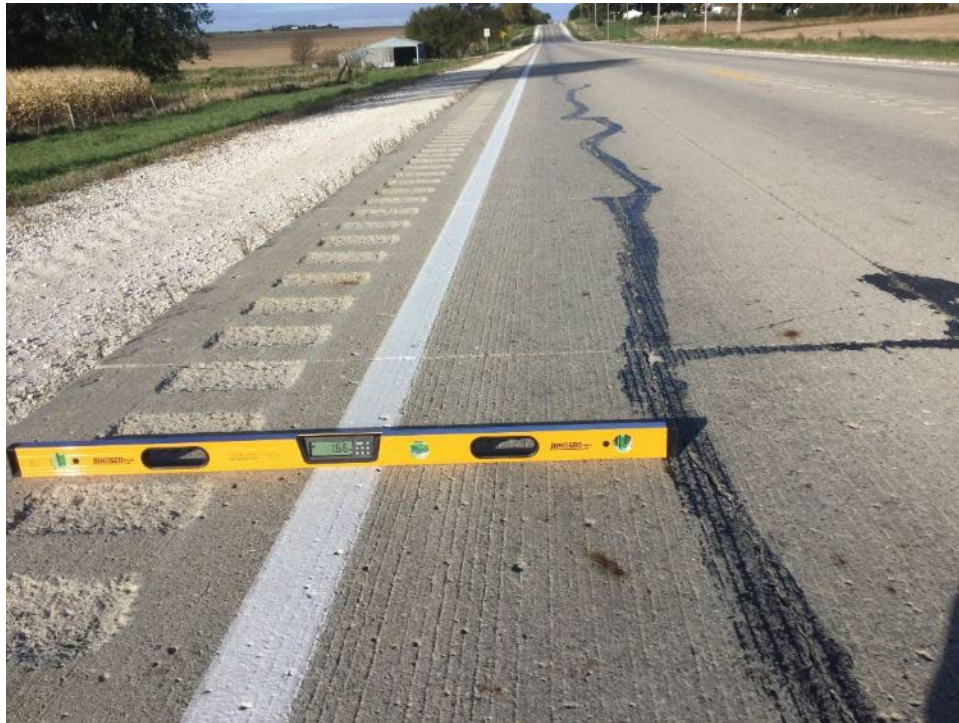
Figure 10 – Sac IA 175 UBOL Left Shoulder Crossslope 1.66%

Cracking occurred in the outside wheel paths in less than two years. It was assumed that the old HMA widening unit was heaving causing the cracking. However, it was later discovered that the outside widening unit was heaving that cause the cracking. This problem led to the use of the 60-inch reinforcing steel bar across the old widening and tied to the new widening.

The district sealed all the cracking and there has not been a lot of patching required. Even with all the cracking, the overlay still rides fairly well at the time of this report.

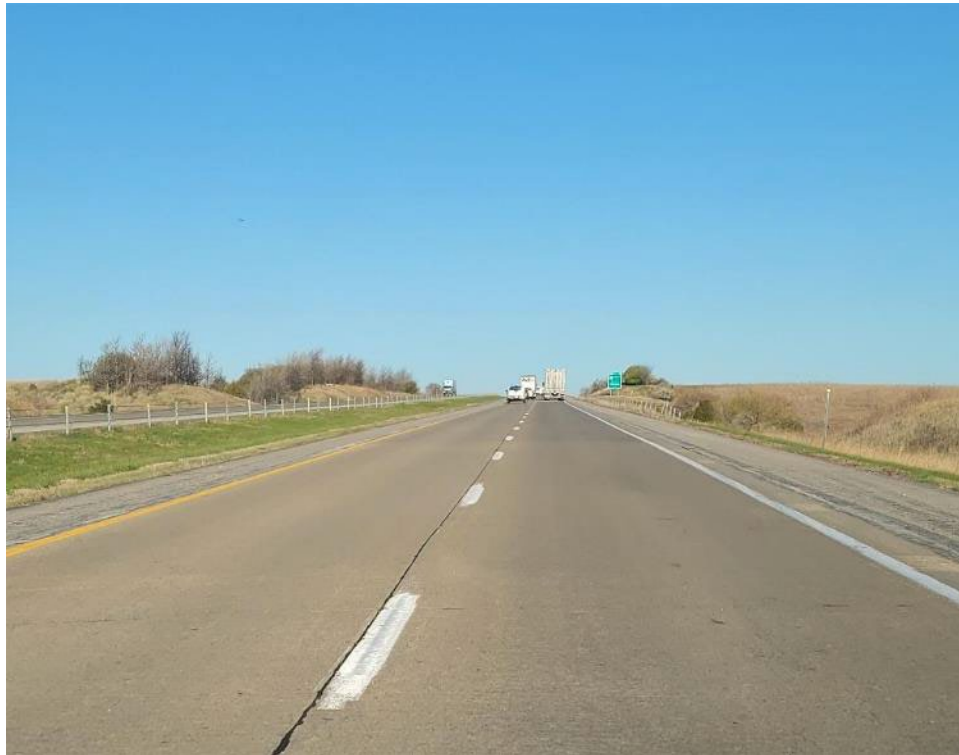
Figure 13 – Adair I-80 WB Whitetopping Overlay Paved 1979 (Picture 2023)

Another whitetopping project that has been in service for more than 40 years is the Adair County I-80 westbound overlay, in 1979. The design was to mill 8 inches of HMA and replace with 10 inches of PCC. Overall, the overlay is in good condition with a few patched areas. The pavement was diamond ground in 2020.

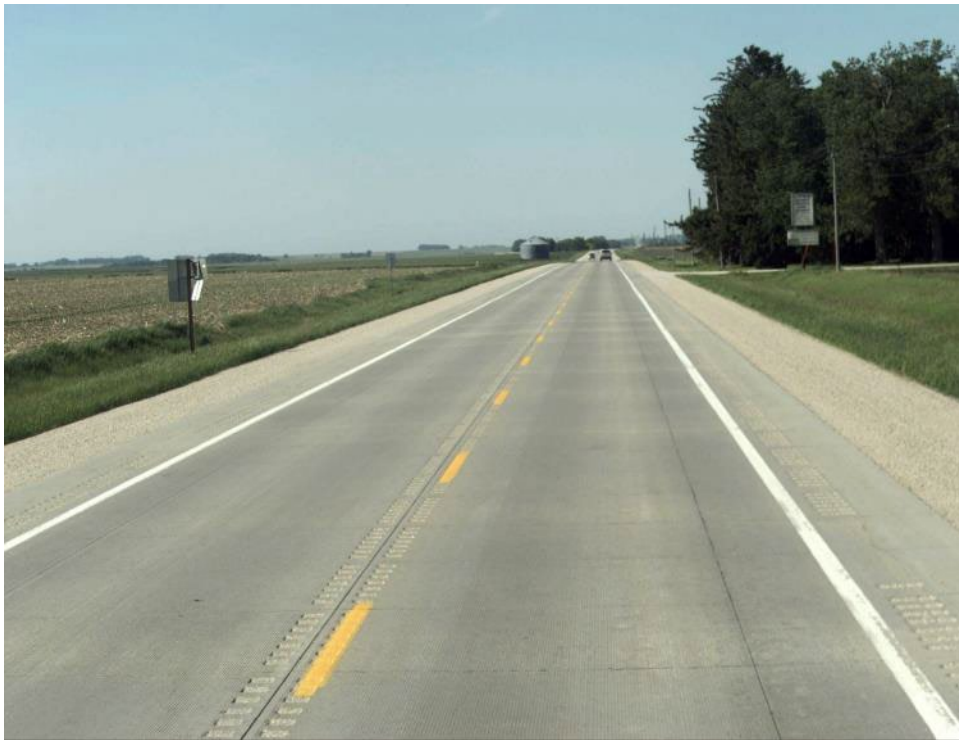
Figure 27 – Clay US 71 2016 UBOL

However, on the Clay US 71 overlays placed in 2015 and 2016, which include both whitetopping and unbonded overlays, both overlay types are in very good condition. As noted earlier, the unbonded overlay placed on Clay/Dickinson US 71 had a few areas of longitudinal cracking. The main difference between the 2012 overlay and the newer overlays was the joint spacing. The 2012 unbonded overlay has 6 x 6-foot panels, with a 6-foot #5 reinforcing steel over the old widening into the tied 4 x 6-foot shoulder. While the 2015 and 2016 overlays have 8 x 9-foot panels with a 6-foot #5 reinforcing steel across the old widening into the 8 x 7-foot shoulder. This design places the sawed joint directly over the old 18-foot original pavement edge.

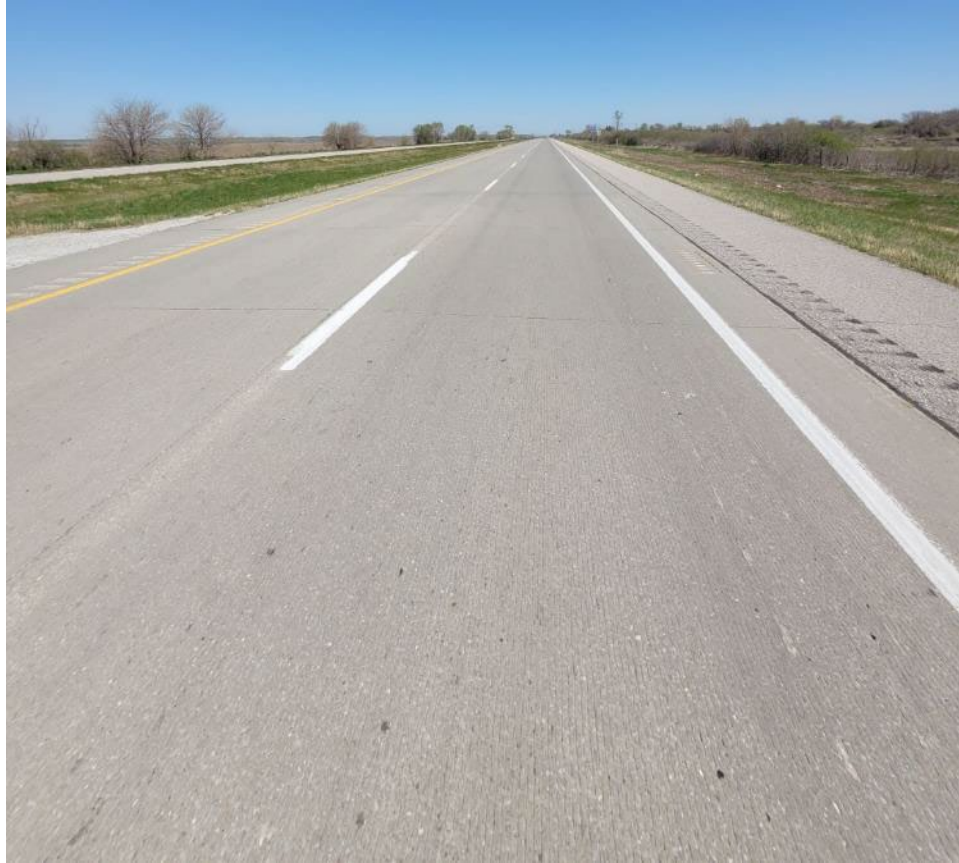
Figure 28 – Fremont County I-29 NB Unbonded Overlay (2023)

The 9 inch unbonded overlays in Fremont and Mills counties placed in 2009 are both performing very good. There are no patches or longitudinal cracking noted during a review in 2023. Interesting to note, the driving lane was widened to 14 foot, or 2 foot over the existing shoulder. No cracking was noted, however, HMA shoulders were used, so there was no tie steel used between the shoulder and the overlay.

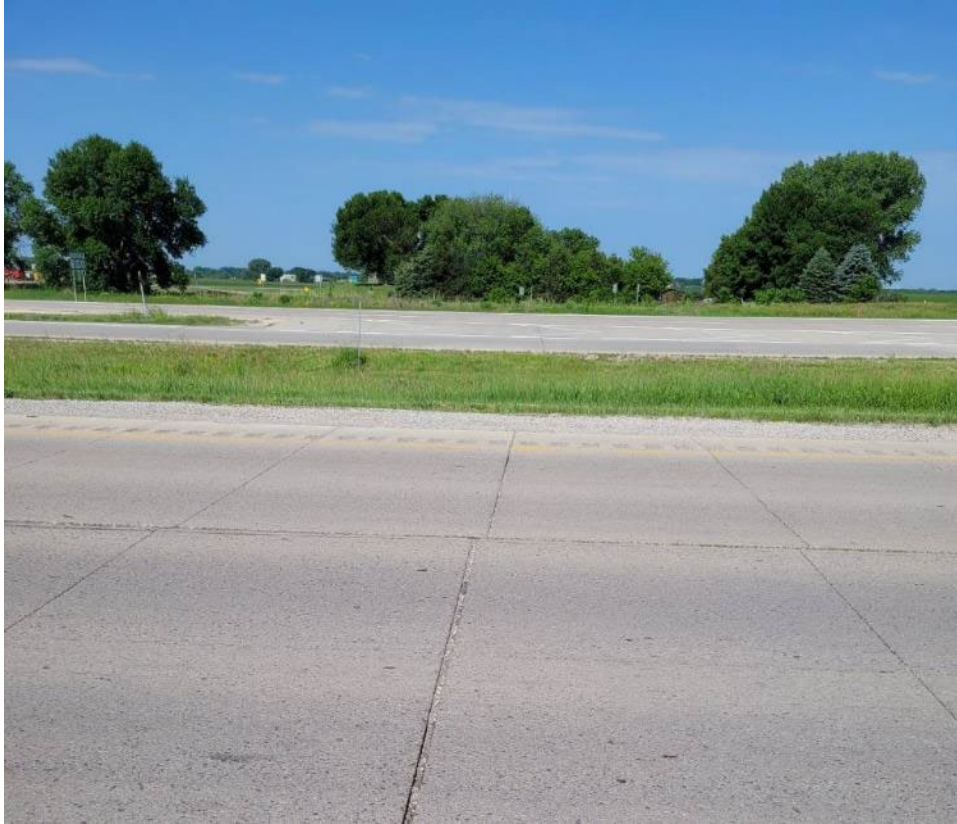
Figure 33 – Clay/Dickinson US 71 NB panels migrating in driving lane at BOP against HMA pavement.

During this review, several design features were noted that have impact on the performance of the overlay. One of the best features noted was using full depth pavement at the beginning (BOP) or end (EOP) of the project and transition between overlay types. Using full depth pavement at the BOP or EOP is especially important if the transition pavement is HMA. Using full depth pavement prevents the panels from migrating due to traffic.

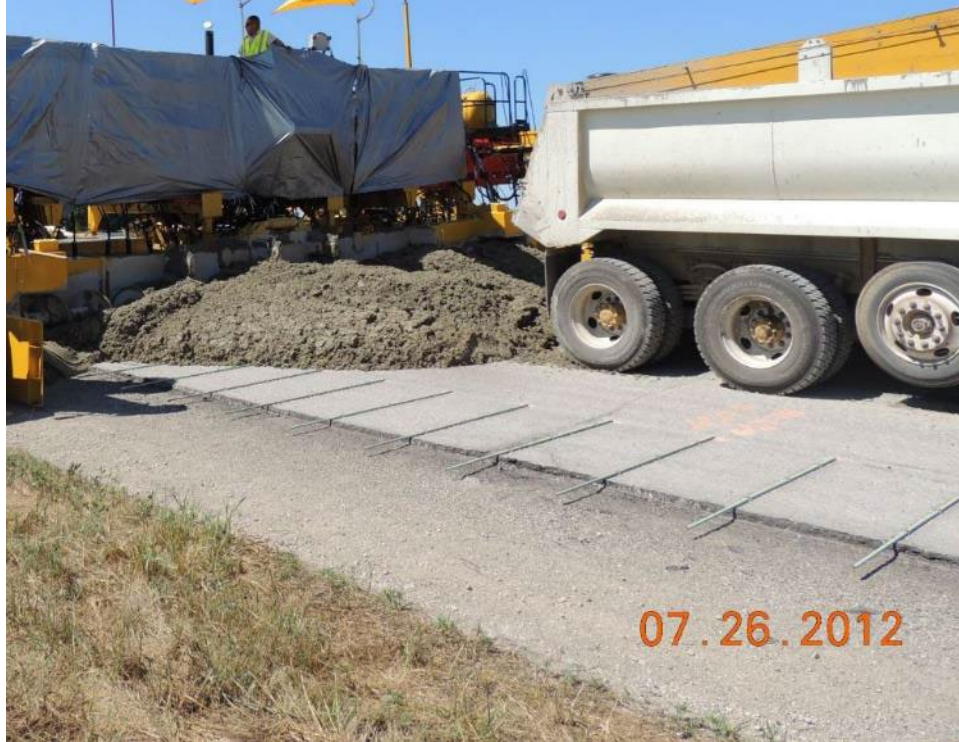
Figure 36 – Typical tie steel on unbonded overlay with existing widening.

Prior to 2011, a #4 reinforcing steel bar 60 inches long was placed over the existing widening and into the new widening unit. From 2011 to 2014 a #5 bar was used and a #4 from 2015 and later. It was noted that the #5 bar may be too rigid and standards were changed back to the #4 bar. Although, it does not appear that changing to a smaller diameter bar has helped eliminate longitudinal cracking. Most all are stapled to the existing pavement and panels throughout the middle are moving with direction of traffic.

Several alternate designs have been placed in the last few years that likely will address the issues found with the 60-inch reinforcing steel. One method used on the Marshall County IA 14 project was a 36-inch reinforcing steel was stapled across the existing widening unit. The overlay was placed full width and the shoulders were not tied.

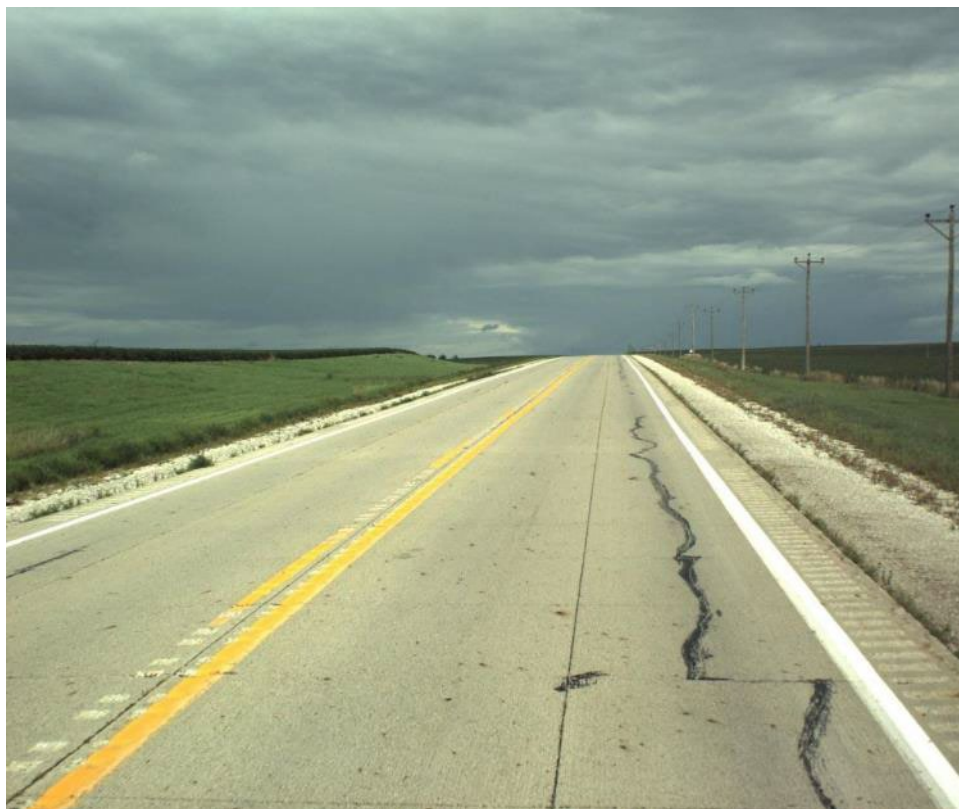
Quite a bit of longitudinal cracking showed up the next year after construction. It was noted that the outside shoulders appeared to be heaving based on the cross slope.

Driving lane panel cross slope 2.09%

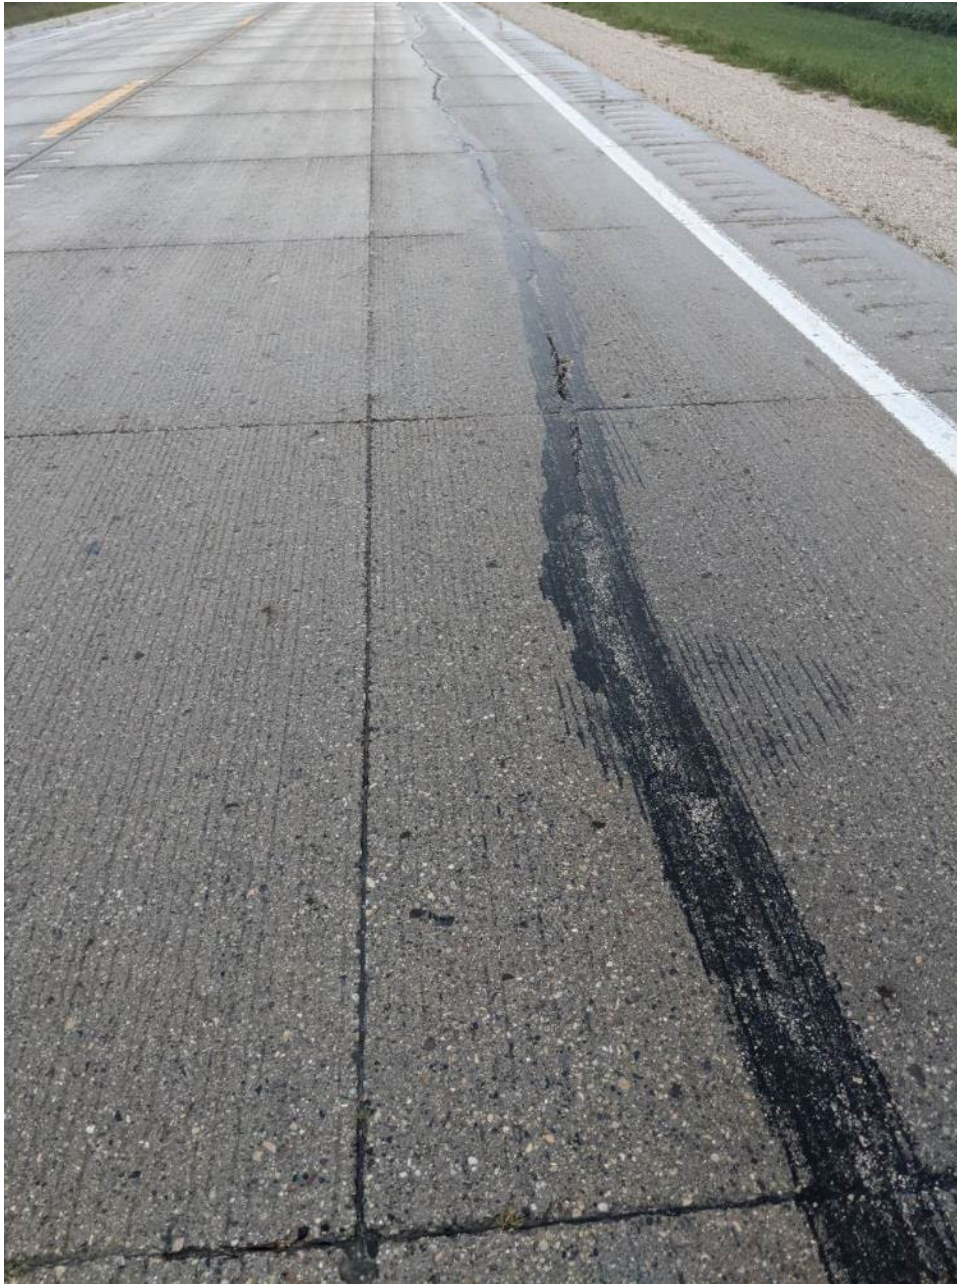
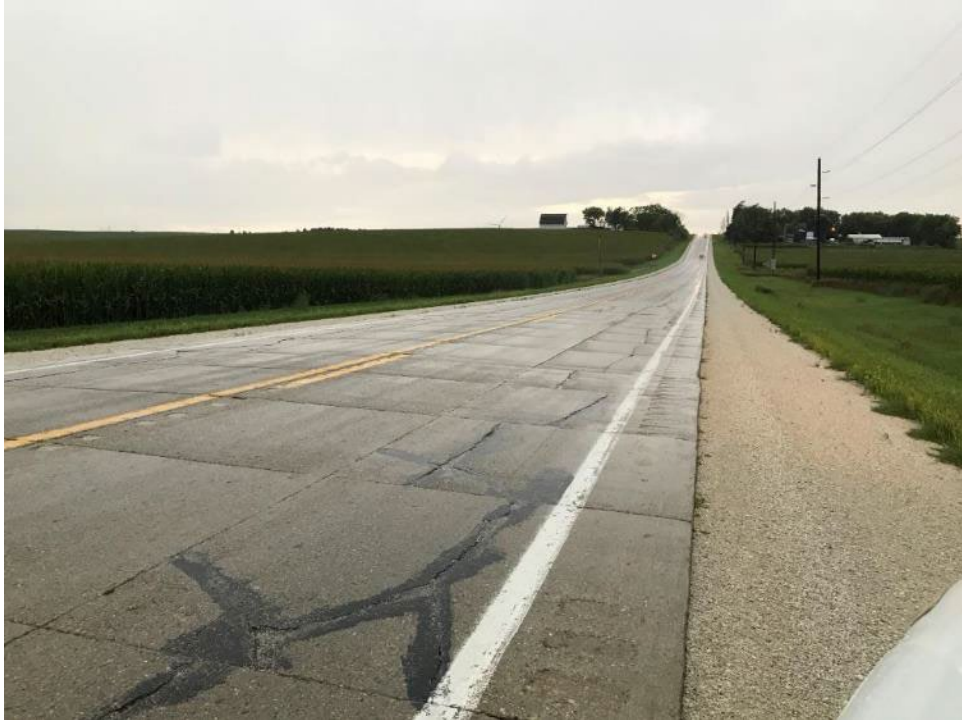
After most of the cracking occurred, the district filled the longitudinal cracks with hot pour sealant. Even with all the cracking that occurred early, the pavement continues to ride fairly well. There are likely areas that need to be patched.

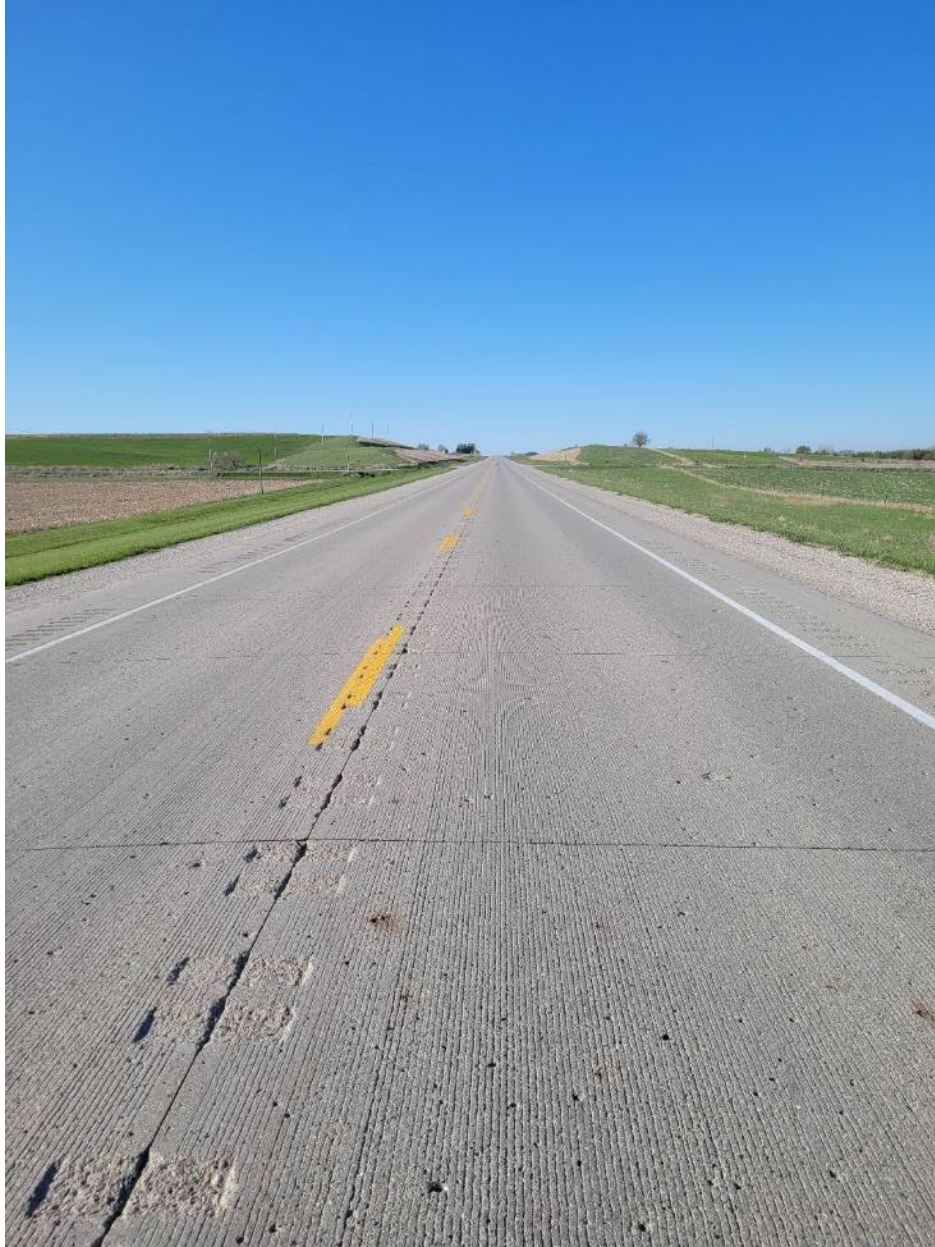
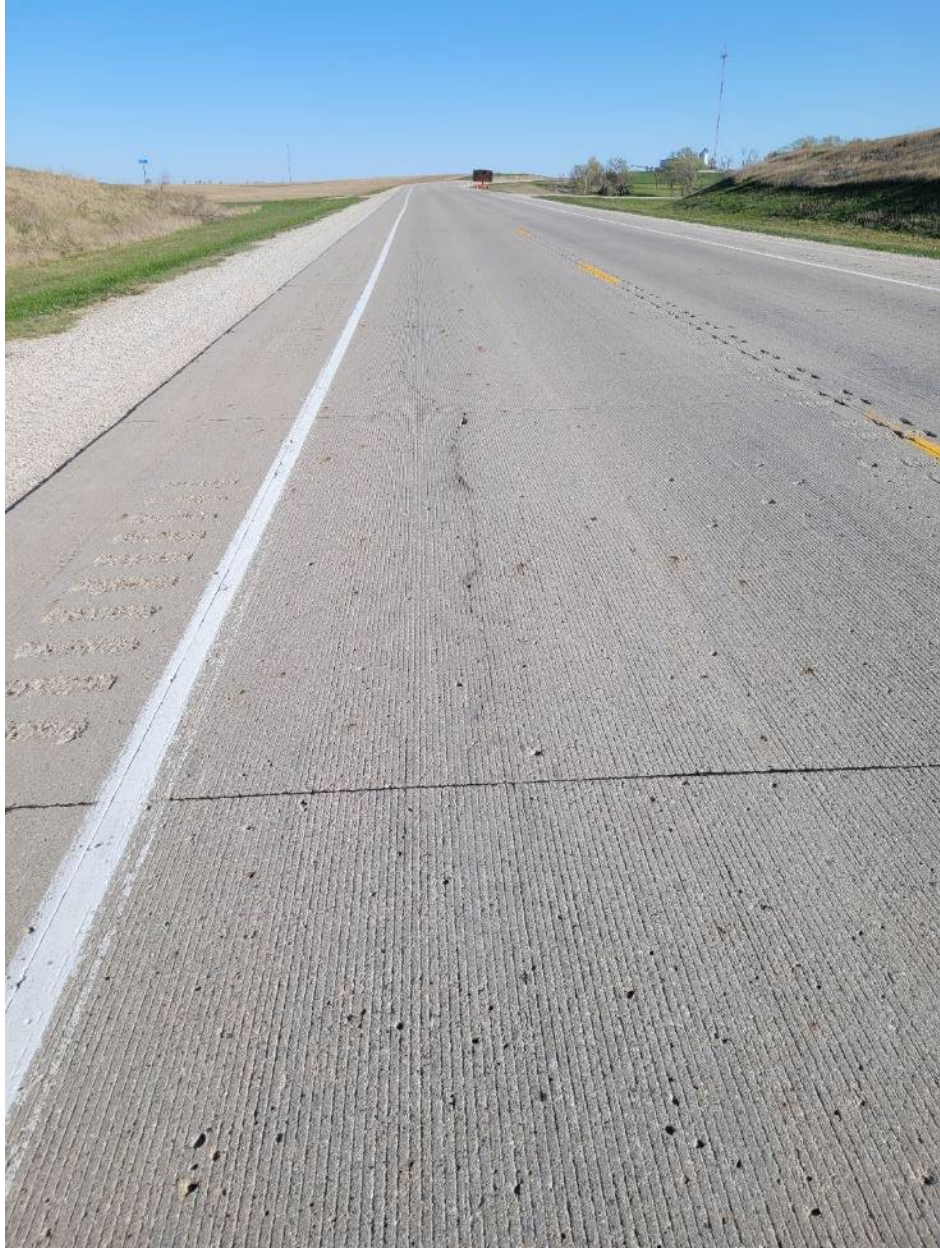
Overall, in good condition. There are approximately 3 to 4 areas with cracking at quarter point. There are also areas where milled rumble strips went through transverse joints and blew out edge.

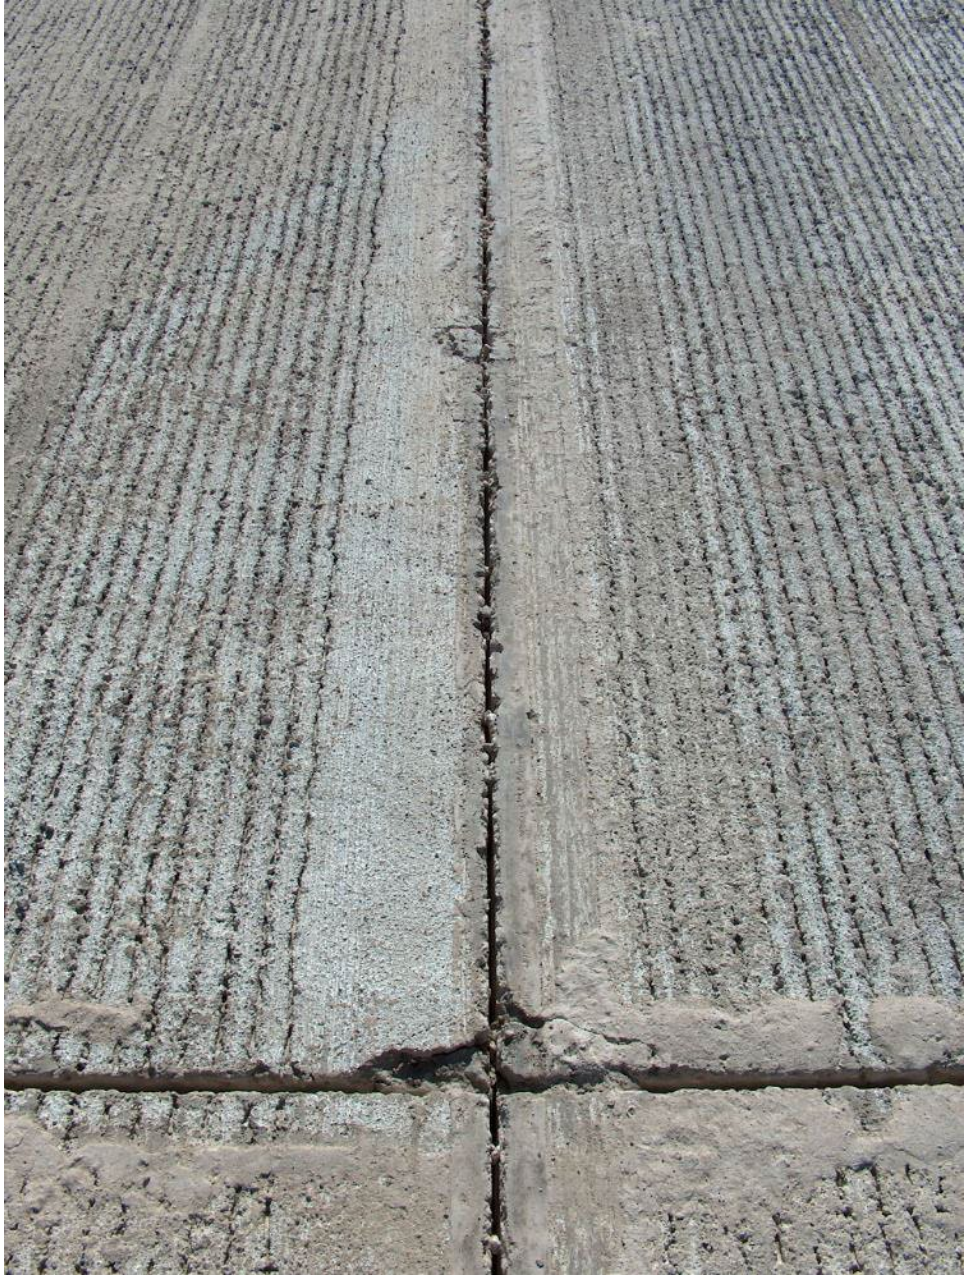
Panels moving, especially west of US 59. Maintenance placed patches with foam on either side to accommodate slab movement. We noted that now the slabs will move even more. District will let a patching project to add full depth patches in areas to prevent slab migration.

Longitudinal cracking

PCC overlay in better condition east of US 59.

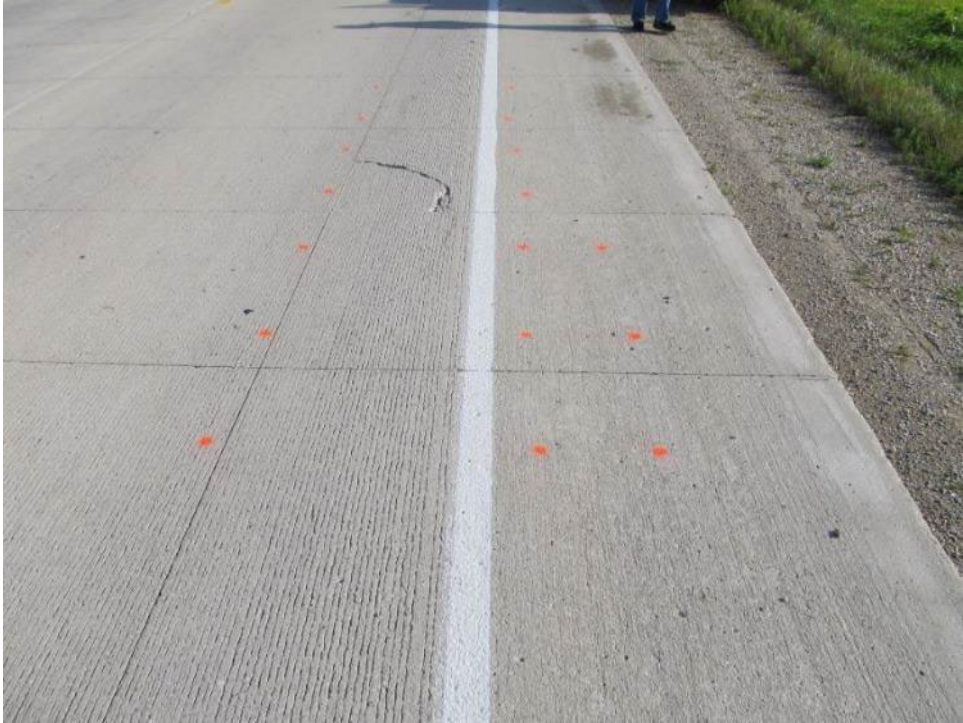
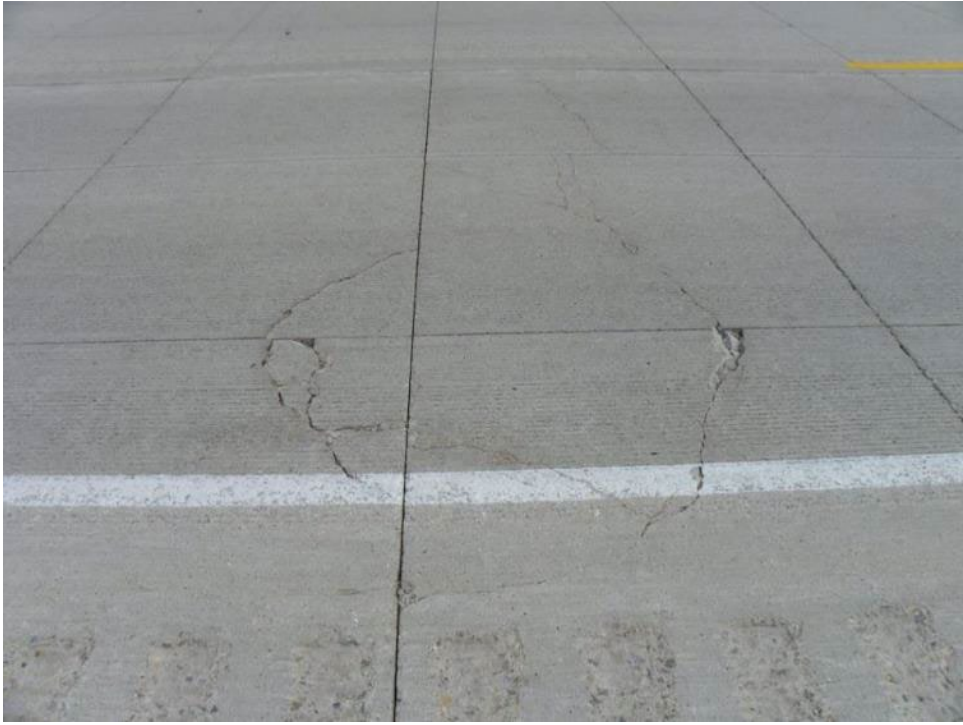
Areas of cracking and broken panels.

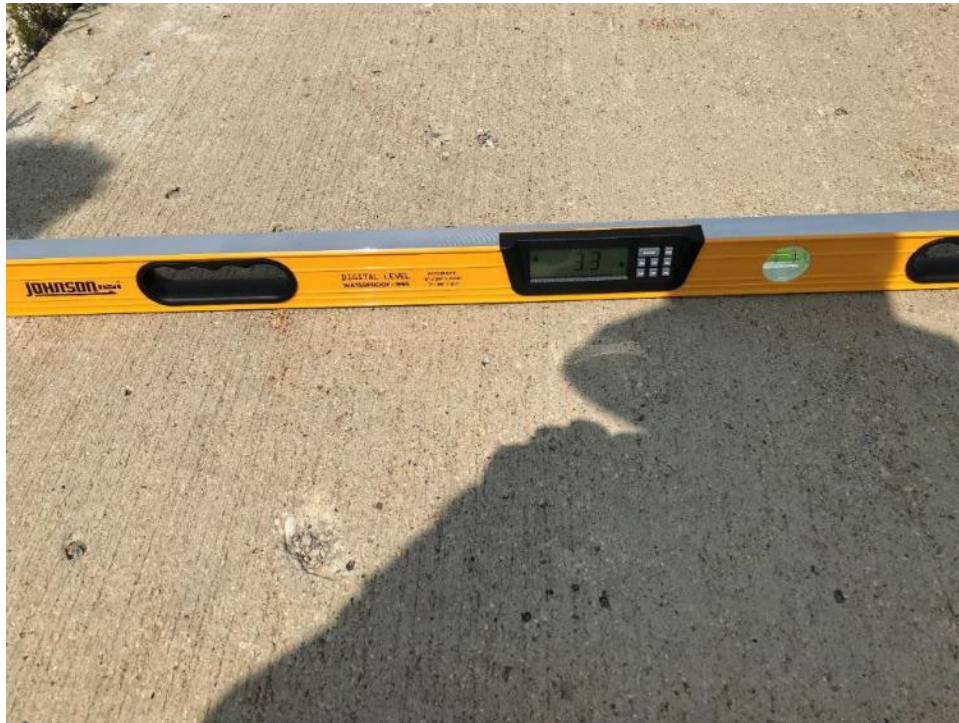
UBOL sections - Longitudinal cracking off end of reinforcing in the outside wheel path. Shoulder heaving. Whitetopping overlay sections in very good condition.

Shoulder cross slope 3.3%, Design 4%.

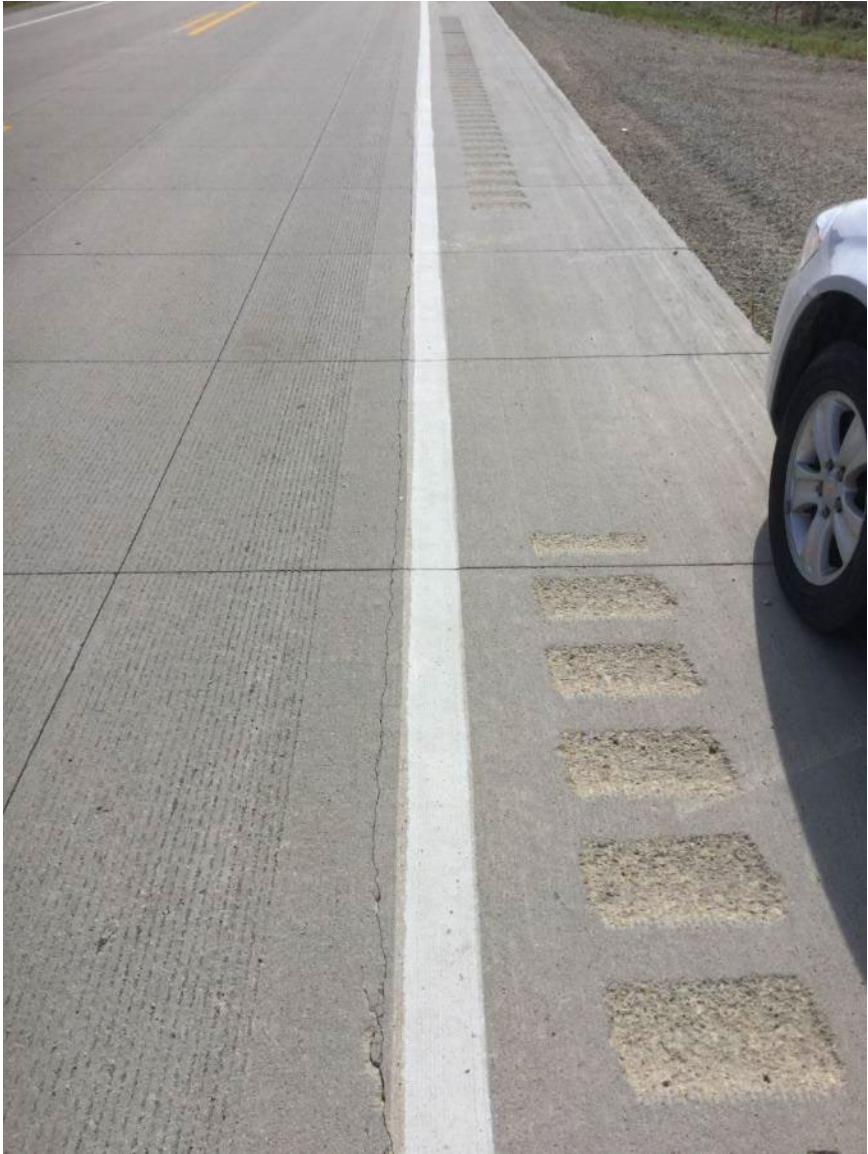
2017 – Cracking at 4 ft from edge. Location of old edge of widened pavement.

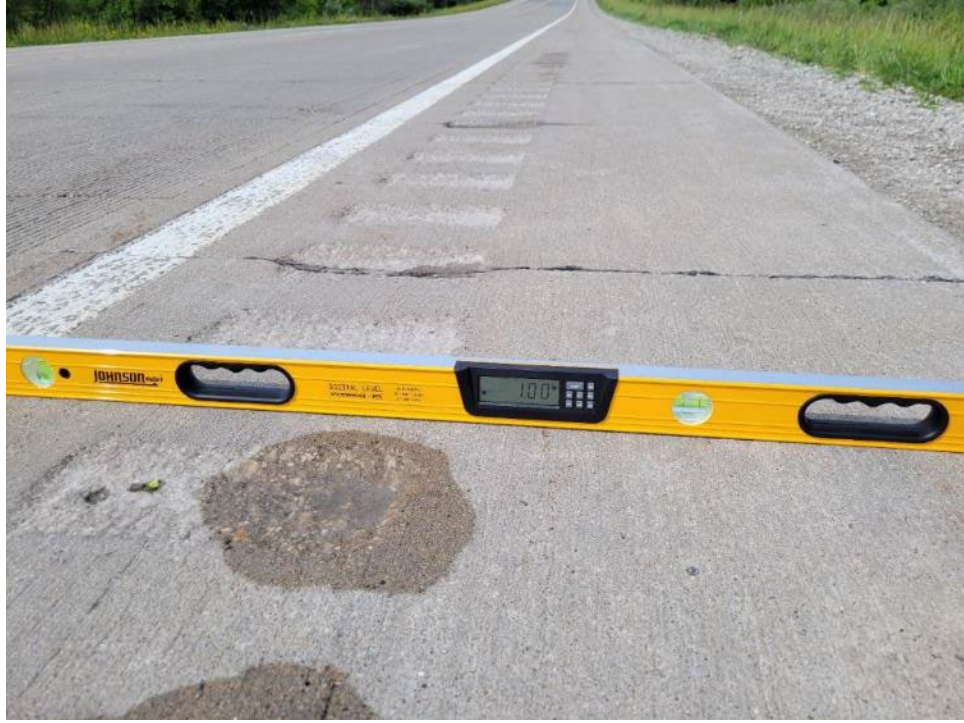
Several areas with patches. Patches were full lane width, with no midpanel longitudinal joint. Several areas with outside wheel path cracking. Shoulder cross slope was 1.0 to 1.5%. Fairly long areas in good condition as well.

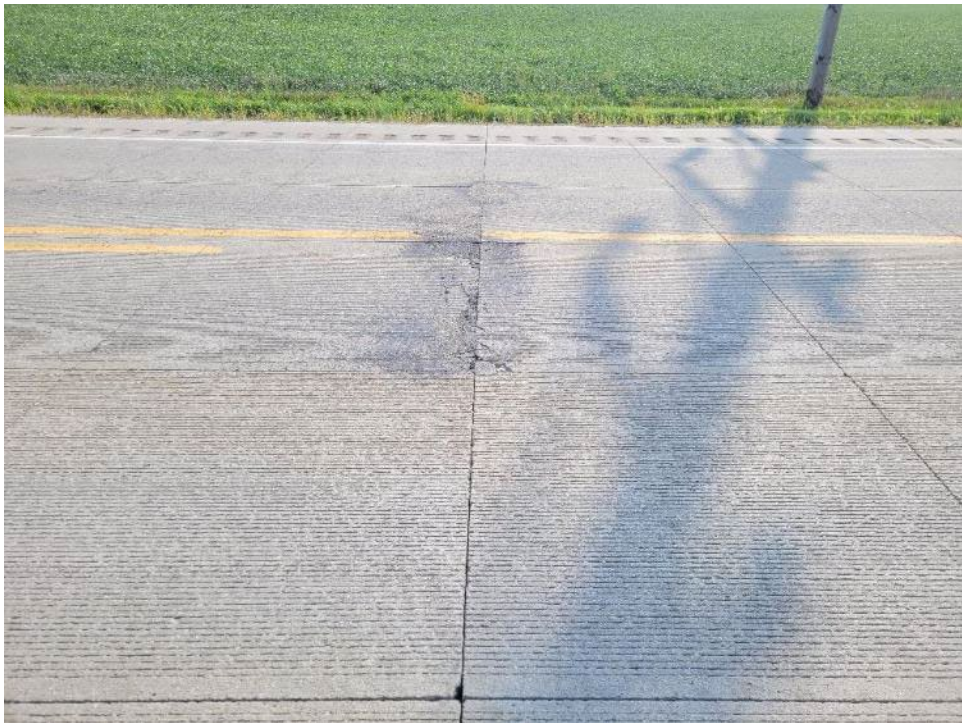
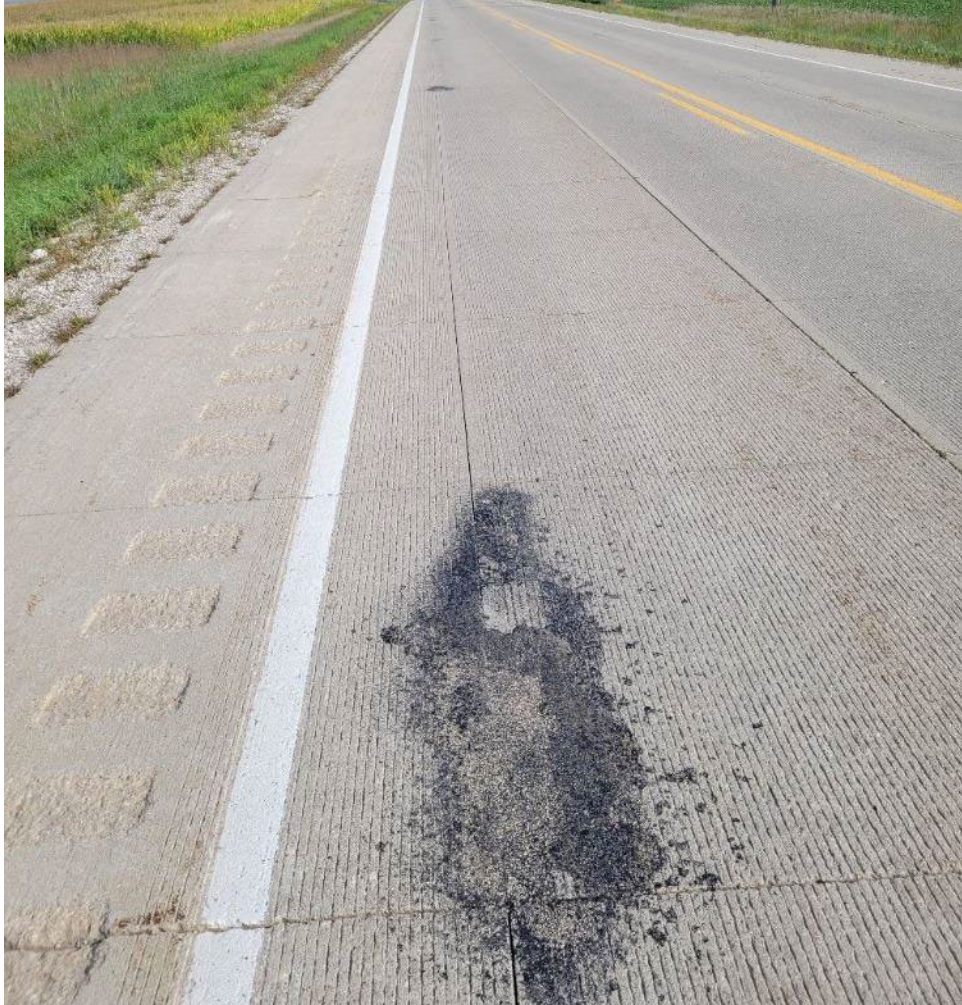
Areas of broken panels with Durapatch.

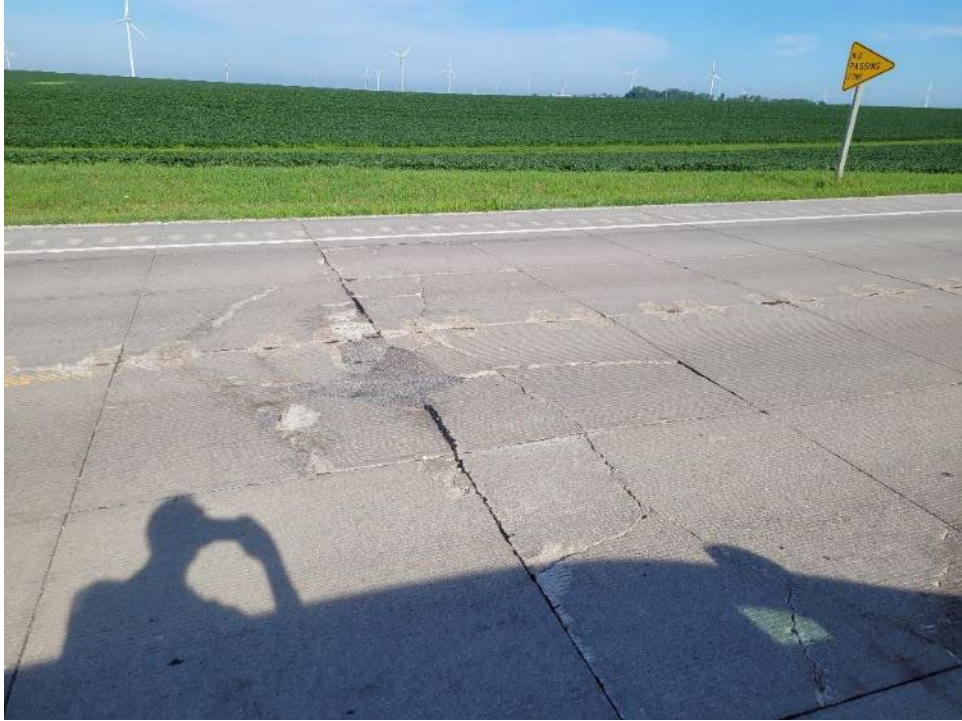
Lots of areas with longitudinal cracking. Some areas with broken panels.

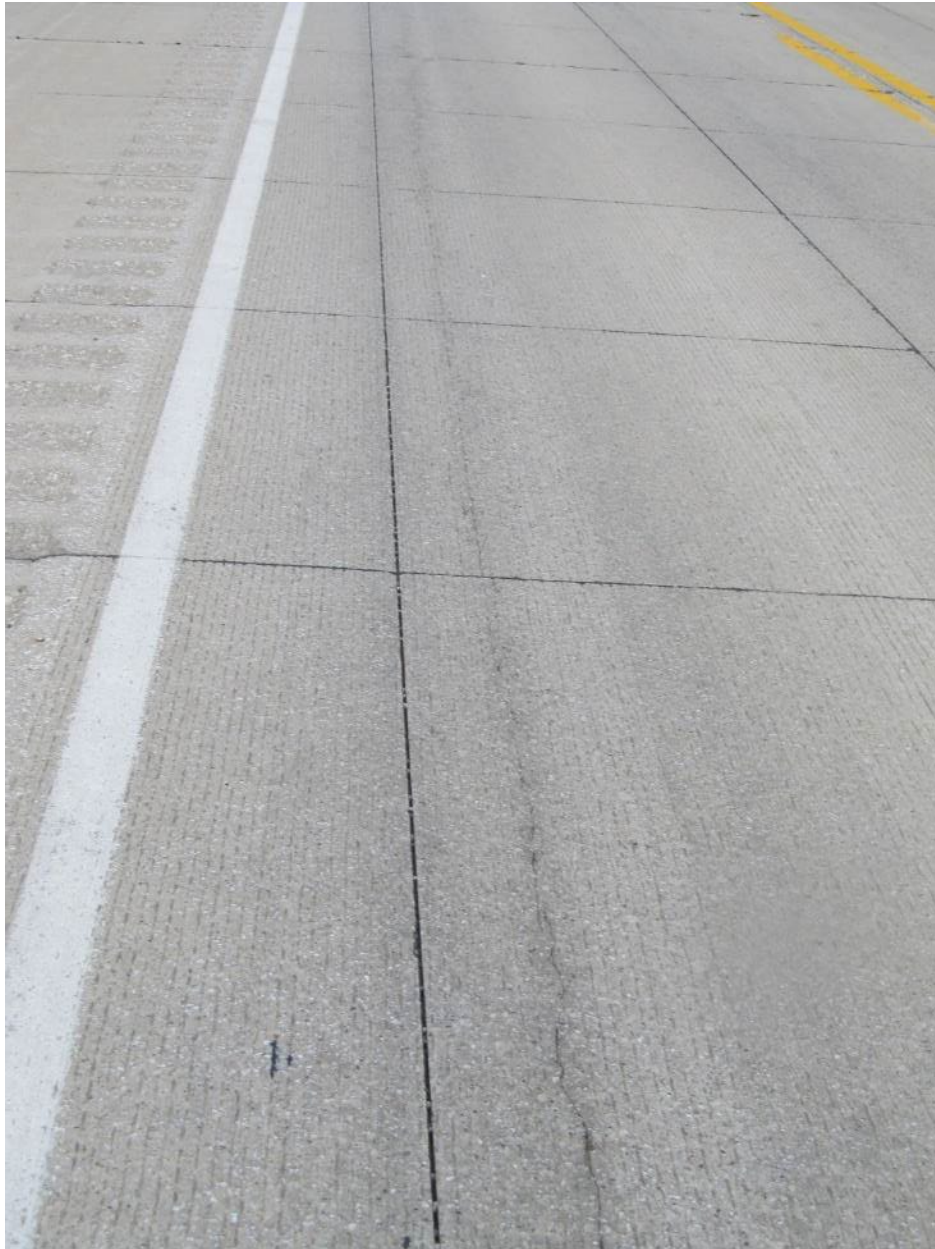
Longitudinal cracking in wheel path.

Shoulder cross slope 3.5%, Design 4%

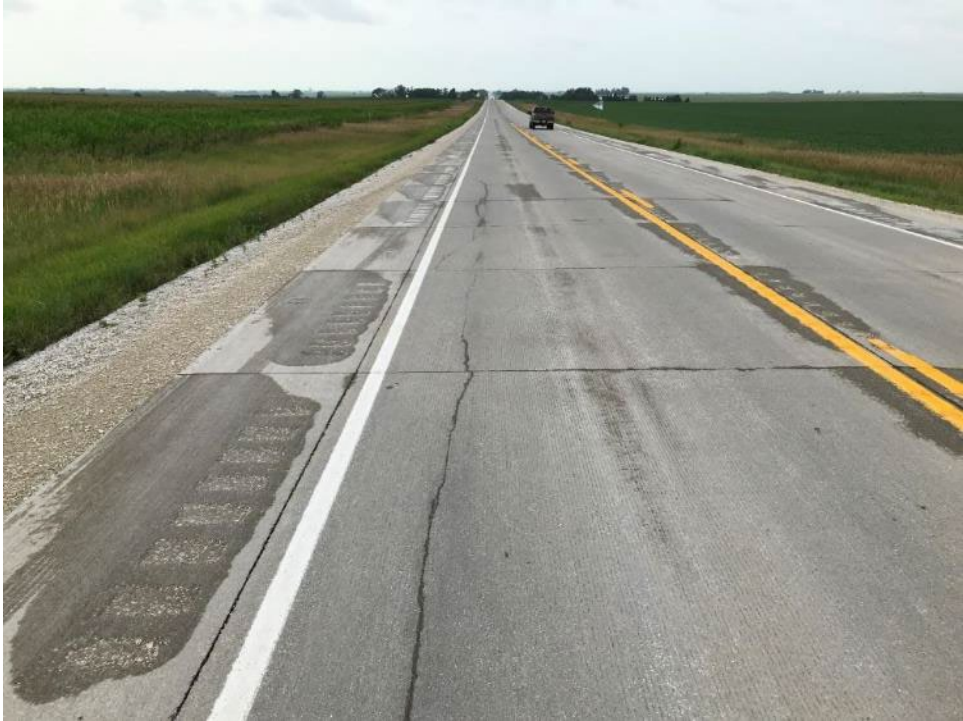
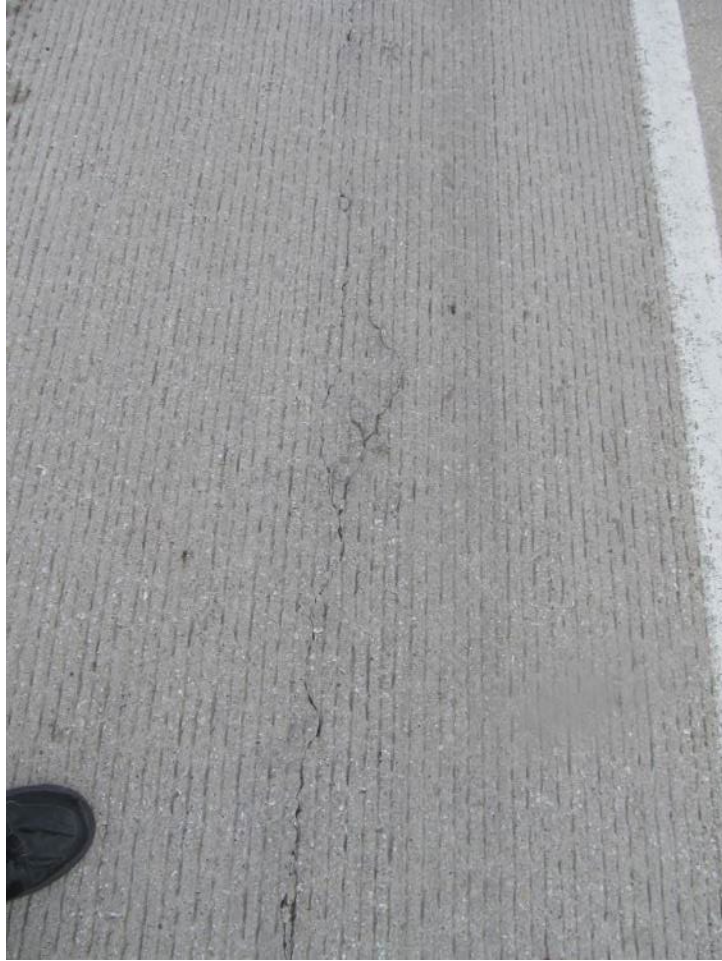
Lots of longitudinal cracking.

Shoulder cross slope 1.2%, Design 2%.

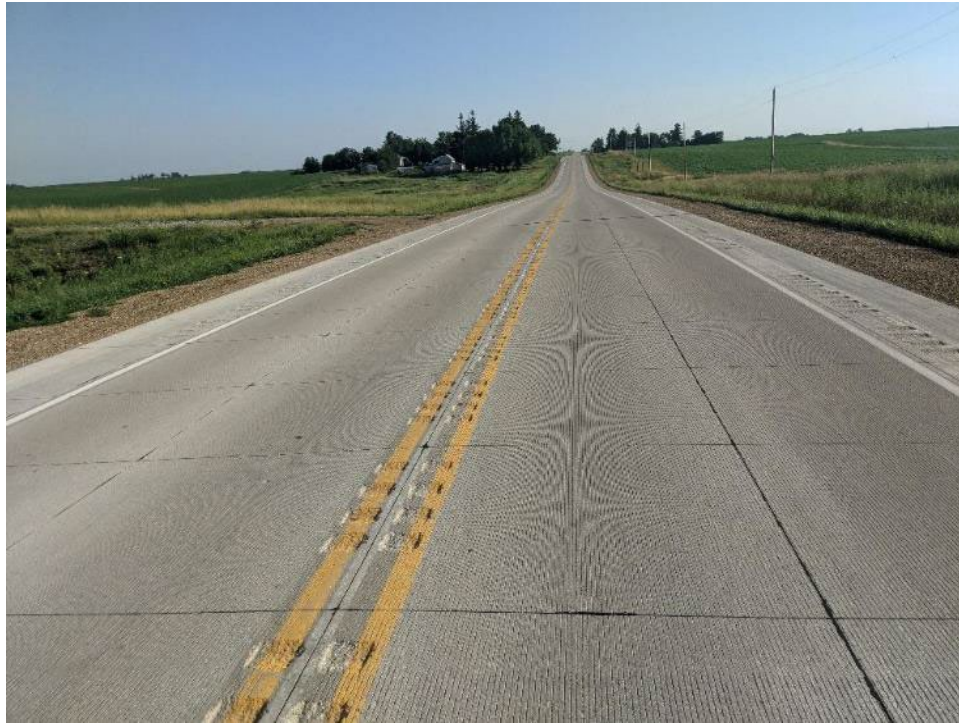
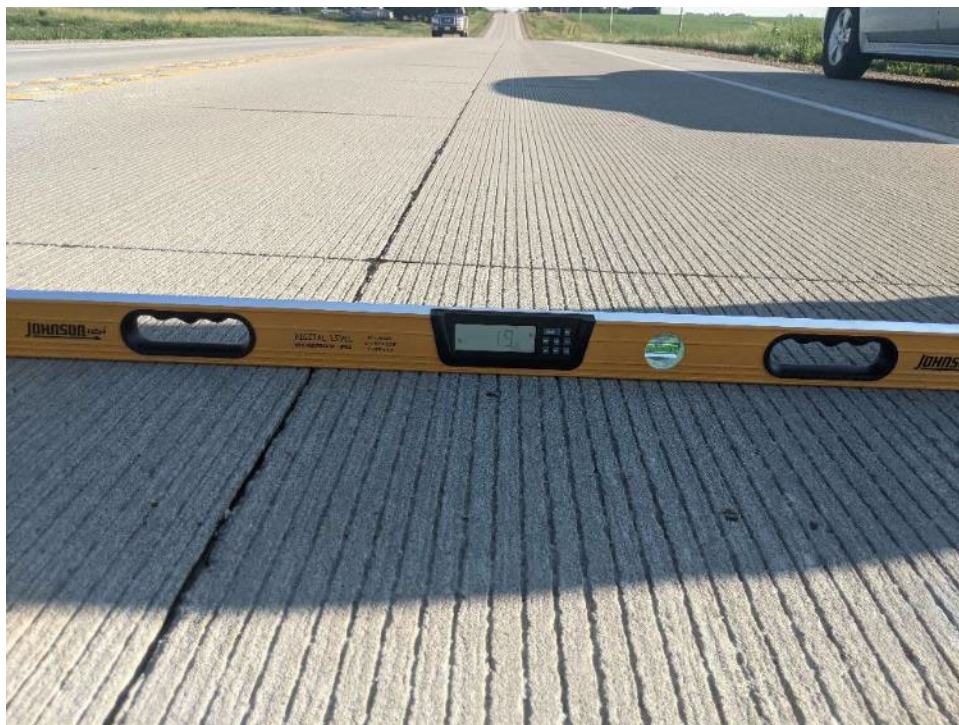
In very good condition. Shoulders do appear to be heaving, but no cracking due to no tie steel.

Sta 33+00 Mainline 1.9%
