# **Interstate and Primary PCC Pavement Overlays Review**

**Final Report  
for  
MLR-23-01**

December 2023  
Construction & Materials Bureau

Construction & Materials Bureau  
Iowa Department of Transportation  
Ames, Iowa 50010

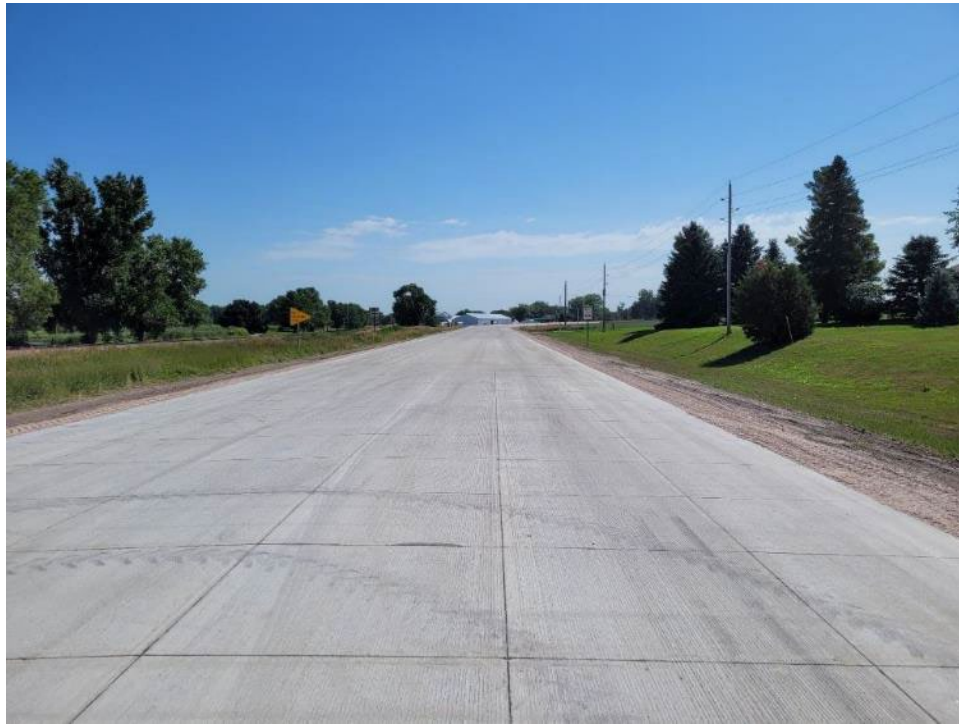
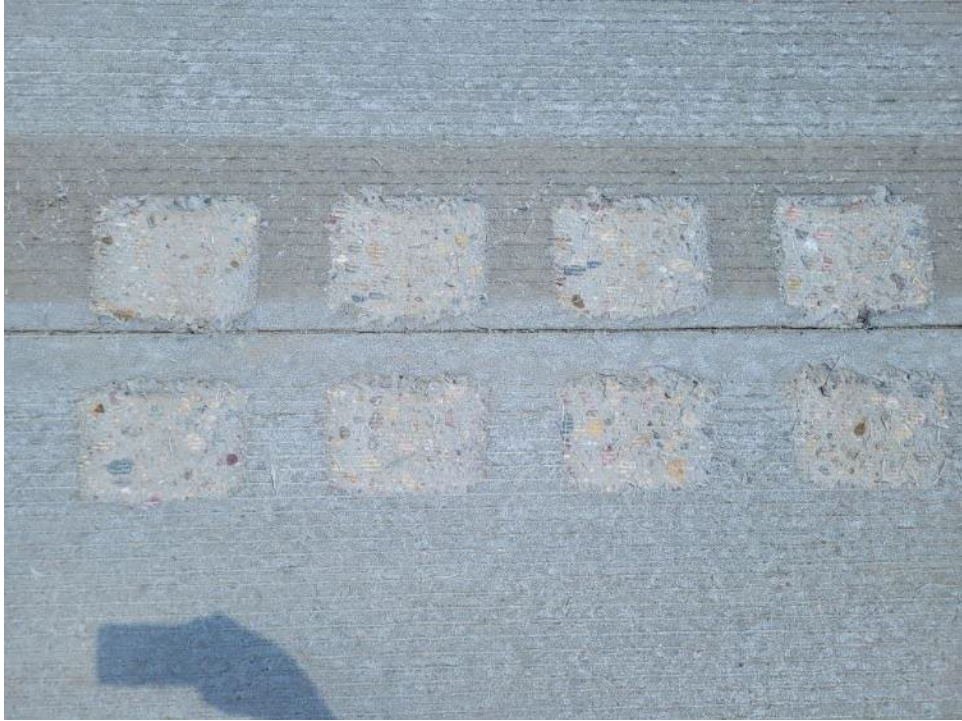
Overall, the overlay is in very good condition. A few areas with random cracking off sawed joints. Issues with center line rumble strip depth and crossing joint.
