# Annulus Void Fill Material for Rehabilitated Sliplined Culverts

Volume 1 of 9

Project ID Number: 109456

*Final Report*

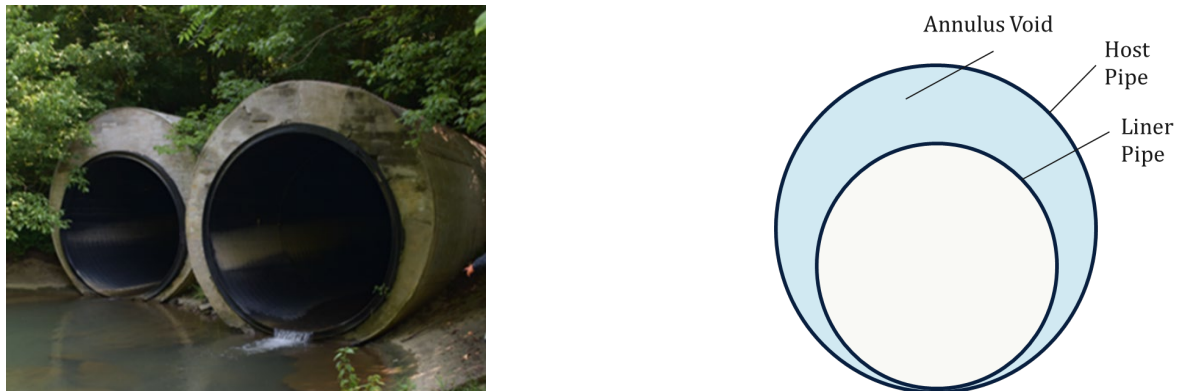
Figure 1: Image (*Left*) and Schematic Diagram (*Right*) of Typical Sliplined Culverts.

*Sliplining* is a method commonly used to rehabilitate deteriorated culverts. In this method, a new pipe with a smaller diameter is inserted into the existing host pipe, and the annular space between the two pipes is filled with grouting material (Figure 1). In general, the new pipe used as a liner can be made from various materials. The grouting material may be either low-strength material (LSM), non-shrink mortar (NSM), or cellular grout (CG). The success of the rehabilitation method depends primarily on maintaining the integrity of the hardened grout within the annulus void, and annulus voids of sliplined culverts need to be completely filled to achieve the desired performance. Successful rehabilitation of a culvert extends the service life of the culvert.

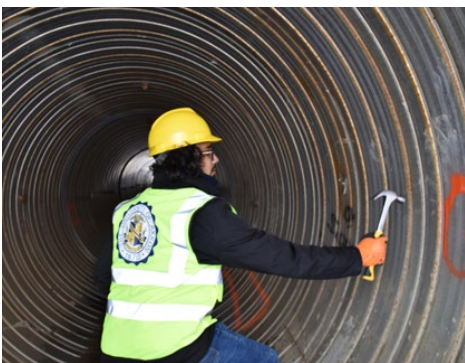
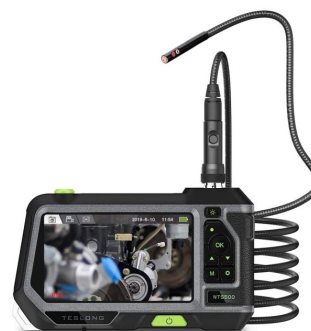
Figure 2: Sounding Method for Culvert Inspection (*Left*); Endoscope Camera for the Inspection of Voids (*Right*).

Twenty-one sliplined culverts were thoroughly evaluated using the sounding method (Figure 2). The inspected culverts were selected in such a way that four distinctly different liner types – corrugated steel spiral rib pipe, steel casing pipe, high density polyethylene (HDPE) pipe, and polyvinyl chloride (PVC) profile wall pipe – would be included in the inspections. Other variables such as the diameter of the liner pipe, the type of host pipe, the age of the sliplined culvert, and the geographic location within the state were also considered.

The research team was able to detect voids with relative certainty based on the different sounds emanated from hammer tests after a little practice. The sound classification summarized in Figure C.35 in Appendix C was the basis for the interpretation of the sounding test responses. To validate the results from the sounding test, an endoscope camera was inserted into a ½-inch-diameter hole that was drilled in the liner pipe at select locations along the length of the pipe.

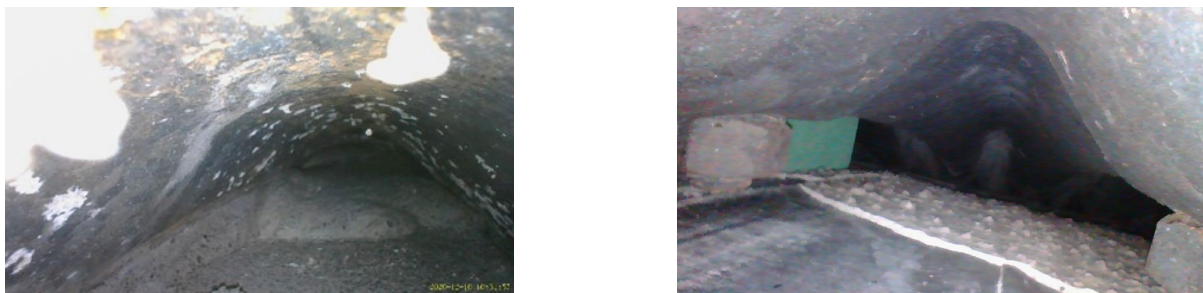
Figure 4: Images Showing Examples of Partially Filled Annulus Voids.

completely empty (Figure 3). The condition assessment also revealed locations of partial filling or places where only thin layers of hardened grout were stuck to the liners (with rest of the void being empty), as shown in Figure 4. Based on the culvert inspections conducted in this project, it was clear that the incomplete filling of annulus voids is a common occurrence for sliplined culverts. This finding has implications for the performance of the liner pipes, as a lack of grout in the annulus voids causes distortions to the liner. The inspections also demonstrated that it is possible to detect different types of annulus void anomalies when using the sounding method.

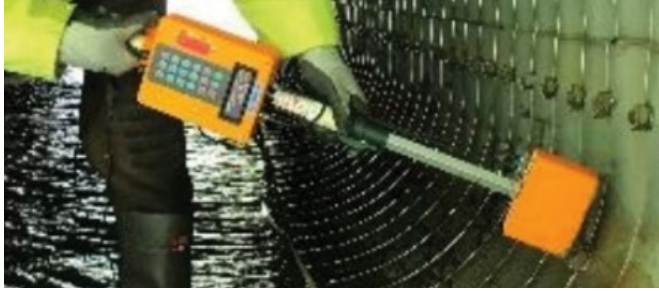
(a) InSight™ Lite

Figure 5: Inspection Equipment for NDT Evaluation.

For the culvert NDT inspections in this study, a preliminary assessment was first made using the handheld InSight™ Lite scanner to identify locations where voids might be present, as shown in Figure 5(a). The preliminary scanning was performed at set distances starting from the inlet and continued toward the outlet of the culvert, with scans along the inside diameter of the liner pipe at twelve positions matching the twelve clock positions.

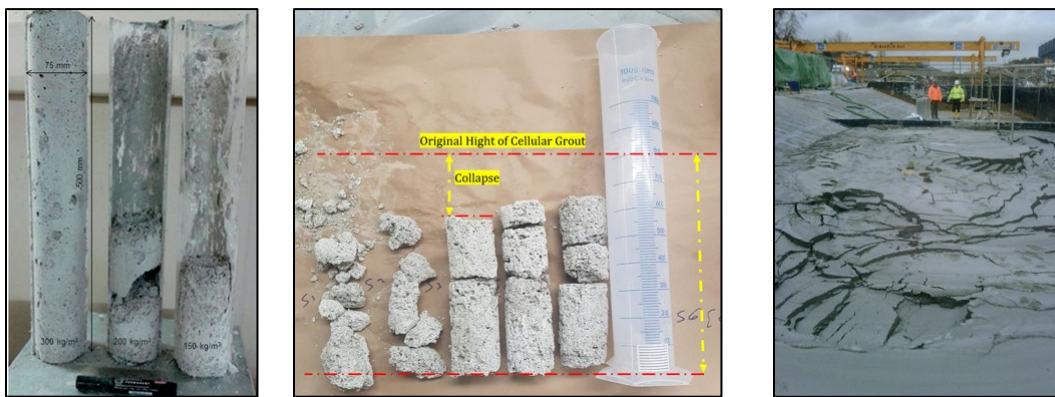
Figure 6: Instability of Ultra-Low Cellular Grout: (a) Lab-prepared Grout from Jones et al. 2016 (left), (b) Lab-prepared Cellular Grout C10 (center), and On-site Instability for Grout Reported by Jones et al. 2016 (right).

Several foaming agents were able to meet the minimum density requirements for foam as specified in ASTM C796 and ACI 523.3R-14. Mixing the foam with grouts at room temperature prevents instability of the foam volume before the foam is mixed into the cement slurry. In addition, the produced foam should not be exposed to high temperatures before being added to the slurry, as this leads to a decrease in the foam volume. Instability of cellular grout was noted when preparing a cellular grout with an extremely low density (such as C10), which resulted in instability throughout the hardening process (over a 24-hour period) as shown in Figure 6 and also observed by others (Figure 6).

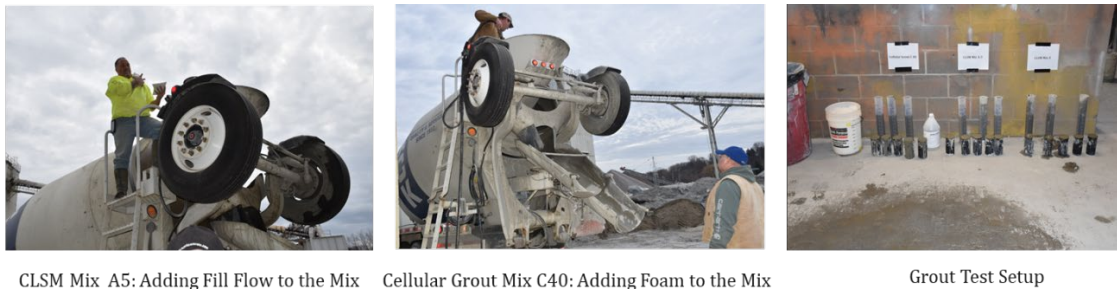
Figure 9: Commercial Scale Mixing of the Proposed CLSM or Cellular Grout C40.

The modified CLSM and cellular grouts with improved flow characteristics and properties were tested at a larger scale to determine if they are suitable for annulus void filling in real projects (Figure 9). Firstly, the selected grouts were mixed in a commercial batching plant to verify the successful upscaling of mixes developed in the laboratory. Three cubic yards each of the improved CLSM and cellular grouts were batched in a commercial batching plant. The wet and hardened grout properties of these mixes were determined and were found to satisfy the relevant ASTM requirements. The test methodology and the relevant details are given in Appendix G.

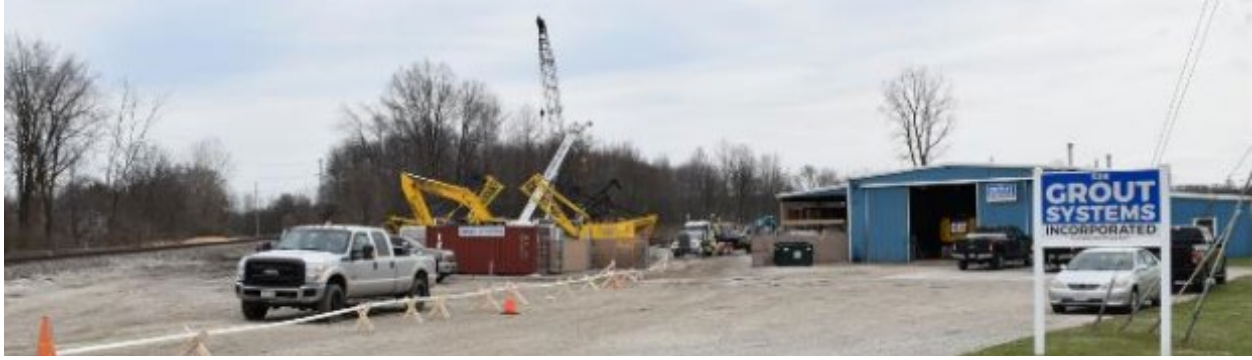
Figure 10: Field Pumping Tests of the Proposed CLSM or Cellular Grout C40.

Pumping tests were performed to evaluate the performance of the mixes for possible field implementation. The pumping of grouts is expected to cause a loss of volume and/or loss of air content when the grouts are pumped over long distances. The CLSM and cellular grouts were pumped through a 2-inch-diameter polyvinyl chloride (PVC) pipe over a length of about 200 ft. with an upslope gradient of 2.5% (see Figure 10). The density and air content of the grouts at three locations along the length of the PVC pipe were determined. Other wet and hardened grout properties were also determined to document how pumping grouts over such lengths might affect these properties.

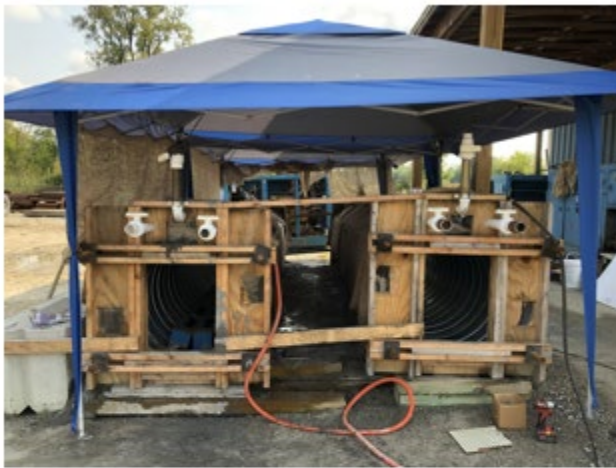
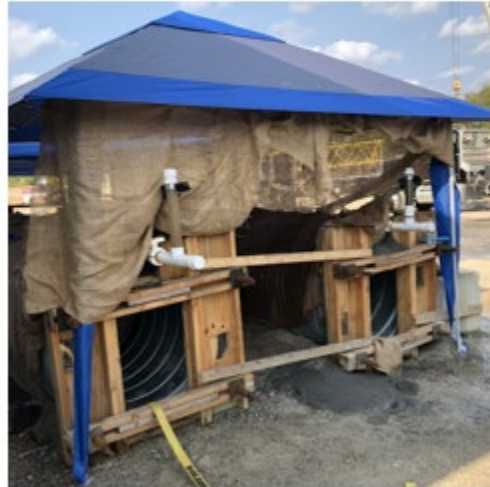
Grout Inlet End

Culvert Test Setup  
End Views

Grout Outlet End

Figure 12: Culvert Grouting Tests: End Details and Instrumentation Details.

After successful grout pumping tests, it was further recognized that larger-scale culvert tests were also needed to verify the fillability of the selected grouts in the annulus voids of culverts. Two large-scale culvert tests were completed by filling the annulus voids of two 20-foot-long test sections with CLSM and cellular grouts. The host conduit of the test culverts were 48-inch corrugated metal pipes, and the liner pipes were 36-inch diameter corrugated metal rib pipes. The suitability of the improved grouts for filling annulus voids at this larger scale was verified from the field tests. Wet and hardened grout properties were also determined at various locations and stages of pumping to document grout performance during the filling of annulus voids of sliplined culverts. The typical field culvert test setup is shown in Figures 11 and 12.

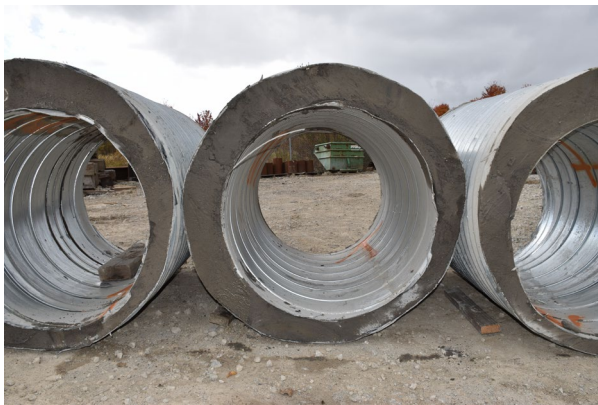
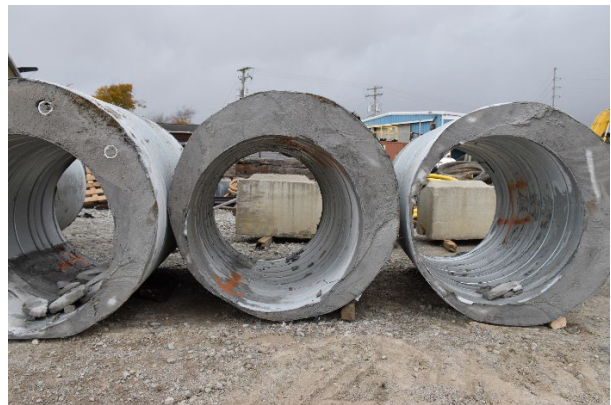
Figure 13: Cut Surfaces of Test Specimens for Culvert Grouted with CLSM (left) and Culvert Grouted with Cellular Grout (right).

The two large-scale culvert test specimens were cut into four equal segments to inspect the condition of the hardened grout within the annulus voids of the culvert specimens. The cut surfaces of the two culverts are shown in Figure 13. The solid-looking surfaces as seen in the figure demonstrate complete filling of the annulus voids in the two test specimens with CLSM and cellular grouts over the entire culvert length. Complete details of the field tests are provided in Appendix G.

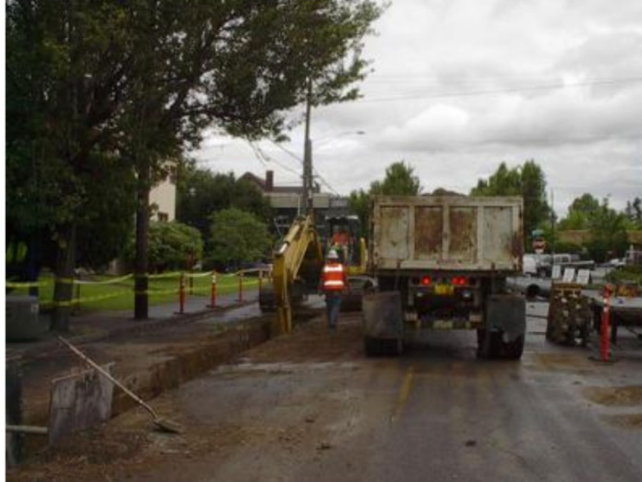
Figure A.2: Open-cut methods (Jin 2016).

The open-cut method (shown in Figure A.2) is a traditional method that is widely used to repair or replace a culvert due to its simple approach and the familiarity of workers with the technique. The open-cut method does have drawbacks in that it may cause increased traffic delays on roadways that may result in increased economic, social, and environmental impacts. Consequently, many state and local agencies have adopted in recent years trenchless renewal techniques for culvert rehabilitation rather than culvert repair or replacement (Thornton 2005).

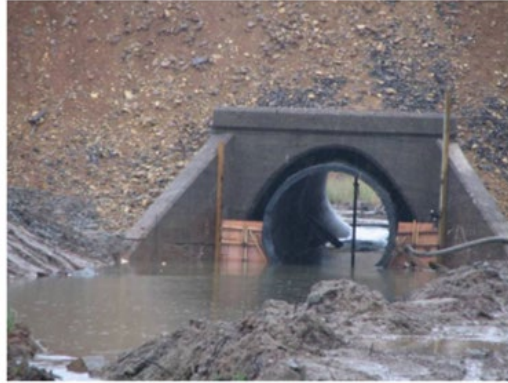
Figure A.5: A culvert renewed by sliplining  
(Source: Terrafix Geosynthetics Inc., Salem et al. 2010).

Sliplining (shown in Figure A.5) is the simplest technique among all the plastic-based relining methods used for culverts. In this technique, a new pipe having a smaller diameter is inserted into an existing pipe, and the annular space between the two pipes is filled with grouting materials. In a typical application, the outside diameter of the liner is at least 10% smaller than the inside diameter of the host pipe, which creates an annulus between the two pipes. This annulus may or may not be grouted. If the annular space is grouted, the grouting can prevent leaks and provide additional structural support. If the annulus is not grouted, the liner is not considered to be a structural liner. Any pipe material can be used as the liner pipe including corrugated metal pipe, reinforced concrete pipe, fiberglass reinforced pipe (FRP), and plastic pipes such as PVC and HDPE; however, HDPE, PE, PVC, FRP, and GRP are the most common pipe materials used for sliplining. The handling and weight of the liner and the construction footprint are the main factors that should be considered when choosing a material for sliplining according to the environment and the physical needs of the installation (Caltrans 2013, Jin 2016).

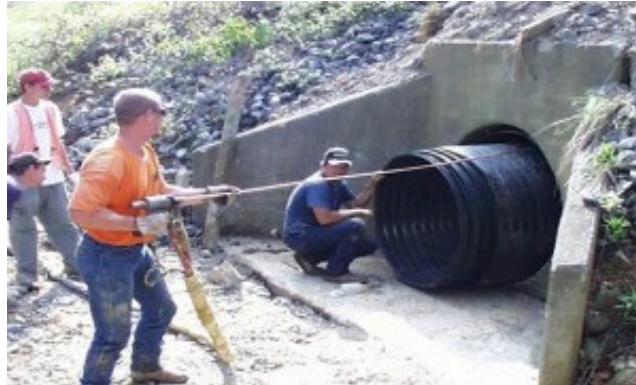
Figure A.12: URETEK team works to inject grout in between the pipes (Armstead 2015).

In a project in Boaz, Alabama, which was conducted for the Alabama Department of Transportation (ALDOT), URETEK Holdings filled the “annular” space between the carrier and host pipes with a geotechnical polymer grout to anchor the two pipes together and prevent relative slippage. For most projects, the installation of the polymer grout can be completed within one hour after the insertion of the liner. During installation (shown in Figures A.12 and A.13), the chemical grout is attracted to deteriorated areas of the host pipe and is pushed through openings in the pipe to fill voids, thereby stabilizing the host pipe. Once installation of the grout was complete, a

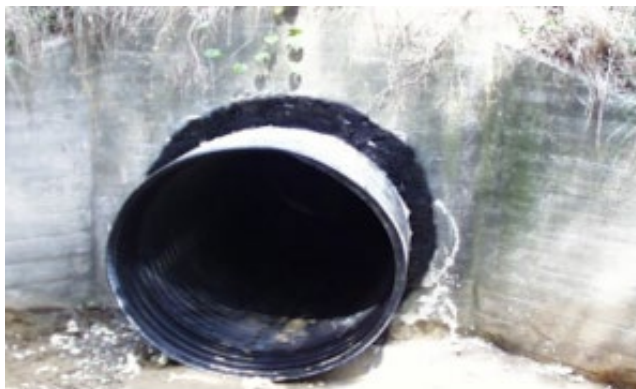
Figure A.13: After grouting, the pipes are sealed tightly together (Armstead 2015).

tight seal between the two pipes was formed. Typically, following installation, the end of the carrier pipe will be trimmed so that it is flush with the culvert; in this case, ALDOT planned to widen the road above and kept the pipe untrimmed to accommodate a future connection (Armstead 2015).

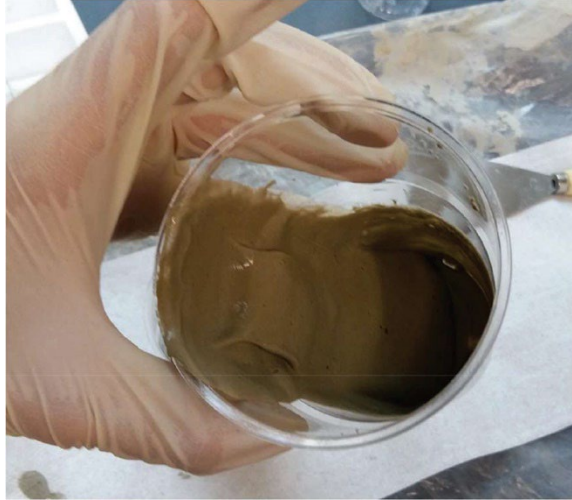
Figure A.14: Two-component grout after gelling (Shah et al. 2018).

Two-component grout displays high early strength and provides early support to the lining. However, in the long term, traditional cement grout provides higher compressive strength. But higher strength of the backfill grout is not a prerequisite for an ideal grout, because the main function of the backfill grout is to transfer the load to the segmental lining, not to bear the load itself. Backfill grout helps to resist not only loads from the ground but also lining forces, thrusting, and forces caused by the movement of the wheel set of the backup trailer on the newly formed rings. It also prevents the choking of the pipelines owing to its long-lasting workability. In fact, the inherent fluidity of a two-component grout makes it more convenient to transport and pump, whereas a single-component grout becomes more difficult to pump into the annular gap as time progresses. Finally, a two-component grout will also show satisfactory performance in saturated ground because no dilution of the grout occurs during the rapid gelling of the mix (Shah et al. 2018), as shown in Figure A.14.

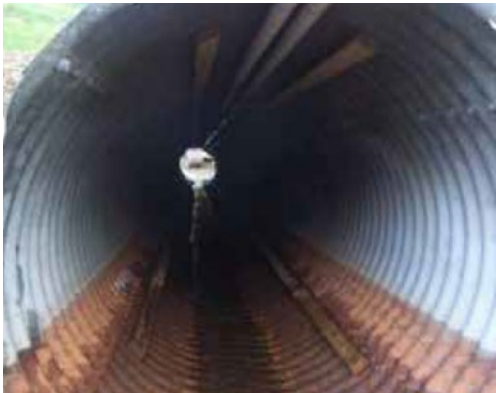
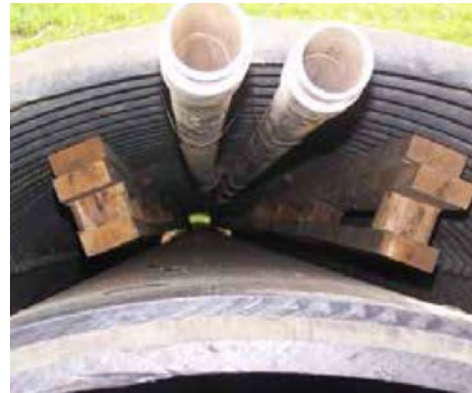
(a) before sliplining

(b) with the liner inserted

Figure A.17: Wooden Spacers Attached to the Inside of the Culvert (Source: ISCO Industries 2013).

Flotation is one of the major concerns during grouting, since lightweight liners like HDPE may float in the grout material and rise to the top of the host pipe, which would change the hydraulic characteristics and the water flow in the liner. Many remedial measures can be adopted to help control this problem. One method is to insert wooden, plastic, or metallic blocks (spacers) inside the culvert, along the top of the host pipe or the top of the liner itself (as shown in Figure A.17) to maintain the alignment of the liner during grouting. Other methods to prevent flotation are to weight the liner with

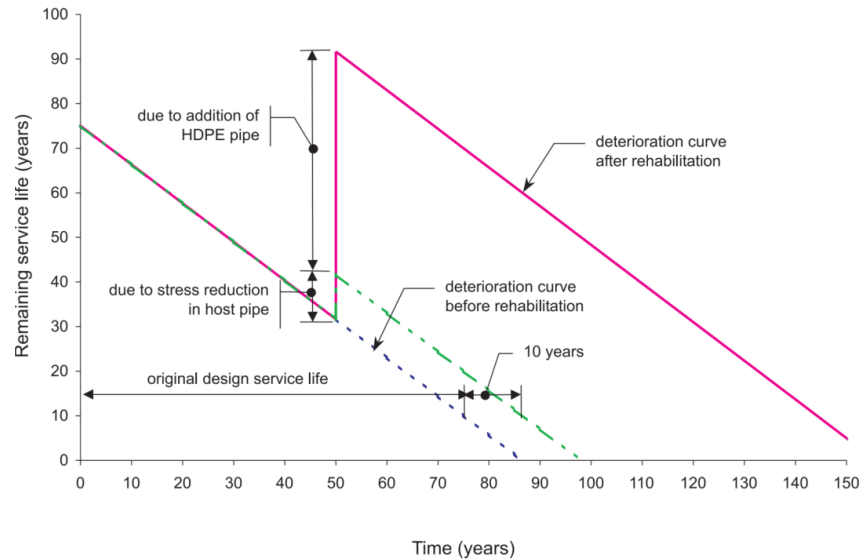
Figure A.23: Schematic deterioration curves of a water main with sliplining (Zhao and Daigle 2001).

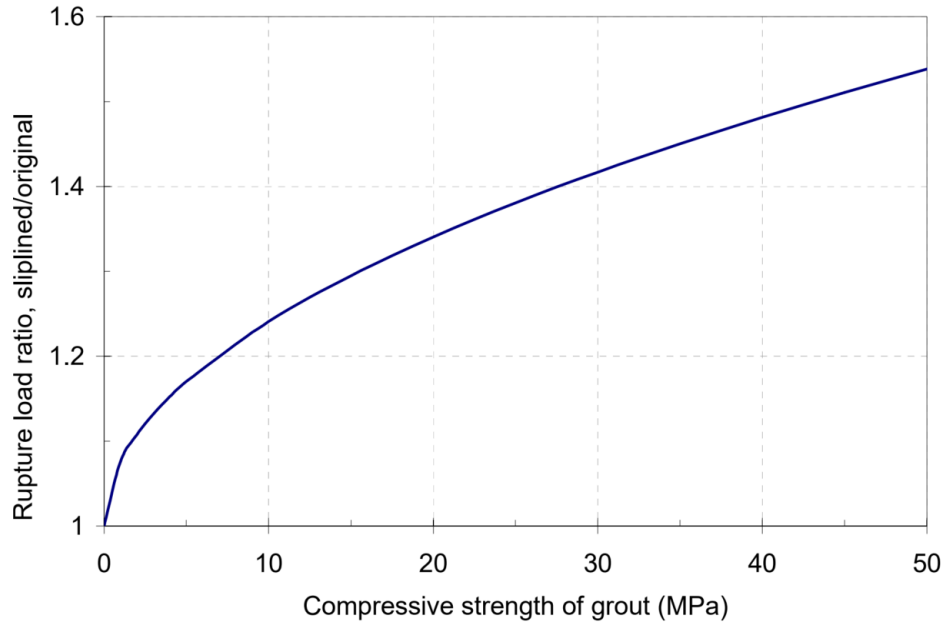
Figure A.24: Effect of grout strength on pipe rupture strength (Zhao and Daigle 2001, Zhao et al. 2003).

In a subsequent study, Zhao et al. (2003) discussed a few more effects of grouts on the long-term and short-term performance of sliplined pipes. They suggested that the use of grouts can increase the buckling resistance of the sliplined pipe. In addition, an increase in grout strength would increase the rupture strength of a composite sliplined pipe (Figure A.24). In an ungrouted pipe, if the host pipe fails suddenly, the fractured pipe may create a point load on the liner pipe (Figure A.25). Annulus voids therefore need to be filled with grout to counter that possibility and to increase the durability of the liner pipe.

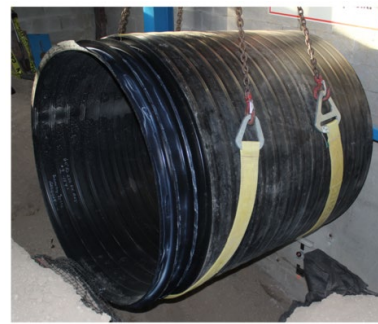
(b) HDPE liner pipe

Figure A.26: Pipe specimens (Simpson et al. 2015).

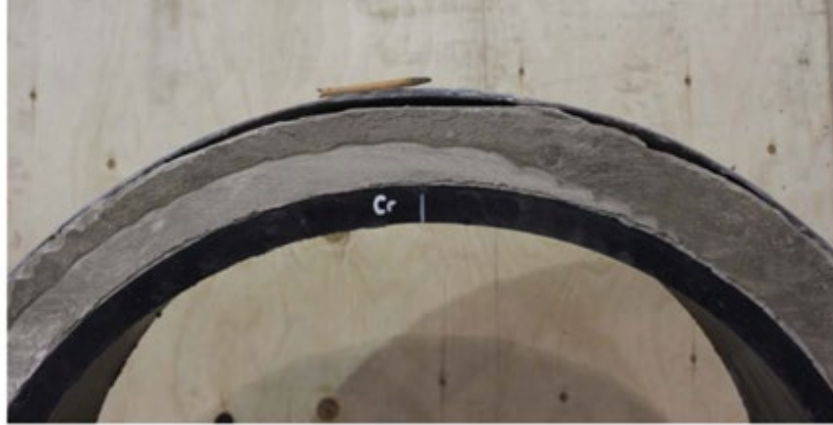
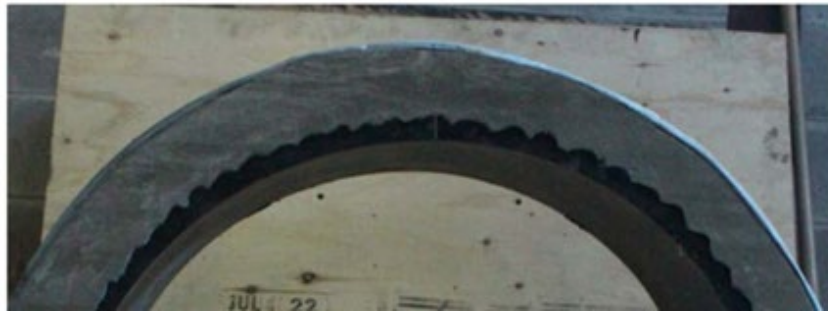
(a) Shrinkage of the high-strength grout in the rehabilitated specimen.

(b) No apparent shrinkage in the low-strength grout specimen

Figure A.35: Difference in placement of high-strength and low-strength grouts (Smith et al. 2015).

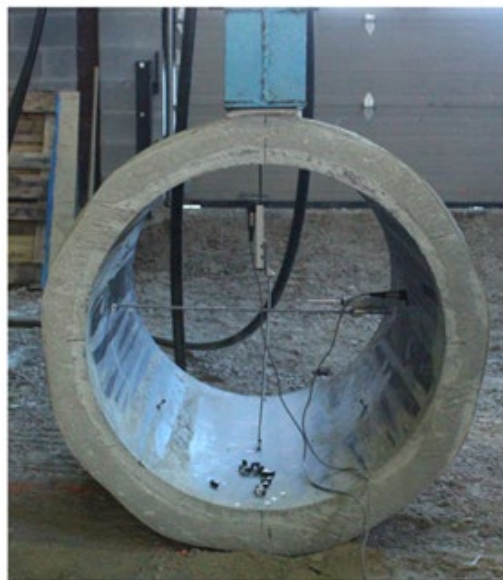
Figure A.36: Two-point loading setup showing the low-strength grout specimen with the liner (Smith et al. 2015).

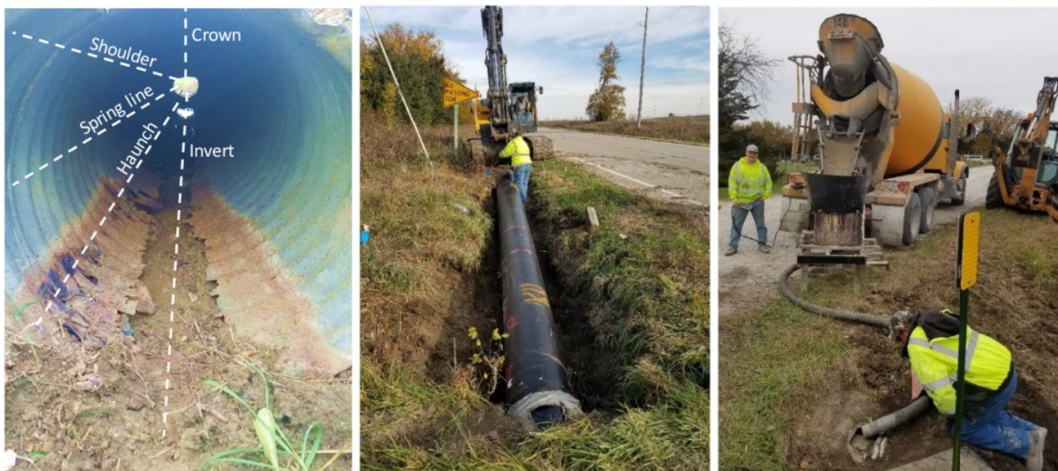
(a) Corroded corrugated steel pipe

The authors selected a corroded corrugated steel pipe located at a T-intersection on the North 482 Road and East 1250 Road (Old 59 Highway) in Douglas County, Kansas. The entire wall thickness along the invert of the pipe was disintegrated due to corrosion (Figure A.53a). After complete removal of the pipe from the soil, the corroded pipe was placed at a shallow depth of 15.75" (400 mm) under an asphalt pavement. A high-density polyethylene pipe (HDPE) was used as the liner pipe (Figure A.53b), and the annulus void was filled with a low-viscosity grout. The mix proportions of the grout were 418 lb/yd<sup>3</sup> (254 kg/m<sup>3</sup>) of cement, 632 lb/yd<sup>3</sup> (384 kg/m<sup>3</sup>) of fly ash, and 810 lb/yd<sup>3</sup> (492 kg/m<sup>3</sup>) of water. The grout exhibited average 7-day and 28-day compressive strengths of 390 psi (2.7 MPa) and 740 psi (5.1 MPa), respectively. The annular space between the liner and host pipes was grouted in a single lift by using a gravity grouting process (Figure A.53c). Wooden blocks were placed as spacers above the liner at both ends of the corrugated steel pipe to prevent uplift of the liner pipe resulting from buoyancy due to grouting. An insulating foam sealant was used to prevent the grout from flowing out of the pipe. Figure A.54 presents a schematic diagram of the cross sections of North 482 Road.

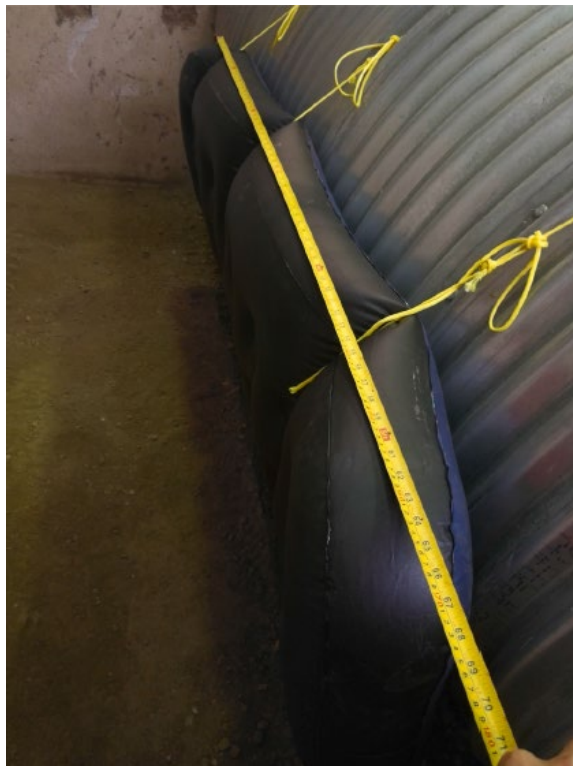
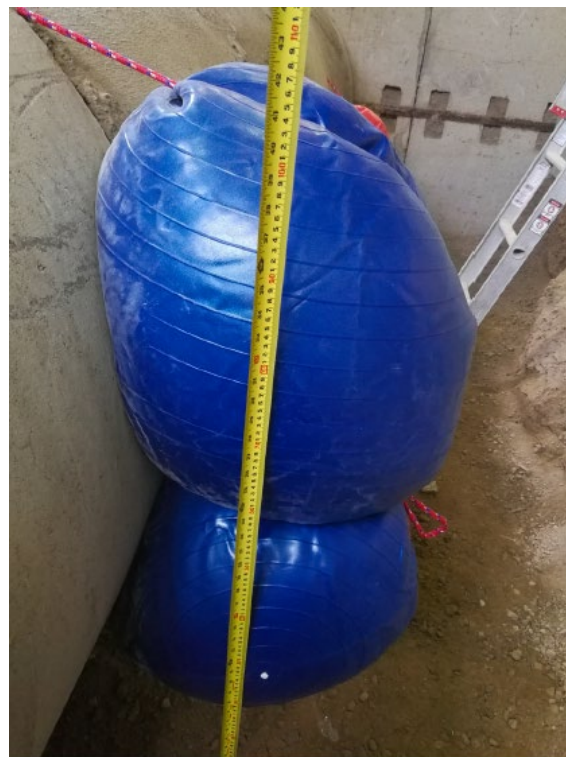
(a) Voids 1 and 2

(b) Voids 4 and 5

Figure A.66: Air mattresses and exercise balls used to create voids (Wang et al. 2012).

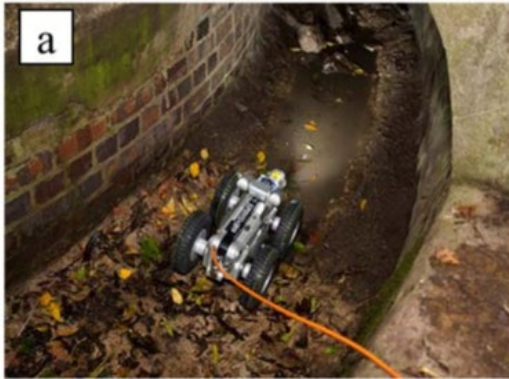
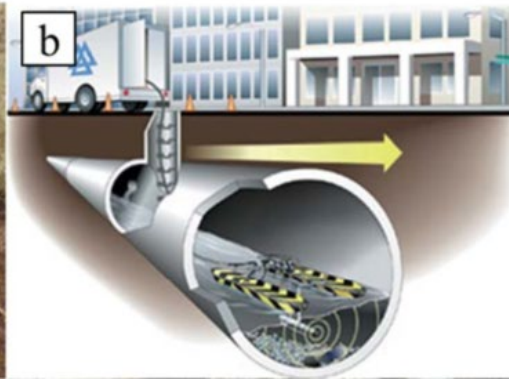
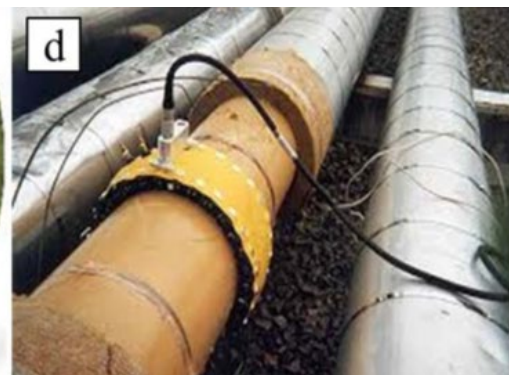
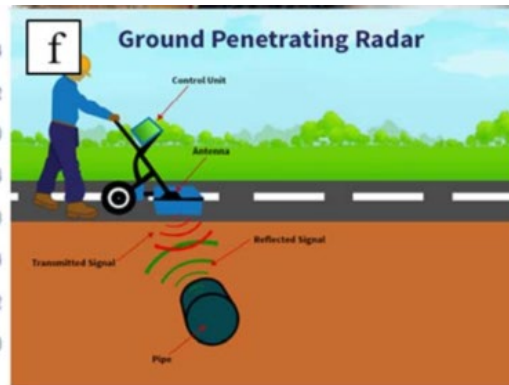
a) CCTV

(b) Sonar scanning

(d) Ultrasonic inspection

(f) GPR

Figure A.67: Illustrations of six pipe inspection methods (Piratla et al. 2017).

Selvakumar et al. (2014) evaluated the performance and project costs of five condition assessment techniques and compared those with conventional closed-circuit television (CCTV). The results revealed that digital scanning, zoom camera, CCTV, and laser scanning can accurately assess the pipe condition above the waterline, whereas the sonar technique can provide satisfactory performance below the waterline. Electro-scanning is able to reveal leakage-related defects all along the pipe circumference. The six inspection techniques are illustrated in Figure A.67, and the advantages and limitations of each are highlighted in Table A.44.

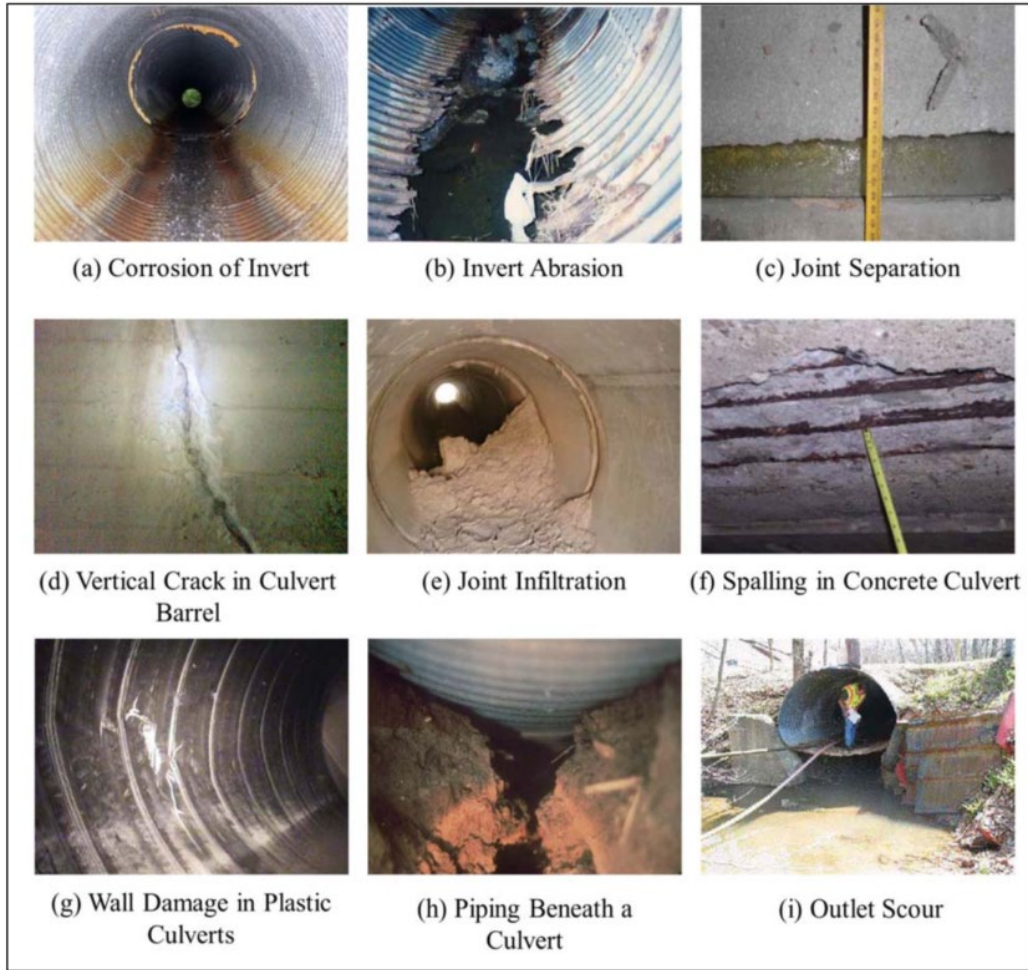
Figure A.68: Common defects observed in culverts (Piratla et al. 2017).

Cracks, invert deterioration, joint misalignment, joint infiltration or exfiltration, corrosion, shape distortion, debris, loss of wall thickness, and bedding voids are commonly observed defects in culverts (Figure A.68). Tables A.45 and A.46 present information about several inspection techniques used to detect defects in culverts that can aid in the selection of an appropriate method (Yang and Song 2009, Agarwal 2010, Allouche et al. 2010, Tuccillo et al. 2010).

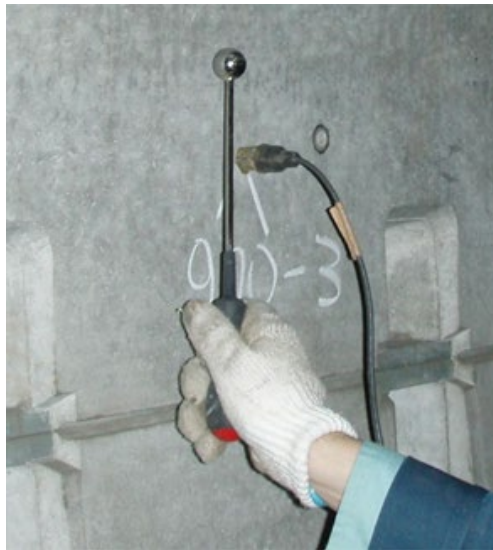
Figure A.72: Excitation using a 1-inch (25-mm) impact hammer near the accelerometer (Aggelis et al. 2008).

Aggelis et al. (2008) discuss a case where impact-echo was used for the evaluation of grouting in a tunnel lining. This non-destructive and time-effective evaluation technique was applied successfully and helped to assess the presence of voids in the grout. In this case, an impact hammer (Figure A.72) was used to create excitation on the concrete surface and an accelerometer was employed to acquire the reflection. The impact hammer was used repeatedly for 10 s and resulted in 20 individual signals. In general, after the application of low-frequency excitation, the spectral analysis of the response of the member can be employed by impact-echo. The frequency of the recorded reflection can give useful information on the member thickness, depth of the defects, and material properties.

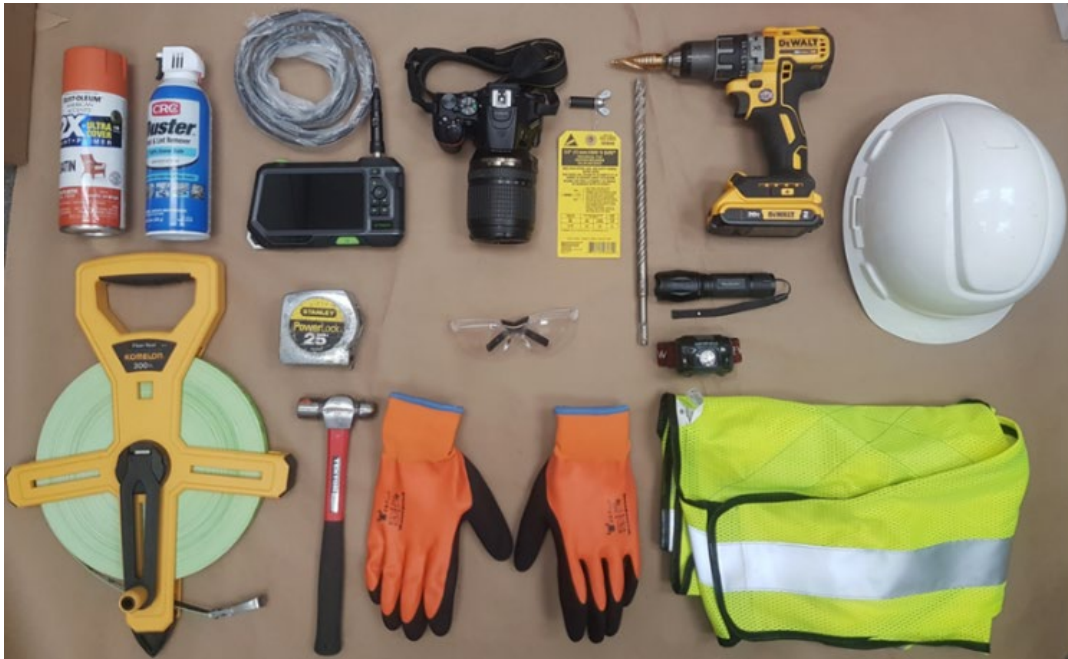
Figure C.1: Inspection Tools and Safety Gear for Conducting Sounding Tests.

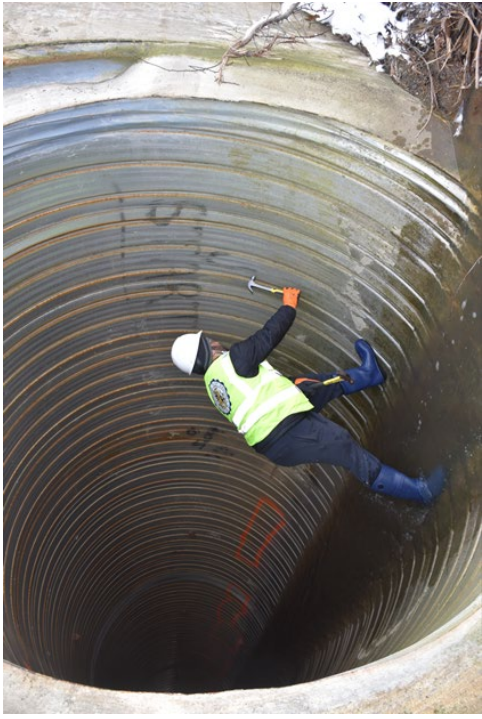
(a) Tapping the Liner Pipe with a Hammer

At the approximate locations of severe voids, the inspector will validate the sounding results by examining the annulus with an endoscope inspection camera. To accomplish this, the inspector drills a ½-inch hole in the liner pipe and inserts the endoscope into the hole to inspect the physical condition behind the liner pipe wall, viewing and recording the images using a camera attached to the probe (cable) of the endoscope. Figure C.2 illustrates the process of evaluating a culvert using the sounding method and an endoscope.

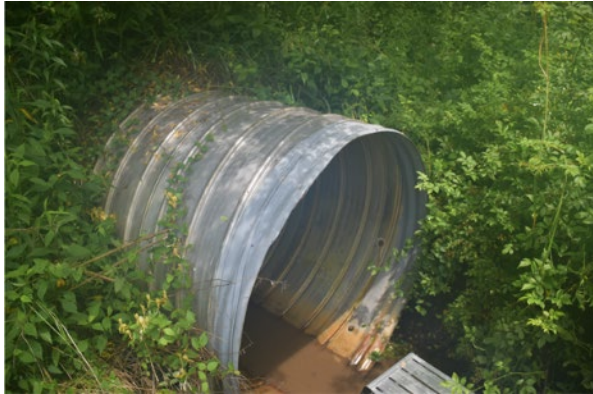
(a) Corrugated Steel Spiral Rib Pipe

The Ohio Department of Transportation (ODOT) provided the research team with an initial list of 68 culverts that were sliplined in recent years and were located in different ODOT districts (Table C.1). The culverts on the list were lined with pipes made from various materials. Examples of some materials that are used for liner pipes are illustrated in Figure C.3.

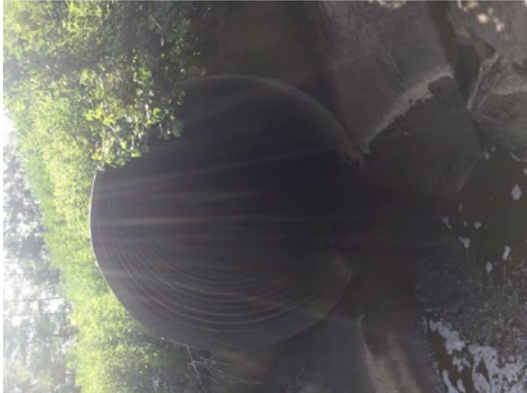
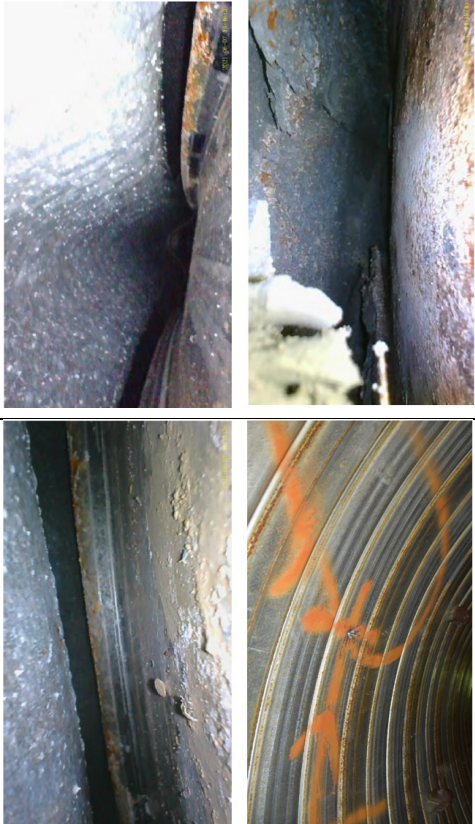
Figure C.6: Culvert Inspection and Map for ATB - 90 - 28.406 (District 4, Ashtabula County)

<p style="text-align: center;">Culvert Access</p>	<p style="text-align: center;">Empty</p>	<p style="text-align: center;">Delamination</p>
---	--	---	--	---

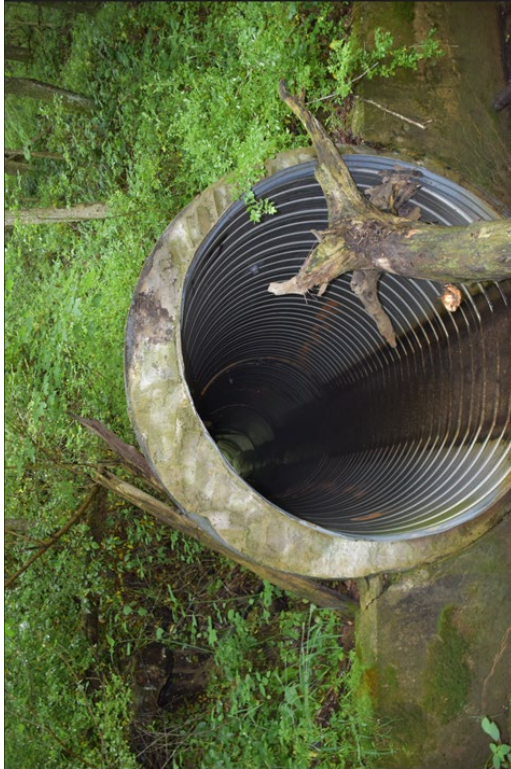
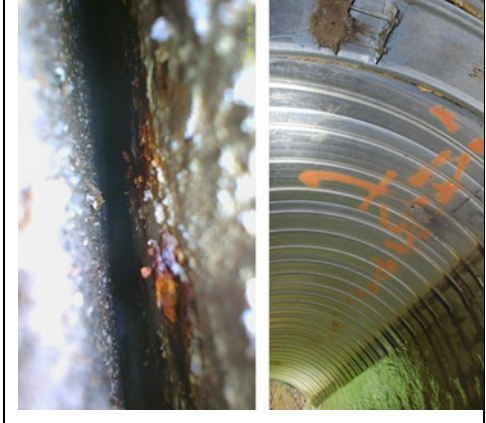
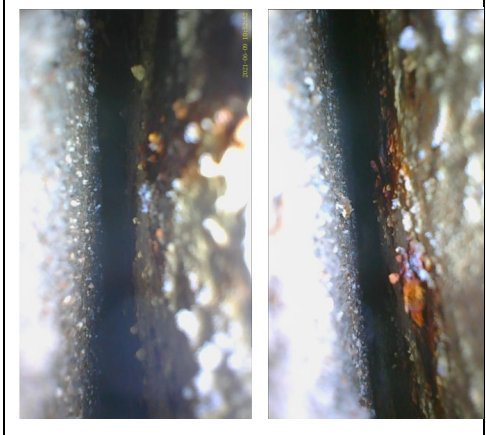
Figure C.7: Culvert Inspection and Map for LIC - 70 - 25.82 (District 5, Licking County)

<p style="text-align: center;">Solid</p>

<p style="text-align: center;">Delamination</p>	<p style="text-align: center;">Culvert Access</p>
---	--	---	--	--	---	--	---	---

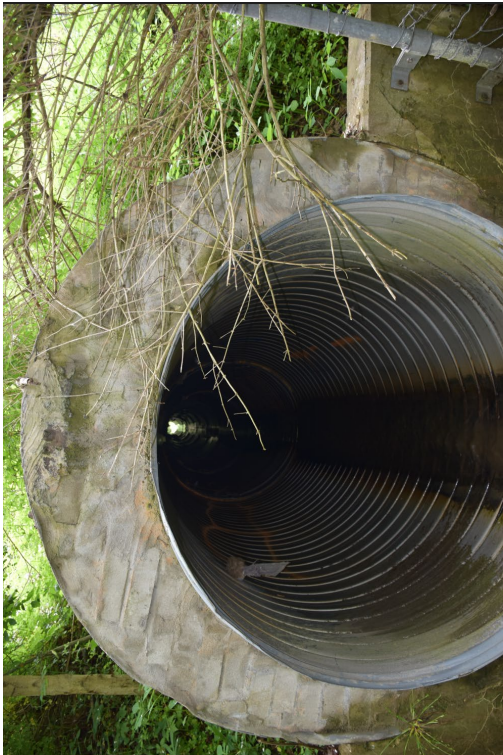
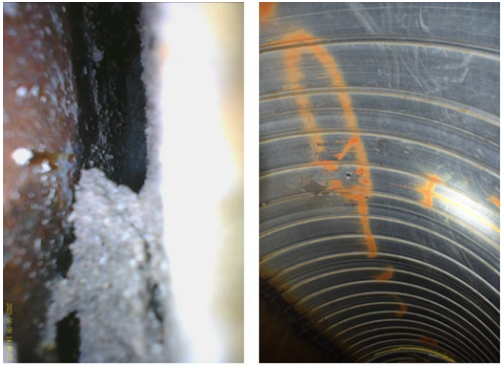
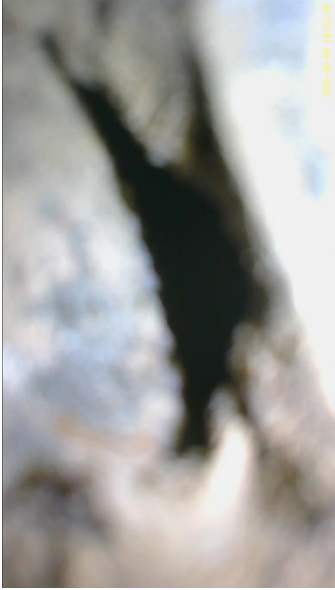
Figure C.8: Culvert Inspection and Map for LIC - 70 - 29.08 (District 5, Licking County)

Culvert Access	Delamination
---	--	---	--	----------------	--------------

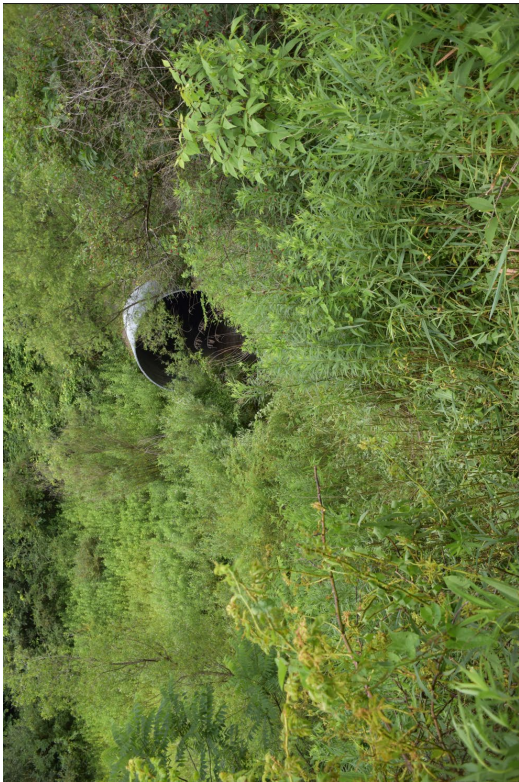
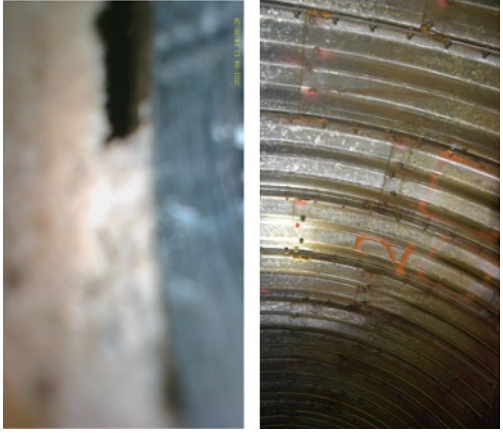
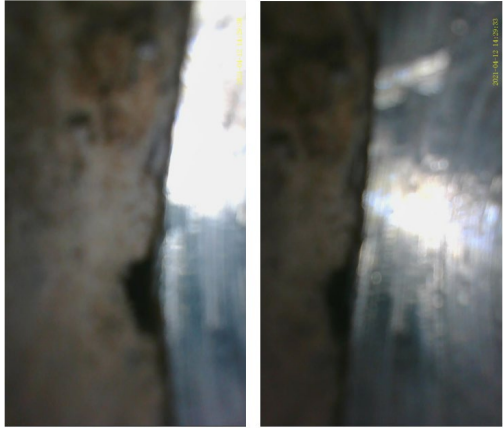
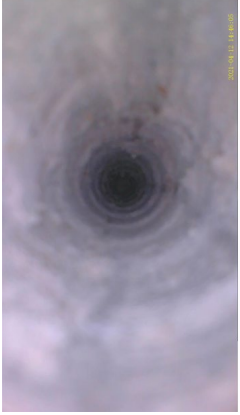
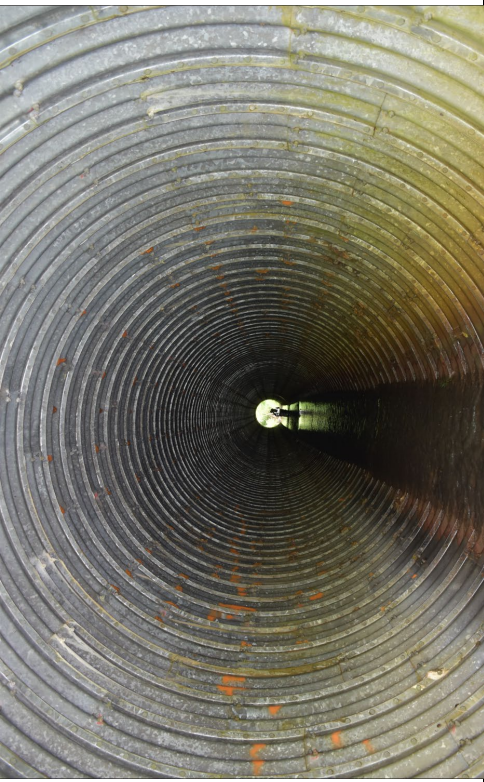
Figure C.9: Culvert Inspection and Map for GUE - 541 - 8.20 (District 5, Guernsey County)

<p style="text-align: center;">Delamination</p>

<p style="text-align: center;">Culvert Access</p>

<p style="text-align: center;">Solid</p>
---	--	---	--	--	--

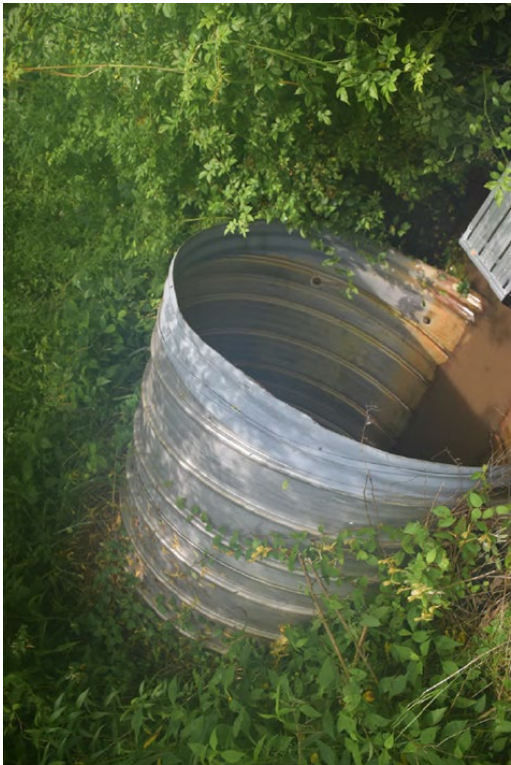
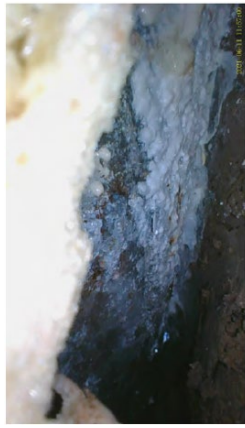
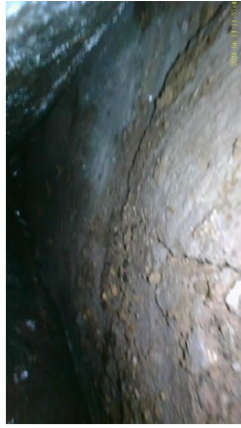
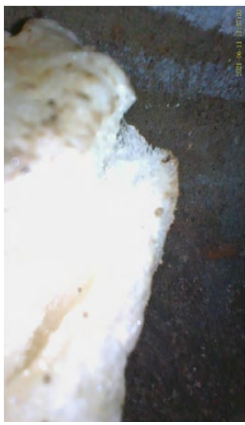
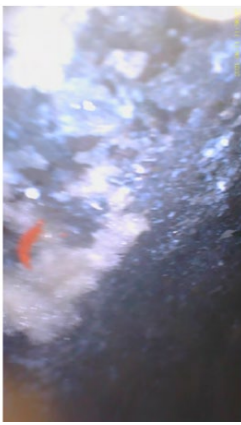
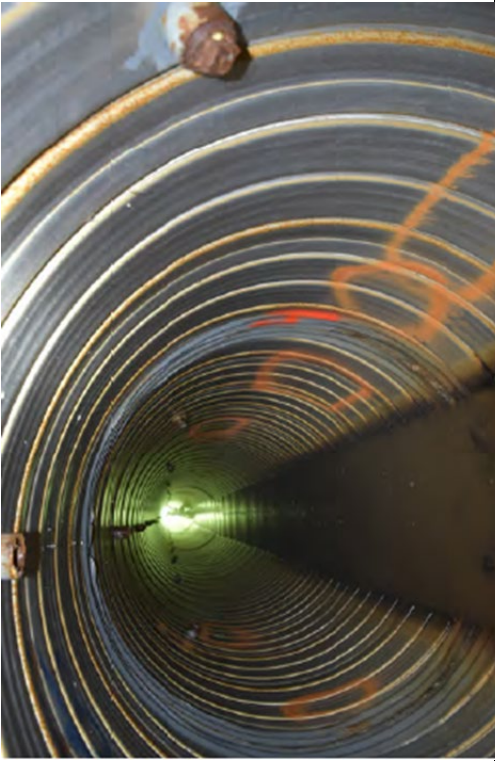
Figure C.10: Culvert Inspection and Map for FAI - 37 - 23.90 (District 5, Fairfield County)

<p style="text-align: center;">Empty</p>

<p style="text-align: center;">Culvert Access</p>

<p style="text-align: center;">Delamination</p>
---	---	---	---	--	---
